The Marmara, Turkey Earthquake of August 17, 1999: Reconnaissance Report

Technical Report MCEER-00-0001
March 23, 2000

Edited by
Charles Scawthorn¹

Technical Report MCEER-00-0001

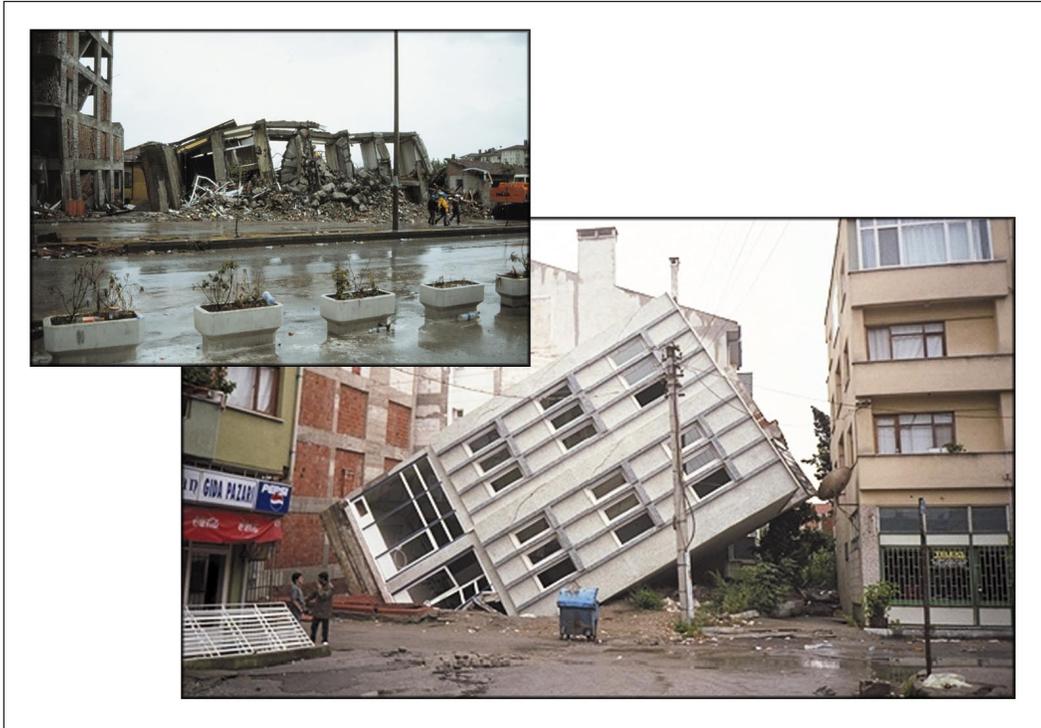
Figure 3-4 Buildings in Adapazarı that either toppled or partially overturned because soil beneath them liquefied and weakened the foundation

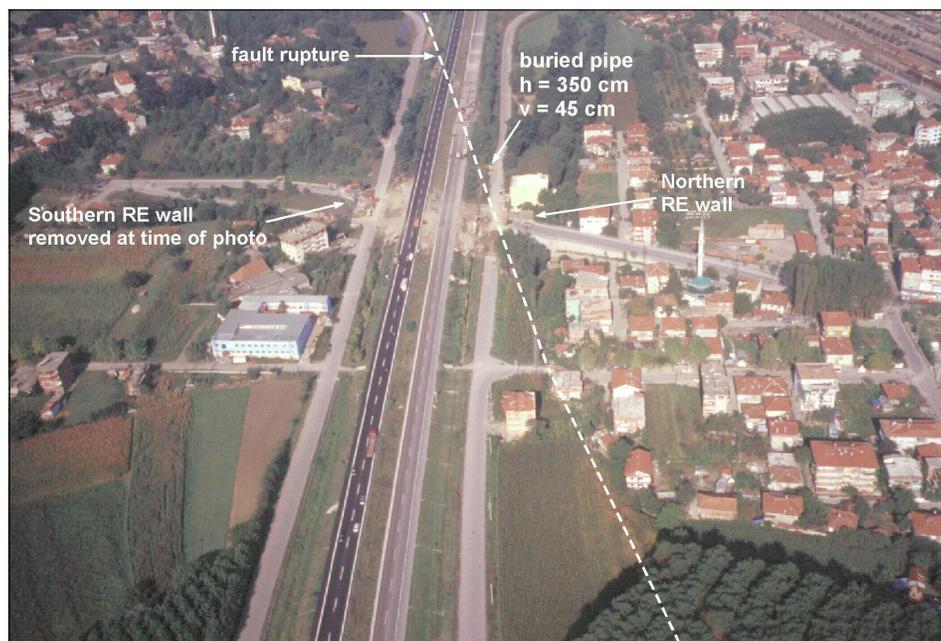
Figure 3-15 Aerial photograph showing surface fault rupture transecting the Arifiye Bridge site. The fault displacement caused collapse of the bridge and large deformations of the reinforced earth abutments.

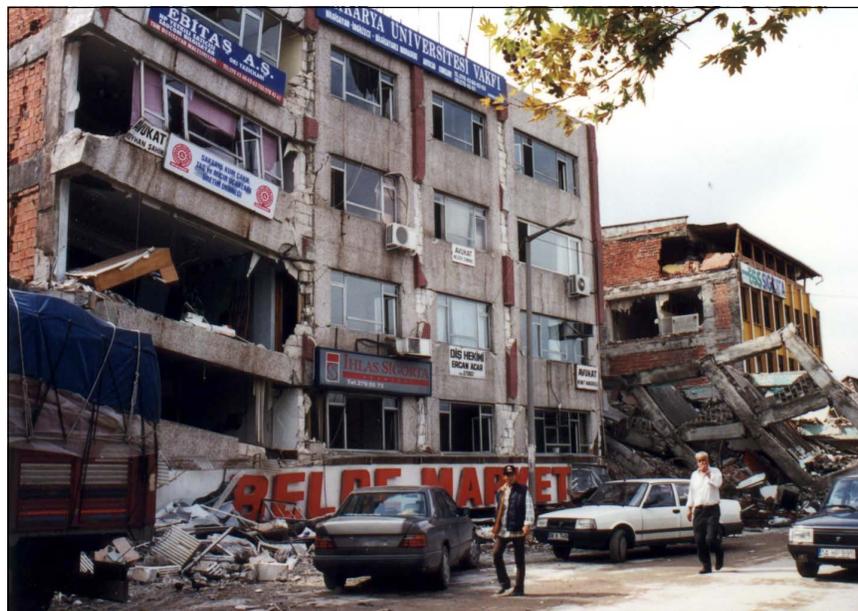
Figure 4-5 Failure of soft first story in a timber building

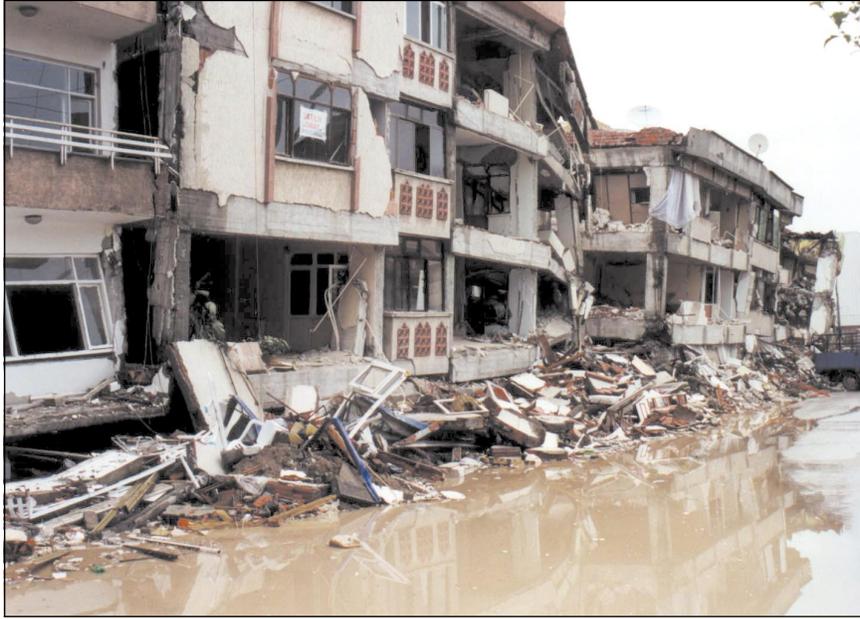
Figure 4-6 Failure of soft first story

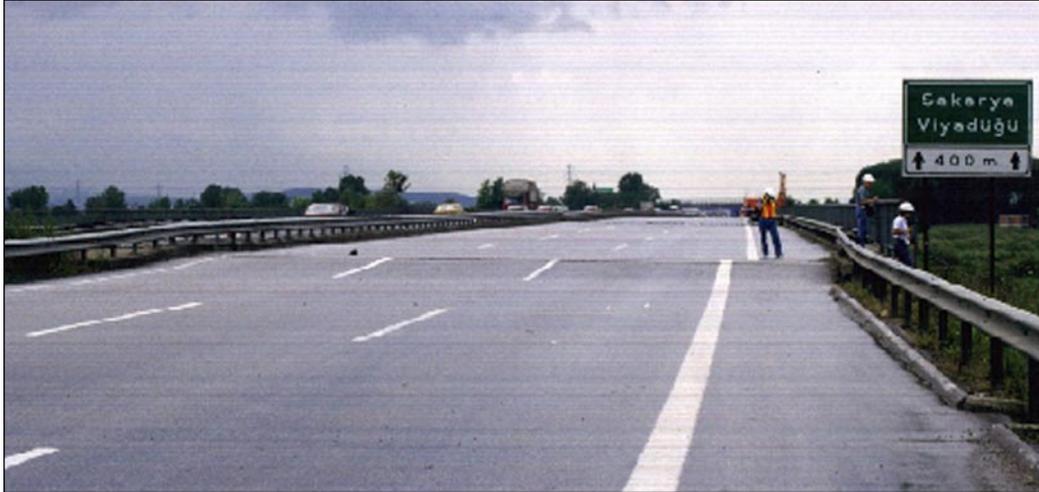
Figure 5-6 The east abutment of the eastbound E-80 Motorway bridge showing the 500 mm offset of the span with respect to the approach road

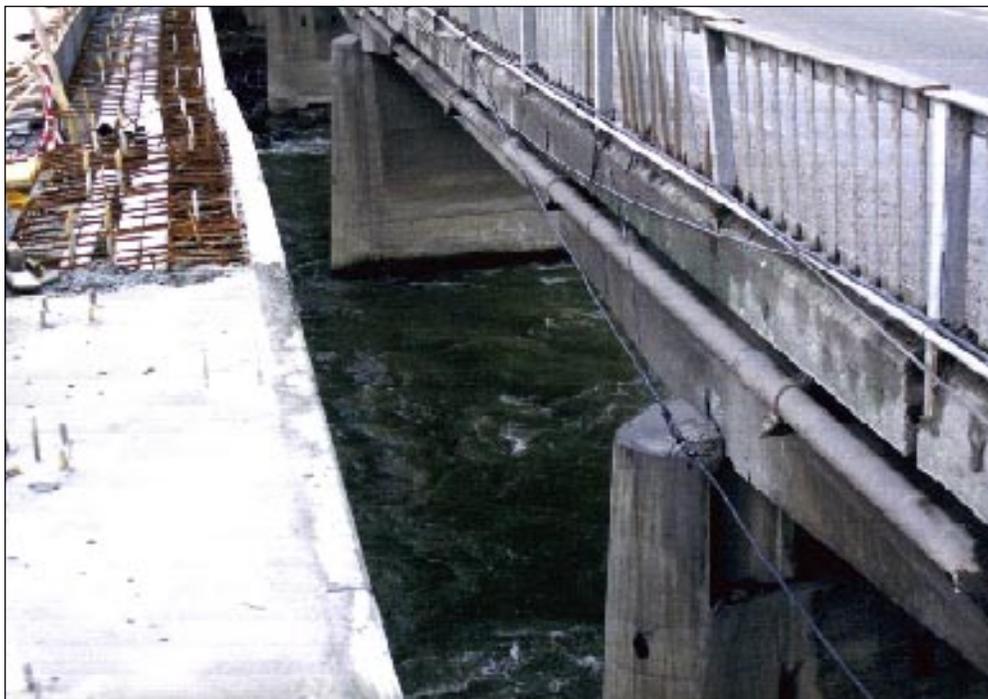
Figure 5-9 The two bridges crossing the Sakarya River on the D100 Highway. The left hand bridge at the time of the earthquake was a new prestressed concrete bridge still under construction. The right hand bridge is the original reinforced concrete, two-lane highway bridge. The damage can be noticed on the new bridge where the fascia girder is misaligned near the top left hand corner of the photograph. Damage to the old bridge can be seen at the junction of the pier cap to span connection in the mid right portion of the photograph.

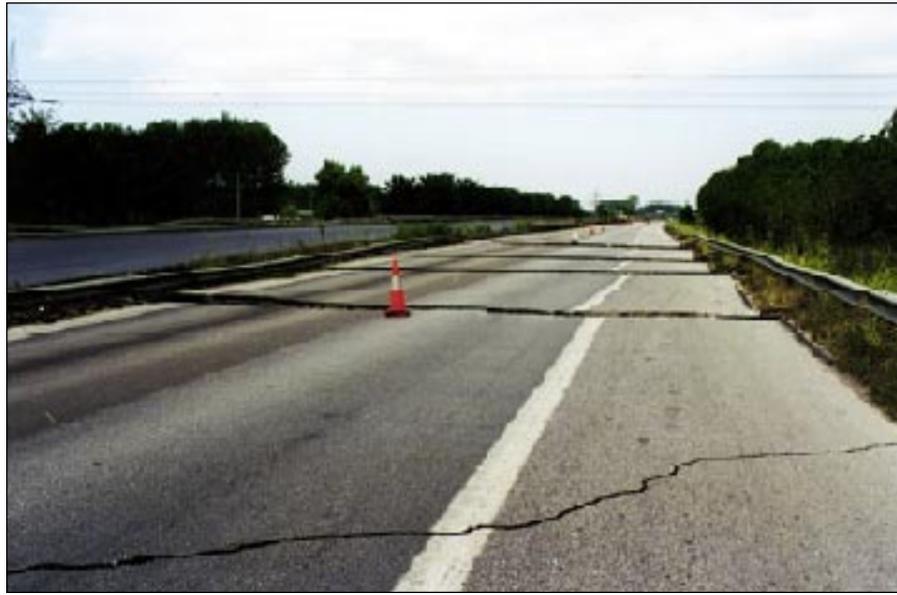
Figure 5-11 Distress to the pavement due to the fault rupture on the E-80 Motorway

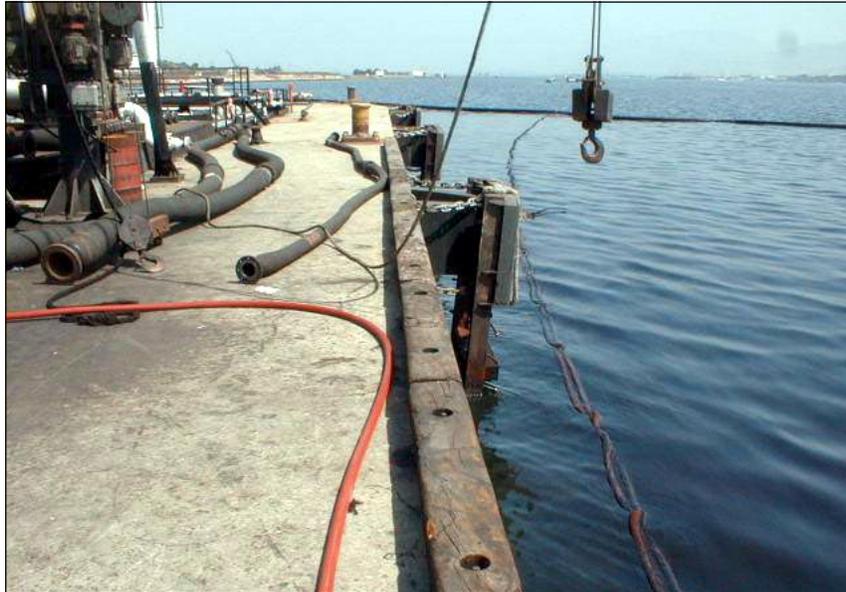
Figure 6-21 Hoses used for transfer operations at port
