The Chi-Chi, Taiwan Earthquake of September 21, 1999: Reconnaissance Report

Technical Report MCEER-00-0003
April 30, 2000

Edited by
George C. Lee¹ and Chin-Hsiung Loh²

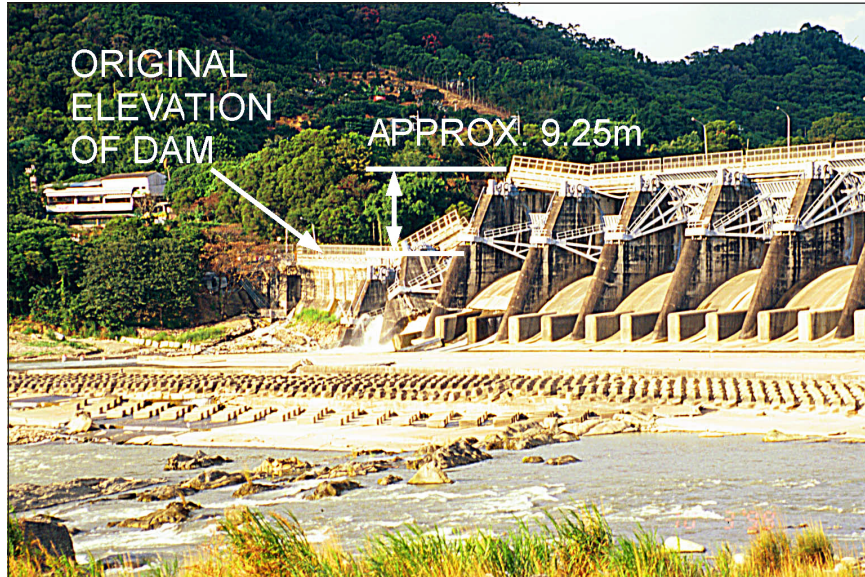
Fault rupture with a vertical offset exceeding 9 m was responsible for failure of the Shih-kang Dam and subsequent release of approximately two million m³ of water. This loss represents 40% of the raw water supply for Taichung County. Figure 3-11 is a photograph of the northern abutment area taken downstream of the dam, and Figure 3-12 is a photograph of the northern abutment from the vertically displaced southern part of the dam.

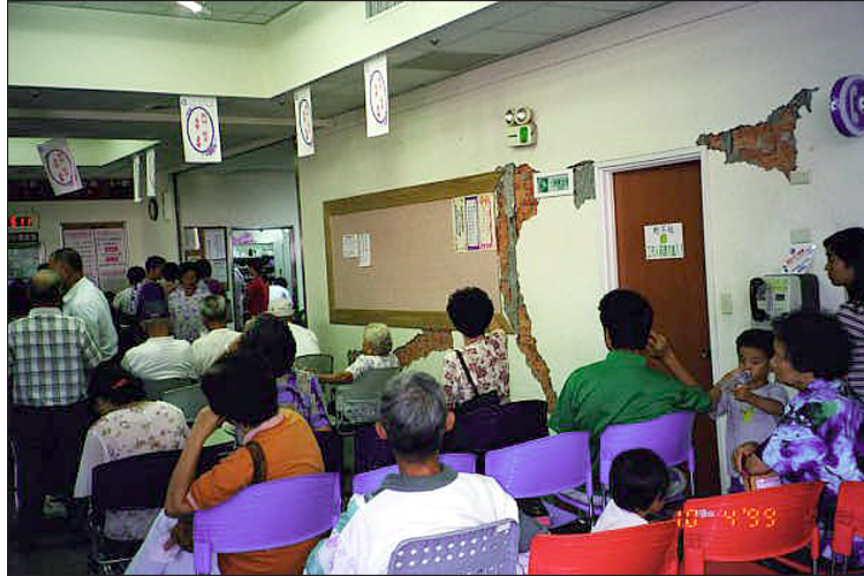
Figure 4-2 The first floor of the Christian Hospital remained open though the hospital suffered extensive interior damage.

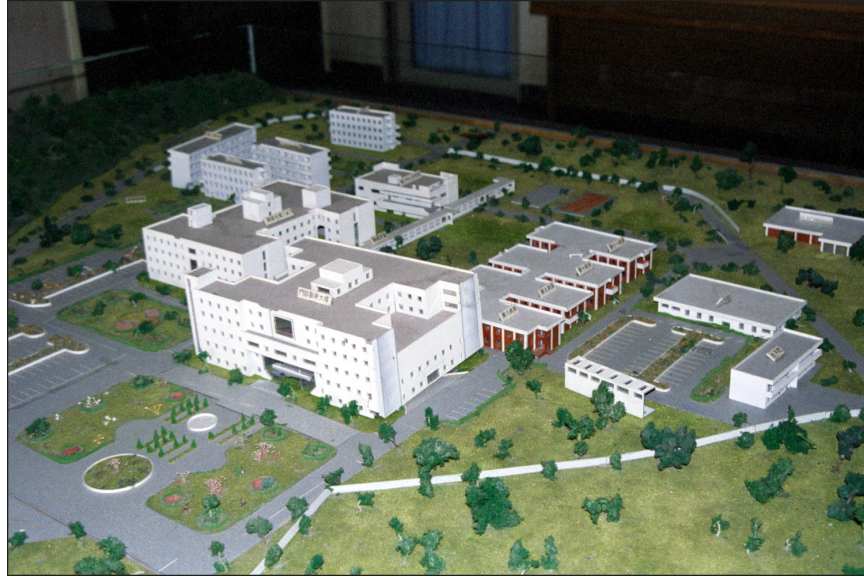
Figure 4-3 An overview model of the Veterans Hospital in Puli. The two white buildings are the newest and both sustained considerable damage.

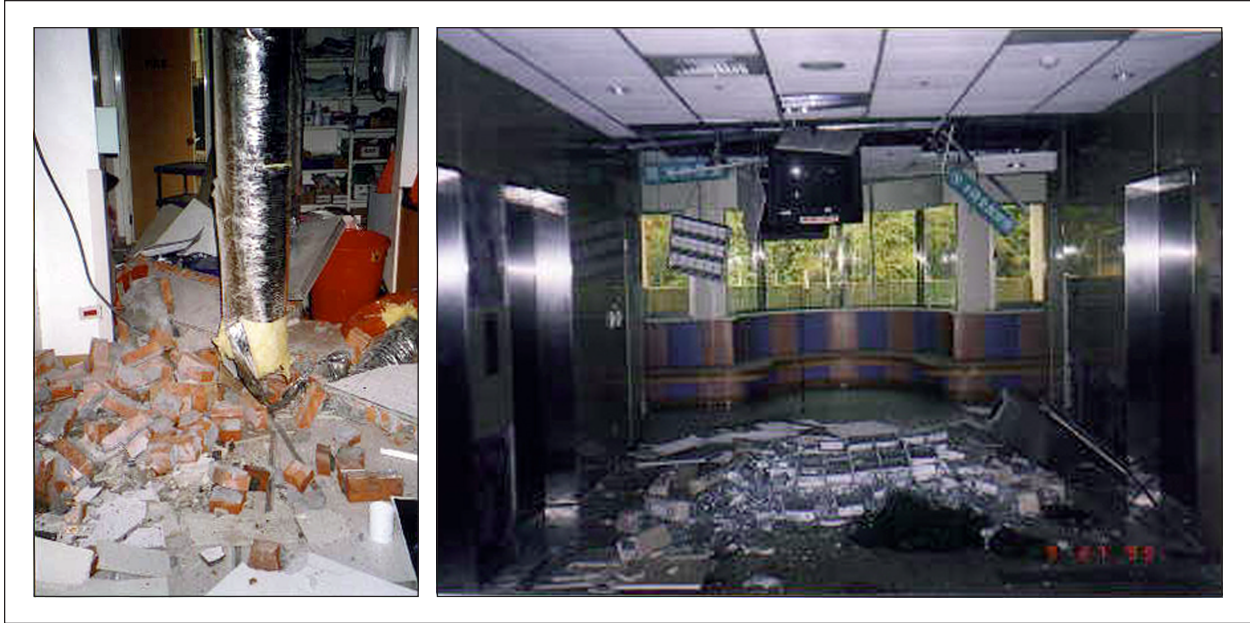
Figure 4-5 Interior damage in the Shiu-Tuan Hospital. Shown are (left) fallen brick inside the hospital and (right) a damaged interior glass brick wall.

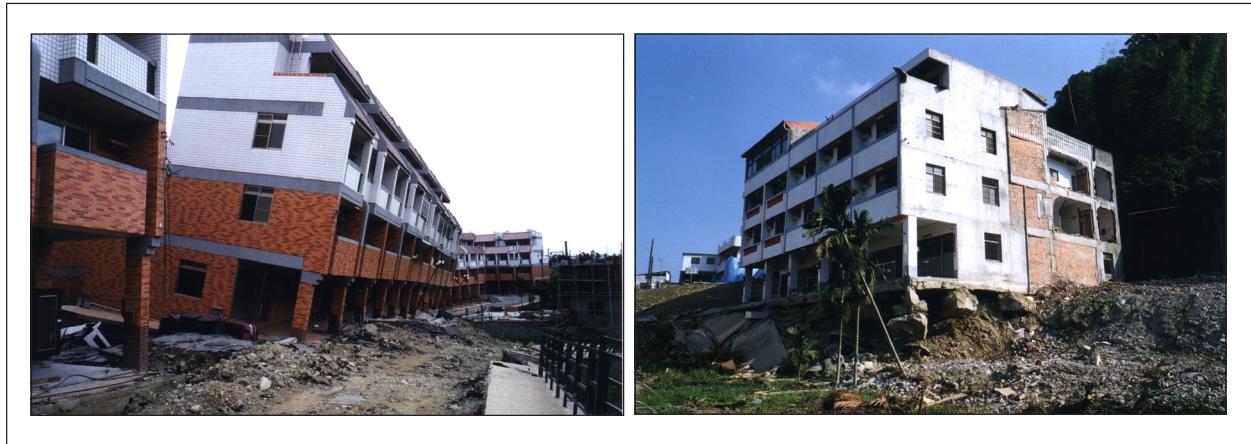
Figure 5-1 Damage to buildings straddling fault line

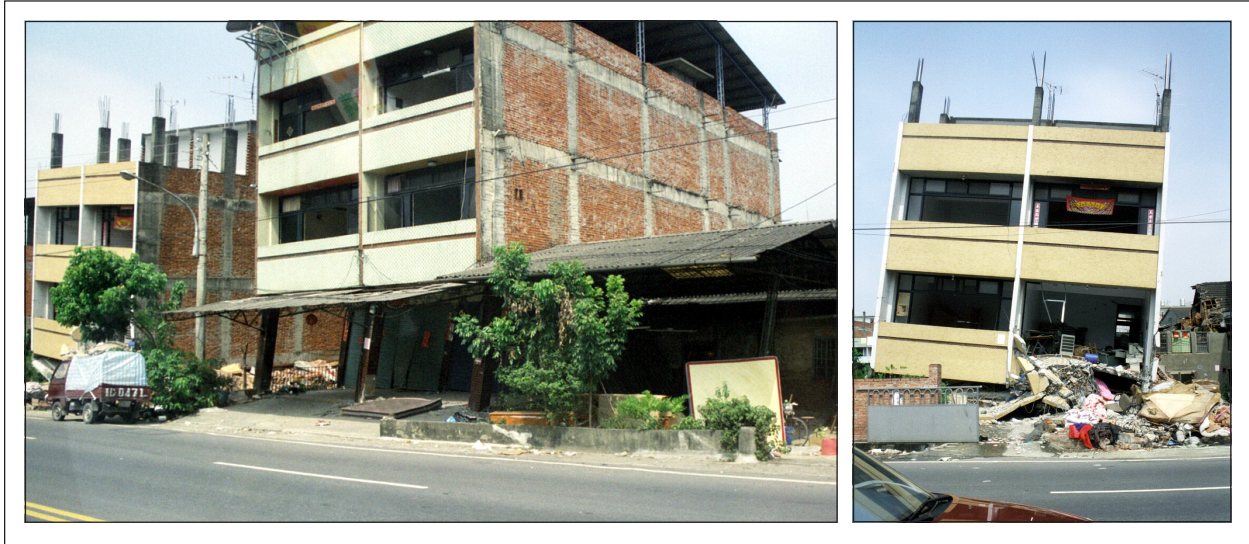
Figure 5-4 Large sway in progression toward collapse (left) and building failure due to soft first story (right)

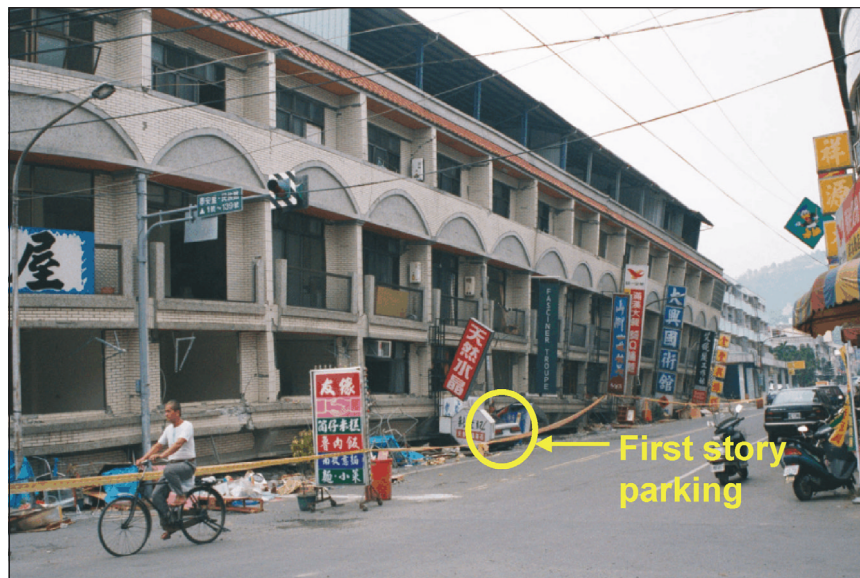
Figure 5-5 Soft-story failure of building having numerous large openings at first story on street side

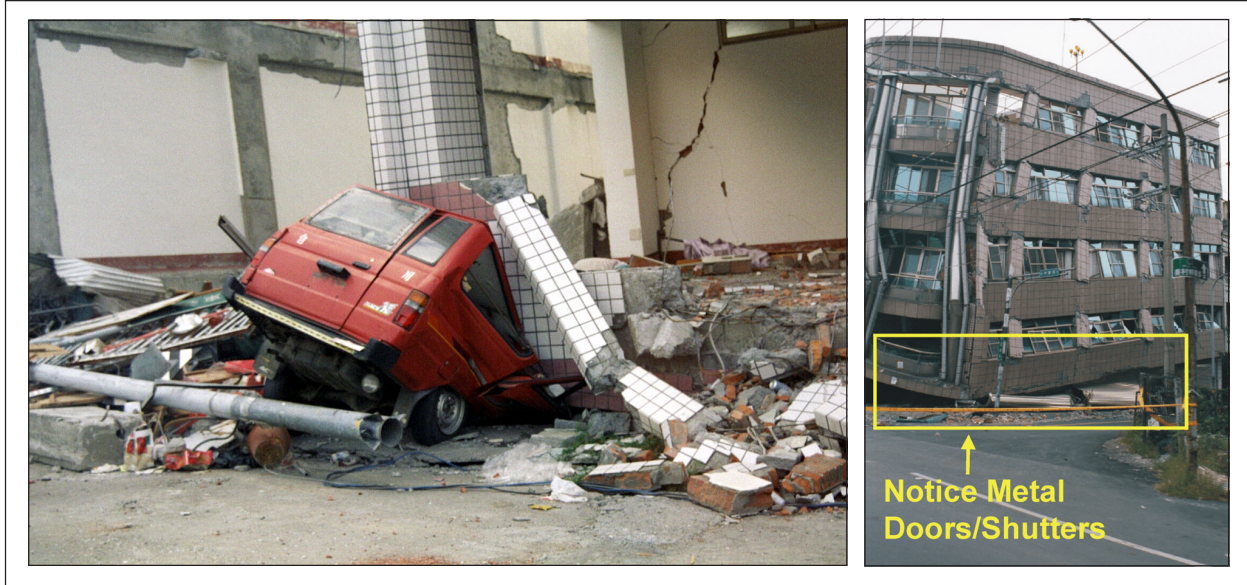
Figure 5-6 Damage due to irregular structural configuration

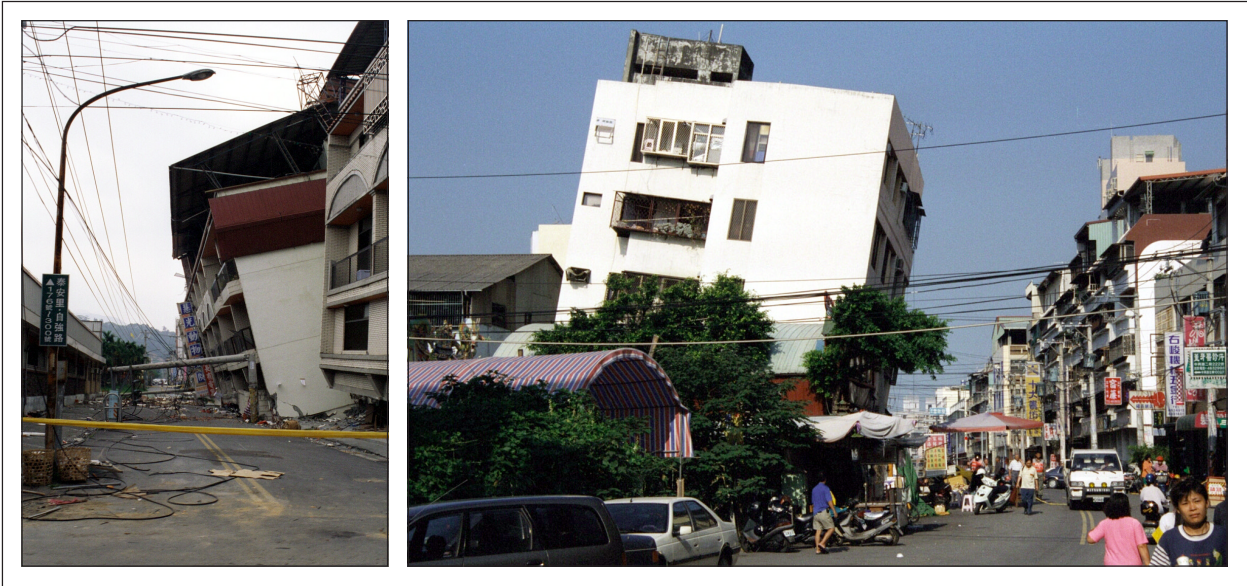
Figure 5-7 Damage due to soft first story on street side of buildings, causing them to topple toward the street

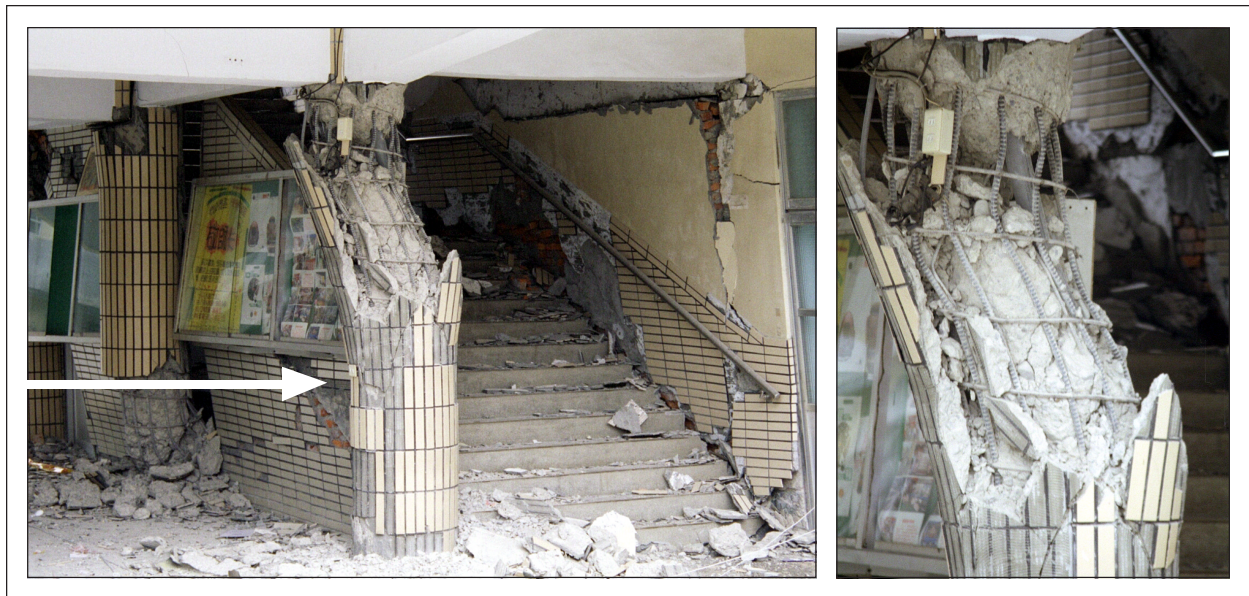
Figure 5-10 Damage to column having widely spaced stirrups and trapped by a partition

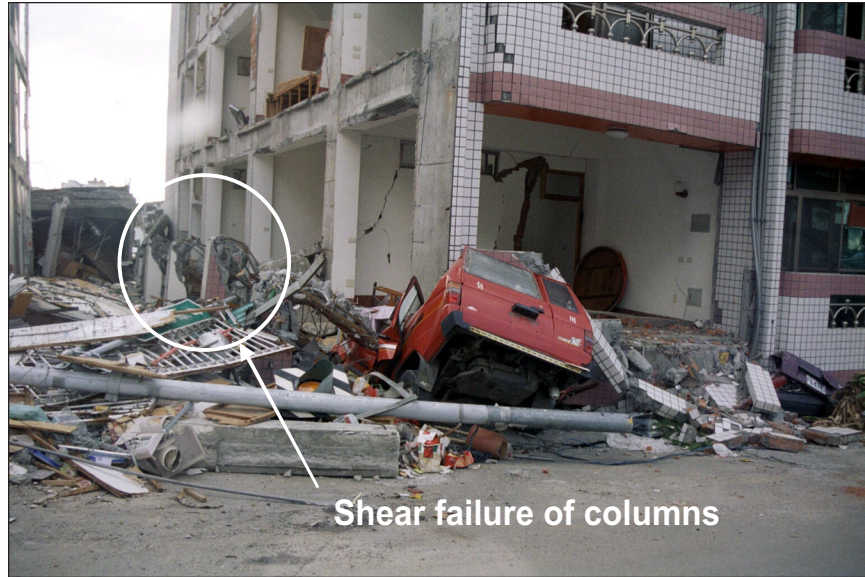
Figure 5-11 Shear failure of columns

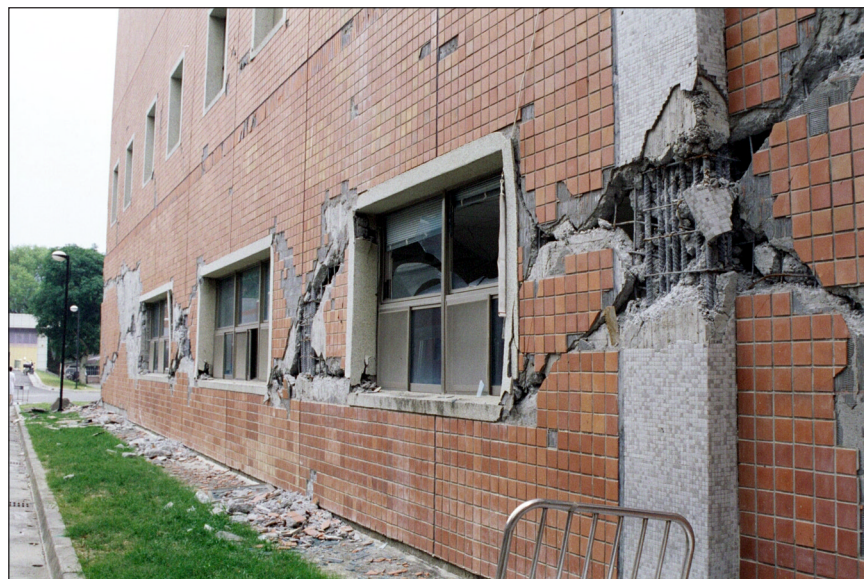
Figure 5-16 Damage due to infill walls at ground level

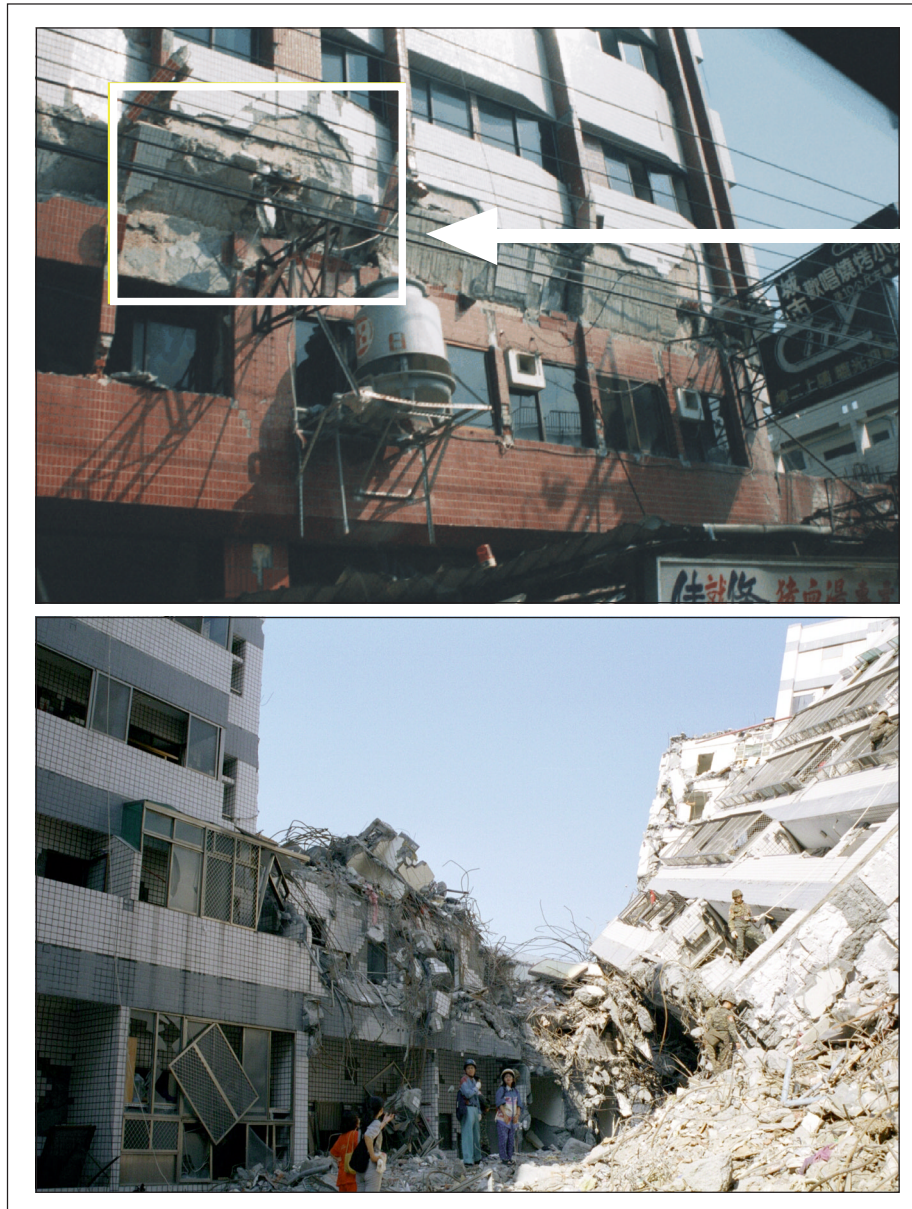
Figure 5-19 Severely damaged building complex; (top) out-of-plane collapse of third story infill wall; (bottom) collapse due to poor detailing practice

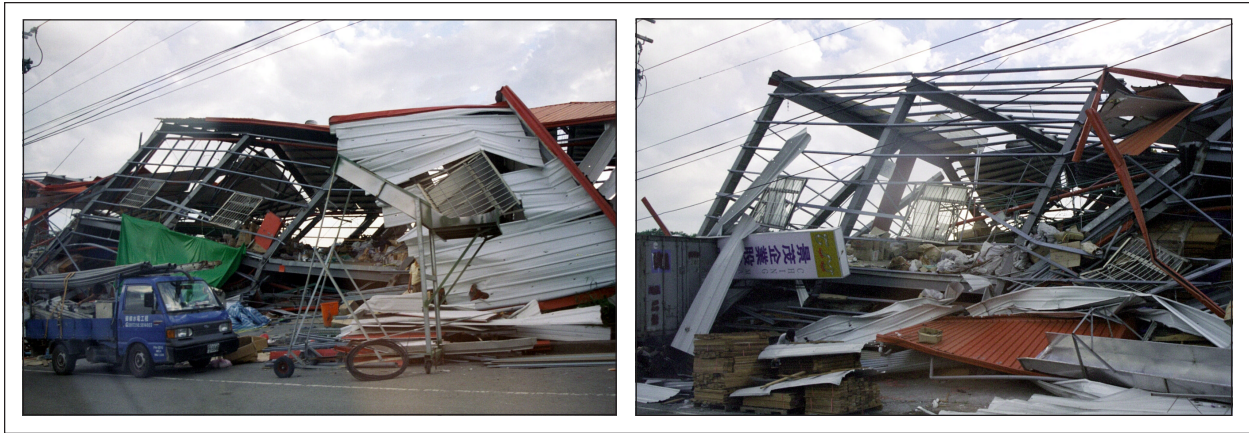
Figure 5-22 Collapse of non-ductile light metal structures

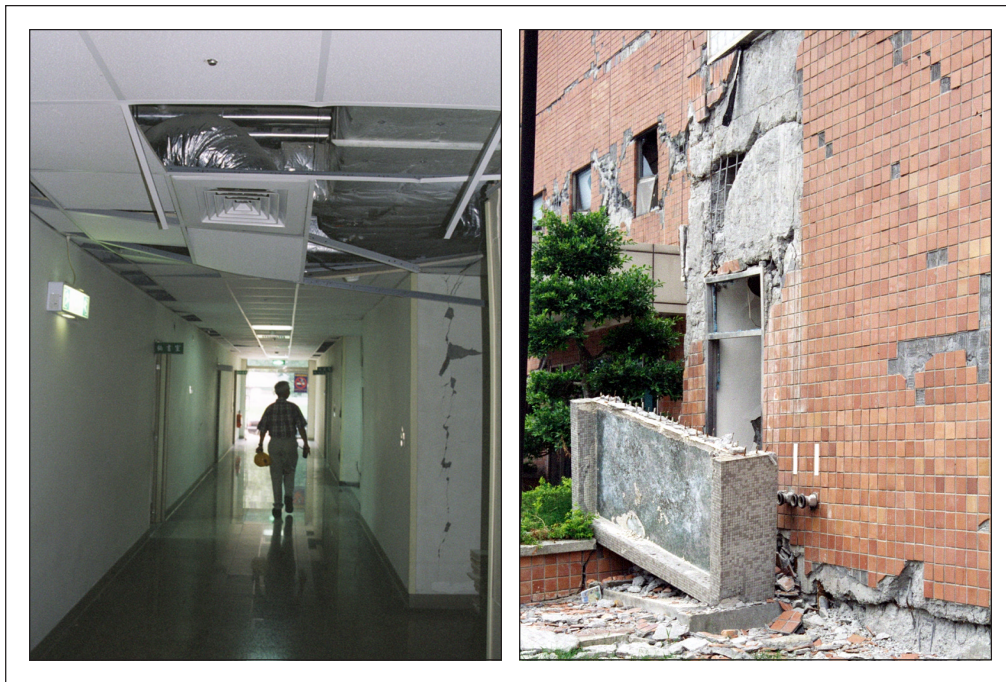
Figure 5-24 Examples of interior and exterior nonstructural damage that may prevent safe egress; collapse of suspended ceiling (left) and collapse of canopy above an exit door (right)

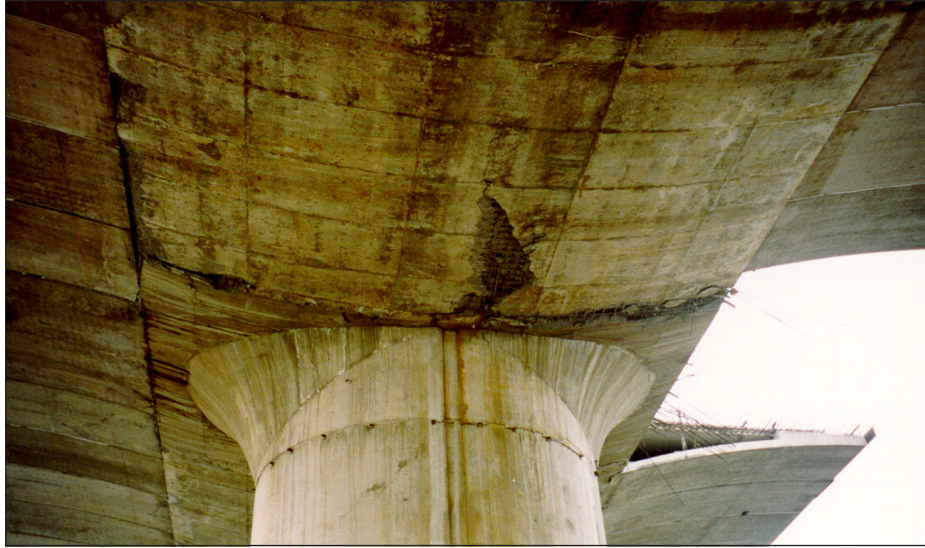
Figure 6-22 Damage to the soffit of the main girder near the pylon of the Ji-lu bridge; missing cantilevered section (right) had not been placed at time of the earthquake

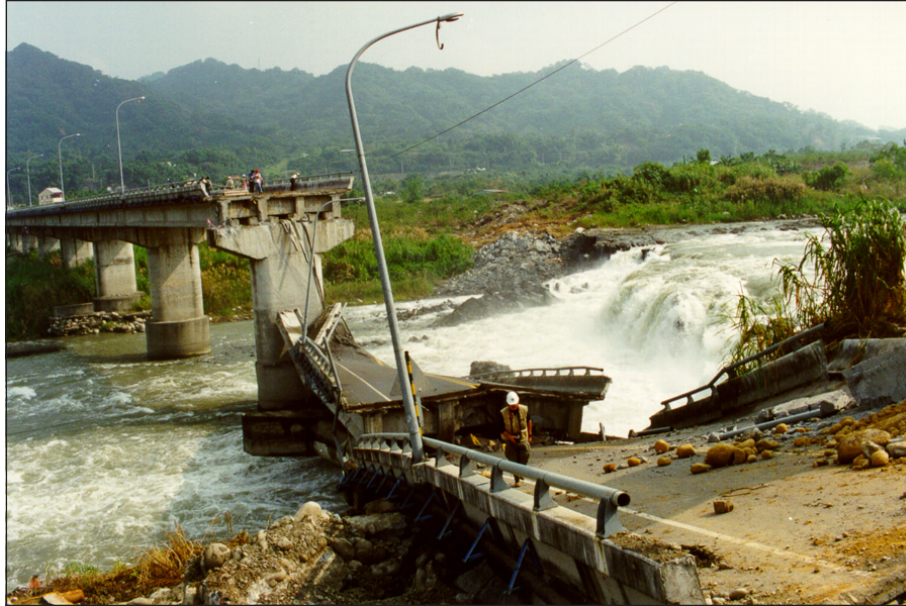
Figure 6-25 Collapse of end spans of Bei-feng bridge due to abutment and bent failures triggered by fault dislocations. Vertical offset of fault is seen crossing the river immediately upstream.
