**Engineering and Organizational Issues Related to  
The World Trade Center Terrorist Attack**

**Reconnaissance and Preliminary  
Assessment of a Damaged Building  
Near Ground Zero**

**Volume 2:  
Reconnaissance and Preliminary Assessment of a  
Damaged Building Near Ground Zero**

April 2002

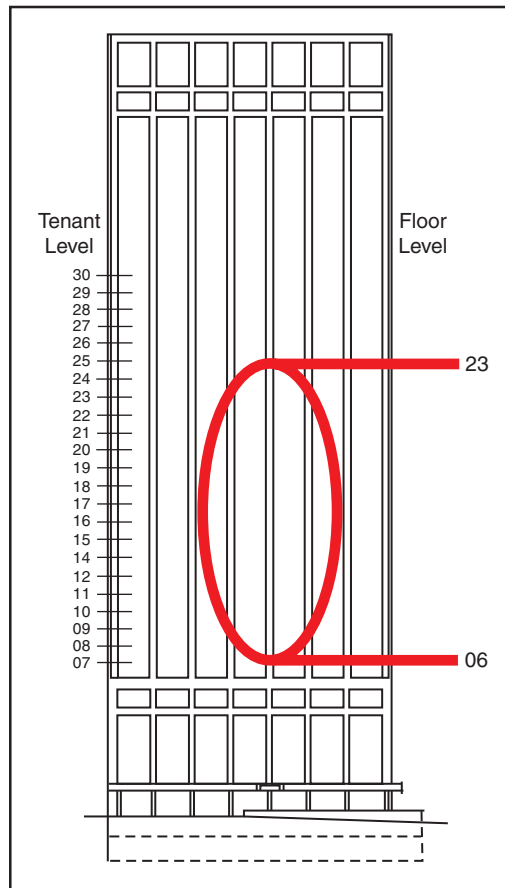
Figure 1.3. Sketch of northern façade showing the zone of damage

The façade of the building is composed of windows and a lightweight cladding system. An artist's rendering of the northern façade is presented in Figure 1.3. This façade was badly damaged by falling debris in the zone described by the elliptical line in the figure. Tenant Levels are identified in the figure to facilitate the description of damage to the building presented in Section 2.

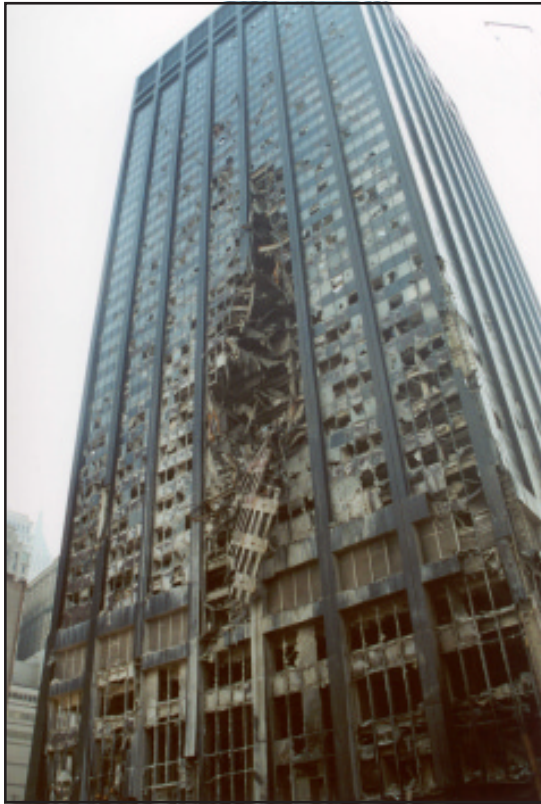
a. View of northern facade

Figure 2.1 presents four photographs of the building taken on September 21, 2001. The view in a. is of the northern façade showing the large gash in the exterior wall caused by falling debris that was ejected from WTC 2 as it collapsed. One large piece of the façade of WTC 2 can be seen in this figure at approximately the 9th floor level. It is highly likely that this three-story high piece of debris caused much of the damage that is evident above TL 7. Clearly seen in this figure is the loss of a column on Line D (see Figure 1.2) between TL 7 and TL 25 (see Figure 1.3).

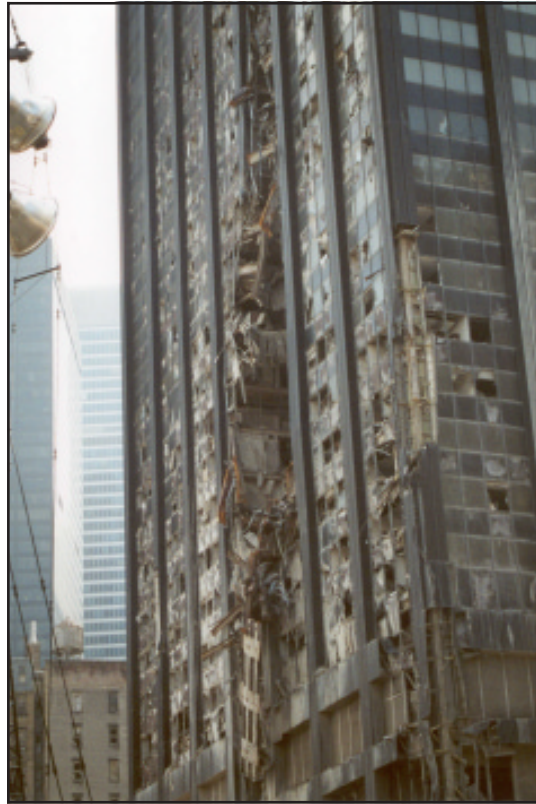
b. View of northern and western facades

Part b. of Figure 2.1 shows damage to the northern and western faces of the building. Windows were broken on both of these faces of the building but the damage on the western face was confined to a one-bay width between Lines 7 and 8. The cladding to corner column A8 was lost between the ground and TL 5 and between TL 9 and 12.

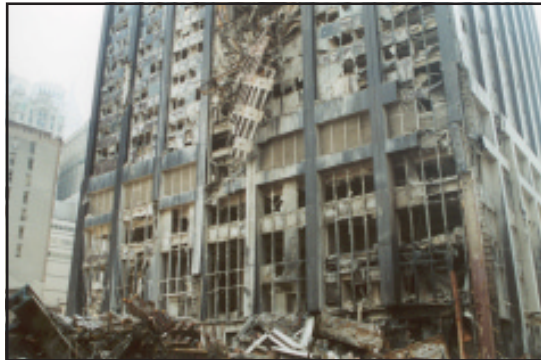
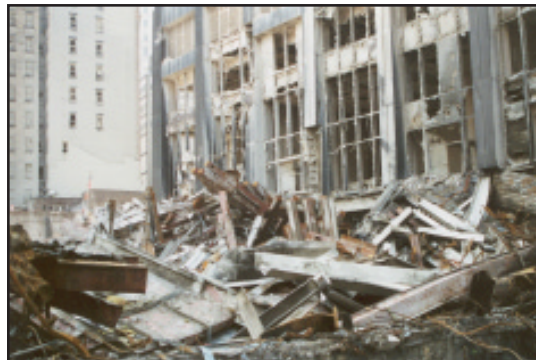
Parts c. and d. of Figure 2.1 show damage to the lower levels of the building on its north face. Burning debris ignited small fires in the lower levels of the building but these fires appeared to have been confined to the perimeter of the building. Most of the windows in the lower levels, especially below the mechanical plant room at the 5th floor level, were broken but it is not known how many of these windows were broken on purpose by the rescue teams to eliminate falling glazing hazards to the rescue workers operating to the immediate south of WTC 2. Part d. of the figure shows the debris pile to the immediate north of the building, 10 days after the terrorist attacks. Much of the debris was from WTC 2.

c. View of lower 10 stories of northern facade

d. Damage to the northern façade at the entry level

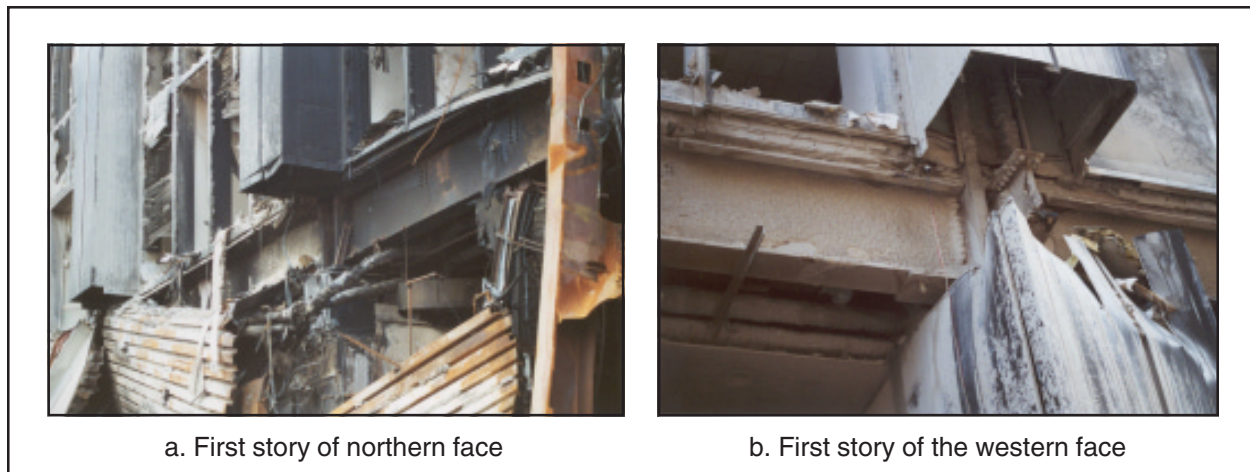
*Figure 2.2. Exposed steel moment framing in the first story of the building*

Figure 2.2 presents information on the moment-resisting connections used in the building. Part a. of the figure shows fire damage to the lower framing, a cover-plated moment connection of the beam to the column, and the connections used to join the steel floor beams to the perimeter girders. No spray-on fireproofing is evident on the side or bottom of the perimeter beam although it may have been knocked off by the impact of falling debris. Façade construction

details can be clearly seen in this figure. Part b. shows a typical beam-column moment connection on the western face of the building. Cover-plates are clearly visible in this connection and damaged (or incomplete) fireproofing can be seen on the exterior face (web) of the perimeter beam.

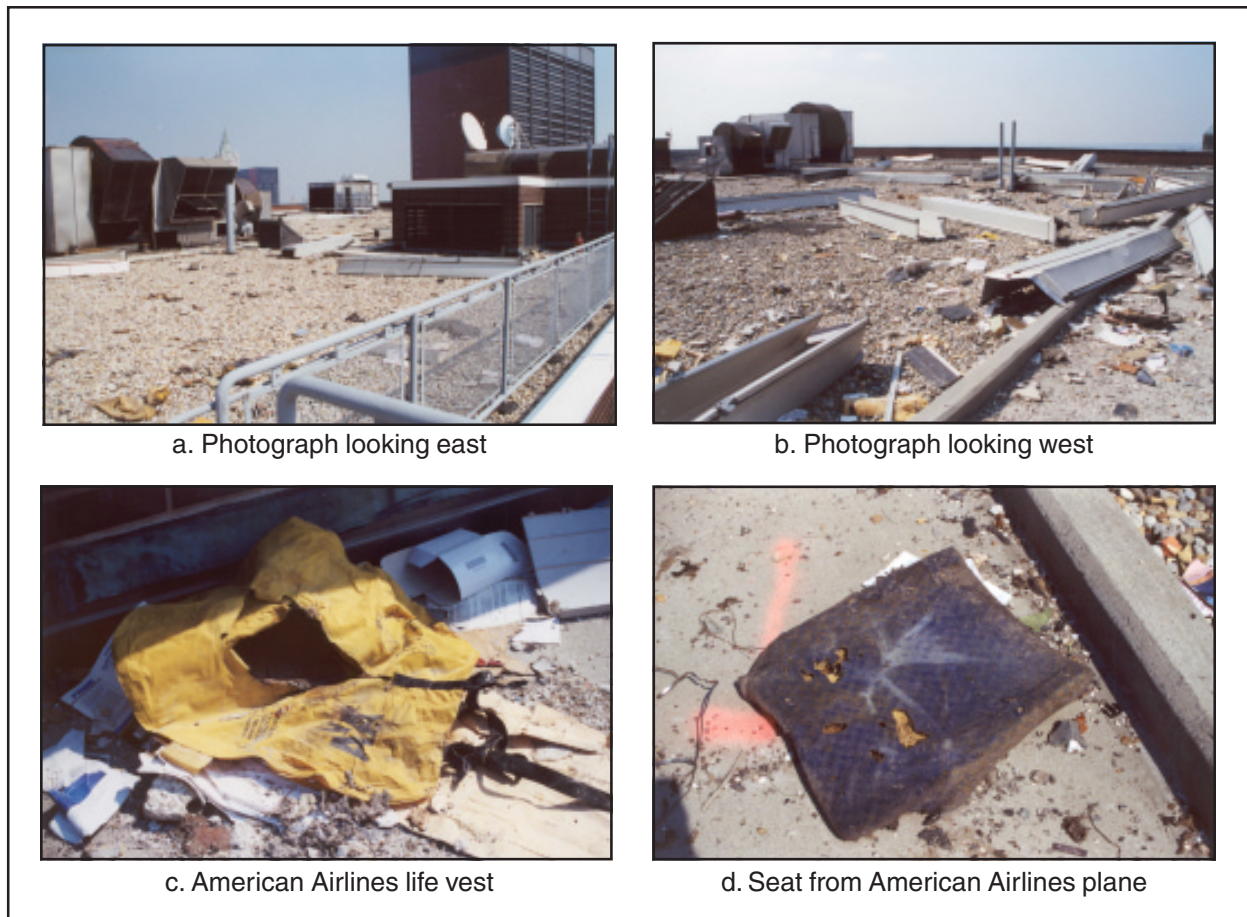
*Figure 2.3. Debris at the roof level of 130 Liberty Plaza*

Figure 2.3 presents photographs taken at the roof level of the building. Part a. of the figure is the view looking east across the roof. Silver U-shaped aluminum panels from WTC 2 can be seen in the figure together with life vests from American Airlines (AA) Flight 11 that struck the north face of WTC 1 (approximately 120 meters from 130 Liberty Plaza). Part b. of the figure is a view looking west across the roof. Aluminum panels and AA life vests are also

visible in this figure. Parts c. and d. are close-up photographs of an AA life vest and a seat from AA Flight 11.

No structural damage was observed at the roof level of the building and there was no evidence that the roof floor slab had been punctured by falling debris from WTC 2. This observation was confirmed by the walk-through of the plant-room spaces immediately below the roof. Apart from broken glass in the stairwells from the roof-level skylights, the structure and mechanical plant in the 38th story were undamaged by the collapse of WTC 2.

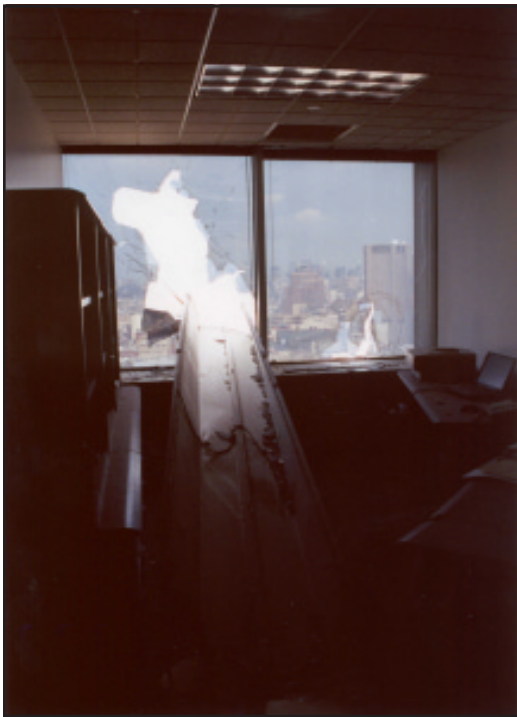
Damage to the building above TL 29 was modest (relative to the damage below TL 25) and was limited to broken glass (caused by debris ejected from WTC 2 as it collapsed). Figure 2.4 shows typical nonstructural damage above TL 29. Part a. shows damage caused by a section of fascia that was ejected from WTC 2 and which penetrated through a window on the northern face of the building. Part b. shows debris in a corner office at Grid A8. The angle section lying atop the

a. Penetration of WTC 2 fascia piece

overturned chair in this figure penetrated through the north-facing window of the building. (The hard hat and flashlight in the photograph belonged to the photographer.)

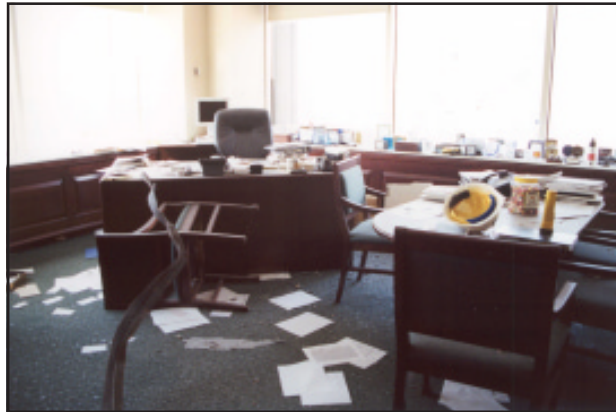
b. Typical damage in office space

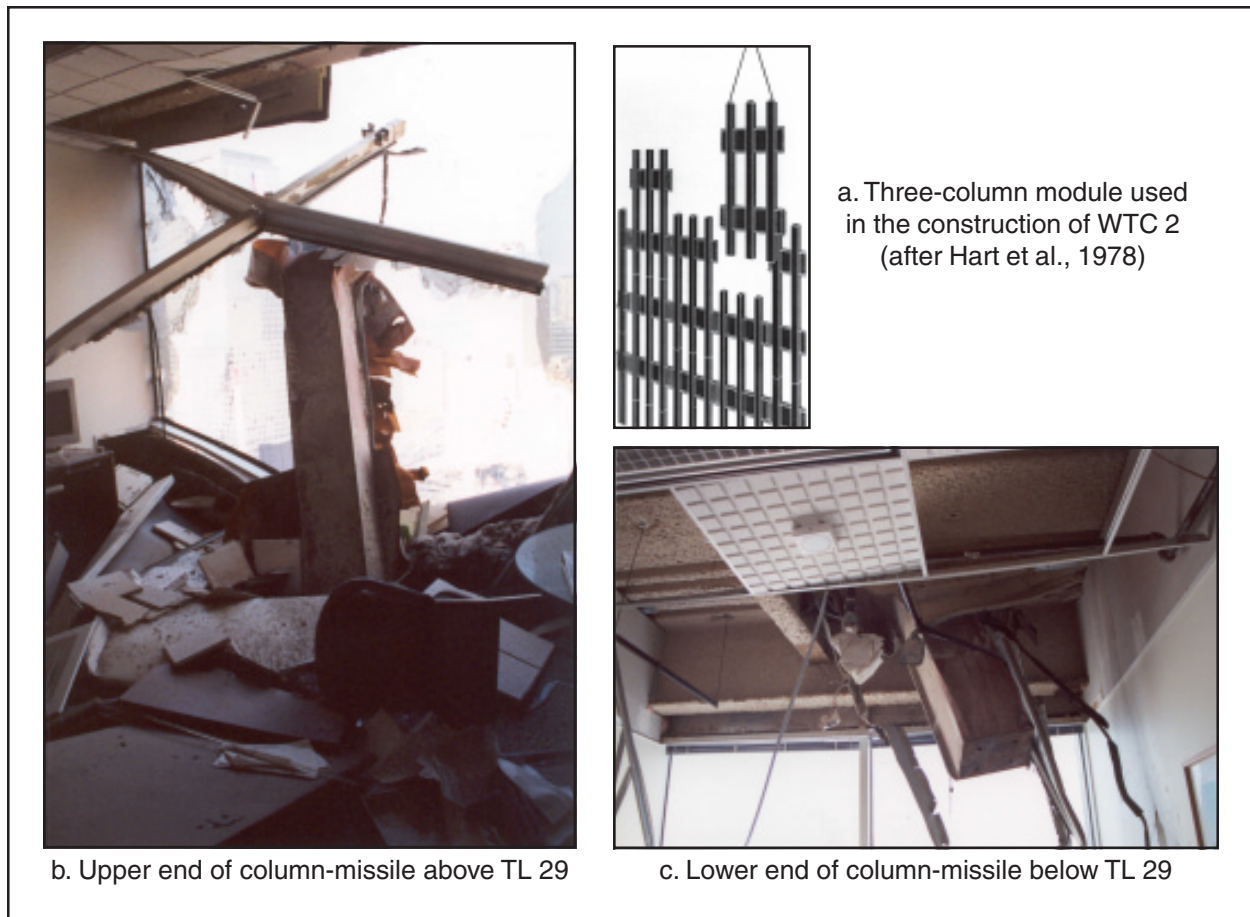
*Figure 2.5. Damage due to column-missile ejected from WTC 2*

The first major structural damage was observed at TL 29 and was due to the impact of one single-story tall structural steel column from WTC 2. (Note that, as described in Bruneau et al., 2002, this column was one of three in a typical spandrel module, so the two steel beams linking the three columns were destroyed before the single column hit the 130 Liberty Plaza building.) Figure 2.5a is a sketch of a typical three-column module. Figure 2.5b shows the upper end of the column above TL 29. Figure 2.5c shows the underside of the column and the damage it caused to the ceiling system. It is noteworthy that one unreinforced slab on the metal deck arrested the fall of this substantial steel member.

There was little evidence of damage to or distress in the building frame in the stories immediately above the zone of structural damage. There was no sign of excessive deflection in the framing above TL 25 as evinced by the total lack of deflection-induced damage in brittle components such as glazing and plasterboard partitions.

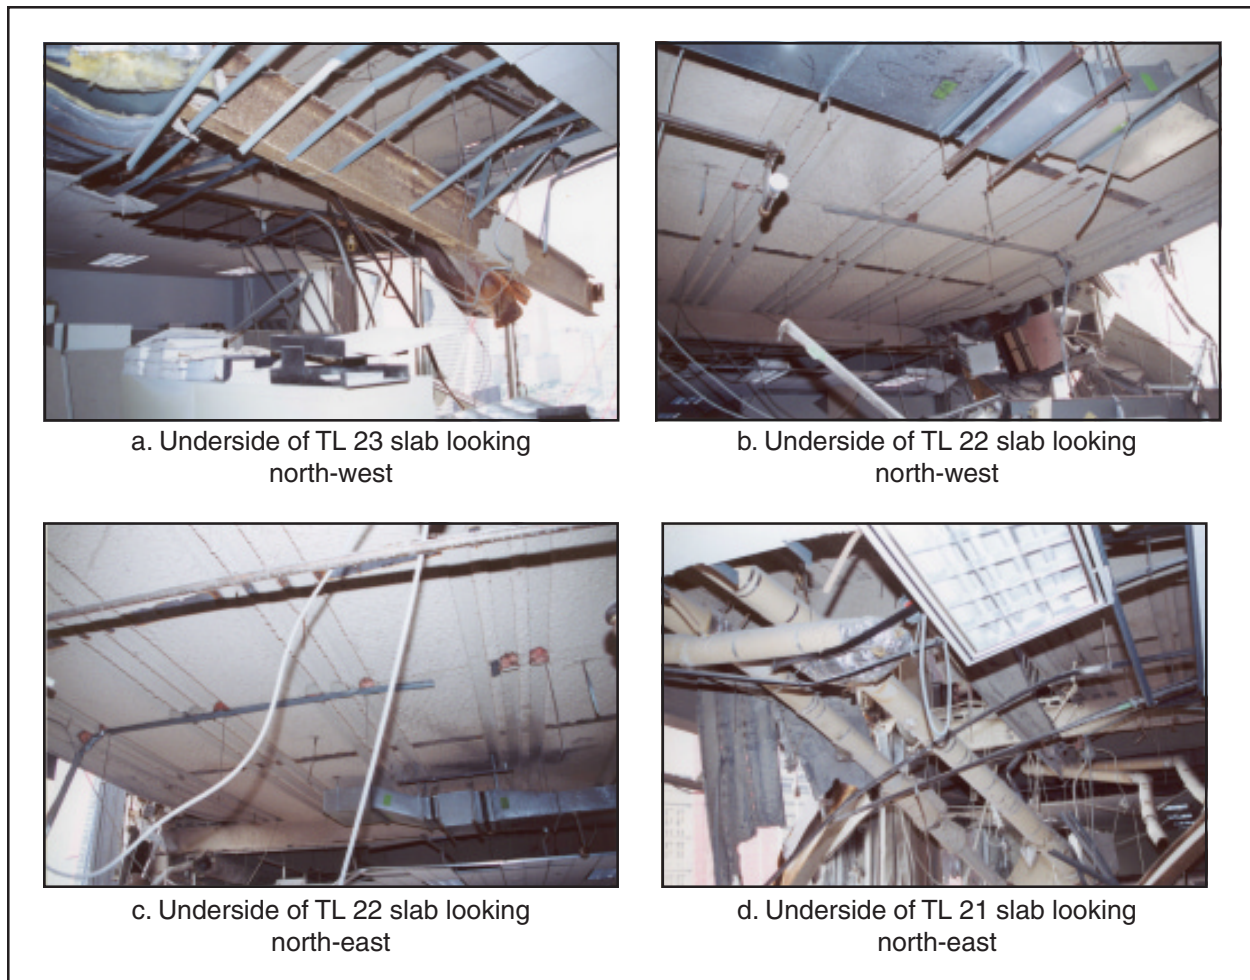
Figure 2.6. Interior damage at TLs 22 and 21

The degree of damage to the structural framing increased substantially below TL 26. Figure 2.6a shows a north-south spanning floor beam at the underside of TL 23 that has lost its support on Line 8 due to the failure (loss) of the spandrel beam between Lines D and E. Note the clean separation of the metal deck from the beam (made possible by the lack of studs joining the beam to the slab). Part b. shows the underside of the floor slab at TL 22. At this level, both north-south spanning floor beams were lost; the locations of these beams are marked by dark stripes on the underside of the metal decking. Of importance to the integrity of the floor system is the fact that the TL 22 slab at this location was able to span three times the distance assumed in design, namely, 26 feet, albeit with large deflections in the slab system. Part c. shows a view of the slab of part b. looking north-east. Part d. is a view looking north-east of the underside of the slab at TL 21: a photograph taken from approximately the same location as Figure 2.6c but one floor lower in the building. Fracture of the metal deck floor system at the line of the girder spanning north-south on Line E can be seen in part d. of the figure together with gross distortion of two steel floor beams spanning north-south to the (lost) spandrel.

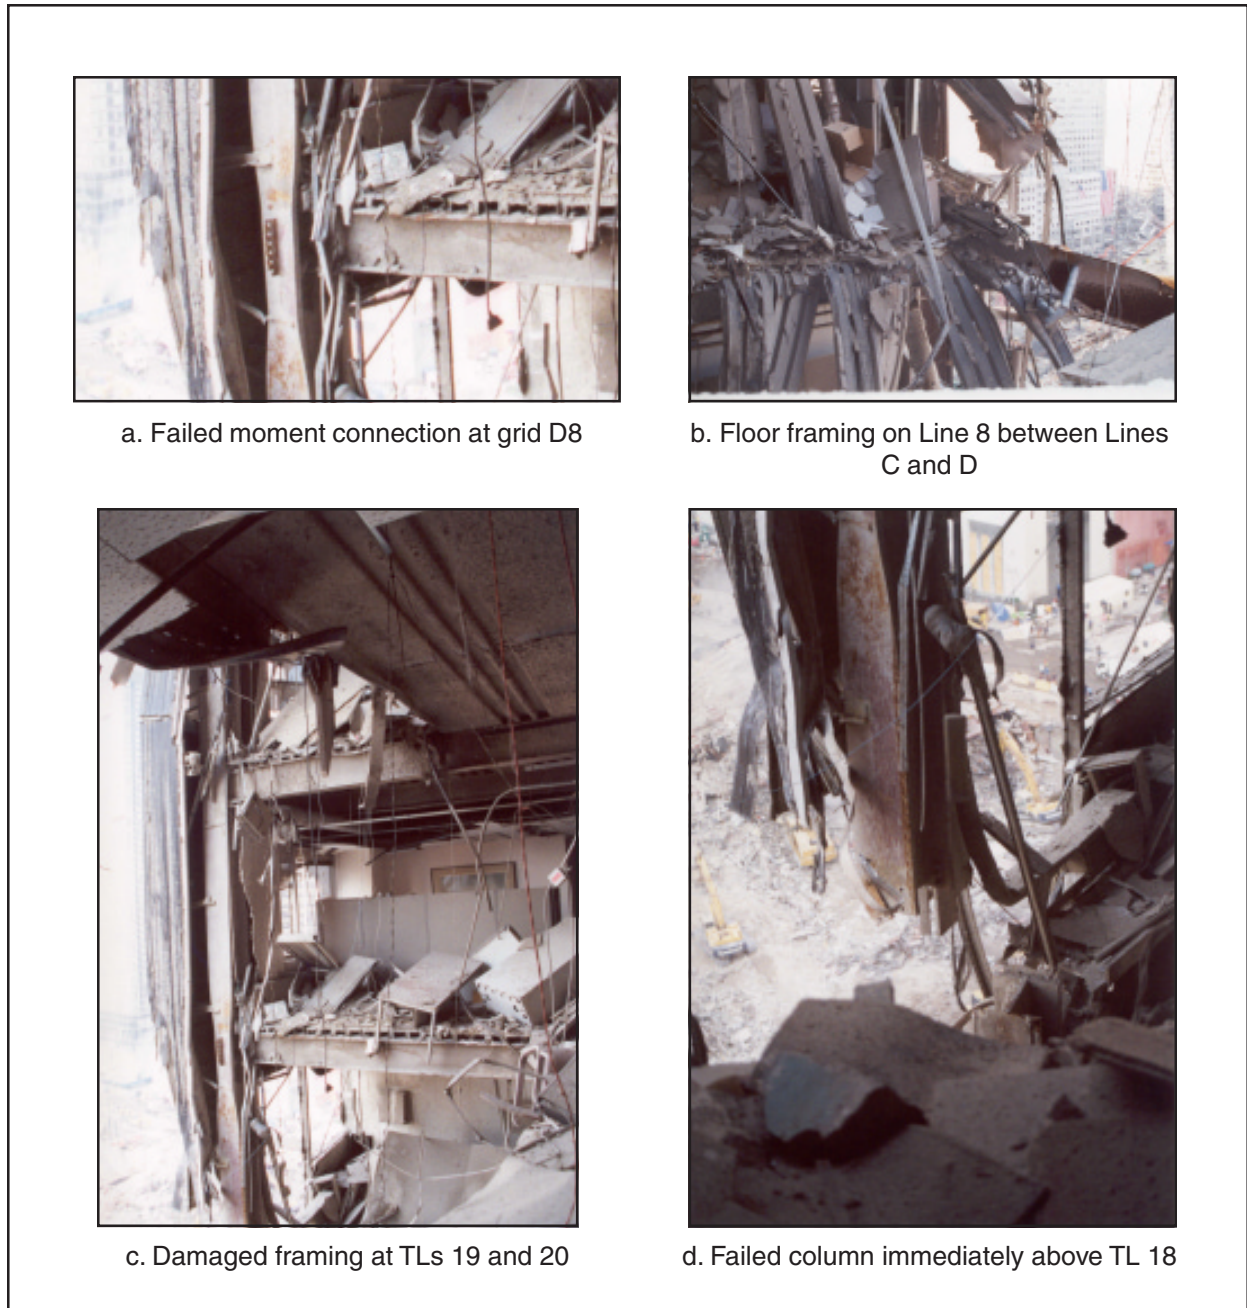
*Figure 2.7. Interior damage photographs from TL 19*

Figure 2.7 presents photographs taken from TL 19 in the building. Figure 2.7a shows the remnants of a moment-resisting connection at grid D8; the fractured flange connections and the welded web tab are clearly visible. Part b. is a photograph taken from the same location as the photograph of part a. but looking towards the north-south spanning girder on Line C. The World Financial Center and Winter Garden can be seen in the background of this photograph. Figure 2-7c is a view of two stories of framing along Line D. Note the distortion in the column flanges at the level of the beam-to-column connection and that the metal decking fractured cleanly along a butt (noncontinuous) joint atop the girder on Line D. Large deflections in the floor framing are not seen in this figure. Part d. shows the fractured column on Line D at approximately three feet above TL 18; immediately below the bottom of the framing shown in part c. of the figure. The debris pile at the base of WTC 2 can be seen in the lower portion of part d.

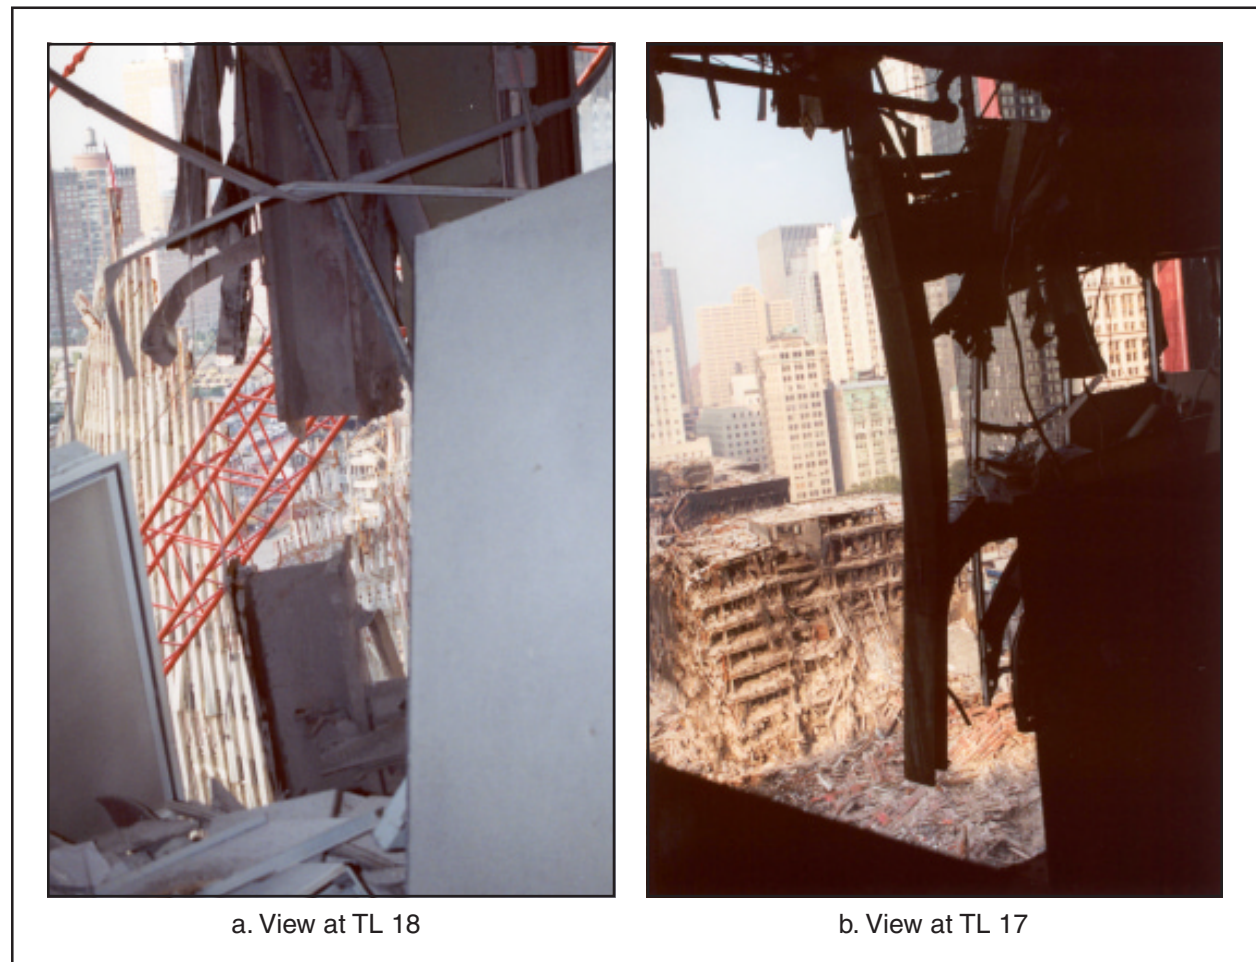
*Figure 2.8. Fractured column on Line D from TLs 18 and 17*

Figures 2.8a and 2.8b show the fractured column on Line D taken from TJs 18 and 17, respectively. The façade of WTC 2 can be seen in the background of part a. and World Trade Center 4 can be seen in the background of part b.

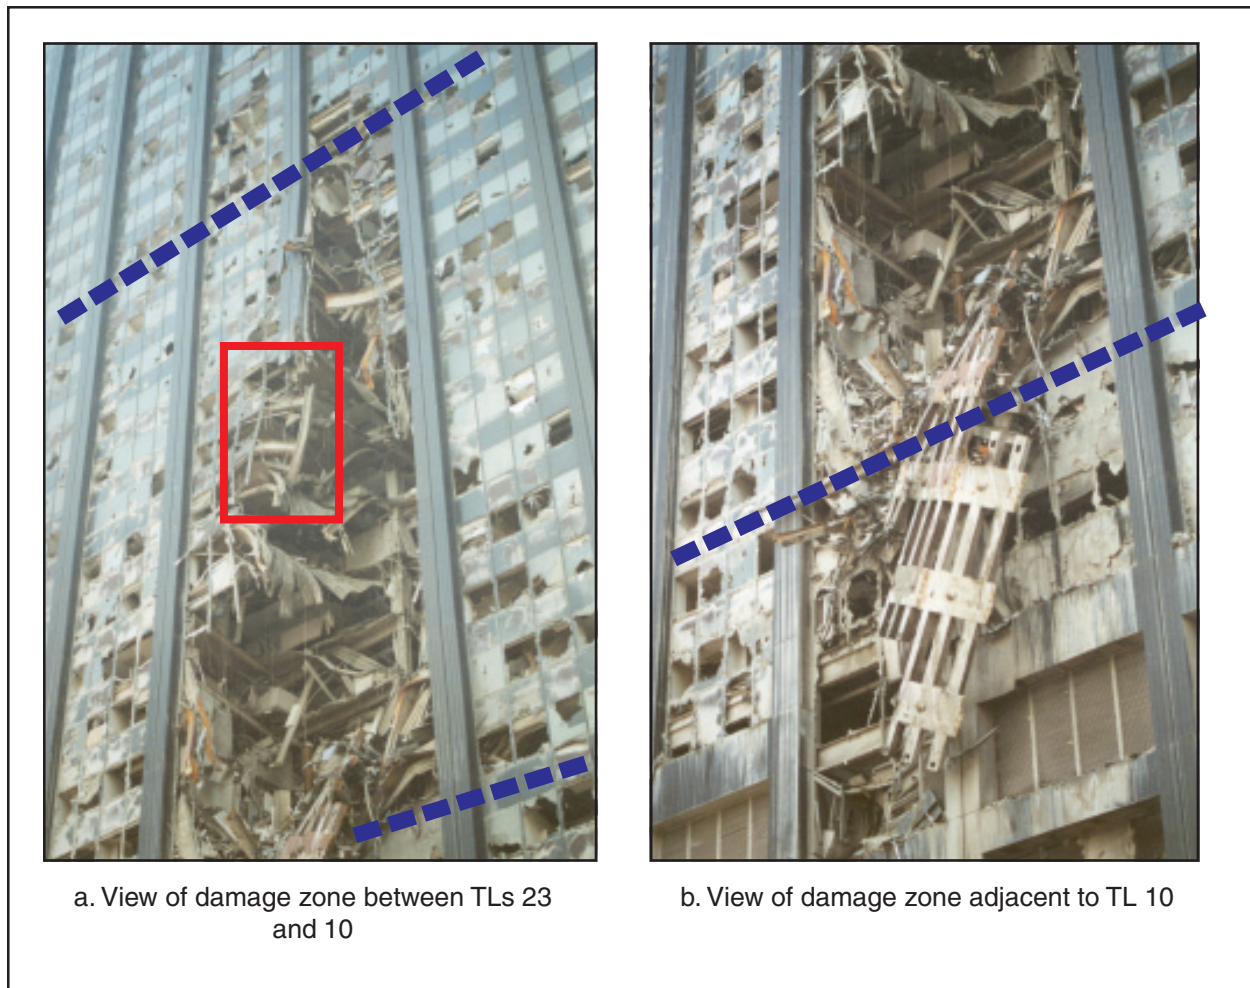
*Figure 2.9. Damage to the northern face of the building between TLs 23 and 10*

Figure 2.9 presents two photographs taken from outside the building looking toward the damage zone. The box superimposed on Figure 2.9a shows the column of Figure 2.8. The fracture evident in Figure 2.8a is located at the top of the box. The distorted but intact 2-story section of column seen in Figure 2.8b is located in the center of the box. In Figure 2.9a, the upper dashed line is at TL 25 and the lower dashed line is at TL 7. The dashed line in Figure 2.9b corresponds to the lower dashed line of Figure 2.9a. The large piece of debris that likely caused most of the damage above TL 10 is seen in Figure 2.9b precariously attached to the façade of the building.

The damage to the structural and nonstructural components between TLs 16 and 10 was most severe. The near-total destruction of the ceiling, mechanical, and plumbing systems in the areas surrounding the collapsed structural framing prevented the reconnaissance team from gaining access to the perimeter of the

damage zone. As seen in Figures 2.9a and 2.9b, the zone of extreme damage expanded below TL 16 to the 2-bay by 2-bay zone bounded by Lines C and E and 6 and 8.

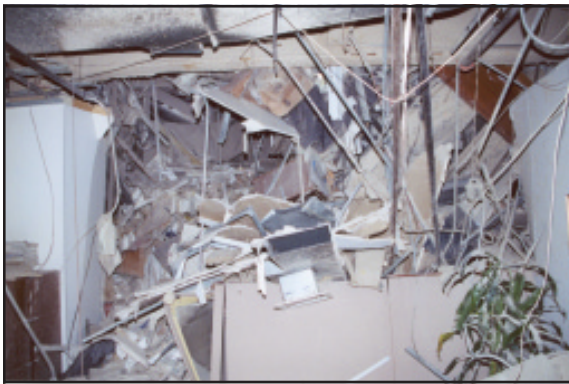
Figure 2.10 shows the damage at TL 9. Figure 2.10a shows the complete destruction of one zone of the floor immediately adjacent to the northern face of the building. Part b. shows the interior face of the section of WTC 2 façade, seen in Figures 2.1a and 2.9b, that caused much of the damage to the building.

a. Complete destruction of one zone of the building

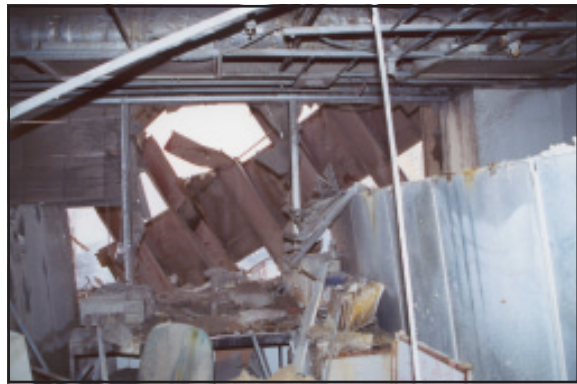
b. View of inside face of WTC 2 façade element

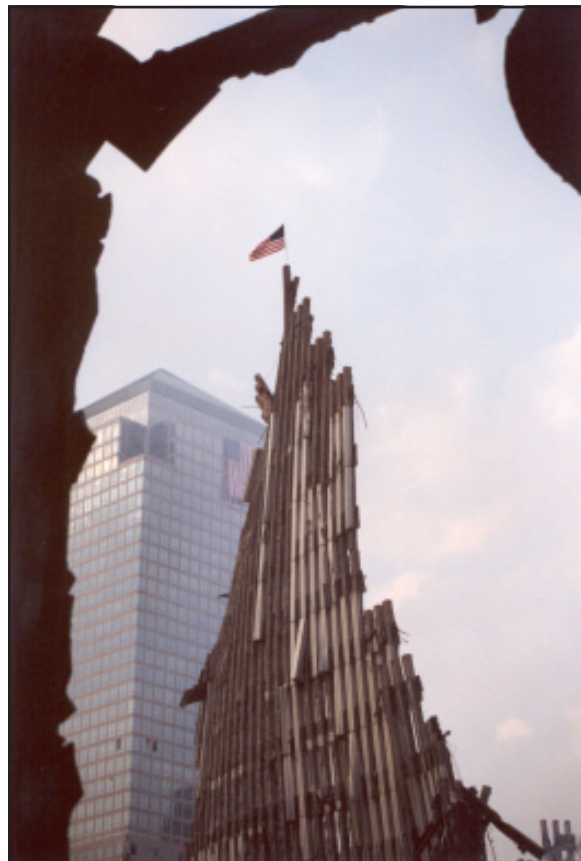
*Figure 2.11. View of the WTC 2 façade looking north-west from the foyer of the building*

Structural damage below the mechanical plant rooms that were located below TL 9 was modest and no photographs were taken at the levels between TL 9 and the entryway to the building. Figure 2.11 is a photograph taken inside the building looking north towards a standing section of the WTC 2 façade.
