An overview of reconnaissance activities using satellite imagery following Hurricane Charley

COLLECTION OF SATELLITE-REFERENCED BUILDING DAMAGE INFORMATION IN THE AFTERMATH OF HURRICANE CHARLEY

Beverley J. Adams, J. Arn Womble, Michael Z. Mio, John B. Turner, Kishor C. Mehta and Shubharoop Ghosh

ImageCat, Inc. and Texas Tech University, Wind Engineering Research (WISE) Center

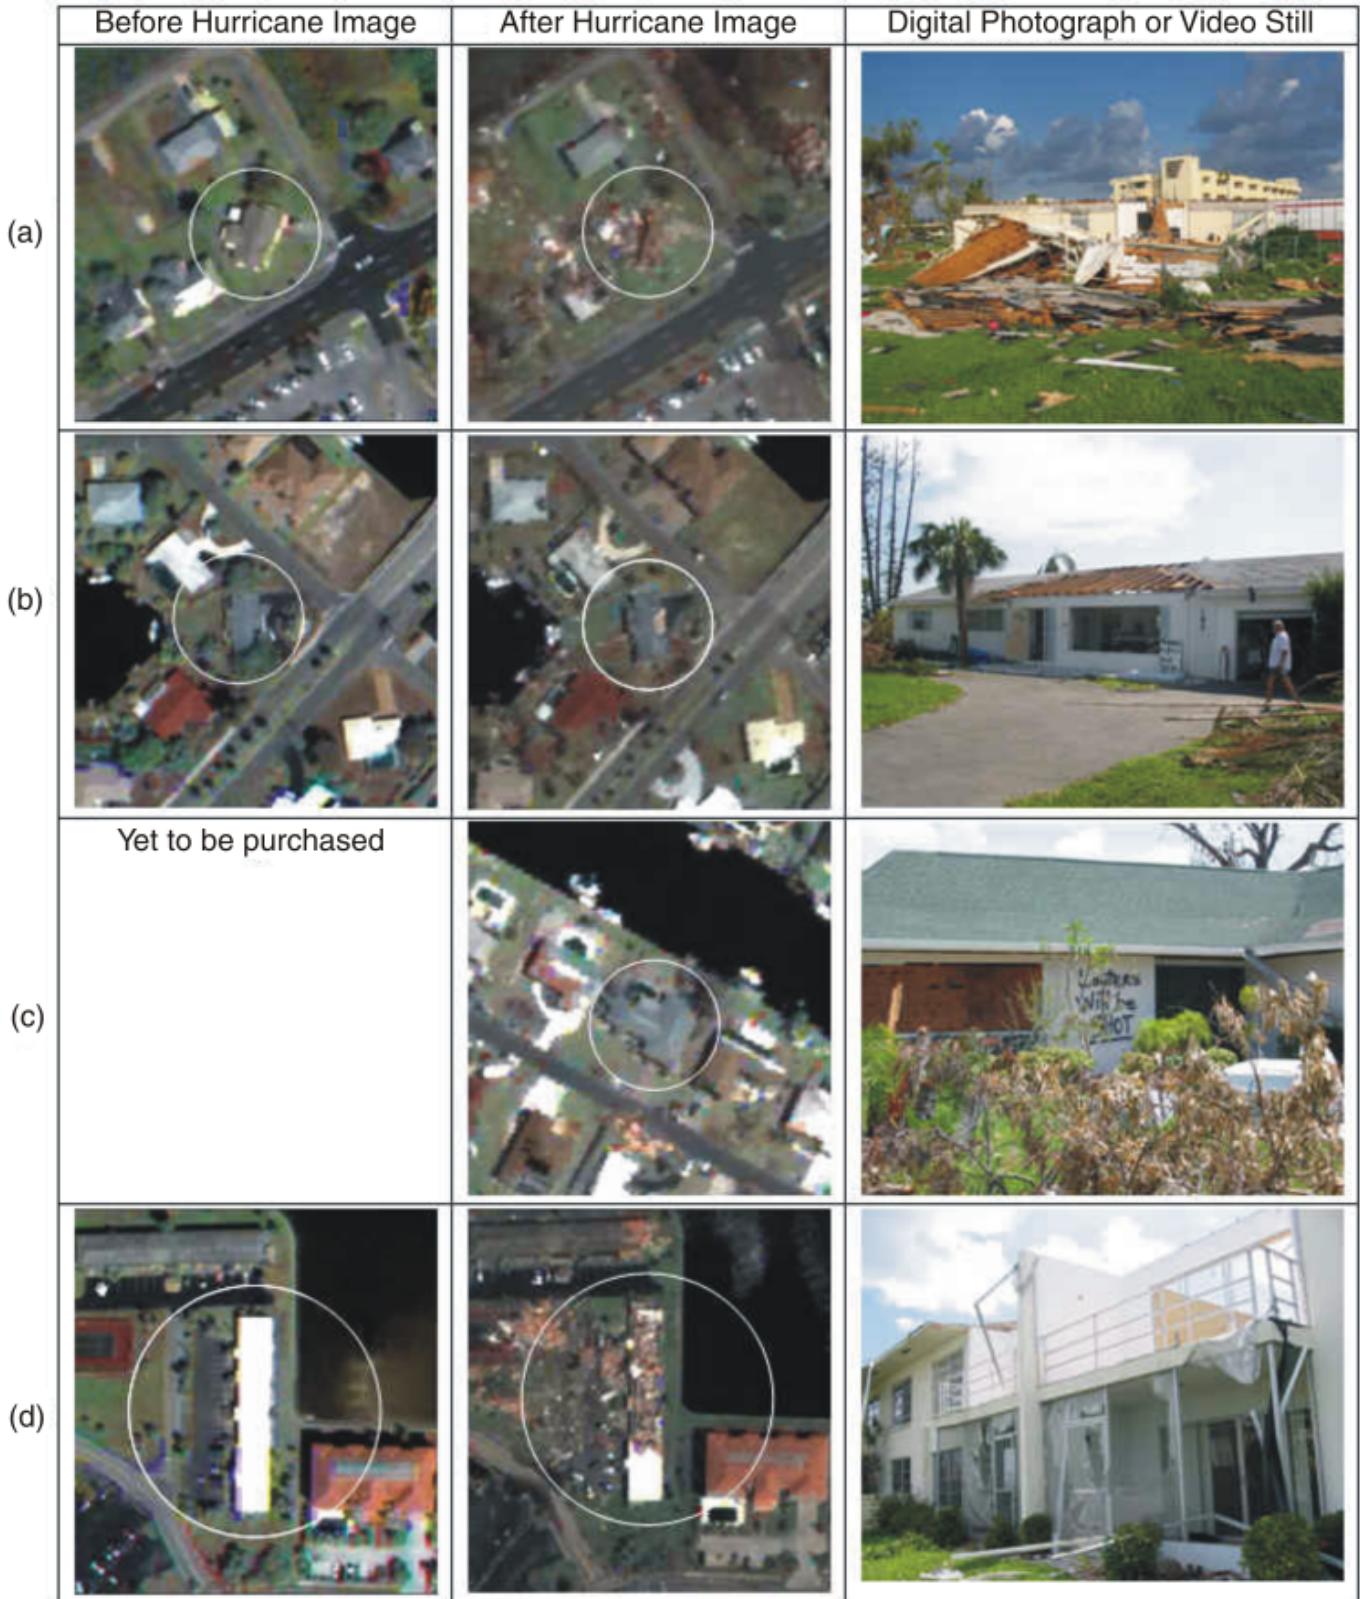
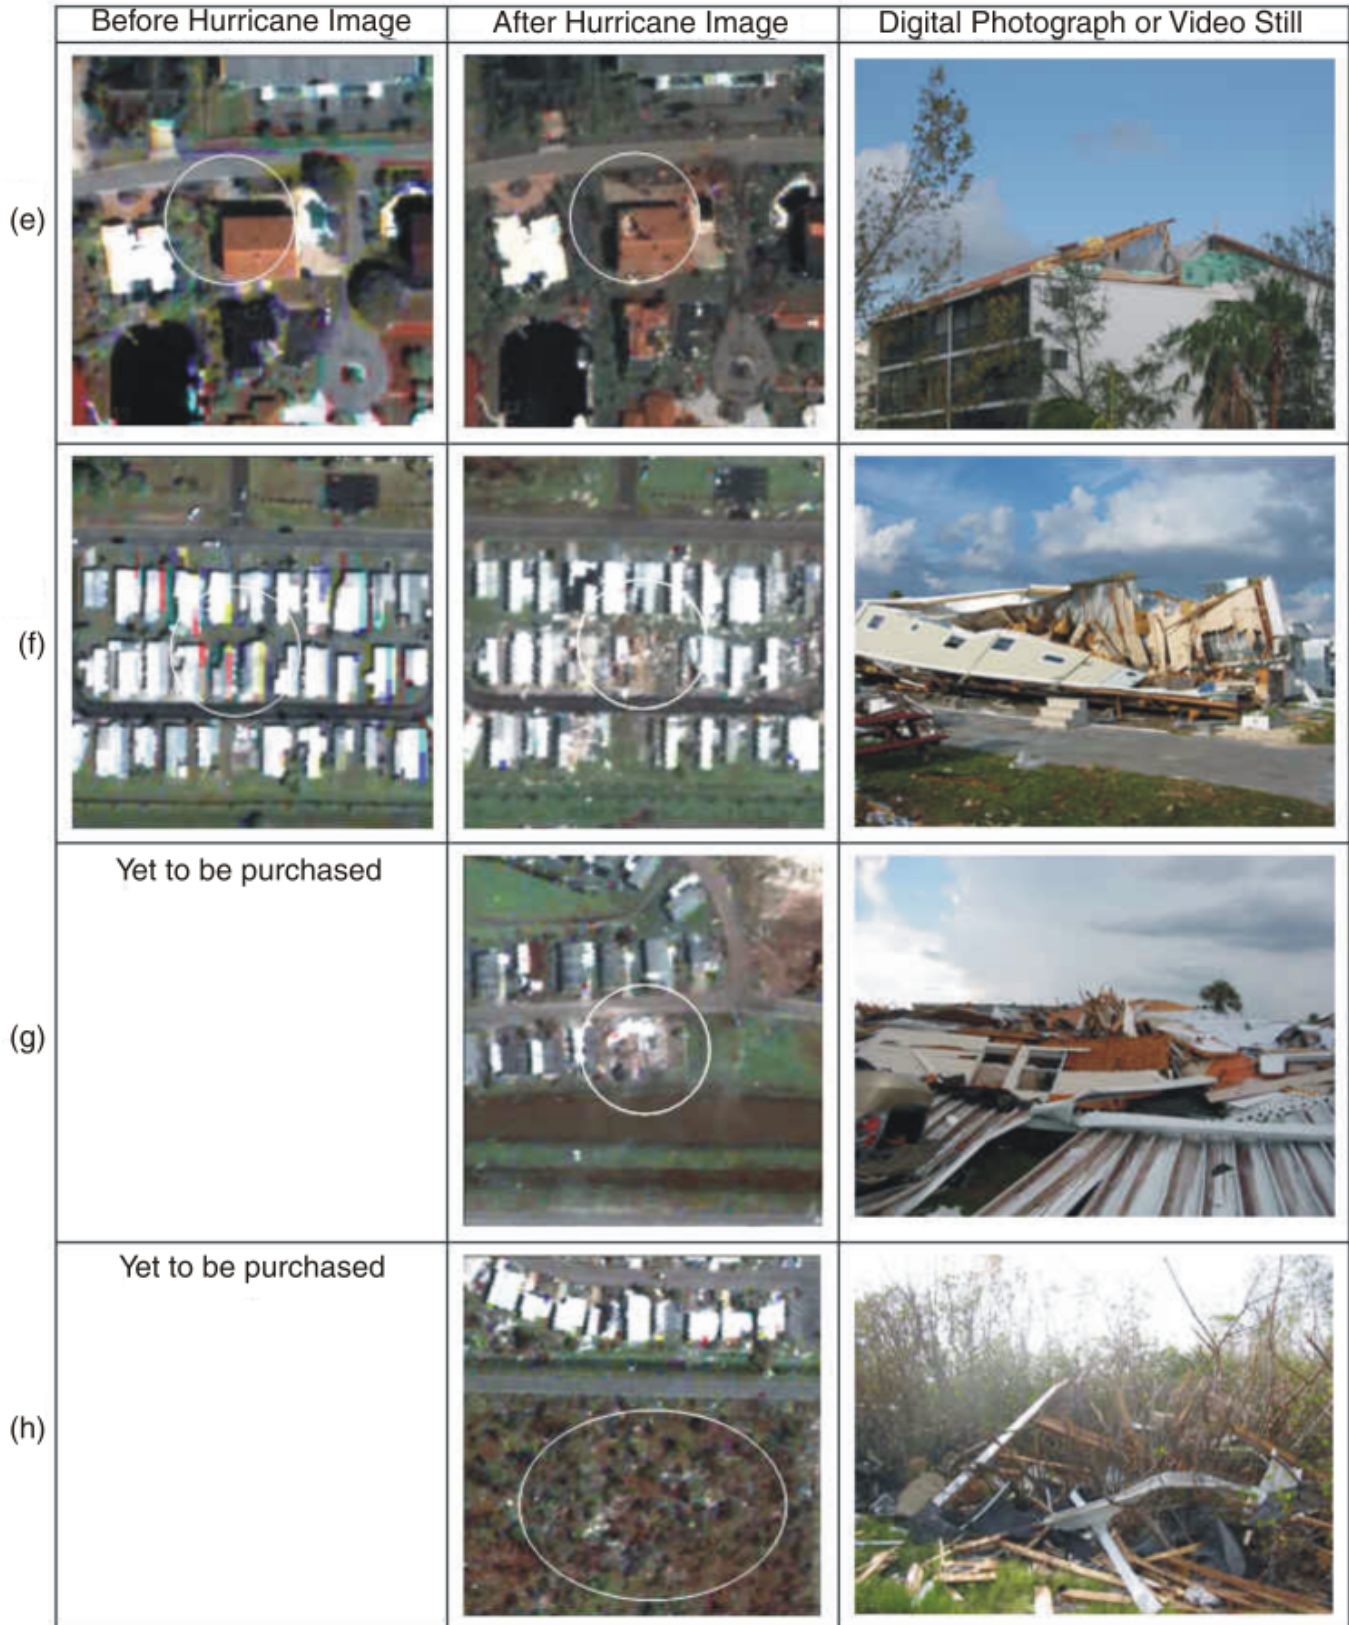
Three main types of residential structure were studied during the survey: (i) single family houses; (ii) apartment complexes; and (iii) mobile homes. For family houses, all levels of damage (see Table 2) were observed, ranging from complete failure of the roof structure (Figure 7a), through partial loss of the roof cover (e.g., tiles and asphalt shingles) and the wooden roof deck below (Figure 7b), to minimal removal of roof coverings (Figure 7c). Figure 7c also illustrates how looting was a major concern in the immediate aftermath of the event. Graffiti-style notices such as this were common throughout all neighborhoods, although in most cases this method was used

to convey the resident's insurance company and claim number. Although difficult to detect from the satellite imagery, damage to garage doors was prevalent and numerous cases of window failure were observed. Where present, wall failure was principally sustained by car ports and pool covers.

Apartment complexes also exhibited mixed performance during the hurricane. As was the case for family dwellings, damage ranged from failure of the roof structure (Figure 7d and Figure 7e) to cosmetic losses of roof covering. Residents' car shelters fared poorly during the storm, with many examples of mangled metal sheeting scattered across apartment parking lots. In many locations, scattered debris

Of the three residential categories, mobile homes sustained by far the highest degree of damage. The field team witnessed numerous examples where mobile homes had been turned into mangled piles of debris (Figure 7f). In some instances, mobile homes had been thrown onto adjacent structures, crushing them both (Figure 7g). Roof cover failure was commonly observed, together with the collapse of attached car ports. Debris from the mobile homes was often scattered across a wide geographic area, extending up to one kilometer from the source. In Figure 7h, highly reflective metallic debris from the

Figure 7. Photo mosaic of damage to residential structures in Port Charlotte and Punta Gorda. For family dwellings: (a) complete roof failure; (b) partial roof cover and roof deck failure; and (c) limited roof damage. For apartment blocks: (d-e) roof structure failure. For mobile homes: (f-g) catastrophic destruction; and (h) scattering of debris across an extended geographic area. For image/photo locations, see Figure 4.

Figure 7 (continued). Photo mosaic of damage to residential structures in Port Charlotte and Punta Gorda. For family dwellings: (a) complete roof failure; (b) partial roof cover and roof deck failure; and (c) limited roof damage. For apartment blocks: (d-e) roof structure failure. For mobile homes: (f-g) catastrophic destruction; and (h) scattering of debris across an extended geographic area. For image/photo locations, see Figure 4.

mobile home park to the north of Van Buren Avenue in Port Charlotte, can be detected in nearby hedgerows and spread across fields to the south.

From a remote sensing perspective, Figure 7f and Figure 7g also illustrate the importance of acquiring both pre- and post-event satellite imagery; it is easier to determine the extent of damage in terms of change with respect to the non-damage scenario. When before imagery is unavailable (as for Figure 7g), interpretation relies on comparison with the appearance of surrounding structures. In the given example this method is also successful, since the degree of damage is high and the mobile homes no longer exhibit a 'normal' rectangular form. However, this approach may prove limited for lesser damage states.

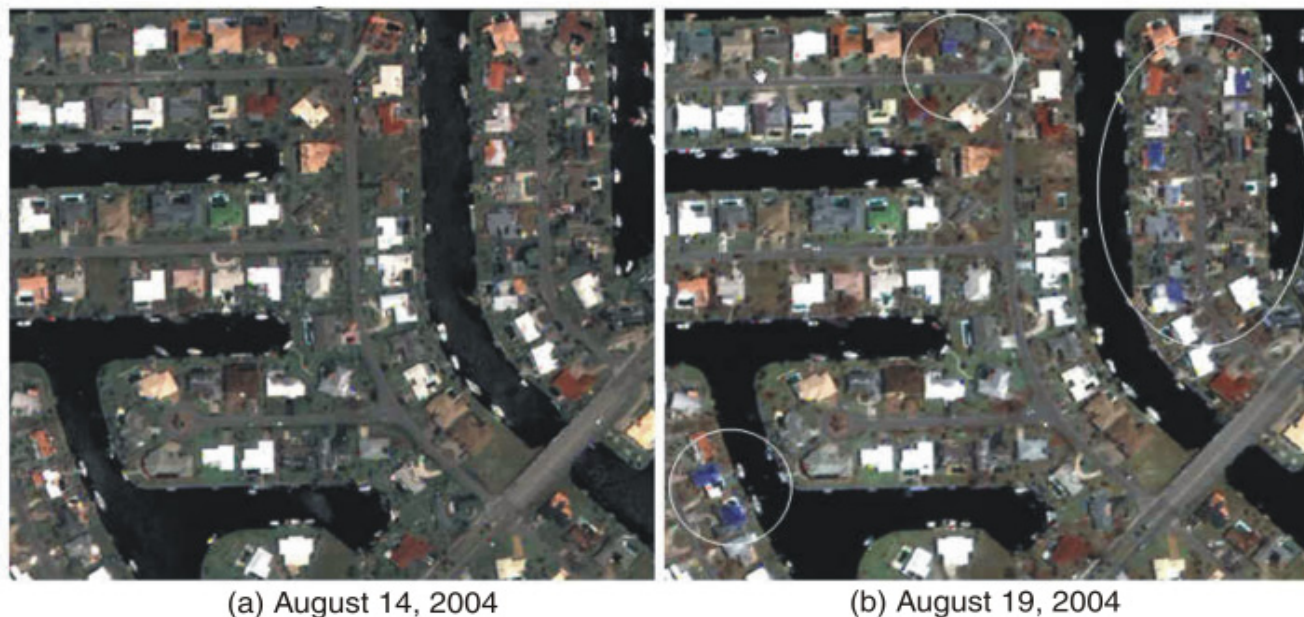
The perishable nature of post-disaster building damage data is borne out by differences to residential properties observed between the two field deployments and between the temporal sequence of 'after' satellite images (see Table 2). In the days immediately following the disaster, many damaged roofs remained exposed to the elements. During the initial field deployment, comparatively few

were tarped, and there was little evidence of repair. At this stage, residents appeared to be focusing on securing of personal effects and building contents and on the clearance of debris and vegetation. Temporary roof-covering materials may have also been in short supply in the local area immediately following the hurricane. During the second deployment, there was a substantial increase in the presence of tarps and plastic covers. This trend is apparent from the Quickbird satellite scenes in Figure 9, which were acquired 1- and 6-days after the hurricane struck. During the second field visit, workers were observed making permanent repairs to the roofs of family dwellings. However, recovery efforts were progressing far more slowly in the mobile homes, where in many cases, debris clearance was only just commencing. Many of the mobile home in these parks are apparently used as winter vacation homes by people living elsewhere, and thus many residents may not have been in the area at the time of the storm to make temporary repairs to their properties.

Figure 9. The perishable nature of building roof damage data is evident by comparing the Quickbird scenes acquired on: (a) August 14, 2004, 1 day after; and (b) August 19, 2004, 6 days after Hurricane Charley. In the latter case, a number of roofs are now tarped.
