MCEER SPECIAL REPORT SERIES  
Engineering and Organizational Issues Before,  
During and After Hurricane Katrina

Damage to Engineered Buildings and Lifelines  
from Wind, Storm Surge and Debris in the  
Wake of Hurricane Katrina

Gilberto Mosqueda and Keith A. Porter

Volume 4

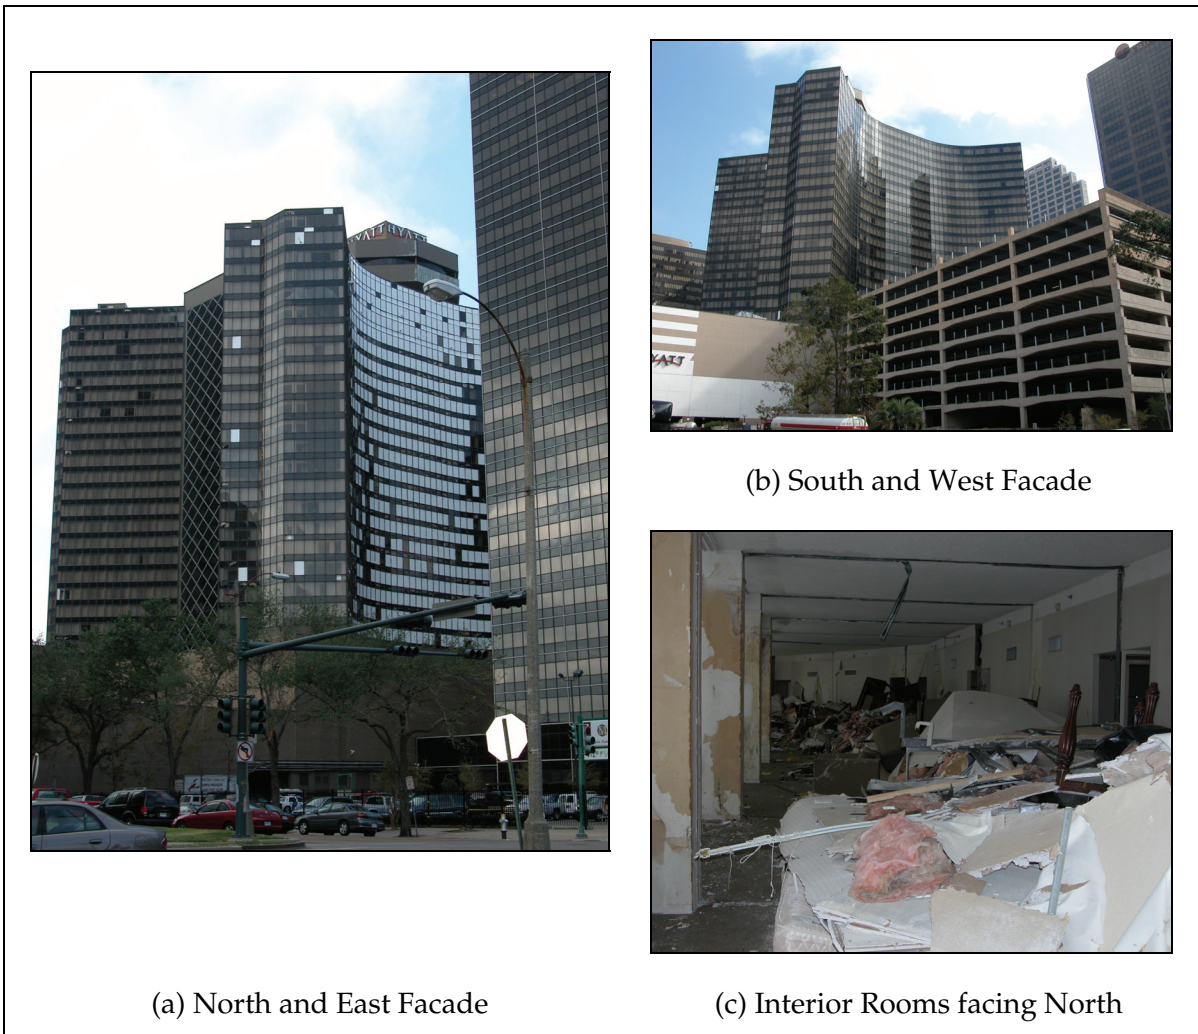
The Hyatt Regency 28-story reinforced concrete building suffered extensive window damage as well as some damage to its asphalt shingle roof, loss of some rooftop fans, and extensive damage to the soffit of a mushroom-shaped rooftop structure housing a bar. Three fourths of the glazing on the north facade curtain wall above the 5th floor broke during the storm as shown in Figure 3-2. The curtain wall comprises 1/4-in tempered single-pane vision glass, and 1/4-in non-tempered single-pane black spandrel glass. Wind, water and wind-born debris including pea gravel infiltrated several of the rooms on the north side, the gravel appeared similar that blown off of the tar and gravel roofing of one or more adjacent buildings north of the hotel. As a result of the damaged exterior, furniture, carpets and gypsum drywall that were dampened by the infiltrating water were infested with mold and were being removed at the time of investigation. This building has no basement and stands on a site slightly above the highest level of flooding. (One block to

*Figure 3-2. The Hyatt Regency Hotel in the New Orleans Business District had extensive window damage on the north facade (a) and limited damage on other sides (b). Broken windows allowed wind-driven rain and debris into the building causing additional interior damage (c).*

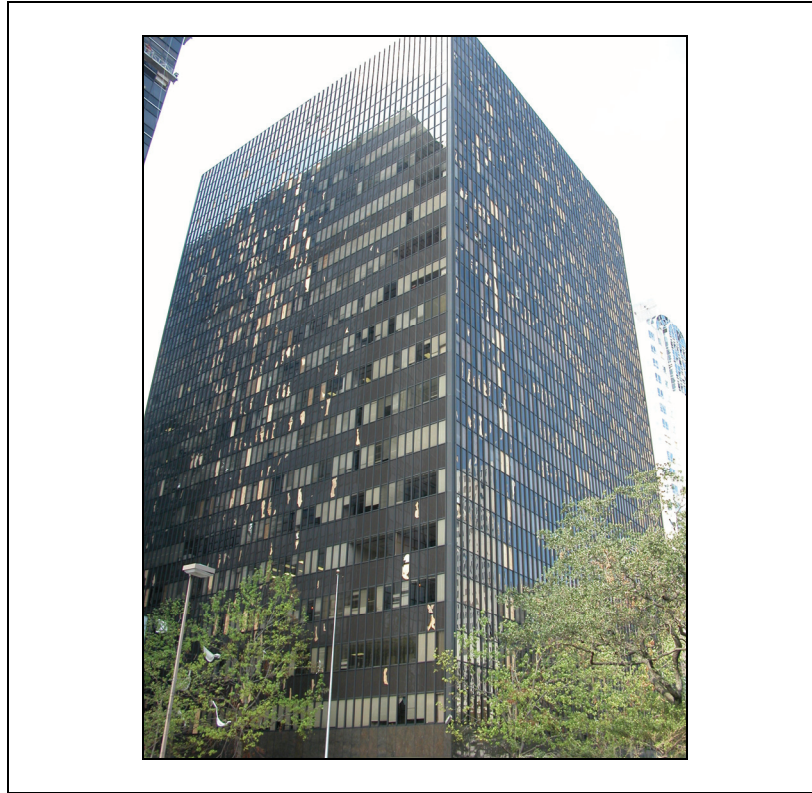
The Amoco Building is an approximately 24-story high-rise in downtown New Orleans to the north west of the Hyatt Regency. This building also suffered extensive damage to its glass curtain wall, with 10 to 20% of its glazing broken. Although close inspection was prevented, the glass was judged to be likely 1/4-in annealed. Eastbound lanes of Poydras St. just north

*Figure 3-3. The Amoco building in New Orleans Business District had extensive window damage on the north and east facades and limited damage on other sides*

of the building were closed because of the risk of falling glass from broken windows. It may be noteworthy that, though the east facade of the Amoco building was heavily damaged (Figure 3-3), the east facade of the adjacent building to the east was largely undamaged (Figure 3-4). These two structures and the Hyatt directly south of them enclose a narrow space, which could perhaps have produced local vortices that aggravated the window damage in the plaza. This serves as a possible explanation to the difference in performance of the east facades of the two buildings. The north facade of the Hyatt, which was also heavily damaged, faces the enclosure.

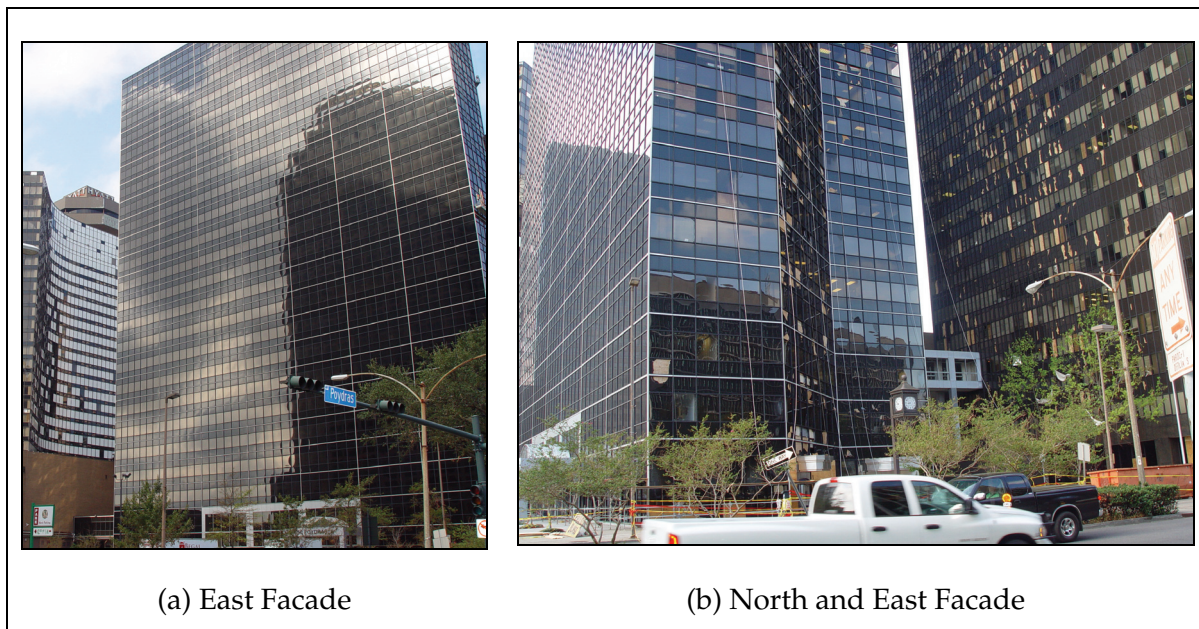
1250 Poydras is a 24-story building on the southwest corner of Poydras St. and Loyola Ave. and adjacent to the Hyatt and Amoco buildings. Although the east facade appears to have suffered no damage, the backside of the building adjacent to the Amoco building, had significant window damage as shown in Figure 3-4. Note the proximity of this building on the left of Figure 3-4(b) to the Amoco building shown on the right.

*Figure 3-4. This office building in the New Orleans Business District had extensive window damage on the west facade (a) and limited damage on opposite sides (b).*

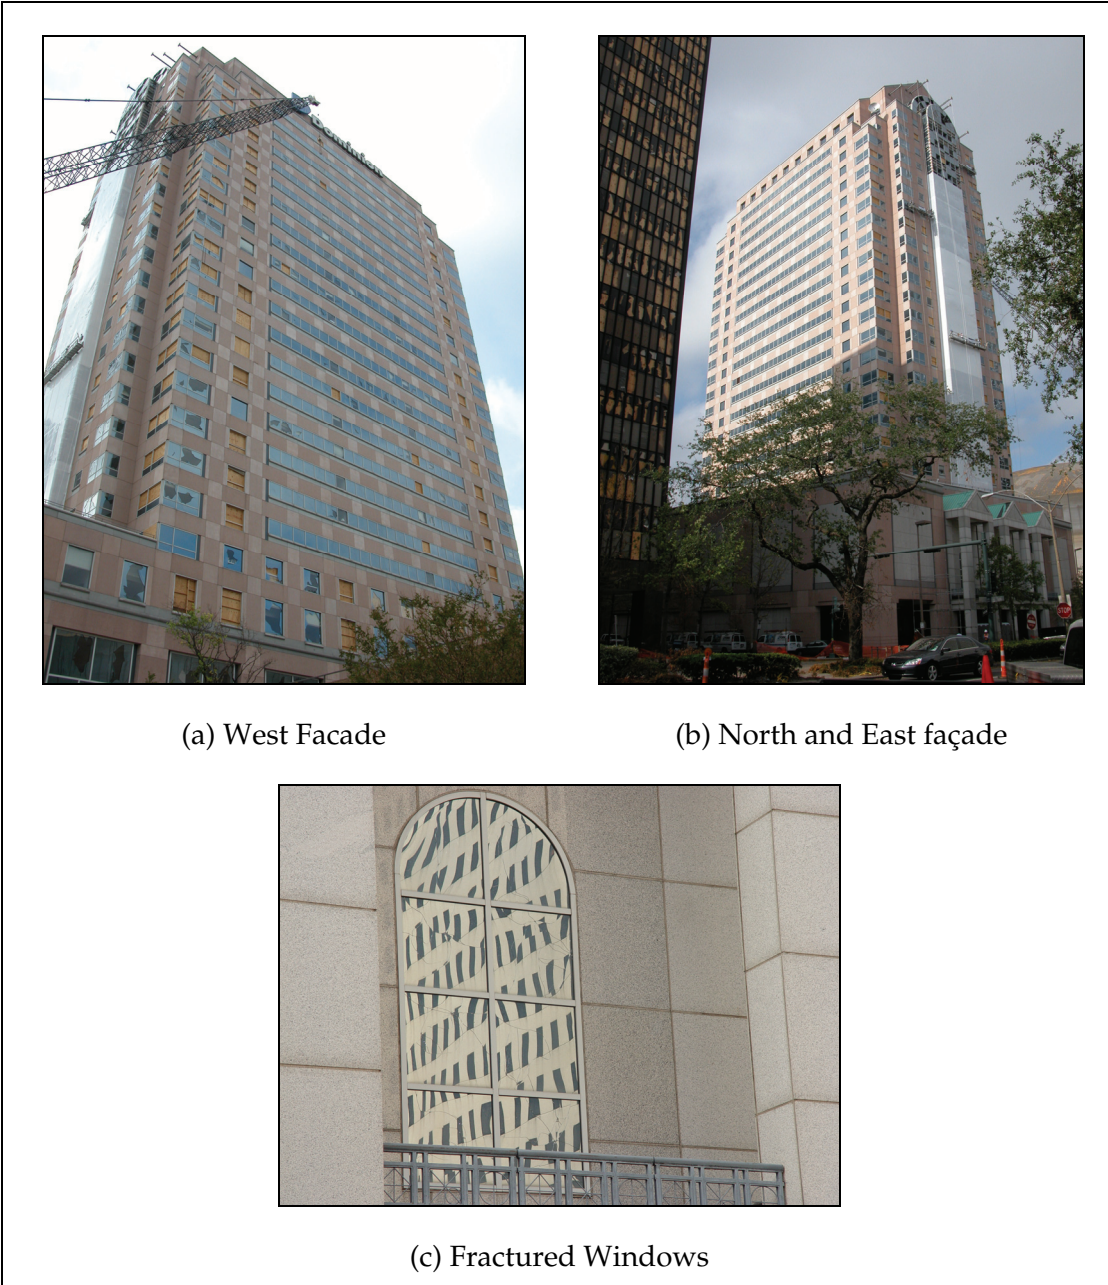
The Dominion Tower is 25-story high rise commercial building to the west of the Amoco building, and just east of the New Orleans Superdome. Glazing on this building also suffered widespread damage. About half of the windows on the north and west facades were broken as shown in Figure 3-5. Windows on the east facade appeared to have suffered minimal damage. The glazing was a mix of 1/4-in insulated and annealed glass. Safety film appears to have prevented fallout of some broken glass as shown in Figure 3-5 (c).

*Figure 3-5. The Dominion Tower in the New Orleans Business District had extensive window damage on the north and east facade (a) and limited damage on other sides (b). Many windows were fractured but remained in place.*

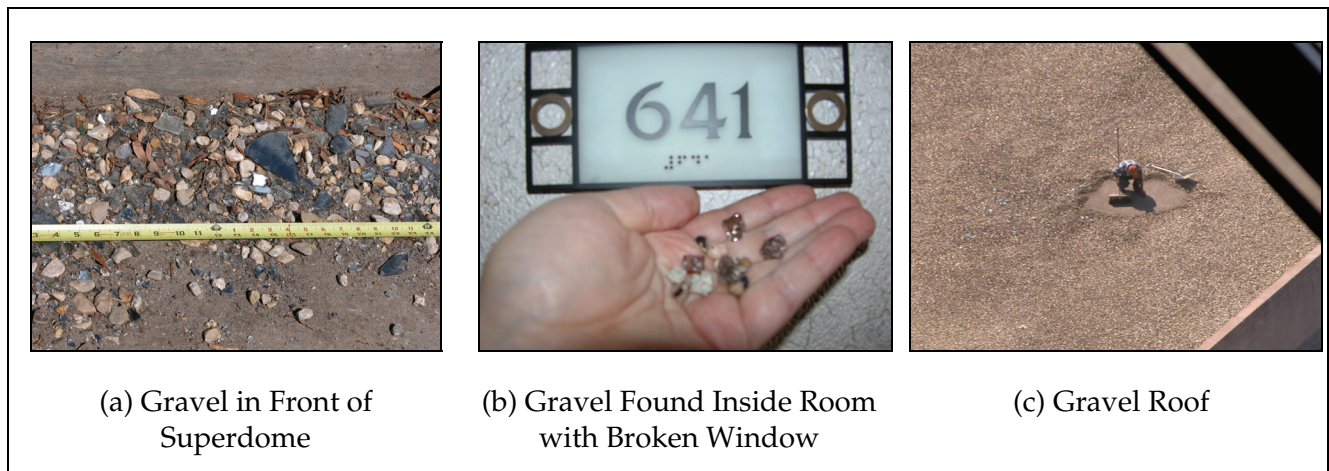
(a) Gravel in Front of Superdome

(b) Gravel Found Inside Room with Broken Window

*Figure 3-6. Gravel found on adjacent street curbs and inside substantially damaged buildings in New Orleans (a/b). Source of gravel was likely roofs from building upwind of damaged windows(c).*

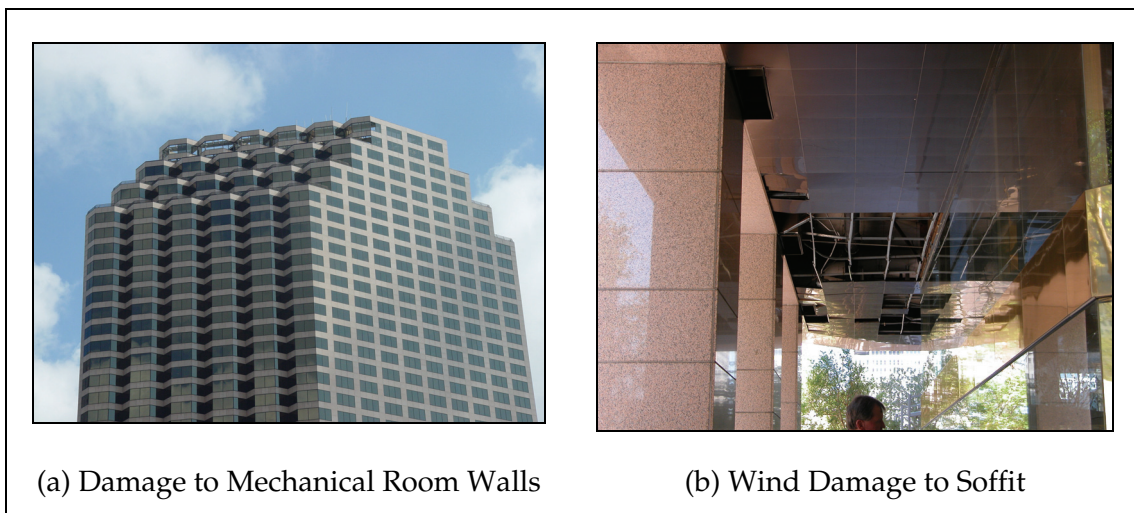
(a) Damage to Mechanical Room Walls

(b) Wind Damage to Soffit

*Figure 3-7. Only visible damage to this building appeared to be broken windows on upper levels corresponding to mechanical rooms and soffit near the main entrance.*

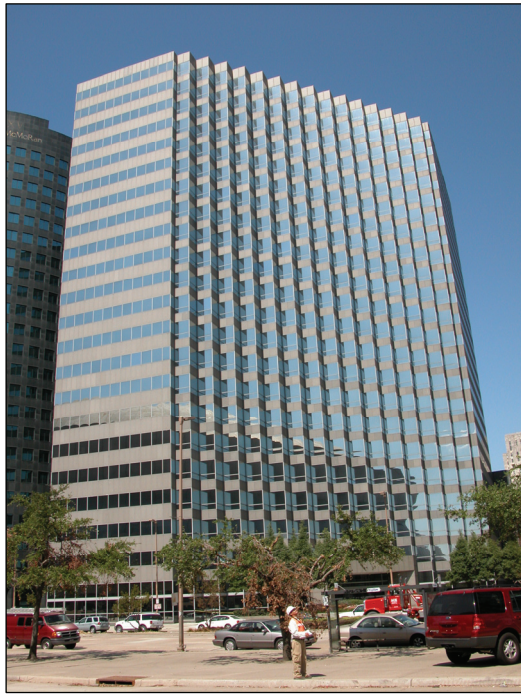
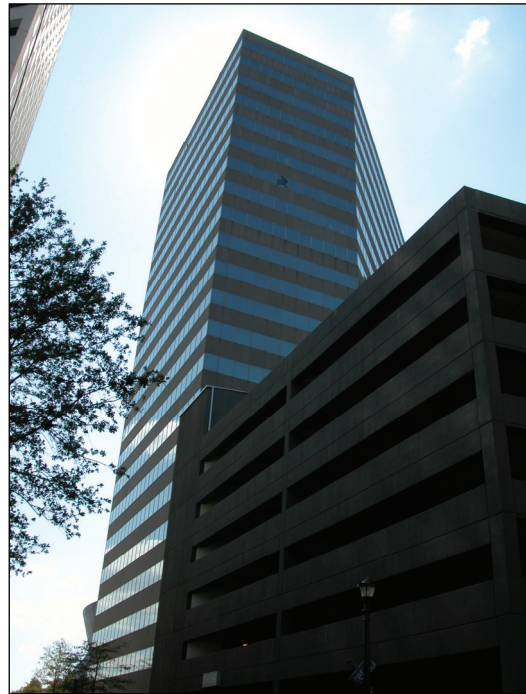
*Figure 3-8. Office building in the New Orleans Business District was exposed to wind forces and 1-2 feet of flooding but quickly recovered.*

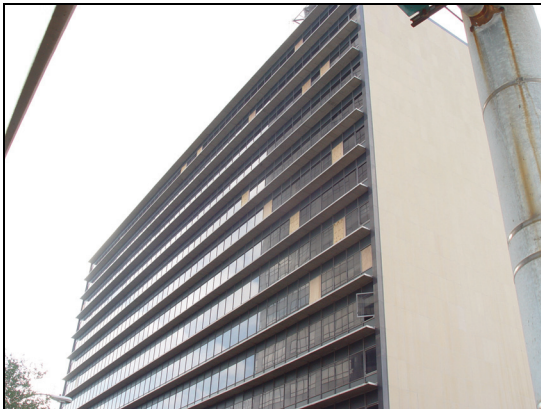
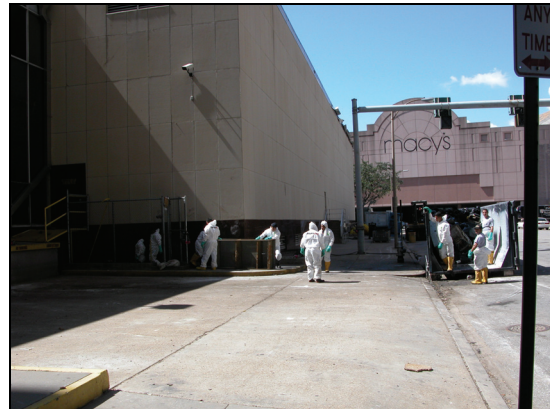
The US Postal Services Building in the New Orleans Central Business district appears to be a 14-story steel-frame building. The south facade of the building had about five broken windows that were boarded up as shown in Figure 3-9. More window damage occurred on the north side shown in Figure 3-9(a), yet fewer than 2% of the windows were fractured. Likely, the most significant source of damage to the Postal Service Building resulted from flooding in the basement. There was no evidence of flooding above the street level at its location. At the time of inspection, the basement flood water had been pumped out and removal of all furniture, electronic components and other items was in progress. Figure 3-9(b) captures the remediation efforts to clean out mold and contaminated equipment from the flooded basement.

*Figure 3-9. The US Postal Service Building had a few fractured windows and flooded basement, though there was no flooding at street level.*

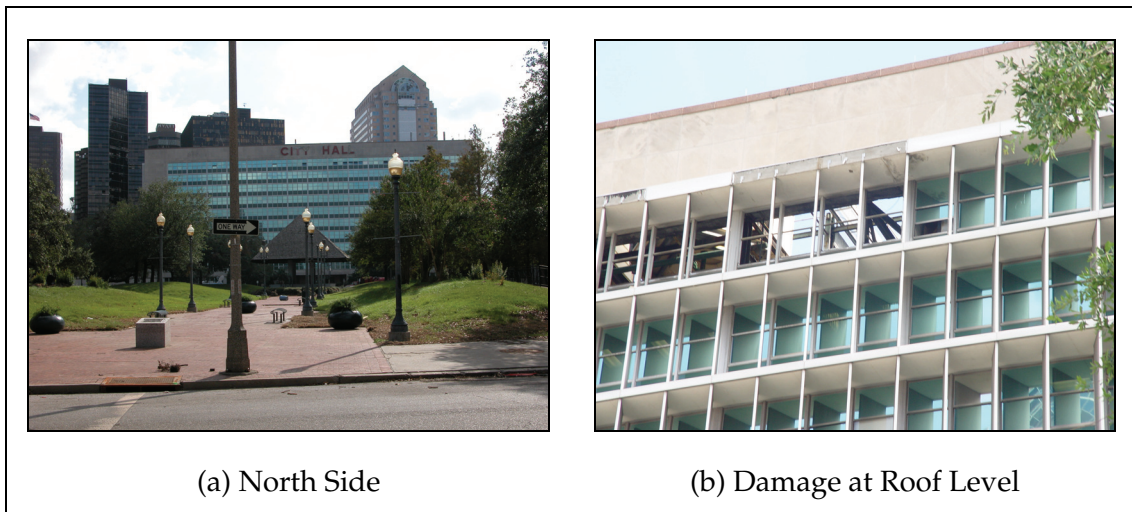
The nine-story City Hall building in New Orleans appeared to have suffered no significant damage during the hurricane. The structural framing appeared to be made of steel. The building was in service at the time of the investigation as indicated by the high traffic of city employees using the south entrance. Potable water was not available, thus occupants were cautioned against coming in contact with the water. Electric power and phone service was currently available in this and surrounding buildings. There were no apparent watermarks above the street level to indicate flooding in the area. Figure 3-11 shows the north side of the building with several open windows at the top level. The only noticeable damage was concentrated on the south side and included a one-third row of broken windows on the top story. Daylight was visible through a few of these windows, indicating that this section of the building was probably used to house mechanical equipment. If roof damage had occurred, the building would have had extensive water damage and likely be out of service. The building is located just north of the Amoco building which suffered extensive glazing damage.

*Figure 3-11. New Orleans City Hall suffered damage mainly at the roof level.*

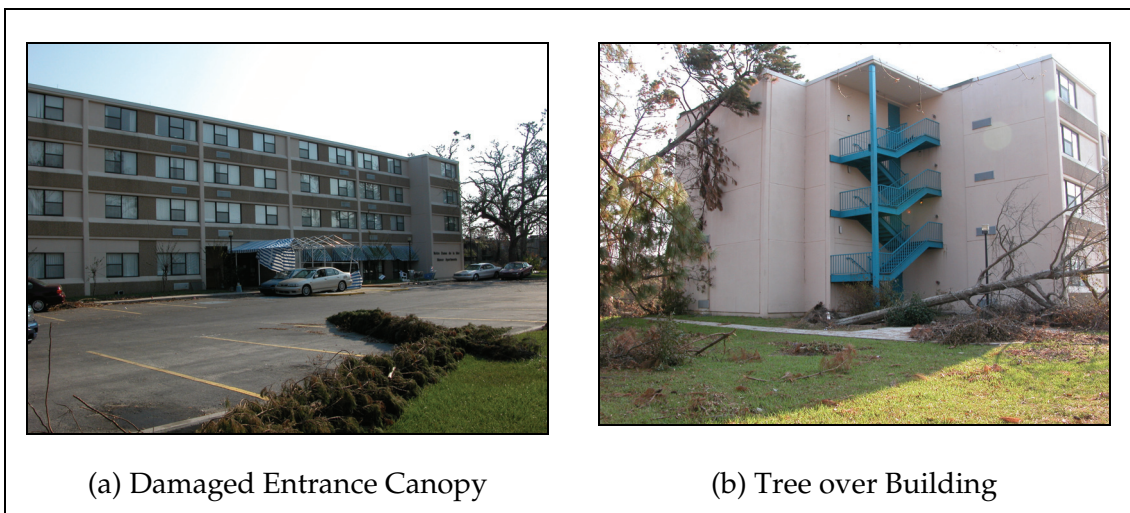
The “Notre Dame de la Mer Manor Apartments” suffered only minor damage despite being located in one of the areas hardest hit by Hurricane Katrina. The four-story reinforced-concrete shear-wall building shown in Figure 3-12 is located on US-90 about 0.5 miles west of the St. Louis Bay Shoreline. Powerful storm surge and winds in the area are evident by the displaced cars in the parking lot shown in Figure 3-12(a) and trees falling onto the building in Figure 3-12(b). The only damage readily apparent on the exterior on this building was one broken window in the rear of the building and a collapsed canopy at the main entrance. Windows in the upper stories of the building were open at the time of inspection, indicating that residents had returned to the building.

*Figure 3-12. Apartment building in Bay St. Louis.*

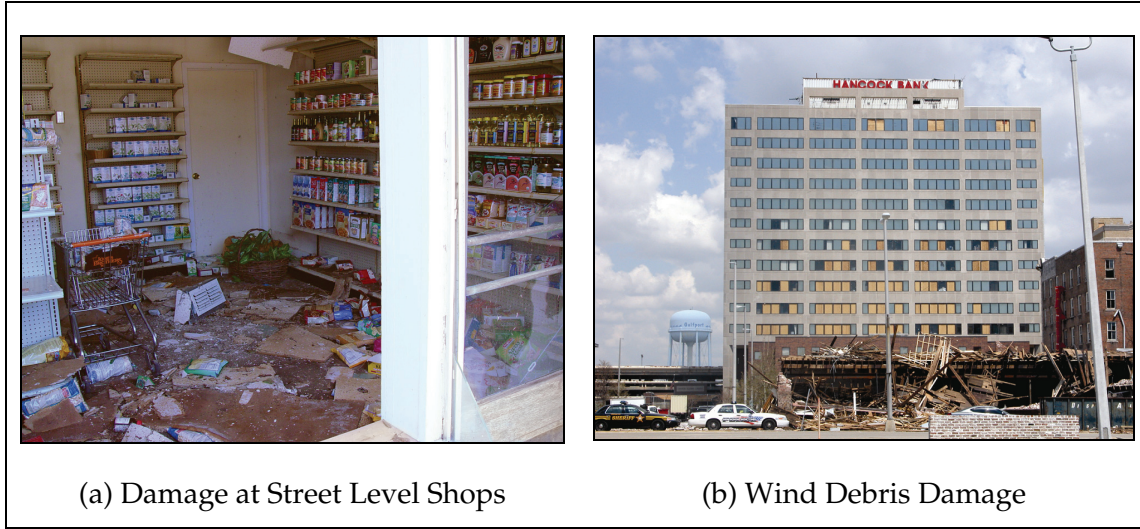
The downtown area of Gulfport, Mississippi, located about one-half mile north of the shoreline, generally appeared to have experienced 1-2 feet of storm surge. All of the buildings in the region had water damage at the ground level, as shown in Figure 3-14(a). Many other buildings had additional wind and wind-debris related damage at the upper stories. A few collapsed buildings were observed in the area as well. Figure 3-14(b) shows a collapsed unreinforced masonry structure at the forefront. The background shows the Hancock Bank building, which appeared to be the tallest building in the downtown area at 14 stories. About 30 percent of the windows were shattered on the south face above the third level. The windows that appear tinted black lost the exterior pane only. The concentration of damage at the lower levels suggests that the windows were shattered from debris picked up by the wind from the ground. At the time of investigation, restoration efforts were under way to clear debris and repair water damage to building interior from water that penetrated it through the damaged windows.

*Figure 3-14. Flooding and wind damage in downtown Gulfport.*

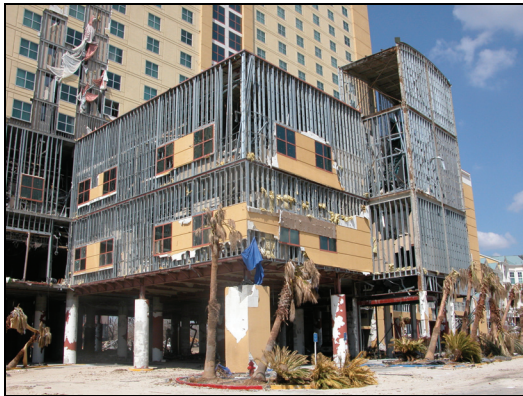
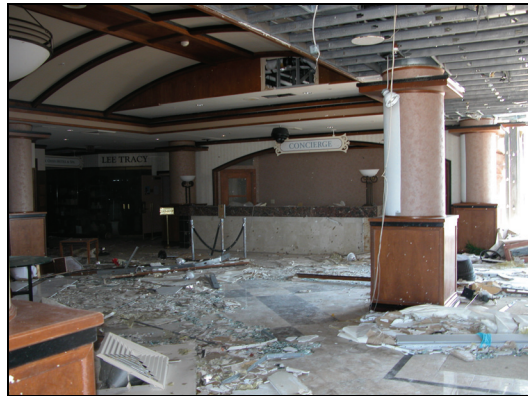
The extent of damage along the Mississippi coast is demonstrated by the beachfront 17-story Grand Casino Hotel constructed of reinforced concrete frame with shear walls. The approximately 20 ft. first story was partially enclosed, probably with break-away walls, to serve as a welcome lobby with access to stairs and elevators. Only the bare structural concrete columns and shear walls remained at this first level, with all else apparently swept away by the storm surge. The second and third stories, with heights of about 15 feet each, housed reception, shops and banquets rooms, among others. A light steel frame extended these two levels over the drive-thru valet parking. The exterior of these two stories suffered extensive damage to cladding. Figure 3-15(a) shows the front view (east facade) of the hotel building, and the exposed nonstructural framing. The building exterior was finished with layers of gypsum board, Styrofoam foam board that allowed for contouring the surface, and fabric lathe with a thin coat of colored plaster. These finishes were stripped from the nonstructural steel stud framing. As a result of exterior damage, high winds entered into the building and destroyed the interior space as shown in Figure 3-15(b). The exterior cladding was also stripped at several locations above the third-story level, exposing the steel stud framing. The casino barge associated with this hotel remained anchored

(a) Exterior Damage

(b) Interior Damage

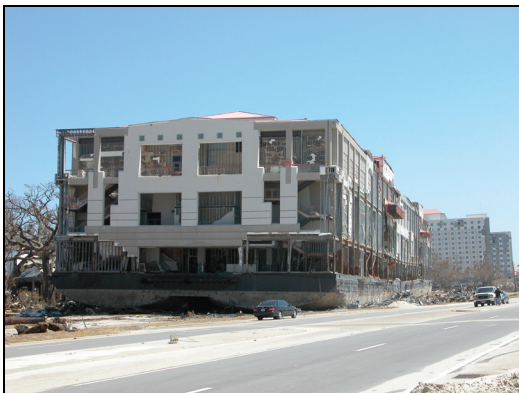
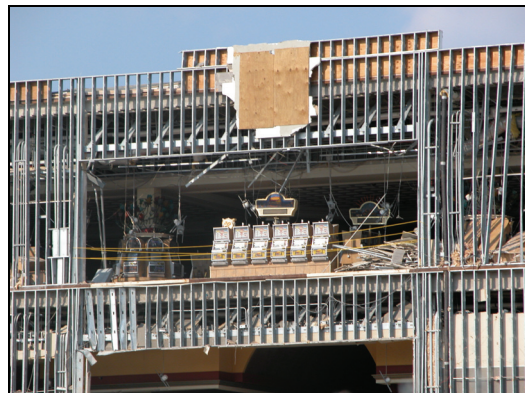
Many casinos, which were originally stationed along the Mississippi shoreline, were carried inland by the storm surge. A few of the casinos were deposited north of the coastal US 90 as shown in Figure 3-16(a). Impact between the barges and structures along the coast resulted in the partial collapse of at least one building and one parking structure. The casinos themselves were severely damaged on the exterior and interior. Figure 3-16(b) shows a close-up view through the third-level opening of another casino that crossed the US-90.

(a) Barge on Land

(b) Damage to Barge

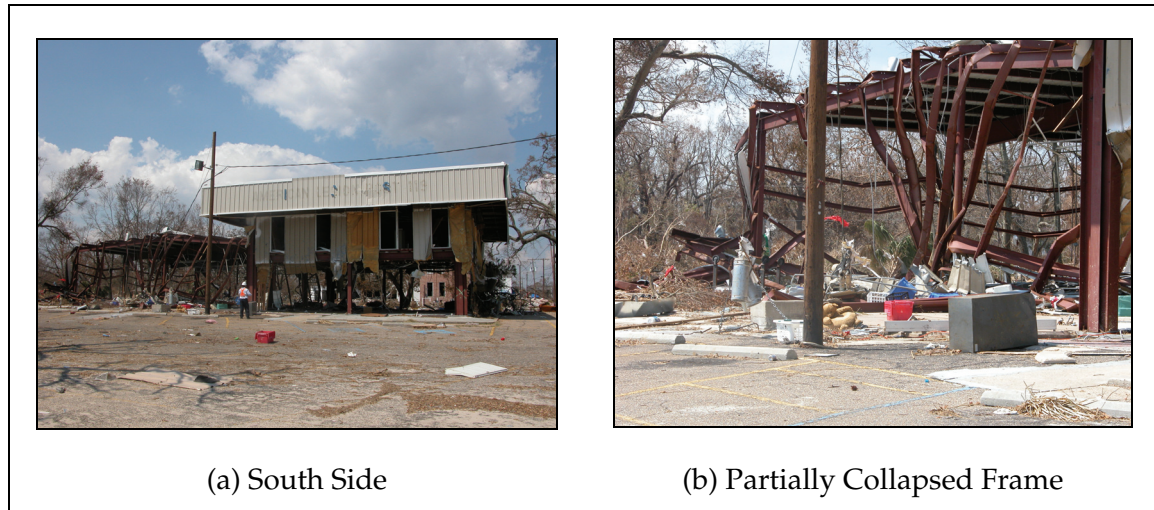
A light steel frame building located on US 90, opposite to the coast in Gulfport, was also severely damaged. The building consists of a two-story rectangular frame adjoined with a single story frame that appears to have served as an auditorium for the American Legion Post 119. The majority of the cladding, made of insulated metal panels, has been stripped from the frame as shown in Figure 3-17(a). Also, the southern bay of the single story portion of the building collapsed as shown in Figure 3-17(b).

*Figure 3-17. Damage to steel building in Gulfport coast.*

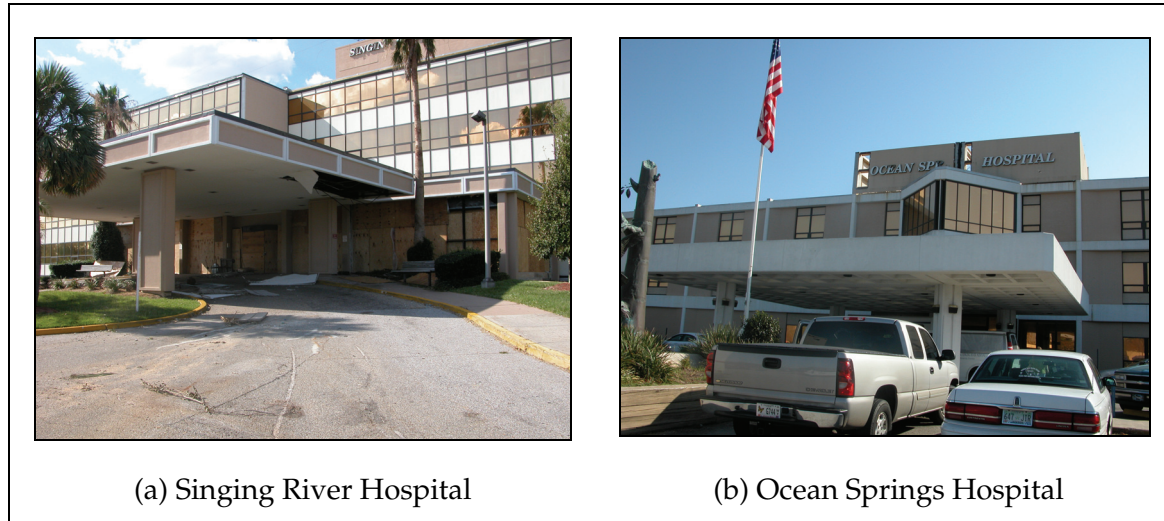
Oceans Spring Hospital shown in Figure 3-19(b) is part of the Singing River Hospital system. Similar to the Singing River Hospital building in Pascagoula, MS, the hospital building suffered minor structural damage.

*Figure 3-19. Hospitals in Mississippi mile at a distance from the coast had minor damage and remained operational through storm.*

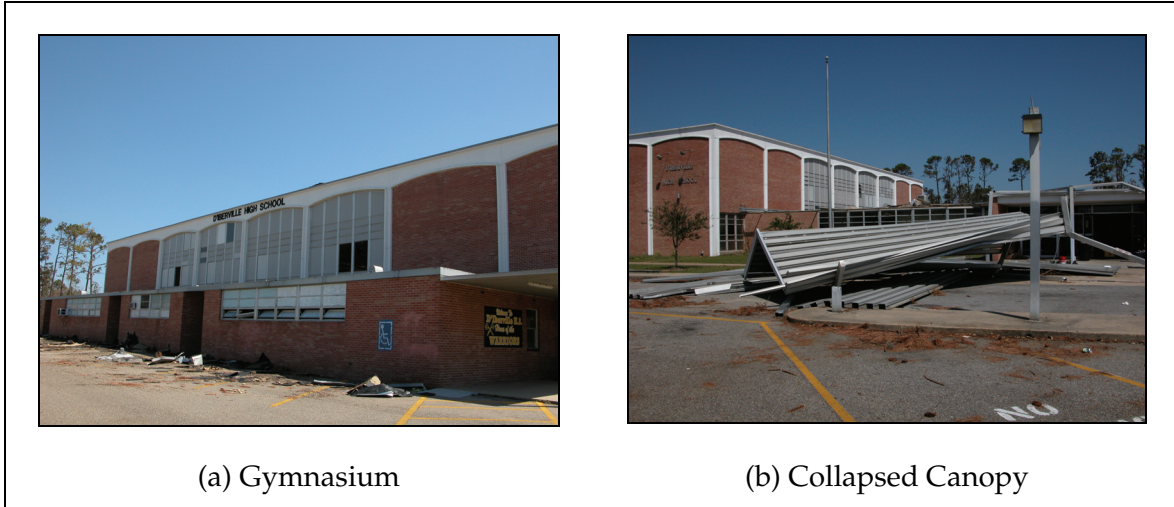
rooftop air conditioning units were damaged, and a 25-ft-by-50-ft light metal entrance canopy shown in Figure 3-20(b) was destroyed. The gymnasium structure, a concrete or steel-frame building, suffered damage to its masonry veneer. The school is located in a suburban neighborhood, in an area that was lightly wooded with pine trees; there was a debris field of pine boughs and pinecones. Approximately 10% of the windows were broken.

*Figure 3-20. D'Iberville high school in Biloxi Bay.*

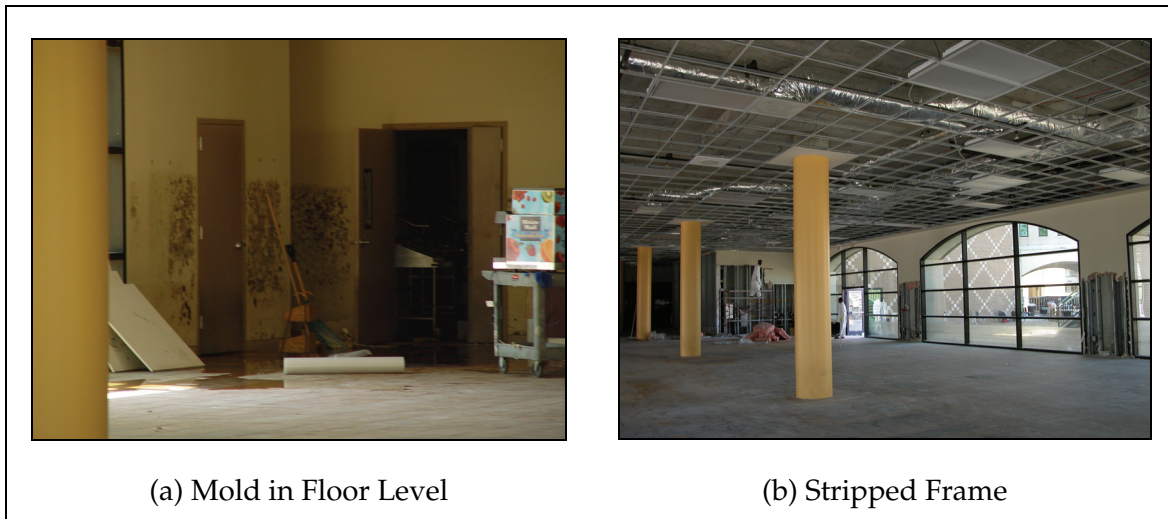
*Figure 3-21. Flood damage to new student center in university near New Orleans.*

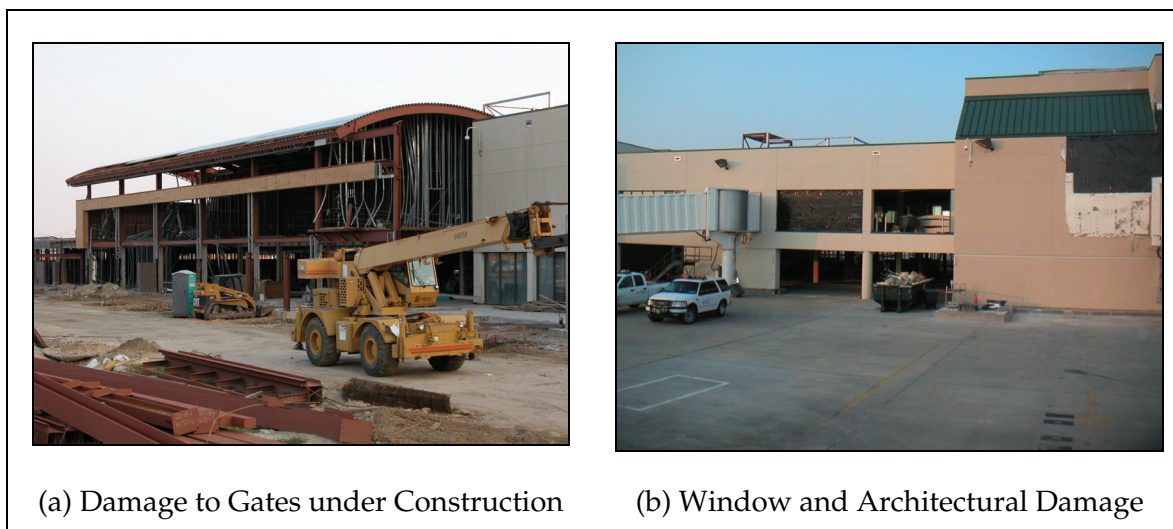
The three-story Gulfport-Biloxi International Airport shown in Figure 3-22 was served by four major airlines, had four existing gates and two under construction at the time of Hurricane Katrina. Its structural system is a steel moment frame clad with gypsum wallboard partition over metal studs. There was no flooding in the terminal and no structural damage, although window breakage and roof damage caused extensive architectural damage to two of four gates. Some window breakage occurred in the air traffic control tower, but not at the level of the control room. There was extensive damage to

*Figure 3-22. Gulfport-Biloxi airport was under construction and suffered damaged to existing and new gates.*

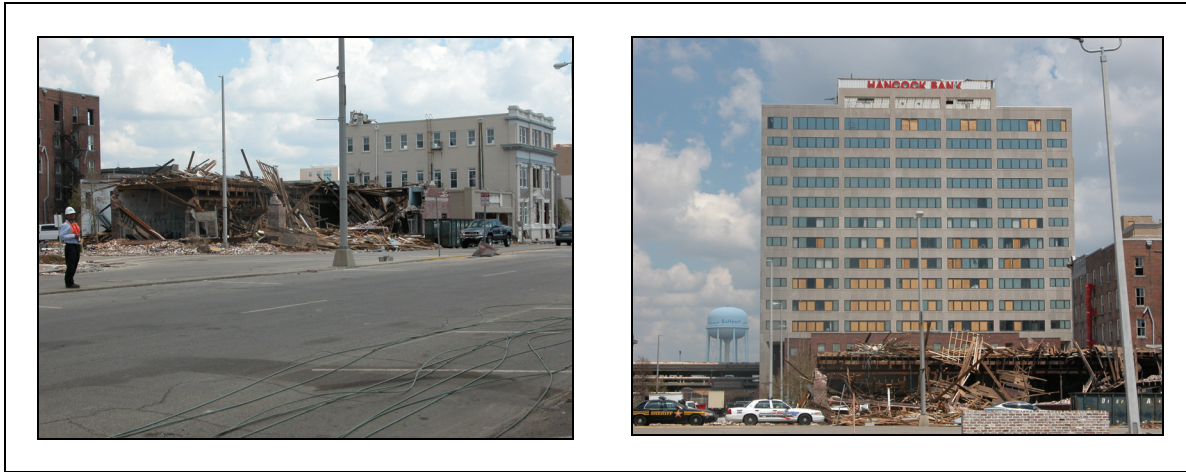
*Figure 4-1. Left: partial collapse of unreinforced masonry bearing-wall building, downtown Gulfport MS. Debris from this building may have impacted a high-rise building downwind, causing extensive wind damage (right).*

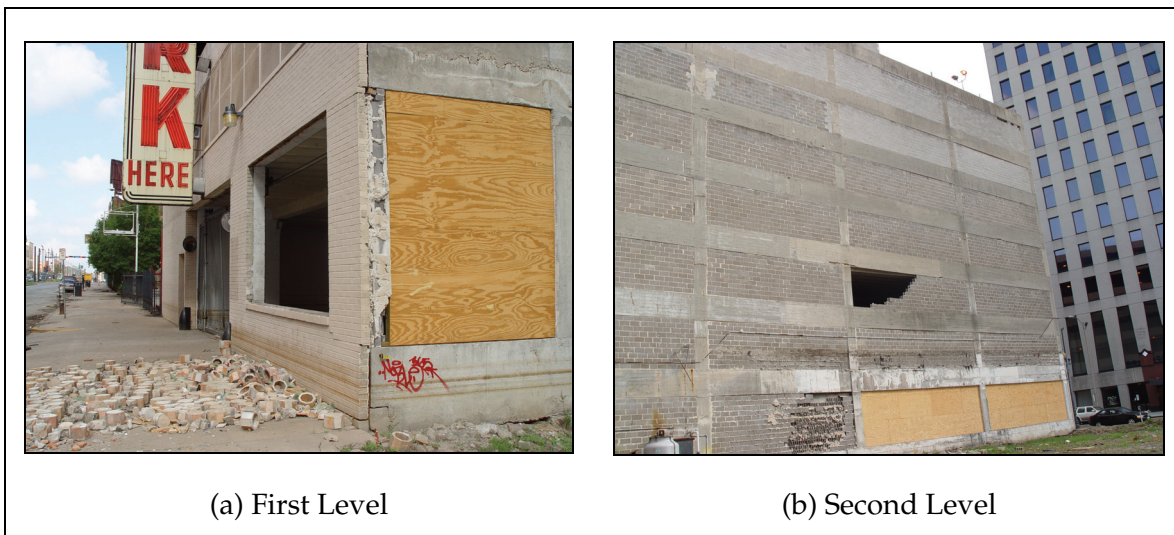
*Figure 4-4. Masonry infill damage.*

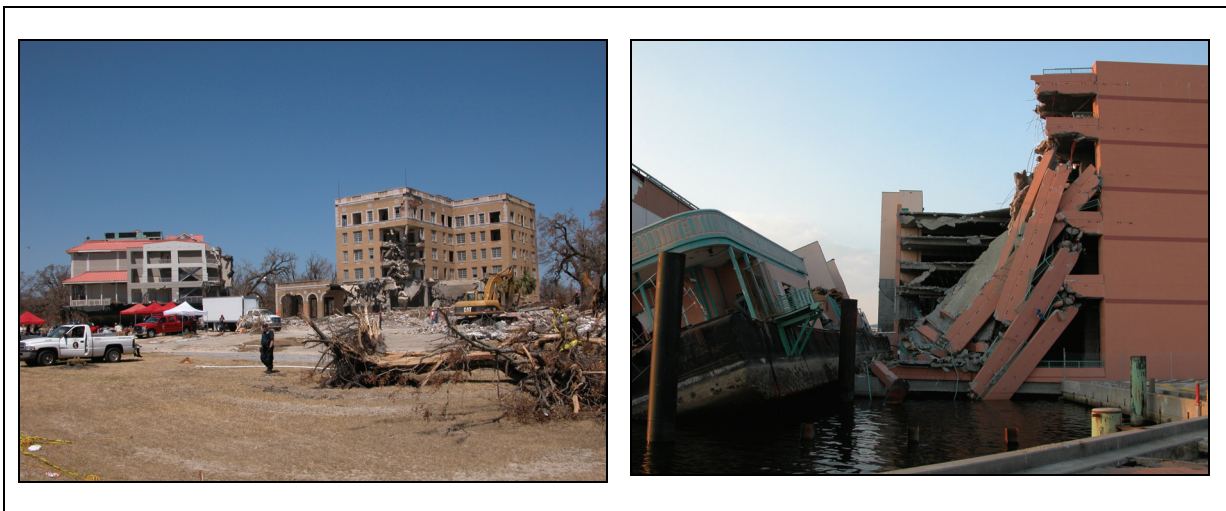
In a similar situation, a five-story (six-level) parking structure constructed of cast-in-place reinforced concrete partially collapsed. The parking structure formed part of a hotel and casino complex in Biloxi, with adjacent barges housing the gambling halls. Four bays on the west facade collapsed, apparently because of impact from the adjacent casino barge that impacted four columns as it was raised by the storm surge (Figure 4-5 right).

*Figure 4-5. Structural damage resulting from surge-borne debris.*

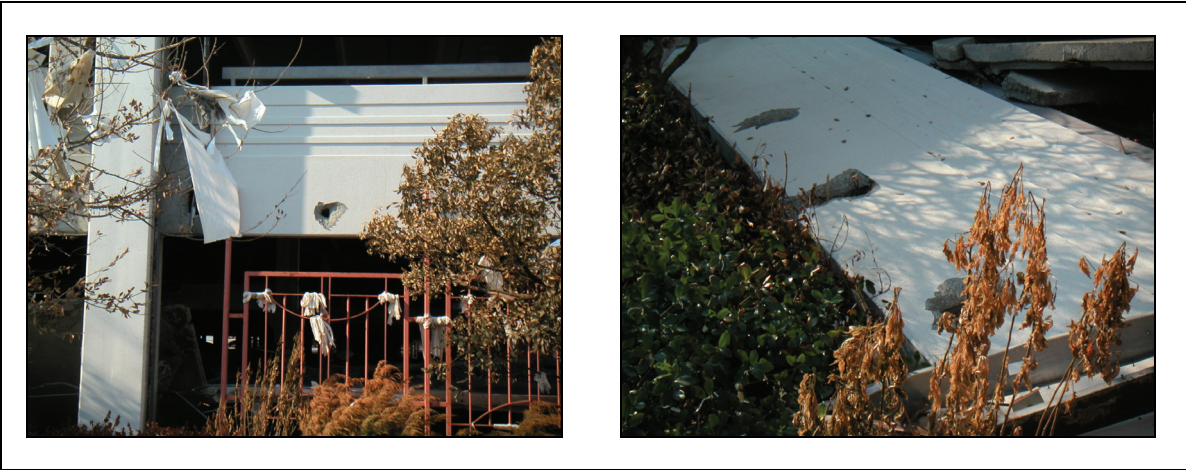
The concentration of collapsed deck on the seaward side, where wave action would be strongest, implies that wave action played a role in the collapse, either vertically, through uplift of the deck beams, or horizontally via the spandrel beam. Evidence of horizontal pounding by waves can be seen in Figure 4-6. Note the holes in spandrel beams where the shear key in the end of the deck-beam web notched into the socket of the spandrel beam; the shear key appears to have punched the holes. But this horizontal action may not have been the principal cause of the failure. In some cases, the collapsed deck beams had been oriented parallel to the seashore, as in Figure 4-7; in others, perpendicular to it, as in Figure 4-8. In some cases, the spandrel beam rested on the outside of the column (Figure 4-9), and could only have moved inward at mid-span, in flexure. (Some flexure, of course, is clearly possible, as shown in Figure 4-10).

*Figure 4-6. Evidence of horizontal pounding by waves. Deck-beam shear key appears to have punched holes in the spandrel beam.*

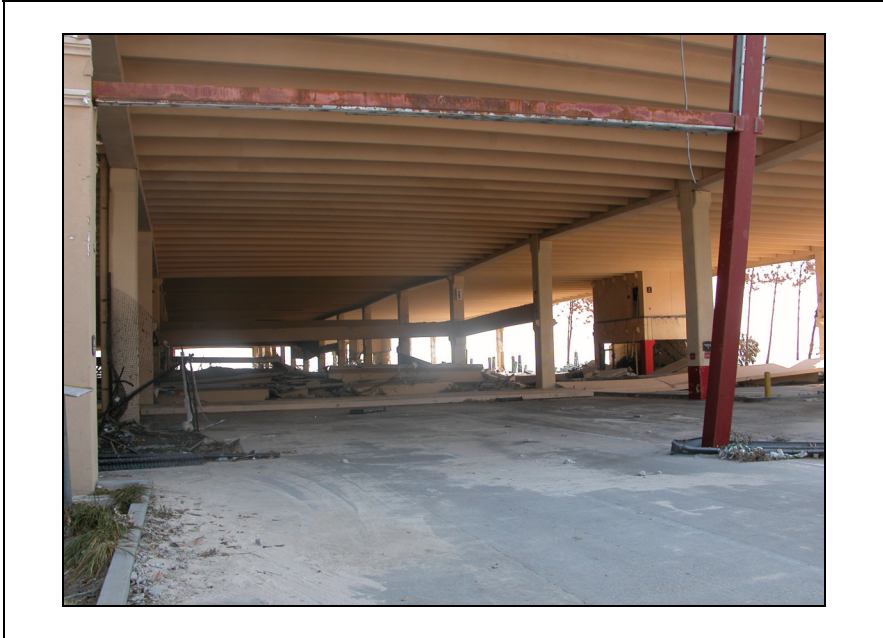
*Figure 4-7. Collapsed deck beams oriented parallel to the seashore.*

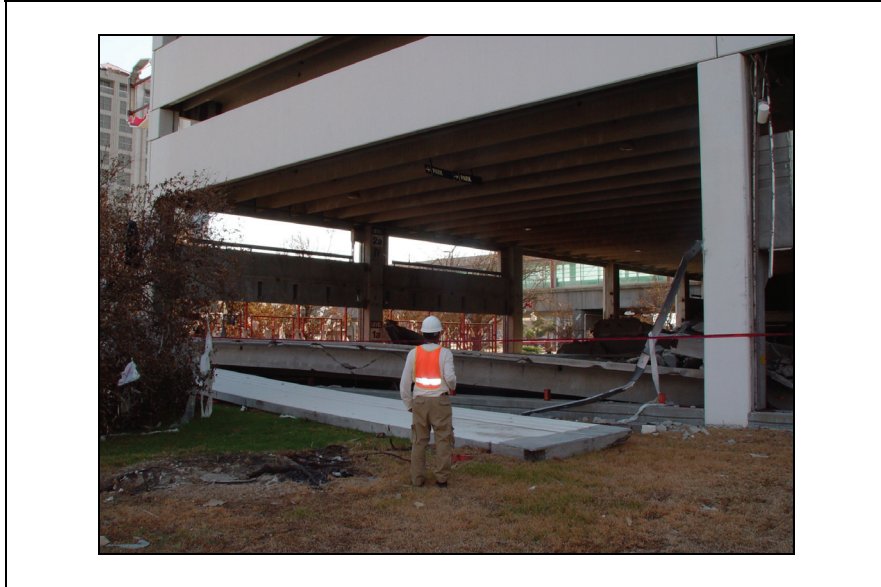
*Figure 4-8. Collapsed deck beams oriented perpendicular to the seashore.*

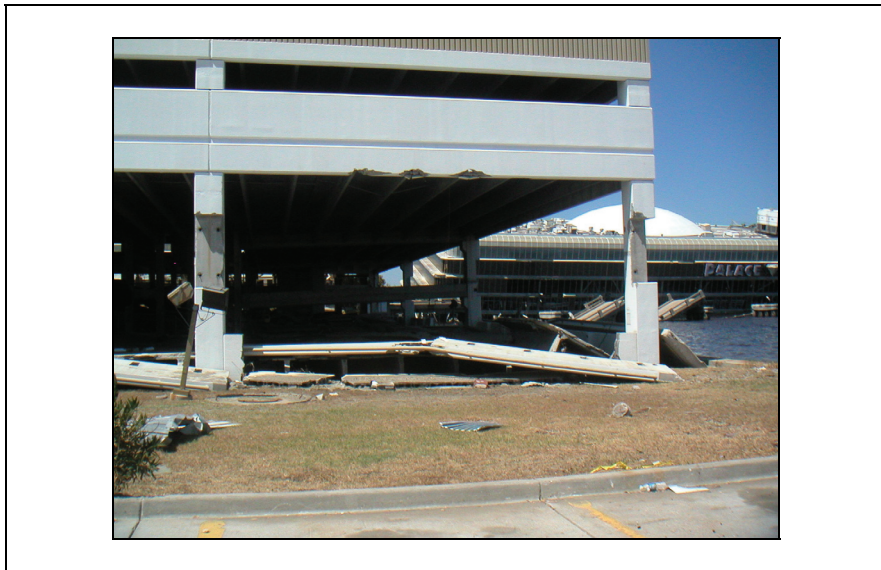
*Figure 4-9. Support of spandrel beam on the outside of the column.*

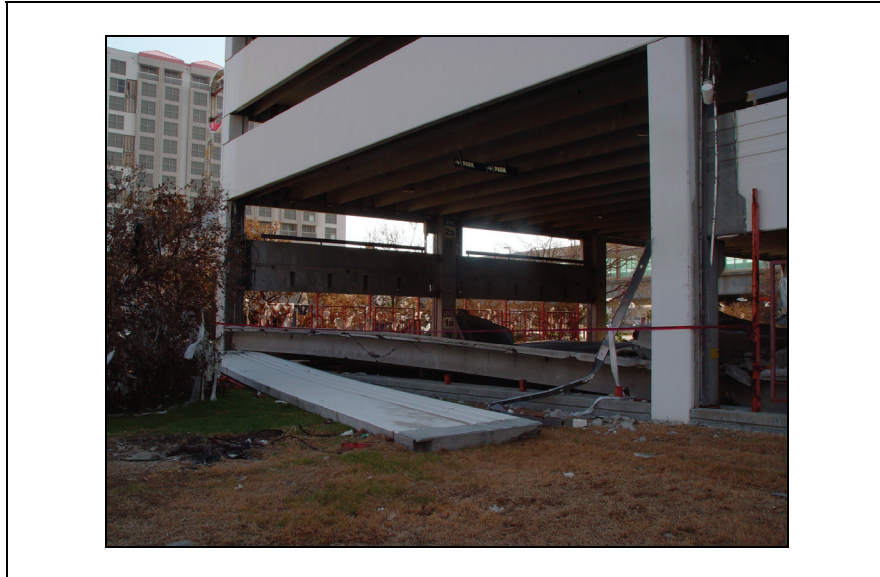
*Figure 4-10. Flexibility of spandrel beams.*

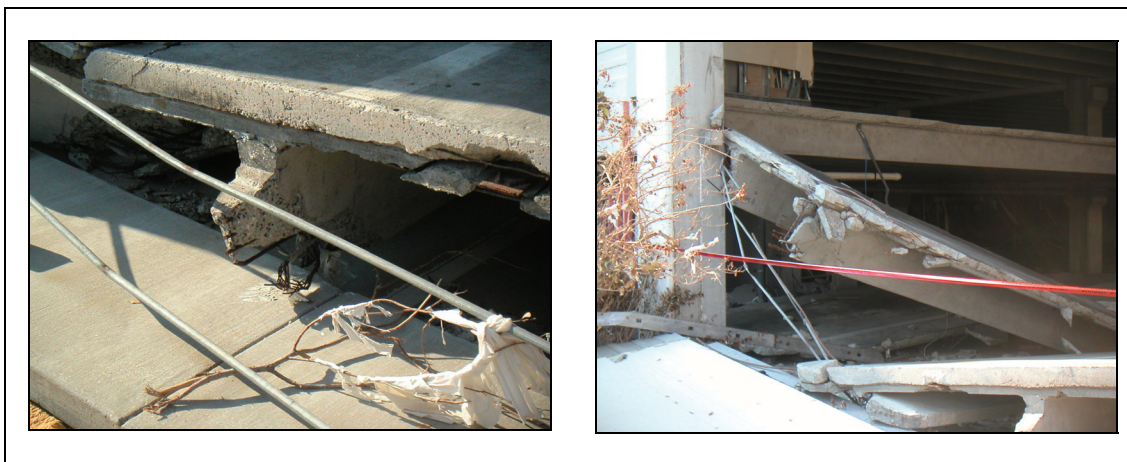
Vertical loading was clearly substantial. Shear failure was observed in deck-beam shear keys (Figure 4-11) and in supporting girders (Figure 4-12(a), the interior girders in the background of Figure 4-12(b), or the three bites in the 3rd-level spandrel beam in Figure 4-12(c)). Such loading could have been caused by pounding resulting from deck beams being lifted and then dropped, or by the weight of water accumulated on the top of the deck before it could pour down a ramp. If the latter occurred though, why would damage tend to be concentrated at the seaward side or corner of the deck? Water would probably flow quickly enough to distribute around the entire second-floor deck and cause more general damage.

*Figure 4-11. Shear failure in deck-beam shear keys.*

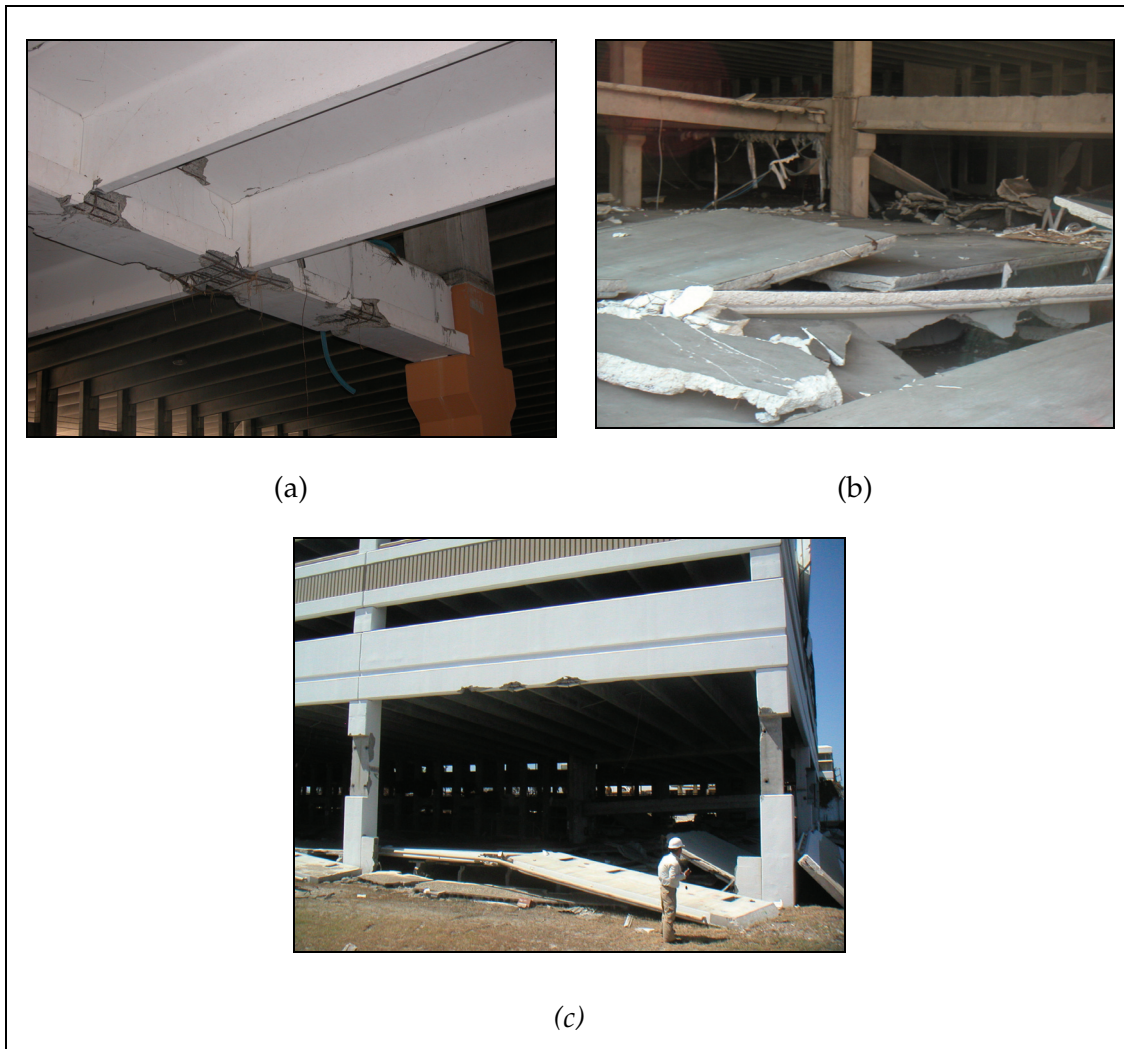
Figure 4-12. Shear failure in girders supporting deck beams.
