MCEER SPECIAL REPORT SERIES  
Engineering and Organizational Issues Before,  
During and After Hurricane Katrina

Damage to Engineered Buildings and Lifelines  
from Wind, Storm Surge and Debris in the  
Wake of Hurricane Katrina

Gilberto Mosqueda and Keith A. Porter

Volume 4

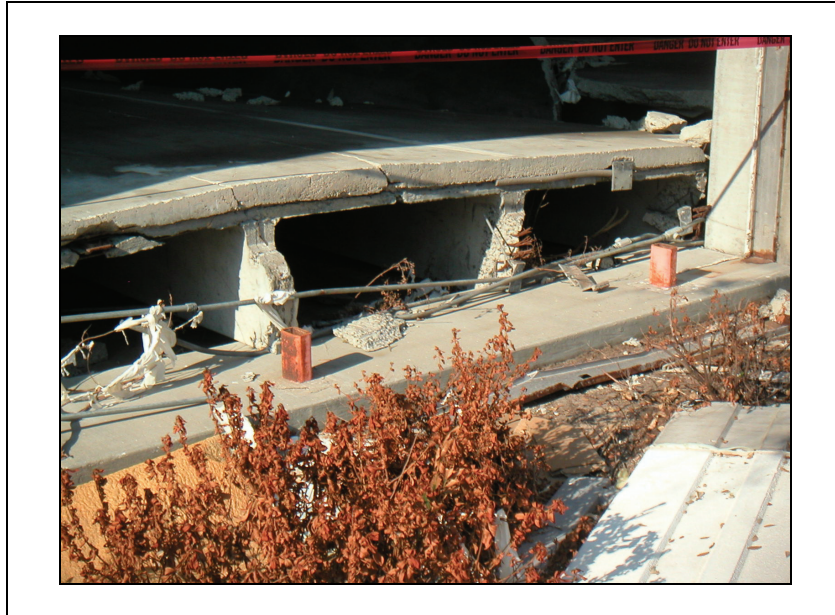
If it were uplift and dropping of the deck beams, rather than the weight of water, what caused the uplift? Wave action alone might conceivably have lifted the deck beams, but it seems likely that buoyant forces contributed strongly. The deck beams and their concrete topping weigh approximately 150 pcf; seawater weighs approximately 66 pcf. By Archimedes' Principle, buoyancy alone would have reduced the downward vertical load on the deck beams by almost half, a loading condition for which these pre-tensioned members were probably not designed. In addition to buoyancy of the deck beams and topping, the shape of the double-tees, whose ends were enclosed by their supporting girders, would have allowed for the creation of air pockets (Figure 4-13). As the storm surge rose to the soffit of the second-level deck, the concrete topping over the deck would have greatly limited the

*Figure 4-13. Space where air pockets could have been created.*

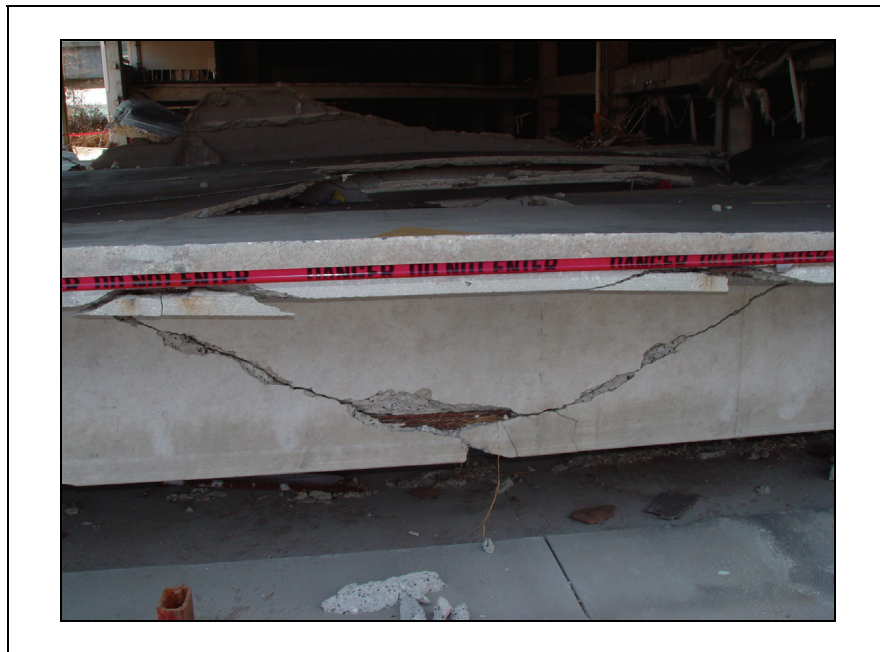
The damage observed here supports the negative bending hypothesis: spalling of concrete at the bottom fiber rather than the top (Figure 4-14) and diagonal cracks radiating outward and downward from the top fiber (Figure 4-15). In Figure 4-15, note the damage to the deck flange every three feet or so at the points where angle clips (visible on the right-hand side of Figure 4-8 as well) connected to the spandrel beam: the concrete cover spalled downward

*Figure 4-14. Spalling of concrete at the bottom fiber of deck beams.*

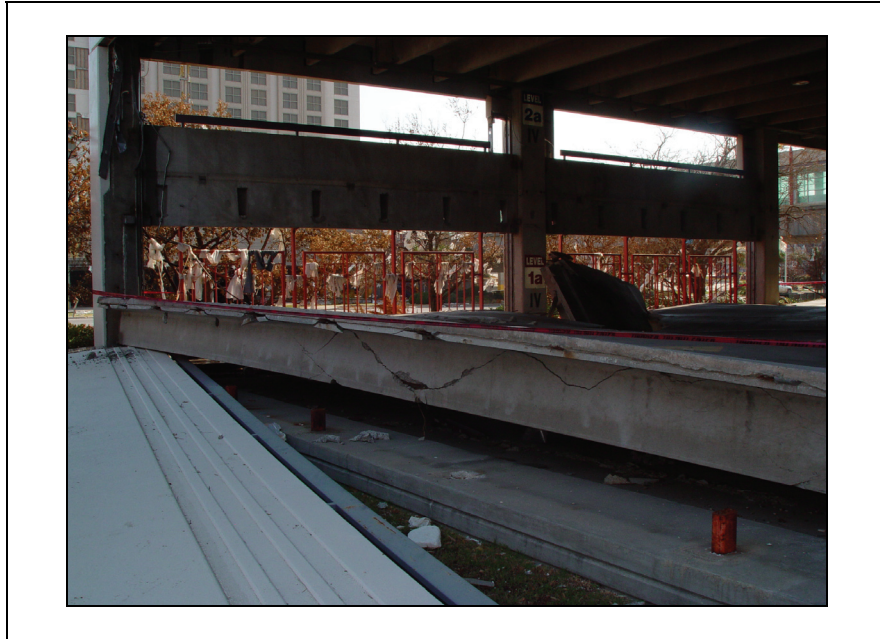
*Figure 4-15. Concrete cover at deck-to-spandrel connections spalled downward, implying that the midspan of the deck moved up.*

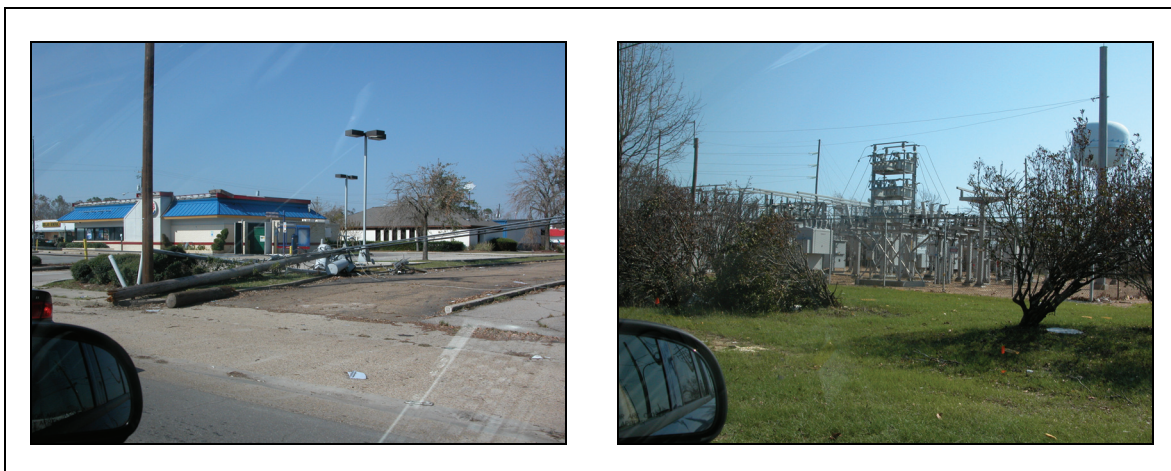
Electric power was lost to much of coastal Mississippi and the New Orleans areas. Damage to electric power distribution lines was observed throughout the affected area, with poles apparently downed both because of tree limbs or other debris (Figure 5-1), and because of wind or water pressure causing overturning of poles whose foundation soils or embedment depth were apparently inadequate. According to electric-utility workers in Biloxi MS and employees of the US government General Services Administration in Gulfport MS, flooding at electric substations caused damage to equipment requiring the replacement of the equipment. According to the electric-utility workers in Biloxi MS, flooded substation equipment was rapidly replaced because mutual-aid agreements and other emergency plans allowed the local electric power utility to have replacement equipment staged a day's drive north of the coast, the day before the hurricane struck, and trucked in as soon as it the storm had passed. As a consequence, electric power was available to 95% of Biloxi customers able to receive it within 10 days of the hurricane.

*Figure 5-1. Downed power pole with poletop transformer; exposed substation equipment in Biloxi, MS, replaced by October 7.*
