Engineering and Organizational Issues Before,
During and After Hurricane Katrina

Damage to Bridges from Wind, Storm Surge and
Debris in the Wake of Hurricane Katrina

**Damage to Bridges from Wind, Storm Surge and
Debris in the Wake of Hurricane Katrina**

MCEER-08-SP05
Red Jacket Quadrangle
Tel: (716) 645-3391; Fax: (716) 645-3399; Email: mceer@buffalo.edu
World Wide Web: <http://mceer.buffalo.edu>

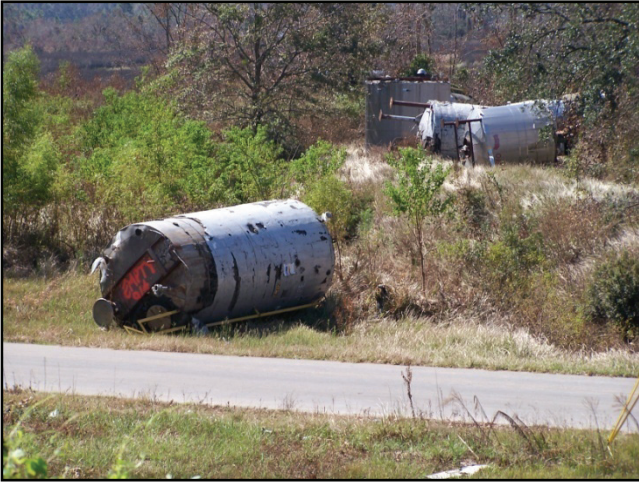
- a. Large steel tanks (about 8 feet in diameter) such as these broke loose and were swept away in flood waters. Items like this caused damage to bridges, homes, and other buildings.

(a) Tanks carried by the surge caused damage.

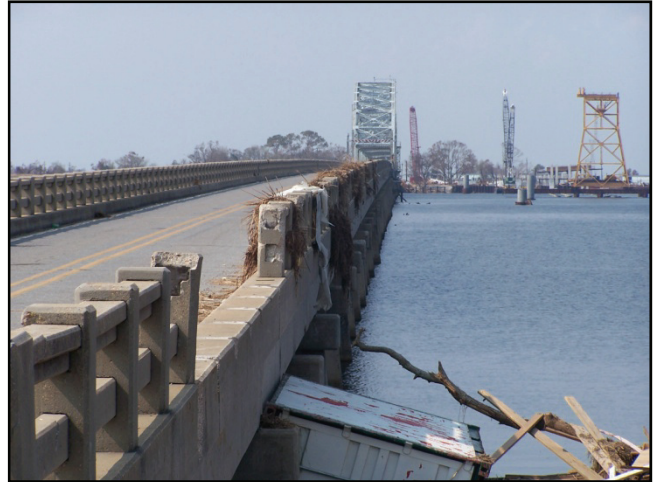
- b. Note the steel shipping container lodged under the bridge. It's dimensions are about 8 feet x 8 feet x 20 feet. This may have caused the damage to the bridge railing on Rigolets Bridge.

(b) Shipping containers hit bridges.

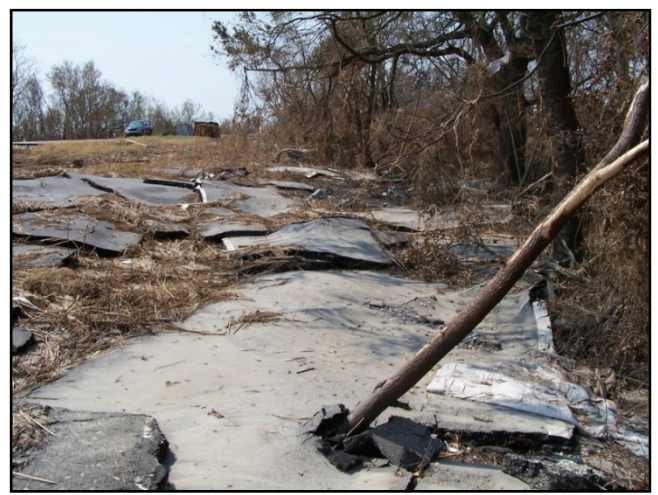
- f. Layers of asphalt pavement on US-90 were peeled up and transported 50-100 feet away.
- g. Debris fields were left behind after the storm. This material was hazardous because of nails and glass but also because it could contain hazardous chemical waste. This scene was at Rigolets.

(f) Layers of pavement moved 50-100 feet.

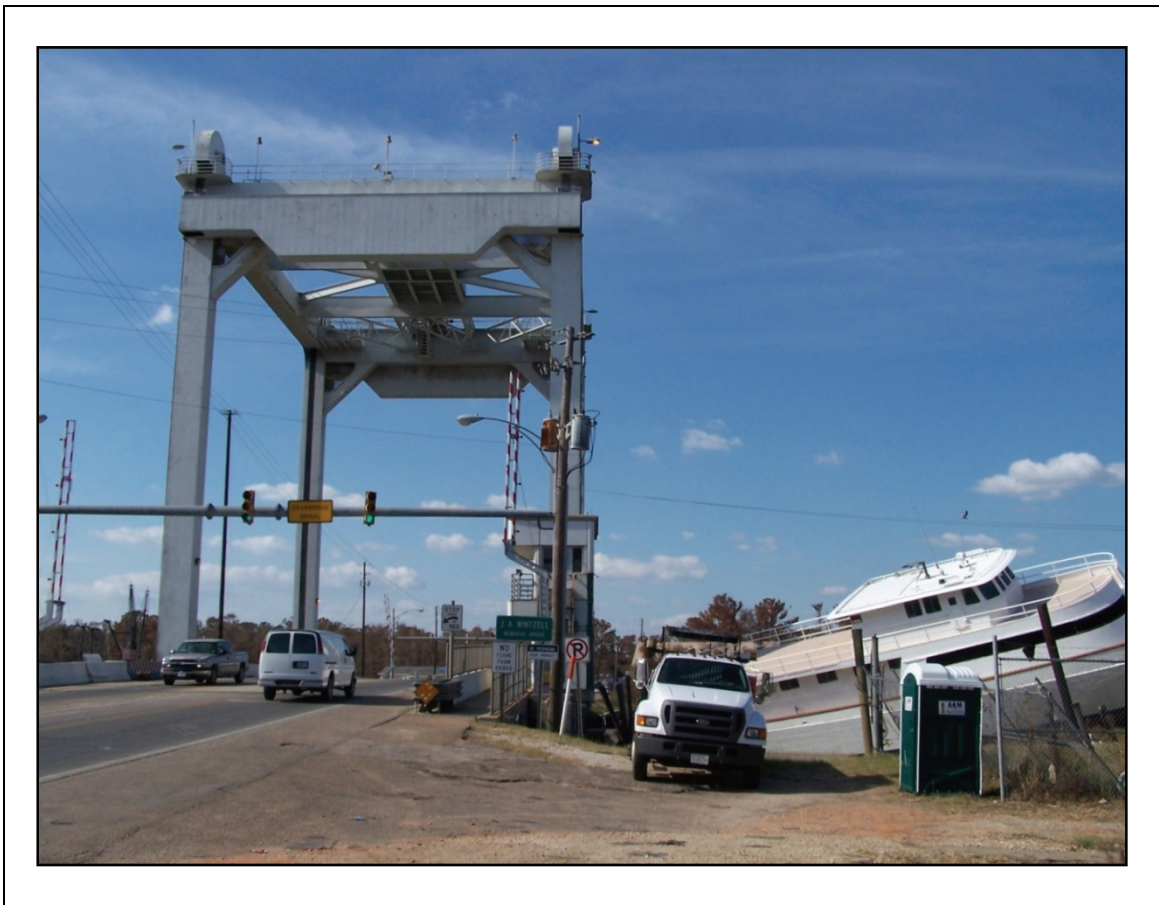
A large boat had been moored nearby and hit the bridge tender's office when it was tossed about in the storm. It apparently caused no major damage, just scrapes along the side of the building.

Figure 2-6. The boat on the right hit this lift bridge. The control room was also flooded.

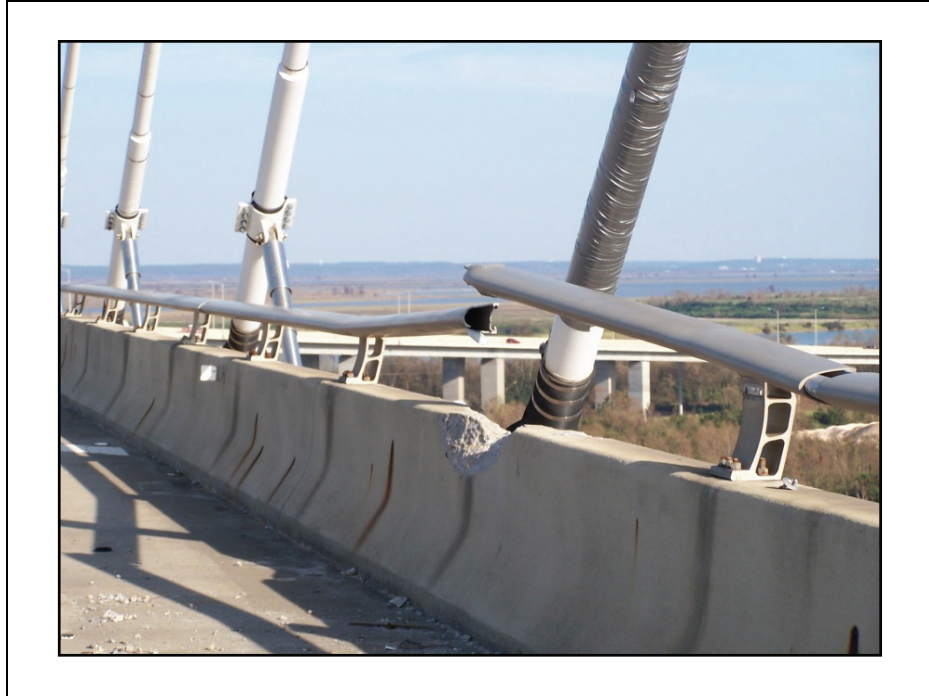
Figure 2-10. From the topside, damage to the railing and concrete barrier can be seen. A cable is wrapped to prevent moisture ingress, suggesting that it also was struck by the part of the oil platform. Note the silver damping devices on the other cables. These are commonly used on this type of structure to control wind vibration.

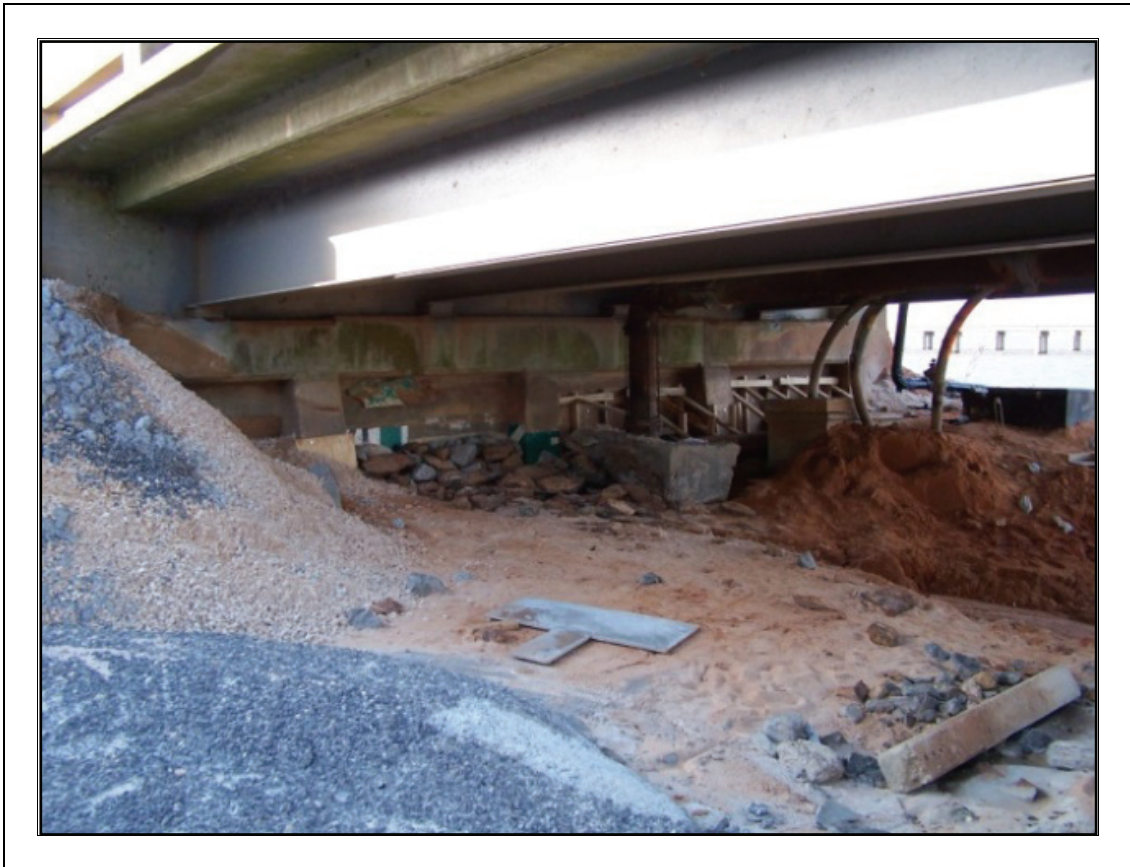
US-90 is a heavily traveled four lane road running E-W just south of Mobile. There was debris caught in the superstructure of the bridge (e.g., 12 inch log) but no damage was evident. There had been severe erosion at the west spill-through abutment but ALDOT had already made repairs. Failure to address this situation quickly could result in settlement of the approach pavement that would have presented a hazard to traffic and a repair that would have necessitated disruption to traffic.

Figure 2-12. Erosion at the west abutment.

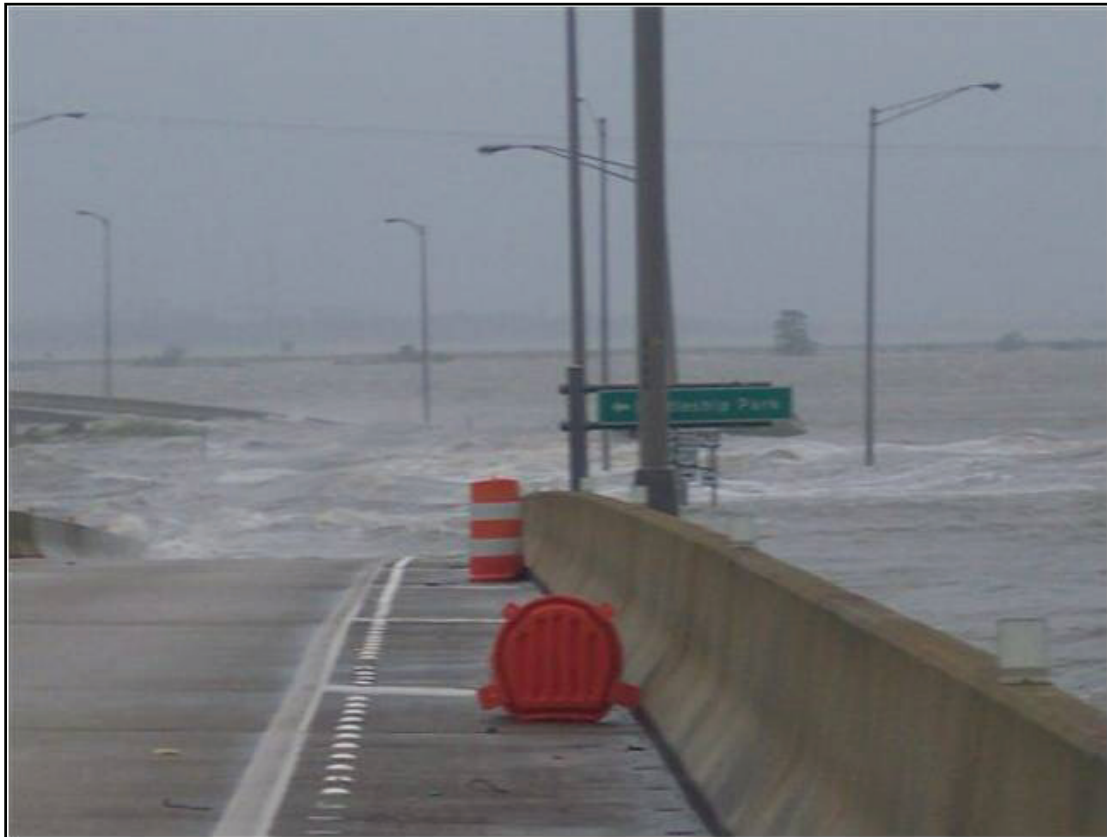
Although Mobile is almost a hundred miles from the path of Katrina's eye, the storm was so powerful that it caused the tide to surge 11-12 feet in Mobile Bay. This had a devastating impact on the low lying structure where US-90 joins I-10 EB, just east of Mobile. The structure, identified as 011926, was built as a series of simply supported prestressed (P/S) concrete spans and is very close to the water near the approach. Tie-down clips either broke or ripped out of the concrete pier cap and five spans were displaced laterally to the north as much as six feet. Figures 2-14 and 2-15 (provided by ALDOT) show the ramp bridge under water, the afternoon of August 29.

Figure 2-14. Several spans washed out the day of the storm. This photo faces east.

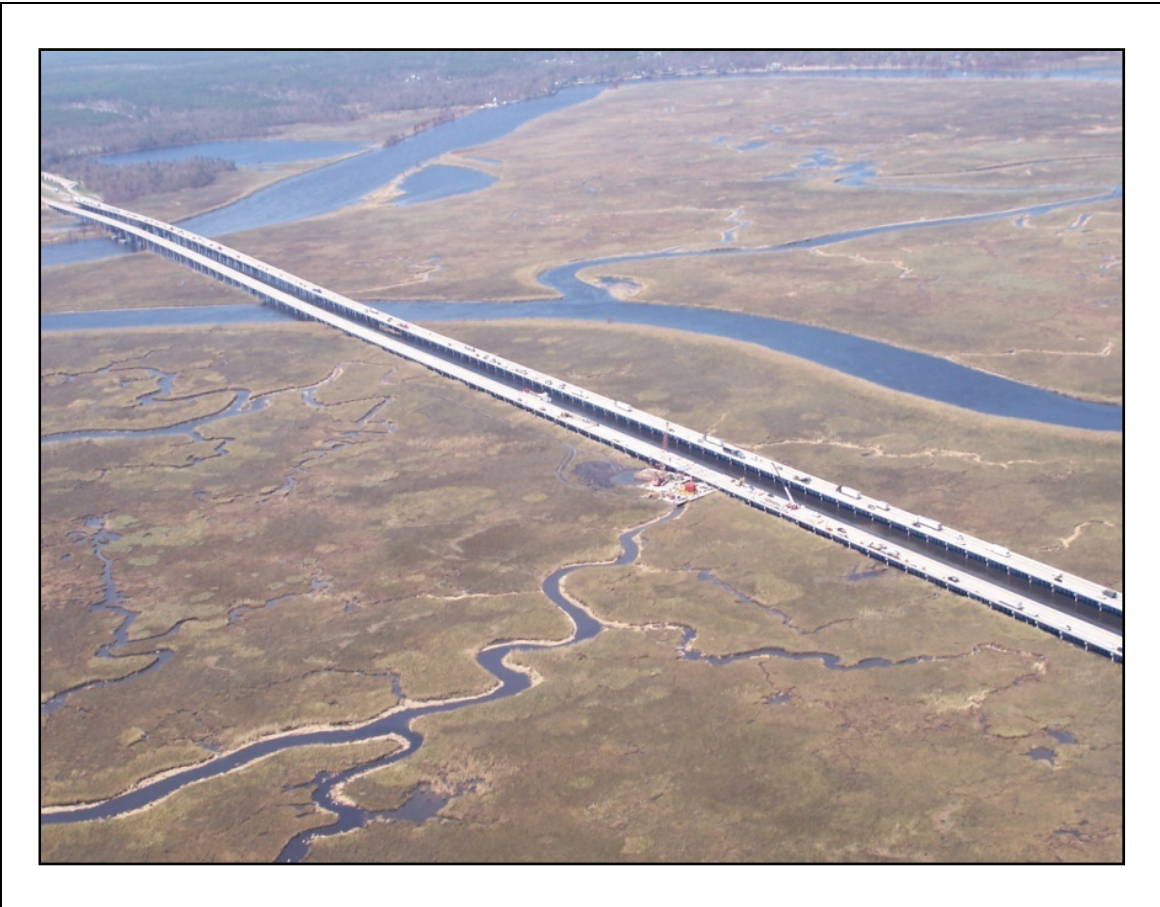
Although the I-10 bridges near Moss Point are several miles inland, they are relatively low and long over a large salt bayou. The high water caused by Katrina swept several boats and barges north until they crashed into the eastbound bridge. Six spans were pushed out of place by a barge with a crane mounted on it. The barge displaced the bridge superstructure about four feet to the north and tipped piers, causing a vertical drop of four to six inches at the deck joint.

*Figure 2-25. I-10 traverses a large salt bayou near Moss Point.
It was hit and damaged by a stray barge.*

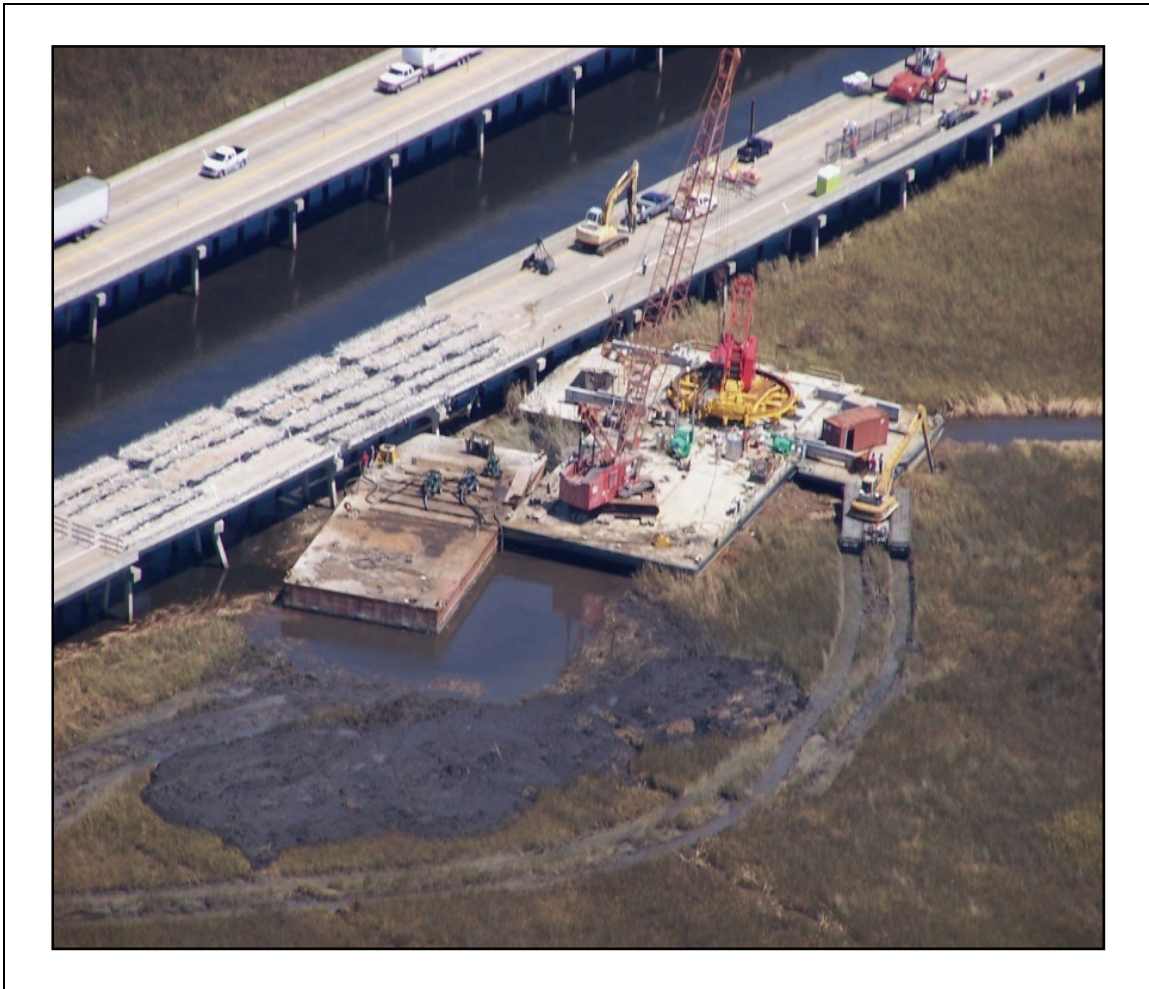
Figure 2-26 The concrete deck was being removed from the I-10 EB bridge on September 11, 2005.

Impacts to bridges caused substantial damage and interruption of service. The damage at the Moss Point site necessitated closure of the EB bridge and a 50% loss of capacity. EB traffic was diverted onto the WB bridge and contraflow was maintained (one lane of traffic in each direction) until repairs could be completed. Important relief traffic was delayed for over one hour each direction due to the subsequent congestion. MSDOT used an emergency repair contract with financial incentives (\$100,000 per day) to rebuild the bridge by October 1, 2005. It was completed in 20 days at a cost of \$5.2 million.

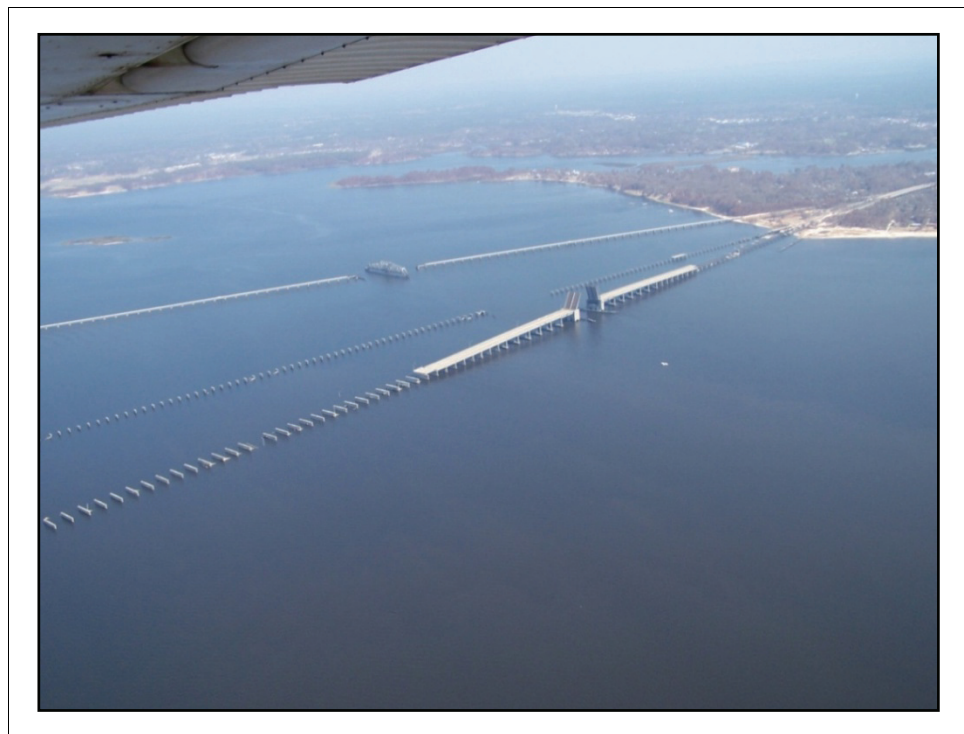
Figure 2-33. This Post-Katrina photograph (taken 9/11/05) shows the three bay crossings from Biloxi facing east toward Ocean Springs. Many spans are missing.

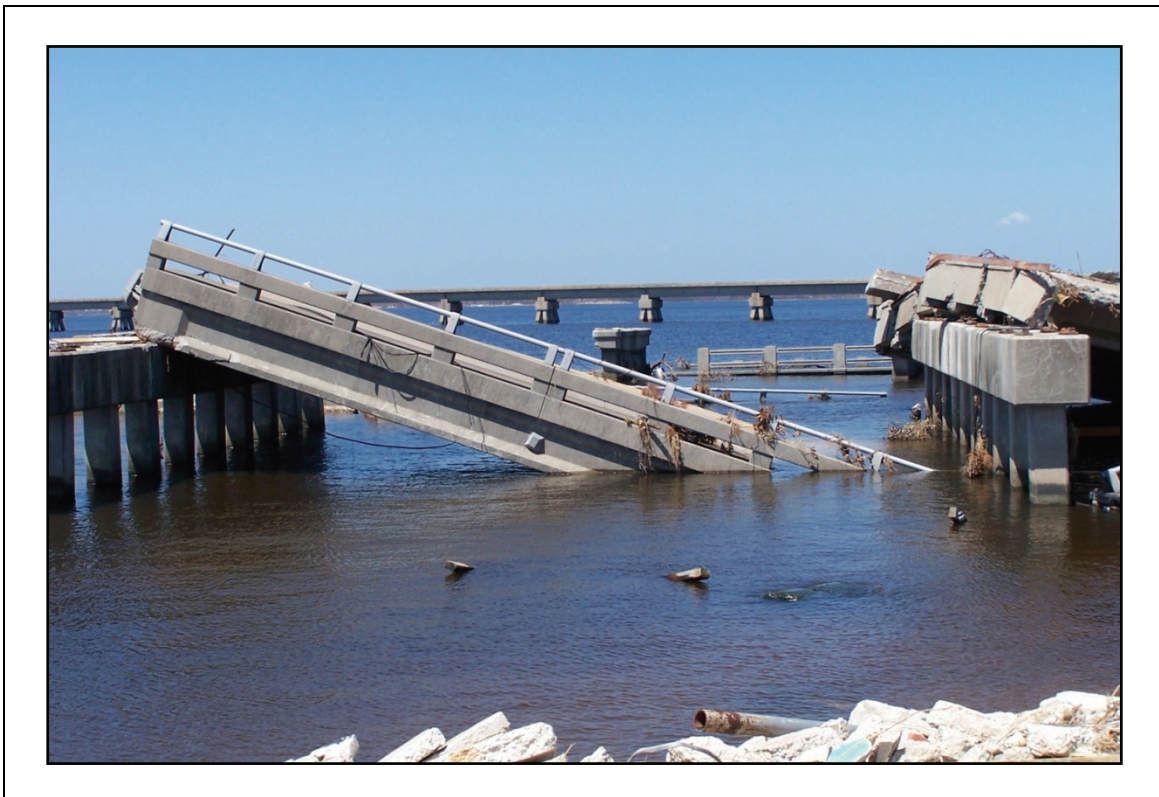
Figure 2-36 is a photograph taken at deck level facing north. In the foreground is an inclined span of the US-90 bridge. Just behind it are the remains of the old highway bridge. In the background is the CSX railroad bridge, structurally intact except for the swing span, which was impaired when it was flooded. As can be seen in the accompanying photos, the railroad tracks were swept off the concrete deck.

Figure 2-36. Although both were subjected to essentially the same conditions, there was a remarkable difference in performance between the US-90 (foreground) and CSX bridges (background).

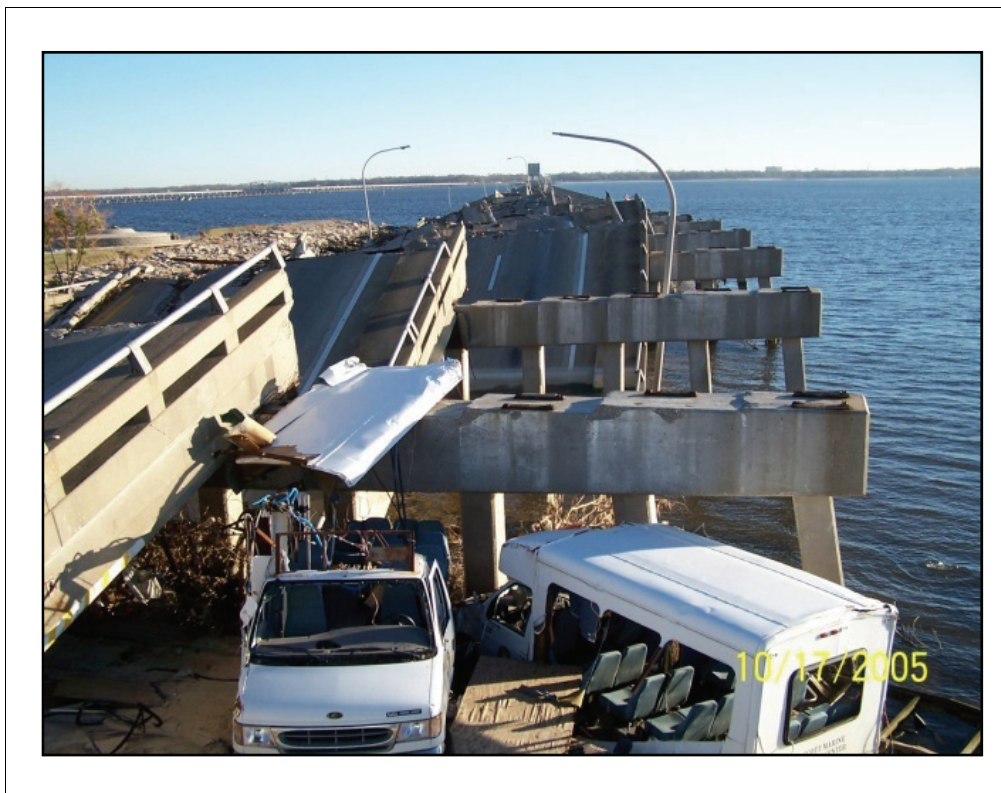
Figure 2-40. Floating debris such as vehicles and shipping containers also caused damage to bridges. This photo was taken at the west end of the US-90 bridge.

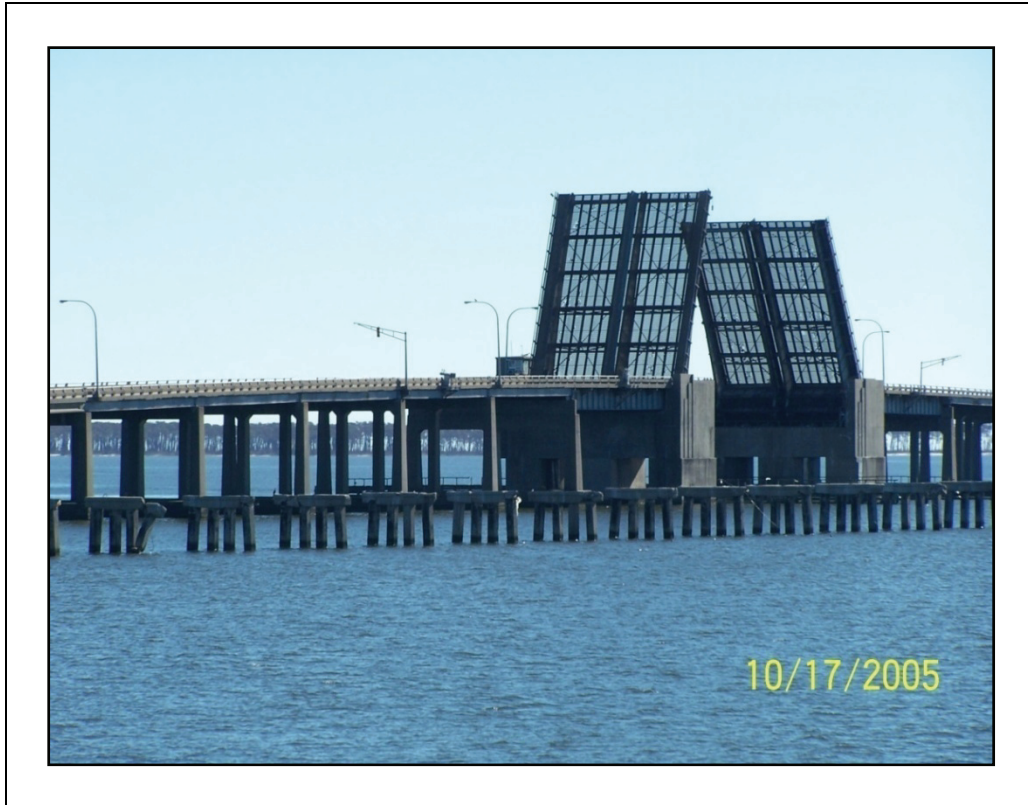
Figure 2-41. The center spans survived because they were at an elevation above that of the surge level.

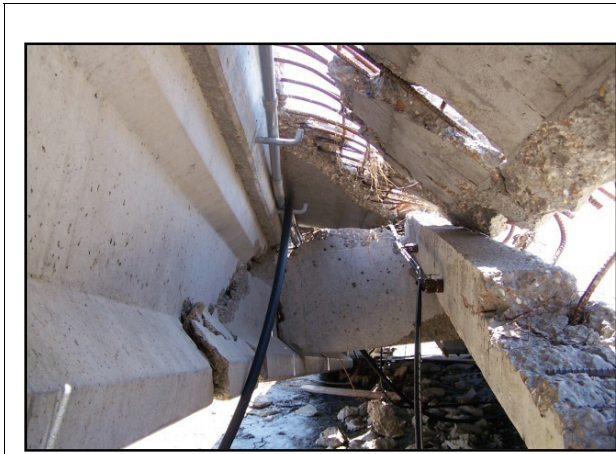
Figure 2-44. The beam, deck and diaphragm failed under surge loading.

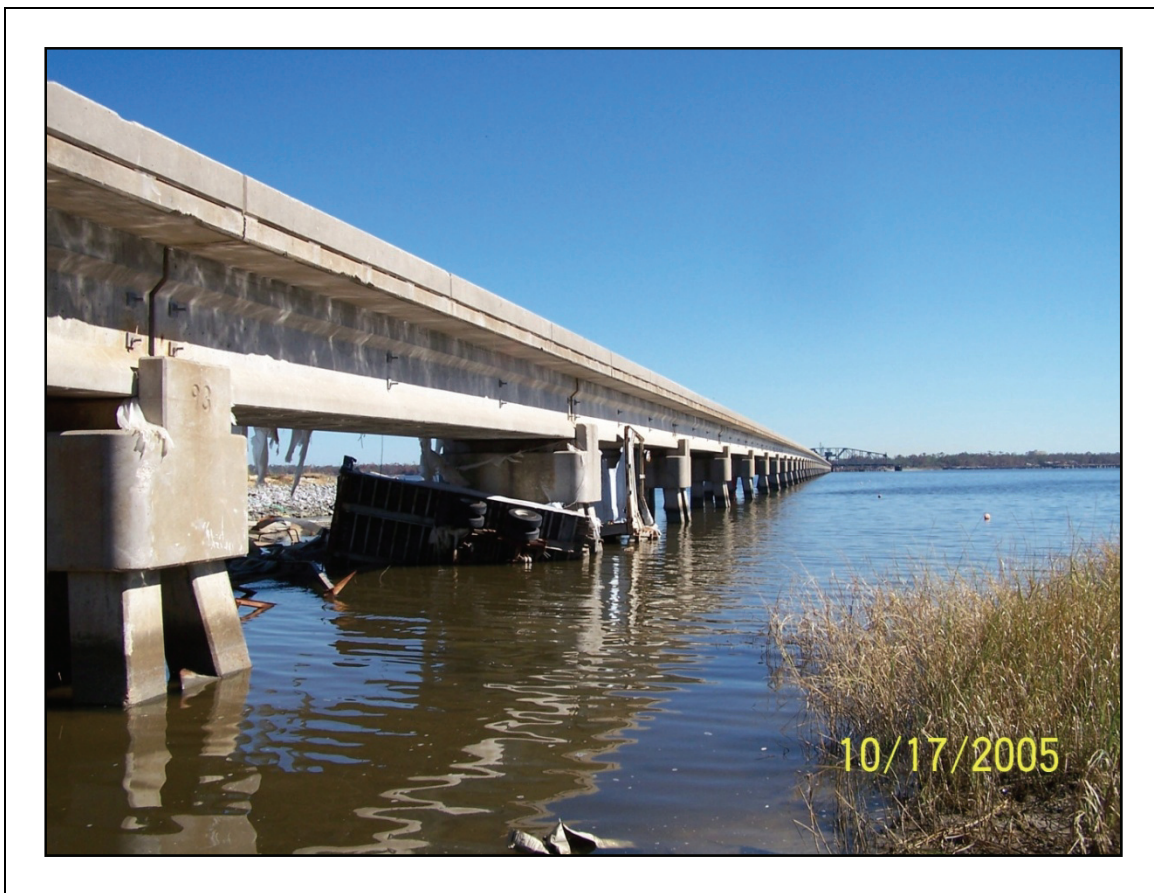
North of the highway bridges is a CSX railroad bridge (see Figures 2-32 to 2-35). The CSX bridge was overtopped by the storm and all of the tracks were swept off and dropped on the north side but the structure itself endured the surge with relatively minor structural damage. Mechanisms of the truss swing span needed repair.

Figure 2-53. CSX railroad bridge, looking east from the west abutment.

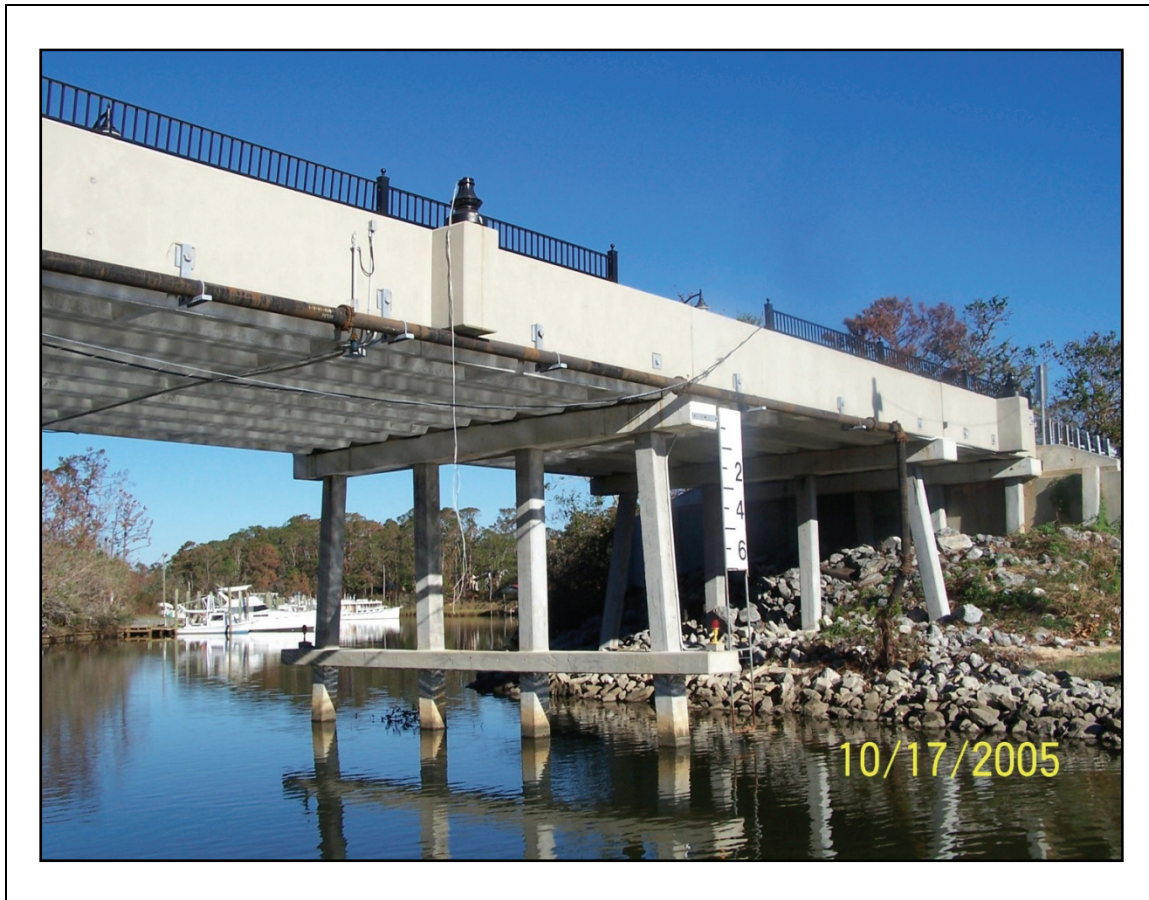
The Shearwater Bridge in Ocean Springs, MS was built in 2003. It is very close to Biloxi Bay and had evidence of being overtopped. Inspectors discovered the broken railing visible in Figure 2-64 and saw that washouts at the approaches had been repaired (Figure 2-65) but there was no apparent damage to the superstructure. Shear blocks (Figure 2-66) helped secure the superstructure from lateral movement, preventing significant damage.

Figure 2-64. The Shearwater bridge is very close to Biloxi Bay and was submerged under water.

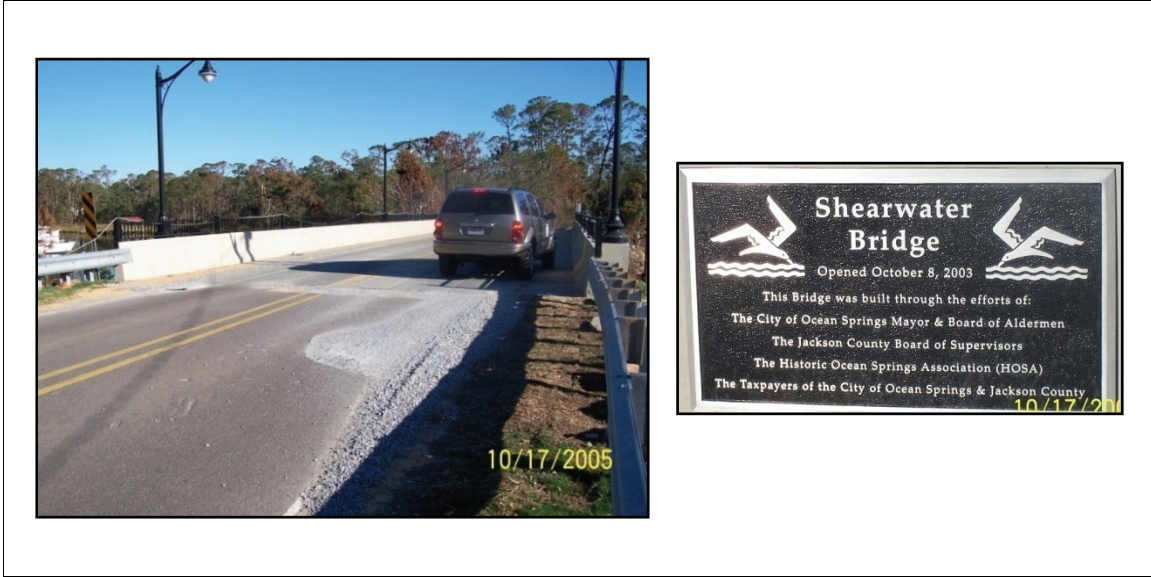
Figure 2-65. Approach erosion was easily repaired.

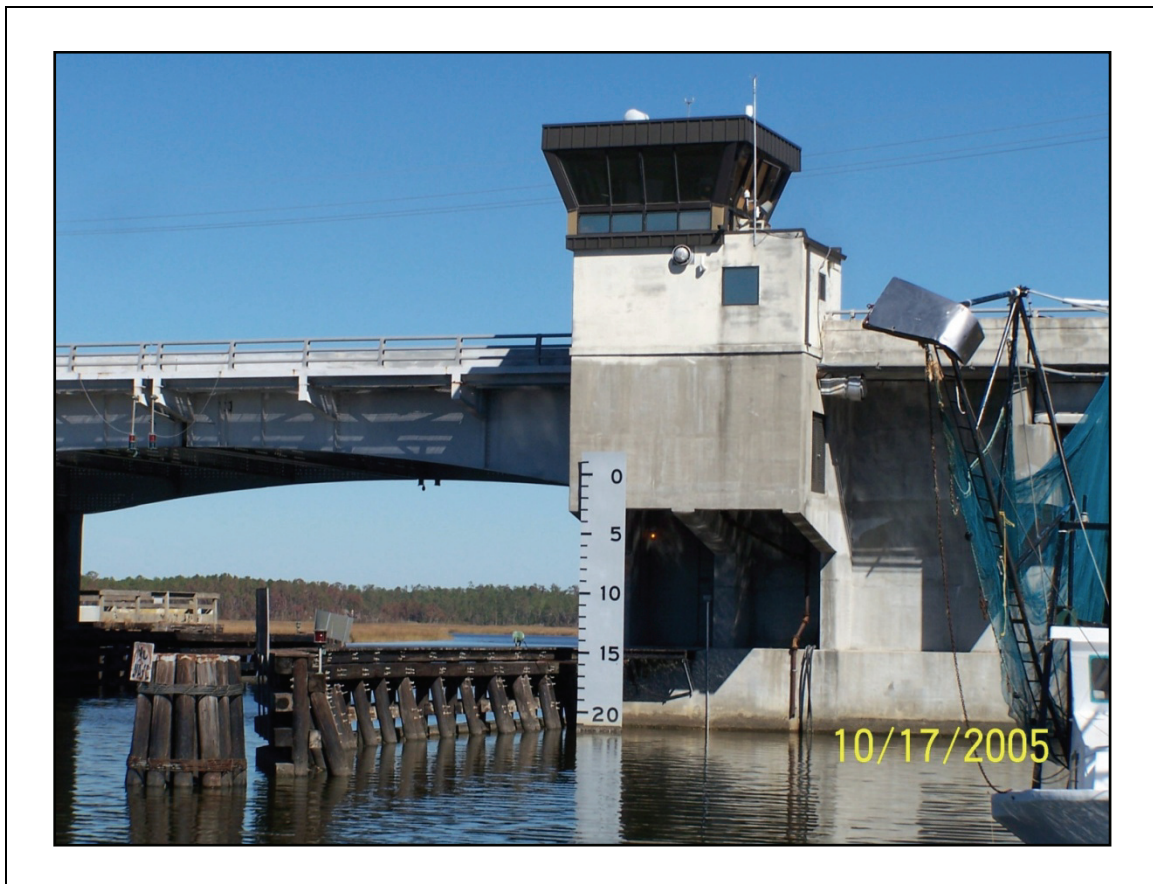
The Fort Bayou Bridge in Ocean Springs, Jackson County was built in 1985. It carries Highway 609 with a north-south orientation and typically has a clearance of 25 feet. The reported surge height at this location was 21 feet. The operators house suffered wind damage, (e.g., broken windows), but the mechanical room was flooded. It submerged generators and motors and electrical switch boxes.

Figure 2-67. The mechanical room of this moveable bridge flooded, making the bridge inoperable.

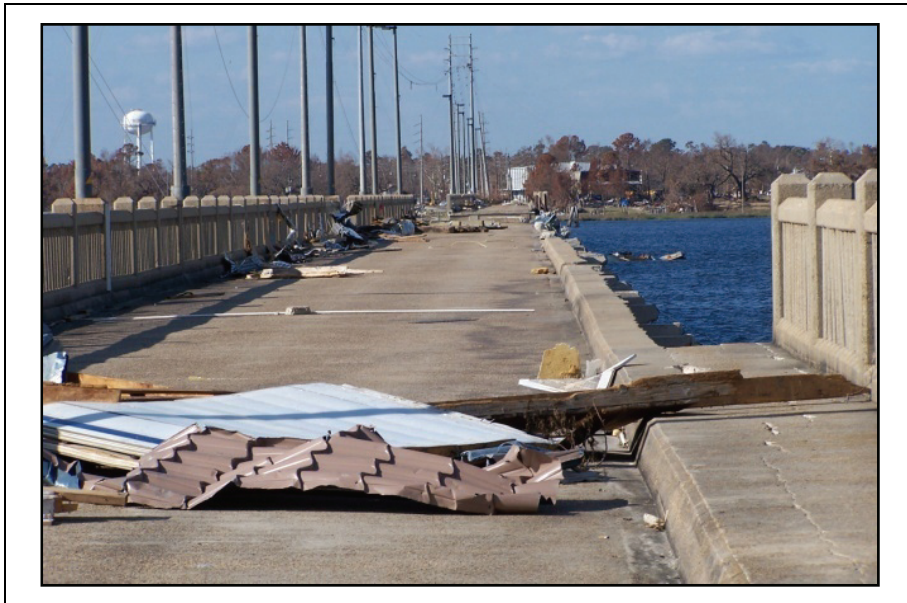
Figure 2-71. Looking north onto old 110 over Back Bay. Note the missing sidewalk and railing on the east side.

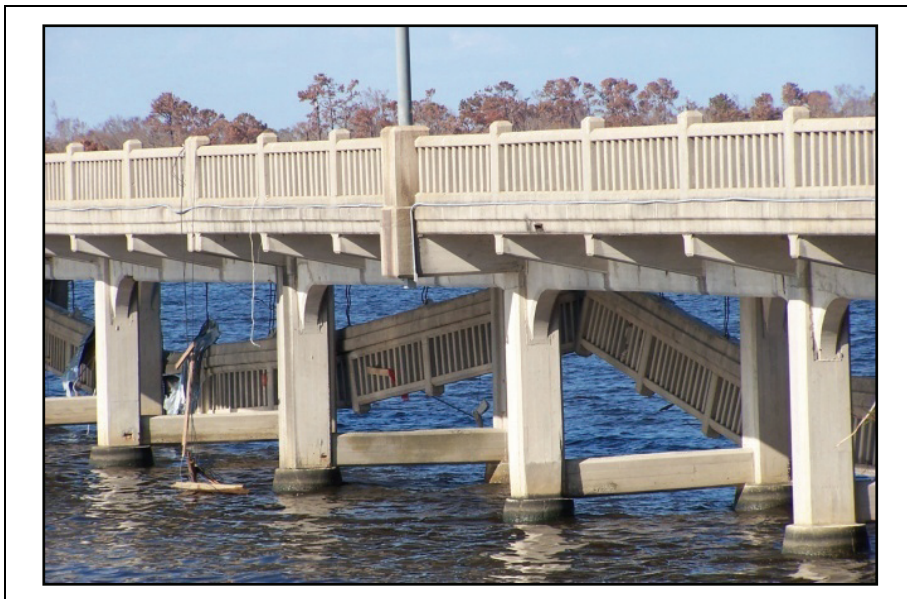
Figure 2-72. Elevation view looking NE at the old 110 over Back Bay which had been used for a fishing pier. Note the dangling concrete railing on the far (east) side.

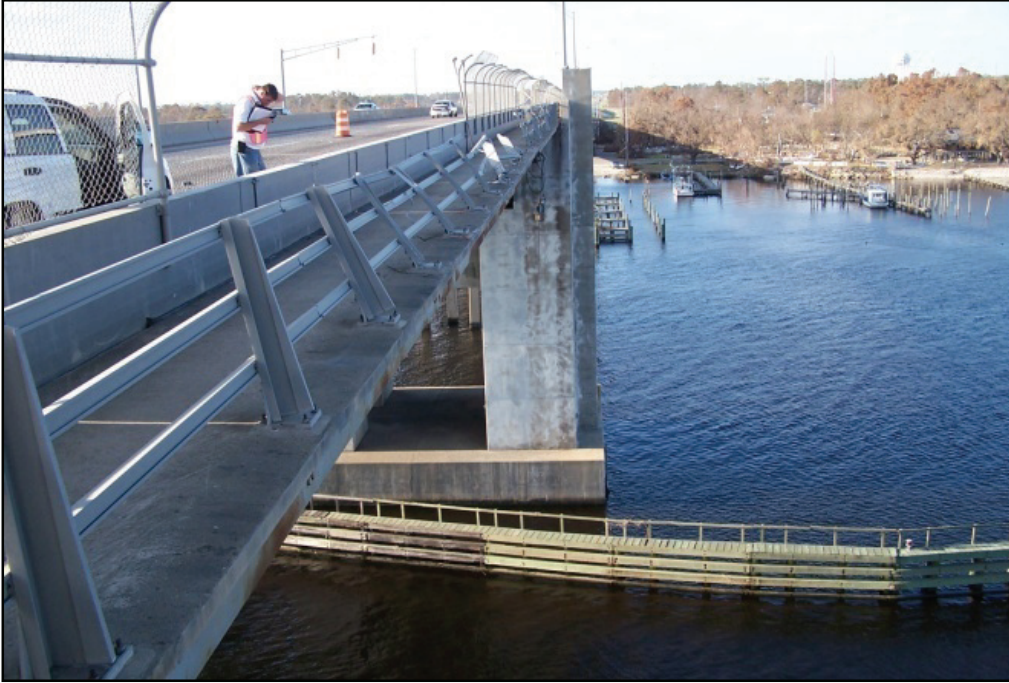
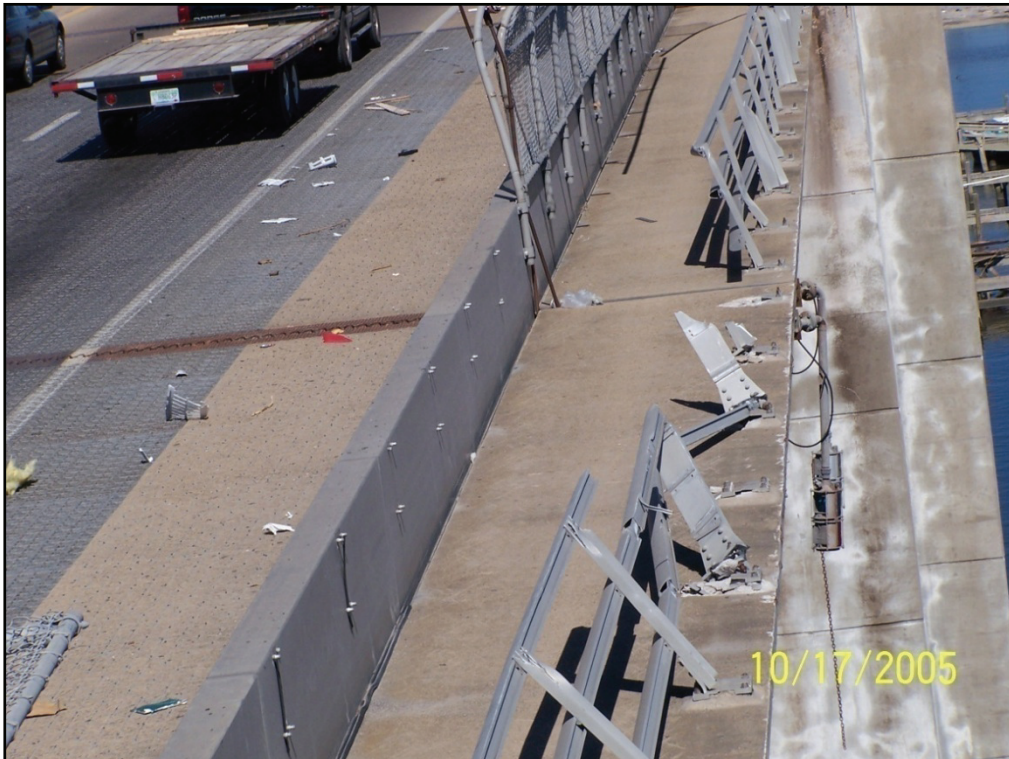
When the bridge was inspected on September 7, northbound traffic was restricted to one lane. Piers on the east side were hit by a barge or other items carried by the surge. When the site was visited a second time on October 17, MSDOT had already shored up the damaged area by driving additional piles adjacent to the damaged ones (Figure 2-73) and had reopened all lanes. The railing and sidewalk on the east side were also damaged from debris (Figure 2-74).

Figure 2-74. The metal railing on the east fascia of the span that carries I-110 over the navigation channel of Back Bay of Biloxi was damaged by boats or debris carried by the surge.

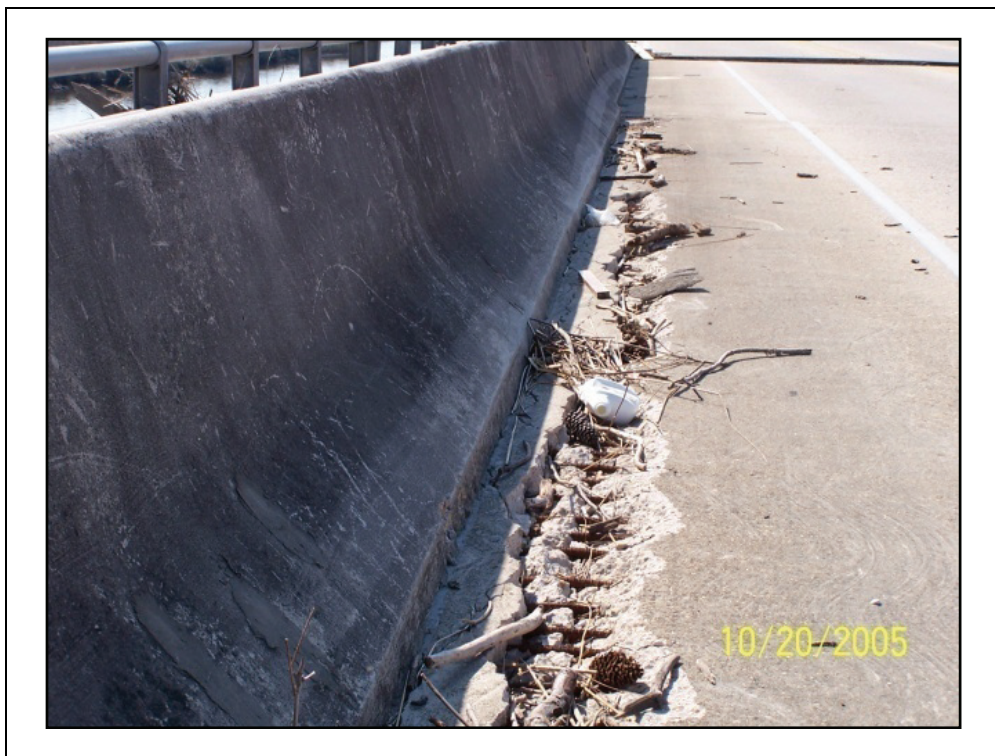
Figure 2-78. Hydraulic pressure on the backside of this barrier probably caused the spalling found at its toe. This photo is along the east fascia of the bridge.

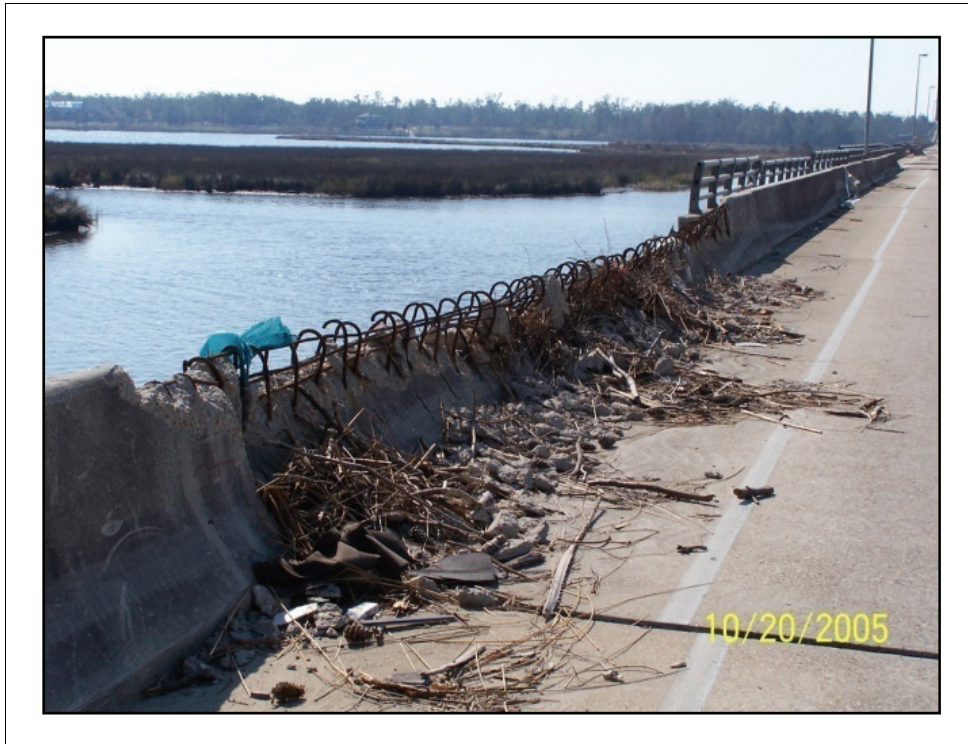
Figure 2-79. A debris dam pounding on the east fascia probably caused this damage to the concrete parapet.

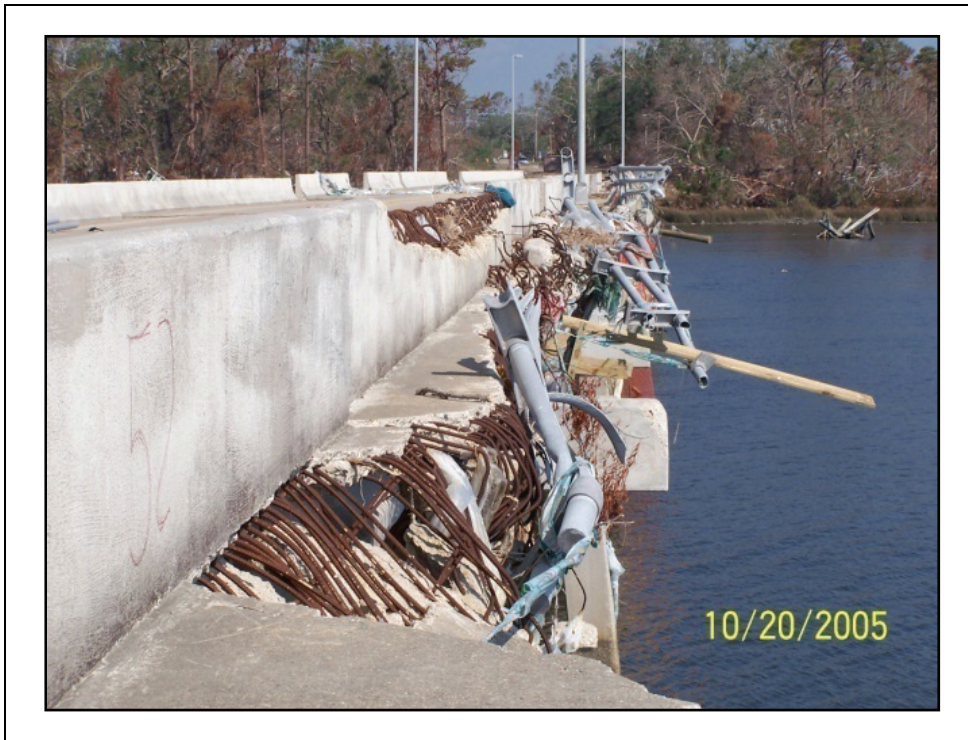
Figure 2-80. The east fascia was destroyed by debris engulfed in the surge.

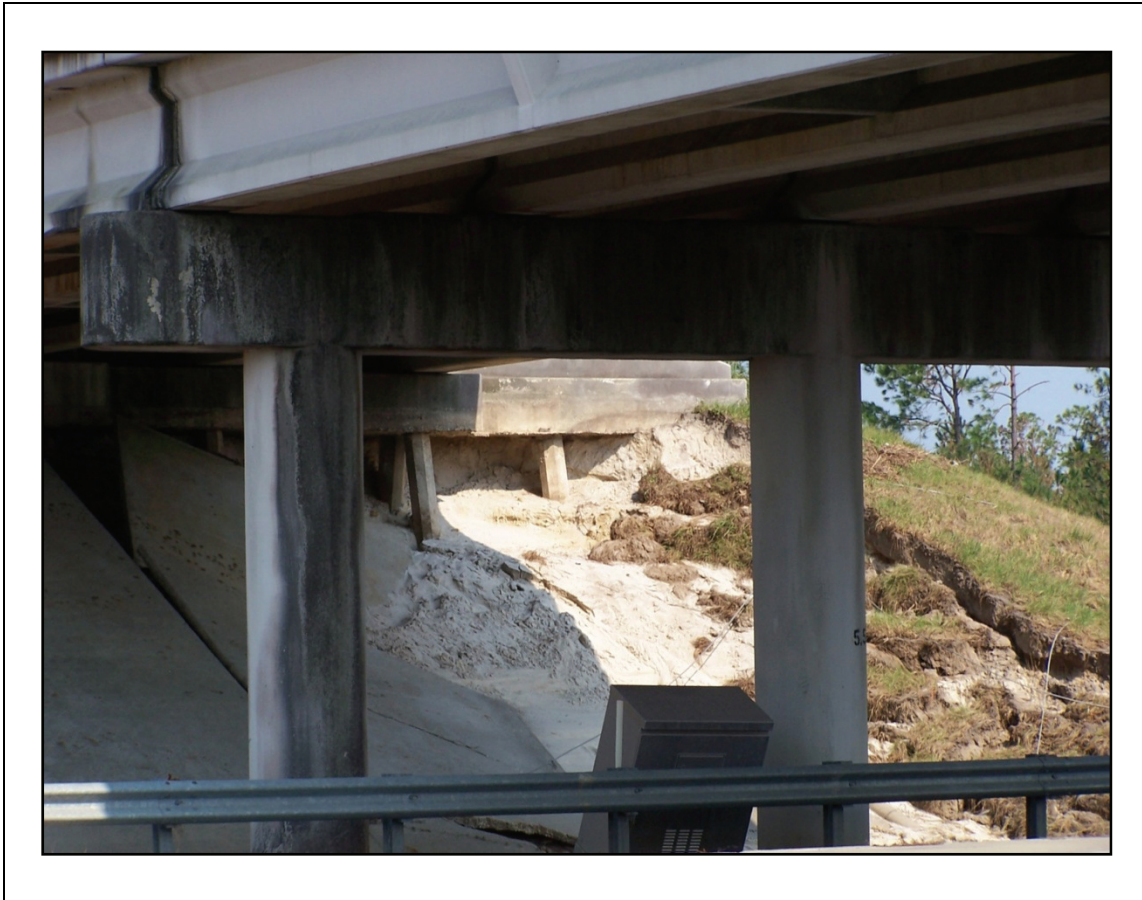
Figure 2-85. Scour is usually associated with water crossings, but this bridge over a road saw scour.

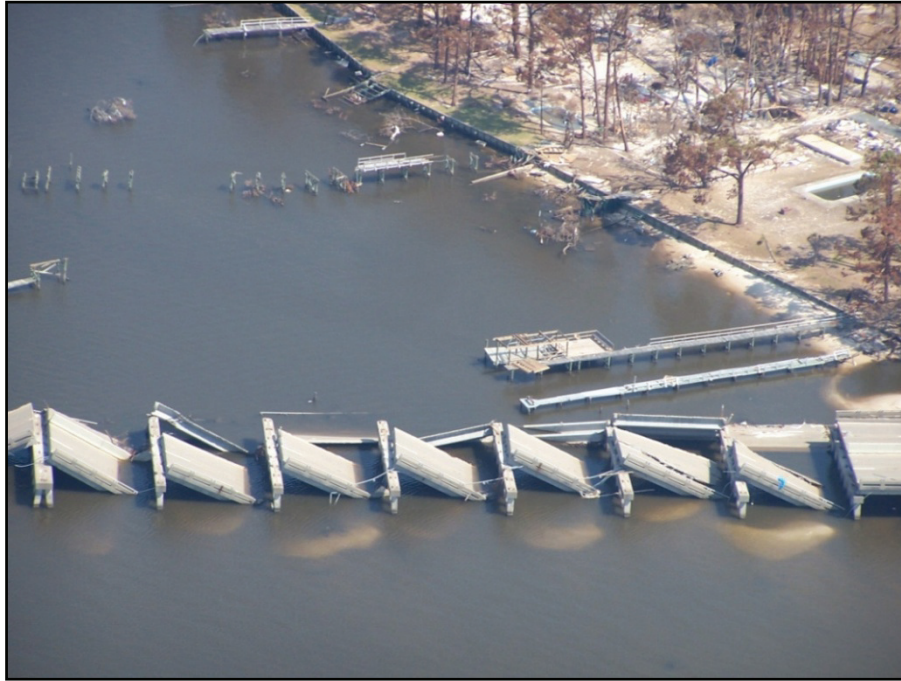
Figure 2-91. Eastern terminus of US-90 over St. Louis Bay, facing north. Lack of structural continuity contributed to the collapse of many spans in a failure pattern that is almost identical to that witnessed after earthquakes.
