Engineering and Organizational Issues Before,
During and After Hurricane Katrina

Damage to Bridges from Wind, Storm Surge and
Debris in the Wake of Hurricane Katrina

**Damage to Bridges from Wind, Storm Surge and
Debris in the Wake of Hurricane Katrina**

MCEER-08-SP05
Red Jacket Quadrangle
Tel: (716) 645-3391; Fax: (716) 645-3399; Email: mceer@buffalo.edu
World Wide Web: <http://mceer.buffalo.edu>

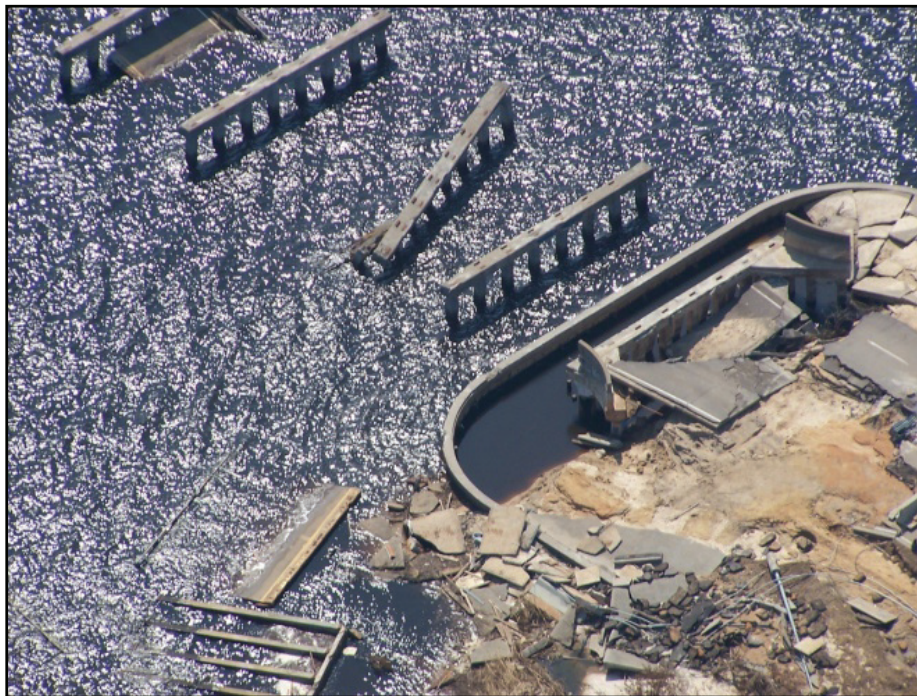
Figure 2-92. West abutment, looking SE, with an overturned span in the foreground.

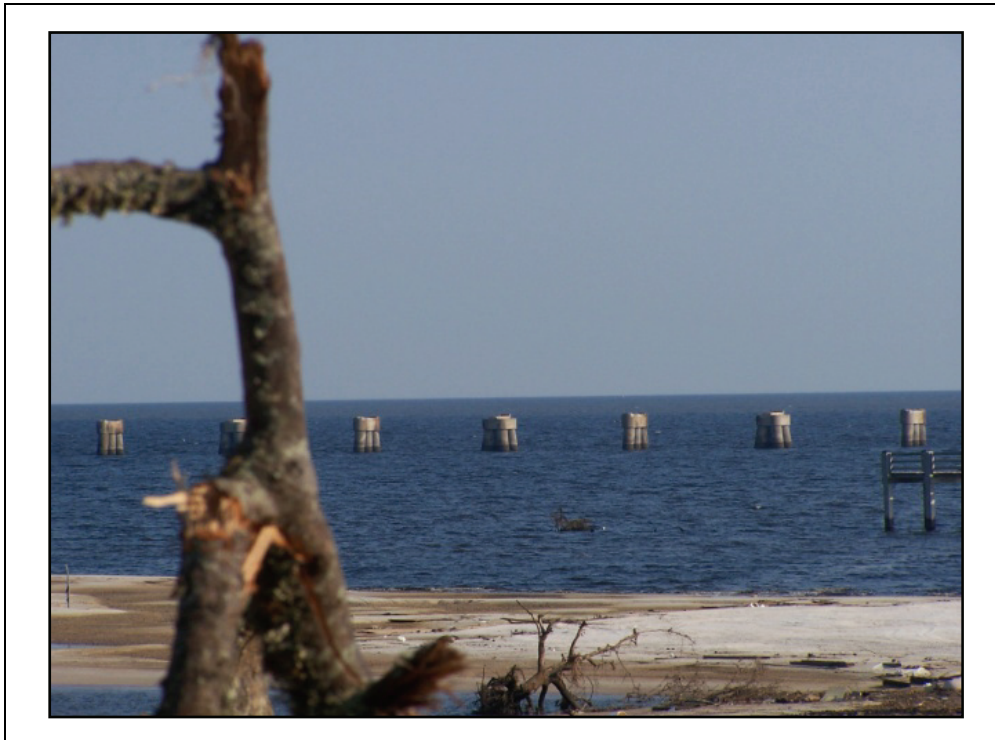
Figure 2-100. Piers from the CSX railroad bridge remain but the superstructure has been lost.

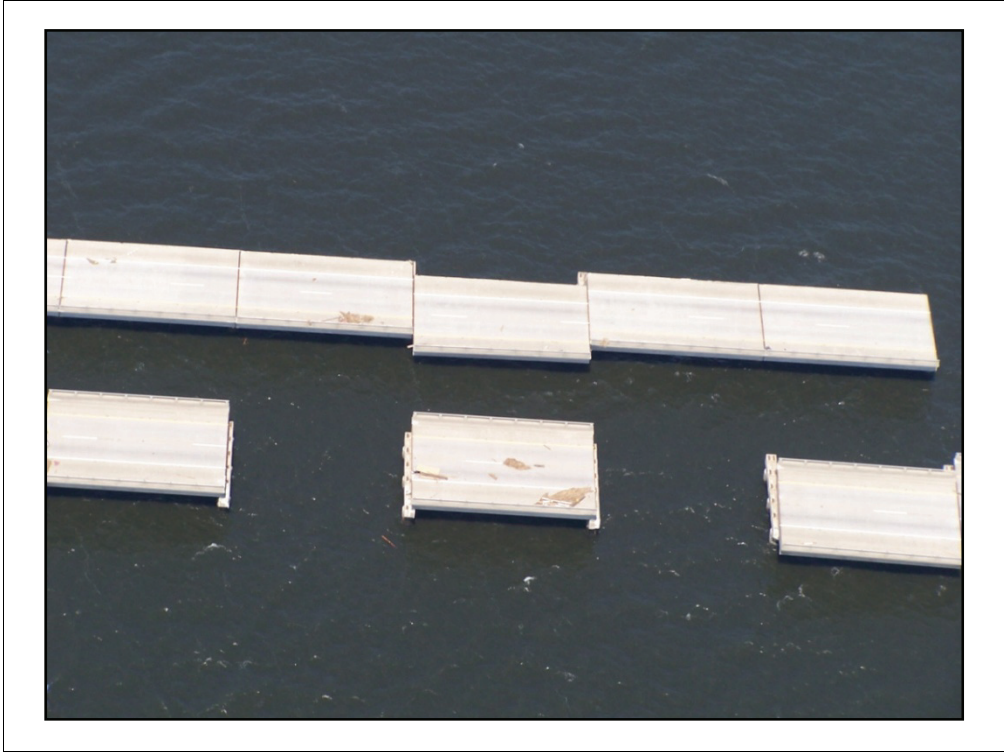
Figure 2-117. I-10, showing spans missing after lateral displacement, facing North.

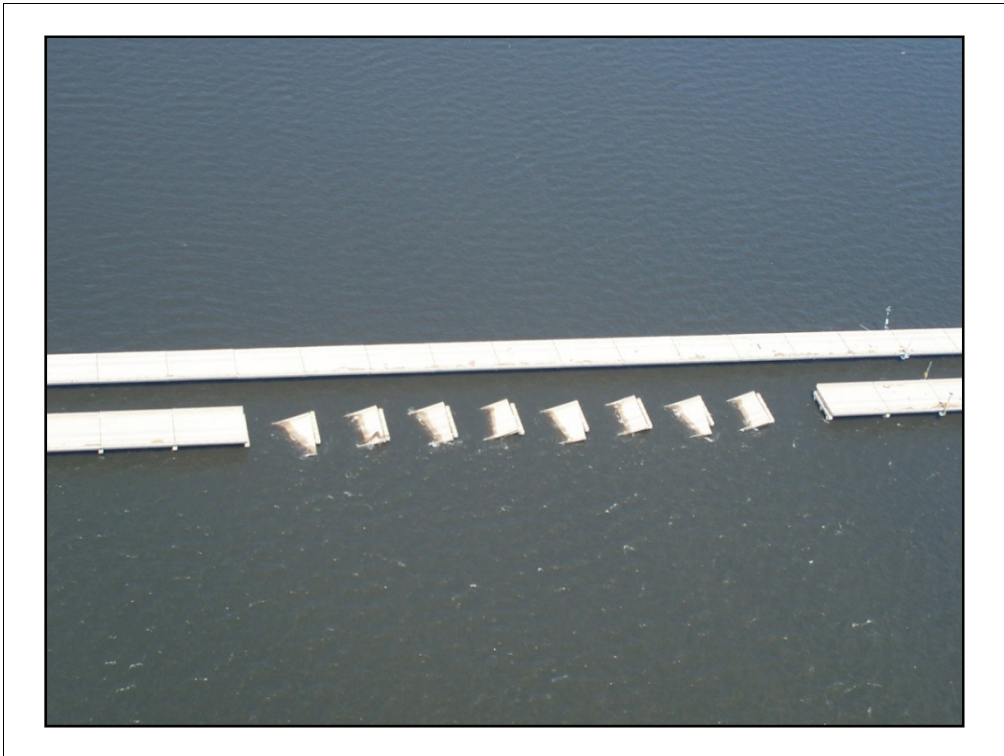
Figure 2-118. The missing span on the far right seems to have slid out, causing the others to topple.

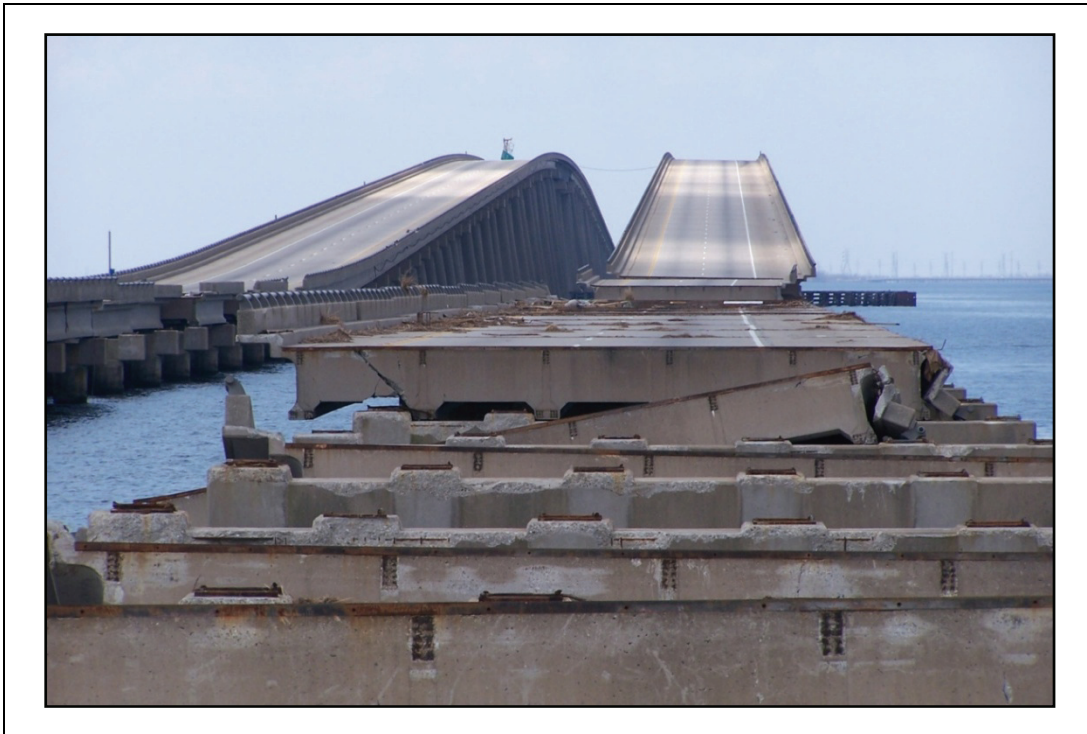
Figure 2-119. I-10 WB, facing west to the high-rise spans over the navigation channel. Note the scrape marks on the pier caps, caused by the falling spans.

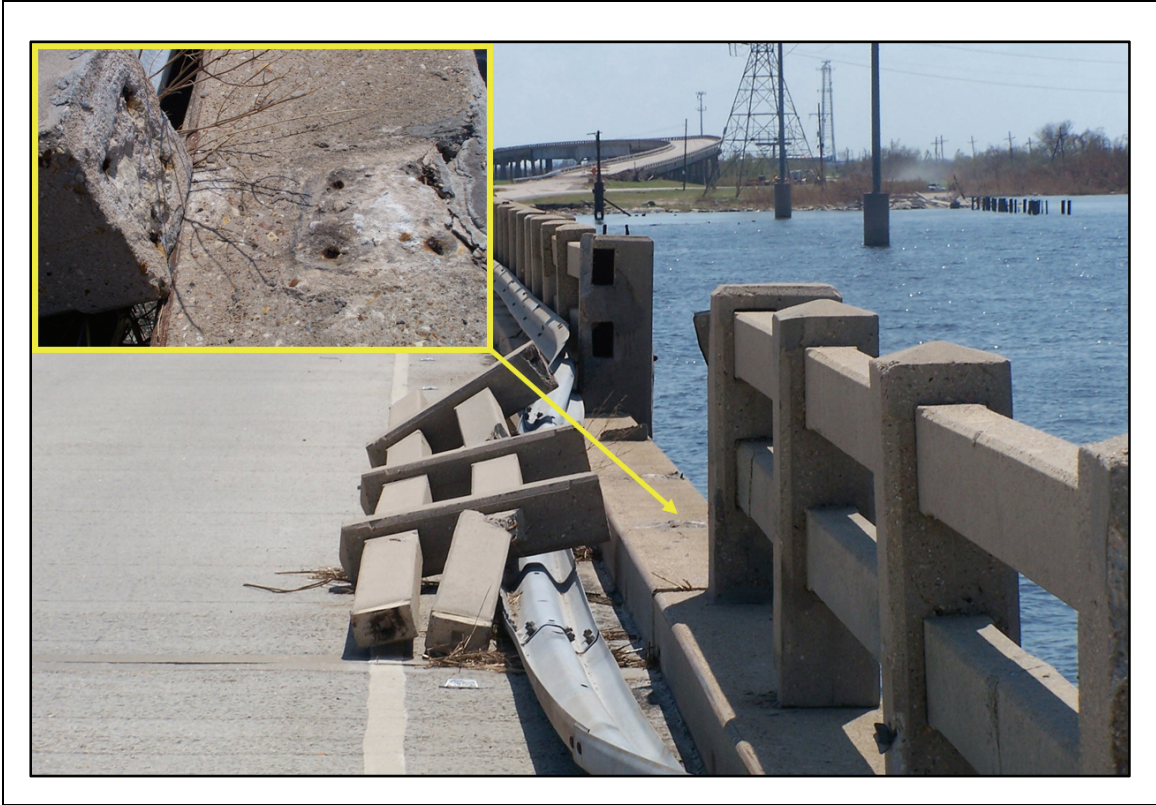
Figure 2-137. This section of concrete parapet on US-11 failed from wave force but was already in a weakened state from corrosion prior to the storm. Corrosion in the concrete barrier contributed to its failure from wave action. A subsequent investigation by LADOTD led to plans for replacement of all of this barrier.

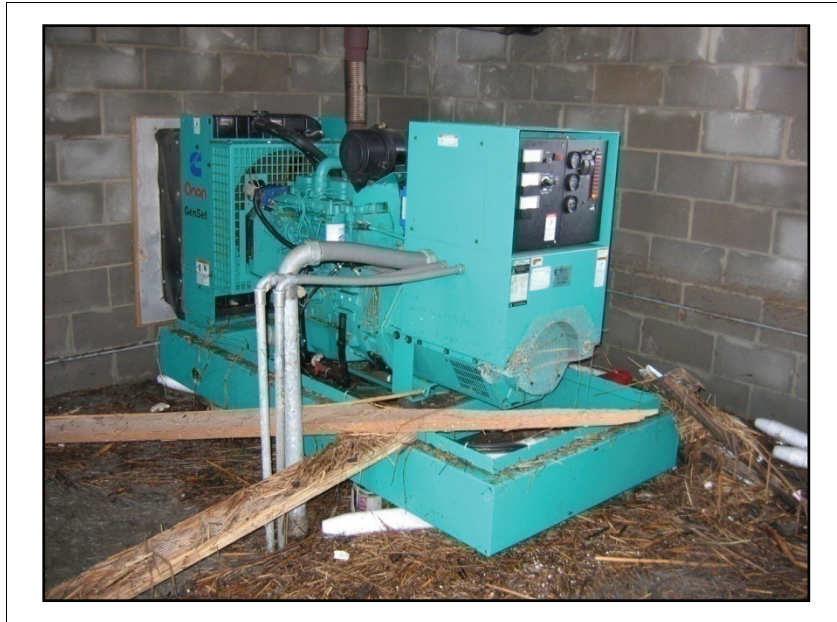
Figure 2-153. Equipment failed after being submerged in salt water.

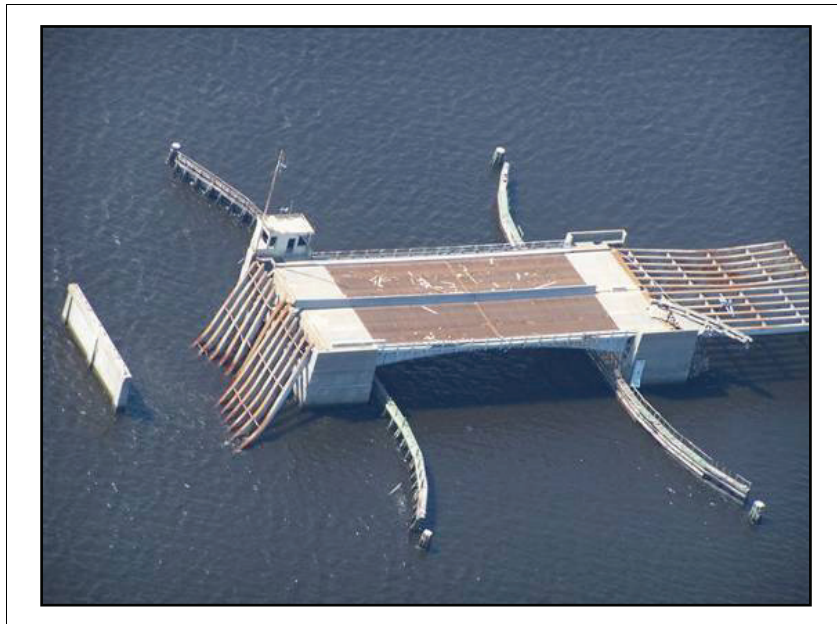
Figure 2-154. Inoperable draw spans prevented use of the channel by vessels.
