L'AQUILA EARTHQUAKE OF APRIL 6, 2009 IN ITALY: REBUILDING A RESILIENT CITY TO WITHSTAND MULTIPLE HAZARDS

by
**Gian Paolo Cimellaro, Ioannis P. Christovasilis,
Andrei M. Reinhorn, Alessandro De Stefano
and Tatiana Kirova**

Technical Report MCEER-10-0010

December 29, 2010

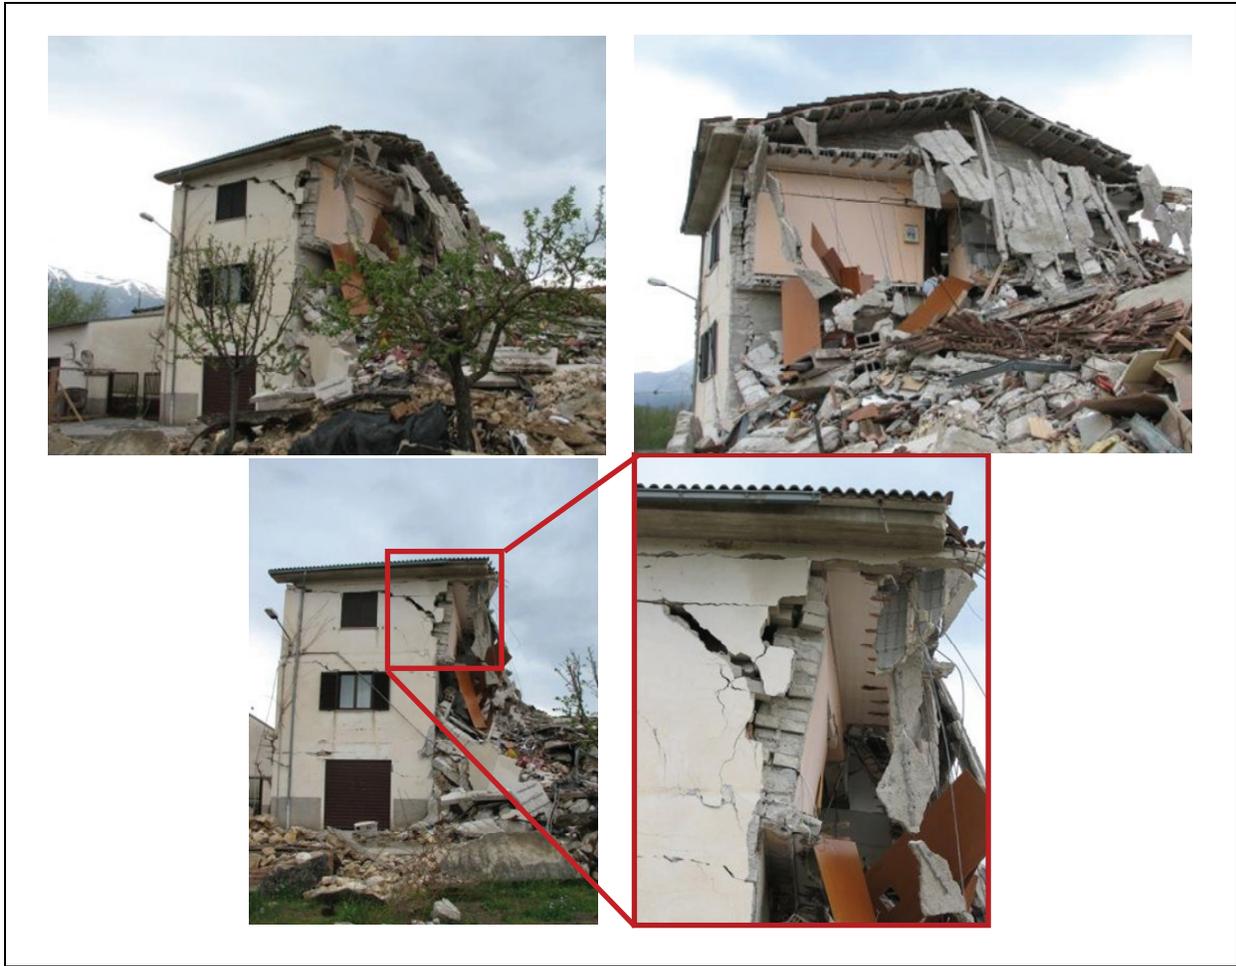
The replacement of floor slabs and roofs (Figure 4-8) and inclusion of RC ring beams in the masonry (Figure 4-6) can have both positive and negative effects. In fact, the lack of or the poor connection between the ring beams and masonry generate eccentricity of the loads on each floor and collapse of walls for out-of-plane forces (Figure 4-6).

Figure 4-8 Collapse of half building in Onna triggered by the RC roof

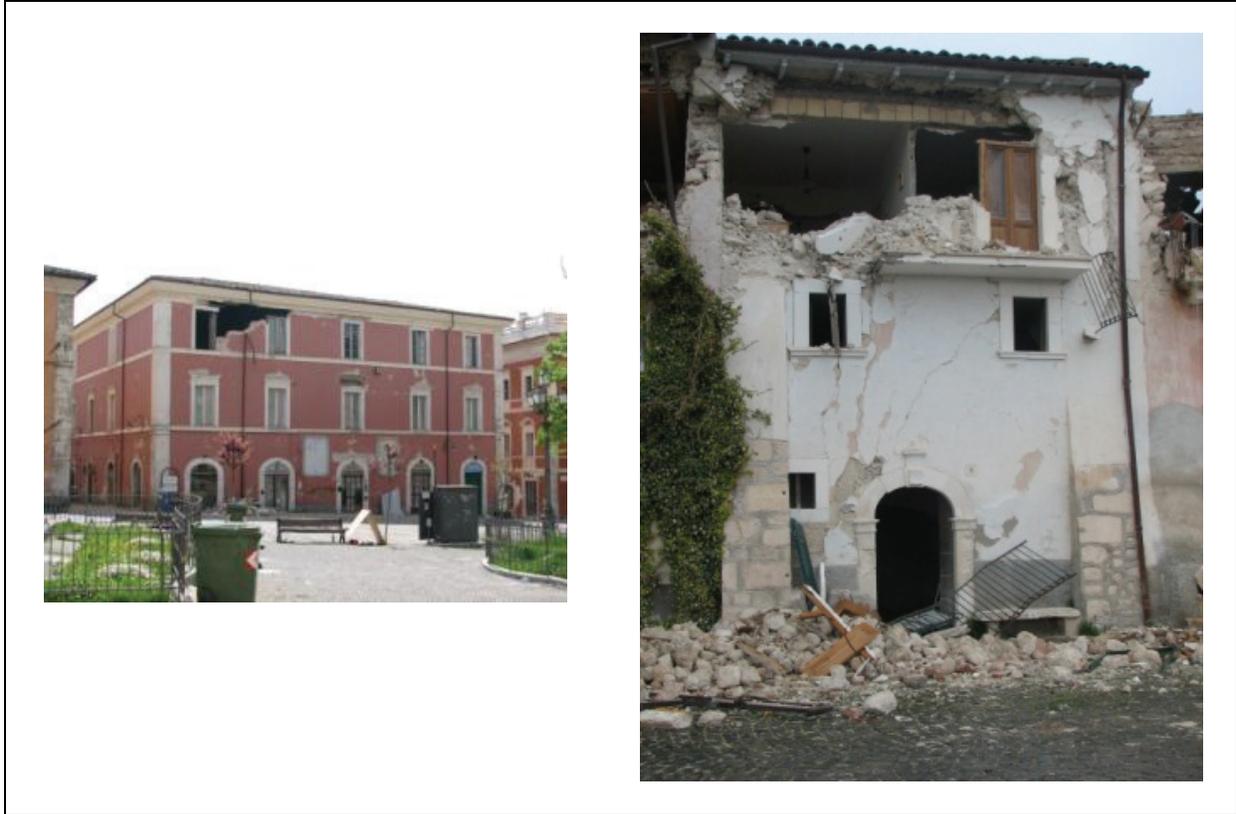
Localized collapse of the top masonry wall is shown in Figure 5-3 and it is probably related to the poor quality of the masonry pattern at the top of the wall.

Figure 5-3 Localized collapse of a portion of the top masonry wall

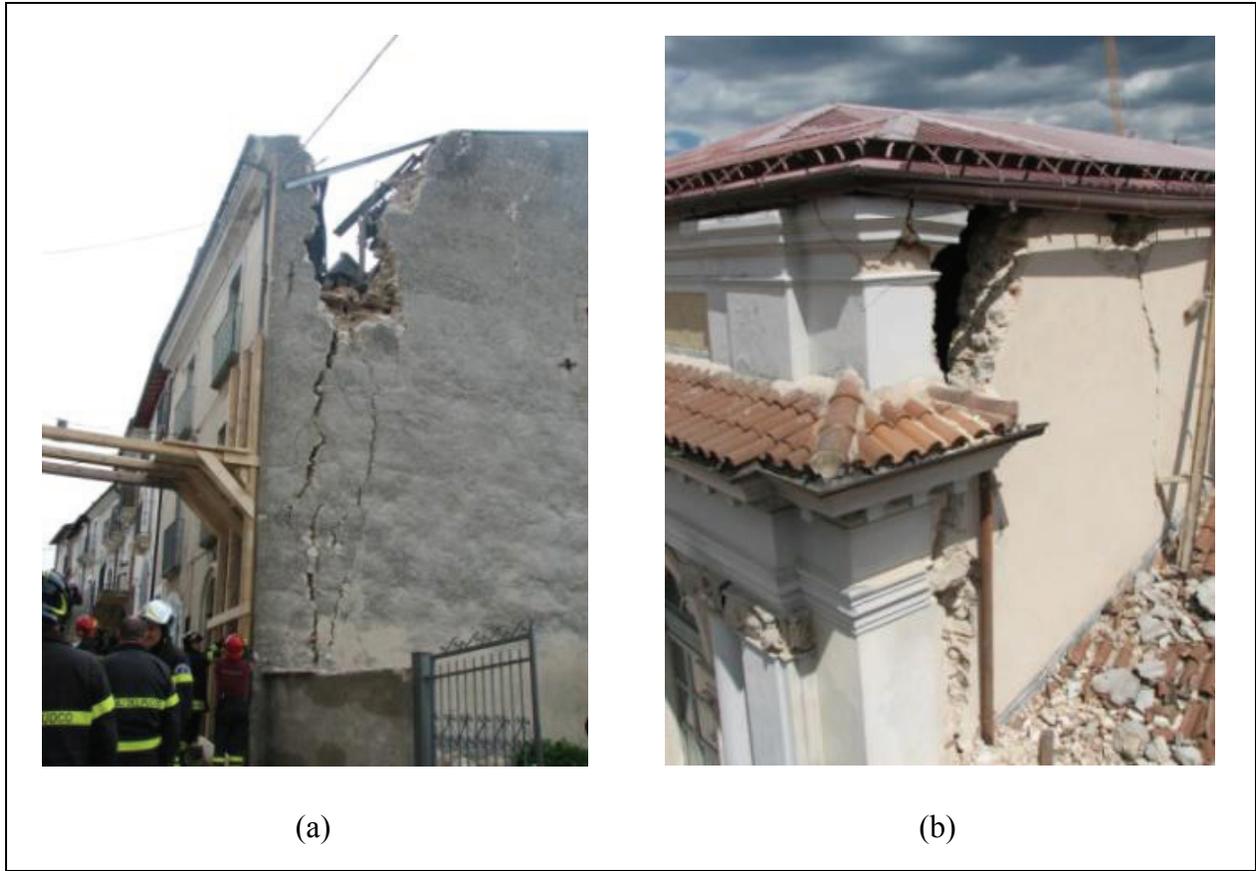
Out of plane overturning of walls was observed in the region, but was very limited because of the systematic use of tie rods in building walls. This collapse mechanism was triggered in cases of poor connection quality at the corners and involved failure of portions of the orthogonal walls (Figure 5-4; Figure 5-5).

Figure 5-4 Out of plane wall overturning

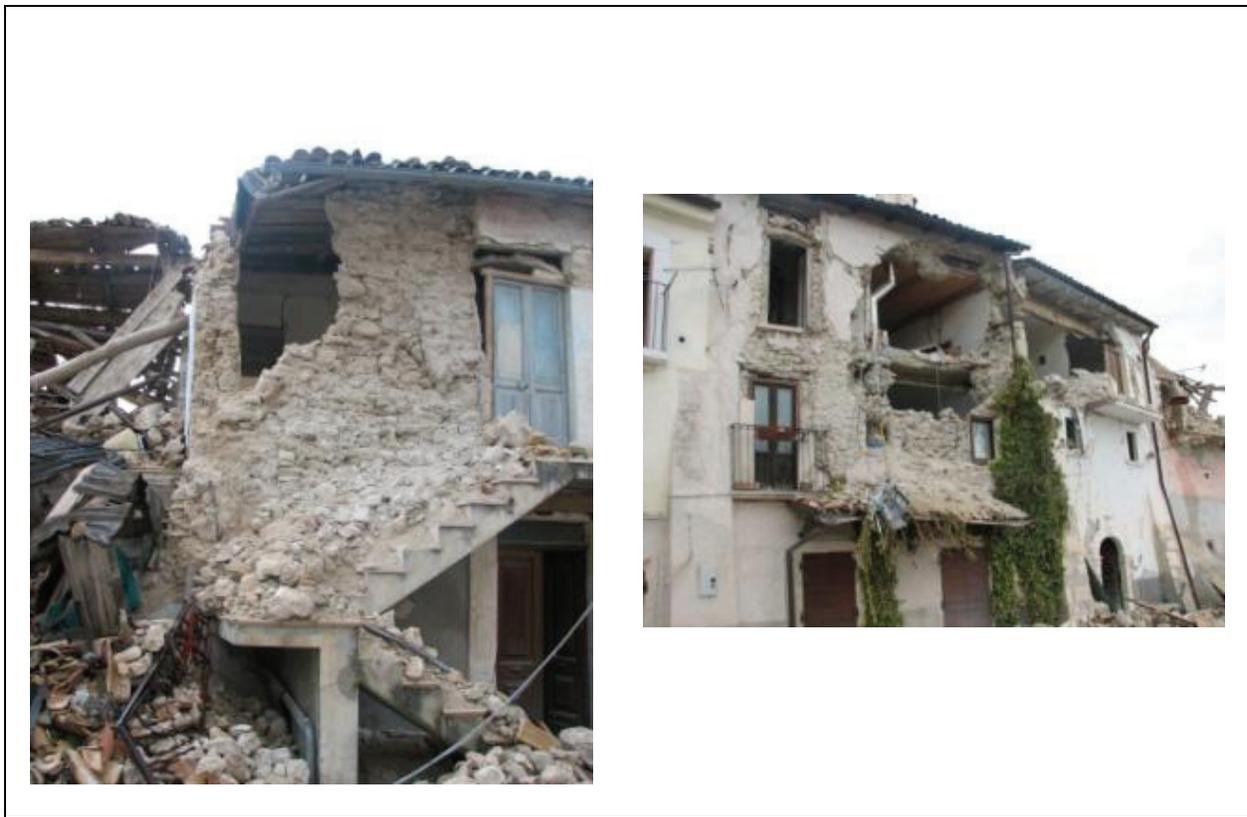
Ruinous collapses or overturning of external façade can be justified by the poor quality of the masonry pattern, poor cement quality and excessive quantity of stone elements, as shown in Figure 5-7. Walls were vulnerable to horizontal forces, because of small or badly placed stone elements, lack of regularity in the pattern and interlocking between the facing sections.

Figure 5-7 Collapse caused by defective masonry quality in Castelnuovo

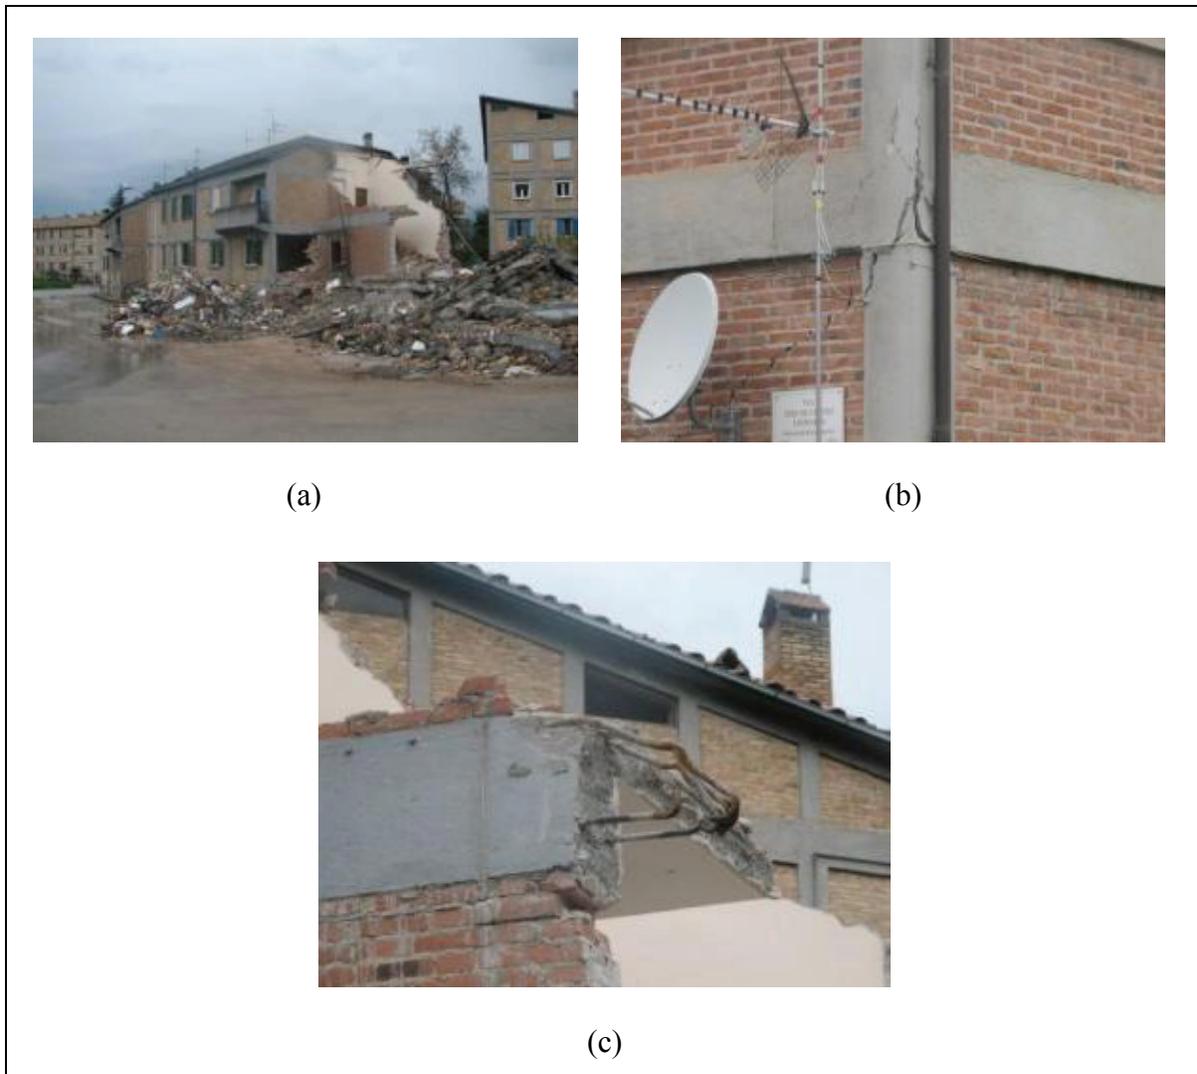
The majority of reinforced concrete damaged buildings was concentrated in the Mt. Pettino region and was originally constructed in the mid-1980s. Pettino is located in the North West suburbs of L'Aquila. The MCEER team observed damage in a series of residential blocks built in the 1980s extending up a hill-side. All these buildings consisted of reinforced concrete frames with hollow core clay bricks as the one shown in Figure 5-15.

Figure 5-15 Collapse of a two story residential building

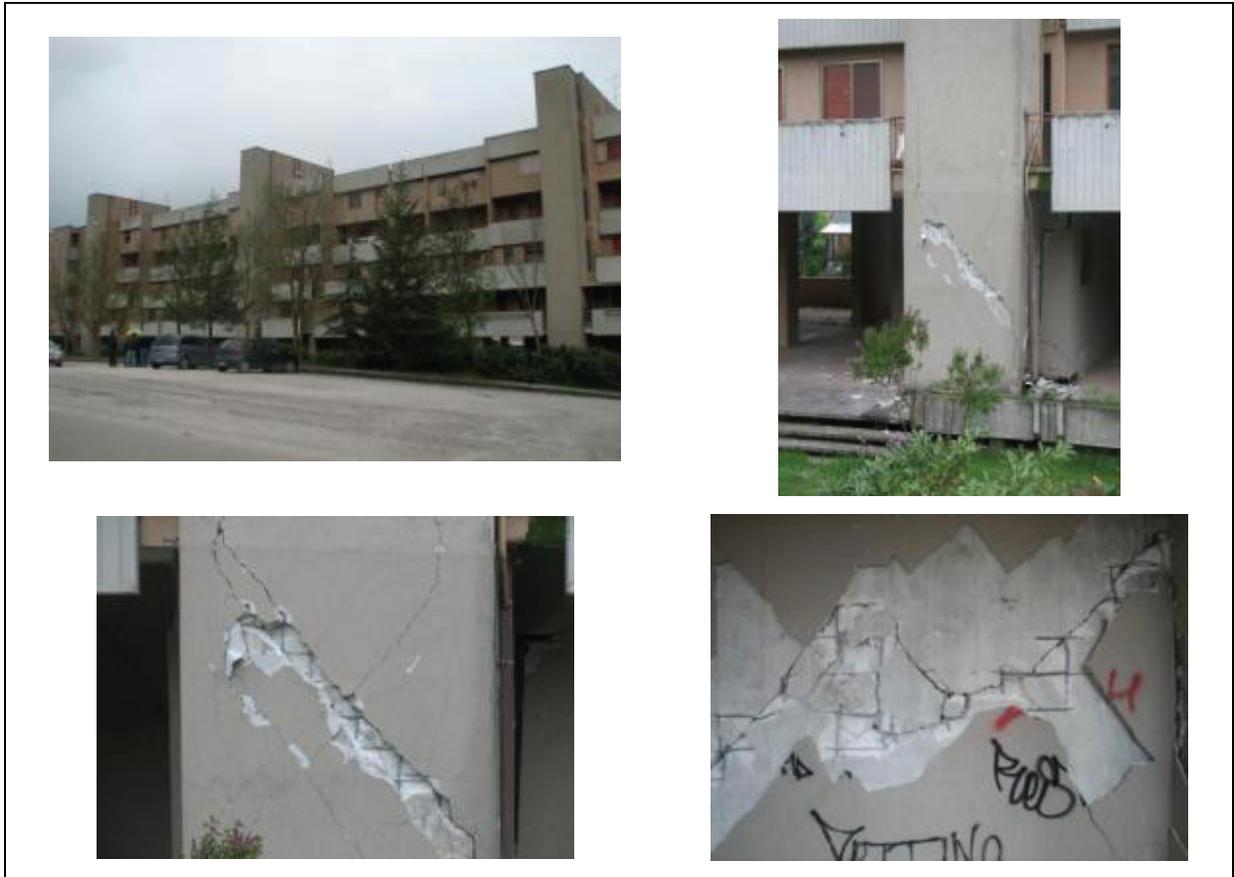
RC frames retrofitted with structural shear walls (Figure 5-16) typically experience less damage because drifts are limited. The 5-story rectangular building shown in Figure 5-16 was constructed with two vertical joints between the three shear walls in order to give a more regular stiffness distribution. However the central shear wall has double mass with respect to the two laterals shear walls and it was severe damaged at the base.

Figure 5-16 Damage to shear walls system in Pettino

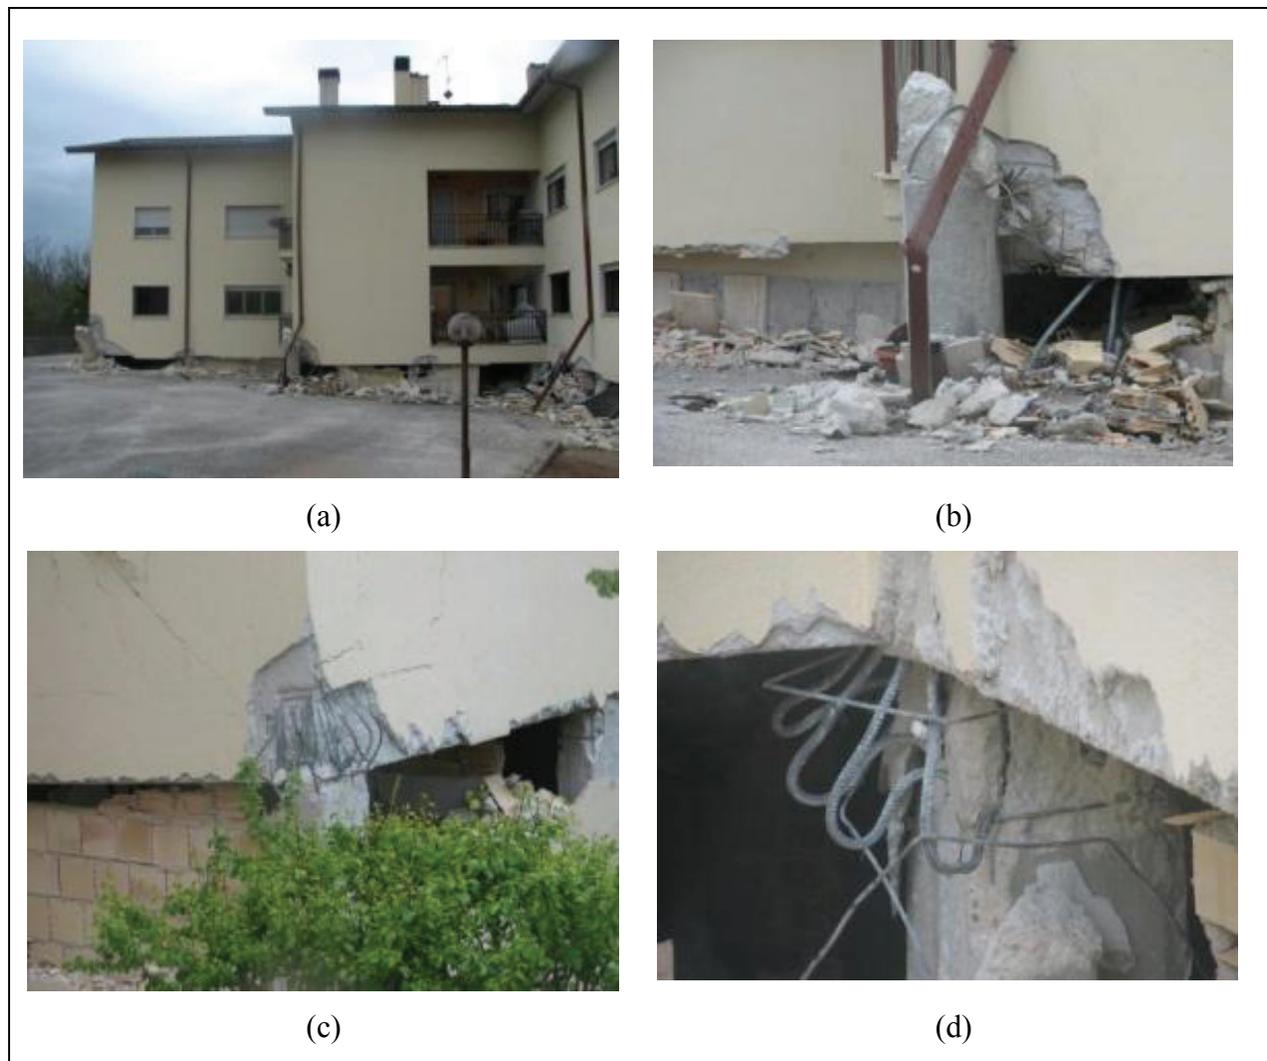
Several buildings suffered a typical soft-storey failure, as the one shown in Figure 5-17 that was located on the hill slope in Dante Alighieri Street. The building is T-shape in plan and therefore it can be considered as irregular in plan. The main reason of collapse is the different infill distribution along the height of the building, because infill walls are absent at the first story level due to the presence of garages entrances. However, an adjacent building located on horizontal ground suffered negligible damage to lower storey columns. This suggests that the reason of collapse might be the topographic amplification effects, combined with some vulnerability such as the infill irregularity in elevation and local interaction between infill walls and adjacent columns at the first level that caused brittle failure.

Figure 5-17 Soft story collapse of building in Pettino

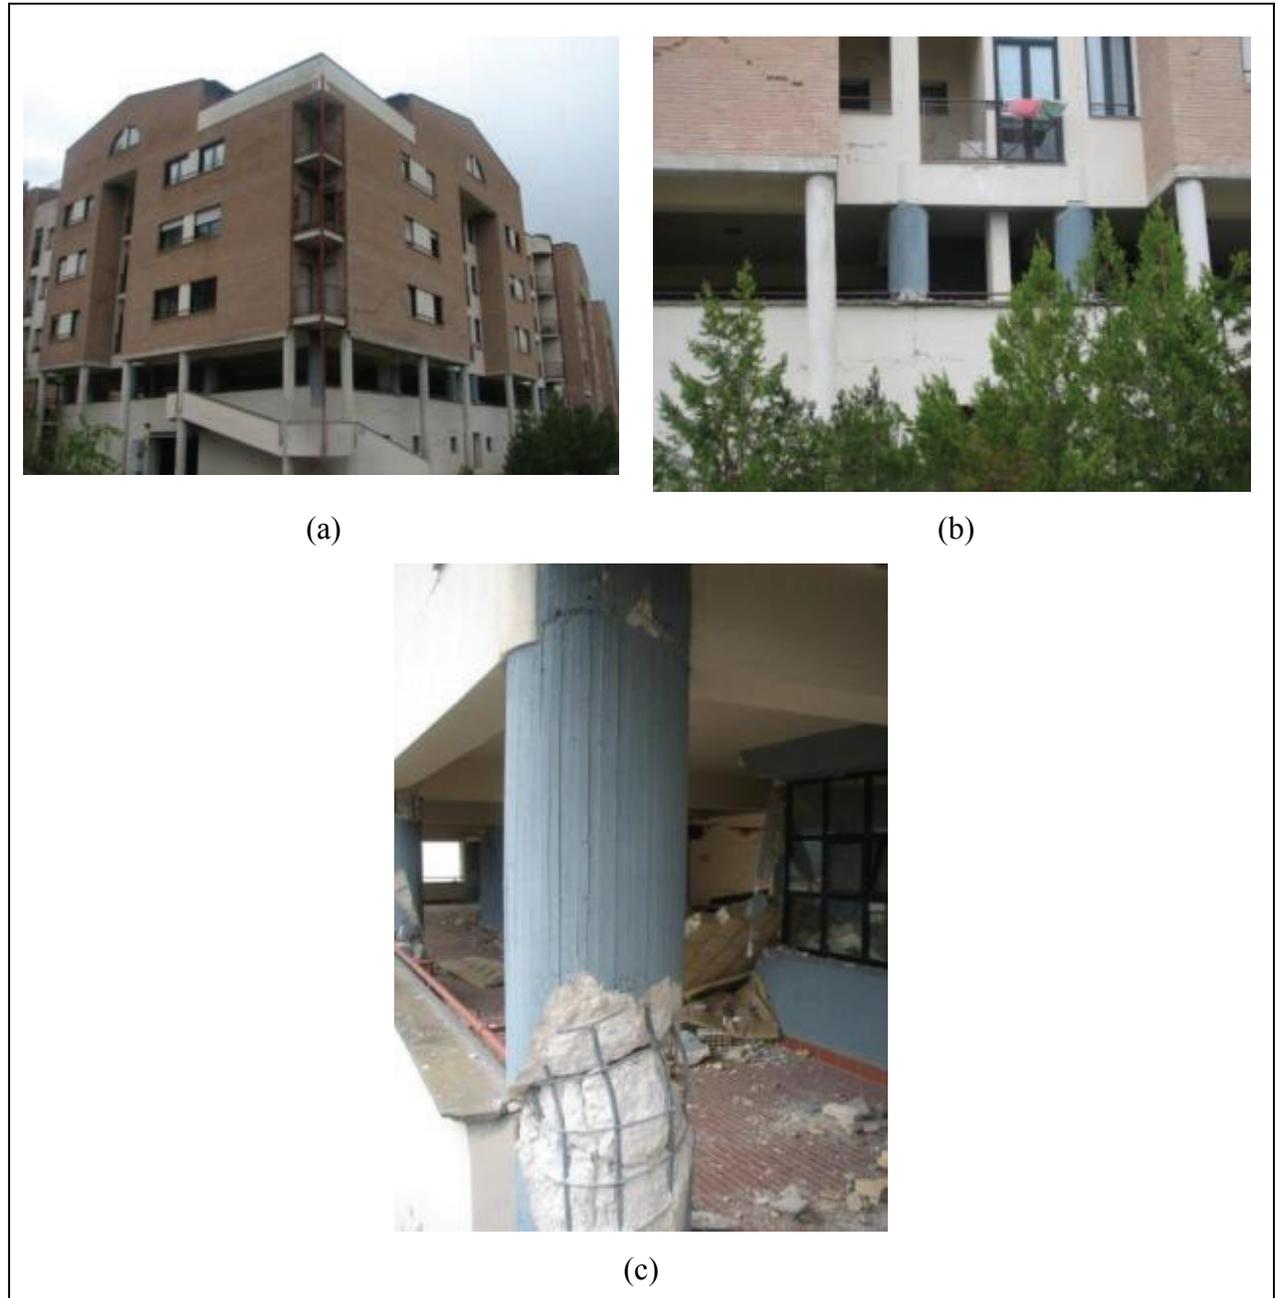
partially fills the frame bay, it can reduce the effective length of the column, increasing the shear demand and the consequent brittle failure of the column (Figure 5-18d). It is important to mention that two new RC villas had recently been completed nearby and were undamaged.

Figure 5-18 Squat column shear failure

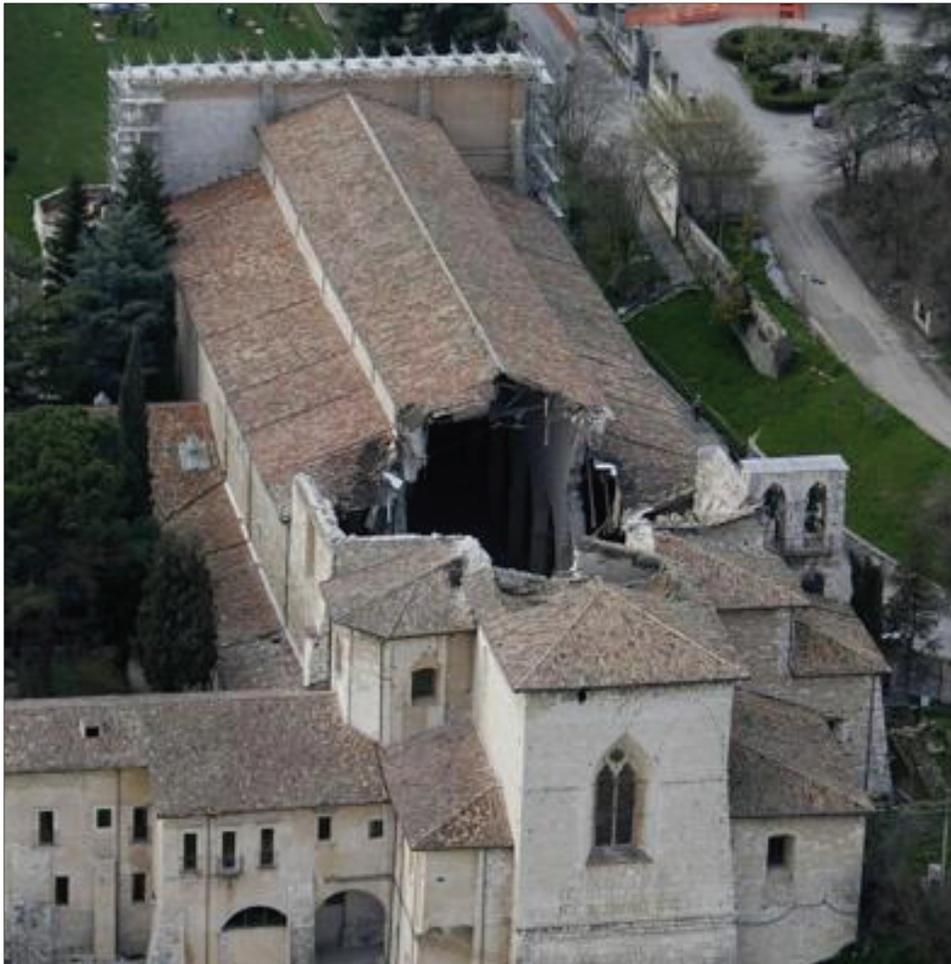
Figure 5-26 Collapse of the Transept

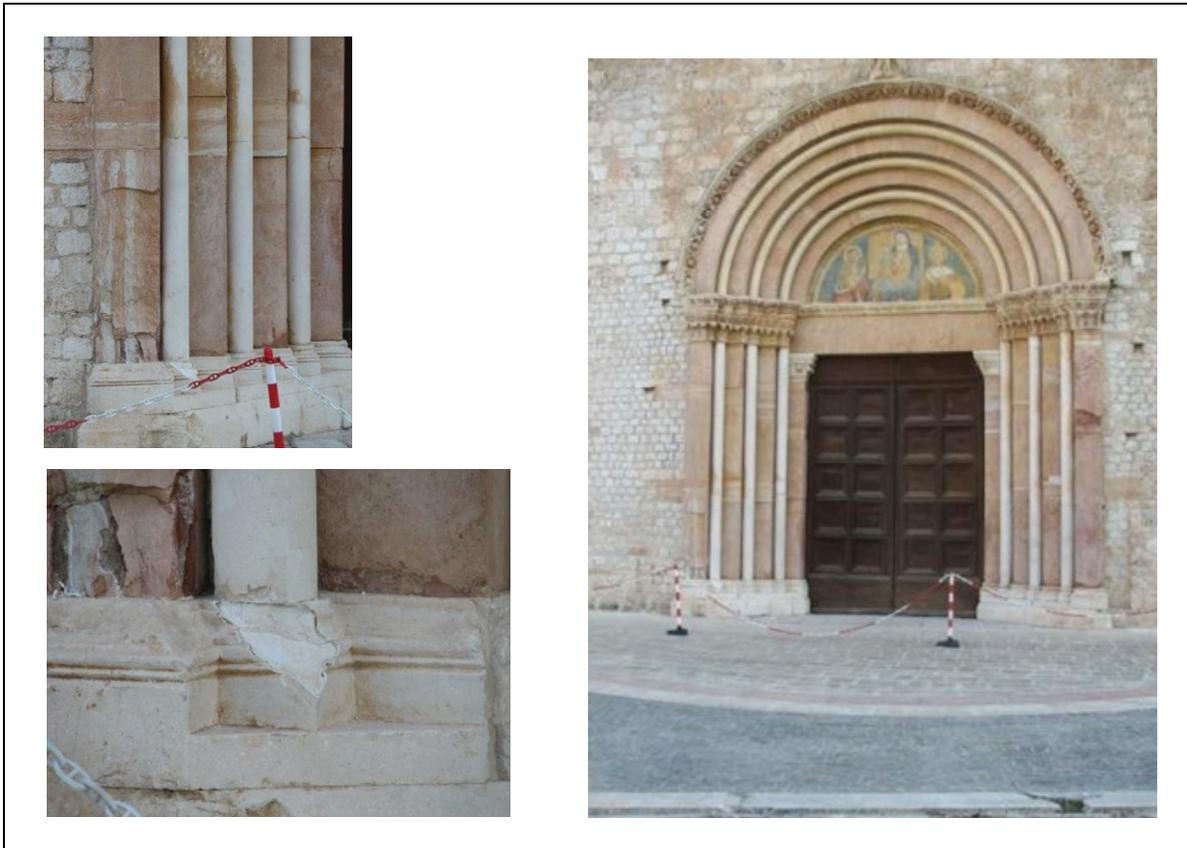
Figure 5-29 Damage to the jubilee "Holy Door" of the Church

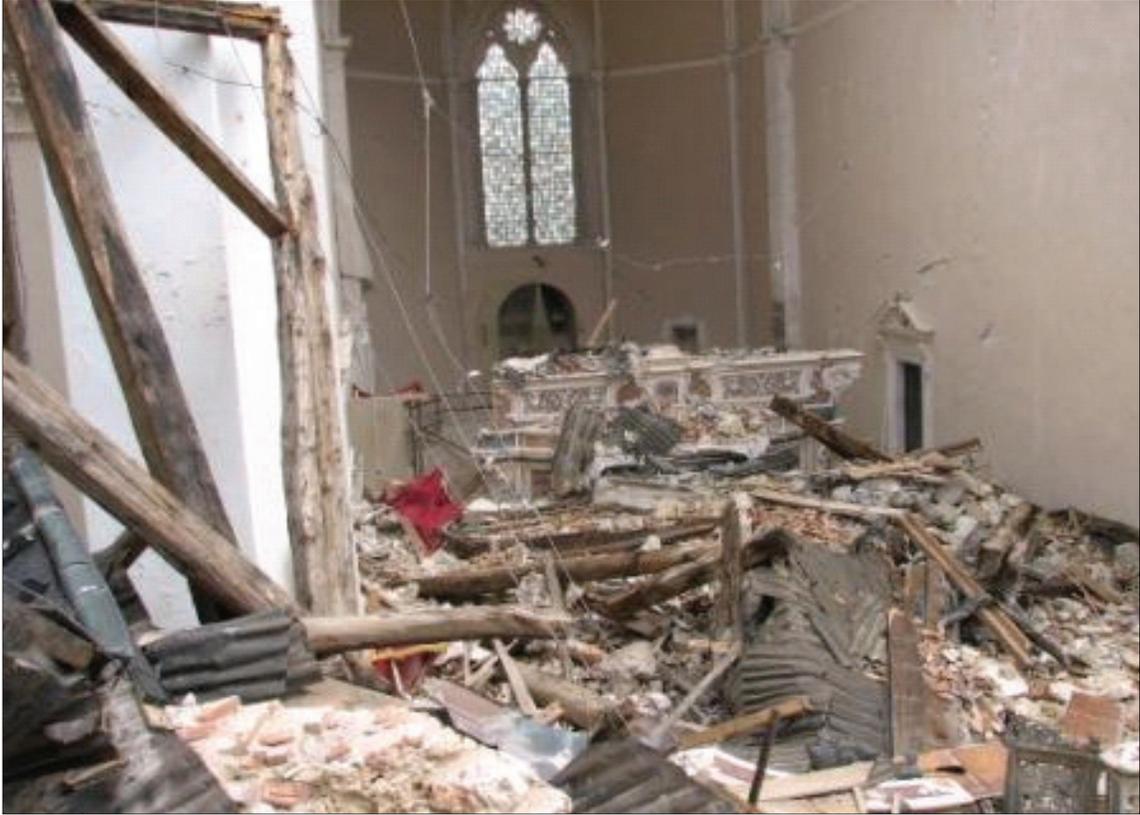
Figure 5-49 Damage to the altar

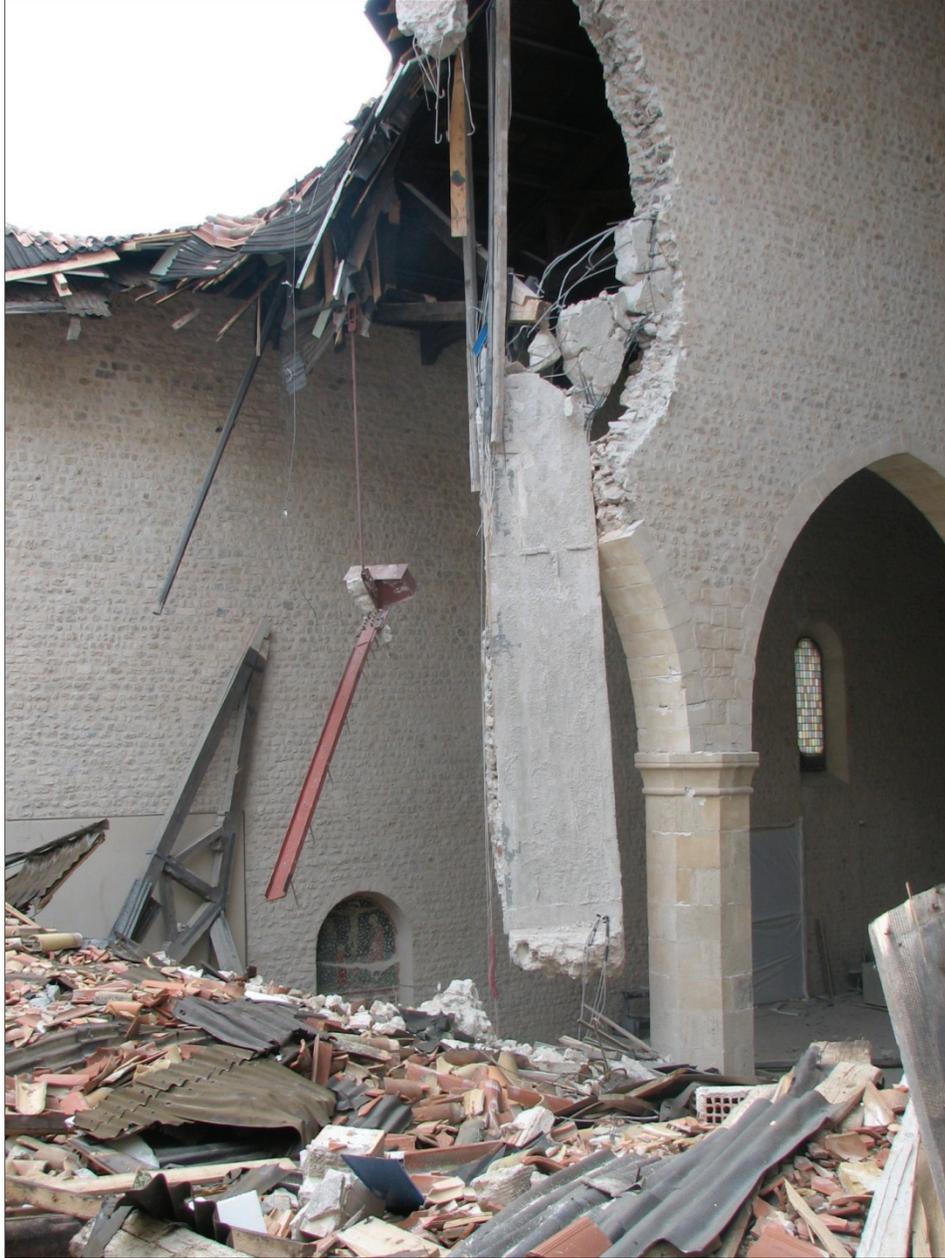
Figure 5-50 Evidence of movement of the church toward the South direction due to the twisting of the ring beam in the South direction after collapse

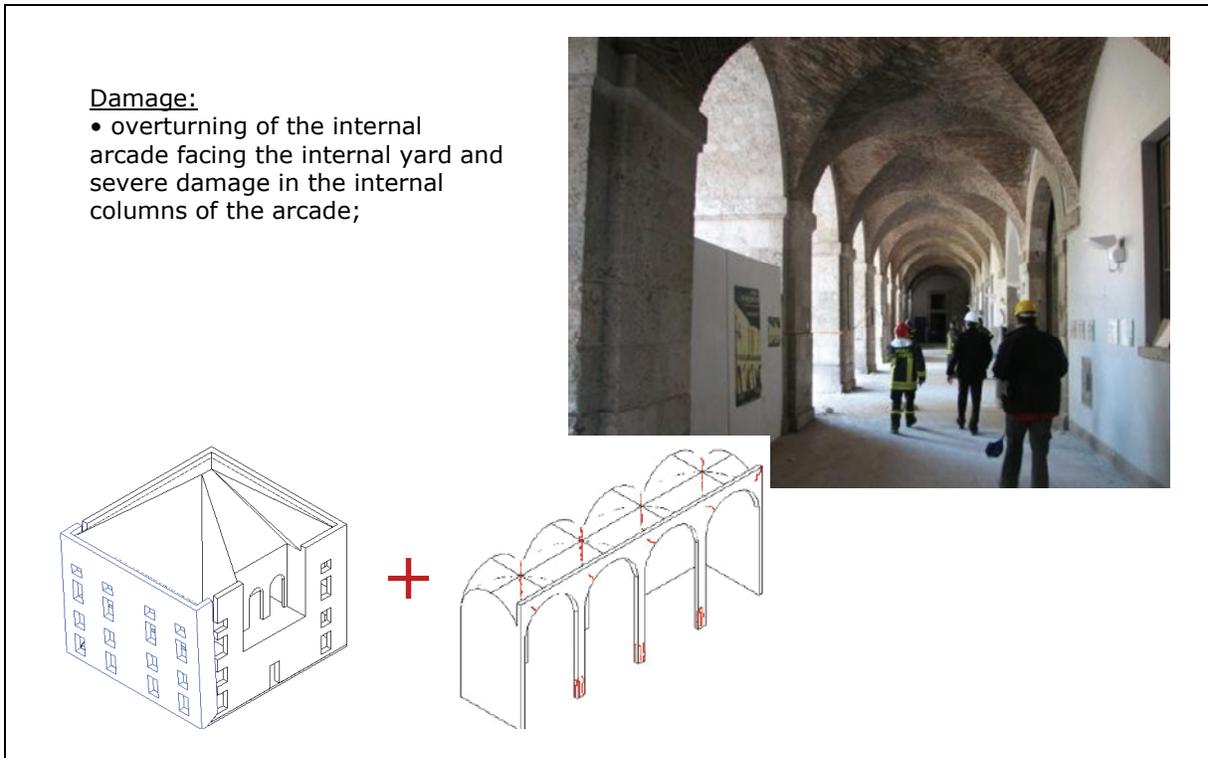
The internal walls of the courtyard overturned (Figure 5-59, Figure 5-61), generating typical cracks in the cross vaults of the arcades (Figure 5-60) and severe damage in the columns due to axial-flexural behavior (Figure 5-62). Evidence of this mechanism can be found in the internal rooms on the second floor and in the corridor (Figure 5-63), where longitudinal cracks are present at the floor level nearby the windows and in the barrel vault of the corridor (Figure 5-64).

Figure 5-59 Overturning of the arcade

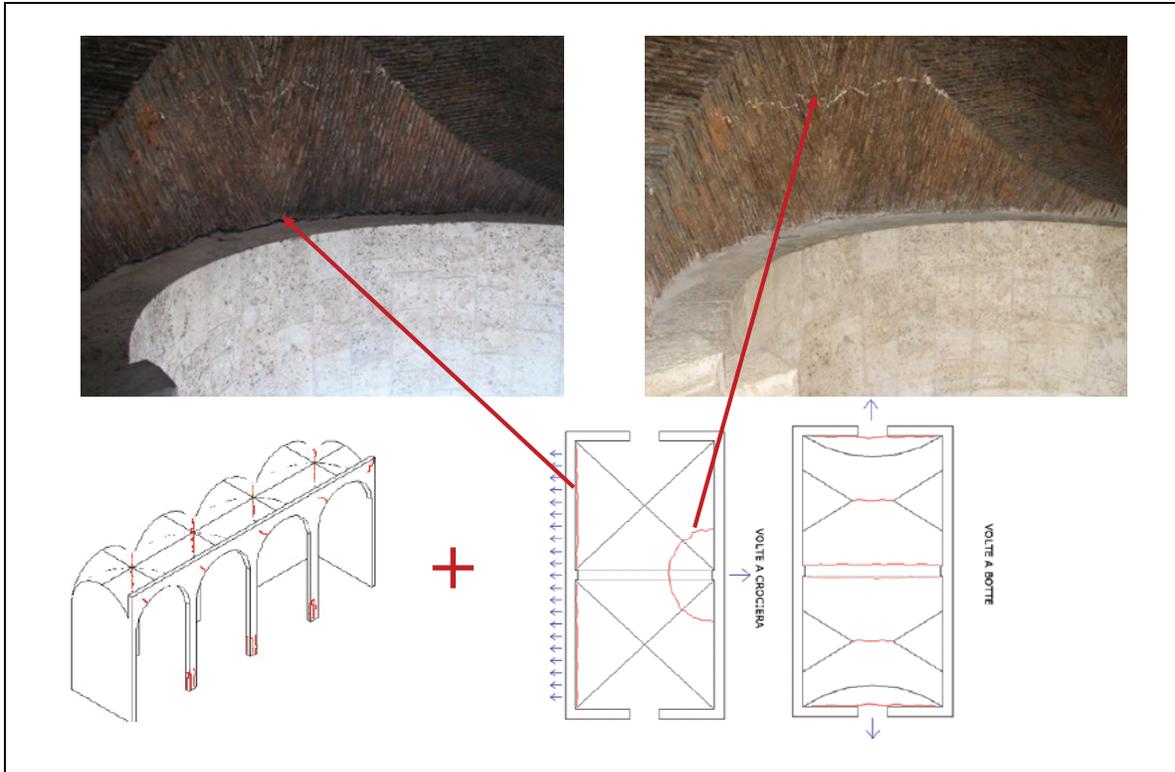
Figure 5-60 Damage to arcade

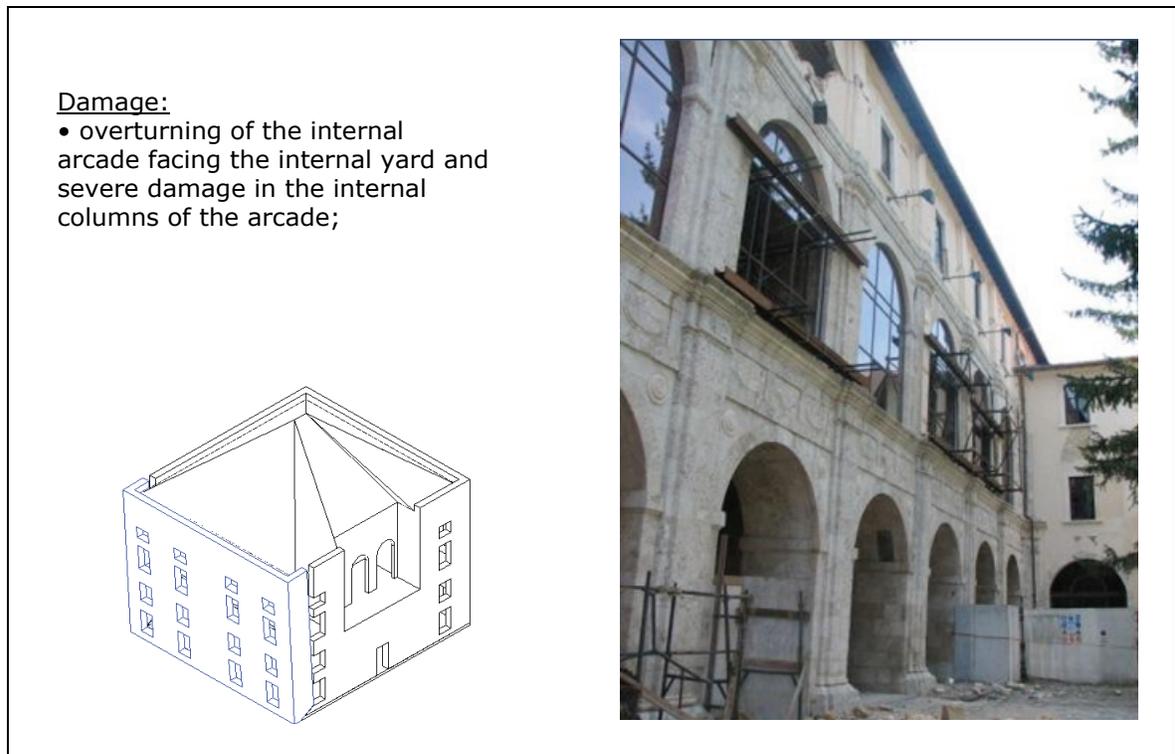
Figure 5-61 Overturning of the internal wall of the courtyard

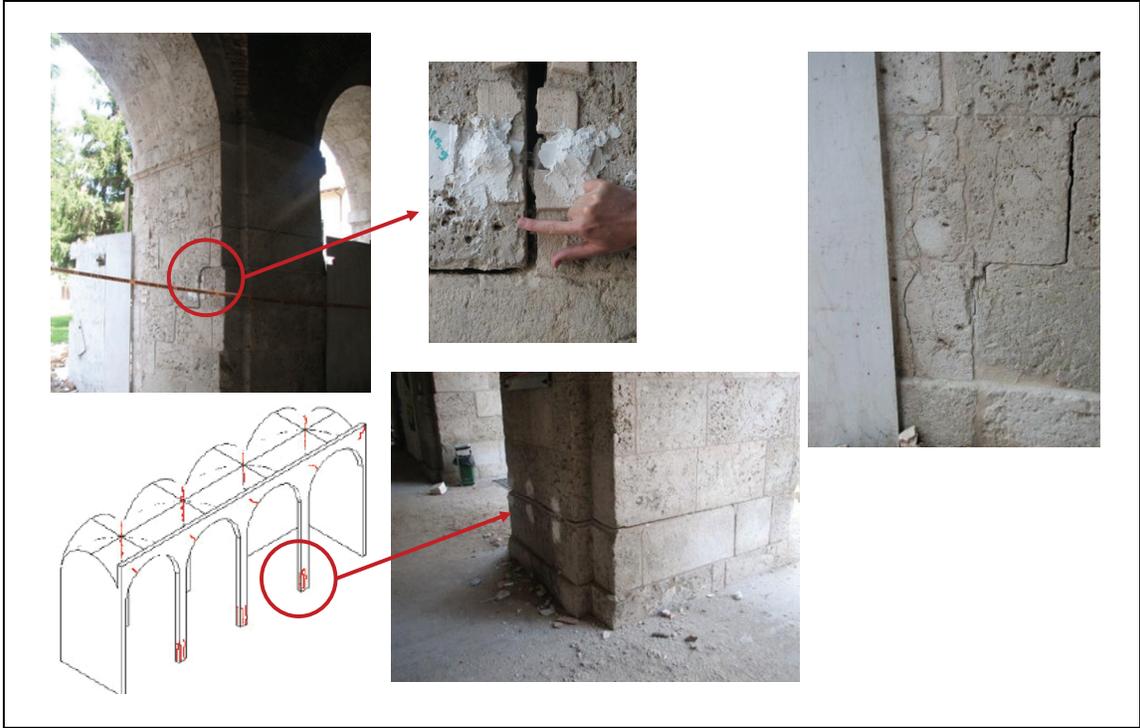
Figure 5-62 Damage to the columns of the arcade

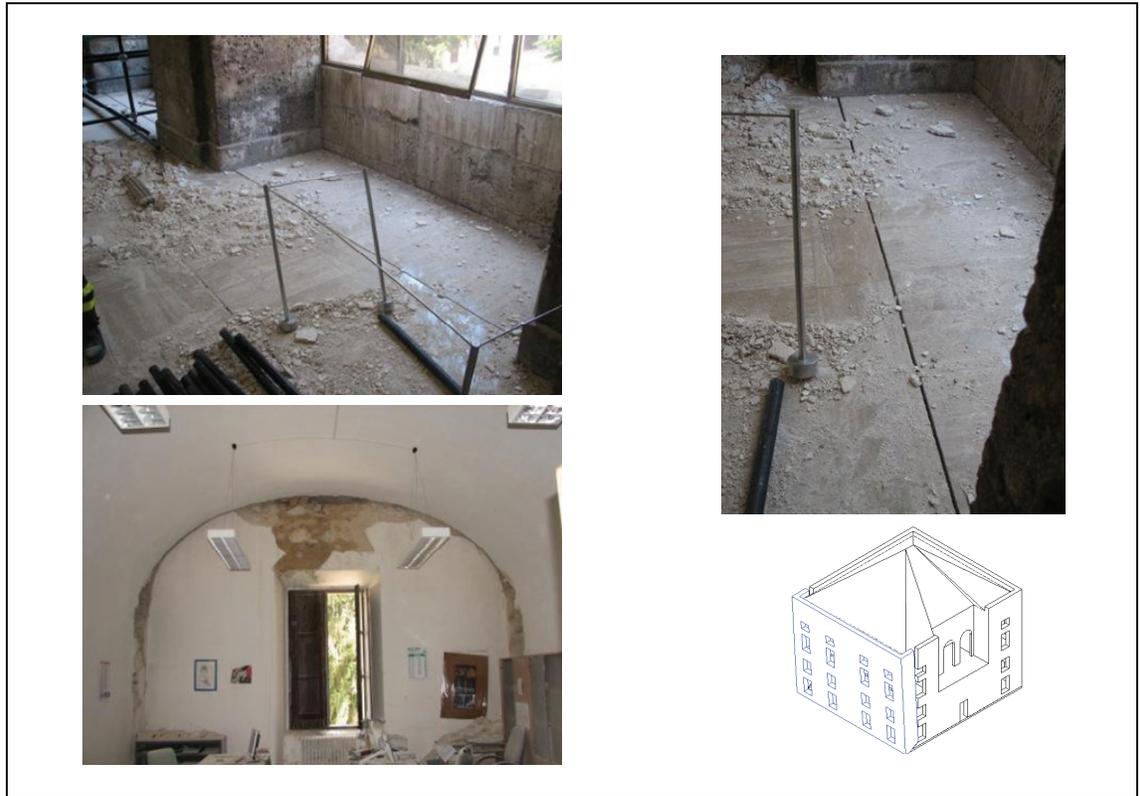
Figure 5-63 Internal evidence of the overturning walls

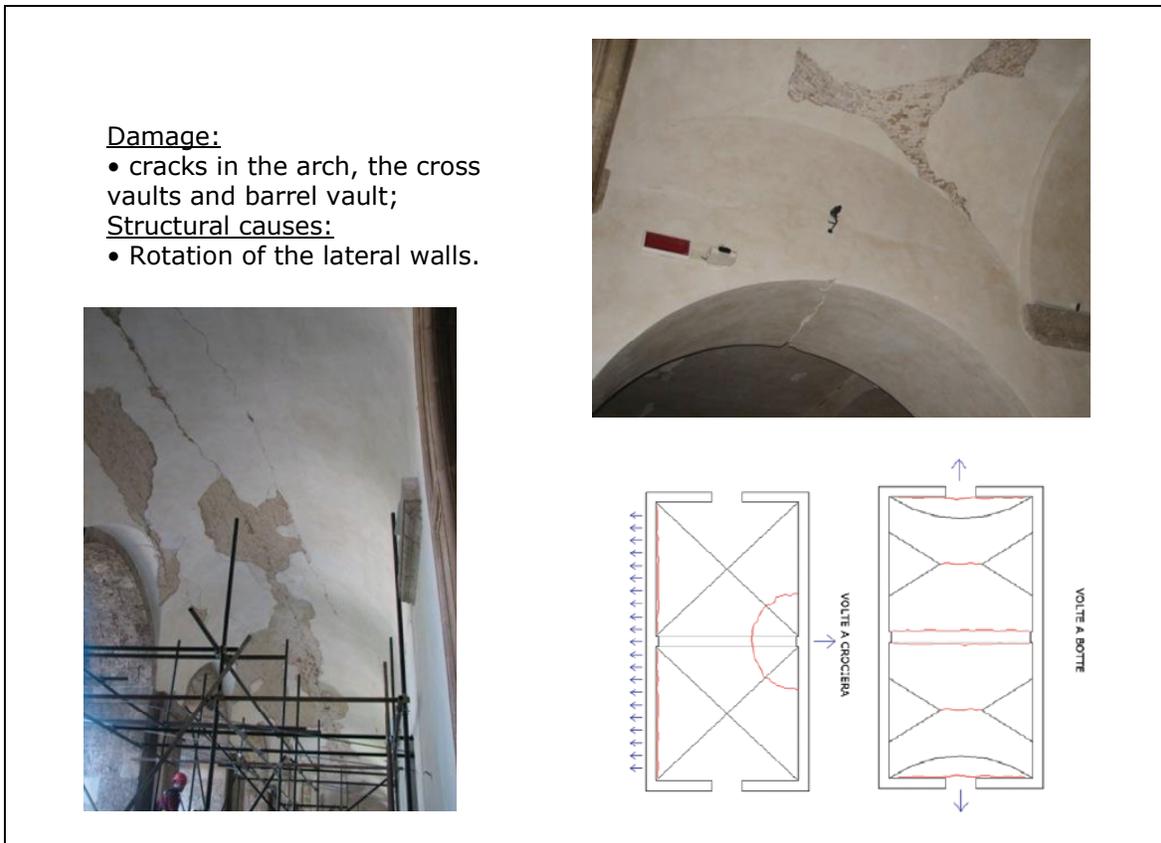
Figure 5-64 Damage to the vaults

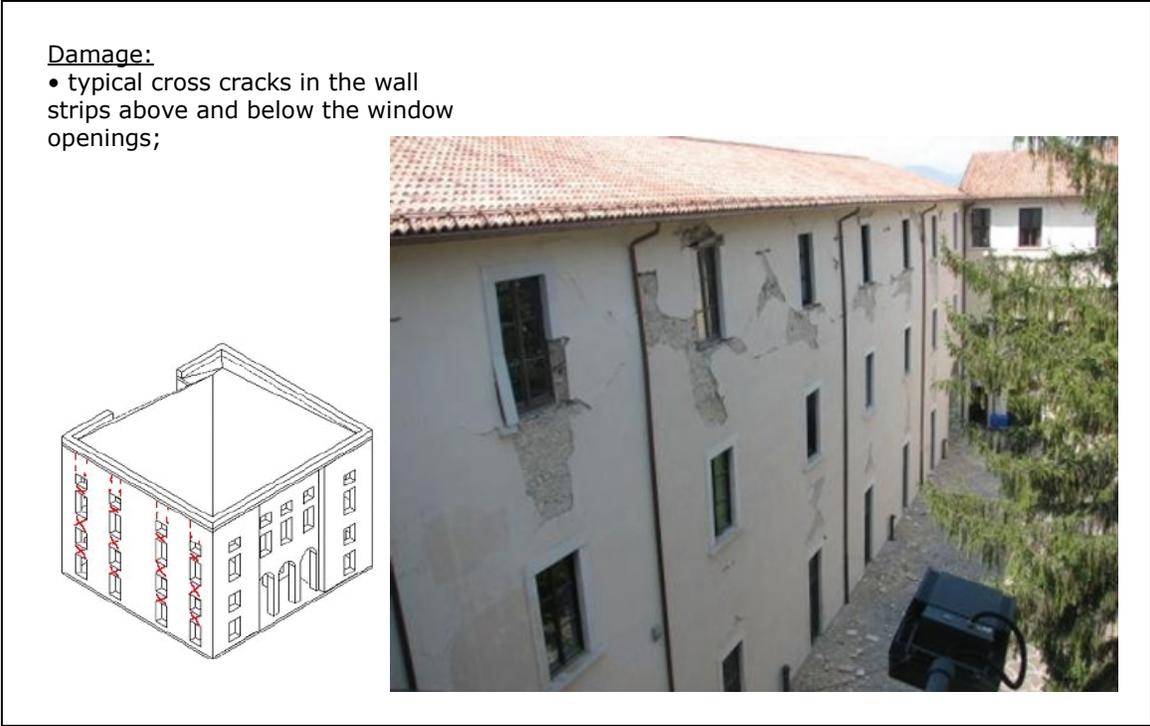
These shear cracks in the walls do not affect the stability of the building that is able to carry the gravity loads.

Figure 5-65 Damage in the wall strips

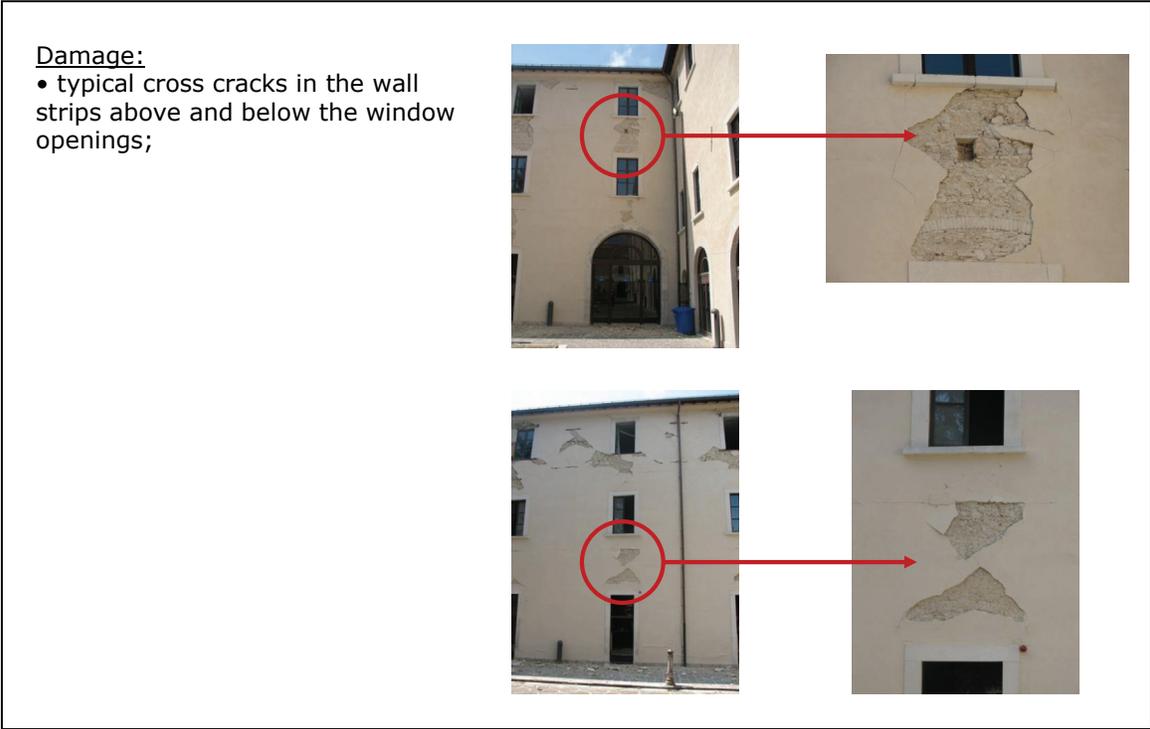
Figure 5-66 Details of damage in the wall strips

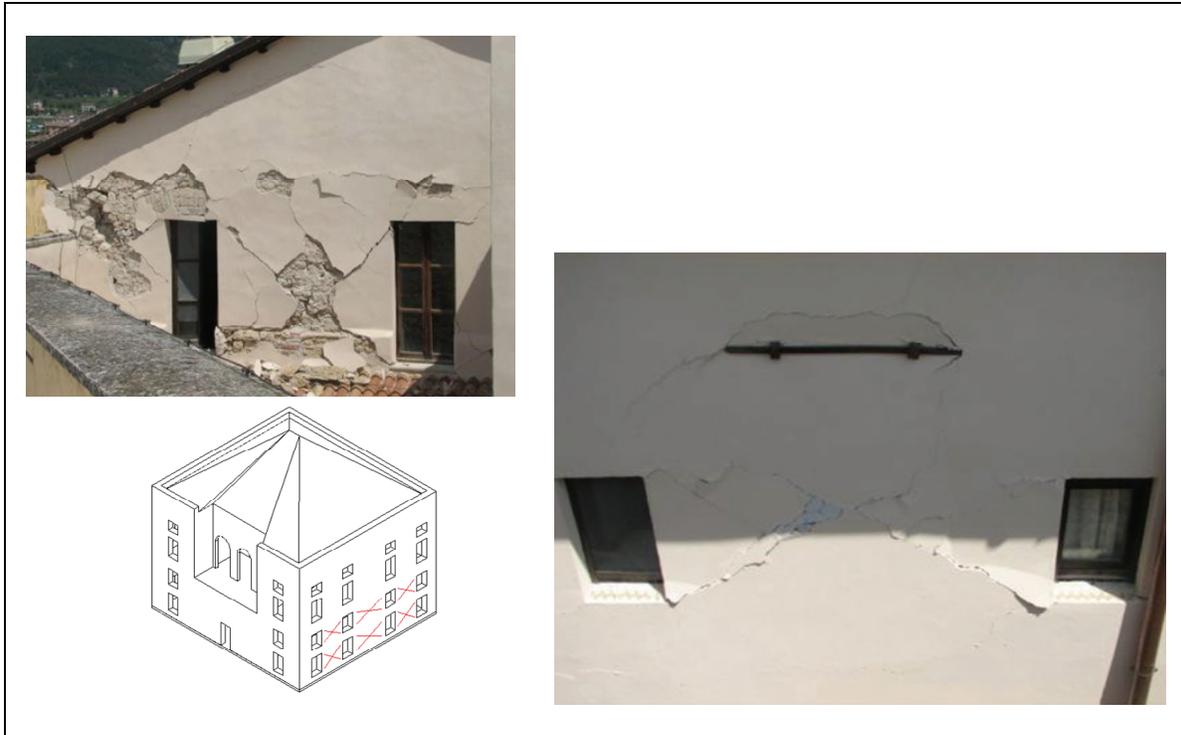
Figure 5-67 Damage in the lateral strip walls
