L'AQUILA EARTHQUAKE OF APRIL 6, 2009 IN ITALY: REBUILDING A RESILIENT CITY TO WITHSTAND MULTIPLE HAZARDS

by
**Gian Paolo Cimellaro, Ioannis P. Christovasilis,
Andrei M. Reinhorn, Alessandro De Stefano
and Tatiana Kirova**

Technical Report MCEER-10-0010

December 29, 2010

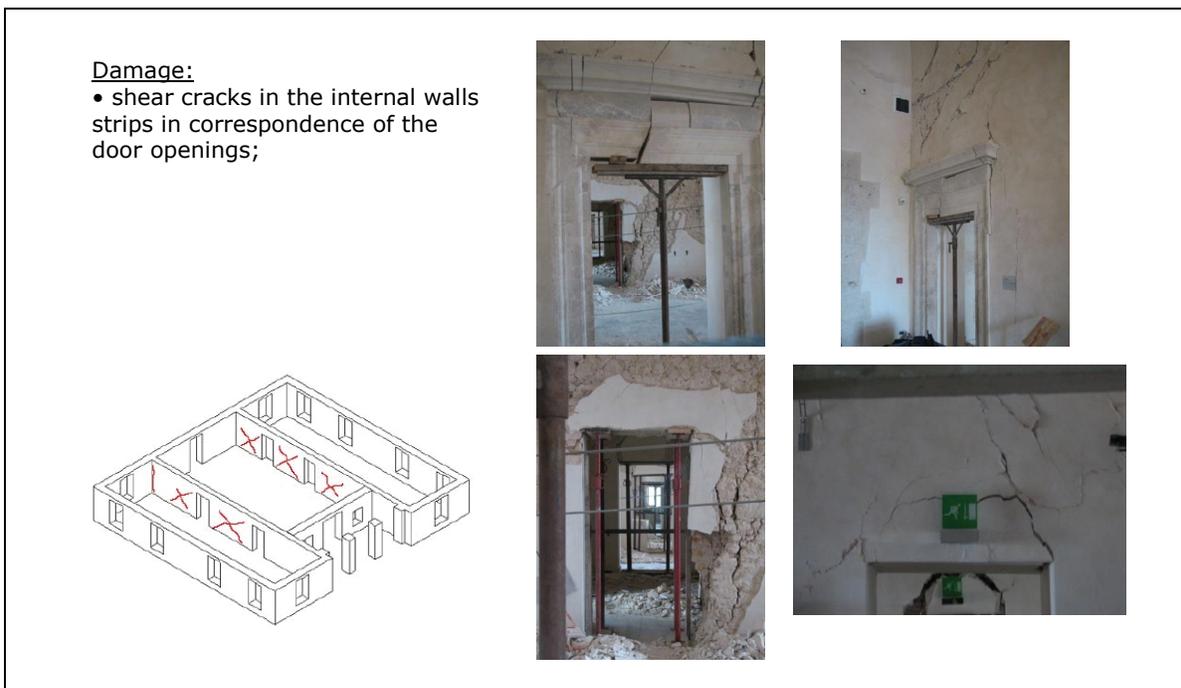
Inside the fortress, damages have been observed near the door openings with collapse of the lintels that have been shored up with restraints props (Figure 5-68).

Figure 5-68 Damage in the lintels

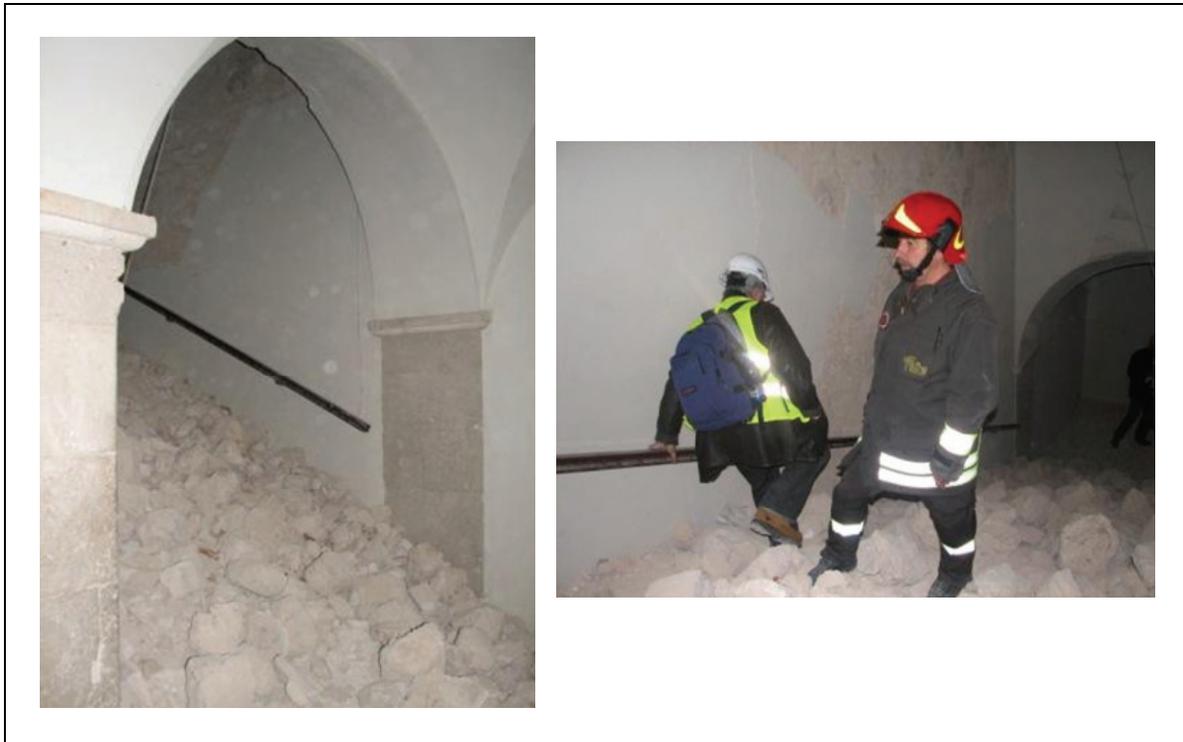
The presence of a large quantity of debris was found near the stairs (Figure 5-69) due to the collapse of one of the vaults. This situation generated additional overloads on the stairs that need to be removed to avoid the collapse of the vaults on the lower level.

Figure 5-69 Damage to the stairs

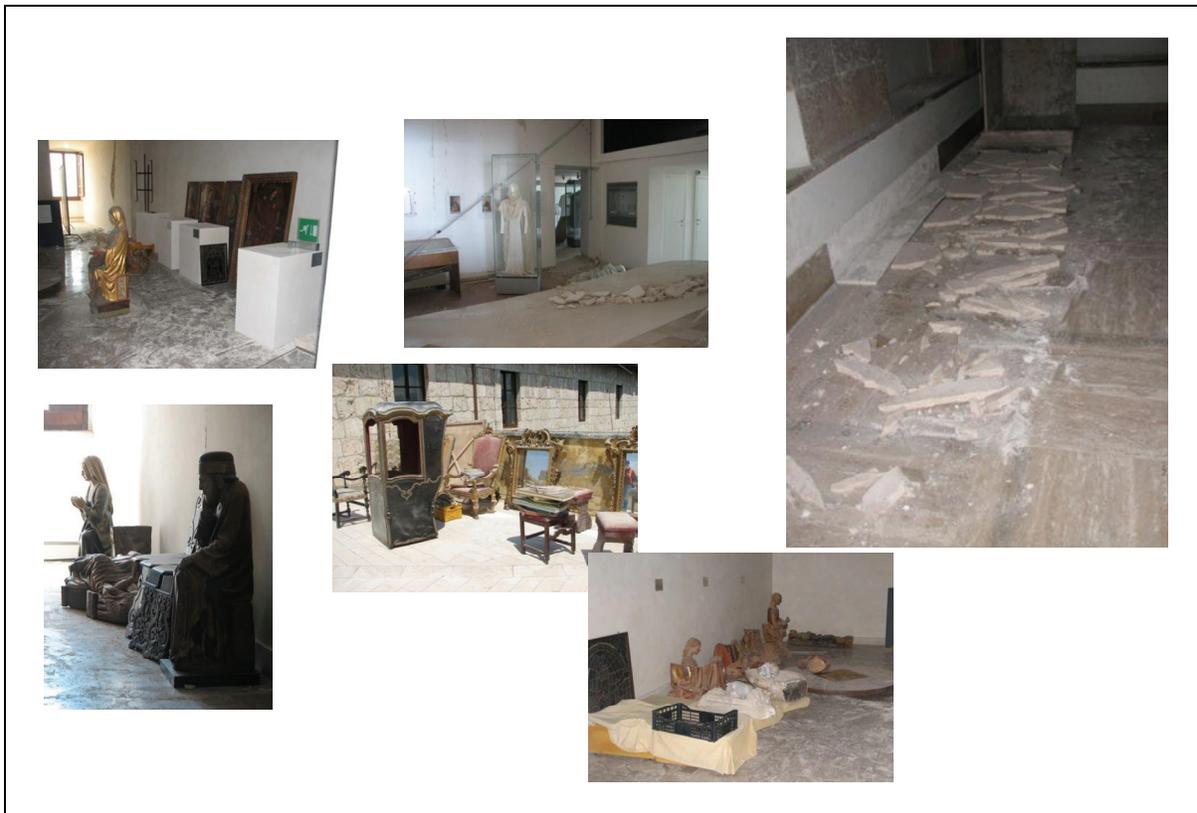
Figure 5-71 Damage to the historical heritage of the National Museum of Abruzzo

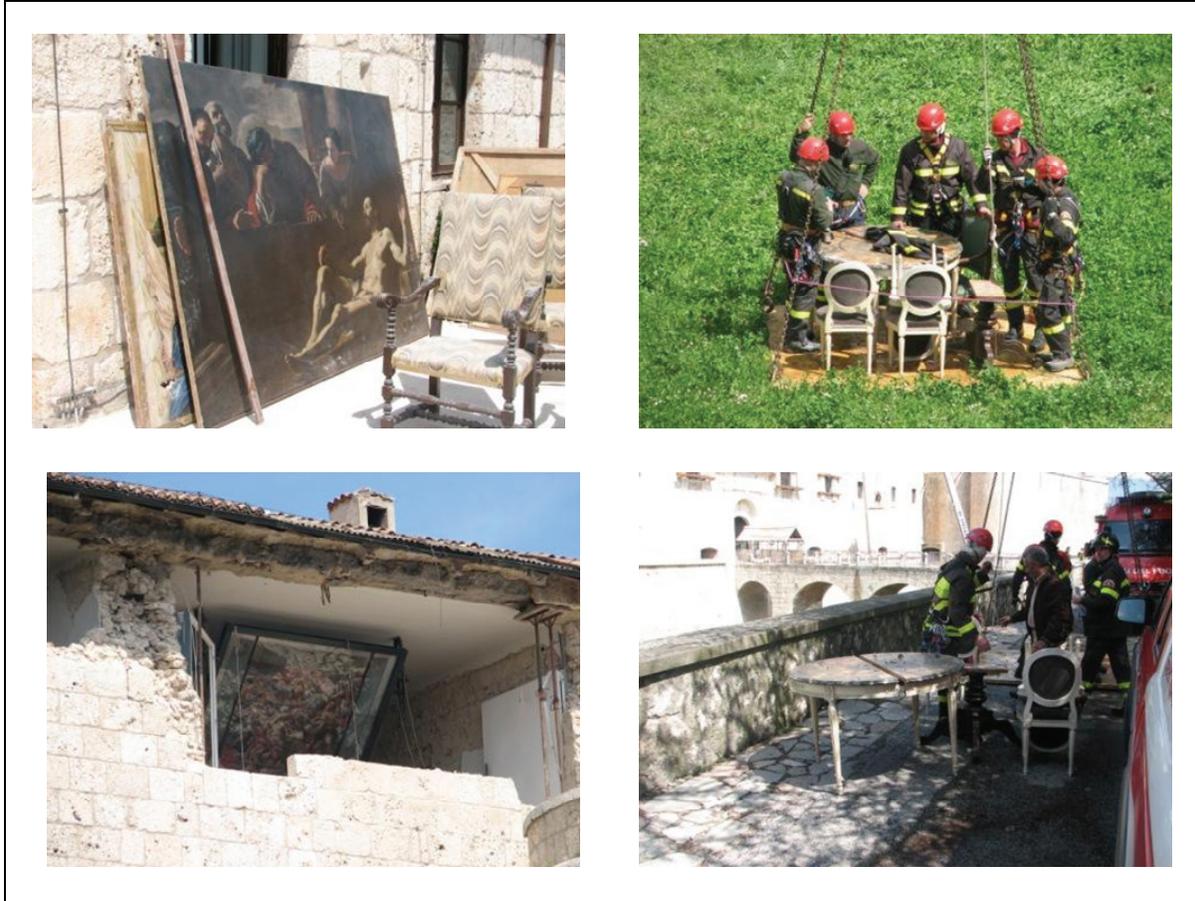
Figure 5-72 Damage to the historical heritage of the National Museum of Abruzzo

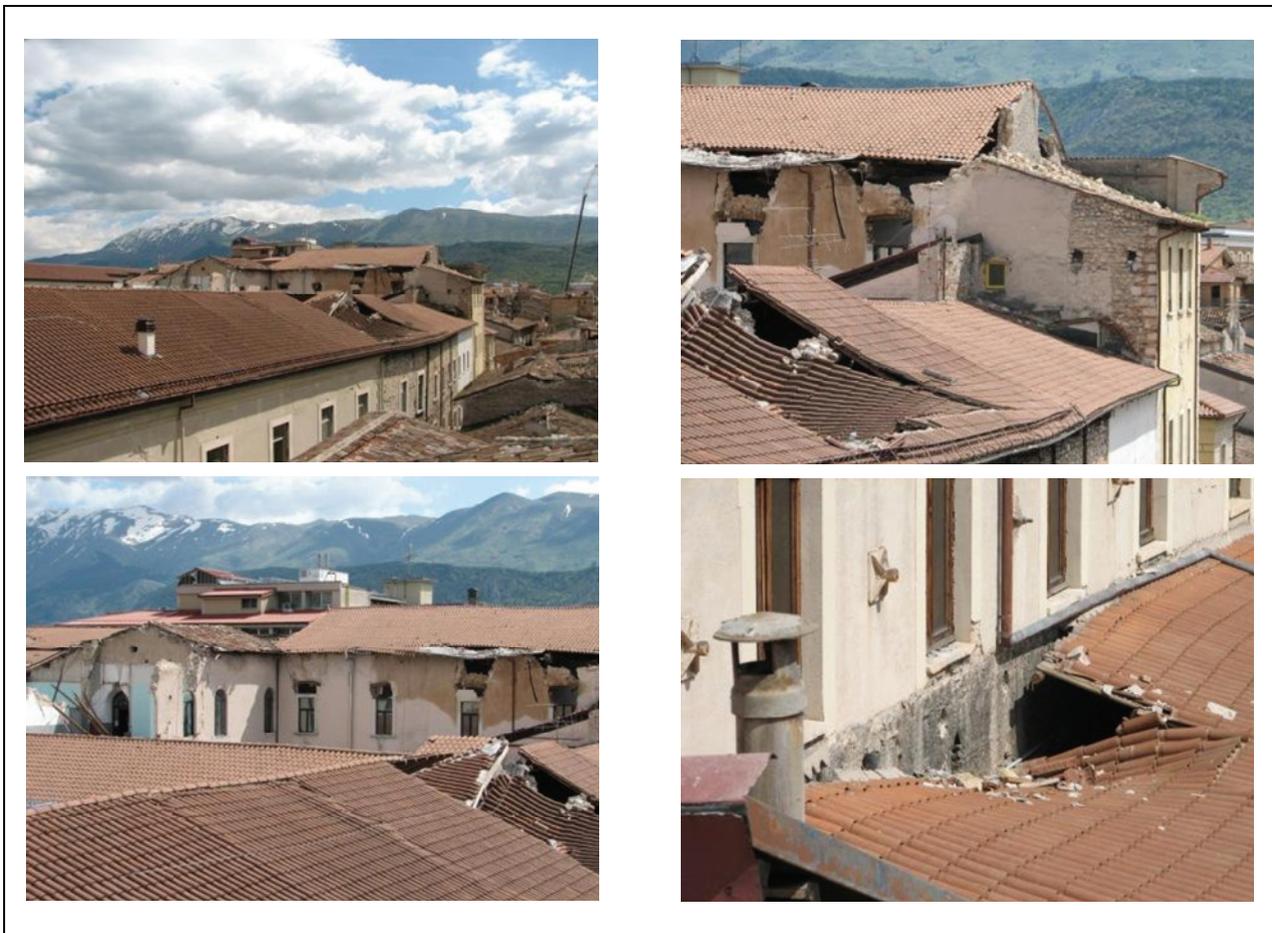
Figure 5-85 Severe damage to roof coverage

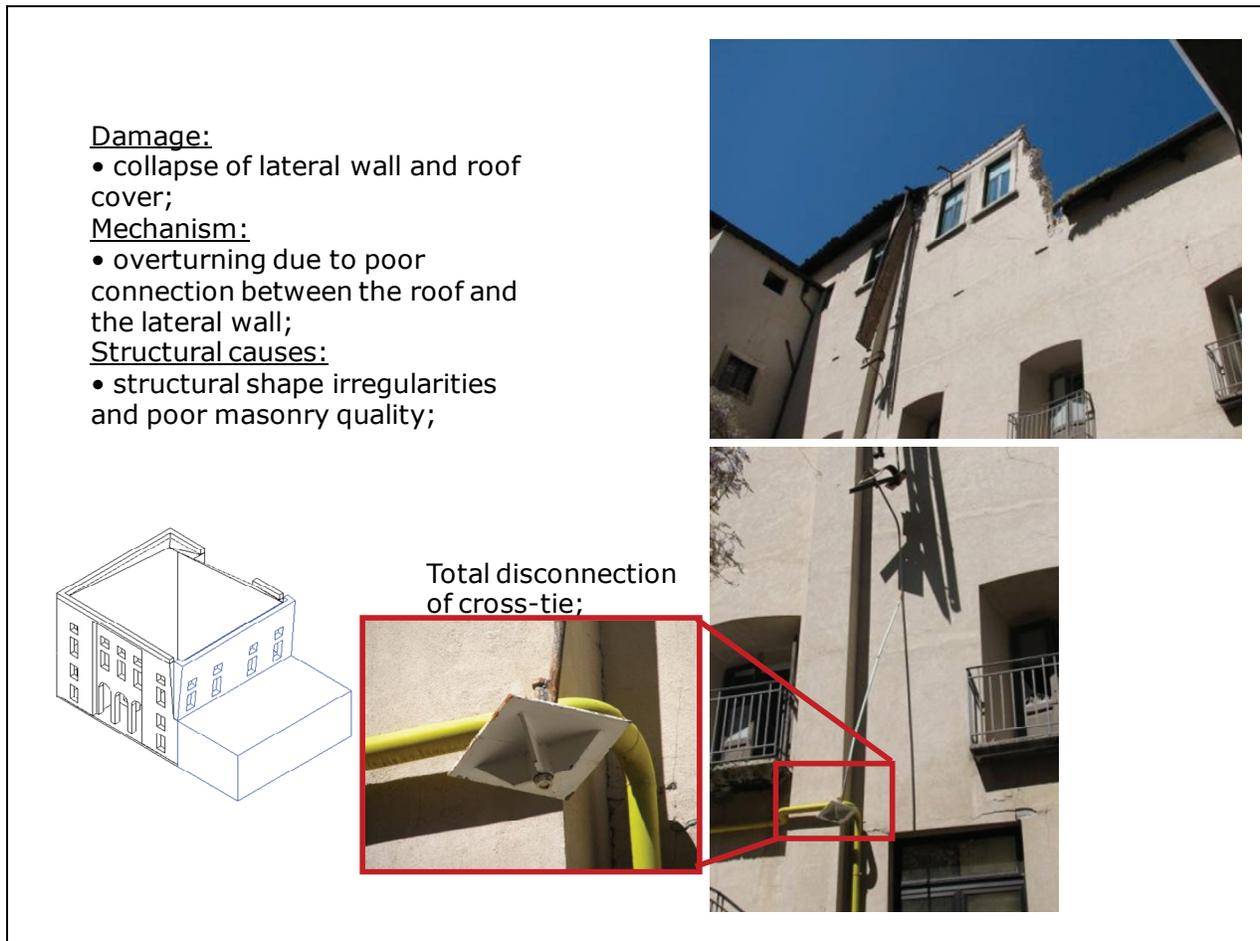
Irregular vertical shapes of the lateral walls of the internal yard, combined with poor masonry quality and improper location of tie rods, generated collapse of the upper lateral walls (Figure 5-88). From these damages it can be summarized that vertical and horizontal asymmetry of the blocks and the lack of ring beams and tie rods in the upper part of the masonry are vulnerability points that impacted on damage.

Figure 5-88 Damage due to irregular shape

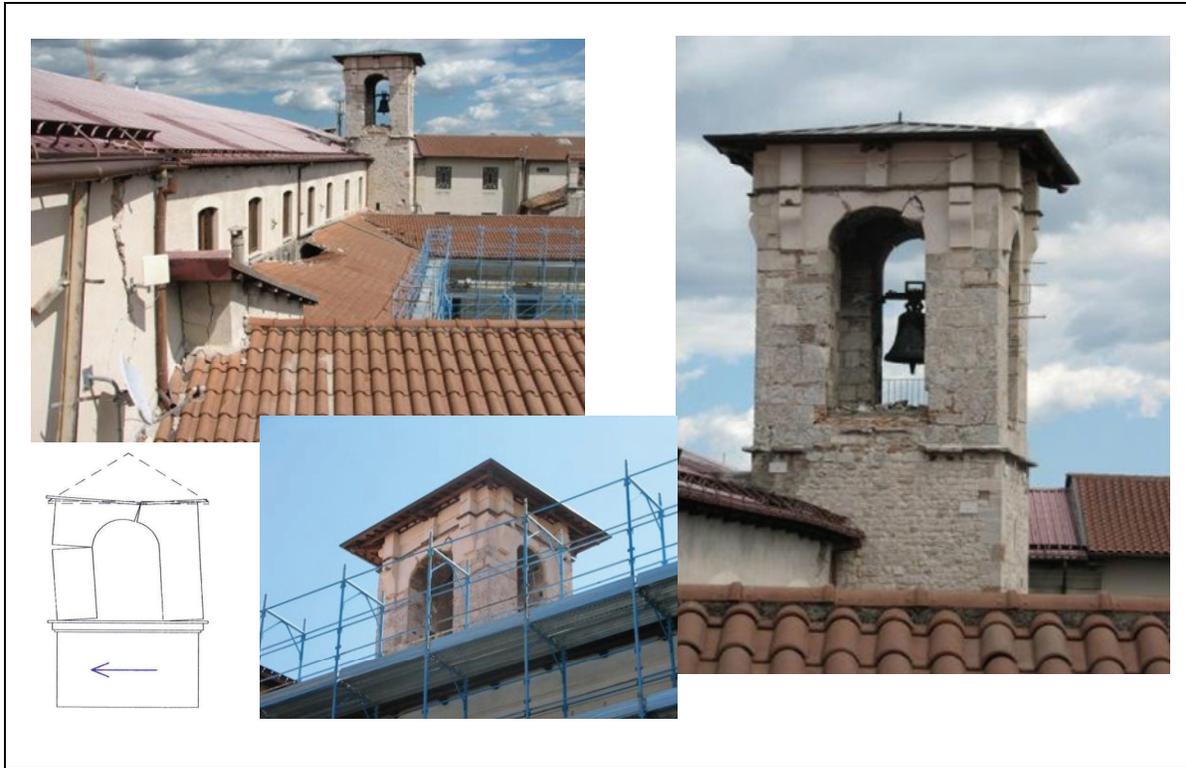
Inside the complex there is also a church and Figure 5-89 shows the damage of the tower bell. Figure 5-90 shows cracks to the vaults of the stairs that were propped by firefighters.

Figure 5-89 Damage to the bell tower of the internal church

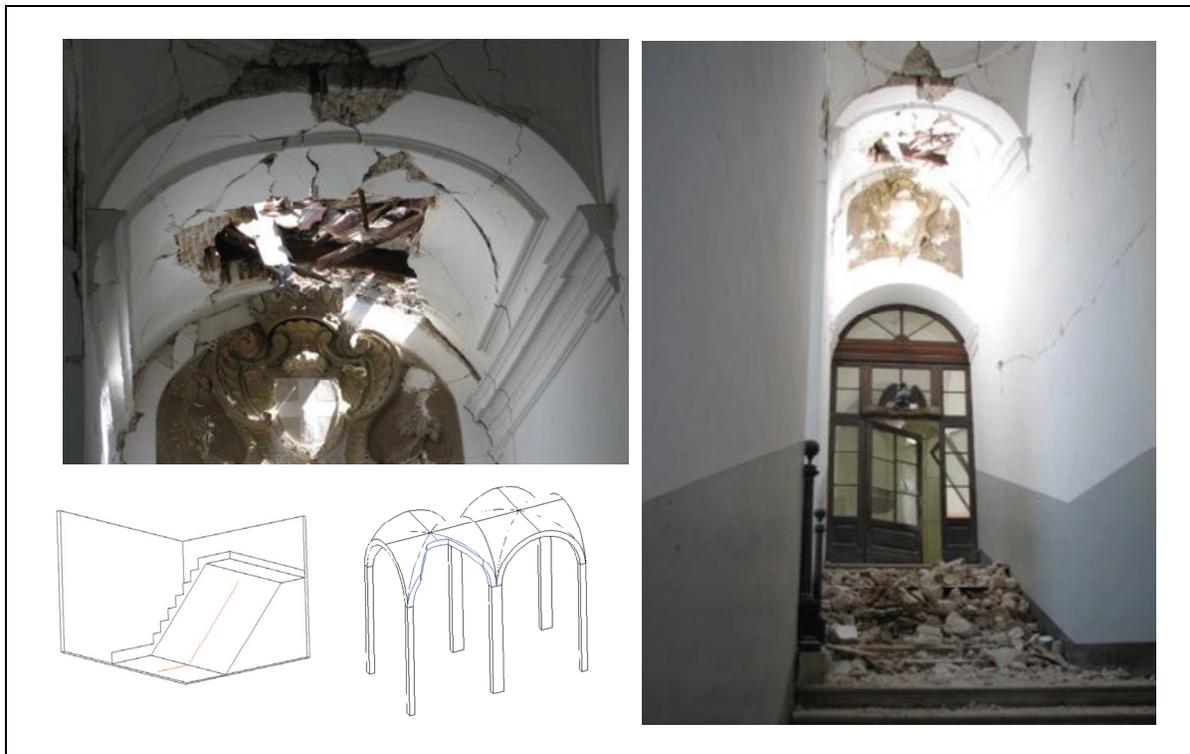
Figure 5-90 Cracks in the vaults of the stairs

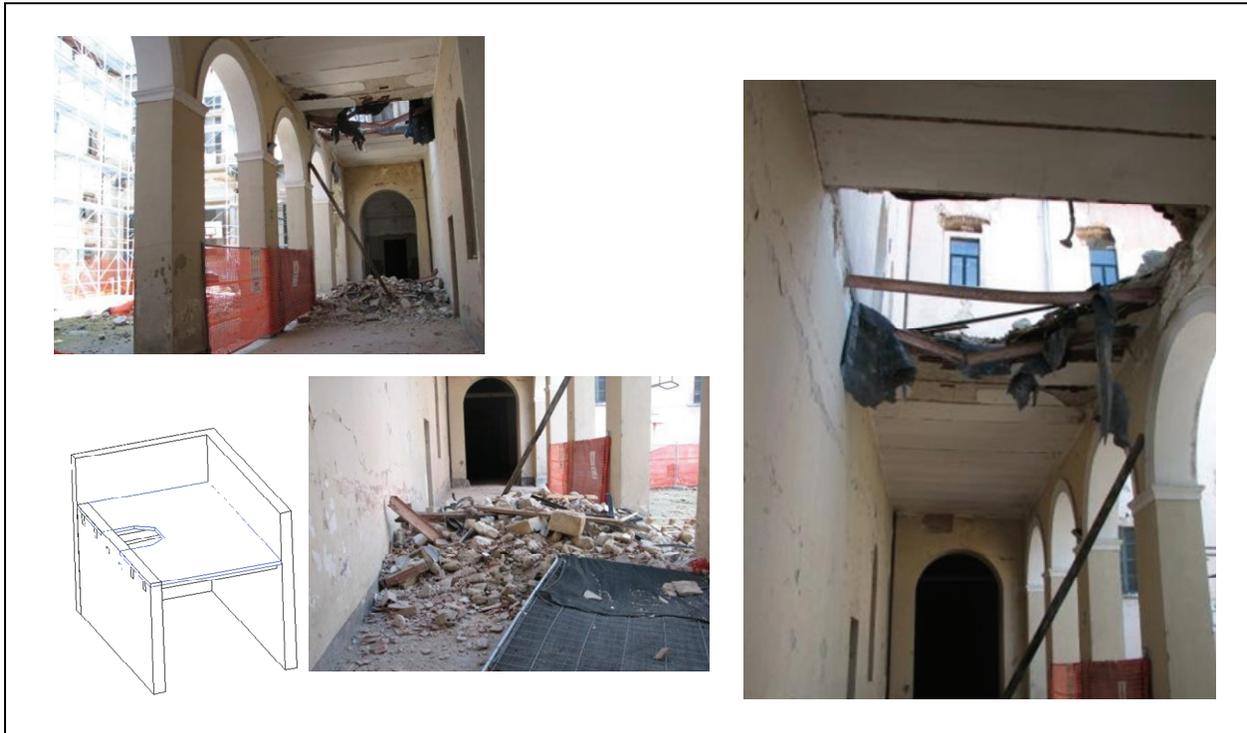
Figure 5-91 shows the local collapse of the horizontal ceiling of the court yard due to the falling debris from the upper levels.

Figure 5-91 Collapse of the horizontal ceiling of the court yard due to a falling rock

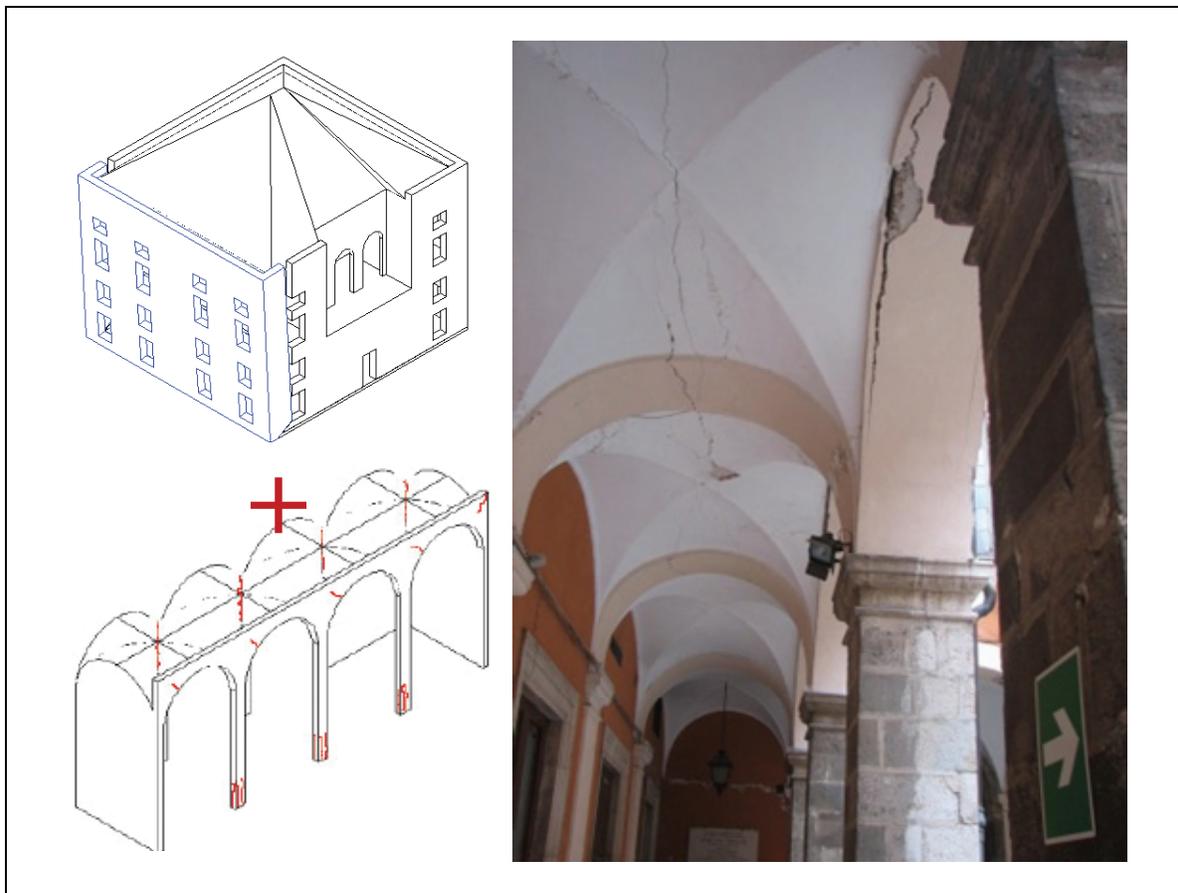
This collapse mechanism is characterized by a rigid rotation of a portion of the wall around a horizontal cylindrical hinge located at the base. The overturning mechanism of the internal wall on the north side of the courtyard developed longitudinal cracks in the cross vaults of the arcade (Figure 5-98, Figure 5-99).

Figure 5-98 Overturning of the internal walls in the courtyard and longitudinal cracks in the vaults of the Arcade without tie rods (North wing of Via Bafile)

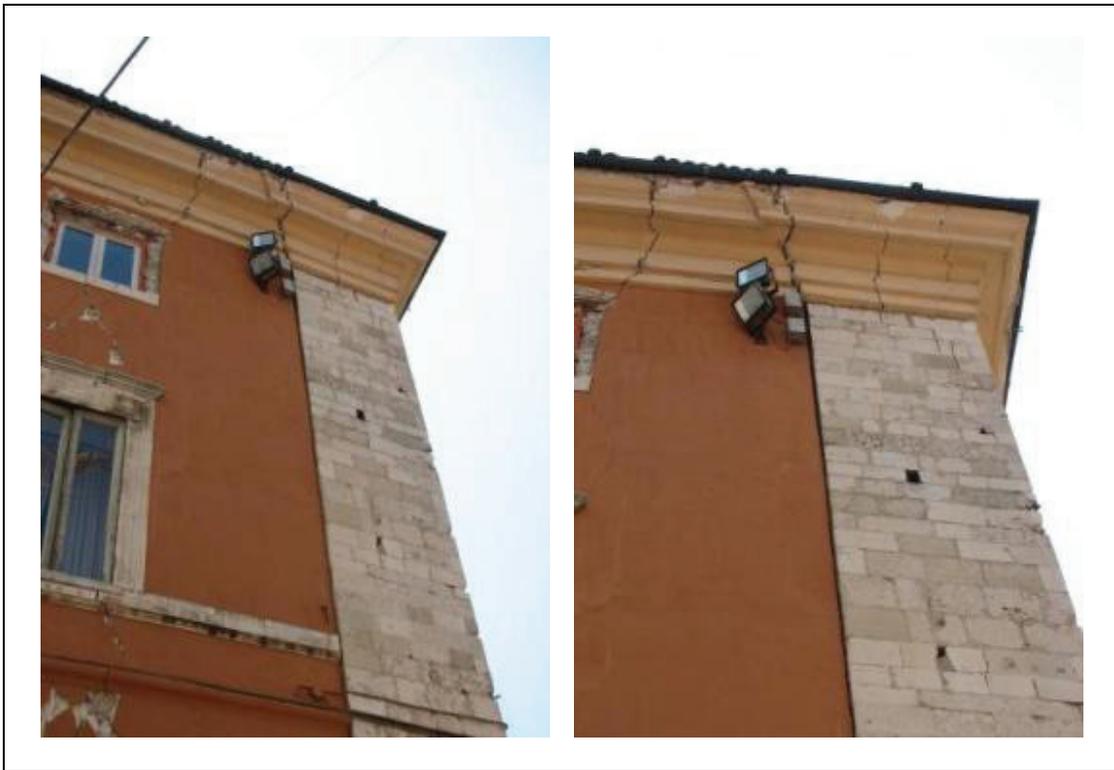
In correspondence of the South-West corner of Palazzo Margherita, vertical cracks are visible on the West wall (Figure 5-105) that confirm the overturning of the whole external wall in Via delle Aquile. The street of via Bafile is a main road for downtown L'Aquila, therefore it needed to be maintained as a viable road and props could not be used, because they would have occupied the entire road. Thus, rods were used, because they occupy less space and they use less material. In order to reduce intervention inside the building, rods passed through the windows and were able to connect the external walls with the internal walls of the courtyard (Figure 5-106).

Figure 5-105 Vertical cracks on the West side of Piazza Margherita

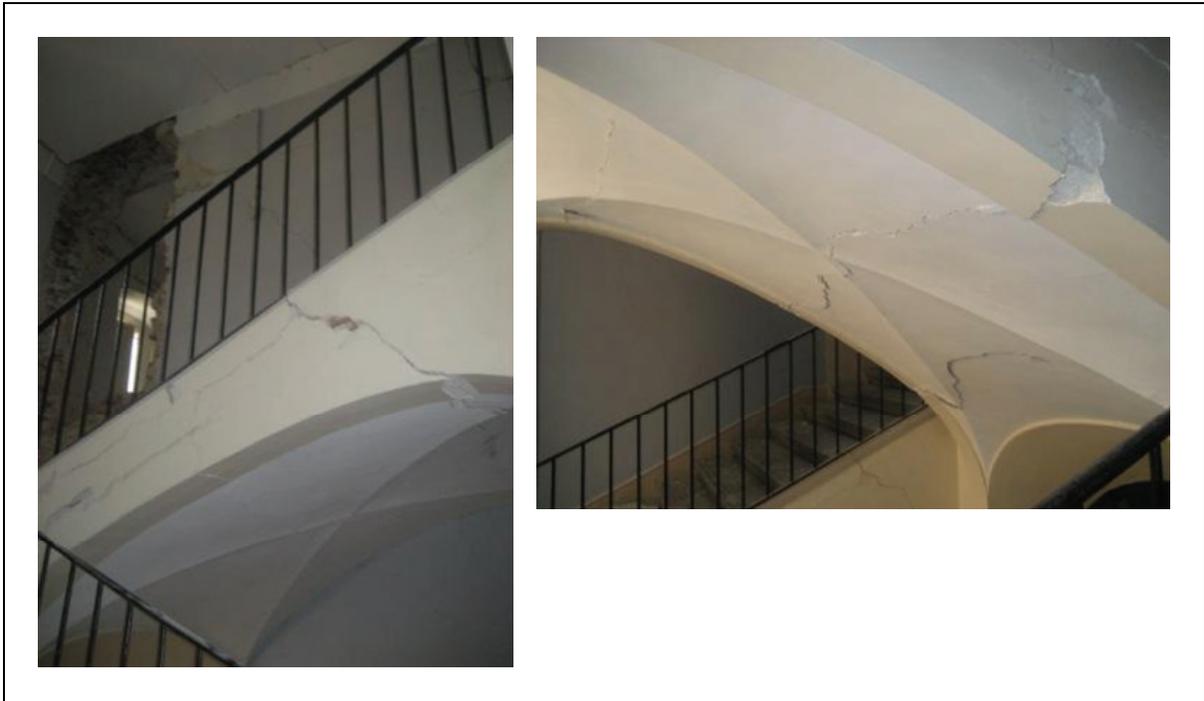
In Figure 5-107 and Figure 5-108, visible cracks due to shear in the vaults of the stairs that are highlighted in red in the plan view in Figure 5-109 are clearly seen. The higher stiffness of the stairs with respect to the rest of the building attracted the seismic forces.

Figure 5-107 Shear cracks in the vaults of the stairs on the first and second story level

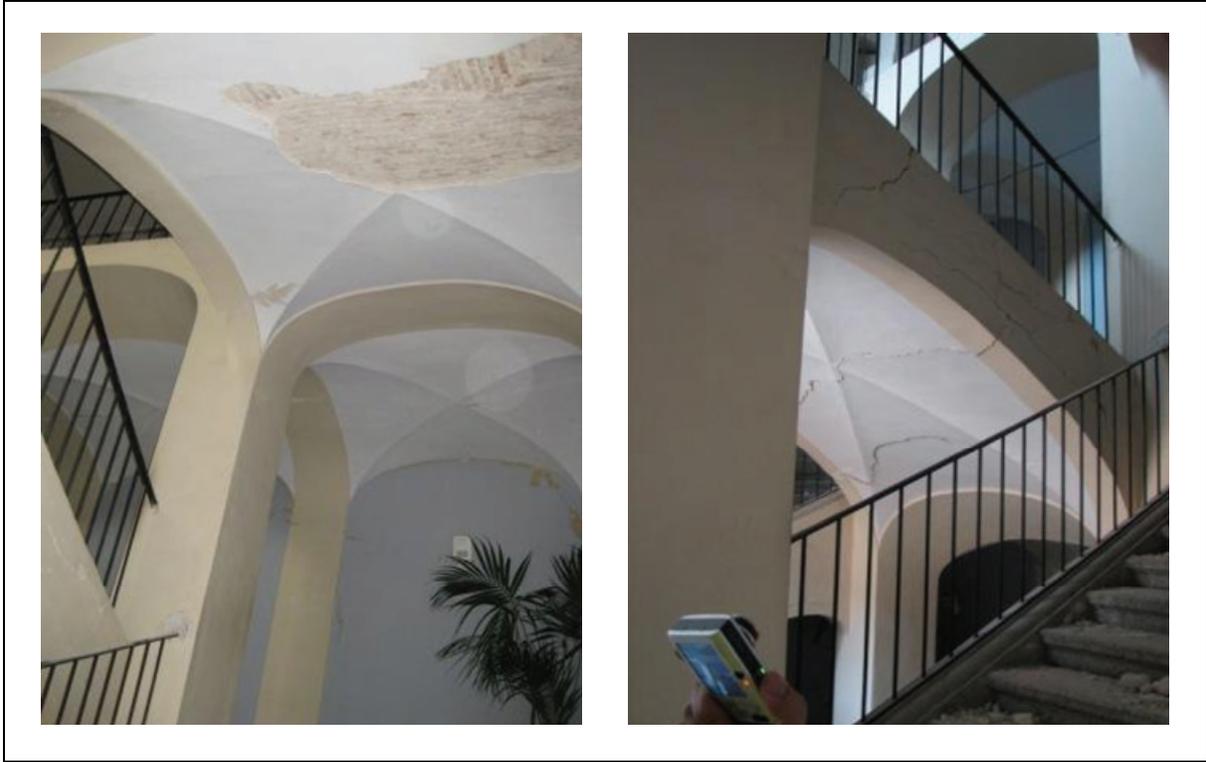
Figure 5-108 Cracks of the cross vaults of the stairs

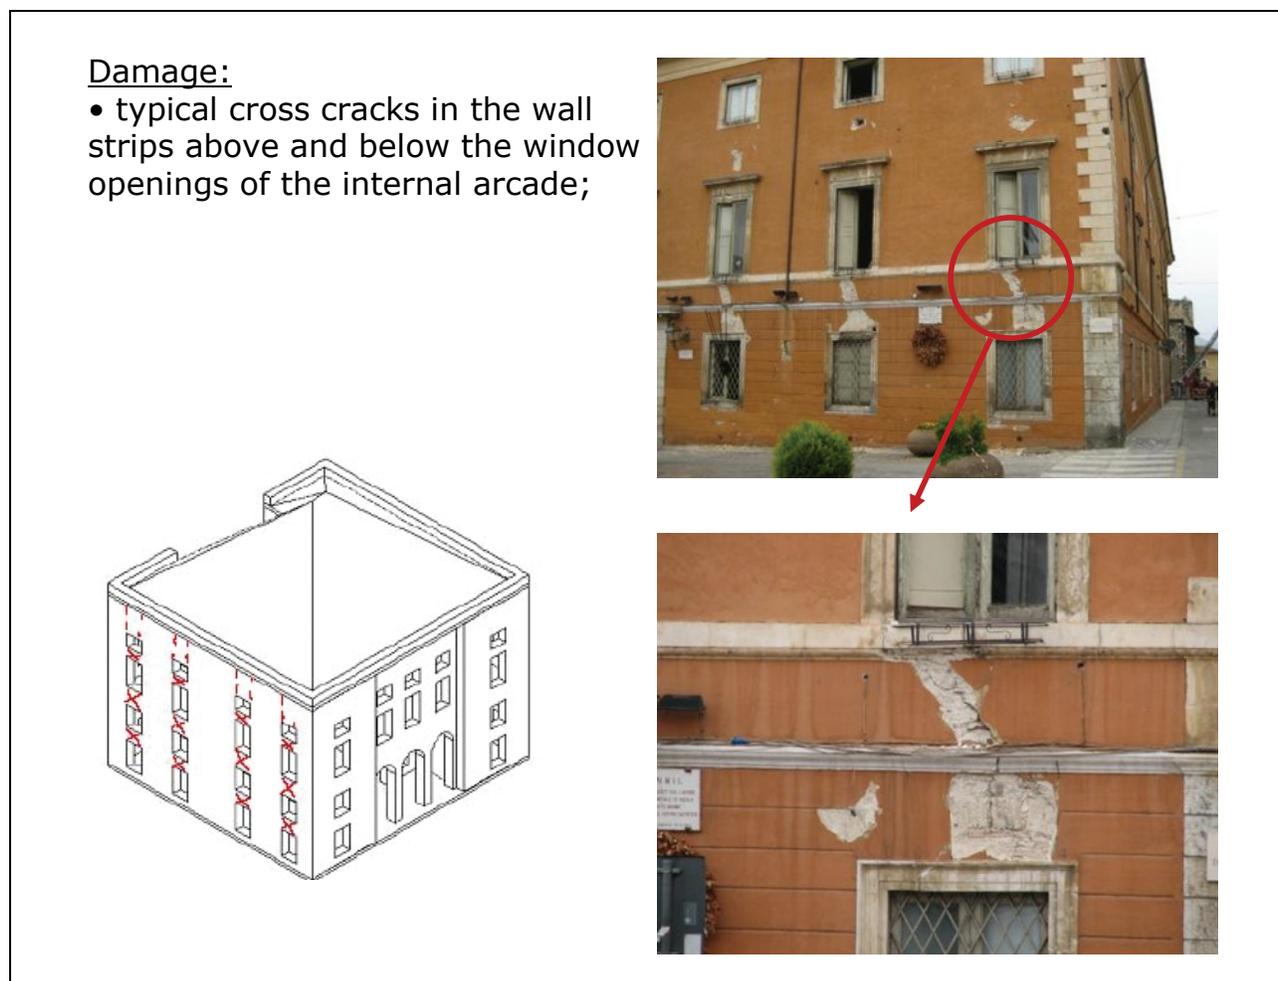
Figure 5-117 Cracks in the masonry strips of the facade of Piazza Palazzo

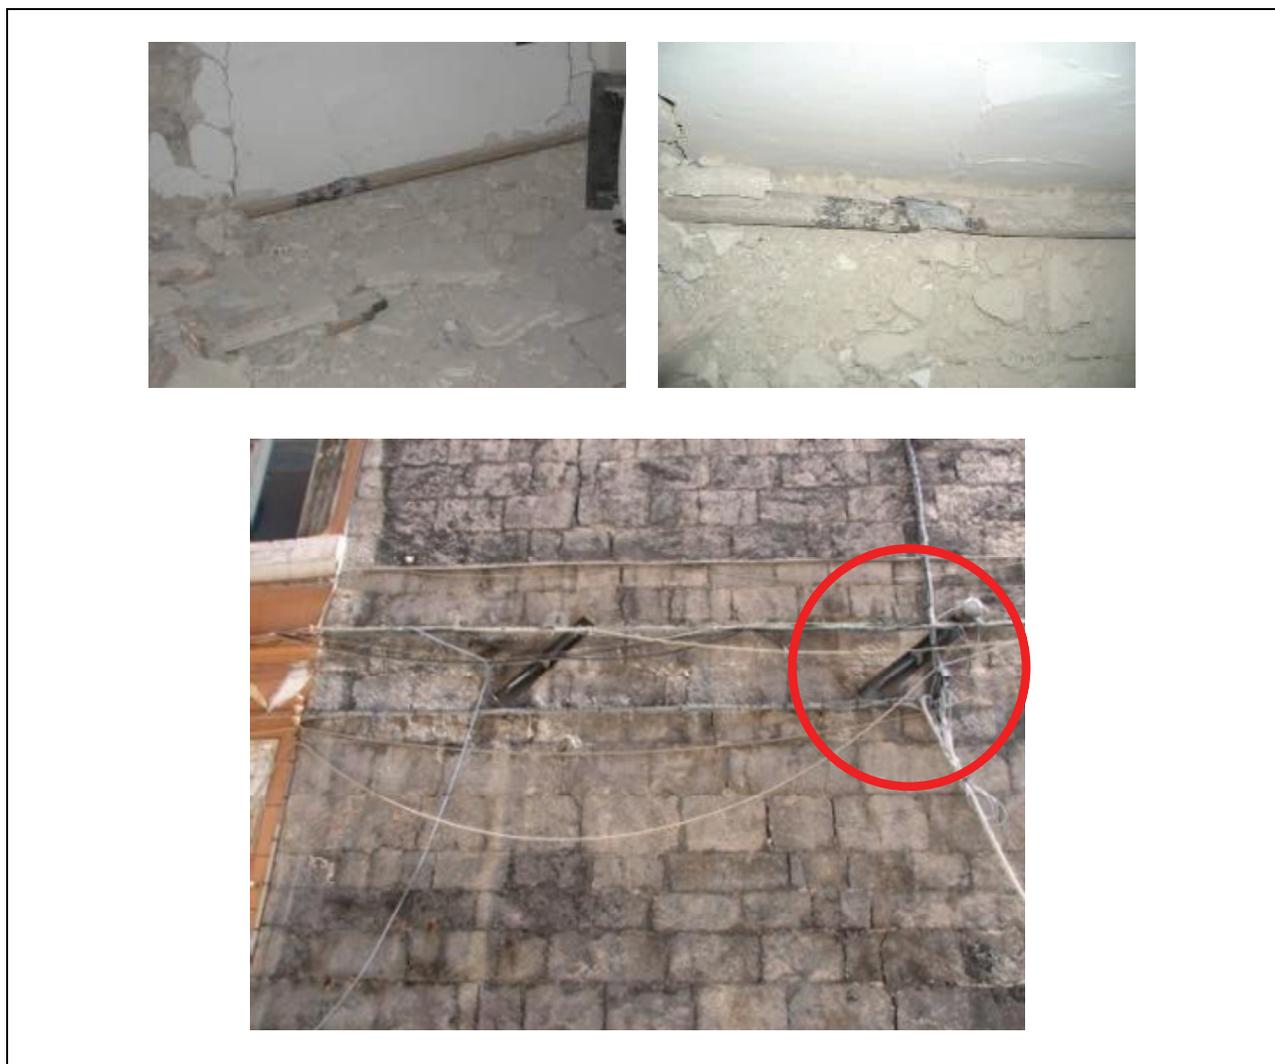
Figure 5-129 External broken chain at the base of the tower in the south side

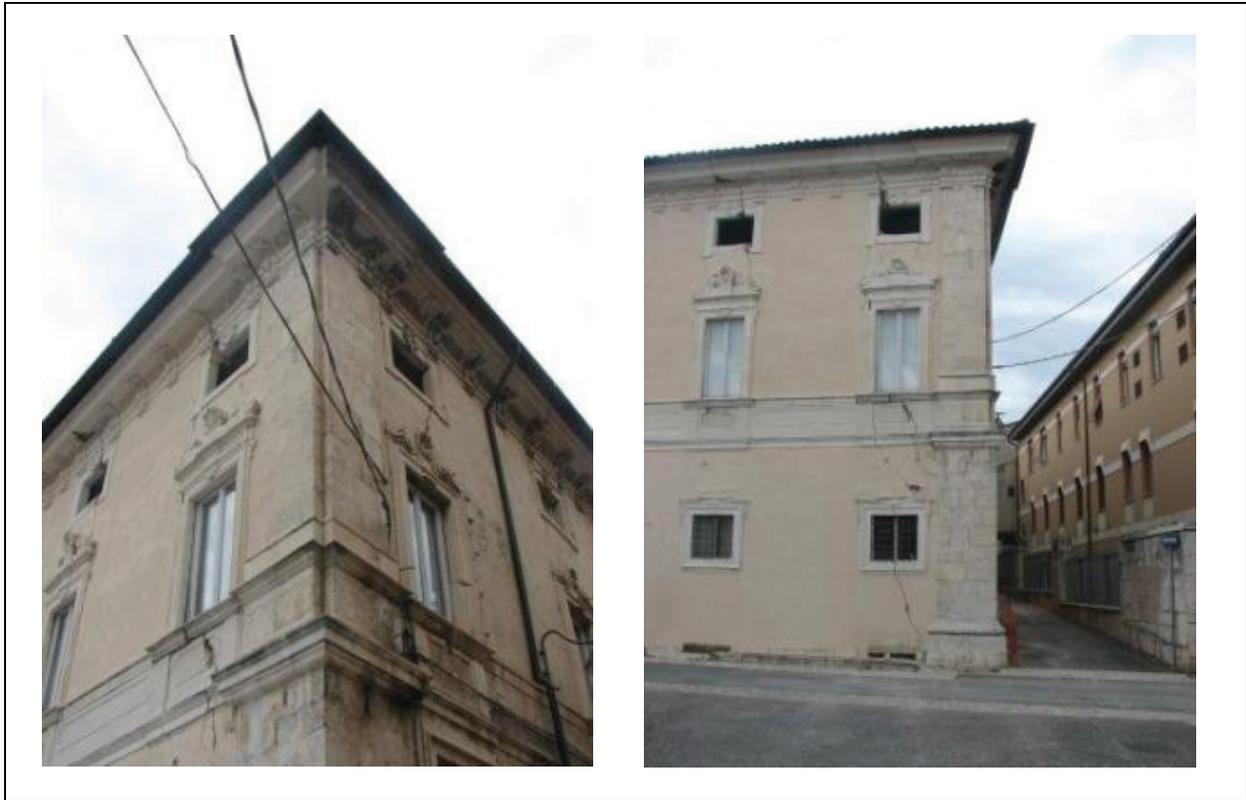
Figure 5-134 Overturning of the corner walls

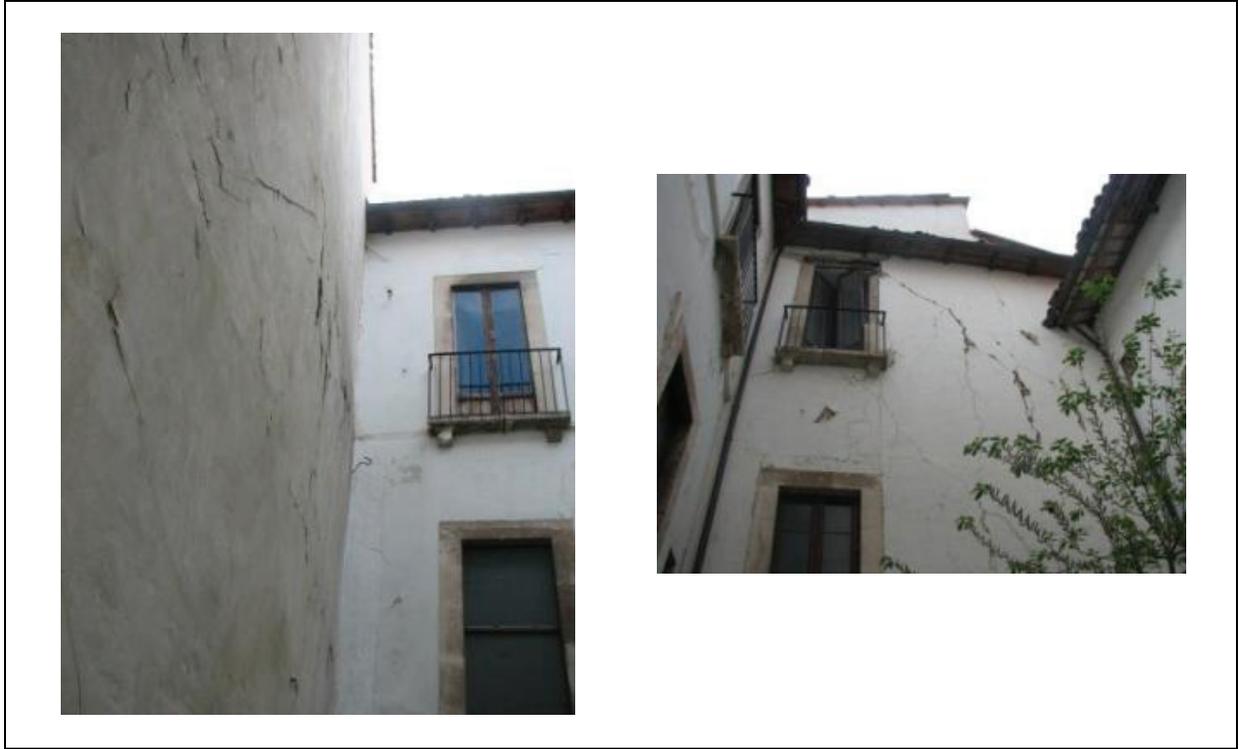
Figure 5-136 Wall instability in the first posterior court yard and shear cracks

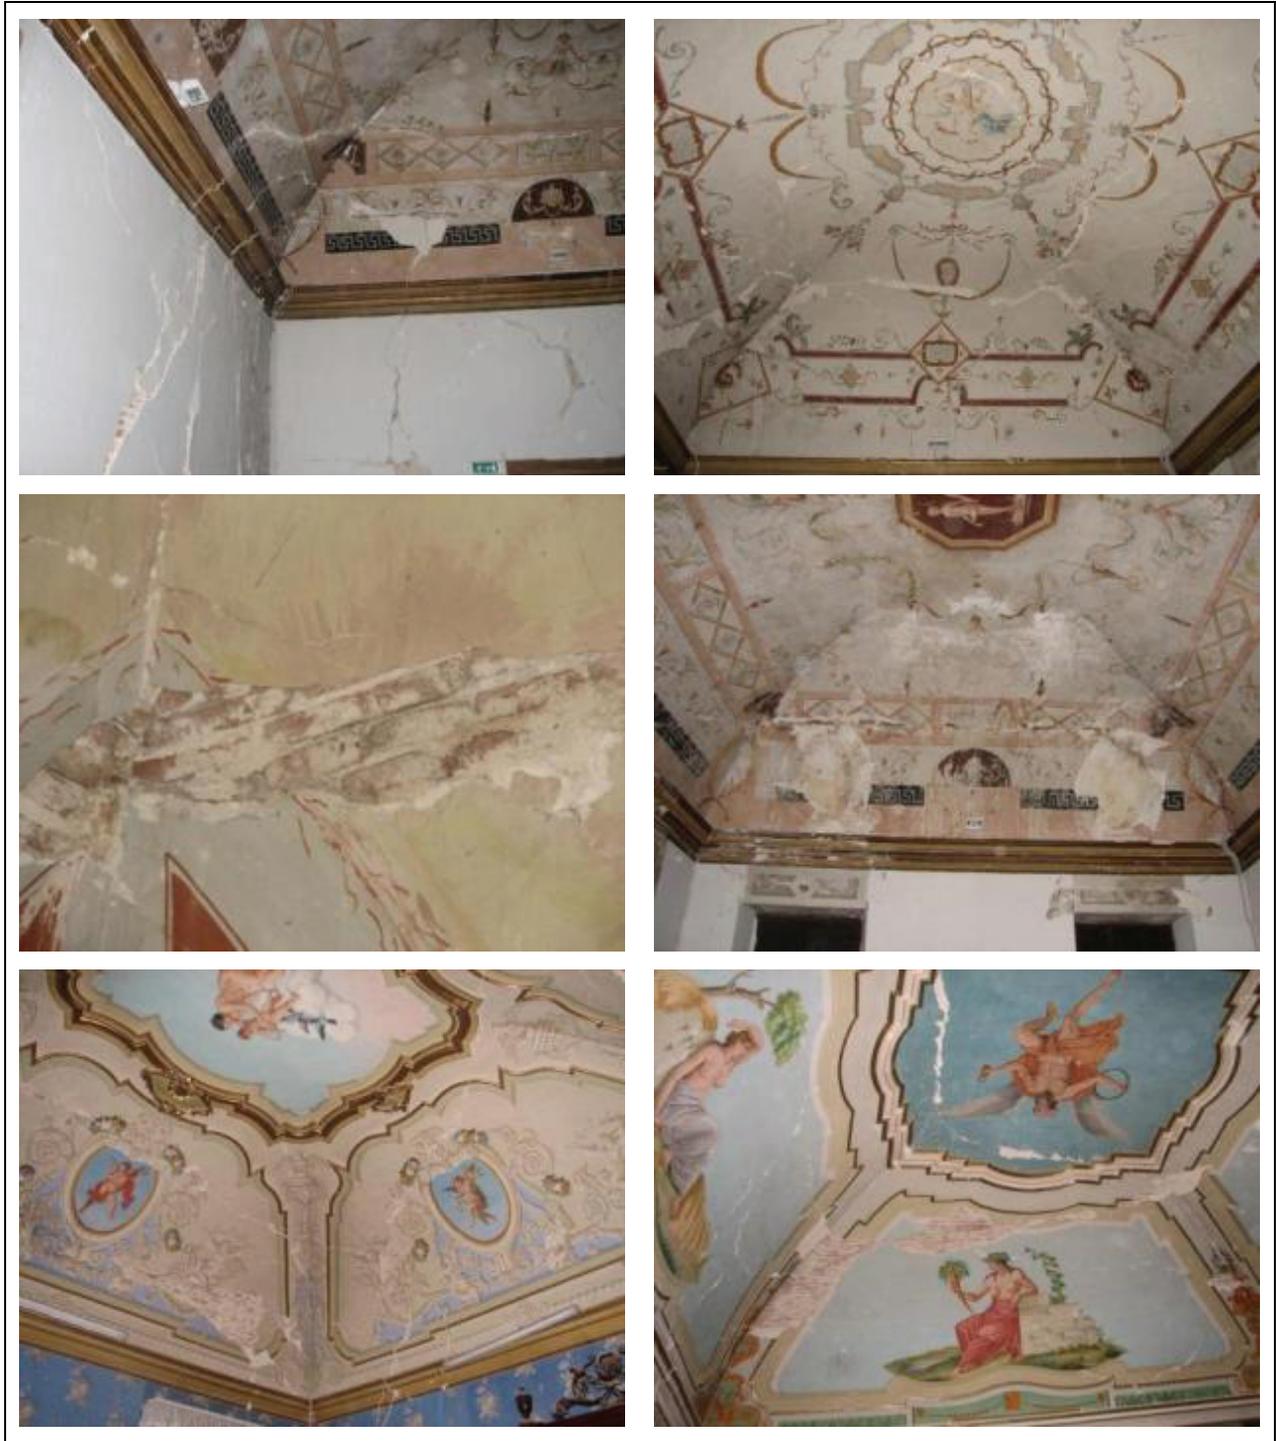
Figure 5-140 Damage in the painted vaults due to rotation of the vertical walls

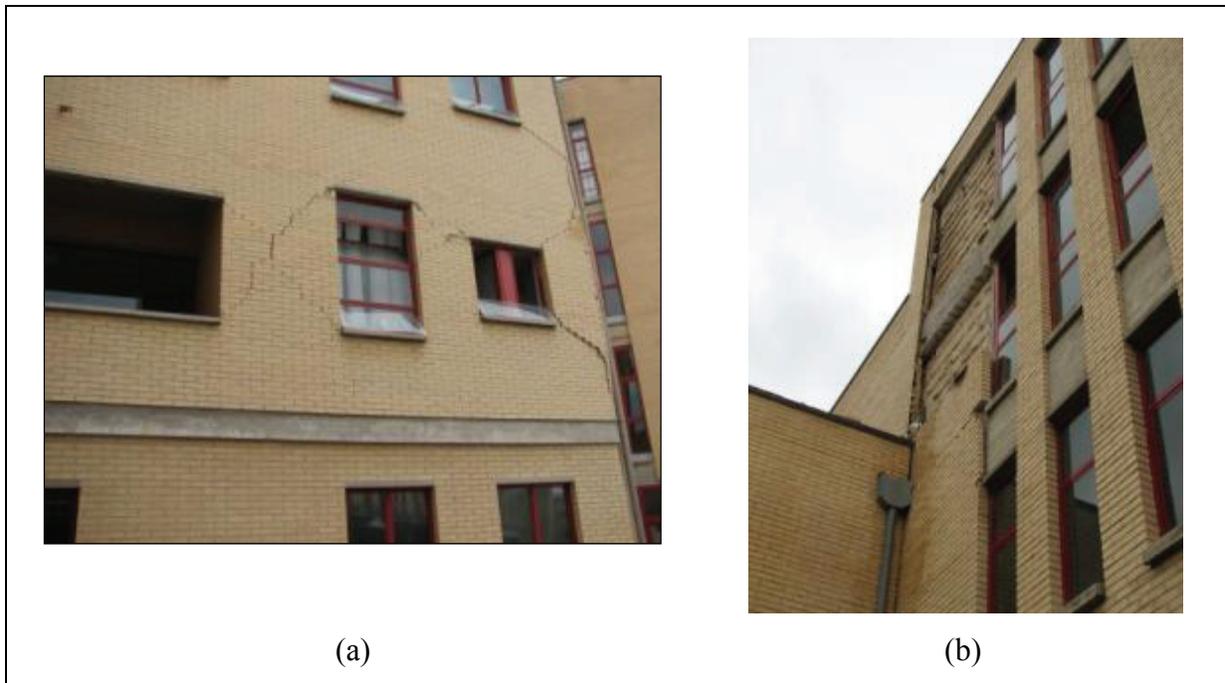
Figure 6-2 Brick covering of the external walls: (a) shear wall damage mechanism; (b) out of plane damage mechanism

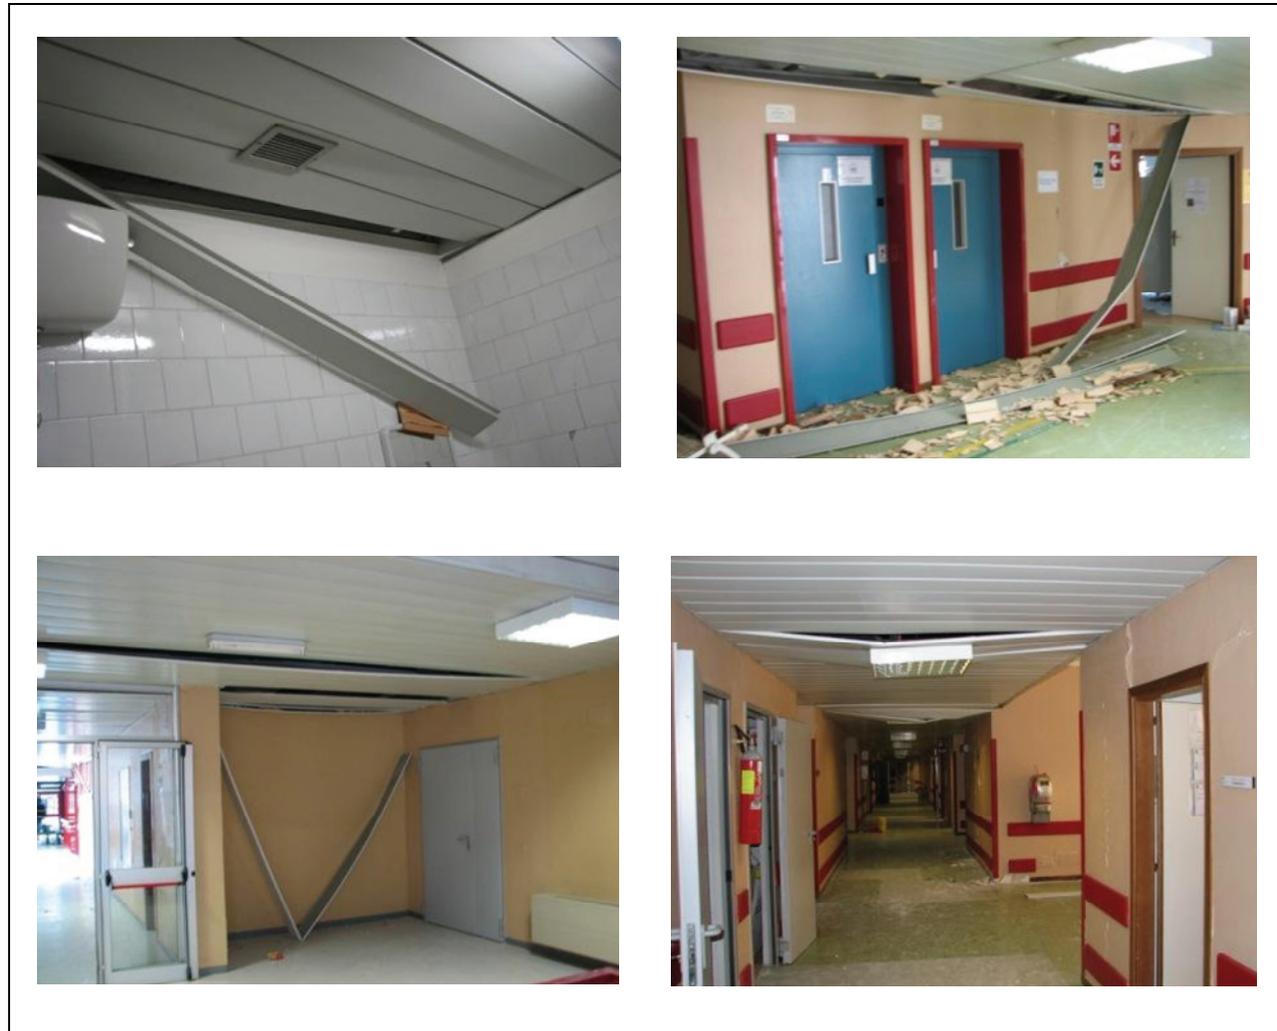
Figure 6-5 Damage to suspended ceiling systems inside the hospital

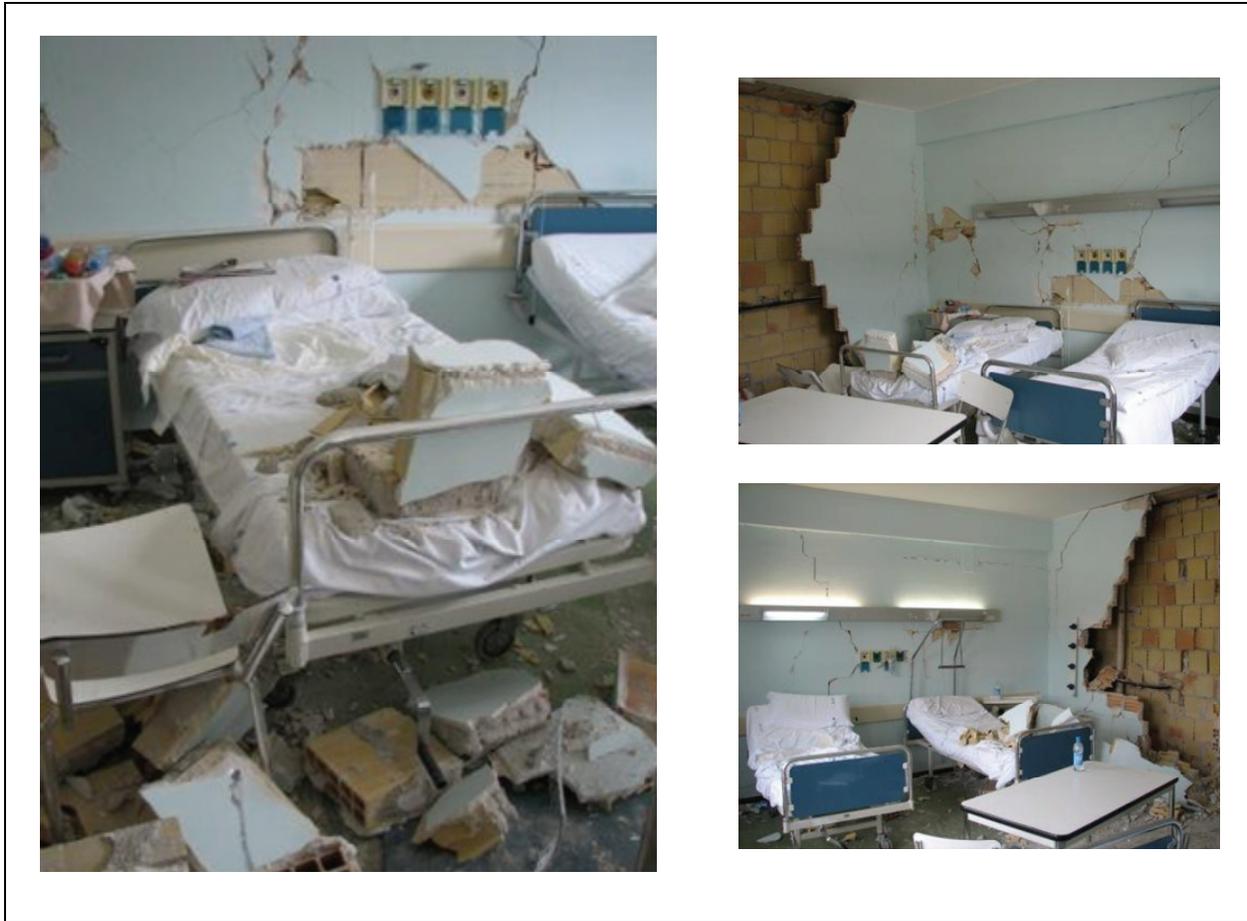
Figure 6-6 Damage to internal infill walls
