L'AQUILA EARTHQUAKE OF APRIL 6, 2009 IN ITALY: REBUILDING A RESILIENT CITY TO WITHSTAND MULTIPLE HAZARDS

by
**Gian Paolo Cimellaro, Ioannis P. Christovasilis,
Andrei M. Reinhorn, Alessandro De Stefano
and Tatiana Kirova**

Technical Report MCEER-10-0010

December 29, 2010

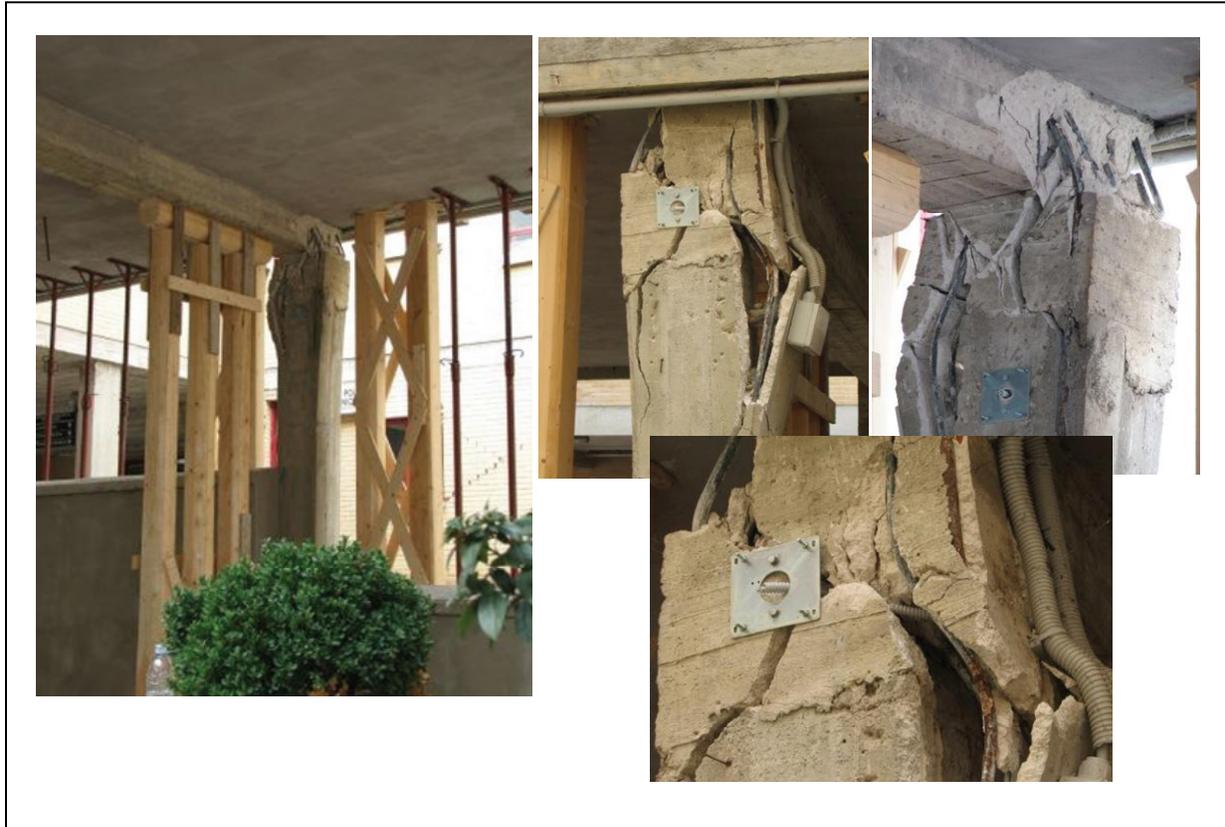
Figure 6-9 Poor construction quality: electric tubes passing through reinforced concrete column of the emergency walkway

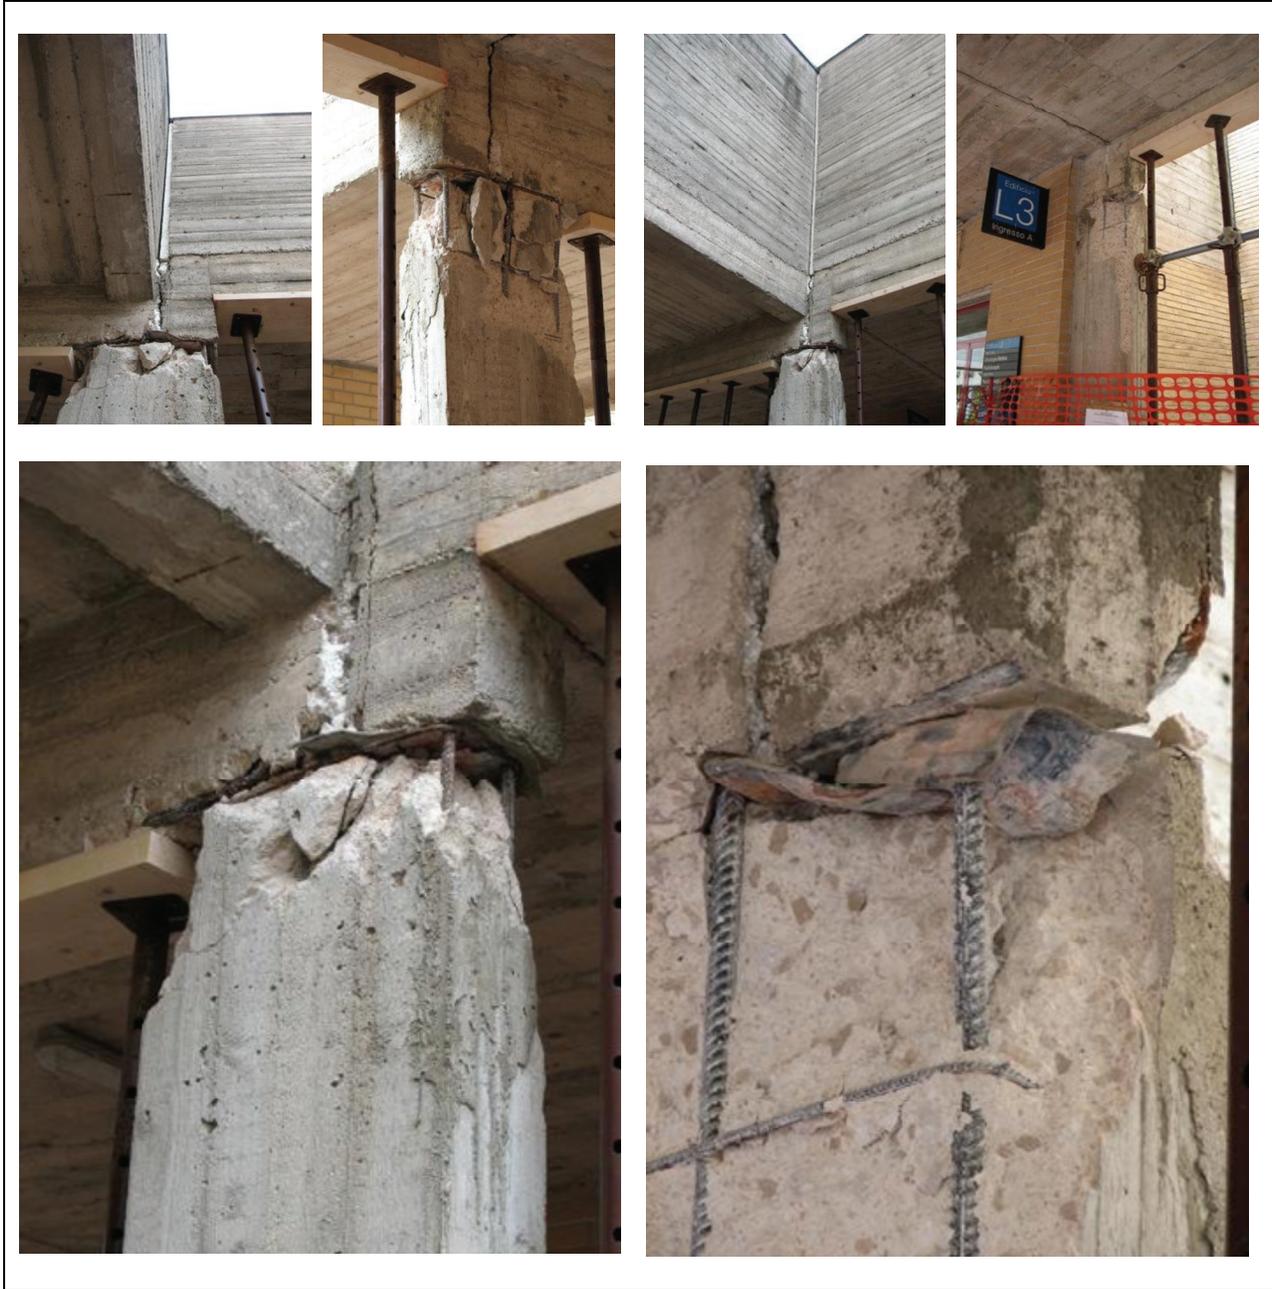
Figure 6-10 Poor construction quality of the expansion joints

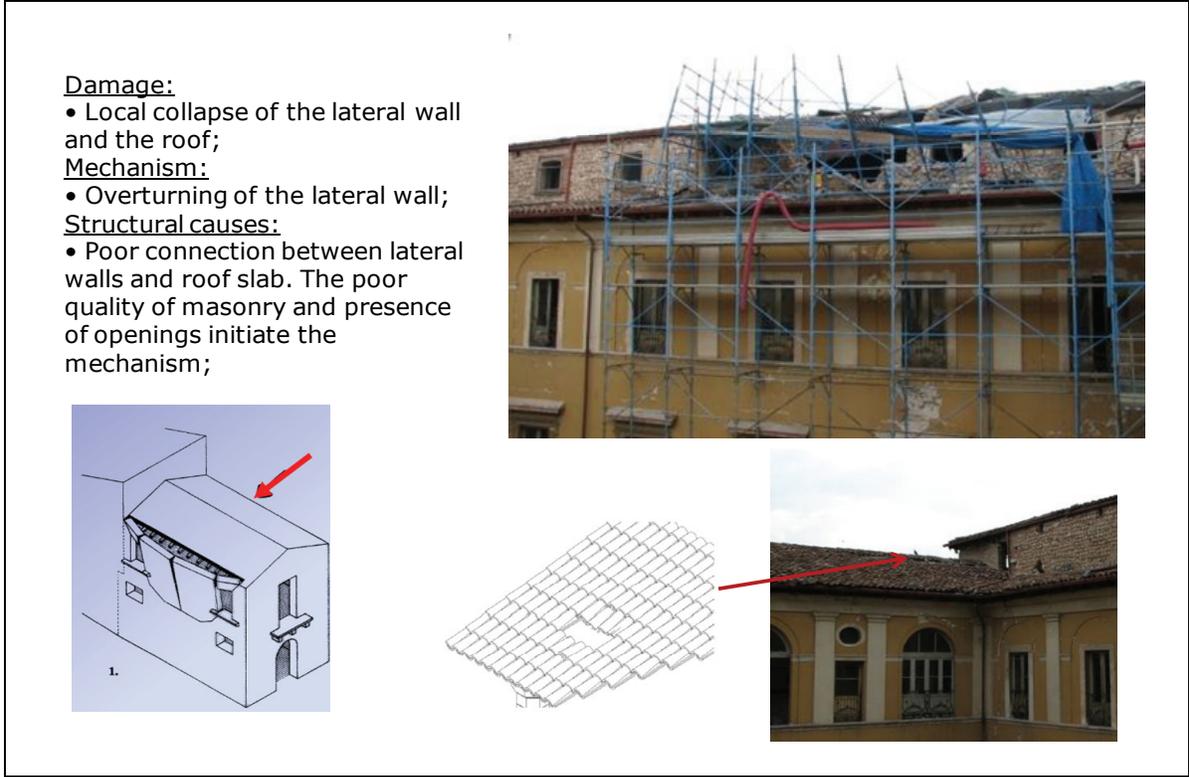
Figure 6-13 Damage to the roof coverage

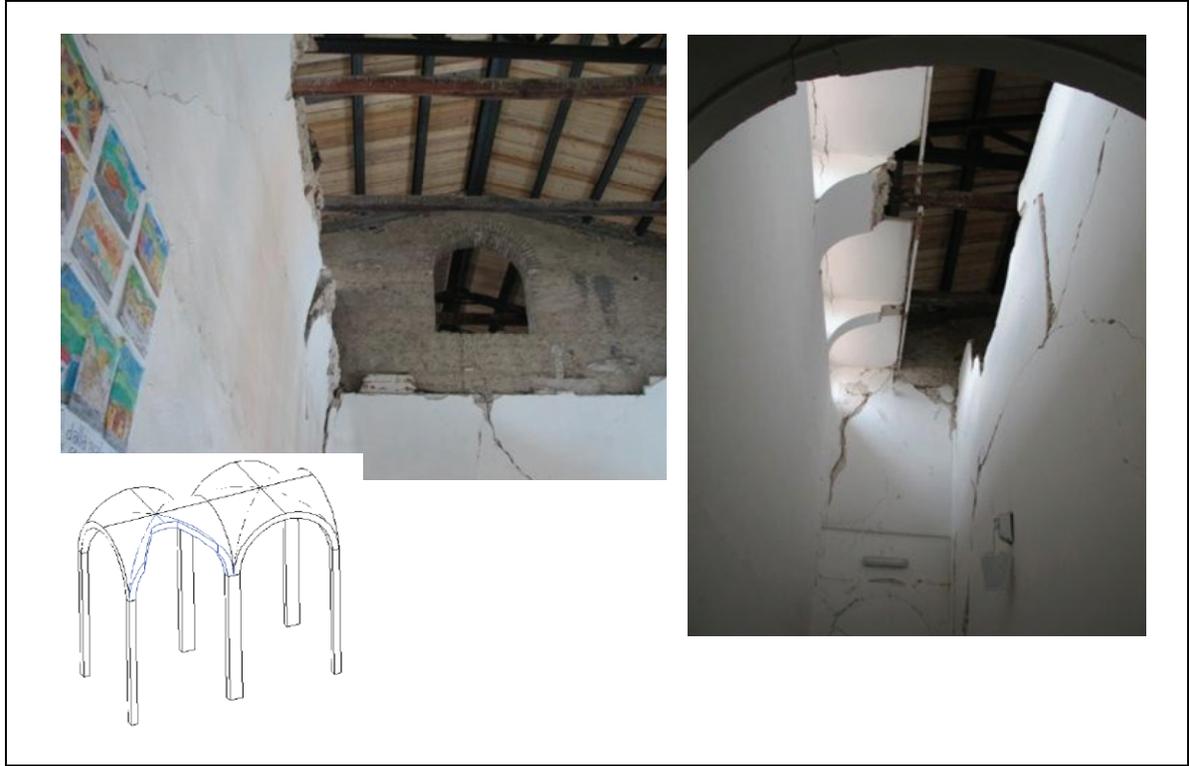
Figure 6-14 Collapse of the barrel vault at the second floor

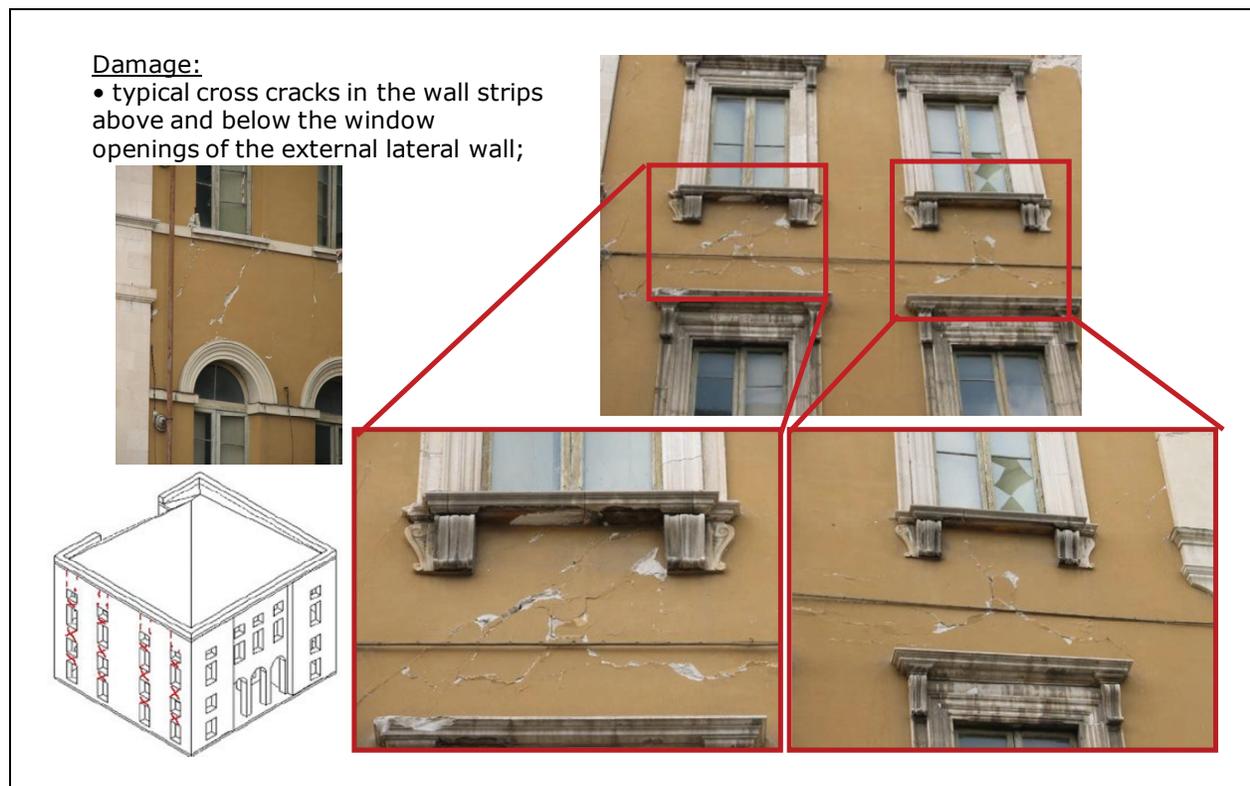
Figure 6-16 Damage in the strip walls

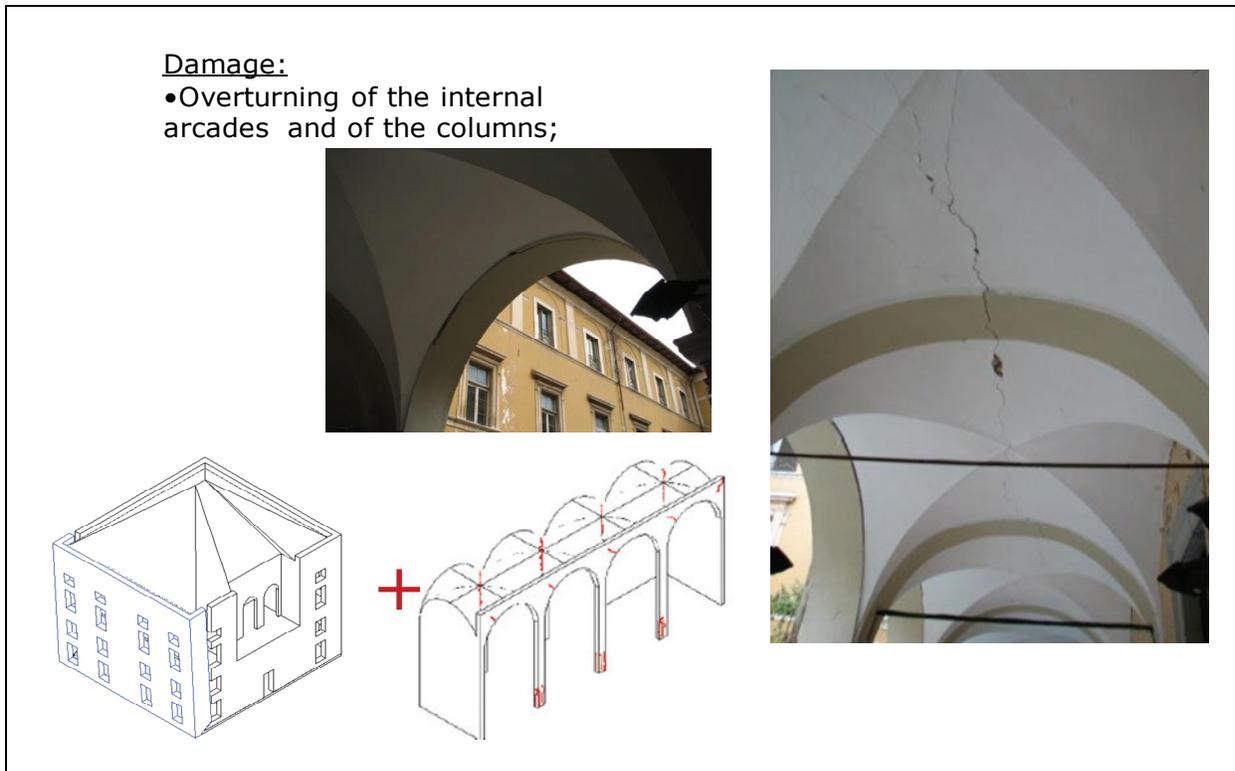
Figure 6-18 Damage in the arcades

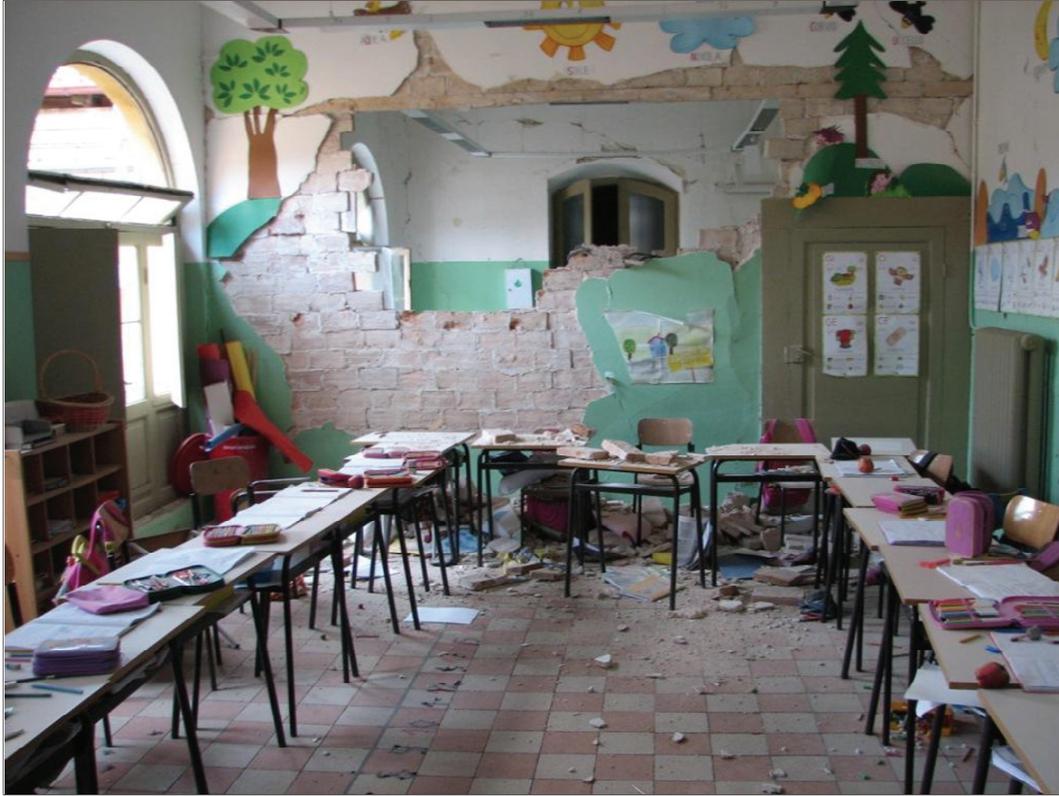
Figure 6-19 Damage in the internal partition walls

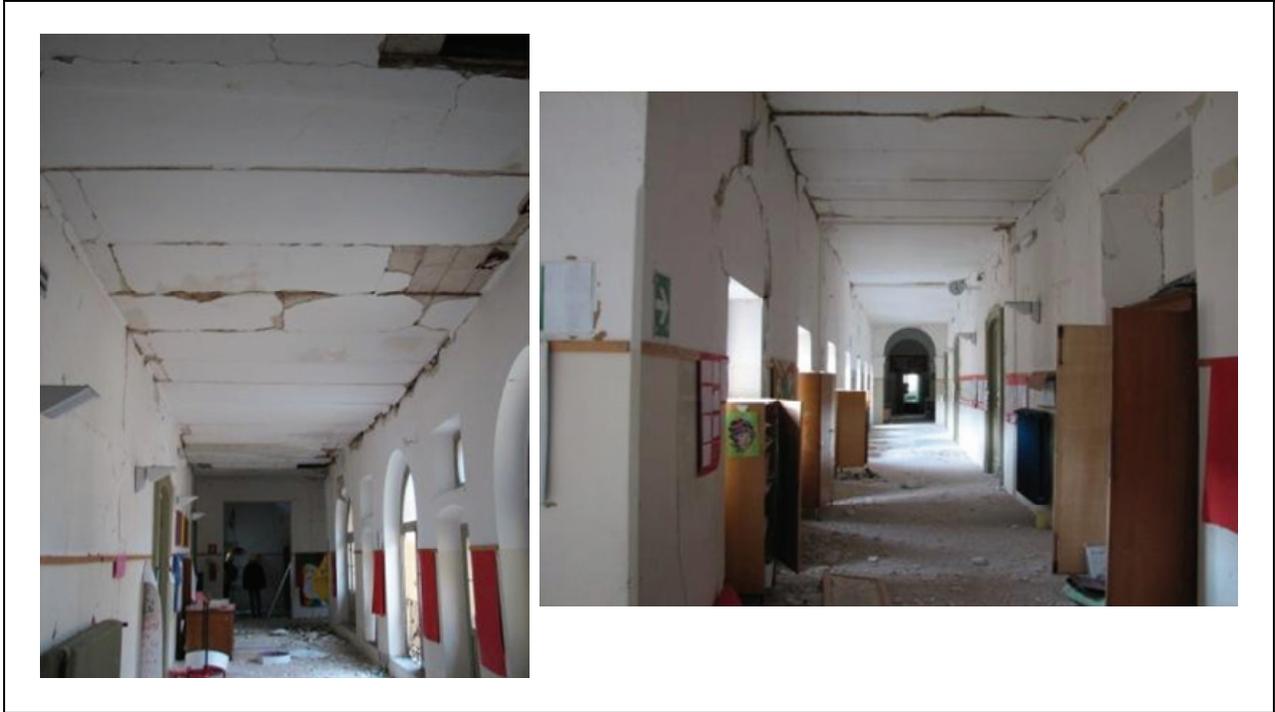
Figure 6-20 Damage in the roof ceiling

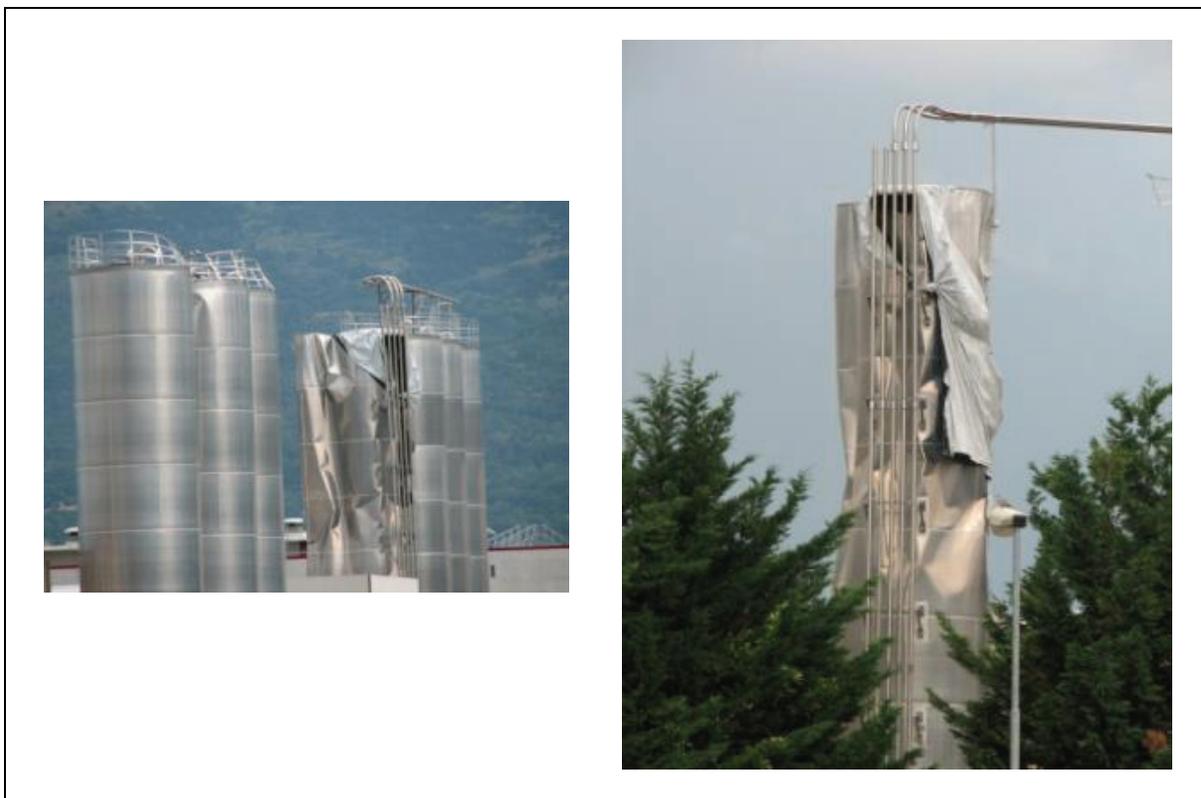
Figure 6-23 Instability of tanks in the polypropylene stock of VIBAC in Bazzano near Onna
