EMILIA EARTHQUAKE OF MAY 20, 2012 IN NORTHERN ITALY: REBUILDING A COMMUNITY RESILIENT TO MULTIPLE HAZARDS

by
Gian Paolo Cimellaro, Marco Chiriatti,
Andrei M. Reinhorn and Lucia Tirca

Technical Report MCEER-13-0006

June 30, 2013

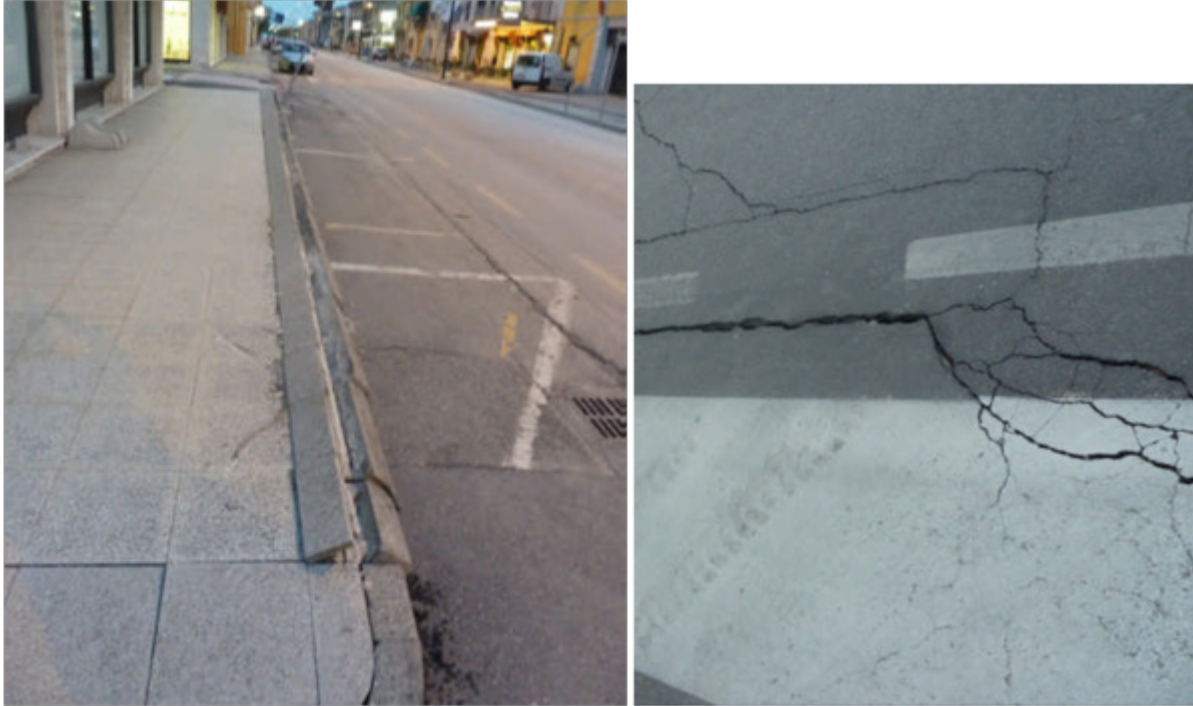
In the town of Mirabello, a movement of buildings lining the main street occurred as rigid bodies down slope. This was due to liquefaction of the soil at a relatively shallow depth. This was visible as uplift of the pavement stone and by the cracks that indicated movement.

Figure 4-2 Evidence of lateral spreading in the street in Mirabello

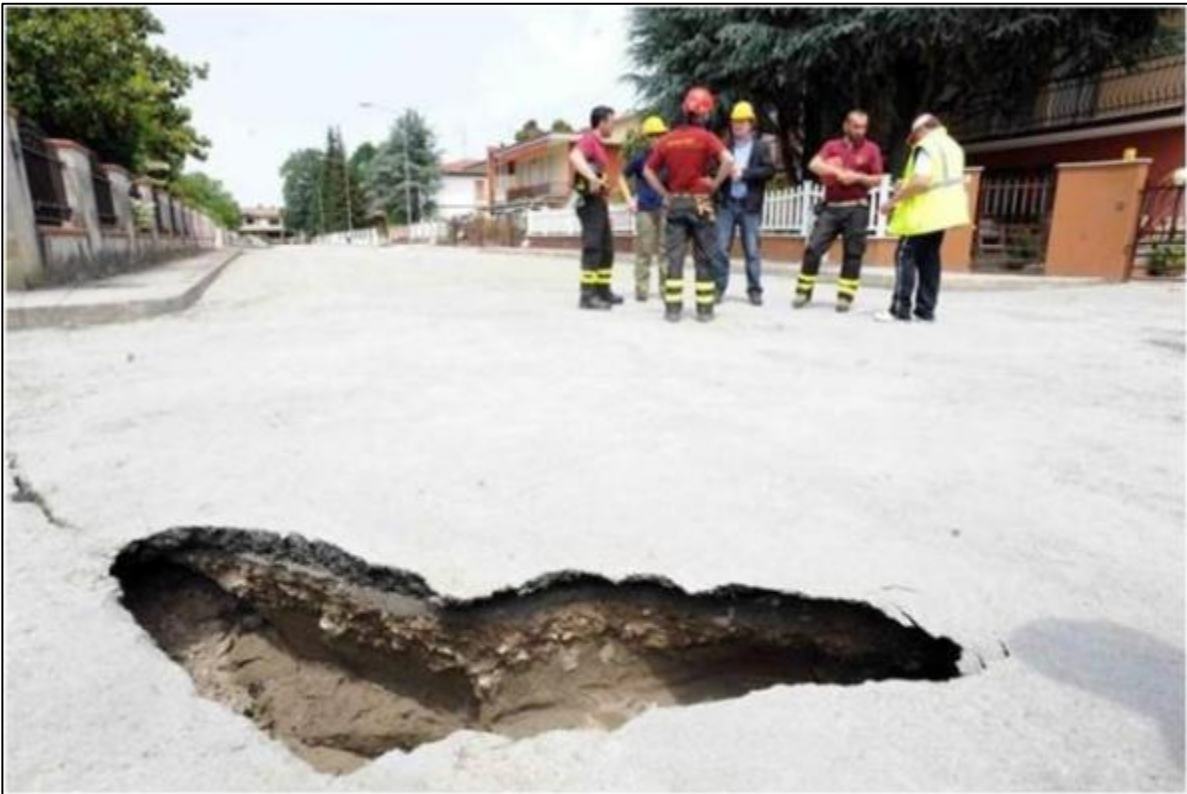
Figure 5-1 Liquefaction in San Carlo

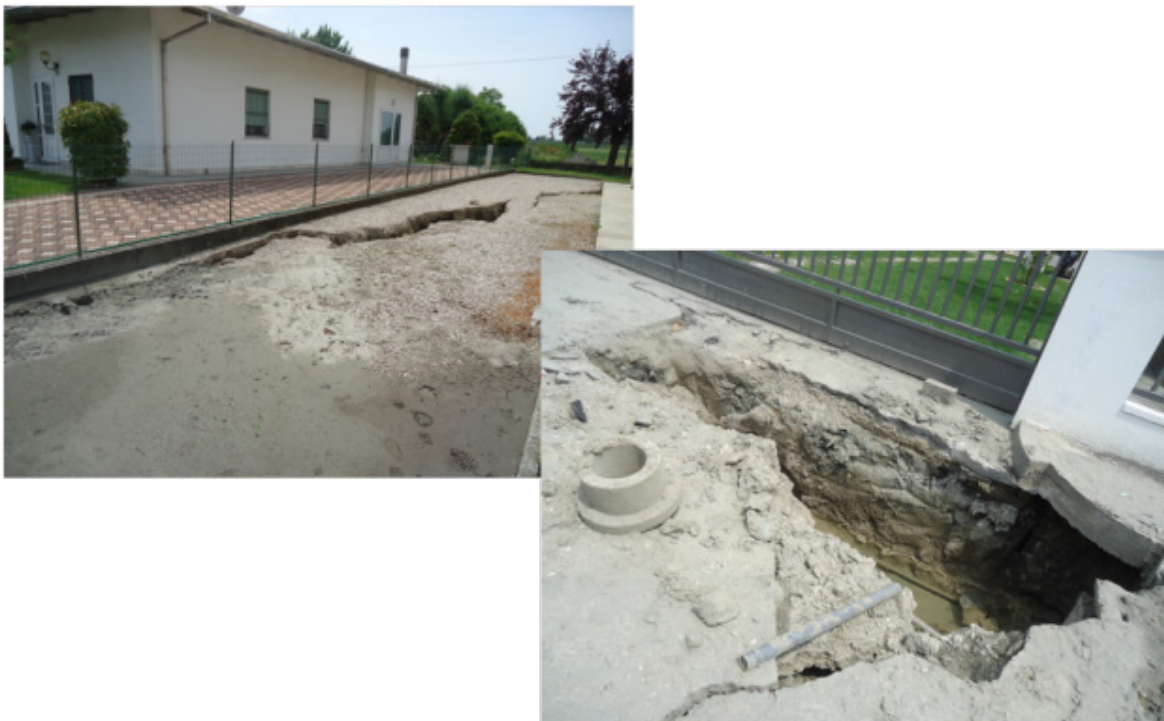
Figure 5-9 Structural damage due to liquefaction in San Carlo (Sant'Agostino)

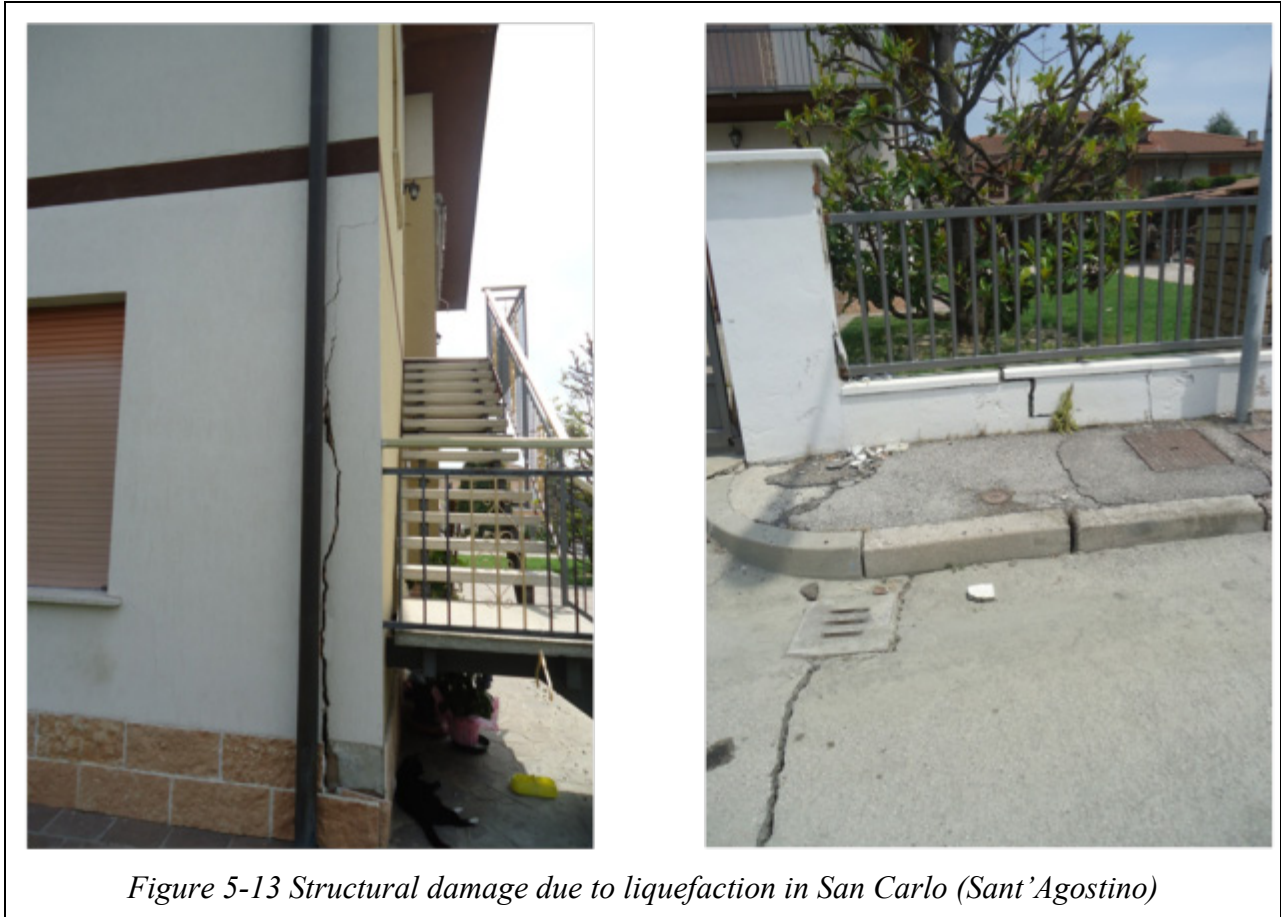
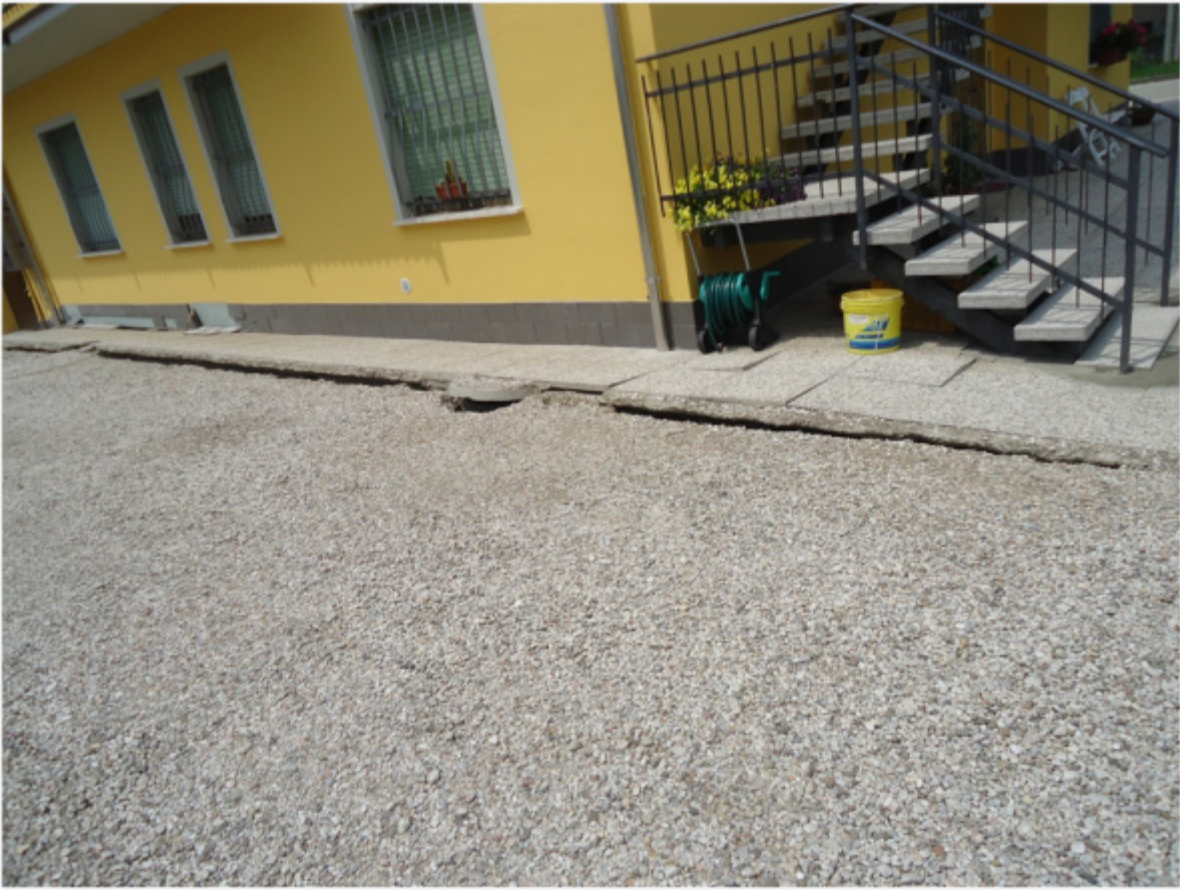
Figure 5-14 Structural damage due to liquefaction in San Carlo (Sant'Agostino)

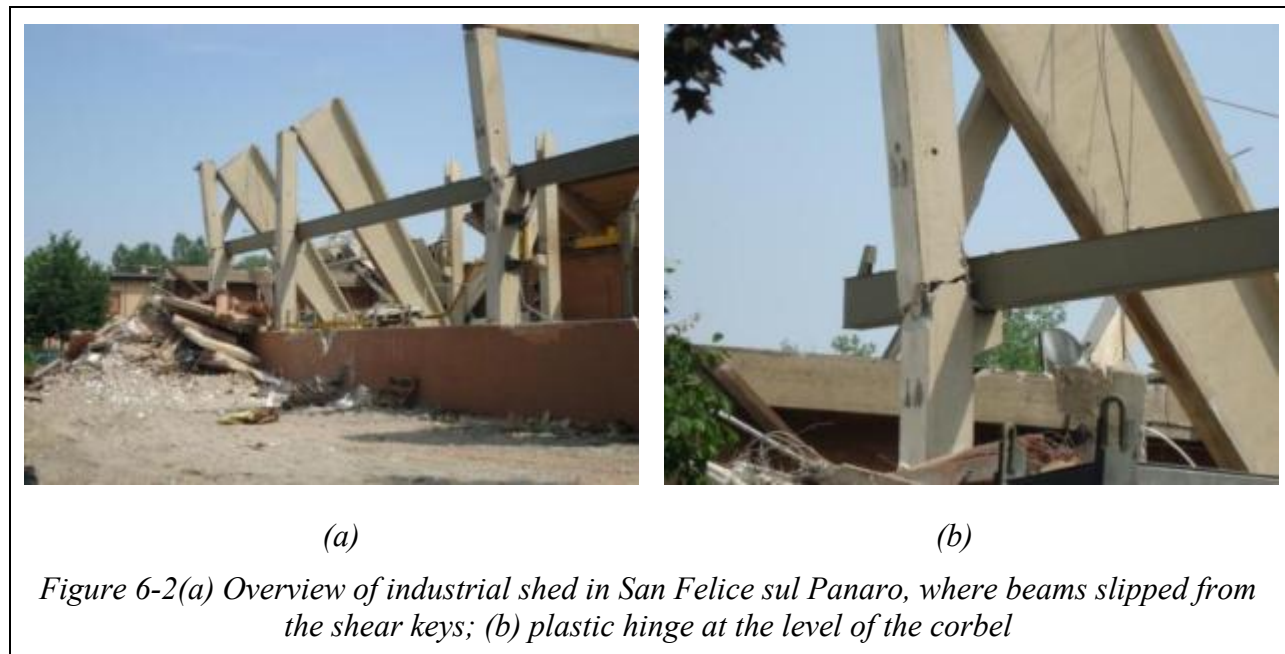
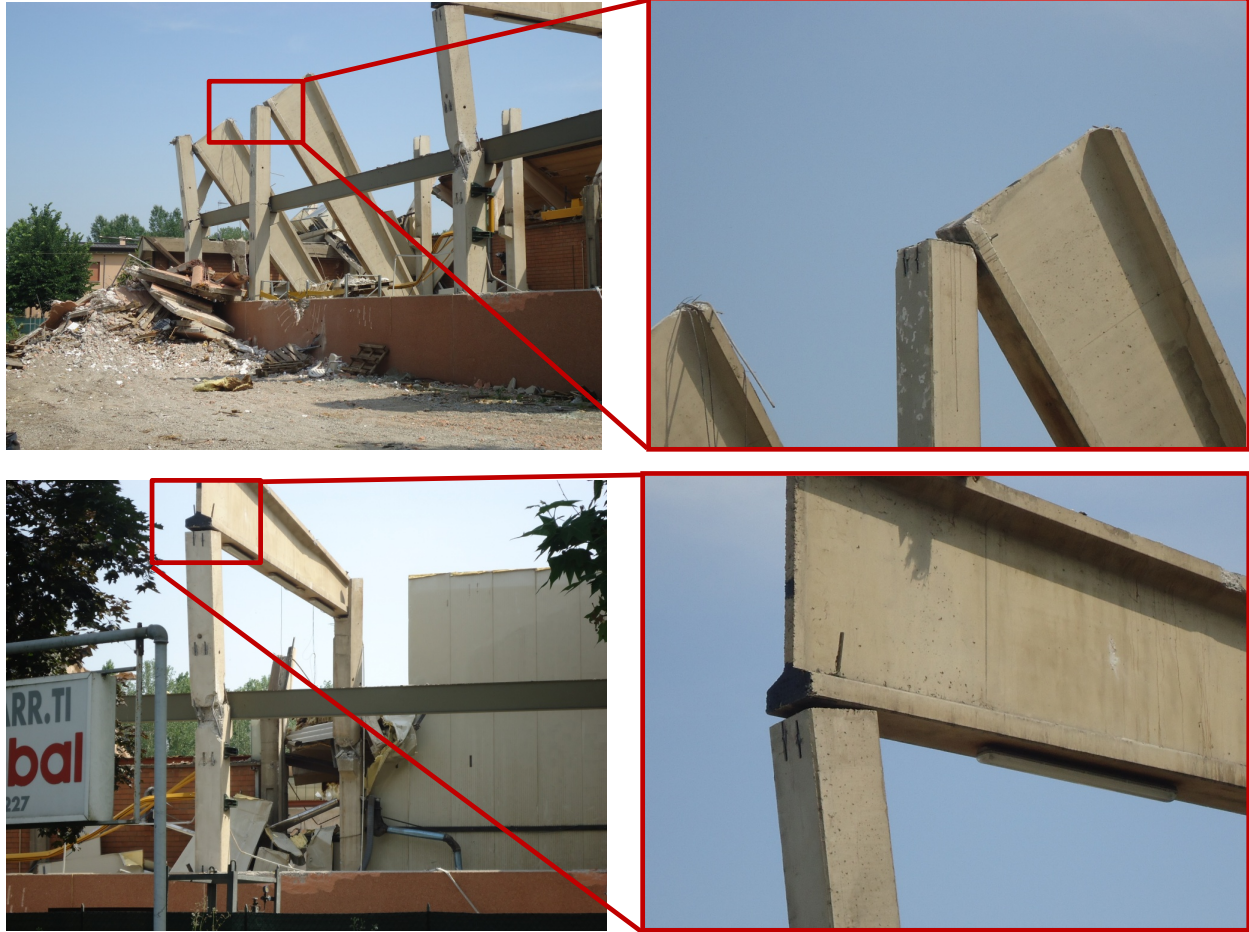
On the same side, the transverse beam is very deep and was connected by two bolts to the lower column. The beams slipped from the shear key on the other side, where no mechanical fixity was observed (Figure 6-2). The most probable reason for collapse in this case was the poor strength of the columns, which were slim and flexible.

Figure 6-3 Typical flathead beam-column connection with insufficient seismic restraints (Mirandola)

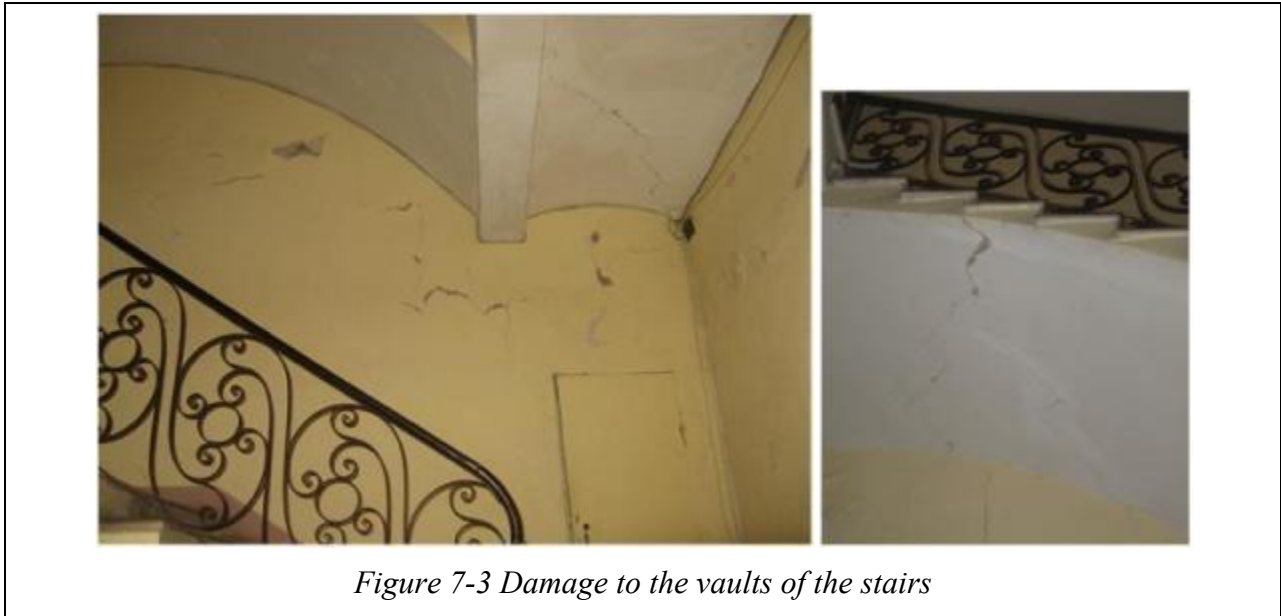
The load bearing masonry walls had serious damage near the stairwell and the vaults of the stairs (Figure 7-3).

Figure 7-3 Damage to the vaults of the stairs

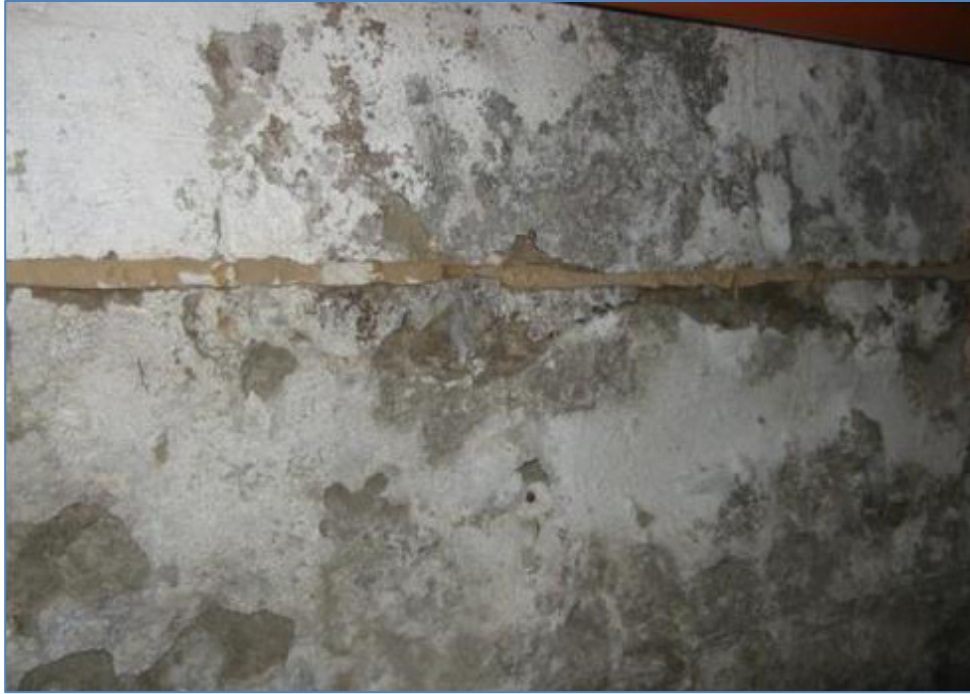
At the foundation level, there is a physical cut made in an attempt to eliminate moisture problems, but during the earthquake, it caused damage at the top of other house.

Figure 7-5 Physical cut at level of foundation

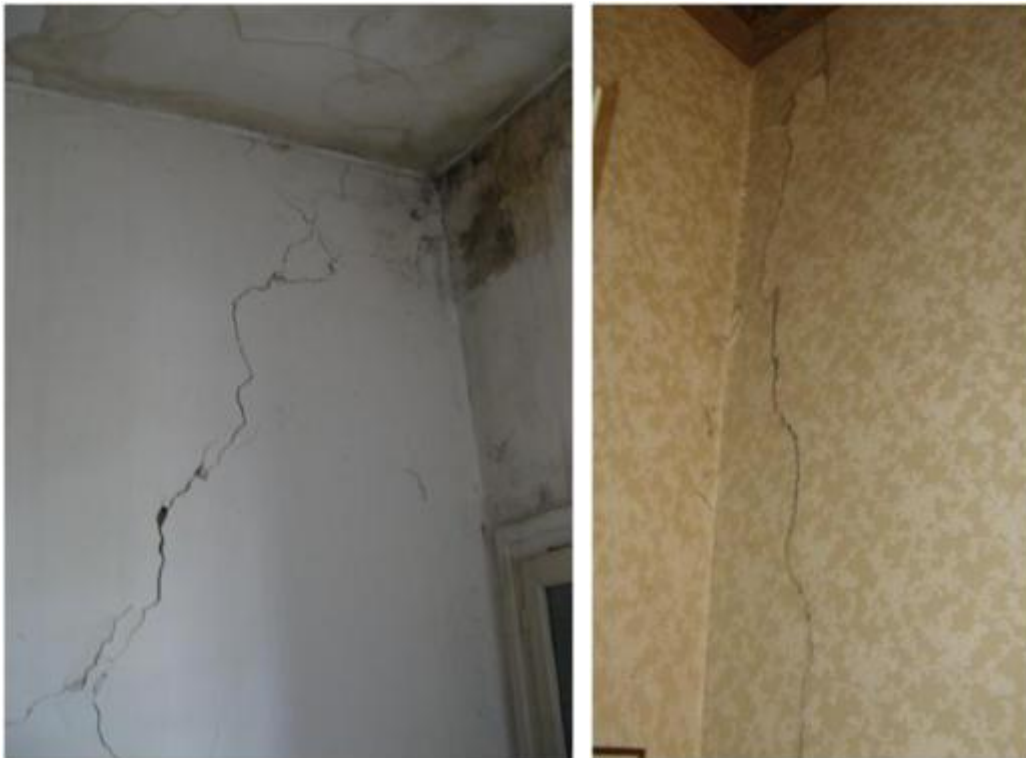
Figure 7-6 Lesions on load-bearing walls

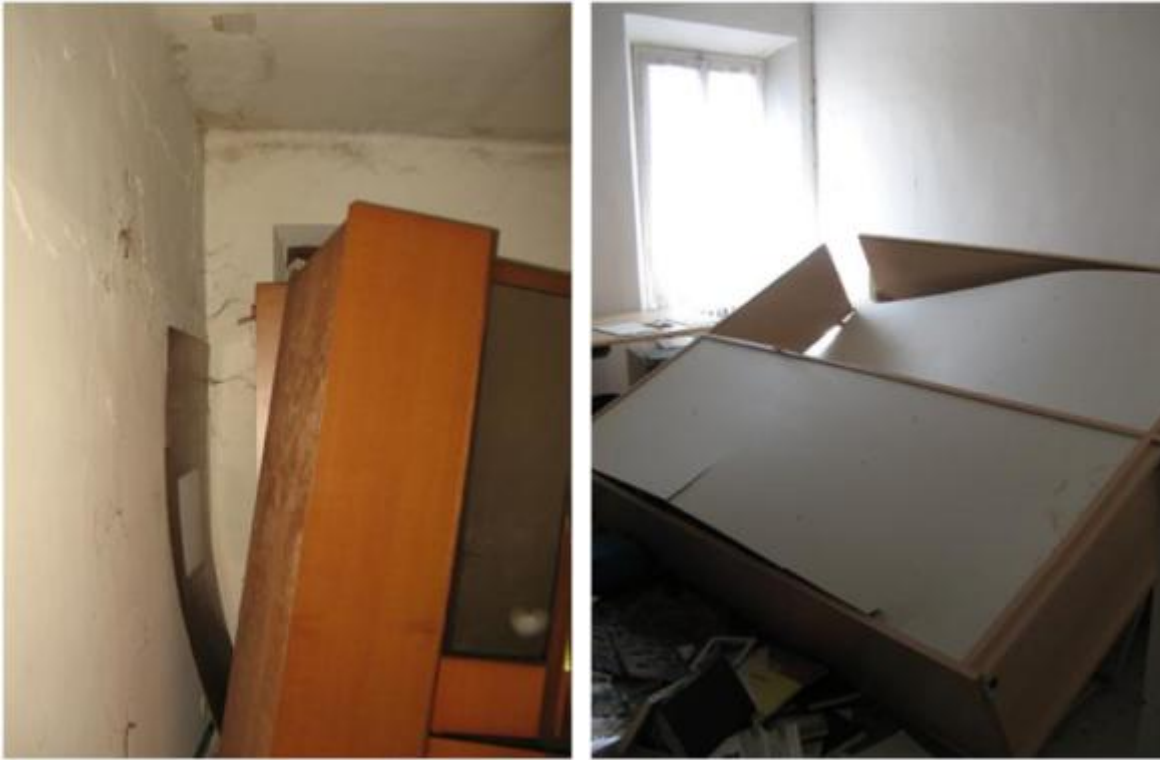
Figure 7-7 Overturning effects: This building has been classified as non-accessible

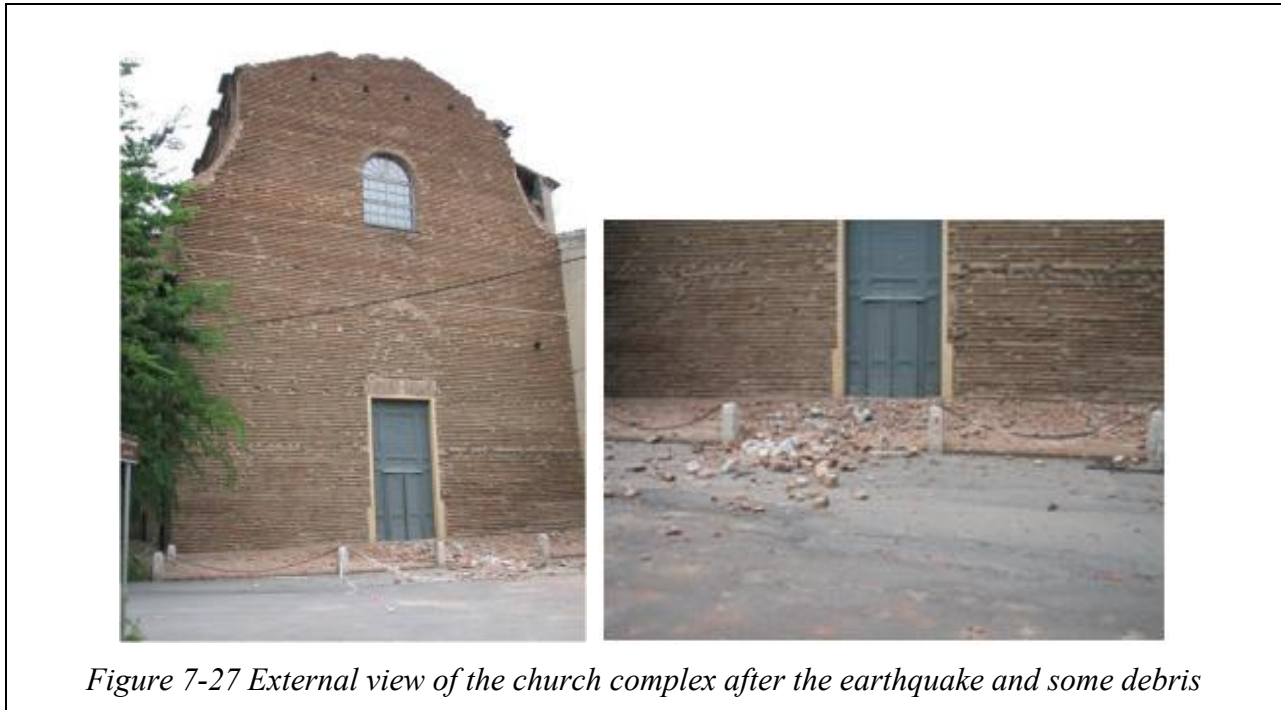
The earthquake caused severe damage to the church. The external wall presents numerous cracks and some buttresses have collapsed (Paupério et al., 2012).

Figure 7-28 Mechanism to break through the wall of the tympanum

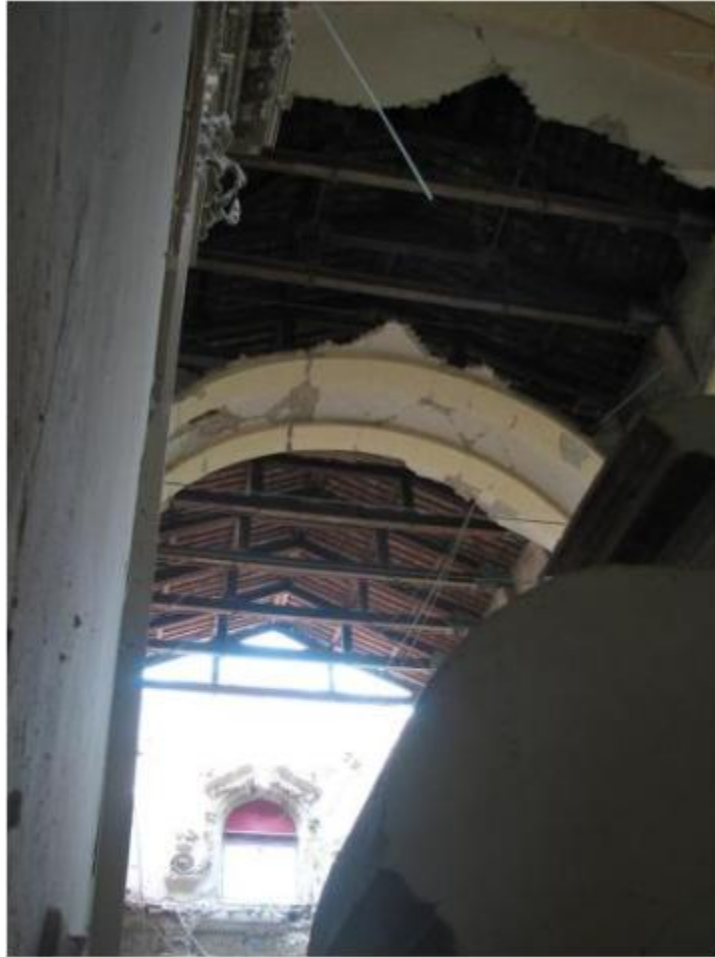
Figure 7-30 Collapsed roof

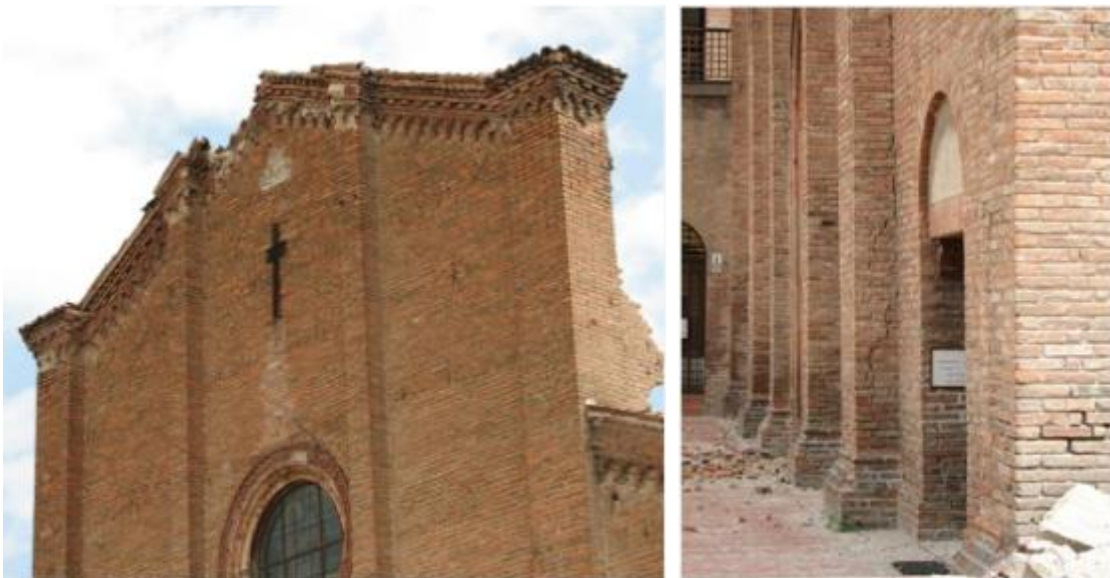
Figure 7-37 Façade damage

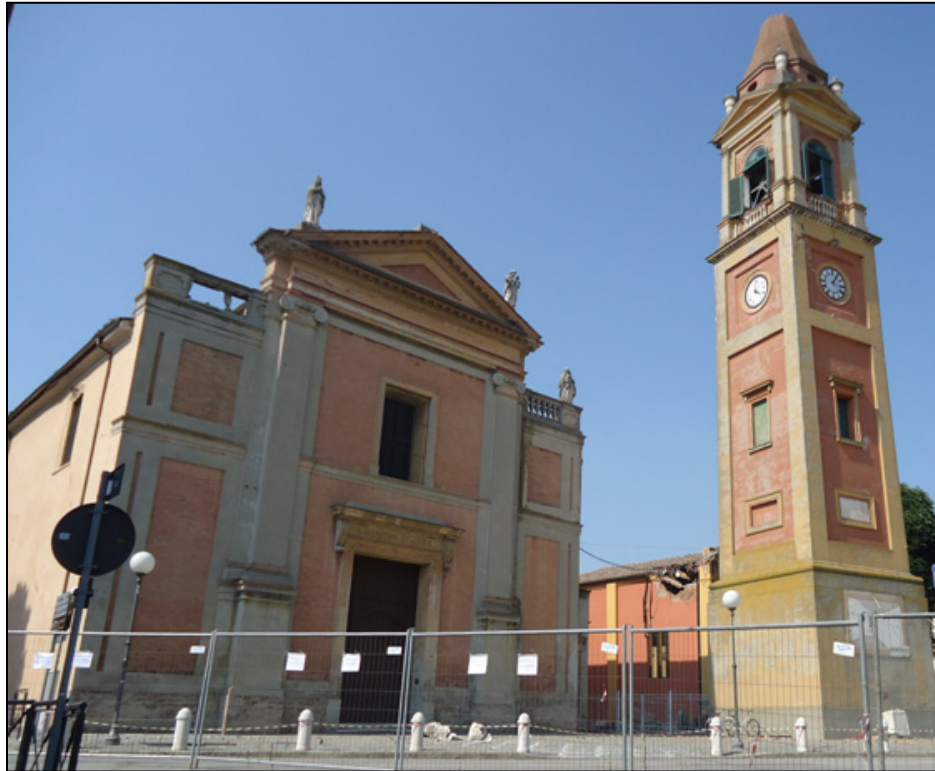
The fall of a decorative statue from the roof may be the primary cause of the damage. The church also has some shear cracks in the north wall and the bell tower is leaning. A partial detachment of the façade is clearly visible.

Figure 7-40 Chiesa in Sant'Agostino

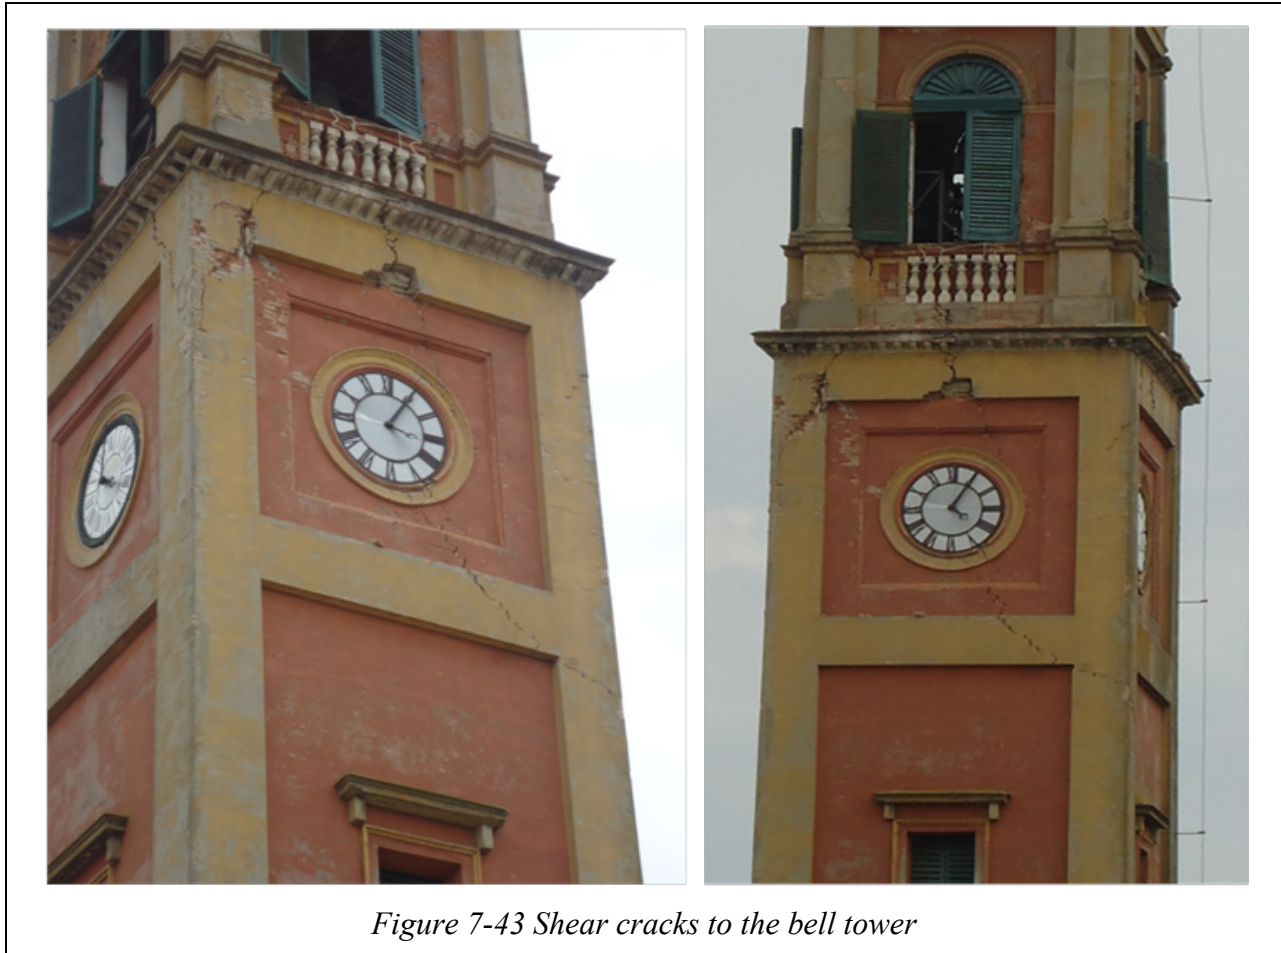
Figure 7-43 Shear cracks to the bell tower

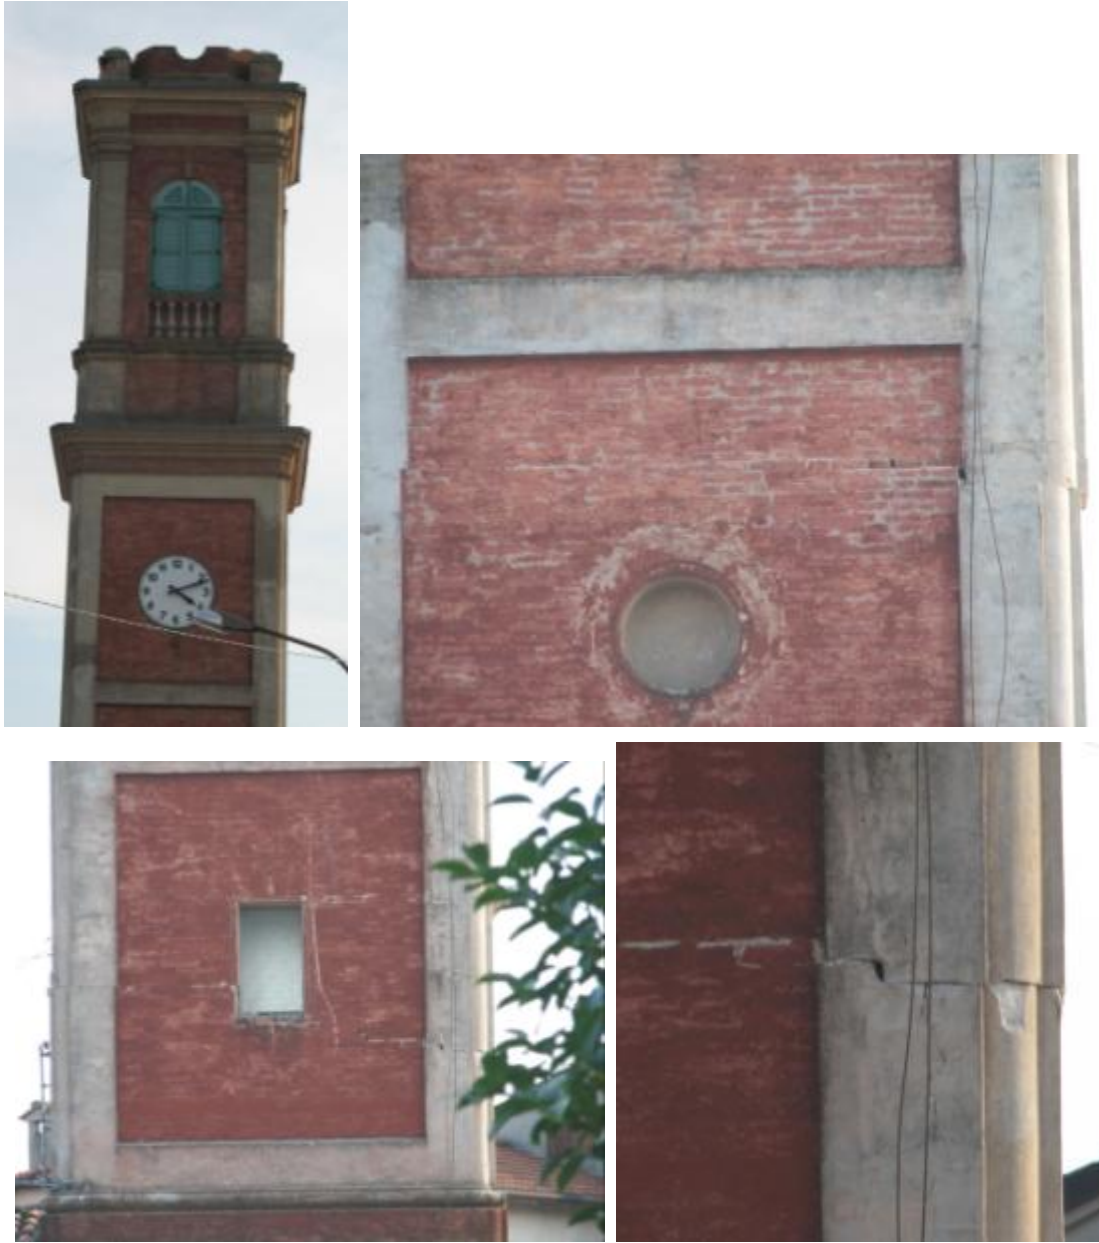
Figure 7-51 Shear fracture was the reason for the demolition

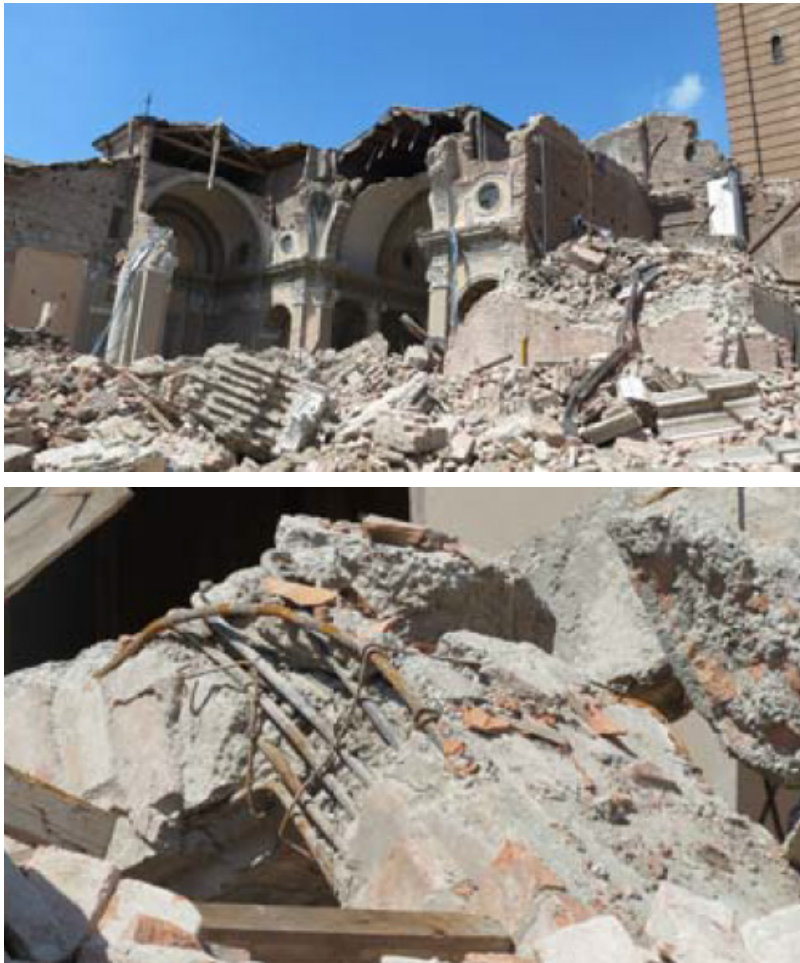
As shown in the previous figure, the main cause of the collapse of the structure was the use of poor materials. Some figures also show the presence of reinforced concrete elements that may have been used for some restoration.

Figure 7-62 Collapse of reinforced concrete element

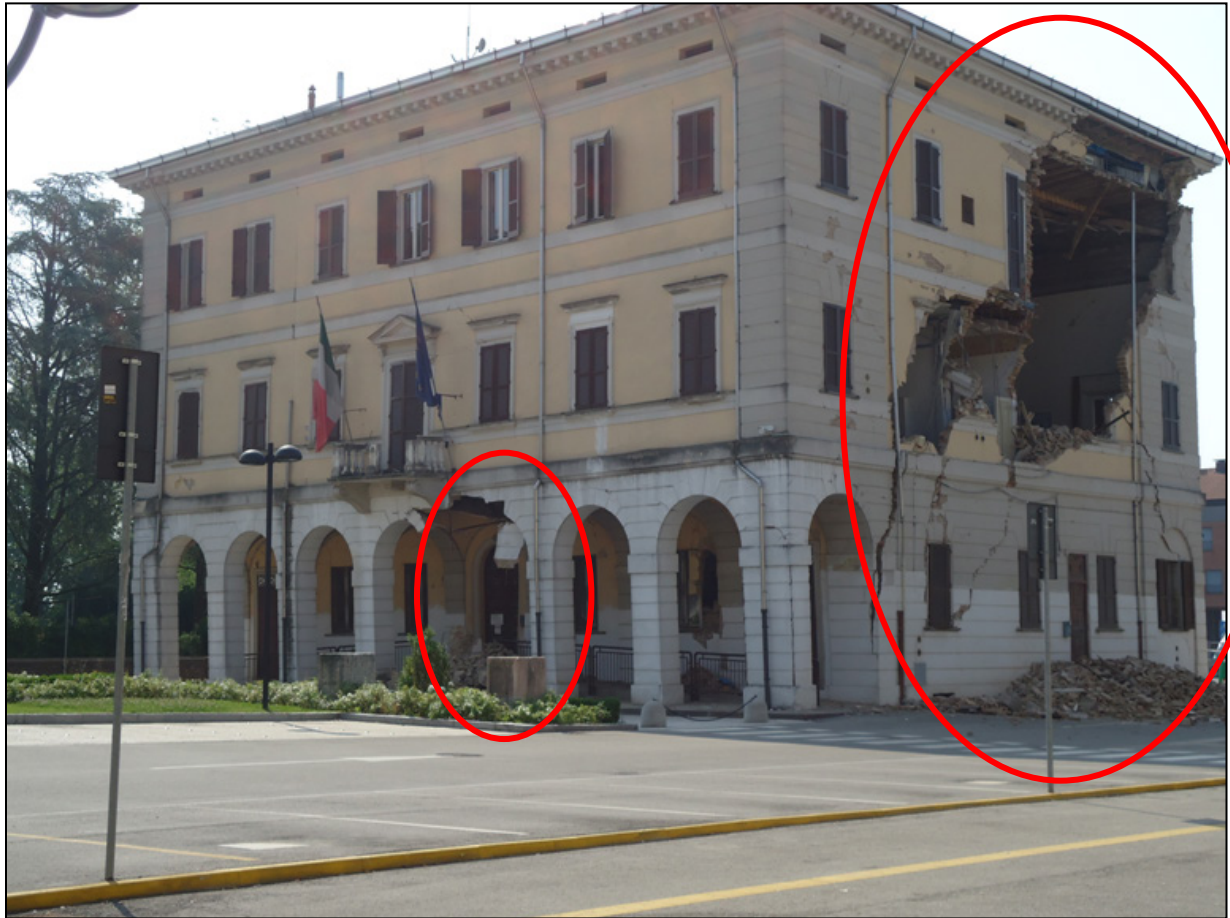
Figure 7-63 City hall of Sant'Agostino – Fallen column and collapse of external wall

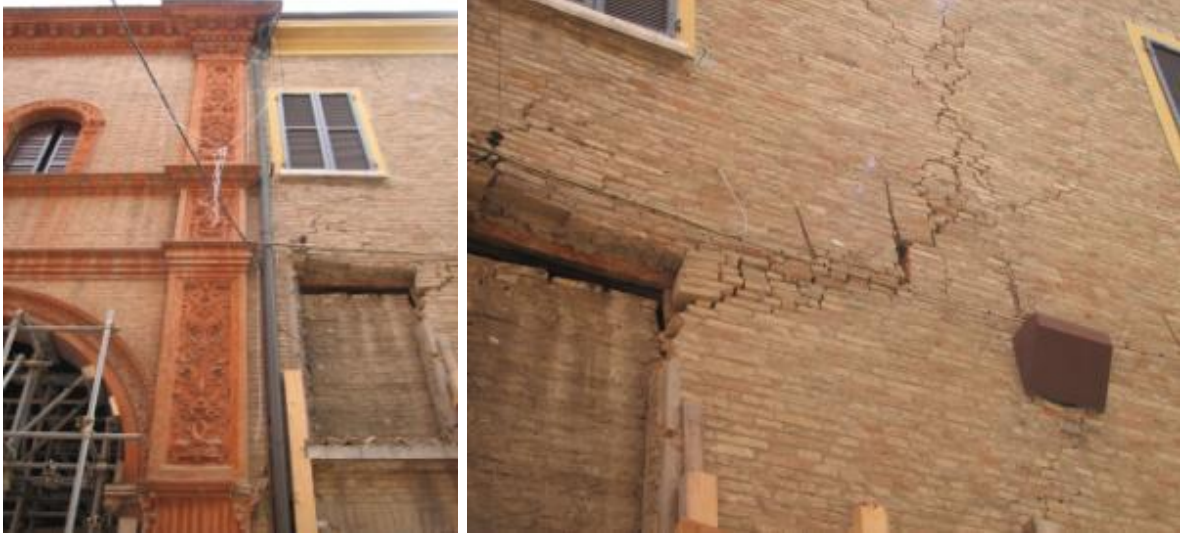
Figure 7-70 Shear crack on the external walls

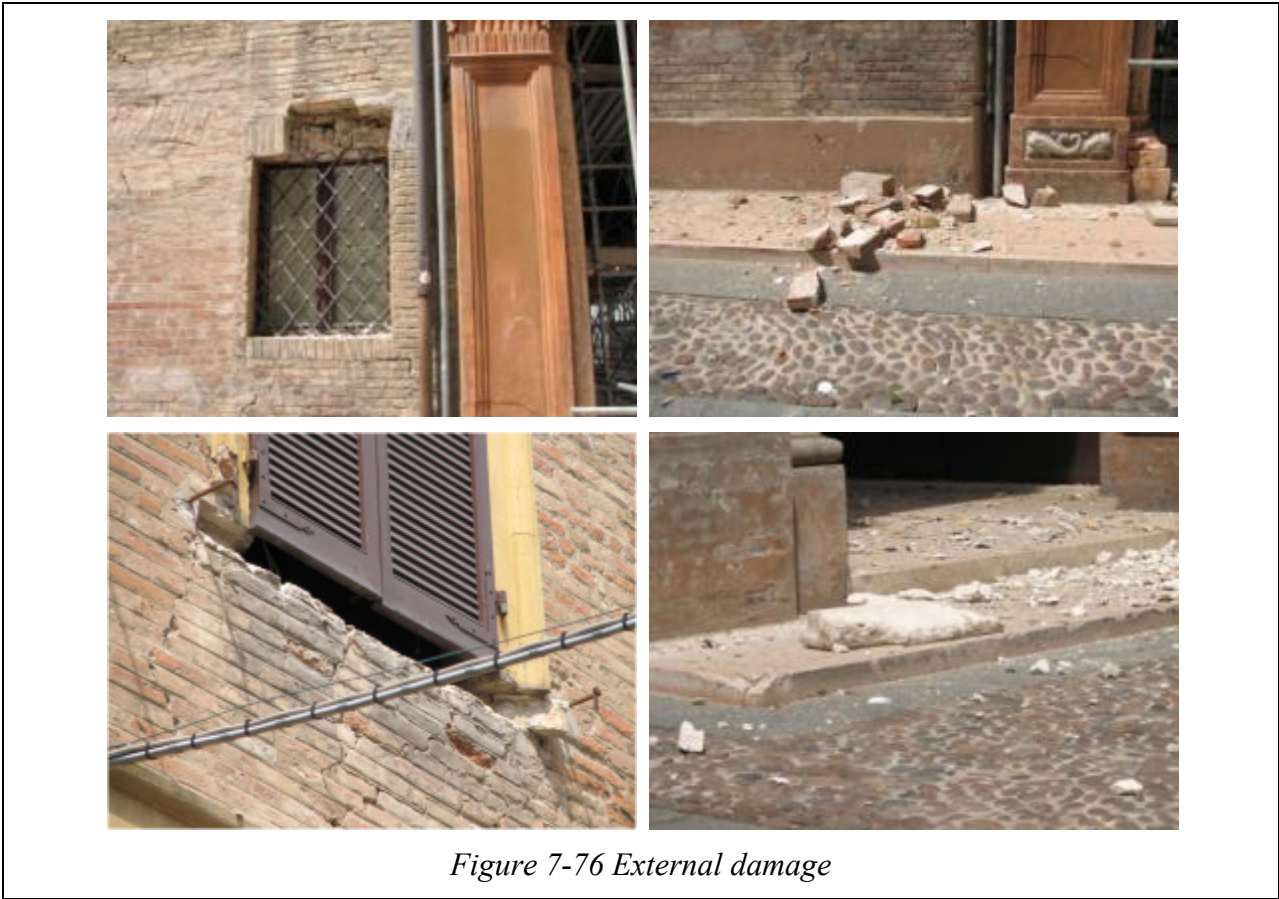
Figure 7-76 External damage

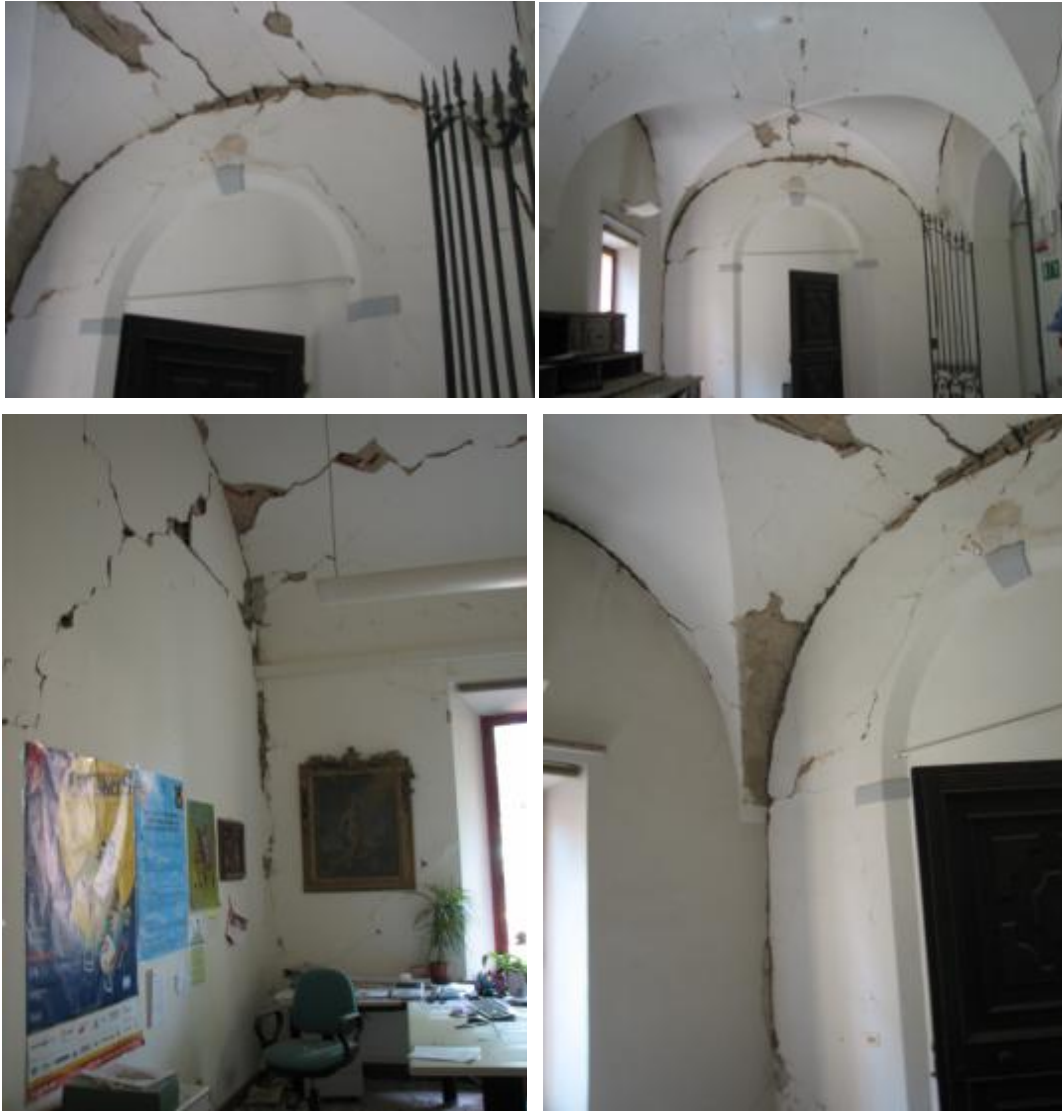
Figure 7-87 Damage to the vaults

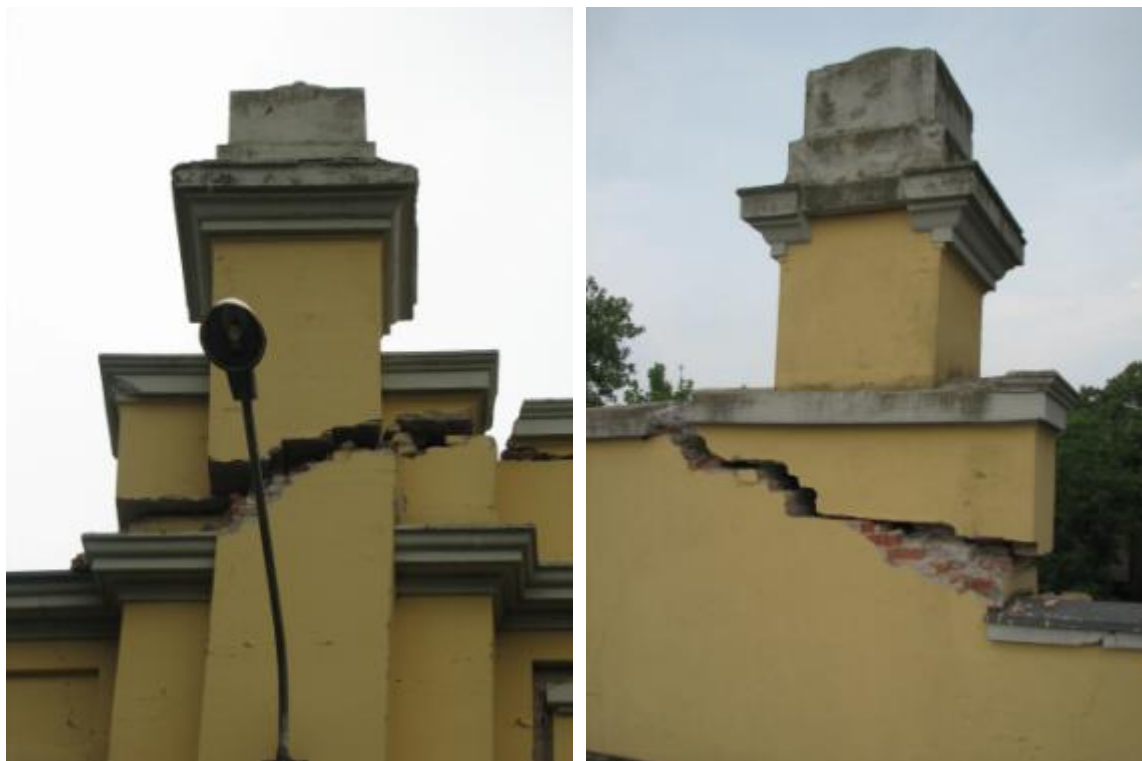
Figure 7-93 Unsafe architectural elements
