EMILIA EARTHQUAKE OF MAY 20, 2012 IN NORTHERN ITALY: REBUILDING A COMMUNITY RESILIENT TO MULTIPLE HAZARDS

by
Gian Paolo Cimellaro, Marco Chiriatti,
Andrei M. Reinhorn and Lucia Tirca

Technical Report MCEER-13-0006

June 30, 2013

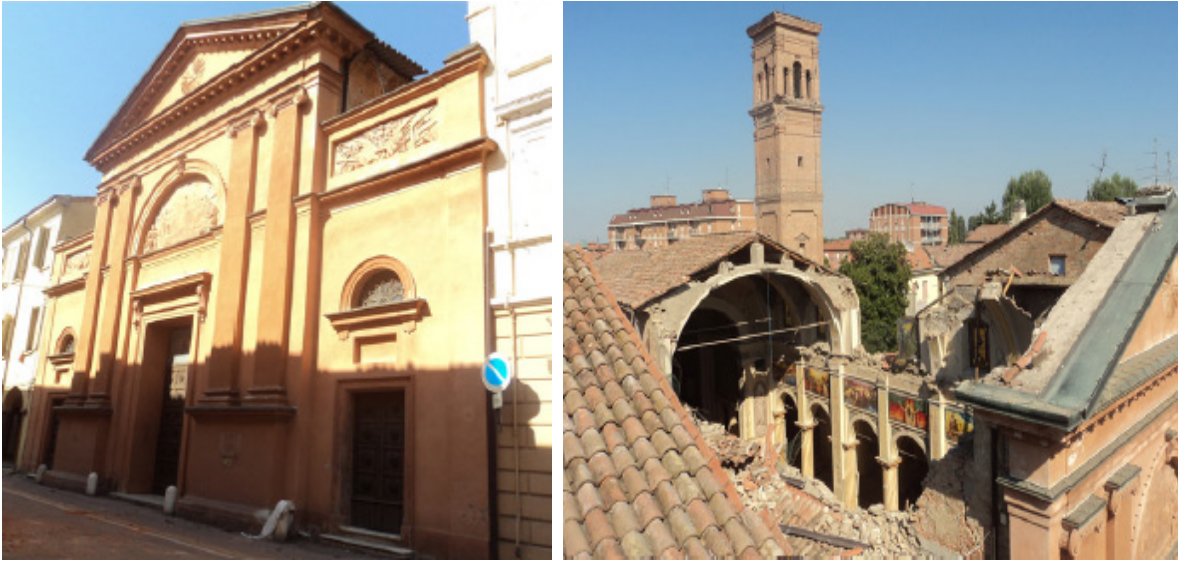
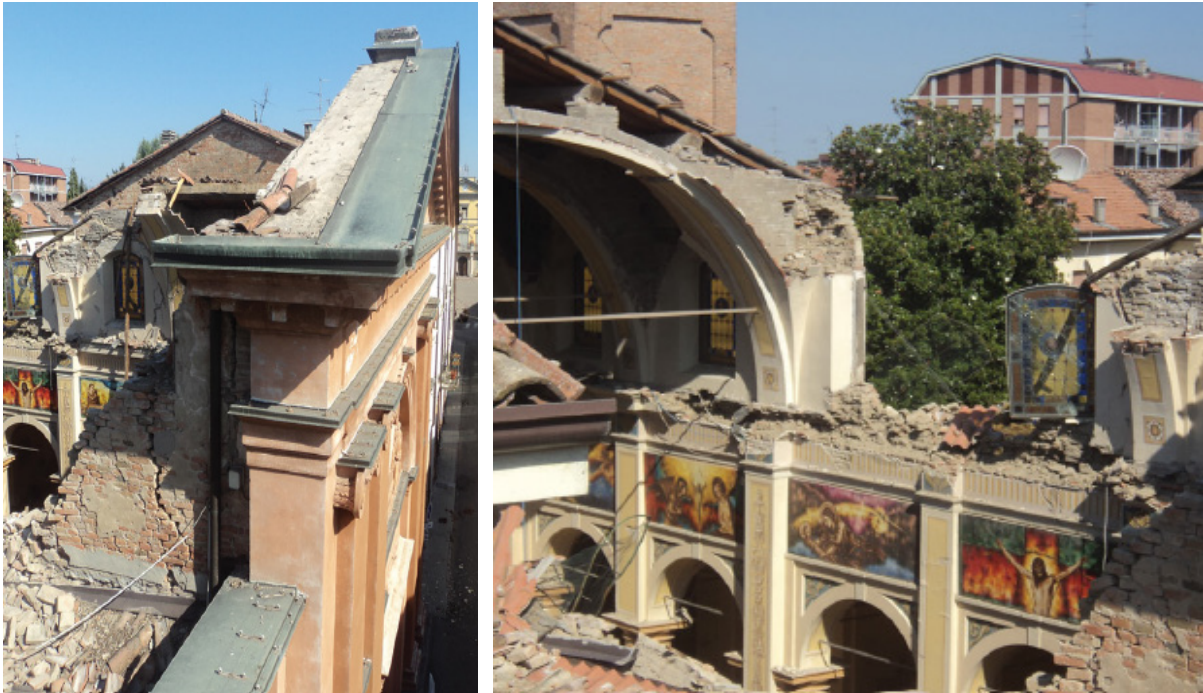
Figure 8-4 Church of St. Paul and its damage

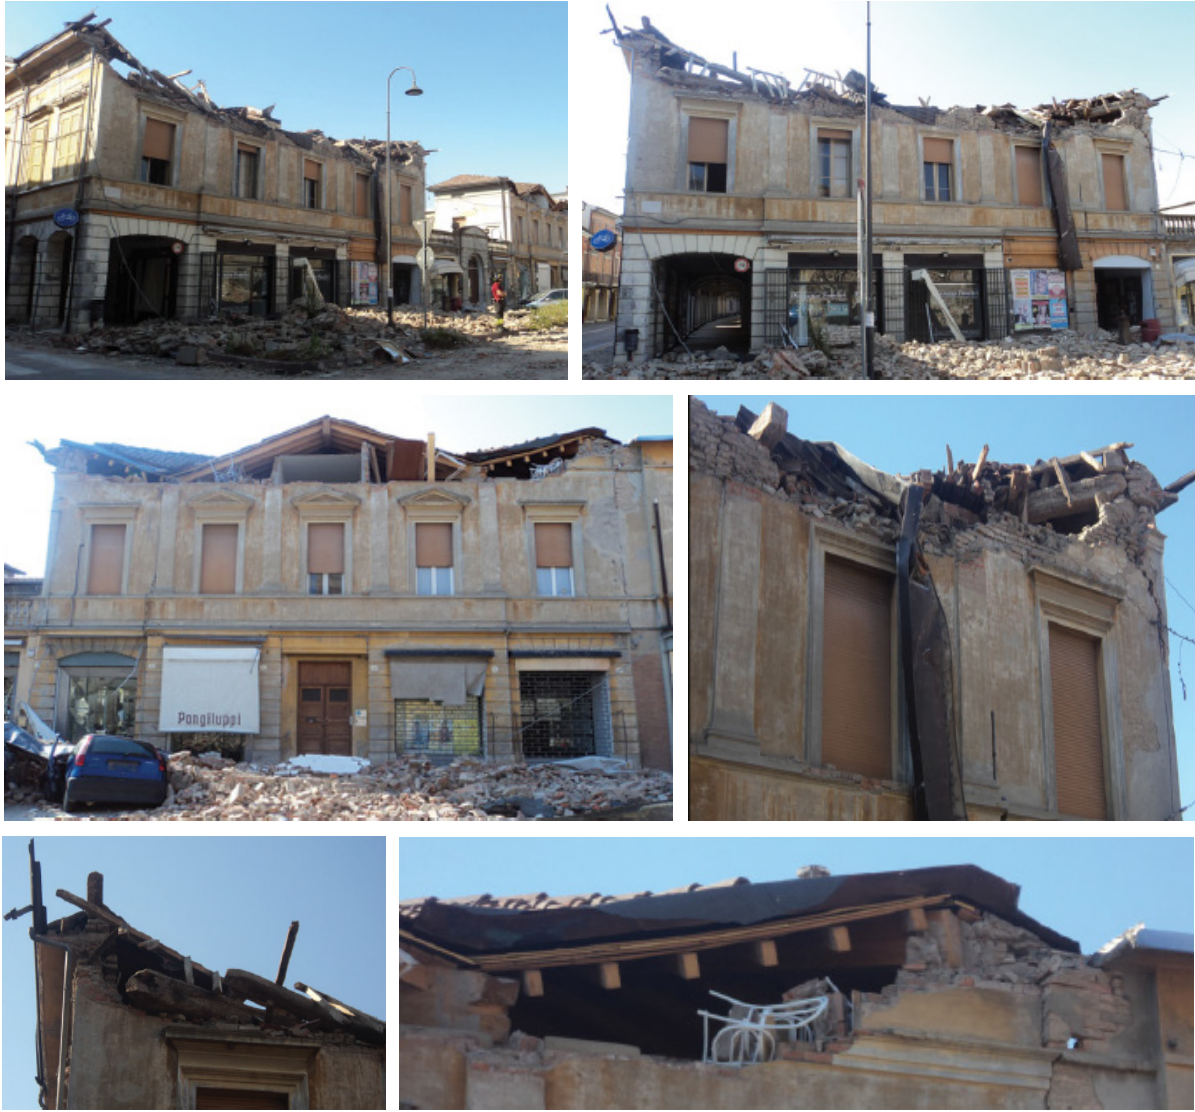
Figure 8-5 Damage to the post office building

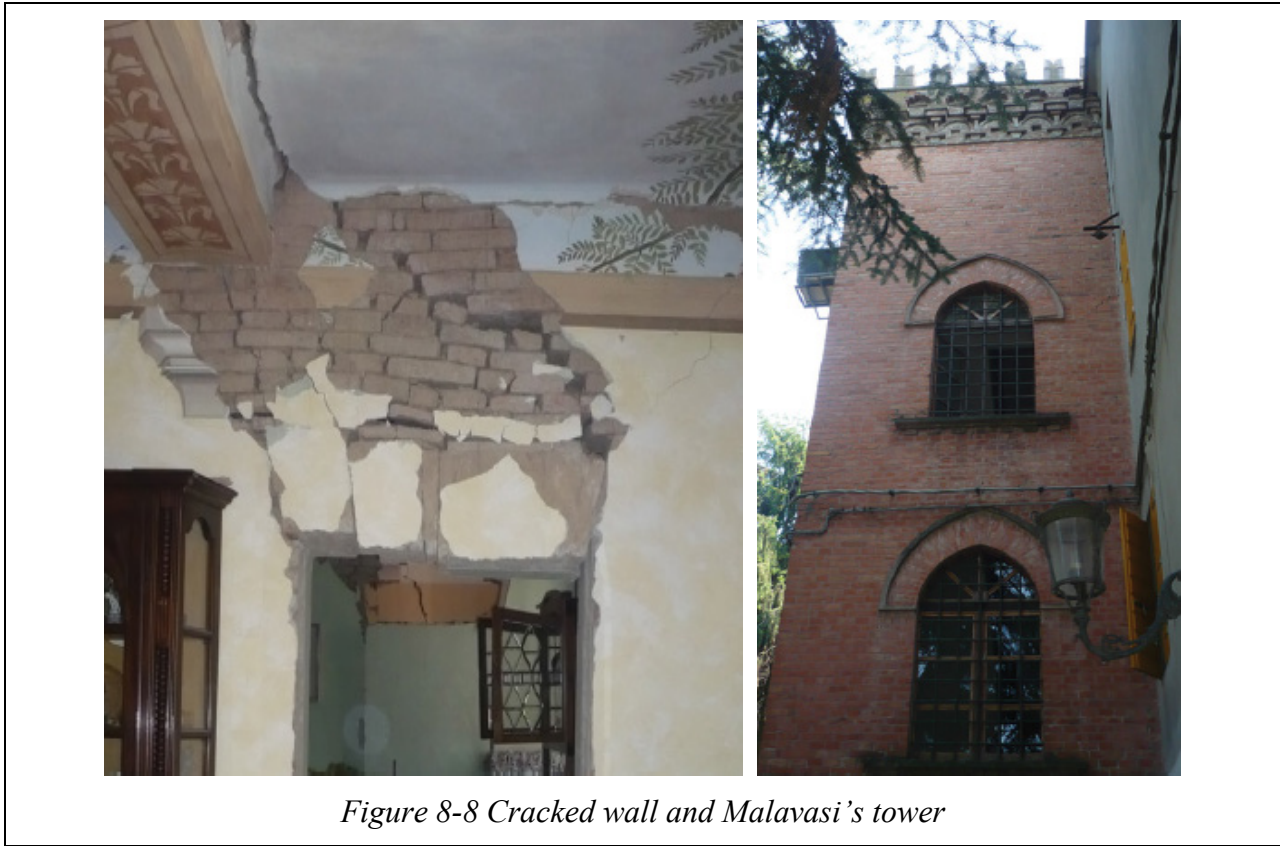
After the earthquakes, the tower separated from the rest of the structure; the cover partially collapsed and the inner walls cracked.

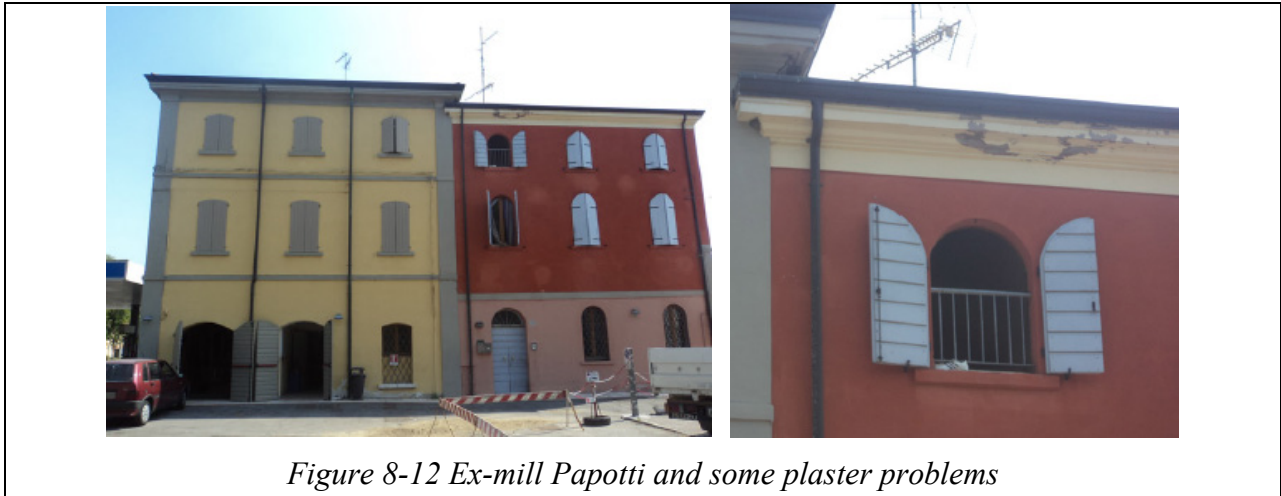
Figure 8-12 Ex-mill Papotti and some plaster problems
