REPORT ON THE WHITTIER-NARROWS,
CALIFORNIA EARTHQUAKE OF
OCTOBER 1, 1987

J. Pantelic and A. Reinhorn

Technical Report NCEER-87-0026

November, 1987

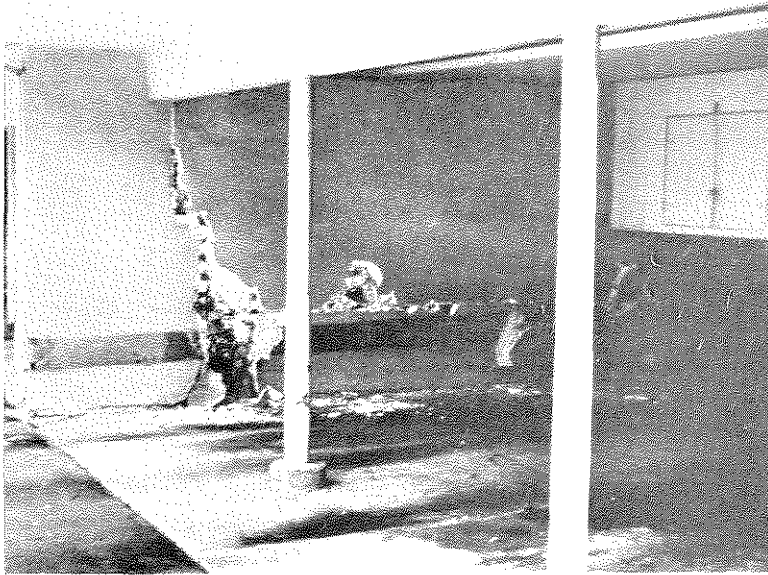
Load bearing unreinforced masonry walls constructed of hollow or solid blocks had a large number of failures and caused collapse of entire walls and roofs. The extent of damage varied from minor cracks to complete collapse of walls. Several commercial buildings in Whittier suffered damage. Some collapsed over vehicles parked next to them. Older, unreinforced masonry walls failed due to in-plane cyclic shear cracking (see Figure 1-3), out-of-plane instability and impact with adjacent buildings (pounding). Several streets with commercial buildings had to be closed in Alhambra, Whittier Center and South Pasadena. Several buildings in San Gabriel Mission (constructed in 1791) were severely damaged. In particular, the bell tower failed and brought about the collapse of part of the adjacent 1500-seat Civic Auditorium. (This tower survived a large number of previous earthquakes.) In areas of Whittier, piers of unreinforced masonry that were acting as shear walls showed flexural failures between windows combined with some diagonal shear cracking.

*Figure 1-3
Masonry walls
cracked severely
in-plane due to high
shear and compres-
sion at the first story
(Photo from the Bay
Area Regional
Earthquake
Preparedness Pro-
gram (BAREPP)
collection).*

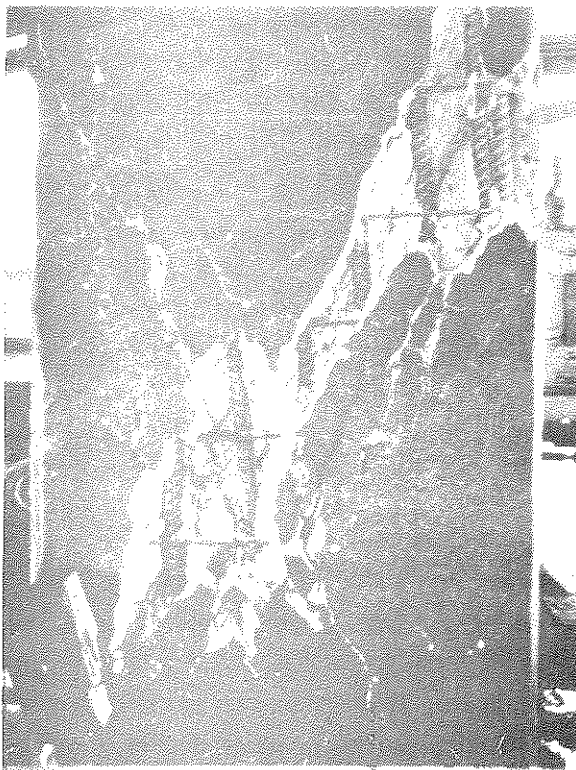
Major damage was caused to the supporting columns of a large highway overpass at the junction of I-5 and I-605. The columns suffered several load reversals and developed sizable diagonal cracks (see Figure 1-4). The columns have large diameter bars (#18) tied with small diameter hoops (#3) with large spacing (12"). Shear failure was expected in this type of structure (communicated by Mr. Ray Zelinski, Caltrans). Presently, investigations are being carried out by researchers at UCLA and Caltrans to clarify the details of these failures.

*Figure 1-4
Cyclic shear produced x shear cracks
in center columns of
the 15 - I605 highway
overpass (Photo
courtesy of State of
California, Department of
Transportation).*

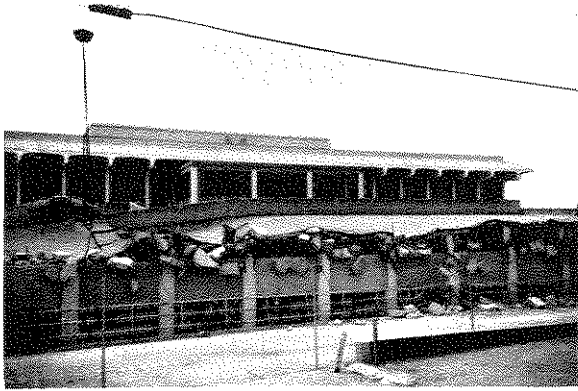
A two-story parking structure adjacent to a department store (May Co.) at Whittier Quad suffered severe damage and partial collapse due to the shear failure of columns (see Figure 1-5). Large girders had much stronger sections than the supporting columns, creating conditions for a catastrophic collapse (strong beams vs. weak columns) (see Figure 1-6). The damaged and the collapsed columns (interior columns) were braced by deep spandrel beams and developed shear failure that is characteristic of short columns [1]. The outside columns were widely tied by #2 and #3 bars without confinement of the beam column connections.

Figure 1-5 (above)
Shear failure of columns and joints led to the complete collapse of the roof of the parking garage at the Whittier Quad.

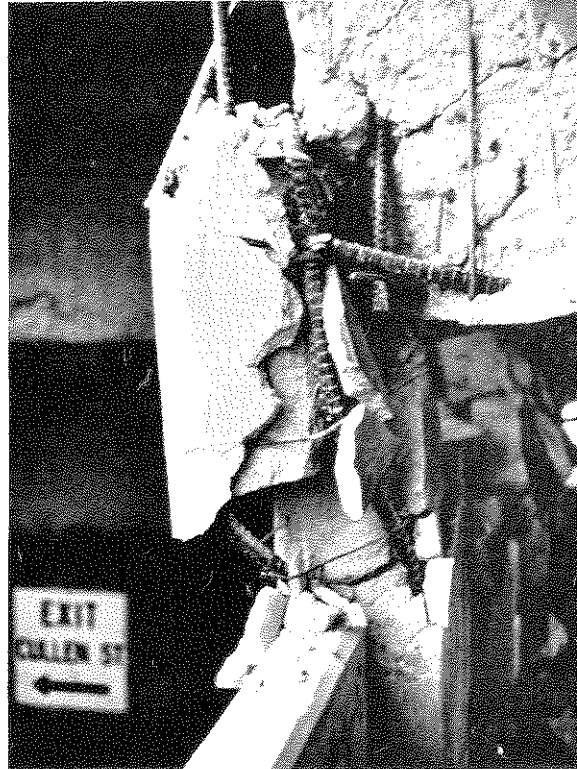
Figure 1-6 (right)
Typical strong beam-weak column connection and "short" column failure due to the lack of stirrups and properly anchored bars (Photo from the BAREPP collection).

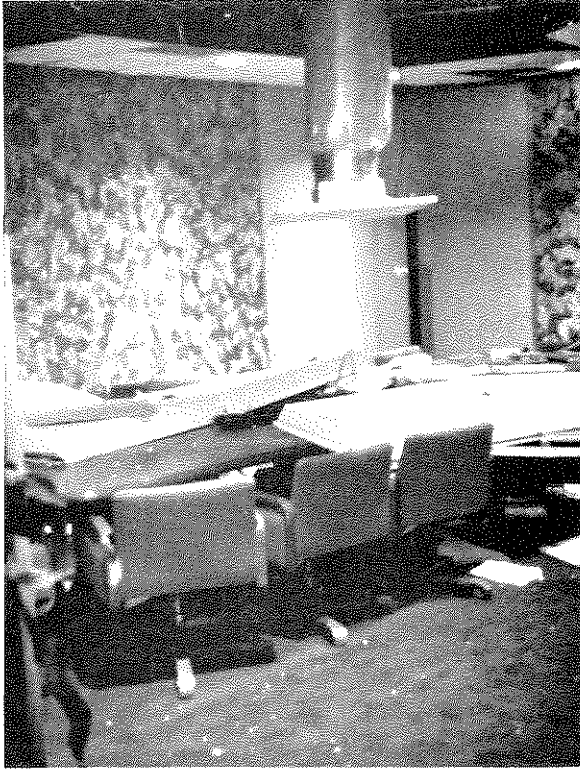
Suspended architectural ceilings, light fixtures and ducts failed in many occasions while the structural system did not have any damage. In a few instances, falling ceiling tiles and light framing destroyed expensive computers, furniture and office accessories (see Figure 1-7).

*Figure 1-7
Considerable damage
was done by falling
ceiling tiles, light
fixtures, pipes and
vents (Photo from the
BAREPP collection).*

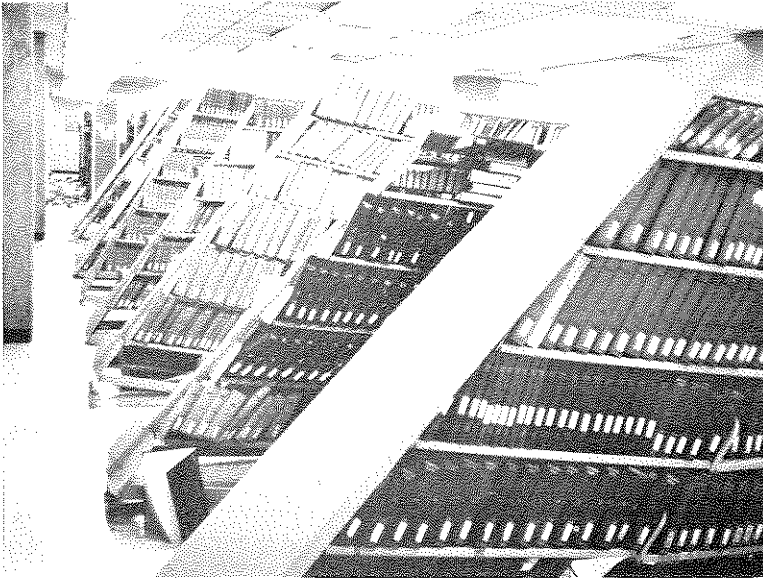
Building contents including storage racks, books, laboratory chemicals, etc., suffered extensive damage in buildings which did not have structural damage (see Figure 1-8). Moreover, flying objects caused extensive damage to walls, claddings and other building contents. In one case, at California State University, chemicals spilled and reacted with each other creating toxic materials. Buildings had to be closed and clean-up operations took several days. The replacement of nonstructural components and building contents was estimated at approximately 50% of the retrofit costs at California State University. According to reports of structural engineers and architects these costs may be exceeded in some tall buildings.

*Figure 1-8
Damaged shelves at
California State
University at Los
Angeles library are
supported by the
confined books.*

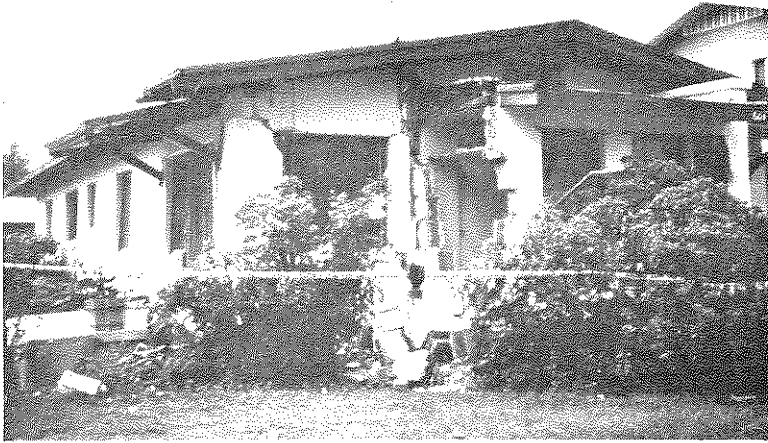
*Figure 2-3
Many single family residences such as this hollow-tile home on Painter Avenue in Whittier were damaged in the earthquake. They were cordoned off as unsafe for occupancy, while the residents sought shelter elsewhere.*
