GEOTECHNICAL AND LIFELINE ASPECTS OF THE OCTOBER 17, 1989 LOMA PRIETA EARTHQUAKE IN SAN FRANCISCO

T. D. O'Rourke, H. E. Stewart, F. T. Blackburn, and T. S. Dickerman

Technical Report NCEER-90-0001

January, 1990

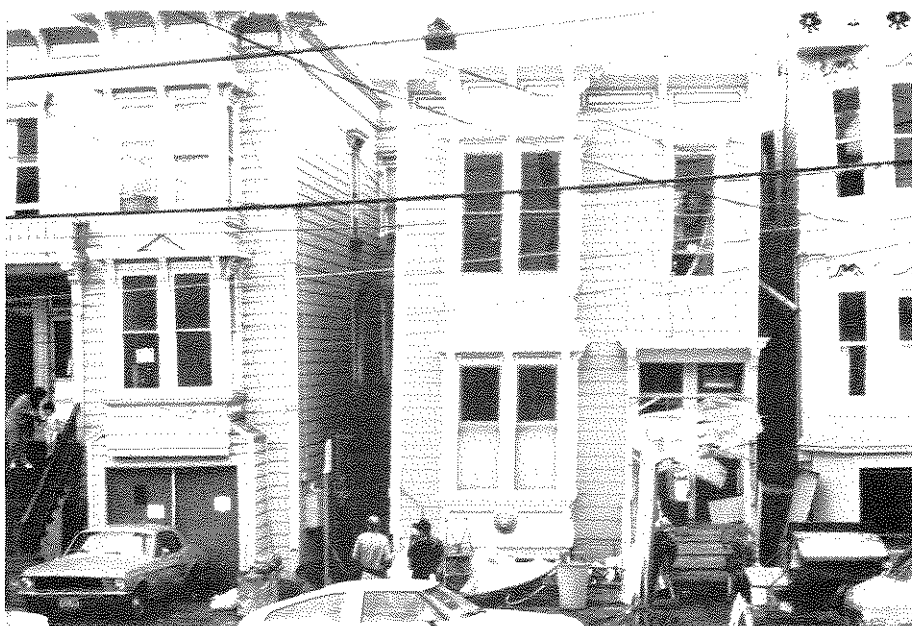
East of Mission and Capp Sts., soil liquefaction occurred in the same places it had been observed after the 1906 earthquake. The most prominent damage caused by soil liquefaction occurred as differential settlement, racking, and tilting of Victorian two to four-story timber frame buildings on South Van Ness, Shotwell, and Folsom Sts. between 17th and 18th Sts. Sand boils were observed at all these locations. The most severe damage was observed at the middle west side of Shotwell St., where maximum building settlements on the order of 0.2 to 0.4 m occurred. Figure 2-2 shows differential settlement and tilting of timber structures in 1906 on the east side of South Van Ness between 17th and 18th Sts. Figure 2-3 shows differential settlement and tilting of similar structures in 1989 on the west side of Shotwell St. between 17th and 18th Sts.

FIGURE 2-3. Racking and Settlement of Houses on Shotwell St. Between 17th and 18th Sts. in 1989. These Houses are Directly Behind the Location of Houses in Figure 2-2 (photograph by T. D. O'Rourke)

sand boils were apparent along the curb line. The occupants of these structures claimed that settlement had continued for as long as four days after the earthquake.

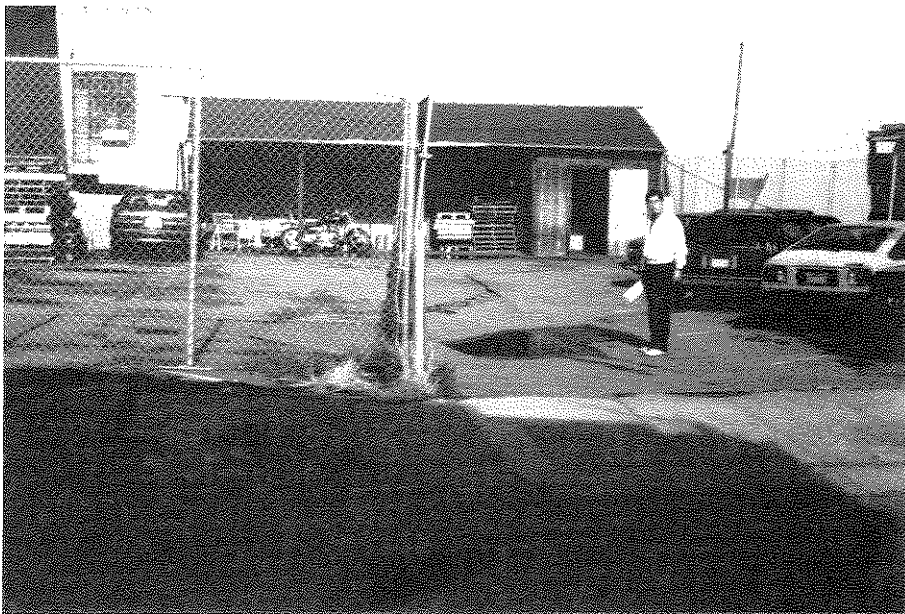
About 0.3 m of subsidence was observed in a parking lot off Dore St. approximately 30 m north of its intersection with Bryant St. This was a location of substantial settlement and lateral spreading in 1906. There was about 100 mm of settlement of the sidewalk adjacent to the building on the northeast corner of Dore and Bryant Sts. and differential settlement of the structure. The sidewalk along Bryant St. adjacent to the building was buckled and a water service had been ruptured. Figure 2-4 shows differential settlement of 1.5 m on Dore St. in 1906 compared with approximately 0.3 m of differential settlement on Dore St. in 1989, as shown in Figure 2-5.

FIGURE 2-5. Differential Settlement Along Dore St. Just North of Bryant St. in 1989 (photograph by T. D. O'Rourke)

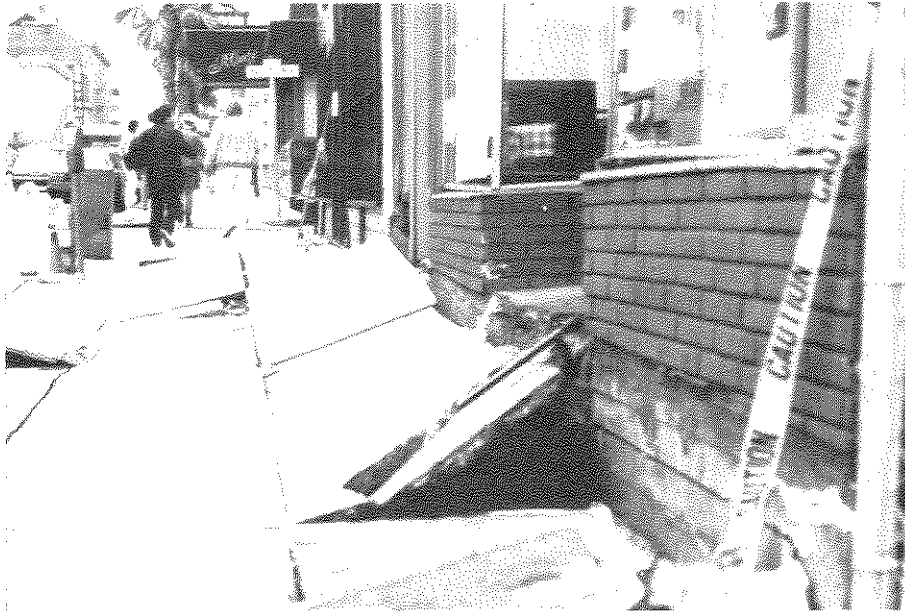
South of Mission St., sand boils were observed along curb and building lines at various locations on 7th, 6th, Natoma, Russ, Moss, Clara, Bluxome, and Townsend Sts. From Mission to Folsom St., 10 to 30-mm-wide cracks were observed down the centerline of 7th St., with differential settlement to the east and west of the cracks. As shown in Figure 2-6, differential settlement of roughly 0.3 m was observed at the southeast corner of Natoma and 7th Sts., with settlement and severe deformation of the two and three-story timber frame buildings at this location. Sand flowed into the basement of a building at the corner of Howard and 7th Sts., filling it with approximately 0.6 m of material. Differential settlements and cracks were apparent on 6th St. between Folsom and Harrison Sts. Approximately 0.3 m of differential settlement and sand boils were observed beneath the Rt. 280 elevated highway near the intersection of 6th, Bluxome, and Townsend Sts. Compression ridges in the form of buckled street pavements and sidewalks were observed along Russ St., approximately 30 to 60 m north of Folsom St.

FIGURE 2-6. Differential Settlement of 0.1 to 0.3 m Adjacent to Building at Corner of 7th St. and Natoma St. (photograph by T. D. O'Rourke)

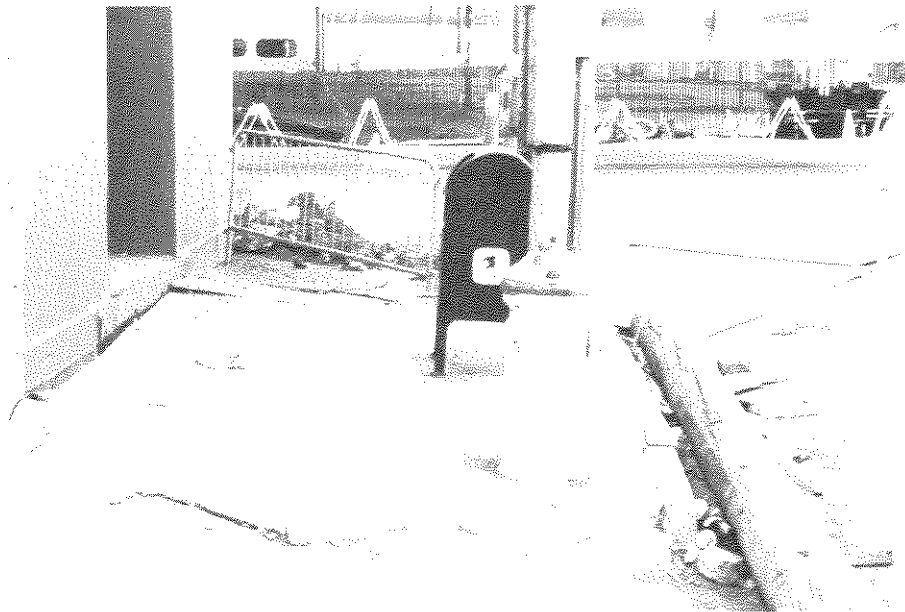
FIGURE 2-7. Differential Settlement at Corner of 6th St. and Townsend St. (photograph by T. D. O'Rourke)

sewer centerline. Figure 2-7 shows local differential settlement of roughly 150 mm adjacent to the building at the northeast corner of 6th and Townsend Sts. Differential settlements of 150 to 250 mm were observed adjacent to pile-supported columns of the Rt. 280 highway ramp at this location. Abrupt settlement with a maximum vertical offset of 200 mm was measured to the west of the pile-supported sewer beneath the Rt. 280 ramp. Recent differential settlements were apparent along the north side of Townsend St. for a distance of about one block to the east and west of its intersection with 6th St. Sand boils were observed beneath the Rt. 280 highway ramp. No sand boils or differential settlements were observed in the vicinity of the rail yard immediately south of Townsend St.

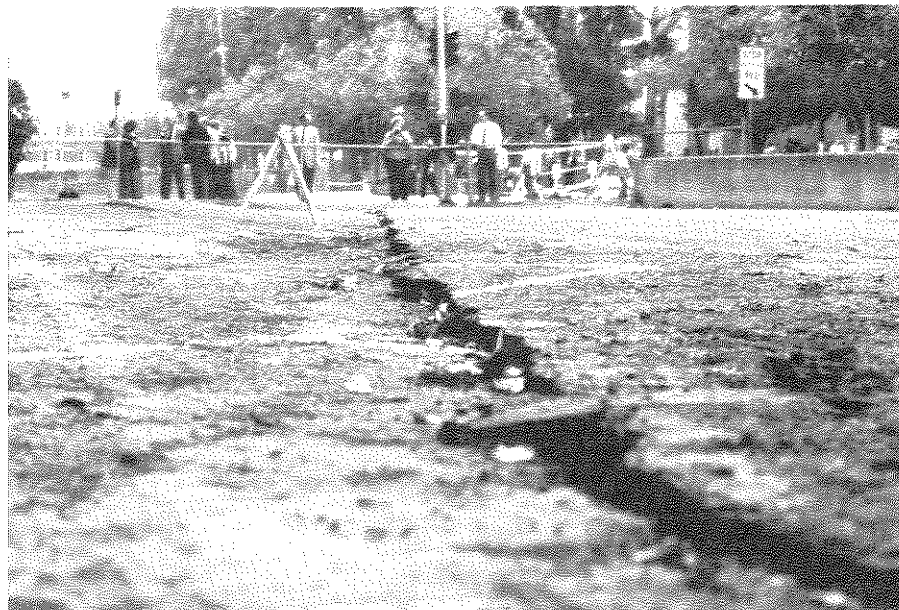
Differential settlements and lateral displacements were observed along the Embarcadero from Howard St. to just north of the Ferry Building. Subsidence of approximately 0.3 m was observed immediately north of the intersection of Market St. and the Embarcadero. Sand boils were observed along the Embarcadero between the Ferry Building and Pier 1.

FIGURE 2-9. Differential Settlement on the Embarcadero Near the Intersection of Market St. in 1989 (photograph by T. D. O'Rourke)

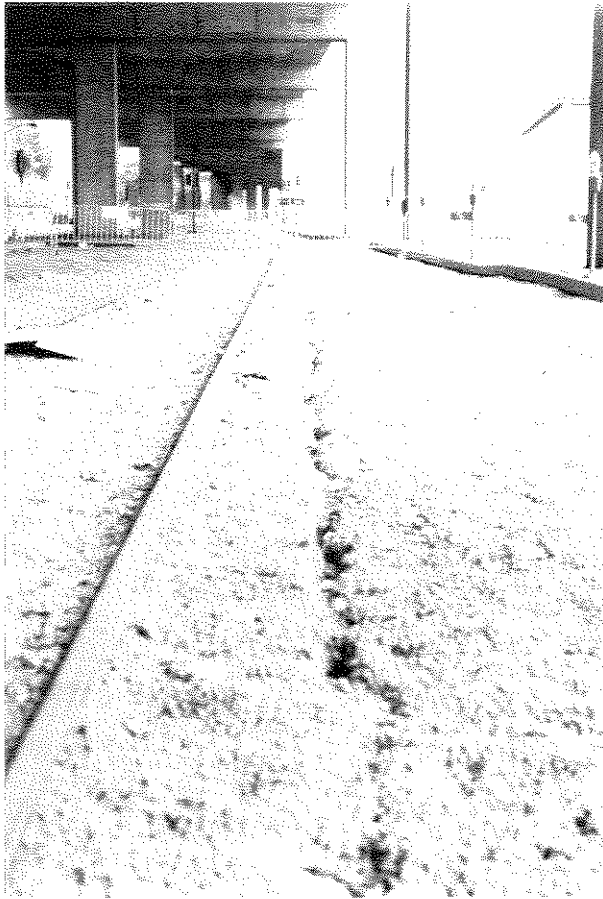
Figure 2-10 shows a prominent 25-mm-wide crack which opened beneath the Embarcadero Skyway, running parallel to the seawall for the full distance between Howard and Mission Sts. The crack indicates lateral movement toward the bay at a distance of about 20 m behind the seawall. Differential settlements of 25 to 100 mm were observed adjacent to the pile-supported columns of the Embarcadero Skyway, as shown in Figure 2-11.

FIGURE 2-10. Open 25-mm Crack Beneath the Embarcadero Skyway Between Howard and Mission Sts. Showing Movement Toward the Bay (photograph by T. D. O'Rourke)

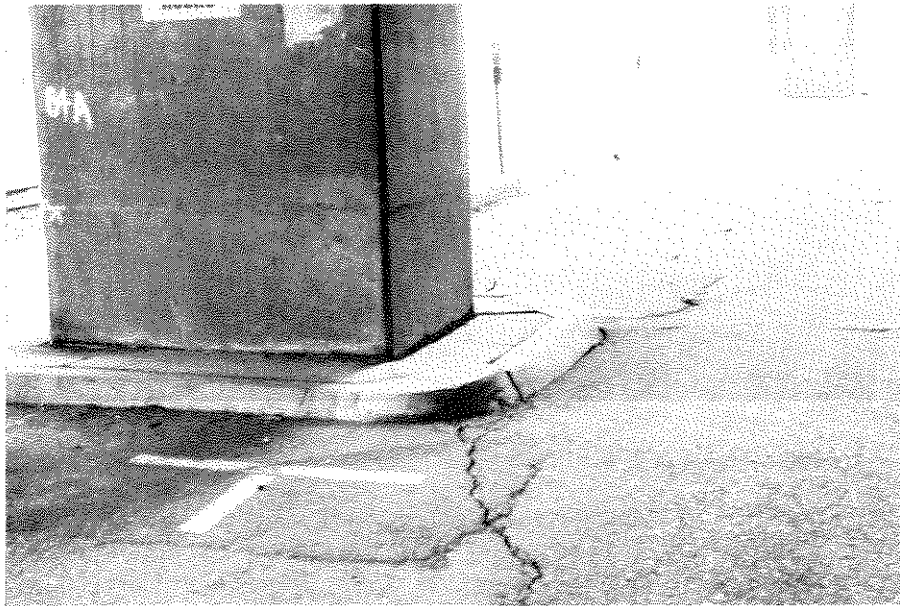
FIGURE 2-11. Differential Settlement Adjacent to Pile-Supported Column of Embarcadero Skyway Near Mission St. (photograph by T. D. O'Rourke)

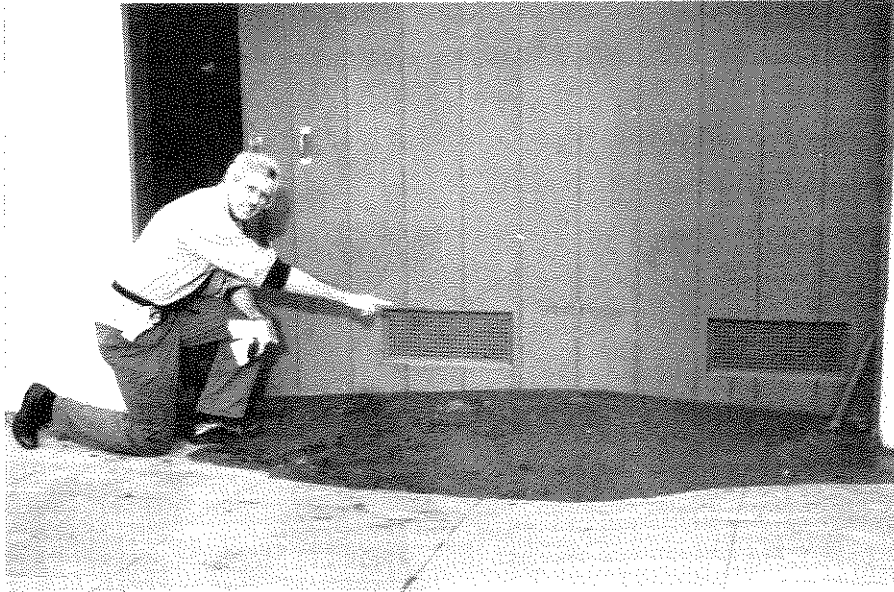
was damage to buildings. Sand boils were observed along curb lines, sidewalks, and foundation bearing walls. In many instances, sand erupted into garages, forming deposits 0.3 to 0.6 m thick. Sand boils also were observed in the front gardens and back yards of houses and at several locations on Marina Green.

FIGURE 2-12. Sand Ejected from Garage of Building on Scott St. (photograph by H. E. Stewart)

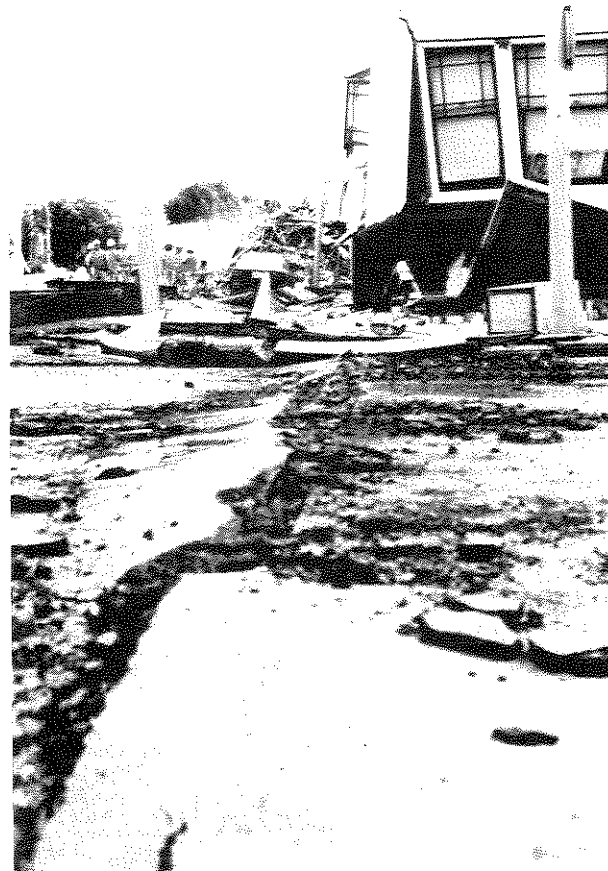
Although ground shaking was the principal cause of building damage, permanent ground movements also contributed to structural distortion. Permanent ground deformation was evident on virtually all streets. Buckled and fractured sidewalks and street pavements were apparent throughout the Marina district. Most buckled streets had compressive ridges oriented in a north-south direction, which appears to be perpendicular to the direction of strongest seismic shaking. The pattern of cracking and surface ruptures in the streets did not show a coherent sense of displacement or lateral movement in a preferred direction. Conspicuous permanent settlements and lateral displacements were confined to relatively small areas. For example, local differential settlements and lateral movements of 50 to 100 mm were observed at the northwest corner of Beach and Divisadero, southwestern corner of Divisadero and Jefferson, and on North Point St. approximately 60 m west of Webster. Lateral displacement of 175 mm northward over 30 m was measured in the Winfield Scott School playground, roughly 40 m east of the intersection of Beach and Divisadero.

FIGURE 2-13. Buckled Pavements and Ground Deformations at Corner of Divisadero St. and Jefferson St. (photograph by T. D. O'Rourke)

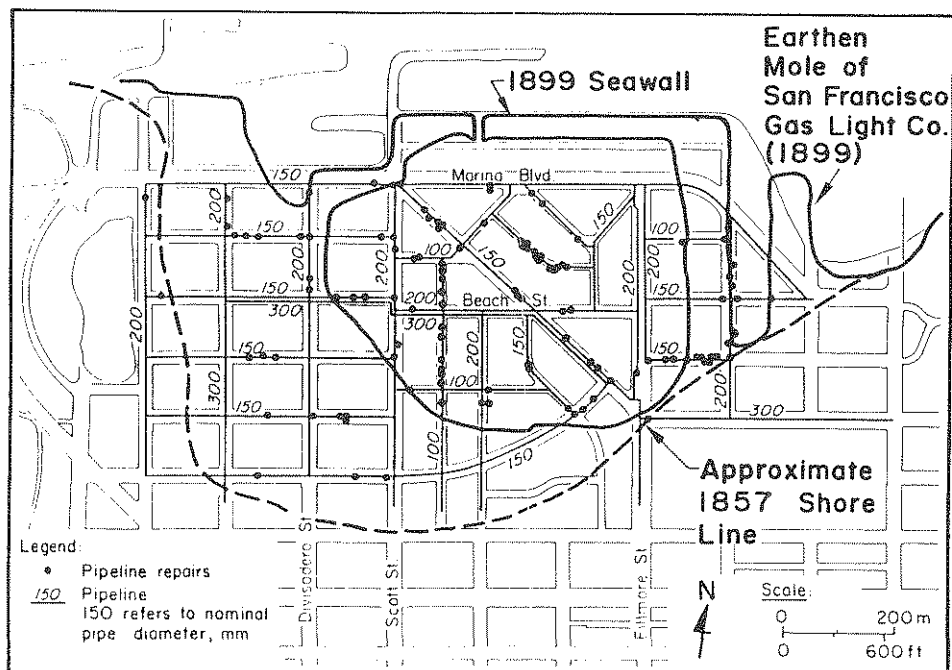
Figure 2-16 shows a plan view of MWSS pipeline repairs relative to the current street system, 1899 shoreline, and approximate 1857 shoreline. Most repairs were concentrated in the area of hydraulic fill within the lagoon bounded by the 1899 seawall or along the eastern margins of the seawall and 1857 shoreline. There were about 120 repairs in the Marina, more than three times the number of repairs in the entire MWSS outside the Marina. Repairs were made at locations of sheared or disengaged service connections with mains, flexural round cracks in mains, and leaking joints. The predominant mode of damage was associated with the first two categories.

FIGURE 2-16. Pipeline Repairs in Municipal Water Supply System (MWSS) in the Marina District

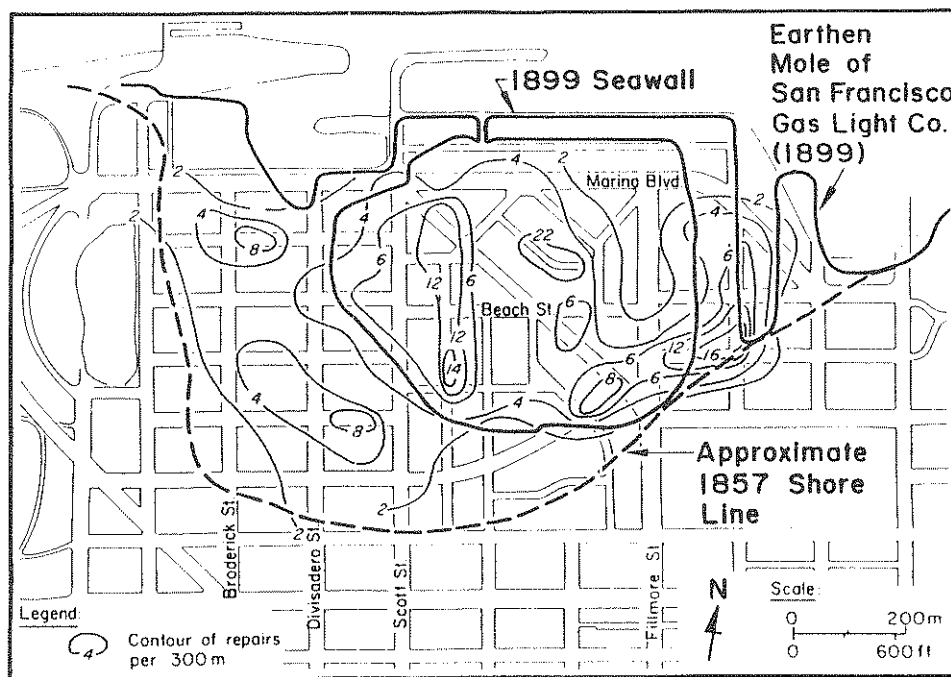
To represent the distribution of damage, the Marina was divided into a grid of approximately 40 cells, and the number of repairs per length of pipeline in each cell was counted. Each repair rate then was normalized with respect to a reference length of 300 m to provide a consistent basis for evaluation. Contours of equal repairs per 300 m of pipeline were drawn and superimposed on the street system and previous shorelines, as illustrated in Figure 2-17. The contours of pipeline repair rates are related closely to the 1857 shoreline, with virtually all pipeline damage falling within this boundary. Higher concentrations of pipeline repair fall within the area of hydraulic fill, with the heaviest repair concentration at the junction of the hydraulic fill, 1899 seawall embankment, and 1857 shoreline.

FIGURE 2-17. Contours of Pipeline Repairs per 300 m for MWSS in the Marina District

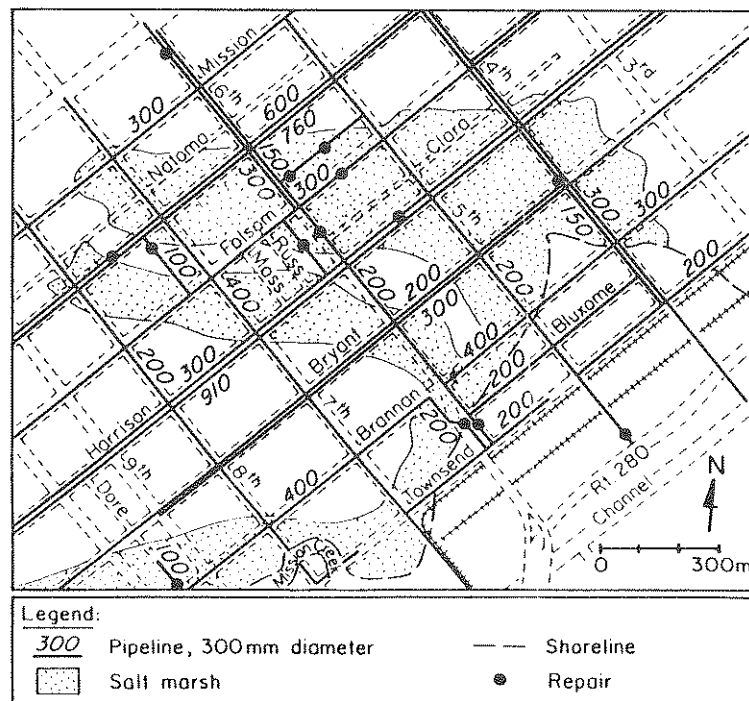
The highest concentration of pipeline repairs was in the area bounded by 8th, Mission, 5th, and Harrison Sts. As described in the preceding section, differential settlements and fractured pavements (indicating lateral movement) were observed throughout this area. Although the level of damage was much more severe in 1906, it is interesting to note that some of the pipeline damage in 1989 occurred in the same general area as in 1906. For example, Reynolds [1906], in

FIGURE 3-4. MWSS Pipeline Repairs in South of Market Area

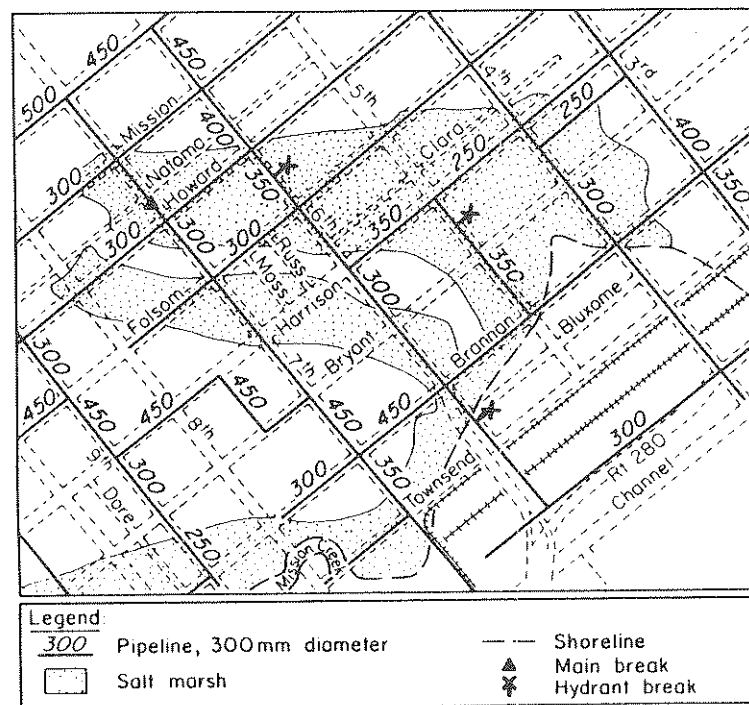
FIGURE 3-5. AWSS Pipeline and Hydrant Repairs in South of Market Area
