RECONNAISSANCE REPORT ON THE
NORTHERN IRAN EARTHQUAKE OF
JUNE 21, 1990

M. Mehrain

Technical Report NCEER-90-0017

October 4, 1990

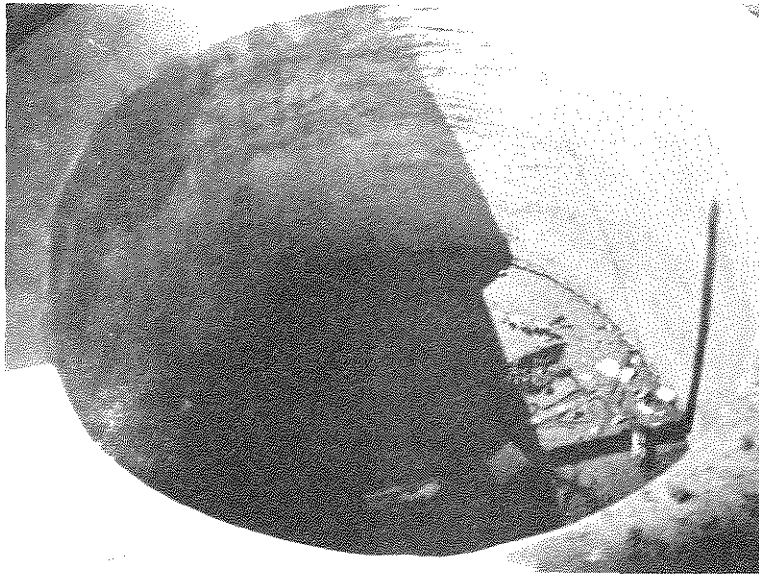
Figure 2-2 Sand filled water well caused by liquefaction

Liquefaction and resulting ground settlement were observed in several towns, most notably in Astaneh Ashrafieh, Loshan and Noosher. Many shallow water wells were filled with sand (Fig. 2-2) and several cases of sand boils were observed. Figs. 2-3 through 2-5 show structural damage due to large differential settlement which resulted from soil liquefaction.

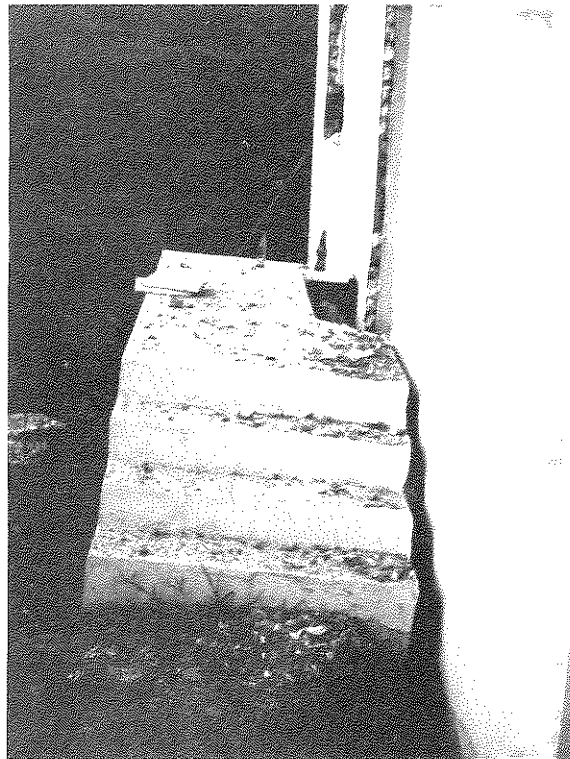
Figure 2-3 Liquefaction related settlement of the house relative to the stair

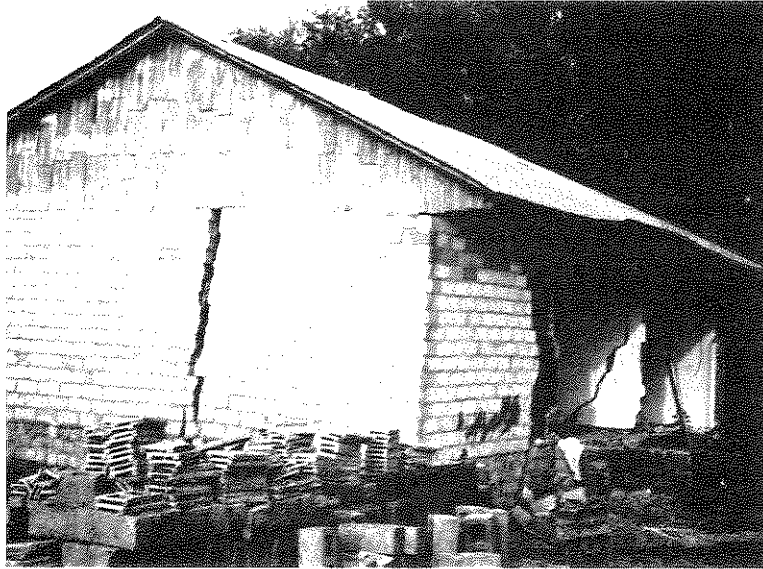
Figure 2-4 Wall crack caused by liquefaction settlement.

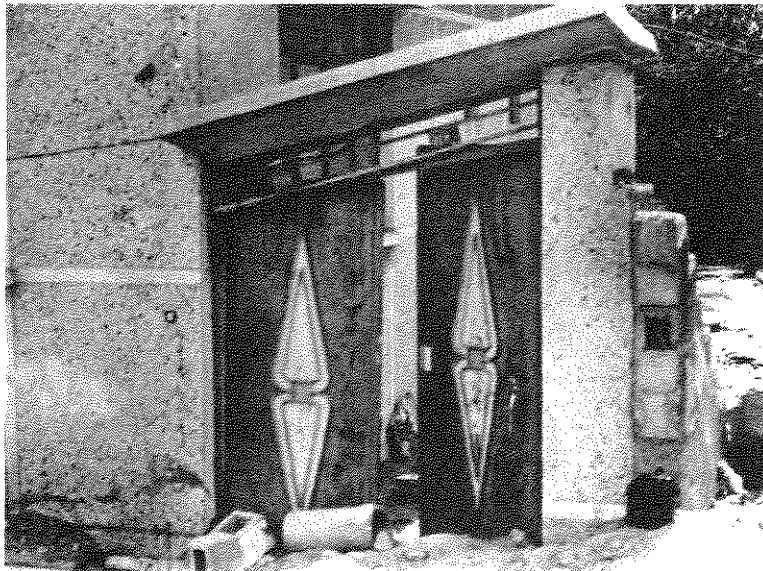
Figure 2-5 Large differential settlement due to liquefaction

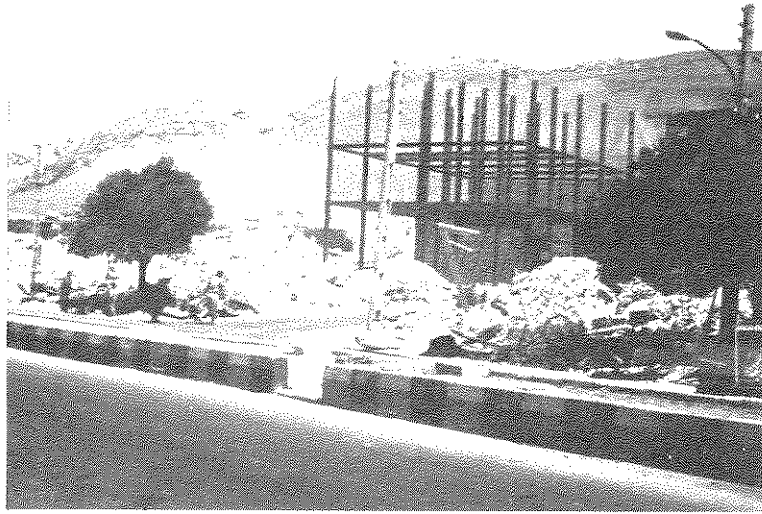
Figure 3-1 Destruction of buildings in the epicentral region

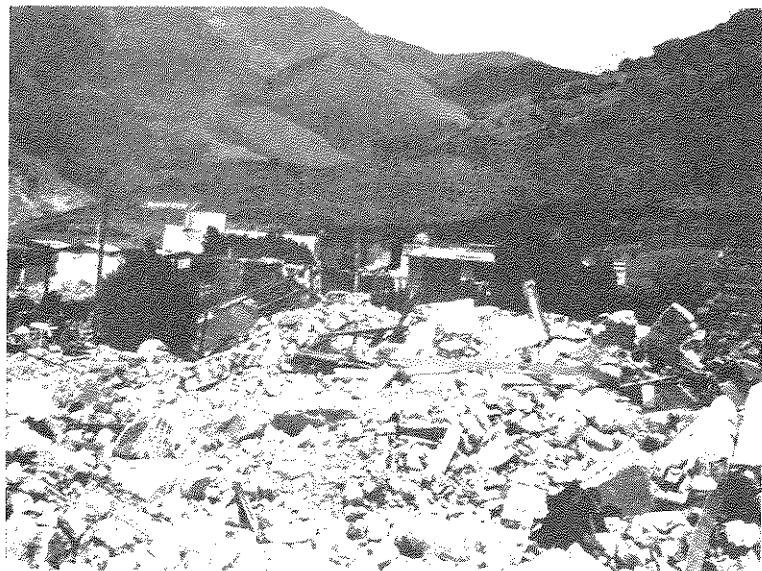
Figure 3-2 Widespread collapse of unreinforced masonry buildings.

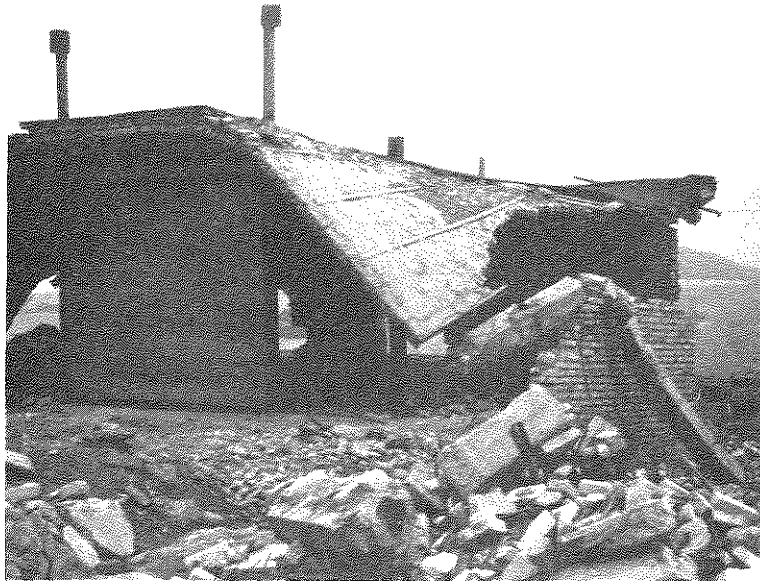
Figure 3-3 Roof collapse in an unreinforced masonry bearing wall structure. The roof is brick infilled steel beam (jack arch) system which is very common in Iran.

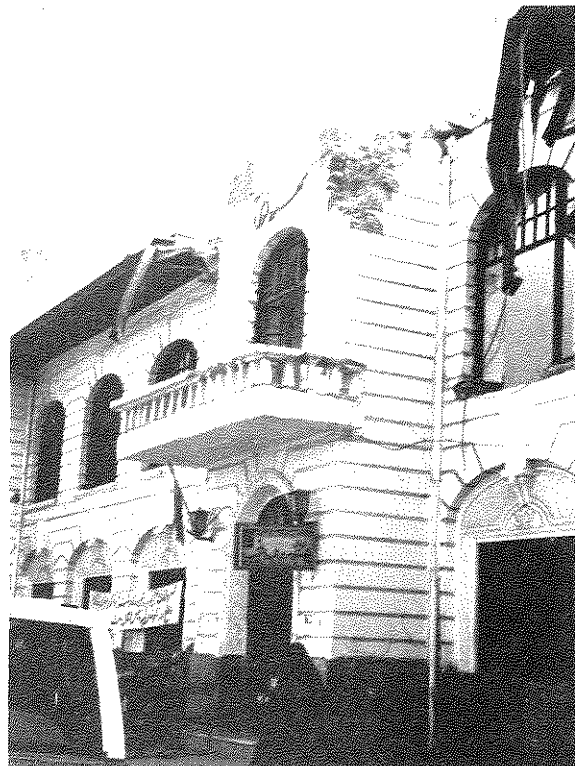
Figure 3-4 Parapet and partial roof collapse of Rasht City Hall.

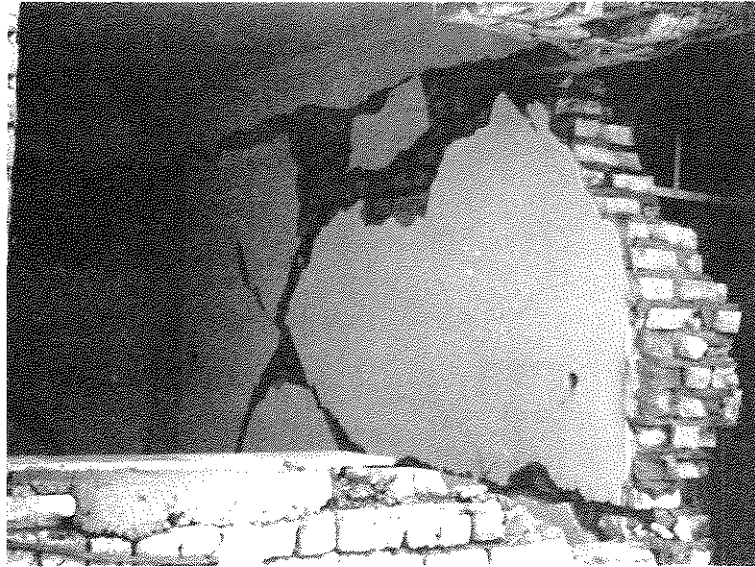
In Manjil and Rudbar, located near the epicenter, the degree of damage to unreinforced masonry buildings is such that only a few buildings remain standing. Most buildings that have not collapsed are beyond repair and require demolition. The damage generally appeared to be equally severe for brick or block walls supporting either lightweight roof systems, concrete slabs, or brick infilled steel (jack arch) roof systems. Fig. 3-1 through 3-3 show the degree of destruction in the Manjil area. Fig. 3-4 shows the collapse of the parapet and roof of the City Hall building in Rasht. Buildings with many unreinforced masonry walls acting as shear resisting elements were also damaged beyond repair (Fig. 3-5).

Figure 3-5 Major damage to buildings with extensive amount of unreinforced shear walls

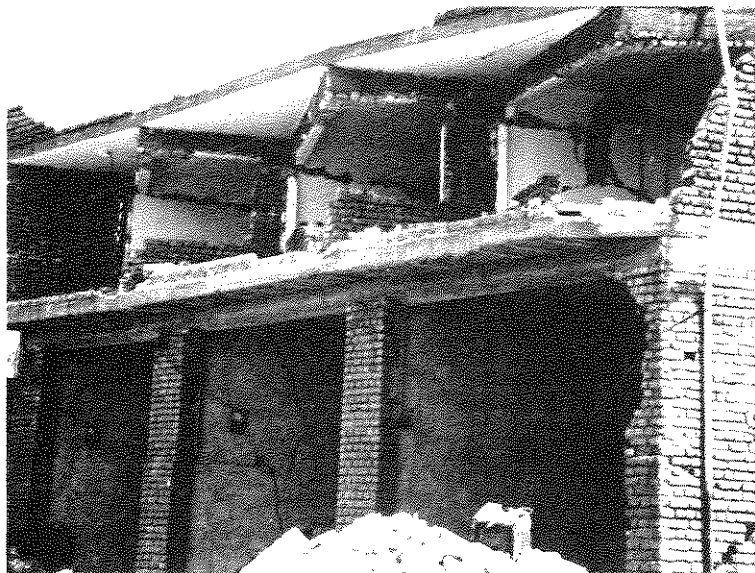
Many unreinforced masonry bearing wall structures used reinforced concrete bond beams (concrete beams poured on top of walls). Potential for total collapse of these buildings appears to have reduced (Fig. 3-6).

Figure 3-6 Building of Figure 3-5. Presence of reinforced concrete bond beam prevented roof collapse

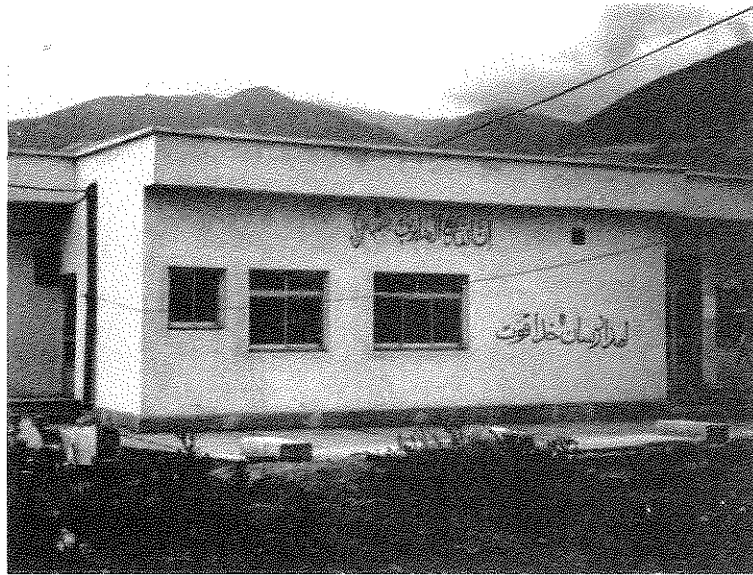
A exception to the damage pattern is the Rostamabad post office (Fig. 3-7) which appears to be unreinforced masonry, but remained undamaged. Further review of this building should reveal the reasons for its good performance.

Figure 3-7 Post office building in the area of high ground motion appears to be undamaged

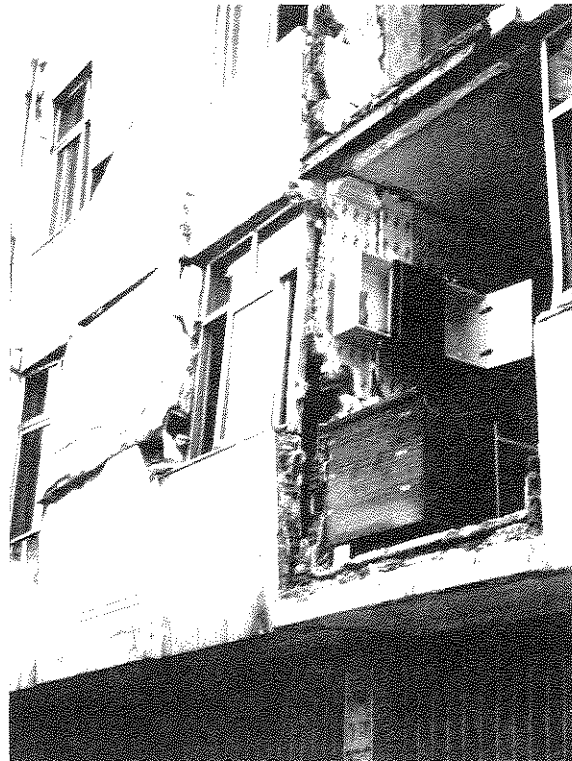
Thin unreinforced hollow or solid brick masonry infill is used almost exclusively in buildings in Iran. These thin walls have repeatedly proved to have poor performance in severe earthquakes. Their performance during this earthquake proved not to be an exception. Widespread damage to buildings with thin unreinforced masonry infill occurred in Rasht, located some 60 km from the epicenter. Numerous relatively modern buildings with expensive architectural finishes were evacuated by their residents due to extensive cracking or collapse of these "non-structural" elements (Fig. 3-8).

Figure 3-8 Typical damage to hollow clay unreinforced masonry infill walls

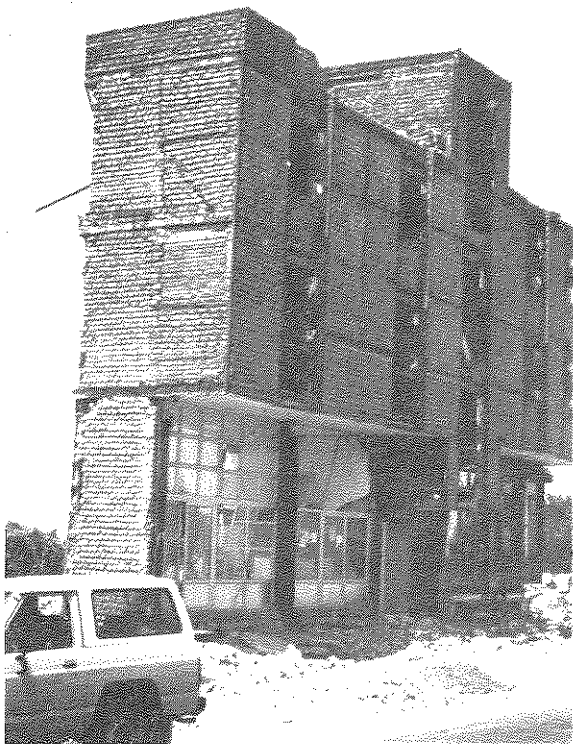
The thin unreinforced masonry infill in a three-story steel structure in Manjil (Fig. 3-9) appears to have performed better due to the presence of light steel sections which had been installed in plane of the wall. This resulted in reduction of wall span for out-of-plane bending.

Figure 3-9 Masonry infill constructed with light steel reinforcement

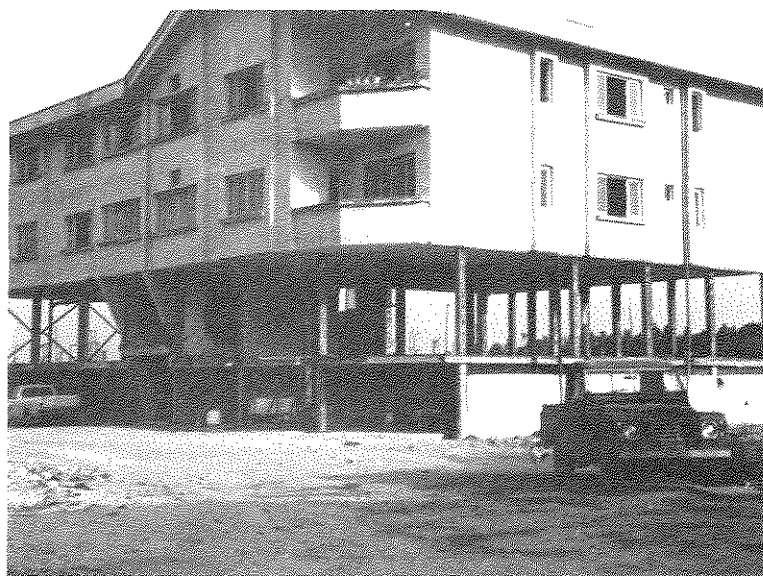
Extensive damage was experienced in many of these steel buildings which have 4 to 8 stories. Several cases of total collapse occurred in the City of Rasht, where a majority of these structures were constructed. The degree of damage to mid-rise steel buildings in Rasht could also be related to the hypothesized long period of the ground motion in this city. The damage to all steel structures surveyed by the author may be traced to major deficiencies in the design and construction of the structures. Fig. 3-10 shows a 4-story damaged steel structure which lacks bracing on one side. The bracing, where provided, is shown in Fig. 3-11. These braces failed at the connections and, according to the building technician, have been repaired to their original configuration. This points to very poor design of brace as well as welding at connections. Poor welding was also observed in the gravity load system of this building.

Figure 3-10 Damaged steel structure with inadequate bracing

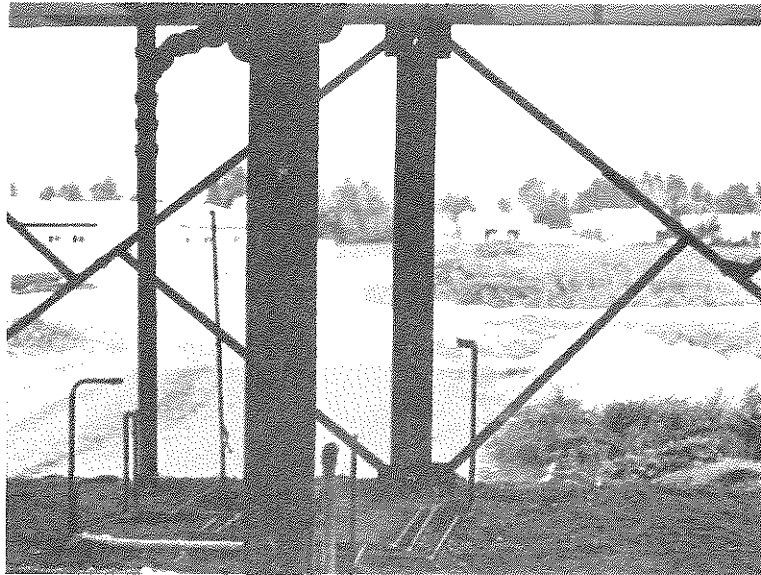
Figure 3-11 Steel bracing of building in figure 3-10.

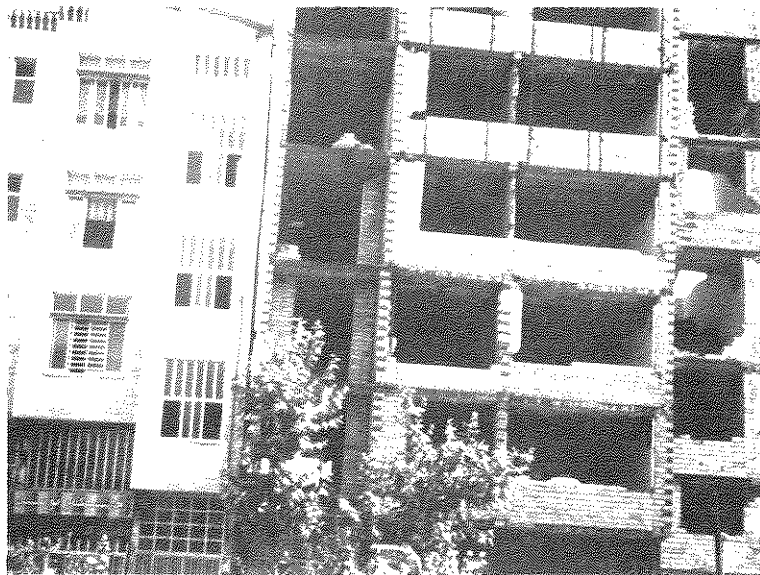
Fig. 3-12 shows permanent sway of an 8-story steel structure which was under construction at the time of earthquake. Fig. 3-13 shows the second floor framing of the same building, indicating a lack of moment frames in the direction in which permanent sway occurred.

Figure 3-12 Permanent sway of an 8-story steel structure under construction

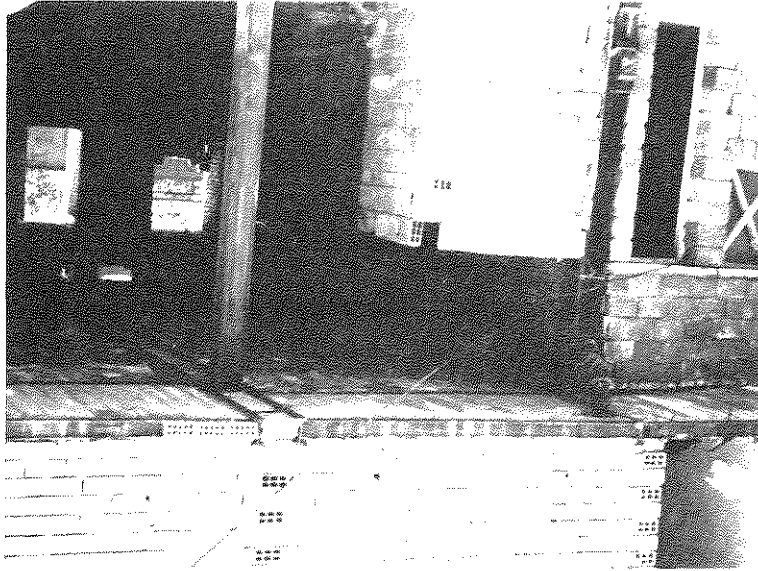
Figure 3-13 Structural steel framing in building of Figure 3-12

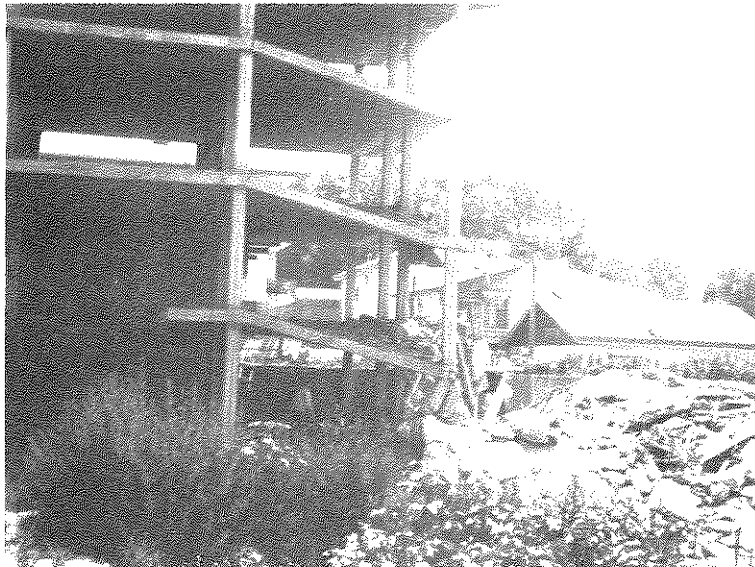
Fig. 3-15 shows two adjacent 5-story concrete frame buildings that were under construction at the time of the earthquake. The structure on the right collapsed completely, impacting and buckling the corner column of the structure to the left.

Note that both collapsed buildings are in the City of Rasht, some 60 km from the epicenter. Although ground motion records are not yet reported for this City, accelerations on the order of 20 percent gravity is estimated. It should also be noted that both buildings were under construction, and did not yet carry the total gravity load to which they were designed.

Figure 3-15 Collapse of a mid-rise concrete building and damage to the adjacent building.

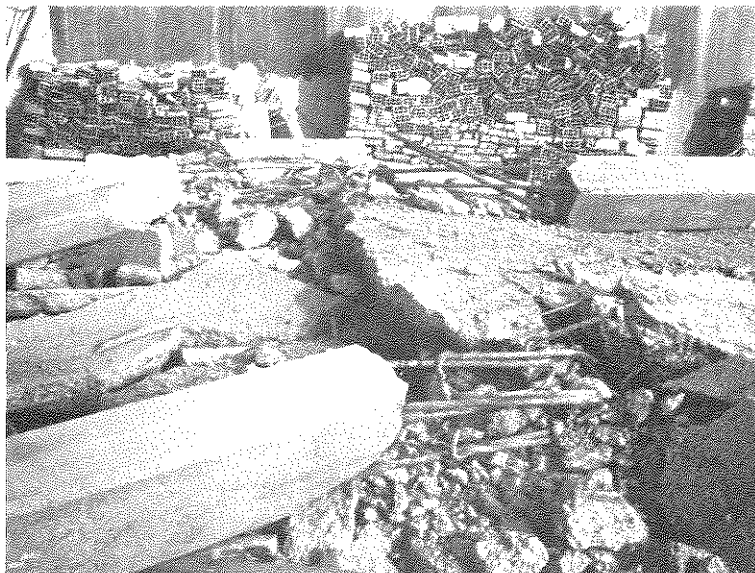
Fig. 3-16 shows another mid-rise concrete building totally collapsed. The reinforcement of this building, as shown in the picture, is plain (undeformed) bars.

Figure 3-16 Collapsed concrete building in Rasht.

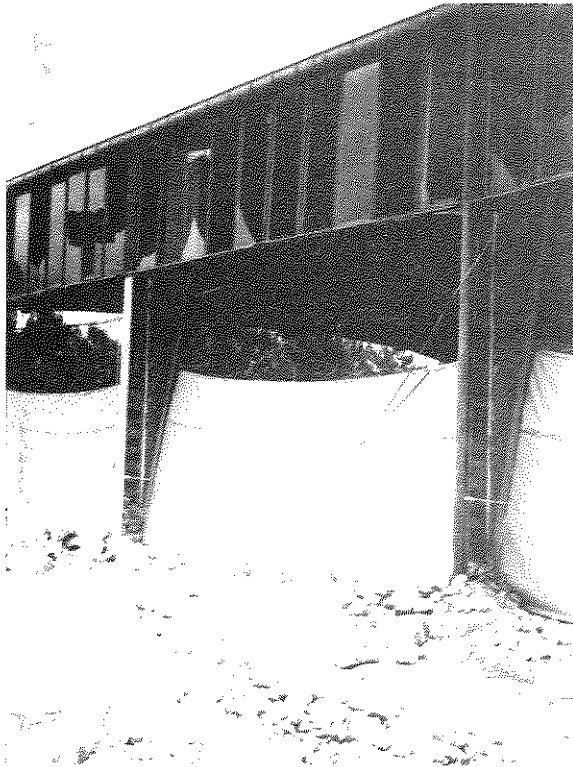
A great majority of industrial buildings in the earthquake stricken area are of light steel construction (Soule or Butler type). Although extensive damage and collapse of infill was experienced, the structure itself performed well. Even when the steel rod-bracing was ruptured, the structure often remained undamaged. Fig. 3-17 shows such a structure in Ganjeh, some 30 km from the epicenter.

Figure 3-17 Light steel industrial building without structural damage after rupture of rod bracing.

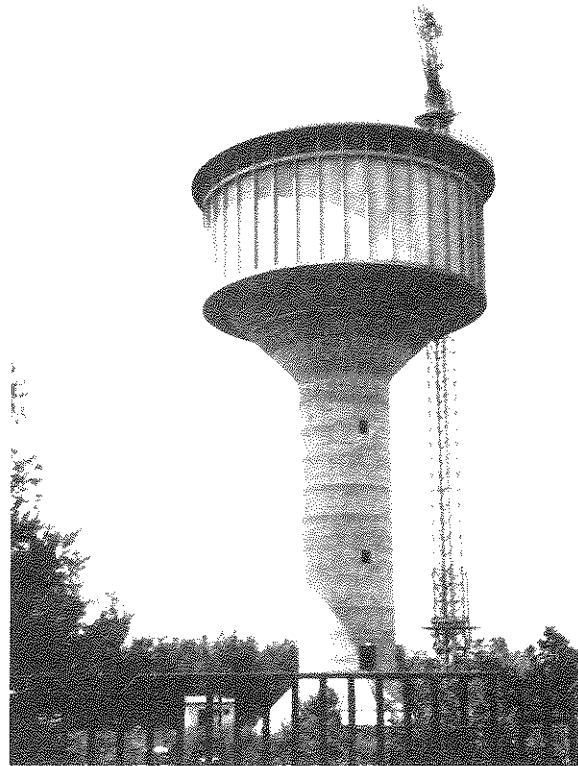
Two similar elevated tanks (Fig. 3-18) in the same area, which were under construction and were thus empty, experienced horizontal cracks at the shaft near the base.

Figure 3-18 Concrete elevated water tank without water exhibited tension cracks at the base of its shaft.

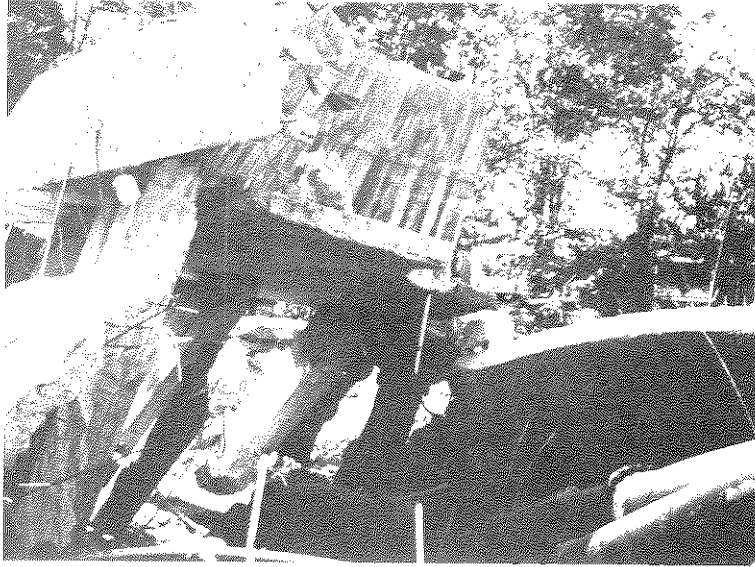
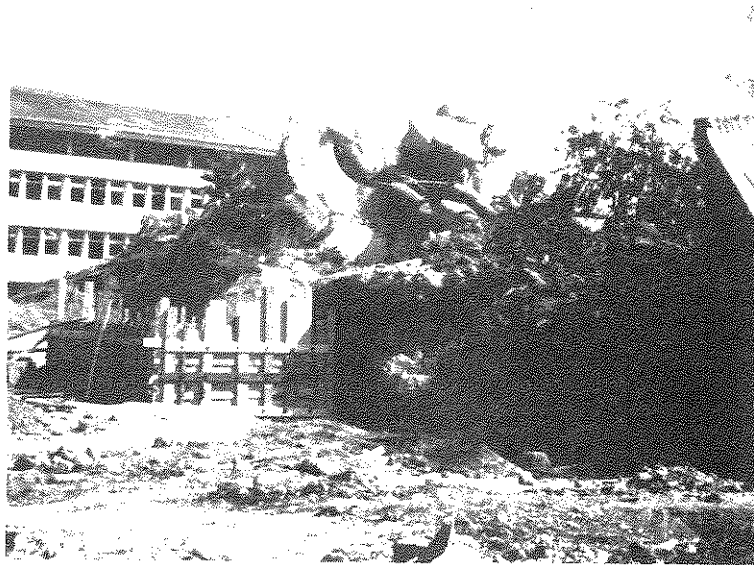
Elevated Tanks: A 1500 m³, 46 meter high water tank, constructed 20 years ago and serving the City of Rasht, completely collapsed. This structure was reported to be about two-thirds full of water. The structure had a reinforced concrete shaft and a prestressed concrete tank. Fortunately, the structure collapsed away from the adjacent structure (Fig. 3-19 and 3-20).

Figure 3-19 Concrete elevated water tank, 2/3 full, collapsed

Figure 3-20 Elevated water tank of Figure 3-19 collapsed away from the adjacent building

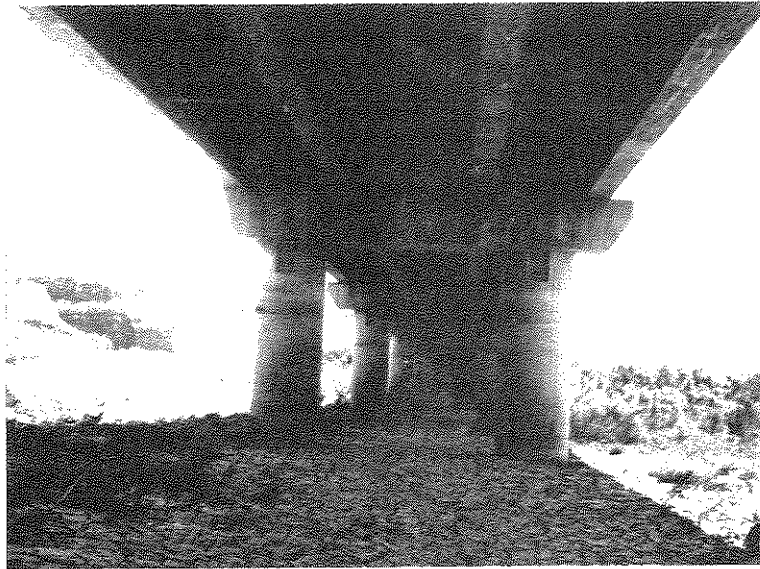
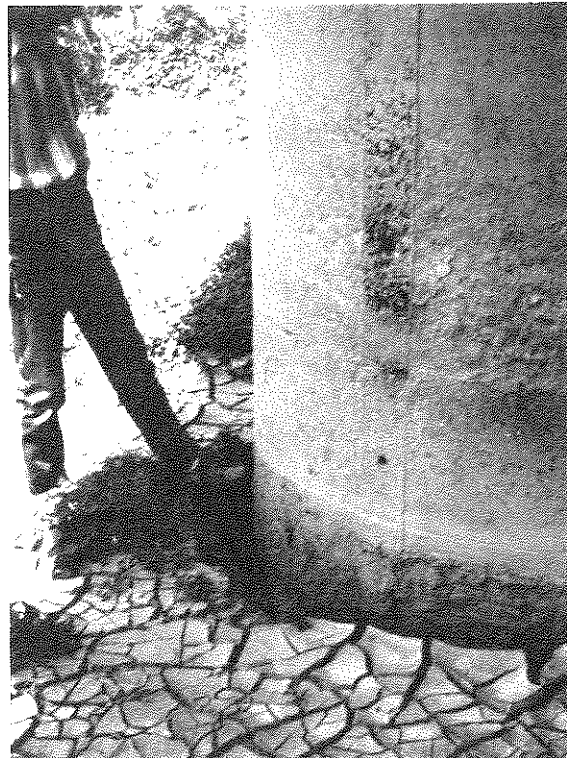
Bridges: There are many steel and concrete bridges in the area. No major damage to bridges was reported. One major bridge (Fig. 3-21) within 20 km of the epicenter showed lateral displacement at the ground level of approximately 10 inches (Fig. 3-22). There was no readily observable damage to the columns or girders of this bridge.

Figure 3-21 Concrete bridge with large lateral pier displacement appears to be undamaged

Figure 3-22 Pier displacement of bridge shown in Figure 3-21.

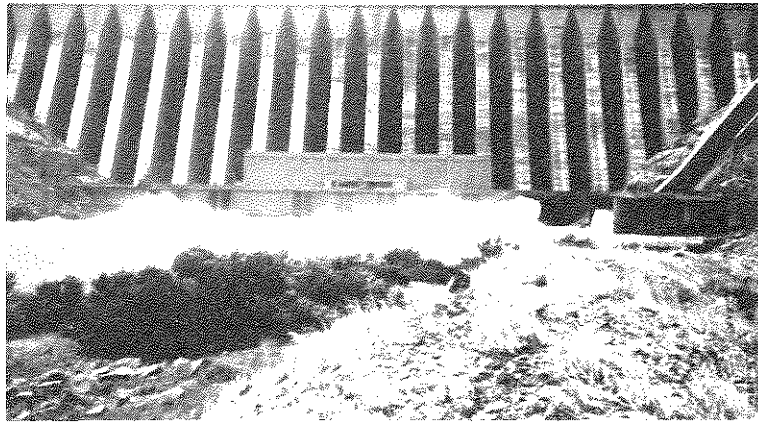
Dams: Sefidrud Dam is probably the most important structure in the epicentral region. It is located less than one km from the fault. The dam is of the buttress type (Fig. 3-23), with a height of 106 meters and length of 425 meters. The upstream and downstream slope is 0.4 and 0.6, respectively, resulting in a base width of 100 meters. It has been reported that the dam was designed for a static lateral force coefficient of 0.25. The reservoir was almost full at the time of earthquake. This dam experienced horizontal and diagonal cracks at the top of some buttresses, but remained stable.

Figure 3-23 Sefidrud dam within 1 km of the fault.
