Observations on Water System and
Pipeline Performance in the Limon Area of Costa Rica
Due to the April 22, 1991 Earthquake

M. J. O'Rourke

Technical Report NCEER-92-0017

June 30, 1992

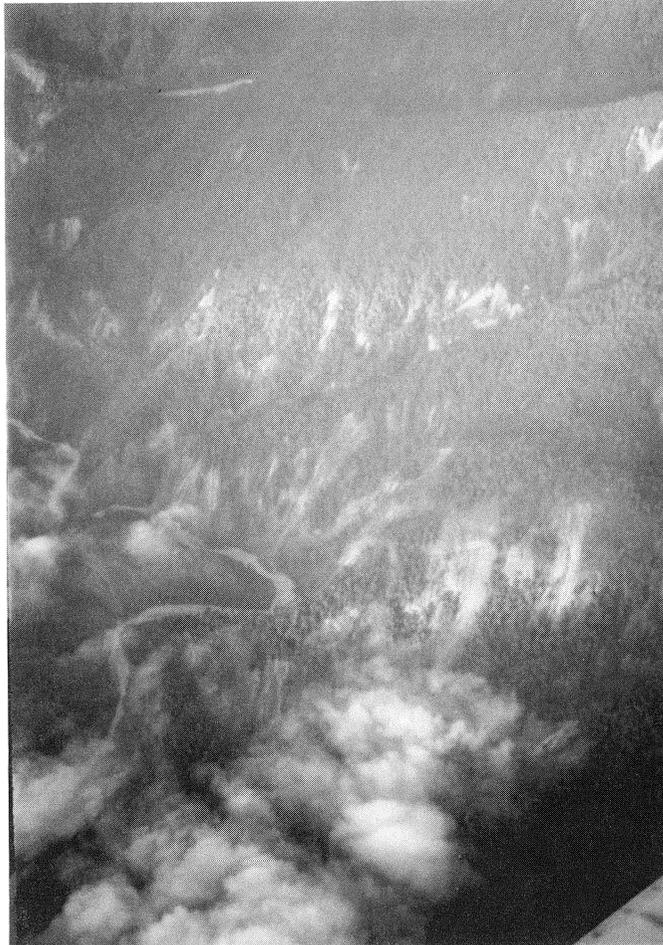
FIGURE 2-3 Air Photo Showing Landslides in Banano River Water Shed

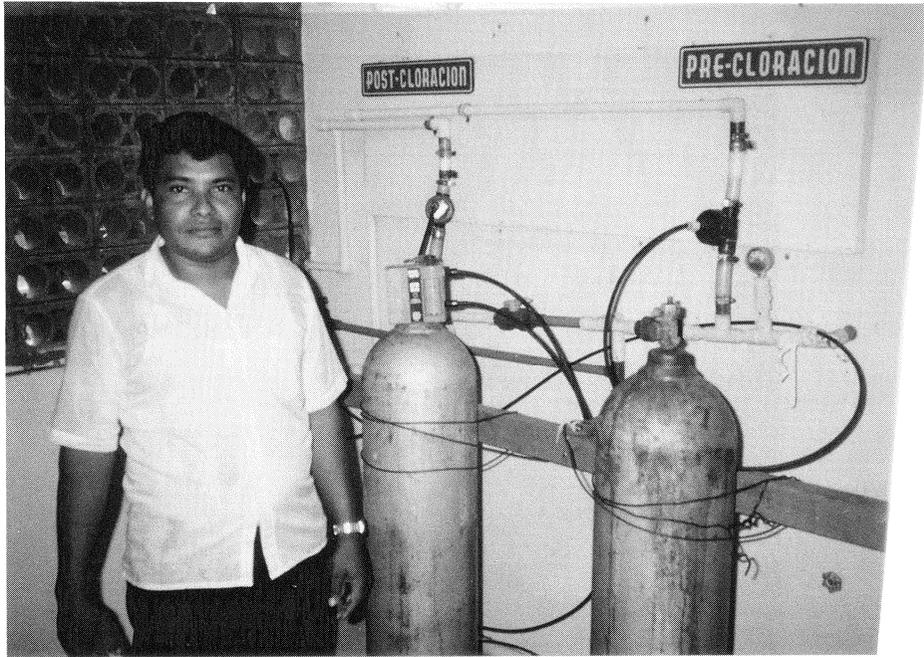
This is the third significant earthquake in the past years where chlorine leaks have resulted from earthquake damage [9, 10]. In both the 1989 Loma Prieta earthquake and the 1990 Philippine earthquake, vertical chlorine cylinders without lateral restraint also toppled, breaking connecting piping.

FIGURE 2-4 Chlorine Cylinder which Topped Breaking Connection Pipe and Releasing Chlorine

The Uniform Building Code [11] now requires that structures housing gaseous chlorine systems be designed to automatically contain and neutralize any chlorine leak. These systems require air scrubbers with emergency generators so they are operable when power supply is lost. As a result of the cost for these facilities, many small chlorination systems are being designed using sodium hypochlorite, chlorine bleach. Although the chemical cost is approximately twice that of gaseous chlorine, the capital cost of the system including life safety components, is much less.

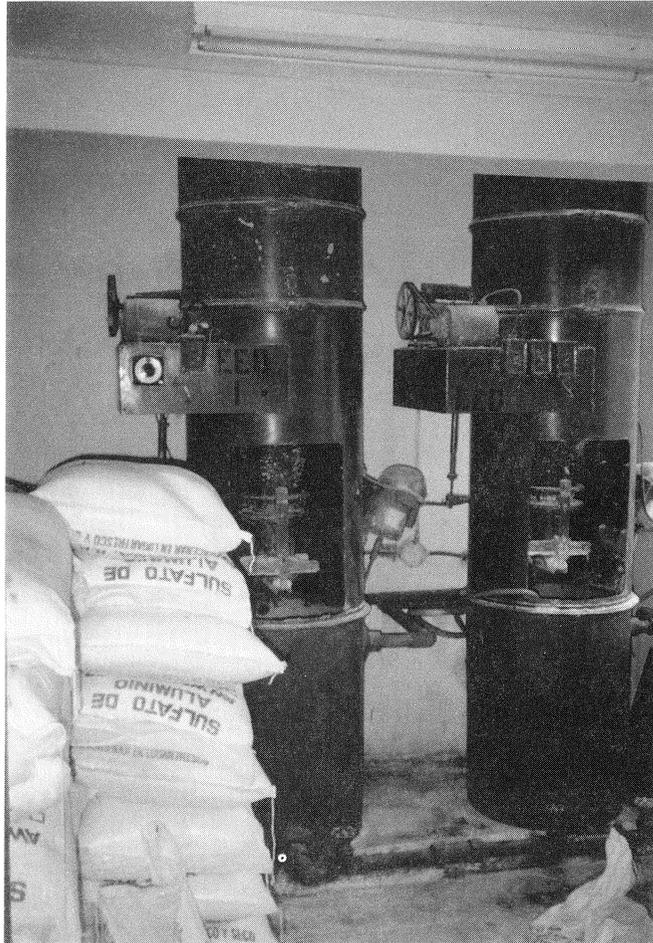
FIGURE 2-5 One of the Two Unanchored Dry Chemical Feeders Fell over and was Reinstalled after Repairs

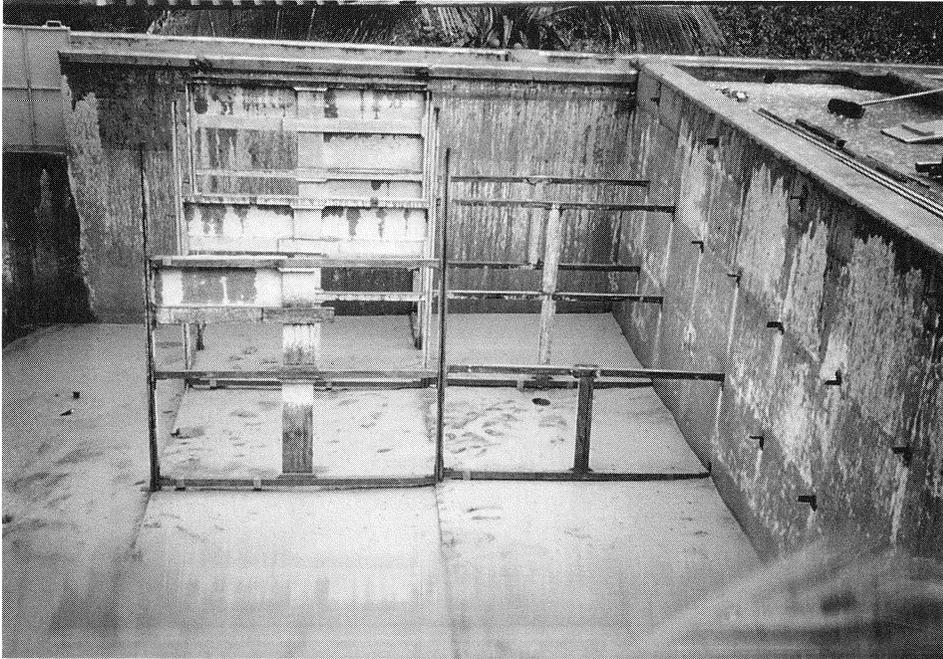
These extreme loads shattered the non-ductile asbestos cement baffles in the flocculators at the water treatment plant in Bomba. Extensive baffle damage occurred in the Loma Prieta earthquake at water and wastewater treatment plants. Examples include racking of the reactor clarifiers at the Rinconada Water Treatment Plant, breaking up of the wooden baffles in the flocculator at the Montevina Water Treatment Plant, and bending of the baffles structural supports in the chlorine contact tank at the San Mateo Wastewater Treatment Plant [12].

FIGURE 2-7 Flocculator Baffles Being Replaced after Earthquake Induced Hydraulic Load Damage

To minimize earthquake damage, baffles must be designed to either resist these significant hydraulic loads, or to break away with a design for easy repair. Design to resist loads, depending on the configuration, become cumbersome. Break away designs are encouraged. Break away designs should provide a restraint to keep the baffle from falling to the tank bottom.

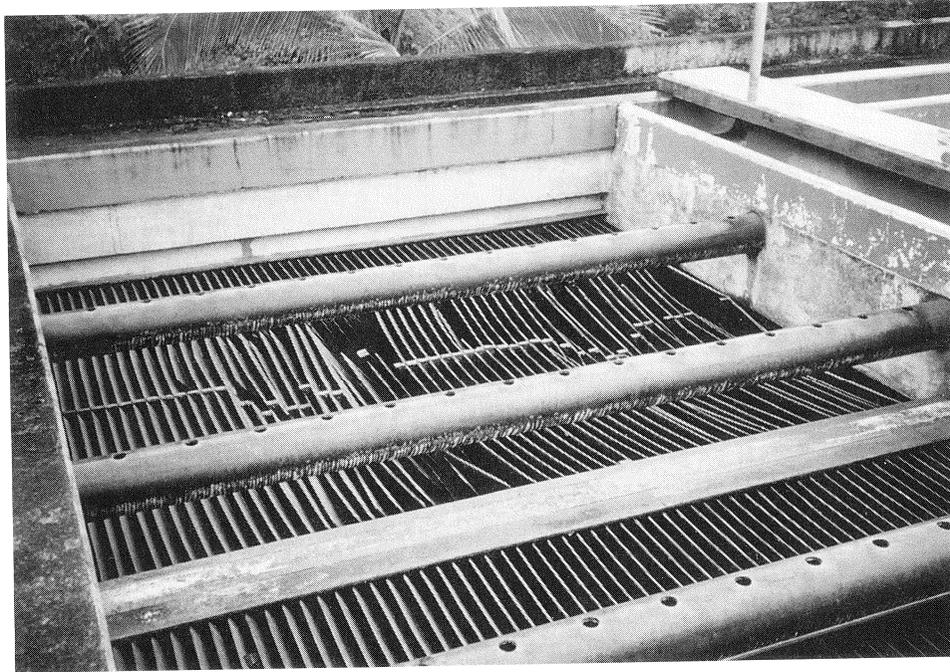
Asbestos cement baffles in the flocculators and asbestos cement clarifier plates were broken as shown in Figure 2-6 through 2-9. One concrete channel cracked. Glassware in the lab and the portable radio, sitting on the shelf, were undamaged. There was no reported damage to the filters.

FIGURE 2-8 Broken Asbestos Cement Clarifier Plates, Similar Plates at Siquerres Water Treatment Plant (~ 190 gal) Were Undamaged

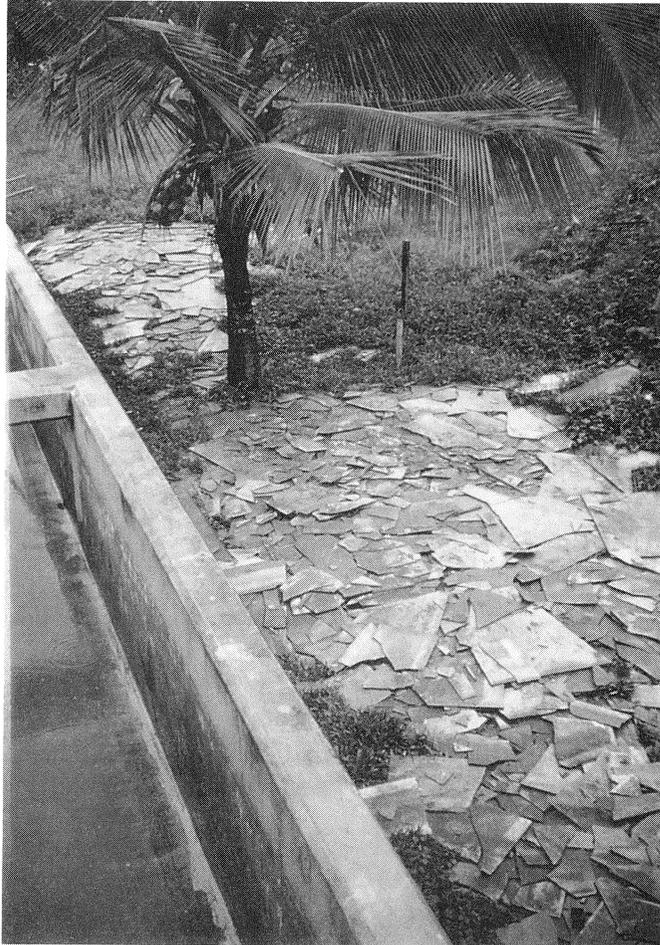
FIGURE 2-9 Piles of Broken and Removed Asbestos Cement Flocculator and Clarifier Plates

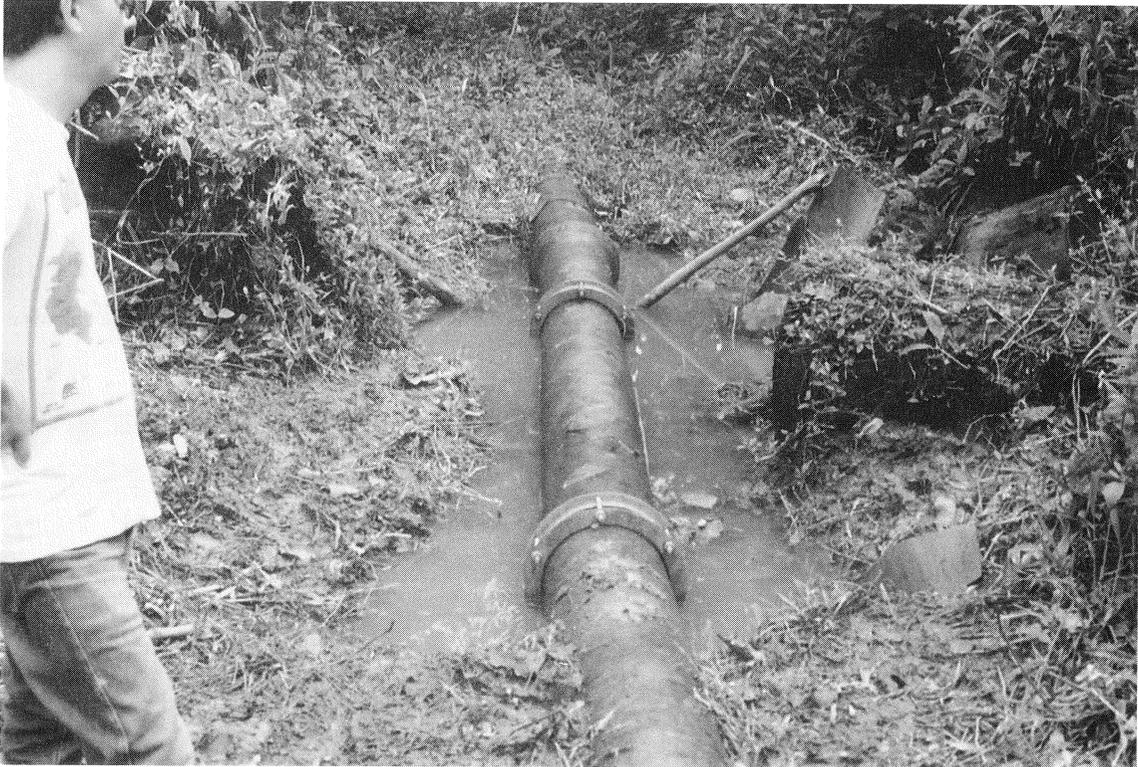
FIGURE 3-4 Repair of Pipe Segment Break (see Figure 3-3a) in 300 mm (12 in) CI Transmission Line from Banano River. AyA Engineer, José Arguedas, on the Left

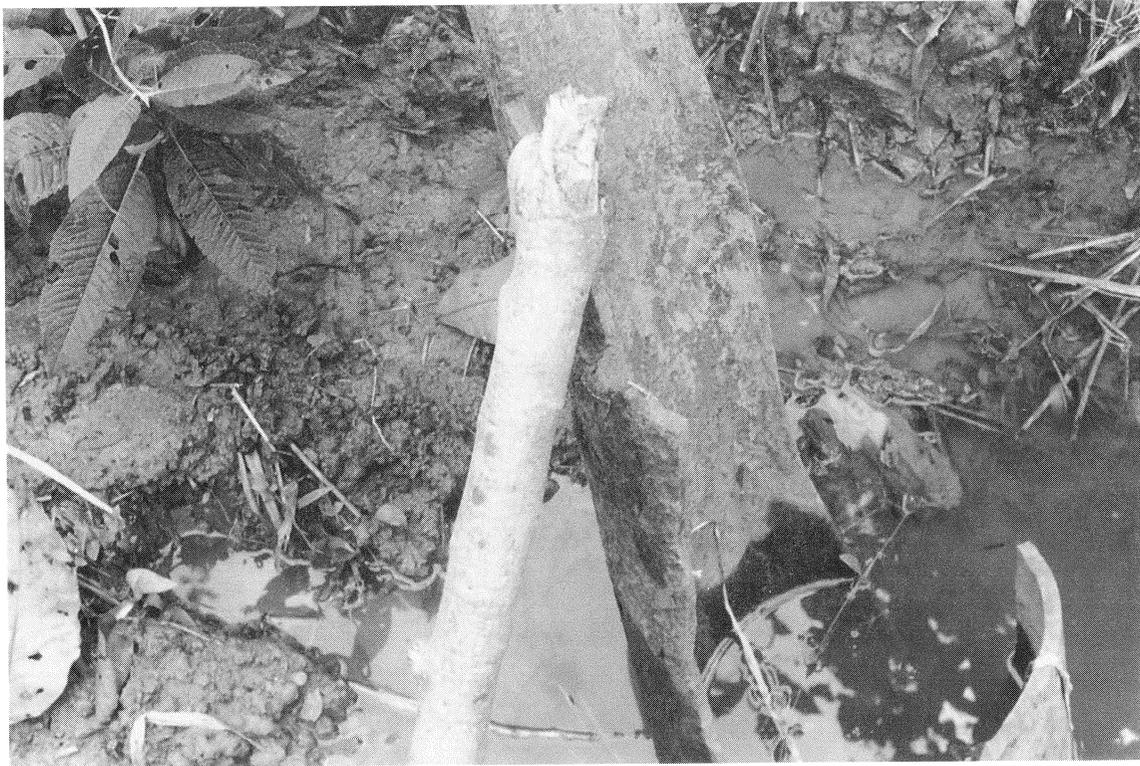
FIGURE 3-5 Close-up of Damaged 300 mm (12 inch) CI Transmission Line Shown in Figure 3-4. Note Apparent Corrosion Pin Hole to Right of Tree Limb.

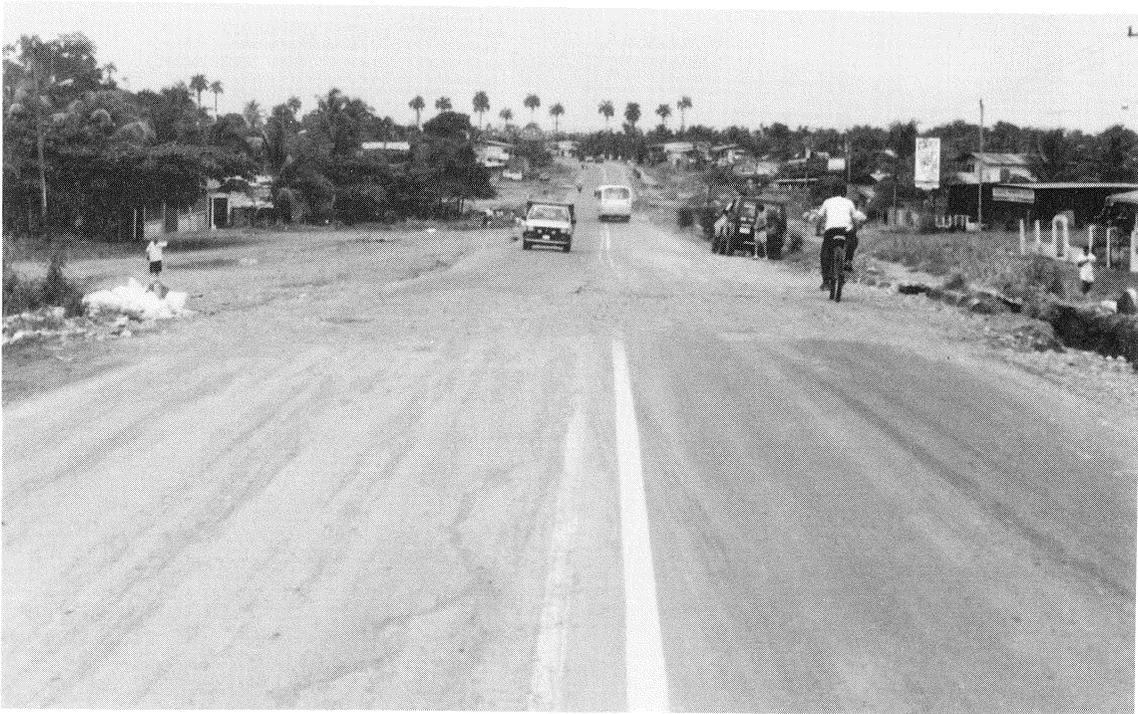
FIGURE 3-6 View Looking East Showing 13 m (42 feet) of Road Damage near Railroad Underpass. RCCP Transmission Line to Right.

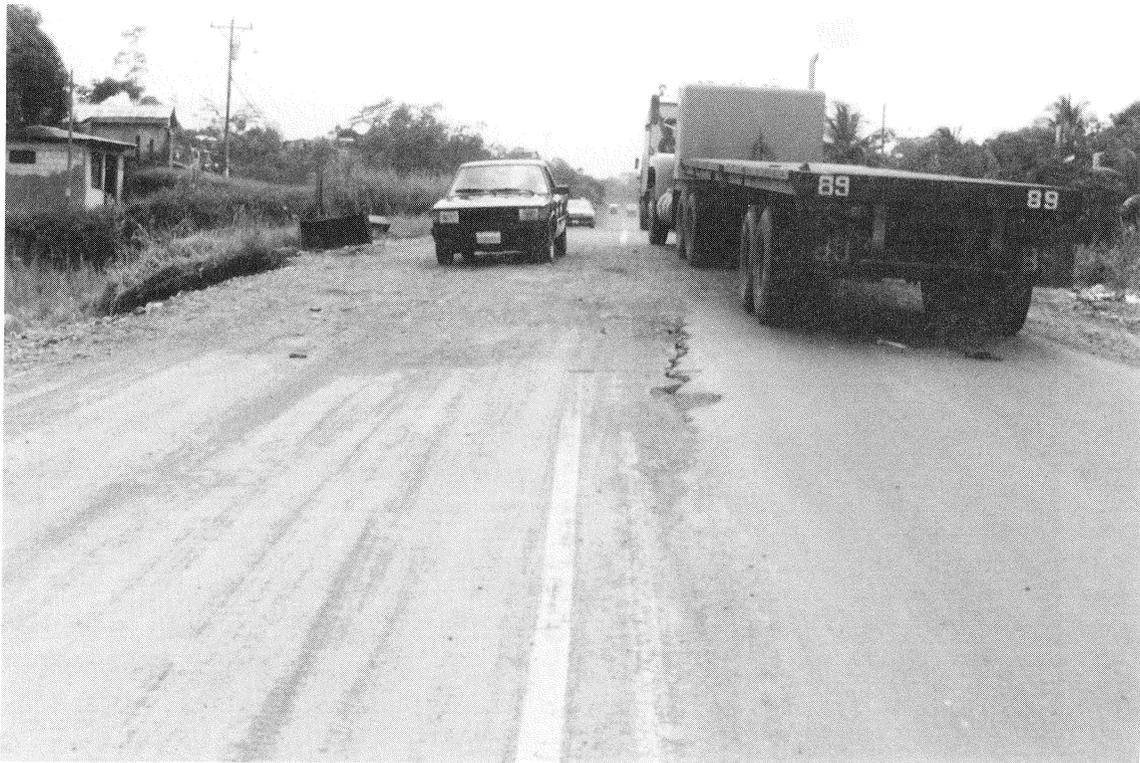
FIGURE 3-7 View Looking West towards Railroad Underpass Showing 40 cm (16 inch) Lateral Offset of Road Centerlines. Cab of Flatbed Truck #89 over Railroad, Width of Road Stripping is 10 cm (4 inch).

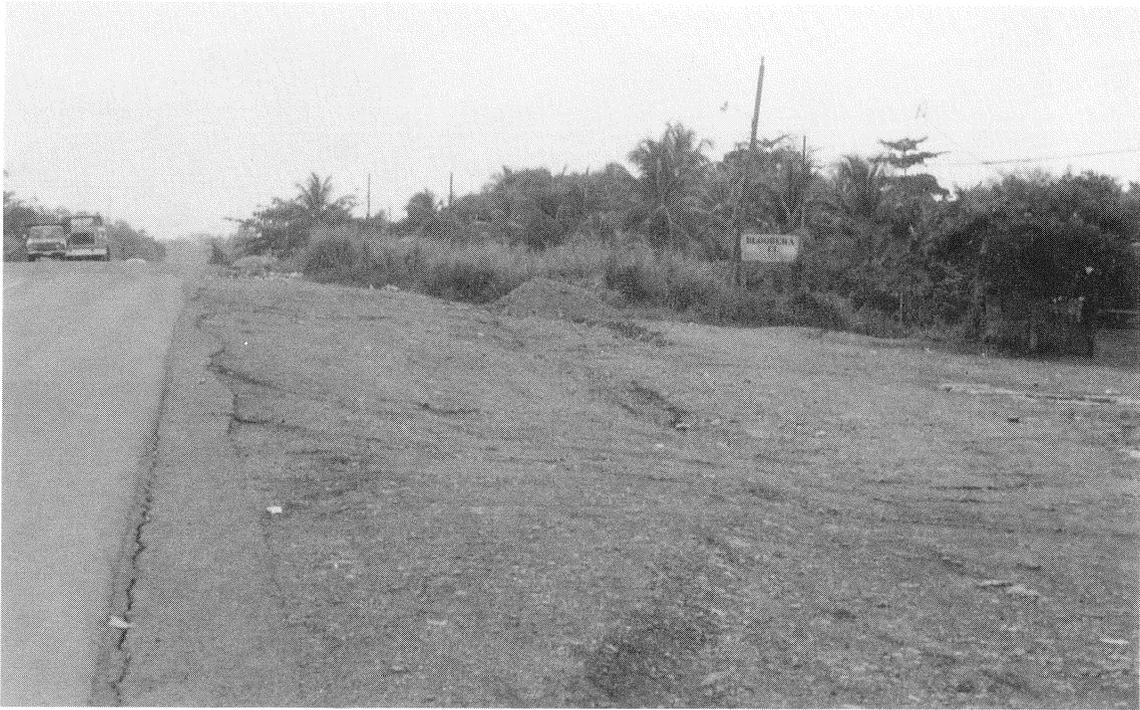
FIGURE 3-8 View Looking West towards Railroad Underpass Showing Garbens at Center, in Front of Dirt Pile

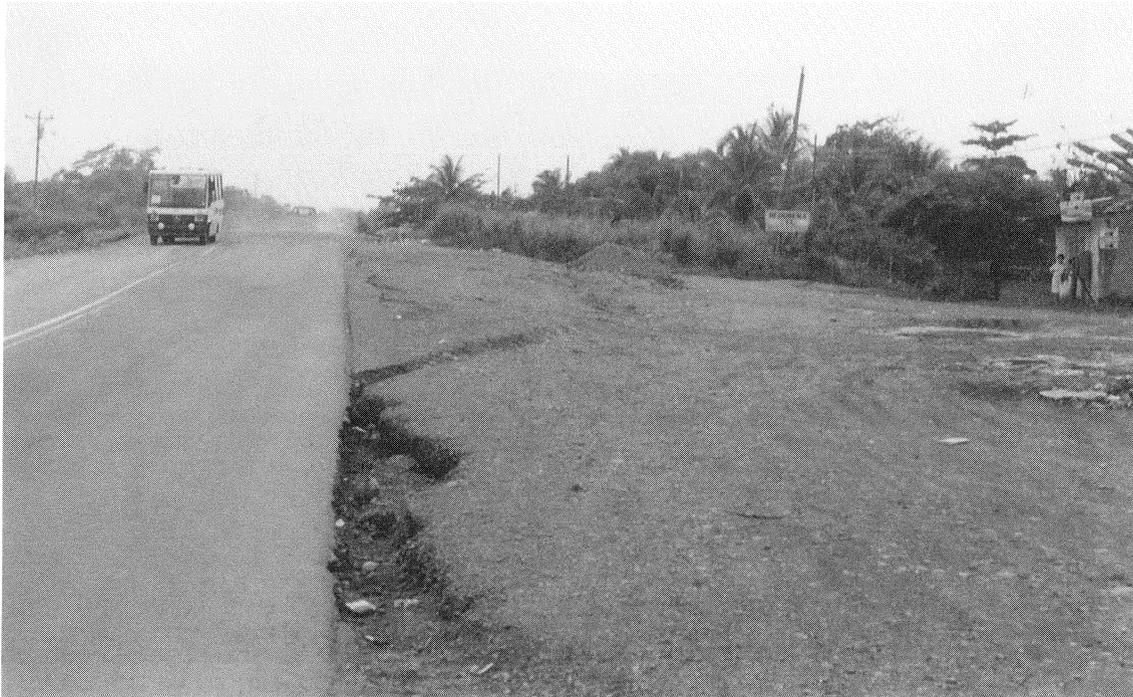
FIGURE 3-9 View Looking West towards Railroads Underpass Showing 15 to 30 cm (6 to 12 inch) Wide Ground Cracks at North Side of Road.

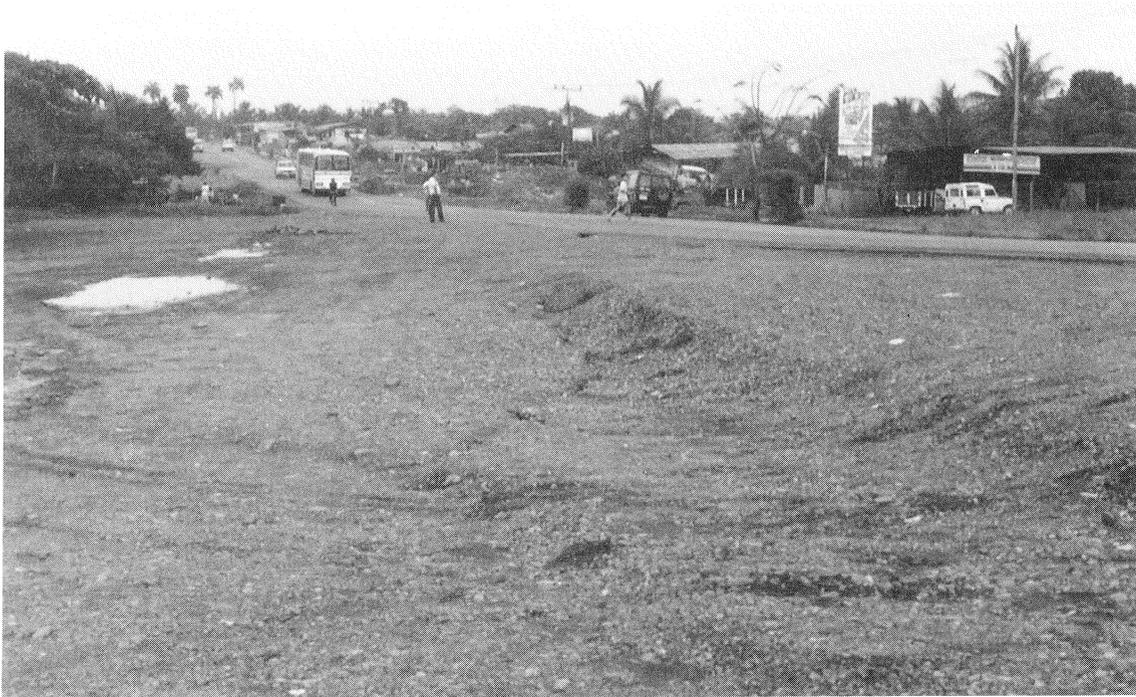
FIGURE 3-10 View Looking East from Railroad Underpass Showing Scarp at Side of Garbens.

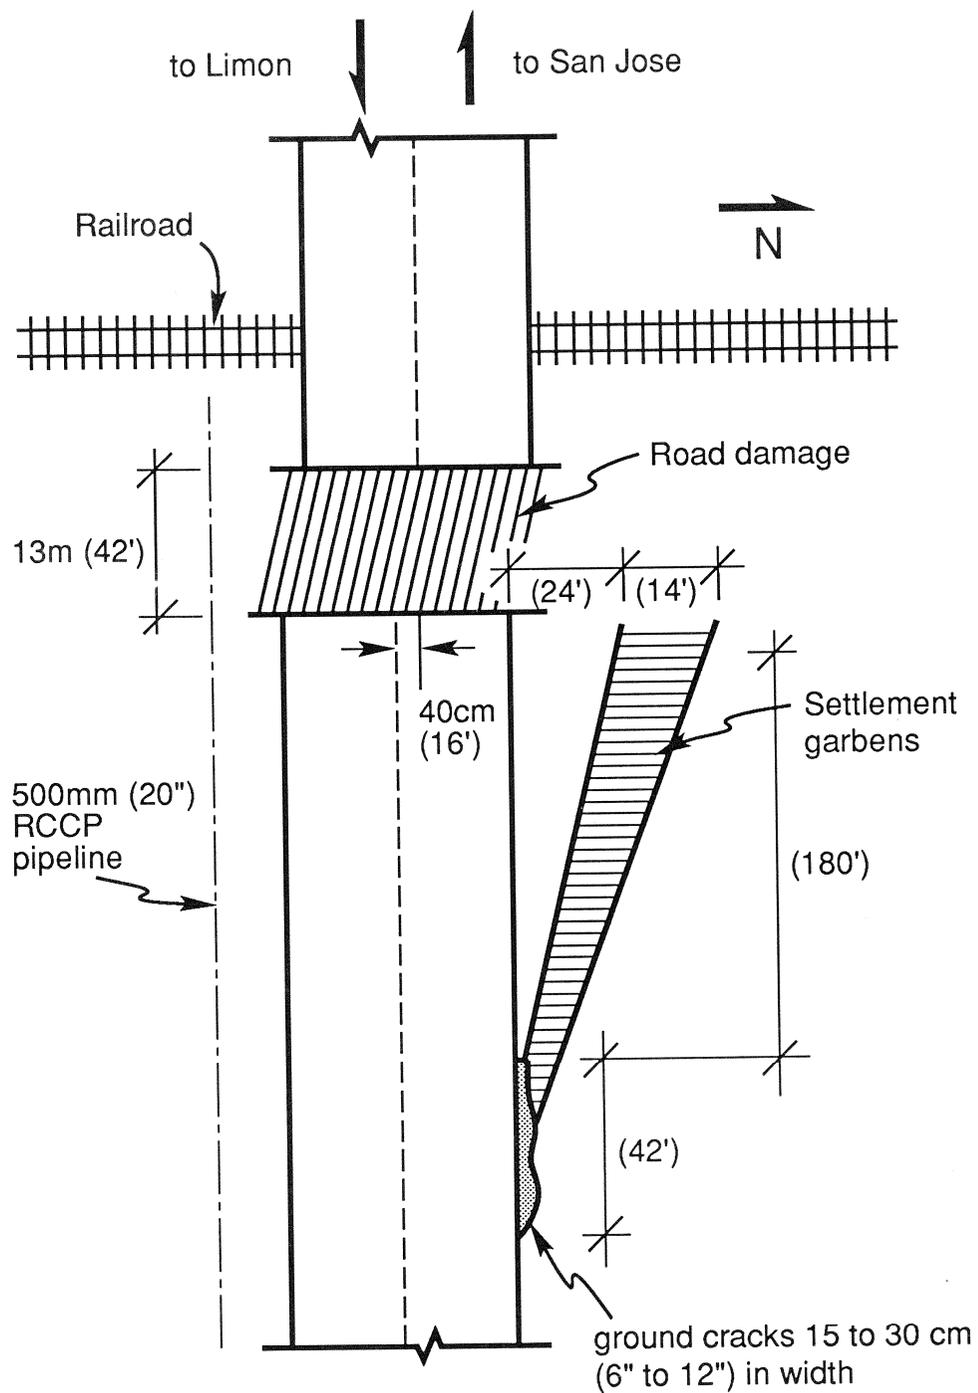
FIGURE 3-11 Plan View of Road Damage, Ground Cracks, Garbens and 500 mm (20 inch) RCCP Transmission Pipe Damage Immediately East of Railroad Underpass.

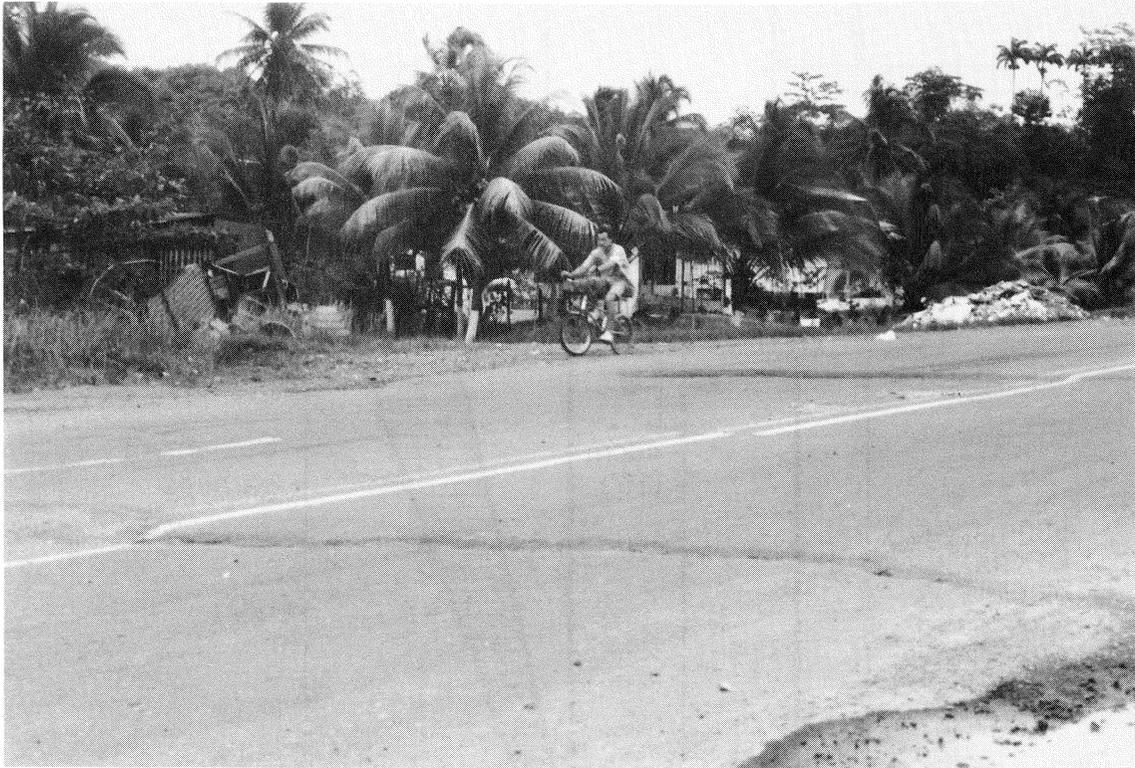
FIGURE 3-12 Vertical Settlement in Road near Pueblo Nuevo Entrance, about 500 m East of Railroad Underpass.

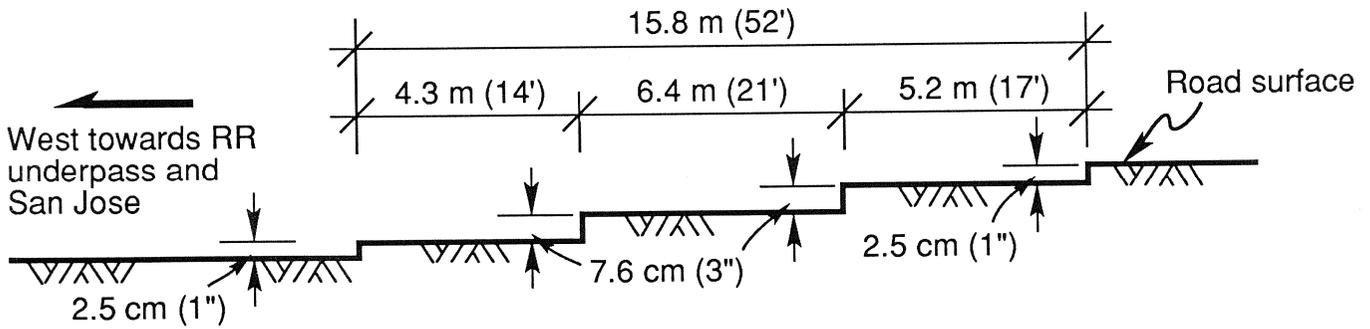
FIGURE 3-13 Elevation View of 20 cm (8 inch) Vertical Settlement over 16 m (52 feet) of Road Surface near Pueblo Nuevo Entrance.

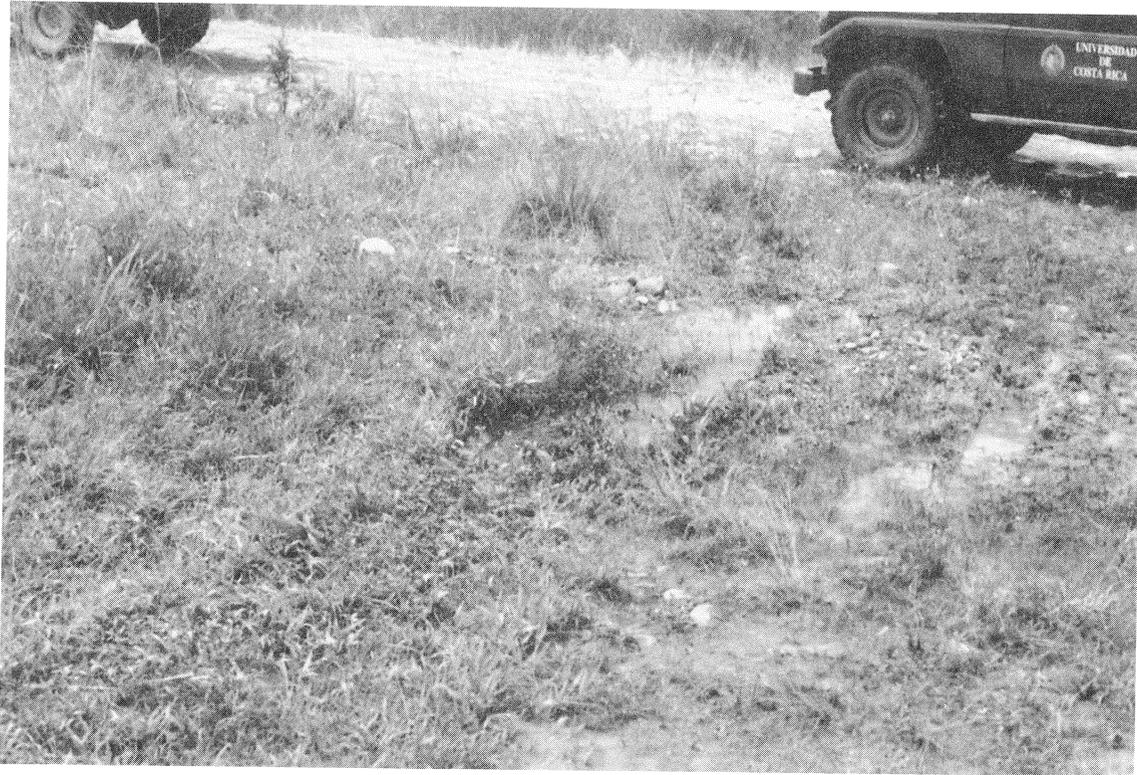
FIGURE 3-14 Water on Ground Surface above Unrepaired Transmission Pipe Leak.

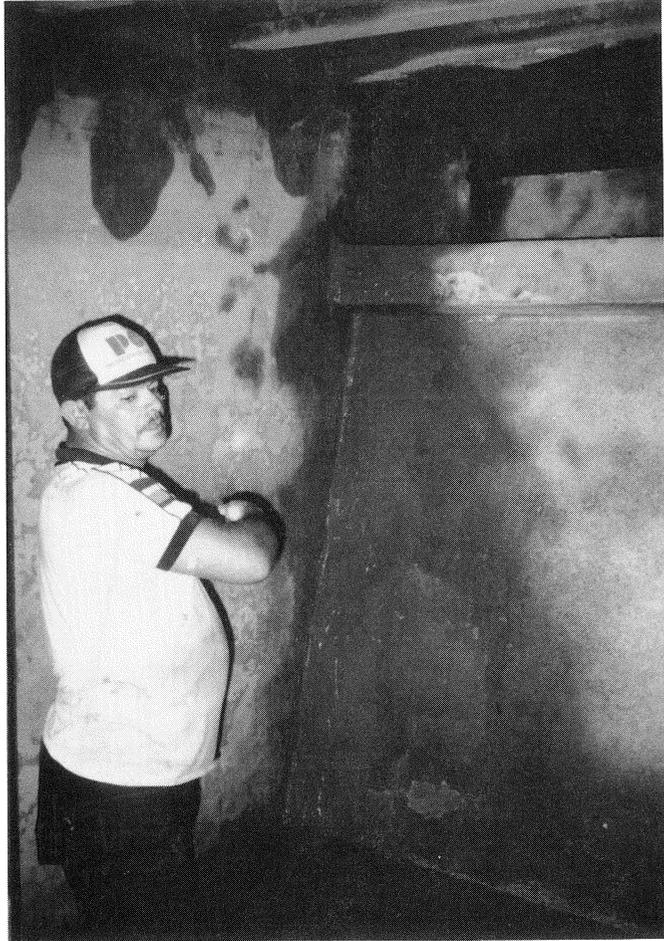
FIGURE 3—17 Repaired Cracking at Top and Corner of the 4 Million Liter Concrete Reservoir in Limón

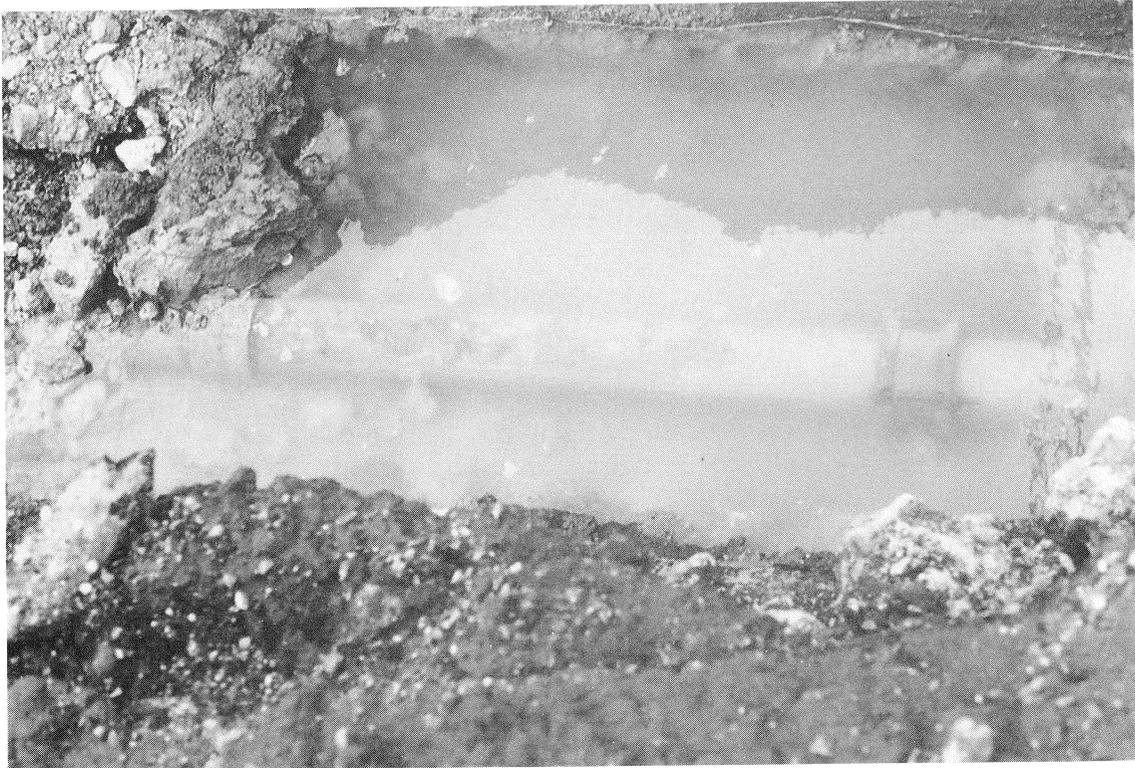
FIGURE 3-19 Repaired Leak in Small Diameter AC Distribution Pipe in Limón, Repair Coupling at Right and Original AC Joint at Left.

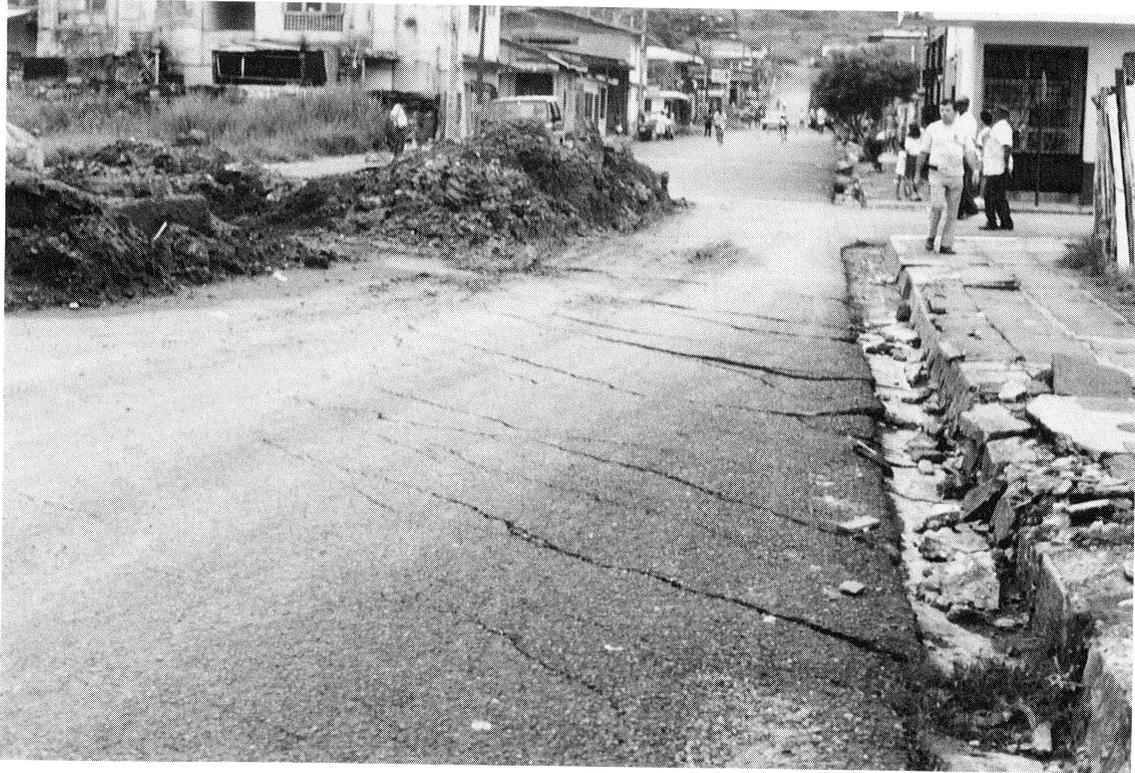
FIGURE 3-20 Road Surface Damage Adjacent to Distribution Pipe Break Shown in Figure 3-19

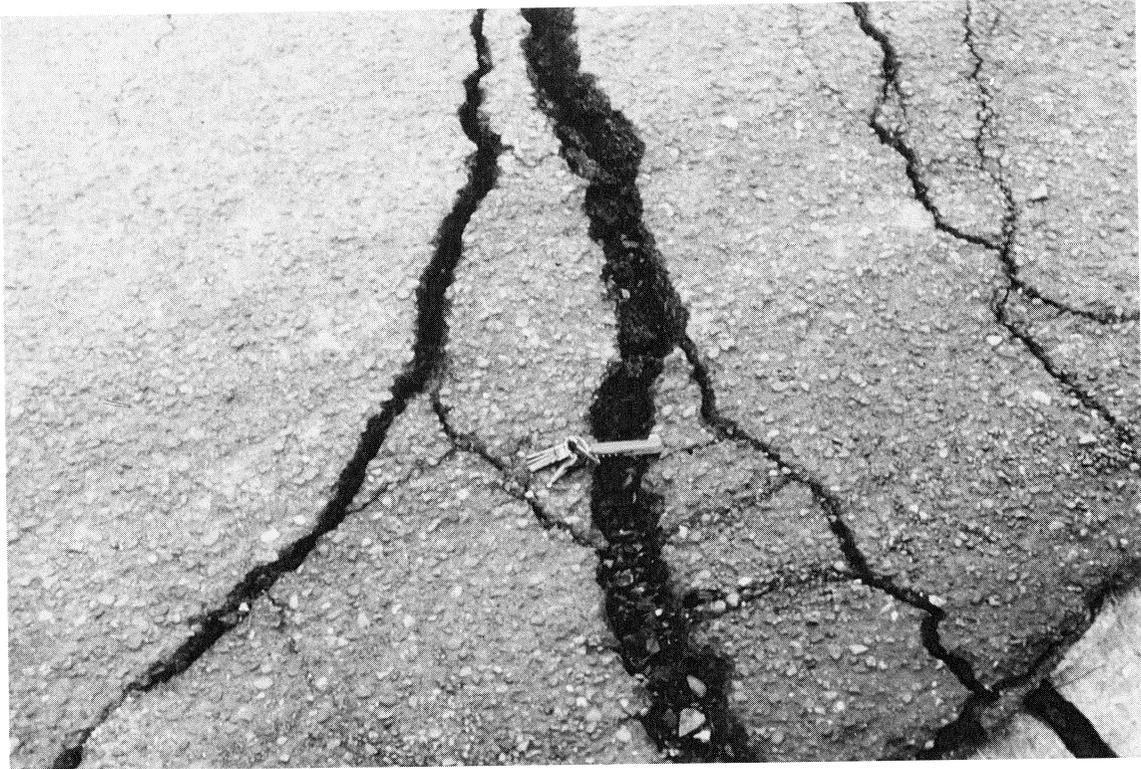
FIGURE 3-21 Close-Up of Superficial Road Cracks Shown in Figure 3-20

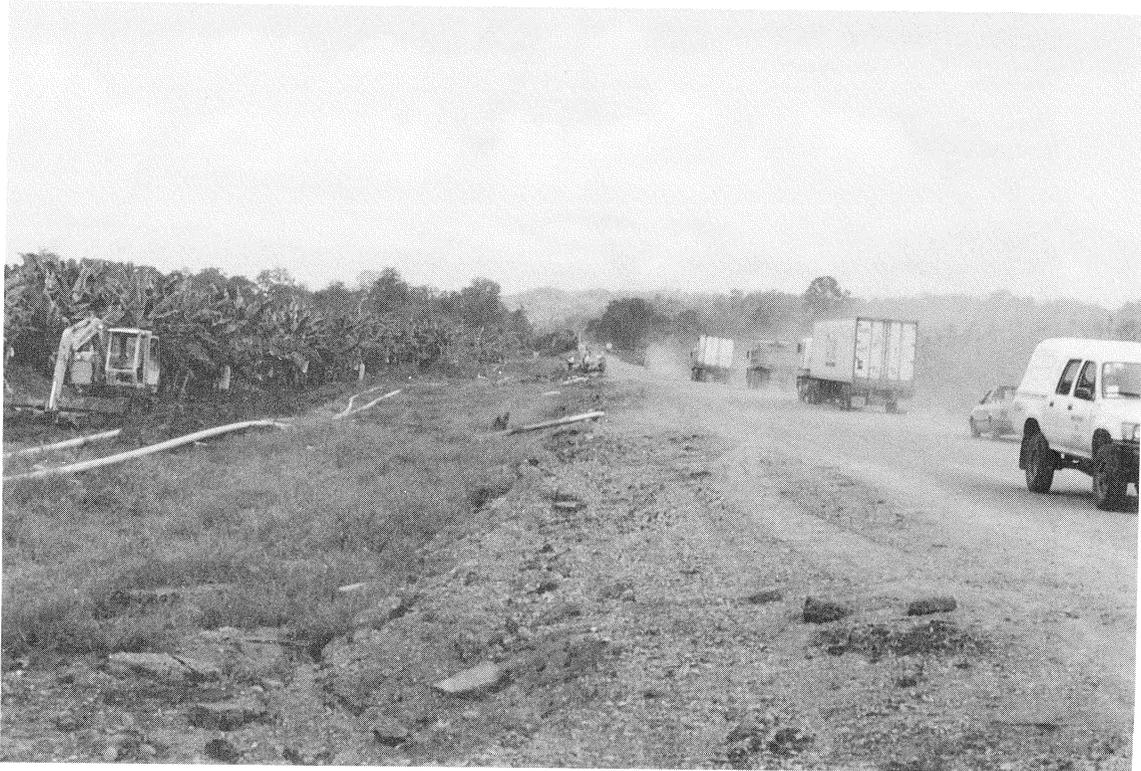
FIGURE 3-22 Heavy Road Damage near Village of Estrada in General Vicinity of RECOPE Pipe Leak, Note That Road Surface at Somewhat Higher Elevation Than Banana Plantation on Left.

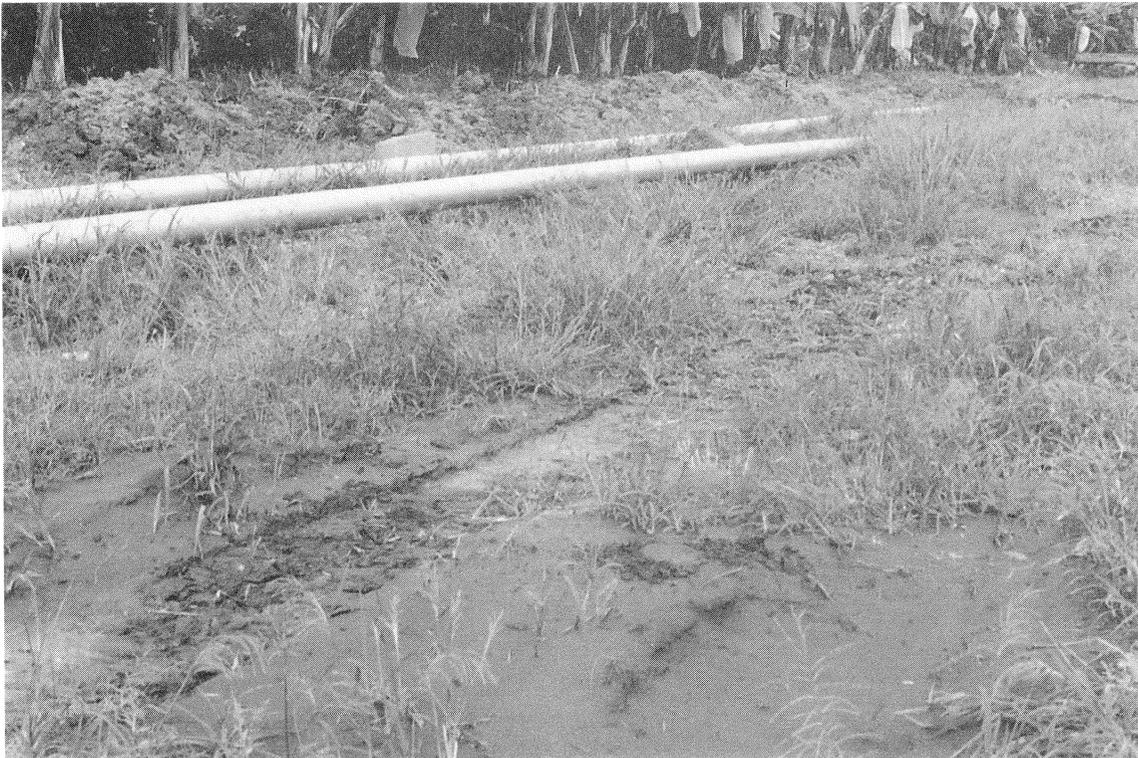
FIGURE 3–23 Ejected Sand on Ground Surface in General Vicinity of RECOPE Pipeline Leak.

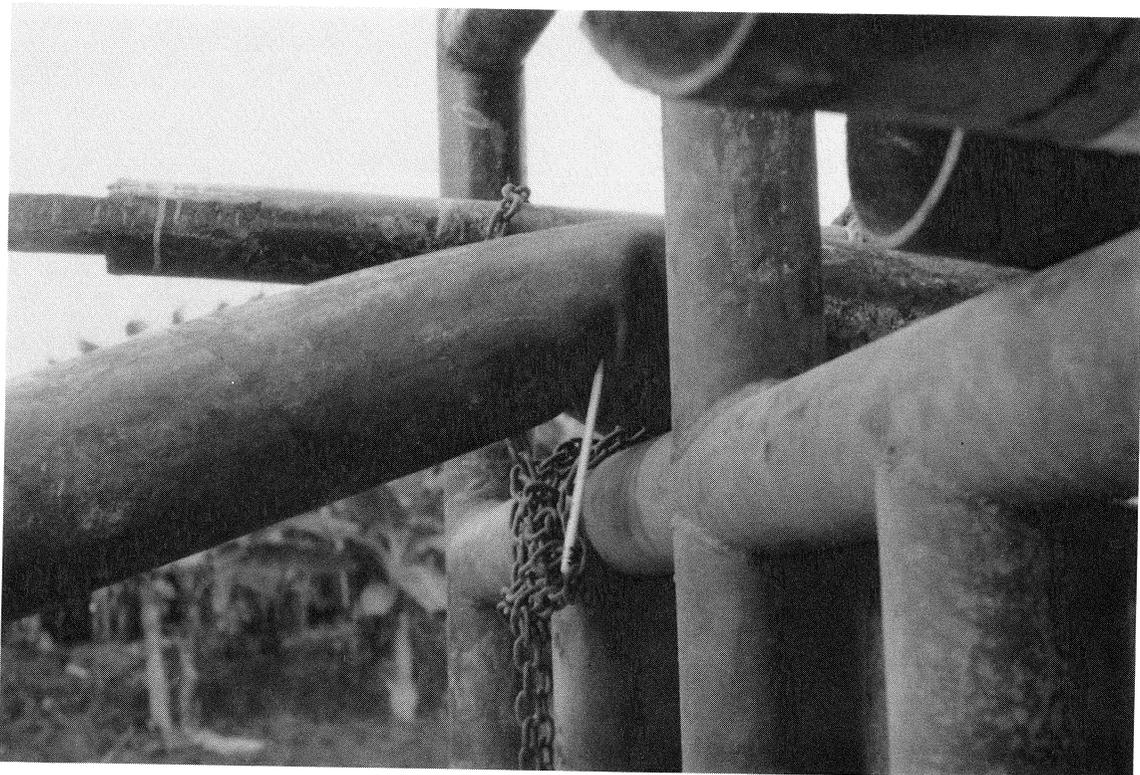
FIGURE 3-24 Damaged Portion of RECOPE Pipeline on Back of Repair Truck, Pencil Stuck in Tensile Crack Generated by Severe Local Buckling (Wrinkling) on Compression Side of This Flexural Failure.

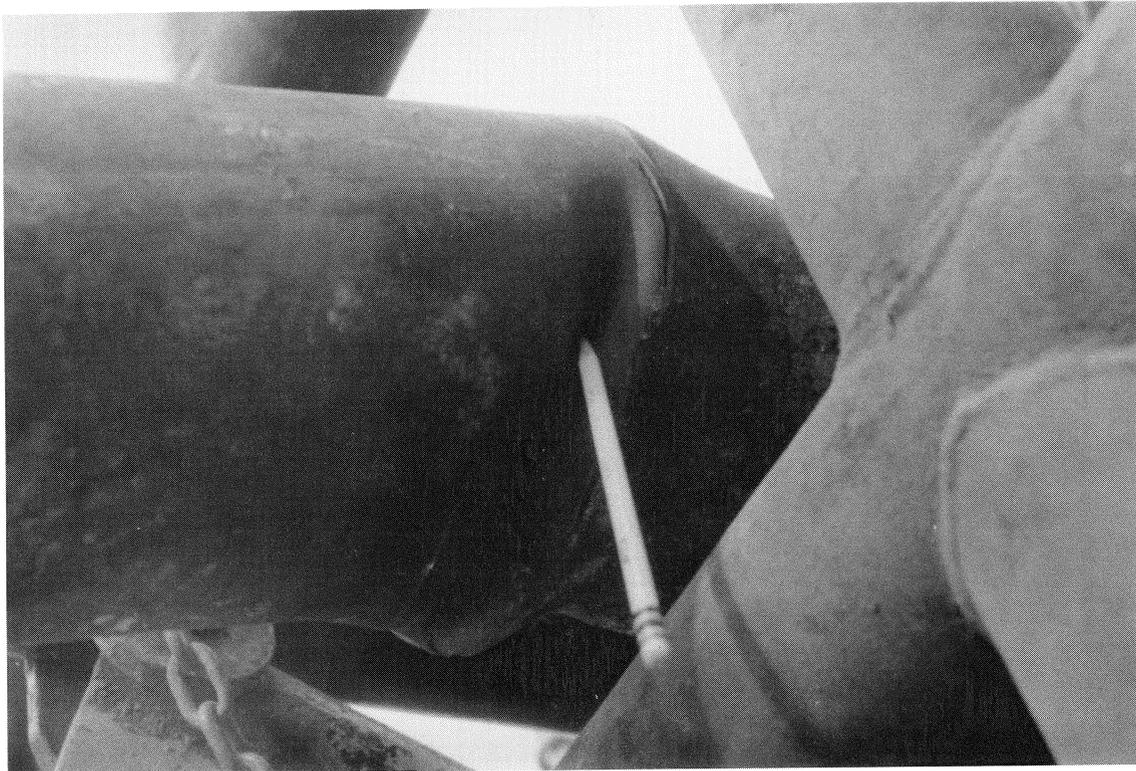
FIGURE 3–25 Close-Up View of Local Buckling (Wrinkling) of RECOPE Pipeline.

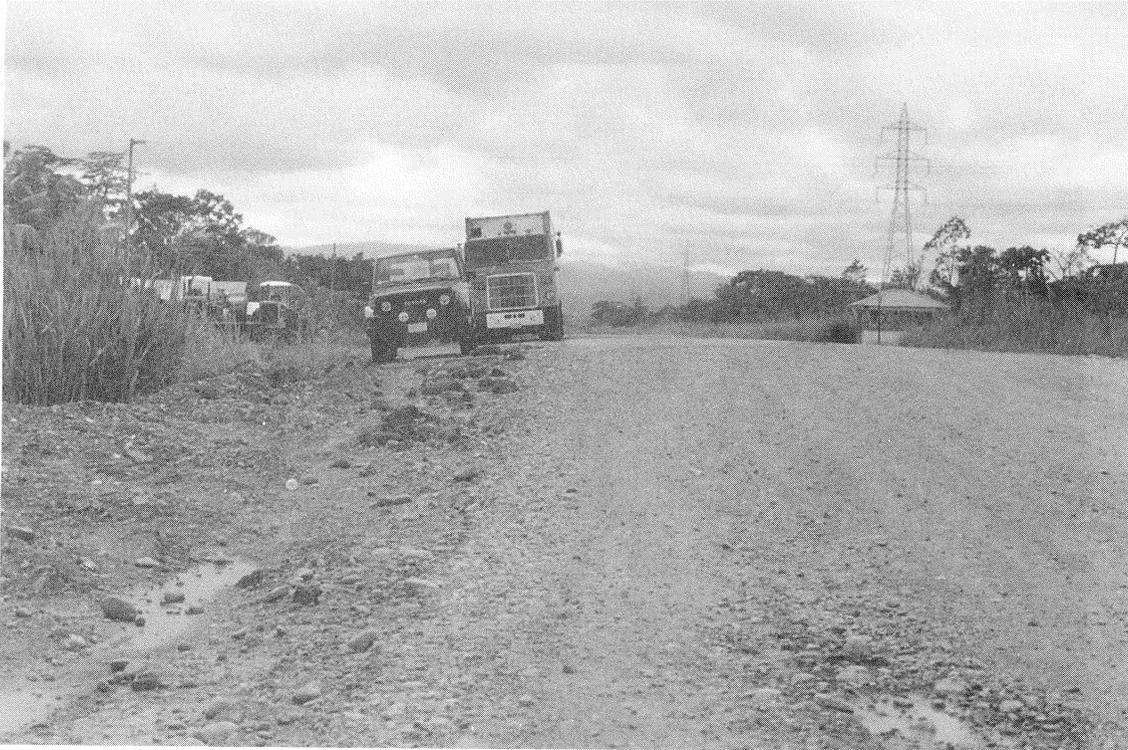
FIGURE 3-26 Road Settlement of Roughly 1 m (3.5 ft.) at Western Edge of 400 m Length of Severe Damage to Route 240. Photograph Taken while Kneeling on Temporary Road Surface with Undamaged Road Surface at Eye Level.

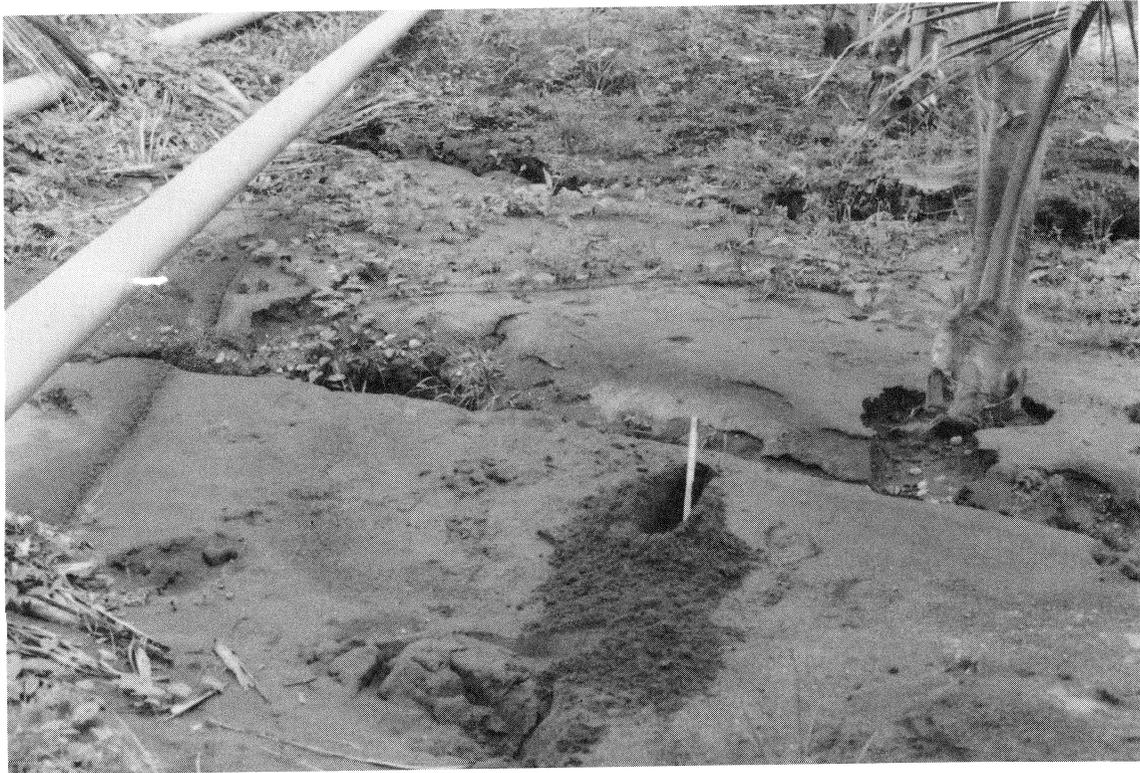
FIGURE 3-27 Ground Cracks and Ejected Sand at Ground Fissure Adjacent to 400 m Length of Severe Damage to Route 240. Note Water Drip Pattern Directly under Undamaged RECOPE Pipeline
