Observations on Water System and
Pipeline Performance in the Limon Area of Costa Rica
Due to the April 22, 1991 Earthquake

M. J. O'Rourke

Technical Report NCEER-92-0017

June 30, 1992

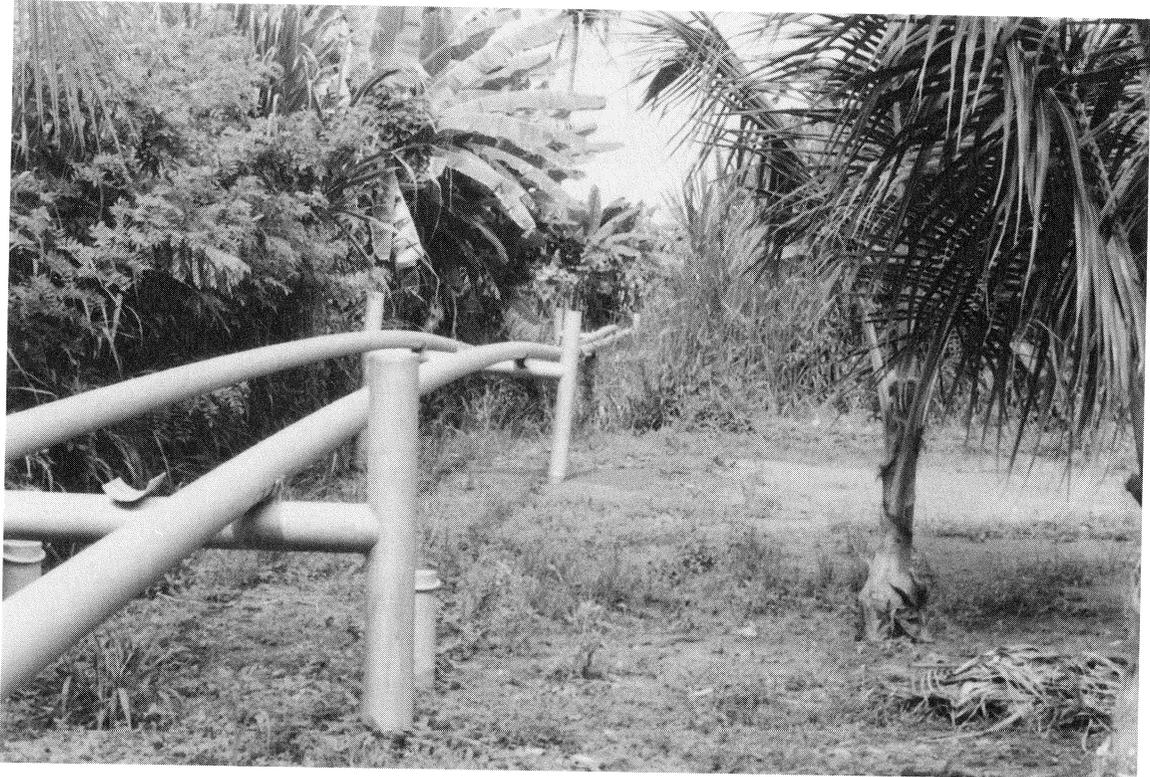
FIGURE 3-28 Ejected Sand at Base and to Right of Tilted Steel Support Frame for Undamaged RECOPE Pipeline.

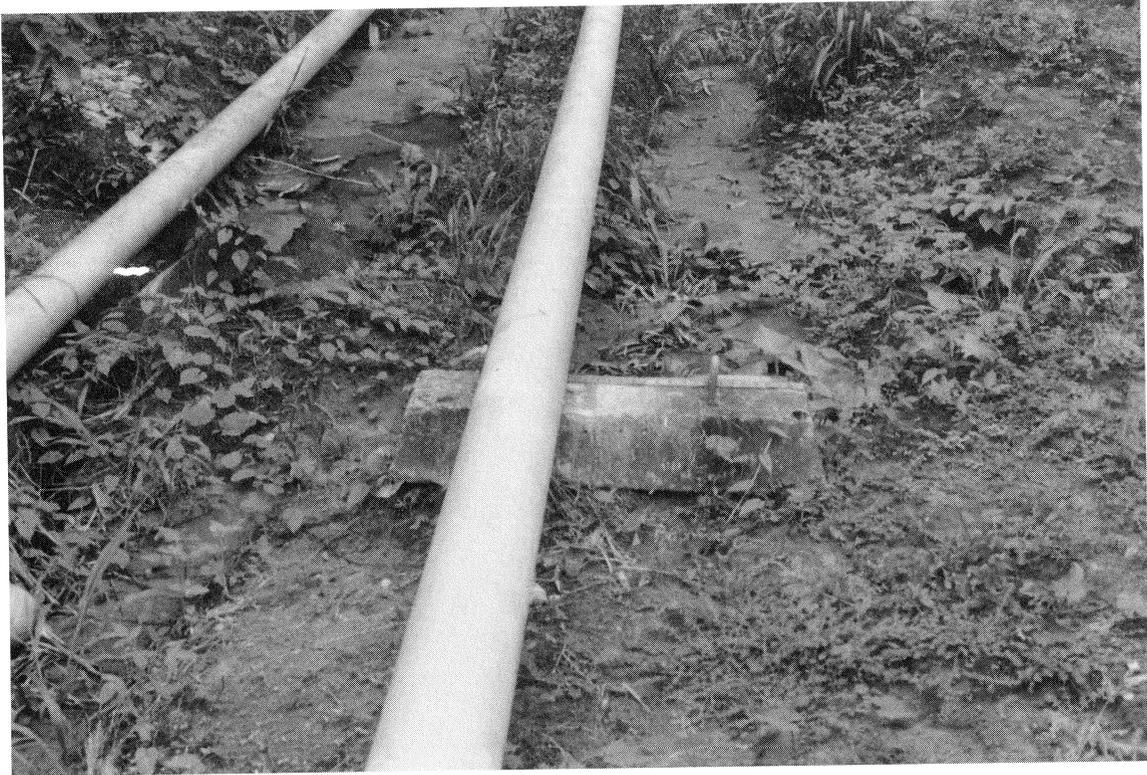
FIGURE 3–29 15 cm (6 in) Relative Movement of Undamaged RECOPE Pipeline Adjacent to 400 m Length of Road Damage to Route 240.

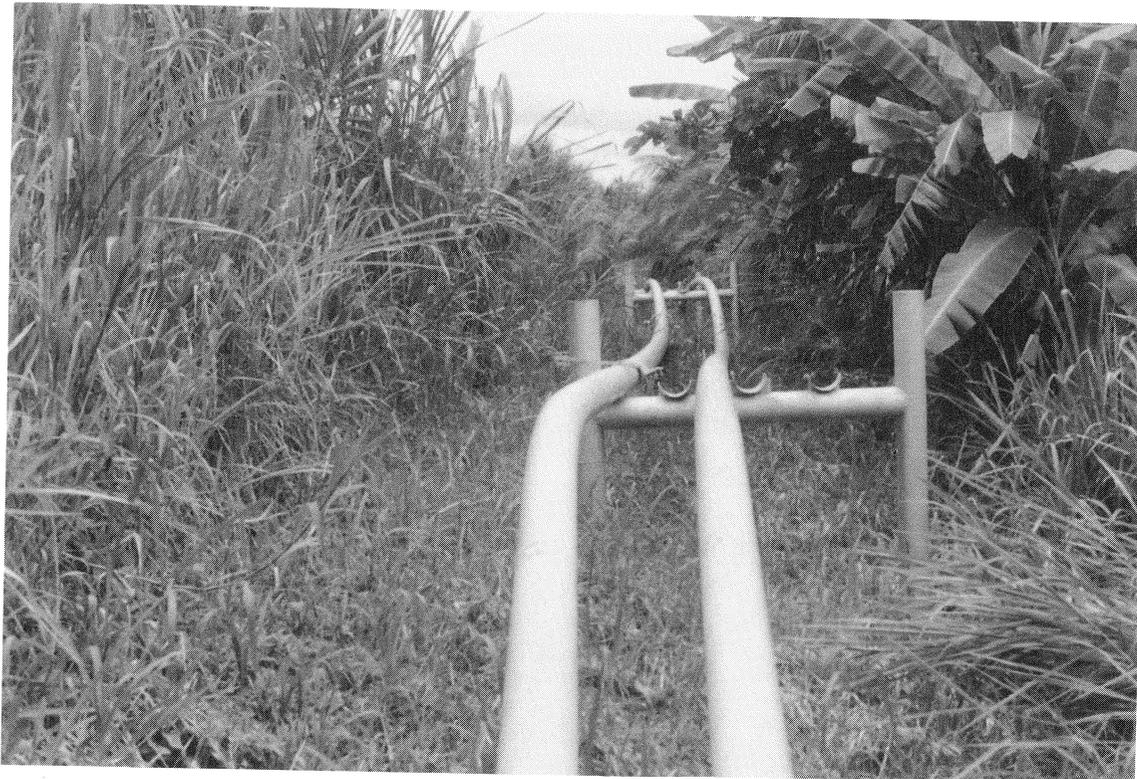
FIGURE 3–30 Severe Distortion of Undamaged RECOPE Pipeline Adjacent to 400 m Length of Road Damage to Route 240. Note Pipelines no Longer in Semicircular Steel Saddles.

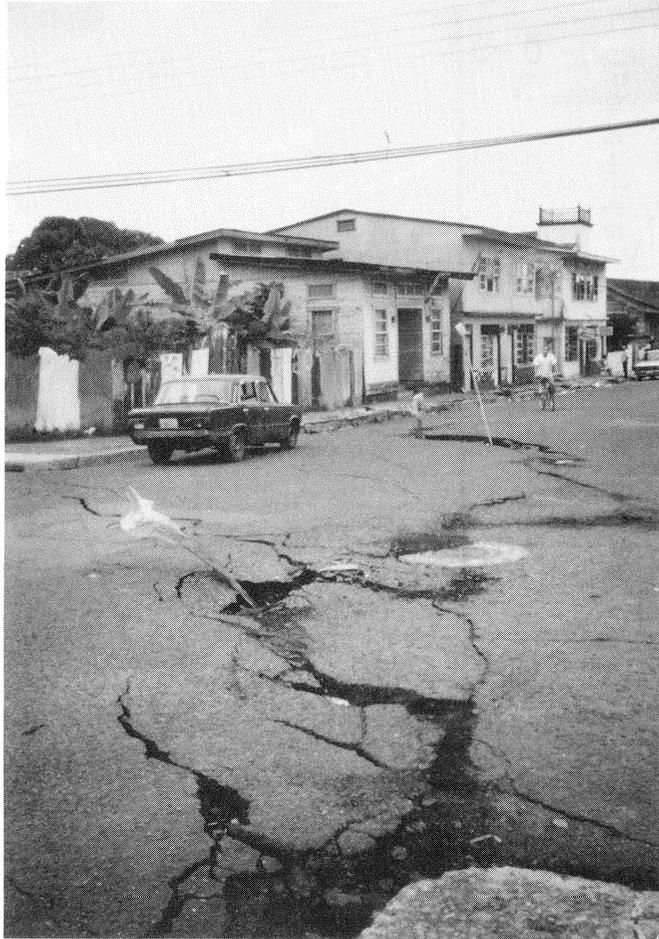
FIGURE 4-3 Ground Cracking Likely due to Lateral Spreading in Limón, which Caused Damage to Buried Pipelines

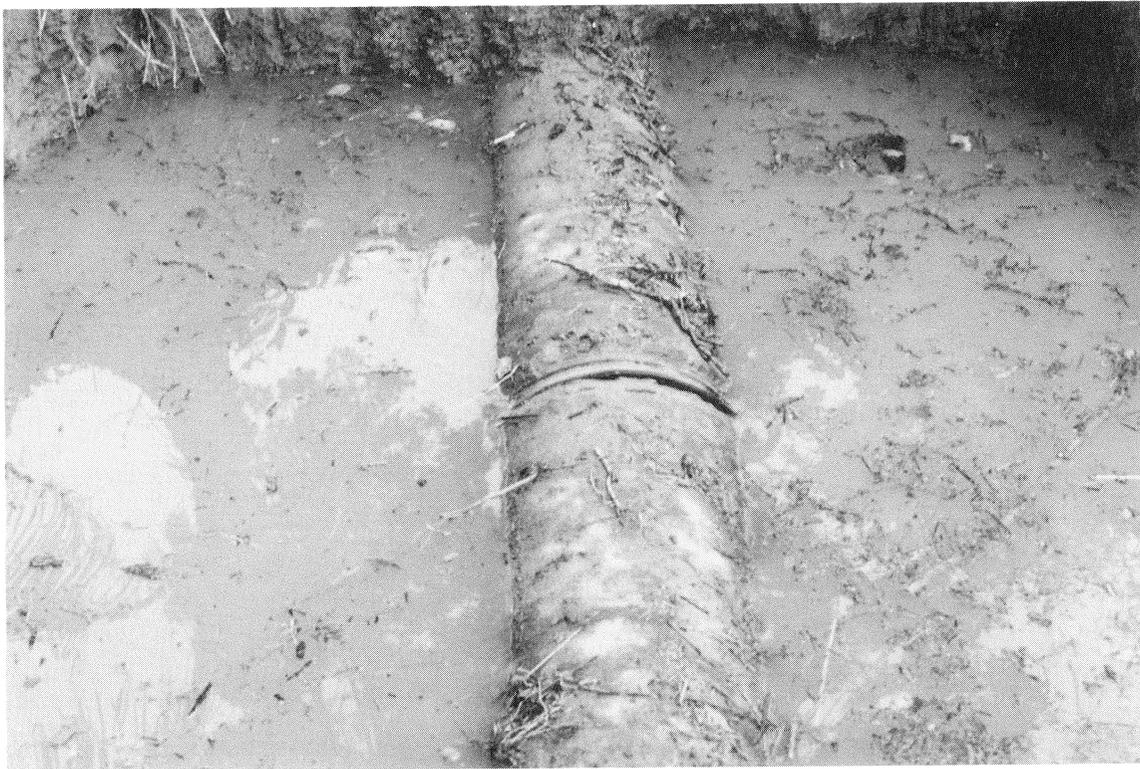
FIGURE 5-3 Unrepaired Tensile Pull-out Failure at Joint (see Figure 3-3(f)) in 500 mm (20 inch) RCCP Transmission line from Banano River. Note Black Rubber Gasket at Top and Right Side of Joint.
