The Island of Guam Earthquake of August 8, 1993

S.W. Swan and S.K. Harris

Technical Report NCEER-93-0017

September 30, 1993

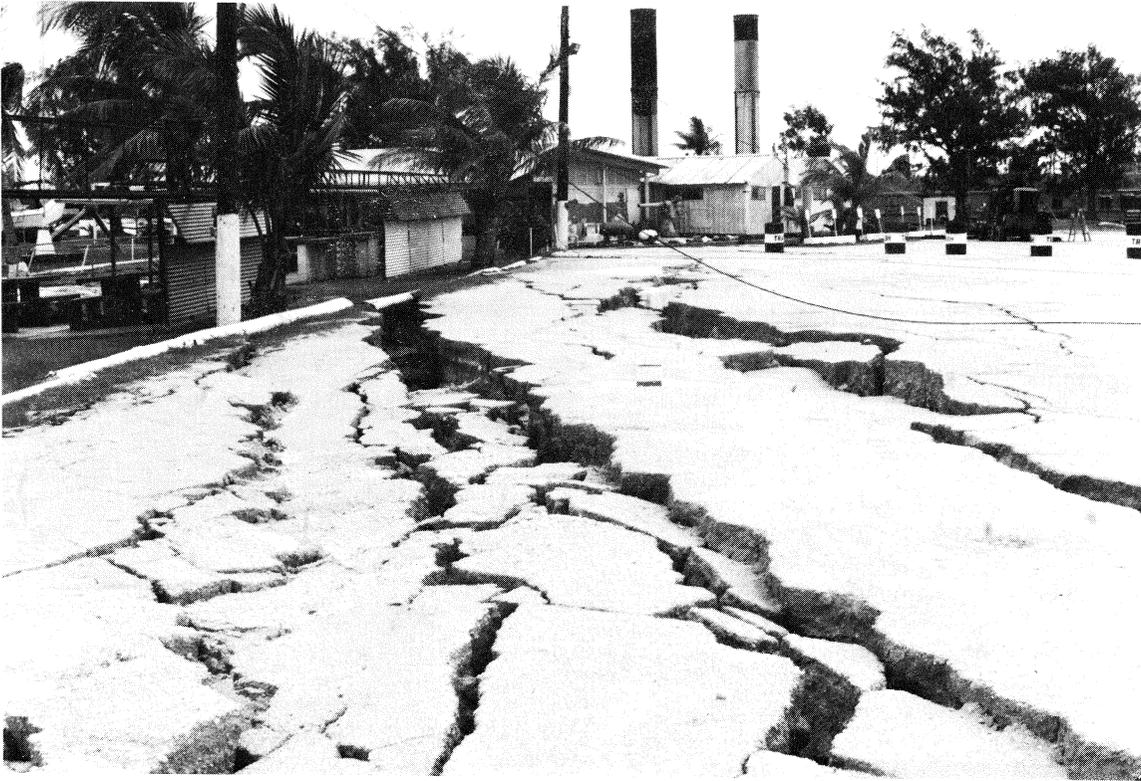
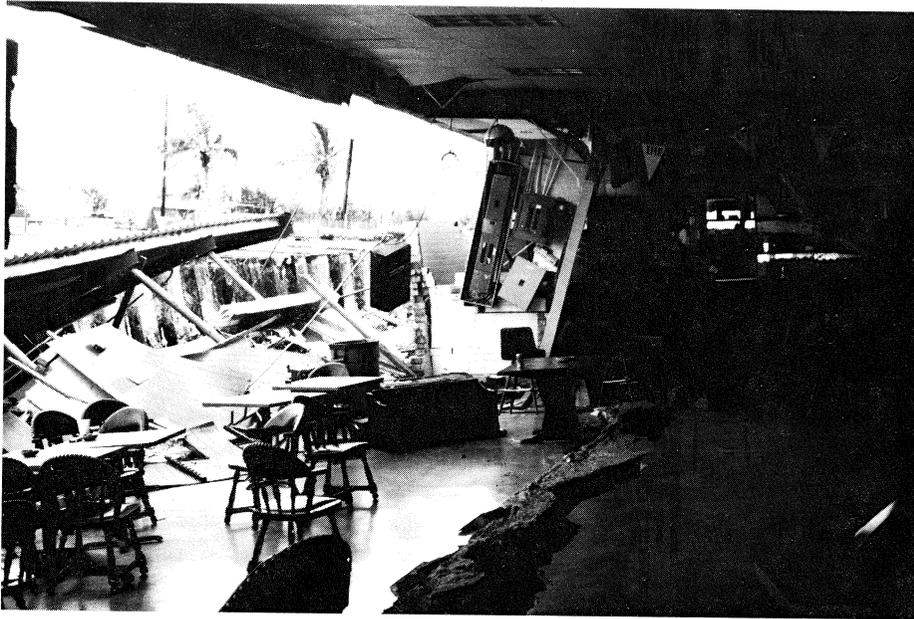
The isolated instances of liquefaction observed in the earthquake occurred in the harbor area. Sand boils were observed at various locations. Settlement and spreading created large fissures running for several hundred meters in sections of the Navy base (Figure 4-2). Buried water lines and electrical conduit were fractured by the soil displacement. Liquefaction-induced spreading split the enlisted personnel's shoreside recreation center on the Navy base, collapsing about half of the wood-frame structure. Although the center was full at the time of the earthquake, people were able to leave before the building began to disintegrate.

Figure 4-2: Liquefaction in the soft alluvium and fill beneath the Navy port area created fissures running several hundred meters (top photo). The enlisted personnel's shoreline club partially collapsed due to liquefaction-induced spreading beneath the structure (bottom photo).

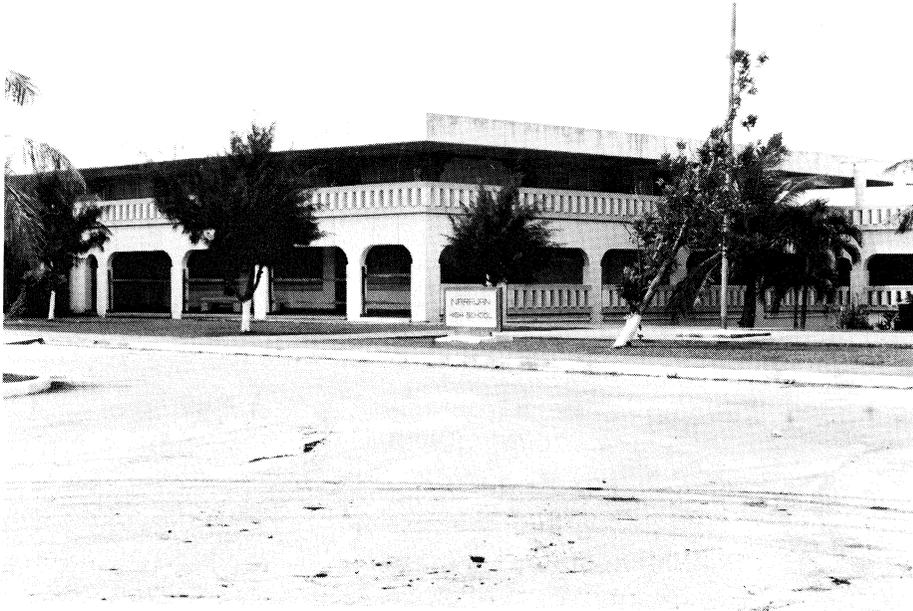
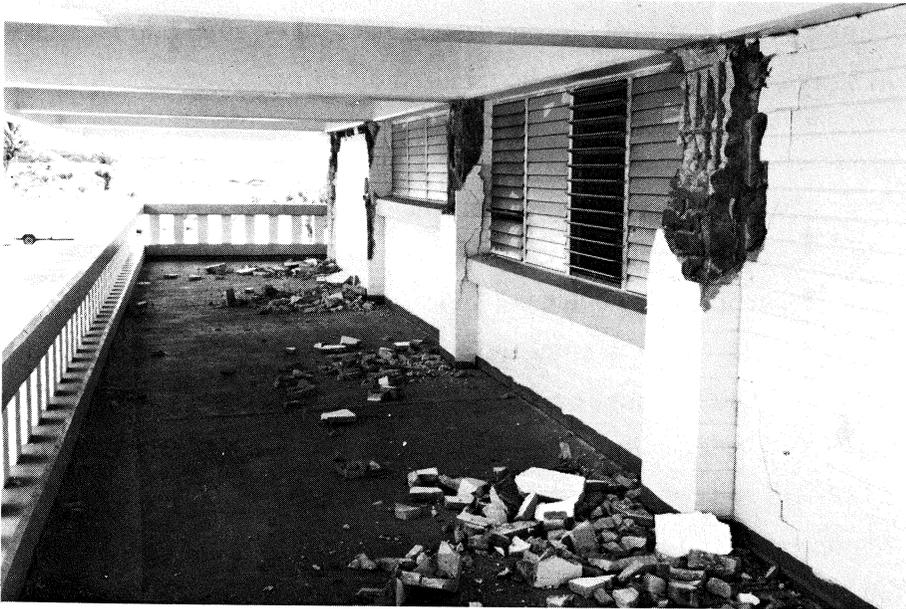
The most severely damaged school was Inarajan High School, at the southern end of the island (Figure 5-1). The school consists of several adjoining two- and three-story concrete-frame buildings with masonry in-fill, and was constructed in 1973. One wing with partial-height in-fill walls suffered severe cracking and spalling of concrete columns. This is an example of the "short column effect", where the presence of the partial-height in-fill walls shortens the effective height of the columns, forcing them to fail in shear. It appeared that at least one wing of Inarajan High School would have to be demolished.

Figure 5-1: One wing of Inarajan High School suffered shattered concrete due to the short column effect, where shear loads from half-height masonry in-fill were transferred into the columns.

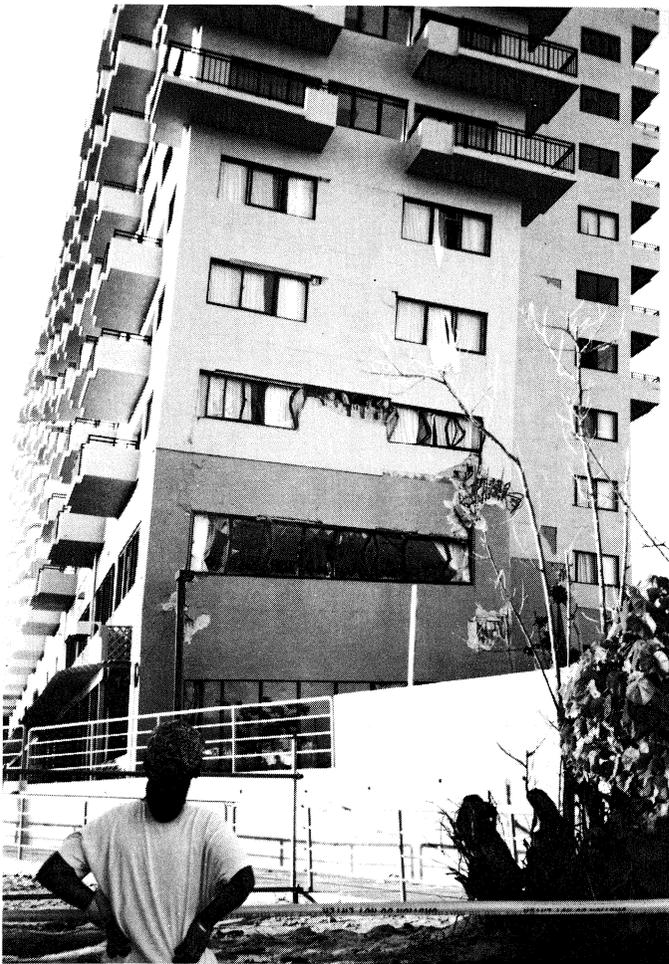
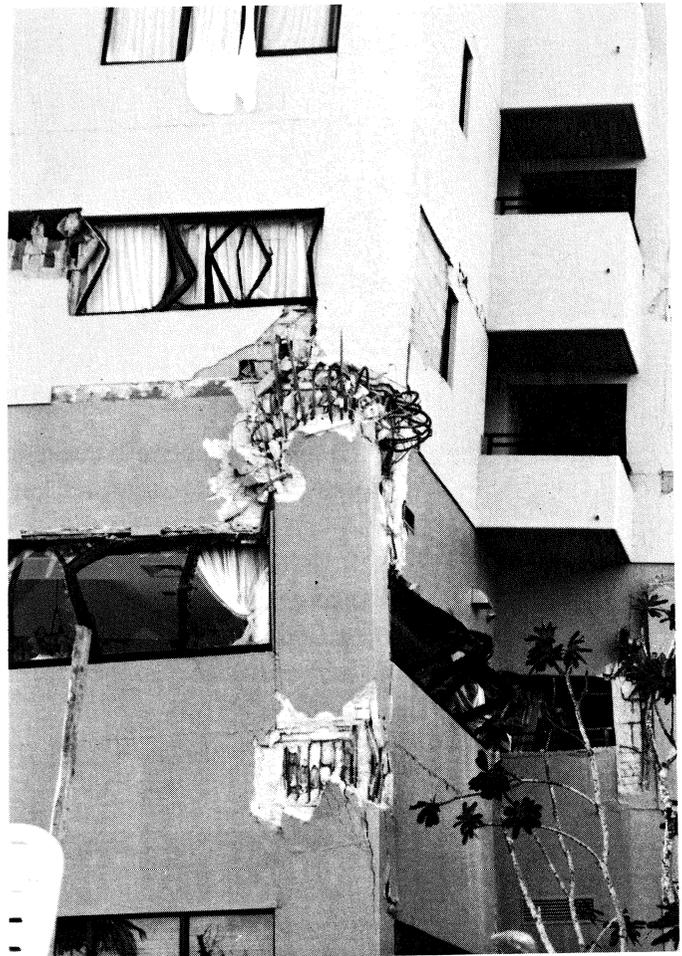
Perhaps the most dramatic effects were suffered by the Royal Palm Resort complex, a twelve-story structure that was open only 18 days prior to the earthquake (Figure 5-2). In the rear wing (adjacent to the beach) several columns in the second story collapsed, causing the wing to tilt substantially. The floors above the damaged level contained guest rooms, while the floors below appeared to contain mostly open common areas. Consequently, most of the in-fill shear walls above appear to have been discontinued below the third floor, creating the soft story. Other damage visible from the exterior included moderate shear cracking of in-fill walls and working of joints between in-fill and concrete elements. Following the collapse, guests were temporarily trapped in the damaged wing. Remarkably there were no serious injuries. It appeared that the rear wing of the building could not be repaired and would have to be demolished.

Figure 5-2: A partial collapse occurred in the seaward wing of the Royal Palms Condominiums. A discontinuity in masonry in-fill at the second floor concentrated shear on the corner columns.

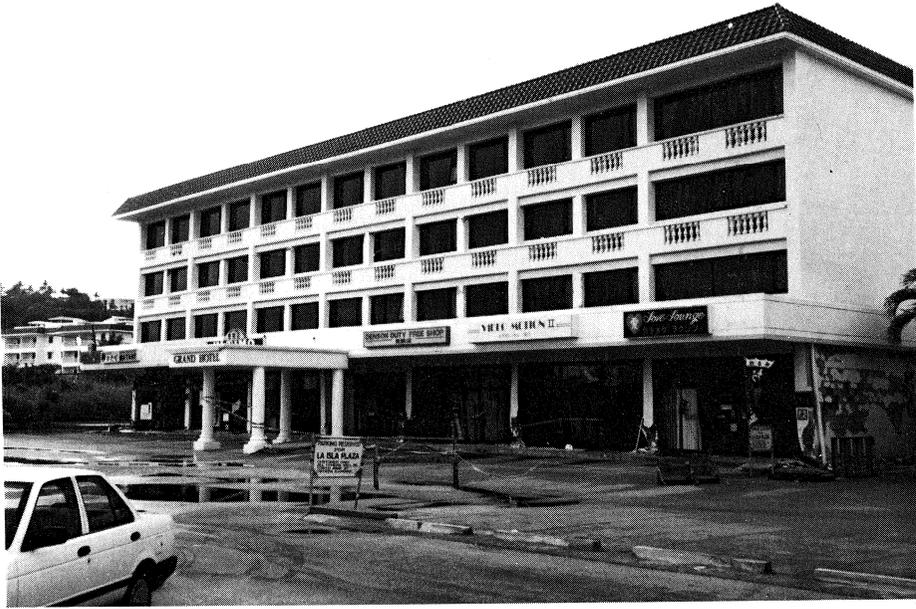
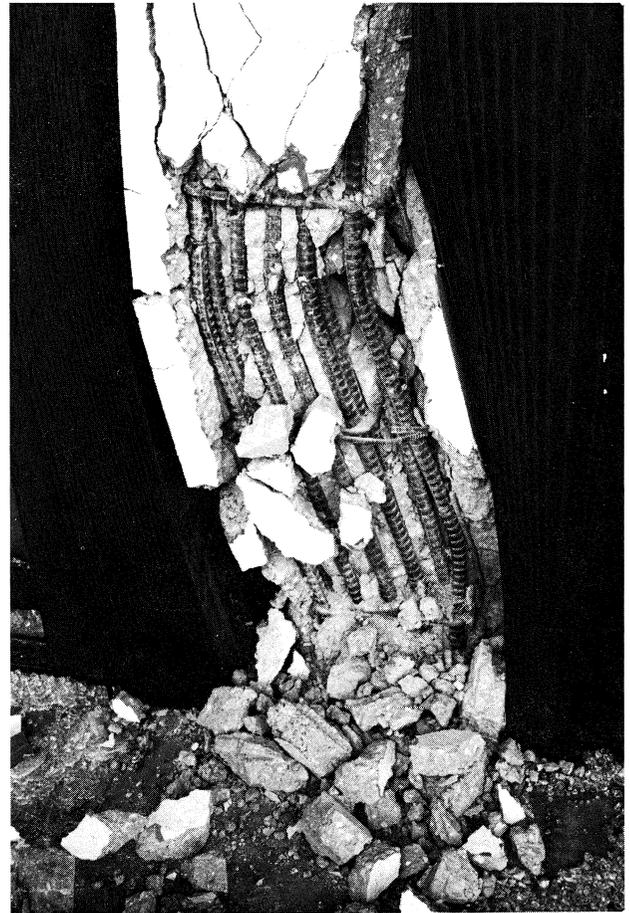
The four-story, five-year-old Grand Hotel was also severely damaged (Figure 5-3). In-fill walls enclosed most of the ground floor along the sides and rear of the building, while the front was mostly open, with large storefront windows between columns. The lack of shear resistance across the front created a soft first story, combined with a tendency for structural torsion. While the upper three stories of the building appeared essentially intact, the second floor shifted nine

Figure 5-3: The Grand Hotel near Tumon Bay suffered the most extensive damage of low-rise structures on the island. A soft first story effect shattered columns at the base of the building and shifted the upper three floors nine inches relative to the ground.

inches relative to the foundation, shattering concrete in the ground floor columns. Some of the columns lost their ability to resist gravity loads, leaving portions of the building supported by the in-fill masonry walls. The building was subsequently slated for demolition.

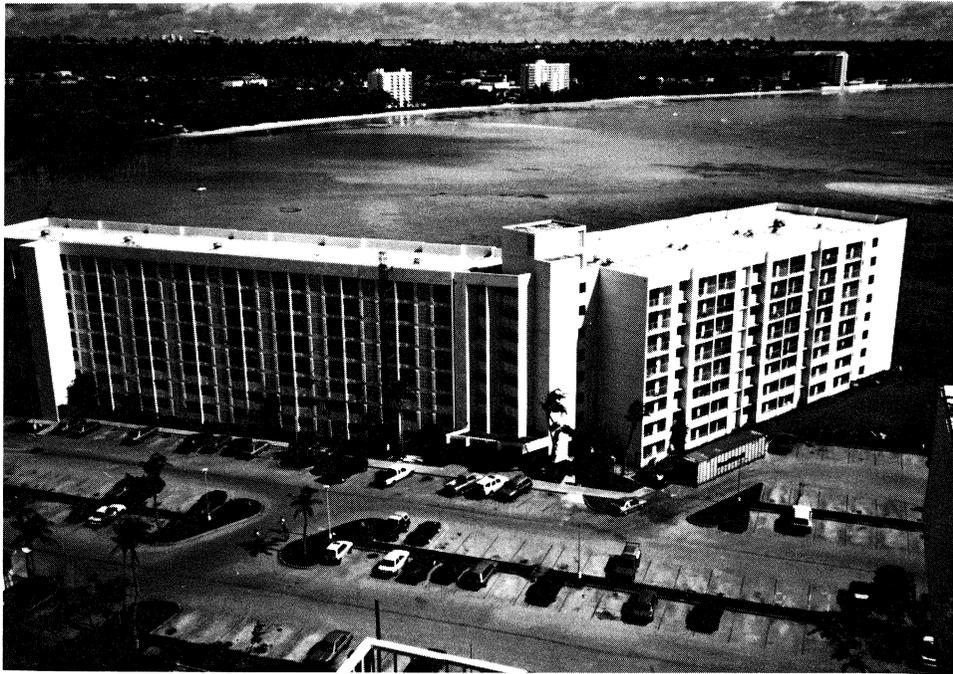
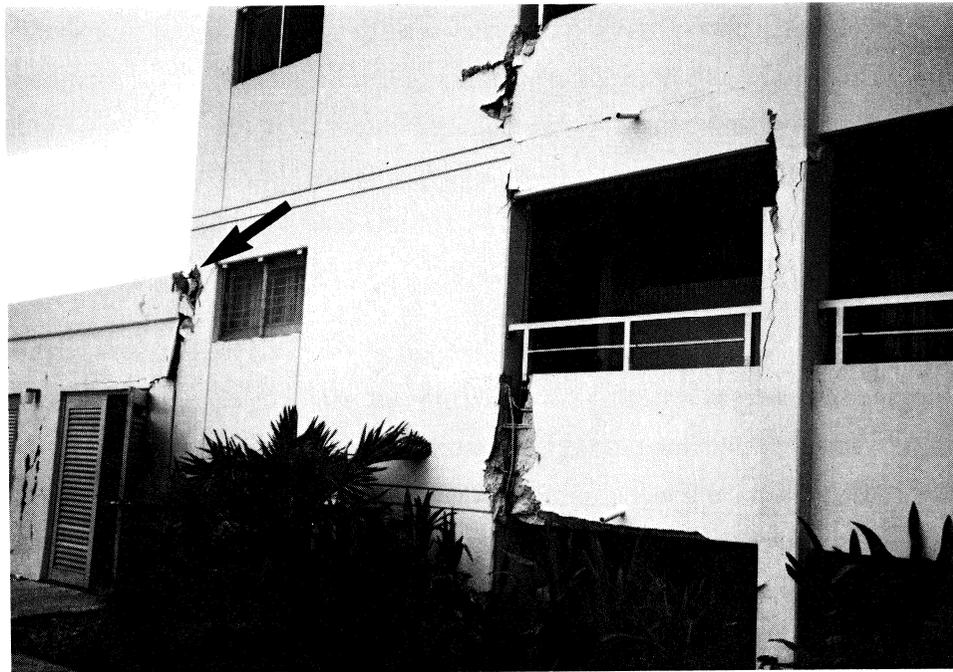
The Alupang Cove condominium complex in Tamuning also suffered serious, although repairable, degree of damage (Figure 5-4). The building consists of two eight-story wings that join at an angle. The most visible damage occurred along a breezeway in the northern wing. In this area, concrete columns and masonry screen walls were severely damaged, leading to a partial loss of vertical support for the breezeway. These elements do not appear to have been intended to resist lateral loads, but were damaged because of the building's flexibility in its longitudinal direction. Shear cracking occurred in concrete spandrels at their interface with a major concrete shear wall at the eastern end of the breezeway. Other damage observed appeared to be due to improper detailing. Major pounding damage to a bearing wall was observed at the ground floor between the main structure and the abutting one-story mechanical building. In the southern wing, concrete spalled from floor slabs at their attachment to a major shear wall,

The Alupang Cove Condominium Complex suffered effects typical of mid-to high-rise buildings in the tourist area.

Figure 5-4: Shattered columns, shear cracking at spandrels, and pounding damage at the interface of the one-story mechanical building (at left) are seen along the front fact of the Alupang Cove.

exposing the slabs' embedded prestressing tendons. Repair of the prestressed slabs presents a problem since the exposed tendons cannot be retensioned.

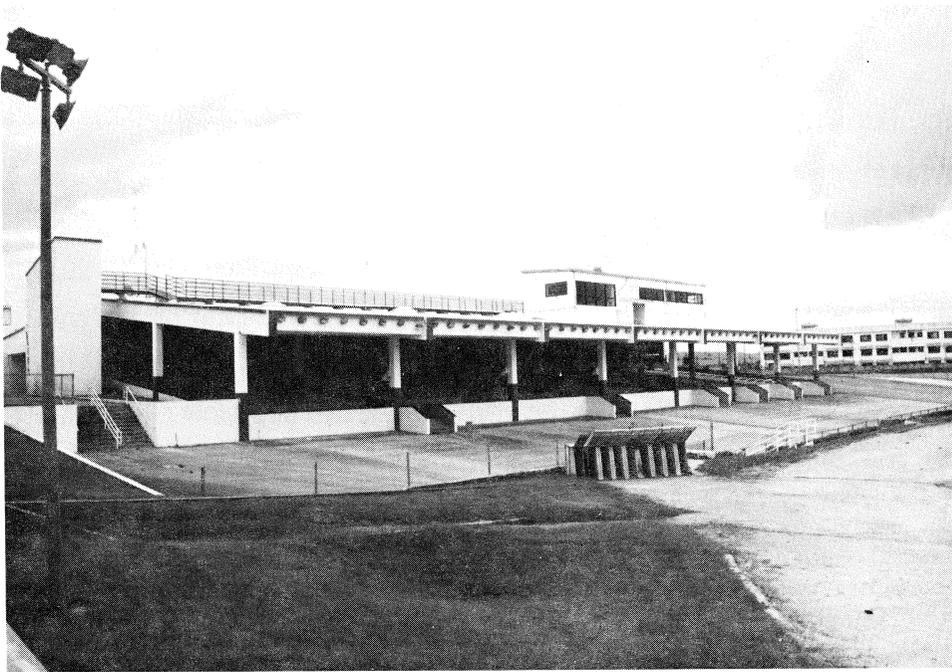
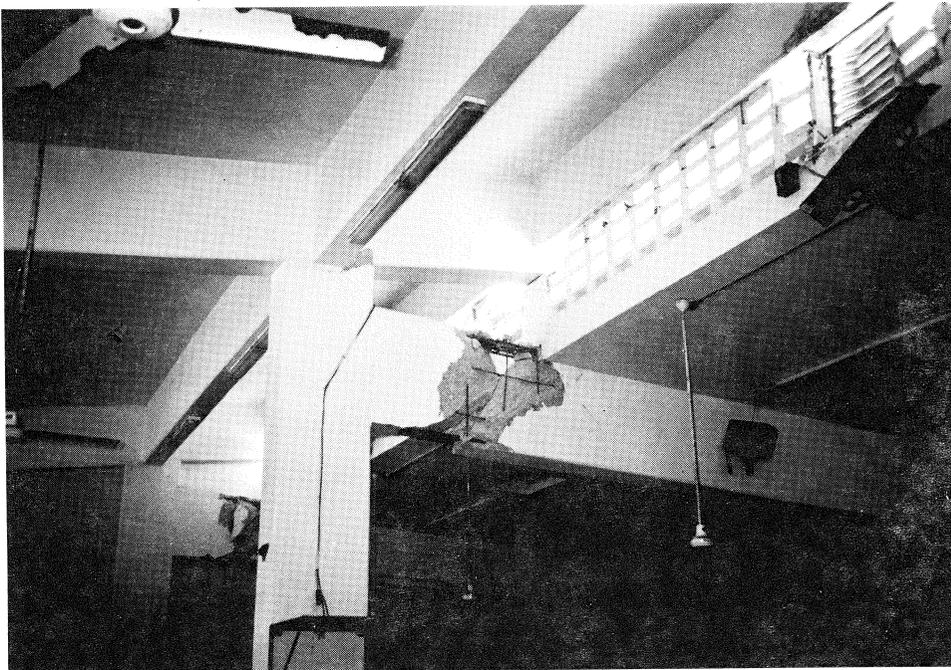
The grandstand roof structure of the Greyhound Racetrack near Tamuning was severely damaged (Figure 5-5). The structure consists of a large main roof, supported only by concrete columns, and a second lower roof, supported on one side by the main-roof columns and on all other sides by concrete shear walls. There is a concrete-block screen wall in the vertical space between the two roofs. The screen wall apparently failed as it attempted to transfer seismic forces from the main roof to the lower roof. At this point the only remaining lateral load path between the two structures was through the large roof beams supporting the lower roof. These beams developed dramatic inclined cracks, apparently due to torsion induced by the shear transfer.

Figure 5-5: The Greyhound Racetrack consists of two concrete canopies offset vertically at the center of the structure. The concrete beams spanning between the two canopies were shattered by the different response motions of the two halves of the structure.

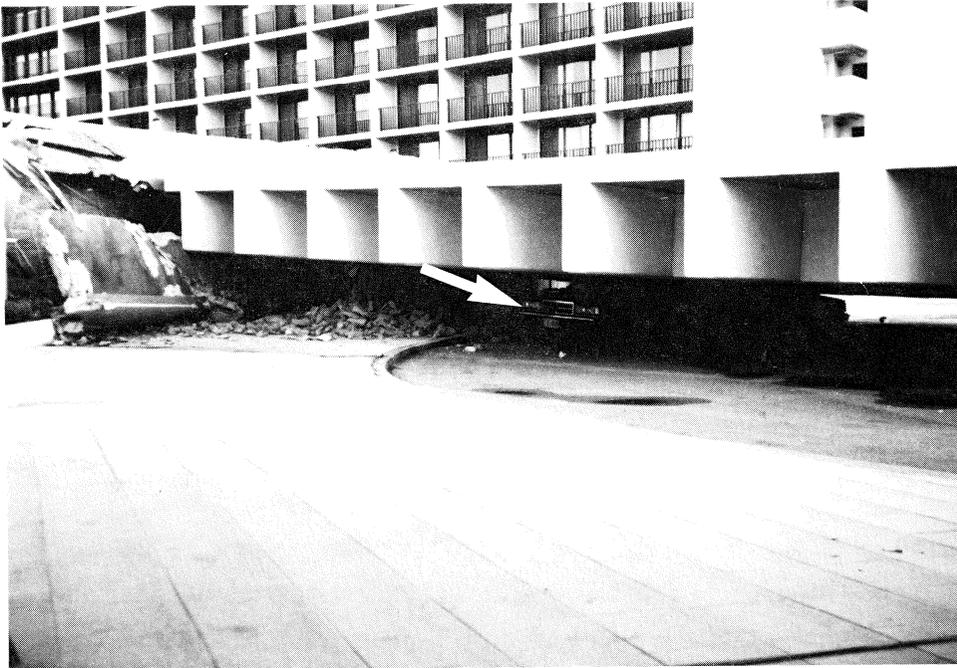
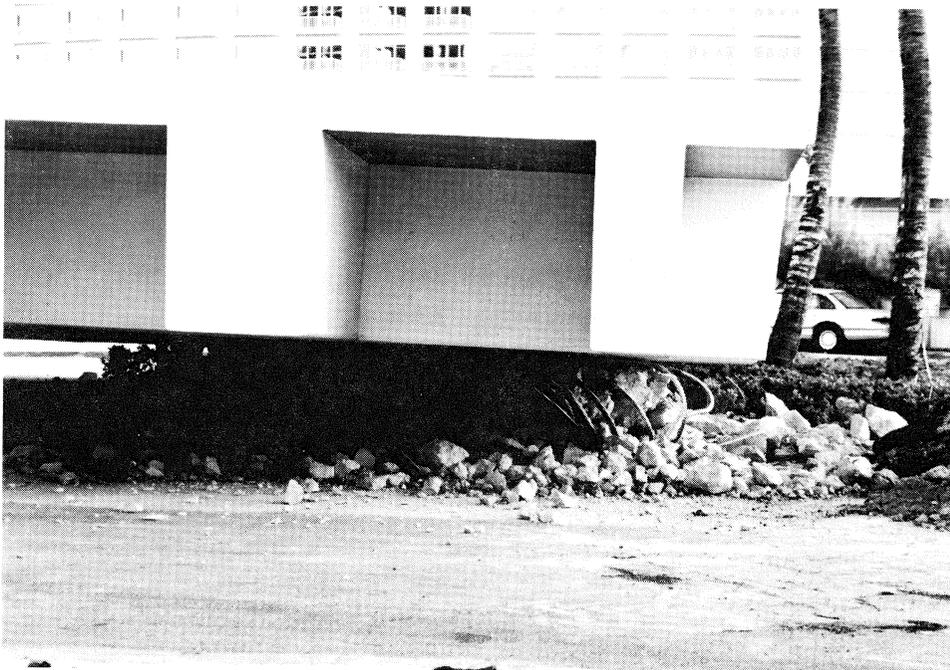
Concrete canopies, consisting of heavy slabs supported by concrete columns, are common on the island. Frequent damage to the supporting columns was observed, apparently due to improper detailing of highly stressed top connections. The most notable instance of such damage was the collapse of the canopy at the entrance to the Reef Hotel on Tumon Bay (Figure 5-6). The canopy's four concrete columns failed catastrophically, dropping the slab onto two parked taxis beneath. Fortunately, the drivers were out of the cars at the time of the earthquake. The concrete columns completely shattered and their longitudinal reinforcing buckled. The minimal horizontal ties appeared to be ineffective in providing confinement. Although there were no other instances of life-threatening collapse of canopies, minor to moderate damage of canopy columns was observed throughout the island.

Figure 5-6: The most severe instance of concrete canopy damage occurred at the Reef Hotel, where crushing of concrete columns dropped a heavy slab onto taxis parked near the entrance.

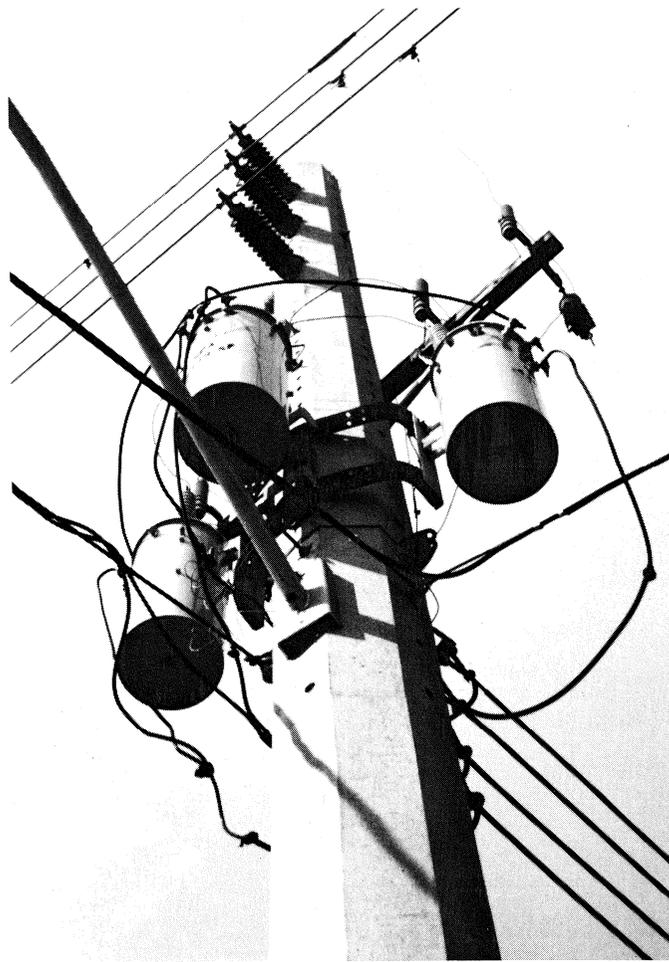
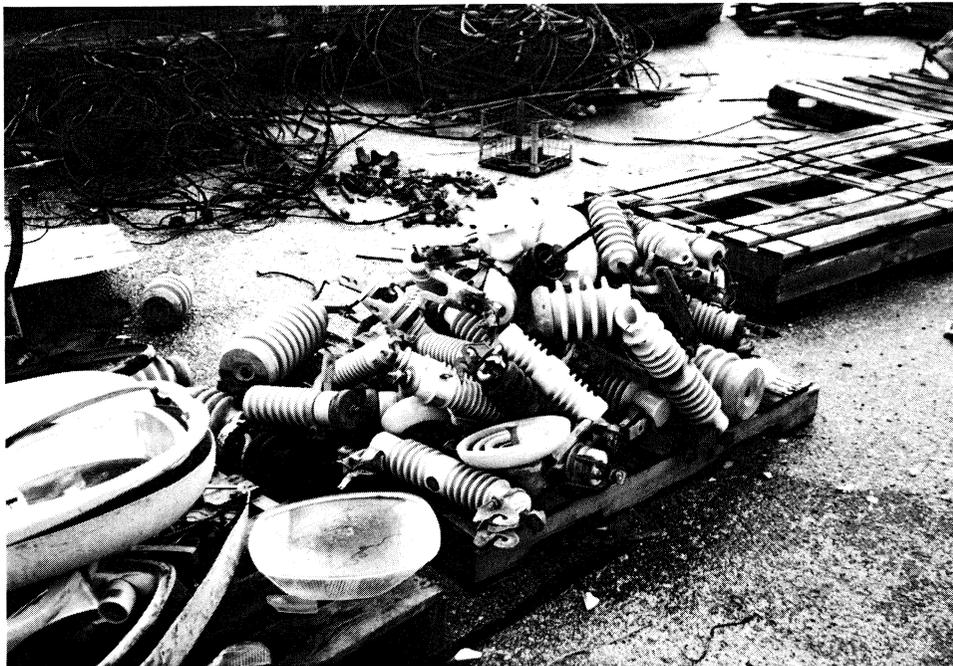
Figure 6-1: Wind loads on Guam result in power and transmission poles of heavy reinforced concrete (top photo). A small portion of poles suffered broken ceramic insulators. Broken insulators are collected on pallets in the Power Authority's service yard (bottom photo).

isolated instances of broken porcelain or detached conductors (Figure 6-1). There was no damage in the major switchyard equipment such as transformers or circuit breakers. Several large substation transformers were noted to have shifted on their base pads, as much as 16 inches at one station. There were no instances of damage to power poles or transmission towers.

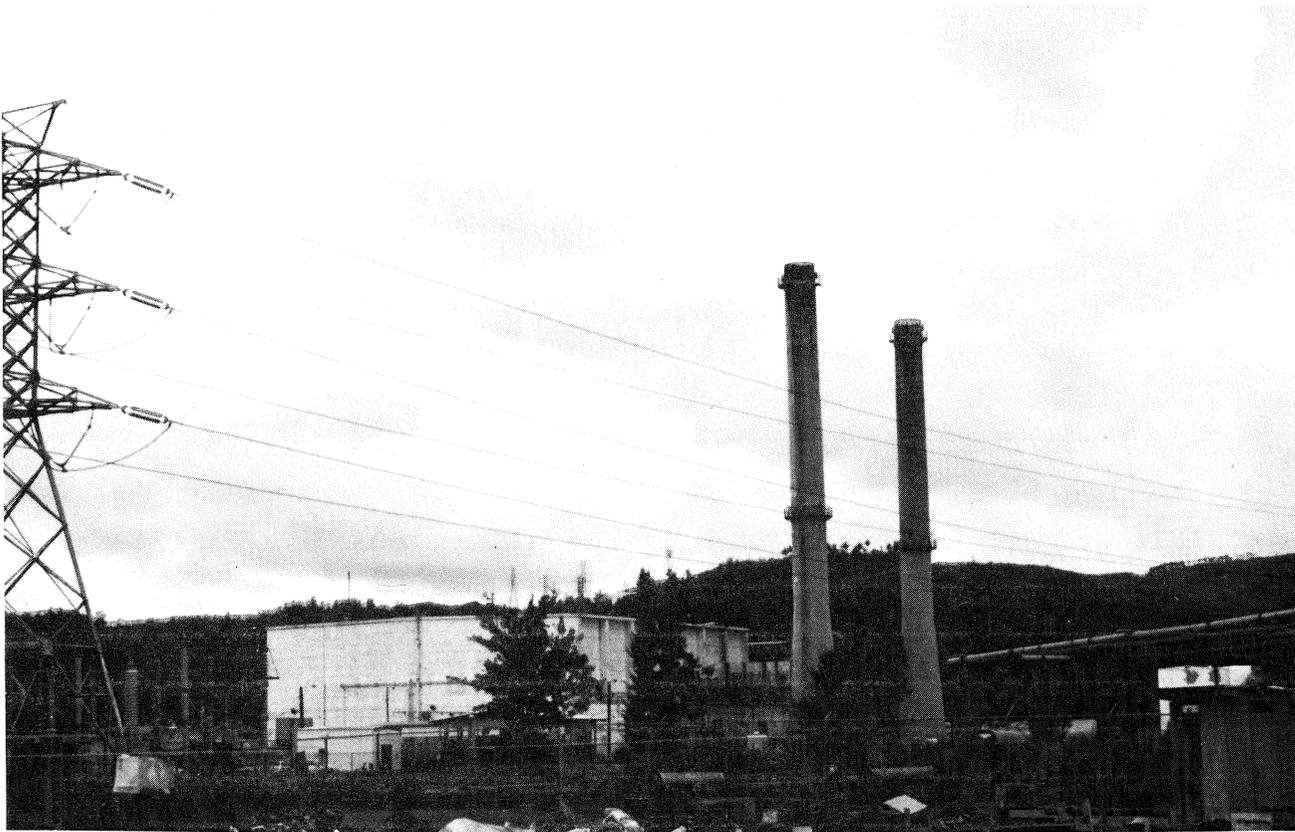
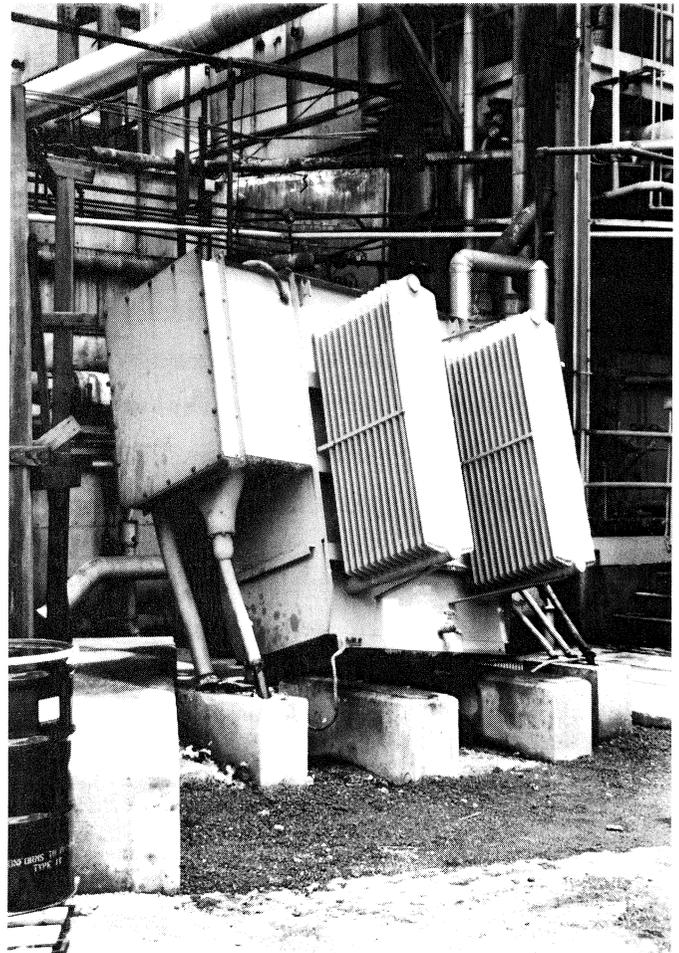
Damage in all generating plants was minor except for the Navy-operated steam plant located in the port area (Figure 6-2). Settlement of soil fill created vertical offsets of up to four feet near the plant's salt water intake channel, fracturing the buried circulating water lines to the condensers. Two of four generating units were operating at the time of the earthquake. The plant's DC power supply was lost when batteries toppled from their racks. Simultaneous loss of DC and AC operating power meant that the spinning turbines coasted down without lube oil pressure, possibly resulting bearing damage. Additional damage in the plant included an overturned station service transformer, an overturned motor control center, and leaks in various piping systems. The turbine buildings were not accessible for a week following the earthquake due to airborne asbestos dislodged from thermal insulation.

Figure 6-2: Overturned power supply equipment, such as batteries, motor control centers, and the station service transformer (at right), cut off both DC and AC power to two operating units at the Navy's Piti Steam Plant. Damage to the plant severely reduces the island's generating capacity.

Repairs were completed to one of the larger units at the Navy steam plant, and it was brought back on line about four weeks after the earthquake. This provided some relief to the island's electrical system. The Navy plant represents about 20% of Guam's generating capacity. With the plant off line, the remaining generating capacity could barely meet demand.

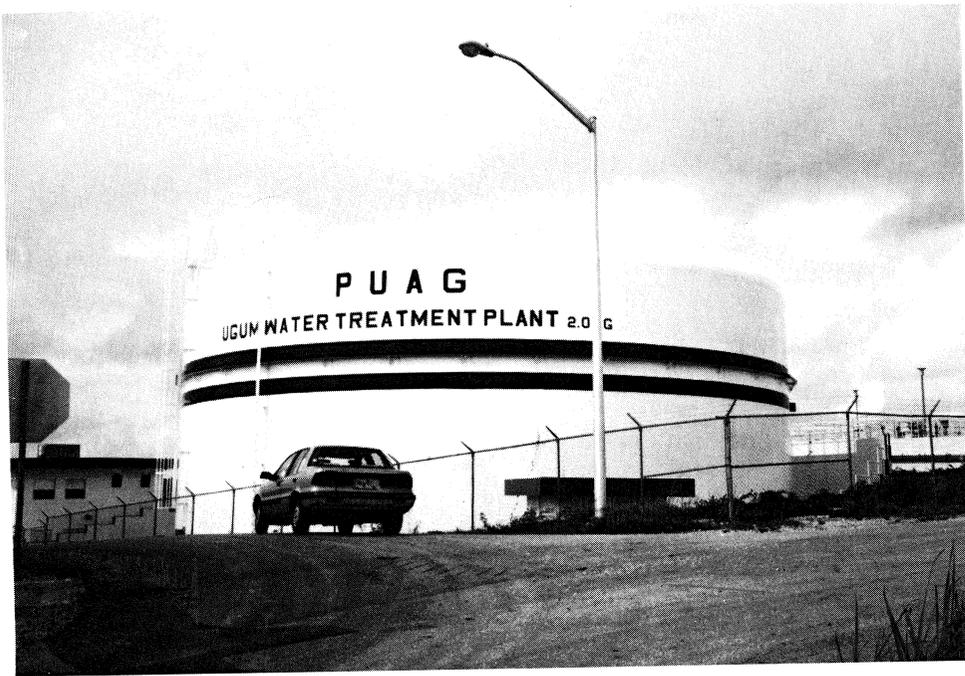
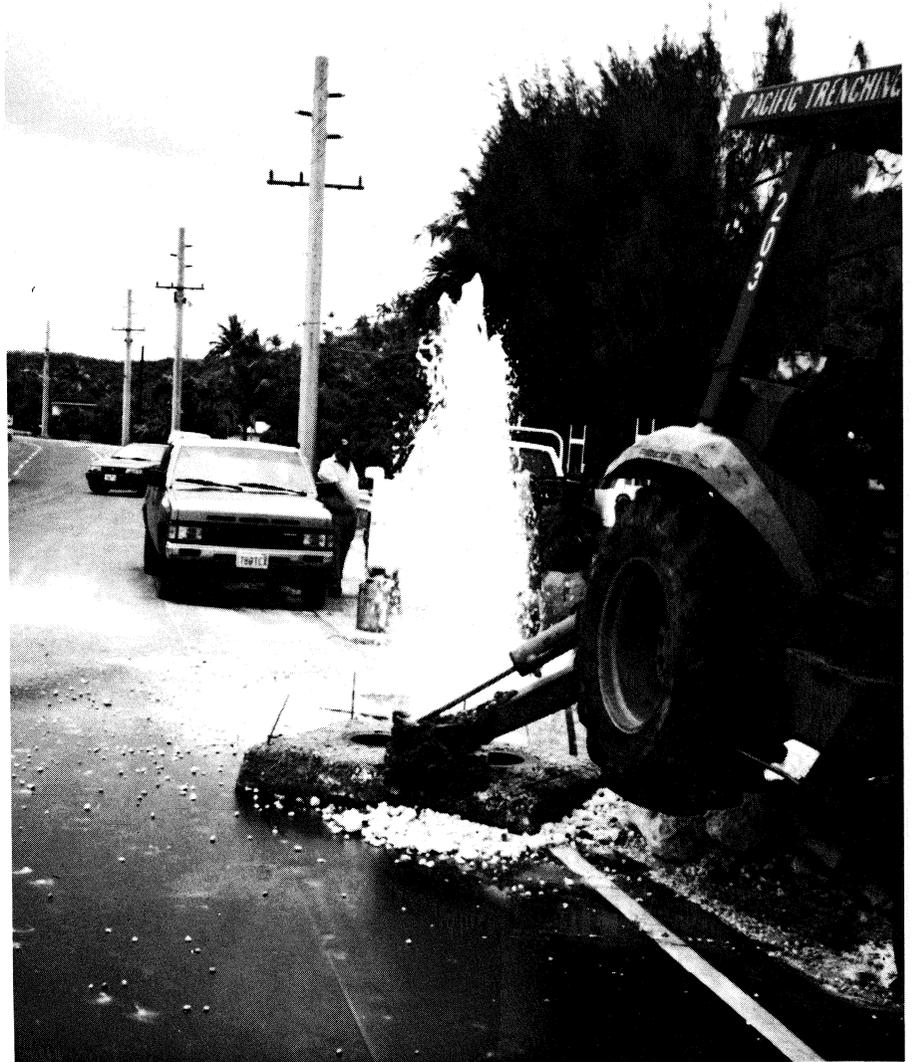
The PUAG water and wastewater system management indicated that all wells, pumps, storage tanks, and treatment plants survived the earthquake without significant damage (Figure 6-3). Restoration of service however was limited by damage in the buried piping systems.

As of Saturday, the sixth day after the earthquake, over 100 breaks had been reported in water mains. Nevertheless, most of system remained pressurized in the heavily populated areas surrounding Agana. Most of the pipe failures appeared to be leaks rather than ruptures. There were, however, instances of total loss of flow in water mains. Within the firm limestone site of Anderson Airbase, for example, a six-inch water line fractured and offset 12 inches.

Figure 6-3: The Public Utility Agency of Guam (PUAG) reported no damage to their welded steel storage reservoirs or the Ugu Water Treatment Plant (above). Over 100 breaks occurred in the island's 500 miles of buried water mains. Repairs are underway to a broken main near Agana at right.

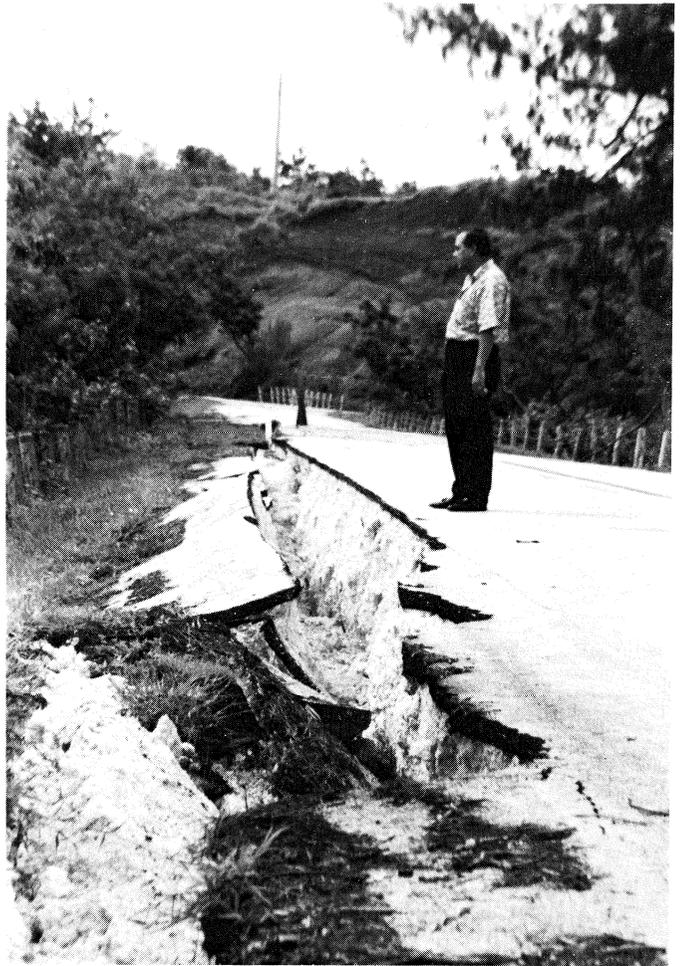
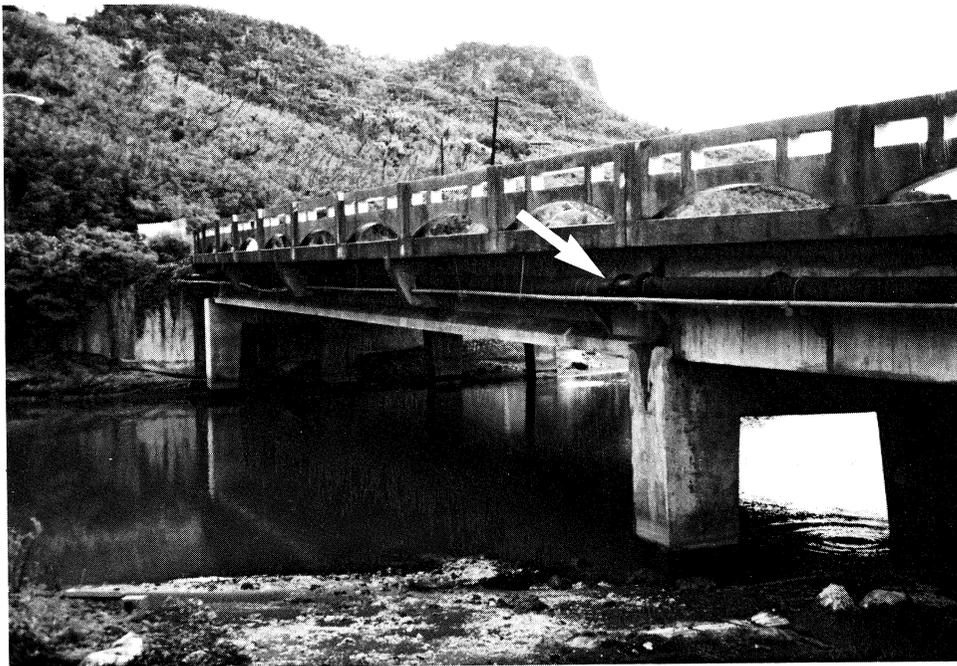
The island's system of two-lane paved highways experienced local slumping or spreading in pavement at a few locations, typically on hillsides (Figure 6-4). Rock slides dumped debris on roads. It was not necessary however to close any roads due to damage.

There was no major damage to any of the island's concrete beam bridges. Several bridges were closed for about a day due to settlement at the abutments and minor cracking in the concrete. Bridges were reopened following inspection and repaving the approaches to compensate for abutment settlement.

Figure 6-4: Soil failure in the form of slumping or spreading damaged roadways in certain locations on the island. Concrete beam bridges suffered minor cracking and slumping at abutments. Water mains attached to the sides of bridges tended to fail due to differential movement at the interface of abutments (arrow, below)

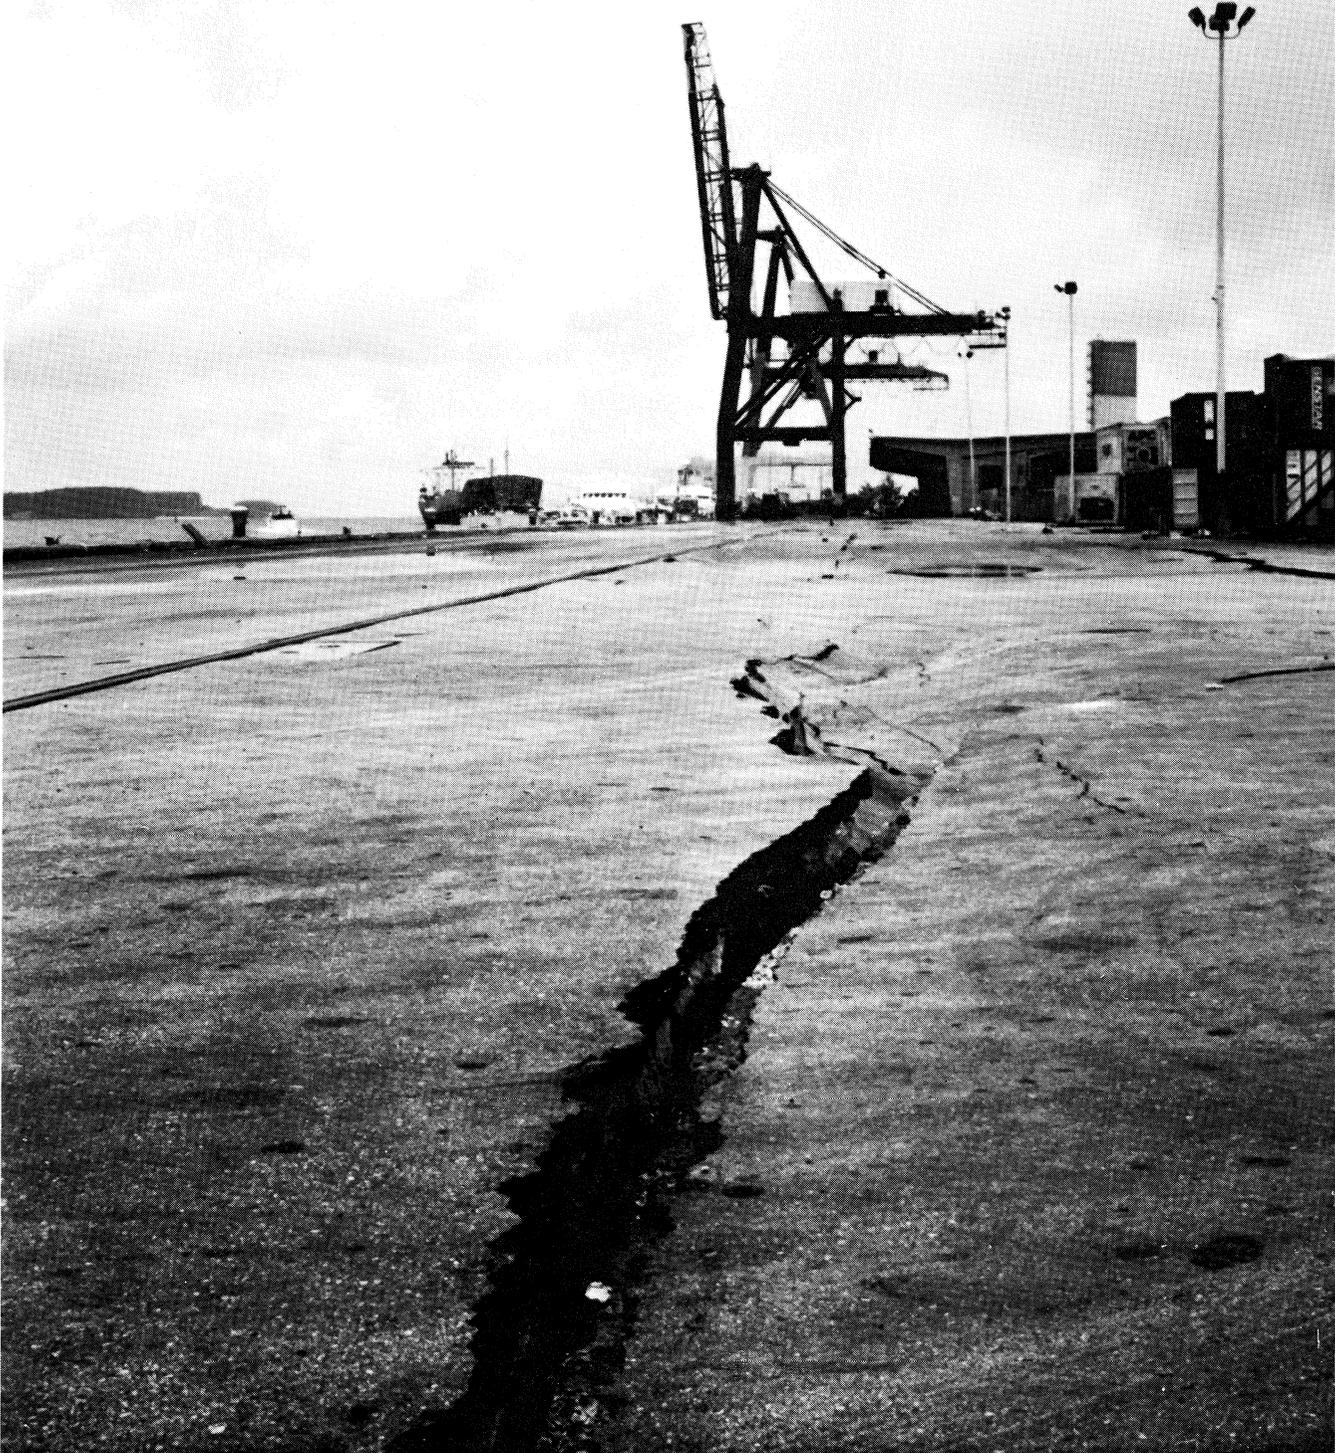
Figure 6-5: Perhaps the most serious effect from the earthquake was due to spreading of fill beneath the crane rails in the container handling section of the commercial port. Offset of the rails severely limits the travel distance of the gantry cranes, curtailing off-loading of container ships, the primary source of supply to the island.

Repairs to the port would involve recompacting the fill in the area of soil spreading, and replacing the rails and pile foundations beneath. In the meantime, service to container ships in the commercial port would be sharply curtailed. The older section of the port, which was relatively undamaged, could still offload non-container cargo from smaller vessels. This, however, seriously reduces the flow of material into the island. Shortages in certain commodities were starting to be seen within a week of the earthquake.
