# Hokkaido Nansei-oki, Japan Earthquake of July 12, 1993

P.I. Yanev and C.R. Scawthorn

Technical Report NCEER-93-0023

December 23, 1993

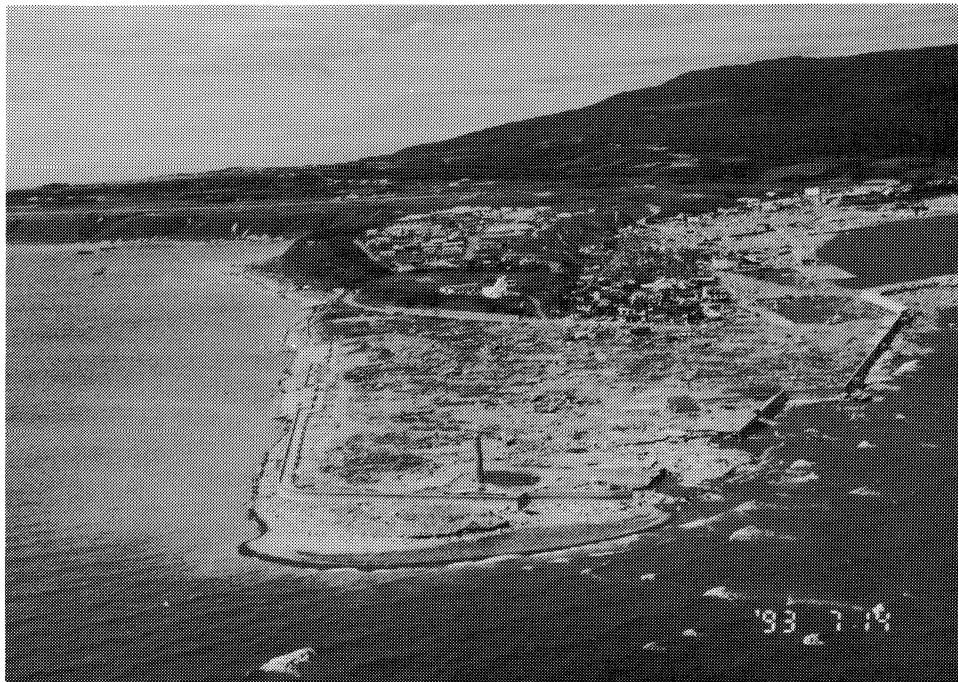
Figure 6-4: The sea-level southern tip of Aonae showing near total destruction of buildings. All destroyed buildings, mostly two-story, were wood frame. Note that the area is completely surrounded by protective, up to 4.5-m tsunami walls. They were ineffective in preventing the destruction, although they probably moderated the height of the run-up, which was 10 to 15 m high. The lower photograph shows much of Aonae, looking south. Photographs by K. Kawashima.

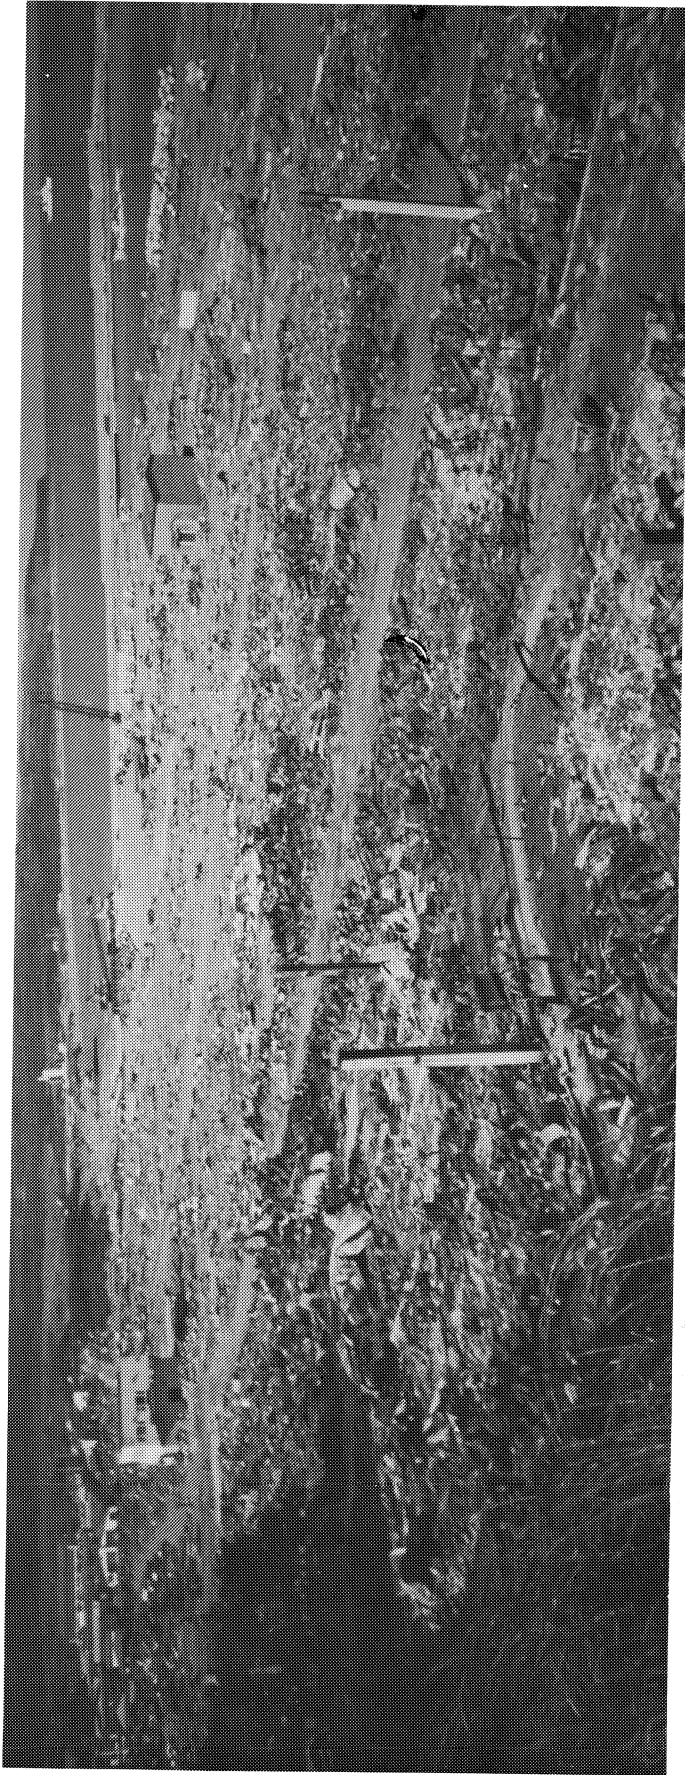
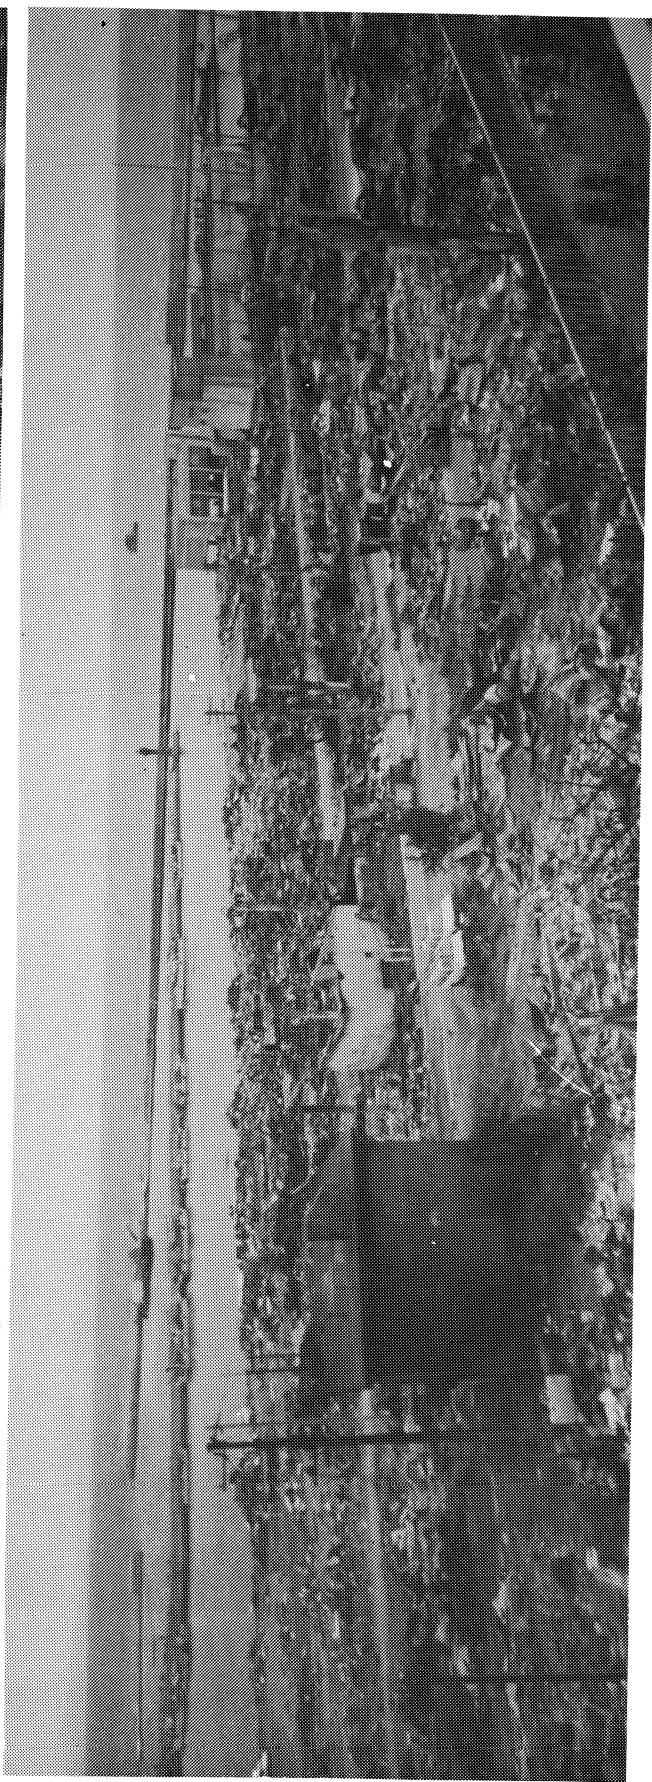
Figure 6-7: Fire and tsunami damage in the central area of Aonae. The area in the forefront has been burned. Note that the tsunami did not topple buildings whose chimneys are still standing. The area in back of the street in center has been obliterated by the tsunami.

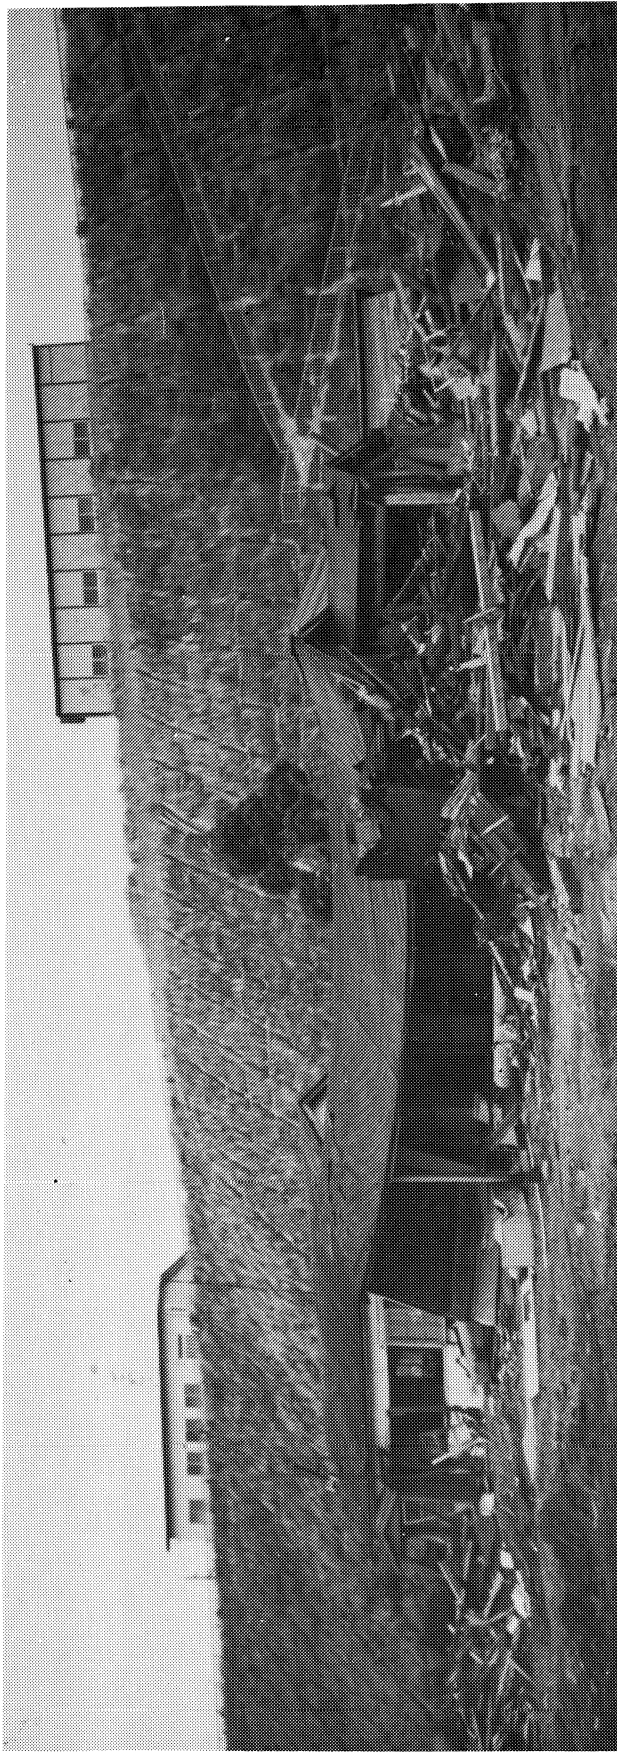
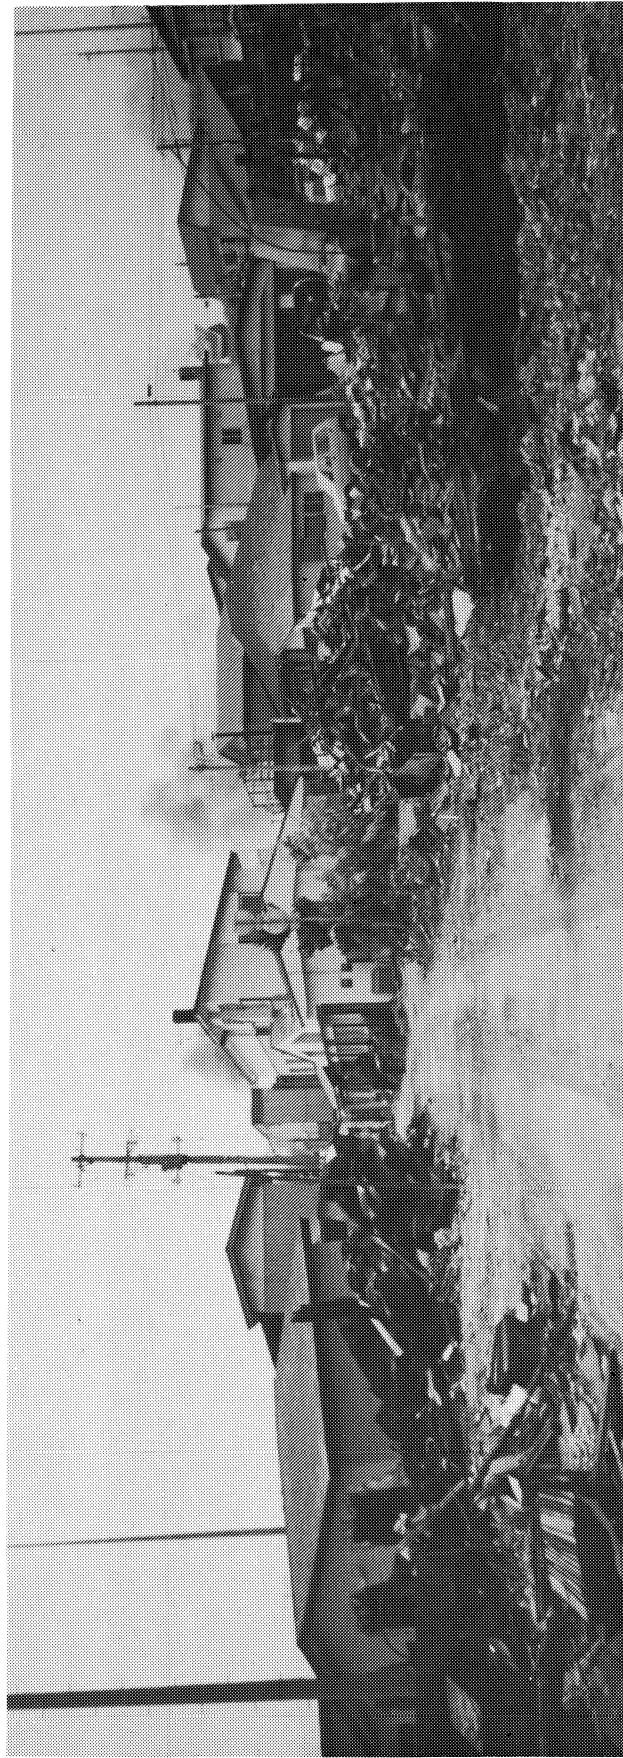
Figure 6-11: Damage to wood-frame buildings from tsunami run up in Aonae at the far edge of the heavily damaged area.

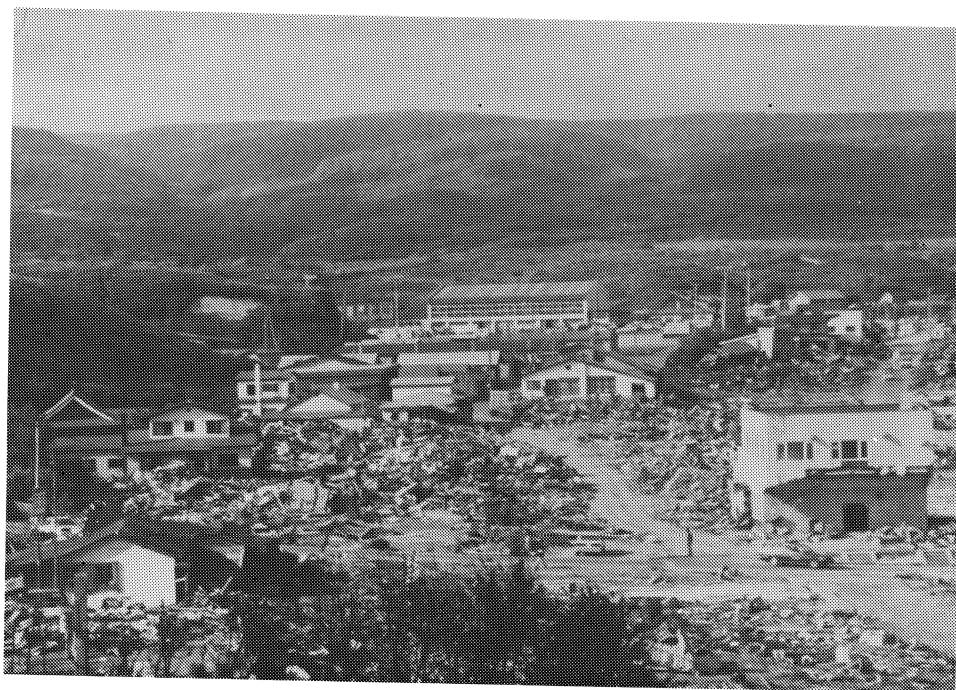
Figure 6-13: A partial view of the central part of Aonae showing tsunami destruction and a surviving steel-frame building on the left. It protected a small wood-frame building (shown in the next photograph)--the only such survivor in this area.

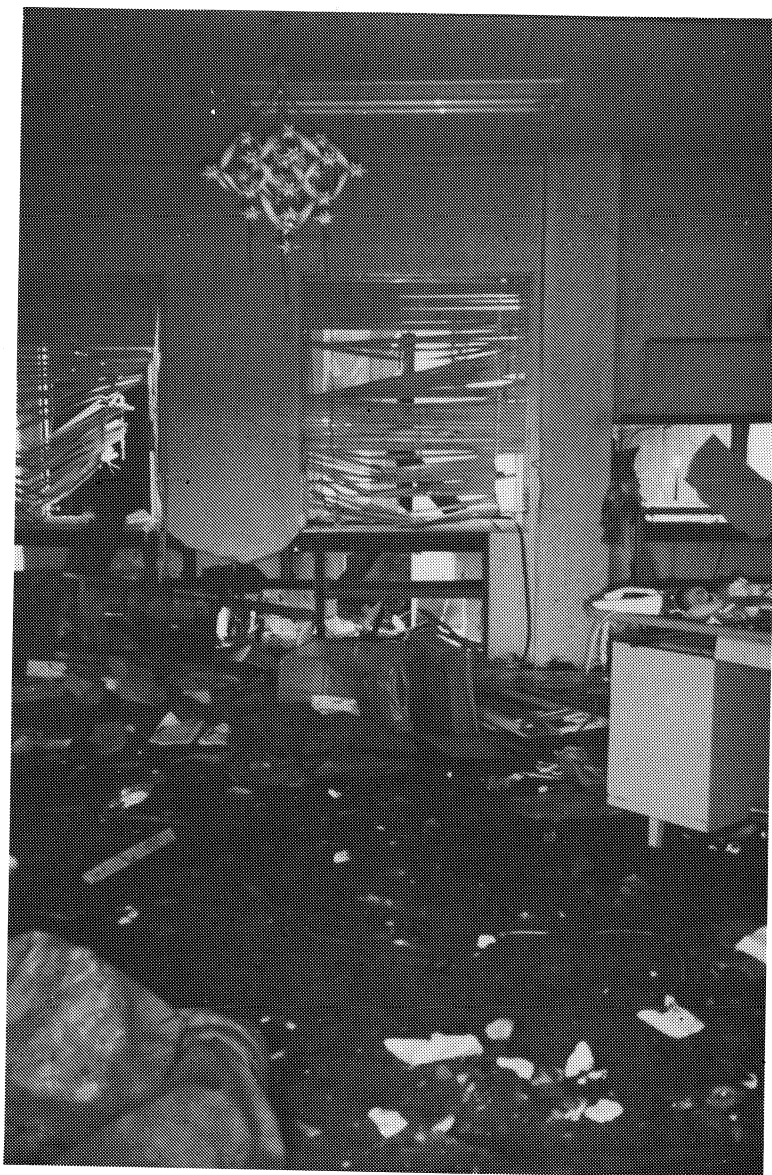
Figure 6-15: The ground floor of the steel-frame two-story building shown in the previous photographs.

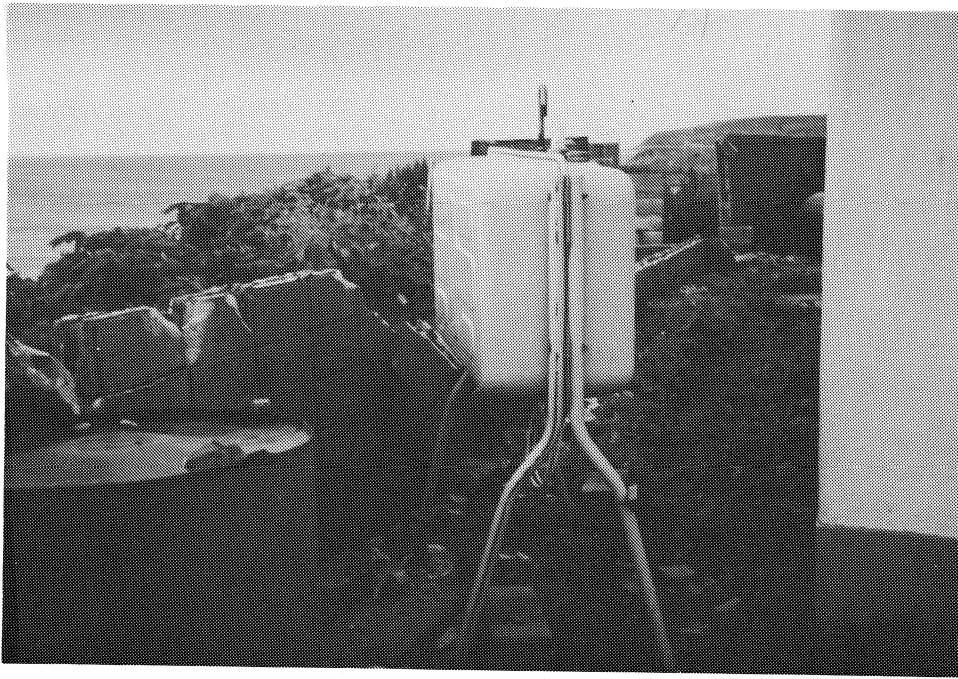
Figure 7-4: A typical kerosene tank for a small building. The fuel is used for heating in Japan (including Tokyo). This tank, in Aonae at the lighthouse, was not anchored and tipped over, severing the small fuel line which is typically about 1/4 inch (0.5 cm) in diameter. Numerous such tanks, many tipped over, were observed on the Island of Okushiri and on Hokkaido (following figure). They are very hazardous and contributed to the fire that destroyed much of the town of Aonae following the earthquake and tsunami. There seemed to be no enforced requirement to anchor such tanks. That practice needs to be changed.

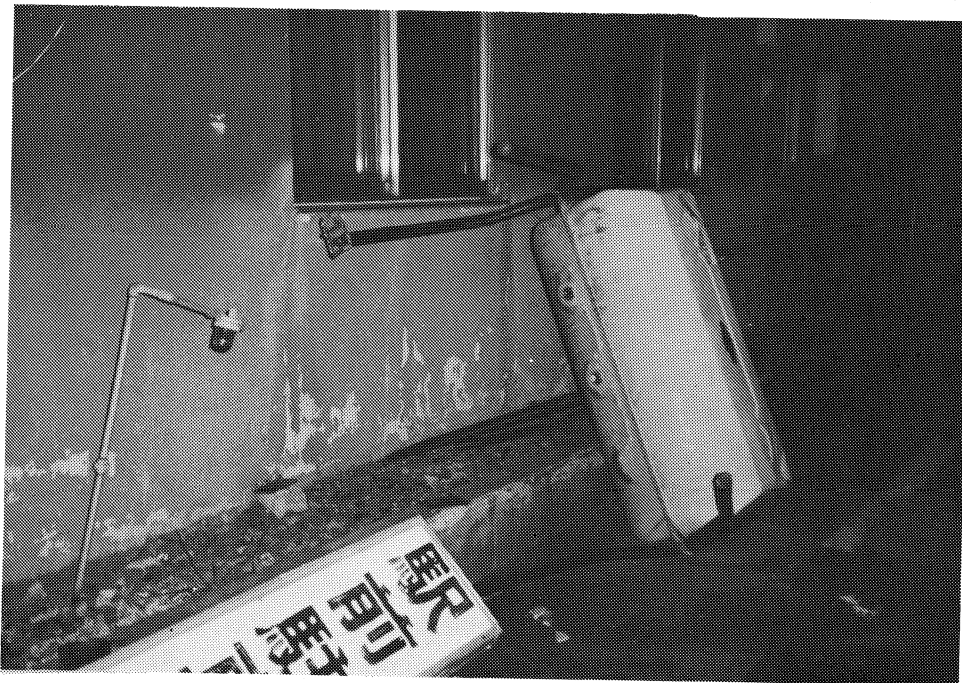
Figure 7-5: An overturned exterior kerosene tank in the town of Kuromatsunai. The highest horizontal acceleration recorded in the main earthquake (0.50g) occurred a few meters away from the tank.

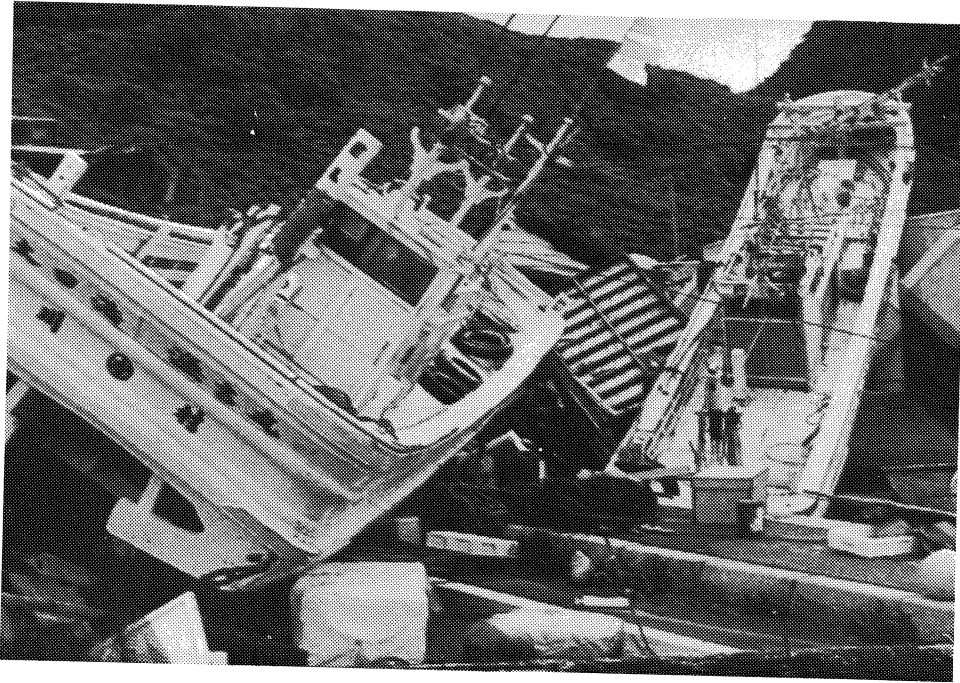
Figure 7-7: Many boats were deposited far inland, some among buildings. It is believed that much fuel was spilled in this way, contributing to the fire and its spread.

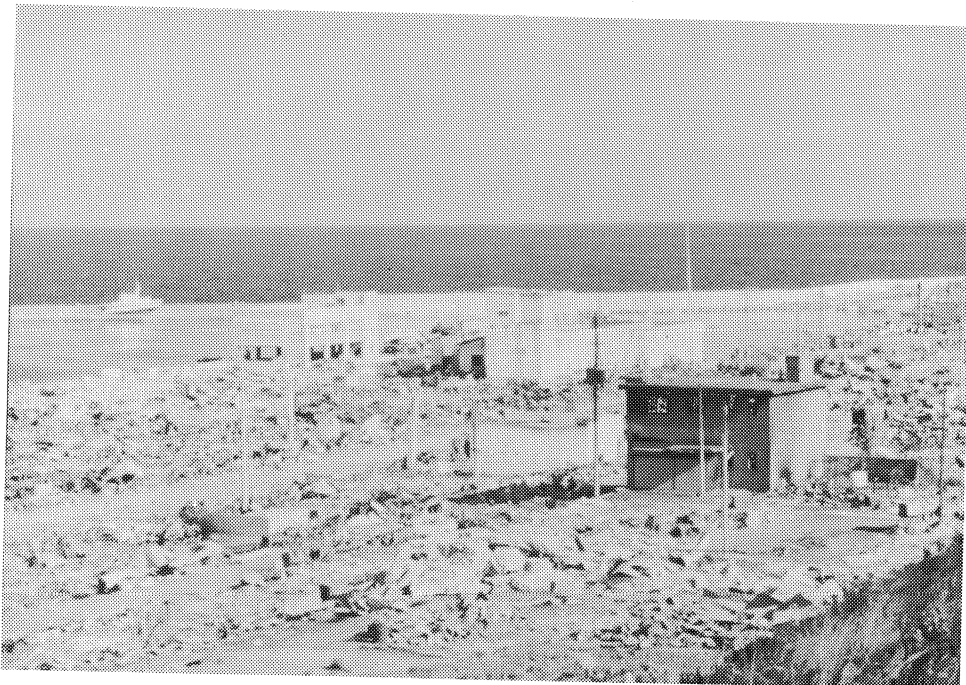
Figure 7-8: A view, looking southeast, of the central port area of Aonae showing tsunami and fire devastation. The only surviving buildings are more substantial concrete-frame buildings. No steel buildings were found in this area.

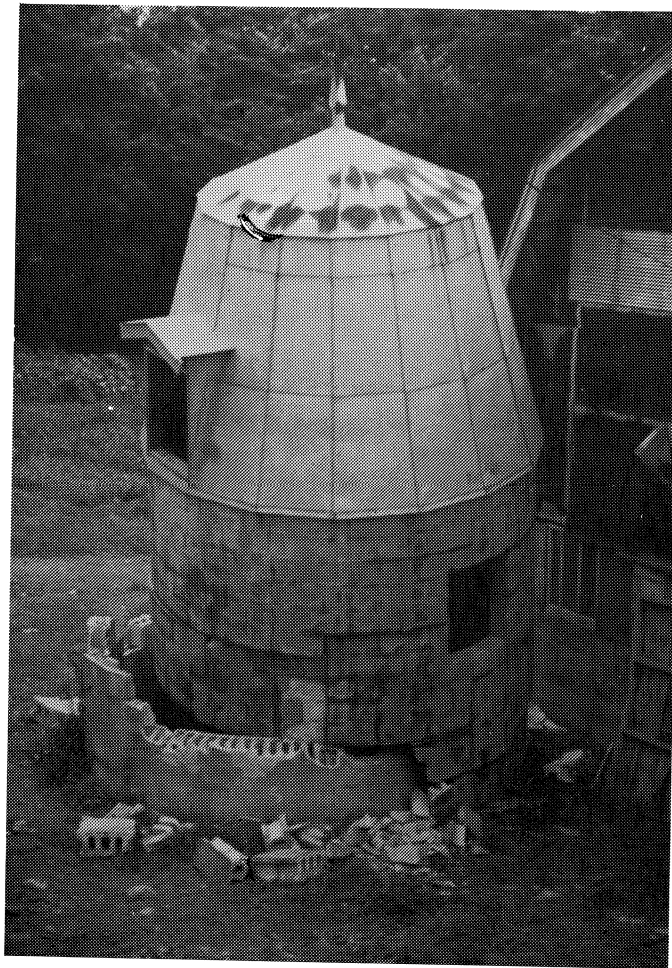
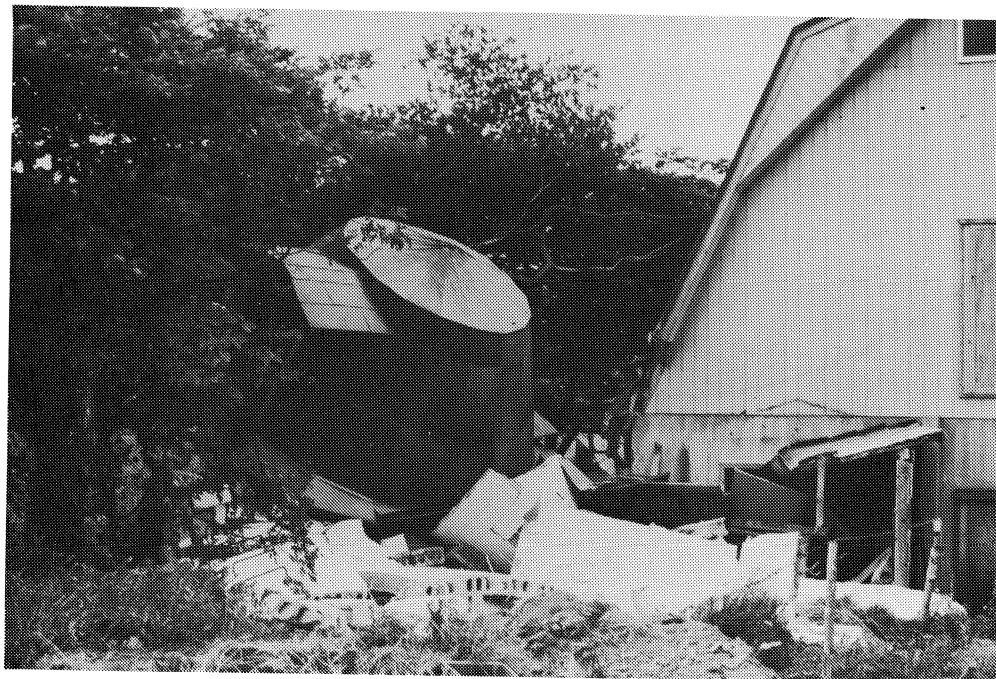
Figure 8-1: Typical collapsed unreinforced concrete-block silos a few kilometers north of Aonae.

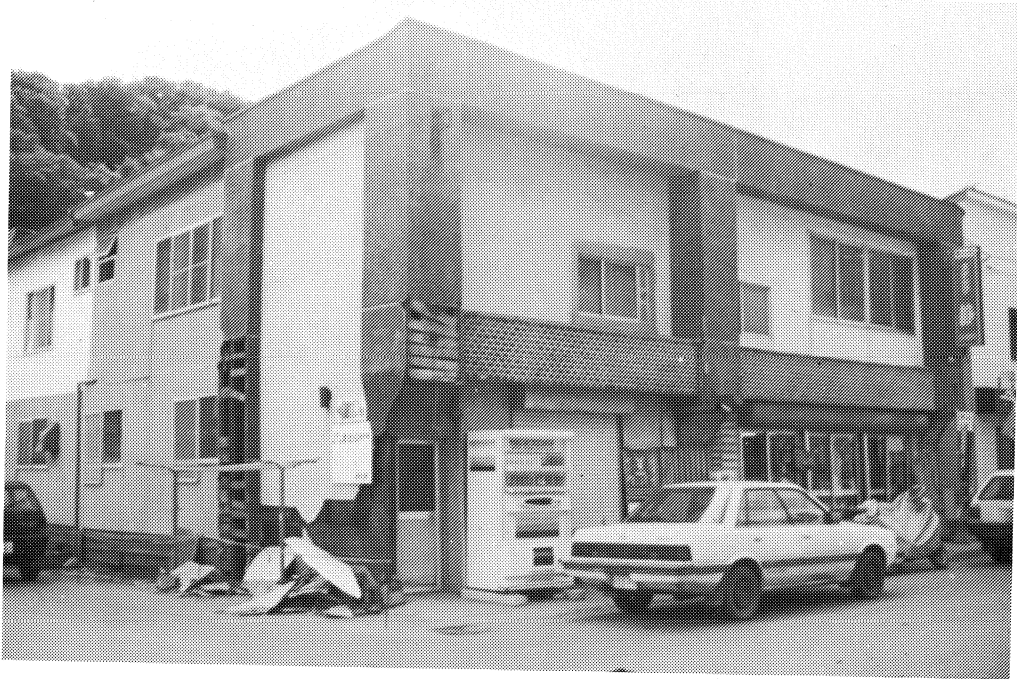
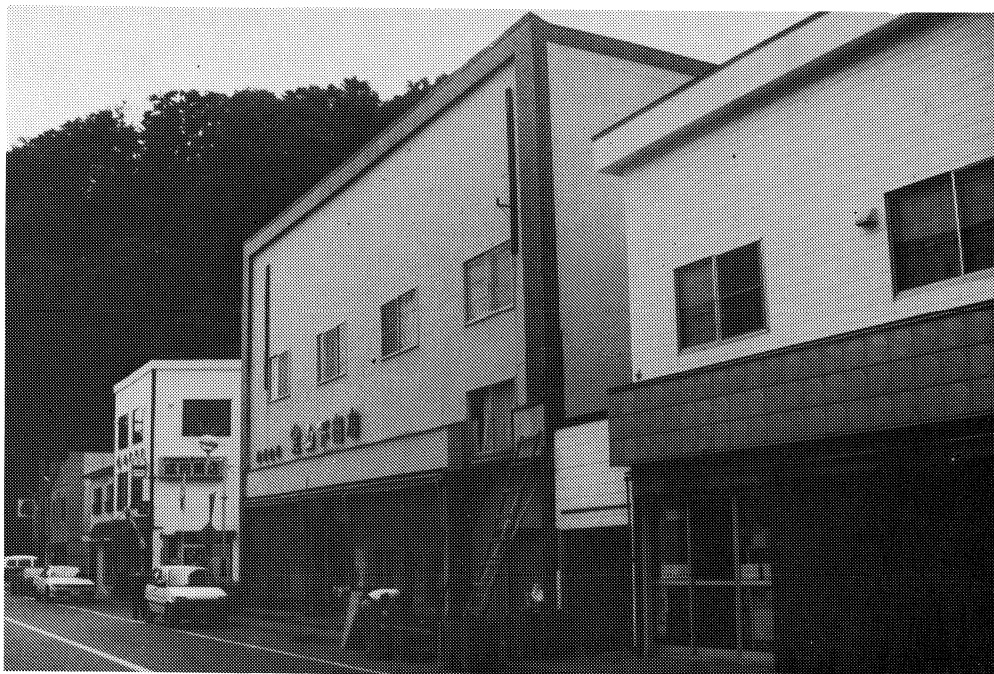
Figure 8-2: Lightly damaged commercial buildings in Okushiri-cho. Typically these buildings are wood-frame with stucco. Note the damaged stucco and brick veneer.

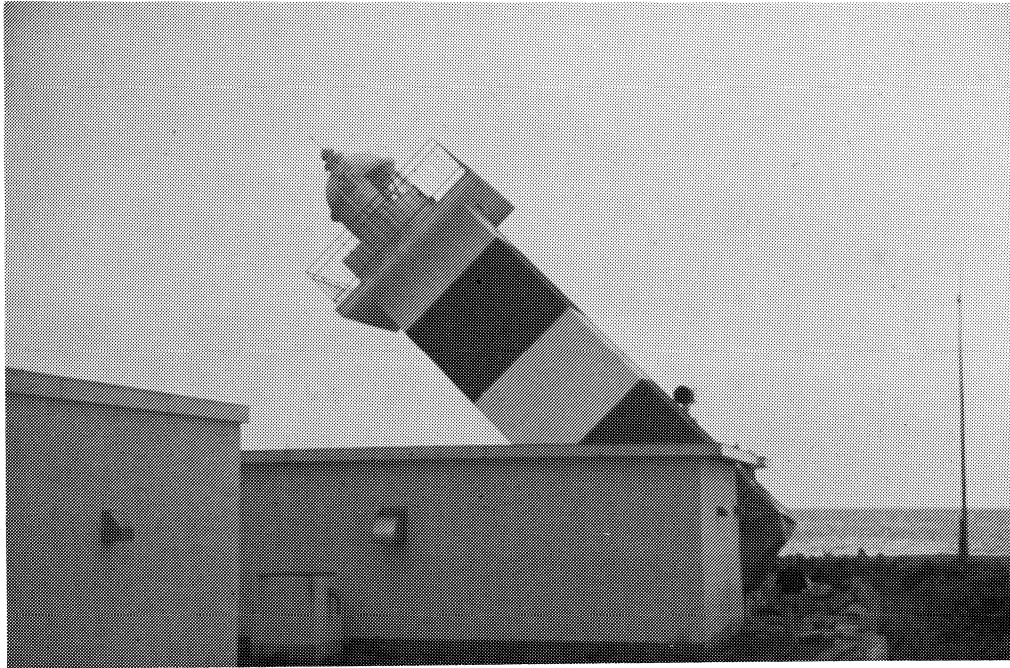
Figure 8-7: The Aonae lighthouse collapsed during the earthquake. The failure was caused by fracture of the tower structure at the base, along with pull-out of reinforcing steel dowels from the foundation. The inspection indicated an apparent bond failure of plain J anchorage bars (approximately 24 mm in diameter).

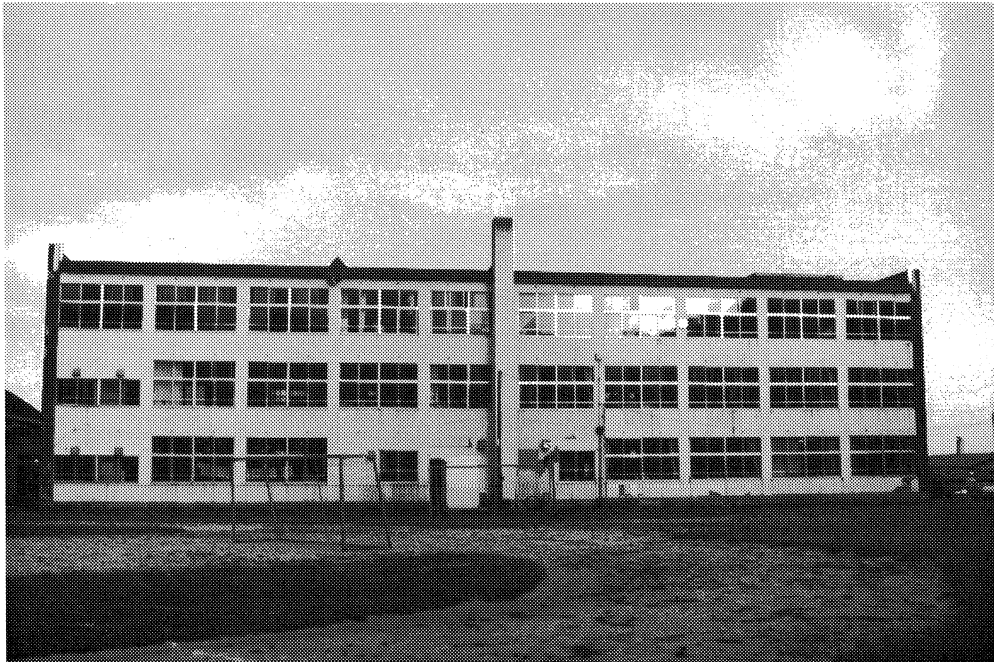
Figure 8-9: Aonae Elementary School, a typical 1950s through early 1970s nonductile concrete-frame building (preceding the lessons learned from the 1971 San Fernando, California, Earthquake). The school, on level ground at sea level, suffered extensive cracking of frame and concrete-block infill-wall elements. These types of buildings have historically suffered extensive damage in Japan (Sendai Earthquake of 1978) and California in 1971, 1979, 1989, etc.). Extensive strengthening of these kinds of buildings has been carried out for all California public schools of similar construction.

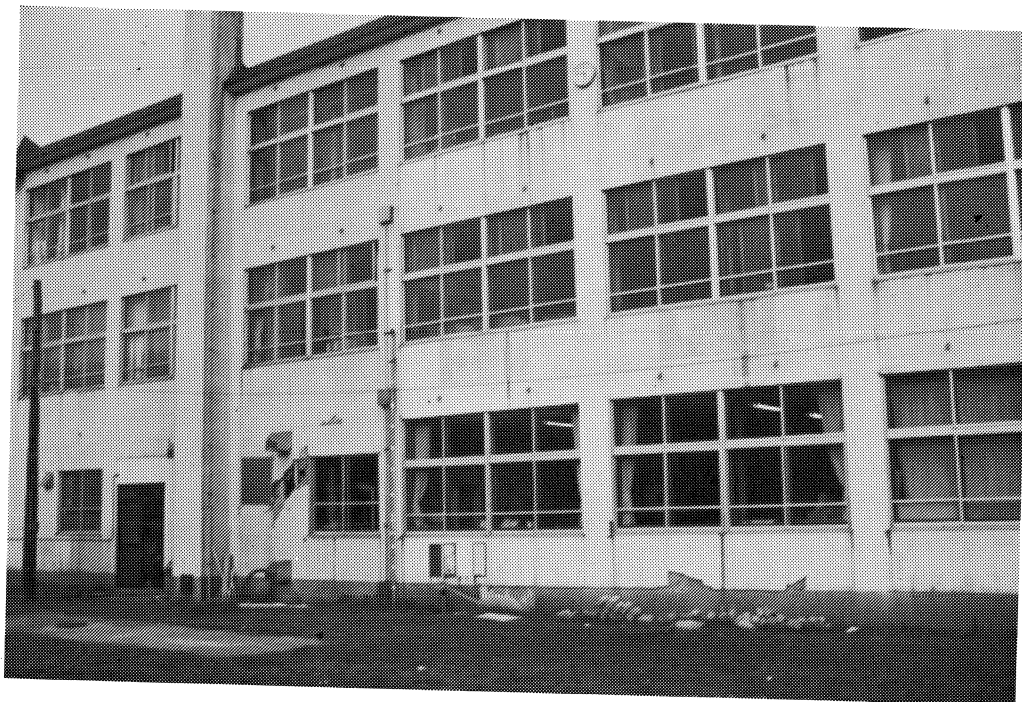
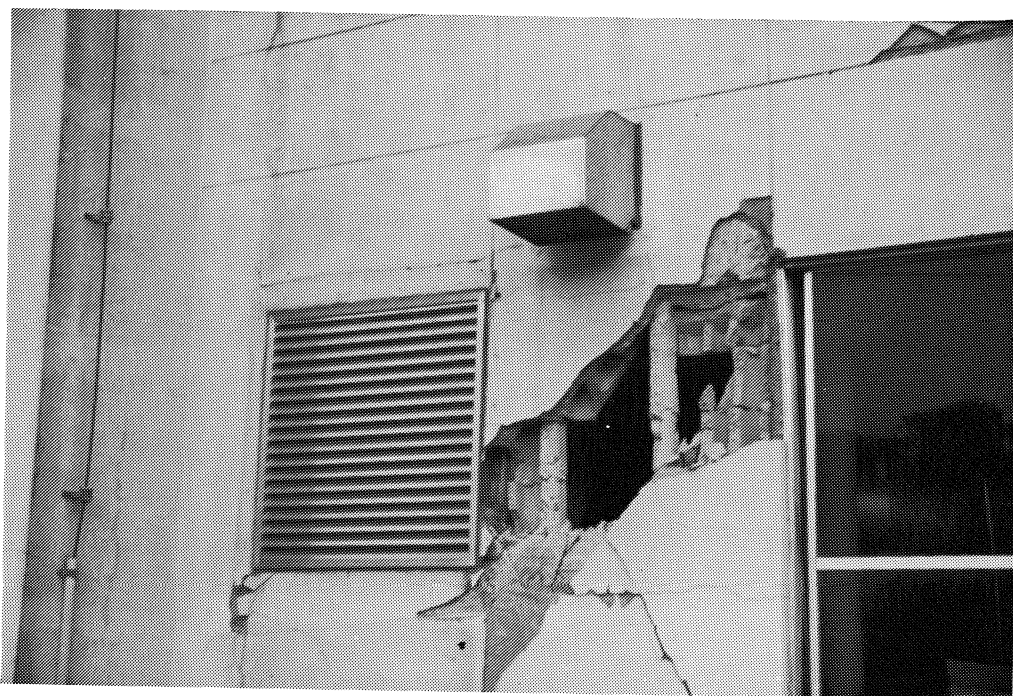
Figure 8-10: Aonae Elementary School damage.

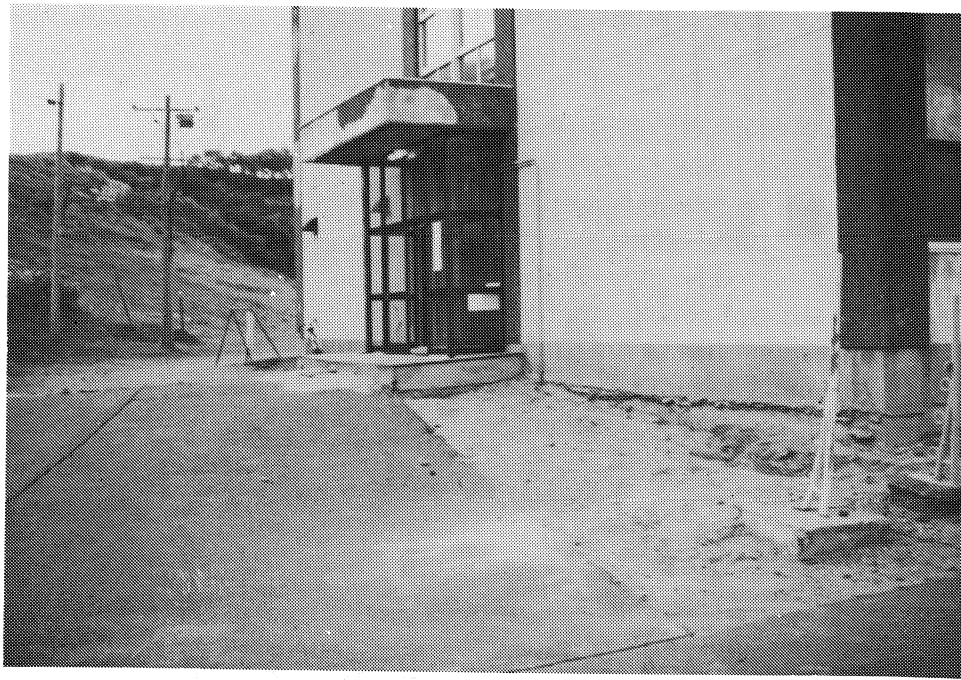
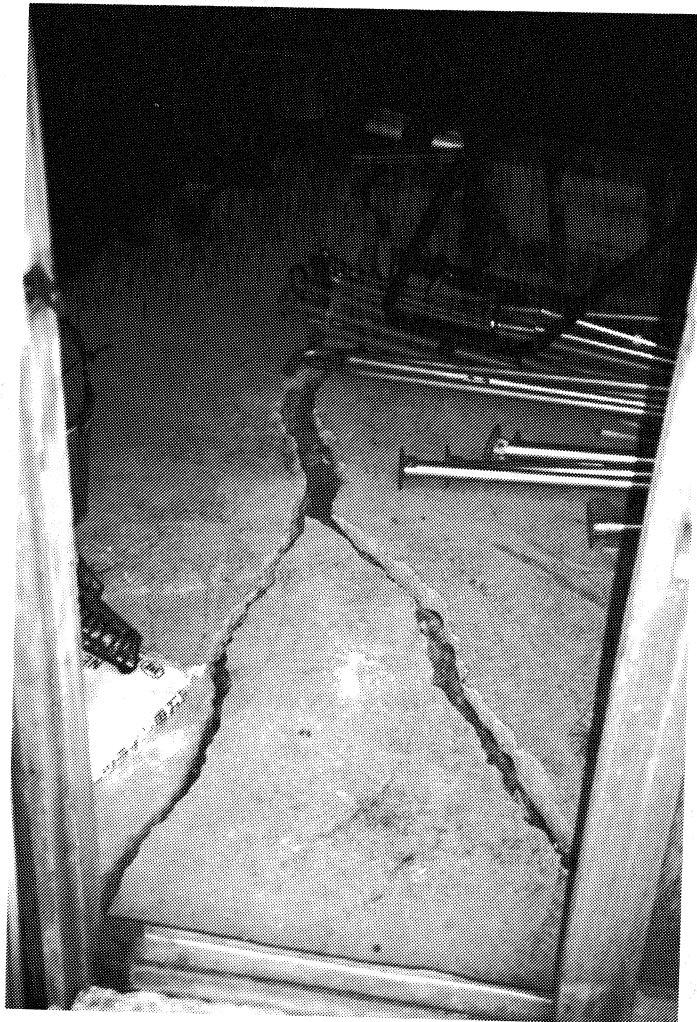
Figure 8-12: Aonae Elementary School. Settlement of fill in the southeast corner of the three-story building (upper photograph) and a cracked floor slab (lower photograph) indicate that the ground failure extended below the structure.

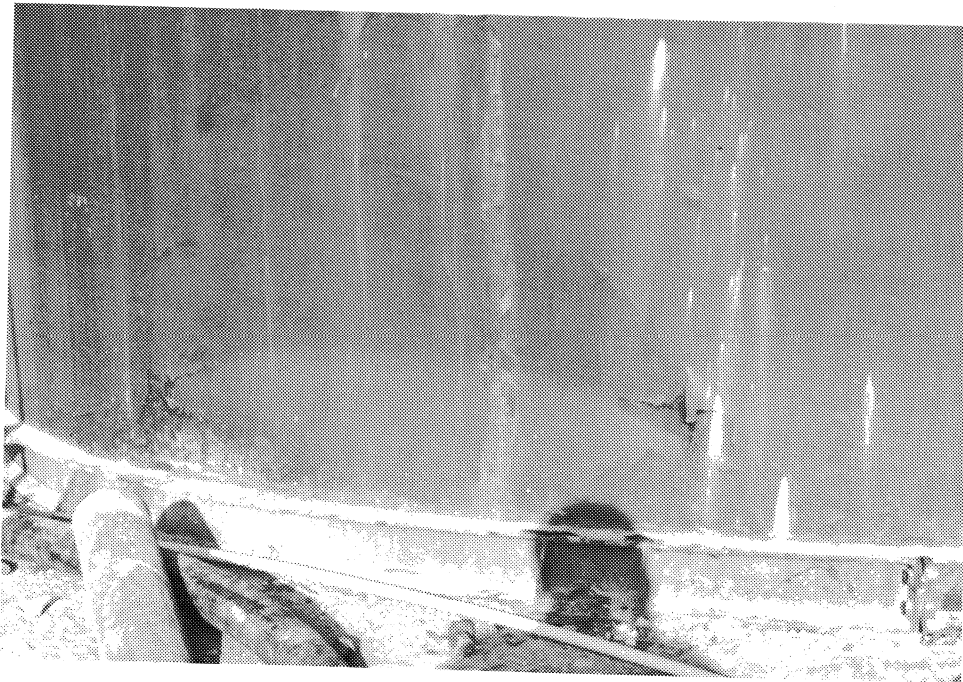
Figure 8-19: OCBP; buckling at the base of one of the two cement silos. Note the damage to the anchorage.

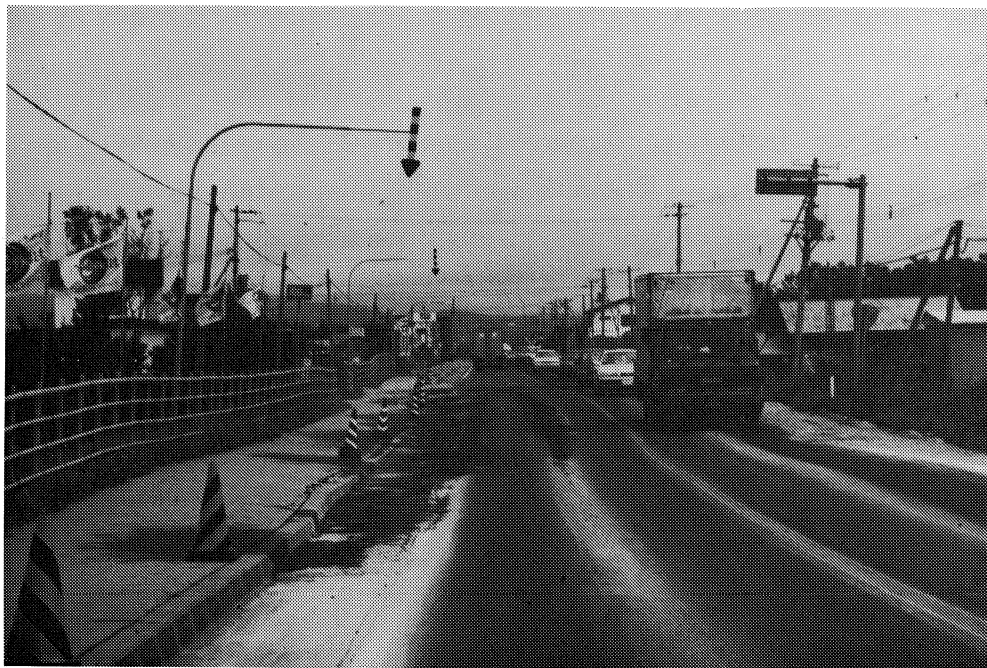
Figure 9-1: Typical damage to roads, at Highway 5 south of Oshamanbe, from liquefaction and/or lateral spreading. Many of the coastal stretches of the road had a roller-coaster appearance following the earthquake.

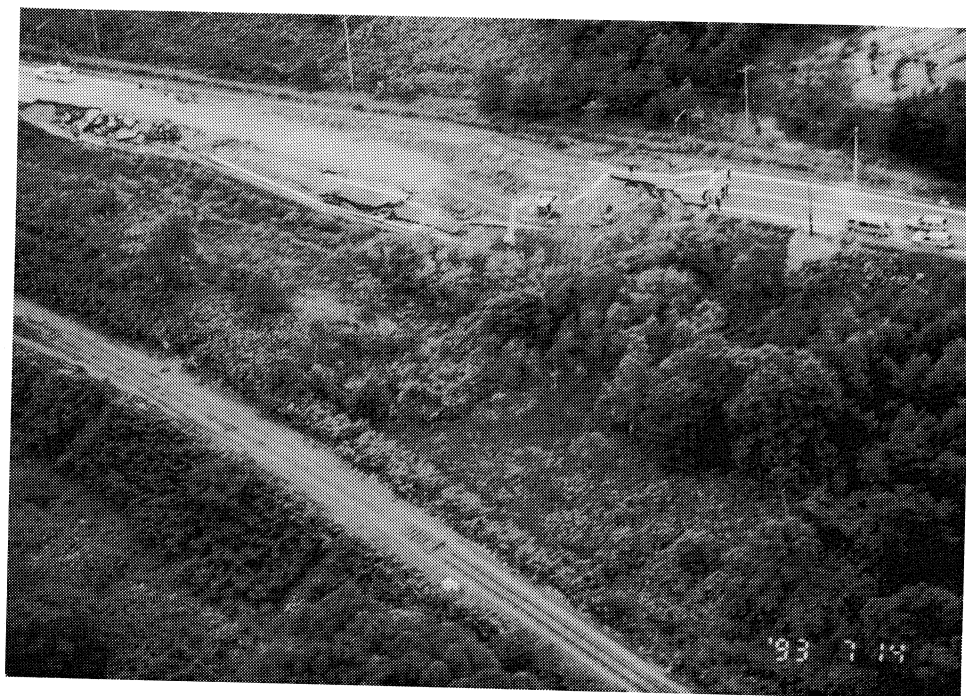
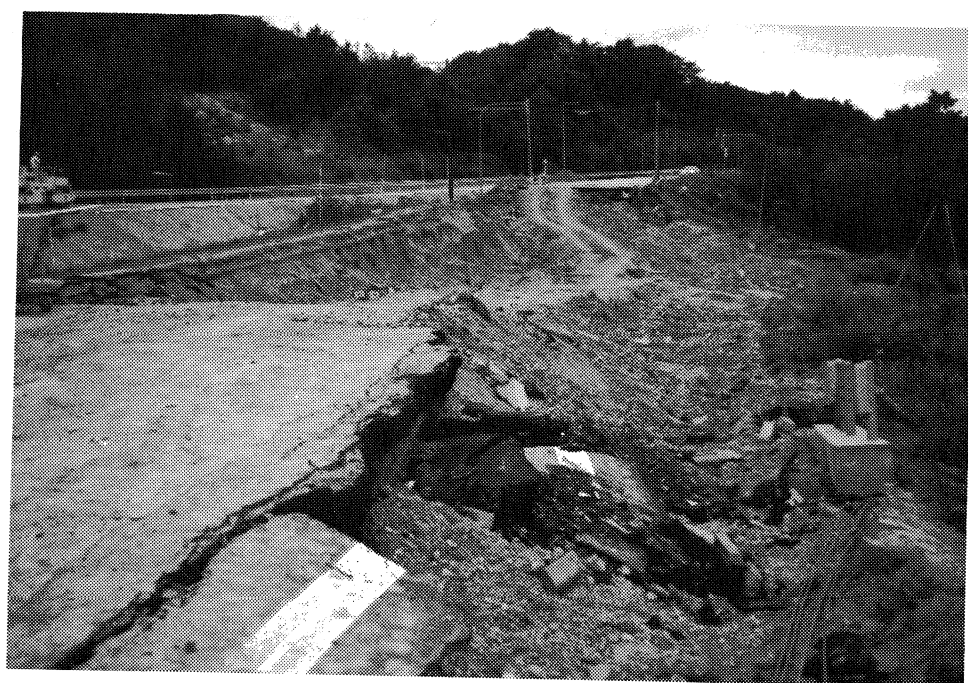
Figure 9-2: The embankment of Highway 5 near Kuromatsunai failed in a flow-slide, taking out both the road and a railroad embankment (which is at the bottom of the upper photograph). Upper photograph by K. Kawashima.

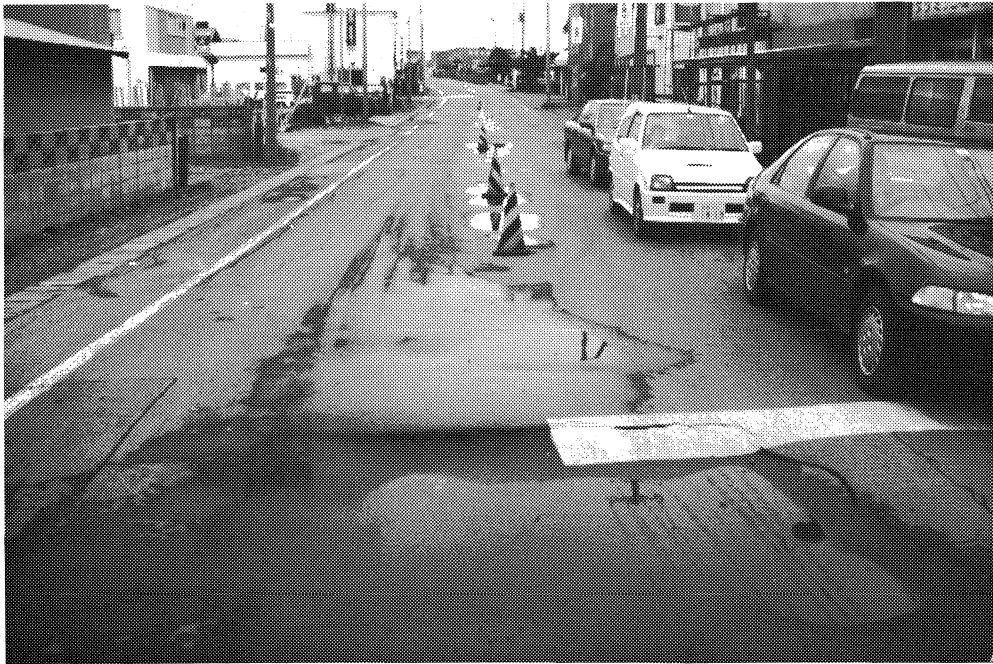
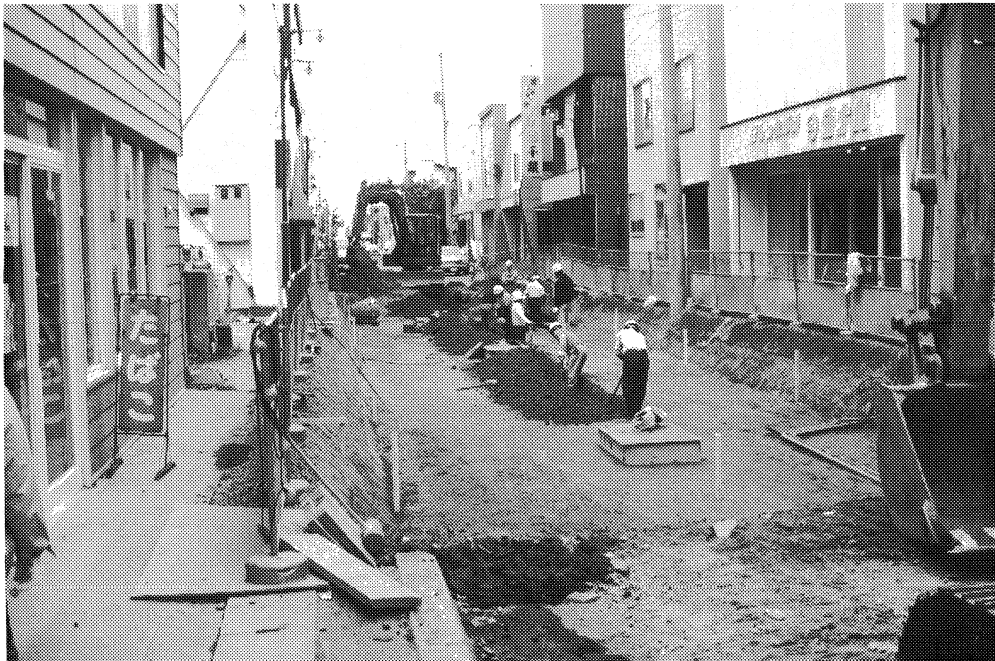
Figure 9-3: Many town streets suffered settlement damage, affecting both paving and various underground utilities. These are examples from Oshamanbe and Setana on Hokkaido.

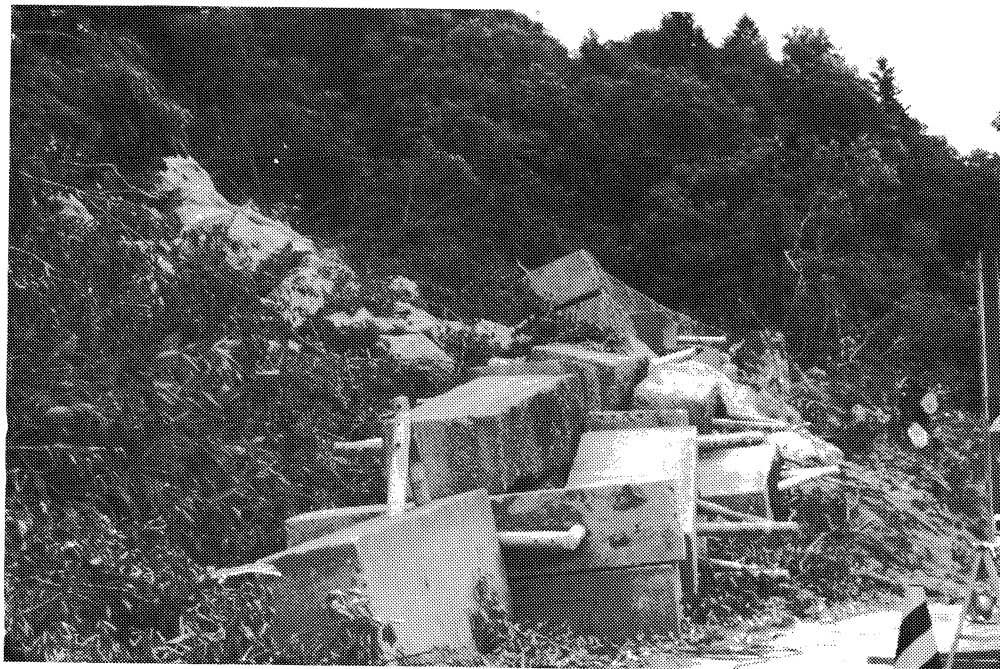
Figure 9-4: Landslide damage to a retaining wall along Highway 230 near Setana.

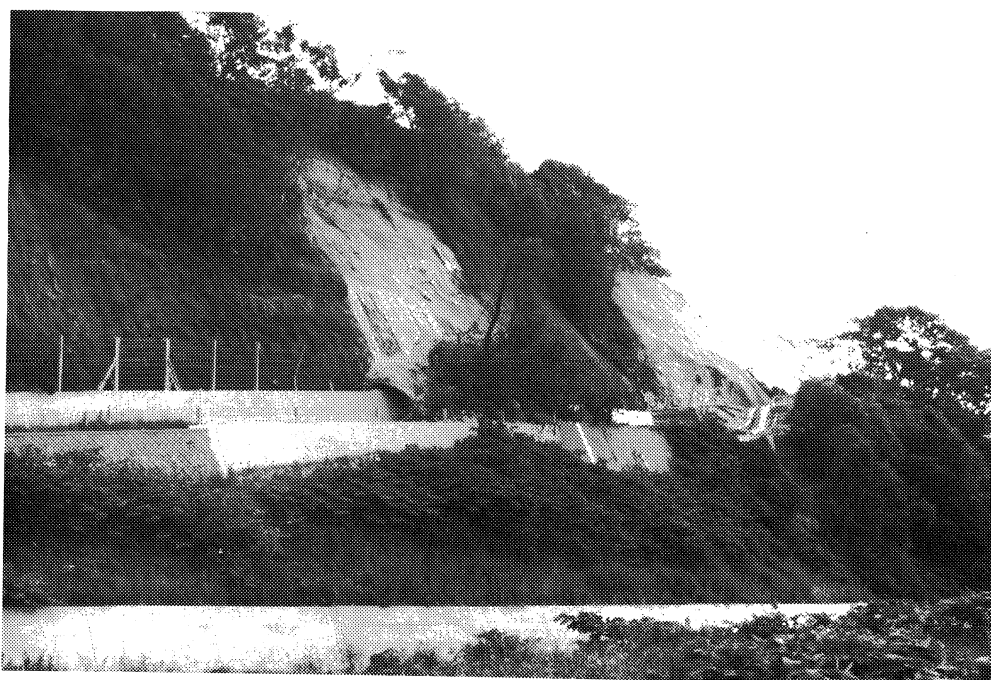
Figure 9-5: Large landslides severed a local road on Okushiri Island, on the plateau north of Aonae in an area of generally higher ground-motion intensities. Several unreinforced hollow-block masonry silos collapsed in this area (see Figure 8-1).
