# Hokkaido Nansei-oki, Japan Earthquake of July 12, 1993

P.I. Yanev and C.R. Scawthorn

Technical Report NCEER-93-0023

December 23, 1993

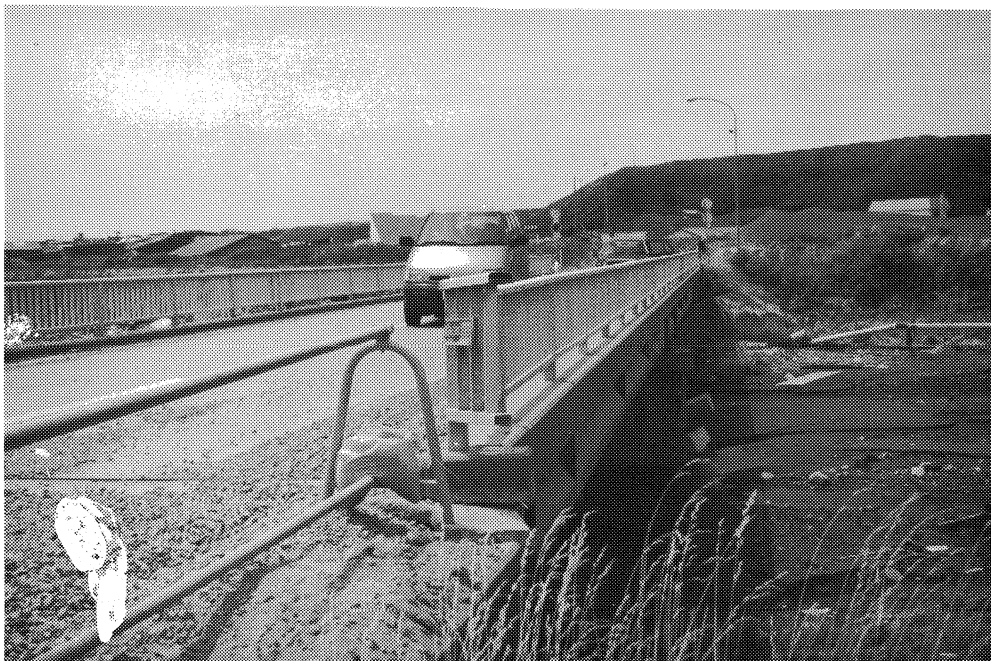
Figure 9-7: A two-lane bridge at Aonae on the coastal road from Okushiri-cho. The bridge was inundated by the tsunami. It suffered minor damage, such as slumping and erosion of abutment fill. One- and two-story wood-frame structures in its vicinity were obliterated by the tsunami.

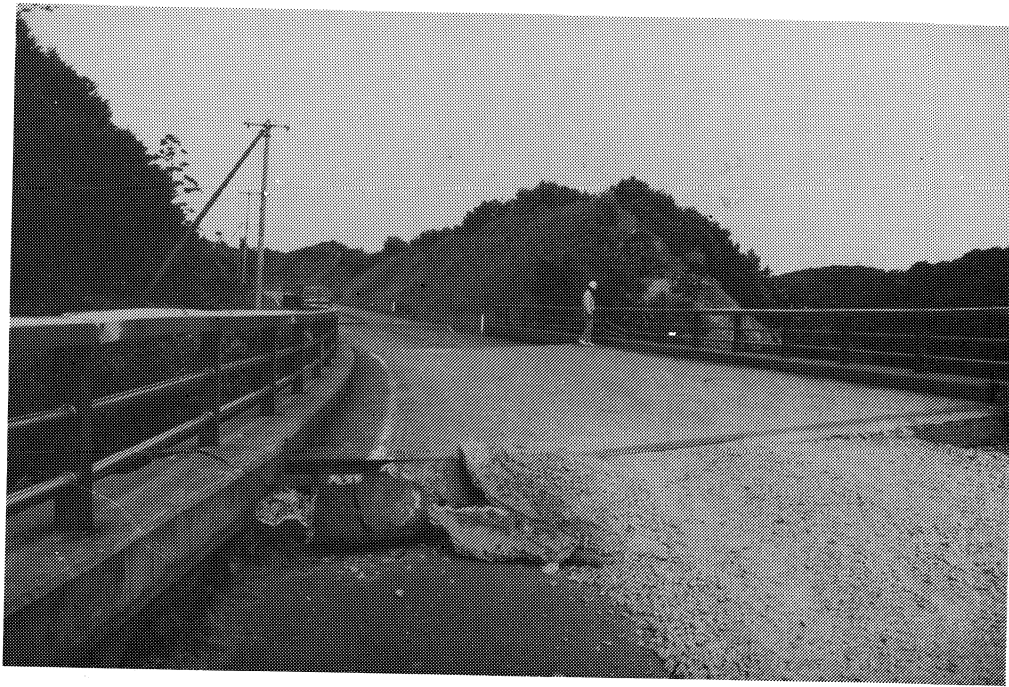
Figure 9-8: Typical road surface damage and abutment fill settlement at a bridge in Okushiri.

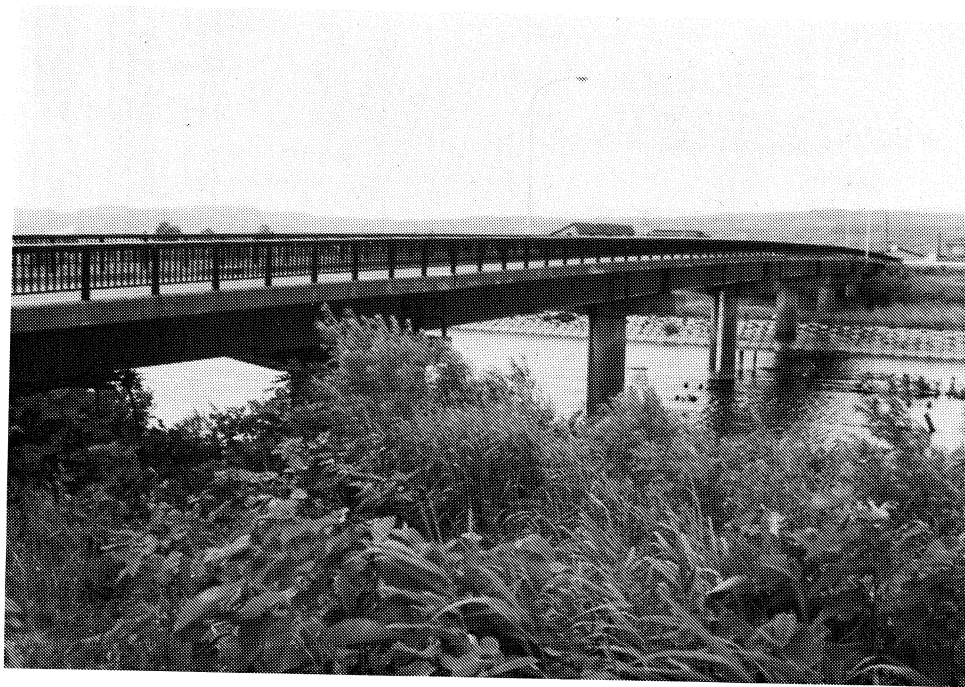
Figure 9-9: A six span, two-lane, 156-m-long, 1970 steel plate girder bridge at Azabu on Highway 277. The bridge suffered severe shear damage to all visible columns, which are about 2 m in diameter. The bridge is located about 70 km from the eastern edge of the aftershock zone. No significant damage to the superstructure was observed. The following figure shows drawings of the bridge.

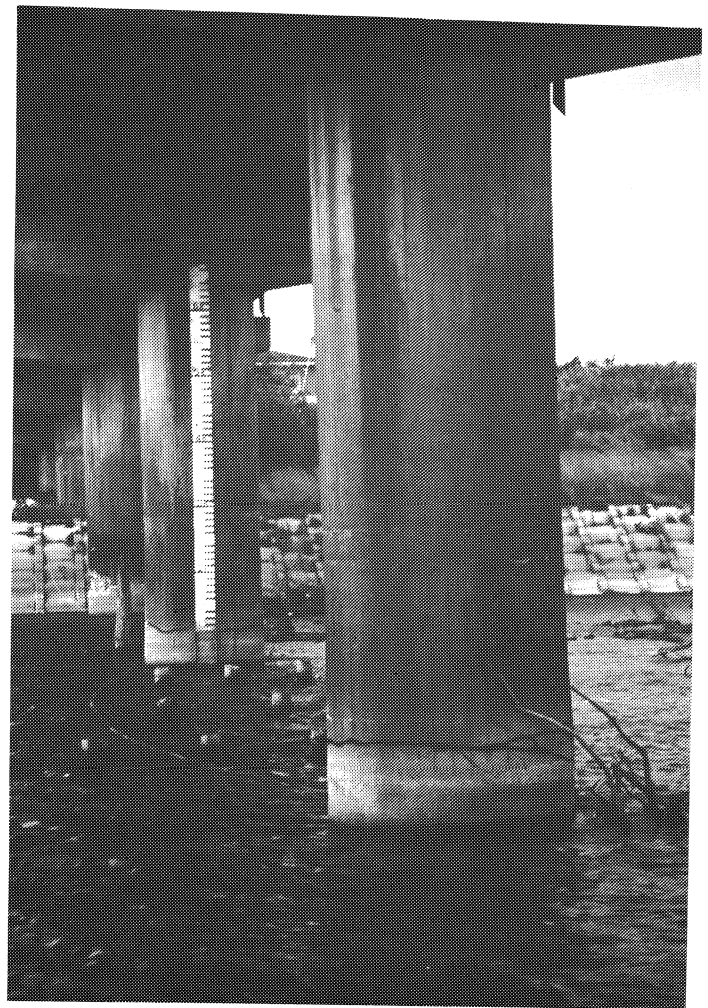
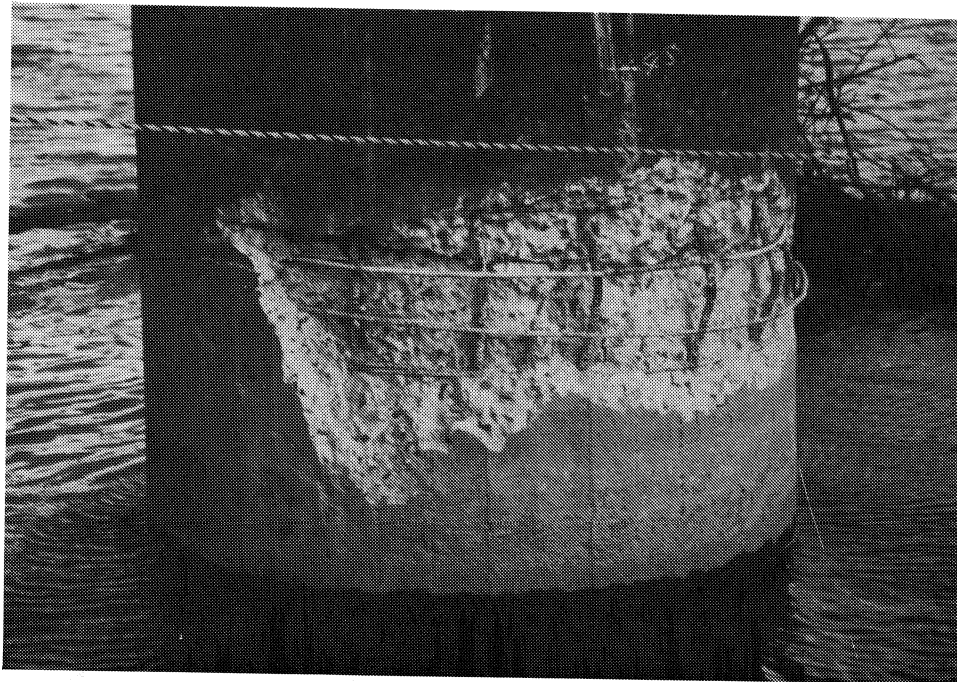
Figure 9-12: Detail of a damaged column of the bridge over the Azabu River. Note the buckling of the vertical reinforcing steel and the wide spacing of shear (horizontal) reinforcement.

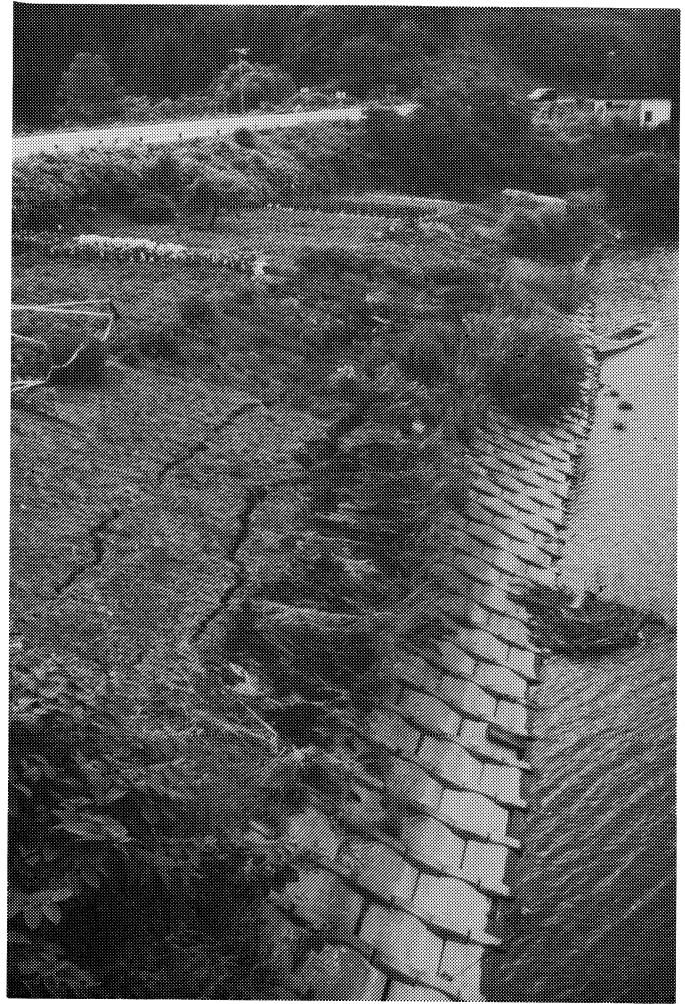
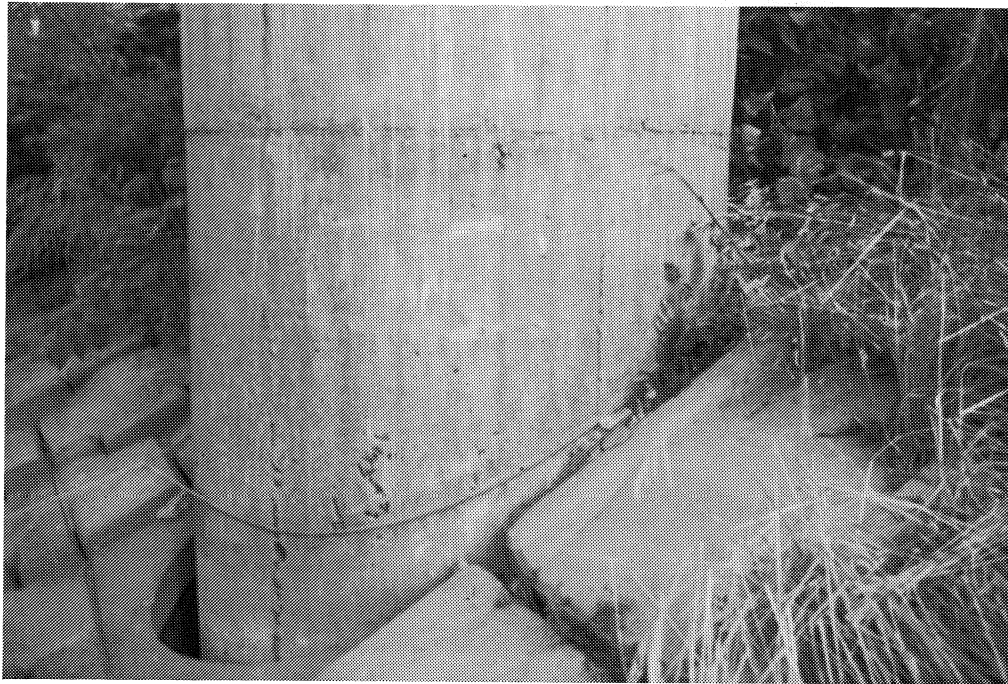
Figure 9-14: Azabu Bridge--settlement of fill (below the paving) away from a bridge pier due to lateral spreading of the fill into the river.

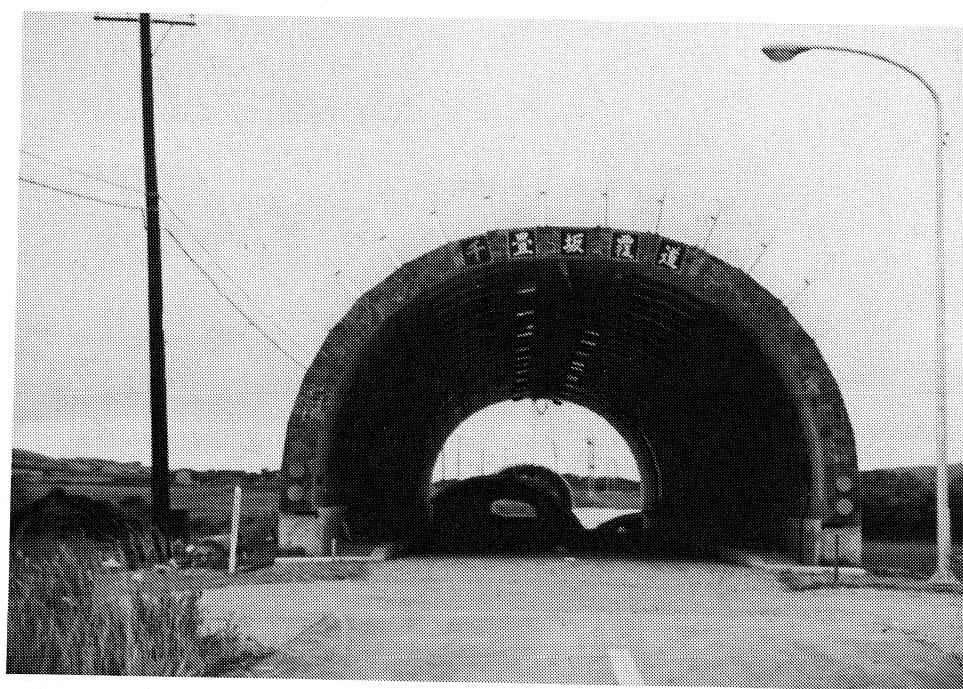
Figure 9-16: A collapsed snowshed (tunnel) north of Aonae. The just-completed structure is on fill in rice paddies. About one-third of the three-hinged arch structure collapsed. The rest is severely damaged. The approximately 2-m-wide quarter-circle panels are precast concrete and are bolted to the footings and to each other at the top.

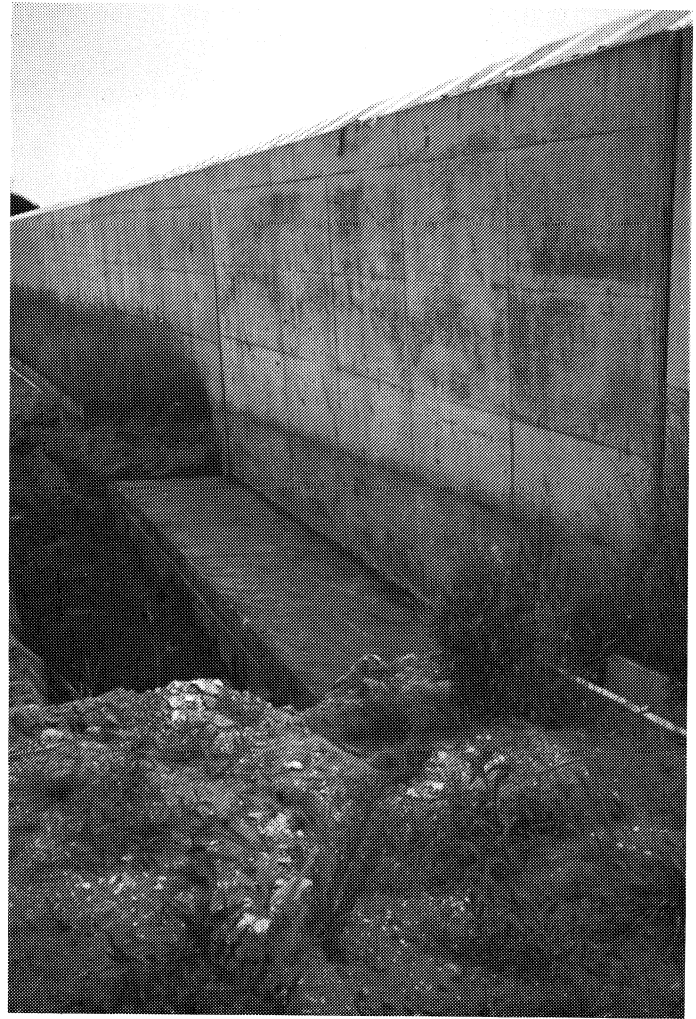
Figure 9-18: Failed east side of the snowshed. Lateral spreading of the fill and/or liquefaction caused spreading of the footings, rotation of the stem wall, and failure of the stem wall.

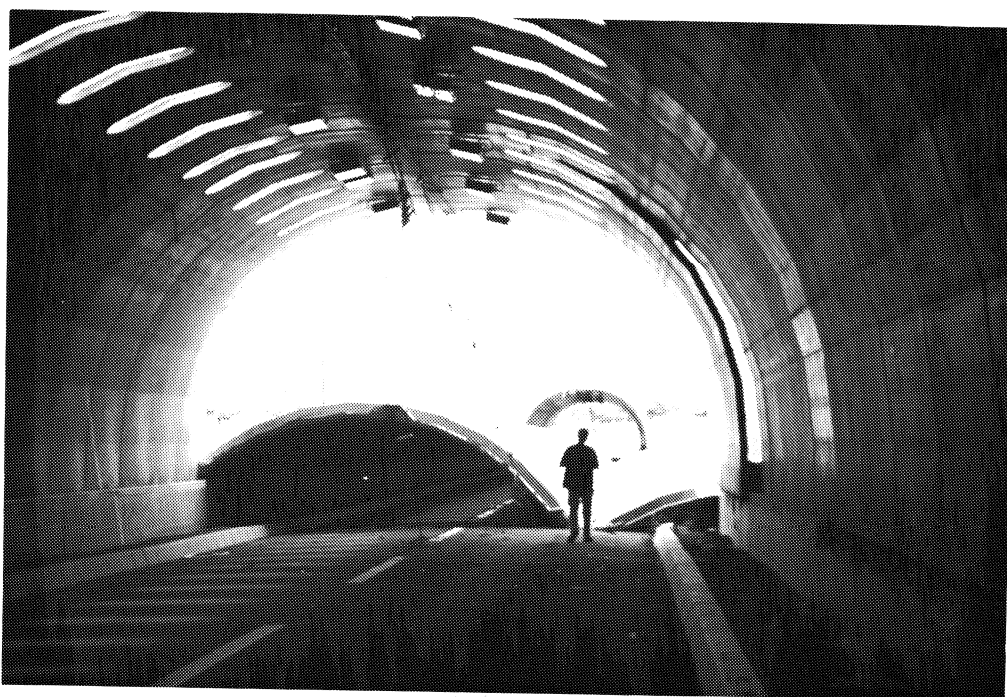
Figure 9-19: Although the arch has collapsed and dropped the precast planks onto the pavement, the planks are relatively undamaged, testifying to the general quality of construction of the superstructure.

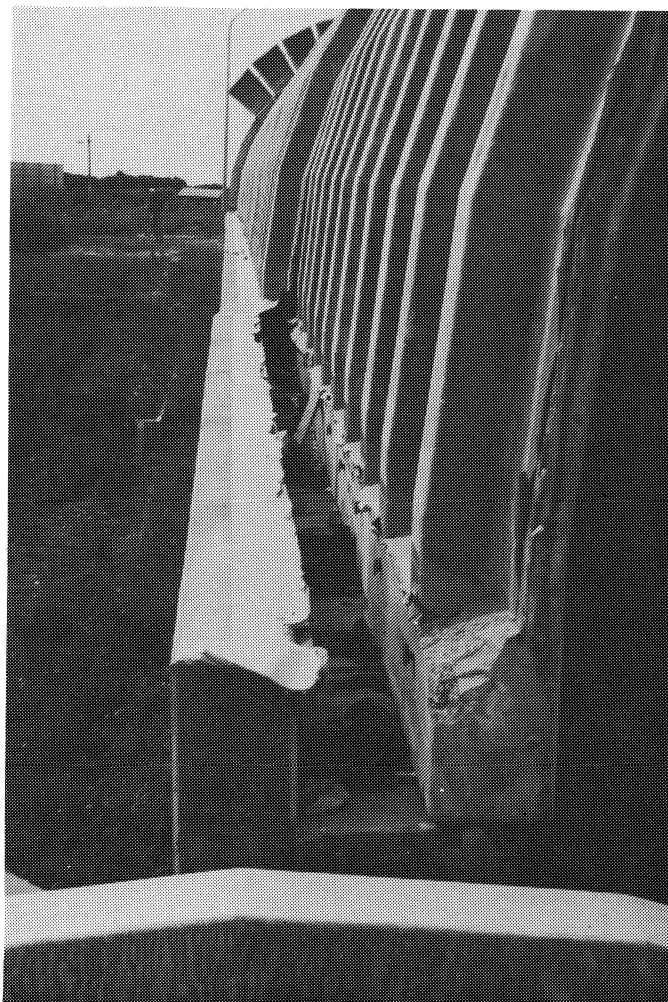
Figure 9-20: Damage at the seat of the precast planks onto the stem wall. The photograph is from the front one-third of the snow shed structure that did not collapse.

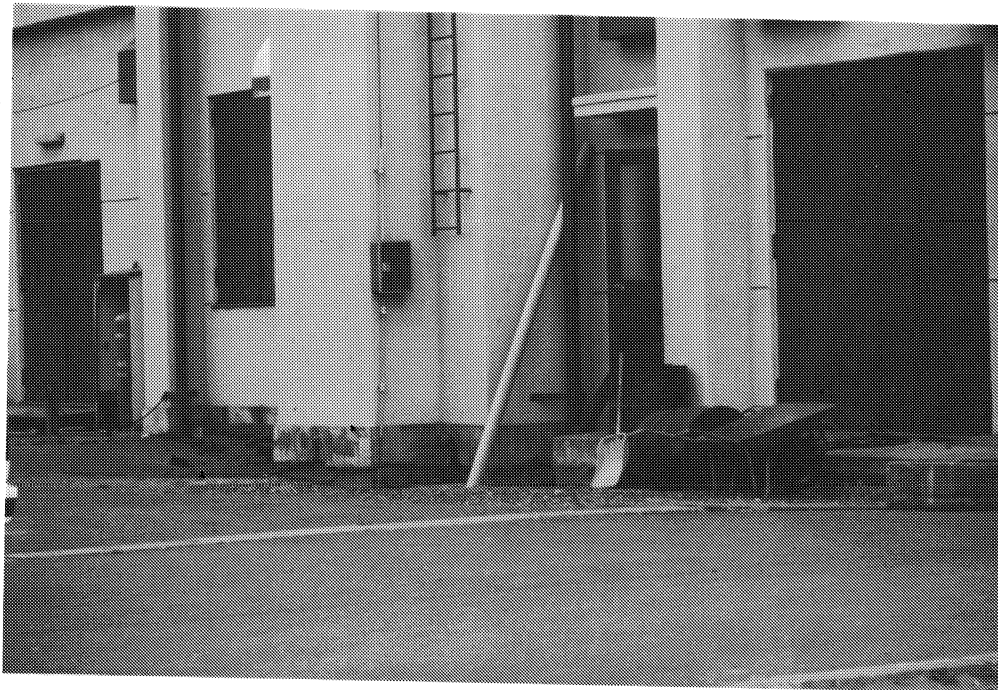
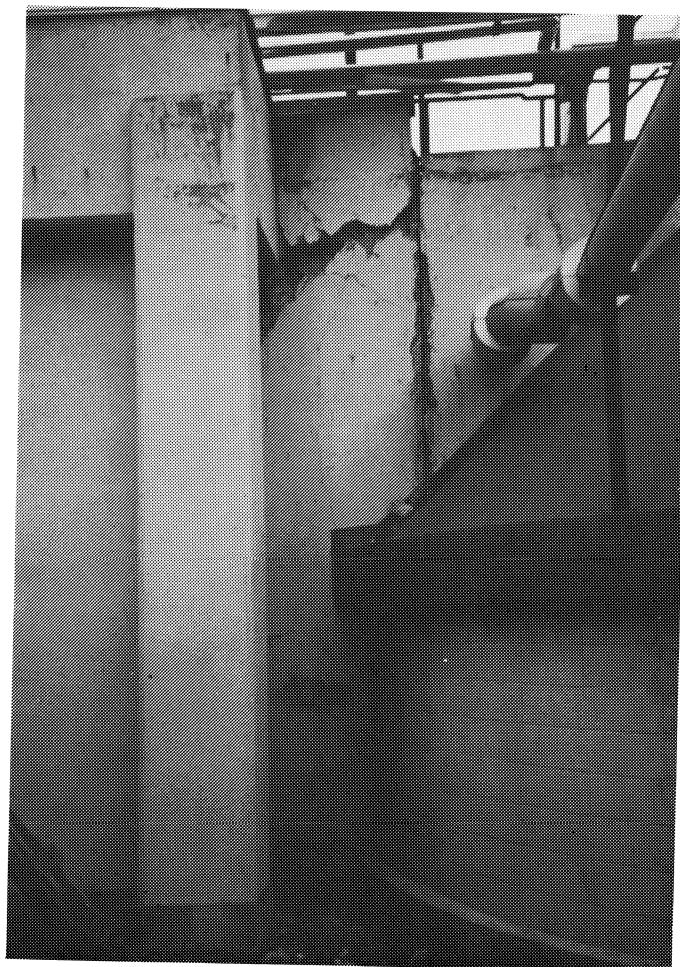
Figure 9-26: ASTP; ground settlement of the main structure of about 30 cm (upper photograph) and damage due to settlement and pounding between a structure and a digester (lower photograph).

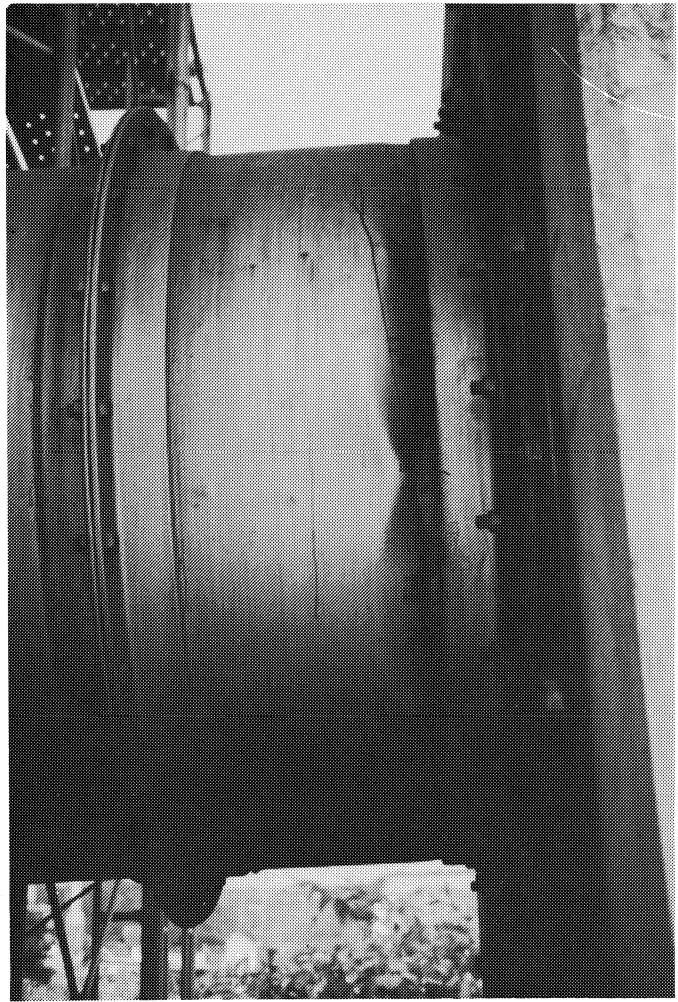
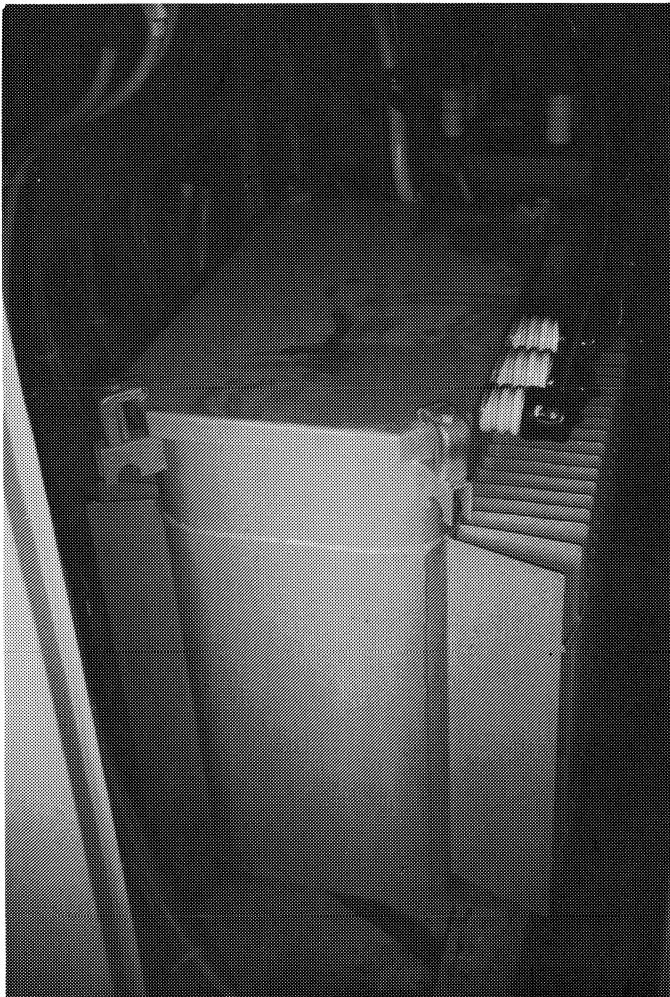
Figure 9-28: ASTP; this transformer overturned. It was housed in the cabinet to the left. It is located on the second floor of the main structure.

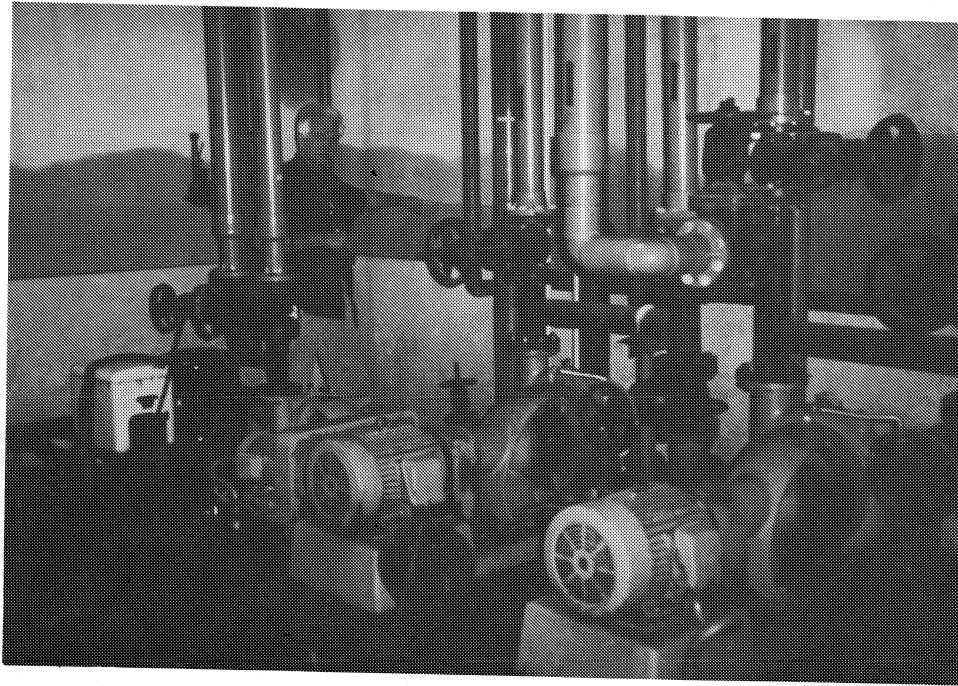
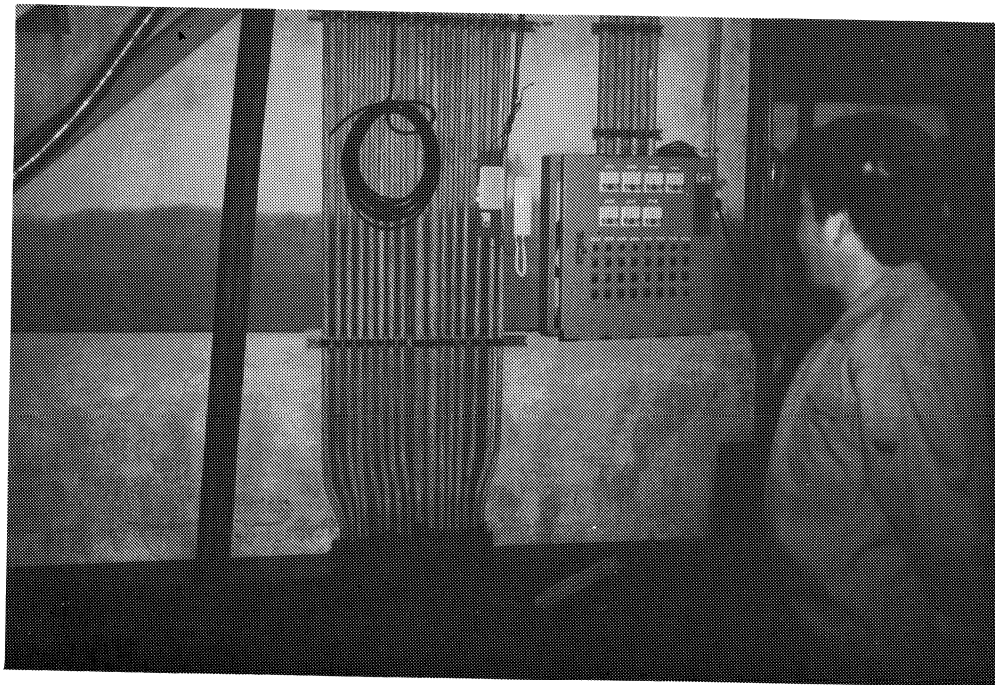
Figure 9-29: View of a basement room of the ASTP. Note the water line in both photographs showing the level to which the basement of the plant was flooded. Various electrical and mechanical equipment were flooded, making the plant inoperable for several weeks. The flood, which was caused indirectly by the tsunami, was due to inundation through the outflow piping. The tsunami forced water through the outflow piping into the basement. Protection against such backflow should be considered in the design of infrastructure facilities.

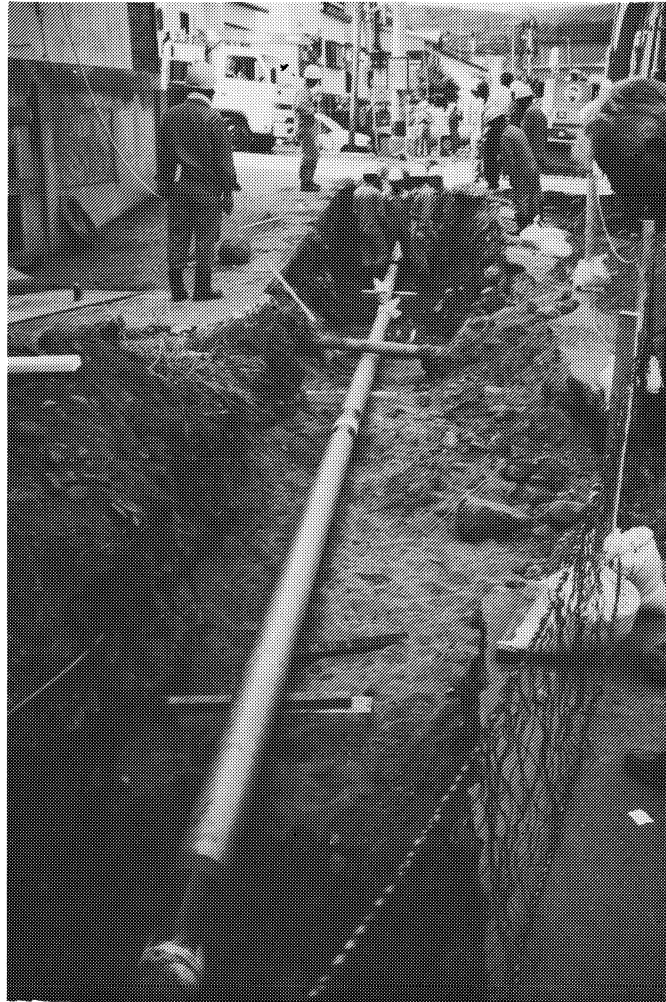
Figure 9-33: Ongoing repairs to a damaged 20-cm welded steel fuel line in the port area of Okushiri-cho. The pipe was probably ruptured by the extensive ground settlement that occurred in this area. The ground spreading was caused by the failure of one of several quay walls and bulkheads in the port.

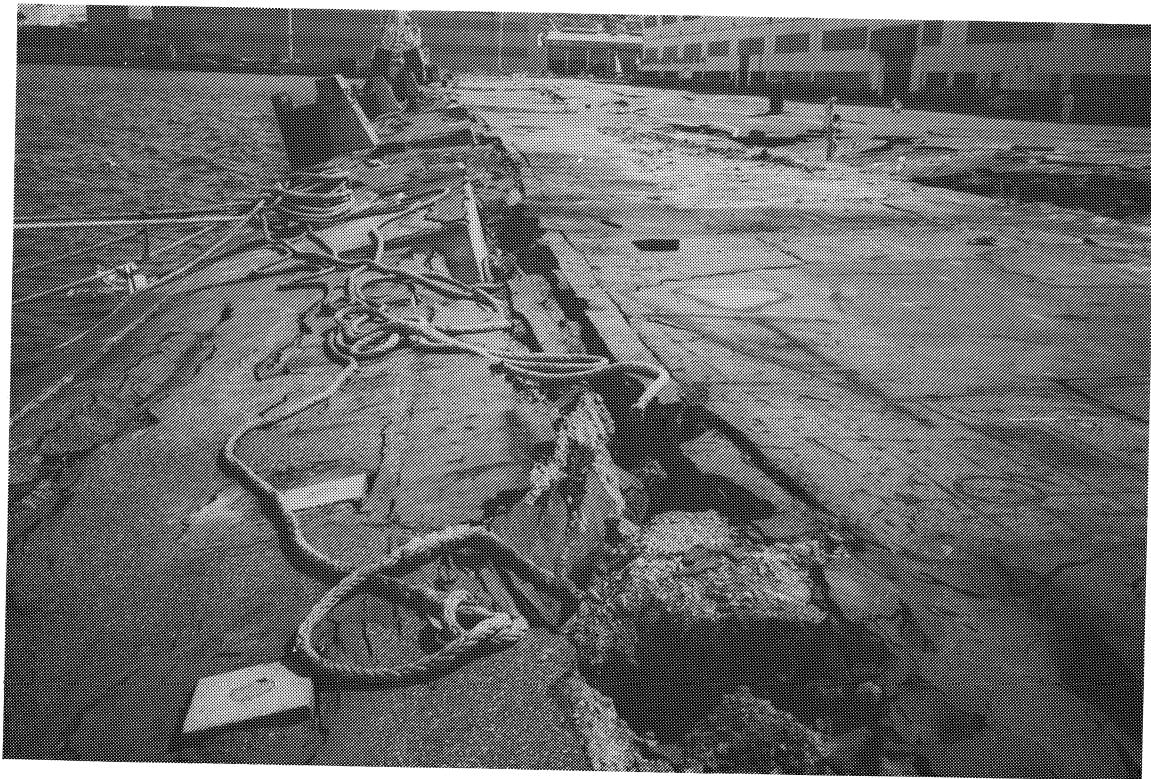
Figure 9-34: Examples of typical damage from the ports of Setana (upper photograph) and Hakodate (lower photograph; photo courtesy of T. Leslie Youd), where quay walls displaced or tilted seaward by as much as 3 m. A peak horizontal ground acceleration of 0.12g was recorded nearby.

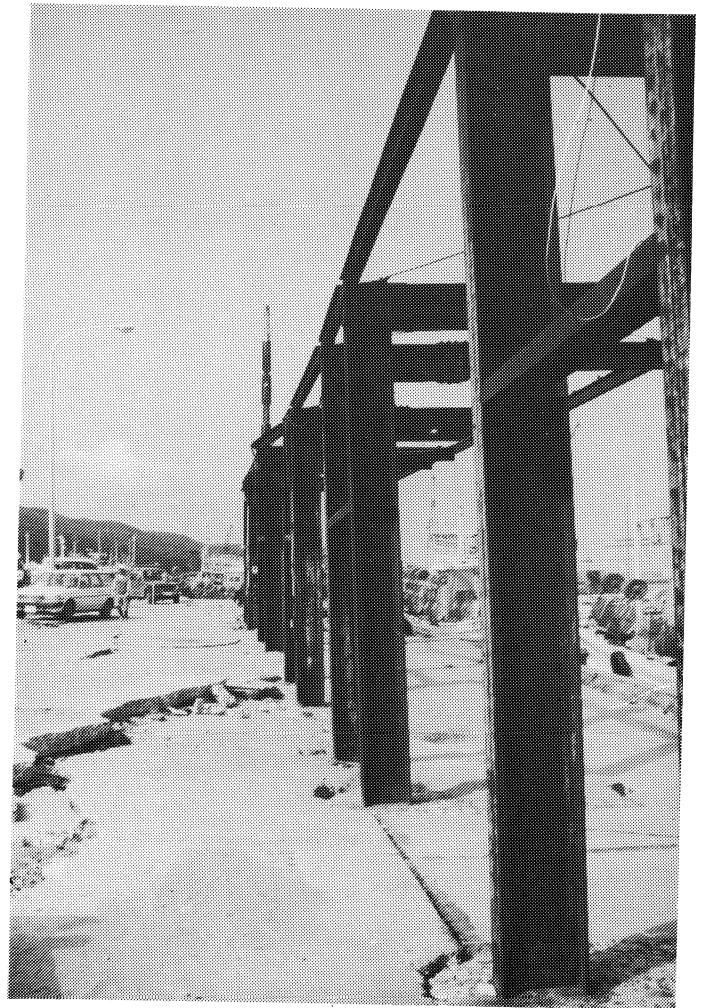
Figure 9-36: Damage to waterfront facilities at Okushiri-cho Port. The illustrated damage is due to soil failures from liquefaction, settlement, and lateral spreading of walls. Some of the damage is due to tsunami scour. Note that despite the severe damage to its foundations, the steel structure shown in both photographs has maintained its overall integrity, illustrating the large ductilities available in steel structures when properly designed and constructed.

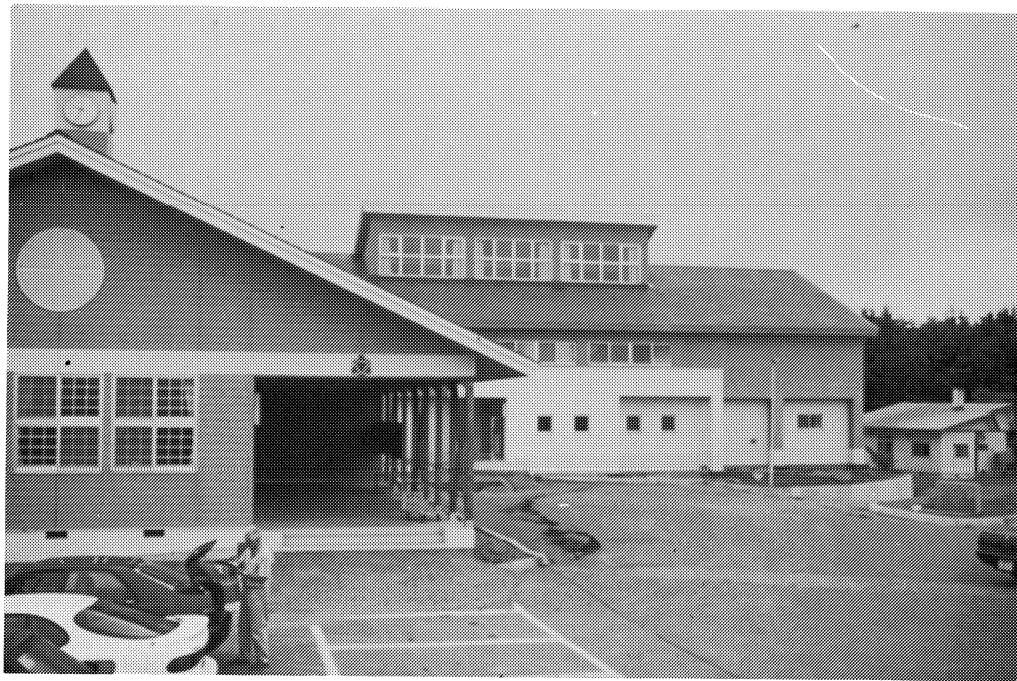
Figure 10-2: Oshamanbe Elementary School; settlement of up to about 1 m and extensive liquefaction occurred. The school is built on top of a 2-m-high fill in a rice paddy area. The school is new. No structural damage other than shearing of piles just below the pile caps was observed. The buildings are a combination of wood frames, concrete frames with shear walls, and steel frames.

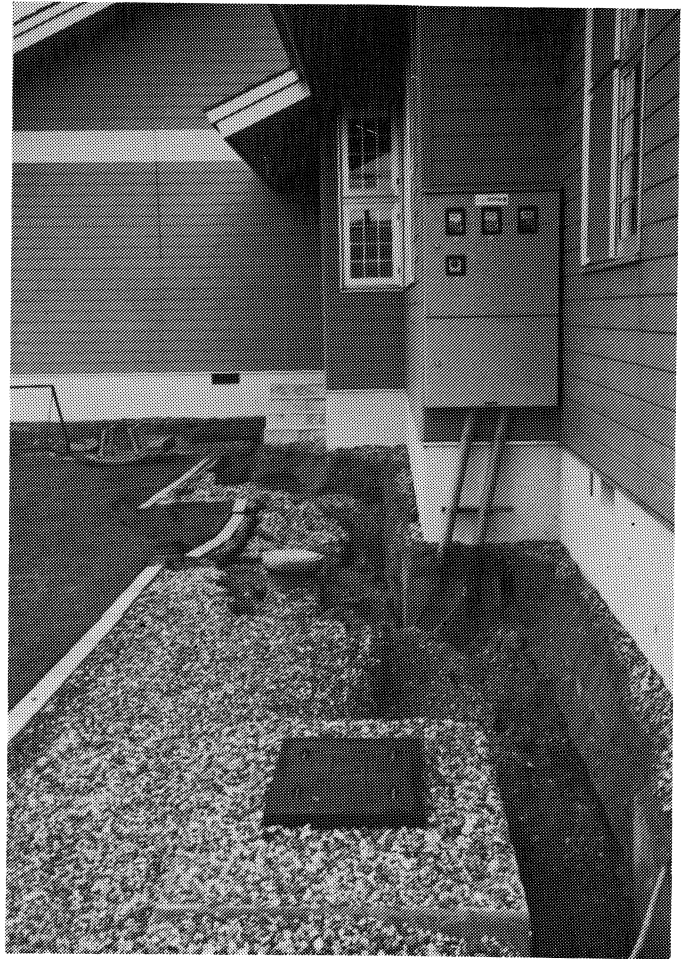
Figure 10-5: Oshamanbe Elementary School--note that the settlement exposed the pile caps.

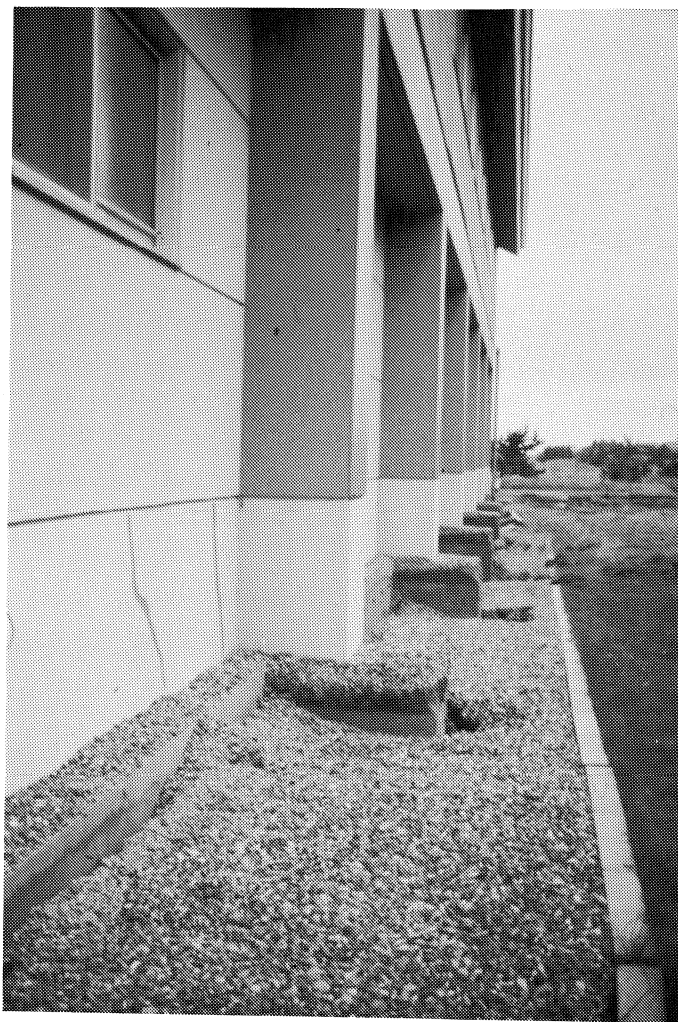
Figure 10-6: Oshamanbe Elementary School--note the minor cracking in spandrels near the column. Other minor cracking of shear walls was observed.

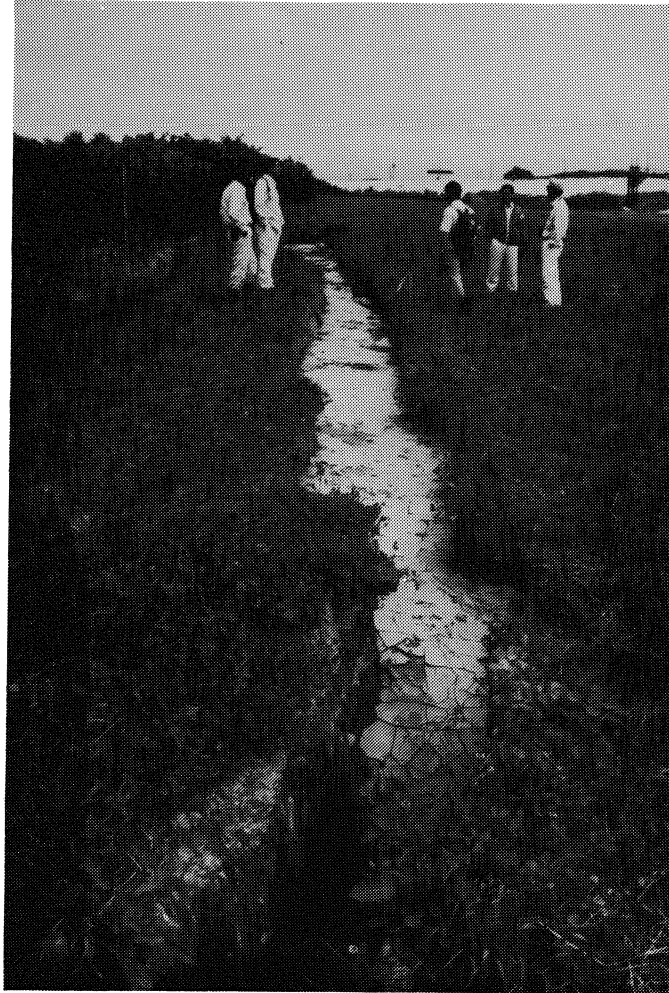
Figure 10-12: Lateral spreading of river deposits near Setana. The river itself is to the left. Note how the spreading fissure has been filled in with ejected sand from liquefaction.

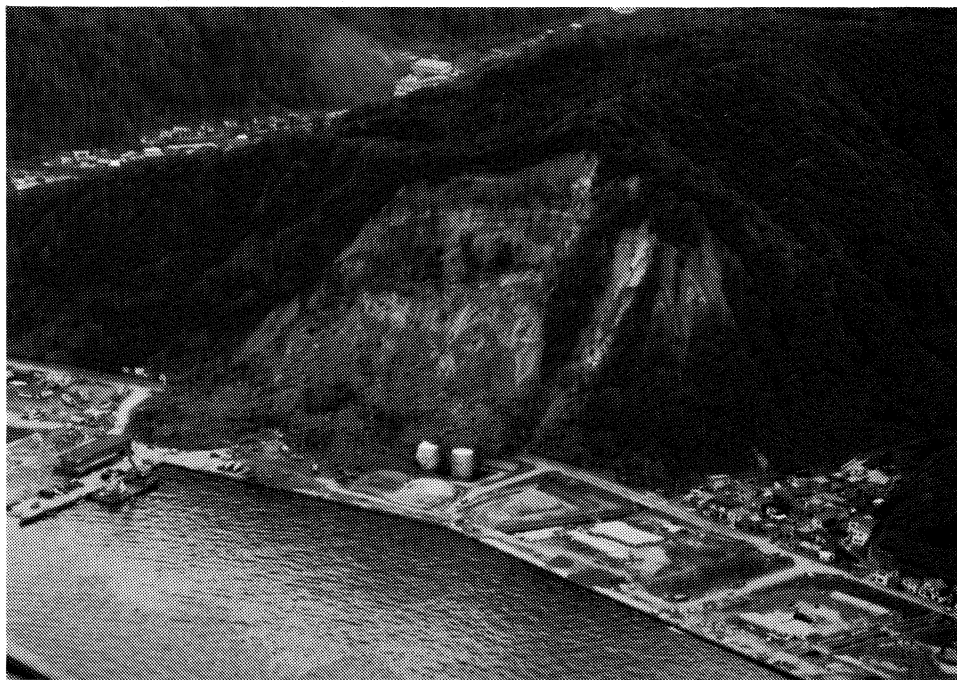
Figure 11-1: The port area of the town of Okushiri. Note the extensive tsunami damage. A large landslide about 100 m high and 170 m wide high buried the Hotel Yo Yo, killing 35 to 40 people and damaging the tanks (on the right side). This was the most destructive landslide of the many hundreds of landslides caused by the earthquake. Photographs by K. Kawashima.

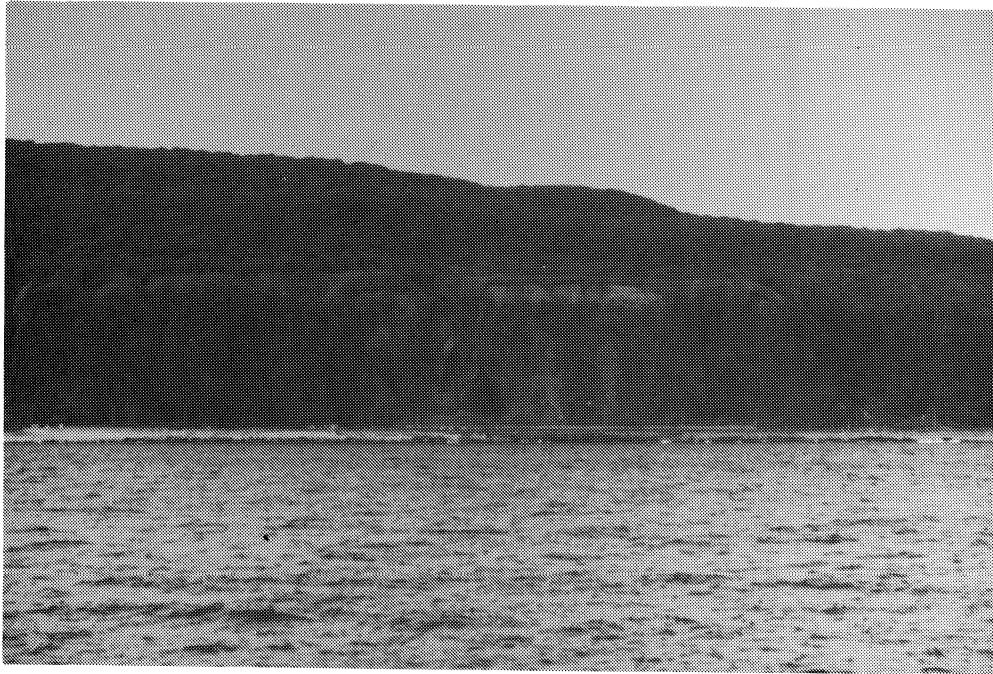
Figure 11-2: Landslides along the eastern coast of Okushiri Island. Similar and very large landslides were observed along the coastal bluffs of the Hokkaido coast south of Setana.
