# The Northridge, California Earthquake of January 17, 1994: Performance of Highway Bridges

Technical Report NCEER-94-0008

March 24, 1994

This reconnaissance report provides an analysis of major bridge damage which occurred during the earthquake. Eight highway bridges are described in terms of their geometry, site ground motions, observed damage and likely failure modes.

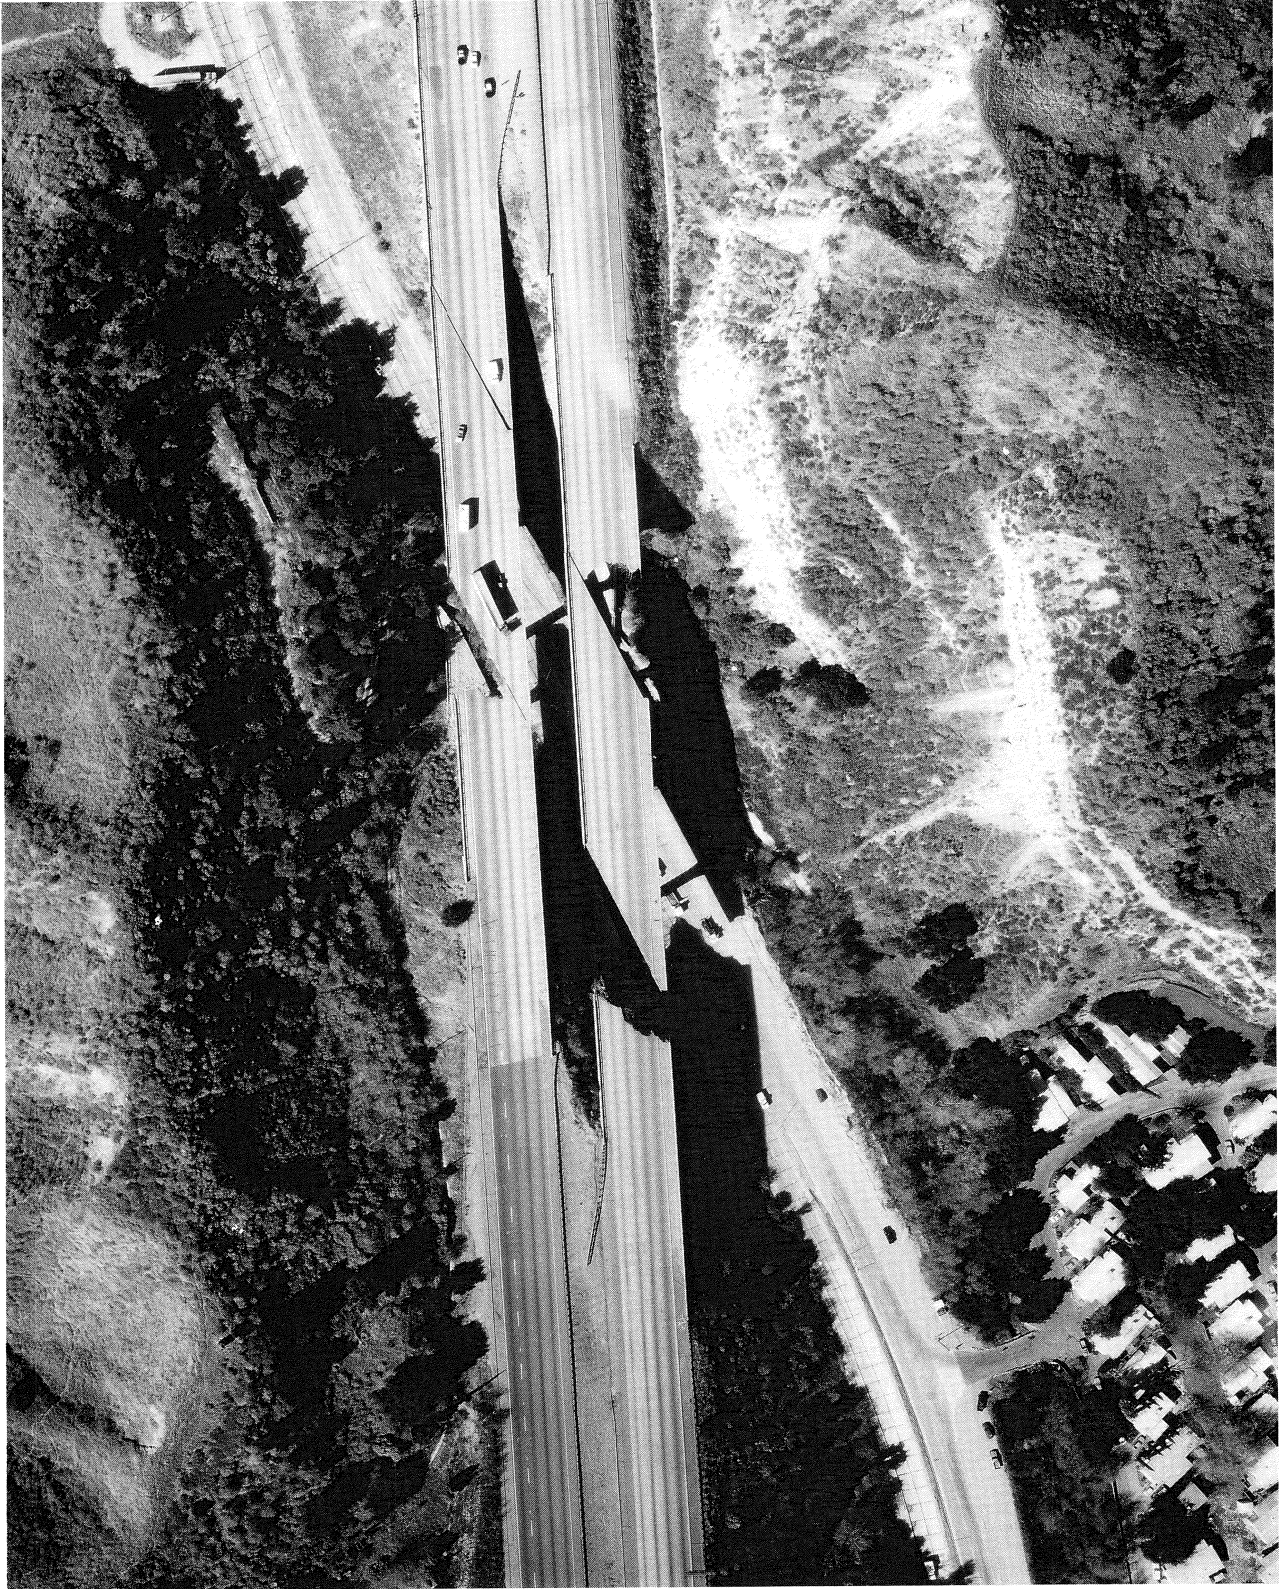
Both structures suffered failures due to total or partial loss of support at the expansion joint hinges. The acute corner of the supported span tended to become unseated first due to a counterclockwise rotation of each the structural sections about a vertical axis (Figure 3-4).

**FIGURE 3-4 Gavin Canyon Undercrossing -  
Aerial View of Collapse**

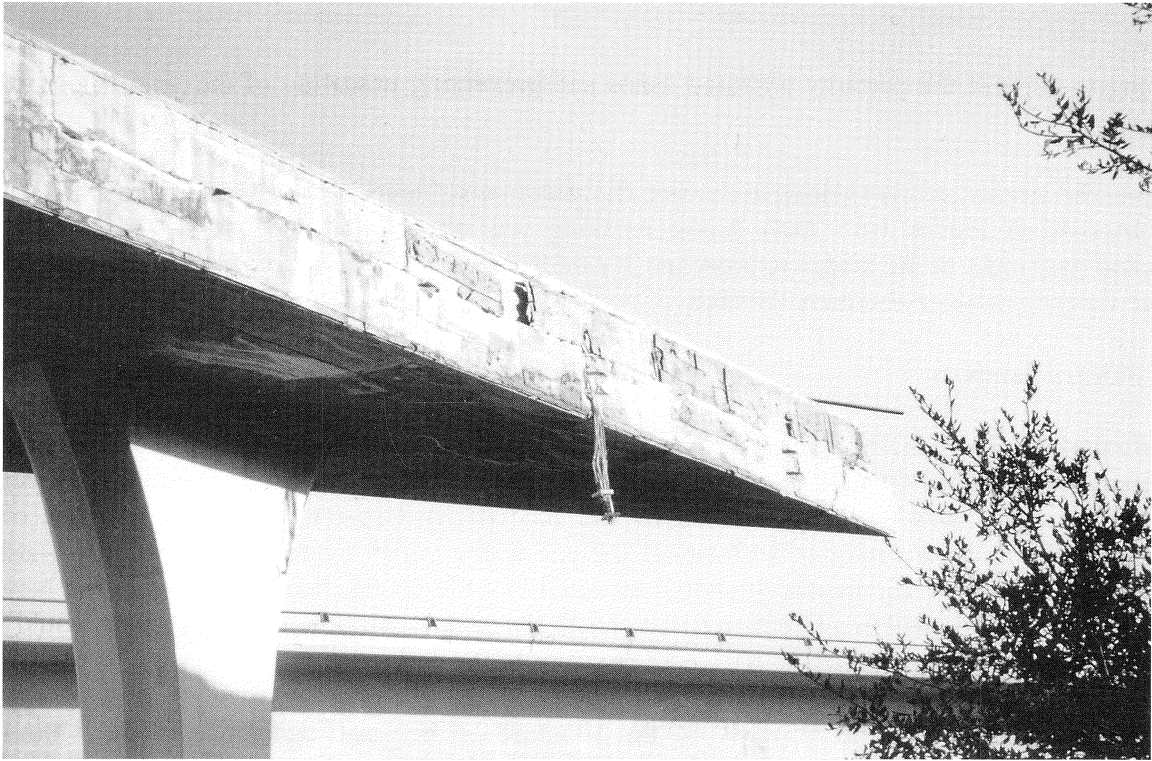
The movement of the superstructure caused restrainer cables to be pulled at an angle to their principal axis as evidenced by spalling at the edges of cored holes through which the restrainers passed. In some cases restrainer cables snapped as the expansion joints separated while in other cases they pulled through the expansion joint diaphragm (Figure 3-5). Some cables remained intact

**FIGURE 3-5 Gavin Canyon Undercrossing -  
Hinge Seat and Failed Cable Restrainer**

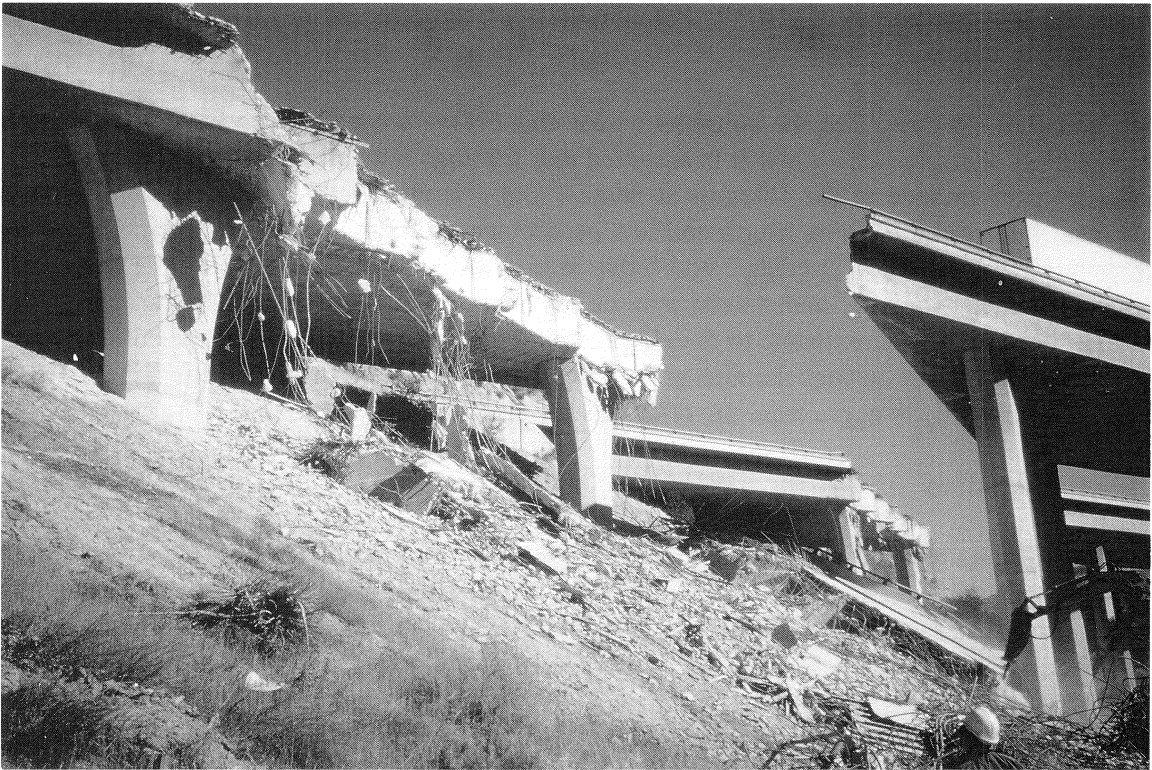
Despite the strong ground shaking at the site, the structure suffered very little column damage as can be observed in Figure 3-6. Only minor cracking was observed at the base of some columns. Cracked pavement at the bridge approaches is evidence that the fills shifted during the earthquake. There was some minor abutment damage.

**FIGURE 3-6 Gavin Canyon Undercrossing -  
Collapsed End Spans After Demolition**

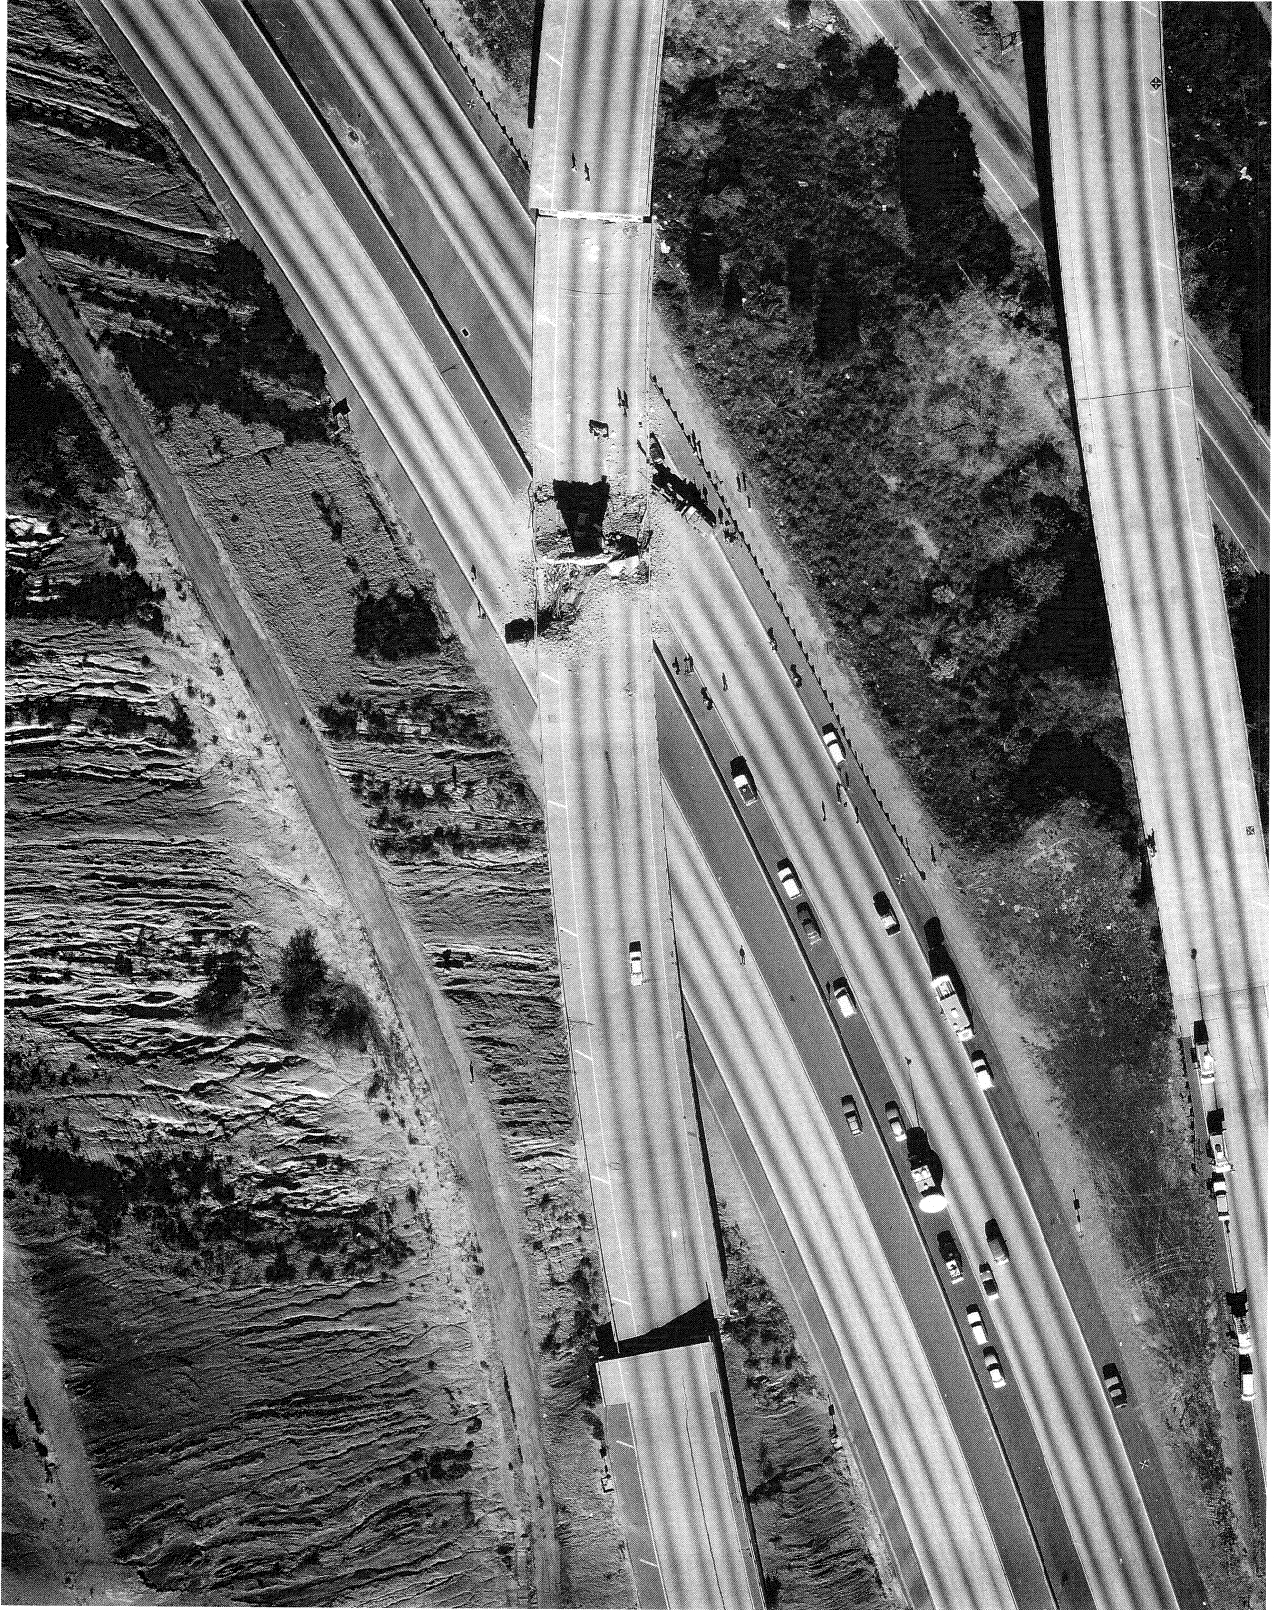
**FIGURE 4-7 SR14/I-5 Separation and Overhead (Southbound) -  
Aerial View of Collapse**

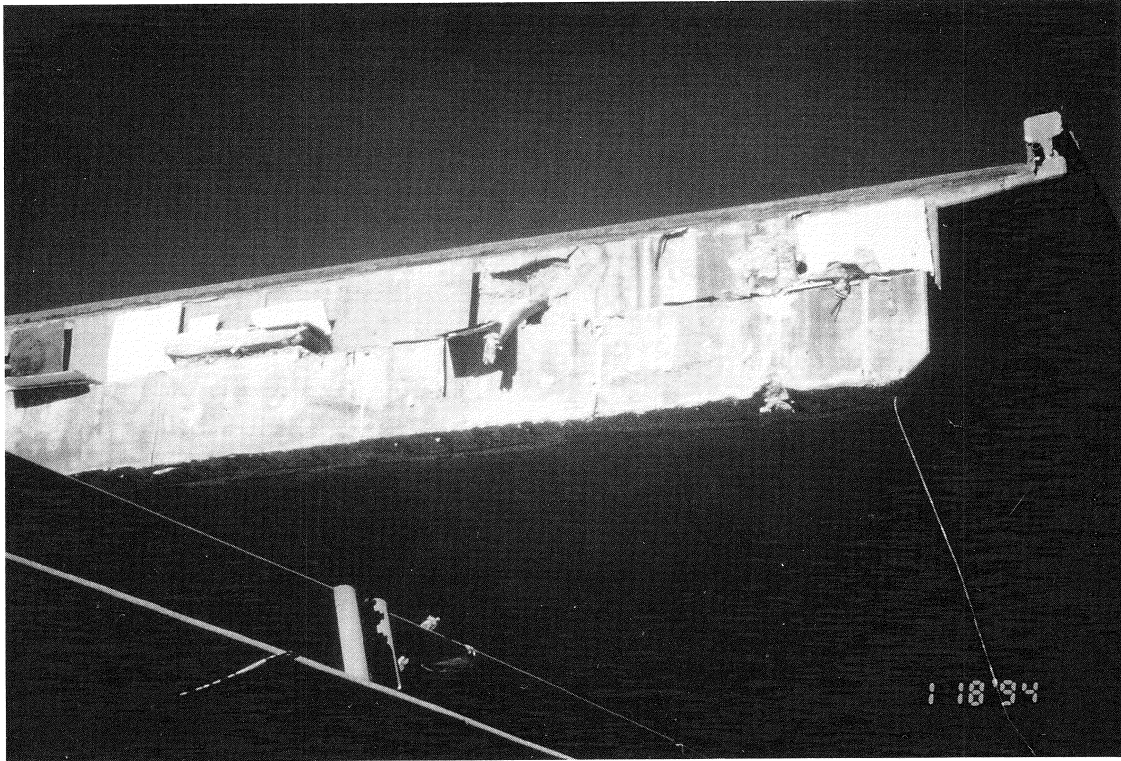
**FIGURE 4-8 SR14/I-5 Separation and Overhead (Southbound) -  
Hinge Seat and Shear Key in Span 3**

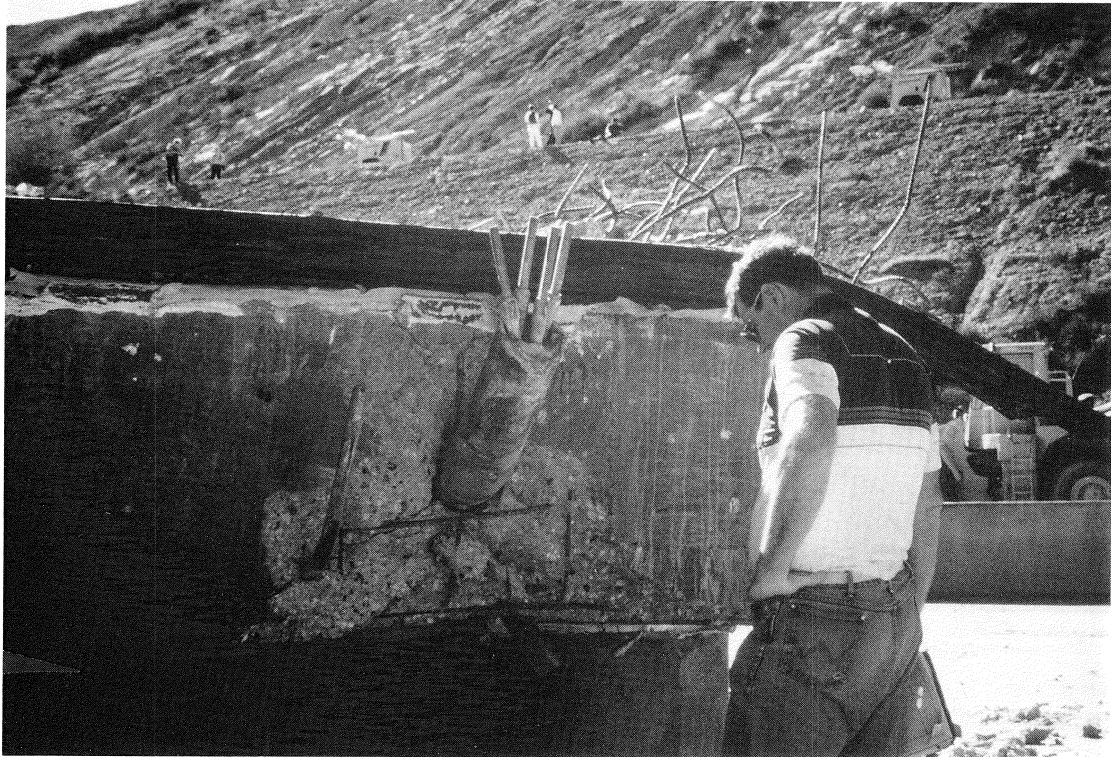
**FIGURE 4-10 SR14/I-5 Separation and Overhead (Southbound) - Equalizing Bolt and Restrainers at Hinge in Span 3**

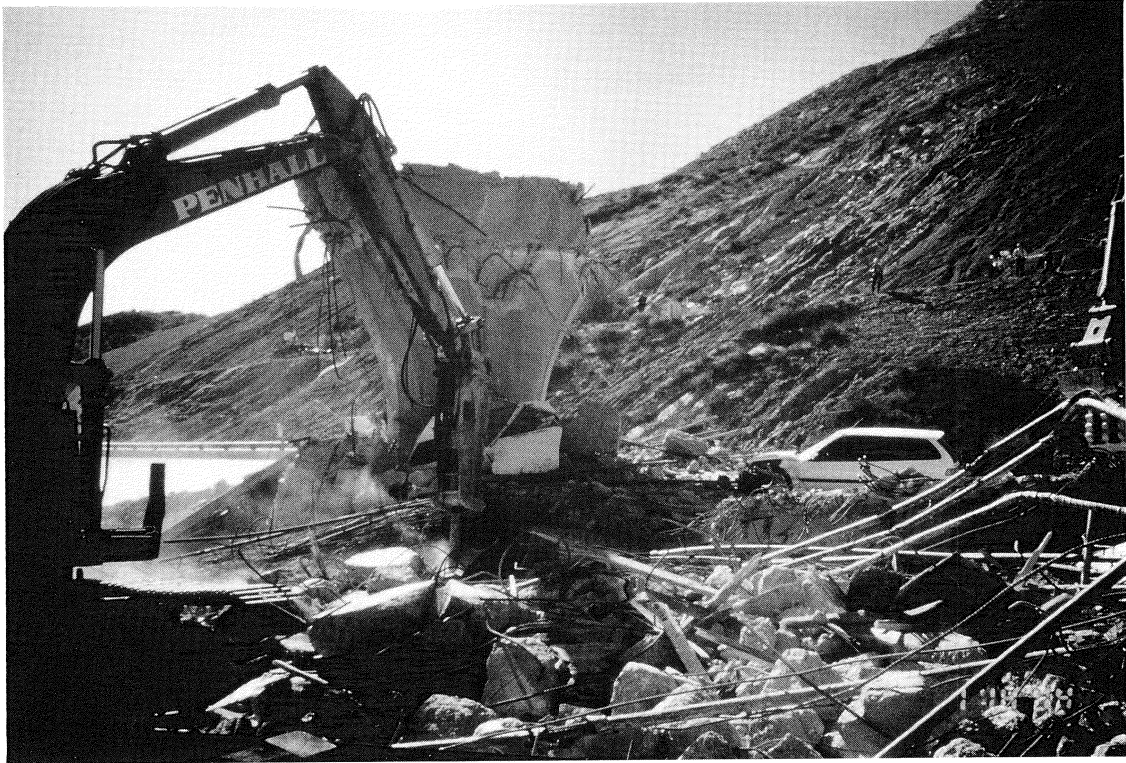
The circumstantial evidence available at the site, especially the damage sustained by the face of pier 3, suggests that mechanism 1. is the likely failure mode.

**FIGURE 4-12 SR14/I-5 Separation and Overhead (Southbound) -  
North Side of Pier 3 and Cap**

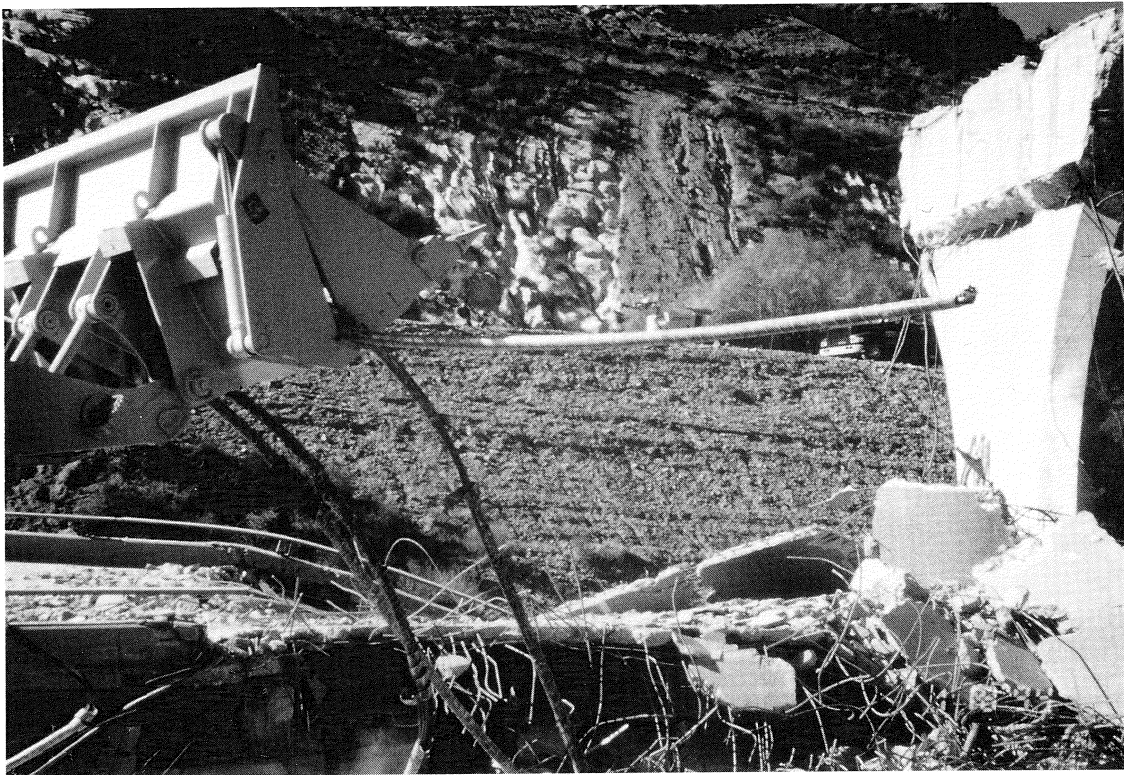
**FIGURE 4-13 SR14/I-5 Separation and Overhead (Southbound) -  
South Side of Pier 3 and Cap**

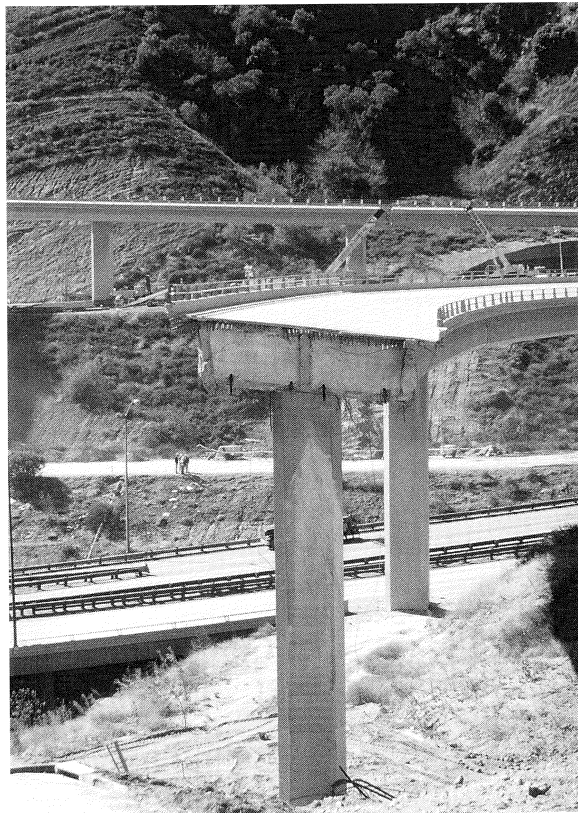
Without analysis, the sequence of failure is uncertain but it seems likely that pier 2 failed first followed by the collapse of the two spans. It is possible that pier 2 attracted a much higher proportion of the lateral load than assumed in design because of its relatively short height. Further, there was probably a significant reduction in the axial load in the pier due to both the severe curvature in the bridge and the high vertical accelerations in the ground motion. This reduction in axial load may have reduced the capacity of the column to less than the demand leading to the failure of the pier.

**FIGURE 5-2 SR14/I-5 North Connector -  
Collapsed End Spans After Demolition**

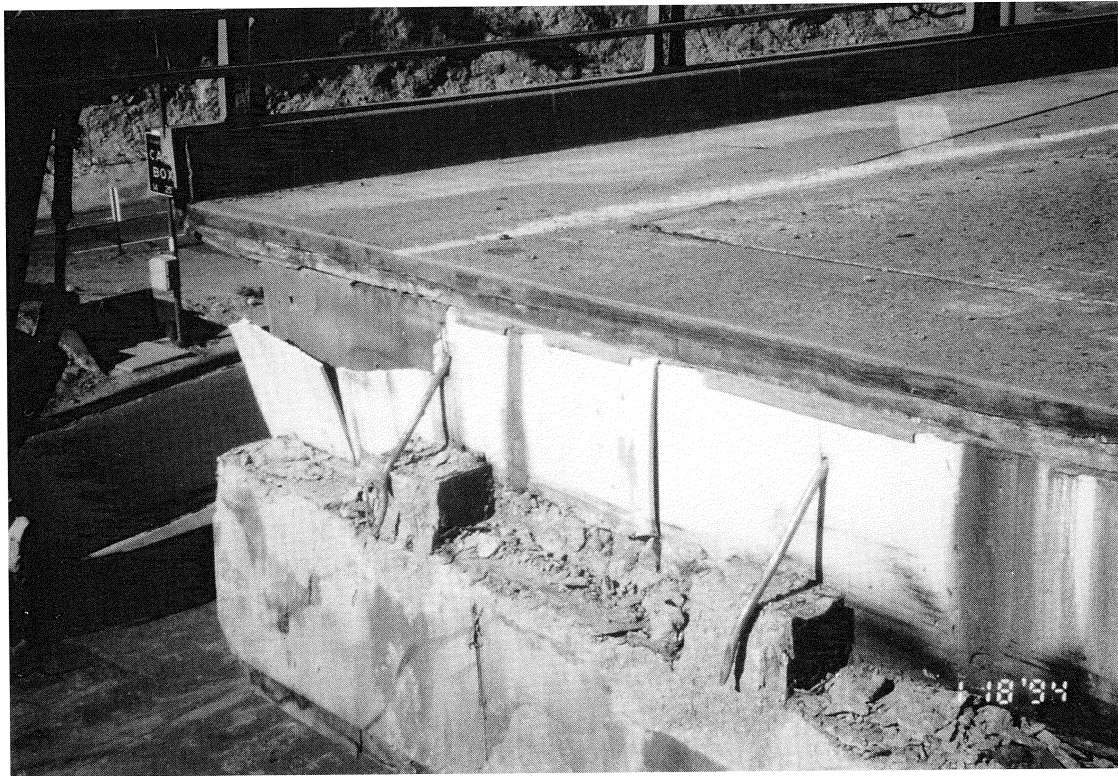
**FIGURE 5-3 SR14/I-5 North Connector -  
Seat and Transverse Shear Keys at Abutment 1**

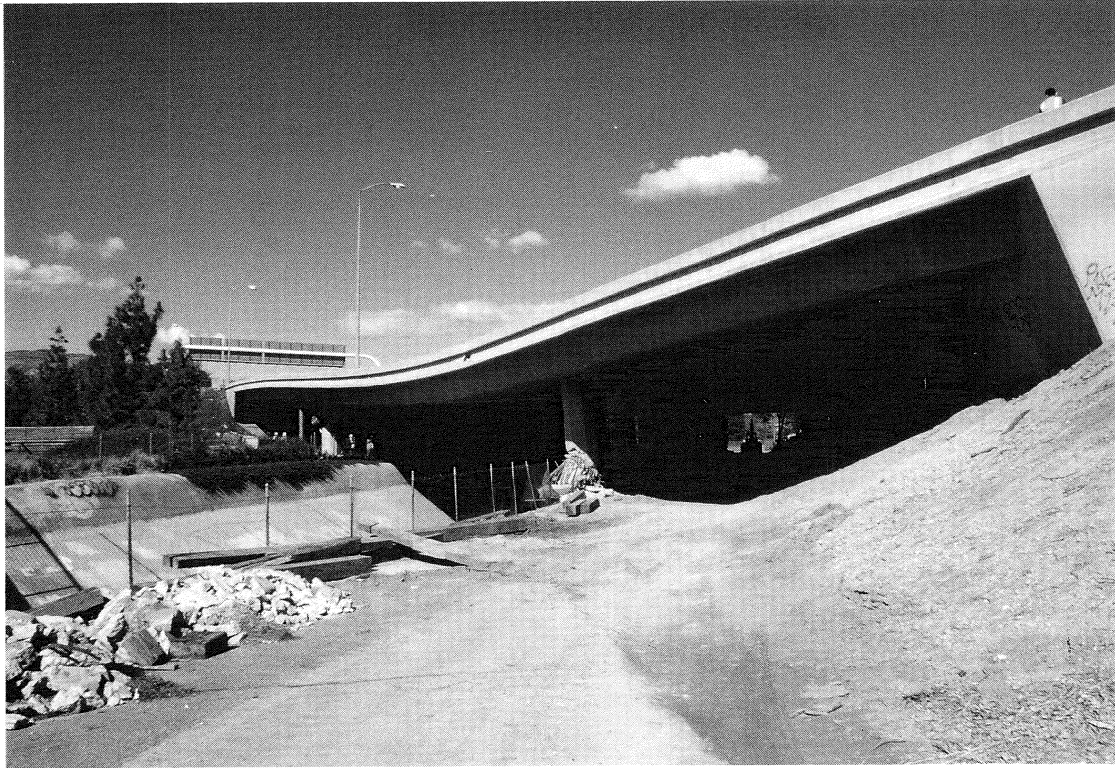
**FIGURE 6-3 Bull Creek Canyon Channel Bridge -  
Side View**

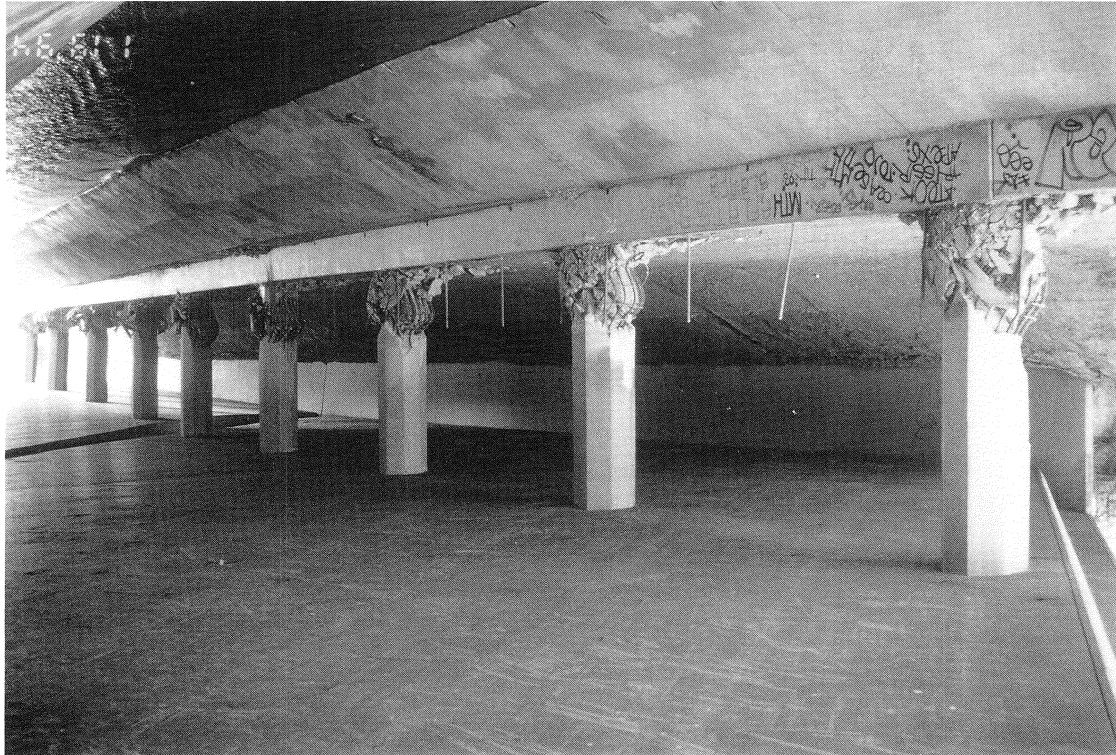
Bent 2 failures and possible abutment shear key failures were probably a result of the failed columns at bent 3 and the subsequent shifting of lateral forces to the remaining supports. It is felt that the bent 2 column failures were essentially shear failures aggravated by the degradation of shear strength that resulted from flexural yielding. This conclusion is supported by the behavior of the various columns in bent 2.

**FIGURE 6-5 Bull Creek Canyon Channel Bridge -  
Hinges in All Columns of Bent 3 Immediately Above the Channel Training Wall**

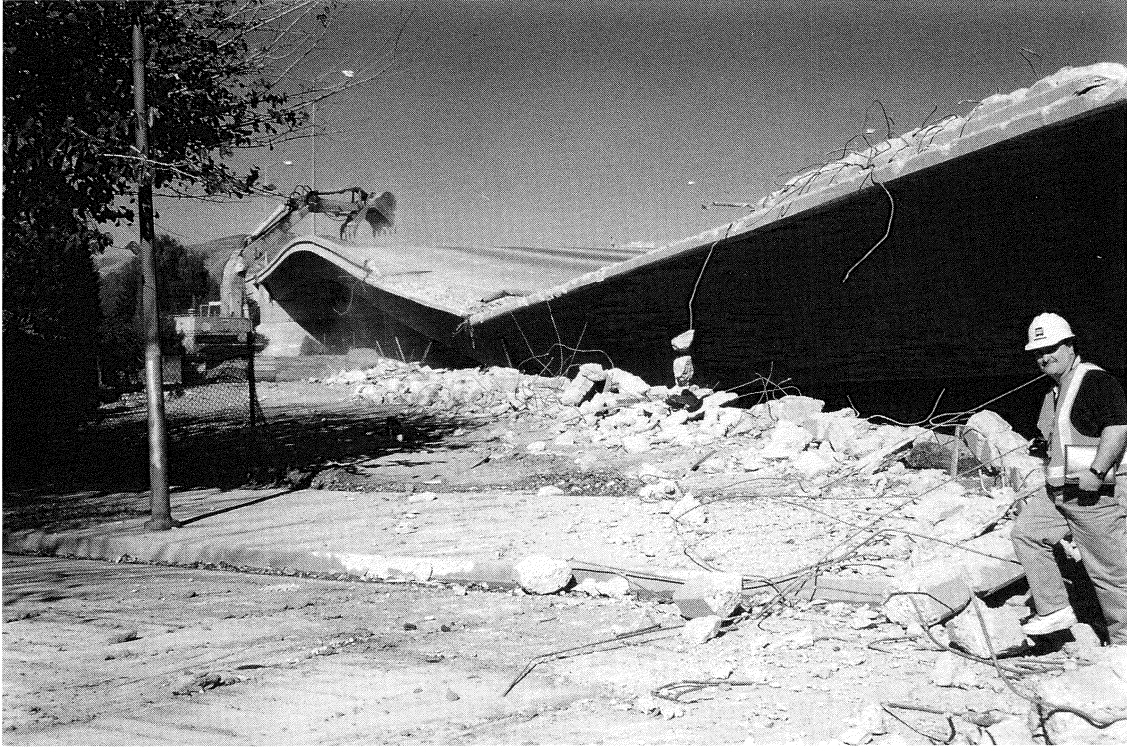
It is likely that several factors contributed to its collapse; one possible scenario is as follows. Since the abutments have opposing skew angles, and are thus at right angles to one another, excessive shear demands could have been placed on the restraints at the east abutments which then failed and triggered the partial collapse of the bridge.

**FIGURE 7-3 Mission-Gothic Undercrossing -  
Side View of Partially Collapsed Eastbound Bridge**

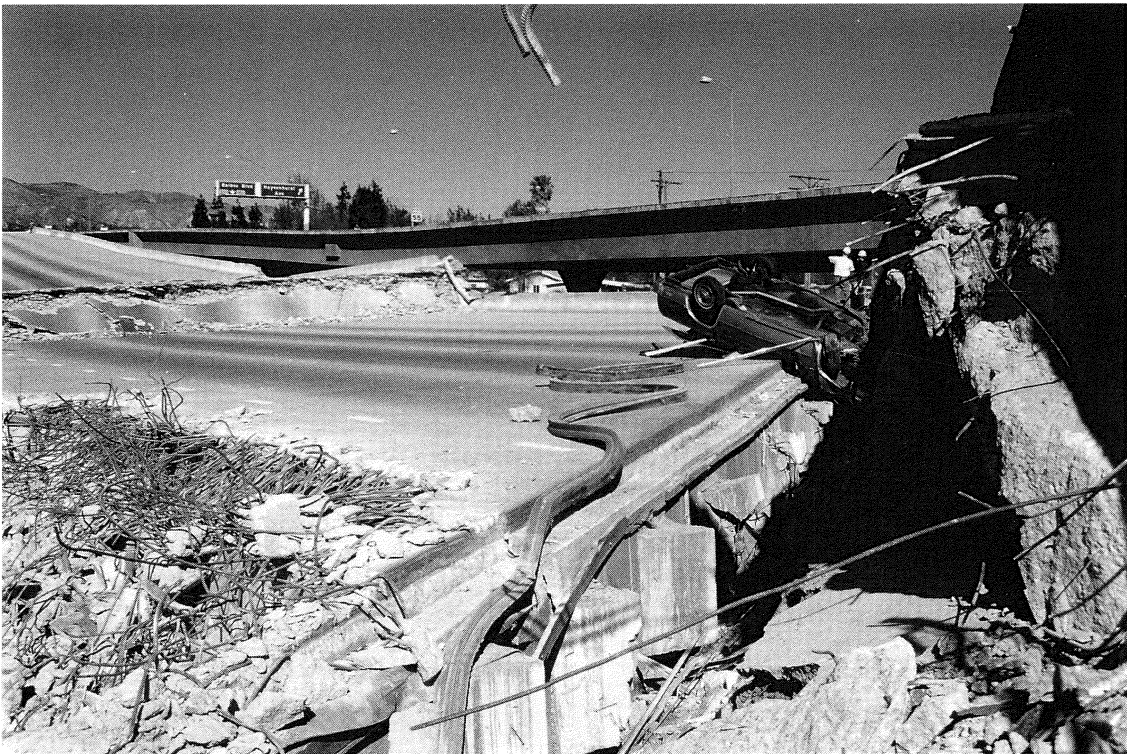
**FIGURE 7-4 Mission-Gothic Undercrossing -  
Span 4 and East Abutment of Eastbound Bridge**

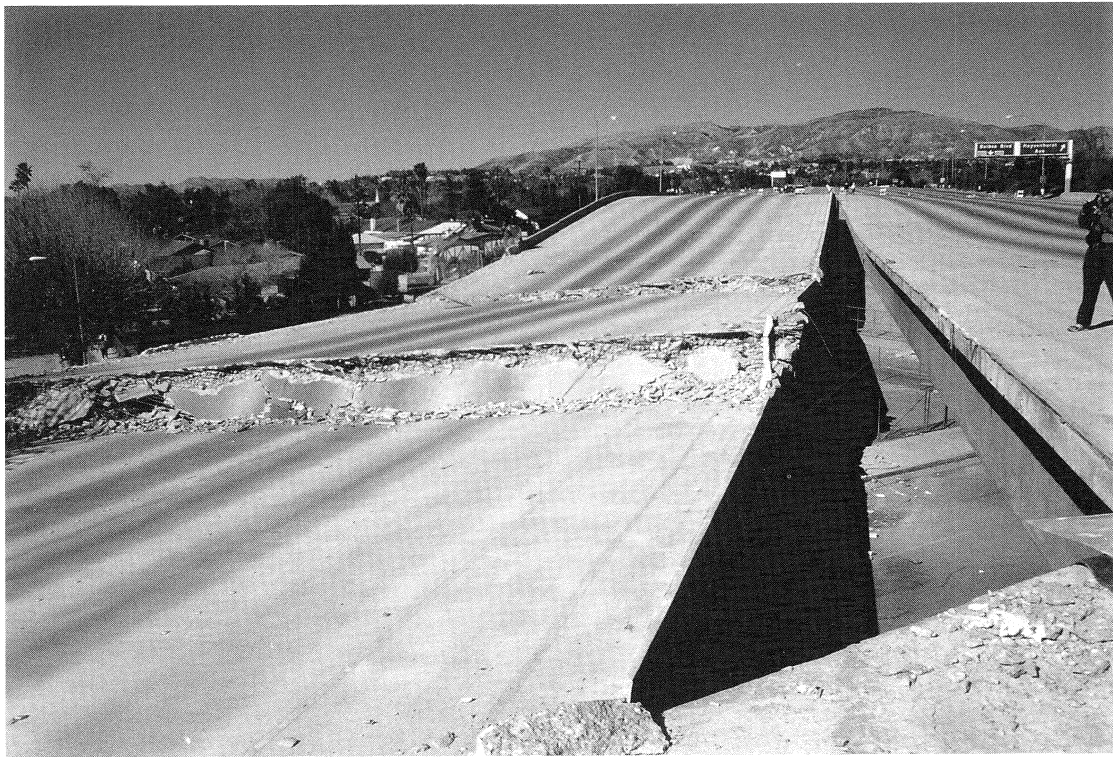
**FIGURE 7-5 Mission-Gothic Undercrossing -  
View from East Abutment Showing Rotation of Eastbound  
Superstructure Away from Westbound Bridge**

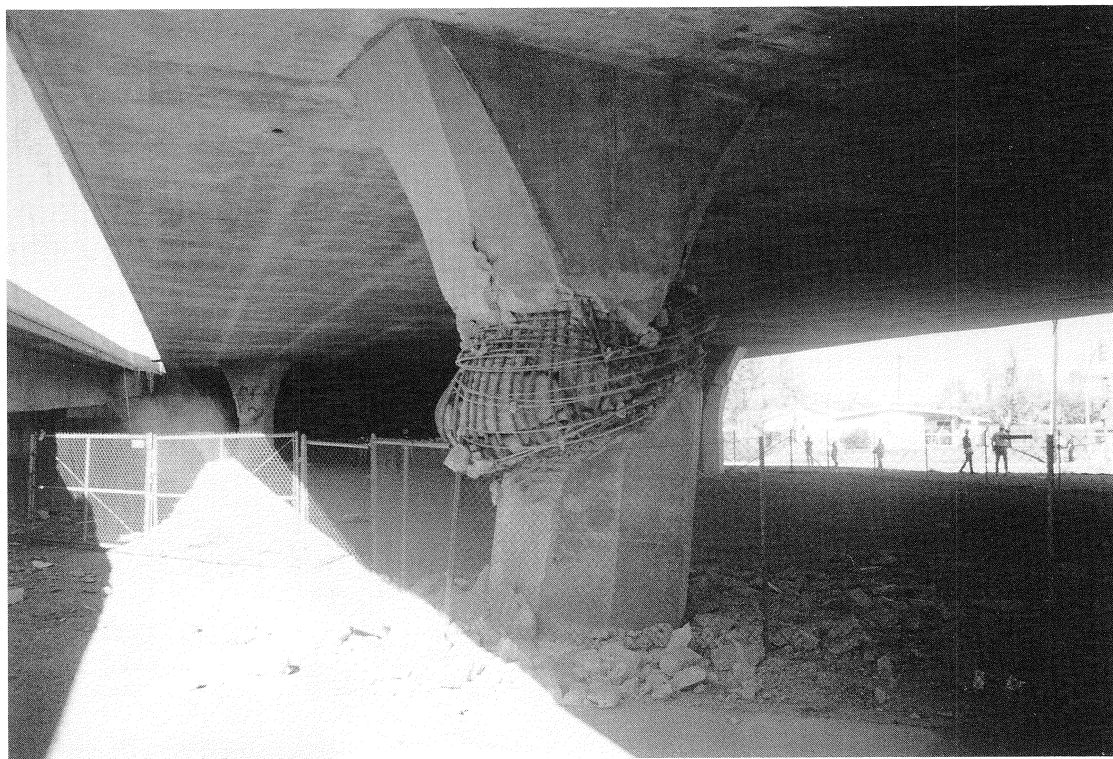
**FIGURE 7-6 Mission-Gothic Undercrossing -  
Hinge Formation Below Flare in Column of Westbound Bridge (Face View)**

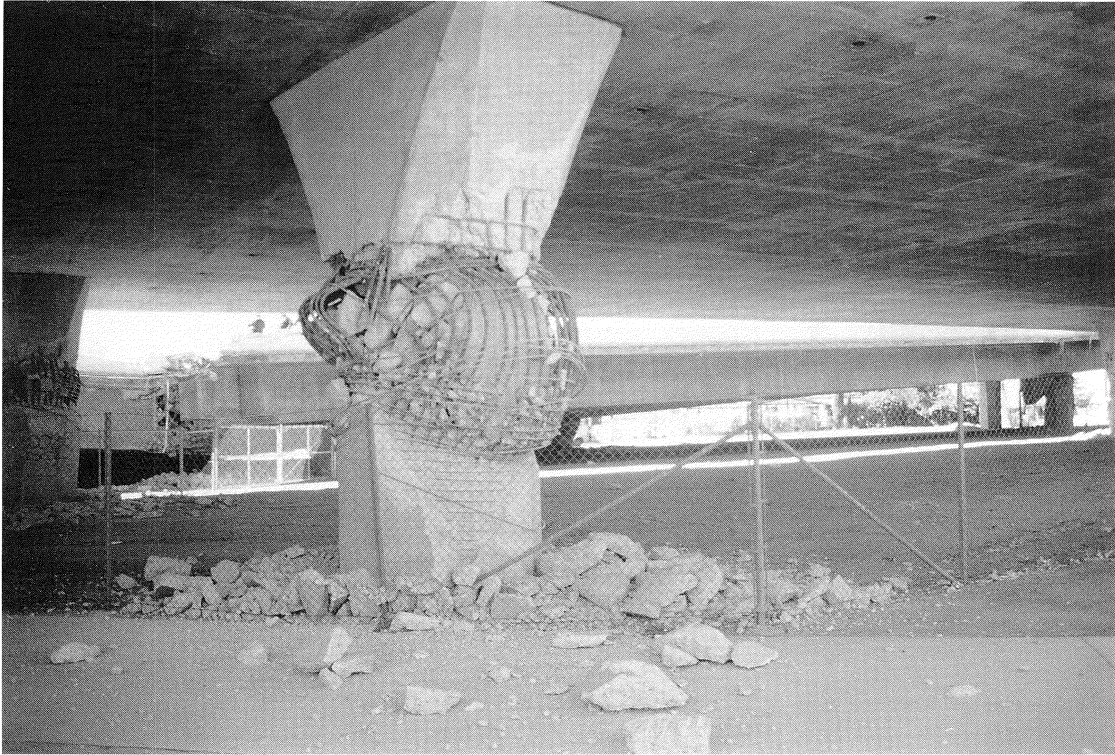
**FIGURE 7-7 Mission-Gothic Undercrossing -  
Hinge Formation Below Flare in Column of Eastbound Bridge (Side View)**

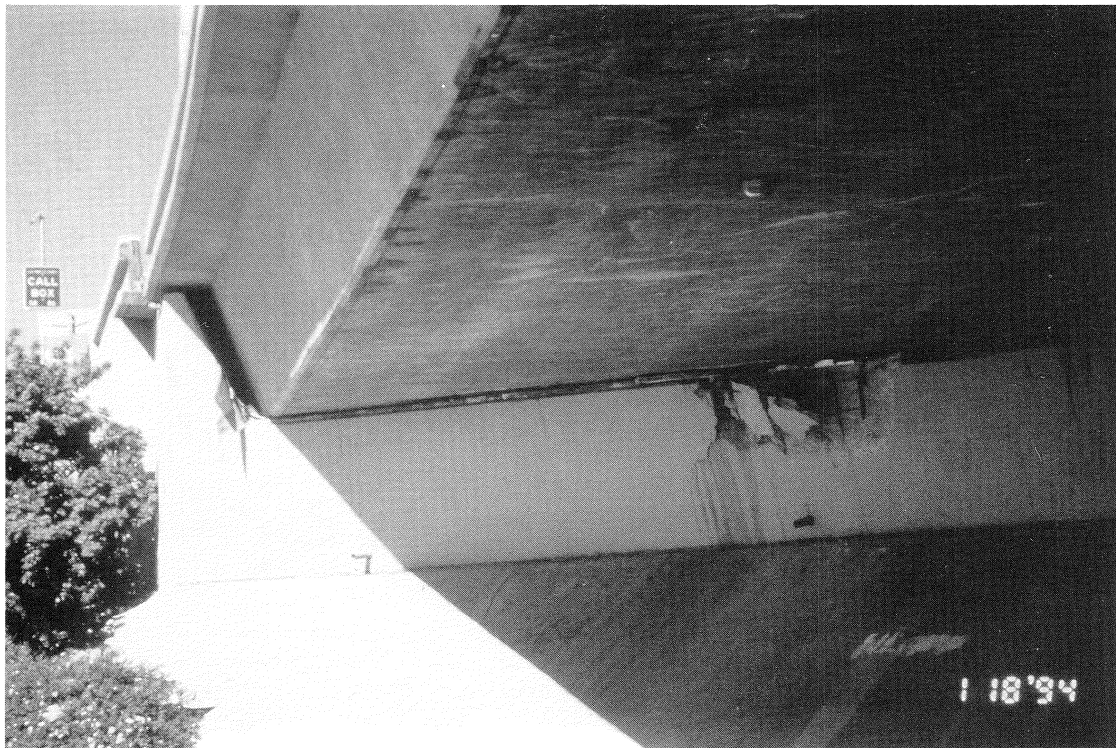
**FIGURE 7-8 Mission-Gothic Undercrossing -  
Shear Key Damage at West Abutment of Eastbound Bridge**

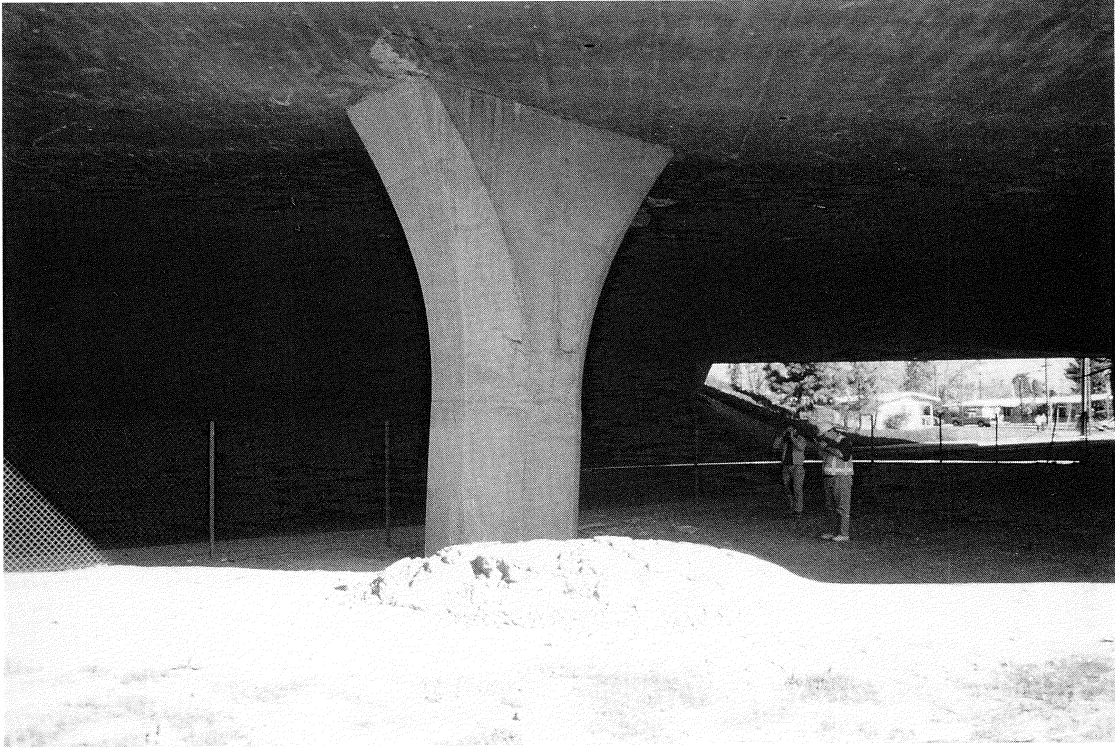
**FIGURE 7-9 Mission-Gothic Undercrossing -  
Soil Upheaval Above Footing of Right Hand Column in Bent 2 of Eastbound Bridge**

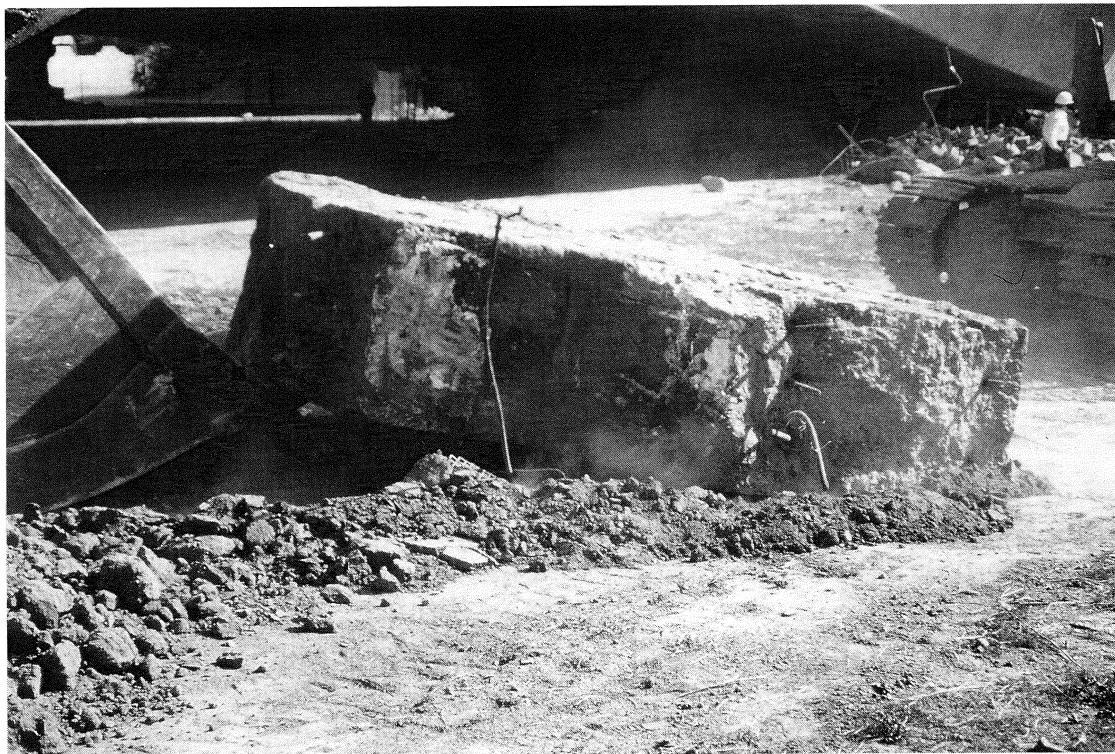
**FIGURE 7-10 Mission-Gothic Undercrossing -  
Excavated Collar from Footing of Right Hand Column in Bent 2 of Eastbound Bridge**

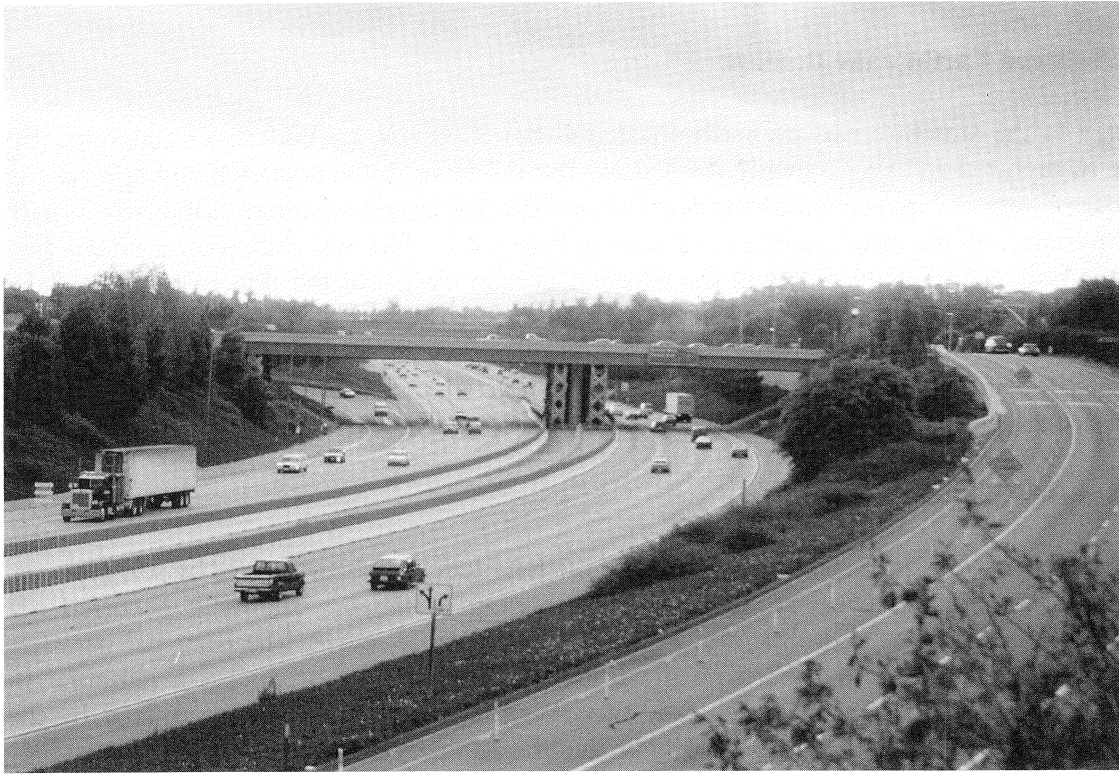
This bridge performed satisfactorily. It resisted the longitudinal seismic forces by soil plowing at the abutments and frame action at bent 3. Undermining at the bin abutment occurred after the waterline(s) carried by the bridge, ruptured during the seismic event. The principal damage to the bridge (and its closure) was therefore the result of colocation of lifelines - a reminder that the vulnerability of a lifeline that shares right-of-way with other lifelines is determined by the most fragile member; which may not necessarily be the lifeline under study.

**FIGURE 8-2 Balboa Boulevard Overcrossing -  
General View**

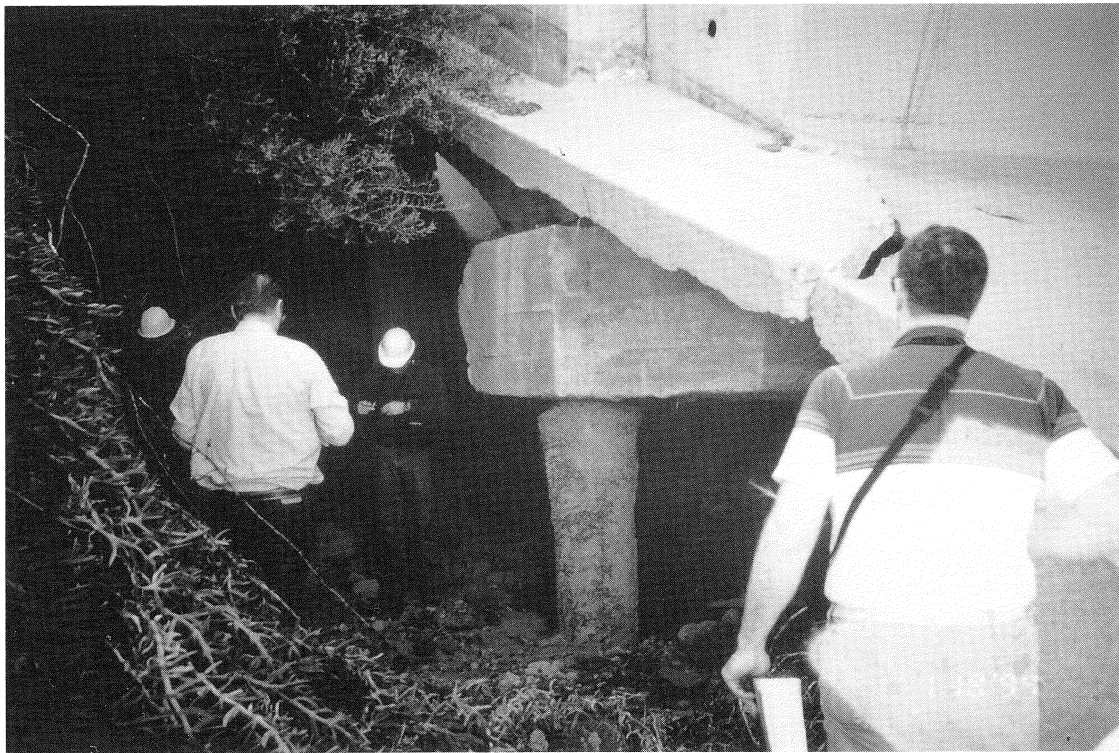
**FIGURE 8-3 Balboa Boulevard Overcrossing -  
Soil Erosion at South Abutment Due to Ruptured Water Lines**

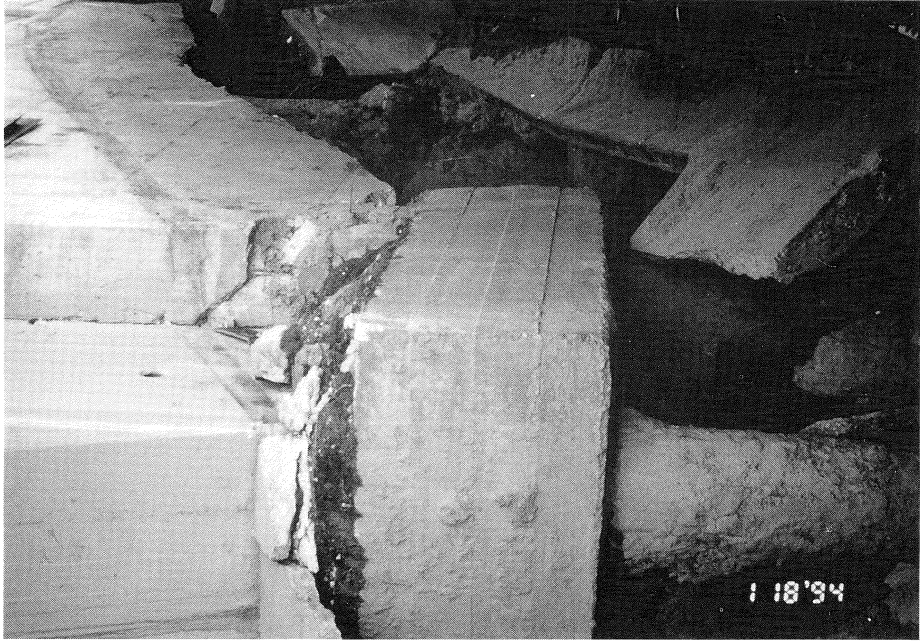
**FIGURE 8-5 Balboa Boulevard Overcrossing -  
CIDH Pile and Cap at Abutment 2**
