# The Northridge, California Earthquake of January 17, 1994: Performance of Highway Bridges

Technical Report NCEER-94-0008

March 24, 1994

This reconnaissance report provides an analysis of major bridge damage which occurred during the earthquake. Eight highway bridges are described in terms of their geometry, site ground motions, observed damage and likely failure modes.

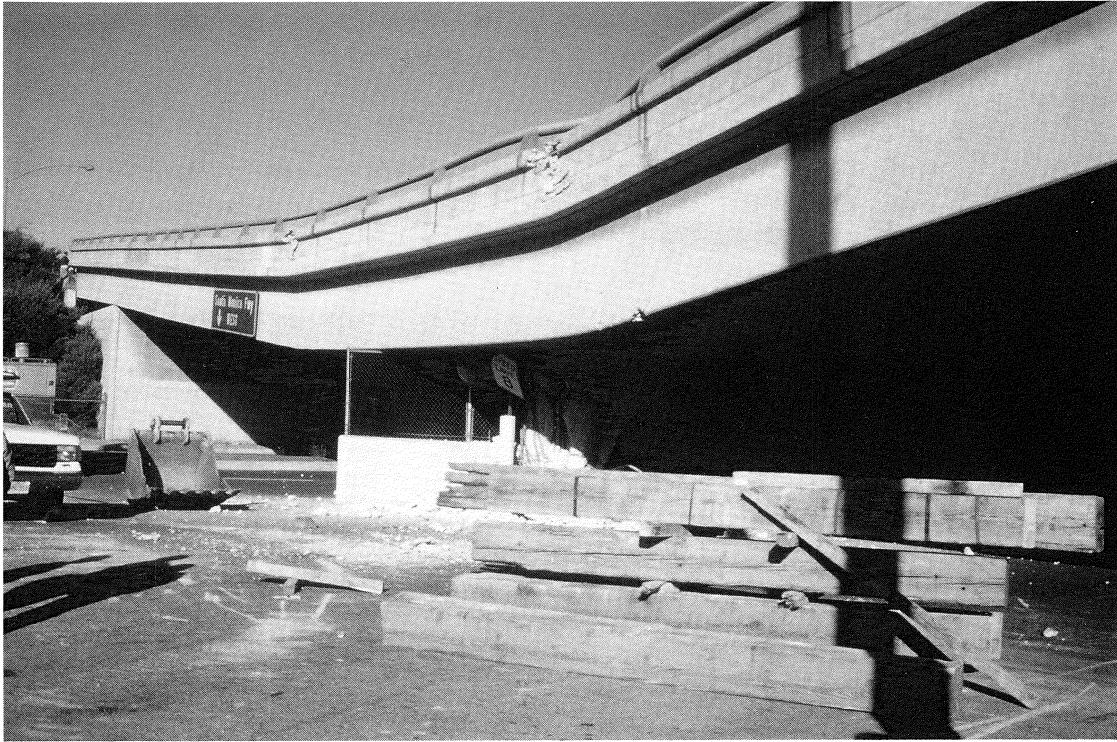
**FIGURE 9-3 Fairfax-Washington Undercrossing - Side View of Partially Collapsed Eastbound Bridge**

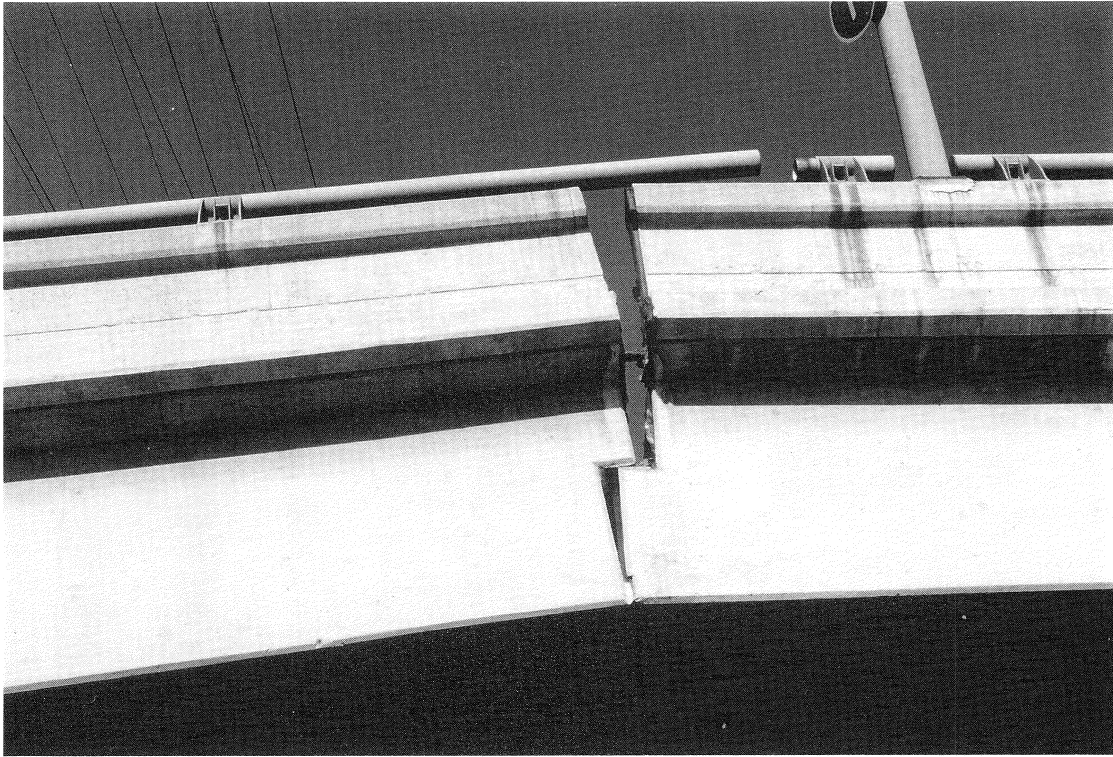
**FIGURE 9-5 Fairfax-Washington Undercrossing -  
Rotation at Hinge in Span 3**

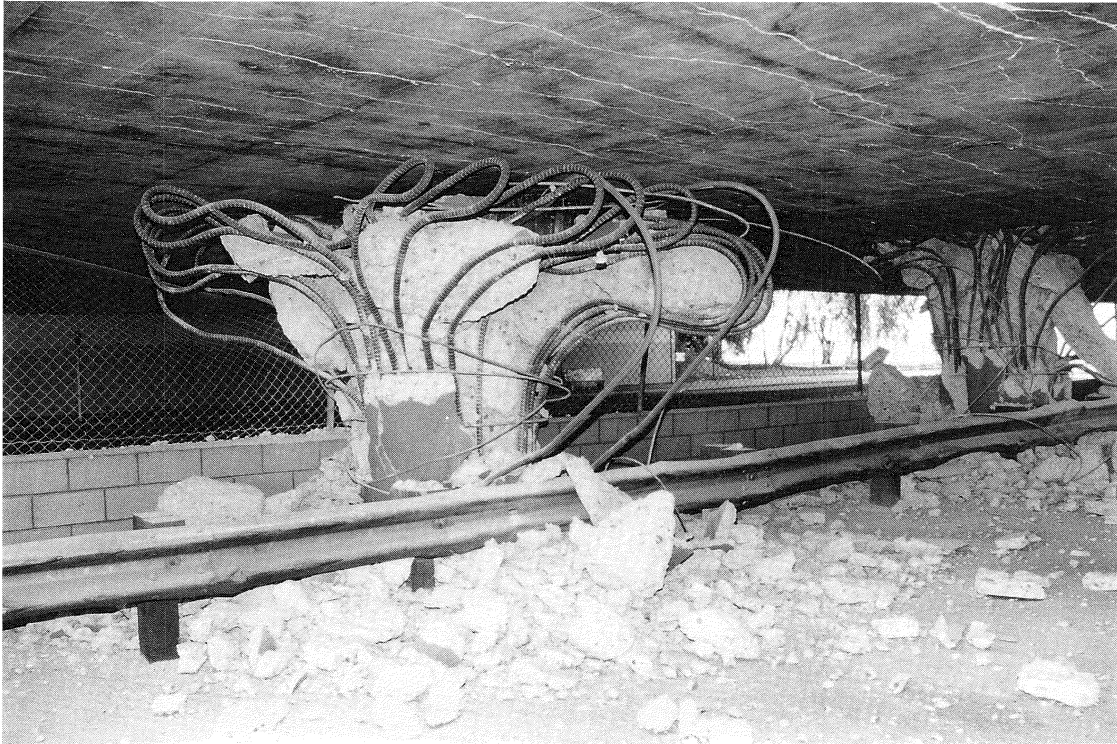
The column failures at bent 3 were most likely caused by excessive shear forces. Flexural yielding in the columns resulted in degradation of shear capacity while producing relatively high ultimate shear demands. To demonstrate this effect, the columns in the right half of the bridge were analyzed for both moment and shear.

**FIGURE 9-7 Fairfax-Washington Undercrossing -  
Total Column Failure in Bent 3**

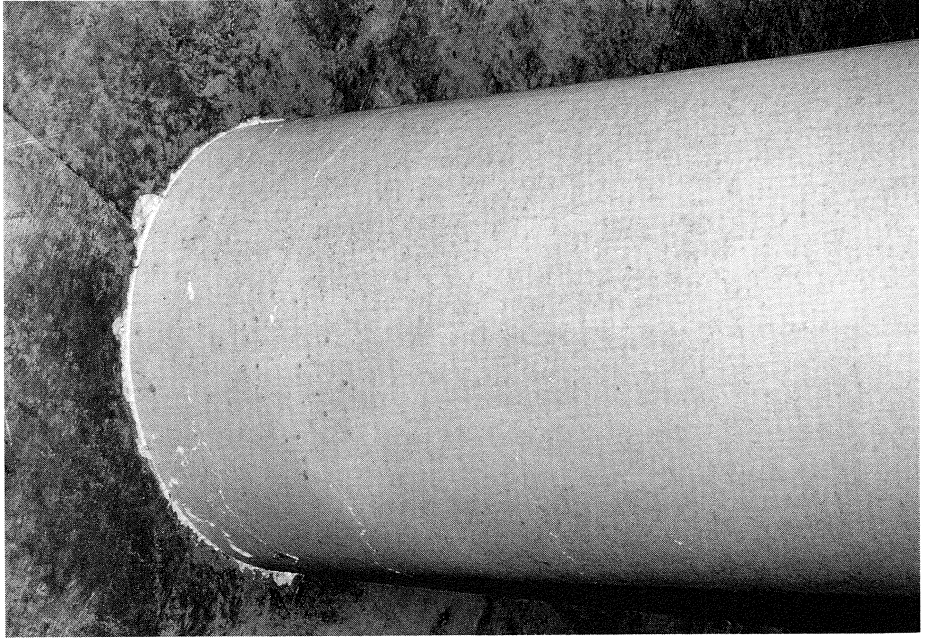
**FIGURE 9-9 Fairfax-Washington Undercrossing -  
Minor Column Damage in Bent 5**

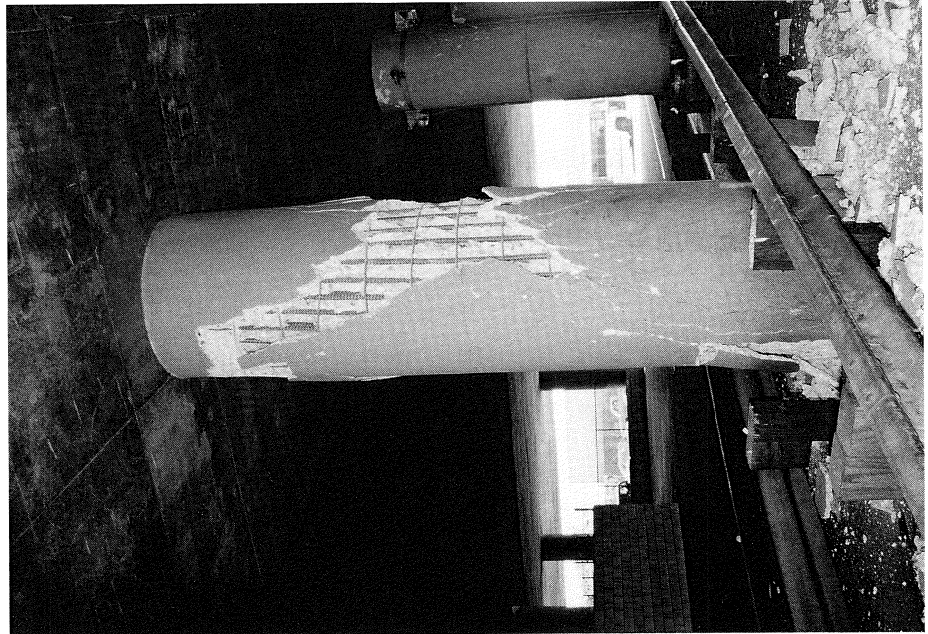
**FIGURE 9-8 Fairfax-Washington Undercrossing -  
Shear Cracking in Column in Bent 4**

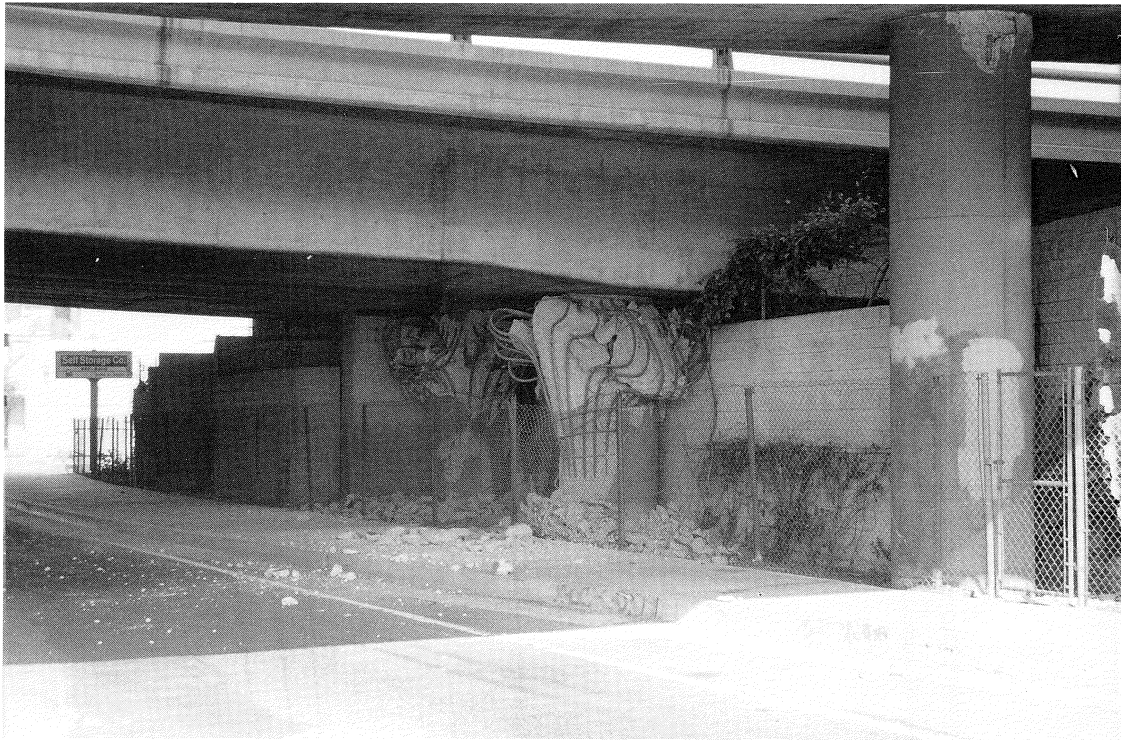
**FIGURE 10-2 La Cienega-Venice Undercrossing -  
Column Failure in Bent 3**

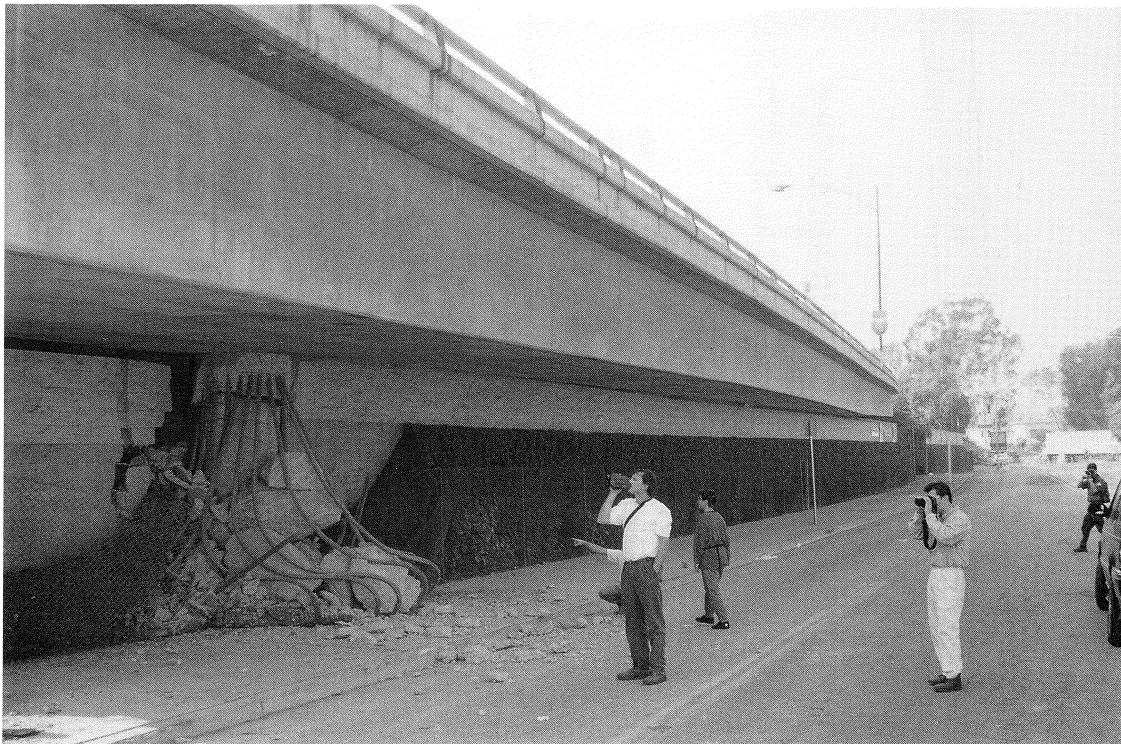
**FIGURE 10-3 La Cienega-Venice Undercrossing -  
Column Damage in Bents 4, 5 and 6 Partially Hidden  
from View by Storage Facility Under Bridge**

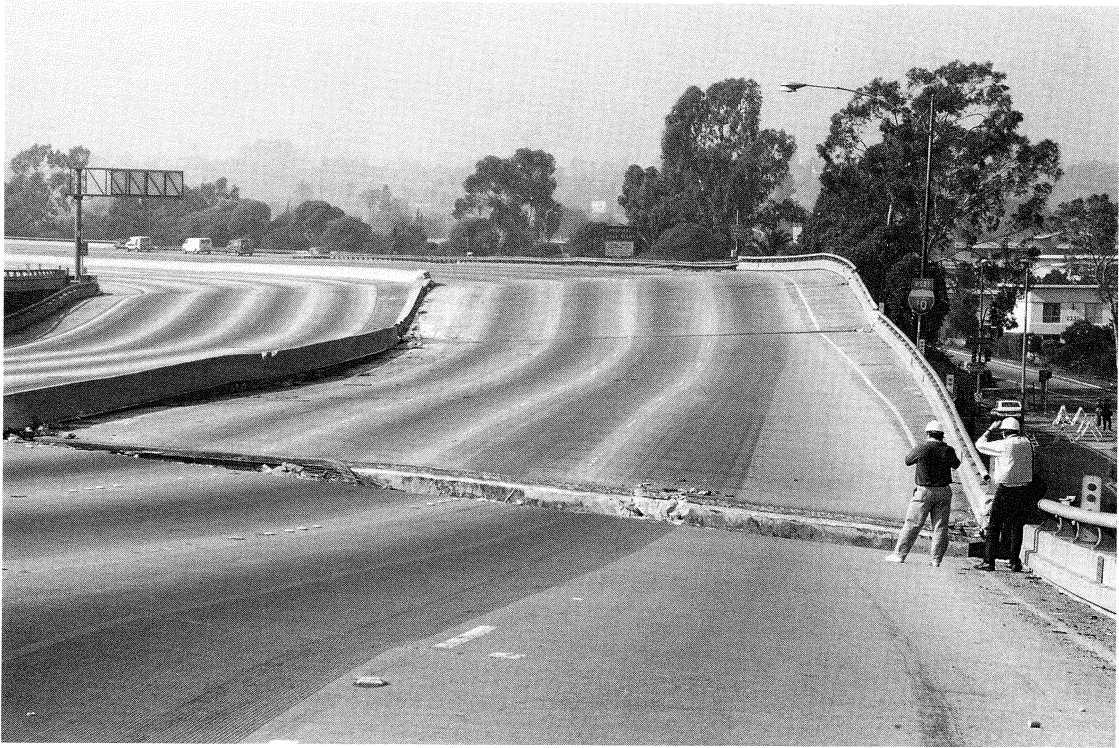
**FIGURE 10-4 La Cienega-Venice Undercrossing -  
Superstructure Settlement Due to Column Failures**

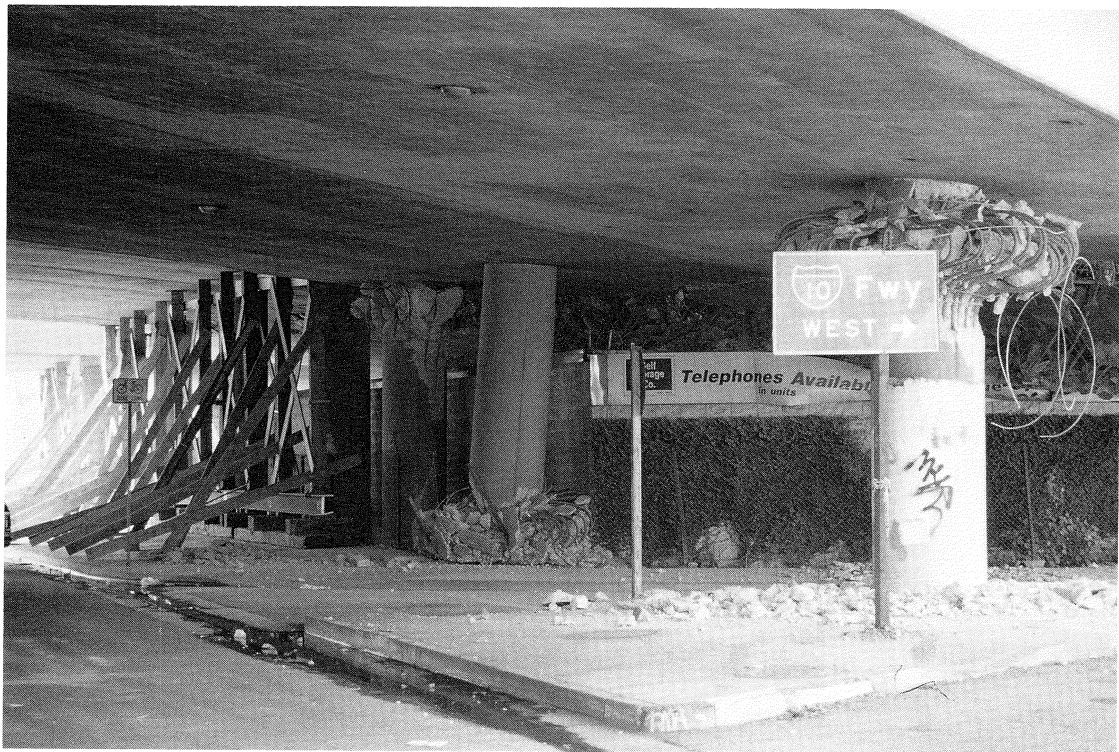
**FIGURE 10-5 La Cienega-Venice Undercrossing -  
Alternating Locations of Hinges in Columns of Bent 7**

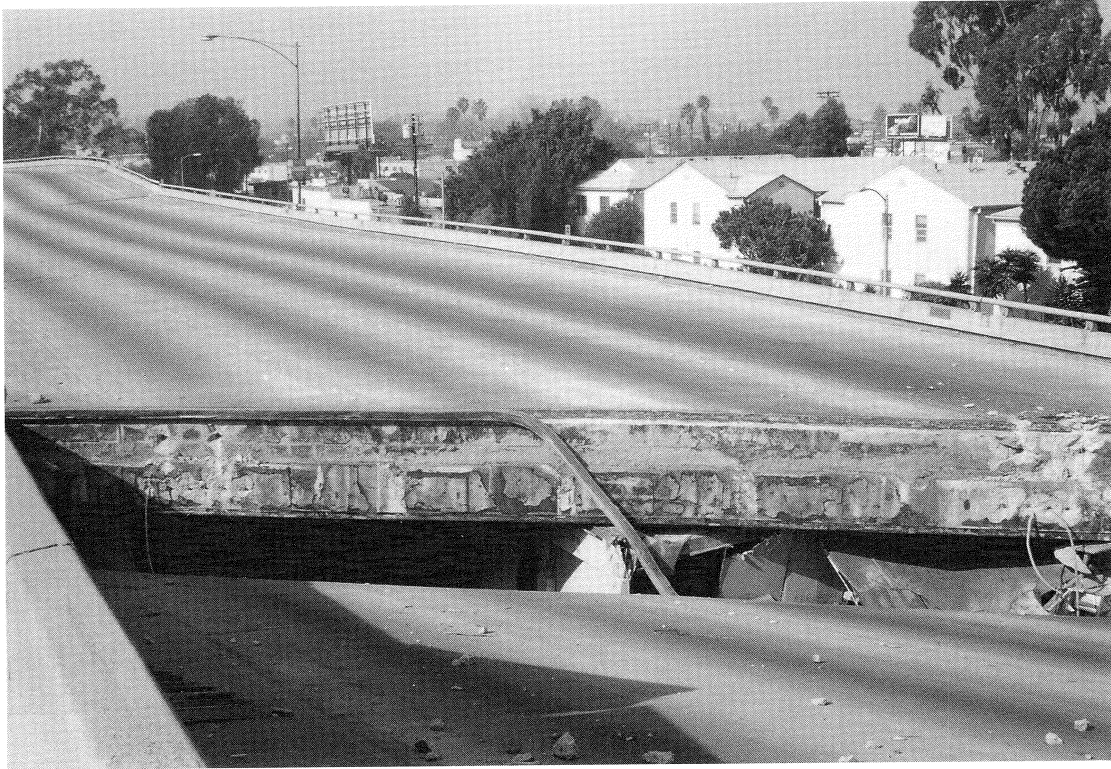
**FIGURE 10-6 La Cienega-Venice Undercrossing -  
Unseated Hinge Near Bent 6**

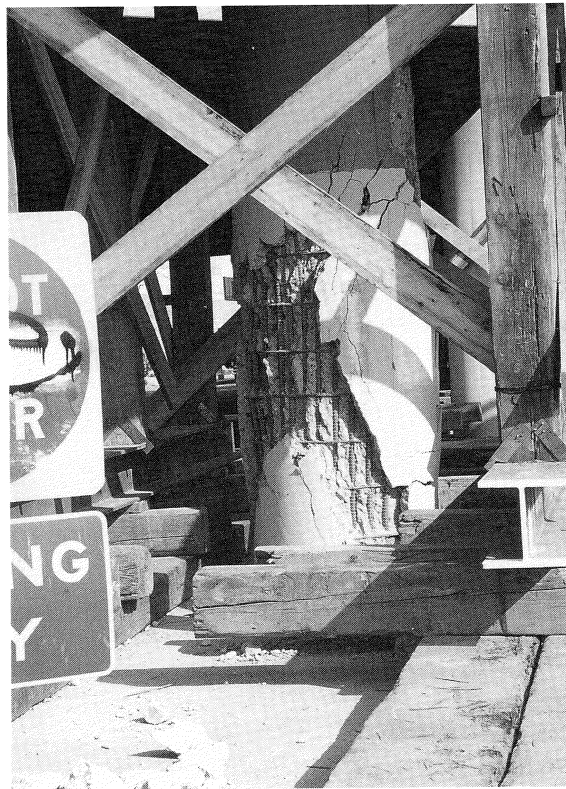
**FIGURE 10-7 La Cienega-Venice Undercrossing -  
Shear Cracking in Column in Bent 8**

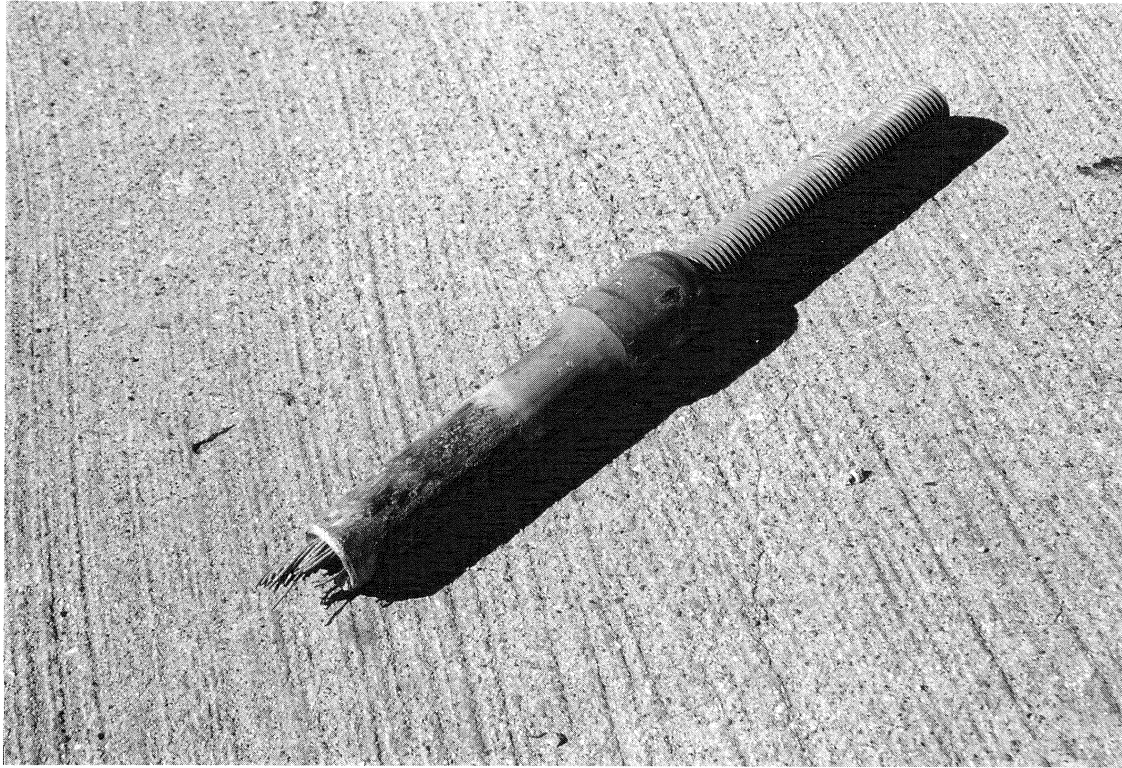
**FIGURE 11-1 SR14/I-5 Interchange -  
Failure of a Type I Hinge Restrainer at the Swaged Fitting**

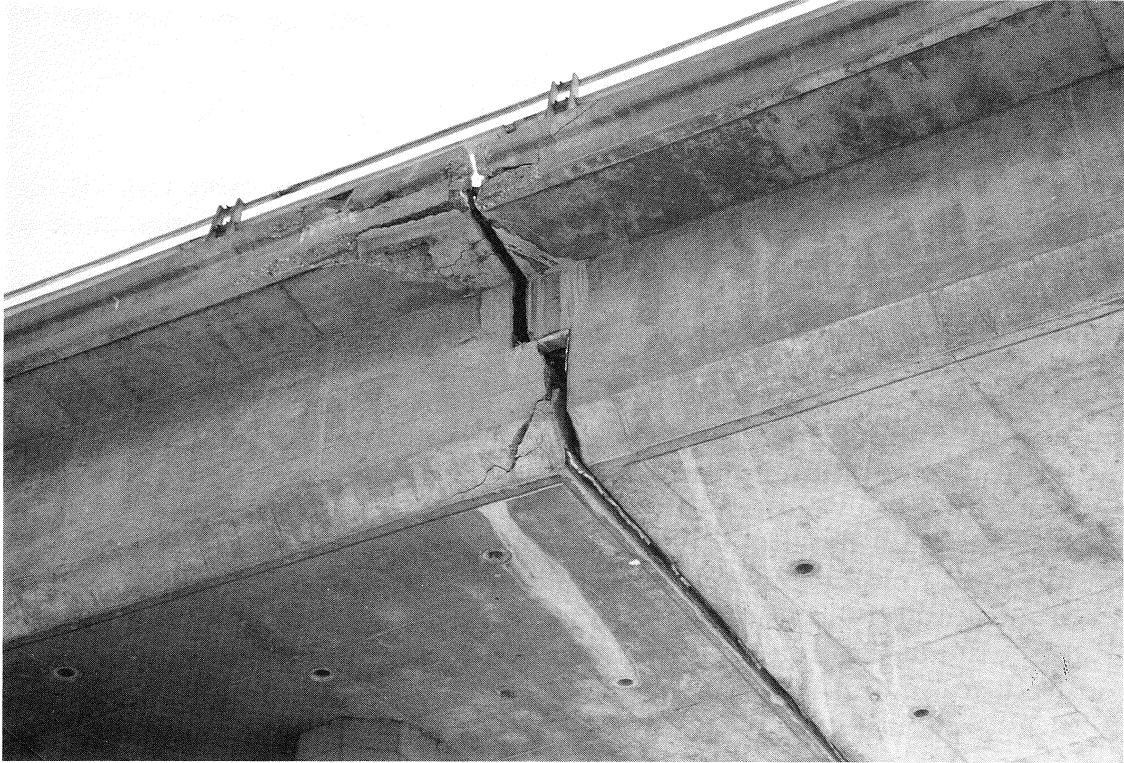
**FIGURE 12-1 SR14/I-5 South Connector -  
Pounding and Damage to Hinge Seat in Span 6**

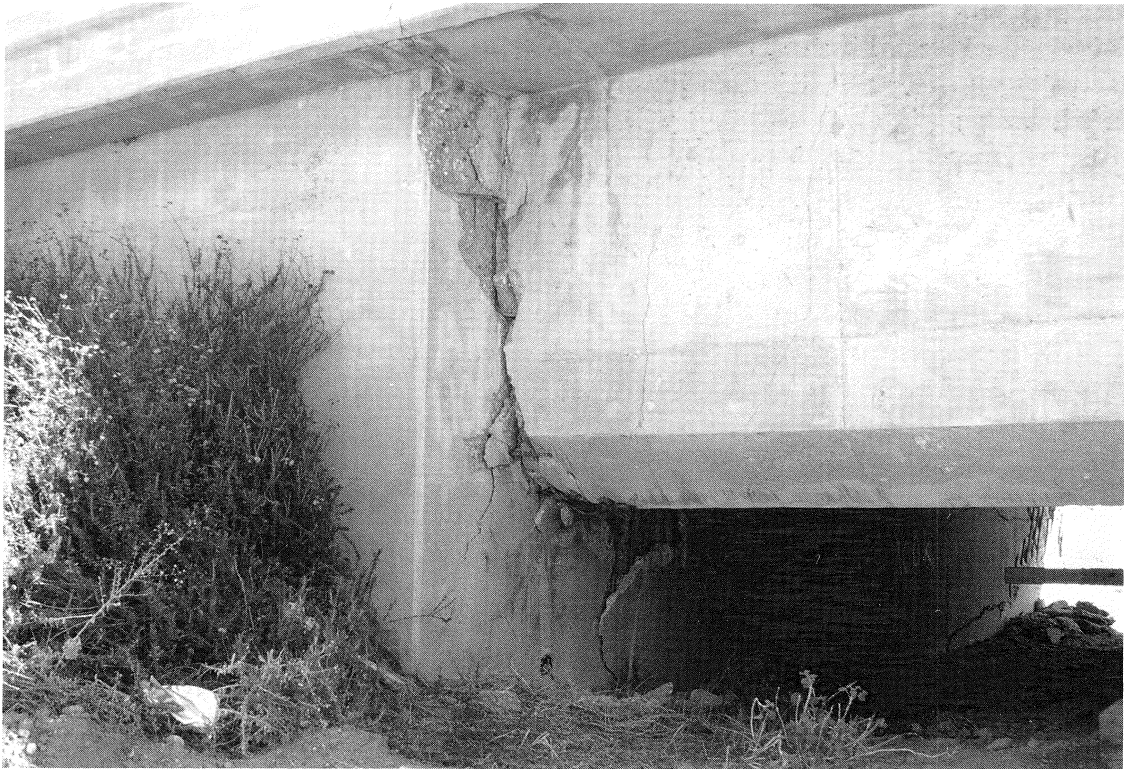
**FIGURE 12-2 SR14/I-5 South Connector -  
Damage to Abutment 10**

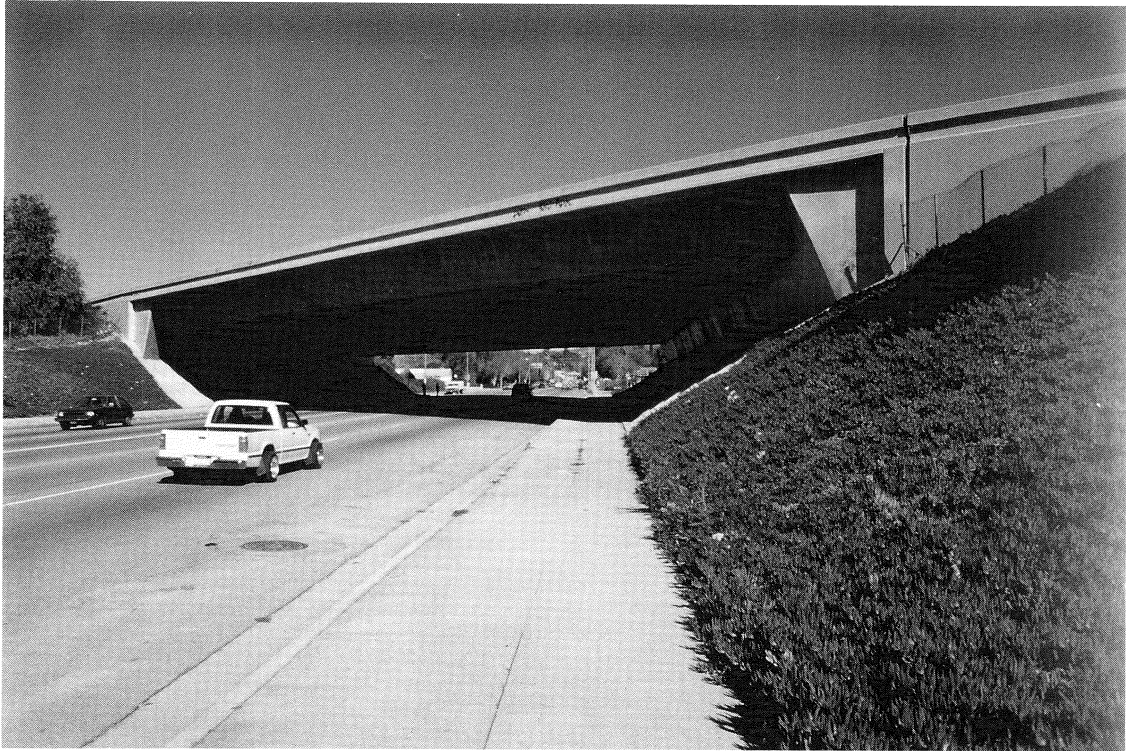
**(a) Single Span Bridge with Integral Abutments Sustained Minor Damage**

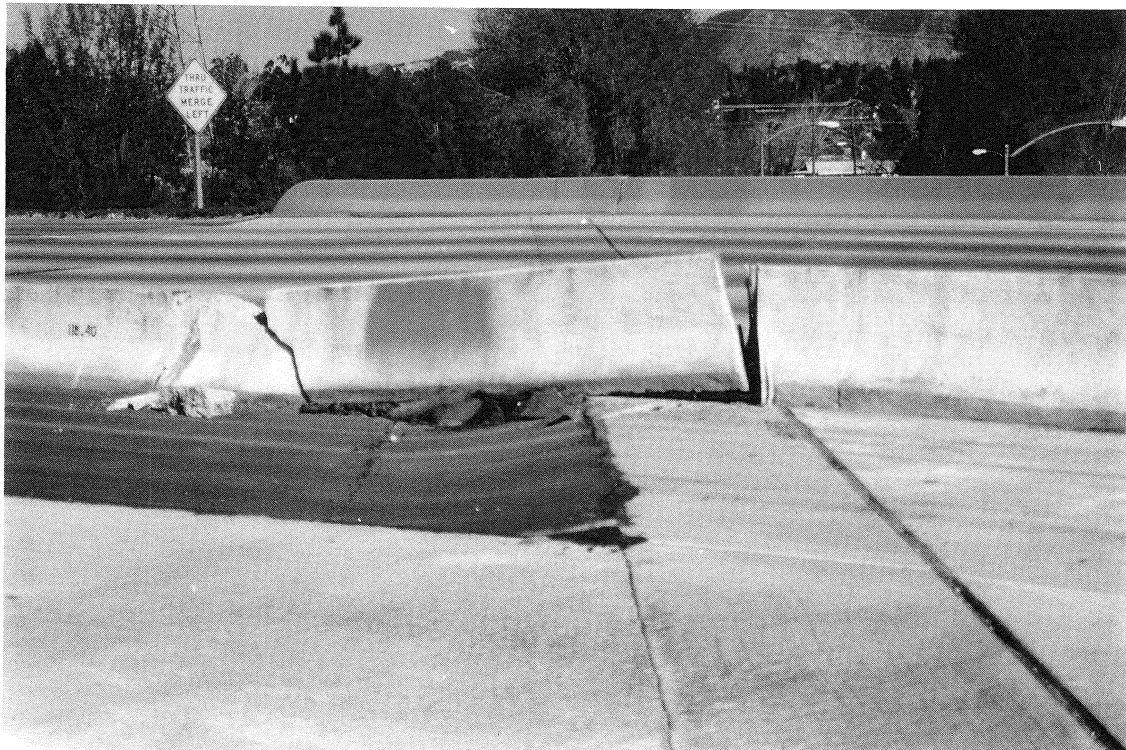
**(b) Slumping of Abutment Fills under Roadway Shoulders; Approach Slab in Foreground Successfully Spans Settlement**

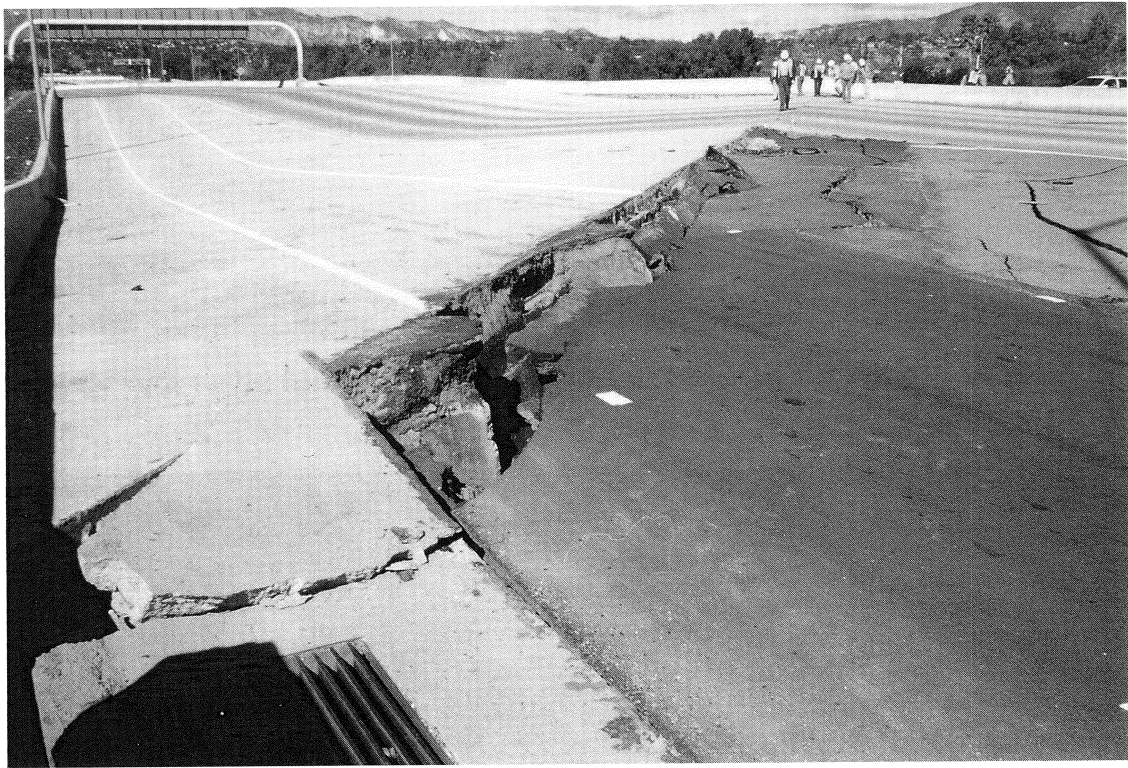
**FIGURE 12-4 Bull Creek Canyon Channel Bridge -  
Slumping of Abutment Fills under Roadway Shoulders**
