The Quindío, Colombia Earthquake of January 25, 1999: Reconnaissance Report

Technical Report MCEER-99-0017
October 4, 1999

Quindío, Colombia Earthquake of January 25, 1999: Reconnaissance Report

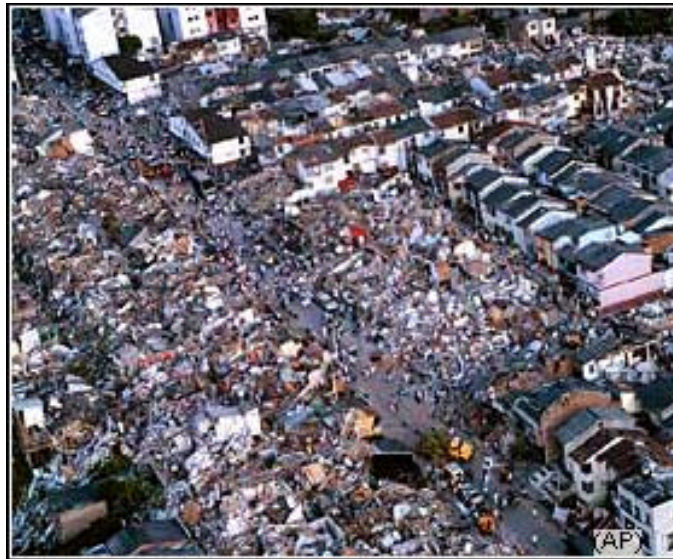
Figure 3-3 Complete Damage in Brasilia, Armenia

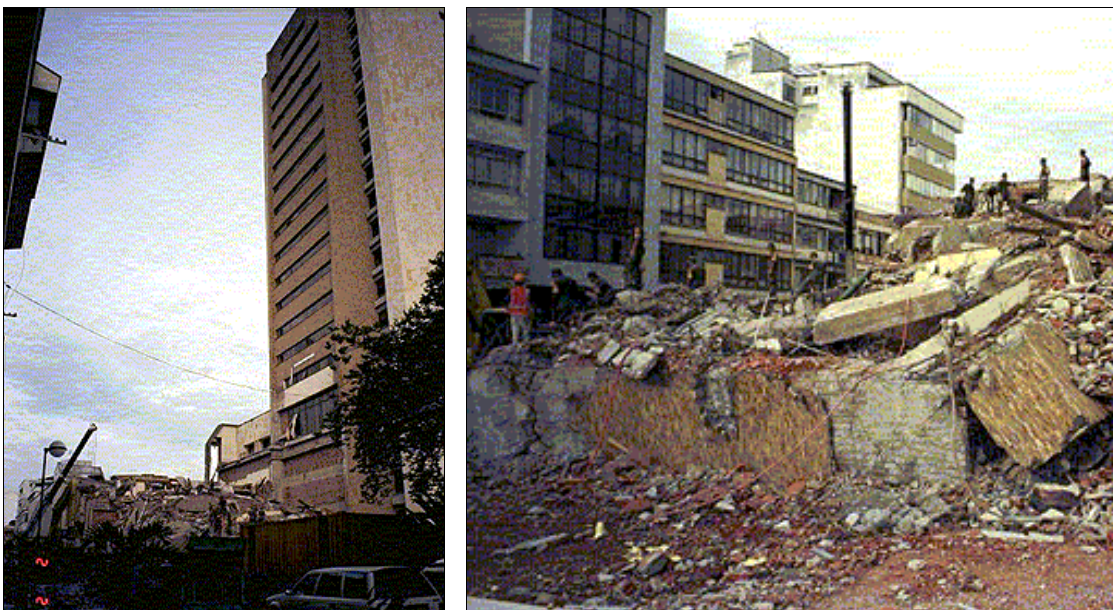
Figure 3-4 Damaged Wing of Armenia Government Building

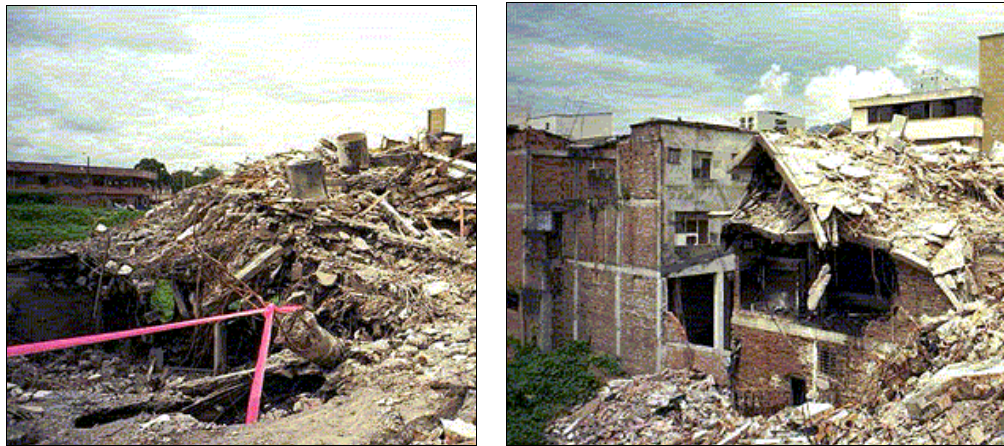
Towns such as La Tebaida and Barcelona, located on a deep layer of soft soil, were severely damaged (see figure 3-7). In comparison, the town of Córdoba, much closer to the epicenter and located on bedrock, suffered less damage. In Pereira, the area most affected was between *calles* 15 and 26 and *carreras* 8 and 16, which is located on man-made non-engineered fill (see figures 3-5 and 3-6).

Figure 3-5 City of Pereira: Damage on Corner of Carrera 11 and Calle 21, 4-Story Building

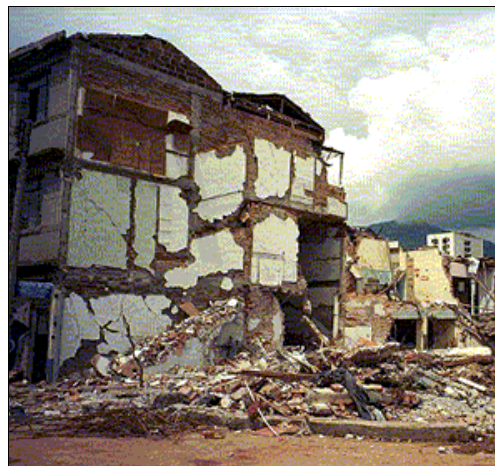
Figure 3-6 City of Pereira: Carrera 12/Calle 22, 3-Story Building, Collapsed

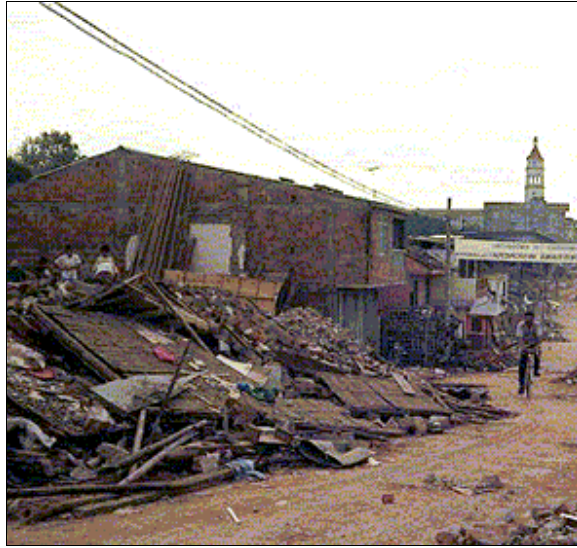
Figure 3-7 City of La Tebaida: Damage on Carrera 6

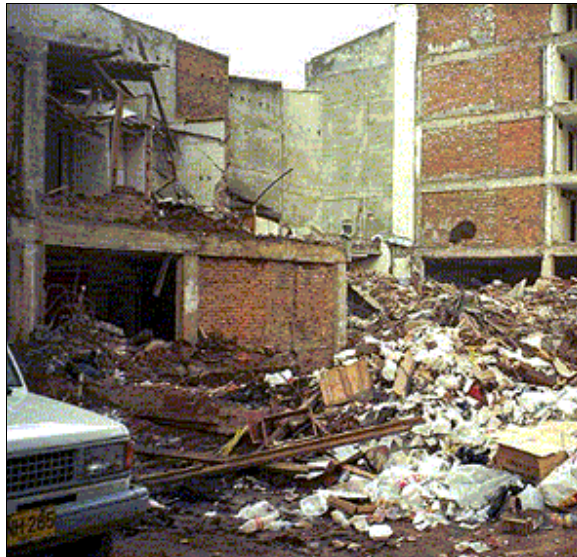
**Figure 3-8 Hotel Armenia-Plaza, Unreinforced Masonry
Calle 22/Carreras 14 y 15, Armenia**

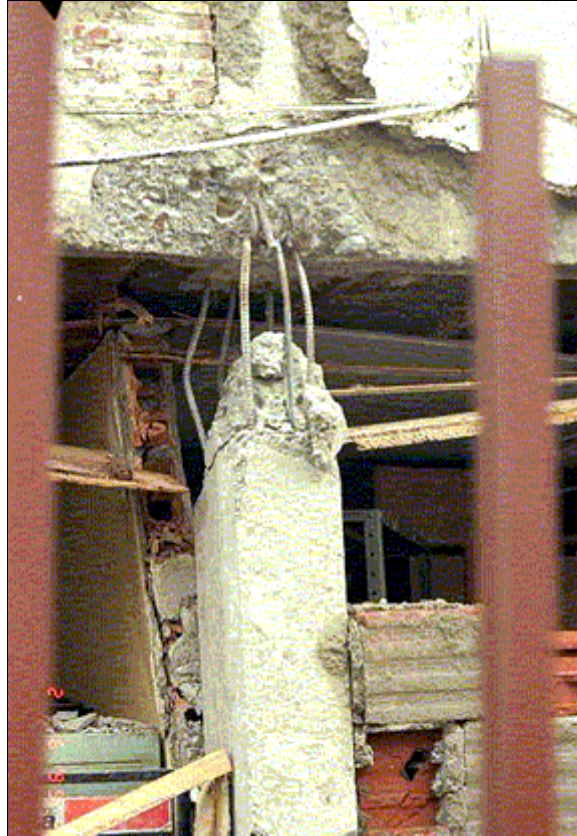
Figure 3-9 Brasilia Neighborhood, Armenia

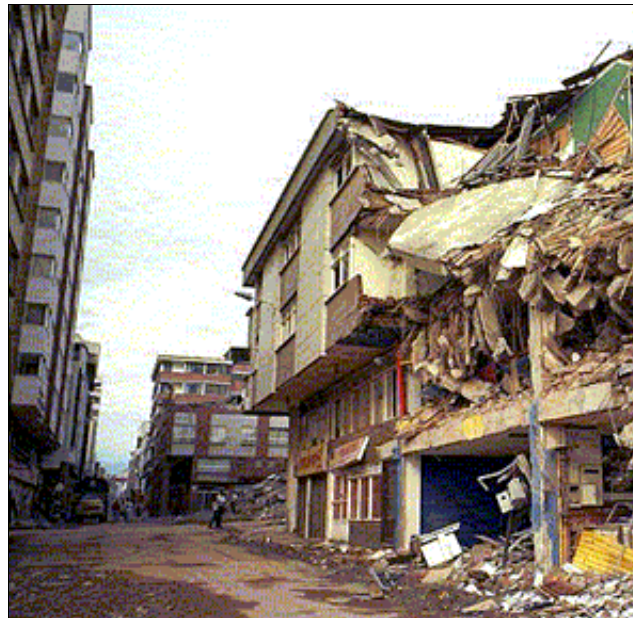
**Figure 3-10 Kokorico Restaurant, Carrera 15/Calle 21, Armenia,
4-Story, Concrete Frame, Masonry Infill**

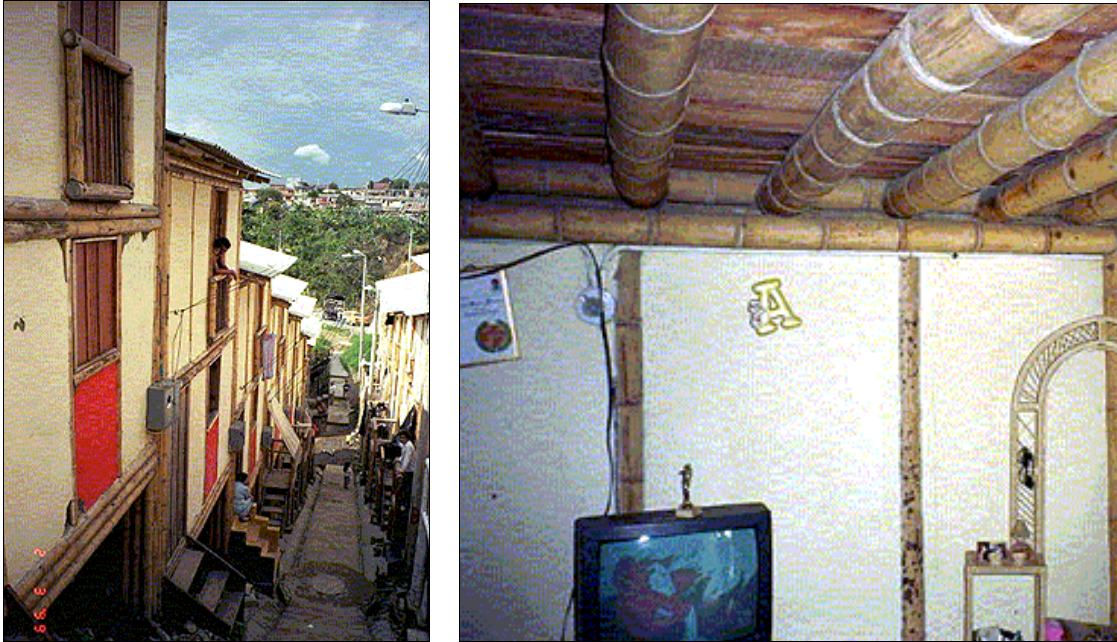
A group of 73 two story houses in the Miraflores neighborhood of Armenia, built with frames of *guadua* (similar to bamboo), behaved well and did not suffer any damage (see figure 3-11). Many masonry houses in this neighborhood were damaged. The same was observed in some rural areas.

Figure 3-11 Miraflores Neighborhood, Armenia: 73 Houses Built with Guadua Frames, No Damage

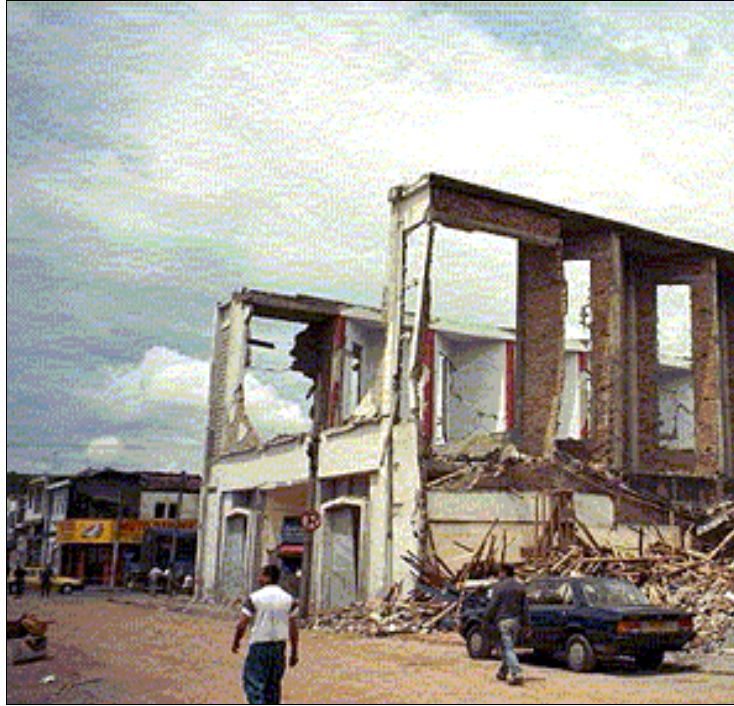
Churches built with unreinforced stone or solid brick masonry were severely damaged in the whole area affected by the earthquake. Also, churches built with concrete frames and unreinforced masonry infill panels suffered severe damage in those panels (see figures 3-12 and 3-13).

Figure 3-12 Pereira Church on Carrera 12/Calles 22 and 23

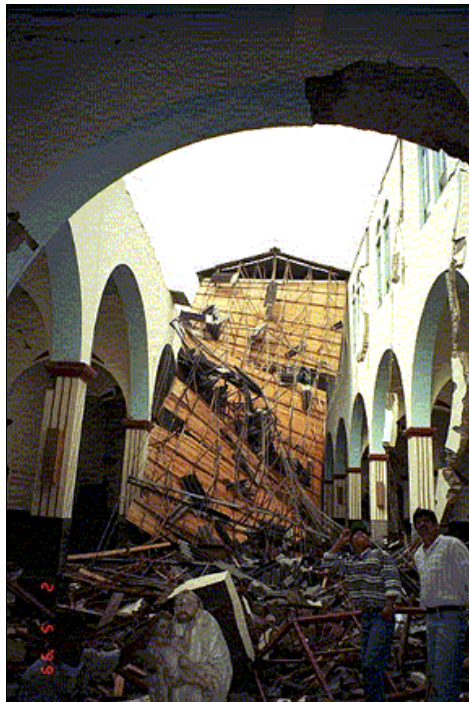
Figure 3-13 Damaged Church in Pijao

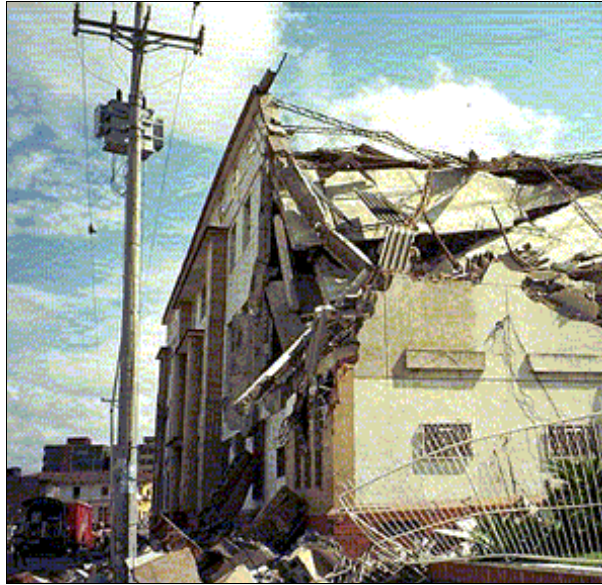
**Figure 3-14 Damage to San Francisco Solano School in Armenia.
URM Building**

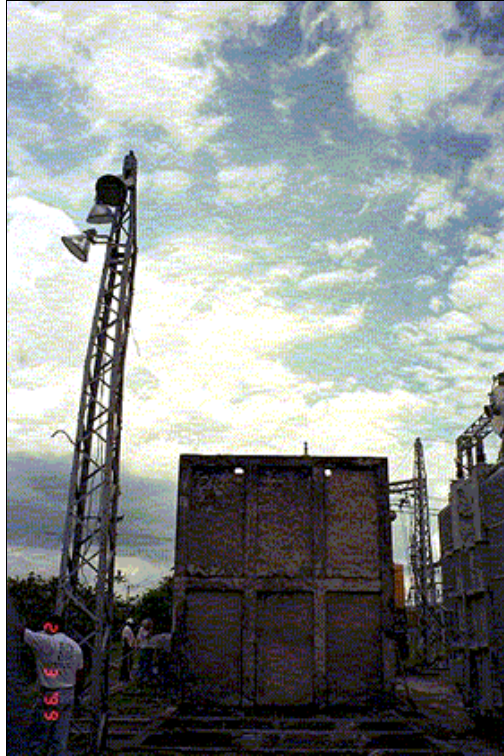
- ❑ Substation Regivit (115 KV/33 KV, 60 MVA, built in 1960). It is one of the two substations that connect the Colombian grid to the department grid, suffered damage in the transformers and circuit breakers. The three transformers (20 MVA each) were not anchored and mounted on wheels and they jumped out of their rails. One of them fell inside the oil-pit and suffered heavy damage, the other two did not completely fall inside the pits but suffered damage in the supports and the bushings. Two ceramic column circuit breakers broke close to their base. This substation is located in the north area of Armenia, in a zone with very little reported damage; however, the transformers were located about 4 meters from a very deep ravine (about 200 meters deep). The substation was out of service at the time of the visit (see figure 4-1).

**Figure 4-1 Substation Regivit (115 kv/33 kv, 60 mva, 1960) in Armenia:
Damage on Tower Due to Transformer Fall**

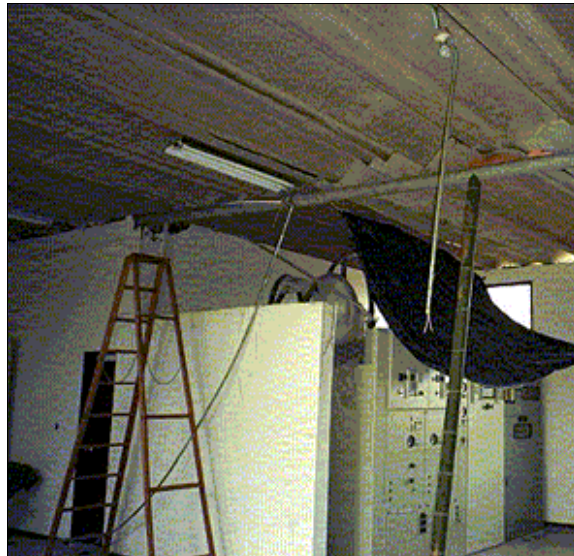
- ❑ Substation Sur (33 KV/13.2 KV, 15 MVA, built 1982). Located in the south area of Armenia has two transformers (10 MVA, 5 MVA) mounted on wheels, they moved but did not fail. Some oil leakage in the 10 MVA transformer was reported. The equipment in the control room was not anchored and moved approximately 2". No equipment failure was reported though. The control room is a one story URM building. The walls and roof were damaged. This substation was still in service (see figure 4-2).

**Figure 4-2 Substation Sur (33 kv/13.2 kv, 15 mva, 1982) in Armenia:
Roof Control Room Almost Collapsed Due to Truss Failure,
Temporary Support**

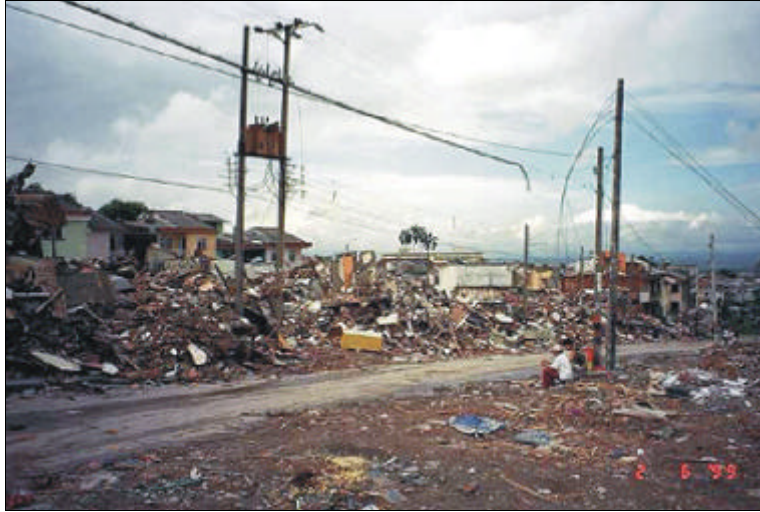
The distribution lines in the cities were damaged due to collapsing structures; however, they were repaired very quickly. The large majority of the street poles and the distribution elevated transformers did not suffer any damage due to the earthquake shaking (see figure 4-3).

Figure 4-3 Damage to Electrical Distribution Lines in Brasilia, Armenia

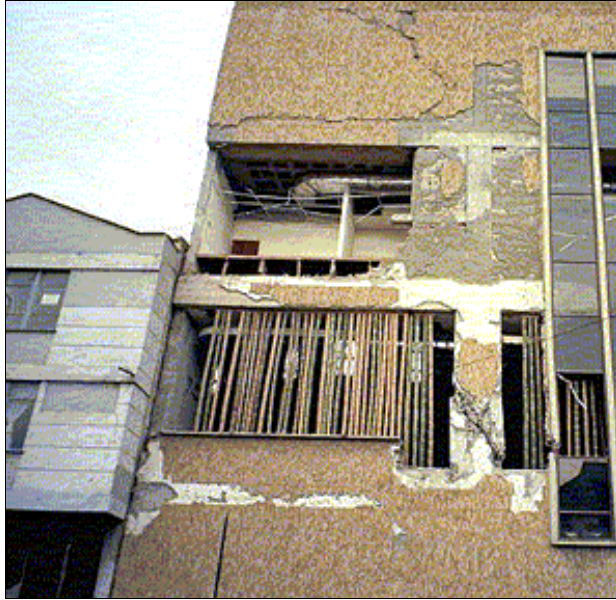
Figure 4-4 Telecom Building in Armenia Suffered Severe Structural Damage

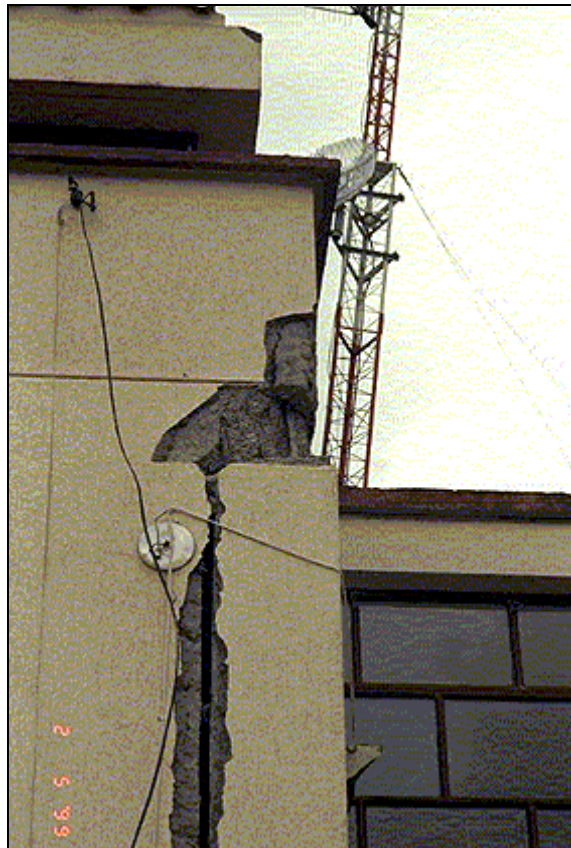
Figure 4-5 Telecom Building in Cordoba Suffered Severe Damage (Concrete Columns with Masonry Infill)

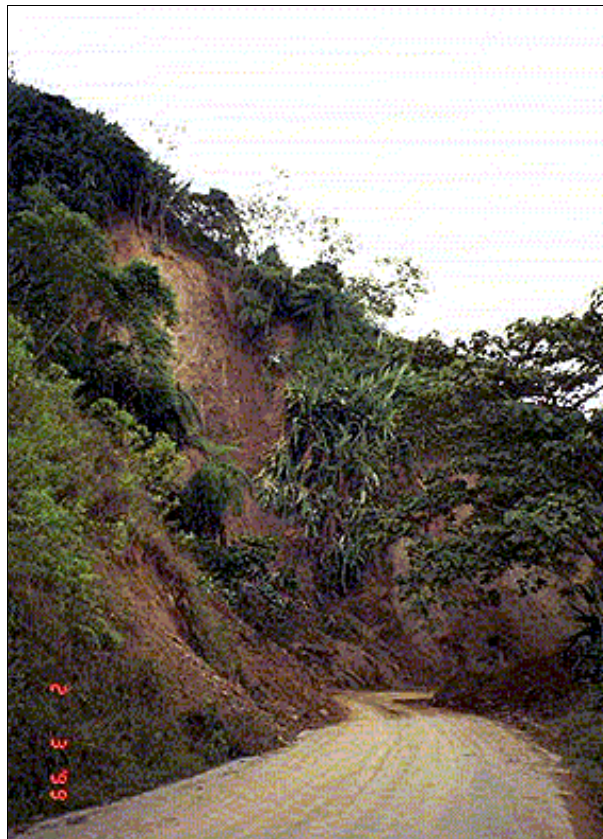
Several two-line paved roads, highways, and bridges were affected by the earthquake. No major damage was detected in the pavement, only some local cracks in the road between Armenia and Pijao were observed. However, four roads were blocked (Armenia-Buena Vista, Armenia-Pijao, Armenia-Córdoba, Armenia-Ibagué) and three municipalities of Quindío were isolated due to landslides. The most affected road was the Armenia-Pijao, which, in about 14 km, had approximately 100 landslides, several of them large enough to completely block the road (see figures 4-6 and 4-7).

Figure 4-6 Landslides on Road Armenia-Pijao

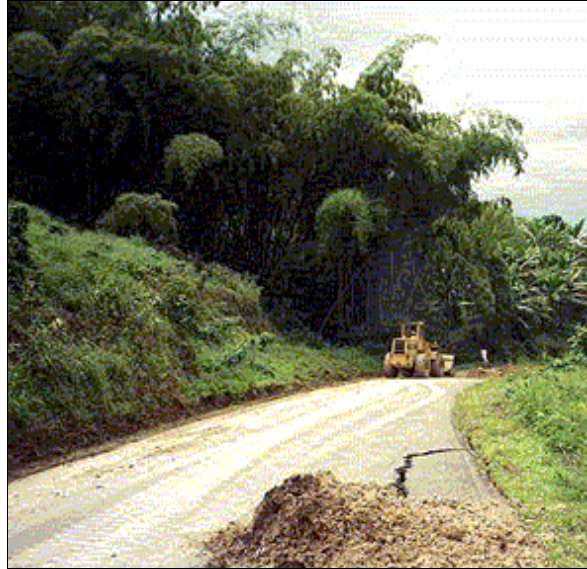
Figure 4-7 Crack on Pavement Due to Movement of Downhill Side of the Road on Road Armenia-Pijao

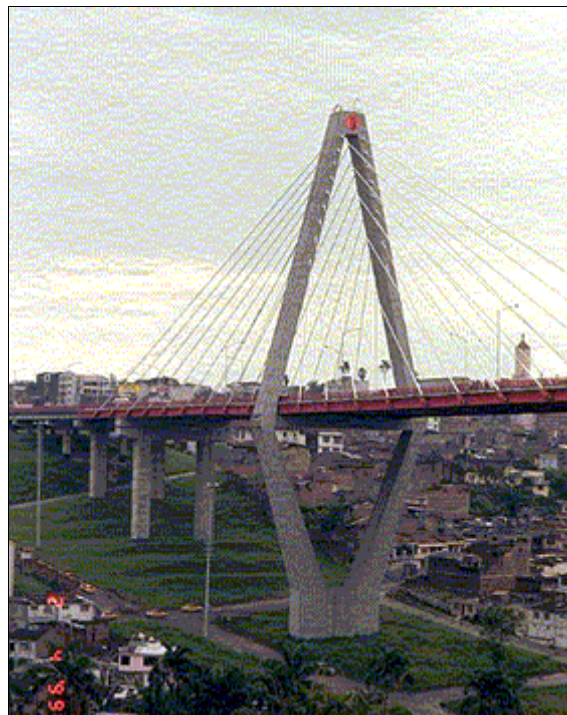
Bridges behaved well in the affected area and no structural damage or settlement was observed. Near Pereira (between Pereira and Dos Quebradas) there is a newly built cable stayed bridge, with two tall central towers and a total length of approximately 1 kilometer, with absolutely no damage (see figure 4-8).

Figure 4-8 Pereira: Bridge Between Pereira and Dos Quebradas

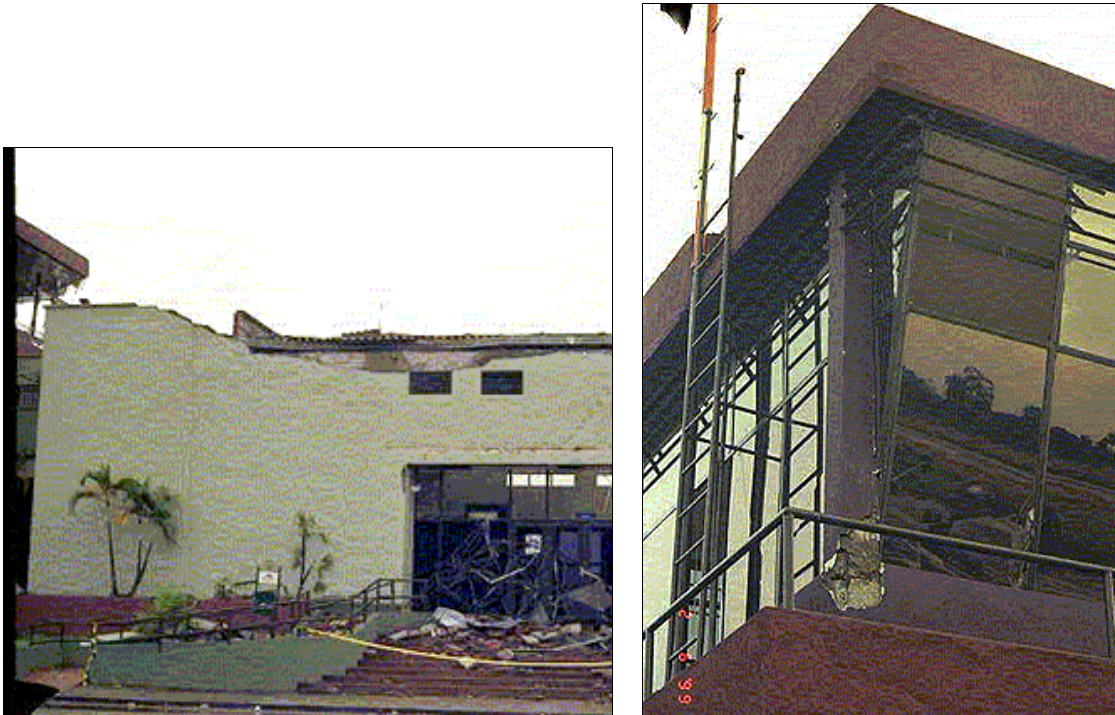
The buildings of the airport El Edén of Armenia were damaged. However, the runway and the outside equipment were not affected and the airport remained functional and able to receive flights carrying emergency personnel and resources. The terminal building is a one-story concrete frame building with masonry infill. It suffered heavy nonstructural damage and damage on the roof (see figure 4-9). The columns of the top floor (3rd) of the control tower were damaged. The concrete slab on top of the tower is supported by two columns located at the back corners of the slab and by two very close columns at the central part of the slab. This floor will be demolished. Apparently, none of the equipment was damaged.

Figure 4-9 Structural Damage to Armenia Airport Terminal and Tower

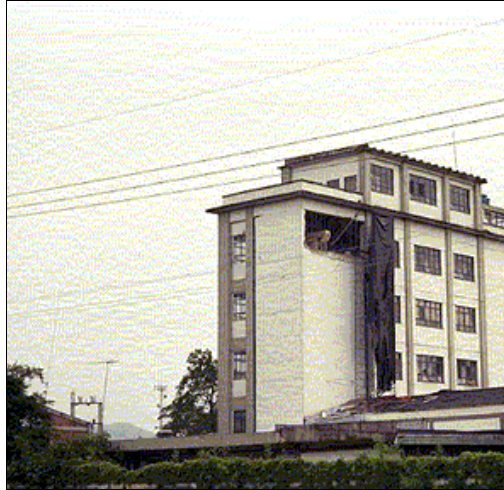
In the industrial area of Dos Quebradas, north-east of Pereira and about 48 kilometers north of the epicenter, damage was observed in concrete frame buildings of two industrial installations (see figure 4-10). No equipment failure was observed or reported. This area is on layers of natural soil. Very close to the two visited installations, there is an accelerometer. The maximum acceleration recorded were 0.184g in the e-w direction, 0.192g in the n-s direction, and 0.075g in the vertical direction.

Figure 4-10 Industrial Building in Dos Quebradas was Damaged and Repaired in 1995, Suffered Damage in Nonstructural Panels and Some Deep Beams

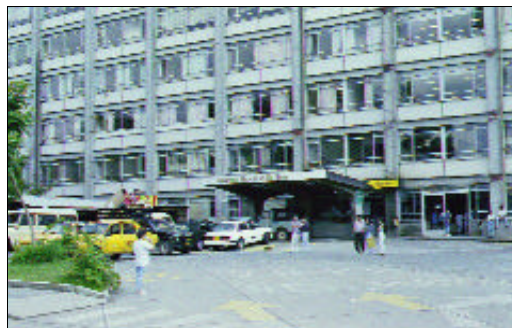
Hospitals and other health care centers were severely affected by the earthquake. The regional hospital in Armenia is a five-story concrete frame structure with masonry infill. Significant non-structural damage was noted to the building, although the hospital continued operating (see figure 4-11). The emergency department was in a new wing of the hospital that suffered little damage. The hospital had emergency generators and was able to operate in the immediate aftermath. In addition to the regional hospital in Armenia, seven of the twelve primary care health centers in the city were also damaged. Three of the clinics, in the hardest hit areas of the city, collapsed. Four additional clinics suffered severe damage and were yellow-tagged although the clinics continued to function. The one clinic visited was a one-story masonry building. The roof of the structure collapsed over all but the front two rooms of the building. In addition, landslides under the rear of the structure were threatening the back two rooms.

Figure 4-11 Regional Hospital in Armenia Suffered Extensive Nonstructural Damage but was Kept Operational

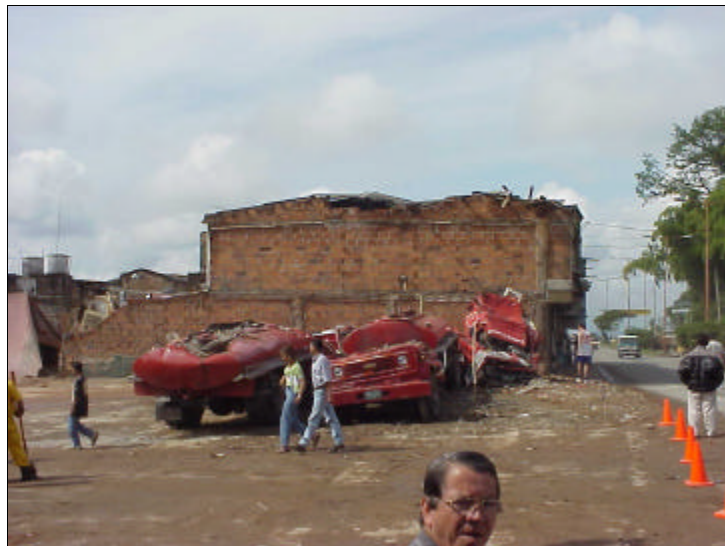
The fire department for the city of Armenia was centralized. The city's fire department and all of its personnel and equipment were housed in only one facility. The building collapsed during the earthquake, destroying all the fire trucks and killing several fire fighters (see figure 4-12). The building was a three-story concrete frame building with masonry infill (mainly in the two top floors). According to the information available, it was built around the 1950's. Fortunately, only one fire broke out due to the earthquake, in a collapsed three-story building, where the first floor was used as a warehouse for chemical products.

Figure 4-12 Damaged Fire Trucks in Area Where Armenia's Centralized Fire Department Facility Stood

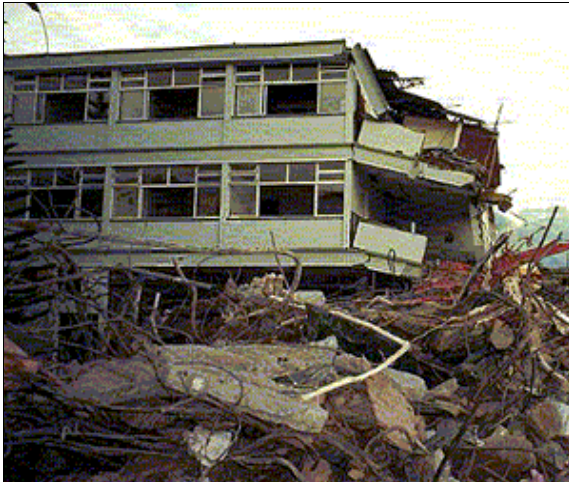
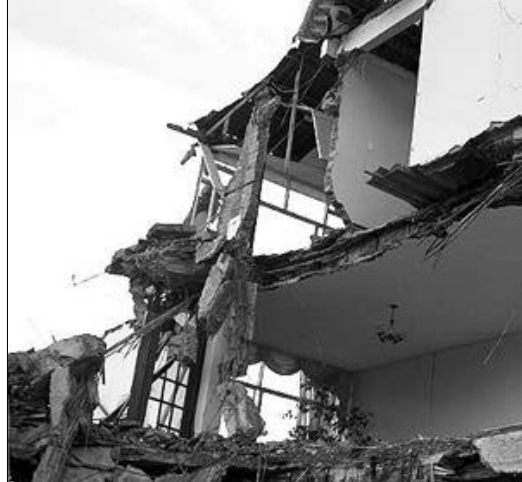
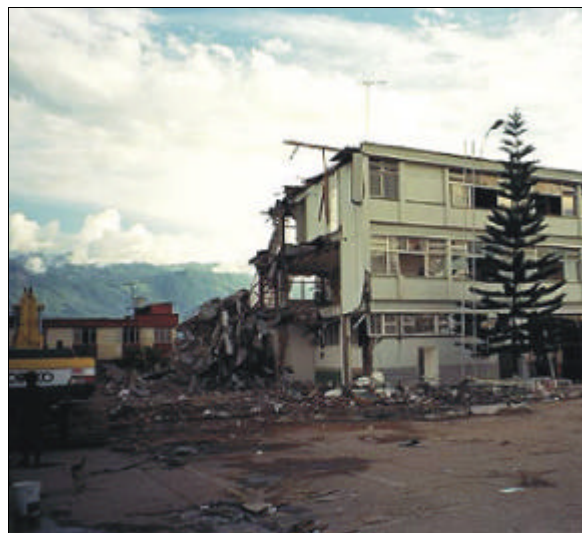
The police department of Armenia was also centralized, and one facility housed all personnel and equipment. This building also collapsed, killing 18 policemen (see figure 4-13). The station consisted of three sections forming a U. They were three-story and five-story concrete frame buildings with masonry infill. It was founded on approximately three meters of volcanic ash. It had a new section that opened in 1998. This new section was severely damaged and will need to be demolished.

Figure 4-13 Collapse of Armenia's Centralized Police Station
