# MCEER RESPONSE

## PRELIMINARY REPORTS FROM THE KOCAELI (IZMIT) EARTHQUAKE OF AUGUST 17, 1999

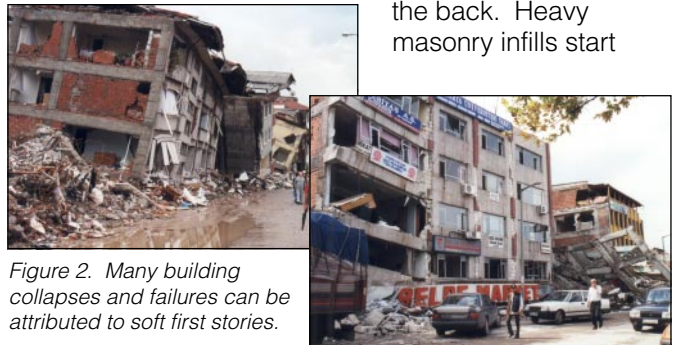
A large number of residential and commercial buildings were built with soft stories at the first-floor level. First stories are often used as stores and commercial areas, especially in the central part of cities. These areas are enclosed with glass windows, and sometimes with a single masonry infill at the back. Heavy masonry infills start

Figure 2. Many building collapses and failures can be attributed to soft first stories.

immediately above the commercial floor. During the earthquake, the presence of a soft story increased deformation demands very significantly, and put the burden of energy dissipation on the first-story columns. Many failures and collapses can be attributed to the increased deformation demands caused by soft stories, coupled with lack of deformability of poorly designed columns. This was particularly evident on a commercial street where nearly all buildings collapsed towards the street.

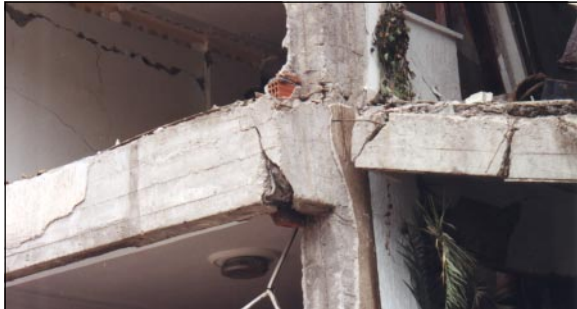
Figure 3. Eccentric beam to column connections induced severe torsion in short perpendicular stub beams.

combinations of many of the above. These errors were often compounded by geometric irregularities such as eccentric beam-to-column connections that induced severe torsion in short perpendicular stub beams (Figure 3).

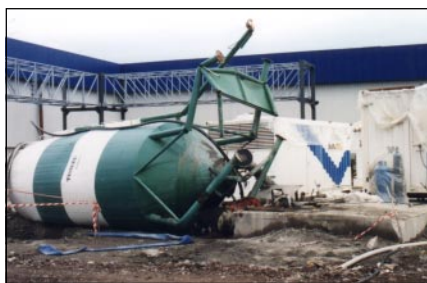
Typical causes for collapses include failure of anchor bolts at column bases and structural instability under overturning forces. Other evidence of damage include

Figure 4. The anchor bolts ruptured and the unbraced support legs buckled, causing this water tank to tip.

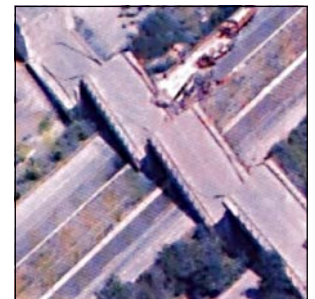
One overpass crossing the E80 did collapse. This was not surprising as the fault rupture passed directly beneath the bridge. The fault movement exceeded the available seat width causing the span to fall to the ground. In so doing, it dragged the remaining three spans off their seats as shown in Figure 1. One of the spans collapsed onto a passing bus, killing ten people.

Figure 1. A collapsed overpass crossing the E80 Trans European Motorway near Adapazari. The fault rupture crossed beneath the bridge in the upper left portion of this photograph.

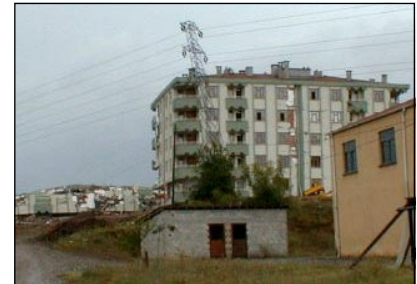
Figure 1. Electric transmission tower pulled to left due to conductors being put in tension due to right lateral fault displacement (fault is to north, or left, of the tower).

Figure 1 shows a tower pulled over due the conductors being put in tension at the fault crossing.

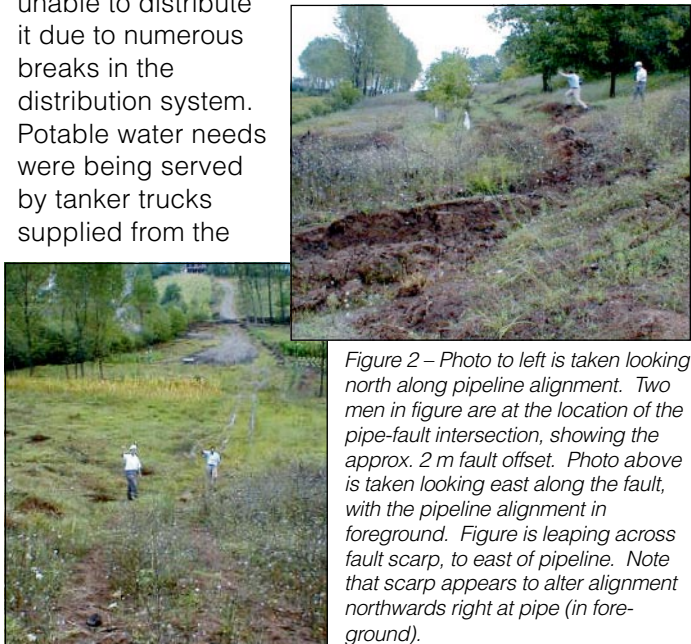
Approximately 1 km downstream of the plant, the steel transmission line crosses the fault trace. This location was inspected and found to have approximately a 2 m right lateral offset but, while some water flowing to the surface was observed (it was raining at the time, however), the pipe was reportedly undamaged at this location (see Figure 2).

Figure 2 – Photo to left is taken looking north along pipeline alignment. Two men in figure are at the location of the pipe-fault intersection, showing the approx. 2 m fault offset. Photo above is taken looking east along the fault, with the pipeline alignment in foreground. Figure is leaping across fault scarp, to east of pipeline. Note that scarp appears to alter alignment northwards right at pipe (in foreground).

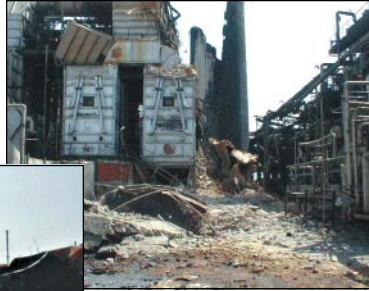
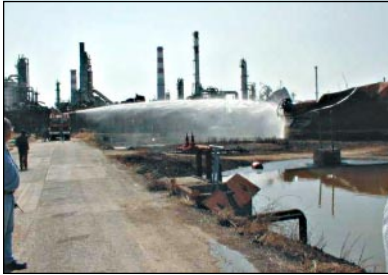
- A fire initiated in the Crude Unit, a primary processing plant in the Refinery, as a result of the collapse of a 90 meter tall, 10 meter diameter, reinforced concrete stack, Figure 4. The collapse of this large stack into the middle of the units caused extensive destruction, released fuel and was the primary cause of the fire within the process unit.
- A second fire initiated in the Naptha tank farm, independent of the crude unit fire. It appears that this fire initiated as a result of sparks created by bouncing of the floating roof in one of the tanks, during the earthquake. The sparks ignited the Naptha. Such floating roof tanks are common in petroleum facilities, world wide.
- The crude unit fire was initially brought under control relatively quickly. However, the collapse of the stack also broke the pipeline from the burning Naptha tank, upstream of the block valve. This

Figure 4. In the photo to the right, a collapsed RC stack is shown. Below, firefighters are cooling burning tanks (source: G. Johnson, EQE International)

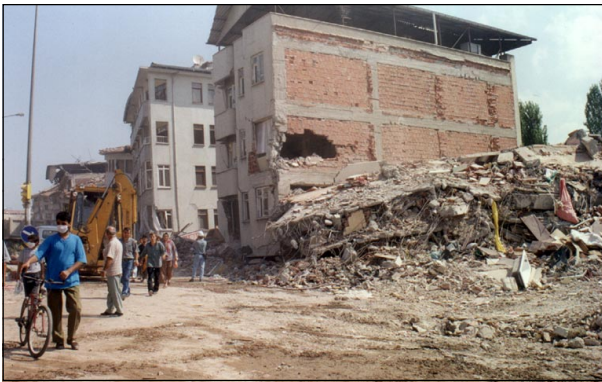
Many residential buildings were severely damaged.

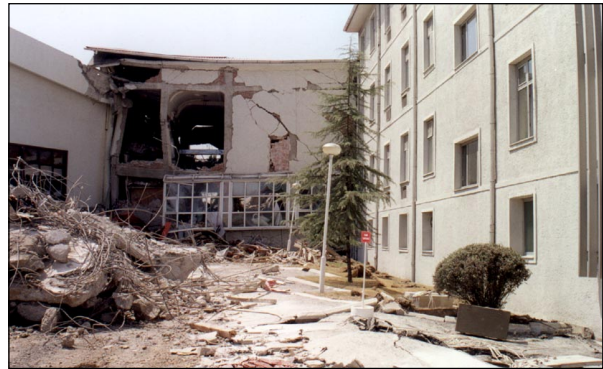
*One building is totally collapsed while another is hardly damaged on the Naval Base in Golcuk.*

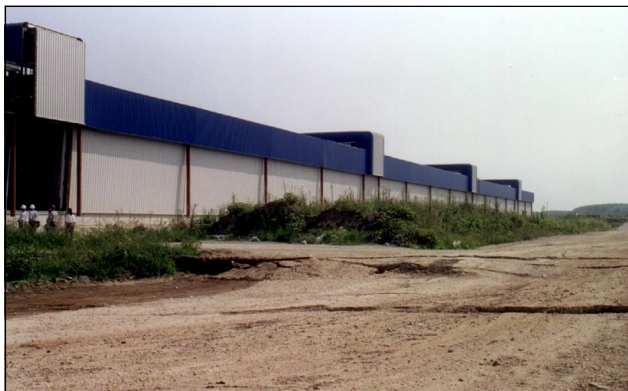
*The fault rupture is visible next to this damaged manufacturing facility, under construction at the time of the earthquake.*
