MCEER NCREE RESPONSE

PRELIMINARY REPORT FROM MCEER-NCREE WORKSHOP ON THE 921 TAIWAN EARTHQUAKE

by George C. Lee and Chin-Hsiung Loh

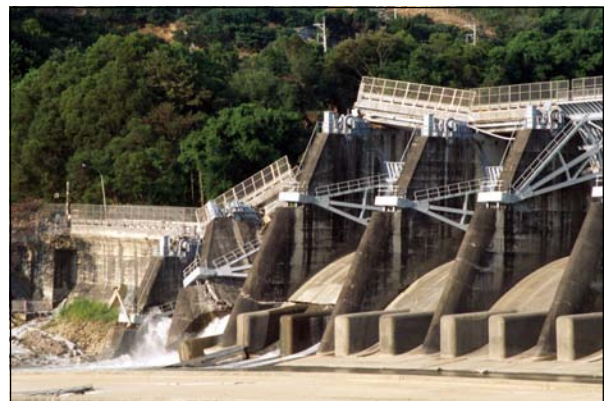
Surface faulting caused major damage to the Shih-kang Dam.

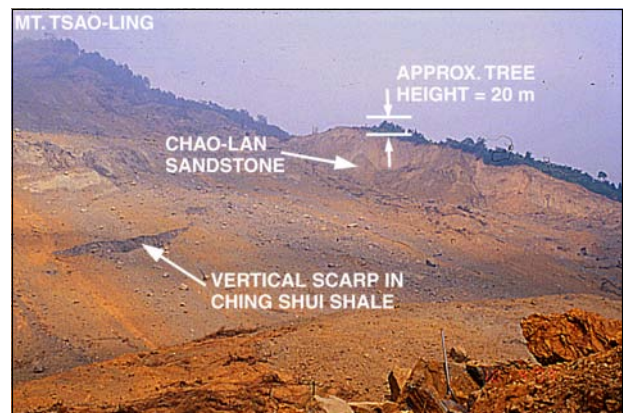
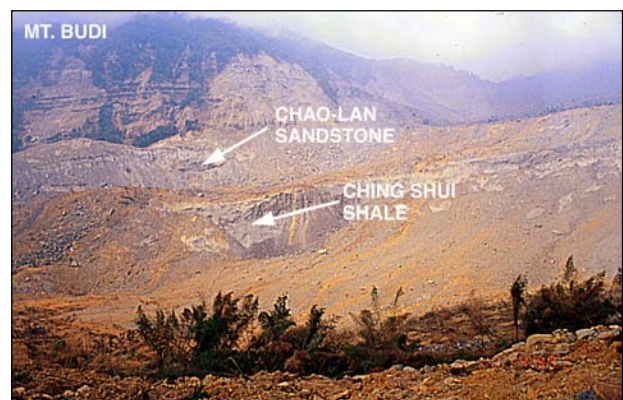
Figure 1a and b shows views of the landslide at its eastern and western margins, respectively. The landslide is at the location of previous landslides that occurred in 1941, 1942, and 1979. The landslide was generated primarily by failure of the Chin-Shui Shale Formation that underlies the Chao-Lan Sandstone (see Figure 1b). The shale is a friable, silty mudstone with weak cementation that deteriorates readily upon wetting and drying.

Figure 1a (top). Eastern and Figure 1b (bottom). Western boundary of Tsao-Ling landslide.

Plans need to be formulated for the reconstruction of Route 8 that take account of the increased vulnerability to landslides associated with fractures and loosening of the weathered rock as well as its increased exposure to precipitation caused by the earthquake. The plans should balance risk mitigation related to control of future landslide activity with the need for rapid reinstatement of the road.

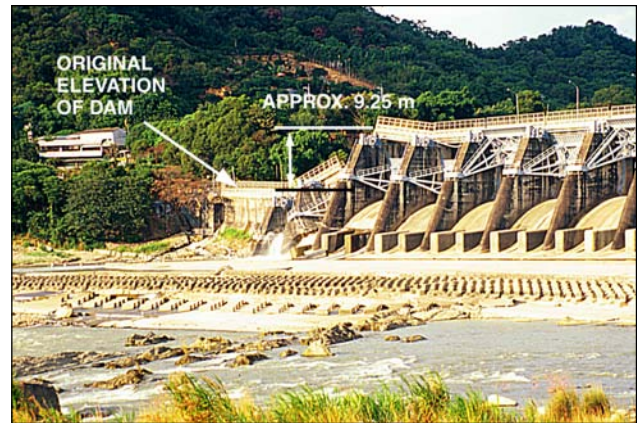
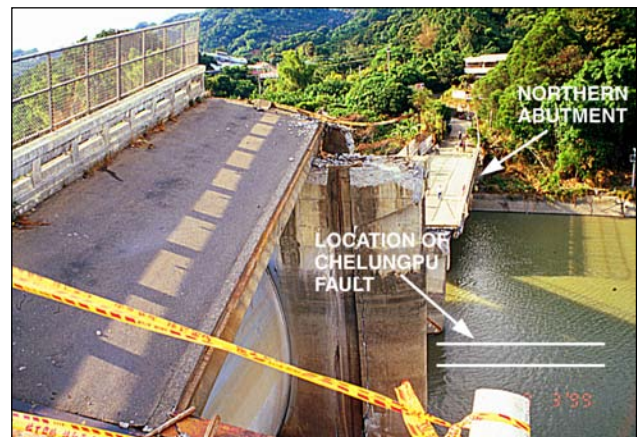
Fault rupture with a vertical offset exceeding 9 m was responsible for failure of the Shih-kang Dam and subsequent release of millions of cubic meters of water. This loss represents 40% of the raw water supply for Taichung County. Figure 2a is a photograph of the northern abutment area taken downstream of the dam, and Figure 2b is a photograph of the northern abutment from the vertically displaced southern part of the dam.

Figure 2a (top). View of northern end of Shih-kang Dam showing over 9 m of vertical offset at Chelungpu Fault and Figure 2b (bottom). View from uptrust side of Shih-kang Dam looking north.

just north of Feng-Yuan where it intersects the northern side of the Shih-kang Dam. In the short-term, it is important to clarify the mechanism of fault rupture in this area and to define better the fault trace and its surface characteristics. Delineating the main fault rupture and establishing the occurrence of subsidiary ruptures, including coseismic movements on the nearby Tamoupu-Hsuangtung fault, are important for an improved understanding of both the near field transient and permanent ground deformations generated by the earthquake. Locating the active trace and strands of the Chelungpu fault is also important for evaluating various options with respect to restoration of the Shih-kang Reservoir.

only of the Chelungpu fault and subsidiary ruptures, but of the current elevation differential at site, relocation of all or part of the dam, and the re-use, if any, of existing undamaged portions of the dam.

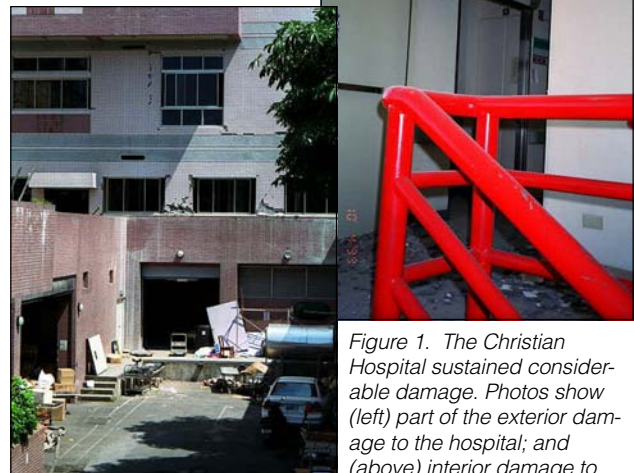
Figure 1. The Christian Hospital sustained considerable damage. Photos show (left) part of the exterior damage to the hospital; and (above) interior damage to partitions and ceilings.

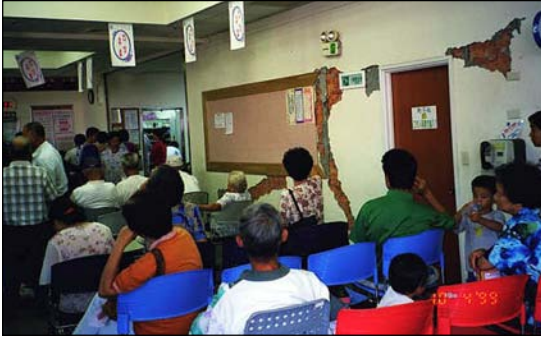
Figure 2. The first floor of the Christian Hospital remained open though the hospital suffered extensive interior damage.

- New section sustained considerable damage from the main event on 9/21/99. Out of safety concerns primarily due to nonstructural damage (power outage¹, water damage, equipment failure, etc.), the building was evacuated with patients housed in tents on the hospital ground. The building was immediately inspected and considered safe. Upon interior cleaning, patients were returned to the building.
- The building suffered significant nonstructural damage again from the 9/27/99 M6.8 aftershock. Patients were again evacuated and housed in temporary trailers with considerably reduced capacity (about 50 beds), with overflow transferred to other area hospitals.
- The first floor of the building remains open and is being used for emergency care, patient registration and processing, command post, etc. (see Figure 2).

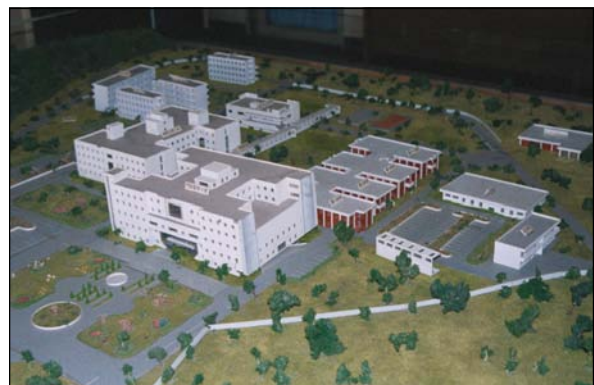
- New buildings sustained considerable damage from the main event. The Medical Building (Bldg. 1) was closed and the patients in the Administration Building (Bldg. 2), along with those in Bldg. 1, were either moved to the older buildings or transferred to other VA hospitals. About 220 patients remain at the hospital.
- Considerable nonstructural damage in Bldgs. 1 and 2, including power failure, water damage, and equipment damage was observed. Bldg. 1 also sustained considerable structural damage, probably due to a lack of ductile detailing.

Figure 3. An overview model of the Veterans Hospital in Puli. The two white buildings are the newest and both sustained considerable damage.

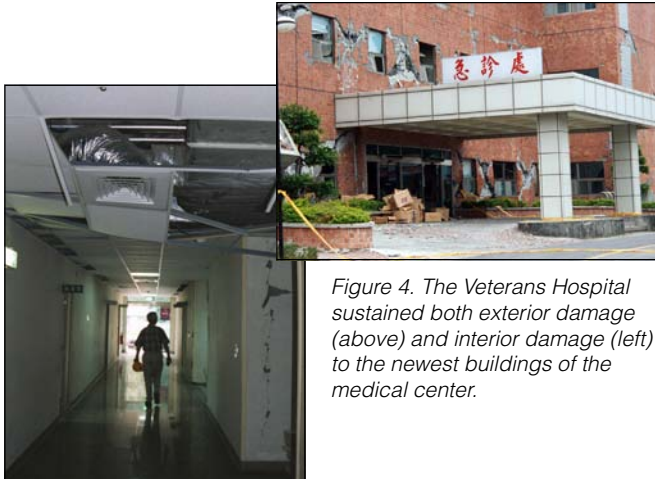
Figure 4. The Veterans Hospital sustained both exterior damage (above) and interior damage (left) to the newest buildings of the medical center.

Whether Bldg. 1 is to be demolished or repaired remains to be determined. Bldg. 2 is expected to be repaired within two weeks.

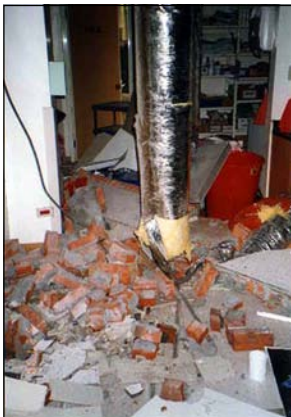
- Structurally intact, it suffered considerable non-structural damage as in the case of the other two hospitals (see Figures 5 and 6). Interior damage was most severe at the second- and third-floor levels where, unfortunately, some of the major facilities, such as operating and recovery rooms, were located.

Figure 5. Interior damage in the Shiu-Tuan Hospital. Shown are (top) fallen brick inside the hospital and (right) a damaged interior glass brick wall.

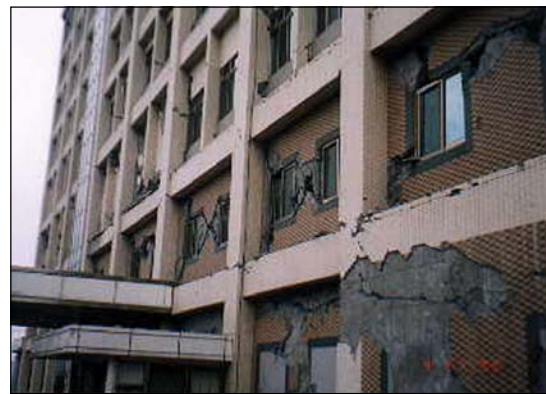
Figure 6. Damage to an exterior wall of the Shiu-Tuan Hospital in Nantou County.

Repair is underway and the process may take one to two months. Funds for the repair remain to be found.

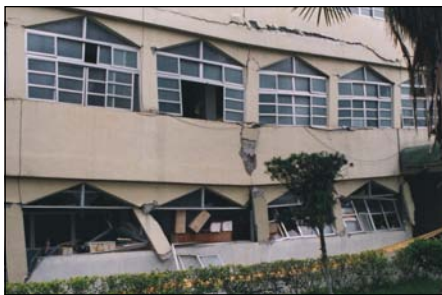
Figures 1 and 2. Failure of non-ductile details.

Commonly encountered were failed columns with widely spaced stirrups (unconfined plastic hinge zone), splices with inadequate development length or located in the hinge region, light or non-existent joint transverse reinforcement, stirrups with 90°, etc. Strong-beam weak-column systems might have resulted in numerous story collapses following excessive column damage. This was particularly frequent in the first story of buildings, as the larger openings and higher story height translated into a lower structural stiffness and strength, leading to “soft-story” mechanisms (see Figure 4).

- Given the extensive damage suffered by reinforced concrete buildings that clearly exhibit a lack of ductile detailing, it is essential that steps be taken to ensure that only ductile details be used in all new constructions and in the repair of damaged structures. Furthermore, until further research findings become available, buildings having “soft-story” characteristics should not be allowed in new constructions.

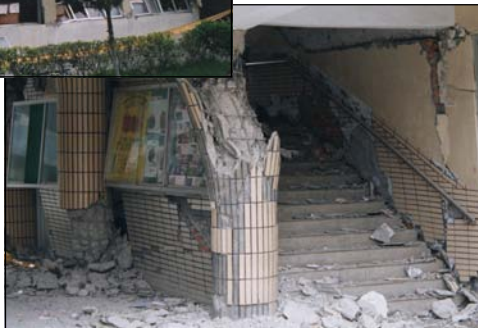
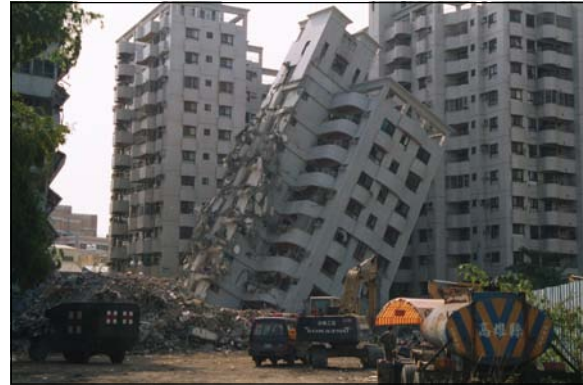
However, in the affected area, more than two dozen modern 10- to 15-story apartment buildings overturned or collapsed (see Figure 3). These were reinforced

Figure 3. Failure of new construction.

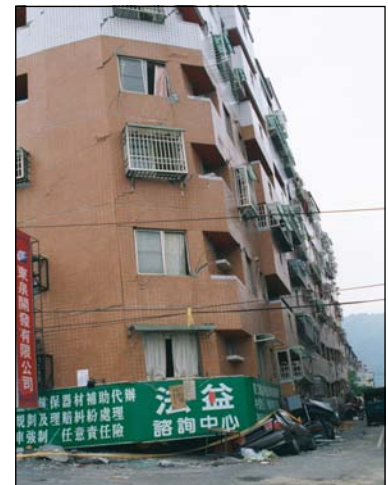
Figure 4. Failure due to soft first story.

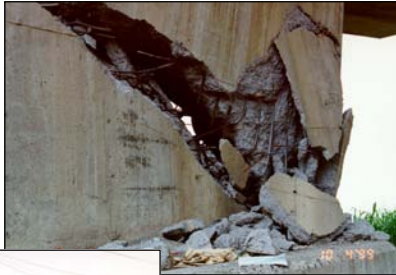
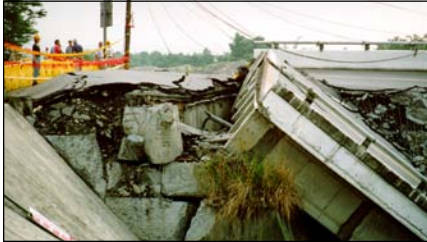
Figure 2 (below). Failure of the back-wall of the south abutment of the Ming-tsu bridge (Route 3), leading to the unseating of adjacent spans. Figure 3 (right). Shear crack in Pier 1 of the Wu-shi bridge (Route 3).

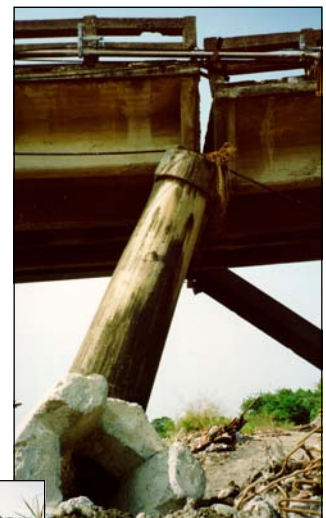
Figure 4 (right). Rigid-body rotation of Pier 10 due to ground failure under the E-jian bridge (Route 129). Figure 5 (below). Tilting of Pier 2 and subsequent collapse of three spans of the Shi-wei bridge (Route 3).
