The 1992 Erzincan Earthquake

by Murat Saatcoglu and Michel Bruneau

A Richter magnitude 6.8 earthquake struck the city of Erzincan in eastern Turkey on March 13, 1992. The epicenter of the earthquake was 7.7 km (4.8 mile) north of the city, resulting in extensive structural damage and casualties in spite of its relatively moderate magnitude. Approximately 300 buildings, mostly reinforced concrete, either completely collapsed or were damaged beyond repair. An additional 500 buildings suffered various degrees of structural and non-structural dam-

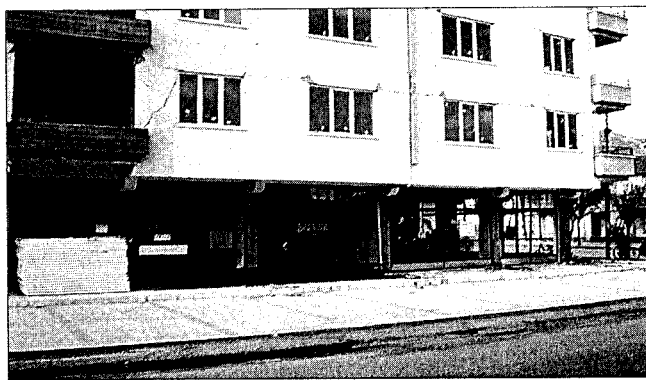
Fig. 1 — A typical apartment building with a soft story.

Soft stories: Many reinforced concrete frame buildings in Erzincan have soft stories. Generally, the first floors are devoted to commercial areas enclosed with glass windows, resulting in soft stories (Fig. 1). This is especially true in the business and commercial districts of the city, although apartment buildings with first floor stores are common throughout the city. Heavy masonry exterior and partition walls start immediately above the commercial floor, significantly increasing mass above the soft story. During the earthquake, the presence of soft stories increased deformation demands on the first-story columns. If these columns were not designed and detailed for large cycles of inelastic deformation cycles, column failures occurred, sometimes resulting in total structural collapse.

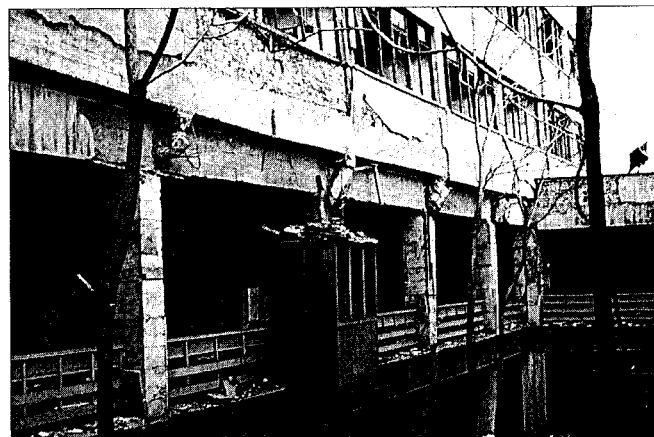
Fig. 2 — Red Crescent commercial center with strong beams and weak columns.

Fig. 2 illustrates the Red-Crescent Business Centre in downtown Erzurum, which clearly had deep and strong beams relative to the supporting columns, and suffered column failures followed by a complete loss of a story. Another example of such failure was observed in a military hospital (Fig. 3), which again illustrates column failures and a loss of a complete story. The same structural system was used in the Social Security Hospital, a wing of which completely collapsed, killing more than 80 people.

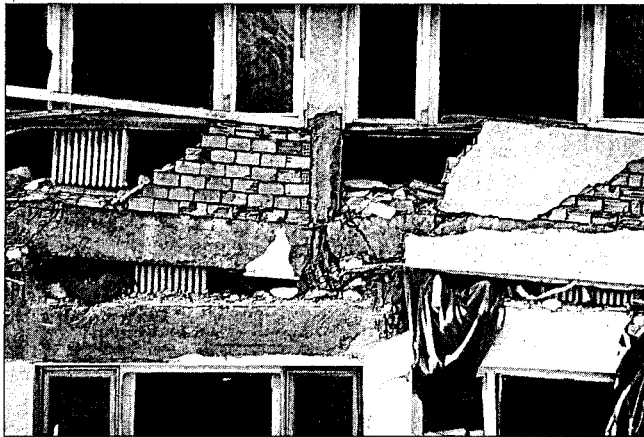
Fig. 3 — Military hospital with strong beams and weak columns.

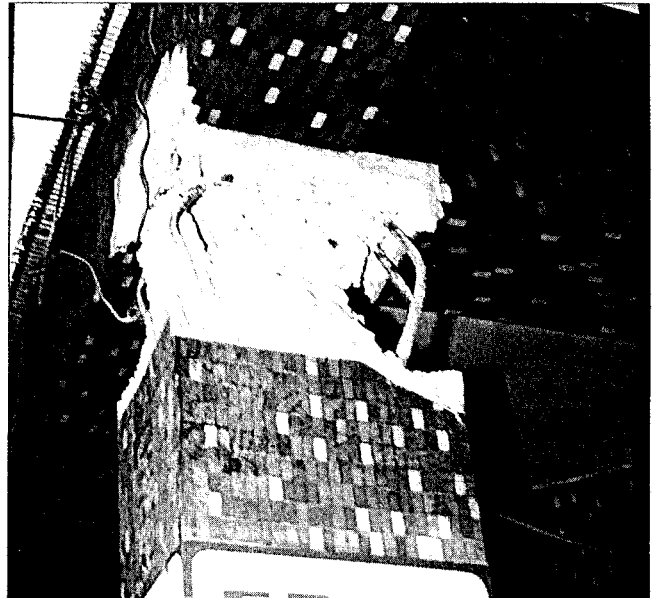
Fig. 5 — Example of lack of transverse reinforcement and resulting brittle behavior in columns.

any cross ties. There were cases where as many as 9 bars were used along the side of a rectangular column without any cross tie, although the TS 500 Code requires adequate support of longitudinal reinforcement by interior hooks and/or cross ties, without a specific guideline. Fig. 5 illustrates column failures due to lack of concrete confinement.

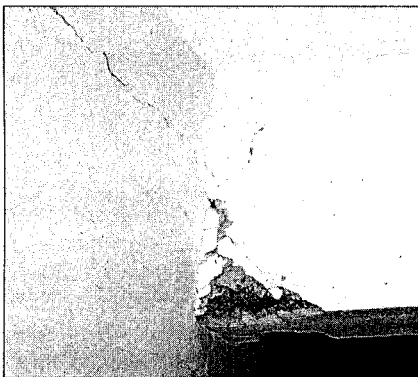
Fig. 4 — Crushing of beam cover concrete in the Officers' Club.

An examination of Turkish codes revealed that neither TS 500 nor the Seismic Code had any provision against the use of strong beams and weak columns. The strong-column weak-beam behavior, as stipulated in the ACI 318-89¹ building code, was observed in the north wing of the New Police Headquarters. This building's beams developed flexural cracks wide enough to signify potential yielding of the longitudinal tension reinforcement near the columns. The columns maintained their elastic behavior without any sign of distress. The Officer's Club behaved similarly, despite the heavy damage observed in its unreinforced brick infill walls, which may be viewed as an indication of high drift demand. Structural integrity and strength was maintained by columns performing well, while hinging occurred at the ends of beams. Fig. 4 illustrates crushing of cover concrete at the end of a beam.

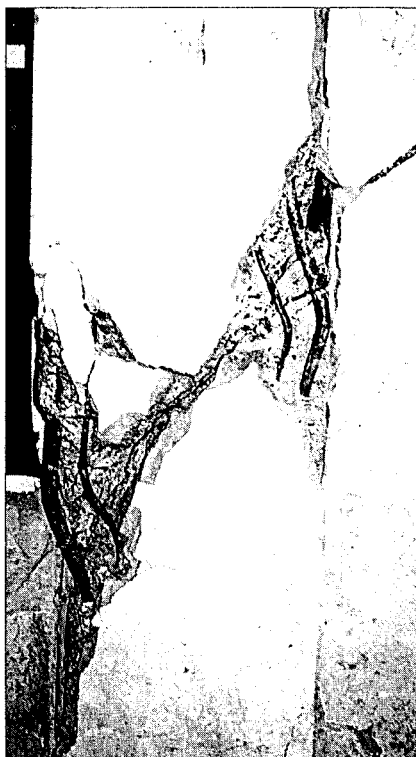
Fig. 6 — Diagonal tension failure in a column.

modes of structural failure observed. The failures were attributed to lack of transverse reinforcement, coupled with the use of low grade reinforcing steel. The minimum code specified steel grade of 220 MPa (32,000 psi) was used extensively in Erzincan. Fig. 6 shows two of the many diagonal tension failures observed throughout the city. Similar cracks were observed in wide rectangular columns, which attracted high shear forces. The rectangular columns of a commercial building and an apartment building (Fig. 7 and 8) illustrate typical diagonal cracks observed in wide columns.

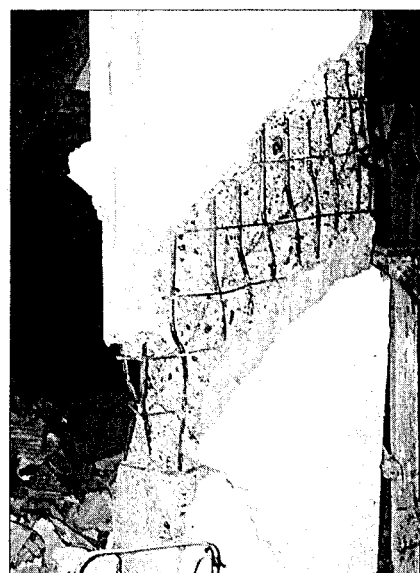
Fig. 7 — Shear failure in a rectangular column.

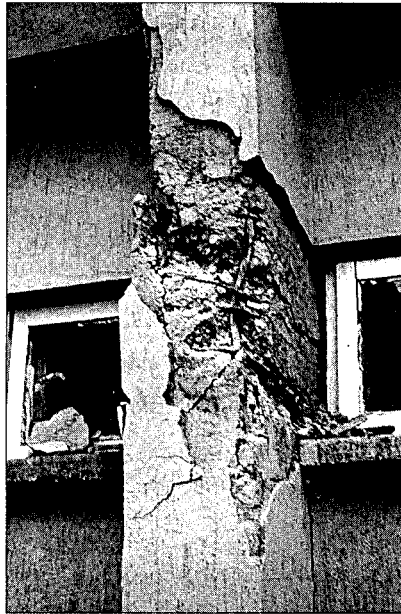
Another group of columns that suffered shear failure was the captive columns. Extensive use of masonry walls produced unintended supports along columns, resulting in short column behavior. This was typical in columns of the Police College. Fig. 9 illustrates a typical short column supported by masonry walls above and below a window opening, reducing shear span and increasing shear vulnerability. It may be of interest to note that the Turkish Seismic Code does not allow window openings above filler walls unless proper recognition of short column behavior is given during design.

Fig. 9 — Short column behavior observed in the Police College.

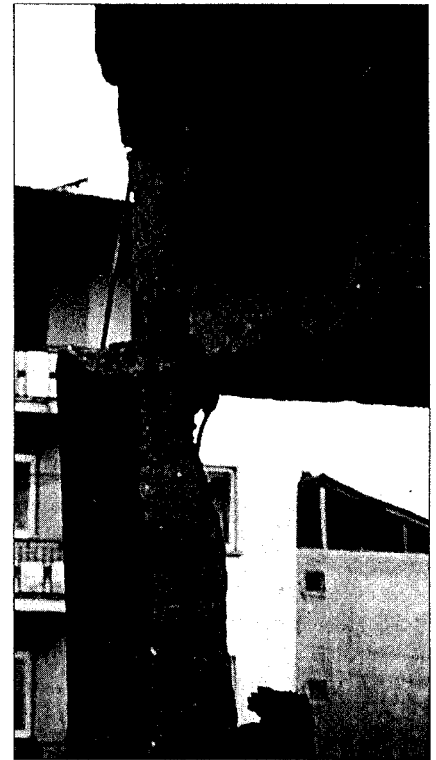
Beam-column joints: Poor behavior of monolithic beam-column joints was observed in many buildings. Lack of joint reinforcement was evident in almost all the exposed joints, although the Seismic Code after 1975 called for seismic design of beam-column joints. The code requirements for joint design are very similar to those specified in ACI 318-89. Fig. 10 illustrates examples of buildings where joint reinforcement was completely missing.

Fig. 10 — Example of poor joint detailing.

The quality of concrete was acceptable in most cases. The minimum concrete strength specified by the Seismic Code was 22.5 MPa (3260 psi), except for low occupancy buildings. The quality of concrete was poor especially in old apartment buildings. Concrete placement problems were observed in some buildings. Low quality concrete and workmanship are evident in some of the photographs shown, especially in Fig. 10.

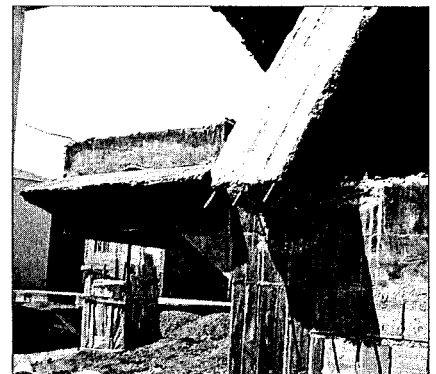
Some detailing deficiencies were observed in columns. While Fig. 11 shows inadequate splice length in columns. Poor detailing of column rein-

Fig. 11 — Inadequate splice length in columns.

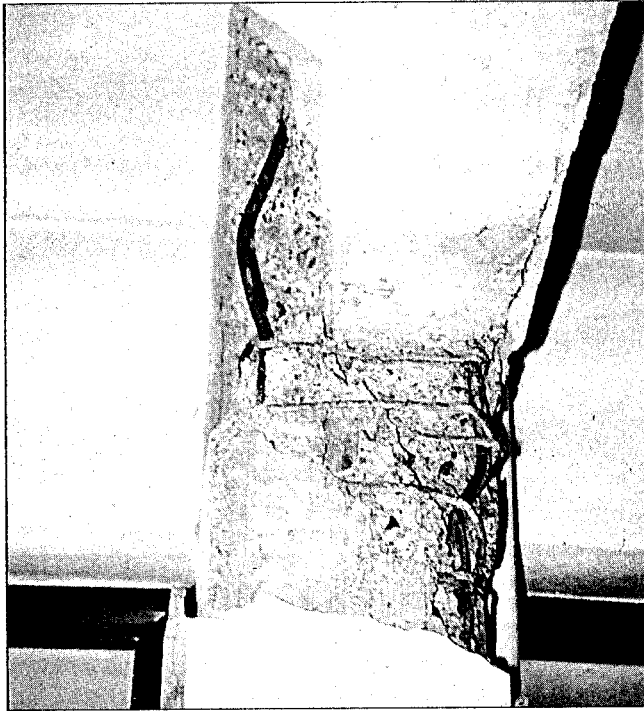
forcement is shown in Fig. 12 where the longitudinal reinforcement did not have lateral support in a joint with a beam offset. Column hoops with 90 degree bends were common in all exposed columns, although the Turkish Seismic Code called for 135 degree hooks, well anchored into the core concrete.

Fig. 12 — Lack of reinforcement detailing in a beam-column joint with beam offset.

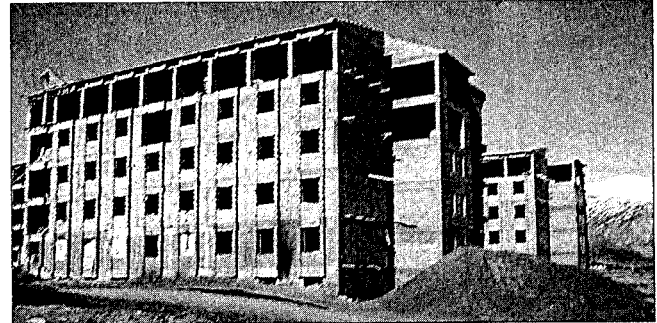
Fig. 15 — Condominium buildings with frame-shear wall interactive systems after the earthquake.

sonry enclosure and partitions. Therefore, practically all the mass of the building was in place during the earthquake. All of these buildings survived the earthquake without any sign of structural or non-structural damage (Fig. 15).

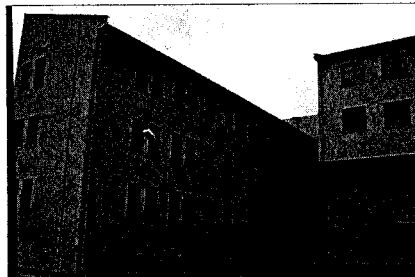
Few buildings contained shear walls, although the north wing of the new police headquarters had shear walls in both orthogonal directions. The shear walls controlled lateral drift during the earthquake, preventing structural and non-structural damage. The masonry infills of this wing survived the earthquake without any visible damage. Reinforced concrete frames behaved in a satisfactory manner with some signs of

beam hinging at the ends, while the columns maintained their integrity and appeared to have responded elastically. The south wing of the same building, separated by an expansion joint, did not have any shear walls. This wing developed extensive damage of unreinforced masonry, and also some structural damage at the roof level. Fig. 13 and 14 illustrate both wings of the building after the earthquake.

Fig. 13 — North wing with shear walls of the New Police Headquarters after the earthquake (on the left).

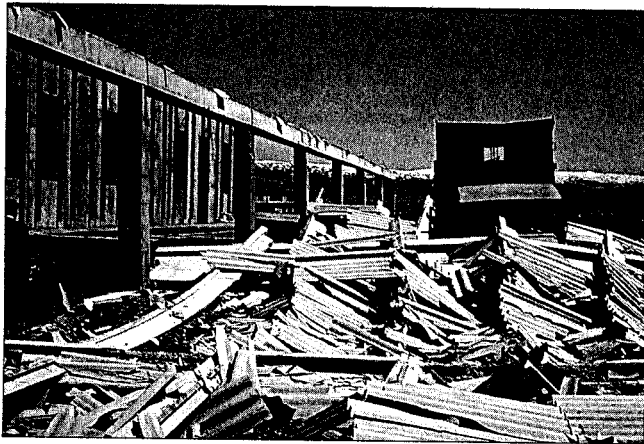
Two industrial complexes with precast concrete elements were found in Erzincan. One consisted of a pair of single story frame buildings with precast columns and beams forming the framing system, which was enclosed with unreinforced brick masonry. No sign of damage was observed in these buildings. The other was a new animal slaughter house consisting of two precast buildings. Long span precast girders and supporting prefabricated concrete columns formed the framing system. One of the two buildings had concrete cladding in both directions. This building survived the earthquake without any damage. The second building, only meters away from the first building, was not enclosed by cladding. It suffered connection failures, and collapsed completely (Fig. 16).

Fig. 16 — Total collapse of a precast industrial building.

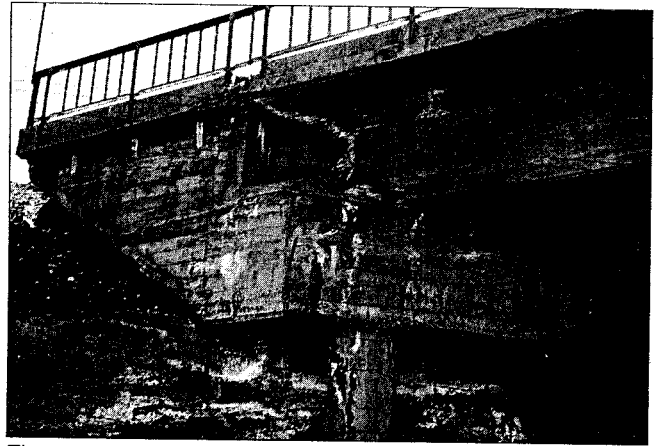
essentially due to the settlement of the abutments. The bridge was a three-span, cast-in-place railroad overpass with two transverse beams supported by three columns each. The columns were 800 mm (32 in.) in diameter and 12 m (39 ft) in height. Fig. 17 shows the overall view of the bridge. The settlement at the north abutment led to the tilting of the retaining wall, which bared against the north columns. These columns developed cracking at the ends wide enough to signify yielding.

Fig. 17 — Cracking of the bridge piers of a three-span reinforced concrete bridge on the south-west highway.
