Numerical Investigation of the Failures Observed in Eccentrically-Braced Frames in the Aftermath of the Christchurch Earthquake Series (2010–2011)

Reza Imani, A.M.ASCE¹; and Michel Bruneau, F.ASCE²

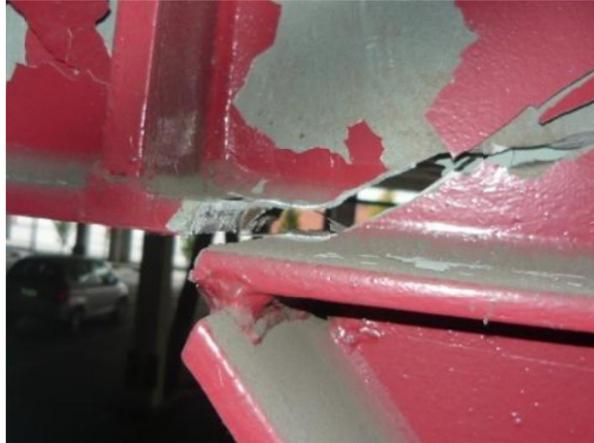
A survey of damage caused by the Christchurch earthquake series of 2010 and 2011 on steel structures showed an unexpected failure type in a number of EBFs used in a parking garage in the city of Christchurch (Clifton, et al. 2011). This is considered to be the first observed failure of EBF systems during an earthquake worldwide. Despite the satisfactory seismic performance of the building due to the presence of six EBF frames in each of the structure's principal directions, the fractures were observed in two braced bays. A typical fracture is shown in Fig. 1. Clifton et al. speculated that

the cause of this fracture might be due to a local stress concentration resulting from the fact that the brace flange was connected to the beam at an offset from the link stiffener. This hypothesis was supported by the observation that fracture didn't occur in cases where the flanges of the brace lined-up with the stiffeners.

Fig. 1. Fracture in EBF Observed in the Aftermath of Christchurch Earthquake Series (Clifton, et al. 2011)

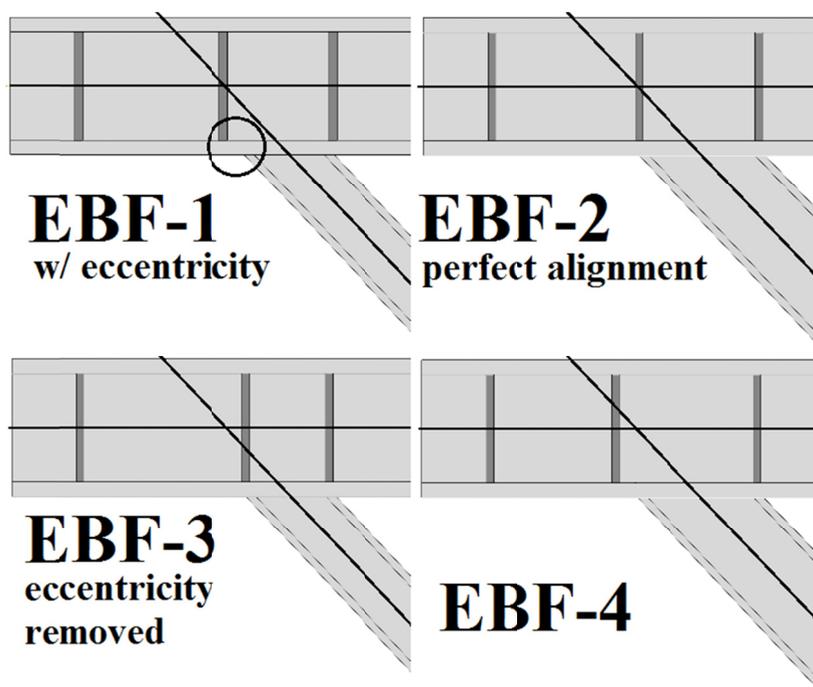
Fig. 2. Detailing alternatives for brace-to-beam connection

Case 1 is similar to the configuration used in the reported fractured EBFs in that the stiffener is placed at the intersection of the brace and beam centerlines but doesn't vertically line up with the edge of the brace flange; Case 2 represents the ideal configuration; The third case, EBF-3, is similar to EBF-1, except that the link end-stiffener has been moved to align vertically with the point where the flange of the brace is welded to the beam. Note that all four configurations are allowed per AISC 341-10.

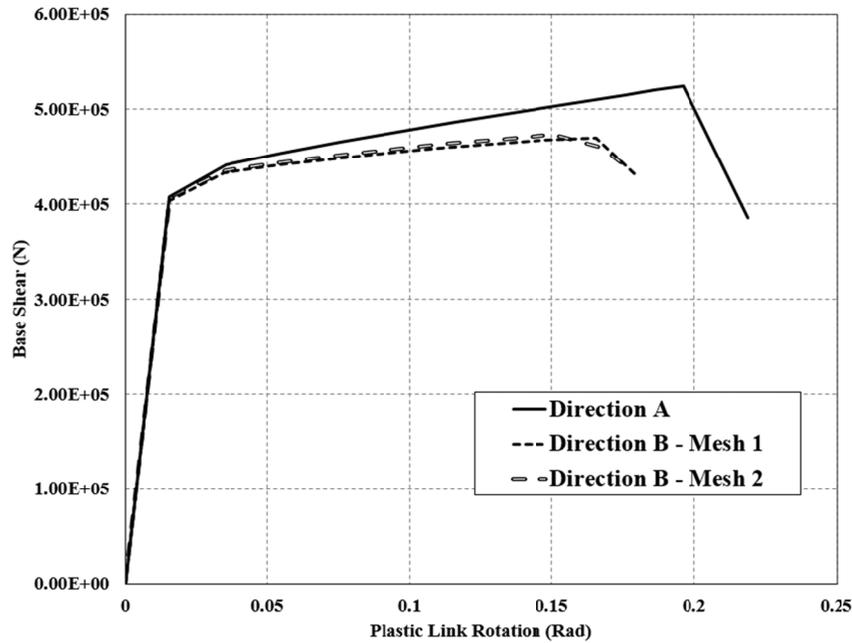
Fig. 4 shows the graphs of base shear versus plastic link rotation for EBF frame Case 1 under monotonic applied displacements in two opposite directions. Both of the curves show significant strength loss at plastic link rotation values in the range 0.15-0.2 rad (expected for properly stiffened EBF frames). Applying displacement in direction A causes tensile forces in the link bottom flange and applying displacement in direction B causes the opposite. Results show that EBF-1 loses strength at a relatively smaller plastic link rotation when monotonic loading is applied in the direction B.

Fig. 4. Push-over analysis results for EBF-1 half frame under monotonic displacements in two opposite directions

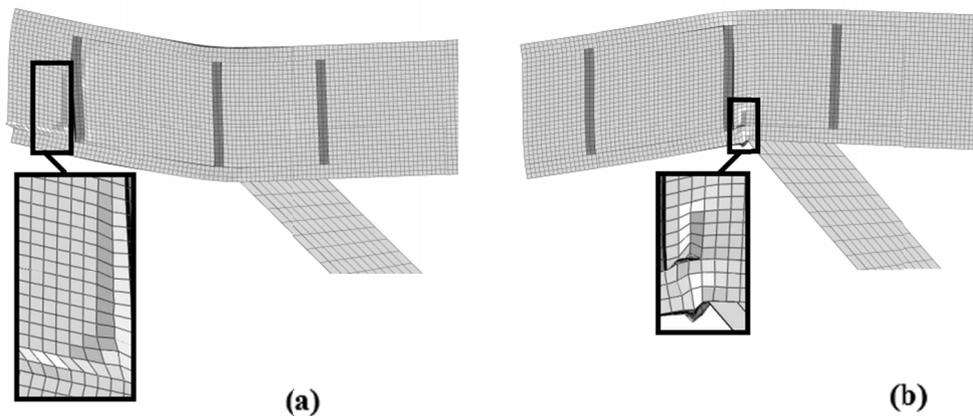
Fig. 5 shows final deformation plots from the same analyses. Case A shows excessive deformations and element distortions in the web of the link close to one of the intermediate stiffener (typical behavior of EBF frames). On the other hand, Case B shows excessive distortions for a different group of elements which are located in the offset area which can be considered as a sign of improper behavior.

Fig. 5. Final deformation results from push-over analysis of EBF-1 in two opposite directions: a) direction A; b) direction B

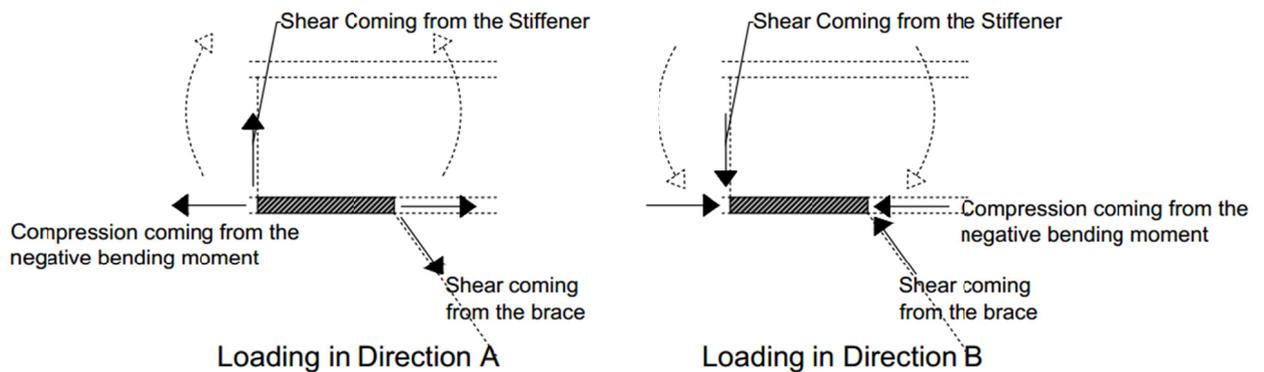
The difference in the mechanisms leading to strength loss under loading from two opposite directions is due to the different stress and strain distributions in two cases. Fig. 6 shows the loads applied to the beam flange in the offset area for cases A and B. Looking into numerical solutions and Mohr circles of the two cases revealed that the combined axial and compression stresses in Case B pushed the elements in the offset area to surpass the Von Mises failure criteria leading to a sooner strength loss in the push over curve. For Case A, on the other hand, Von Mises stress values in the offset area remain below the failure limit until failure occurs in the web of the link.

Fig. 6. Loads applied to the segment of the beam flange located at the offset

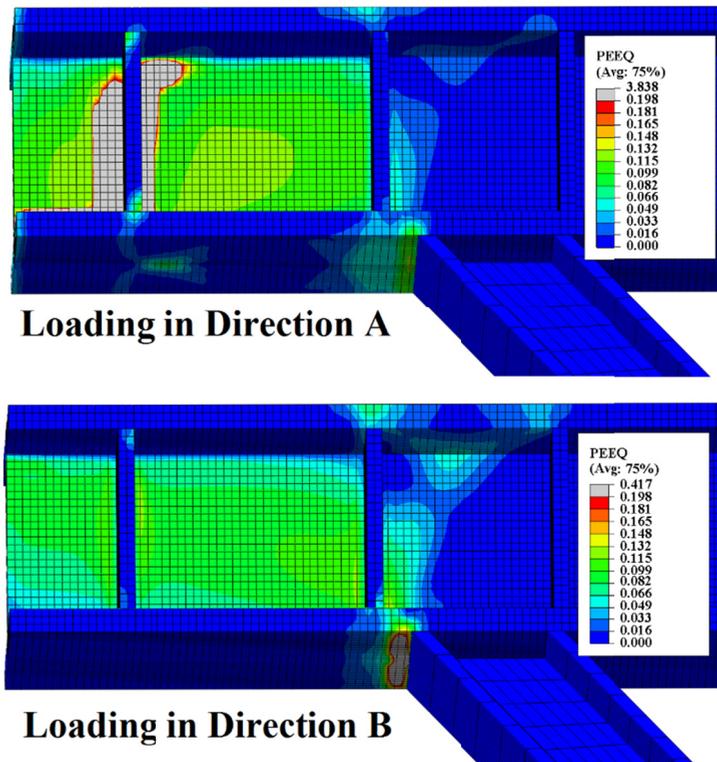
Occurrence of failure in different location is also shown with plastic strain contours for both cases in Fig. 7.

Fig. 7. Equivalent plastic strain distribution for EBF-1 under monotonic loading in two opposite directions

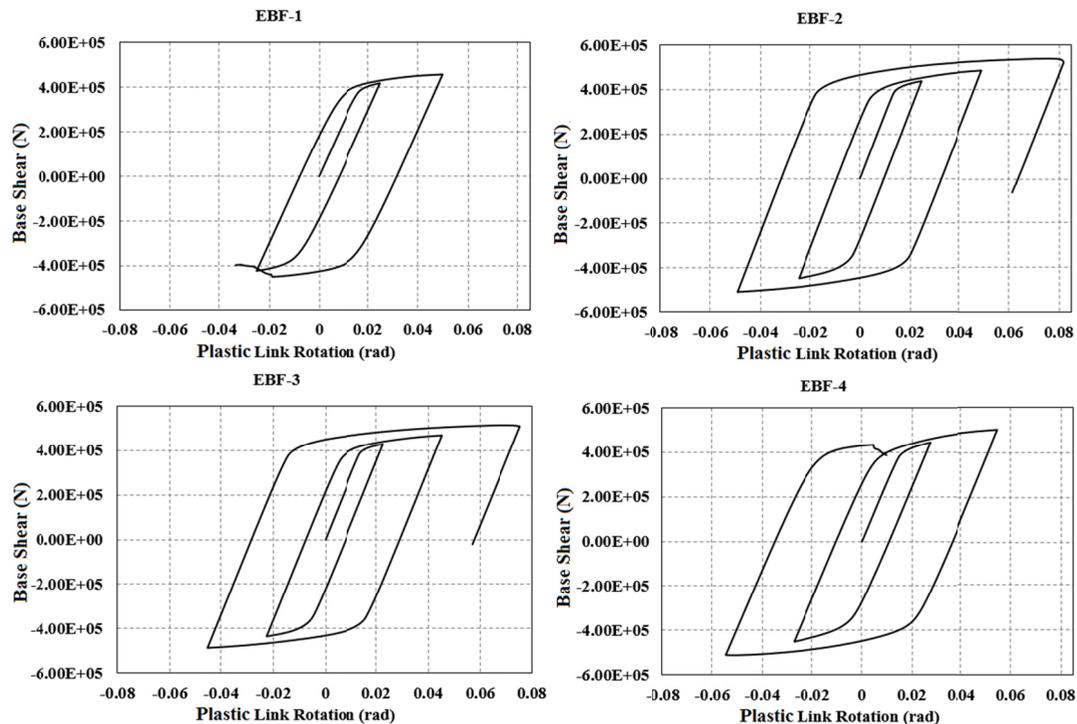
Fig. 8 shows the resulting base shear versus plastic link rotation values from analyses of all four models subjected to cyclic displacements with increasing amplitudes. Cases 2 and 3 have reached the 0.08 rad plastic rotation limit (AISC 341-10 recommendation) without failure. However, cases 1 and 4 have reached failure at much lower plastic link rotation limits.

The superior behavior of cases 2 and 3 is due to proper distribution of plastic strain inside the EBF link, while cases 1 and 4 have severe stress and strain concentrations in the offset area, leading to a premature failure. Proper behavior of Case 3 shows that if the geometry of EBF-2 cannot be accomplished (due to limits in brace depth), satisfactory ductile behavior of the frame can still be ensured by locating the stiffener such as to eliminate the stiffener-to-brace flange offset.

Fig. 8. Base shear versus plastic link rotation results from cyclic analyses
