Performance of structures during the 1992 Erzincan earthquake

MURAT SAATCIOGLU AND MICHEL BRUNEAU

Can. J. Civ. Eng. 20, 305-325 (1993)

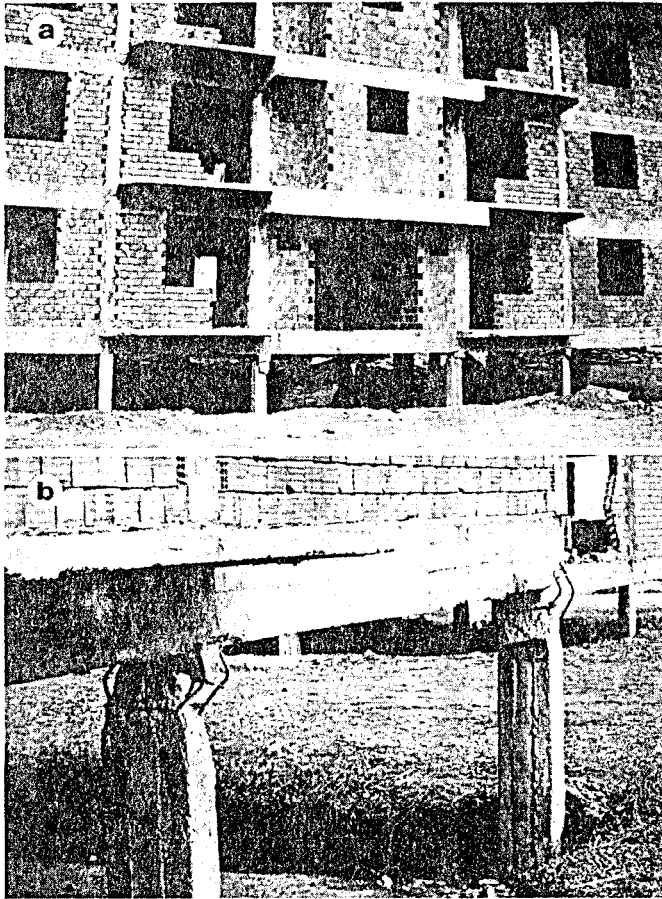
FIG. 8. (a) A reinforced concrete frame building with a soft storey, under construction; (b) close-up view of first-storey column failures.

masonry infill at the back. Heavy masonry infills start immediately above the commercial floor. During the earthquake, the presence of a soft storey increased deformation demands very significantly, and put the burden of energy dissipation on the first-storey columns. Many failures and collapses can be attributed to the increased deformation demands caused by soft storeys, coupled with lack of deformability of poorly designed columns. Figures 8 and 9 illustrate examples of apartment buildings with soft storeys.

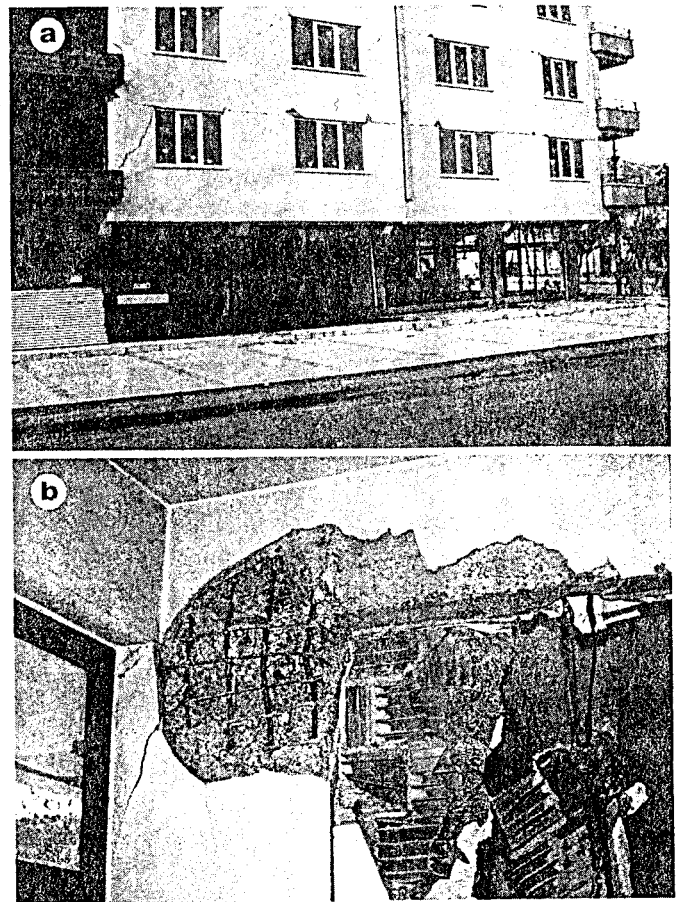
FIG. 9. (a) A typical apartment building with a soft storey; (b) close-up view of column damage in the first floor.

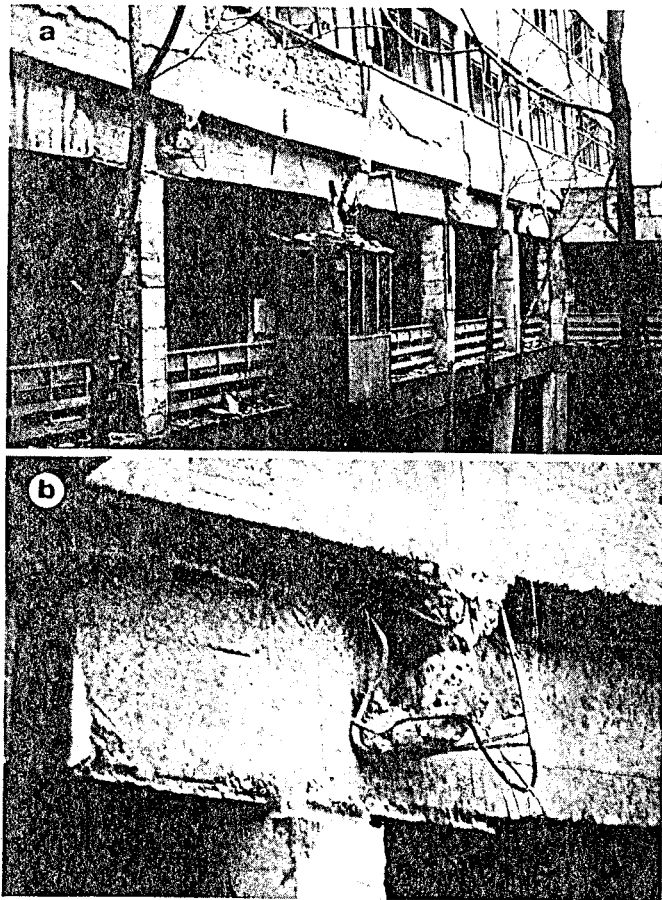
FIG. 10. (a) Example of a commercial centre with strong beams and weak columns which suffered the loss of a complete storey; (b) close-up view of column failures.

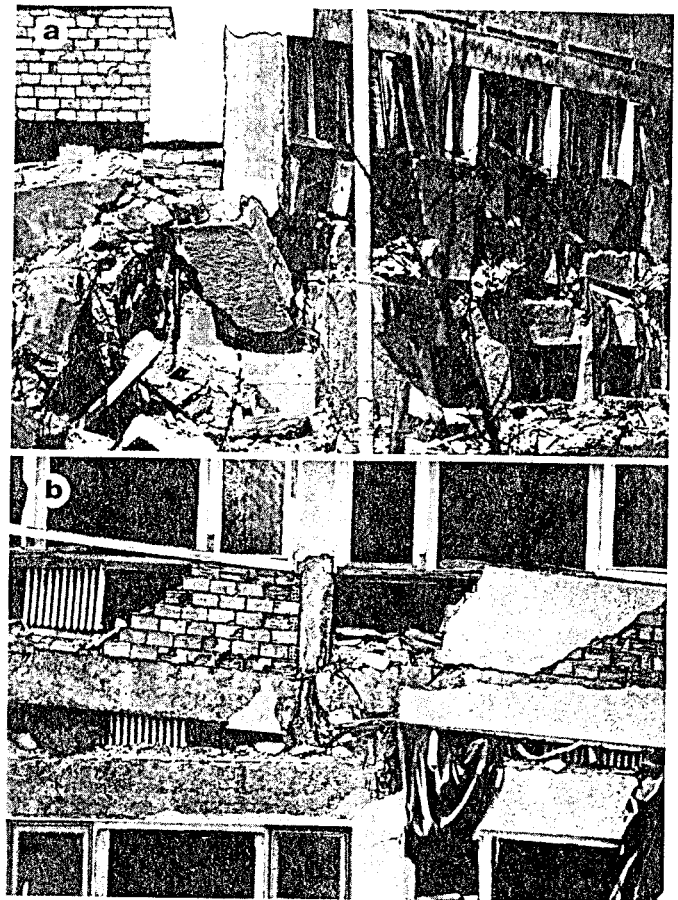
FIG. 11. (a) Military Hospital with strong beams and weak columns; (b) close-up view of a complete storey failure.

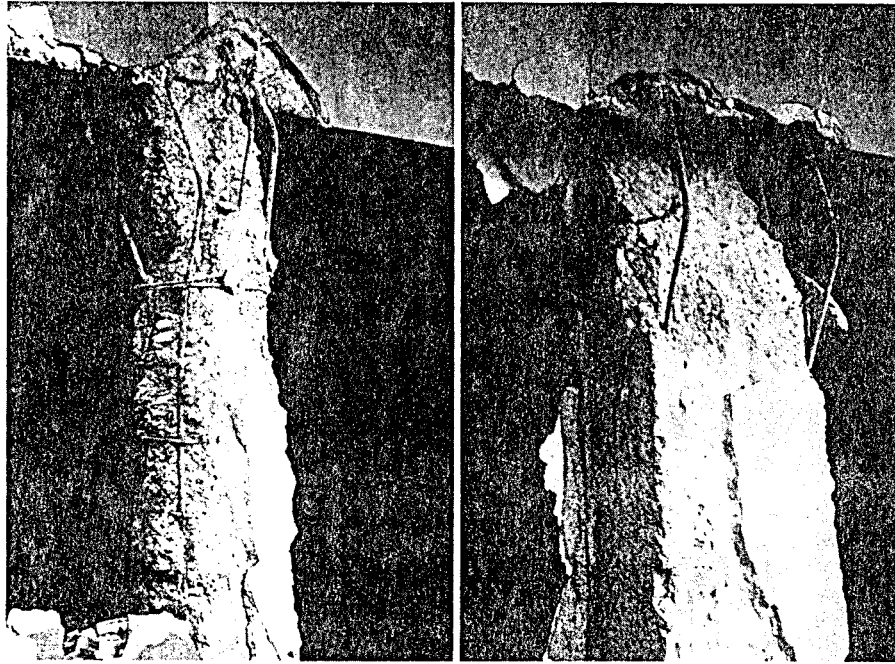
FIG. 13. Column failures in the southeast residential area, caused by lack of transverse reinforcement.

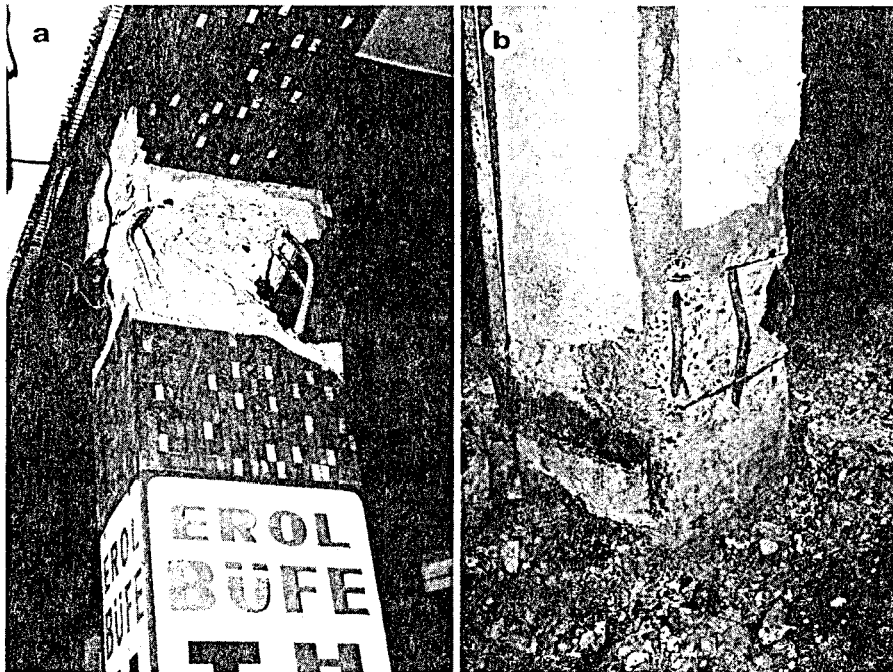
FIG. 14. (a) Lack of column confinement and buckling of longitudinal reinforcement in the first storey of a commercial building in centre town; (b) lack of column confinement in Sumerbank Textile Factory.

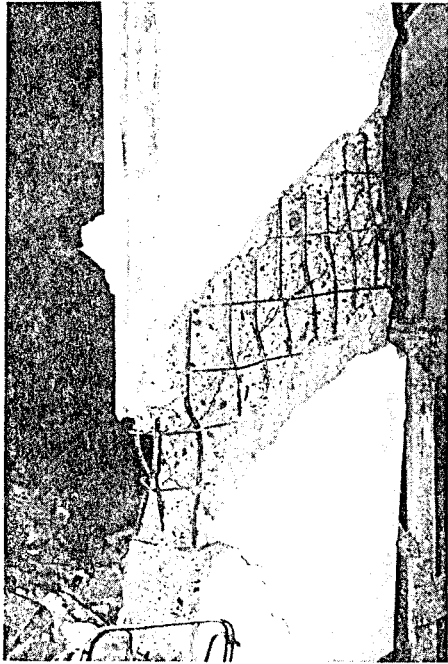
FIG. 15. Example of a rectangular column where no interior hoops or cross-ties were used to support the longitudinal reinforcement.

the rectangular columns, as many as 9 longitudinal bars were used with perimeter hoops only. Figure 9b, 14b, and 15 include examples of columns without the cross-ties. The current edition of TS 500 specifies that interior bars be

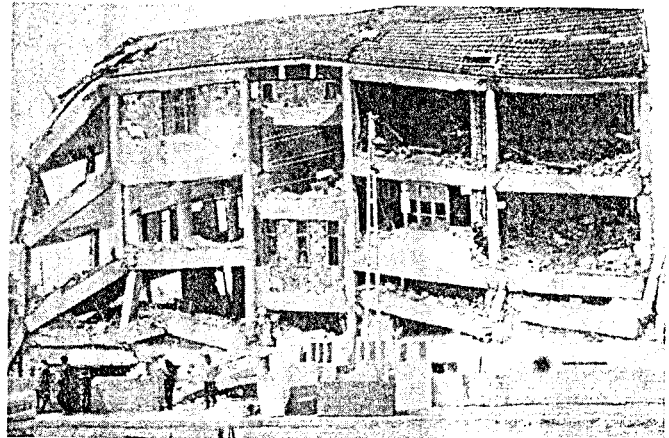
FIG. 16. Example of a reinforced concrete frame building with well-confined interior circular columns and poorly confined exterior square columns (courtesy of Profs. Ersoy and Tankut).

In one of the multistorey buildings, spirally reinforced circular columns and square columns were used together. The spiral columns showed superior performance as expected, while the square columns, lacking confinement steel, failed along with the supported slabs. Figure 16 illustrating this behaviour, clearly shows the importance of column confinement on seismic resistance of buildings.

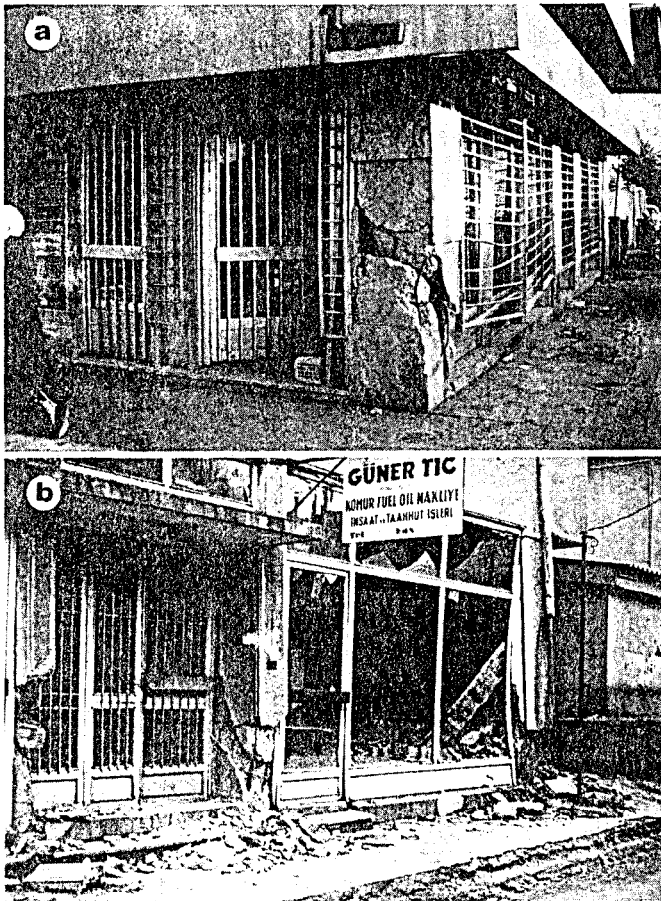
FIG. 17. Typical column shear failures in (a) a bank and (b) a commercial building in centre town.

There were many cases of diagonal tension failures of first-storey columns. Figure 17 illustrates typical diagonal tension failures in a bank building and a commercial building. These failures are attributed to lack of sufficient transverse reinforcement. Compounding the problem was the use of relatively low grade steel. The minimum code-specified yield strength for all plain bars used in Erzincan is 220 MPa.

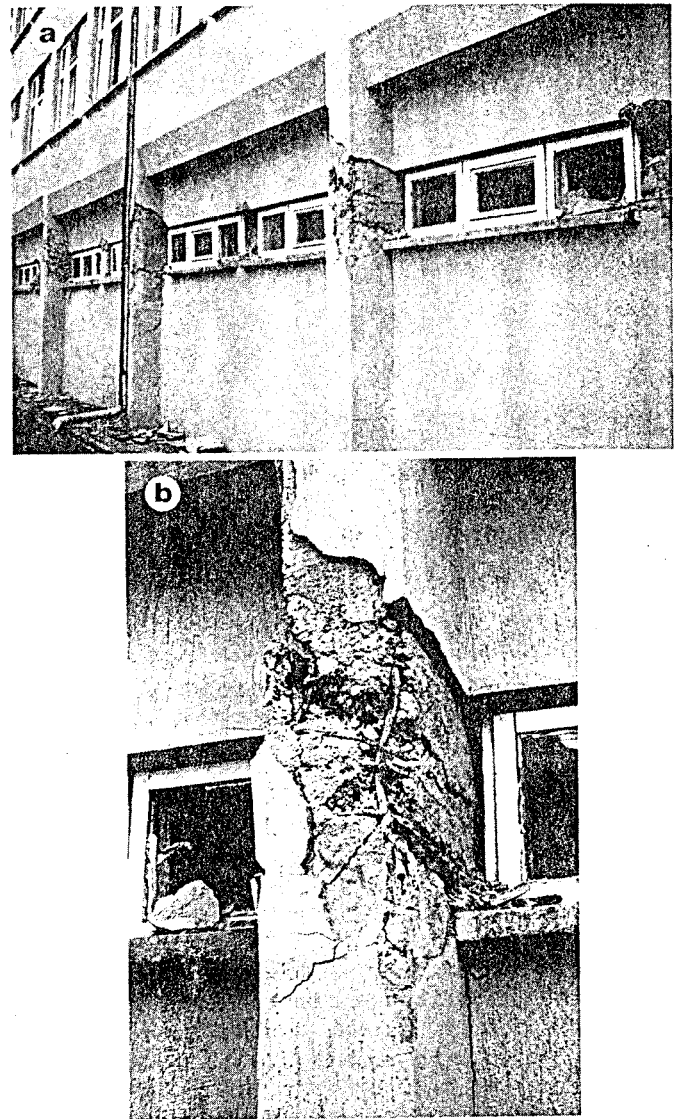
FIG. 18. (a) Short columns and (b) close-up view of short column behaviour in one of the buildings of the Police College.

Another reason for column shear failures was high shear forces attracted by short columns, captive columns, and wide columns. Widespread use of masonry walls, providing unintended supports, resulted in captive columns in many buildings, increasing shear vulnerability of these members. Figure 18 illustrates the captive columns behaving as short columns in one of the buildings of the Police College. Incidentally, the Turkish Seismic Code does not permit window openings above the filler walls, as they lead to short columns. However, exceptions are made with proper recognition of short column behaviour. In some cases diagonal shear failures occurred in columns fully supported by brick masonry. Figure 19 includes one such example, illustrating local crushing of brick masonry and resulting

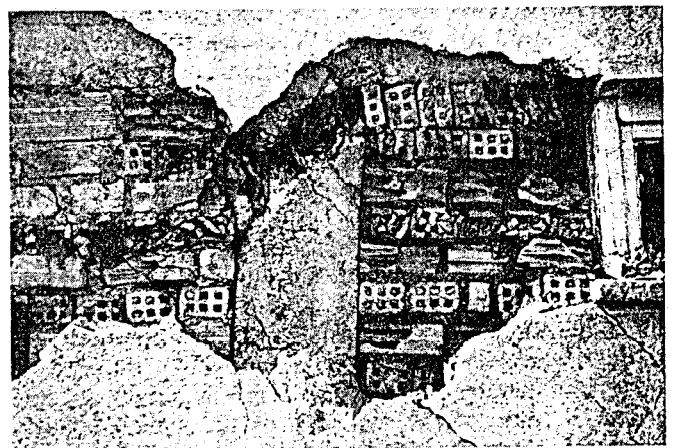
FIG. 19. Shear failure in a column supported by brick masonry.

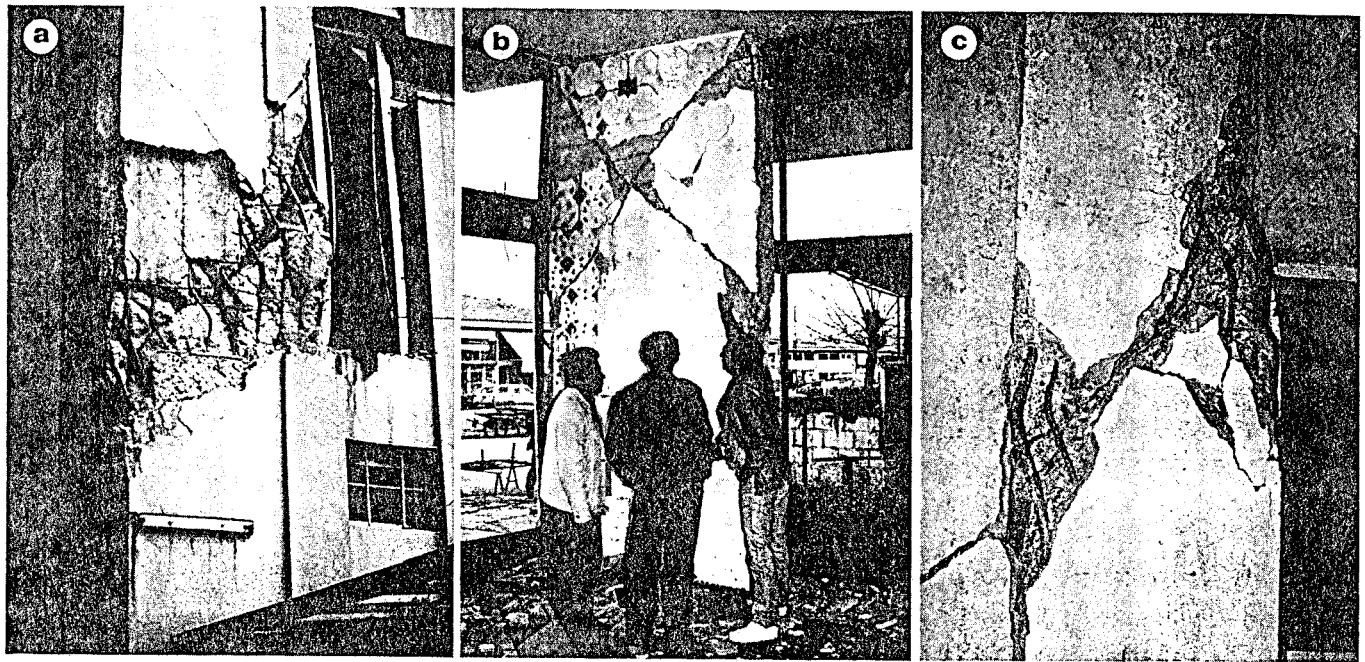
FIG. 20. Lack of shear capacity in rectangular columns: (a) multistorey office building in centre town; (b) two-storey commercial building on east-west highway, downtown area; (c) Sumerbank Textile Factory.

Some of the wide rectangular columns, attracting higher shear forces, also developed diagonal tension failures. These columns were responsible for resisting the total base shear in a given direction, and could not withstand the applied force with the shear capacity provided. Figures 15 and 20 show examples of such failures in apartment, office, commercial, and factory buildings.

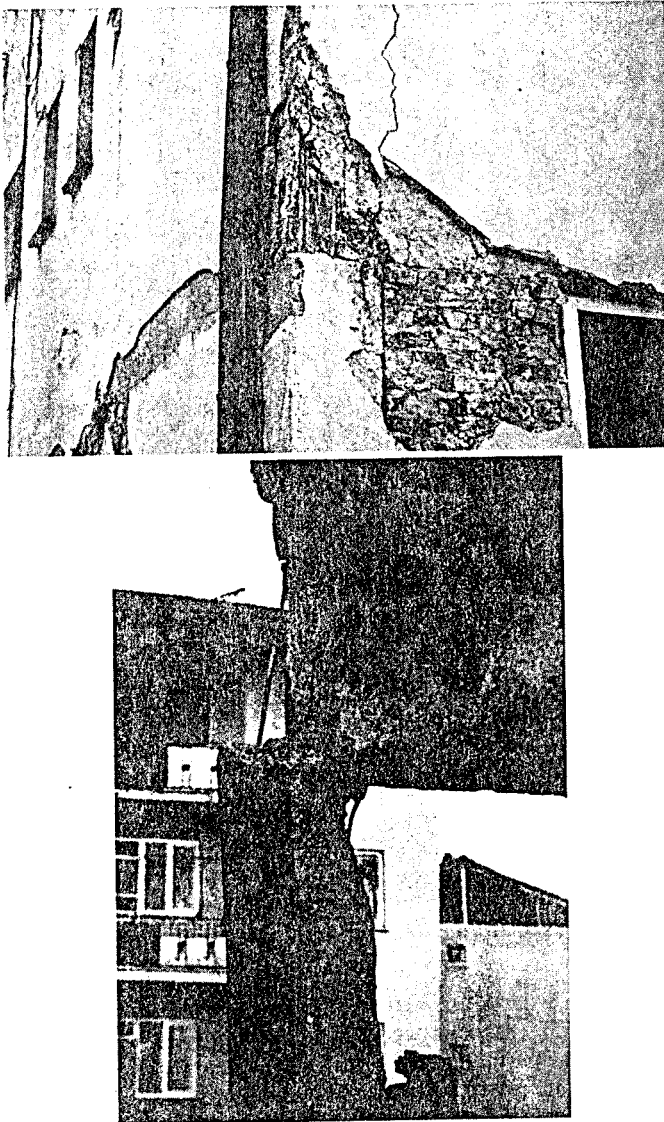
FIG. 21. Examples of poor joint detailing.

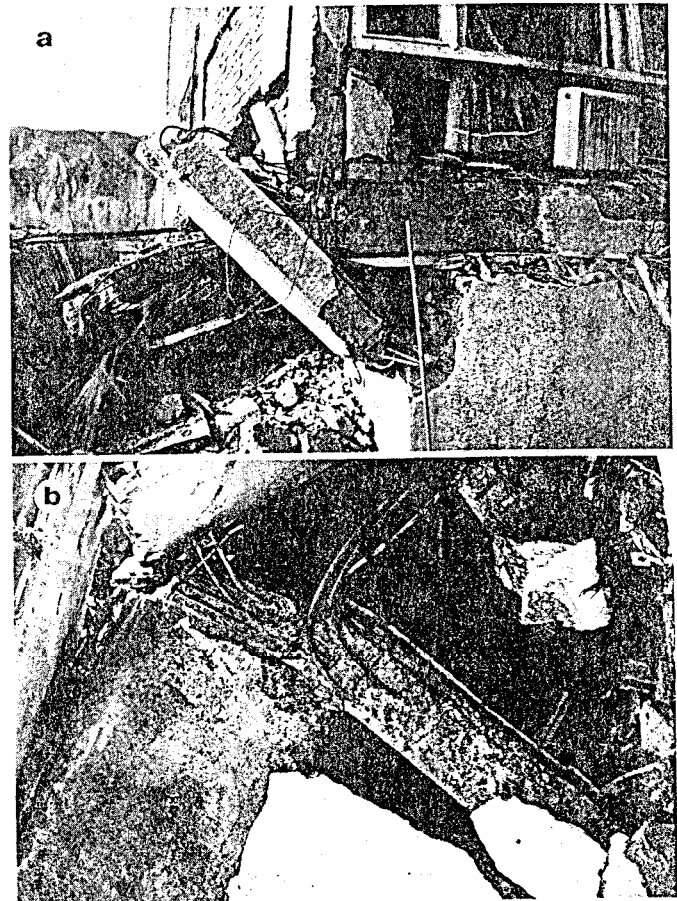
Joint shear failures were the second most common cause of frame failure after the columns. Although the Turkish Seismic Code after 1975 called for seismic design of monolithic beam-column joints, virtually no joint reinforcement was observed in the buildings. This was true not only in the older buildings but also some of the recently built structures. Examples of joint failures are illustrated in Fig. 21. Observations made on the exposed beam-column joints of the collapsed wings of the Military Hospital and the Red Crescent Business Centre, shown in Fig. 22, indicate that no transverse reinforcement was used in the joints.

FIG. 22. Failures attributed to lack of joint reinforcement: (a) Military Hospital; (b) Red-Crescent Business Centre.

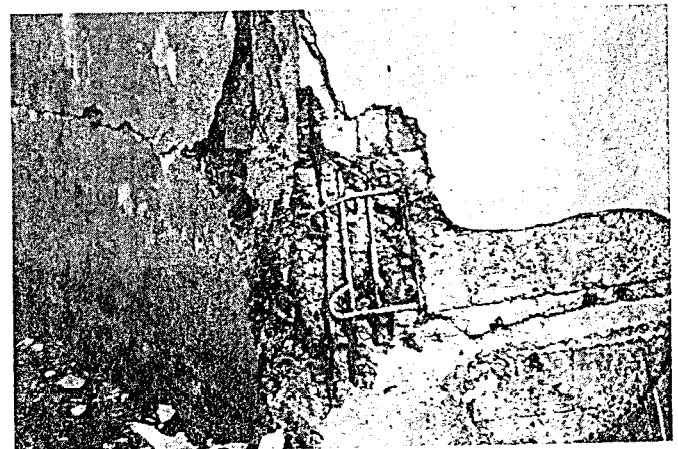
A number of detailing deficiencies were observed in the damaged structures. One common fault was the anchorage of beam reinforcement in exterior and interior joints. Figure 23 illustrates an exterior joint of one of the buildings of Sumerbank Textile Factory where the beam reinforcement was anchored into the cover concrete outside the column cage. These bars lost their anchorage as soon as the cover concrete spalled off. Similar anchorage problems were observed in the Military Hospital as well as the Red Crescent Business Centre.

FIG. 23. Anchorage of beam reinforcement in joint cover concrete.

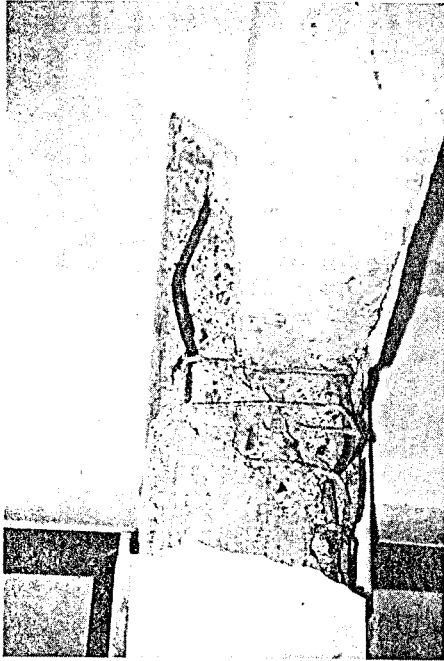
Other detailing deficiencies were observed relative to column reinforcement. Figure 24 illustrates a beam-column joint with an offset. The column reinforcement outside the

joint was not supported laterally, and hence buckled upon spalling of the cover. Figure 25 illustrates lack of continuity between the columns and footings of the Sumerbank Textile Factory, where the column reinforcement was terminated at the surface of the footing. Insufficient splice length was also observed in the second-storey columns of a building that was under construction at the time of the earthquake. The resultant column failure is illustrated in Fig. 26. The use of 90° hooks for the hoop steel was another common problem, although 135° hooks has been required by the Turkish Seismic Code after 1975 for ductile columns. Opening of these hoops under lateral confinement pressure was the source of many failures.

FIG. 24. Lack of reinforcement detailing in a beam-column joint with beam offset.

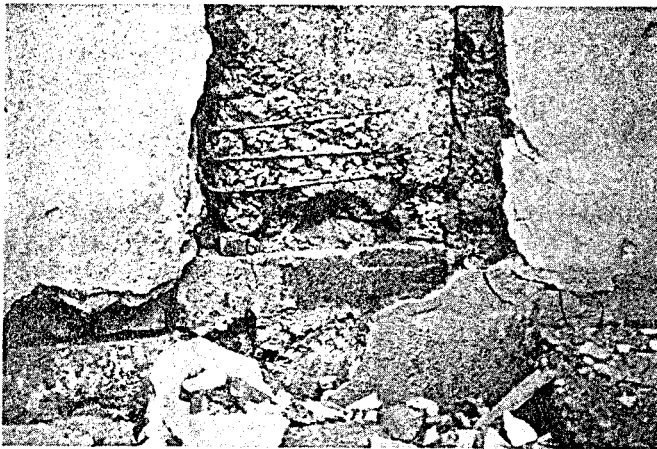
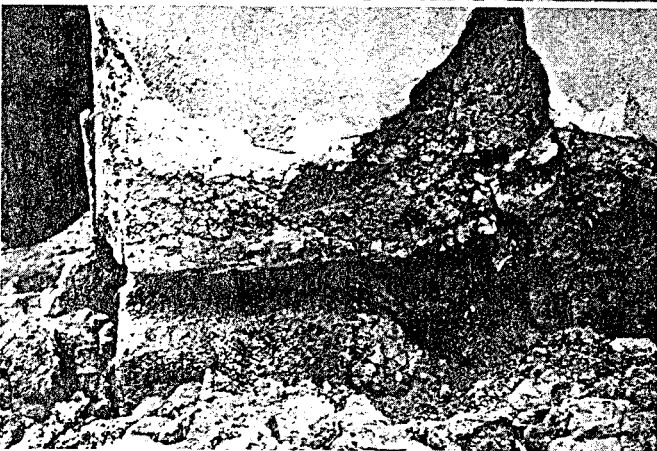
FIG. 25. Lack of continuity in column reinforcement, Sumerbank Textile Factory.

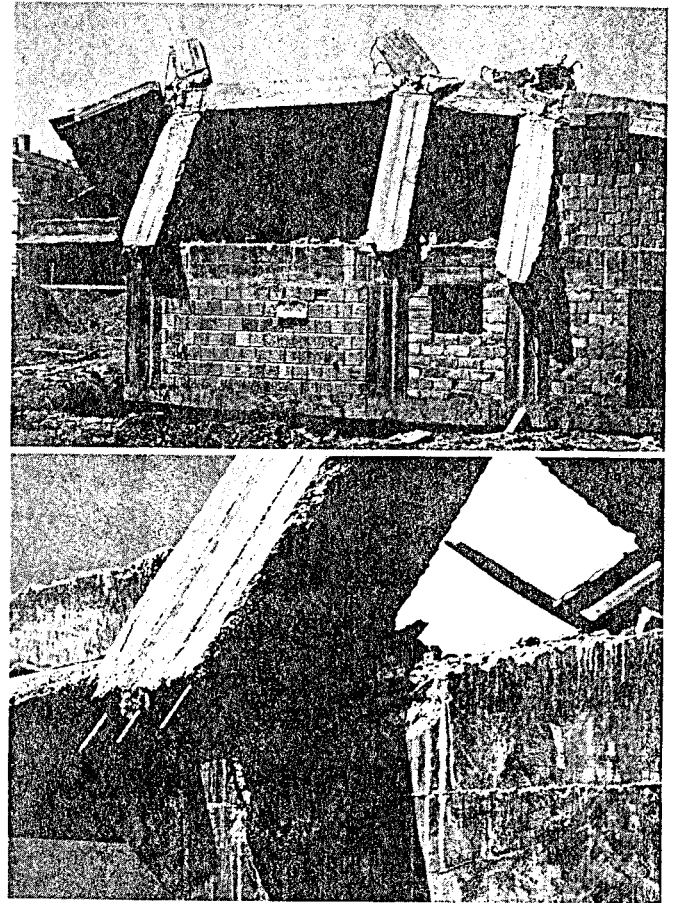
FIG. 26. Inadequate splice length in column reinforcement.

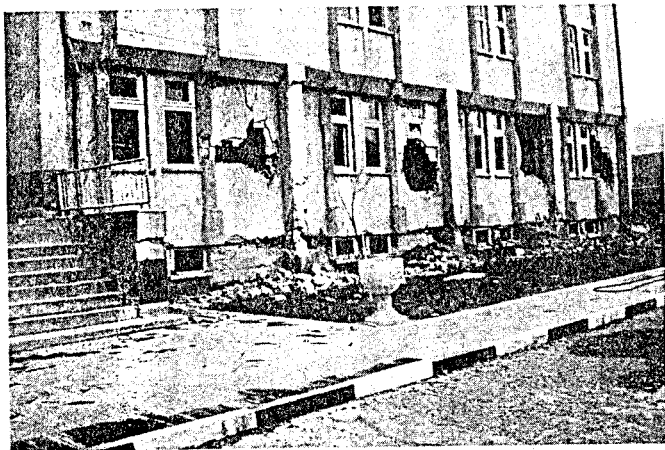
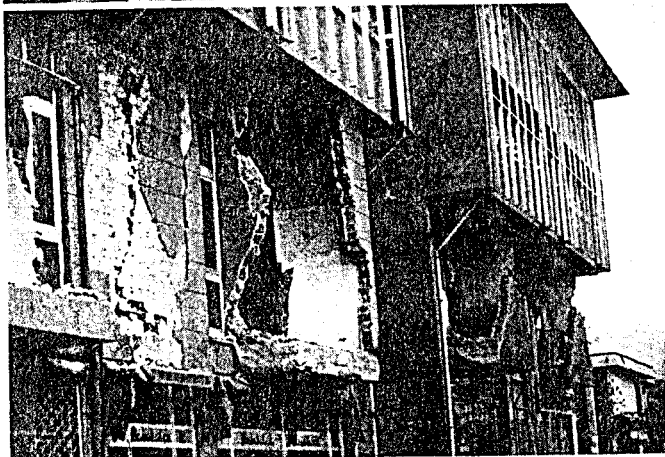
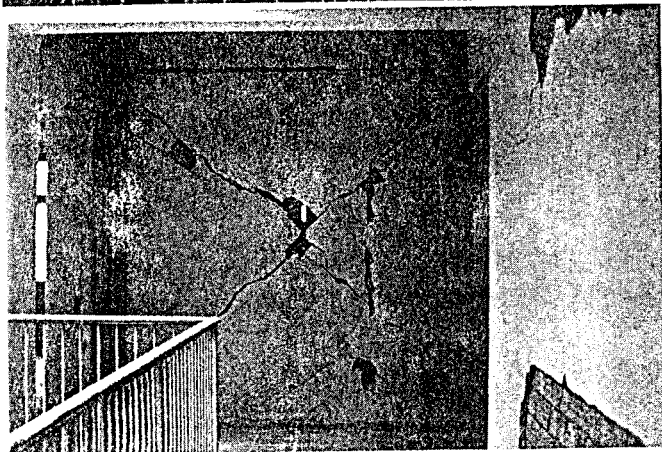
generated during the earthquake, and high deformability demands of frame structures. Therefore they developed diagonal tension and compression failures, as shown in Fig. 27. Crushing of the cells of the hollow brick units leads to the separation of the infills from the frame, as shown in Fig. 28. In one of the buildings of the Sumerbank Textile Factory, this separation was followed by out-of-plane movement of the infill, as illustrated in Fig. 29.

FIG. 27. Typical diagonal tension and compression failures in masonry infills.

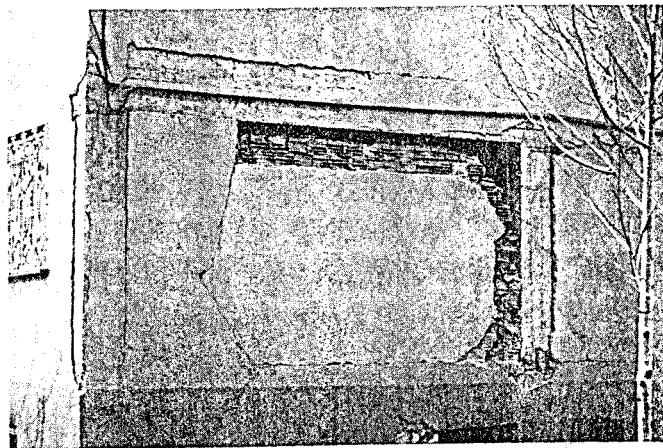
FIG. 28. Crushing of hollow brick masonry and separation of infills from the frames.

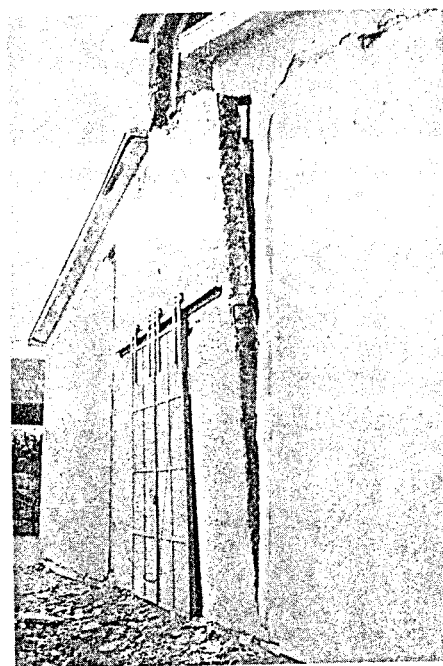
FIG. 29. Out-of-plane movement of a masonry wall in Sumerbank Textile Factory.

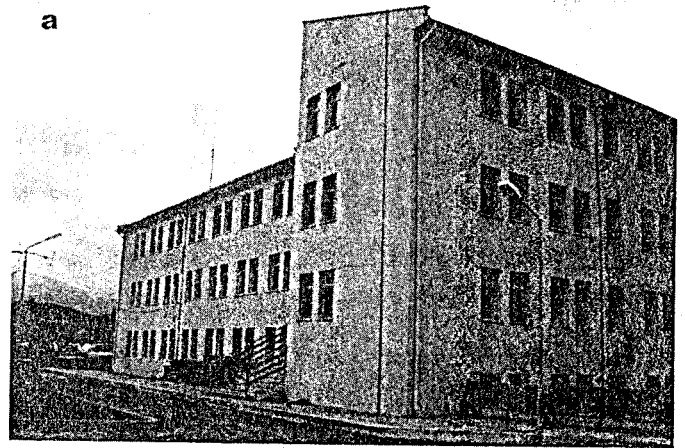
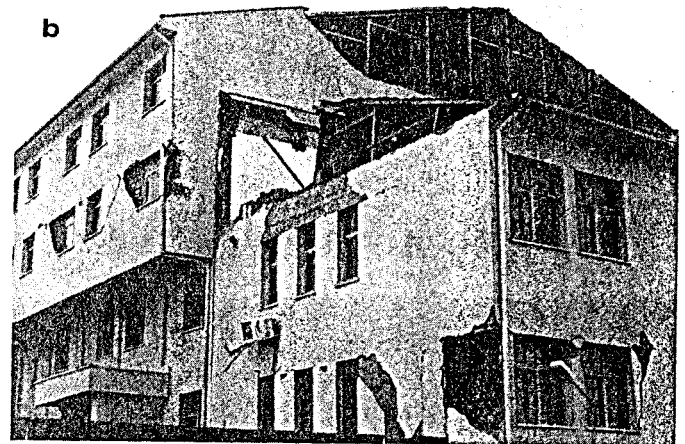
wings after the earthquake. This comparison and the observed behaviour of the shear wall buildings that were under construction clearly indicate the superior response of shear wall structures during the earthquake.

FIG. 32. New Police Headquarters: (a) north wing with shear walls; (b) south wing without shear walls.

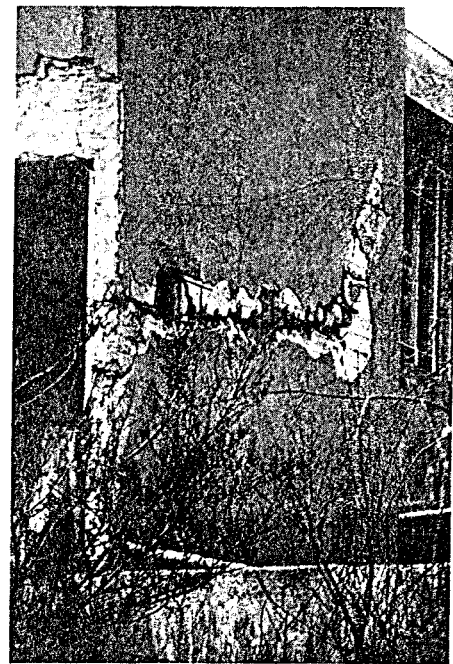
Another multistorey building that contained reinforced concrete shear walls was the west wing of the Red Crescent Business Centre. In this building the lower part of the shear wall was supported in the same plane by an adjacent shear wall. The wall suffered a sliding shear failure at the plane of discontinuity, as shown in Fig. 33.

FIG. 33. Sliding shear in the shear wall of the Red Crescent Business Centre.

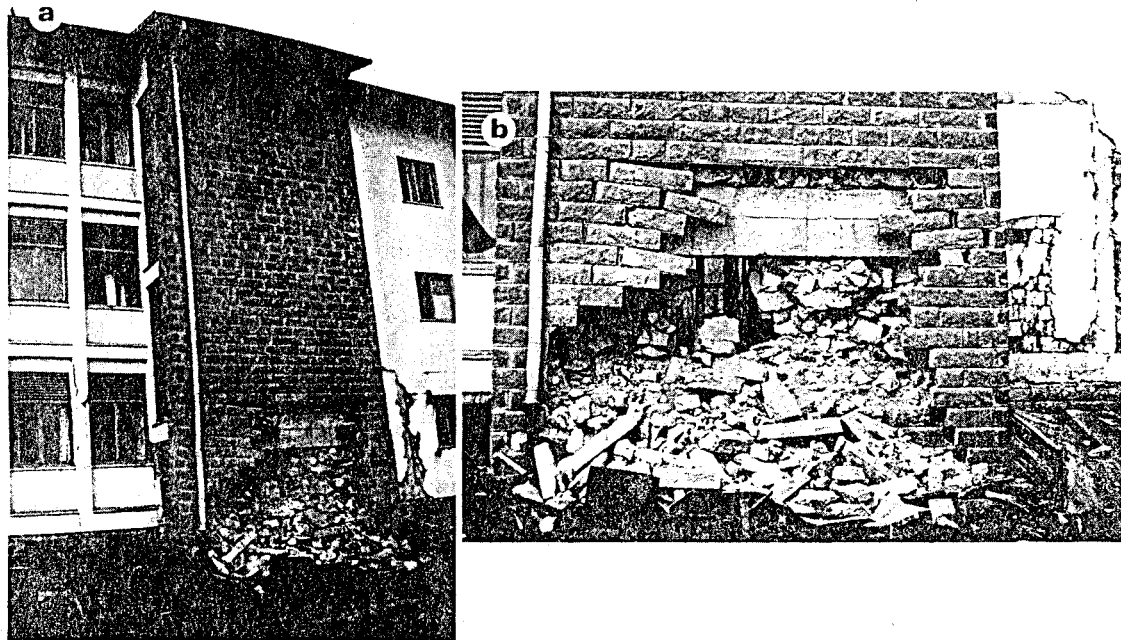
direction. The stone masonry, shown in Fig. 34, was damaged at the base, but controlled the drift in this direction, thereby saving the structure. In general, the shear wall structures behaved remarkably well during the earthquake.

FIG. 34. (a) Stone masonry shear wall of the State Hospital; (b) close-up view of the wall.

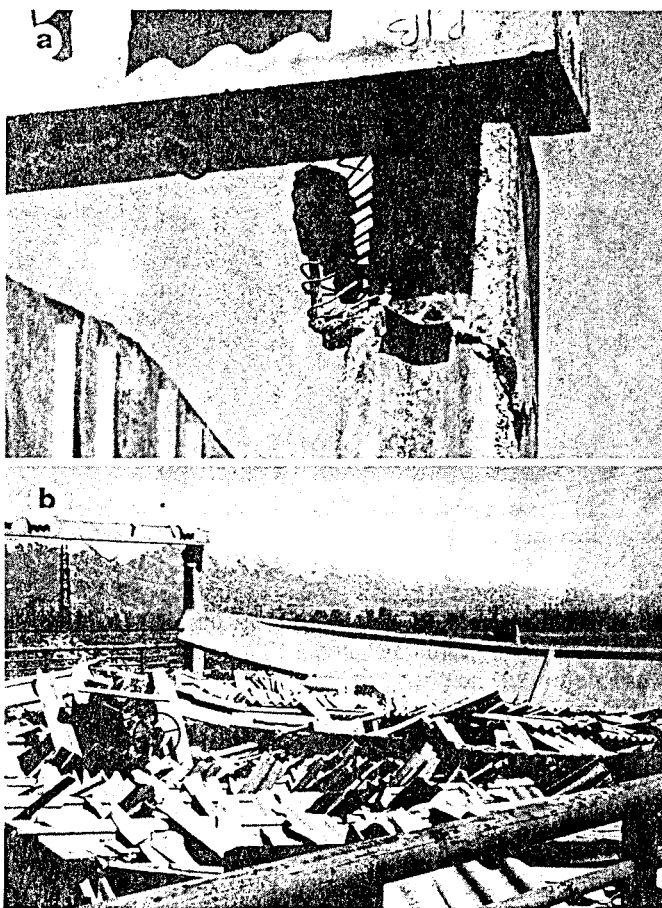
Precast concrete columns, beams, and walls were used in two industrial complexes. One of them was the newly constructed animal slaughter house that consisted of two nearly identical buildings. The buildings were positioned side by side and both consisted of prefabricated columns providing support to long-span precast concrete girders. One of the buildings was also enclosed by precast concrete wall panels in two orthogonal directions. This building survived the earthquake without any damage, while the open building, i.e., without the cladding, collapsed, as shown in Fig. 35.

FIG. 35. Precast concrete animal slaughter house: (a) beam-column connection; (b) overall view.

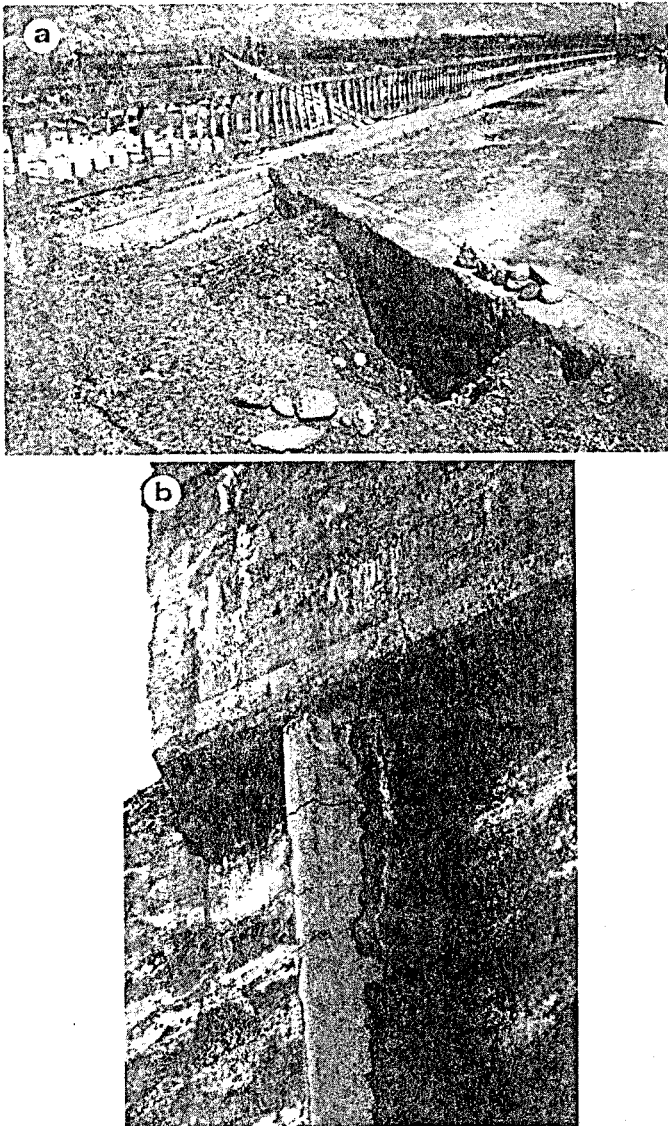
Only one of the bridges in the area suffered damage during the earthquake. This was a three-span reinforced concrete railroad overpass located on the southwest highway, leading to Kemah, just outside the city limits (Fig. 36). Each span was supported by three main girders that were resting on transverse beams monolithically built with three supporting piers. The middle span was 12 m long and the middle piers were 6 m tall. The piers had an 800 mm diameter circular cross section. The settlement of the abutments at both ends left separations that caused the bridge to be closed to traffic (Fig. 37a). The settlement at the north abutment led to the sliding and tilting of the retaining wall, which accidentally beared against the north piers, applying a horizontal force in the longitudinal direction (Fig. 37b). This resulted in flexural cracking of the piers at the ends, wide enough to signify yielding.

FIG. 37. (a) Settlement of west abutment and (b) pier cracking of the bridge on the southwest highway.

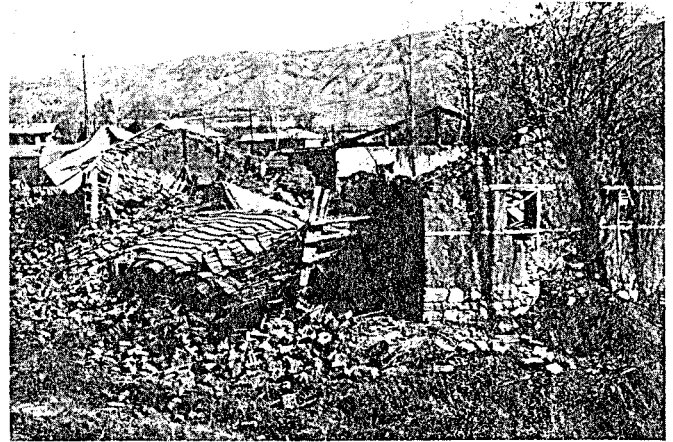
FIG. 38. Example of collapsed mud-brick masonry construction.

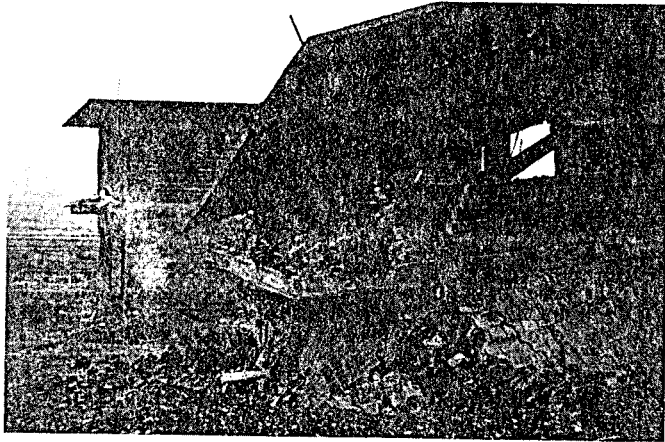
FIG. 40. Collapse of a URM building due to diagonal crushing of non-bearing masonry brick.

to seismically generated compressive diagonal stresses. The very thin cell walls of these bricks proved unstable as soon as the compressive capacity was exceeded, producing an effective "delamination" accompanied by a rapid drop in strength, often leading to overall collapse (Fig. 40). By comparison, very large diagonal cracking was observed to occur in walls built with circular-cell masonry blocks; a lower

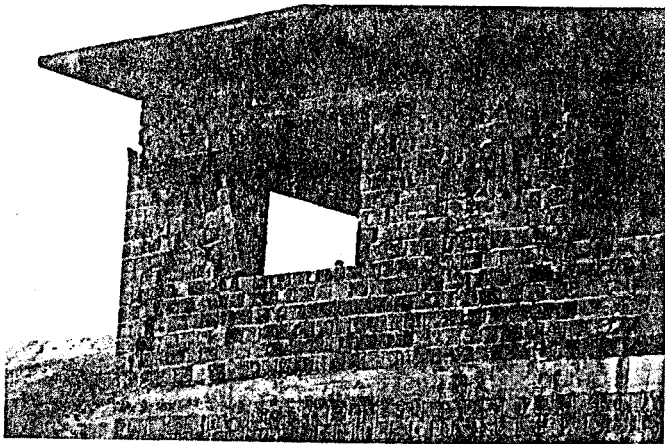
FIG. 41. Large diagonal cracking in URM walls built with circular-cell non-bearing masonry blocks.

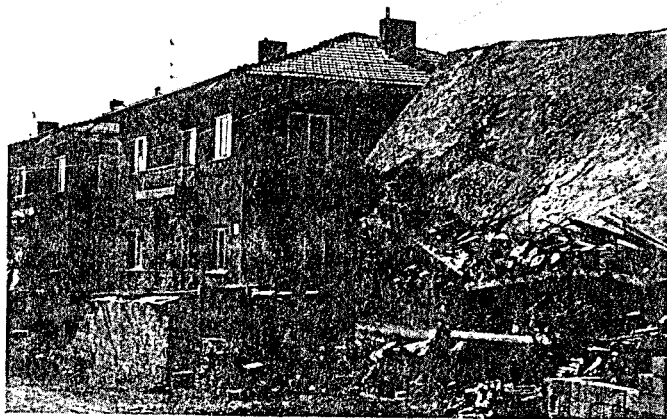
FIG. 42. Example of older residential URM masonry buildings which have survived intact, next to a new building collapsed while under construction.

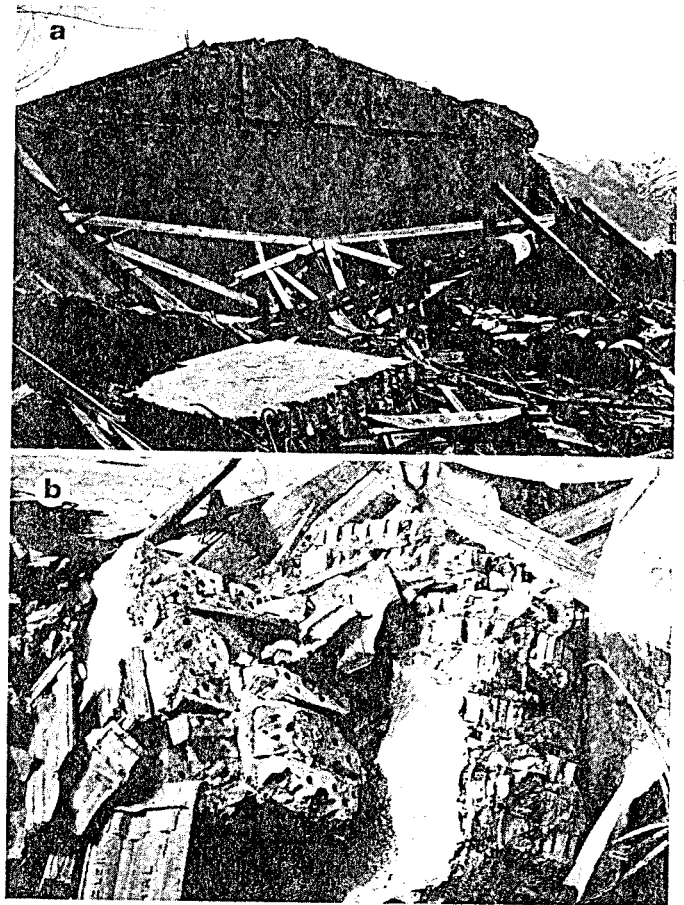
FIG. 43. (a) Completely collapsed warehouse due to out-of-plane failure of near-solid brick masonry at the Rural Services Affairs; (b) close-up view of the brick masonry.

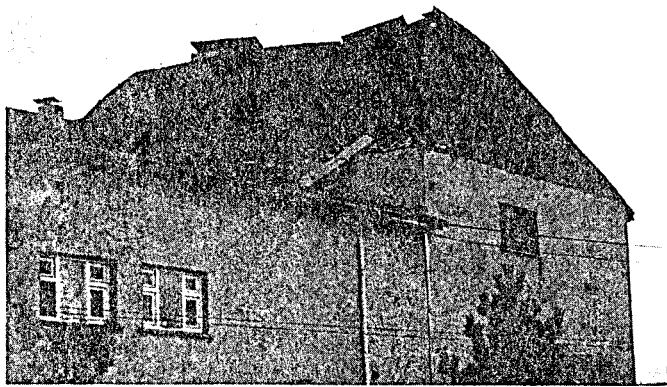
A number of other URM structures were also present in Erzincan, and their performance was similar to that observed worldwide in similar circumstances. For example, an URM warehouse completely collapsed at the Rural Services Affairs (Fig. 43). Constructed of 325 mm thick masonry walls of near-solid bricks coated by more than 25 mm of stucco, for a height-to-thickness ratio of 11.5, the out-of-plane failure of this practically solid-wall rectangular enclosure occurred, largely as a consequence of the absence of anchorage at the

FIG. 44. Typical out-of-plane failure of un-anchored gable roofs.

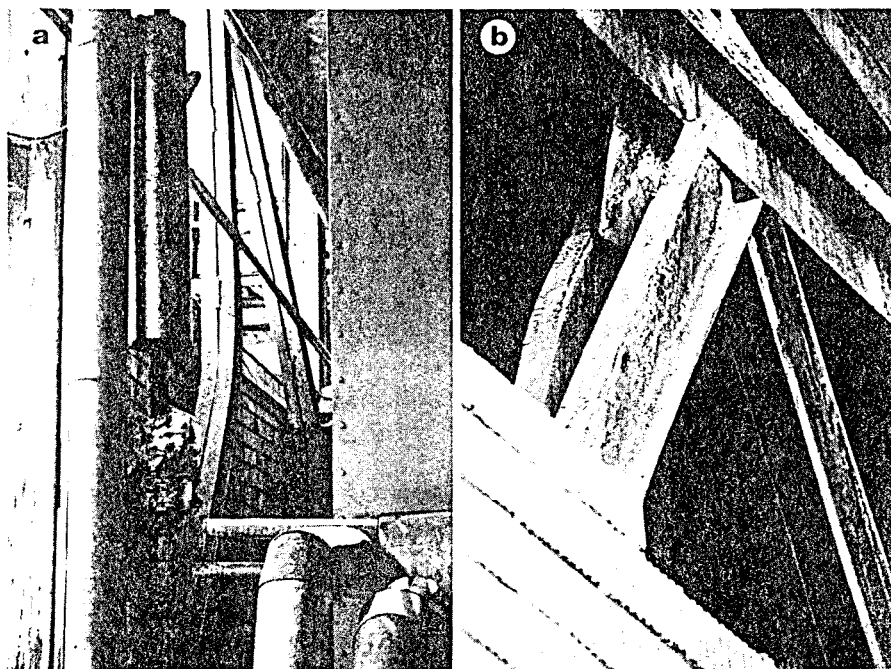
FIG. 46. (a) Buckling of both members of an inverted-chevron braced frame; (b) rupture of a brace-to-gusset weld which initiated a localized buckling of the remaining channel of the built-up section from the gusset-plate connection to the first batten plate (east building of the Sugar Factory).

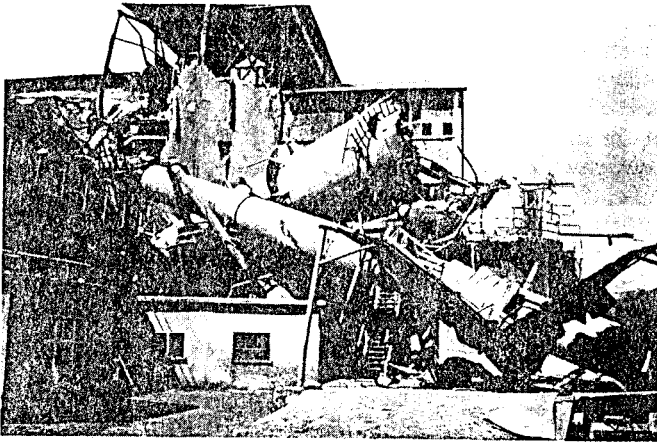
FIG. 47. Collapse of a tall steel chimney which buckled near its base and fell on the adjacent building (Sugar Factory main building).

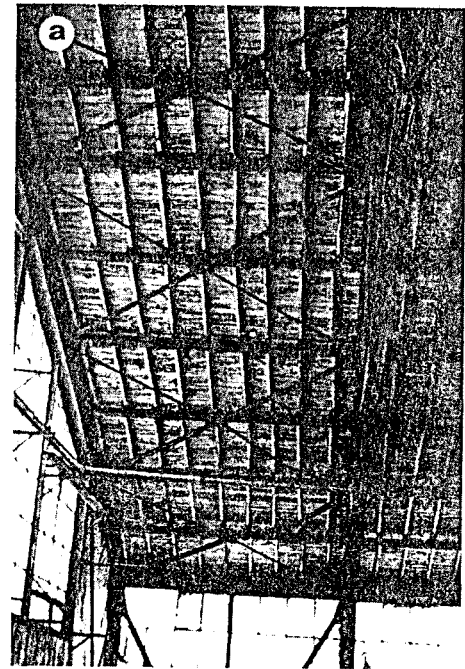
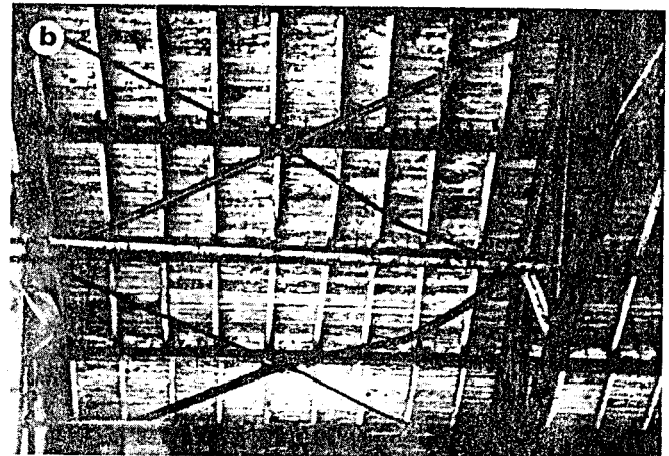
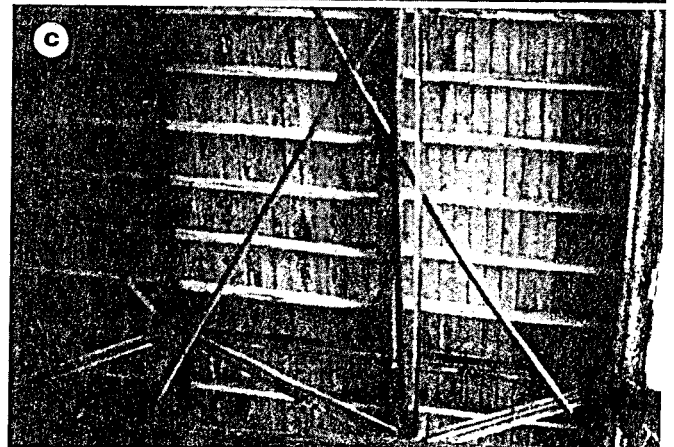
FIG. 48. Examples of horizontal roof bracings (a and b) buckled and (c) ruptured at their connections (Sugar Factory main building).

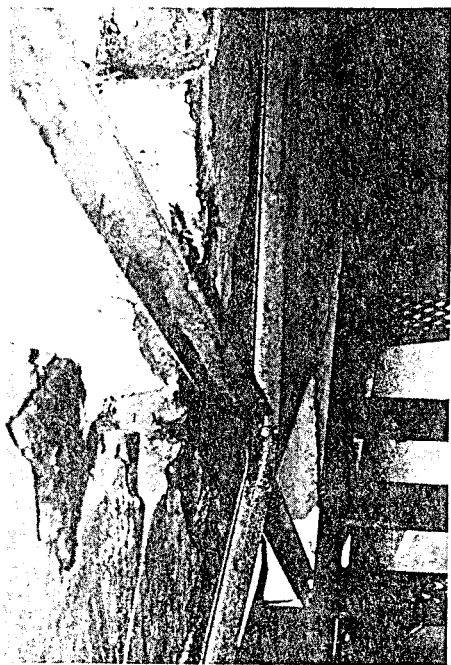
FIG. 49. Typical buckling of diagonal members of non-ductile braced frames of the lateral-load-resisting structural system (Sugar Factory main building).
