Damage from 20th century earthquakes in eastern Canada and seismic vulnerability of unreinforced masonry buildings

MICHEL BRUNEAU

AND

MAURICE LAMONTAGNE

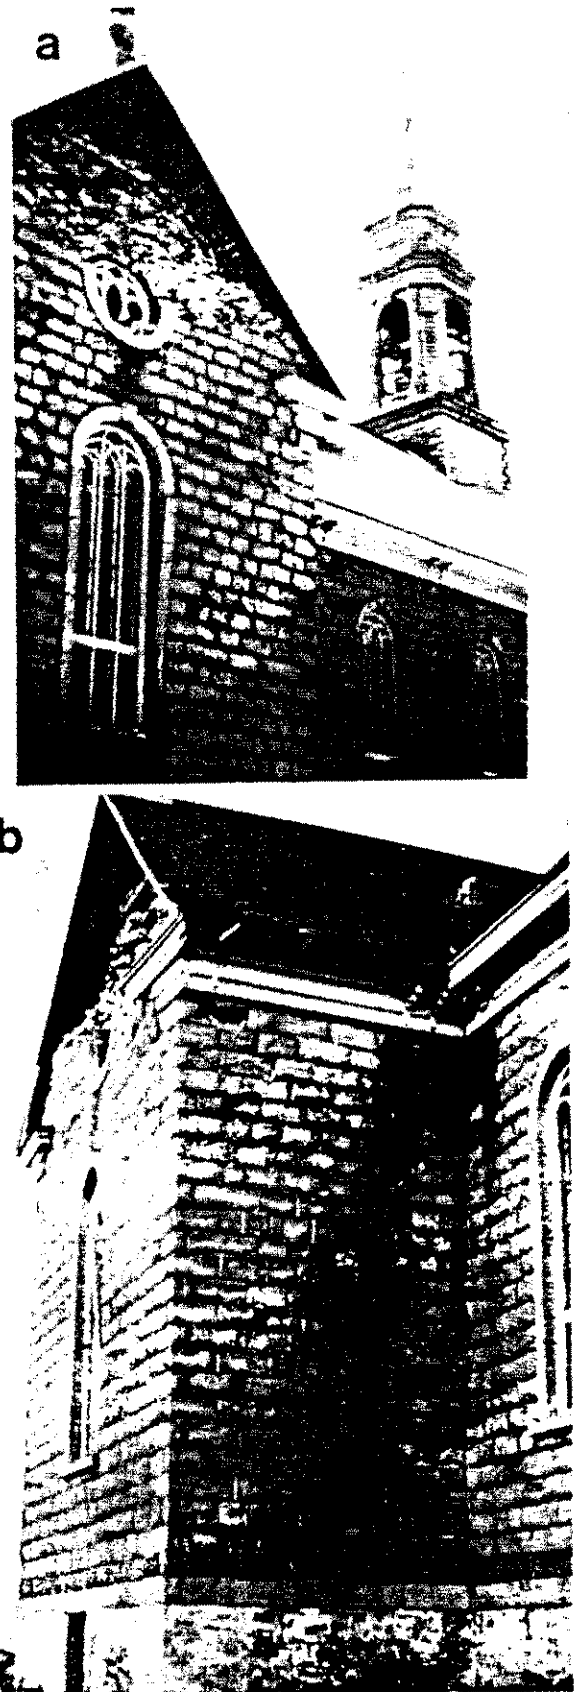
FIG. 3. Damage to Rivière-Ouelle's church (Hodgson, unpublished photo): (a) closeup view of out-of-plane failure of gable and in-plane shear cracks in walls; (b) side view of transept (Hodgson 1925).

deposits (Figs. 3a and 3b). The out-of-plane failure of its unreinforced masonry gable, typical for this type of structures, is attributable to the lack and inadequacy of anchorage between the roof and walls and, in this particular case, to the lack of integrity between the wythes of an otherwise thick stone masonry wall. Some in-plane shear cracks in the walls are also visible. Contrary to what is stated in Hodgson (1925), the church was not demolished following the earthquake; repairs were made only to the damaged portions (Hudon 1972). In Rivière-Ouelle's cemetery, located in the vicinity of the church, most monuments fell (Fig. 4). Some cracks in clay deposits were also noticed nearby. Nearly all chimneys in the district were thrown down by the earthquake.

Unreinforced masonry buildings are most vulnerable to flexural out-of-plane failure (Figs. 3*a*, 11, 12, 21, 22, and 24). Moreover, the unstable and explosive-like out-of-plane failure of unreinforced masonry walls can endanger the gravity-load-carrying capabilities of a wall and can seriously injure or kill occupants and passersby. Note that out-of-plane failure may occur even if joist-to-wall anchors are present in sufficient numbers and strength to provide out-of-plane support to the walls at each floor and roof level, as demonstrated elsewhere (Bruneau 1994). Nonstructural elements, such as parapets, gables of churches and other buildings, and other elements extending beyond the roof line, can also fail in an out-of-plane manner, creating severe life-safety hazards (Figs. 3*a*, 13, and 30). Similarly, chimneys, also located at the top of buildings where the greatest amplification of the ground motions occurs, are often toppled with potentially lethal consequences.

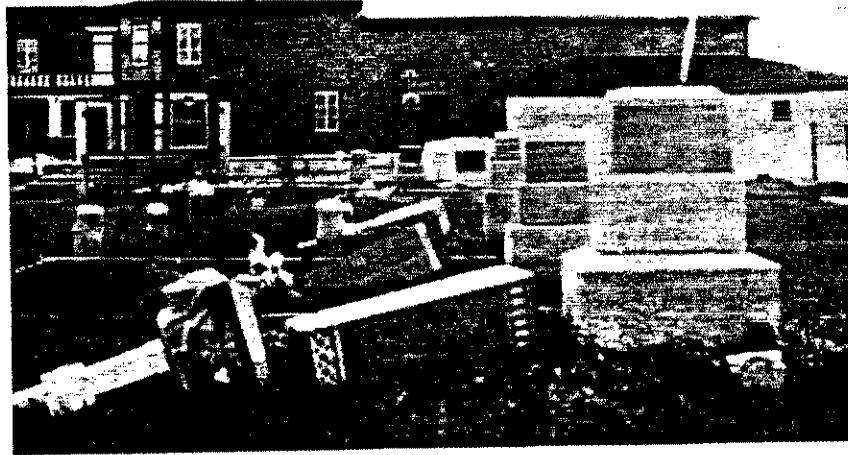
FIG. 4. Fallen monuments at Rivière-Ouelle's cemetery, located in the vicinity of the church. Photo taken 4–6 weeks after the earthquake (Hodgson 1925).

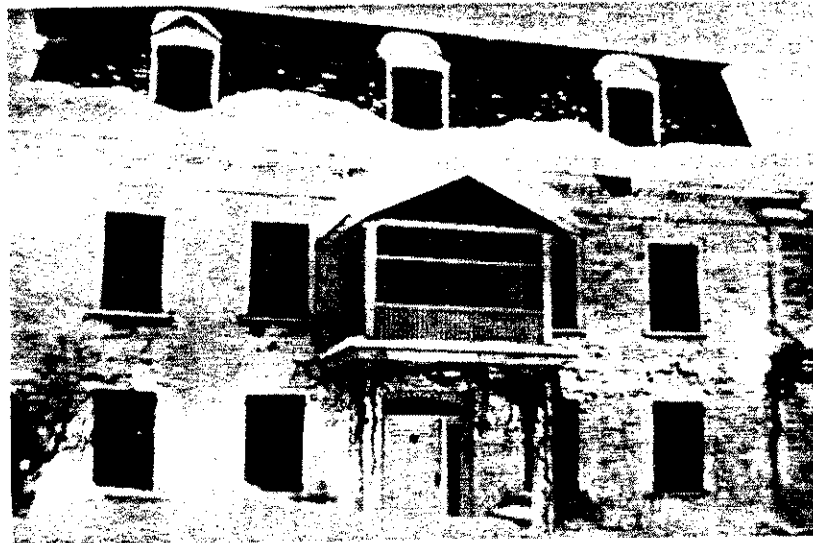
FIG. 5. Photo of Manoir Cabot east of La Malbaie on the north shore of the St. Lawrence River (Hodgson, unpublished photo) — in-plane shear failure of spandrel beams.

Although some structural damage was also reported to have occurred on the north shore, photographic evidence is scarce. Damage to Manoir Cabot is noteworthy; although hardly visible, some in-plane shear cracking occurred in spandrel beams of this residential masonry house near the epi-

central region (Fig. 5). Hodgson (1950) reported important damage to this house including two chimneys at both ends of the house. Hodgson (1925) stated that the house was standing on a deep sand slope. Other buildings in the vicinity were not seriously damaged.

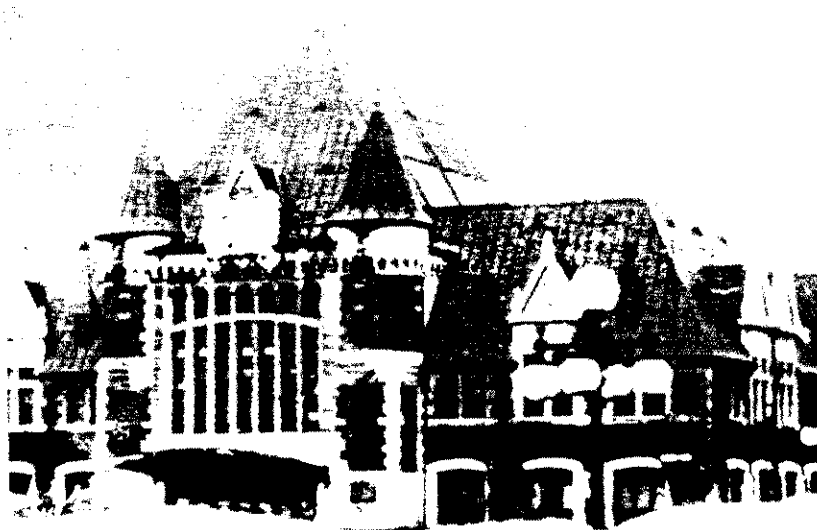
FIG. 7. Gare du Palais, Québec, about 150 km southeast of the 1925 epicentre (Hodgson, unpublished photo).

(Fig. 7). While its walls were widely reported by local newspapers to have been damaged during this earthquake, the exact nature of the damage suffered by this building is not well documented. It is known that cracking developed above large windows in a waiting room, leading to the collapse of five rows of bricks into the concourse. Cracks also developed in many walls; and parts of the ceiling, skylight glass, and heavy lights fell. Yet, only a (somewhat disappointing) photograph taken during repairs could be found in photographic archives searched (Fig. 8). On the other hand, damage to the supporting steel columns of a freight shed in the port of the city of Québec is better documented. The column shown in Fig. 9 shifted by approximately 8 cm from its foundation because of motion and ground settlement. Many columns were reported to have settled by as much as 9 cm. Buckling of at least one steel angle connecting two steel columns supporting a span of the freight shed is documented (Fig. 10). Some other minor damage was reported, but most of the port facilities survived the earthquake intact. It is noteworthy that these port facilities were largely constructed on reclaimed land.

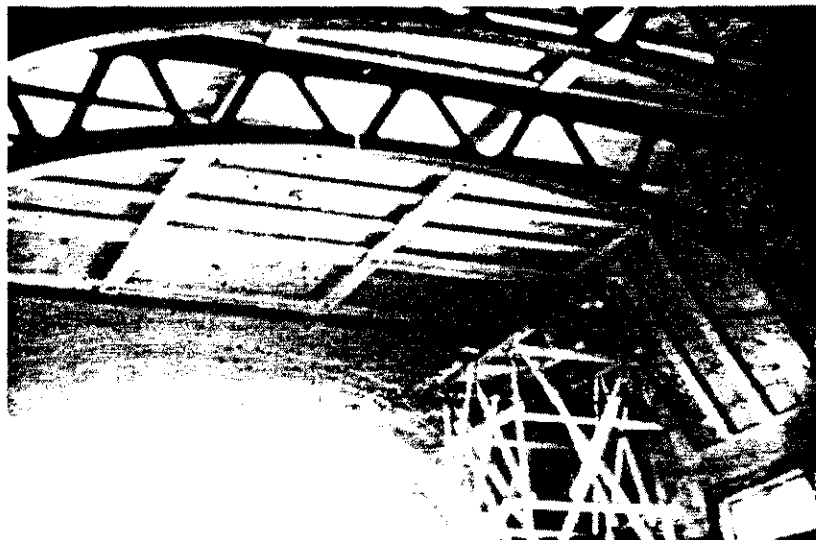
FIG. 8. Photo during repairs to walls of the Gare du Palais (Hodgson, unpublished photo).

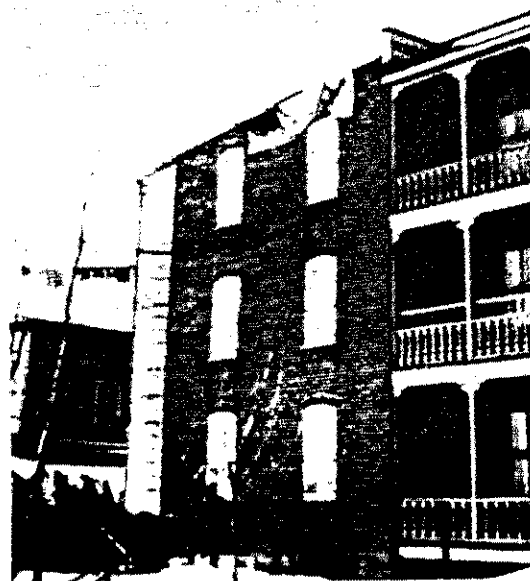
FIG. 11. Out-of-plane failure of unreinforced masonry wall in Shawinigan, approximately 250 km from the epicentre (Hodgson 1950).

In Shawinigan, approximately 250 km from the epicentre, a few buildings suffered damage. In the absence of reported damage in similar structures between Québec and Shawinigan, soil amplification due to local geological conditions is probably responsible for part of this damage. Other causative factors noted in Hodgson (1950) from a report by Abbott (1926) are poor workmanship, shoddy material, insecure terrain, or improper design. Damage was essentially confined to the out-of-plane failure of unreinforced masonry walls and (or) their exterior wythe, as shown in Figs. 11 and 12. Out-of-plane failure of an unreinforced masonry transept

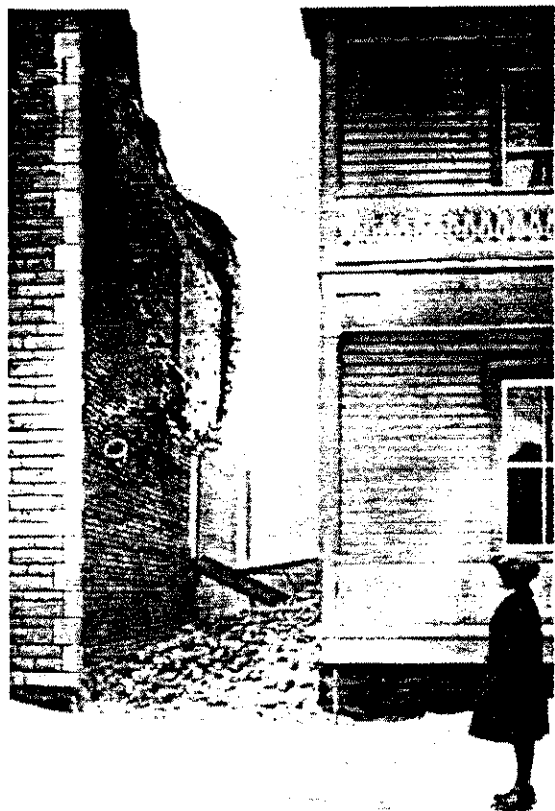
FIG. 12. Out-of-plane failure of unreinforced masonry wall in Shawinigan (Laroche 1982).

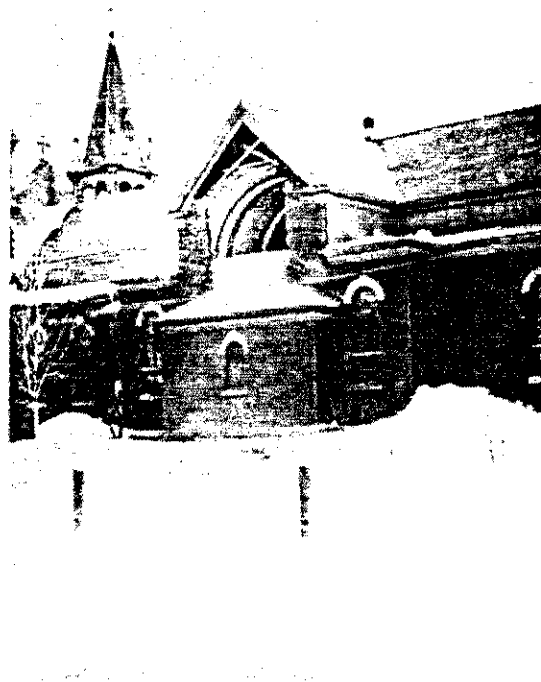
wall of St. Marc Church in Shawinigan also occurred, as illustrated in a recently discovered photograph (Fig. 13). Clearly, the unreinforced masonry gable collapsed outwards, taking with it the stained-glass window and part of the exterior wythe of the masonry wall directly under that window.

FIG. 13. Out-of-plane failure of unreinforced masonry transept wall of St. Marc Church in Shawinigan (Geological Survey of Canada archives).

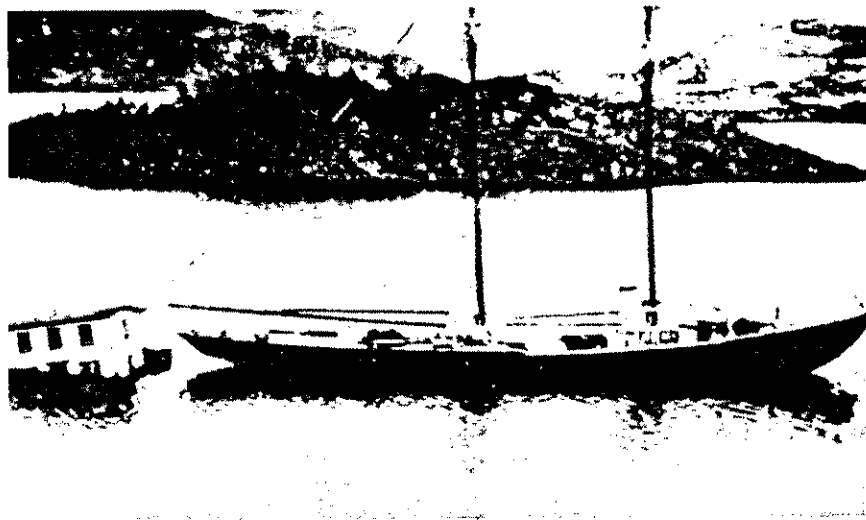
FIG. 15. Two-story house swept to sea by the 1929 tsunami, and subsequently recovered and secured to a Grand Banks fishing schooner (still and moving image collection of the Public Archives of Newfoundland and Labrador, 1929, St. John's, Newfoundland).

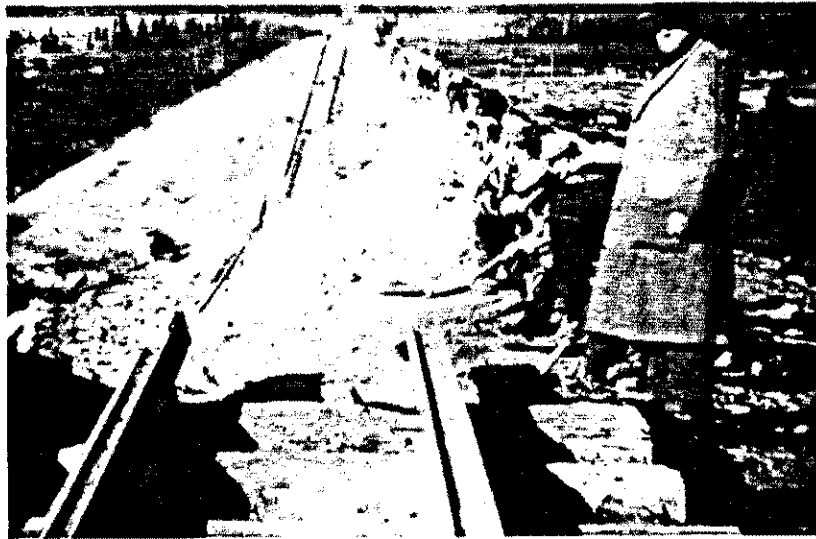
FIG. 18. Slide of railroad embankment near Parent, Quebec, some 350 km from the epicentre (photo by Canadian National Railways, Geological Survey of Canada archives).

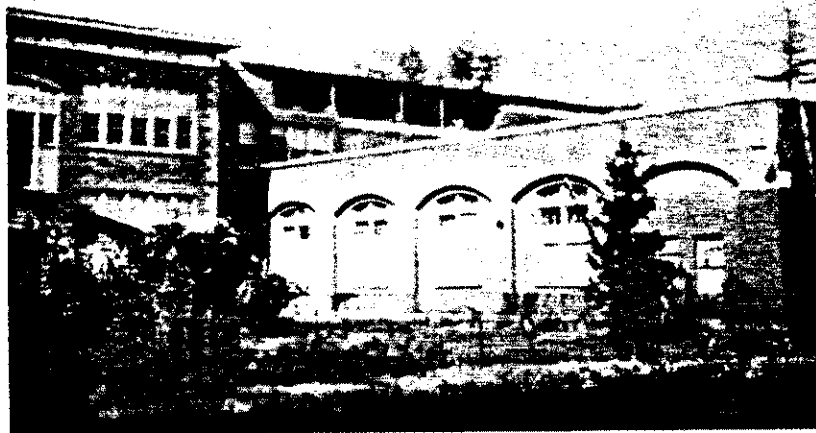
Considerable damage was caused at the Collegiate and Vocational School, a two-story-and-basement brick building located in Cornwall. The out-of-plane failure of the unreinforced masonry wall at the top story of a wing of this college was considerable and surprising, considering the small magnitude of this earthquake (Fig. 21). The falling masonry broke through the roof of the adjacent gymnasium, damaging it badly (Fig. 22). Out-of-plane failure of the unreinforced masonry veneer of an apartment building in Cornwall (Fig. 23) also occurred. At another two-story unreinforced masonry house in Cornwall, the top section of its second story brick wall failed out-of-plane, collapsing inward (Fig. 24). Finally, spectacular damage to a two-story residential unreinforced masonry dwelling in Cornwall was photographically documented (Figs. 25 and 26); there, the exterior wythe of walls having multi-wythes improperly bonded along their collar joint failed out-of-plane, with some in-plane shear cracks also visible. The County Court House and Orange Block buildings reportedly also developed similar bulges of several inches in their unreinforced masonry walls (Legget 1944; Sweet 1944).

FIG. 21. Damage at the Collegiate and Vocational School, Cornwall (Sweet 1944) — out-of-plane failure of masonry wall.

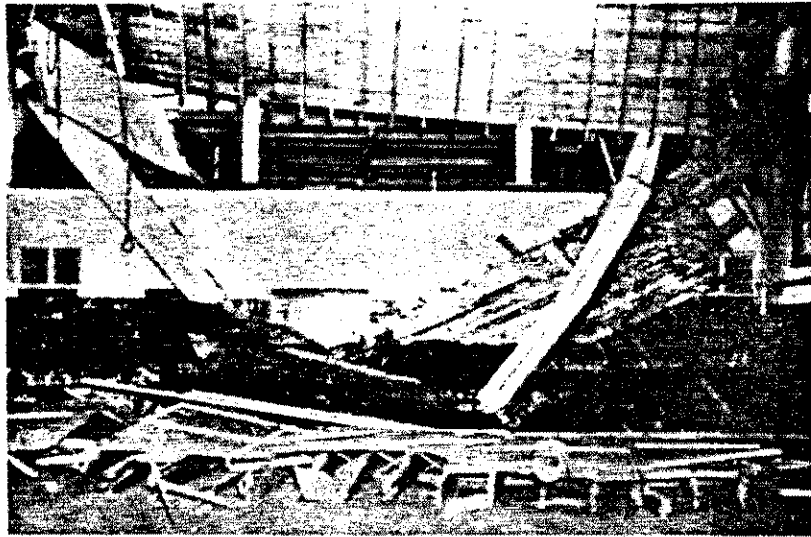
FIG. 22. Damage at the Collegiate and Vocational School, Cornwall (Cornwall Daily Standard-Freeholder 1944).

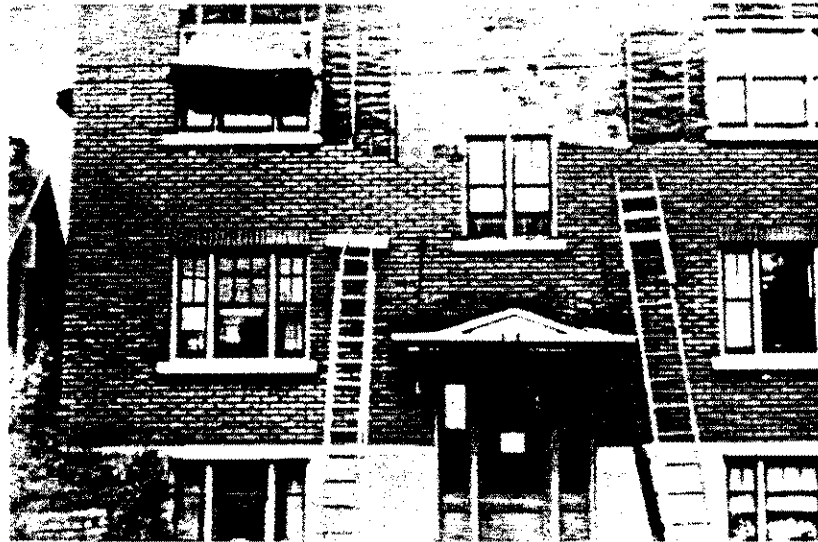
FIG. 23. Out-of-plane failure of the unreinforced masonry veneer of an apartment building in Cornwall (Sweet 1944).

When the mortar of collar joints is either absent, discontinuous, or of poor quality, multi-wythe walls are extremely vulnerable to seismic excitation. With each wythe behaving independently as an individual thin wall, the exterior layers will usually fail first as they are less effectively connected to any other structural components (Figs. 25 and 26). By analogy, this is also true for unreinforced masonry veneers (Fig. 23).

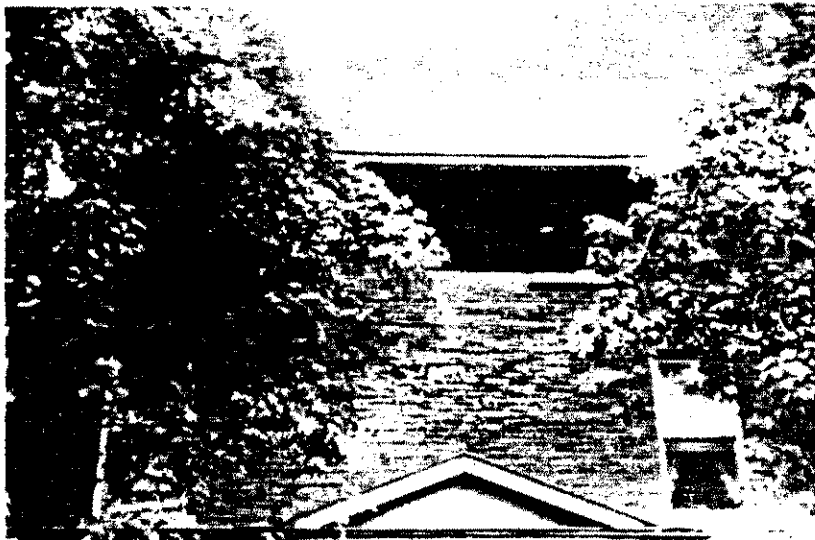
FIG. 24. Unreinforced masonry out-of-plane failure, top part of a wall, residential building in Cornwall (Sweet 1944).

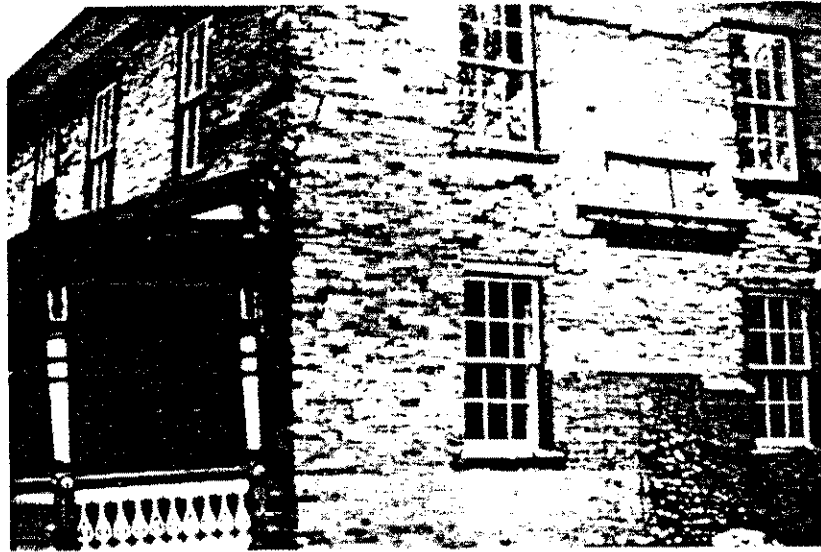
FIG. 25. Damage to a two-story residential unreinforced masonry dwelling in Cornwall (Berkey 1945) — in-plane shear cracks and out-of-plane failure of multi-wythe wall due to inadequate collar joint are visible.

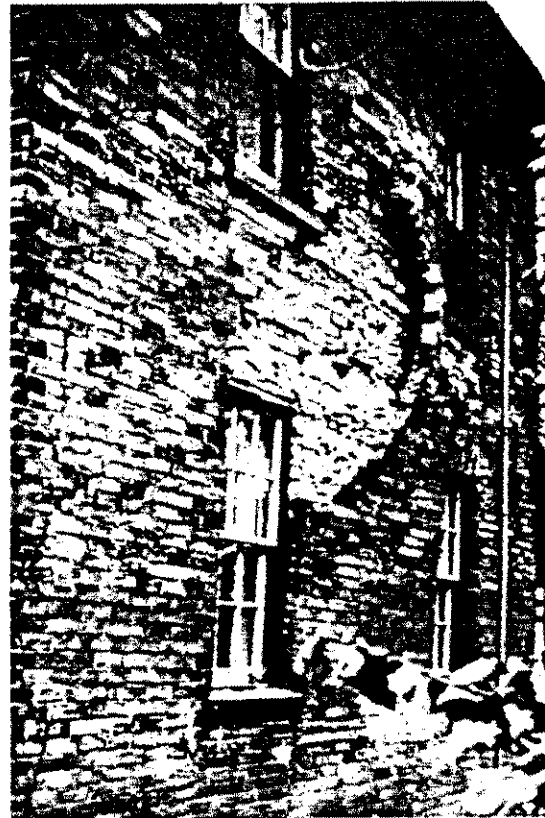
FIG. 26. Damage to opposite side of the two-story residential unreinforced masonry dwelling of Fig. 25 (Berkey 1945).

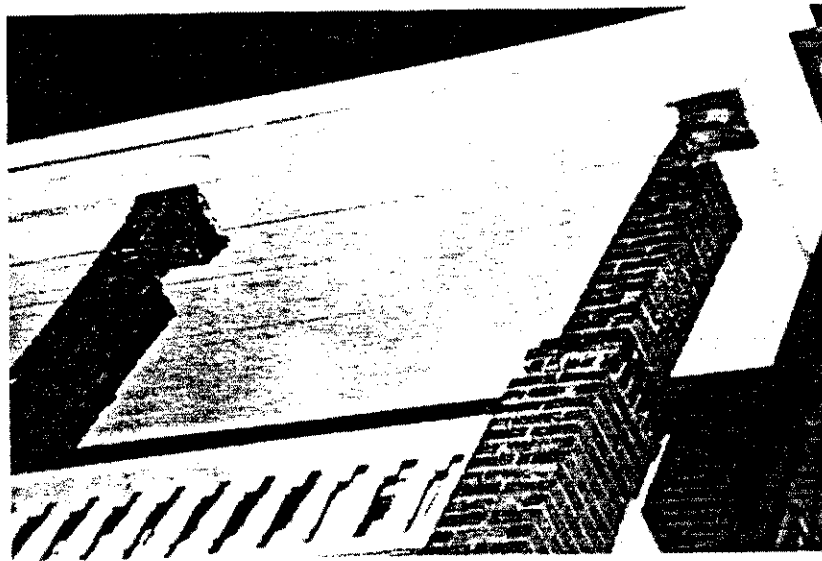
Excessive bending or shear may produce in-plane failures and familiar through-thickness cracks in masonry walls. In many cases, these more common cracks are overshadowed by simultaneous more spectacular type of failures, but nonetheless present (Figs. 3*b* and 25). For unreinforced masonry walls, in-plane shear failures are more common, as expressed by diagonal shear cracking. Fortunately, until the shear cracks become unduly severe, the gravity-load-carrying capacity of the walls is not jeopardized. In masonry facades having numerous window openings, spandrels and the short piers between them may also fail in shear (Fig. 5). Flexural failure is also possible for more slender unreinforced masonry elements (Fig. 29).

FIG. 29. 1988 Saguenay earthquake; flexural failure of unreinforced masonry pilaster, multi-units residential building in downtown Québec (Gilles Fréchette, personal communication).

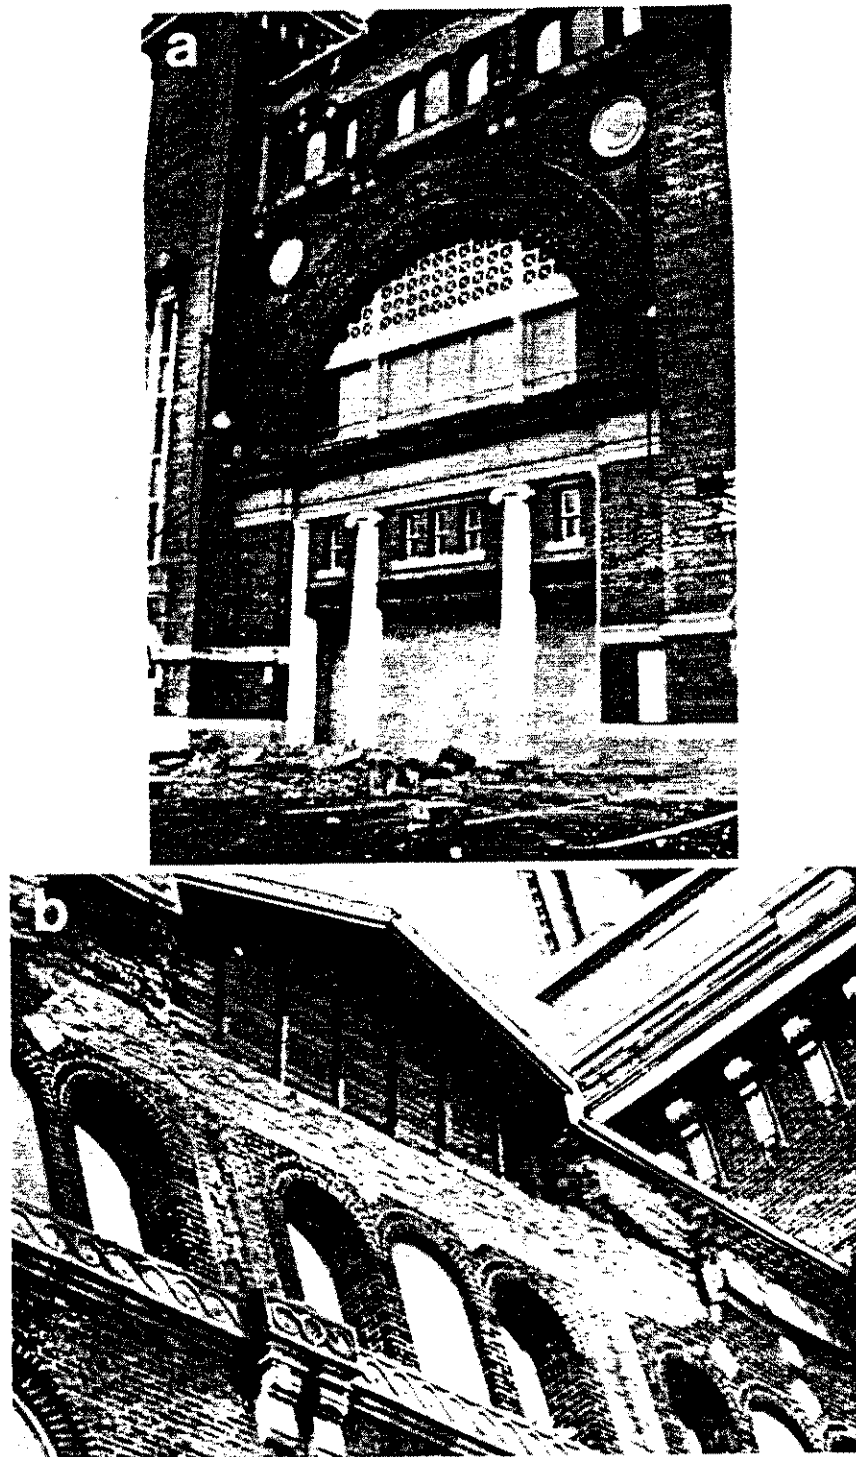
FIG. 30. 1988 Saguenay earthquake; out-of-plane failure of unreinforced masonry gable, Hippodrome de Québec: (a) global view; (b) closeup view (photos by first author).
