Performance of bridges in the 1994 Northridge earthquake

Denis Mitchell, Michel Bruneau, Martin Williams, Donald Anderson, Murat Saatcioglu, and Robert Sexsmith

Key words: Northridge, earthquake, seismic, bridges, damage, performance.

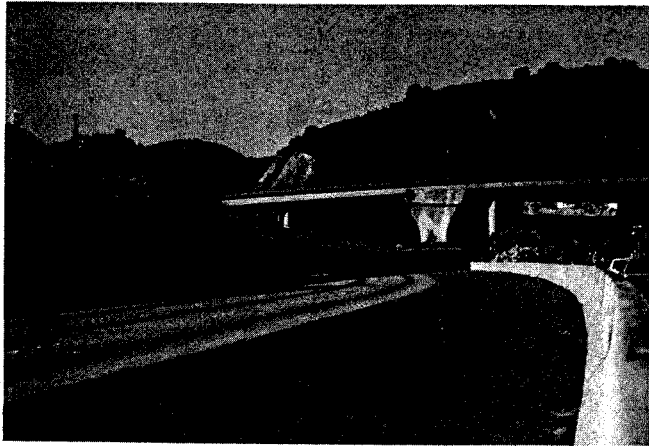
Figure 2 gives an overall view of the failure of the I-5/14 South connector. The structure was damaged, while under construction, in the 1971 San Fernando earthquake, and was

Fig. 2. Overall view of the I-5/14 South connector failure.

The significant movements of the superstructure during the earthquake resulted in a shear failure at the short column closest to the abutment, failure of the reinforced concrete wing wall and shear keys at the abutment with subsequent loss of support of the superstructure. This was followed by failure of the superstructure at the diaphragm over the continuous support, leaving the flared column standing (see Fig. 3). The column that failed contained 20 #18 (57 mm dia.) longitudinal bars and #5 (16 mm dia.) ties at a spacing of 305 mm in the 3.6×1.2 m section. This amount of confinement and shear reinforcement is inadequate to ensure ductile behavior and to prevent a shear failure.

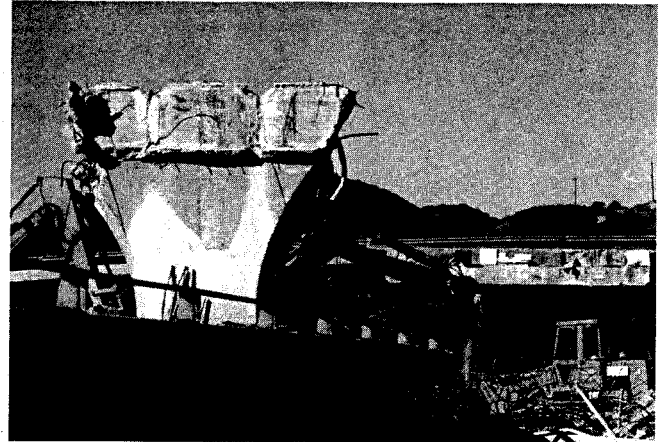
Fig. 3. Flared column of the I-5/14 South connector.

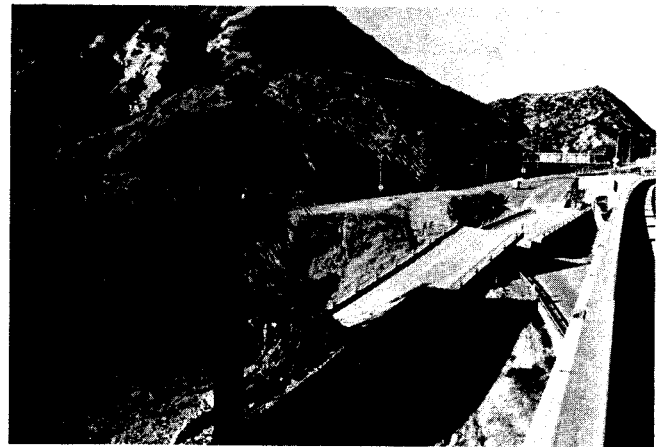
The I-5/14 North connector overcrossing structure consists of ten spans and a 2.4 m deep hollow box superstructure, some spans of which were post-tensioned. The structure was designed in 1968 and was completed after the 1971 San Fernando earthquake. Figure 4 shows the collapse that occurred in the first two spans as the column closest to the abutment failed in shear (CALTRANS 1994; Priestley et al. 1994). The single column supports consisted of 1.2×2.4 m octagonal columns. The column that failed contained 42 #18 (57 mm dia.) longitudinal bars with #4 (12.7 mm dia.) confining bars spaced at 305 mm as shown in Fig. 5. The clear heights of the columns (measured from the top of the footings to the underside of the superstructure) varied from 8 to 23 m, with the failed column having a clear height of 8 m. The shorter length of the failed column and the lack of horizontal restraint at the adjacent abutment most likely resulted in larger shears being attracted by this column. In addition, the low amounts of confinement and shear reinforcement in this short column contributed to the shear failure.

Fig. 4. Collapse of the I-5/14 North connector.

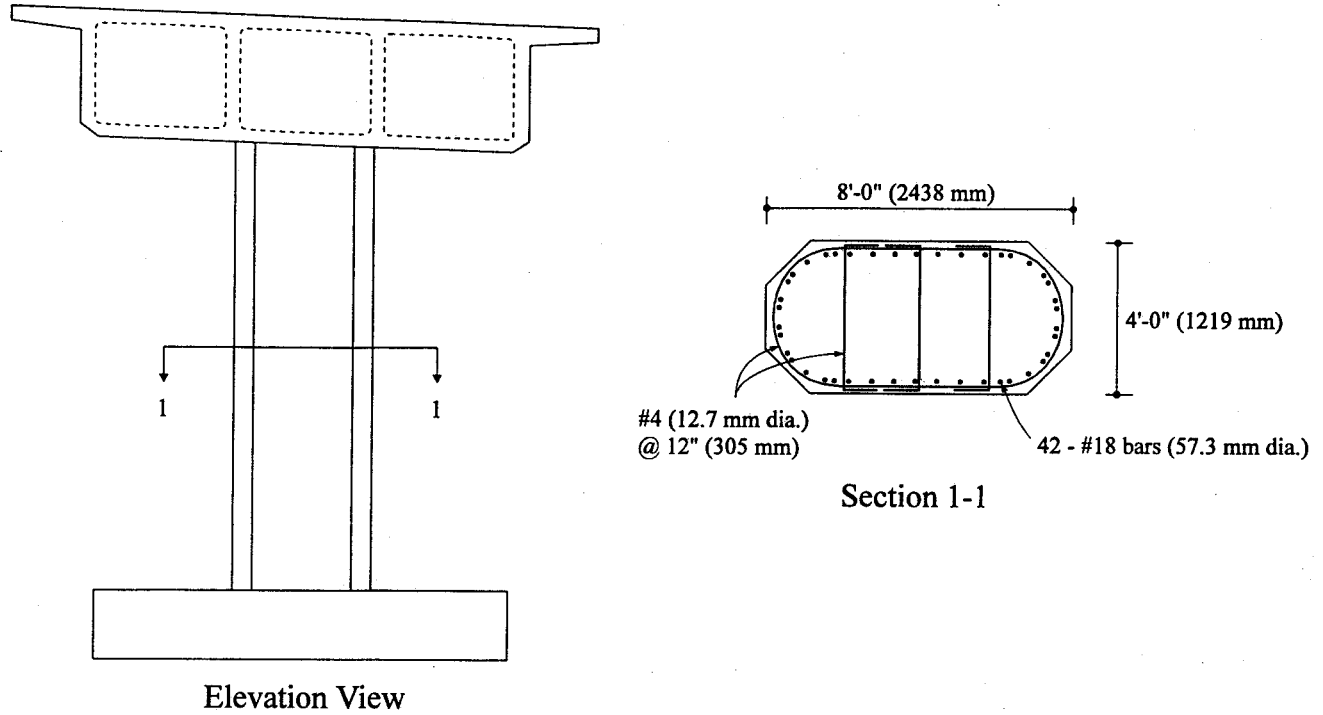
Fig. 5. Details of failed column of the I-5/14 North connector.

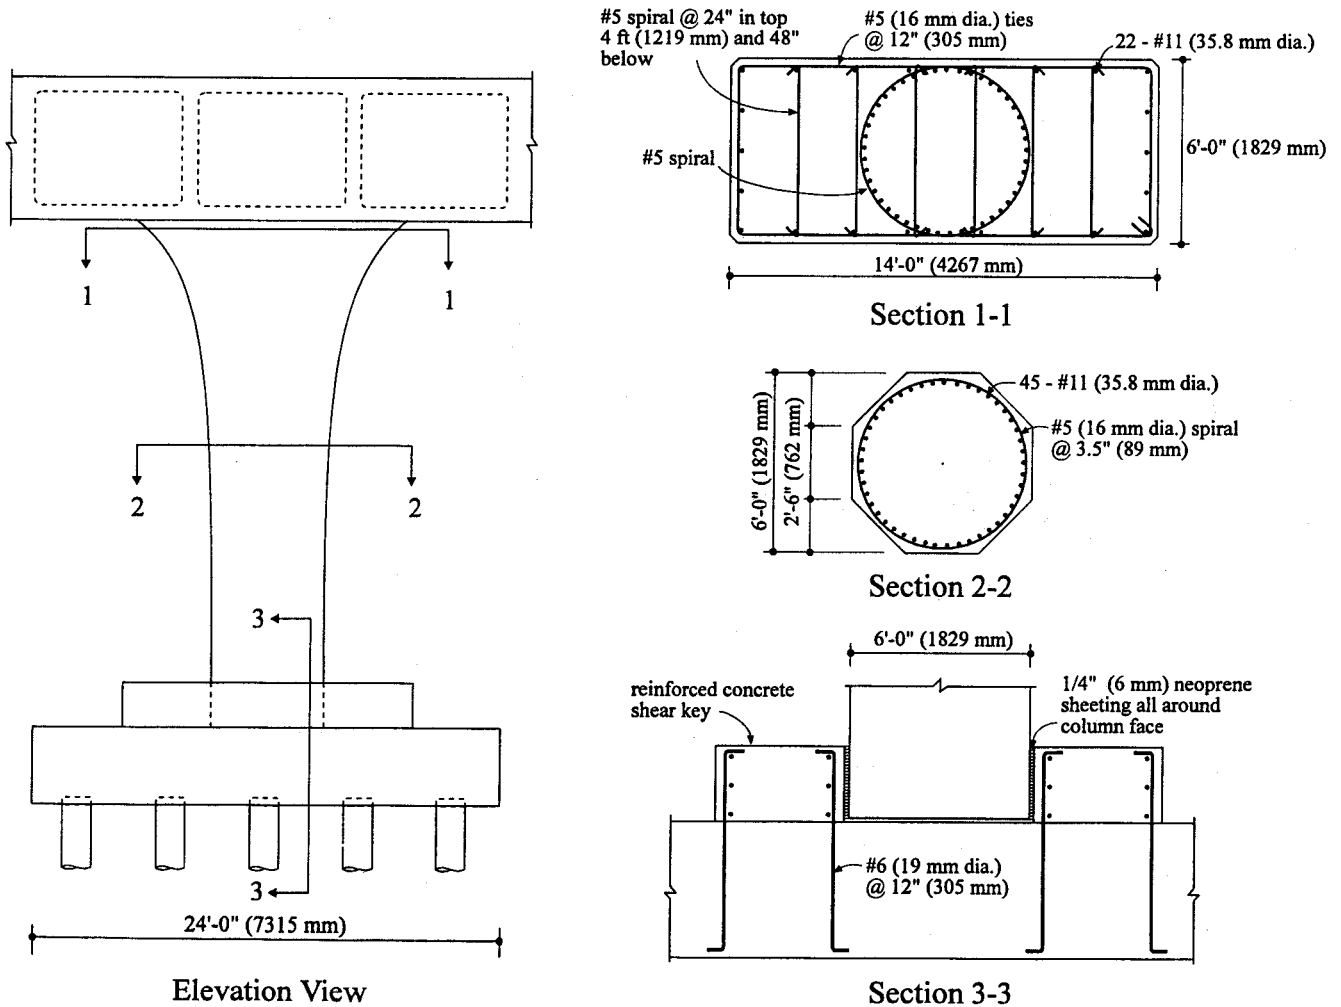
Fig. 6. Details of columns in 118/Mission-Gothic undercrossing.

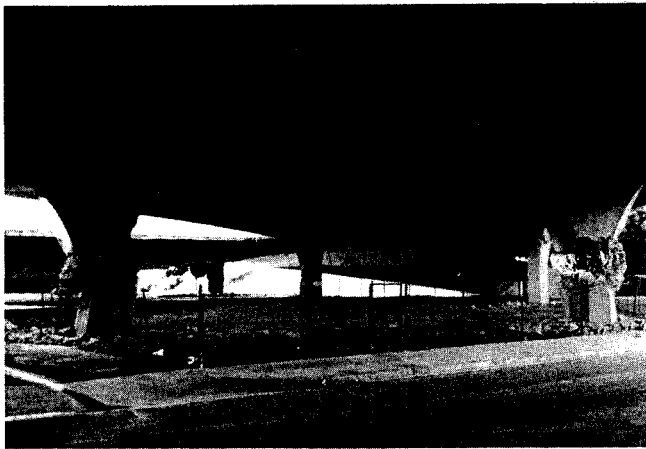
bridge comprises two structures separated by a longitudinal joint, the superstructure consisting of cast-in-place post-tensioned box girders. The twin column bents consist of 1.8 m octagonal columns with a 3.6 m long flare at their tops (see Fig. 6). The octagonal columns contain 45 #11 (35.8 mm dia.) bars confined with #5 (16 mm dia.) spiral reinforcement having a pitch of 89 mm. The bases of the columns were pinned during the post-tensioning operation and were later clamped by cast-in-place reinforced concrete collars to provide some fixity at their bases. Figures 7 and 8 show the failures that occurred in the columns in regions just below the flares. Calculations by Priestley et al. (1994) suggest that the reinforcing details were sufficient to prevent brittle shear failure prior to flexural hinging, but that shear failure occurred after flexural plastic hinging had caused a reduction in the shear capacity of the concrete and (or) fractured the spiral reinforcement. The column flares forced the plastic hinges to develop at the bottom of the flares rather than at the deck level, resulting in higher shear forces when the columns formed a mechanism. This is contrary to the design assumption which had the flair concrete spalling off and the plastic hinge located at the top of the column. The reinforced concrete shear collar failed around one column (CALTRANS 1994), resulting in large column base movements as indicated by the ground heaving and large gaps

Fig. 7. Shear failures in columns of 118/Mission-Gothic undercrossing.

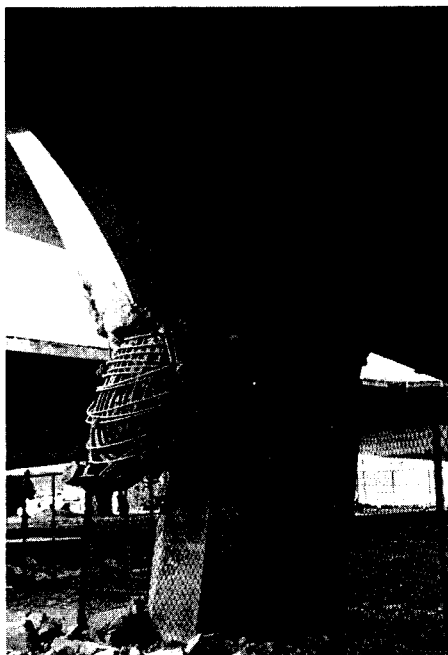
Fig. 8. Shear failure of column of 118/Mission-Gothic undercrossing.

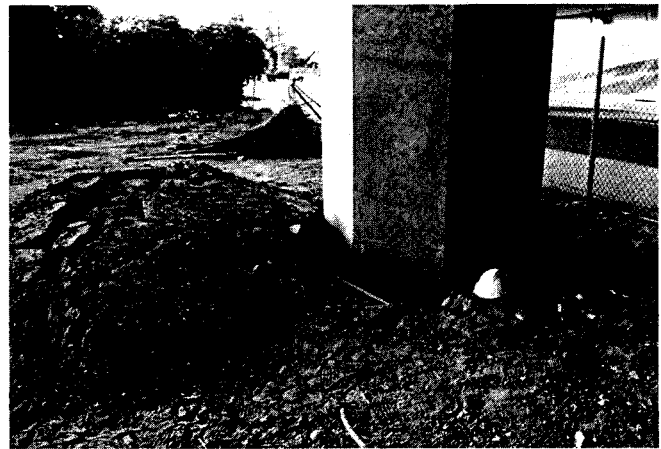
between the column and the soil (see Fig. 9). The failure of the shear collar resulted in a smaller shear being attracted to this column and may have contributed to a significant torsional eccentricity in the bridge structure.

Fig. 9. Evidence of significant movement at base of column of 118/Mission-Gothic undercrossing.

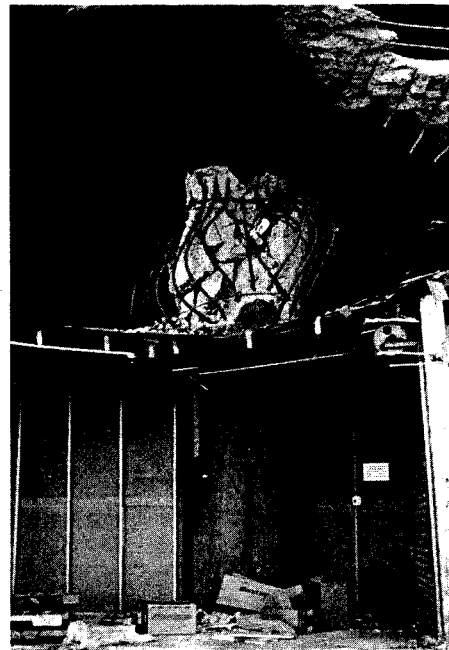
This structure on Interstate 10 (Santa Monica Freeway) which crosses La Cienega and Venice boulevards suffered severe damage to the columns. Built in 1964, it is supported by prismatic 1.2 m diameter circular columns reinforced with 12 to 48 #11 (35.8 mm dia.) bars and confined by #4 (12.7 mm dia.) hoops with 460 mm lap splices at 305 mm spacing. Some columns suffered severe damage at their tops (see Fig. 10) while others were damaged near their bases. The inadequate amounts of confinement and shear reinforcement provided by the widely spaced hoops, combined with

Fig. 10. Failure of column of I-10/Venice-La Cienega undercrossing.

failure of the lap splices of these hoops, led to the flexure-shear failure of the columns.

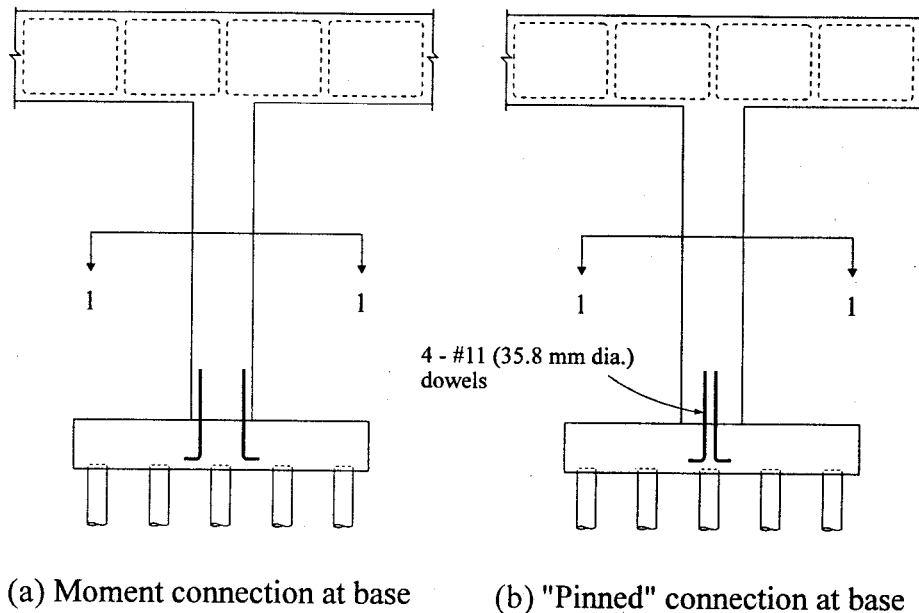
Fig. 11. Details of columns of I-10/Fairfax-Washington undercrossing.

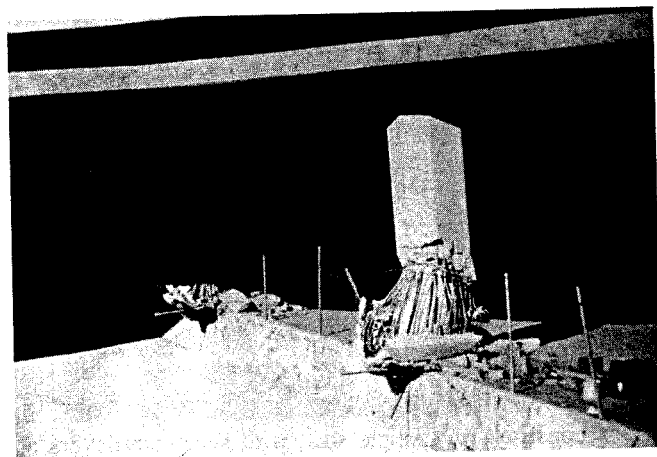
column bents consist of prismatic 1.2 m octagonal columns supported on pile footings. The vertical column bars are continuous from the bottom of the footing into the bent cap. The transverse reinforcement consists of #5 (16 mm dia.) spirals at 305 mm with a closer spacing of 75 mm over lengths of 1.2 m just above the footing and just below the connection with the superstructure. Figures 14 and 15 show the failures that occurred at the bottoms of some columns and at the tops of other columns. A typical failure at the top of a column occurred at the location where the spacing of the transverse reinforcement changed from 75 to 305 mm. The failures near the bottom of the columns were just above a culvert wall which provided some lateral restraint in the region where the spacing of the transverse reinforcement was 305 mm. These failures were flexure-shear failures with loss of confinement and buckling of the longitudinal bars.

Fig. 14. Failure of columns of 118/Bull Creek Bridge.

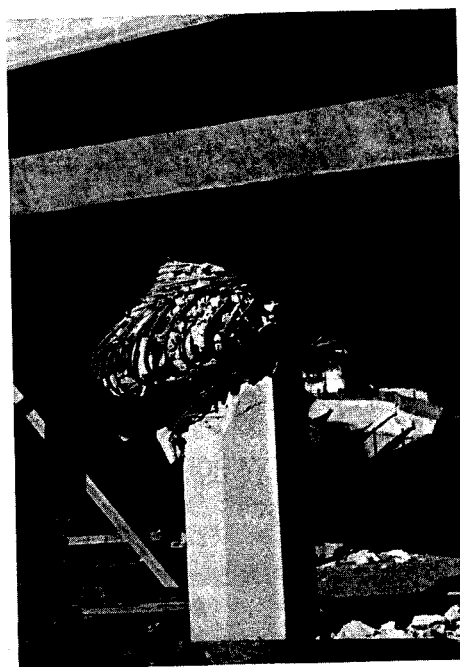
Fig. 15. Failure of columns of 118/Bull Creek Bridge.

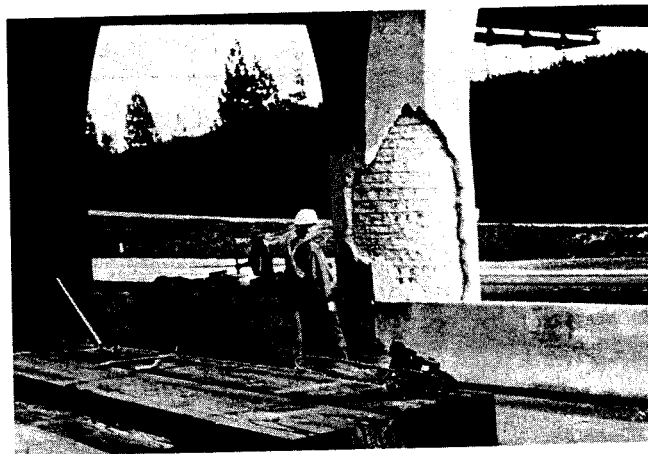
The Ruffner Avenue overcrossing is on State Route 118 and is supported by two column bents. These octagonal columns contained #14 (43 mm dia.) longitudinal bars confined with #5 (16 mm dia.) spirals having a pitch of 90 mm. Only minor damage occurred to the columns with spalling of the shell concrete below the column flare (see Fig. 16). Although this column had a smaller amount of confinement reinforcement

than that required by current design procedures, the core concrete remained intact and only minor repair would be necessary for the bridge (CALTRANS 1994).

Fig. 16. Spalling of concrete shell in column of 118/Ruffner Avenue overcrossing.

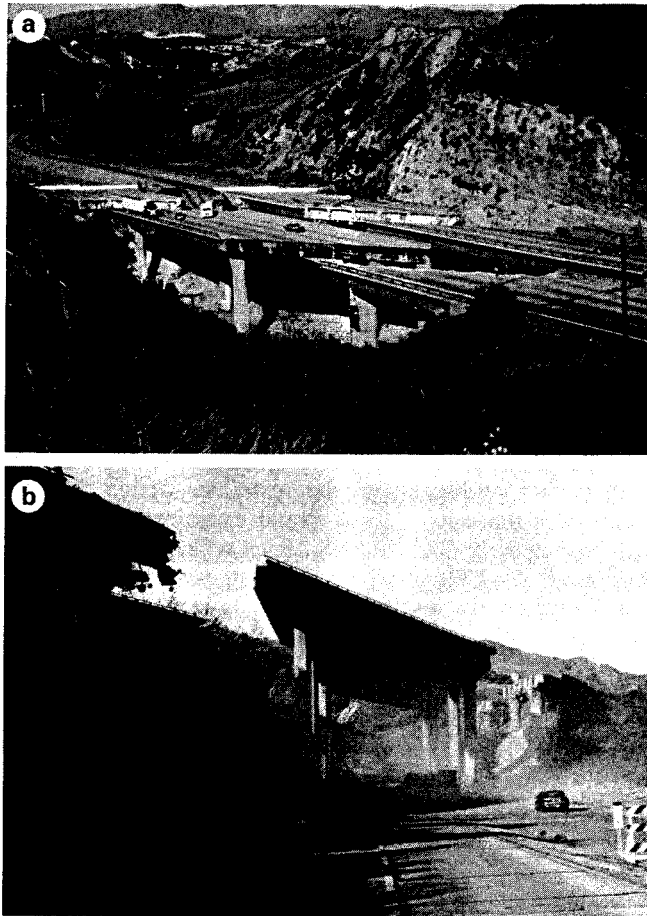
Fig. 18. Collapse of second and fourth spans of the Gavin Canyon Bridge: (a) overall view of damaged bridges; (b) view of surviving third span, dust cloud from demolition work.

During the earthquake, all but one of the second and fourth spans of both bridges collapsed owing to unseating at the expansion joints (Fig. 18). The large skew and the unsymmetric lateral load support system most likely caused large torsional movements of the deck during the earthquake, leading to relative lateral motion between the deck sections at the skew joints, and hence loss of seating. The longitudinal restrainers would have provided little resistance to this motion. The restrainers appeared to have been pulled sideways, causing ripping of the longitudinal holes, and then to have failed by punching through the end diaphragms of the suspended deck sections as they fell. Intact restrainers with bearing plates still in place could be seen hanging from the undamaged central cantilever section of deck (Figs. 19a and 19b). It would appear that the bolt restrainers pulled out of the cantilever end, as is evidenced by what looks to be freshly exposed concrete at the bolt hole locations situated above the cable restrainer holes.

Applying [1] to the Gavin Canyon bridge gives a minimum required seat width of just over 2.0 m, which is ten times the value actually provided. (Without the skew the required seat width would be 1.3 m.) Except over bents, it would not be easy to provide for such a long seat width and this may be one of the reasons that new bridges do not have as many inspan movement joints.

With regard to restrainers, it is clear that their orientation should be perpendicular to the joint if they are to provide effective resistance to unseating, especially if lateral shear keys are not provided. It is possible that the wording of the various design guidelines has caused some confusion over this point. For example, CALTRANS' Bridge Design Specifications (CALTRANS 1990) specifies that *longitudinal* restrains must be provided, and AASHTO's Standard Specifications for Seismic Design of Highway Bridges (AASHTO 1991) requires that a *longitudinal* linkage force be considered in the design process. It appears that this wording has resulted in some restrainers being designed and installed parallel to the roadway of skewed bridges rather than perpendicular to the joint. In the Gavin Canyon bridge there was not sufficient lateral room inside the cells of the box girder to core holes perpendicular to the end diaphragms, and so to retrofit the structure with perpendicular restrainers would have been very difficult. Some more recent joint retrofits by CALTRANS have used heavy pipe sections placed in holes cored through the diaphragms to provide shear restraint or to act as seat length extenders, and these may have been of help for this bridge.

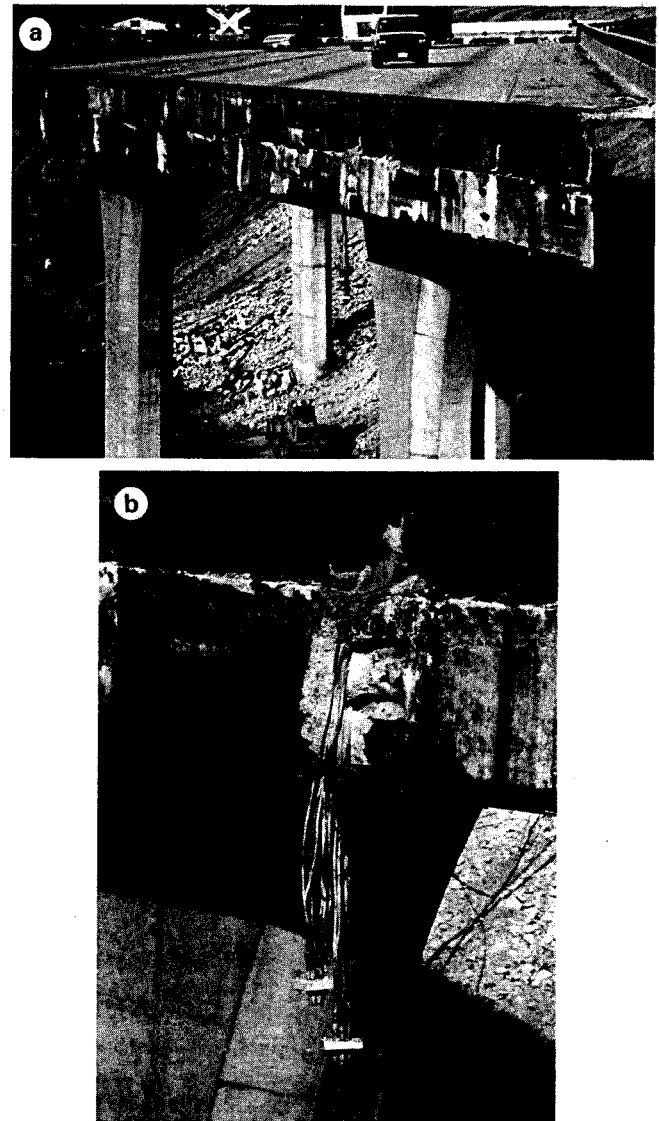
Fig. 19. Views of expansion joint face of the Gavin Canyon left bridge: (a) overall view showing five restrainer locations; (b) restrainers with failed end anchorages, note evidence of sideways pull by spalling of concrete on left side of restrainer holes.

since opening of the joints can be caused by twisting and lateral movements as well as longitudinal movement. The very large skew of this bridge made the problem particularly acute. Clearly, it would be preferable to construct highly skewed bridges without expansion joints along their length if at all possible. Where this is not possible, extra-large seat widths are needed.

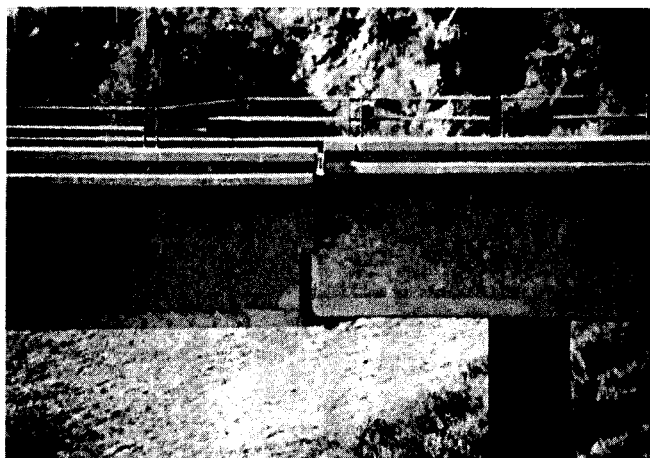
Fig. 20. I-5/14 North connector overcrossing: badly damaged expansion joint with one span bearing on approximately 50 mm of concrete.

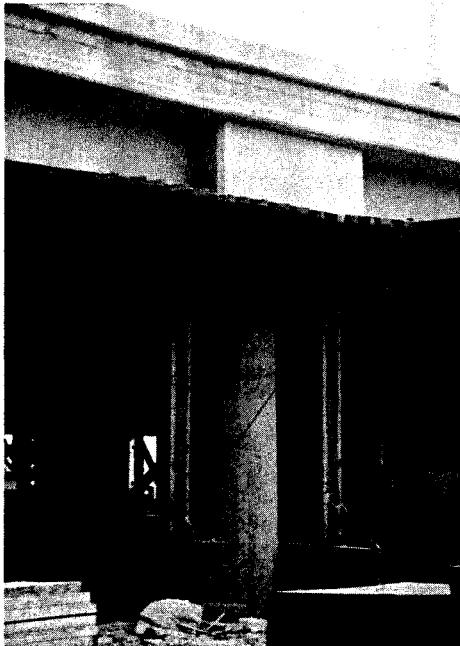
Fig. 23. I-10/Fairfax-Washington undercrossing, view of repaired deck and supporting formwork.

The Santa Monica Freeway reopened to traffic on April 12, 1994, 84 days after the Northridge earthquake. Crews worked around the clock and in all weather conditions to make reopening of this freeway possible two and a half months ahead of the June 24 deadline set to the contractor, thanks to an extraordinary \$200 000 per day bonus incentive for each day cut from that deadline. It was reported by some, but denied by others, that the contractor would collect a \$14.6 million bonus for this early completion. Considerable time was cut from the original deadline by using deck formwork capable of carrying traffic loads, as shown in Fig. 23, and by using rapid setting concrete for the deck slab.
