Performance of steel structures during the 1994 Northridge earthquake

Robert Tremblay, Peter Timler, Michel Bruneau, and André Filiatrault

Abstract: The performance of concentrically braced steel frames and moment resisting steel frames during the January 17, 1994, Northridge, California, earthquake is examined. Most of the observations made during the reconnaissance visits confirmed the current knowledge on the inelastic response of these structural systems. This permits the anticipation of proper seismic behavior for buildings designed according to the seismic provisions that have been recently introduced in the Canadian building code and standard for steel structures. In some cases, however, the observed damage raised concerns that should be addressed in future investigations or next editions of these codes. Preventing potentially hazardous nonstructural damage, avoiding premature nonductile failures anywhere along the lateral load paths, limiting structural and nonstructural damage due to brace buckling, and accounting for the vertical ground motion are among those issues.

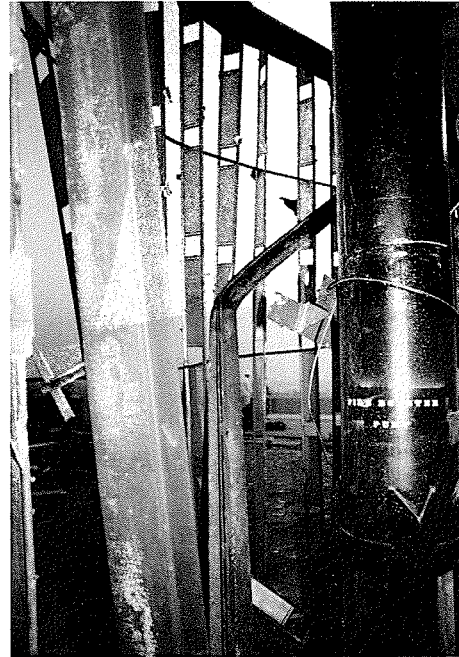
This existing hospital was a ten-storey reinforced concrete building located only a few kilometres from the Northridge epicenter. The facility suffered significant mechanical (HVAC) losses due to severe damage to a steel framed penthouse. This mechanical room was constructed from a light structural steel frame with a cast-in-place concrete roof deck incorporating double angle chevron bracing. The penthouse was severely racked in the north-south direction displaying near complete cladding loss and extreme buckling (both in-plane and out-of-plane) of the bracing system (Figs. 1 and 2).

Fig. 2. Kaiser Permanente Hospital: buckled double angle chevron bracing in penthouse.

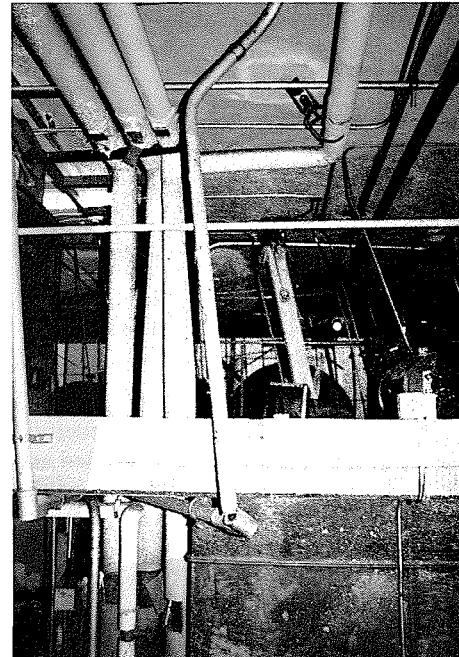
Since the electrical, plumbing, and ventilation were rigidly connected to both the roof soffit and walls, their associated systems suffered either damage or service loss resulting in the closure of the top three floors of the hospital until repairs could resume their functionality (Fig. 3). It is estimated that the hospital's capacity for patient care was reduced to approximately the 60% level as a result of mechanical penthouse failures.

Fig. 3. Kaiser Permanente Hospital: racking of services attached to penthouse roof.

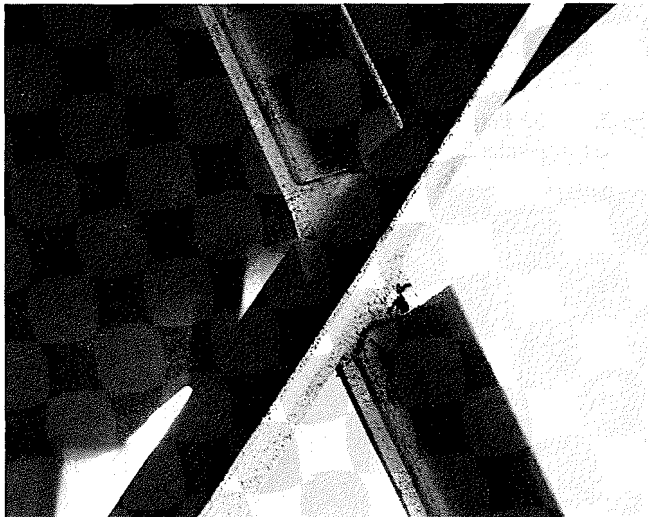
bracing members (Fig. 5). At the base of the columns of the X-braced bays, evidence of uplift could be observed, as the tiles on the ground and the stucco covering the columns were damaged (Fig. 6). This suggests that neither the anchorage nor the brace connecting plates could sustain the load that developed in the braces.

Fig. 5. First Interstate Bank Building in Northridge: buckling of connecting plate at brace intersection.

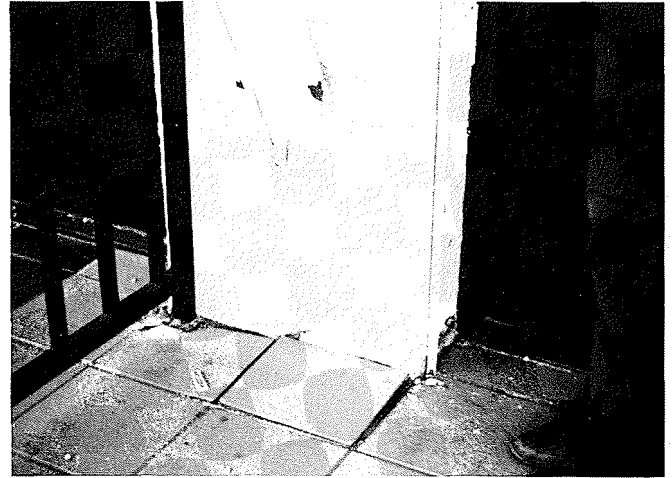
Fig. 6. First Interstate Bank Building in Northridge: column uplift at the base of the X-bracing.

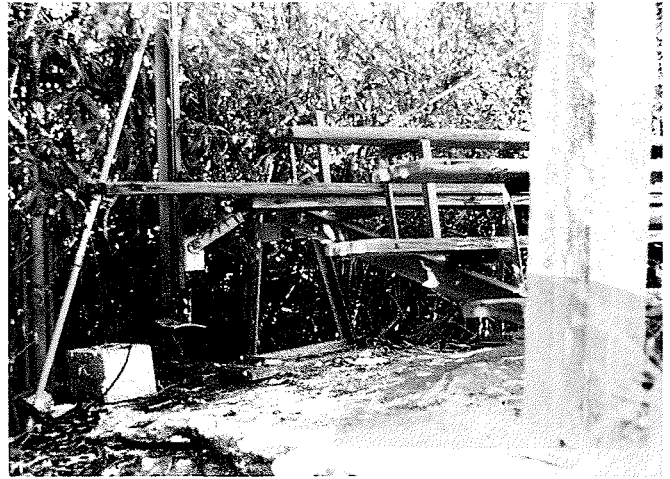
Fig. 10. Roof structure covering the bleachers of the football field at the California State University at Northridge: uplift of the back ties.

back ties during the earthquake (Fig. 10). Complete collapse of these four bays was inhibited only by the rotational restraint offered by the column base plate. The fact that anchor bolt failures occurred at the base of ties where longitudinal bracing diagonal members were attached as well as at the base of ties with no such diagonal members indicates that vertical accelerations undergone by the cantilevered roof likely contributed to the observed damage. According to the owner's representative, the structure has been dismantled after the earthquake and was to be replaced with a new one.

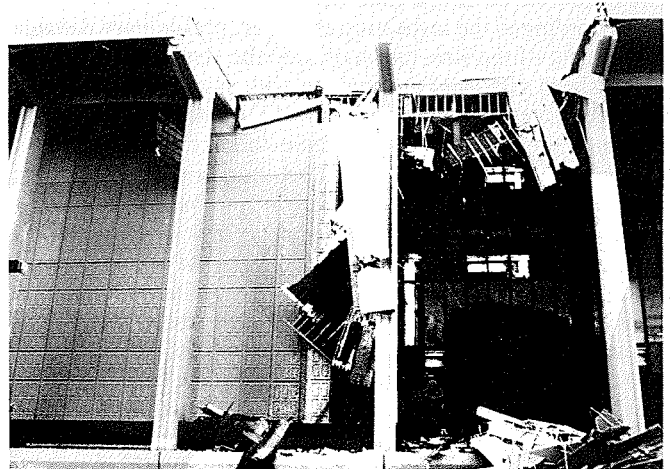
Fig. 11. Oviatt Library Building at the California State University at Northridge: failure of the overhanging roof.

This is a four-storey building including a concrete framed central part built in 1971. Two wings made of steel braced frames were added in 1991 at the east and west ends. The building had a steel framed overhanging roof along its perimeter. At two locations along the north wall, the steel beams of that projected roof running parallel to the exterior wall, and spanning across an expansion joint in the main framework, collapsed (Fig. 11). This failure has been attrib-

uted to the loss of bearing support of these beams and pounding damage due to the relative horizontal movement that took place at the expansion joints. No other structural damage could be noticed at the time of the visit.

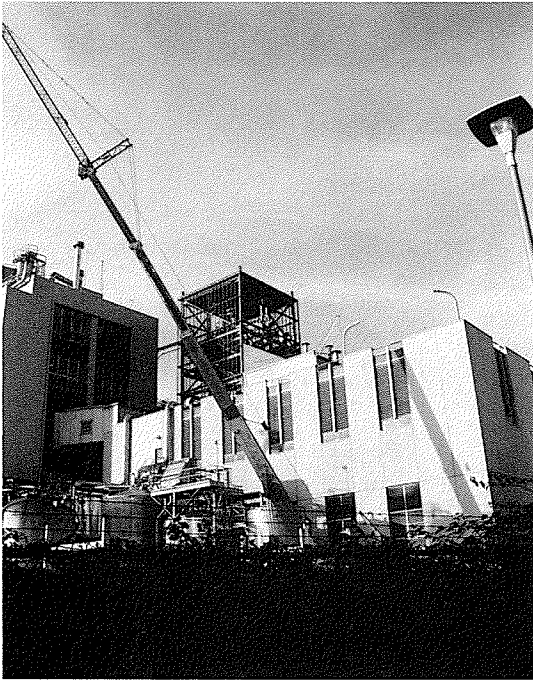
Fig. 15. No. 2 Brewhouse, Anheuser-Busch, Inc.: cladding failure on tower structure.

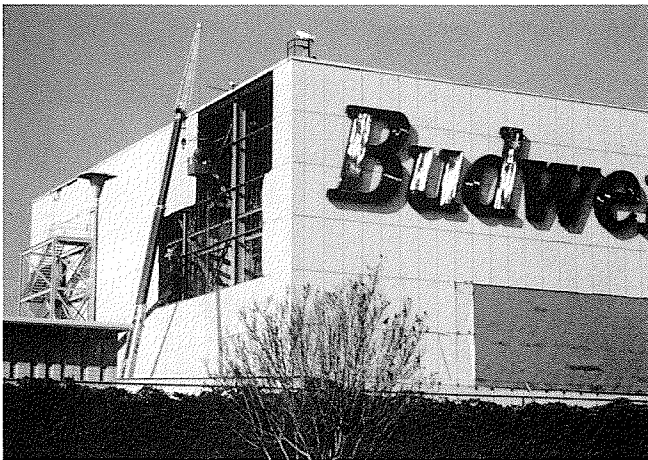
Fig. 16. No. 2 Brewhouse, Anheuser-Busch, Inc.: global view of cladding failure on warehouse.

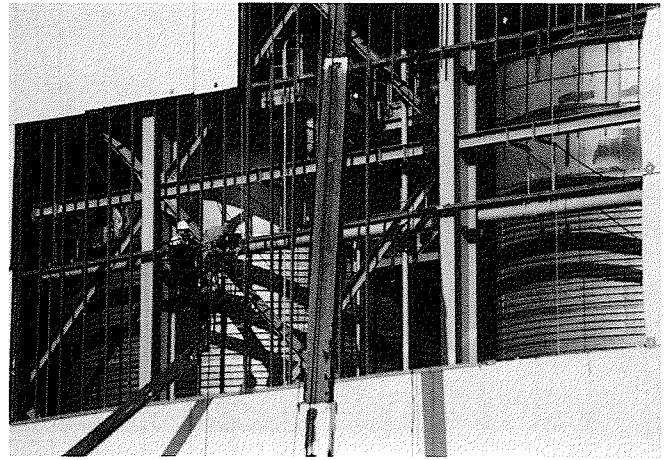
Fig. 17. No. 2 Brewhouse, Anheuser-Busch, Inc.: close-up view of cladding failure on warehouse revealing steel braced frame.

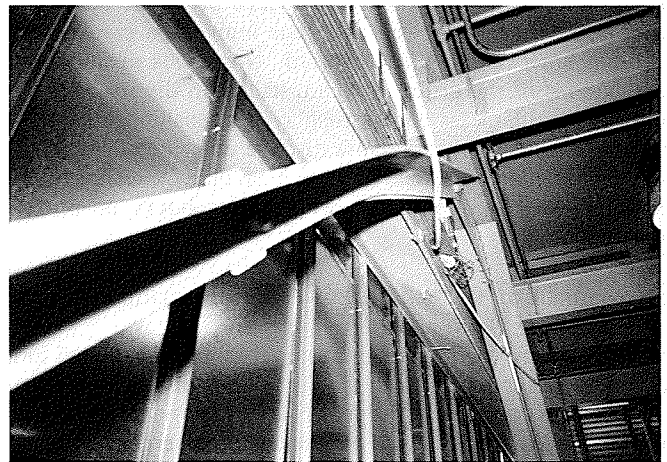
ridge epicenter. Significant shaking at the plant was experienced by personnel during the main shock and aftershocks. The No. 2 Brewhouse is a four-storey concentrically braced structure incorporating wide flange shapes as bracing members. An additional five-storey mechanical tower structure was located on the east end of the brewhouse roof. Significant cladding loss and damage occurred on the tower section of the brewhouse, and other warehouse structures located at the plant experienced similar problems (Figs. 15–17). In addition to the cladding failure, several double angle chevron bracing in the tower portion had buckled (Fig. 18).

Fig. 18. No. 2 Brewhouse, Anheuser-Busch, Inc.: buckling of double angle chevron bracing in the tower portion.

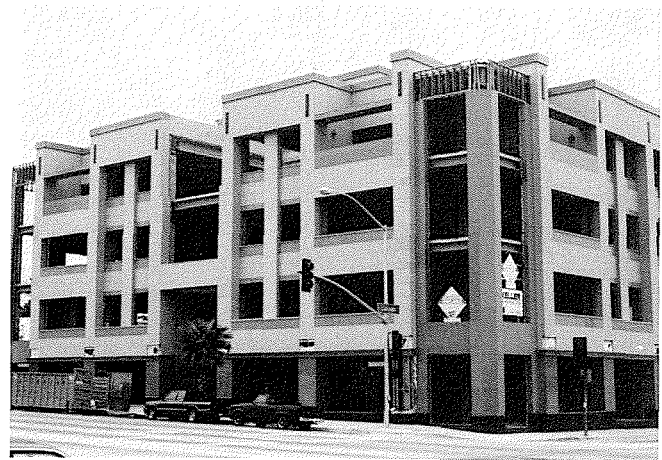
elsewhere, the contractor decided to randomly inspect a few beam-column connections by removing the fireproofing installed prior to the earthquake. Nearly all joints of the moment resisting frames located on the north side of the building were found to have severe fractures.

Fig. 39. Moment resisting frame under construction: north facade along which beam-column connections suffered cracking and fractures.

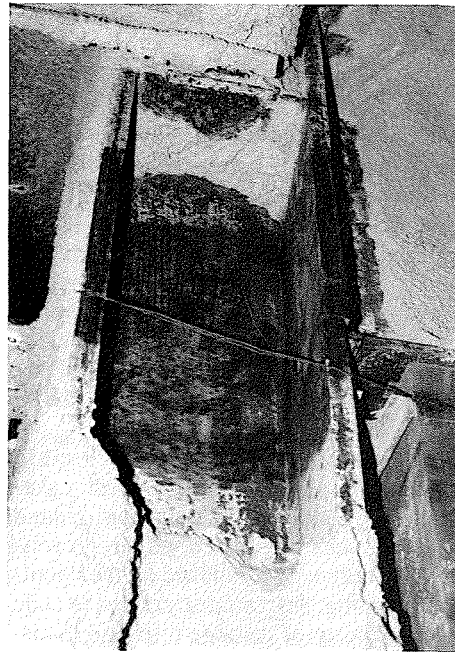
Fig. 40. Moment resisting frame under construction: typical beam-column connection damaged by column cracking and fracture at the level of the beam's lower flange weld.

the beam's lower flange, and cracking propagated into the column's web a short distance horizontally, then mostly vertically and toward the other flange weld of the same beam.

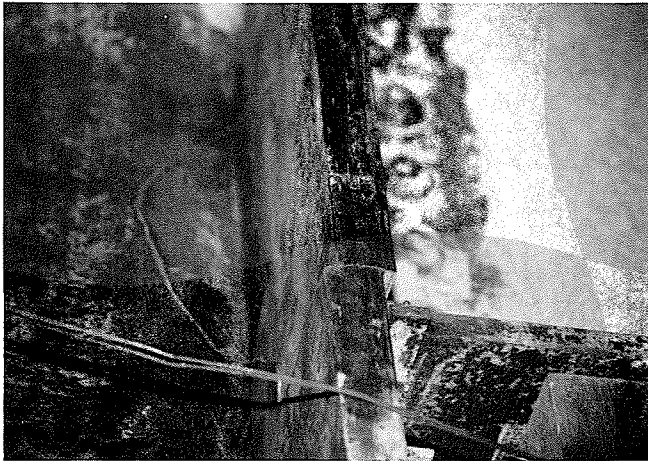
Fig. 41. Moment resisting frame under construction: close-up view of the fractured column shown in Fig. 40.

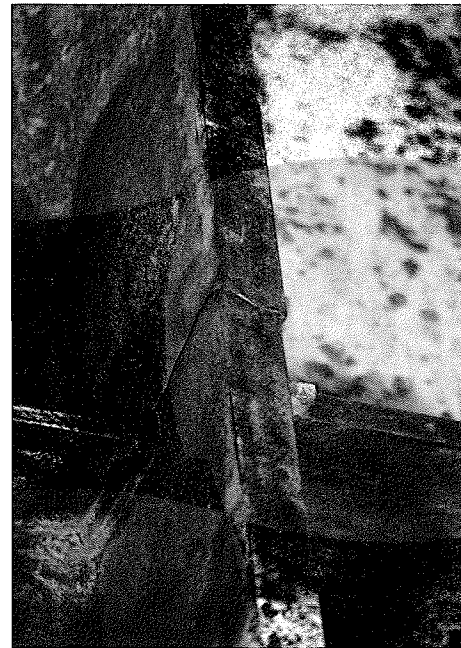
Fig. 42. Moment resisting frame under construction: close-up view of a beam-column connection damaged by column flange fracture at the level of the column web stiffener (left) and beam's lower flange (right).
