Performance of masonry structures during the 1994 Northridge (Los Angeles) earthquake

Michel Bruneau

Abstract: The surface magnitude 6.8 Northridge earthquake which struck the Los Angeles area on January 17, 1994, damaged a large number of engineered buildings, of nearly all construction types. As earthquakes of at least similar strength are expected to occur in most of eastern and western Canada, the study of the effects of this earthquake is of particular significance to Canada. This paper, as part of a concerted multi-paper reporting effort, concentrates on the damage suffered by masonry buildings during this earthquake, and explains why the various types of observed failures occurred. The seismic performance of all masonry construction similar to that commonly found in Canada is reviewed, but a particular emphasis is placed on providing an overview of damage to unreinforced masonry structures which had been rehabilitated before this earthquake. To provide a better appreciation of the impact of this earthquake on masonry buildings, and a better assessment of the engineering significance of their damage in a Canadian perspective, this paper first reviews the evolution of buildi

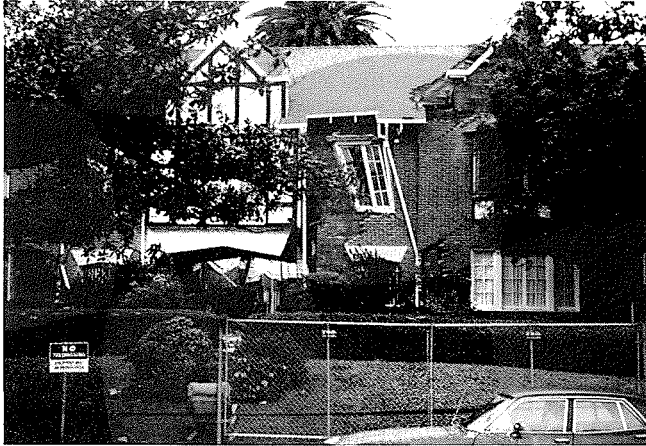
Fig. 1. In-plane damage to nonstructural masonry veneer, Ye Old San Vicente Apartments, Santa Monica.

Many wood-frame residential constructions having architectural masonry finishes and veneers suffered considerable damage during this Northridge earthquake. Generally, poor connection and flexibility mismatch between the wood framework and masonry typically resulted in severe damage to the nonstructural masonry. In cases of continuous veneers, as in some types of residential construction, the veneer itself can attract a considerable portion of the seismic force, depending on the relative rigidities of the masonry and wood walls. Even when the veneer is poorly connected to the structure, it may be engaged into a joint seismic-response mode by setbacks, irregular floor plans, and other geometric features. Such veneers may subsequently experience severe in-plane failure, as shown in Fig. 1.

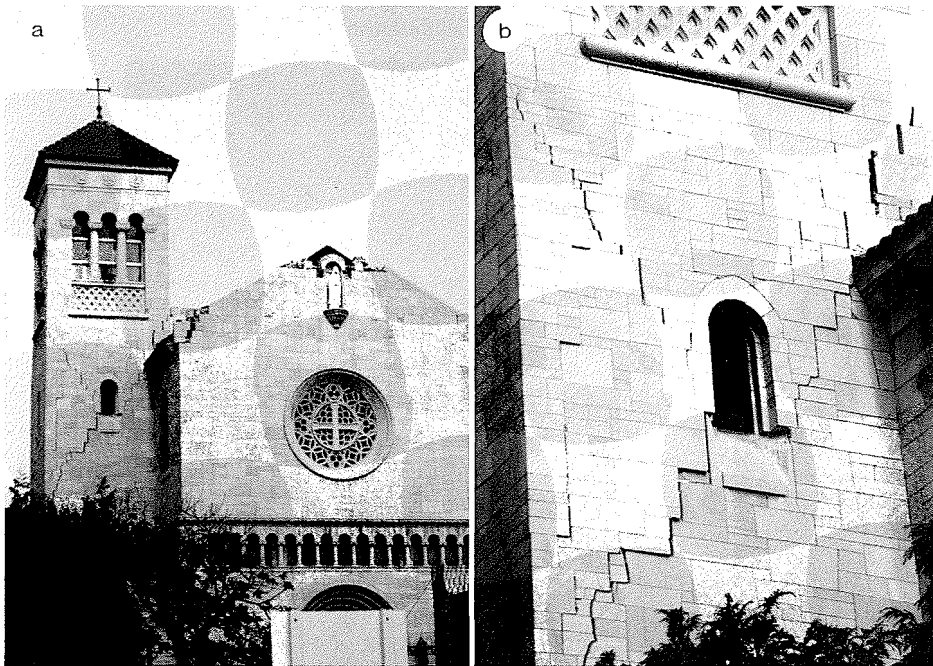
Equally dramatic in-plane X-cracking is visible on the spire of the First Catholic Church of Santa Monica (Fig. 2). Although accidentally initially identified as an unreinforced masonry building by the City of Santa Monica when issuing notices of substandard and potentially hazardous buildings, a structural engineering investigation later revealed this church to be a reinforced concrete structure clad with special Arizona limestone blocks "interlocked" together. Severe cracking of the masonry veneer also occurred elsewhere throughout the church, and out-of-plane failure of one loadbearing unreinforced masonry wall also occurred. Even though the visible damage suggests an unreinforced masonry tower in a state of eminent collapse, the structural integrity of this tower has actually not been affected by this earthquake. In fact, somewhat similar but milder damage was suffered by the tower during the 1987 Richter magnitude 5.9 Whittier earthquake epicentered approximately 35 km east of Santa Monica. This severely cracked masonry veneer had been restored then, and was undergoing repairs anew at the time of this writing. However, without an engineered solution properly considering the relative rigidities of the veneer and structural system, similar damage in future earthquakes is likely to recur.

Fig. 2. Damage to nonstructural Arizona limestone cladding of First Catholic Church of Santa Monica: (a) overall view of facade; (b) closeup view of X-type shear-cracking cladding damage of tower.

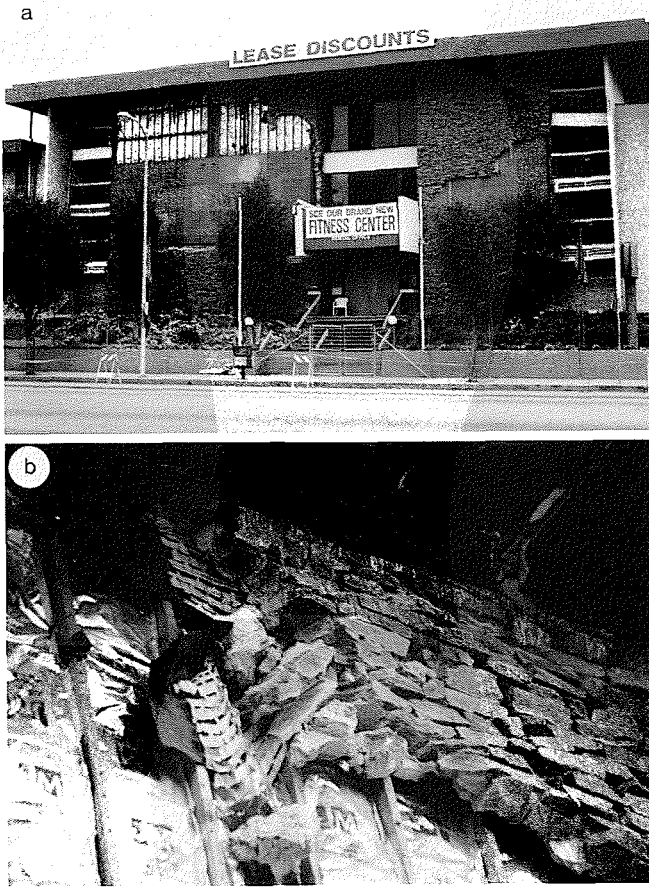
Many slender anchored veneers improperly connected to their backup structure have failed in an out-of-plane direction (e.g., Fig. 3; see also TMS 1994). The 1991 edition of the

Fig. 3. Out-of-plane failure of nonstructural stone veneer of building near Woodman and Ventura avenues, Sherman Oaks, San Fernando Valley: (a) overall view of damage; (b) closeup view of failed veneer.

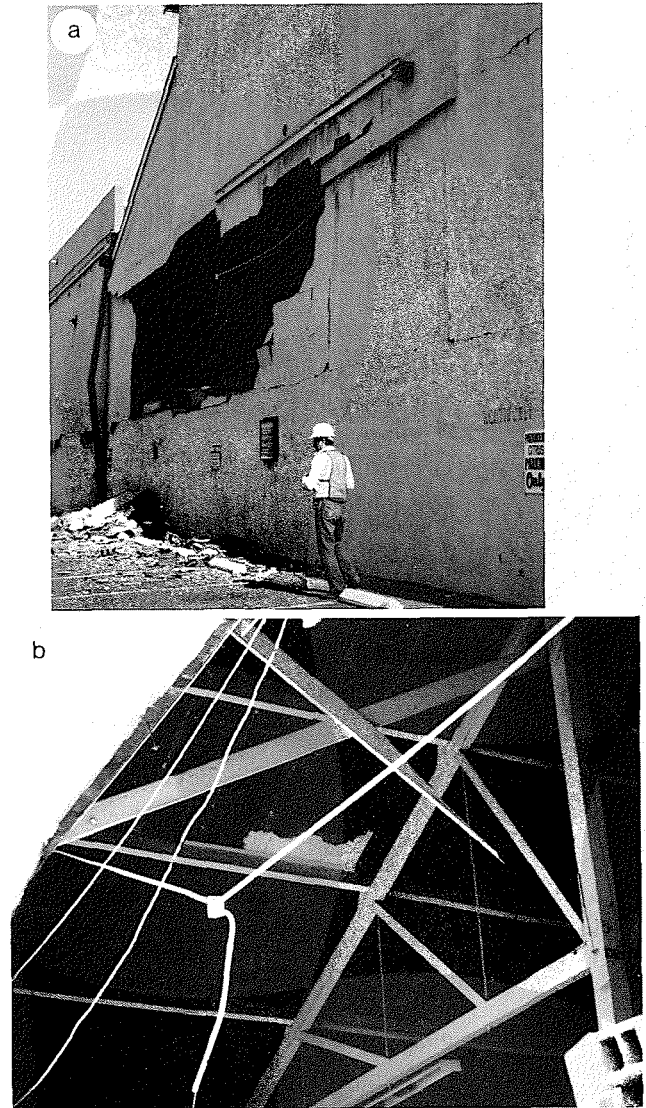
Failures of some hollow clay-tile nonstructural infills or partitions, not reinforced and not properly tied to their structure, also occurred during the Northridge earthquake. Typically, during earthquakes, such infills separate from the swaying buildings, and are vulnerable to out-of-plane failure. Examples of this unsatisfactory behaviour are shown in Figs. 4 and 5.

Fig. 4. Hollow clay-tile masonry infill failure, Paramount Citrus building, Mission Hills, San Fernando Valley: (a) overall view of infill separation and out-of-plane failure; (b) failure of timber bracing tying unreinforced masonry wall at the out-of-plane failure location.

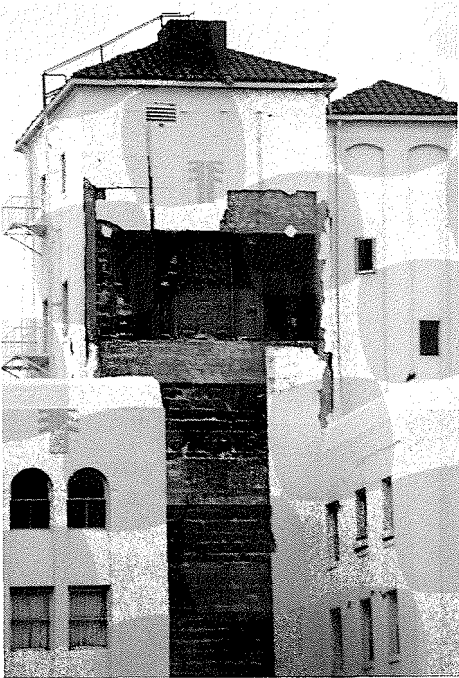
Fig. 5. Failure of hollow clay-tile masonry infill in reinforced concrete frame, Appian Way, Santa Monica.

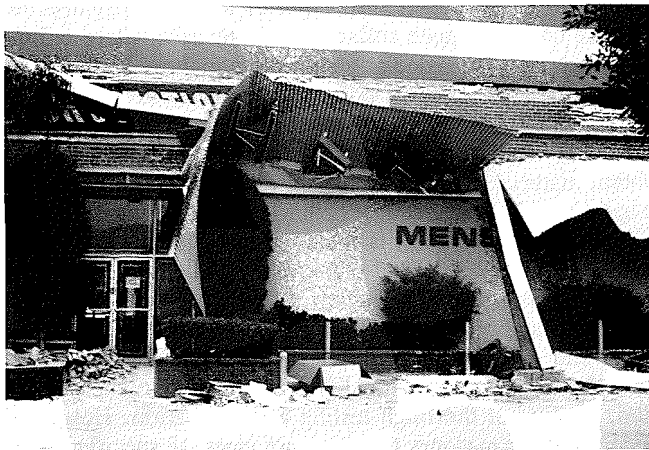
As is usually the case, out-of-plane failures were numerous. These pose a severe life-safety hazard, but fortunately, nobody died from falling masonry during the Northridge earthquake as it struck at 4:30 a.m., a time when people are away from the downtown cores where unreinforced masonry buildings are usually located. For example, a minor out-of-plane failure, such as the parapet failure on the alley side and back of Henshey's Men Shop in downtown Santa Monica, could have killed or maimed many as part of the debris and loose masonry fell across the store's main entrance (Fig. 6).

Fig. 6. Parapet failure, Henshey's Men Clothing Shop, Santa Monica Boulevard, Santa Monica.

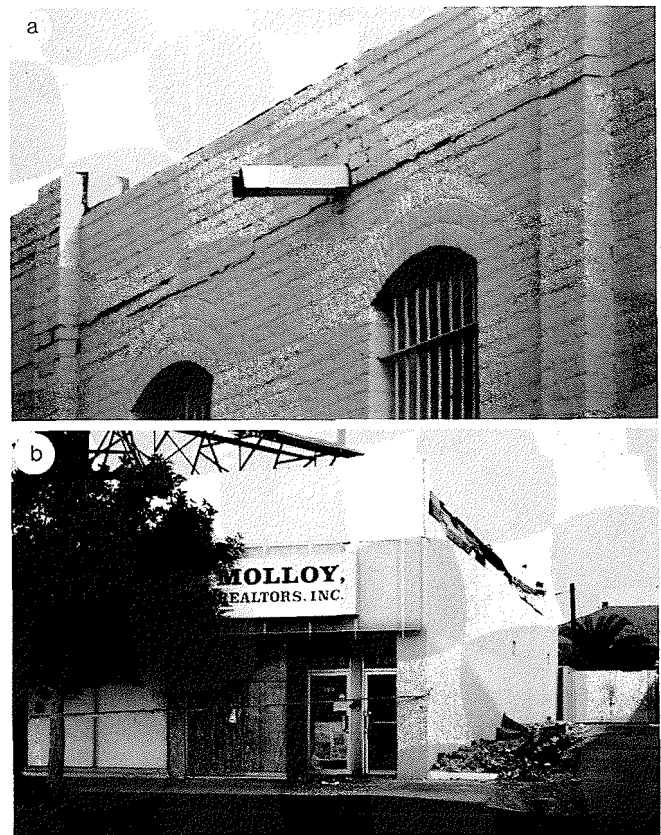
Parapets behave as cantilevers protruding from the roof level, cracking at that level and rocking over the cracked plane until a sufficiently strong jolt overturns them completely. Figure 7 illustrates this particular behaviour well in a building for which the east parapet has completely failed while the west parapet coincidentally only cracked and rocked in a stable manner without collapsing. The mechanisms of out-of-plane rocking and dynamic stability are discussed elsewhere (Bruneau 1994b).

Fig. 7. Out-of-plane parapet failures in unreinforced masonry building, near Santa Monica Boulevard and Lincoln Avenue: (a) visual evidence of west wall parapet cracking and rocking at roof level; (b) collapsed east wall parapet.

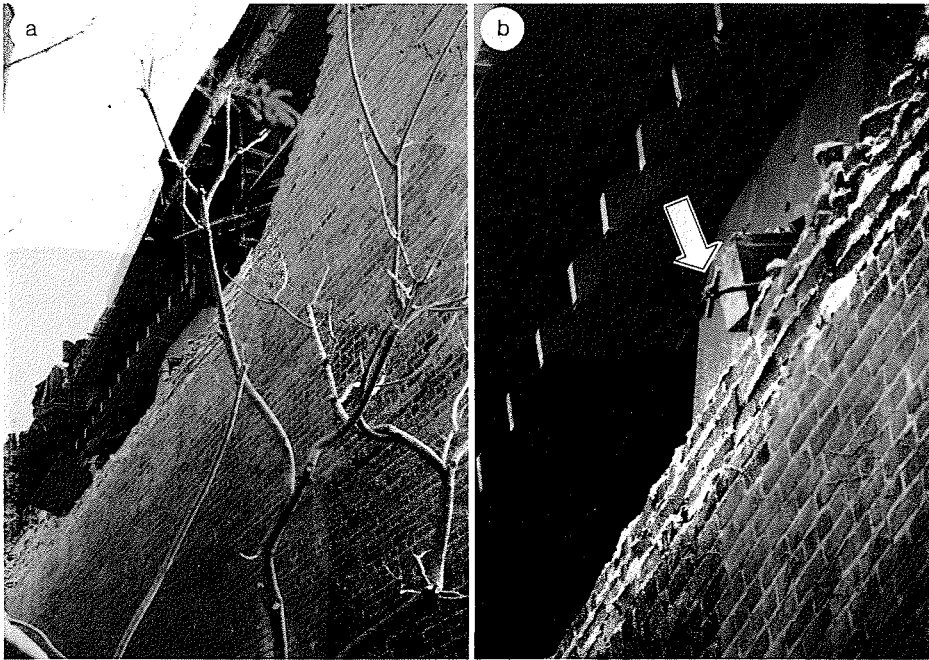
A closer inspection of buildings that have suffered out-of-plane wall failures revealed that, in many instances, some anchors were present in the walls that failed. A frequently encountered type of archaic anchor, known in California as government anchors, is shown in Fig. 8. Clearly, these existing anchors provided insufficient restraint against the seismically induced forces, and masonry walls ruptured around the anchors. This is not surprising as government anchors, like many other types of old anchors, have never been designed

Fig. 8. Collapsed unreinforced masonry north wall of First Christian Church of Santa Monica: (a) global view of out-of-plane failure; (b) closeup view of ineffective government anchor.

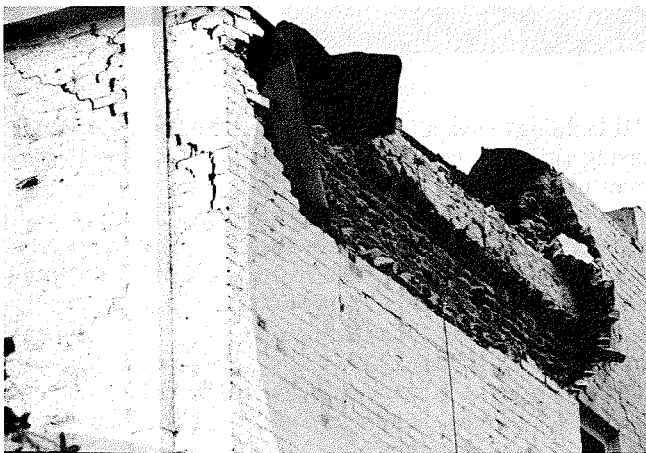
or intended to provide earthquake resistance. Exterior wythes of multi-wythe walls also failed in an out-of-plane manner because of inadequacy (or sometimes absence) of the collar joint. In such a case, each wythe could behave as an individual slender one-wythe wall wherever the collar joint is deficient, and risks failure as shown in Fig. 9. It is noteworthy that header units, generally used in pre-1933 Californian unreinforced masonry constructions to provide connection between the wythes of multi-wythe walls, did not alone provide a sufficient mechanical connection between the wythes.

Fig. 9. Out-of-plane failure of exterior wythe of multi-wythe walls having poor-quality collar joint, near 4th Street and Santa Monica Boulevard, Santa Monica.

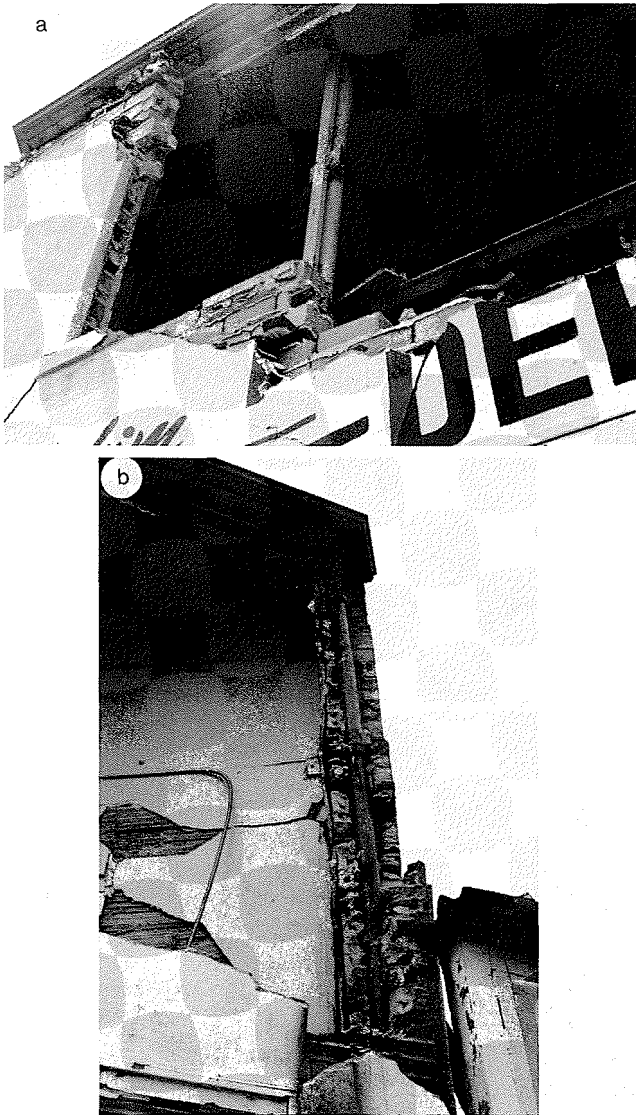
Although the majority of unreinforced masonry buildings damaged during this earthquake were in good condition, and of archaic but competent construction, a few obviously displayed extremely poor quality construction. Out-of-plane failure of such a shoddily constructed wall, where bricks and blocks have been used interchangeably without any systematic pattern and where both the head and collar joints are missing throughout, is shown in Fig. 10. In that example, the roof drainpipes embedded in the walls created additional weaknesses which helped precipitate failure.

Fig. 10. Example of extreme poor quality unreinforced masonry wall construction, Lankershim Boulevard, North Hollywood: (a) irregular use of bricks and blocks, and missing head and collar joints; (b) embedded roof drainpipe weakening out-of-plane resistance.

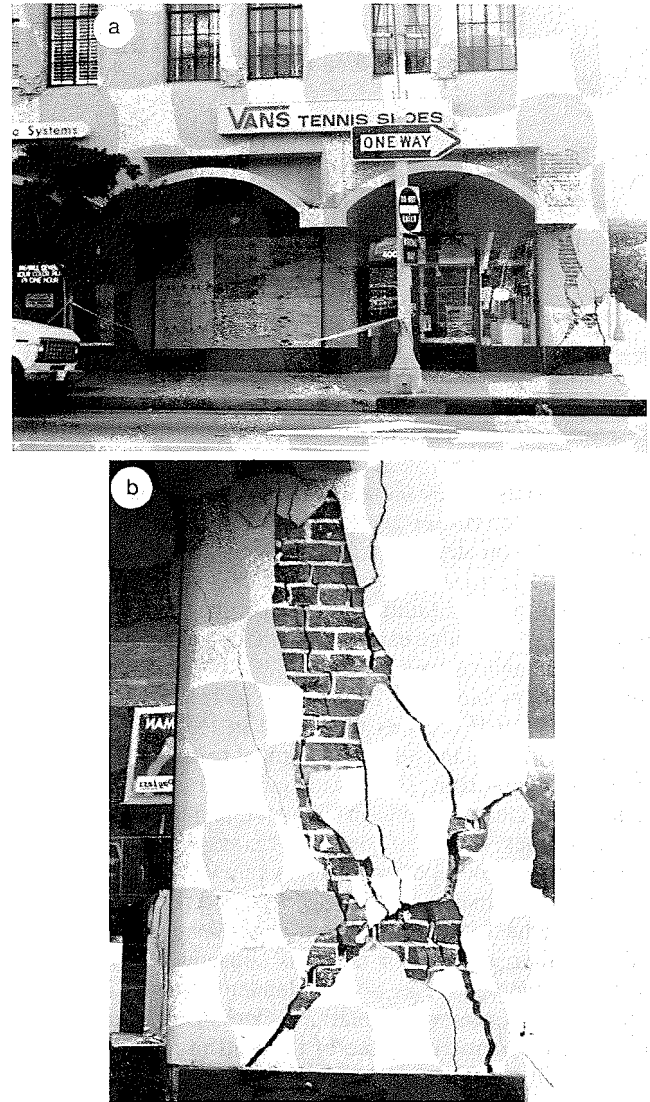
Numerous in-plane failures of unreinforced masonry piers and walls also occurred. For example, the 400 Broadway building, in Santa Monica, suffered severe in-plane shear failure of many piers, including the corner piers (Fig. 11)

Fig. 11. Severe in-plane shear failure of unreinforced masonry pier, Broadway and 4th Street, Santa Monica: (a) global view; (b) closeup view of seismically induced X-type shear cracking.

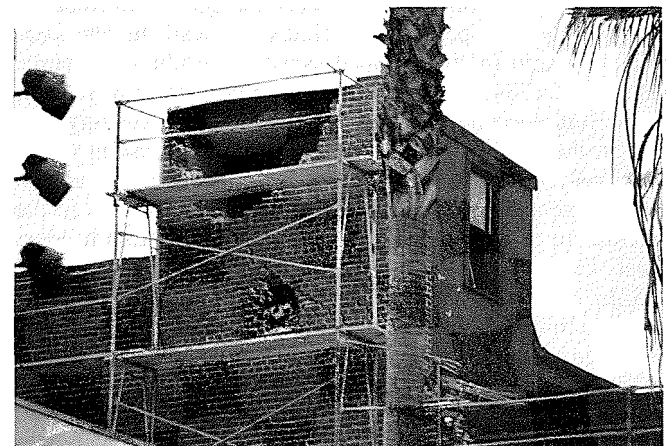
which exhibited seismically induced X-type cracks in both orthogonal directions. Finally, some cases of apparent combined in-plane and out-of-plane failures were observed (e.g., Fig. 12).

Fig. 12. Example of combined in-plane and out-of-plane failures, 3rd Street, Santa Monica.

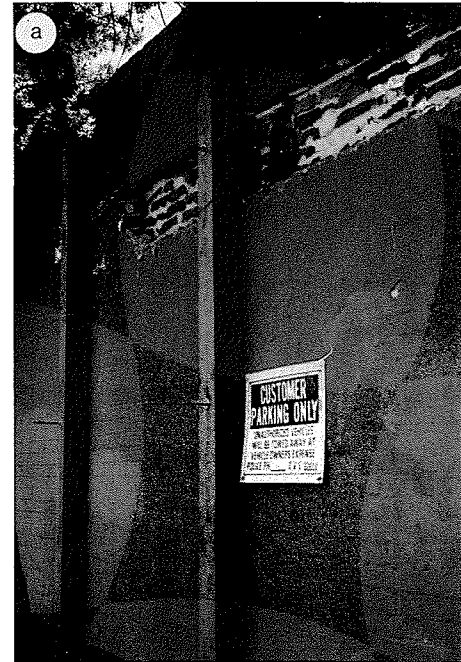
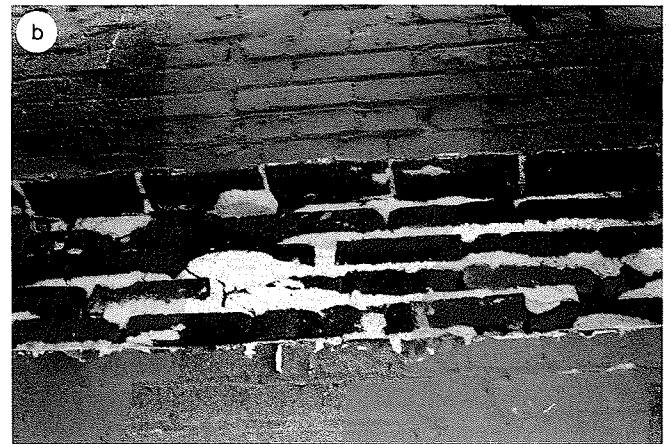
Fig. 14. Local out-of-plane failure of outer wythe of masonry walls of a retrofitted building on Washington Boulevard, Culver City: (a) view of wall, stabilized after the earthquake; (b) close-up revealing localized poor quality of workmanship in interior wythe of a three-wythe thick wall, particularly absence of collar joint where failure occurred.

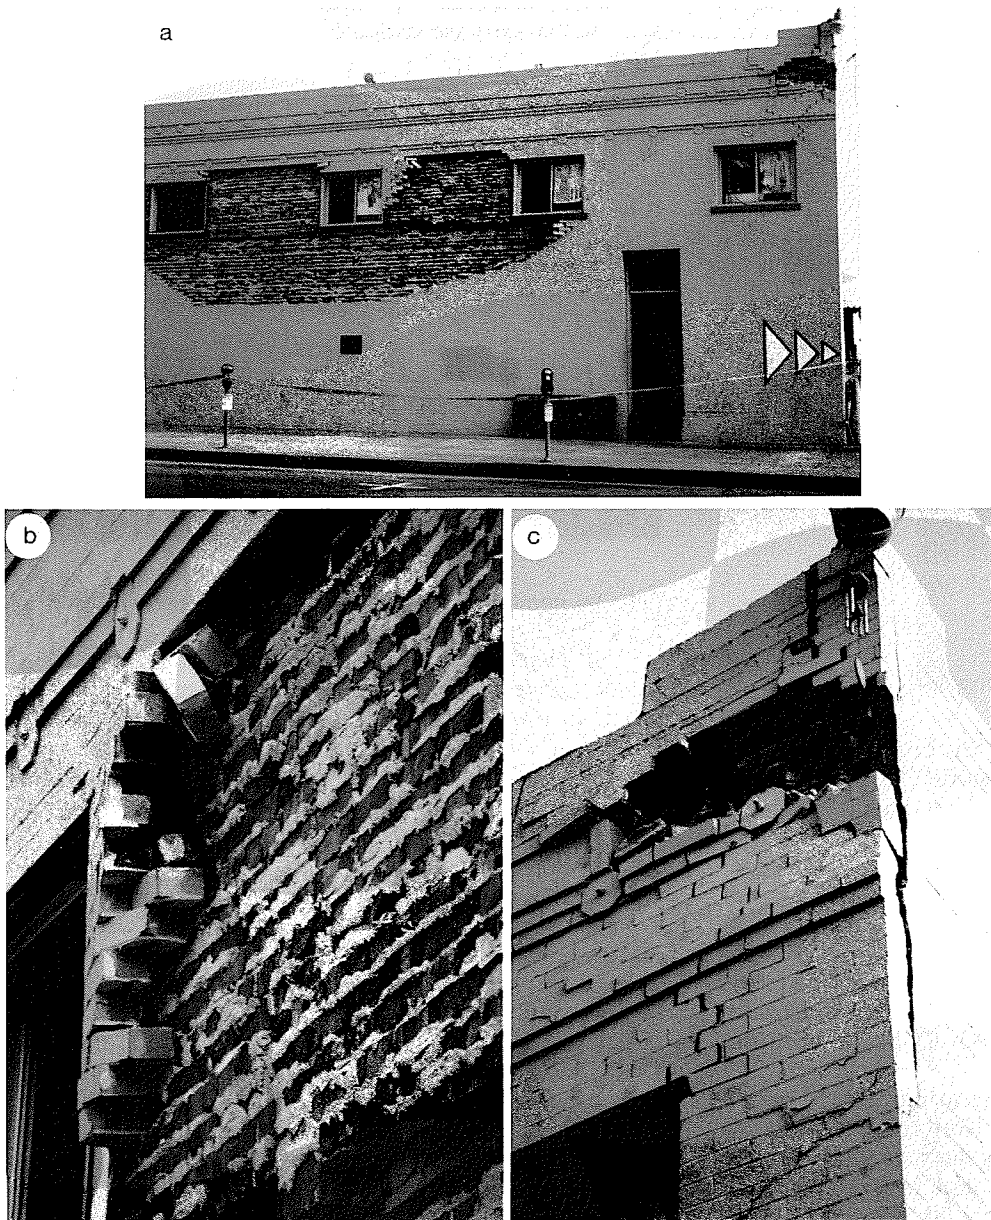
Fig. 15. Localized veneer failure on west wall and southwest corner of a retrofitted building which survived the Northridge earthquake without structural damage, Santa Monica Boulevard: (a) global view of peeled veneer; (b) closeup view of veneer failure and poor collar joint; (c) damage to corner.

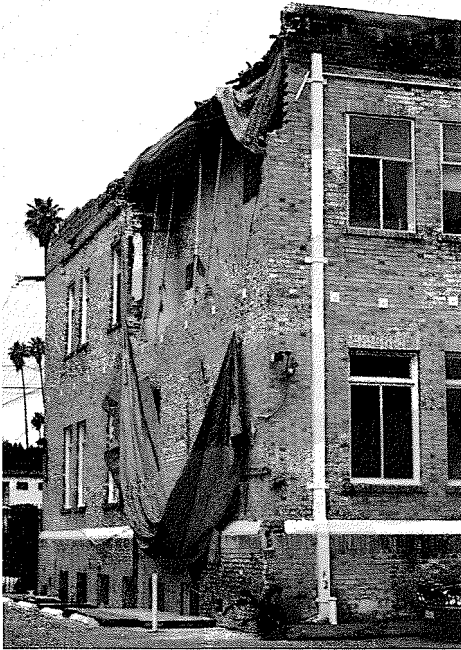
Fig. 16. Out-of-plane failure of top-story two-wythe brick unreinforced masonry wall and one-wythe veneer of a retrofitted building in Hollywood, due to excessive height-to-width ratio.

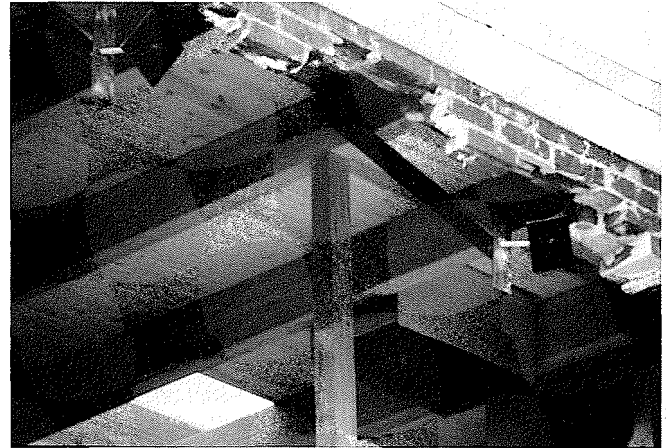
Fig. 17. Intermediate brace exposed by out-of-plane failure of unreinforced masonry wall of a retrofitted building on Santa Monica Boulevard and 4th Street, Santa Monica; vertical wood support visible under the diaphragm brace-end anchorage, and absence of effective vertical steel member along wall to carry the vertical force component of the steel brace.

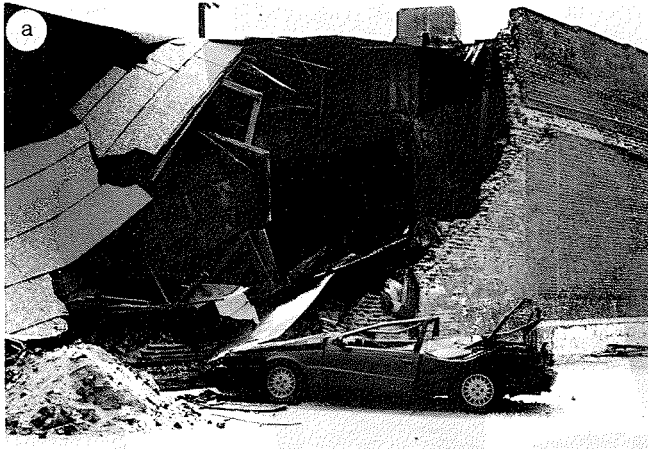
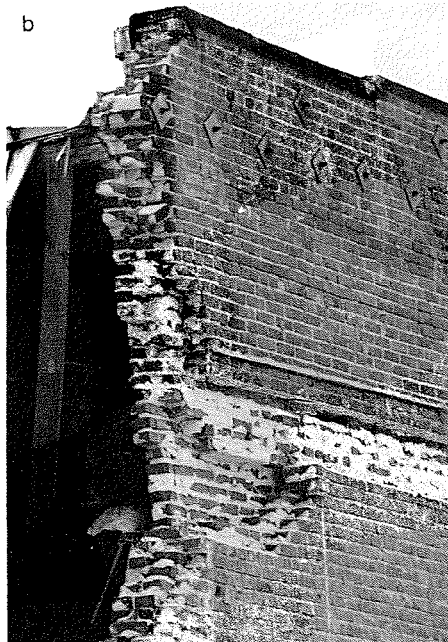
Fig. 18. Out-of-plane wall failure due to unbraced ceilings battering the walls, and inadequate anchorage from intermediate braces at ceiling level, for retrofitted building on Lankershim Boulevard, in North Hollywood: (a) global view of failed wall; (b) closeup view of roof anchorage and wall construction.

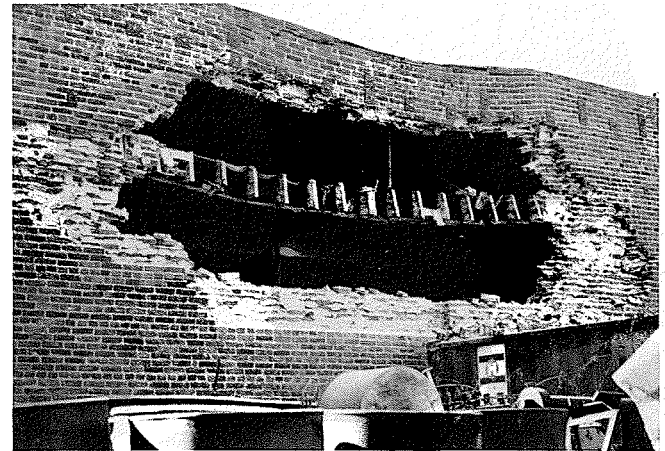
Fig. 19. Out-of-plane wall failure due to ineffective intermediate braces and battering action of unbraced ceilings, for retrofitted building located on Washington Street, Culver City.

Another example of this undesirable behaviour is shown in Fig. 19. Again, the original government anchors and newer intermediate braces, visible at 2.25 m (7.5 ft) spacing at the ceiling level, proved ineffective against the battering action of the ceiling on this 330 mm (13 in.) wall. It is noteworthy that maximum spacing of intermediate braces is restricted to 1.8 m (6 ft) by the UCBC (Section A110.(e).3.), or 6 wall thicknesses by the CGSEEB (Clause A6). Moreover, the anchor plates of the intermediate braces visibly have approximately only 70% of the minimum area of 20 000 mm² (30 in.²) required by the UCBC (Section A110.(a).2.) and CGSEEB (Clause A7) for tension anchors in walls at least three-wythe thick.

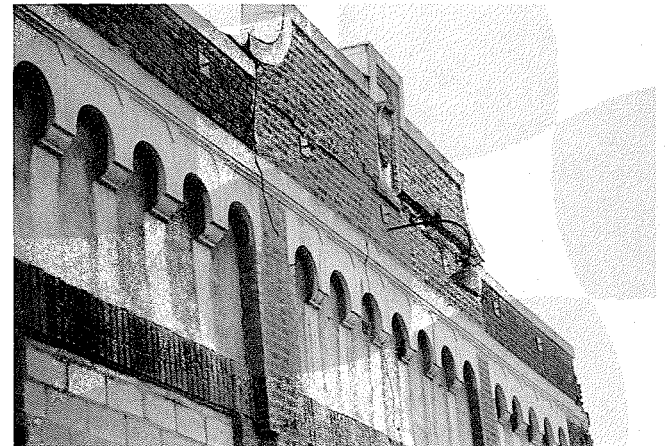
Fig. 20. Out-of-plane failure and near collapse of the central taller portion of a parapet, due to an incomplete retrofit, Washington Street, Culver City.

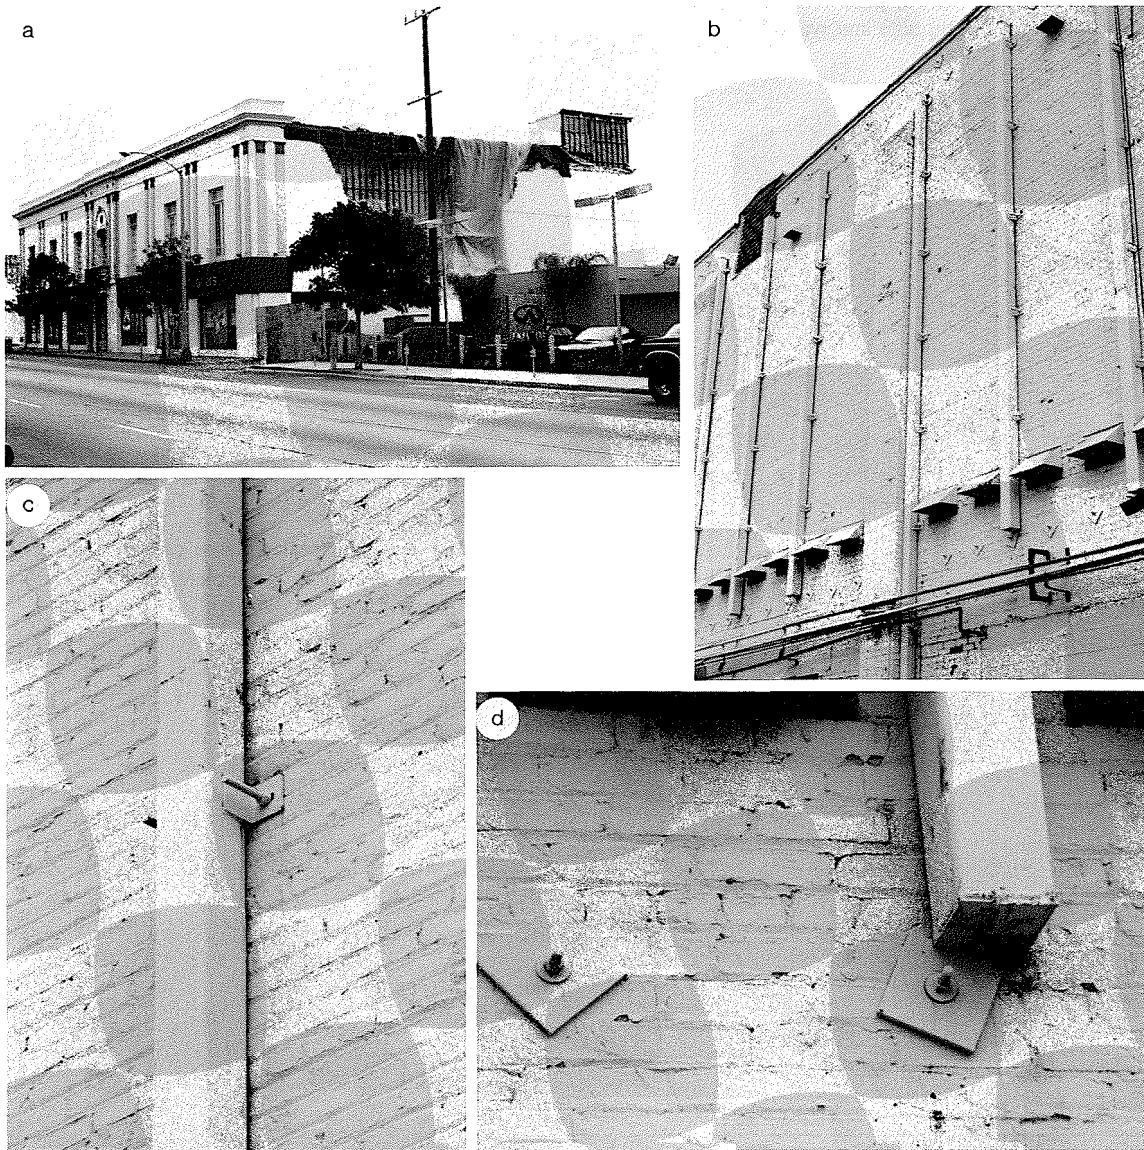
Fig. 21. Santa Monica Masonic Temple: (a) out-of-plane failure of slender unreinforced masonry west walls with excessive height-to-thickness ratio; (b) undamaged south wall retrofitted with vertical bracing members; (c) closeup view of typical brace intermediate anchors; (d) closeup view of typical brace base detail.

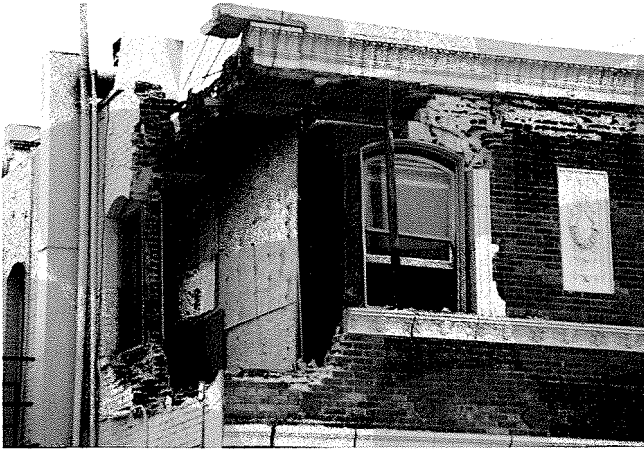
Fig. 22. Severe corner damage in retrofitted building: collapsed corner wall L-shaped in plan, Hollywood Boulevard, Hollywood.

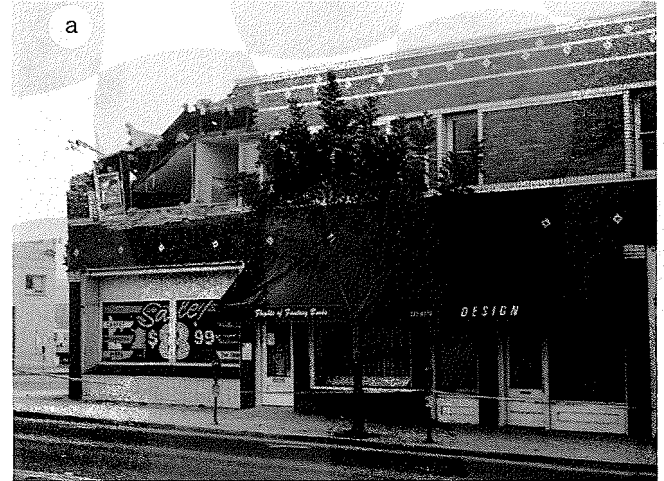
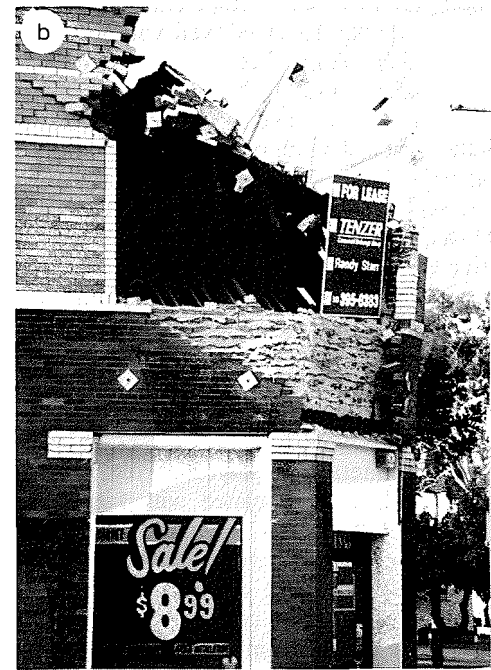
Fig. 23. Severe corner damage in retrofitted building: collapsed small piers which were located between openings and seismically excited along both of the building's principal directions, Santa Monica Boulevard, Santa Monica: (a) global view of east corner of building; (b) closeup view of corner damage, including veneer damage.

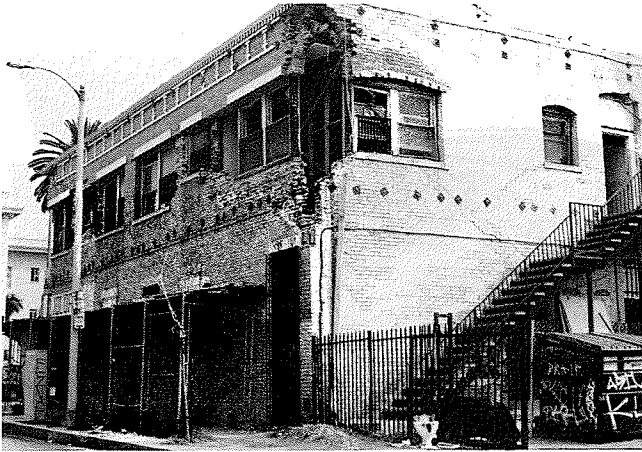
Fig. 24. Severe corner damage in retrofitted building; collapsed small pier which was located between openings and seismically excited along both of the building's principal directions, Hollywood Boulevard, Hollywood.

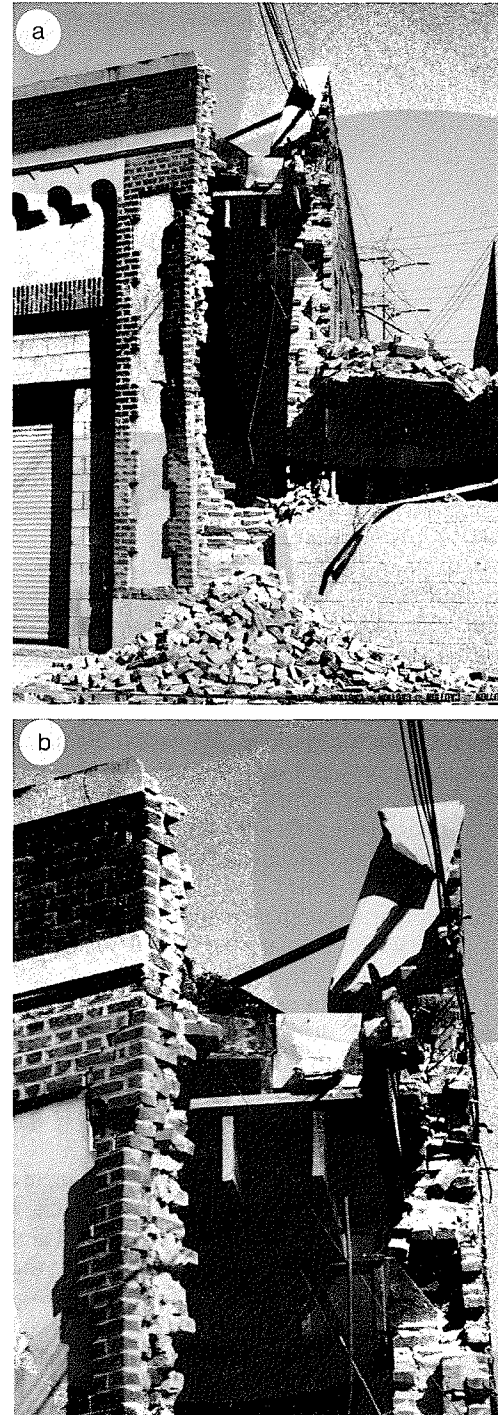
Fig. 25. Severe corner damage in retrofitted building at the acute corner of walls meeting nonorthogonally, Washington Street, Culver City: (a) global view; (b) close-up at roof level.

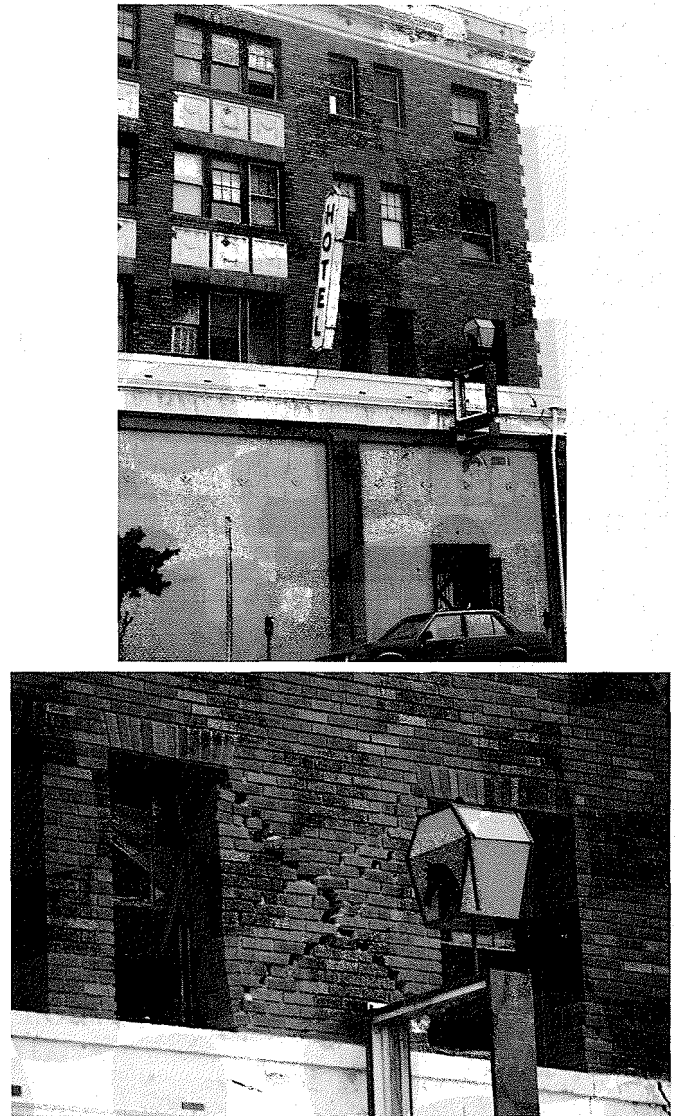
Fig. 27. Damaged retrofitted Staton Hotel, Western Avenue, Hollywood: (a) global view; (b) severe in-plane X-cracking of piers.

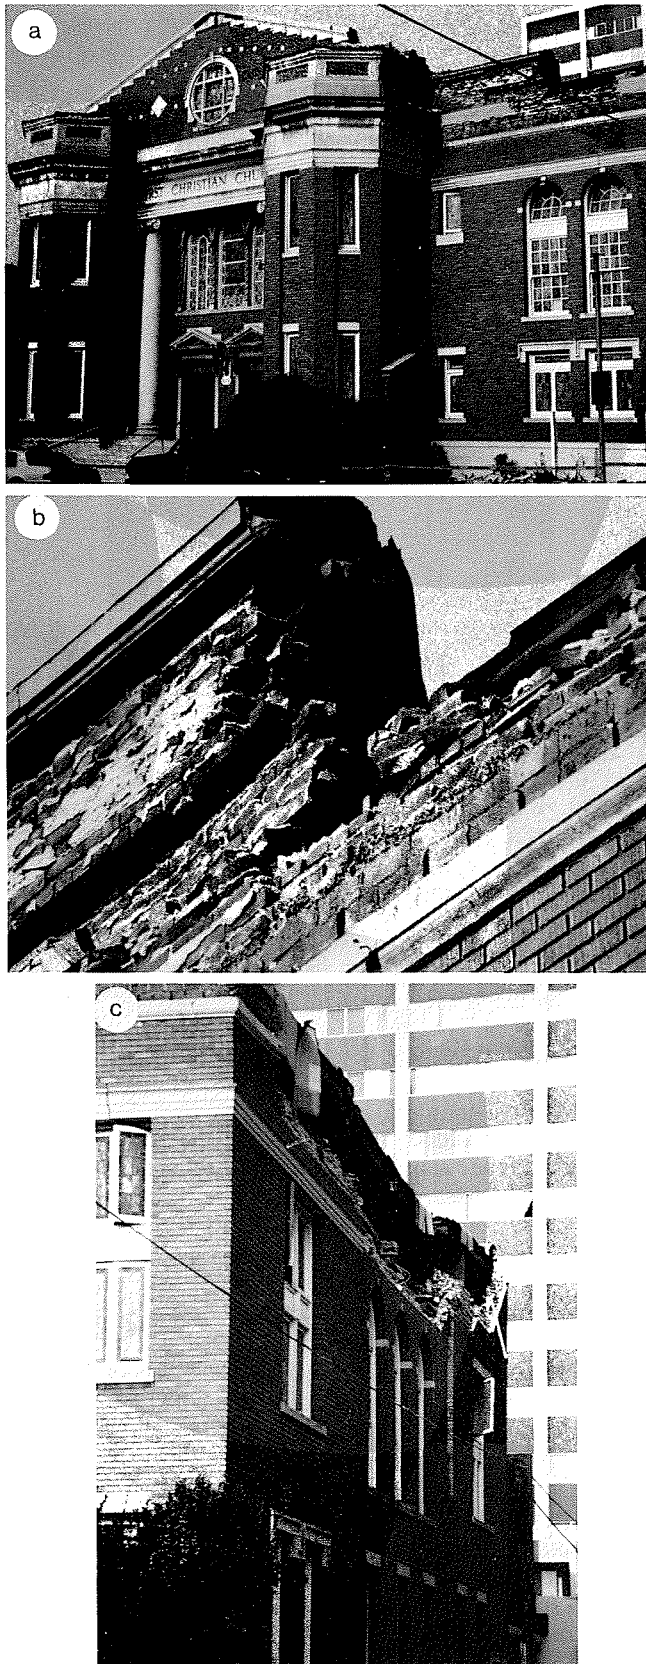
Fig. 28. Damage to First United Church of Santa Monica: (a) global view, showing in-plane cracking of turrets and collapse of unbraced parapet; (b) close-up of collapsed unbraced parapet, and poor quality collar joint; (c) out-of-plane collapse of top of east wall.

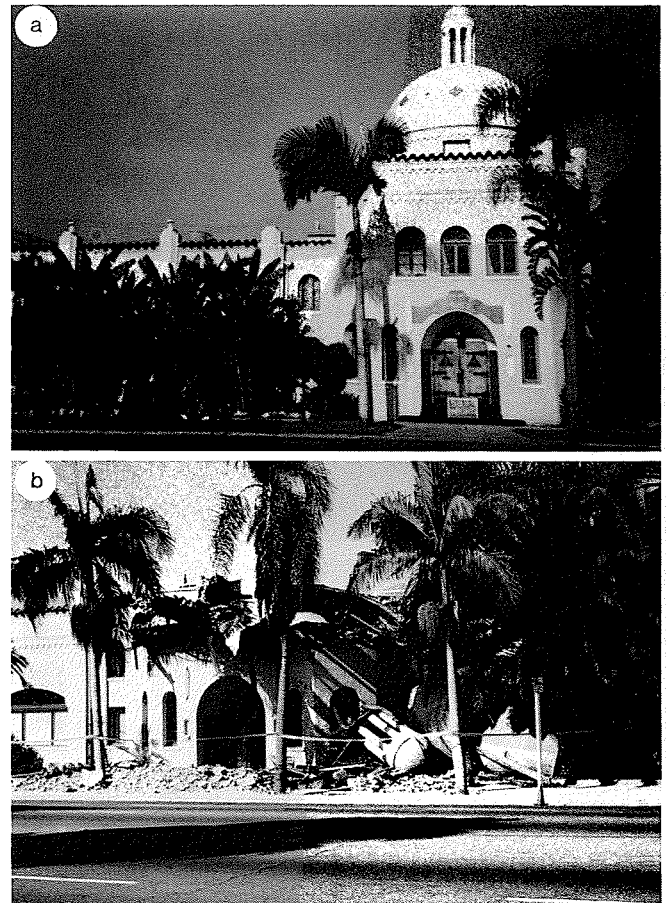
Fig. 29. Damage to Metropolitan Community Church of Los Angeles, in Culver City: (a) front view, showing tower and Byzantine-style dome — photo taken prior to the earthquake; (b) collapsed tower, after the Northridge earthquake.

found to be poorly connected, crosswalls were added as a minimum partial retrofit. Shortly thereafter, the church was granted unlimited exempt status on account of its historical importance. Figure 28 illustrates some of the extensive damage to the First United Church of Santa Monica from the Northridge earthquake: considerable parts of the north and east walls collapsed, a large portion of the veneer on the west walls peeled off, severe in-plane cracking occurred in turrets, unbraced parapets on the facade collapsed, and some of the aforementioned questionable gravity-resisting structural elements toppled. Clearly, the added crosswalls prevented local collapse of the building, and the parapets braced in 1975 survived. However, the extent of damage made repairs prohibitive, and the church was demolished shortly after the earthquake.

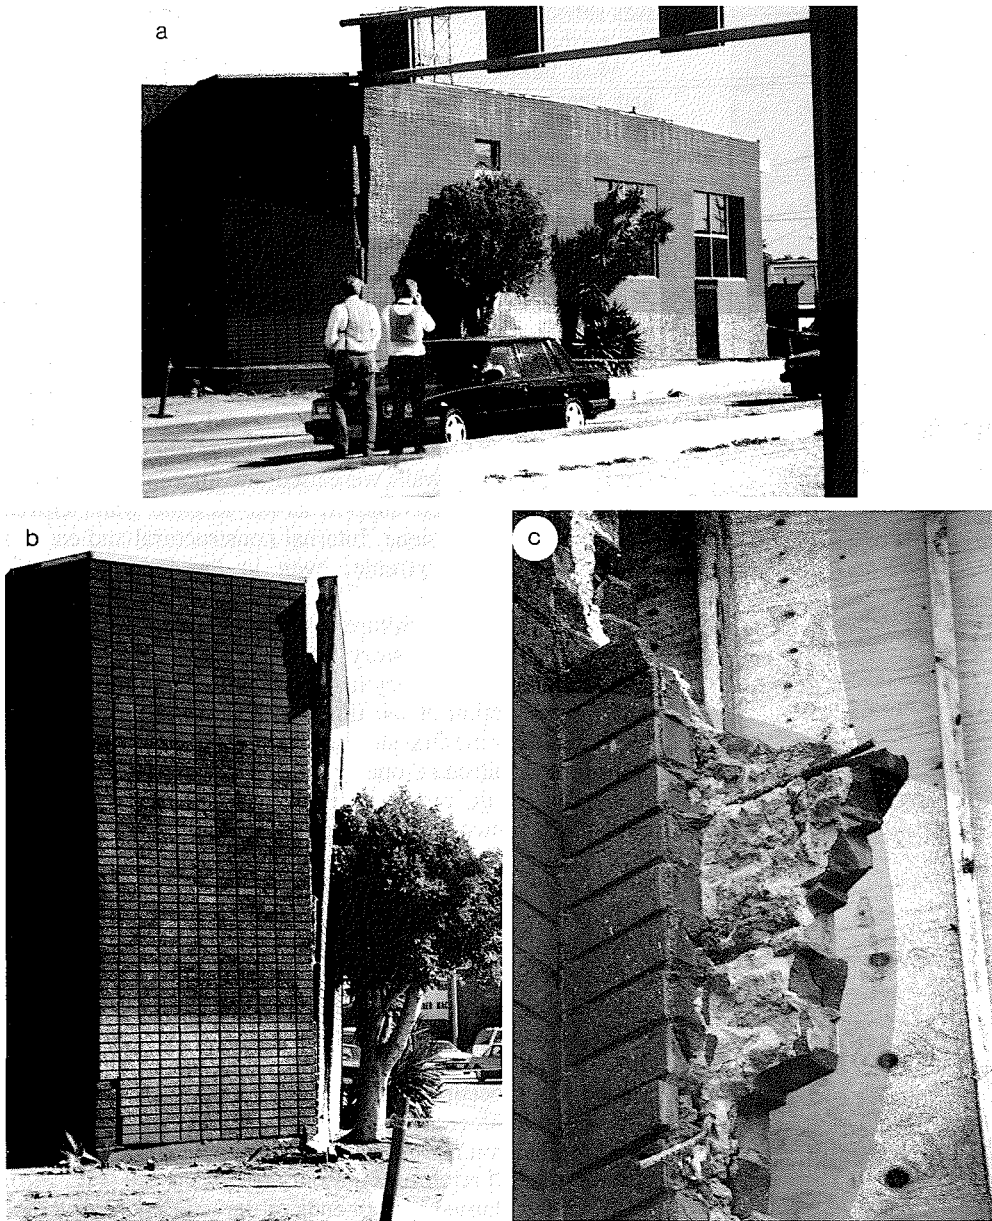
Fig. 30. Damage due to lack of integrity between adjacent panels of stacked bond reinforced brick, and between panels and roof diaphragm, Adams Street, Culver City: (a) global view of building; (b) separated and severely leaning panel; (c) close-up of reinforcement exposed after demolition of damaged part of wall.

Damage due to lack of integrity between adjacent panels of stacked bond reinforced brick, and between panels and roof diaphragm, was observed (Fig. 30). This emphasizes the need and importance of continuity reinforcement in masonry, even though the very light reinforcement present in the walls could preserve the integrity of the individual panels. It is noteworthy that panels with the least amount of openings, thus with the largest reactive mass, pulled apart more severely from the roof of that building.

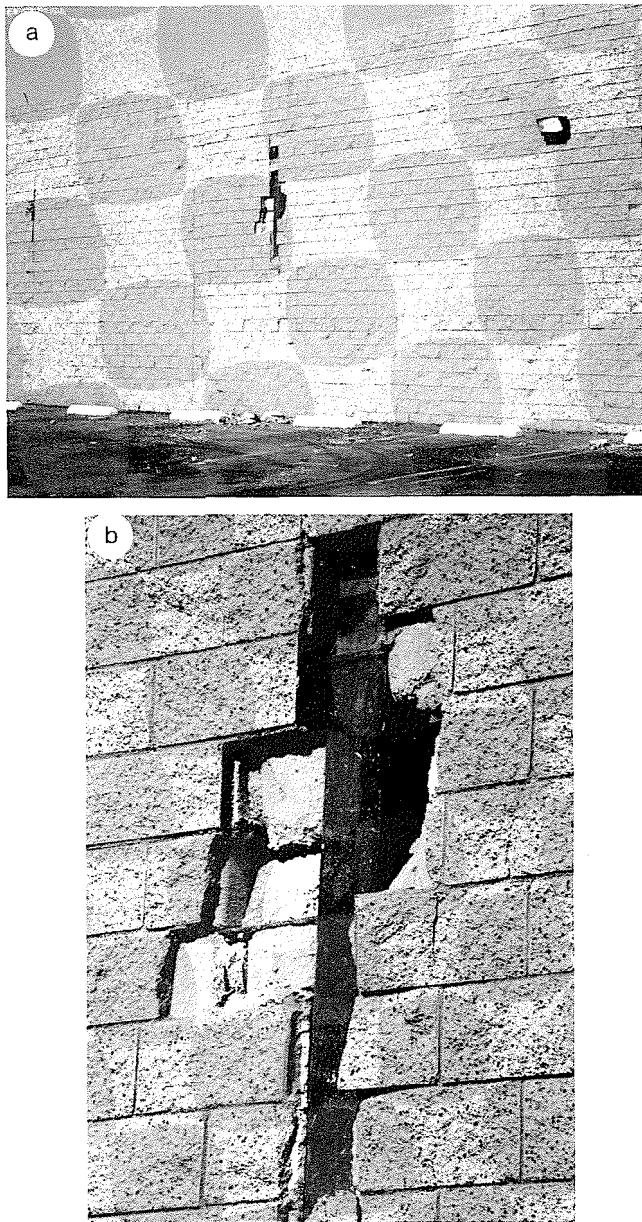
Fig. 31. Reinforced masonry wall damaged by pounding and punching of wood beams, Lamp Plus Building, Northridge: (a) global view of damaged wall; (b) closeup view.

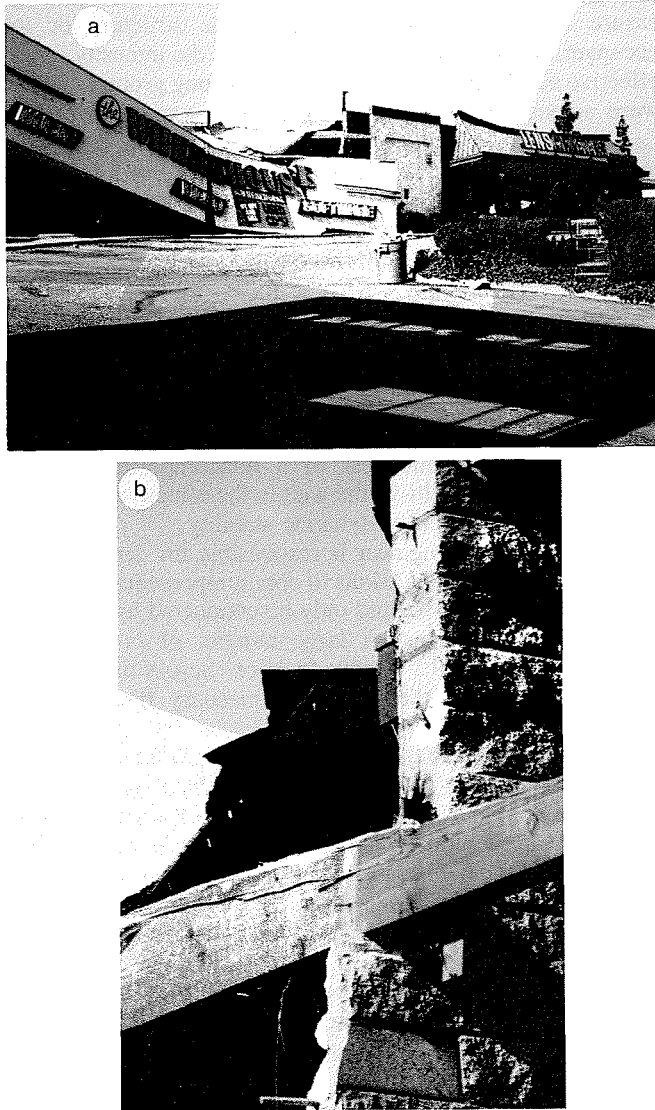
Fig. 32. Collapsed Warehouse and Lenscrafter building due to pounding and punching of beams through reinforced masonry wall, Northridge: (a) global view; (b) closeup view of wood beam punched through a reinforced masonry wall.
