Damage to masonry buildings caused by the 1995 Hyogo-ken Nanbu (Kobe, Japan) earthquake

Michel Bruneau and Koji Yoshimura

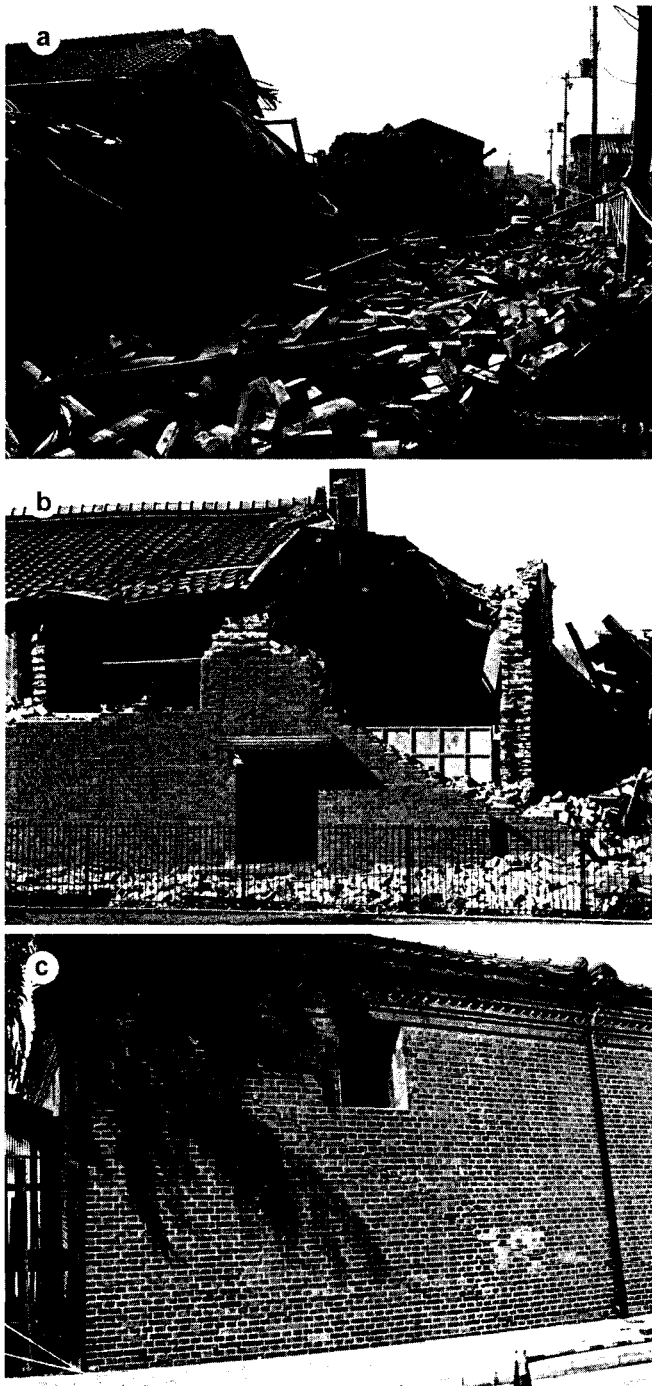
Fig. 3. Collapsed unreinforced brick masonry buildings of a sake-distillery: (a) global view of rubble blocking a street, and showing type of masonry units; (b) walls partly collapsed in out-of-plane manner; (c) wall with visible in-plane cracking.

All unreinforced masonry buildings that could be found by the authors have suffered extensive damage, whether or not they were surrounded by damaged buildings constructed of other materials. For example, a sake-distillery near the shoreline east of Kobe suffered from the collapse of a large number of its buildings (Fig. 3), while none of the adjacent

reinforced concrete and steel buildings showed signs of damage. Out-of-plane failures were dominant for that group of buildings (Fig. 3b), although some severe in-plane shear cracks could also be observed in the few uncollapsed single-story buildings (Fig. 3c). By contrast, another building that suffered significant out-of-plane failure of its walls at the higher stories, and the "caving-in" of its central portion (Fig. 4), was located in downtown Kobe and surrounded by numerous heavily damaged buildings of other construction types.

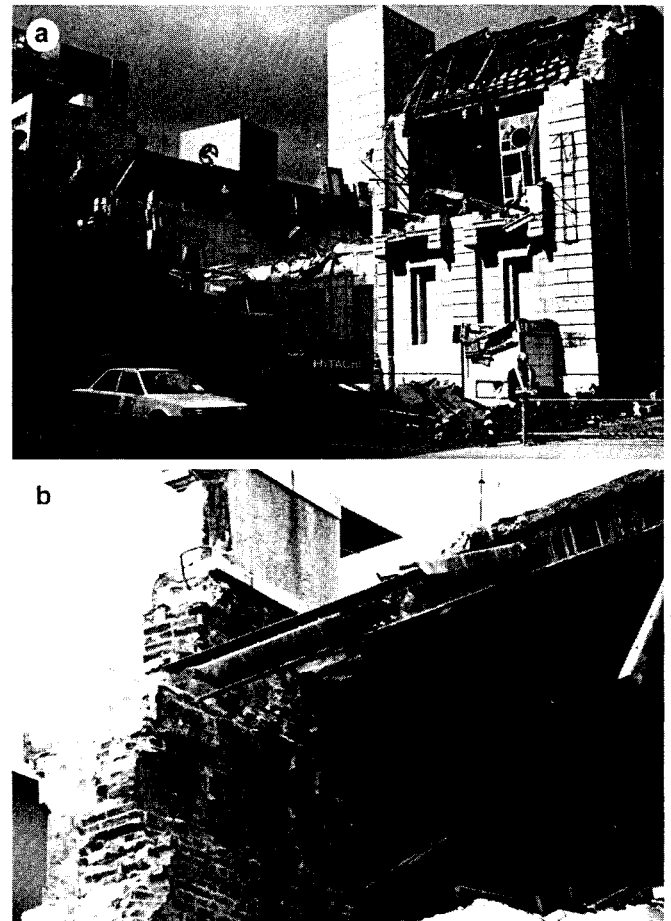
Fig. 4. Severely damaged unreinforced masonry building in downtown Kobe: (a) global view; (b) close-up view of a simply supported gravity structure.

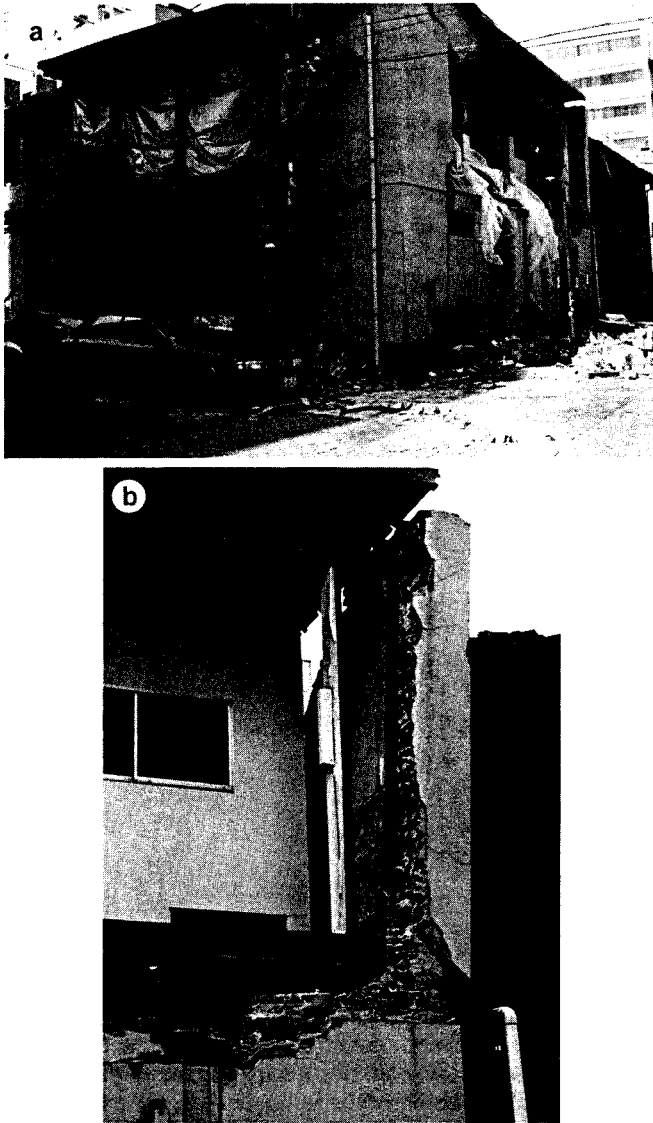
Interestingly, some buildings that appeared to have suffered no damage when seen from their main entrance side were actually found to have lost significant portions of their higher-story walls in an out-of-plane manner when inspected on the other sides. For example, this happened to the building shown in Fig. 5, located in downtown Kobe near one of the expressways that collapsed. Given the otherwise excellent in-plane behaviour of this building, this out-of-plane failure could have easily been prevented by adding vertical reinforcement braces or using other equally simple seismic retrofit techniques reported in the existing literature (Bruneau 1994c).

Fig. 5. Out-of-plane damage to unreinforced masonry building walls in downtown Kobe: (a) global view of a wall; (b) close-up view.

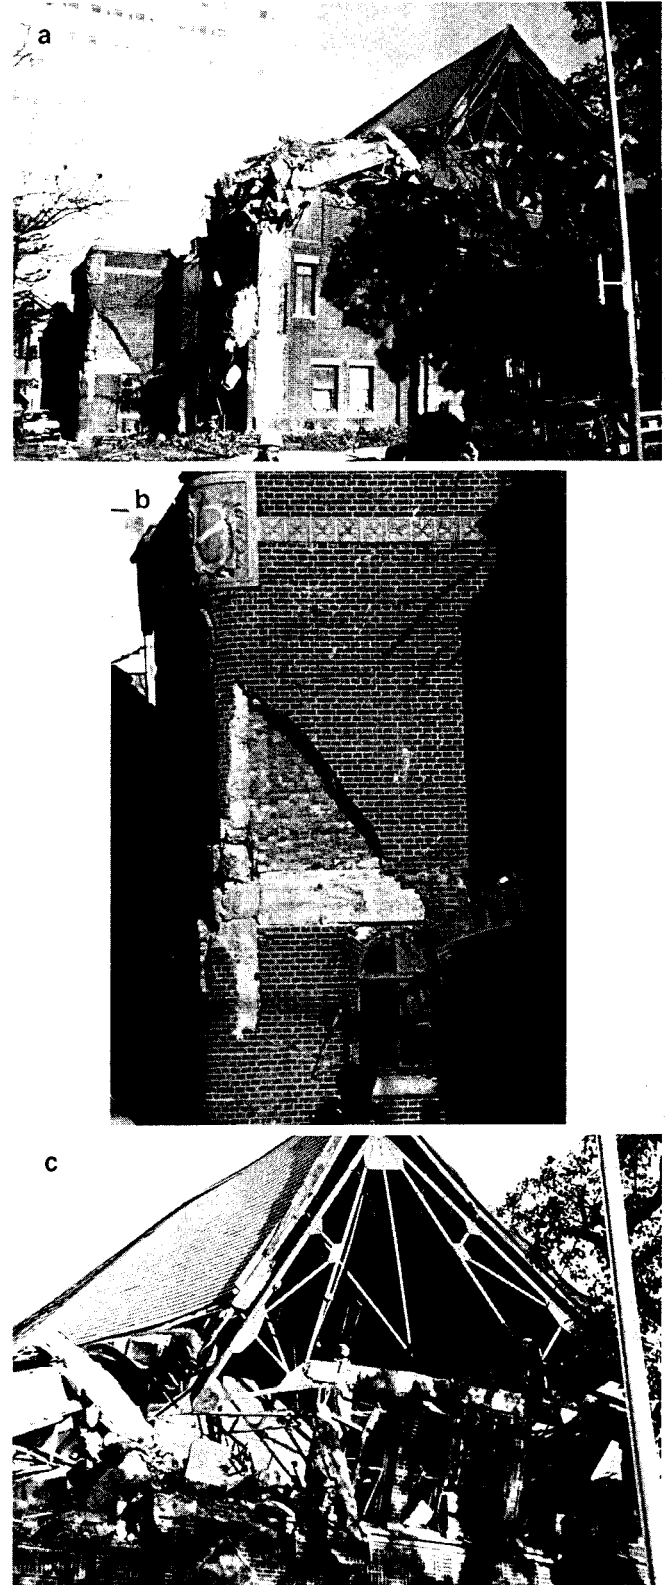
Fig. 6. Damaged church having reinforced concrete frames infilled with unreinforced masonry: (a) global view; (b) minor damage to masonry wythe covering the infilled frames at the church's lower level; (c) close-up view of the damaged level where more openings existed in the infilled reinforced concrete frame.

In a few instances, damage was observed to reinforced concrete frames for which unreinforced masonry had been used as infills. For example, one church suffered a tremendous amount of damage to its lightly reinforced concrete frame and infills at the level where numerous window openings were present (Fig. 6). Damage to the lower part of the church was actually slight, as the infills and smaller amount of openings provided a considerable amount of overstrength to the

reinforced concrete frames. However, the gable of that church was a “pure” unreinforced masonry gable as opposed to an infilled gable. Being inadequately tied to the steel roof-frame, it partly collapsed in an out-of-plane manner. Some wall anchors, consisting of bent bars originally embedded in the masonry, were seen hanging from the steel frame (these can also be seen in Fig. 6, but somewhat difficultly).

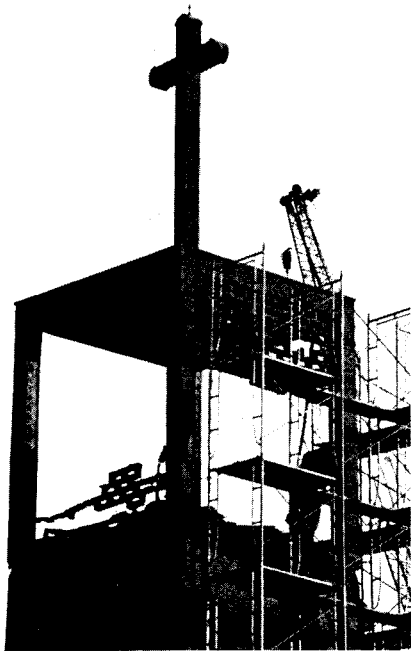
Fig. 7. Damage to nonstructural masonry elements used as decorative infill masonry at the top of a church tower.

Another interesting example of infill failure occurred at the top of a modern church tower. The tower consisted of a multilevel reinforced concrete frame, infilled by slightly recessed unreinforced masonry. Solid bricks were used at all levels, except at the top where units with large voids were utilized to provide a striking architectural finish (Fig. 7). The church and tower were both undamaged, except for the tower at its top level where the weaker masonry units were used. These were quickly crushed, providing no additional strength to the concrete frame that, in turn, suffered column damage at that level.

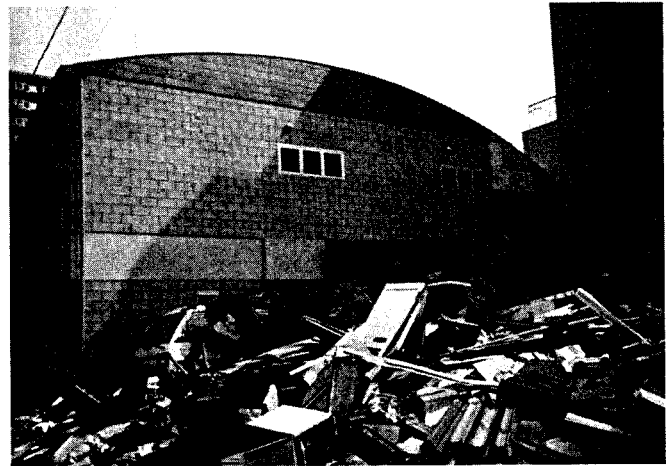
Fig. 8. Undamaged small reinforced masonry building located in Kobe (from Japanese Society for the Promotion of RM Buildings).

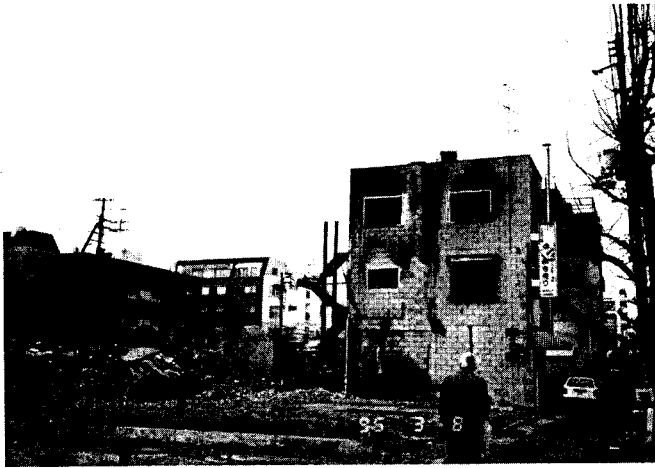
Fig. 9. Undamaged small reinforced masonry building located in Kobe (from Japanese Society for the Promotion of RM Buildings).

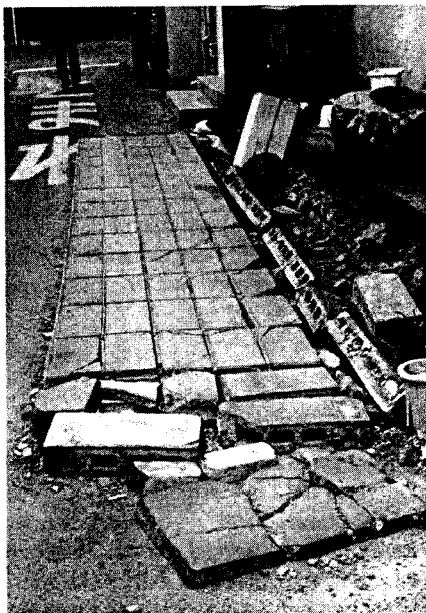
Fig. 10. Damage to unreinforced concrete block masonry garden walls.

Slender unreinforced concrete block masonry walls typically failed by out-of-plane overturning due to rupture at

their base (Fig. 10), as did older thicker walls generally constructed of clay brick unreinforced masonry (Fig. 11, showing a wall located in a part of town where adjacent buildings did not suffer visible damage), and lightly reinforced slender reinforced masonry walls (Fig. 12). That latter and fairly representative wall was built using 150 mm wide blocks, 6 mm diameter bars in grouted cells at 400 mm spacing, and buttresses.

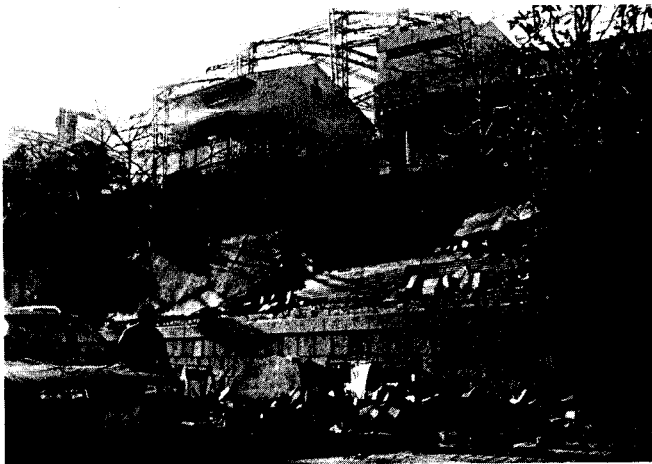
Fig. 11. Collapsed thick unreinforced clay brick masonry property wall.

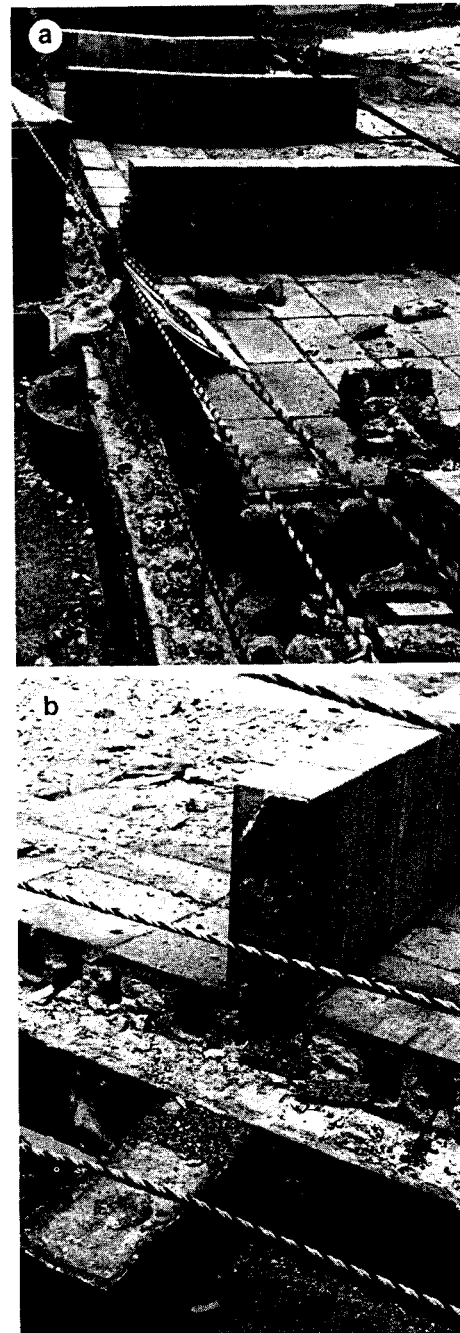
Fig. 12. Failed reinforced concrete block masonry garden wall: (a) global view; (b) close-up view.

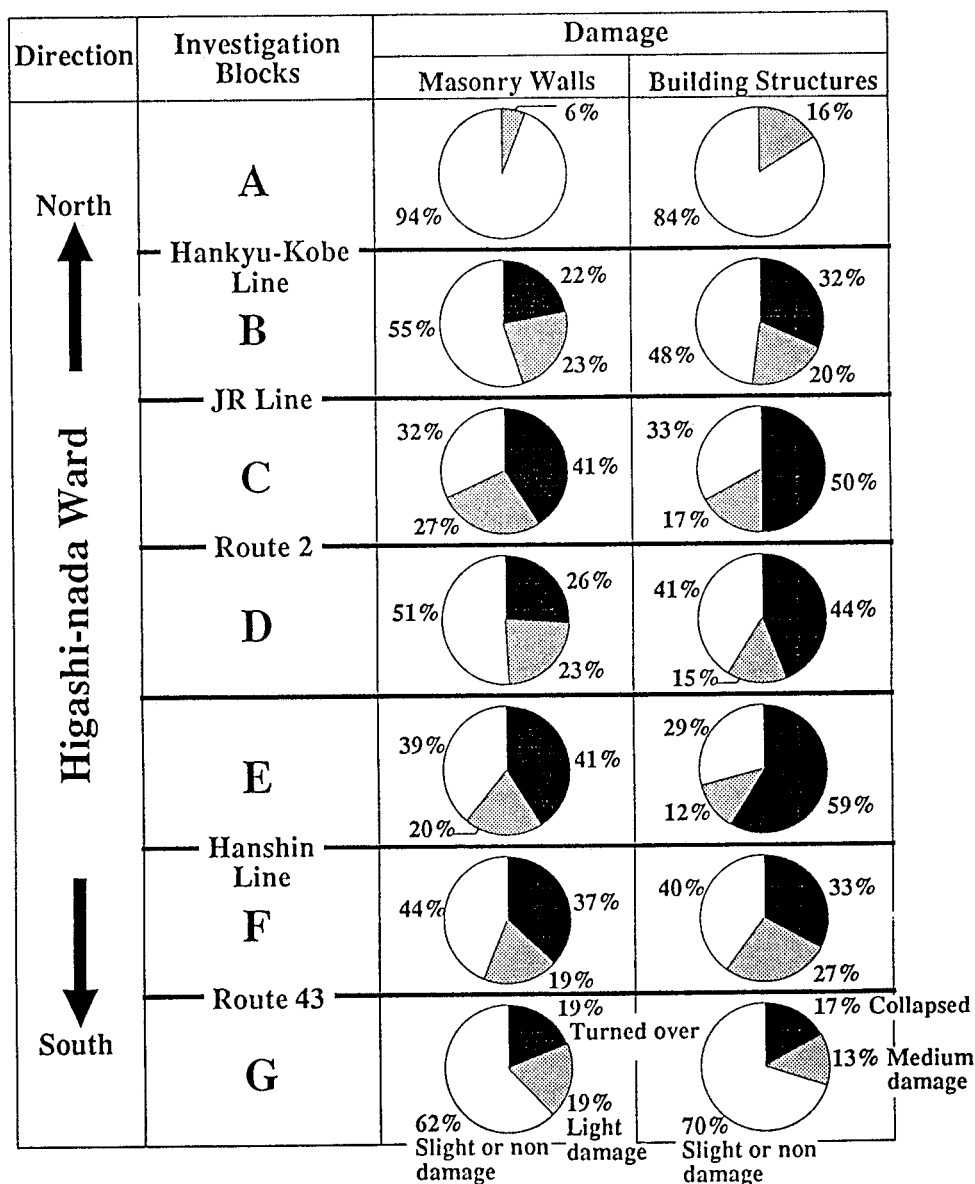
Fig. 13. Comparison of the severity of damage to masonry walls and buildings in the Higashi-Nada Ward of Kobe.

A comparison of the severity of damage to garden walls with that of buildings along six kilometres of parallel roads in the Higashi-Nada Ward of Kobe is presented in Fig. 13, for 236 walls and 603 buildings along those selected roads. Although in many areas, damage was frequently more extensive in buildings than in garden walls, damage to garden walls was widespread, particularly south of that Ward nearer to the shoreline.

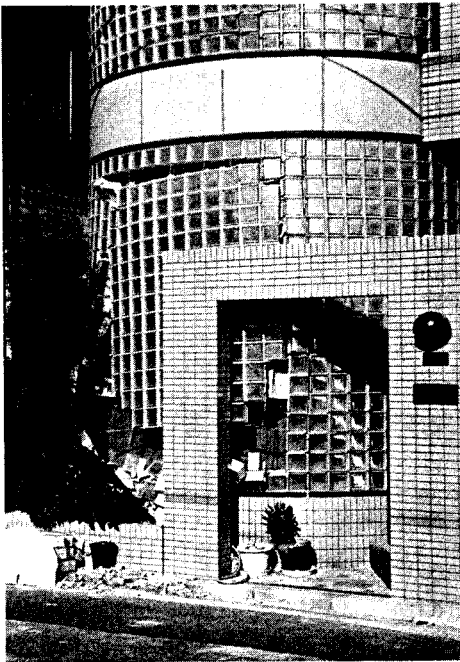
The seismic performance of nonstructural masonry was not reviewed extensively by the authors. However, damage was sometimes observed to nonstructural masonry used in decorative architectural elements. For example, a circular reinforced glass-block wall that has been damaged is shown in Fig. 15. Also shown in the figure is an example of the excellent behaviour of thin adhesive masonry coverings, an architectural finish frequently used in Japan.

Fig. 15. Damaged circular reinforced glass-block masonry wall.
