Seismic design of steel buildings: lessons from the 1995 Hyogo-ken Nanbu earthquake

Robert Tremblay, Michel Bruneau, Masayoshi Nakashima, Helmut G.L. Prion, Andre Filiatrault, and Ron DeVall

Key words: earthquake, seismic design, steel structures.

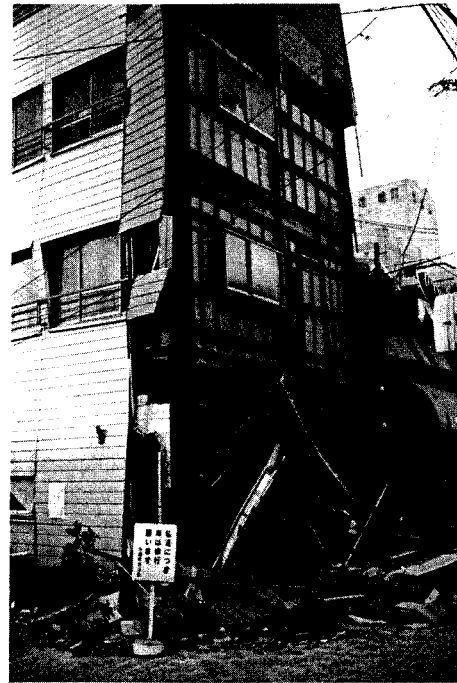
Fig. 7. Typical slender multistorey residential building with large front opening at first floor (cladding loss due to large interstorey drift).

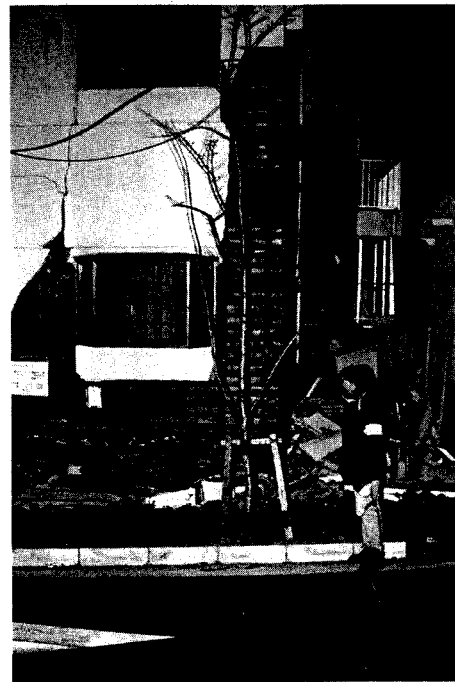
Fig. 10. Latticed beams and columns in three-storey residential building with wood lattice infill (note collapsed first storey).

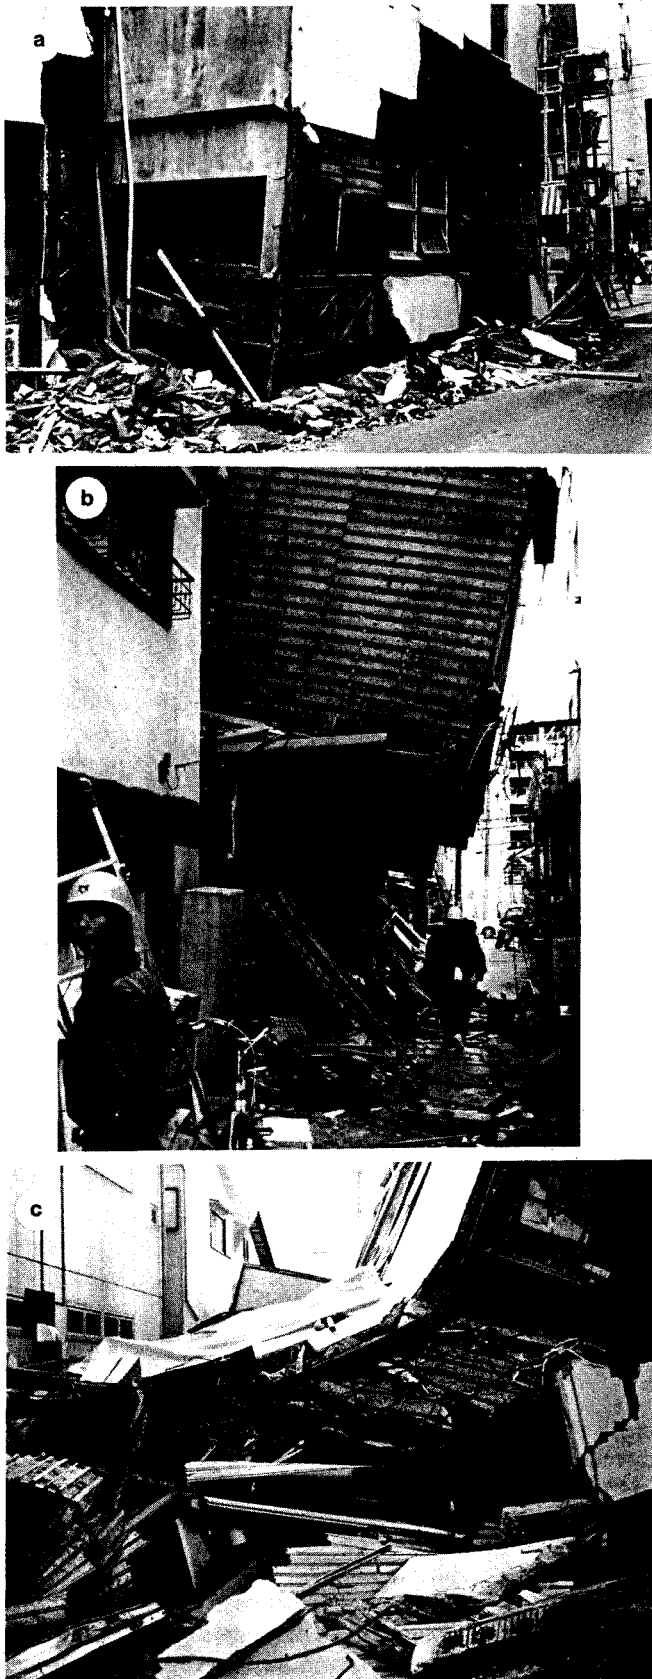
Fig. 17. Collapsed light-gauge steel framing: (a) first-storey collapse; (b) failure of the second-storey columns; (c) local buckling in a failed column.

Old buildings made of light-gauge steel sections had been designed and constructed without much regard for seismic considerations, which resulted in any combination of low resistance to lateral loads, nonductile members, and inappropriate strength hierarchy. Hence, not surprisingly, these structures suffered a considerable amount of damage during the Hyogo-ken Nanbu earthquake.

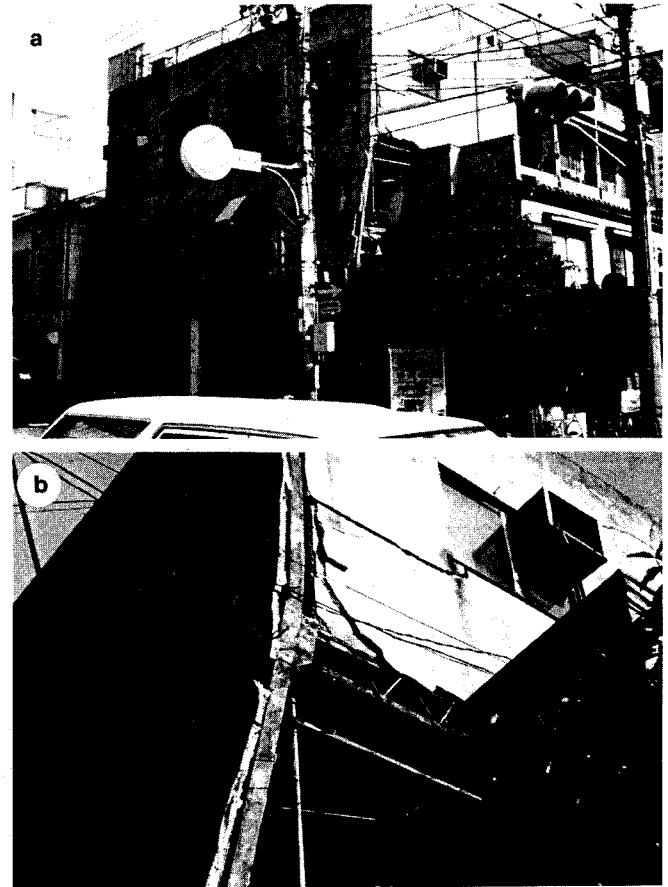
Fig. 18. Tension failure of the bottom chord of a moment-connected floor truss in a three-storey residential building: (a) overall view of the building; (b) close-up of the failed connection.

These old steel frames also experienced other types of structural damage, including tension failure of braces and fracture of beam-to-column connections. For the latter, various failure patterns could be readily observed: tension fracture of truss bottom chords (Fig. 18), peeling-off of cover

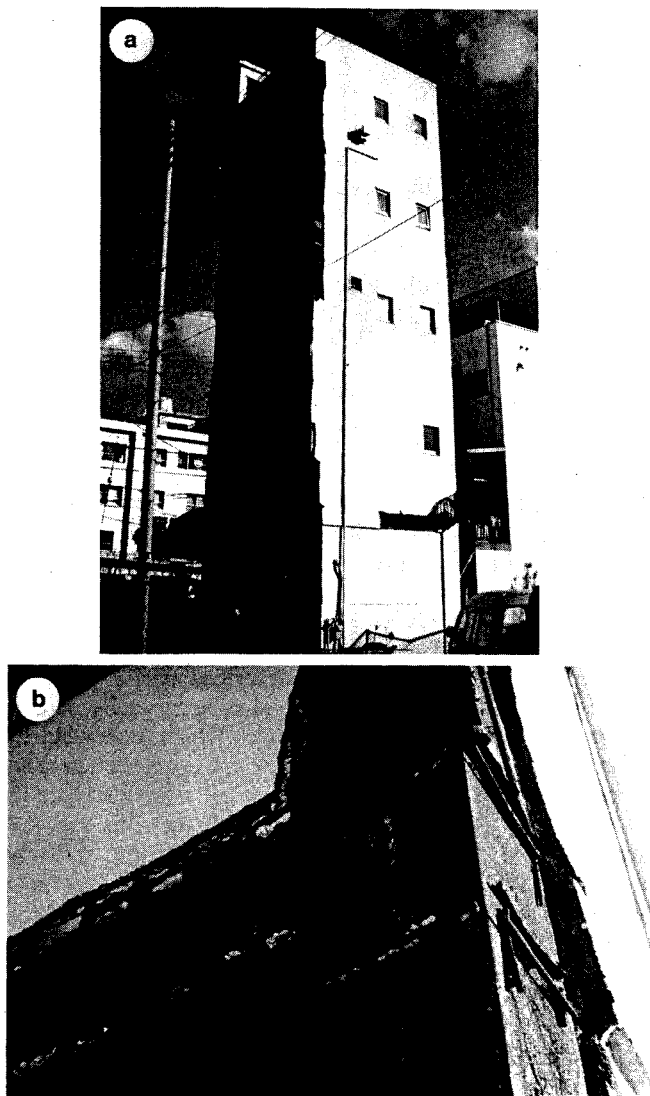
Fig. 19. Peeling off of the cover plate of a built-up box column (at the beam top flange connection) in a five-storey residential building: (a) overall view of the building; (b) close-up of the first-storey beam-column connection.

moment capacity. Ductile column hinging was not possible and the structure was destined for a brittle collapse unless some other ductile mechanism could develop prior to the column's failure. To aggravate matters, many of these buildings had severely corroded columns as a result of years of water infiltration. Yet, while numerous such buildings have collapsed (Figs. 10 and 17), many others have survived (Fig. 7), although they most frequently shed their veneer finishes in the process. The survivors likely owe their sometimes surprising seismic performance to a combination of nonrigid framing action and interaction with their internal wood-frame partitions.

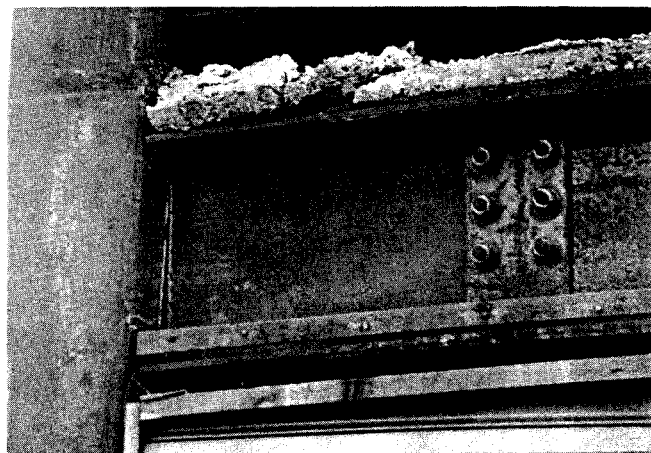
Fig. 20. Failure of the beam-to-column welded connection at the first storey of the building shown in Fig. 7.

plates in built-up box columns (Fig. 19), or failure of beam-to-column welds (Fig. 20).

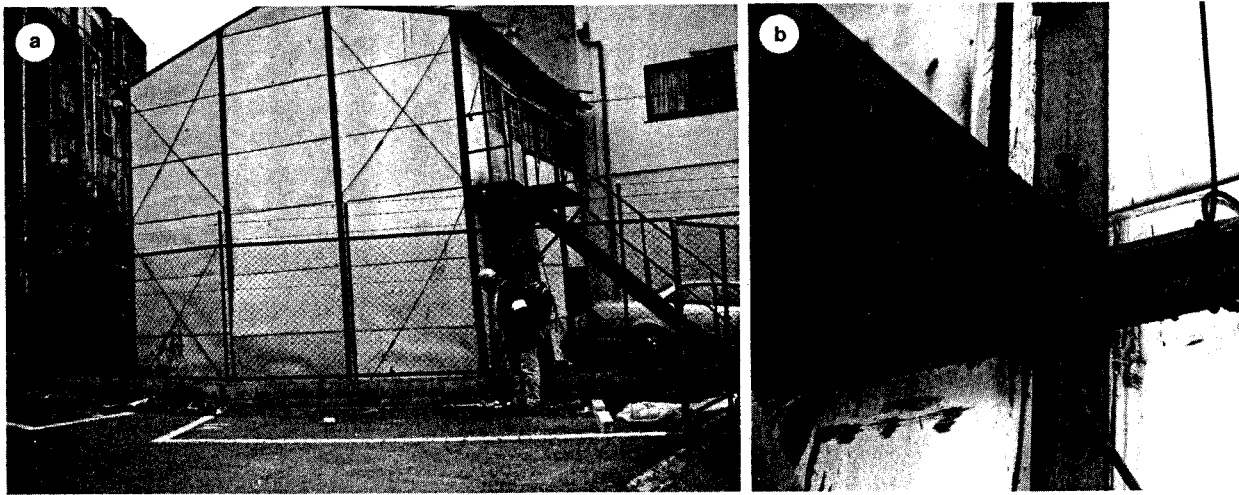
Extensive yielding of bracing members took place in mass produced prefabricated steel housing structures (Fig. 21a). In some cases, the connection latches unbuttoned when the braces yielded in tension and became loose (Fig. 21b). In most cases, an adequate number of braces remained, however, to keep the structures from collapsing.

Fig. 21. Damage to prefabricated housing units with tension bracing: (a) braces yielded and some fell-off; (b) brace connection detail (note top bracing missing).

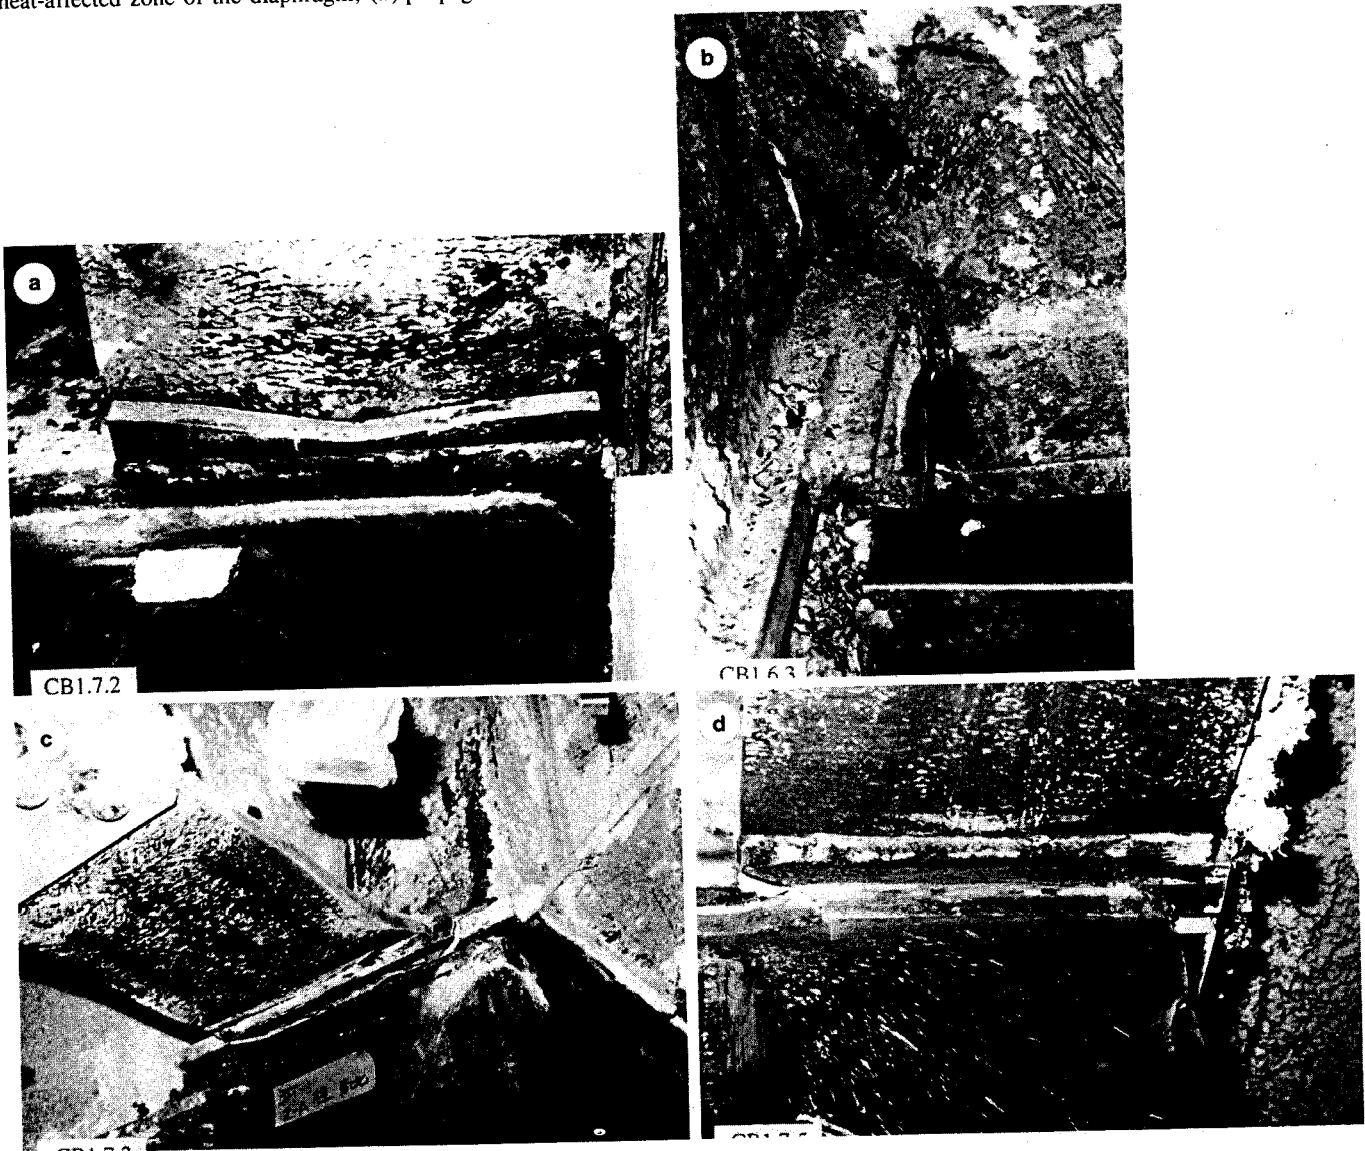
The failures observed during this earthquake differed somewhat from the Northridge failures, however, in that cracking and fracture was frequently (but not always) accompanied by yielding of beams. This evidence of inelastic response was mostly observed in the more modern unbraced frames having square-tube columns and full penetration welds at the beams. In the majority of these cases, no sign of yielding was observed in the adjoining columns. Most of the fractures occurred in the lower flange of the beams, and the beams exhibited clear signs of yielding as well as local buckling in many cases (Figs. 22a, 22b, and 22c), although, in some cases, the level of visible yielding was modest. Typically, fracture initiated either from the corner of a weld access hole, near a run-off tab or a weld toe, or in the heat-

affected zones on the beam flange or diaphragm. In many cases, the fracture progressed into the beam's web (e.g., Fig. 22*b*), and even, in some cases, progressed or initiated into the column flanges (e.g., Fig. 22*d*). Most of the buildings that sustained such cracking and fracture did not exhibit large permanent deformations or significant damage to their exterior and interior finishes, and repairs were expediently accomplished by re-welding through the cracks.

Fig. 22. Damage to beam-to-column connections in modern moment resisting frames with square-tube columns and full penetration welds at the beams: (a) fracture at the lower beam flange; (b) propagation of fracture in the beam web; (c) fracture initiated in the heat-affected zone of the diaphragm; (d) propagation of fracture in the column. (Courtesy of the Architectural Institute of Japan.)

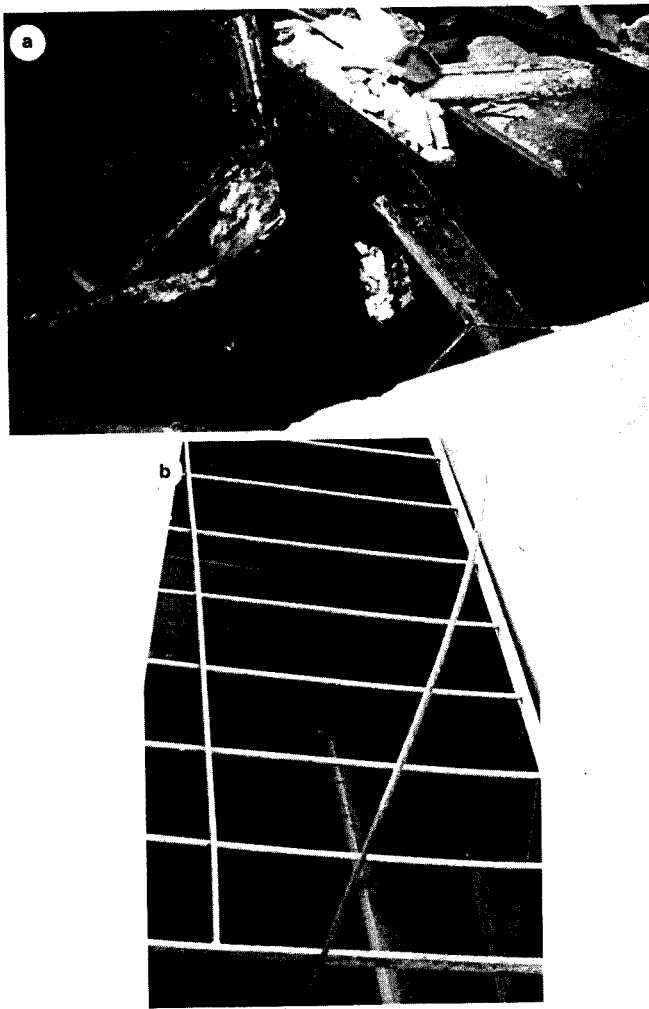
When fillet welds were used in moment resisting frames, many beam-to-column connections cracked and fractured without any sign of yielding, as these welds were apparently too small to develop the capacity of the connected members. Fracture of beam-to-column welds, such as the one shown in Fig. 20, was typical and many of the buildings having such connections suffered serious unrepairable damage. It is noteworthy that when tube columns were used, cracking and fracture also frequently occurred in the columns above or below the top or bottom diaphragm (Fig. 23). In Fig. 23*a*, a 6 mm fillet weld was used to connect a $305 \times 305 \times 16$ mm tube column to the diaphragm plate, which is an unequivocal example of undersized welds. As a result, complete overturning and collapse of the structure frequently occurred (Figs. 24*a*–24*c*). In fact, damage to the beam-to-column connections of at least 59 unbraced frames having square-tube columns was reported by the Architectural Institute of Japan, with about 70% of those rated as either collapsed or severely damaged. It is worth noting that capacity design is not mandatory in the 1981 Japanese specifications for beam-to-column connections in short-span buildings not more than three storeys high for which level-two design is omitted (Fig. 2), which could explain some of the reported failures. While most of these surveyed buildings that collapsed had fillet welds, at least three collapsed in spite of having full penetration welds (AIJ 1995*d*).

Fig. 23. Failures of undersized fillet welds between tube column and diaphragms.

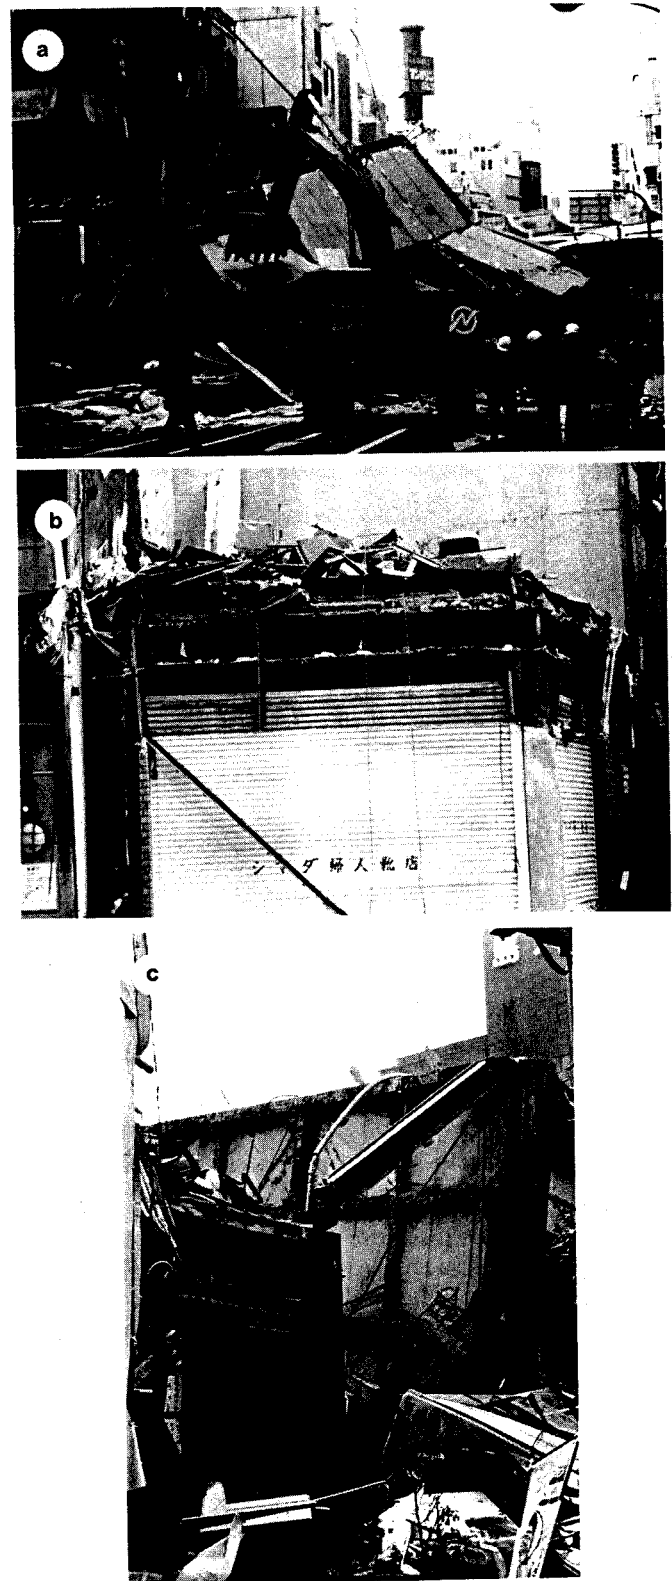
Fig. 24. Collapsed moment resisting frames with fillet welds at beam-to-column connections.

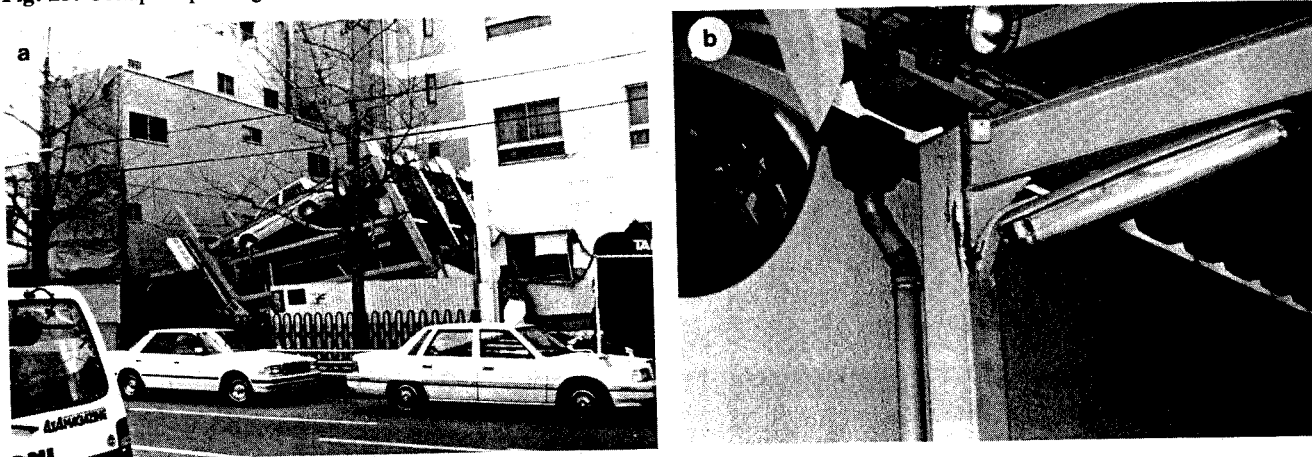
Fig. 25. Collapsed parking structure: (a) overall view; (b) close-up of failure of the unstiffened tube wall at beam-to-column connection.

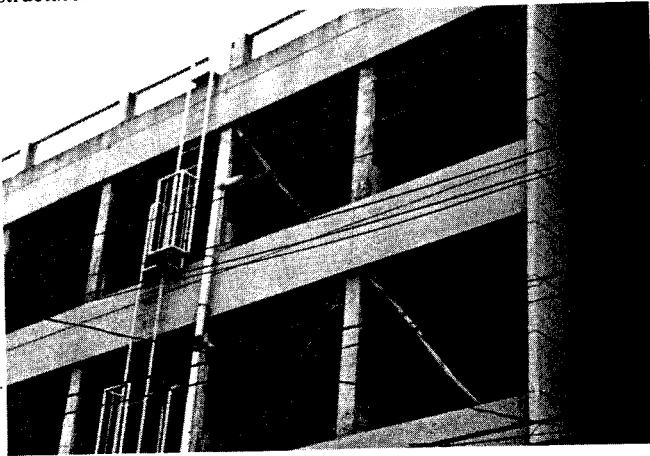
Fig. 26. Elongated plate braces in a four-storey parking structure.

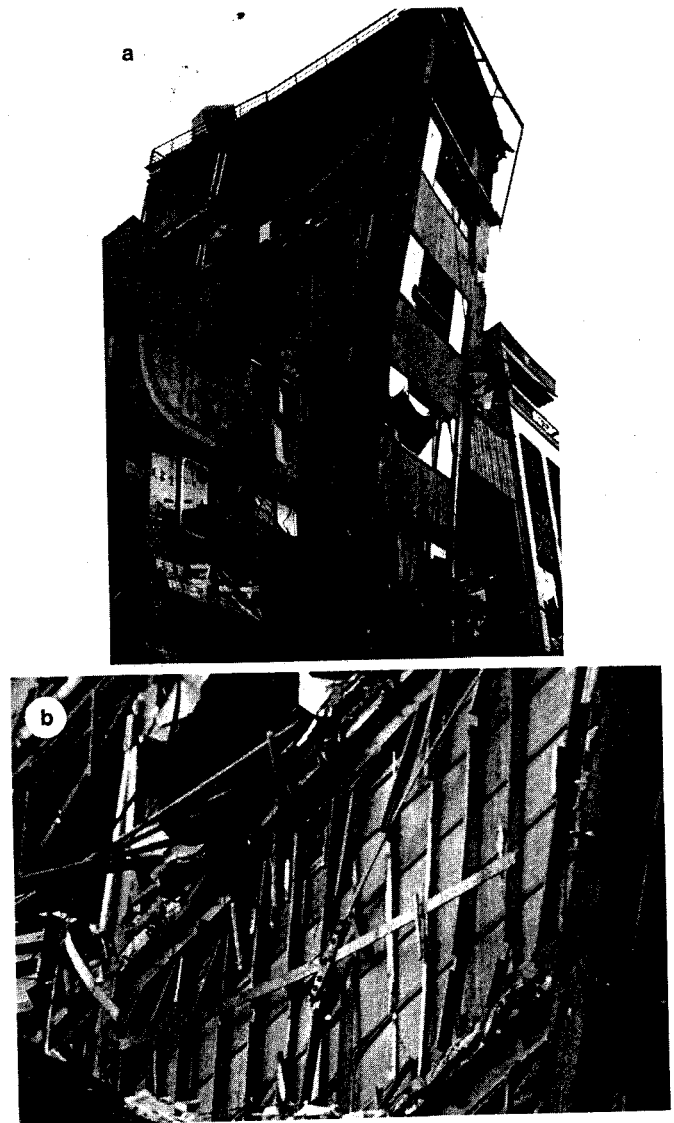
Fig. 27. Tensile connection failure of plate braces in a seven-storey residential building: (a) general overview; (b) close-up of brace fracture.

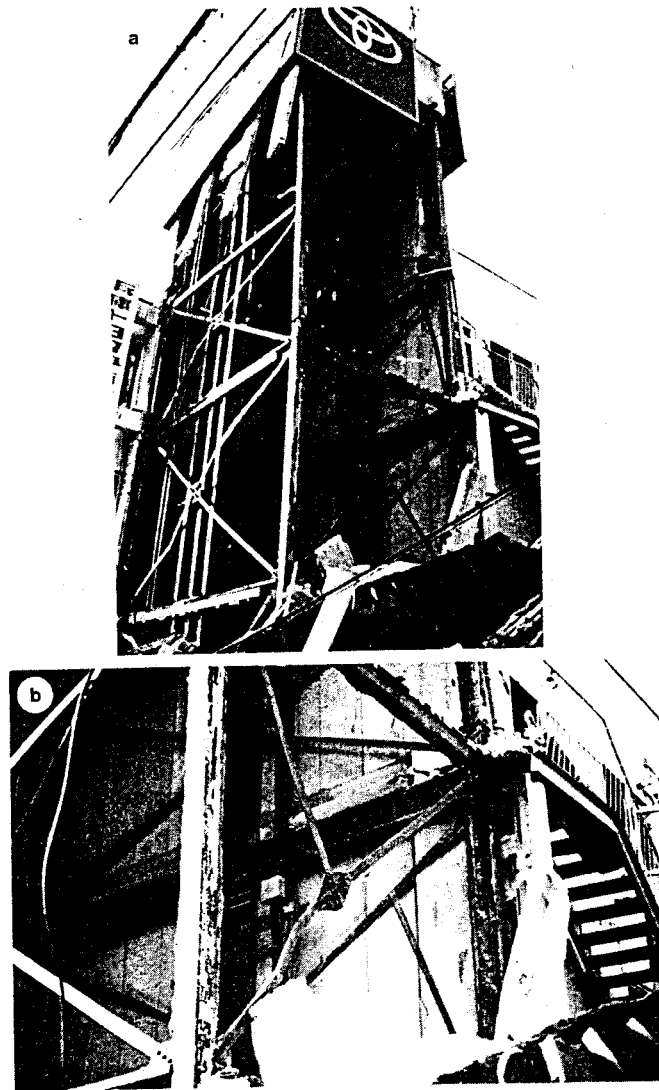
Fig. 28. Tensile connection failure of plate braces in a four-storey car lift: (a) overview of the structure; (b) close-up of brace fracture.

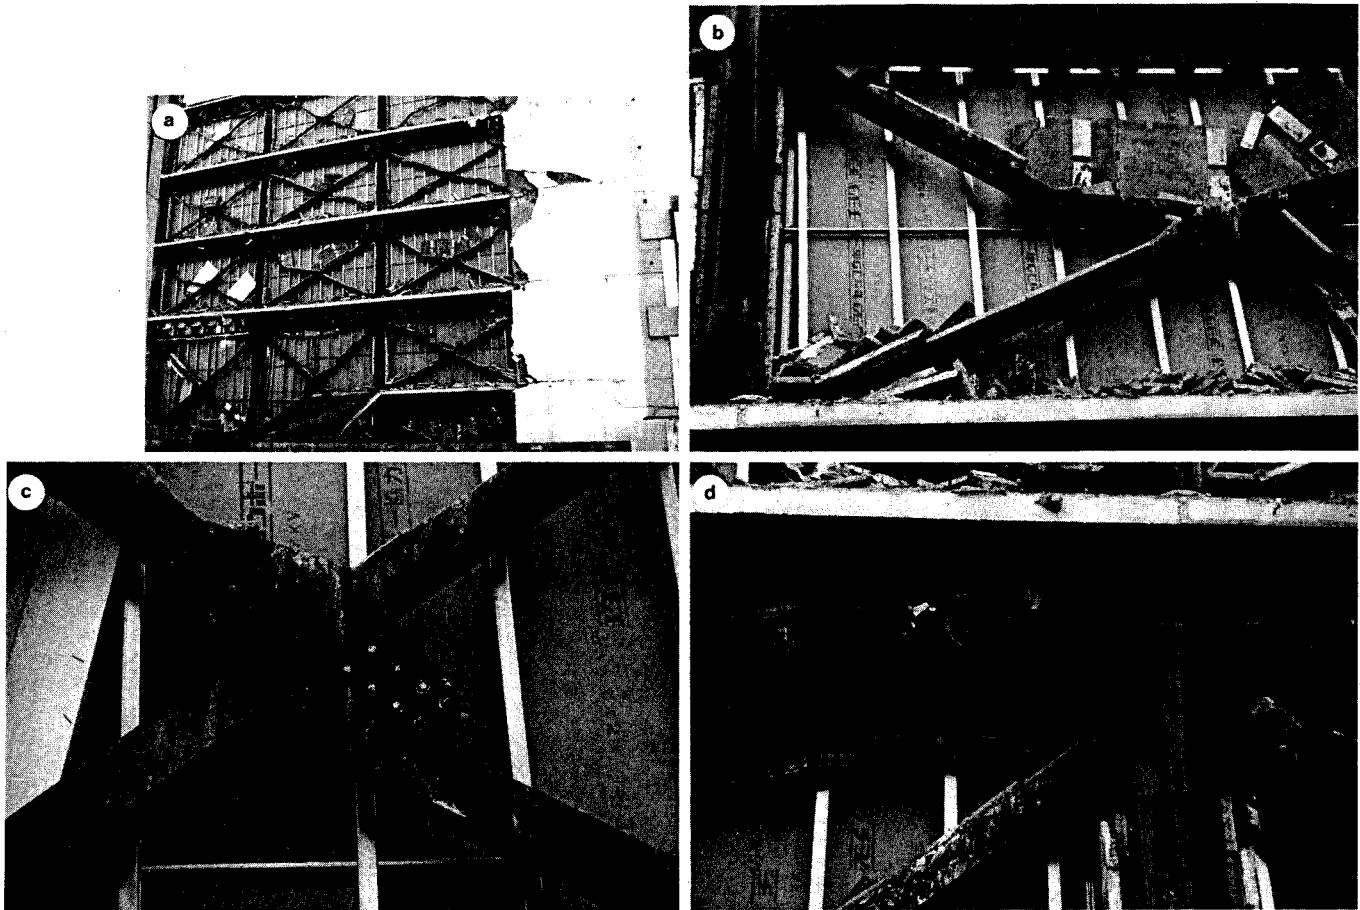
modes observed for these structures: low-cycle fatigue fracture of braces at plastic hinge location (Fig. 30b), fracture of bolted brace-to-gusset connections at net area (Fig. 30c), and failure of the welded connections between some gusset plates and the frame (Fig. 30d).

Fig. 30. Performance of a seven-storey braced frame: (a) overall view of a braced wall at the upper floors; (b) fracture of a bracing member at location of plastic hinging; (c) brace fracture at net area; (d) failure of a gusset plate to frame connection and damage to trussed beams.

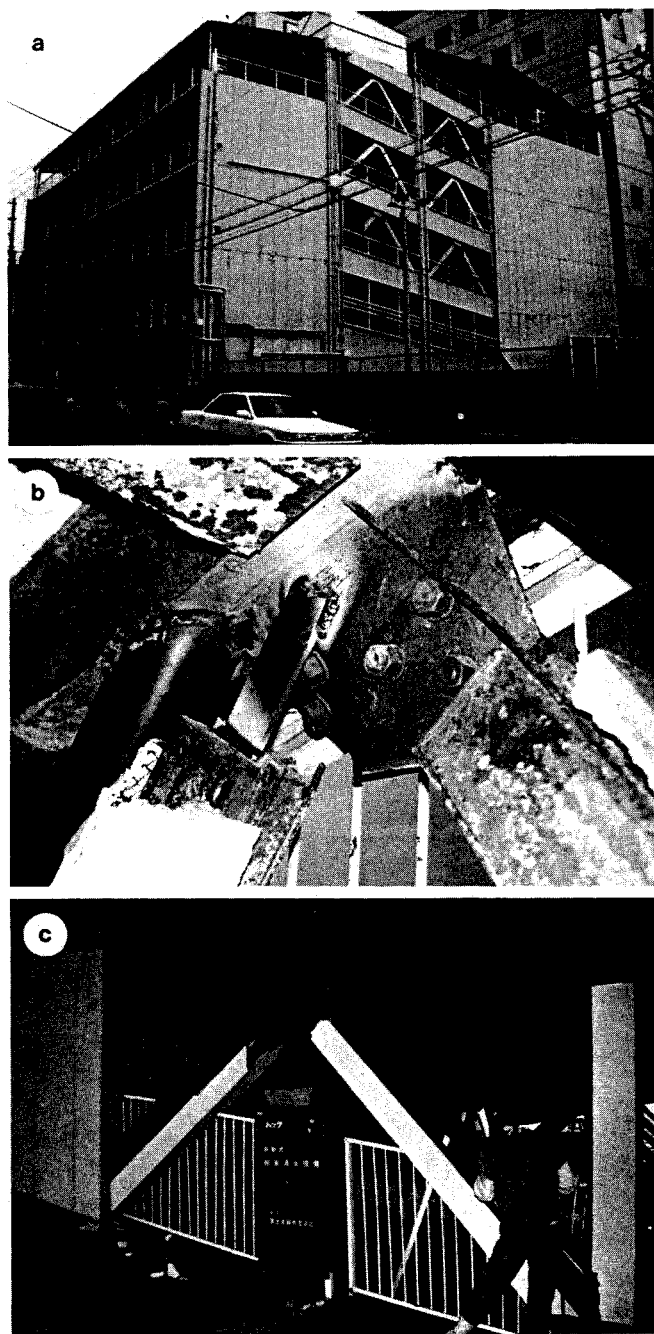
Fig. 31. Damage to a four-storey chevron bracing parking structure: (a) overall view; (b) fracture of a brace connecting plate, buckling of a gusset plate, and temporary repair scheme; (c) installation of additional bracing members.

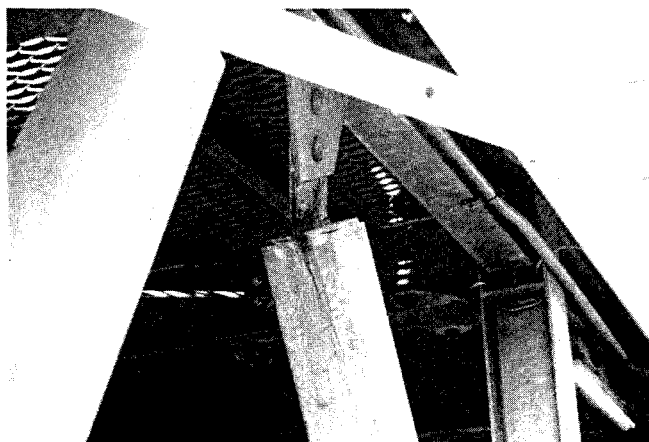
Fig. 32. Typical out-of-plane buckling of brace connecting plates.

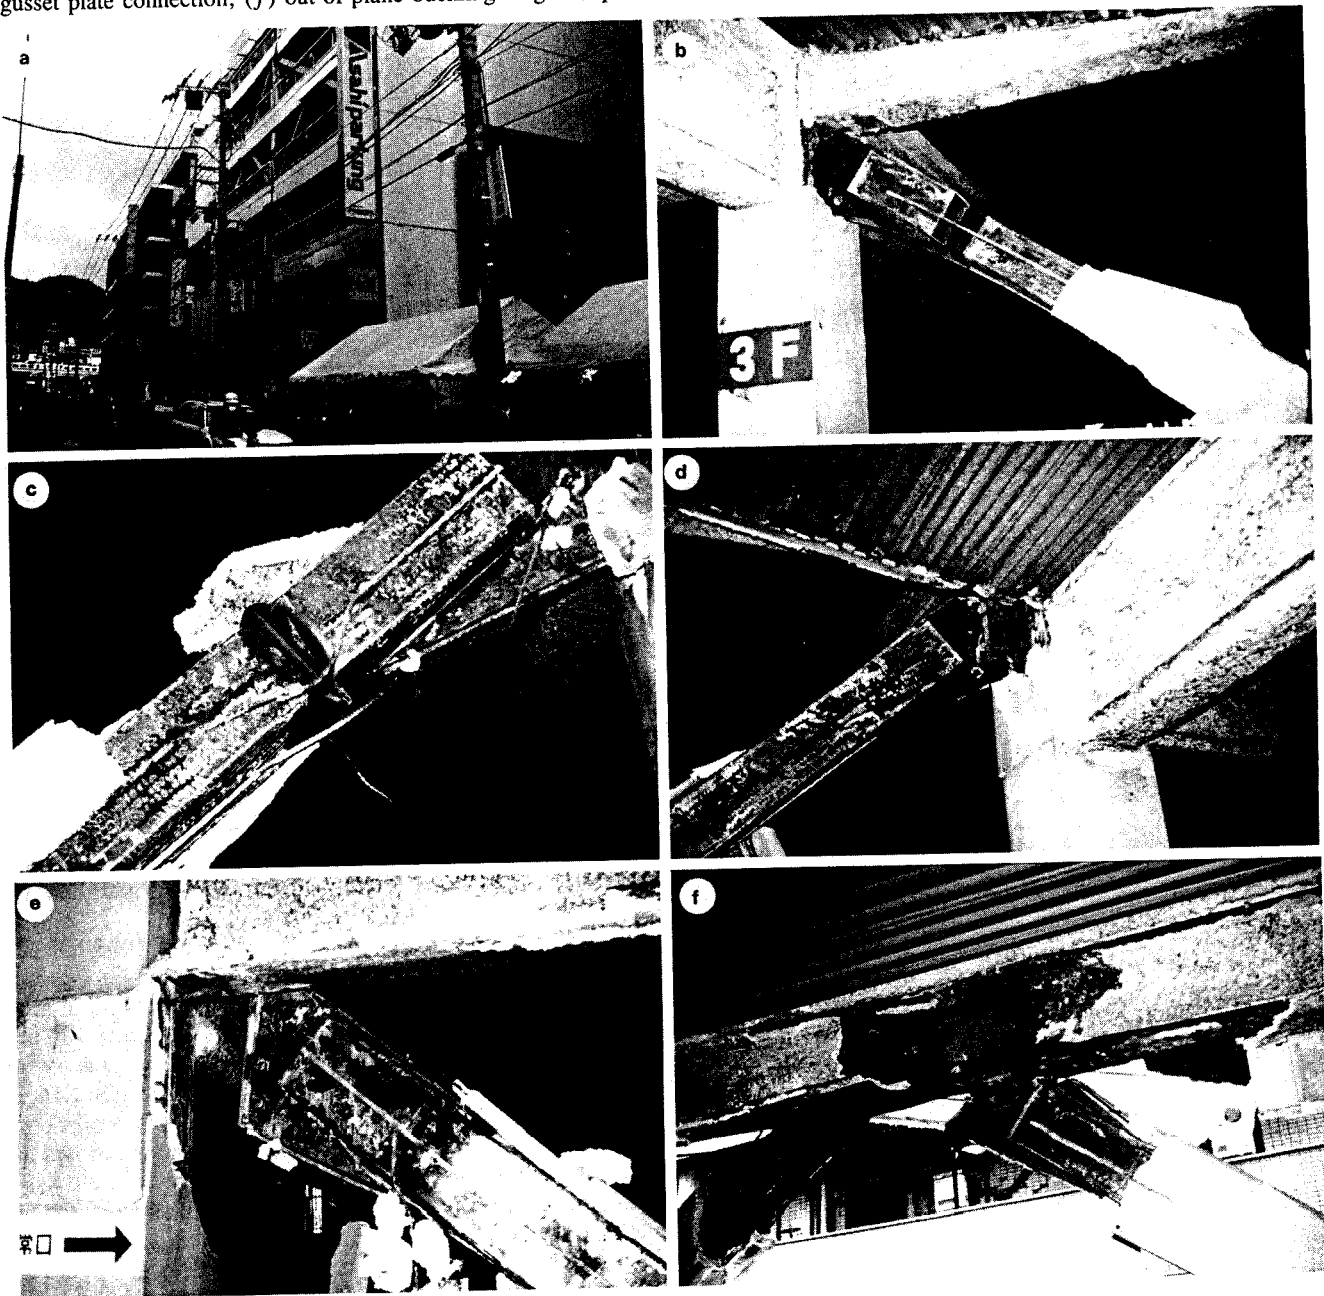
Fig. 33. Damage to a five-storey split-X braced parking structure: (a) view of the facade; (b) tension failure of a tube bracing member; (c) local buckling of a tube bracing member; (d) failure of a bolted gusset plate connection; (e) failure of a welded gusset plate connection; (f) out-of-plane buckling of gusset plates and severe beam distortion at brace connection.

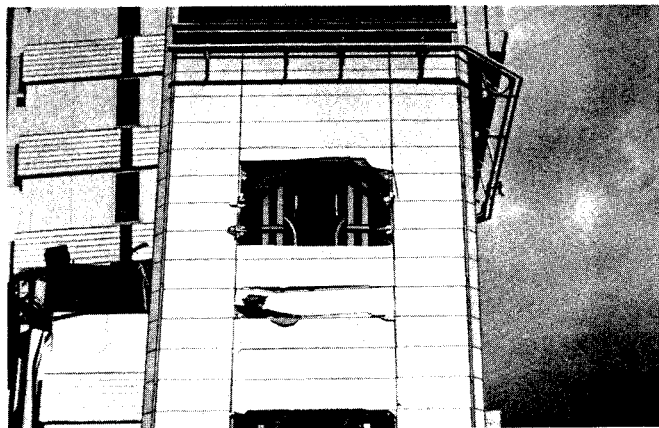
Fig. 34. Shedding of the exterior cladding of the slender parking structure shown in Fig. 16a as a result of the out-of-plane buckling of chevron braces.

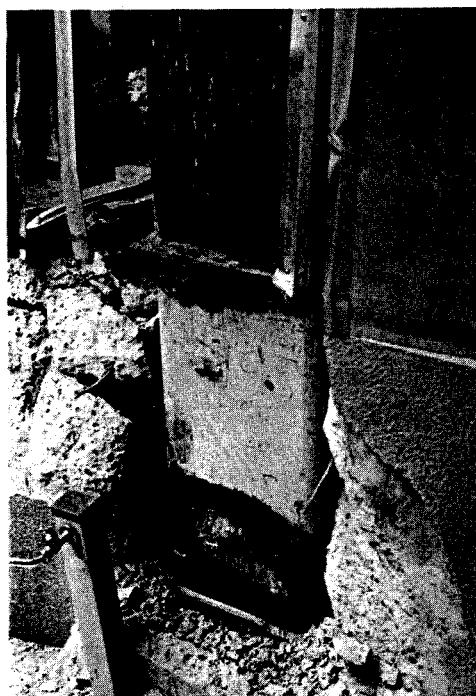
Fig. 35. Column damage in a braced frame.

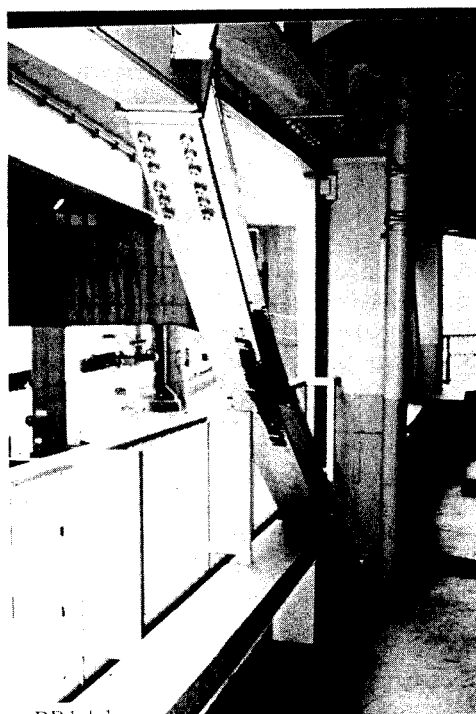
Fig. 36. Adequate inelastic performance of bracing members in a modern braced frame. (Courtesy of the Architectural Institute of Japan.)

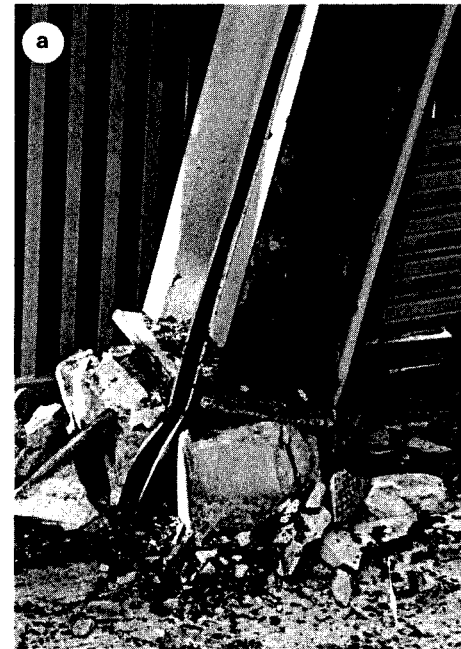
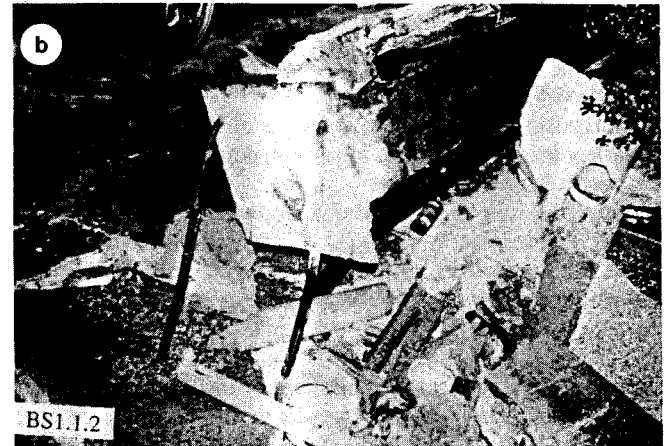
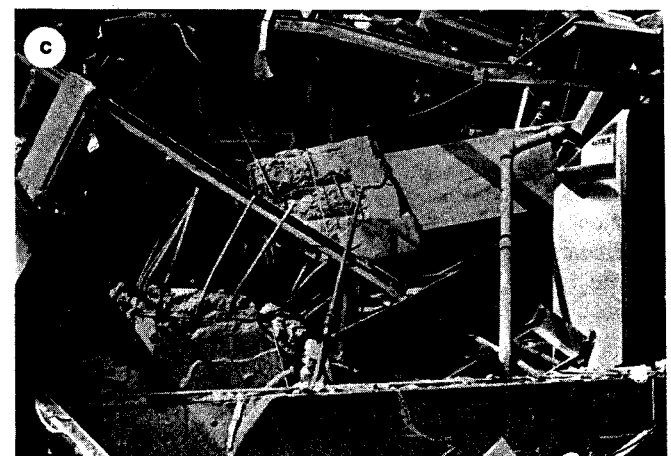
anchor bolt fracture (Fig. 38a) or anchor bolt pull-out (Fig. 38b). Concrete-encased column base connections also suffered damage in many instances (Fig. 38c).

Fig. 38. Damage to column base connections: (a) anchor bolts fractured; (b) anchor bolts pulled out; (c) concrete encased column base rupture. (Courtesy of the Architectural Institute of Japan.)

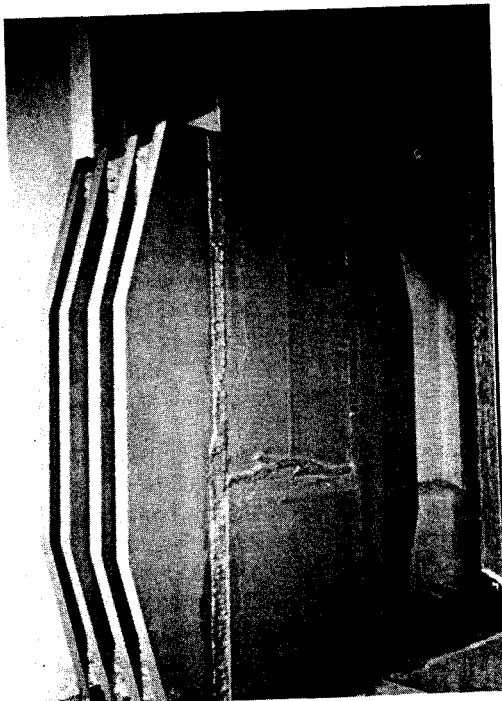
Fig. 41. Welded of and addition of reinforcement plates to cracked columns in the Ashiyahama Residential Complex.
