Preliminary report of structural damage from the Loma Prieta (San Francisco) earthquake of 1989 and pertinence to Canadian structural engineering practice

MICHEL BRUNEAU

Can. J. Civ. Eng. 17, 198-208 (1990)

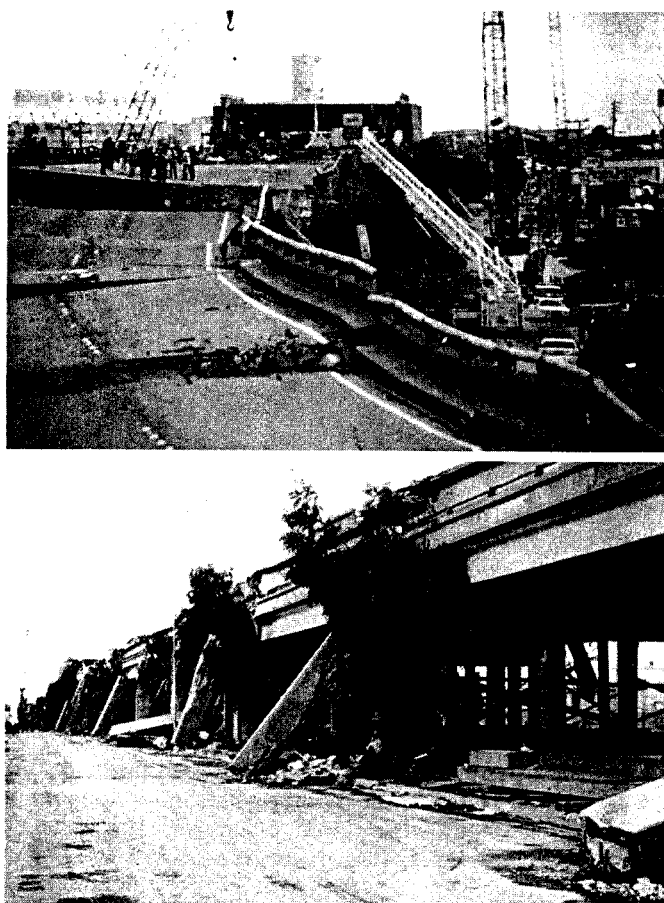
An approximately 2 km stretch of the elevated highway I-880, crossing west Oakland, has completely collapsed (Fig. 4). This double-decker highway carried 4 lanes of traffic in each direction. Typically, after failure of its supports, the upper deck fell on the lower deck, trapping a number of vehicles between the decks and killing a large number of people.

There is not sufficient evidence at this time to determine if all affected spans collapsed simultaneously or if a "domino" effect was initiated by the failure of a single span. Nevertheless, all spans between the points where the freeway changes from a double to a single deck highway partially or totally collapsed.

FIG. 4. I-880 highway in west Oakland: (a) looking longitudinally south from north end; (b) looking at elevation from west side.

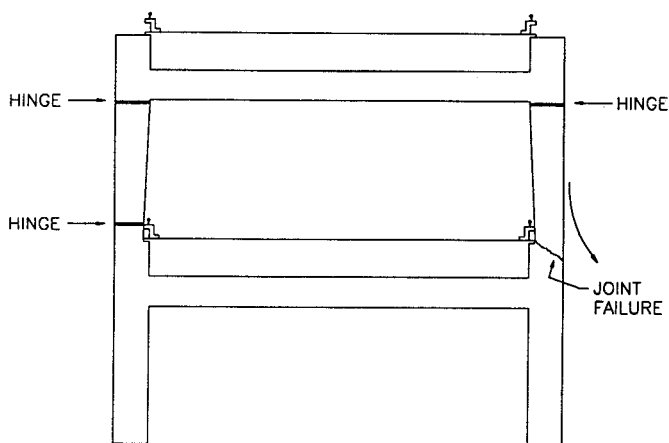
Figure 5 presents schematically the highway cross section. In most instances, columns supporting the upper deck were hinged such as to make the system statically determinate. Typically, only the base of one column was not hinged, and

FIG. 5. I-880 highway schematic cross section, structural concept, and location of initial failure.

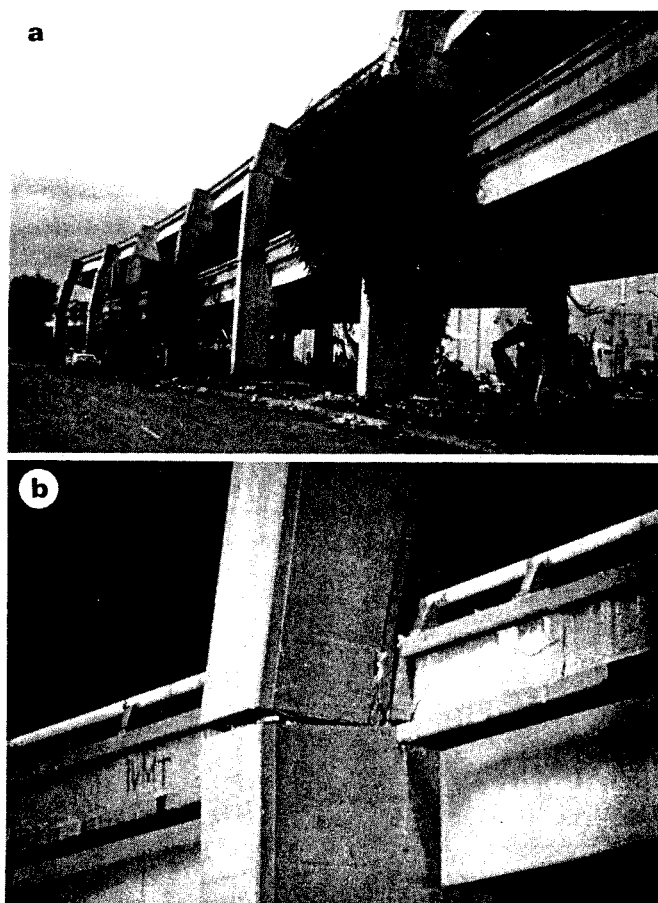
this “continuous” column was not regularly constrained to be on the same side of the highway. The original drawings will be required to determine the actual hinges layout. Hinges were accomplished by the insertion of a felt-type material effectively reducing the concrete area of the column from a 38 ×

48 in. (97 × 122 cm) heavily reinforced cross section to a 36 × 22 in. (91 × 56 cm) core with only 4 × #11 bars continuous for approximately 2 ft (0.60 m) beyond the hinge into the lower column (Fig. 6). The original hinge design was intended to make the higher level of the structure statically determinate, thus simplifying the evaluation of thermal and traffic overloads stresses in the structure, as well as stresses due to a prestressing scheme across the width of the upper deck that could have been implemented had it been judged necessary to connect additional access ramps to the upper level of the structure after completion of the highway.

FIG. 6. (a) General view of typical hinged upper column on west side; (b) close-up view of same.

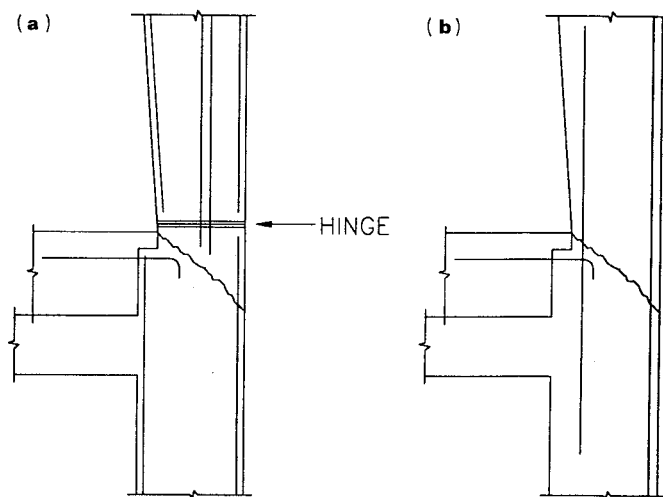
FIG. 7. Schematic illustration of joint failure at (a) hinged base of upper column and (b) continuous base of upper column.

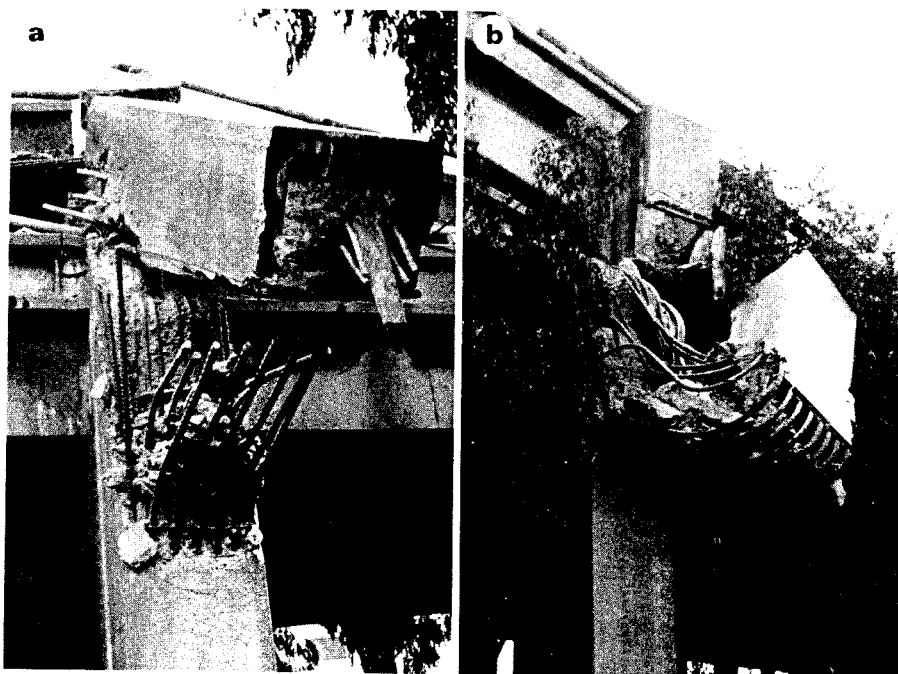
Typical joint failures of hinged and continuous columns of the highway I-880 are shown in Fig. 8, where the failure surfaces are clearly seen to be above the bent of the horizontal

reinforcement, and to intersect no stirrups. It should nevertheless be noted that if a single frame would have been present with both columns hinged top and bottom, a mechanism would have been created with no theoretical lateral load resistance, but no such frame has been identified at this time. Finally, a resonance phenomenon should not be ruled out, as the exact influence of the soft underlying soils on the ground motion characteristics are also uncertain in this particular case.

FIG. 8. Typical joint failure at (a) base of hinged upper column and (b) base of continuous upper column.

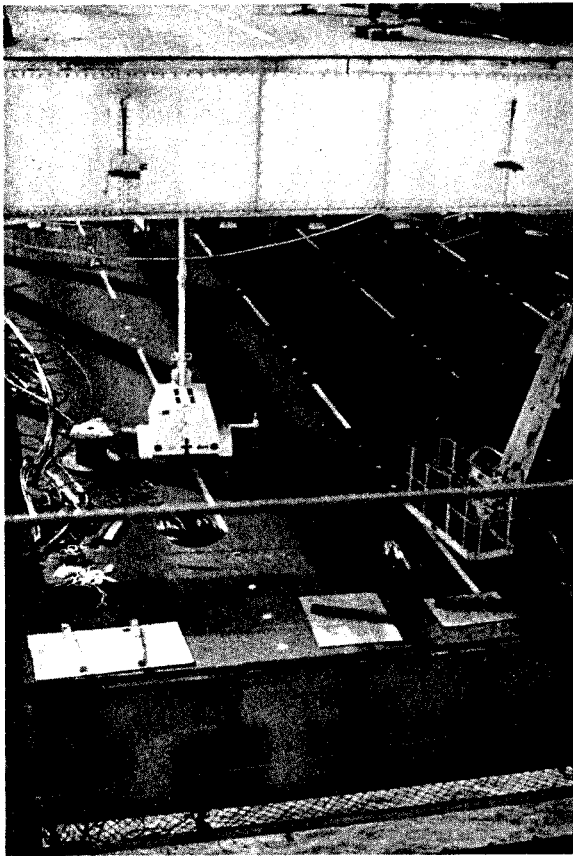
The unattached side of the spans simply slid off their supports to produce the observed collapse.

It is noteworthy that movement restrainers, in the form of steel buttress beams installed at the east end of the bridge to limit its lateral movement and which have served their function during the earthquake, have not been sufficient to prevent the aforementioned failure.

FIG. 9. West side supports of span across pier E-9 of San Francisco–Oakland Bay Bridge.

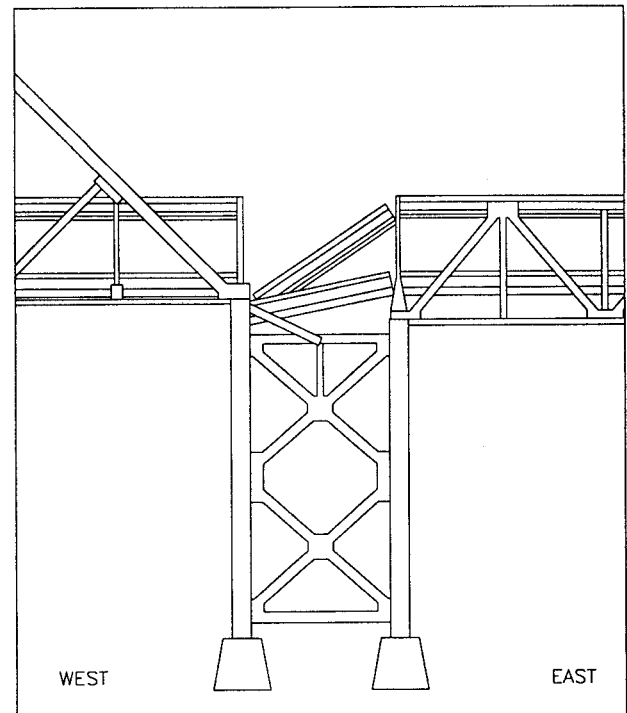
FIG. 10. Schematic representation of pier E-9 (Bay Bridge).

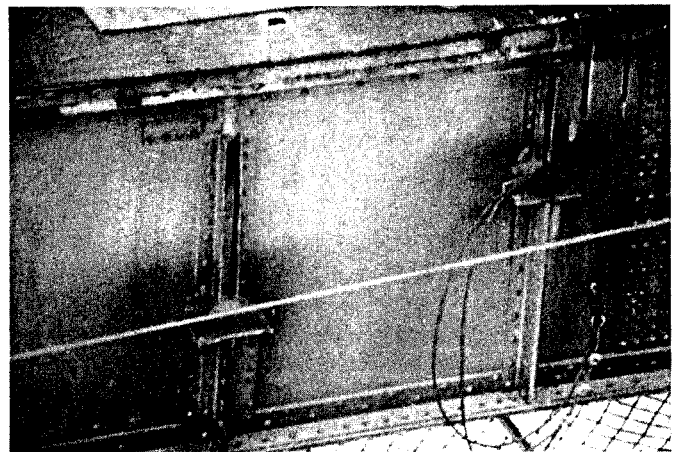
The Bay Bridge, opened to traffic November 12, 1936, consists of a suspension section connecting San Francisco to Yerba Buena Island, and a cantilever section from that island to Oakland. Trains were originally carried along the southern half of the lower deck, and lighter traffic on the upper deck, which explains the unusual variable depth/spacing girder configuration that can be observed (Fig. 9). The strengthening solutions implemented during conversion to traffic only, while interesting, have not modified the fundamental design concept in the damaged area. The only damage to this very long span occurred above pier E-9. This structural steel pier is of a four-legged very rigid braced design, schematically reproduced in Fig. 10. The truss bridge sections east and west of pier E-9 were rigidly connected to the east and west legs of the pier respectively. The roadways built across this pier were simply supported. The original design assumption was that each side of the pier would not move relative to each other. Yet, after the earthquake, the residual displacement of the bridge section east of this pier was 13 cm (5 in.) east (longitudinally) and 2.5 cm (1 in.) north (laterally), and the twenty 2.5 cm (1 in.) diameter bolts that connected it to the pier were sheared off. It is estimated that the bridge might have moved 18 cm (7 in.) eastward during the earthquake. The simply supported spans across pier E-9 were connected to the east part of the bridge that broke free, and rested on seat connections with web alignment plates, totally free to move, on the west side (Fig. 11).

FIG. 11. Typical beam seat and web alignment plates (Bay Bridge).

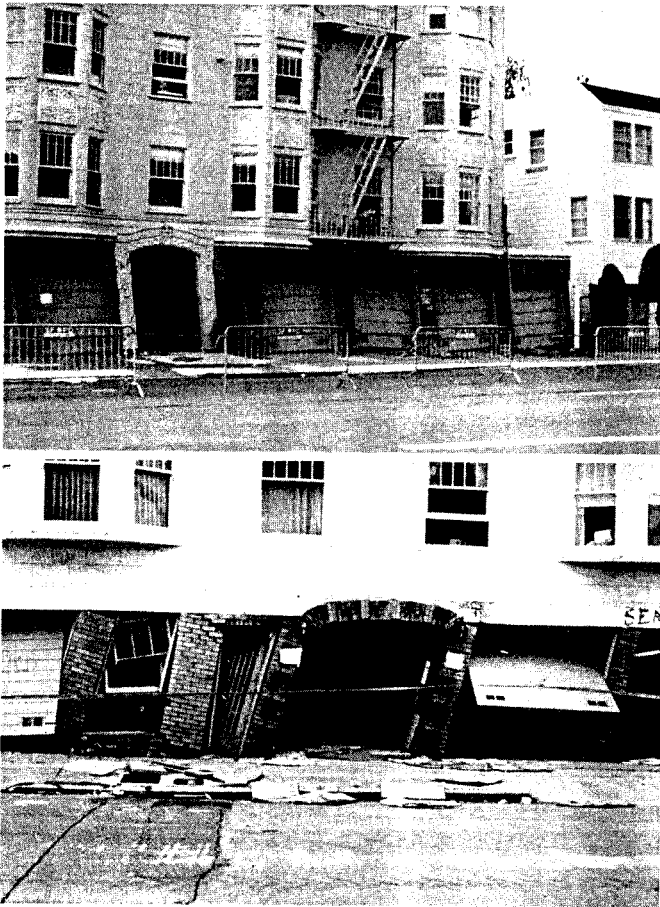
As seen in Fig. 12 of typical residential buildings which nearly collapsed, the first story of such structures is mainly open to be used for parking purposes. A softer story is there-

fore created, i.e., a story where a relatively small number of partitions is available to resist the seismic excitation, when compared to the upper stories which are subdivided by a large number of wall partitions. Consequently, all the energy dissipation (i.e., structural damage) will be constrained to take place in the first story. It is noteworthy that most modern structural engineering codes are not rigorously designed to prevent this very undesirable behavior. Further, in most damaged buildings, not only were there few structural elements on the first story effective in resisting lateral forces, but those remaining elements were often walls of latticed wood construction, not believed very good in transferring the seismically induced shear forces. Soft stories have been recognized to be a problem in engineered structures since the Richter magnitude 6.6 1971 San Fernando Valley earthquake (Bertero 1979); this is the first time it has been observed on residential structures to such a large scale.

FIG. 12. Typical residential structures with "soft-story" problem (Marina district, San Francisco).

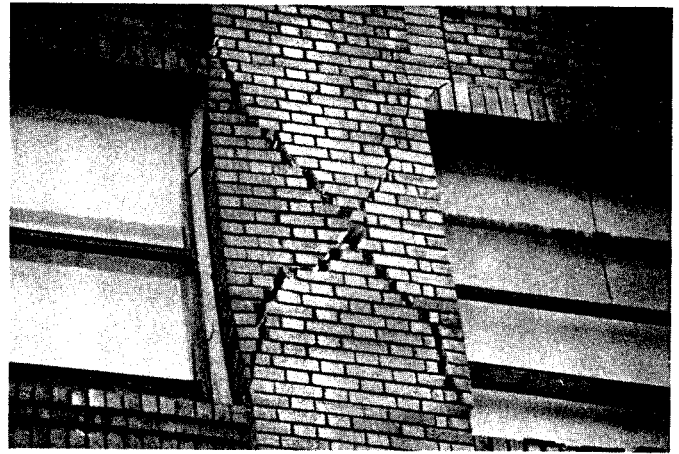
Most well-known types of unreinforced masonry building failures were observed, including severe diagonal cracking in columns between windows (Fig. 13), loss of masonry walls improperly tied to the rest of the building (Fig. 14), roof joists or beams slipping off their supporting wall (Fig. 15), fallen parapets, cornices, exterior cladding/glazing or veneers, or decorative elements, and, of course, failure of the building as a whole due to insufficient lateral load resistance. Pounding of adjacent buildings was also apparent in many instances.

FIG. 13. Typical short column shear failure of masonry structure (Oakland).

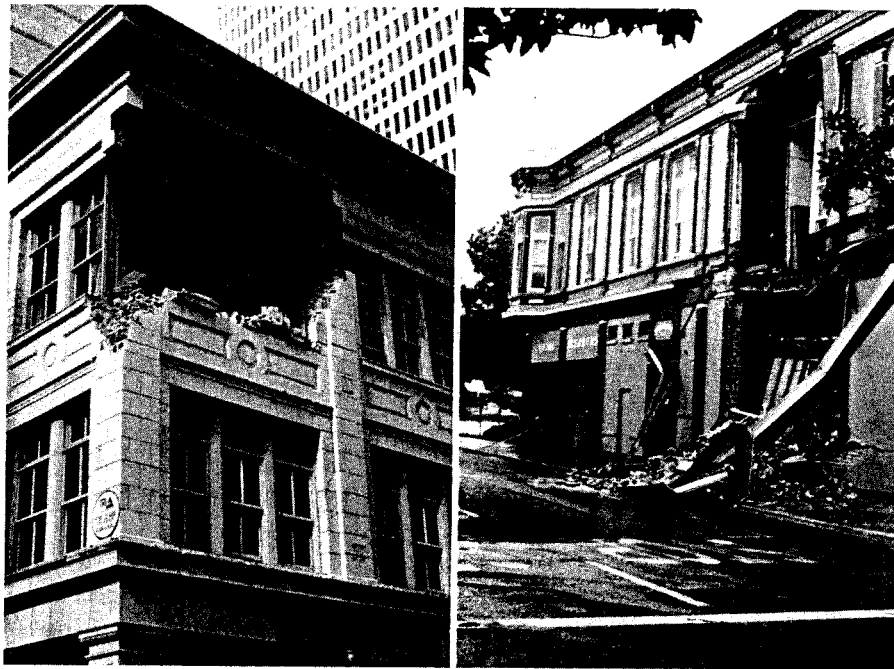
FIG. 14. Typical loss of masonry walls (San Francisco and Santa Cruz).

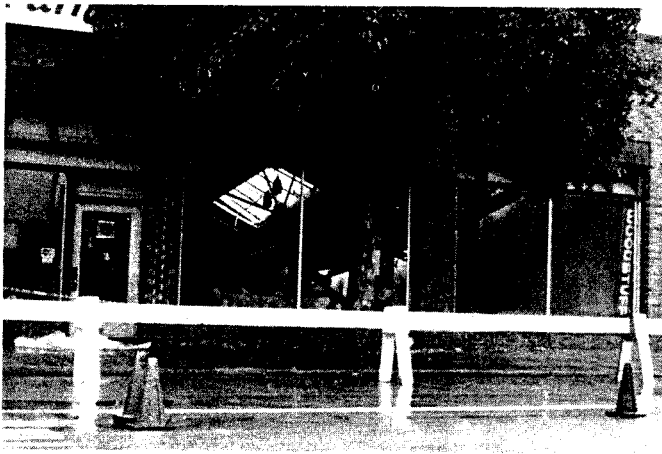
FIG. 15. Typical failure due to slip of roof joists off their wall supports (Santa Cruz).

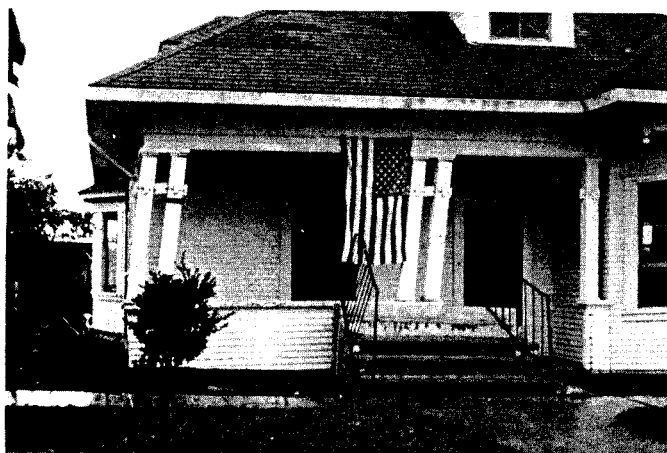
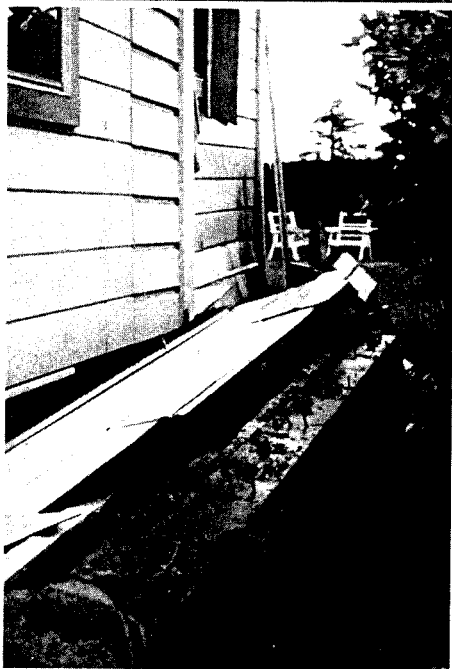
As shown in Fig. 17, a widely used older residential construction practice consisted of using small "pony wall," typically 46 cm (18 in.) tall, in order to raise the first floor above concrete foundations extending only a few centimeters beyond the surface; pony walls were made of wood construction, and in most cases poorly connected to the foundation. Rigid-body rotation of these walls displaced the houses laterally under seismic excitation, a deficiency not unlike that of a soft-story concept. Newer residential construction has fared generally very well.

FIG. 17. Older residential structure on "pony-walls," not properly connected to its foundation (Hollister).
