Hysteretic behavior of repaired C-shaped concrete filled-composite plate shear walls (C-PSW/CF)

Emre Kizilarslan^{*}, Michel Bruneau

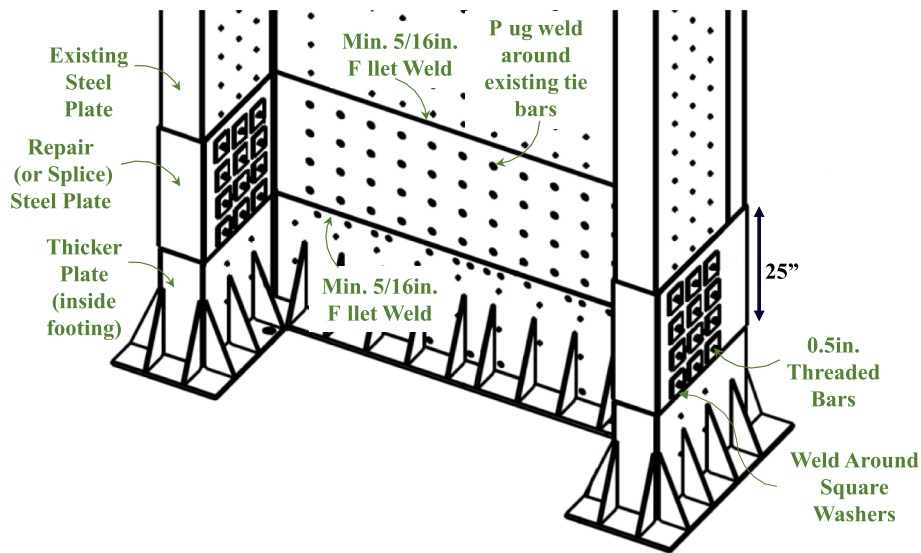
Fig. 3. Repair concept for the Specimen C2 (Note: 1 in. = 25.4 mm).

- 1) Chipping away a part of the concrete footing (Fig. 2a) at the face of the wall, removing enough concrete to expose the CJP weld of the wall plate to the thicker wall plate inside of footing (Fig. 3).

- 2) Cutting and removal of the buckled and fractured steel and removal of the loose concrete exposed by removal of the plates. This was expected to involve some chipping of the exposed concrete all around the wall, and removal of concrete through the entire thickness of the wall in some locations (such as in most of the webs).

- 3) Adding steel plates along the entire perimeter of wall at its base where buckled/fractured plates were removed. These new steel plates, effectively acting as splice plates, were to be fillet-welded at their top and bottom ends. At the bottom end, this would be to the existing thicker plate located inside the wall's footing, and at the top end to the existing non-damaged steel plate. Note that, at the bottom, the splice plate was fillet-welded to the thicker wall plate to "by-

pass” the thinner plate at the wall base, in order to achieve load transfer directly to the thicker plate and ensure no yielding of the thinner plate there. The new splice would be made of plates of identical dimensions “wrapping” all around the wall, as shown in Fig. 3.

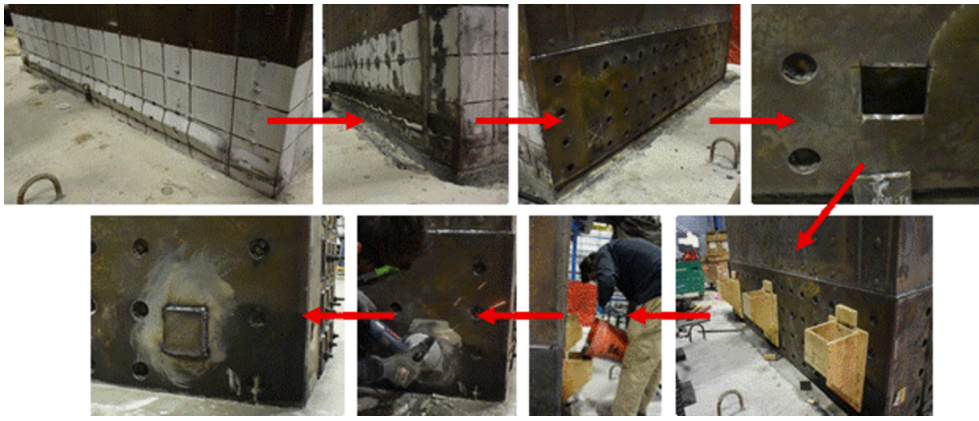
Fig. 7. Repairing sequence of flanges.

For the implementation, there was no damage in the west flange. Therefore, a 3/8 in. (9.53 mm) repair plate having holes at the same spacing as for the existing tie bars, was placed on top of the 3/16 in.

(4.76 mm) existing steel plate. The top and bottom of the repair plate were fillet-welded to the existing plate and the tie bars were plug-welded to the repair plate around the holes. On the east flange, where the steel in 1st and 2nd tie-bar row had buckled during the prior test, the same approach was used, except that the buckled steel was cut out prior to application of the repair plate. This cutout was done in a way that left some steel around the tie bars were left for plug welding. Also, the damaged concrete behind the buckled steel was removed (approximately 3 in. (76.2 mm) of the wall thickness) prior to adding the splice plate. Note that in order to facilitate welding the splice plate to the thicker plate inside the footing, the bottom of the splice plates was beveled, as shown in Fig. 5. After that, three 3 in. \times 3 in. (76.2 mm \times 76.2 mm) holes were cut in the middle of 1st and 2nd tie-bar rows, 3 ft. (914.4 mm) apart from each other. Scuppers were attached to the surface of the plate with screws; these were wood boxes with an opening at their bottom attached to the surface of the wall, where the 3 in. \times 3 in. (76.2 mm \times 76.2 mm) holes were located (as shown in Fig. 6). Then, a MasterEmaco S-440CI self-consolidating repair mortar with 3/8 in. (114.3 mm) aggregate, integral corrosion inhibitor and high workability was poured through scuppers. During pouring, the plate was tapped with hammers to generate vibration to help fill all voids. Filling the scupper to the top created enough pressure to fill all empty space of chipped concrete. To further confirm that the concrete reached the top of the cavity, this was also checked by hand (with fingers through the holes as far as could reach), and by concrete leakage from small holes of 1/8 in. (38.1 mm) diameter, that were drilled at the top level of chipped concrete on

the far ends and middle of the splice plates. Then, the lids of the scuppers were slid to close the holes. Next day, the scuppers were removed and the surface was cleaned. Finally, the opened spots were capped by welding around slightly bigger plates (Fig. 7).

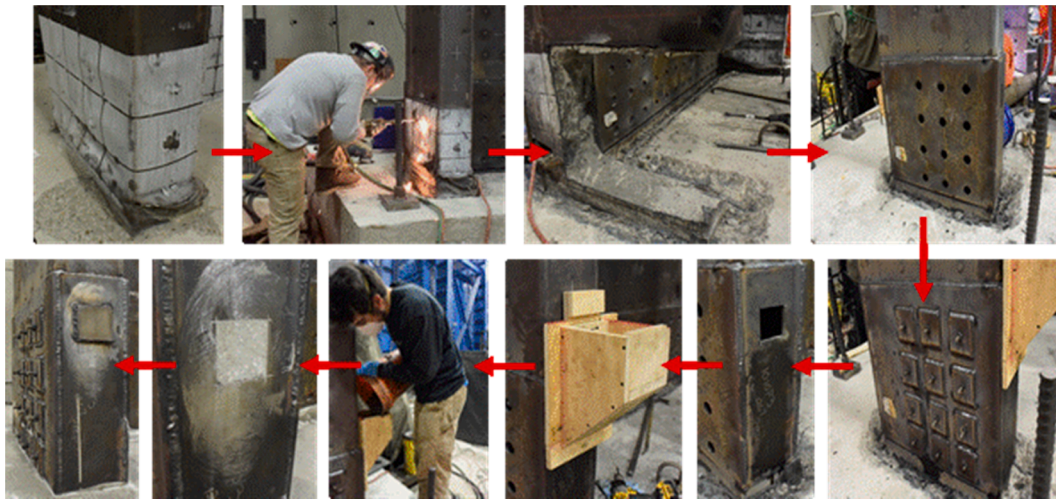
Fig. 8. Repairing sequence of webs.

The damage on both north and south webs spread up to four rows of tie-bars (Fig. 8). Therefore, the same repair strategy was applied to both webs, which consisted of removing the steel plates, concrete and tie-bars in the damaged area, and installing new ones. The steel plate was flame-cut first. Then, the concrete and tie-bars were removed with concrete chipping machines (i.e., jack hammers). The repair plates were positioned in-place and fillet welded at their top and bottom. Then, 0.5 in. (152.4 mm) diameter threaded rods were placed through pre-cut holes in the repair plates and washers were put on each side of the webs and tightened with bolts. In order to prevent concrete leakage, the washers were welded around the plate. Then, concrete was poured through a scupper that was mounted to a pre-cut hole (3 in. \times 3 in. (76.2 mm \times 76.2 mm)) on the cap plate, as described above for the flange. The same procedure was followed, except that, in this case the 1/8 in. (38.1 mm) holes were drilled at the end of web, close to the corners of the wall.

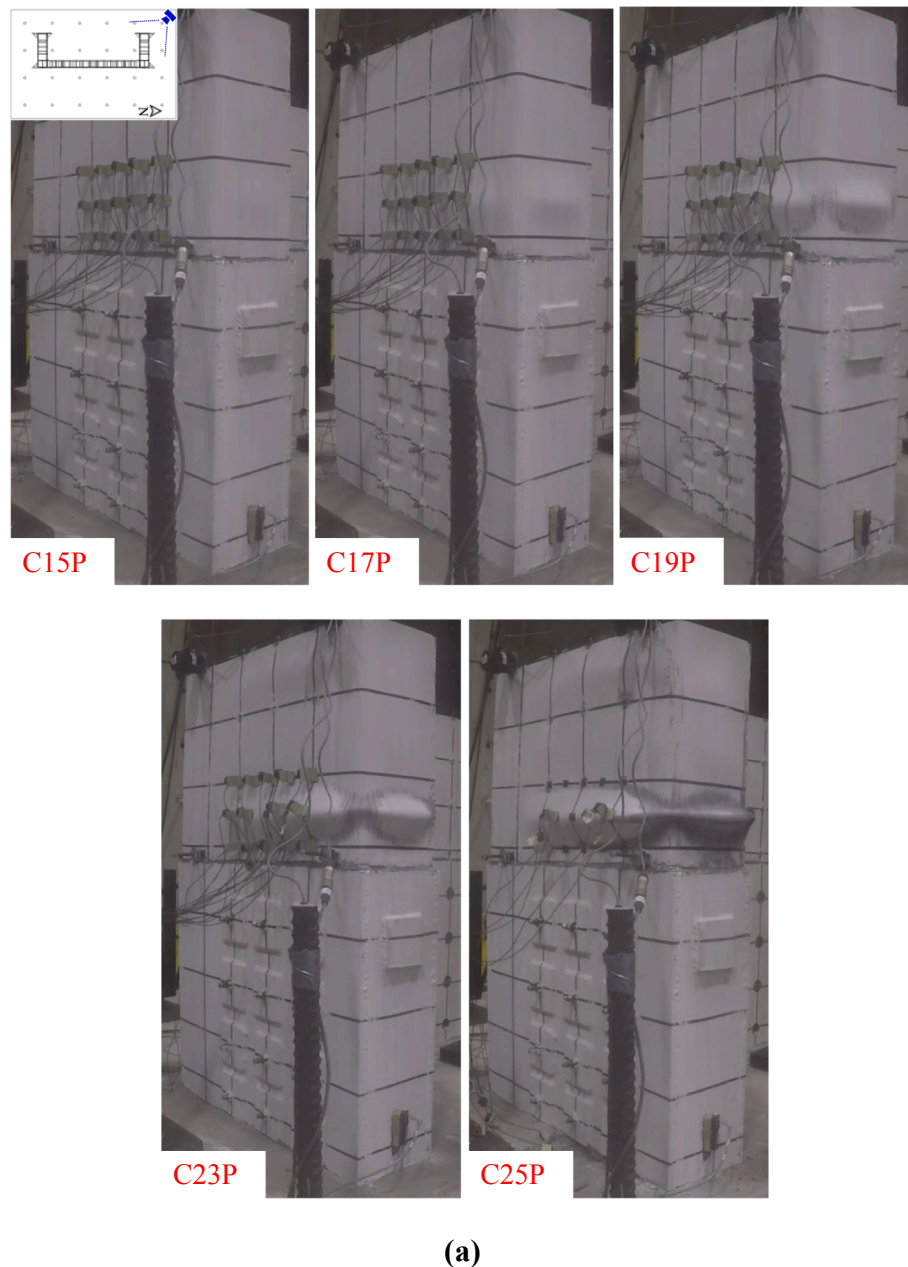
Fig. 11. Local buckling in Repaired Specimen C2 at different displacements cycles and locations: (a) the North Face of North Web (NWN), (b) the South Face of South Web (SWS), and; (c) The East face of Flange (FE).

excursion of $1.5\Delta_y'$ (3.0 in. (76.2 mm)/ -2.25 in. (57.2 mm)) displacement (i.e., Cycle 14). This buckling occurred on the steel plate between the 1st and 2nd tie rows on both the South face of the North Web (NWS) and North face of South Web (SWN). Moreover, steel at 4 in. from the top of the repair plate also started to buckle on the West surface of North web (NWW). During the third excursion at that peak displacement (i.e., Cycle 16), buckling was also observed to initiate on the steel plate between the 1st and 2nd tie rows at the North face of the North Web (NWN) and the steel located at 4.5 in. and 11 in. from the top of the repaired part on the West surface of South web (SWW) also started to buckle (C16P in Fig. 11 a). During the cycles at $2\Delta_y'$ (i.e., Cycle 17 with amplitude of 4 in. (101.6 mm) and -3 in. (76.2 mm)), the lateral strength of Repaired Specimen C2 reached the maximum values of 427 kips/ -197 kips (1899.4 kN/ -876.3 kN) in the positive and negative drift directions, respectively. Moreover, the steel plate between 1st and 2nd

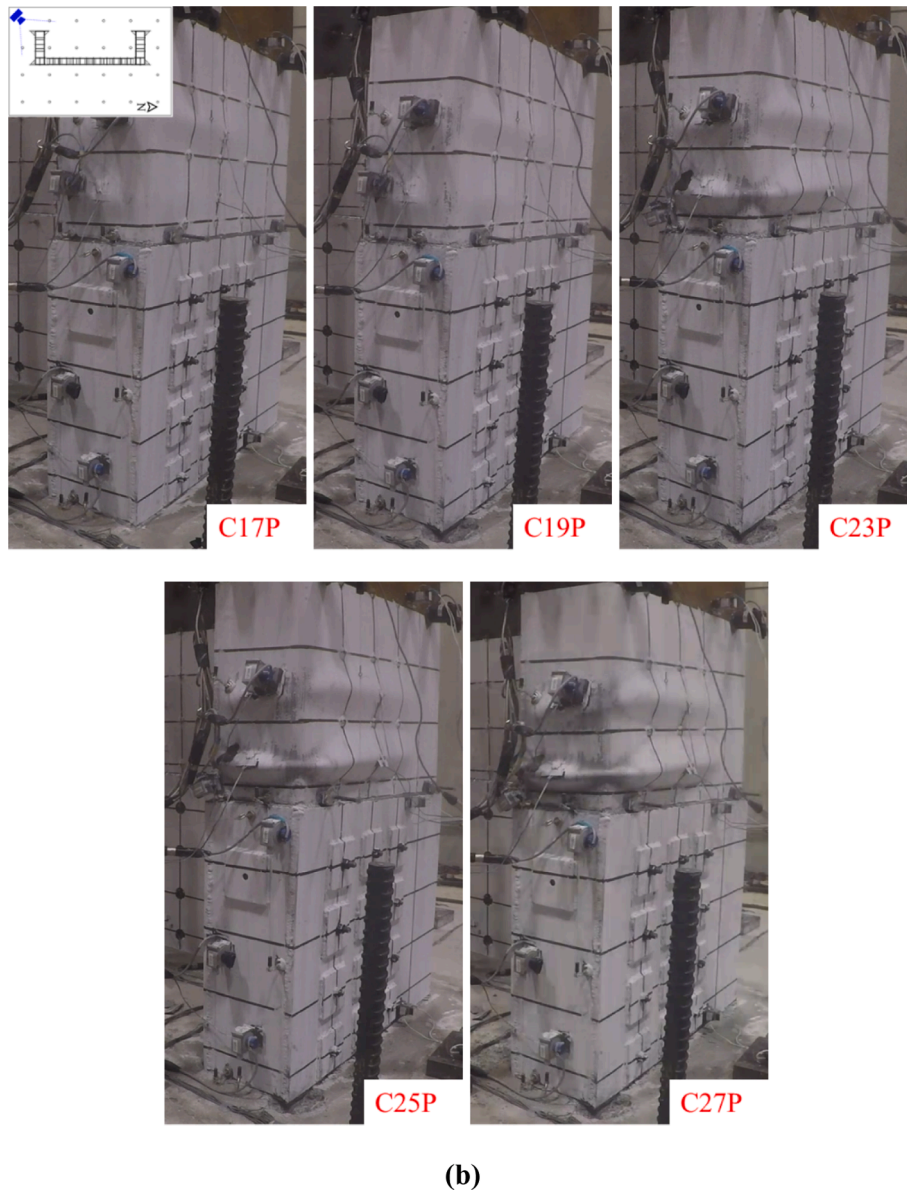
(b)

Fig. 11. (continued).

tie bar row on the South face of the South Web (SWS) started to buckle (C17P in Fig. 11b).

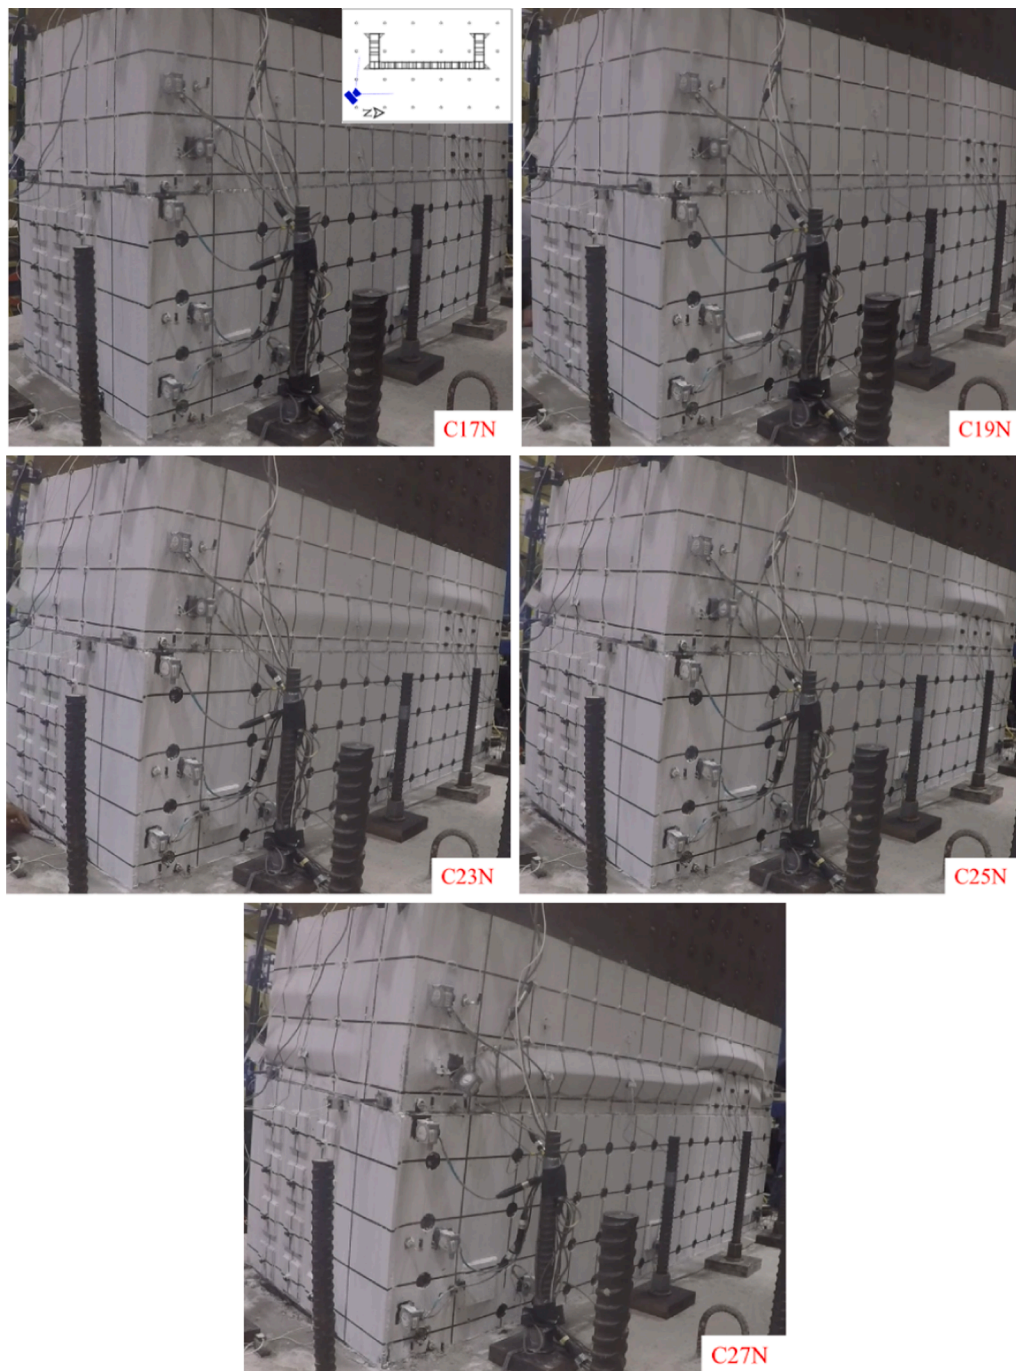
(c)

rows buckled on the East flange (labeled FE afterwards) for about 27 in. from the North side of the wall in the negative direction as in C18N in Fig. 11c. Buckling was also visually observed to initiate on the steel plate at the East face of the Flange (FE) between the 1st and 2nd tie rows in the second cycle (i.e., Cycle 18). During last excursion at the negative drift (i.e., Cycle 19), local buckling initiated on the steel plate between the 1st and 2nd tie bar rows on FE, except for the place on FE that had buckled between 2nd and 3rd tie-bar row in the previous cycle (refer to in Fig. 11c). Table 1 provides a comprehensive outline of the buckling that developed on the specimen throughout the test [11].

Fig. 11. (continued).

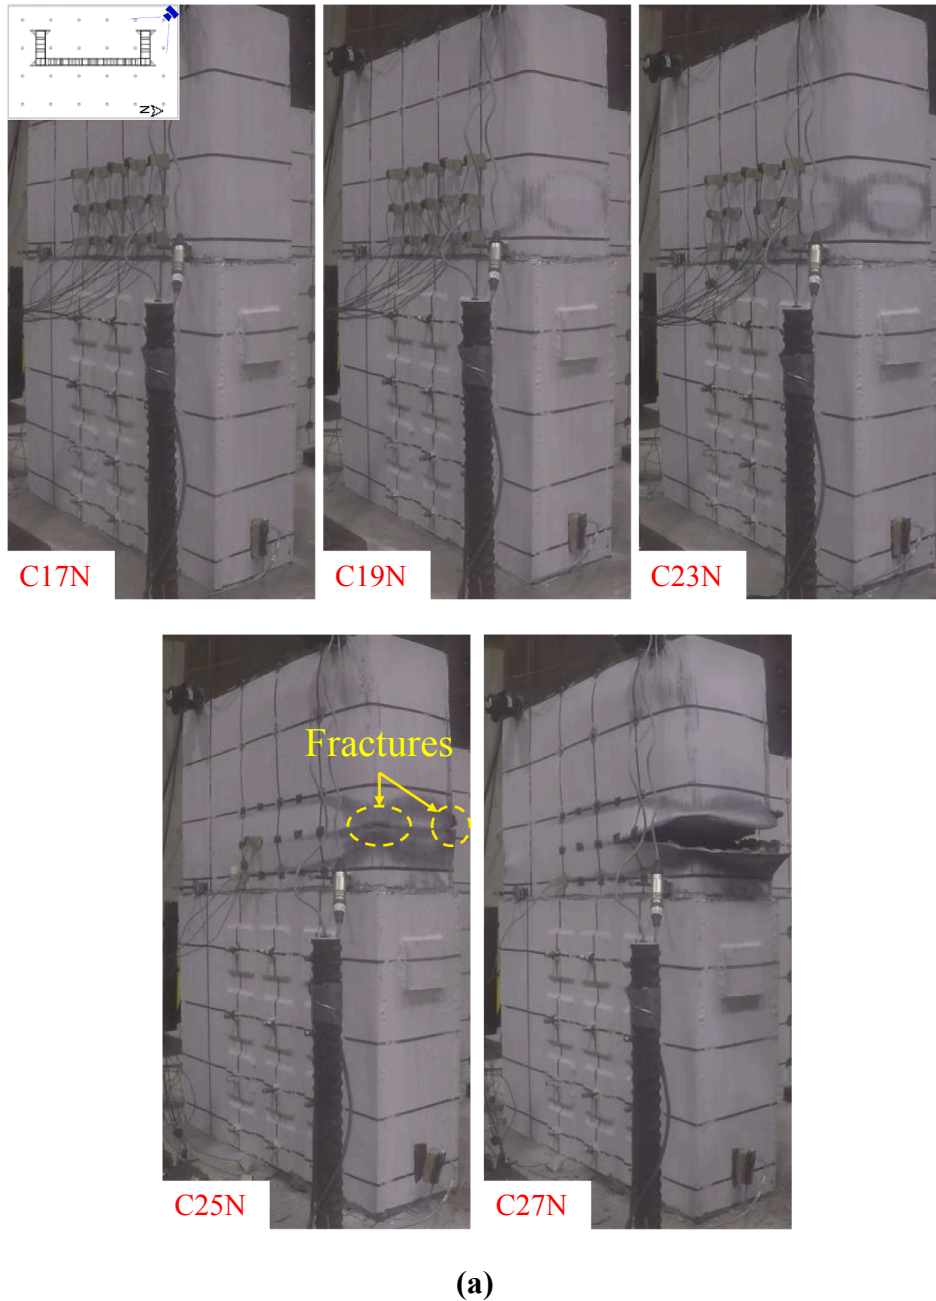
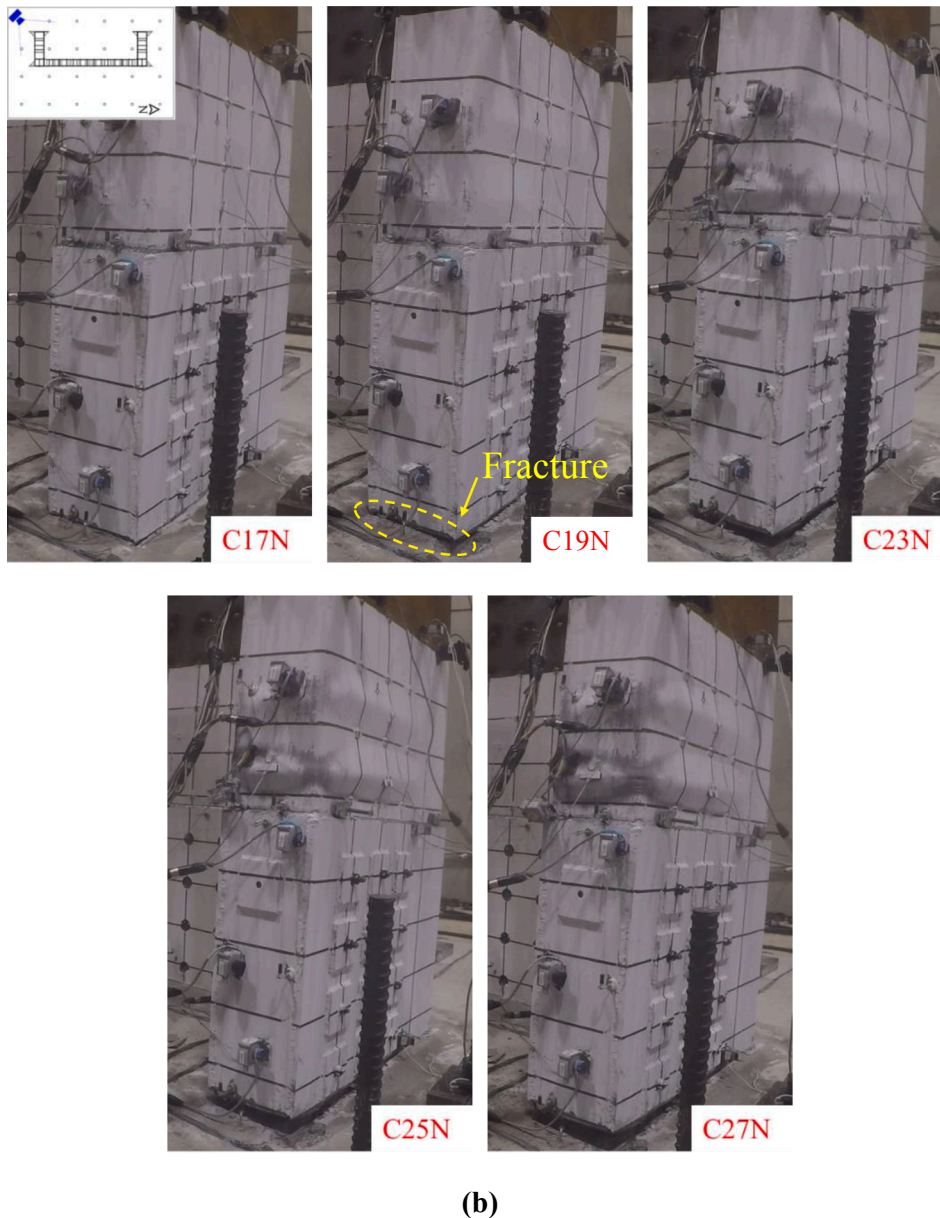
Fig. 12. Fractures in Repaired Specimen C2 at different displacements cycles and locations: (a) the North face of North Web (NWN), and; (b) the South Face of South Web (SWS).

The above behavior is in part captured by Fig. 11, which maps where local buckling occurred on the specimen at different peak displacements. Likewise, Fig. 12 shows fractures in Repaired Specimen C2. The labels in these figures (in the form of CnP and CnN) refer to peak positive and negative displacements during Cycle n . For example, $C15P$ refers to the peak positive displacement (P) reached during the test's fifteenth cycle ($C15$).

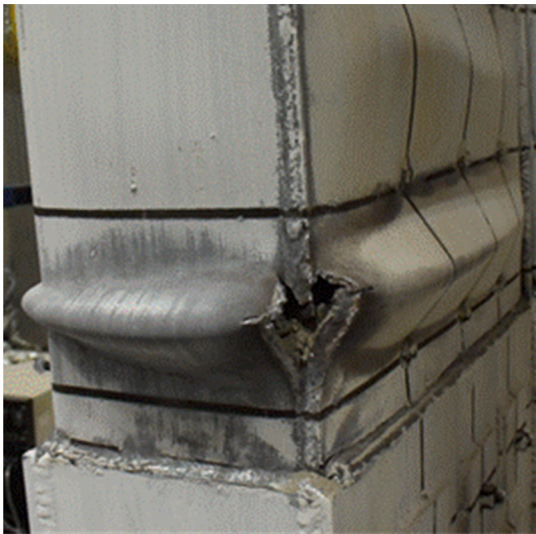
Fig. 13. Vertical weld fracture at the corner of the NWS and NWW surfaces.

fracture surface after completion of the test showed that the fracture of the new weld at that location revealed lack of fusion with the beveled splice plate, as shown in Fig. 15. In actual buildings with a number of underground levels, peak moment in the wall would be in the slab at ground level, making concrete removal in the less heavily reinforced slab around the wall easier, thus improving access to weld details and

making it possible for the detail at the bottom of the reinforcing plate to be a mirror image of the detail at the top. However, the experimental results here are helpful to emphasize the need to provide a good/clean access to all critical repair locations. This fracture propagated more through web during the negative drift of the Cycle 23, and did not change in the following cycles. The same phenomenon happened for the fracture at NWN, but the fracture at NWS was through the thicker plate in the footing. Note that in the laboratory setting, due to the presence of the footing, the weld connecting the splice plate to the thicker plate was difficult to accomplish, as it was hard for the welders to see the bottom of the splice plate, even though it was beveled.

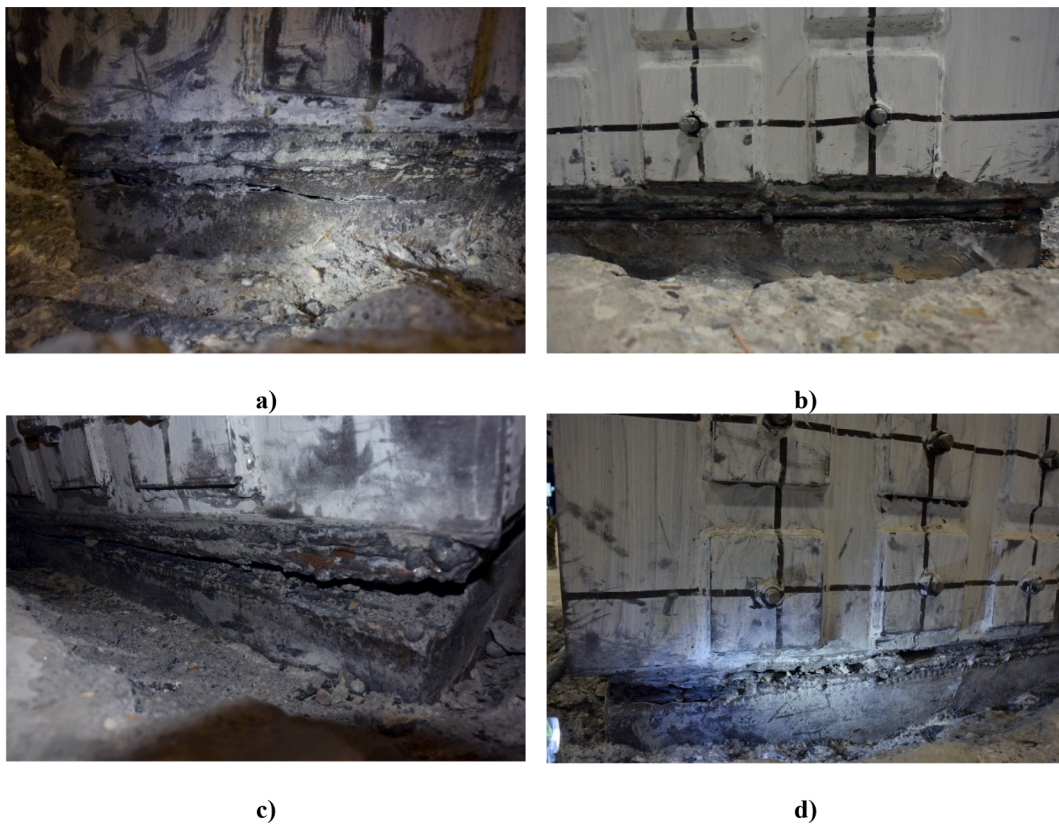
Also, when the test was over, the concrete all around the webs and at the corners of the flanges in the footing was chipped off to reveal how much the fracture propagated in both webs of the wall. Fig. 14 shows the fractures of welds connecting the repair plate to the thicker plate inside of the foundation at NWS, NWN, SWN and SWS, respectively. The weld in the south web fractured almost all of the web's cross section, up to the flange (24.5 in. (622.3 mm) at SWS and 24 in. (609.6 mm) at SWN). However, the weld fractures at NWN and at NWS were shorter, at 20.5

in. (520.7 mm) and 9.25 in. (234.95 mm), respectively. The initial fractures at SWS and SWN were attributed to the fact that the location of the existing weld that connected the wall steel plate to a thicker plate in the footing, was not at the same height around the webs. Note that this thicker plate in the footing is an artifact of the experimental set-up used to prevent yielding in the footing and for needing a heavily reinforced shallow footing to be able to transfer the wall base moment to the strong floor. This heavy reinforcement created obstacles to removal of concrete in the footing. As a result, the splice plate added as part of the repair scheme ended-up to be a bit short in some places, making it difficult to weld the splice plate to thicker plate in the footing, as originally intended as part of the repair scheme (the same obstacles also challenged the welder in accessing this bottom detail). Therefore, in order to transfer loads to thicker plate inside the footing, five passes of fillet weld were done at that bottom location, trying to span the distance. However, in some places at the bottom end of the web, not enough weld material was added, and the splice plate ended-up being connected to the thinner part of the wall above the footing plate. As a result, a fracture initiated in the existing weld on the South Web. Furthermore, observation of the

The weld inside the footing in the South web fractured early during the test. This is because the repair weld at the base of the web was not executed as designed and failed prematurely. Therefore, the lateral load capacity of the wall in the negative drift direction was anticipated to be more than what has been obtained experimentally, which was the summation of the two recorded horizontal actuators forces. Hence, in Fig. 16, the applied horizontal force is also compared with twice of the horizontal force from the North actuator (2xNorth) as the weld inside

Fig. 14. Weld fractures at a) NWS, b) NWN, c) SWN and d) SWS.

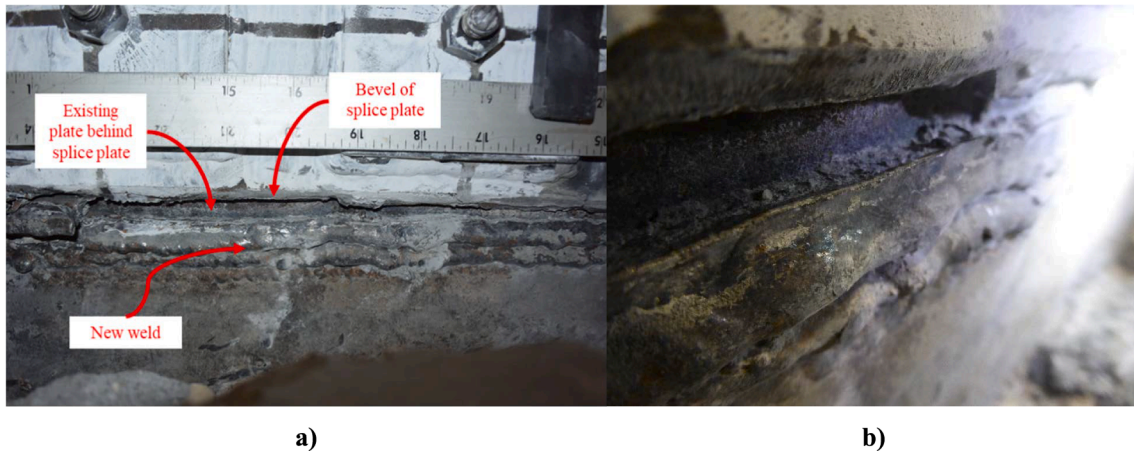
Fig. 15. Close-up picture of the fracture propagation at SWS from a) front view and b) side view.

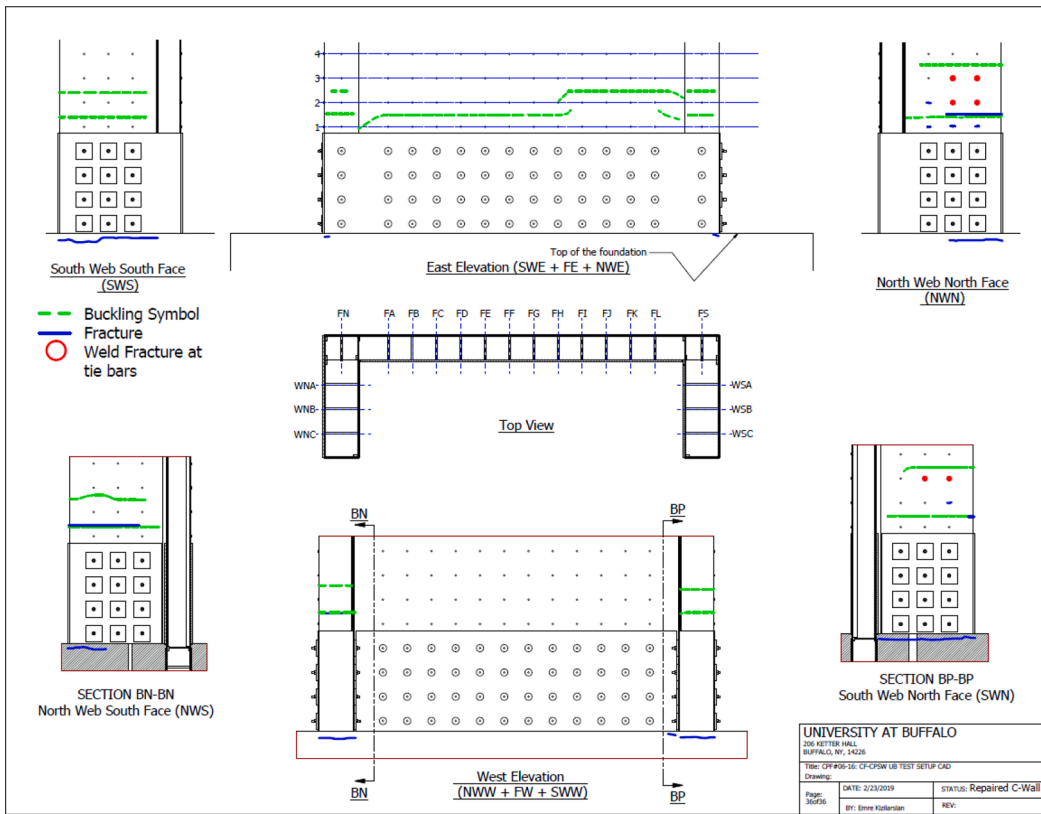
The specimens were inspected after the test. Fig. 24a schematically documents the buckling and fracture damage observed on the steel plates for Repaired Specimen C2. The corresponding pictures of the specimen in all directions are also shown in Fig. 24b. Note that when tie failures were observed, these were due to weld failure at one of their end connections.

Fig. 24. Post-test damage inspection of the wall steel plates for Repaired Specimen C2: (a) in sketch, and; (b) in pictures.
