DAMAGE TO ENGINEERED BUILDINGS FROM THE 1995 HYGOKEN-NAMBU EARTHQUAKE

ABSTRACT

A large number of engineered structures suffered damage due to the Hyogoken-nambu earthquake of January 17, 1995. Visual evidence of this damage to reinforced concrete and steel buildings together with preliminary descriptions of the possible reasons for this damage is given.

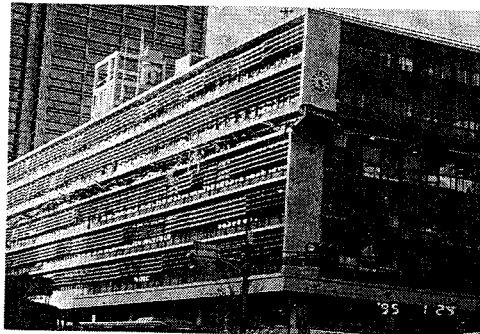
(a)

Never since the 1985 Mexico earthquake have so many reinforced concrete buildings in an urban area lost one or many stories completely, or collapsed totally (Photo 1). Although some of the causes for these collapses are identical to those identified following the Mexico earthquake, a number of the contributing reasons for this fatal damage are new due to the sometimes distinct Japanese construction practices.

Loss of a higher story can be attributed to a number of different causes. Frequently, setbacks and adjacent lower building-portions provide additional strength and rigidity to lower stories, and damage is concentrated in the first story above these lower stories. Another type of story loss was at the first story above a structural discontinuity, such as the end of a shear wall, a change in column cross-section, or even the transition story from a composite steel-reinforced-concrete structural system to a pure reinforced-concrete system. In the last case, it must be understood that the encasement of a steel frame in a reinforced-concrete frame has been a popular, uniquely Japanese approach to enhance the seismic resistance of buildings. Until a few decades ago, for economy the steel frame was constructed only over part of the height of building. This is the first earthquake in which story losses at the point of discontinuity of embedded steel frames have been observed.

Photo 1 Story collapse in RC buildings
[[a) 6th story collapse, (b) 2nd story collapse]]

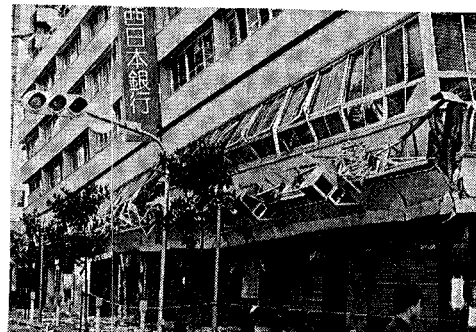
(b)

Loss of a story is typically the consequence of the excessive accumulation of damage in a single story, as opposed to the uniform sharing of damage and ductility through all stories which is implicit in modern building design codes. During the Hyogoken-nambu earthquake, these failures, also known as soft-story failures, frequently were found for the first story of buildings. Past experience during prior earthquakes worldwide has demonstrated that the contemporary architectural design of buildings, which emphasizes a maximum amount of clear open space at the first story, combined with the taller story height typical of these buildings, is responsible for higher flexibility and thereby the accumulation of damage in that first story.

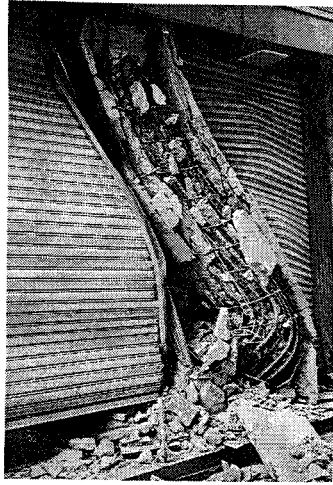
All-story collapses occurred in older buildings designed prior to the introduction of the requirement of the use of ductile material in Japanese buildings codes. For example, a close view of typical reinforcement detailing discloses the gross inadequacy of transverse reinforcement as compared to current requirements (Photo 2). It was standard practice prior to 1971 to space transverse reinforcement at a 300 mm interval center-to-center. Code changes introduced in 1971

Photo 2 Failure of an RC column with insufficient transverse reinforcement

limited the spacing to 150mm, further reducing it to 100 mm at the ends of structural members, thus providing more appropriate shear resistance and concrete confinement. Furthermore, the latest building code changes (1980) introduced other stringent ductile-design requirements as well as a two-level design procedure which effectively requires that the *ultimate* seismic-resistance of buildings be verified. As a result of this evolution of design requirements, striking contrasts in the life-safety protection afforded by adjacent buildings of different eras were readily observable following the earthquake (Photo 3). Although newer buildings sometimes suffered internal structural damage, they did not totally or partially collapse. This observation is supported quantitatively by data collected in a portion of downtown Kobe where damage was particularly severe (Fig.1).

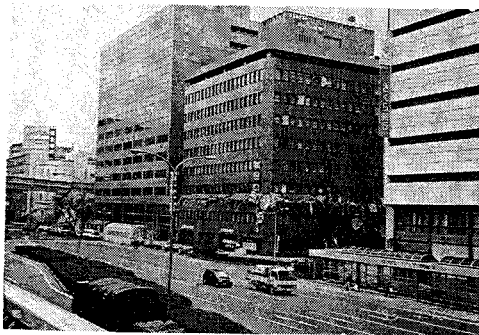
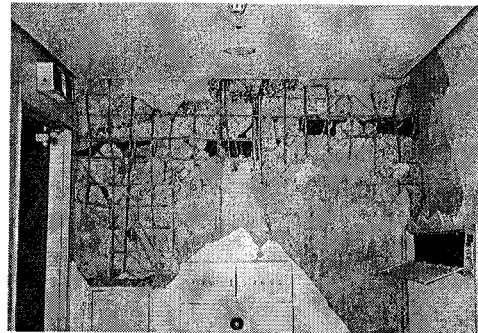
Photo 3 Difference in damage sustained by new and old RC buildings
[(a) new building (left) and old building (right), (b) damage to shearwalls in the new building]

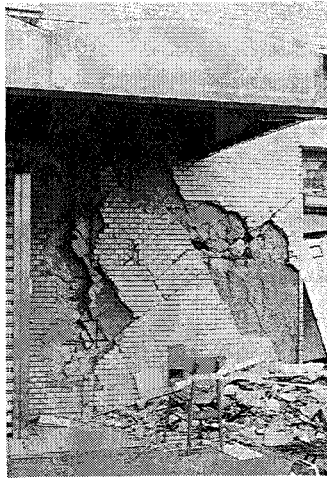
Photo 4 Damage to shearwalls in an older RC building

Very diversified types of non-fatal damage to reinforced concrete also were observed in this earthquake. For example, ductile and nominally ductile shear walls suffered considerable amounts of damage, even when properly detailed boundary elements were present. These shear walls, however, have behaved as expected as apparently no buildings relying on shearwalls for lateral load resistance collapsed. This is true in spite of the sometimes extensive damage to the walls in older buildings. Photo 4 shows such an example, in which, despite significant damage to the shearwalls, the building itself survived with neither much damage to its beams and columns nor a large permanent lateral deformation.

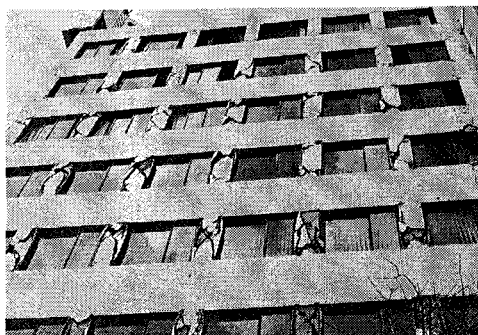
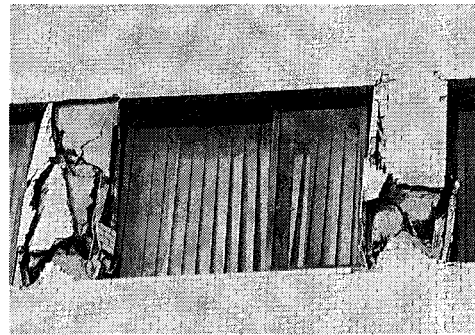
Photo 5 Shear cracking to RC columns
[(a) overview, (b) close-up]

Furthermore, a large number of buildings suffered severe shear cracking and other damage to their columns, beams, or joints. In all cases, the damaged elements were visibly of non-ductile detailing. When damage occurred in columns, buildings owed their survival mainly to the presence of numerous large columns and other fortuitous features that increased their redundancy (Photo 5).

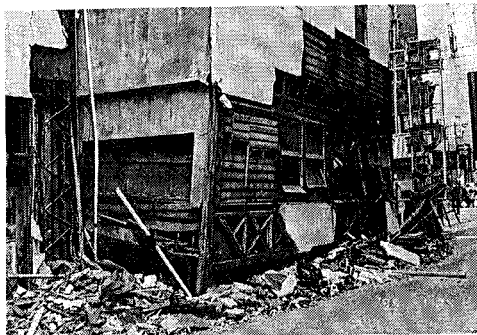
A typically Japanese type of steel buildings construction was developed in the early 1960s in answer to steel shortages and the high cost of structural steel in Japan. Many of these buildings, designed and constructed without much regard for seismic considerations, suffered considerable damage during the Hyogoken-nambu earthquake. The potential ductility of these buildings is severely limited, because the cold-formed steel sections used for columns typically develop local buckling prior to reaching their plastic moment capacity. Ductile column-hinging therefore is not possible, and such buildings are destined to brittle failure unless some other ductile mechanism develops prior to column damage. Yet, although numerous such buildings collapsed (Photo 6), many others survived (Photo 7), but they most frequently shed their veneer finishes in the process. The surviving buildings probably owe their sometimes surprising seismic performance to a combination of semi-rigid framing action and interaction with their internal wood-frame partitions.

Photo 6 Collapse of a steel building

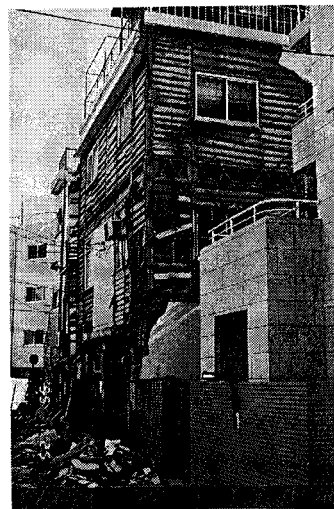
Photo 7 Loss of mortar finishes on a steel building

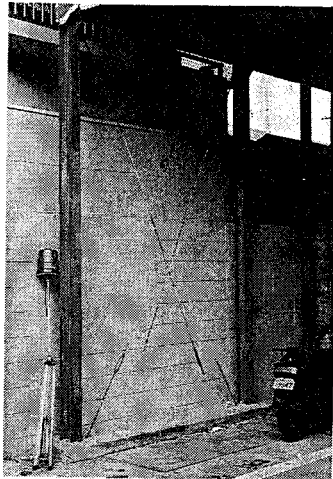
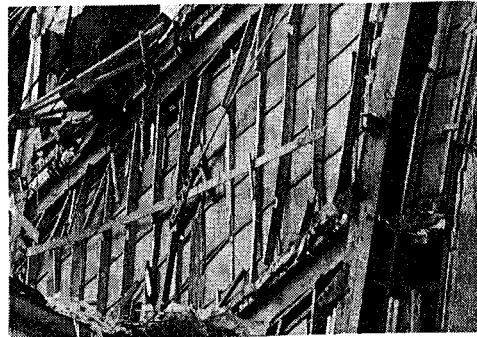
A large number of braced frame structures suffered damage, but few collapsed, even when poor workmanship was discovered. Generally, frames with extremely slender braces, such as rods or thin plates, had poor seismic performance (Photo 8), with the braces frequently rupturing in tension. Braced frames made of cold-formed sections also were encountered (Photo 9) and showed signs of local buckling.

Photo 8 Rupture of steel braces [(a) rod brace, (b) flat-bar brace]

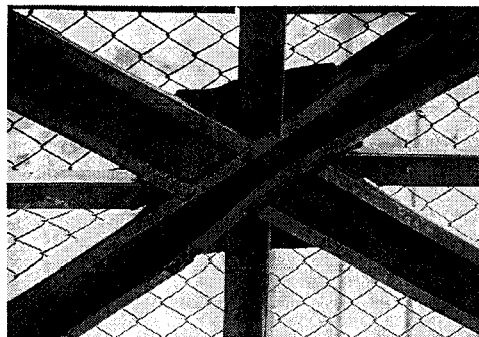
Photo 9 Local buckling of braces with a cold-formed section

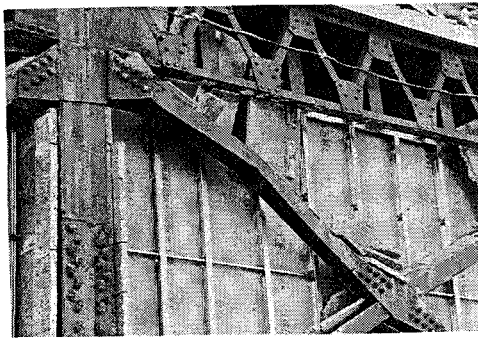
Constructions with more substantial braces performed markedly better although brace buckles (Photo 10), and gusset buckling and fractures (Photo 11) were frequent. It is noteworthy that the survival of buildings with such significant damage may owe much to the redundancy used in Japanese steel construction. This is notable, for example, in Photo 12, where all the bays of a long parking garage can be seen to be braced.

Photo 10 Buckling of a brace

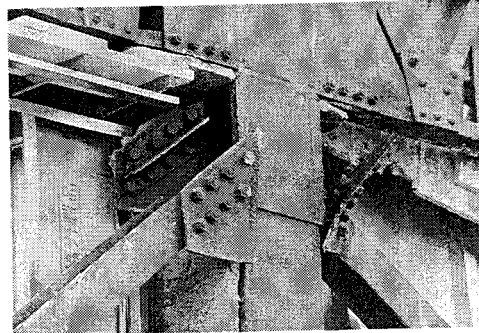
Photo 11 Gusset buckling and fracture

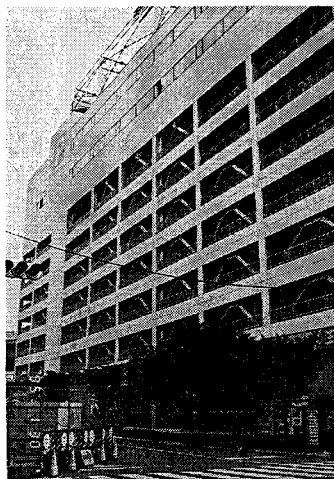
Photo 12 Arrangement of braces in a long parking structure

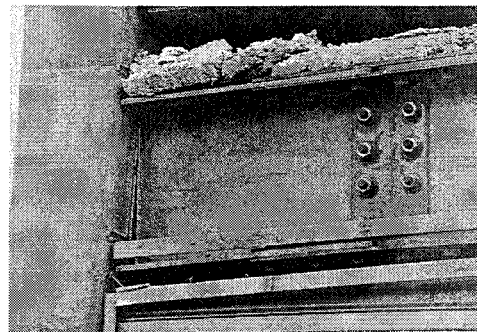
Photo 13 Failure of a beam-to-column connection

Few moment-frames suffered damage in their beam-to-column connections. In many cases, damage could be attributed to the failure of the welds (Photo 13). Many connections in Japan have been designed to permit shop-welding and field bolting, under the ensuring premise of a higher quality for the welds. Further study therefore is urgently needed to identify the true causes of the damage to beam-to-column connections.

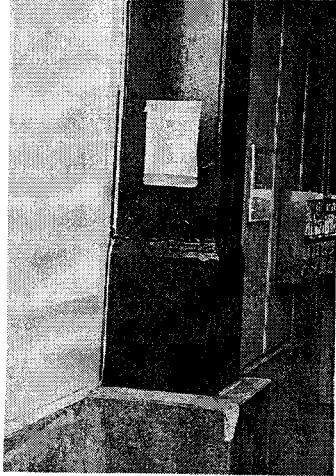
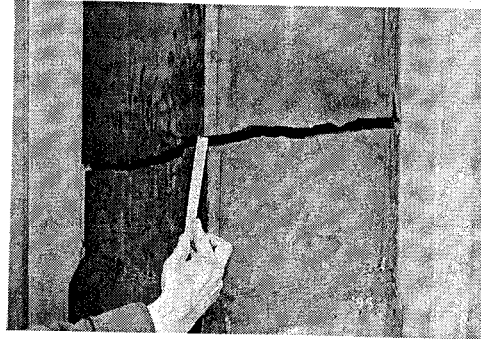
As steel structures frequently are hidden behind fireproofing coatings and architectural finishes, it will take more time before the full extent of damage to steel buildings is known. At the time of this writing, however, some new steel buildings are known to have suffered important damage. Whereas most of the damage to these new steel buildings has been ductile deformations, expected as per the design philosophy, some brittle failures of steel sections and welds also have been found (Photo 14). Speculations abound as to the cause of these failures, and more elaborate studies are underway to provide definitive answers.

Photo 14 Rupture of heavy steel sections
[(a) rupture along a column-to-column connection, (b) wide opening due to fracture]
