OVERVIEW OF BUILDING DAMAGE AND DAMAGE TO WOOD HOUSES FROM THE 1995 HYOGOKEN-NAMBU EARTHQUAKE

ABSTRACT

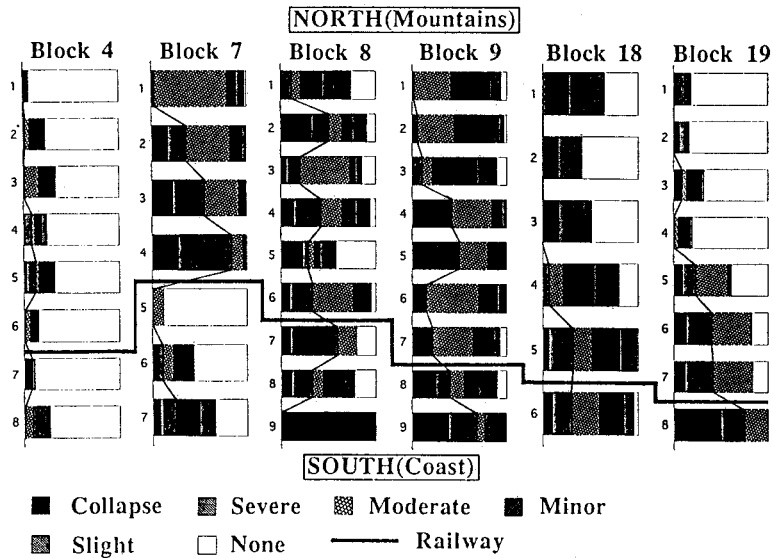
Damage to and the collapse of wood residential buildings was excessive and broadly distributed over the all areas where severe ground shaking was felt. Figure 1 is a map of Chuo-ku (the downtown Kobe) area, where many buildings and houses are clustered, and Fig.2 illustrates the damage distribution for wood houses in several selected blocks (Blocks 4, 7, 8, 9, 18, and 19). The attenuation of damage from south to north (from the sea to the mountains) is clearly seen in Fig.2. This reduction in damage correlates with changes in soil conditions; from soft soils along the coast to progressively more shallow and dense soils, and eventually rock, at the foot and on the slopes of the mountain ridge. The reduction in damage, i.e., less severe damage on the mountains to the north also correlates well with the age of construction, as Kobe grew first along the railway then to the coast in the south, and eventually to the mountains in the north. Block 9 in Fig.1 is crowded with many small wood houses. The damage distribution in this block (Fig.2) indicates that approximately 30% of all the houses collapsed or were severely damaged in that part of Kobe, the ratio being closer to 70% in the parts of the block near the sea. It is notable that this average is considerably larger than any ever recorded over the last decades in Japan. For example, only 5% of all the houses suffered any kind of damage during the 1983 Kushiro-Oki earthquake (ranked 6 on the Japanese intensity scale) and only 0.45% of all the houses totally or partially collapsed.

Fig. 2 Distribution of damage to wood houses (Blocks 4, 7, 8, 9, 18, and 19 in the Chuo-ku area)

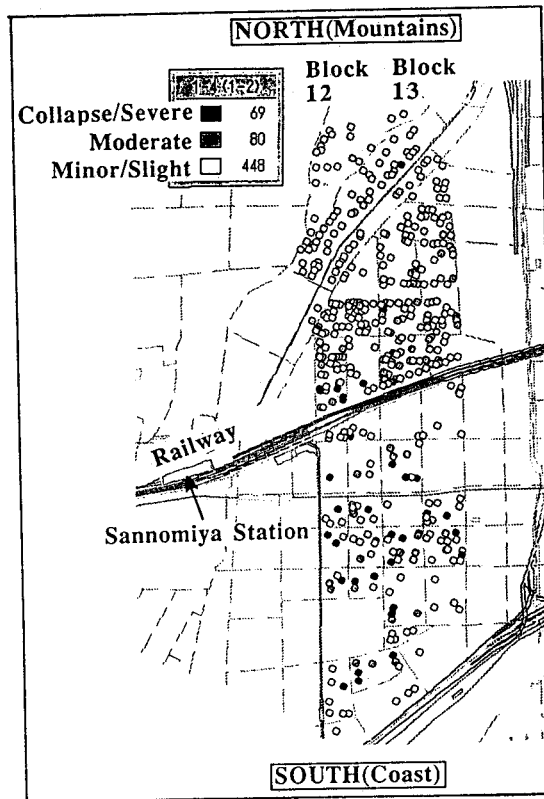
Tables 1 and 2 gives the number of damaged RC and steel buildings in the Chuo-ku area. The damage ratio with respect to the total number of buildings is not available at the time of this writing, but damage to more than 2,500 engineered buildings and serious damage (ranked moderate or more) to more than 350 buildings within the small area of 10 km² is clear evidence of the great severity of this earthquake. An example of the distribution of damage to engineered buildings is shown in Fig.3, for plots of Blocks 12 and 13: the downtown business district.

Fig. 3 Distribution of damage to engineered buildings (Blocks 12 and 13 in the Chuo-ku area)

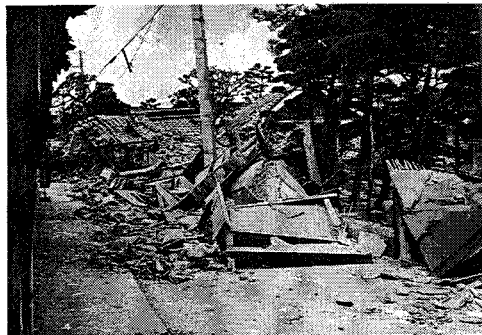
Heavy ceramic tile roofs are widely used in Japan as they provide excellent resistance to the strong gusty winds of typhoons which frequently sweep across the country. As the seismic forces imparted to a structure, however, are inertial forces induced by the ground shaking, heavy constructions such as buildings with heavy tile roofs sustain larger seismically-induced forces (Photo 1). Thus, houses with light roof systems, such as asphalt tiles or light metal sheets rather than heavy ceramic tiles, generally performed better during this earthquake.

Photo 1 Collapse of wood houses roofed with heavy ceramic tiles

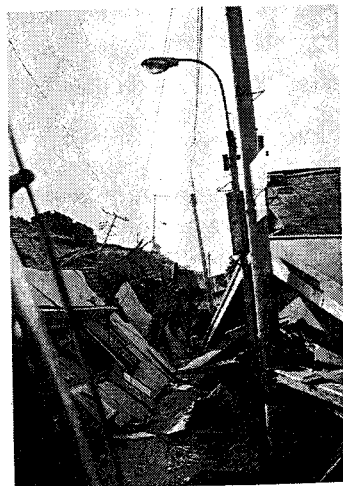
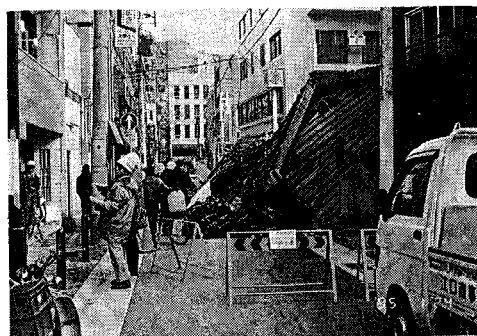
For many years, structural engineers have known that buildings with large open first stories that have fewer partitions than the above stories are very sensitive to a severe concentration of damage in that first story. Unfortunately, such damage-prone softer stories are characteristic of Japanese residential constructions, in which a large tatami room surrounded by sliding doors (hence large openings) is customary. In older and smaller homes, this room may be the dominant feature of the first story, with detrimental effects during earthquakes. Soft-story failures frequently result in a sway-mode type of failure, the second story typically moving sideways while falling down. During the Hyogoken-nambu earthquake, the homes that collapsed in that manner frequently blocked the narrow city streets, thus blocking access to numerous neighborhoods (Photo 2).

Photo 2 Collapsed wood houses blocking streets [(a) Chuo-ku area, (b) Hyogo-ku area)]

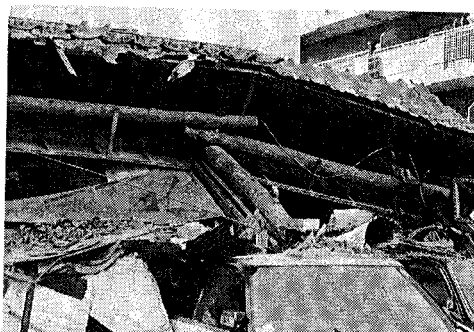
interlocking wood parts (tenons and mortices) without the use of nails or other positive non-wood connectors. Examples of beam-ends prepared for this purpose are shown in Photo 3. More complex, but equally ineffective connections, are shown in Photo 4. At best, a few but insufficient number of nails were found in the members of collapsed structures. Thus, during severe shaking, the beams frequently pulled out of their socketed supports in the columns or beams, causing the immediate caving-in of the supported story.

Photo 3 An example of old beam-to-column connections used in wood houses

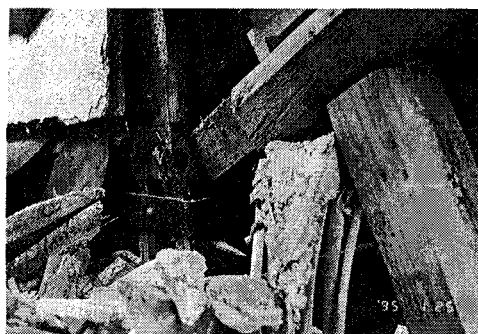
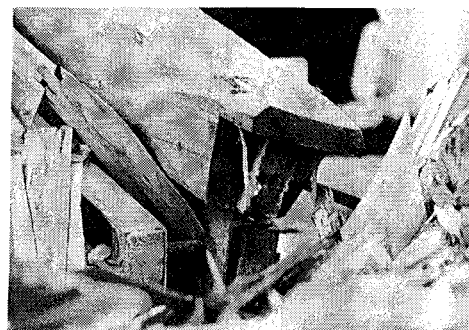
Photo 4 Examples of tenons and mortices used for beam-to-column connections [(a) overview, (b) close-up]

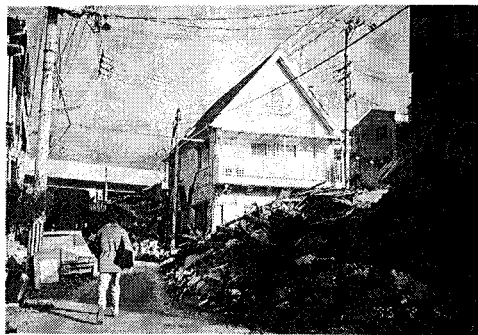
It is notable that, in many cases, new houses that were undamaged or had sustained at most minor damage were found adjacent to totally collapsed dwellings (e.g., Photo 5). Some of these new houses were pre-fabricated structures with light-gage steel beams and columns, bar braces, and light asphalt sheet roofing. Others were constructed of 2" by 4" walls, a practice imported from

Photo 5 A relatively new house that sustained minor damage, whereas adjacent old houses collapsed

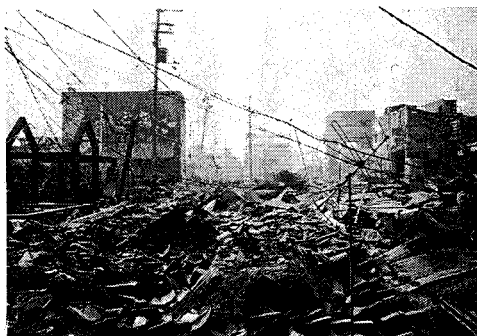
The rapid spread of earthquake-triggered fires further compounded the seismic-related problems inherent to residential constructions in the dense Japanese urban environment. A large number of fires triggered by this earthquake devastated many of the neighborhoods that had a dense inventory of wood houses (e.g., Photo 6). Figure 4 gives the number of fires which had to be fought by emergency units in the days following the earthquake. Fortunately, most fires were brought under control within a few days, but sometimes not before spreading to significant areas.

Photo 6 Remains of houses destroyed by fire
