Building damage from the Marmara, Turkey earthquake of August 17, 1999

Michel Bruneau

Key words: buildings, code, damage, design, detailing, concrete, earthquake, masonry, steel

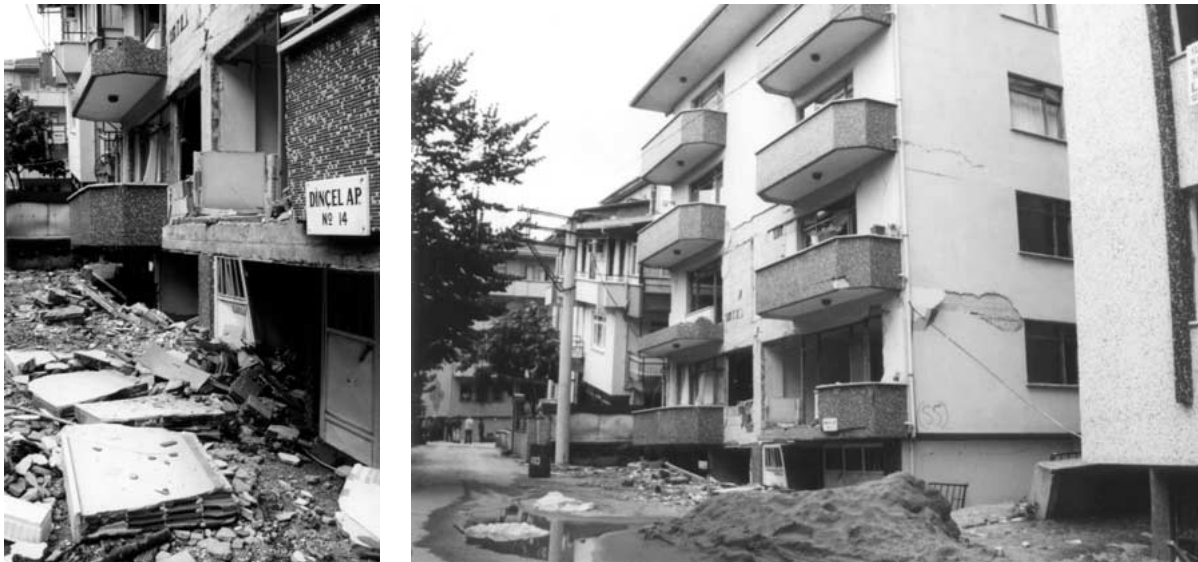
An example of severe settlement is shown in Figure 1. Taking the distance from balcony to balcony as a reference, one may observe the short-distance left between the second floor balcony and ground level.

Figure 1. Damage due to foundation failure.

Foundation failures generally occurred as a result of soil liquefaction or bearing pressure failures. Note that geotechnical evaluations of site conditions are apparently often not conducted in Turkey, except for important structures.

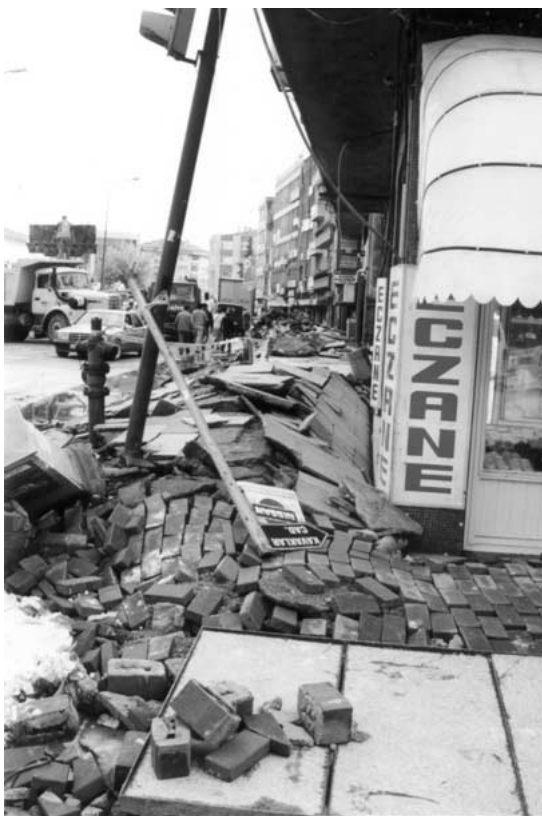
Figure 2. Ground heave was extensive all around this building.

This provides a qualitative measure of the magnitude of settlement that occurred. Figure 2 also shows the extent of ground heave all around the building as the soil under the building is pushed outward during settlement.

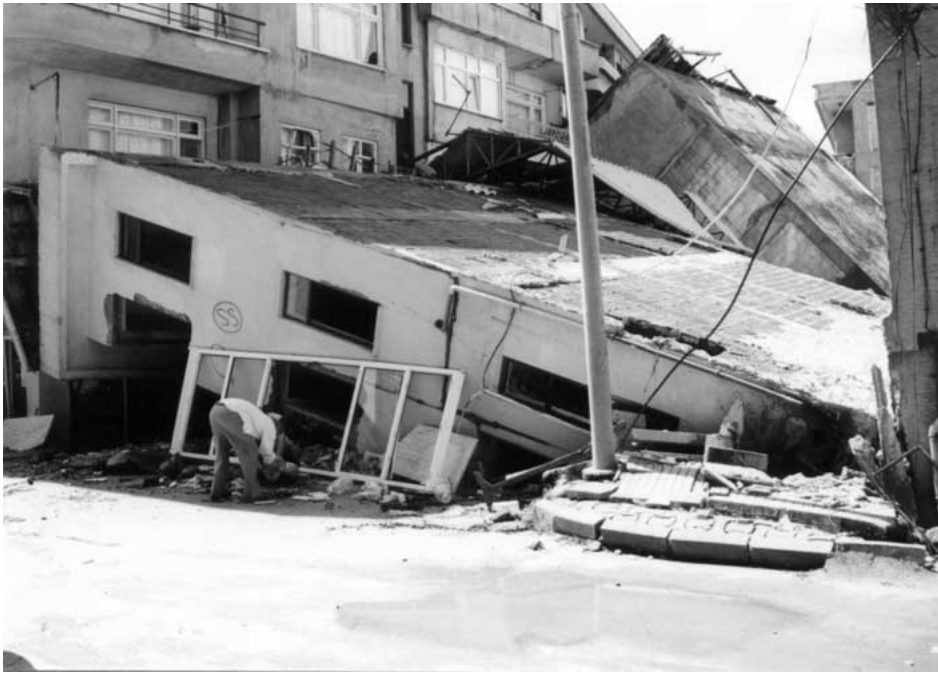
Examples of overturned buildings are shown in Figures 3 and 4. In the latter case, force vectors are superimposed on the building to illustrate its significant resistance to lateral loads (Figure 4b). As shown in that figure, the resultant weight of the structure, schematically located at the center of gravity of the above-ground portion of the toppled building, can be decomposed into its components perpendicular and parallel to the building's original vertical axis. Calculations indicate that the building, in its new leaning 'position,' resists a statically-applied force approximately equal to 0.9 g perpendicular to its original vertical axis. This resistance is essentially provided by the numerous partition walls that increase lateral strength.

Figure 3. Overturned building due to foundation failure.

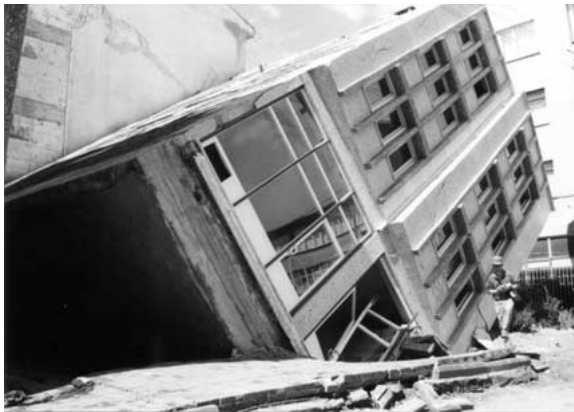
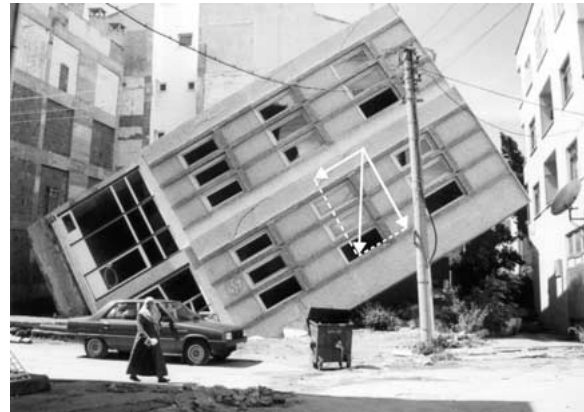
Figure 4. Overturned building due to foundation failure.

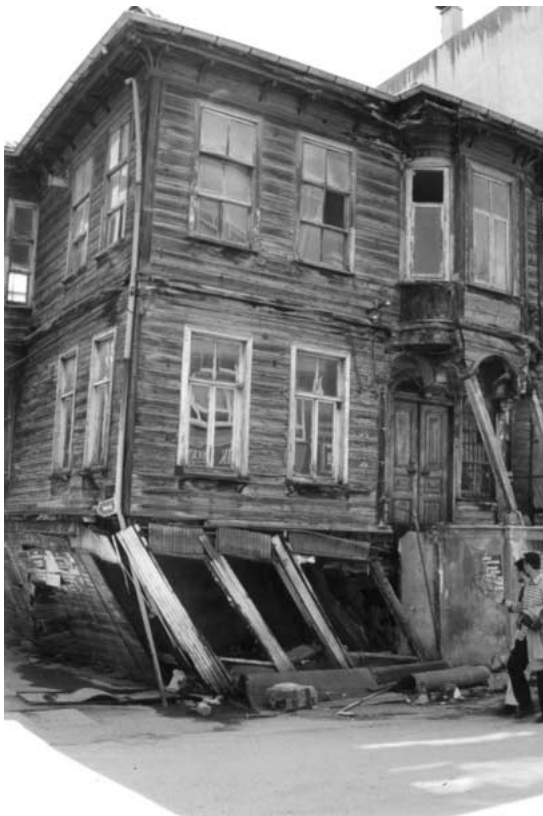
first-story structural elements, as opposed to distributing the burden along the entire height of the building. Many failures and collapses can be attributed to the increased deformation demands caused by soft stories, coupled with lack of deformability of poorly designed columns. Examples of soft-story failures can be seen in Figures 5 to 9. The timber building shown in Figure 5, having a wide obstruction-free ground floor, has nearly collapsed and clearly illustrates how signific-

Figure 5. Failure of the soft first story in a timber building.

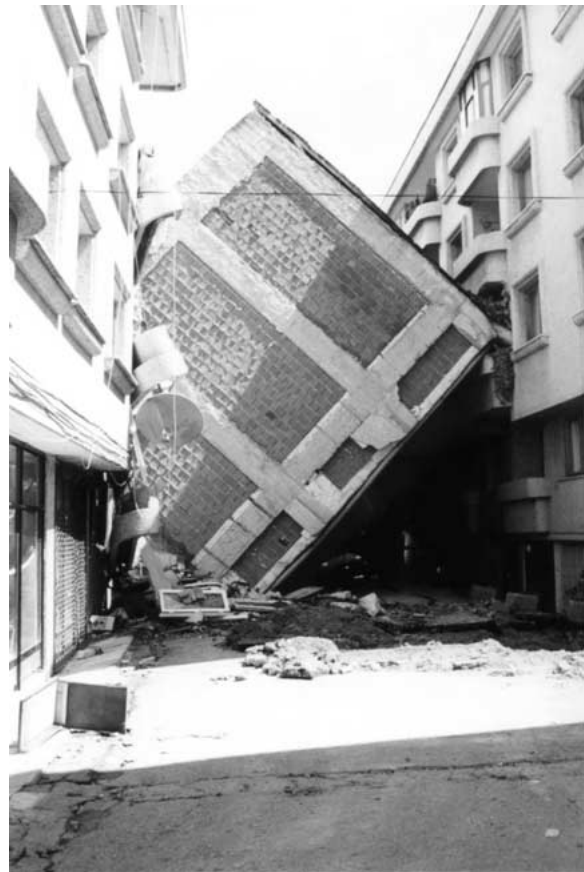
Figure 8. Failure of the soft first story.

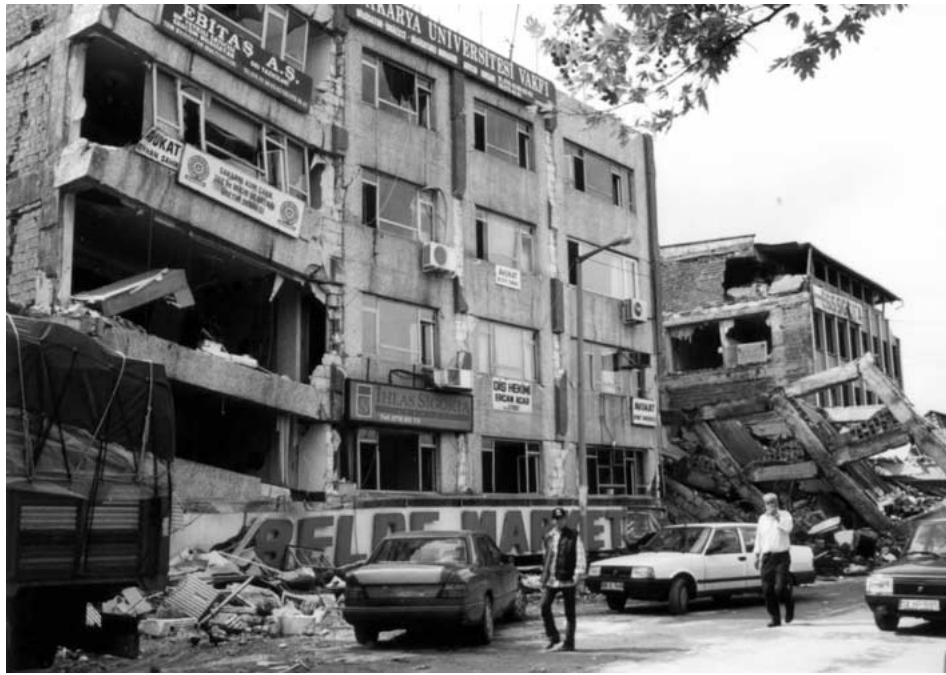
Figure 6. Failure of the soft first story.

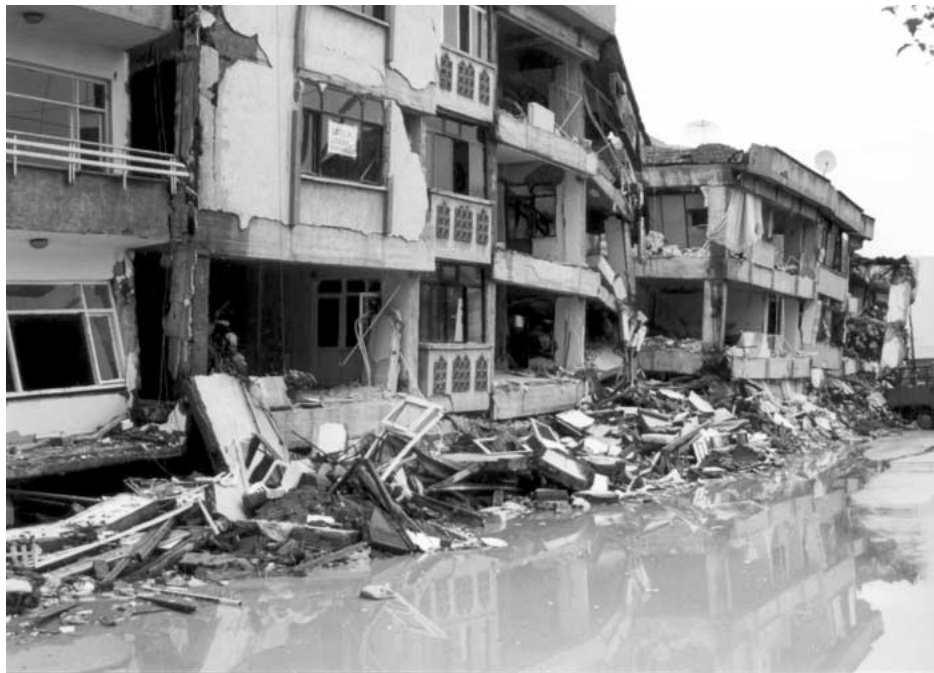
Figure 7. Failure of the soft first story.

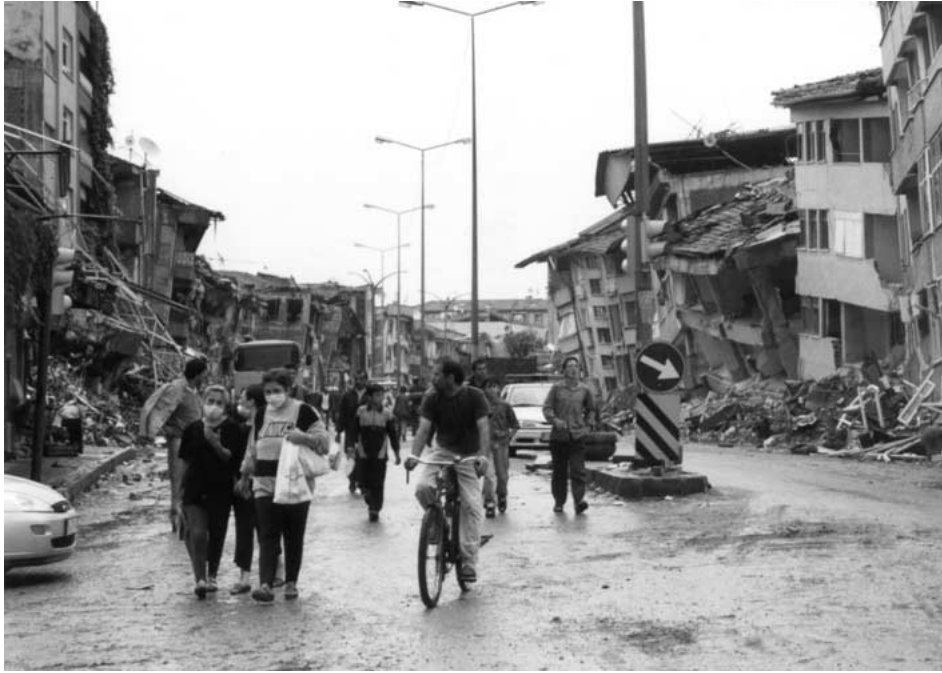
Soft-story buildings having open street facade and solid back-walls tend to collapse toward the street as a result of the torsional plan eccentricity. Story sway is greater on the more flexible facade side, resulting in greater displacement and ductility demands on the more vulnerable columns on the facade side (Figure 8). This was particularly evident on a commercial street where nearly all the buildings collapsed towards the street (Figure 9).

Figure 9. Buildings in this commercial area collapsed towards the street due to open facades (soft story) and walls on back side adding torsional eccentricity.

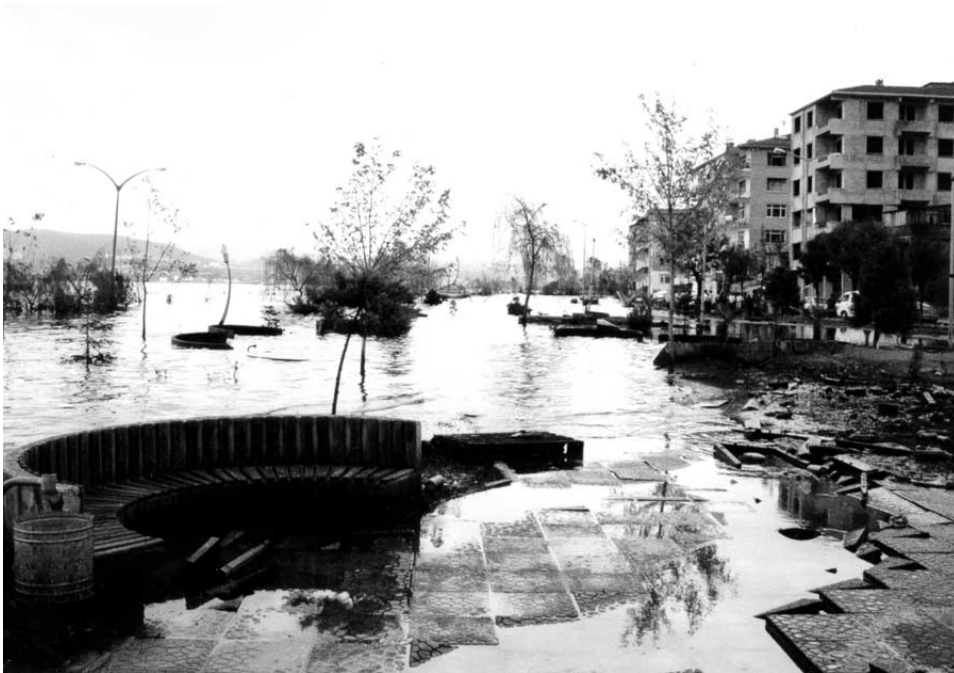
Soft-story failures combined with ground failures were also observed along the waterfront in Gölcük. As shown in Figure 10, the water of the Marmara Sea submerged parts of the waterfront as a result of ground lateral spreading. Some buildings located along the waterfront (e.g., Figure 11) were thus impacted by both geotechnical and structural deficiencies.

Figure 10. Marmara Sea submerged parts of the waterfront as a result of ground lateral spreading.

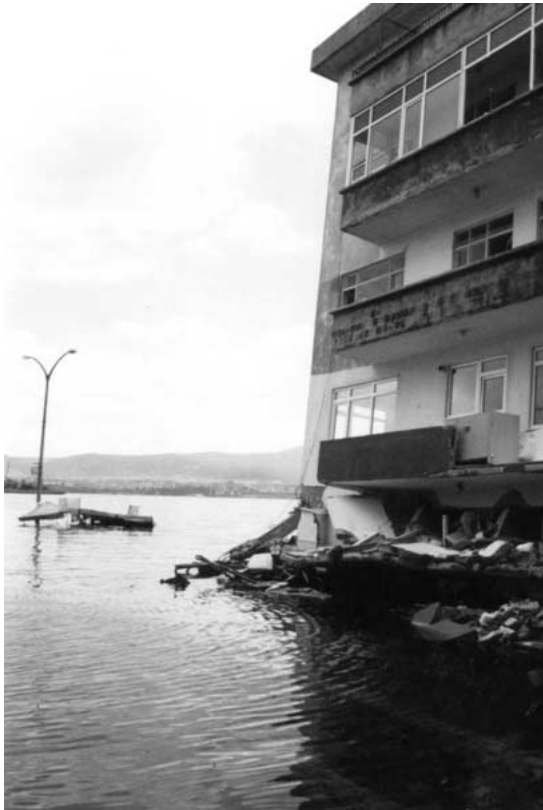
Figure 11. Some waterfront buildings were impacted by both geotechnical and structural failures.

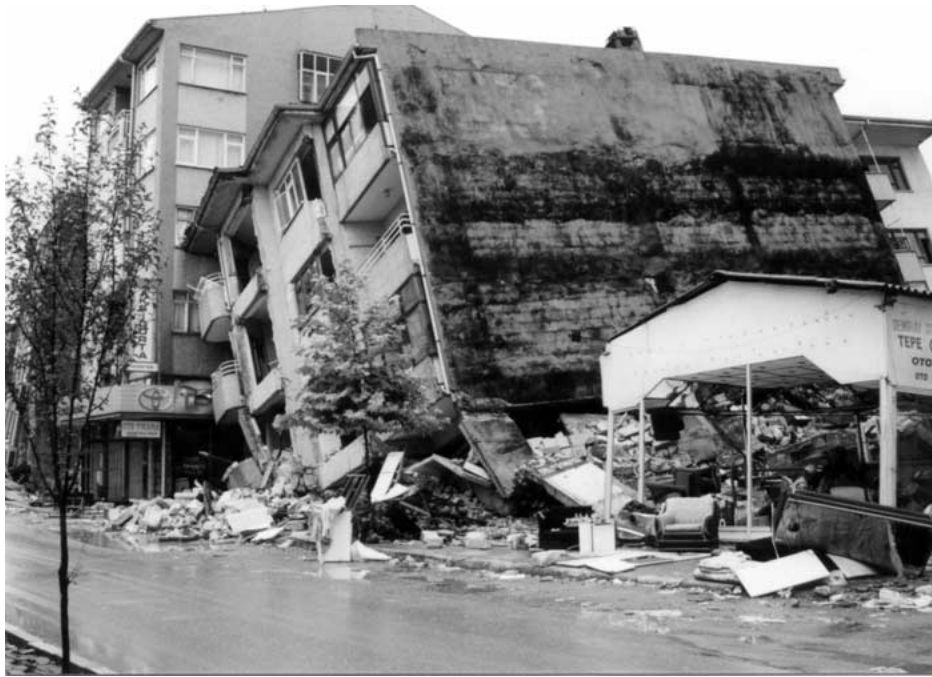
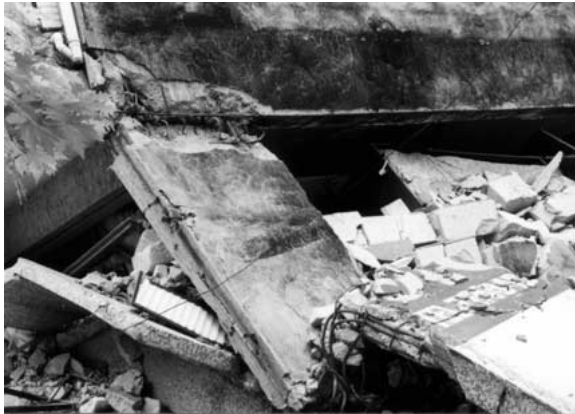
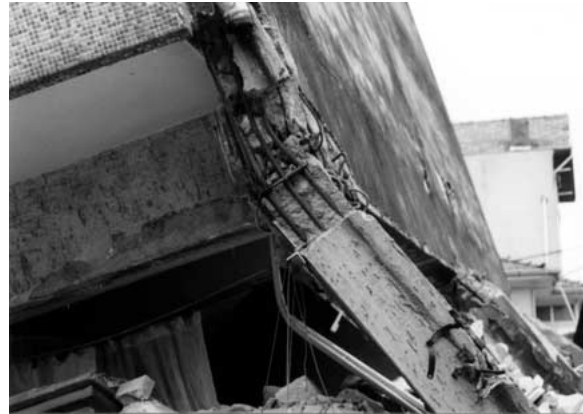
suffered damage and failure in the form of compression crushing, plastic hinging, or shear failure. In many cases, relatively deep beams were used with flexible columns, contributing to a strong-beam weak-column behavior. This undesirable behavior is illustrated in Figure 12 and 13. In Figure 12, for example, the column depths are sizeable along the building alley sides, but they are narrow and thereby less able to resist by flexure the seismically-induced horizontal forces parallel to the front street, particularly when compared to the beam depth and strength at the story above. Not surprisingly, the building collapsed swaying in the direction of weakest column flexural strength.

Figure 12. Damage due to strong beams and weak columns.

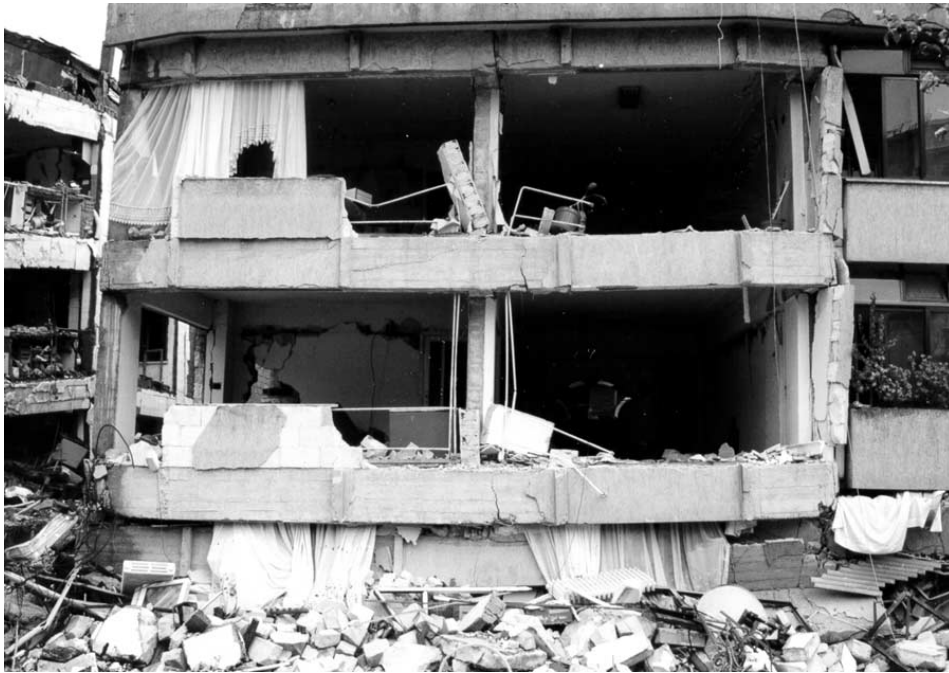
Figure 13. Damage due to strong beams and weak columns.

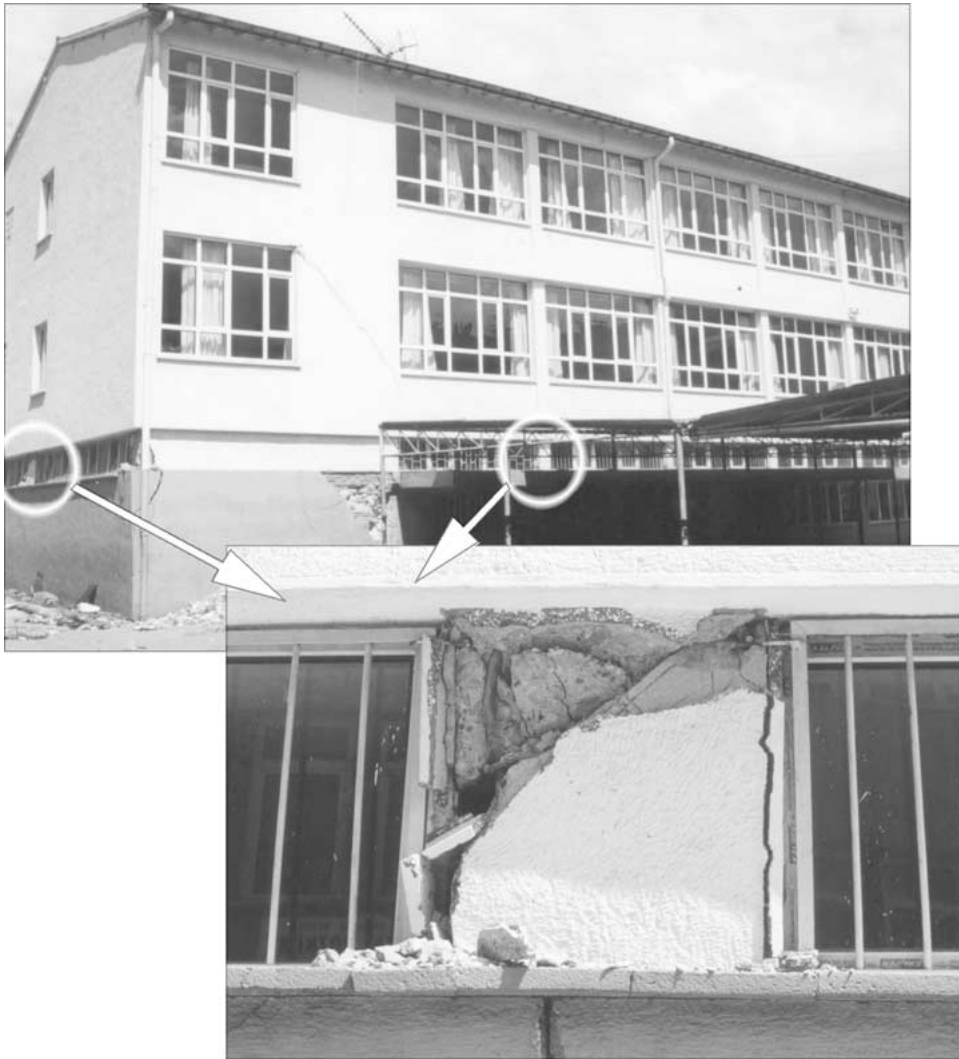
Column damage varied as a function of column geometry and detailing. Examples in Figure 14 and 15 illustrate shear failure in short captive columns 'trapped' between partial height infills, and flex-

Figure 14. Damage due to short (trapped) columns.

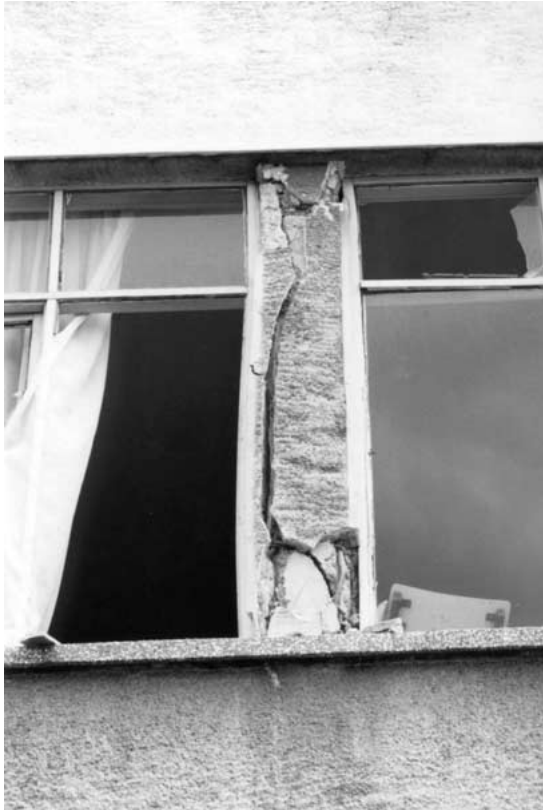
Figure 15. Damage due to flexural failure in non-ductile plastic hinges.

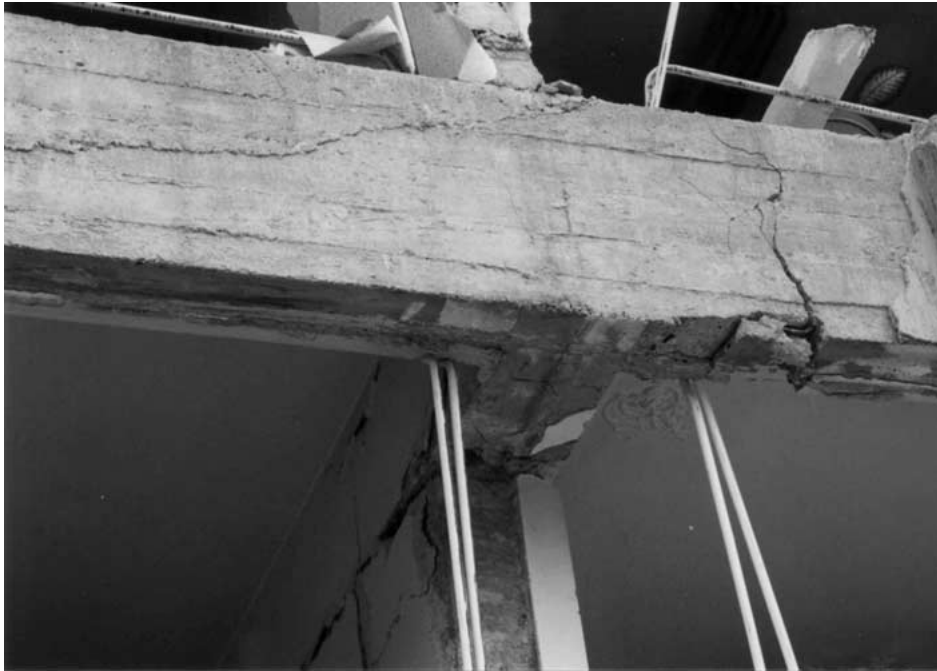
Most of the structural damage observed in frame buildings was concentrated at column ends. Unfortunately, confinement reinforcement was virtually nonexistent in these members, making them unable to maintain the required ductility. A number of detailing deficiencies were observed in the damaged structures. This included lack of anchorage of beams and columns reinforcement, insufficient splice lengths, use of 90° hooks, poor concrete quality, less than full height masonry infill partitions, and frequent combinations of many of the above. These errors were often compounded by geometric irregularities such as eccentric beam-to-column connections that induced severe torsion in short perpendicular stub beams (Figure 16).

Figure 16. Damage due to eccentric beam-to-column connections.

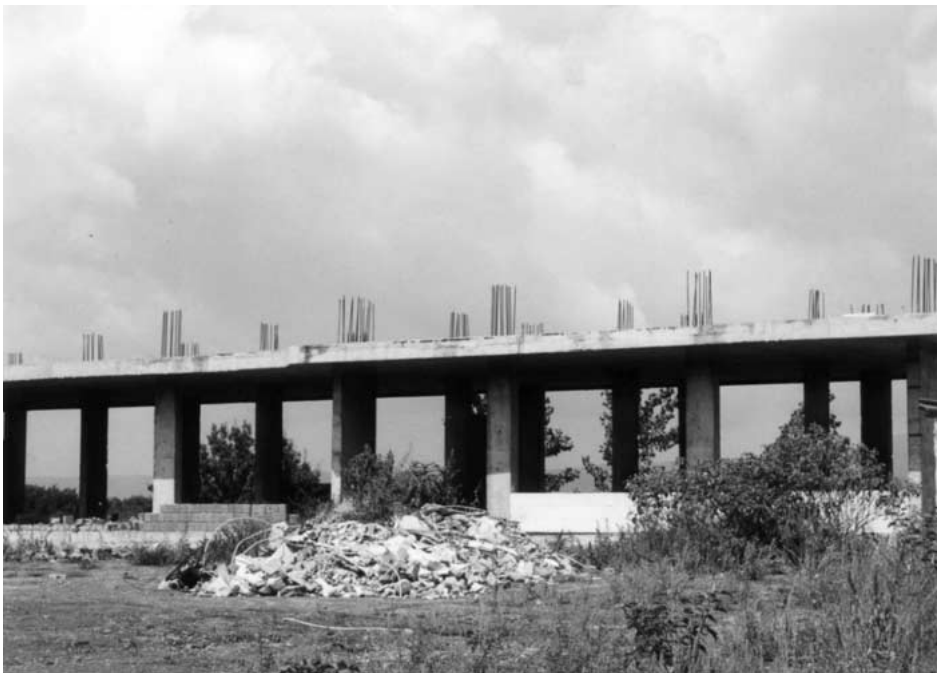
The construction sequence adopted in residential buildings in some of Turkey's new developing semi-urban districts is partly responsible for some significant failures due to lack of column reinforcement anchorage. Typically, residential buildings are constructed over a large number of years, one story at the time. Families do not wait for completion of the entire building prior to occupancy, and usually elect to live in the lower completed stories. Additional stories are added as the need arises. Figure 17 illustrates a one-story building during construction. Note the column vertical reinforcement extended above the roof line. Infill walls will be added to the first story and residents will move in, and this reinforcement will be left extending above the slab until the day (maybe years ahead) when construction will resume to add another story. As a result of this practice, and because smooth bars are frequently used, anchorage of the column bars in the slab is often deficient, and may have contributed to many collapses. Figure 18 shows an example of such bar pull-out in a building on the verge of collapse.

Figure 17. One story building during construction with column bars extended above roof slab to accommodate possible construction of other stories in future years.

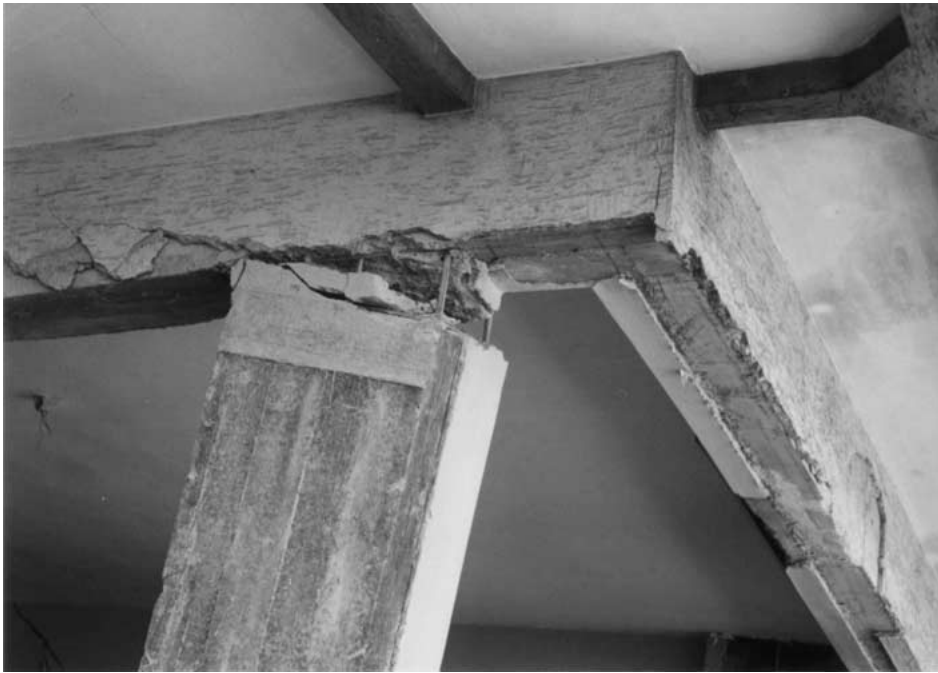
Figure 18. Example of bar pull-out due to deficient anchorage.

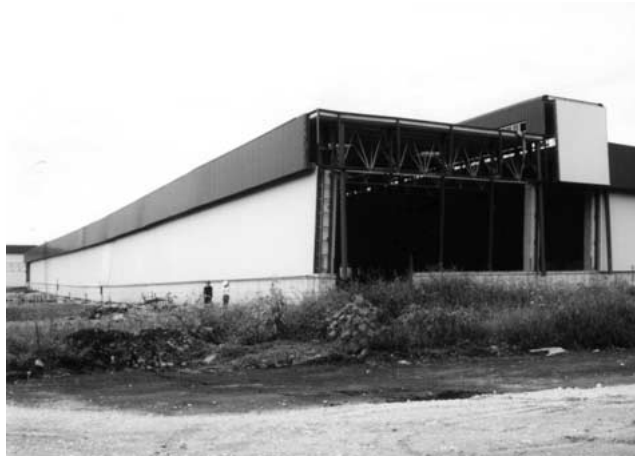
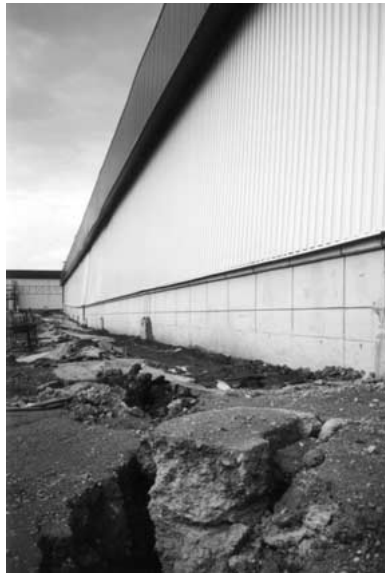
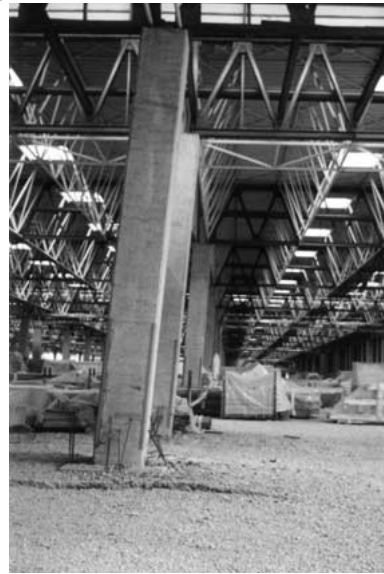
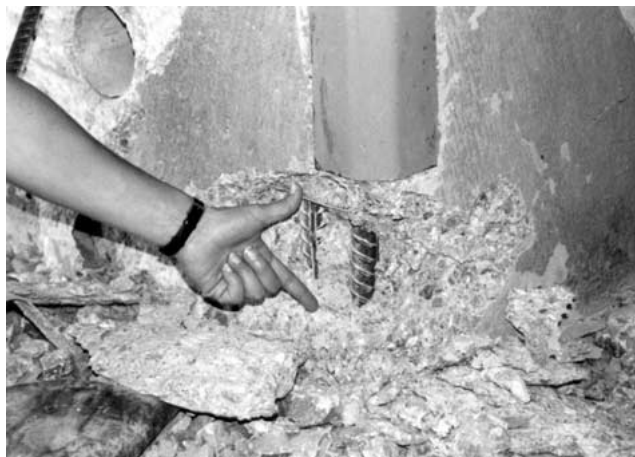
A number of buildings sitting directly on the fault were also destroyed by the relative movements of the fault. However, numerous buildings immediately adjacent to the fault survived without structural damage. For residential buildings, this is generally attributable to the additional strength unintentionally provided by the infills, as indicated previously. Industrial buildings similarly located, however, survived on the merit of their explicit design. For example, an industrial complex being constructed 100 feet from the fault had very well confined columns. Extensive ground settlements induced large structural permanent displacements to parts of the structure, and the columns developed plastic hinging with considerable permanent deformation and visible concrete spalling, but collapse was prevented in spite of this damage as the spacing of the column's transverse reinforcement was adequate to ensure ductile behavior (Figure 19).

Figure 19. Industrial facility near the fault: (a-b) global views of damage due to large ground settlements; (c-d) leaning column with limited damage at base as a result of ductile details (spacing of transverse reinforcement is indicated by thumb and index fingers).

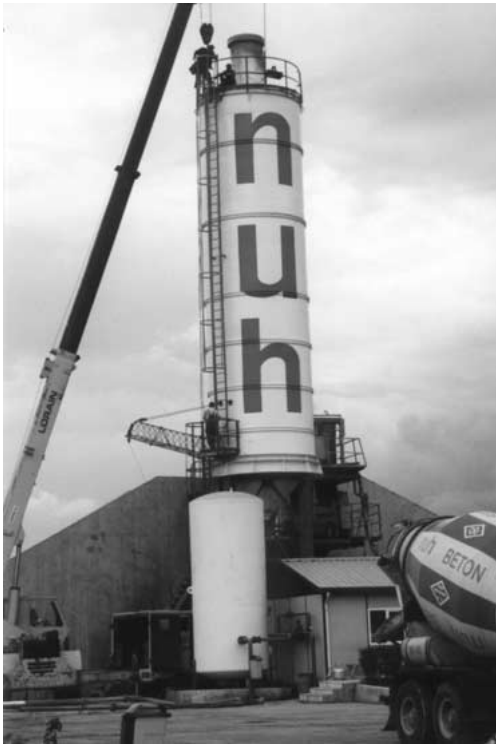
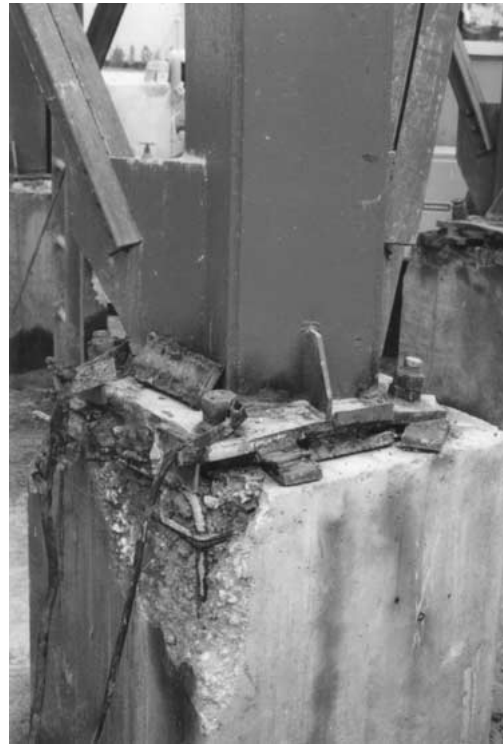
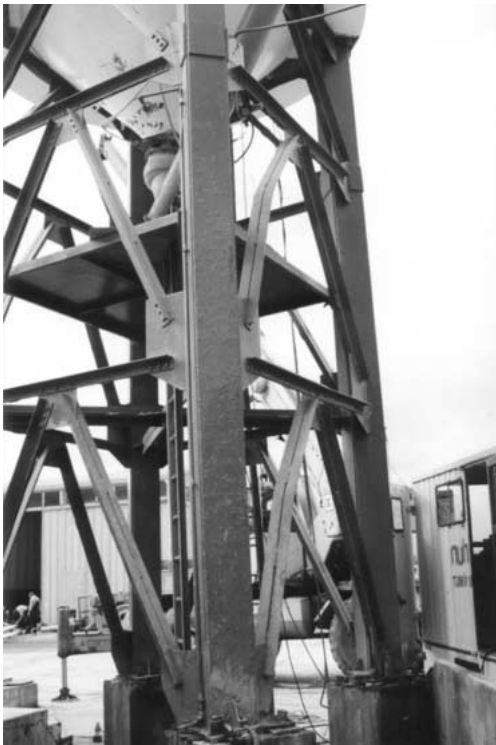
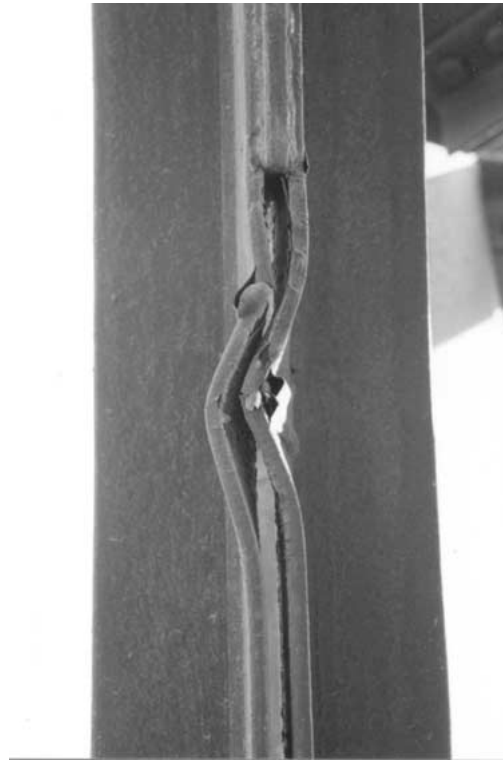
An interesting comparison between ductile and non-ductile steel details for nearly identical structures is shown in Figures 20 and 21. In Figure 20, the anchor bolts of the tank supports of the NUH concrete producing facility yielded in tension, and concrete of the 2.8 m deep pedestals spalled under the compression impact. Although this is not a ductile detail, the braces would be in partial compliance with the AISC seismic design provisions. The 2,400 mm long braces are 2L80×80×8 back-to-back 10 mm from each other with batten plates at the 1/3 points, resulting in mem-

bers having slenderness KL/r of 97 and b/t of 10; note that the AISC limits for ductile concentrically braced frames are 101 and 7.35 respectively for Grade 50 steel, 120 and 8.7 for Grade 36 steel. Connections were also stronger than $A_g F_y$ of the members. Hence, these braces partially met (intentionally or not) the AISC 1997 requirements for ductile concentrically braced frames (DCBF). Inelastic action developed in the braces, allowing ductile structural response through dissipation of hysteretic energy in a stable manner, with the exception of the deficient anchor bolts detail and somewhat premature local buckling, and the braced frame survived. Global brace buckling, and local buckling at the brace mid-length plastic hinge (Figure 20d) illustrate this ductile plastic response. Also typical of braced-frame with Chevron brace configurations, buckling of the diagonal in compression occurred prior to yielding in tension; this led to force redistribution within the structure and resulted in plastic hinging at mid-span of the horizontal member and slight permanent vertical deformations was visible at that point. This typical mechanism of Chevron braced frames is well known and explained in greater detail elsewhere (Bruneau et al., 1997).

Figure 20. Damage to steel structures at NUH concrete plant: (a) global view; (b) spalled pedestal; (c) global buckling of braces; (d) local buckling at brace mid-length.

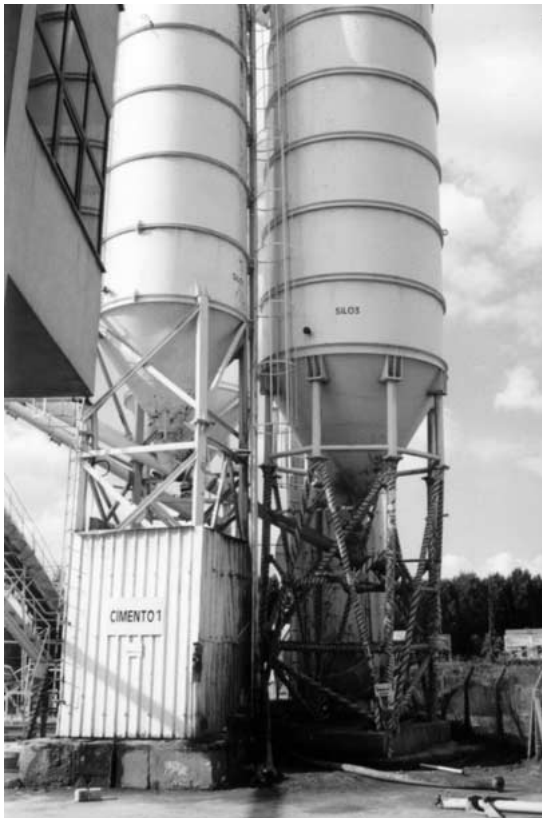
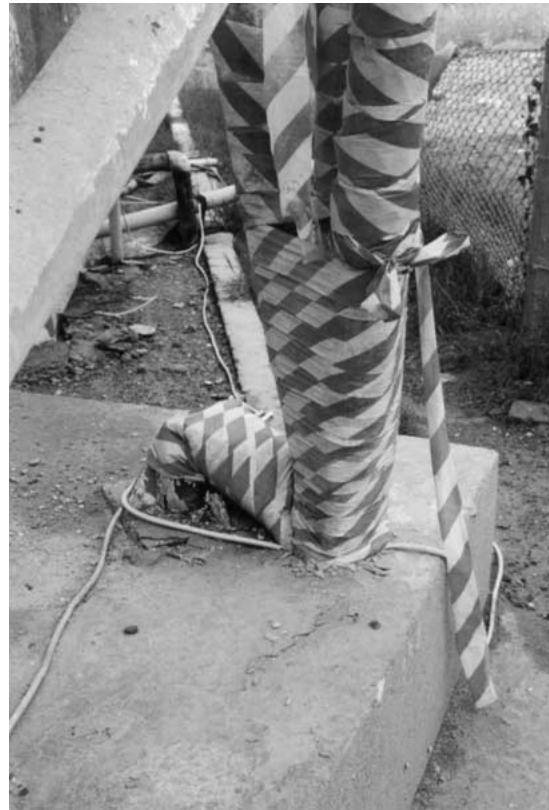
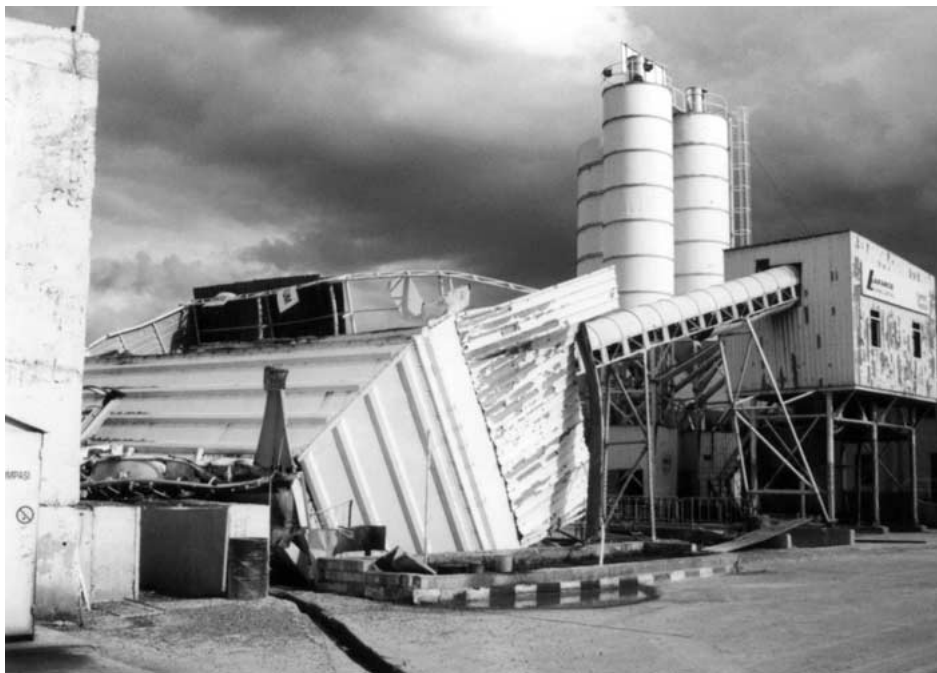
By comparison, structures serving the same purpose at the Lafarge concrete plant suffered excessive damage. In this case, all members of the braced towers

were hollow structural circular steel members, 150 mm in diameter and approximately 3 mm thick, for a resulting D/t slenderness ratio of 50, greatly in excess of the limit of 26 imposed for Grade 50 steel braces by the aforementioned AISC seismic provisions. However, braces did not buckle in this particular case. Because the lower brace was connected to the tower leg 16" above the base, the tower behaved as a rigid braced structure supported on a 16" tall moment frame, and the tower leg buckled at that location under the combined axial and flexural stresses resulting from this localized severe eccentricity (Figure 21). Steel locally fractured in some locations as a result of the large strains induced by this collapse. Note that the most severely damaged tower was estimated to be 85–90% full (85 m^3 out of a 110 m^3 capacity) at the time of the earthquake, while the other towers were approximately 65% and 90% full. Incidentally, a gravel and sand bin (approximately 25% full) adjacent to these towers, overturned and collapsed. It was supported on six legs, each tied with a 24 mm diameter bolt to a concrete base. The legs buckled on one side, and the anchor bolts pulled out of the foundation or tore out of the leg as the bin collapsed (Figure 21c). Note that damage or collapse of elevated reservoirs was common throughout the affected area (Figure 22).

Figure 21. Damage to steel structures at Lafarge concrete plant: (a) global view; (b) buckled leg; (c) overturned sand bin.

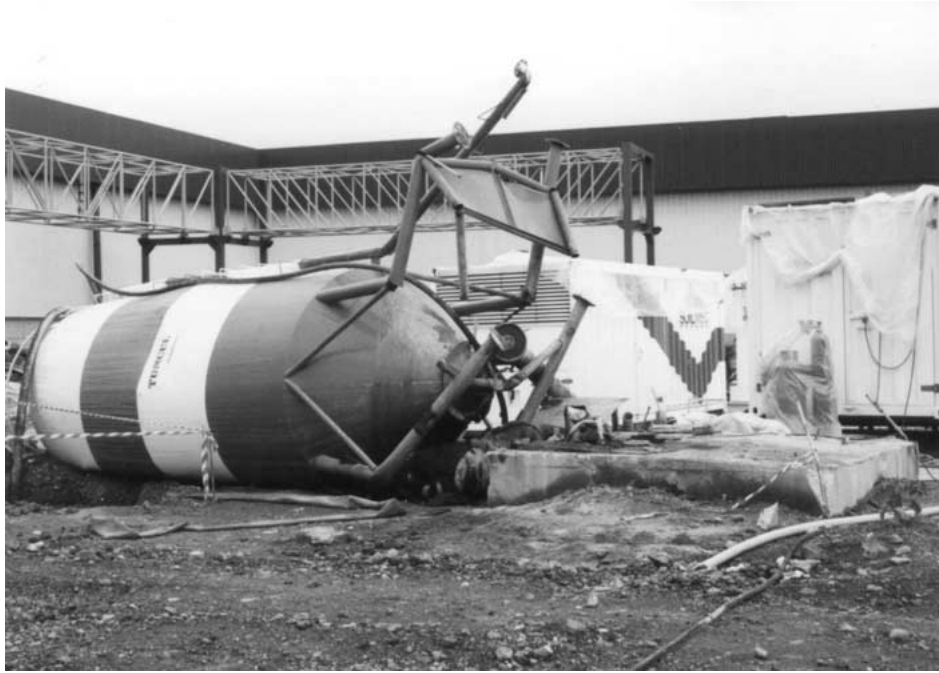
Figure 22. Overturned reservoir.

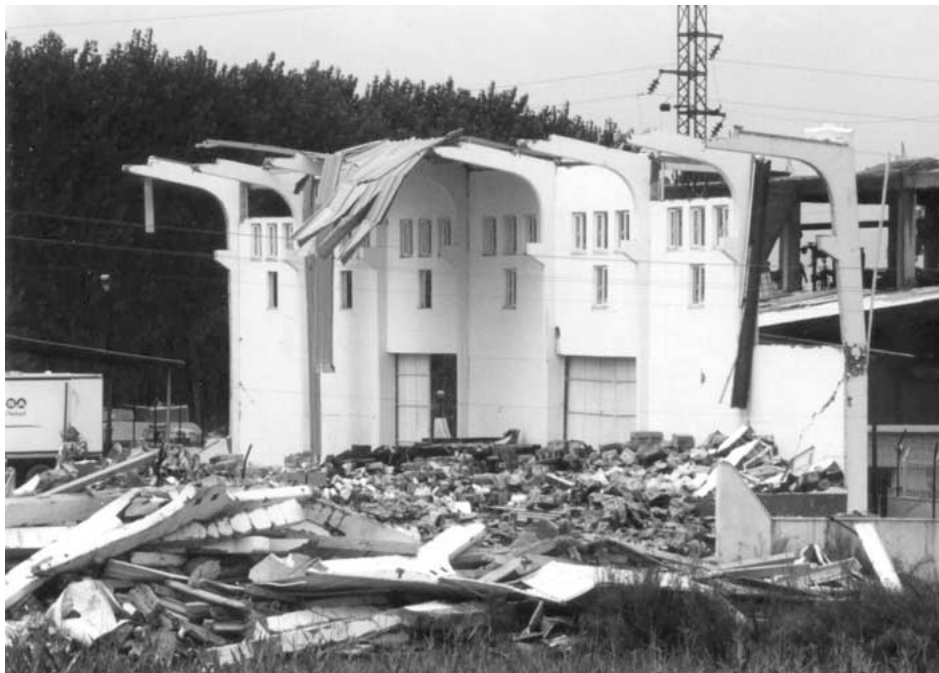
Damage to buildings of other construction materials was also observed throughout the affected area. For example, many industrial facilities of pre-cast concrete collapsed as a result of failures at the beam to column connections (Figure 23). Damage to unreinforced masonry buildings was also sometimes observed. For example, the building shown in Figure 24 suffered severe shear failure of its corner wall, as a result of bi-axial seismic action. The number of such buildings was, however, small in proportion to the overall building inventory.

Figure 23. Damage to a precast concrete building.

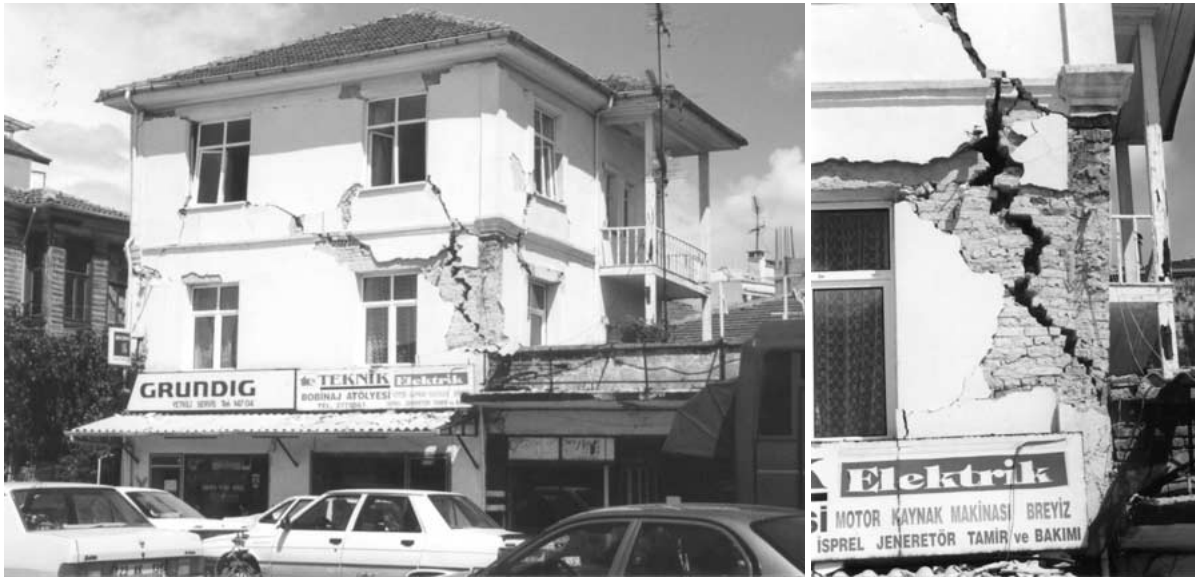
Figure 24. Damage to an unreinforced masonry building.

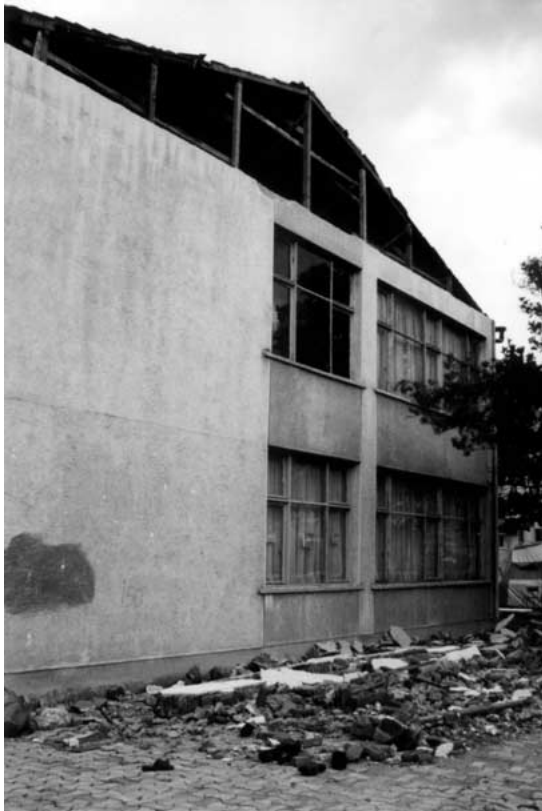
(a)

In the presence of such an overwhelming amount of structural damage and collapse, the seismic hazards ensuing from nonstructural damage tend to be forgotten. These should not be overlooked as they may result in extensive injuries and casualties. For the school building shown in Figure 25a, out-of-plane failure of an unreinforced masonry gable due to inadequate anchorage to its backing could have killed or maimed

Figure 25. Nonstructural damage to a school building.

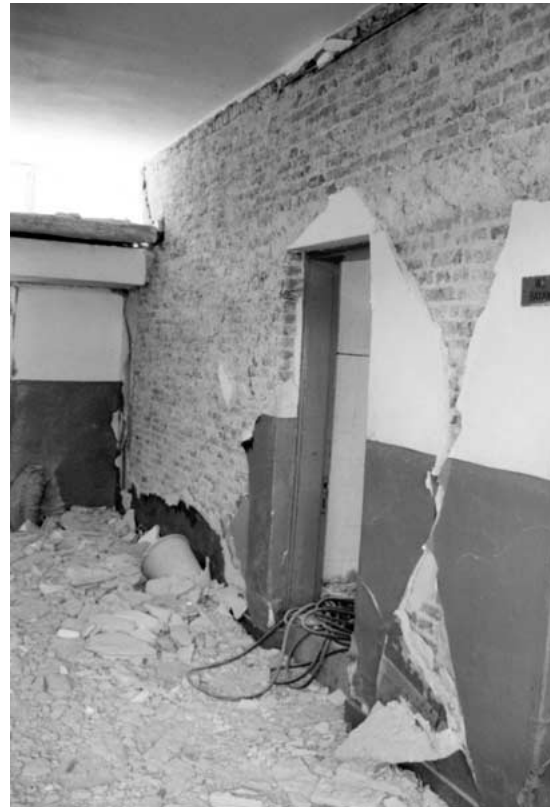
(b)

many children had this earthquake occurred at a time when the school yard was being used. Likewise, failure of the plaster wall finishes inside the corridors of the same school (Figure 25b) could also have hurt many small children.

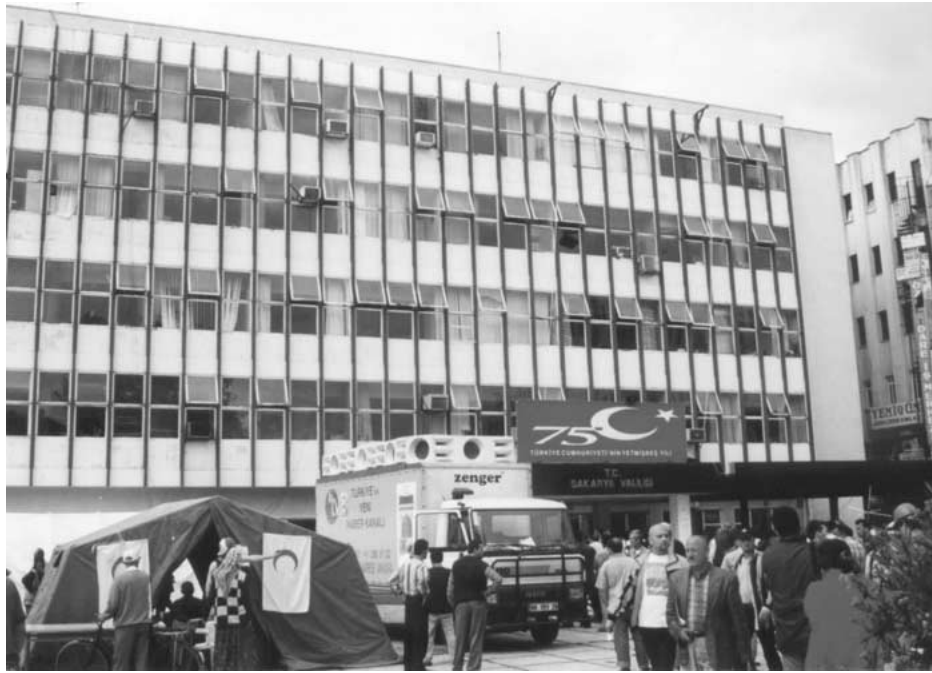
As noted earlier, at the time of the earthquake, seismic awareness in Turkey had not reached a level that made it possible to focus on the seismic hazard posed by the structures designed without due attention to earthquake-resistant design. This may explain why, to the author's knowledge, only one building in the severely affected region had apparently been seismically retrofitted prior to the earthquake. The Sakarya 'province' government building, shown in Figure 26, was allegedly retrofitted by the addition of shear walls some years prior to the earthquake. This building sustained damage to its infill walls at the ground story during the 1999 earthquake and was subsequently repaired. However, it remained operational following the earthquake, which is significant considering that it was literally surrounded by collapsed and severely damaged buildings, such as the one shown in Figure 27.

Figure 26. Undamaged Sakarya 'province' government building retrofitted by shear walls prior to earthquake.
