Building damage from the Marmara, Turkey earthquake of August 17, 1999

Michel Bruneau

Key words: buildings, code, damage, design, detailing, concrete, earthquake, masonry, steel

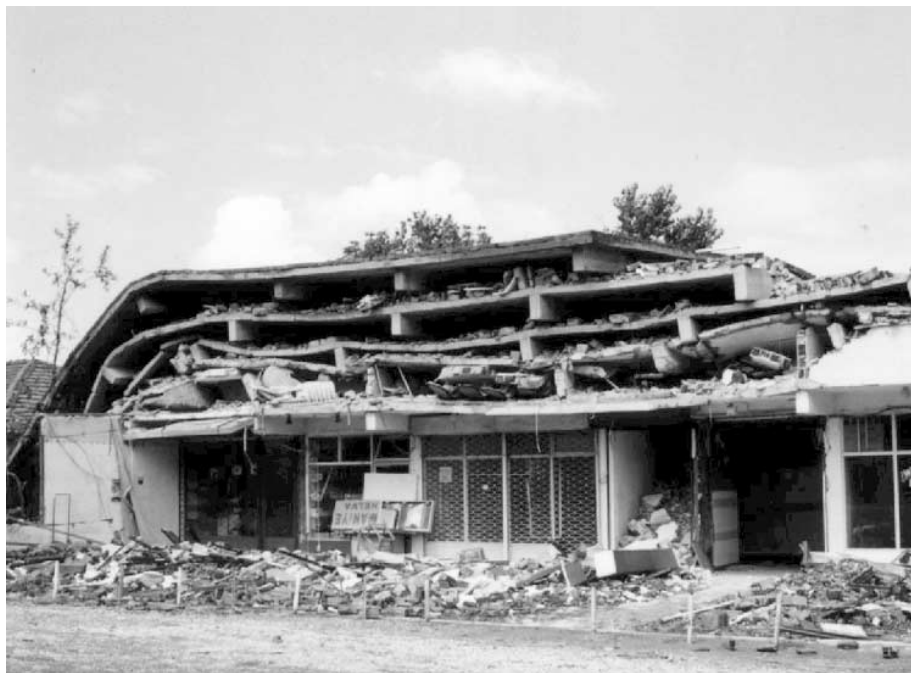
As noted earlier, at the time of the earthquake, seismic awareness in Turkey had not reached a level that made it possible to focus on the seismic hazard posed by the structures designed without due attention to earthquake-resistant design. This may explain why, to the author's knowledge, only one building in the severely affected region had apparently been seismically retrofitted prior to the earthquake. The Sakarya 'province' government building, shown in Figure 26, was allegedly retrofitted by the addition of shear walls some years prior to the earthquake. This building sustained damage to its infill walls at the ground story during the 1999 earthquake and was subsequently repaired. However, it remained operational following the earthquake, which is significant considering that it was literally surrounded by collapsed and severely damaged buildings, such as the one shown in Figure 27.

Figure 27. Typical building adjacent to retrofitted Sakarya 'province' government building.
