RECONNAISSANCE AND PRELIMINARY ASSESSMENT OF A DAMAGED HIGH-RISE BUILDING NEAR GROUND ZERO

GORDON WARN, JEFFREY BERMAN, ANDREW WHITTAKER* AND MICHEL BRUNEAU

SUMMARY

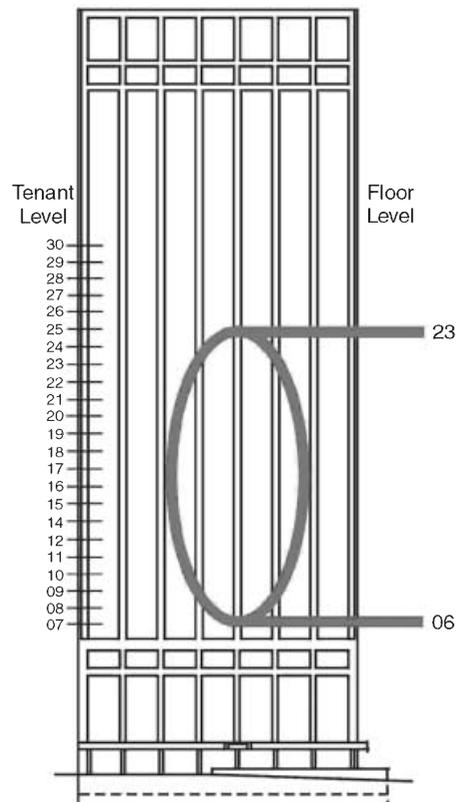
Figure 3. Rendering of northern façade showing the zone of damage

The façade of the building is composed of windows and a lightweight cladding system. A sketch of the northern façade that was badly damaged by falling debris is presented in Figure 3. The elliptical line in the figure identifies the zone of damage to the façade of the building.

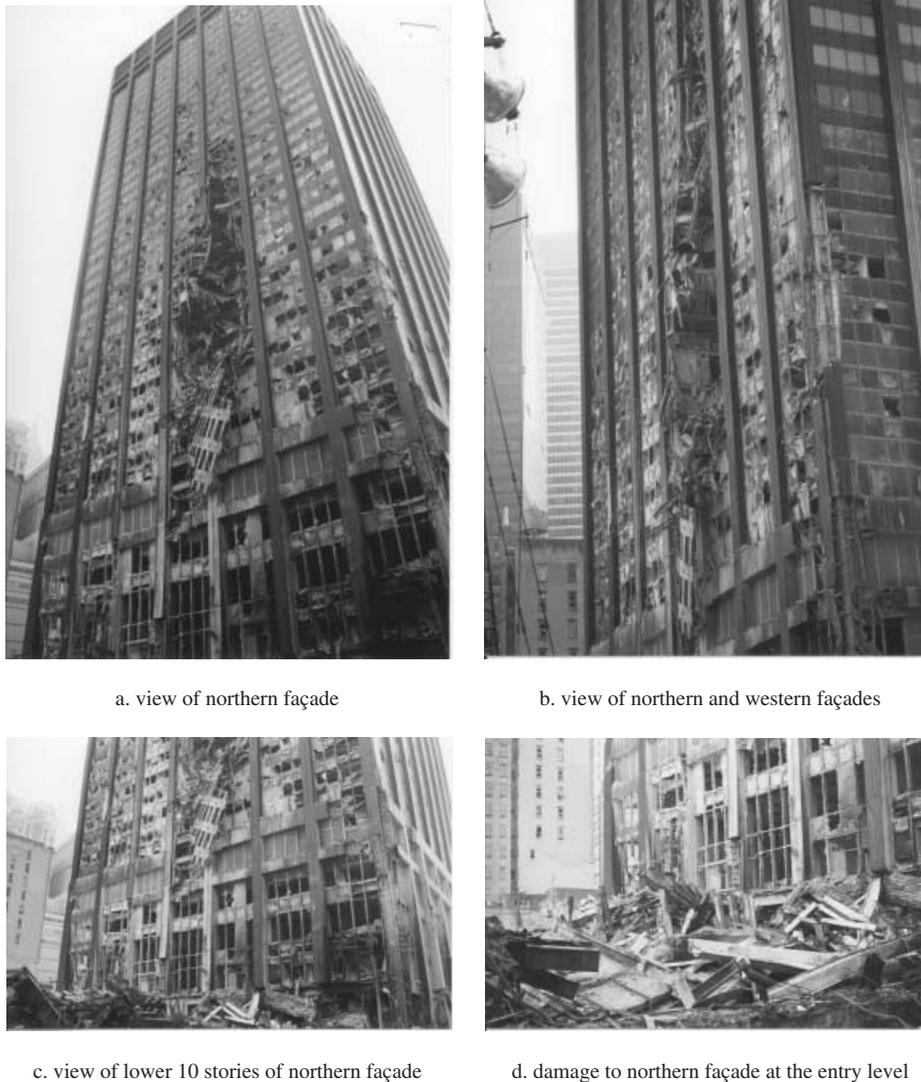
Figure 4. Damage to the 130 Liberty Plaza building from the exterior

The visit of September 21 involved an exterior inspection of the building from ground level as part of a broader survey reported elsewhere (Bruneau *et al.*, 2002). Figure 4 presents four photographs of the building taken on September 21, 2001. Part (a) is a view of the northern façade showing the large gash in the exterior wall caused by falling debris that was ejected from Tower 2 as it collapsed. One large piece of the façade of Tower 2 can be seen in this figure at approximately the ninth floor level. It is highly likely that this three-storey high piece of debris caused much of the damage that is evident above the ninth floor level. Clearly seen in this figure is the loss of a column on Line D (see Figure 3) between Tenant Level 7 and 25.

Part (b) of Figure 4 shows damage to the northern and western faces of the building. Windows were broken on both of these faces of the building but the damage on the western face was confined to a one-bay width between Lines 7 and 8. The cladding to corner column A8 was lost between the ground and Tenant Level 5 and between Tenant Level 9 and 12.

Parts (c) and (d) of Figure 4 show damage to the lower levels of the building on its north face. Burning debris ignited small fires in the lower levels of the building but these fires appeared to have been confined to the perimeter of the building. Most of the windows in the lower levels, especially below the mechanical plant room at the fifth floor level, were broken but it is not known how many of these windows were broken on purpose by the rescue teams to eliminate falling glazing hazards to the rescue workers operating to the immediate south of Tower 2. Part (d) of the figure shows the debris pile to the immediate north of the building, 10 days after the terrorist attacks. Much of the debris was from Tower 2.

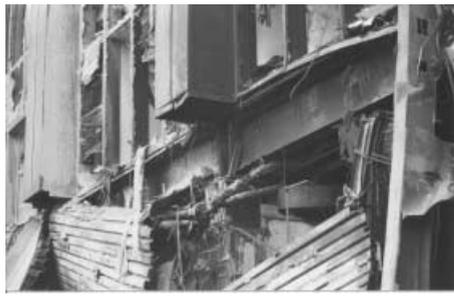
a. first story of northern face

Figure 5 presents information on the moment-resisting connections used in the building. Part (a) of the figure shows fire damage to the lower framing, a cover-plated moment connection of the beam to

the column, and the connections used to join the steel floor beams to the perimeter girders. No spray-on fireproofing is evident on the side or bottom of the perimeter beam although it may have knocked off upon impact. Façade construction details can be clearly seen in this figure. Part (b) of the figure shows a typical beam–column moment connection on the western face of the building. Cover-plates are clearly visible in this connection and damaged (or incomplete) fireproofing can be seen on the exterior face (web) of the perimeter beam.

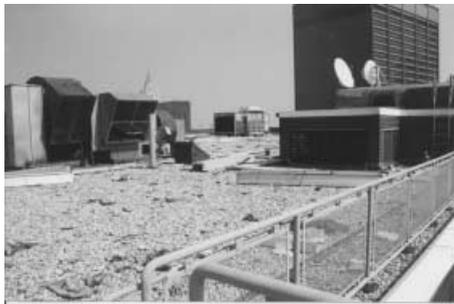
a. photograph looking east

Figure 6 presents photographs taken at the roof level of the building. Part (a) of the figure is a photograph looking east across the roof. Silver U-shaped aluminum panels from Tower 2 can be seen in the figure together with life vests from American Airlines (AA) Flight 11 that struck the north face of Tower 1 (approximately 120 m from 130 Liberty Plaza). Part (b) of the figure is a photograph looking west across the roof. Aluminum panels and AA life vests are also visible in this figure. Parts (c) and (d) of the figure are close-up photographs of an AA life vest and a seat from the AA Flight 11.

No structural damage was observed at the roof level of the building and there was no evidence that the roof floor slab had been punctured by falling debris from Tower 2. This observation was confirmed by the walk-through of the plant-room spaces immediately below the roof. Apart from broken glass in

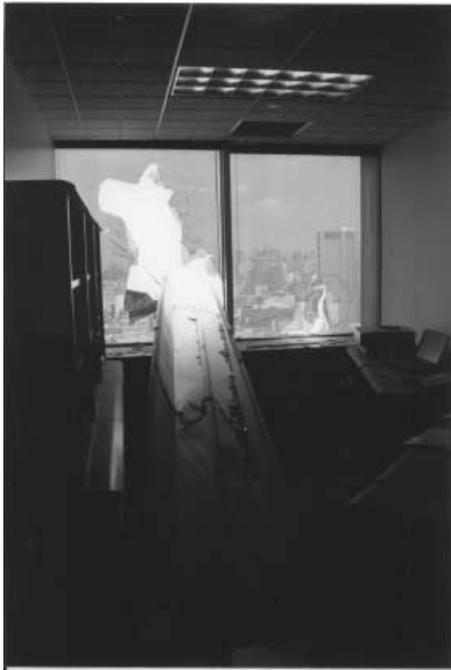
a. penetration of Tower 2 fascia piece

Damage to the building above Tenant Level 29 was modest (relative to the damage below Tenant Level 25) and was limited to broken glass (caused by debris ejected from Tower 2 as it collapsed). Figure 7 shows sample non-structural damage above Tenant Level 29. Part (a) of the figure shows damage caused by a section of fascia that was ejected from Tower 2 and which penetrated through a

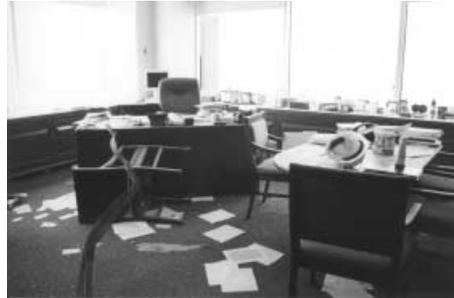
b. typical damage in office space

window on the northern face of the building. Part (b) shows debris in a corner office at Grid A8. The angle section lying atop the overturned chair in this figure penetrated through the north-facing window of the building. (The hard hat and flashlight in the photograph belonged to the photographer.)

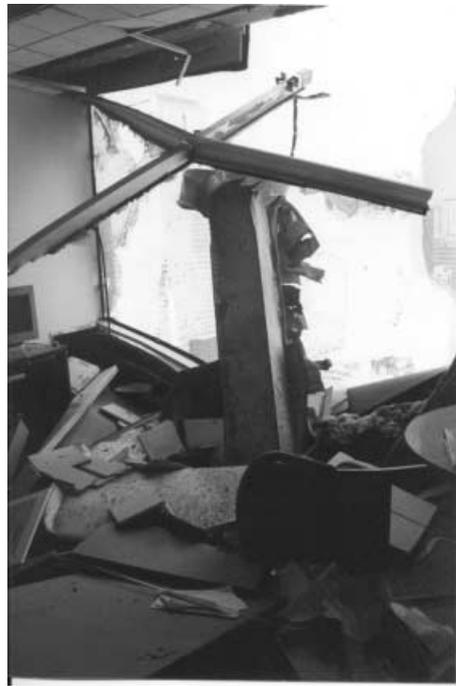
b. upper end of column-missile above Level 29

The first major structural damage was observed at Tenant Level 29 and was due to the impact of one single-story tall structural steel column from Tower 2. (Note that, as described in Bruneau *et al.* (2002), this column was one of three in a typical spandrel module, so the two steel beams linking the three columns were destroyed before the single column hit the 130 Liberty Plaza building.) Figure 8(a) is a sketch of a typical three-column module. Figure 8(b) shows the upper end of the column above Level 29. Figure 8(c) is a photograph of the underside of the column and the damage it caused to the ceiling system. It is noteworthy that the unreinforced slab on metal deck arrested the fall of this substantial steel member.

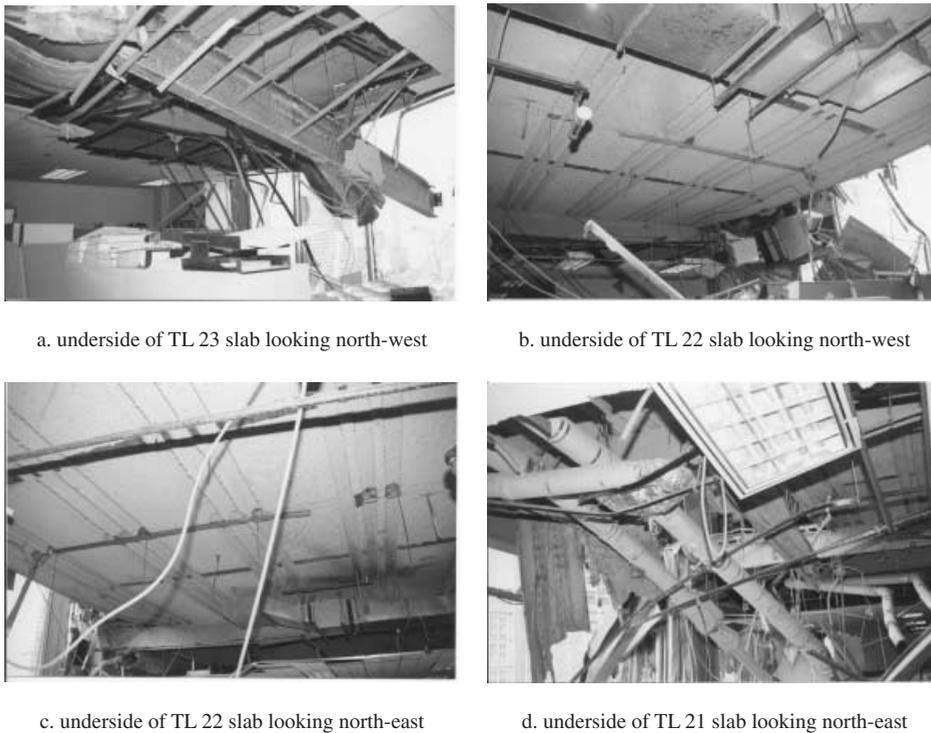
Figure 9. Interior damage at Tenant Levels 22 and 21

The degree of damage to the structural framing increased substantially below Tenant Level 26. Figure 9(a) shows a north-south spanning floor beam at the underside of Tenant Level (TL) 23 that has lost its support on Line 8 due to the failure (loss) of the spandrel beam between Lines D and E. Note the clean separation of the metal deck from the beam (made possible by the lack of studs joining the beam to the slab). Part (b) of the figure shows the underside of the floor slab at Tenant Level 22. At this level both north-south spanning floor beams were lost; the locations of these beams are marked

by dark stripes on the underside of the metal decking. Of importance to the integrity of the floor system is the fact that the Tenant Level 22 slab at this location was able to span three times the distance assumed in design, namely, 26 feet, albeit with large deflections in the slab system. Part (c) of the figure shows a view of the slab of part (b) looking northeast. Part (d) of the figure is a view looking north-east of the underside of the slab at Tenant Level 21: a photograph taken from approximately the same location as Figure 9(c) but one floor lower in the building. Fracture of the metal deck floor system at the line of the girder spanning north-south on Line E can be seen in part (d) of the figure together with gross distortion of two steel floor beams spanning north-south to the (lost) spandrel. Figure 10 presents photographs taken from Tenant Level 19 in the building.

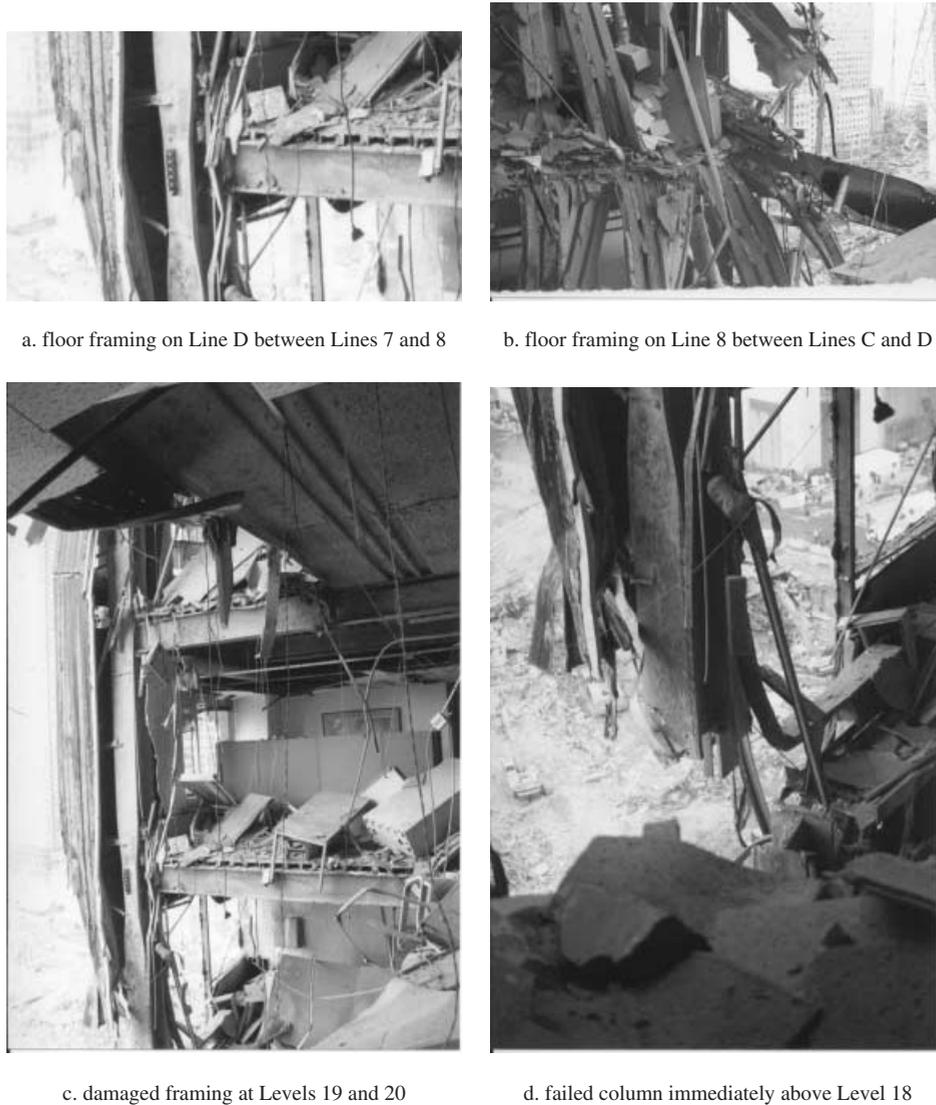
Figure 10. Interior damage photographs from Tenant Level 19

Figure 10 shows the remnants of a moment-resisting connection; the fractured flange connections and the welded web tab are clearly visible. Part (b) of the figure is a photograph taken from the same location as the photograph of part (a) but looking towards the north-south spanning girder on Line C. The World Financial Center and Winter Garden can be seen in the background of this photograph. Figure 10(c) is a view of two stories of framing along Line D. Note the distortion in the column flanges

at the level of the beam-to-column connection and that the metal decking fractured cleanly along a butt (non-continuous) joint atop the girder on Line D. Large deflections in the floor framing are not seen in this figure. Part (d) of the figure shows the fractured column on Line D at approximately 3 feet above Tenant Level 18, immediately below the bottom of the framing shown in part (c) of the figure. The rubble pile at the base of Tower 2 can be seen at the bottom of Figure 10(d).

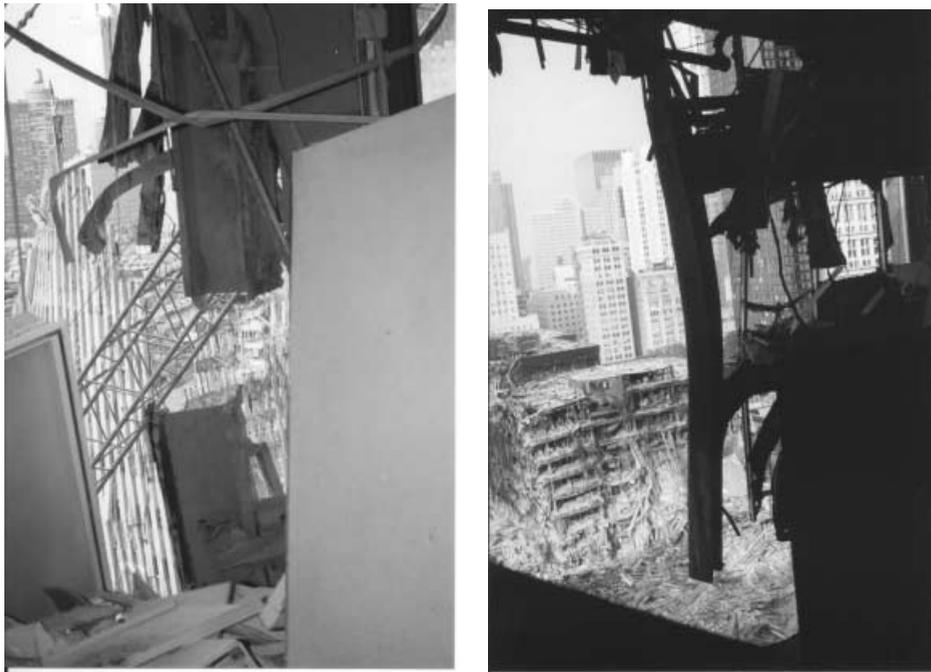
Figure 11. Fractured column on Line D from Tenant Levels 18 and 17

Figures 11(a) and 11(b) present photographs of the fractured column on Line D taken from Tenant Levels 18 and 17, respectively. The façade of Tower 2 can be seen in the background of part (a) of the figure and WTC 4 can be seen in the background of part (b) of the figure.

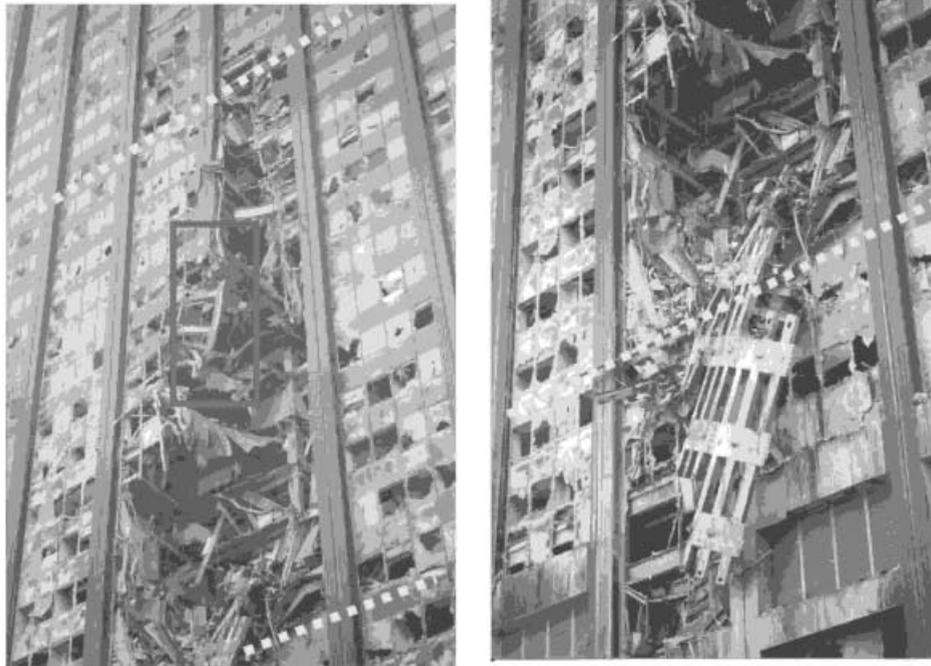
Figure 12. Damage to the northern face of the building between Tenant Levels 23 and 10

Figure 12 presents two photographs taken from outside the building looking toward the damage zone described in the previous pages. The box superimposed on Figure 12(a) shows the column of Figure 11. The fracture evident in Figure 11(a) is located at the top of the box. The distorted but intact, two-story section of column seen in Figure 11(b) is located in the center of the box. In Figure 12(a), the upper dashed line is at Tenant Level 25 and the lower dashed line is at Tenant Level 7. The dashed line in Figure 12(b) corresponds to the lower dashed line of Figure 12(a). The large piece of debris that likely caused most of the damage above Tenant Level 10 is seen in Figure 12(b) precariously attached to the façade of the building.

The damage to the structural and non-structural components between Tenant Levels 16 and 10 was most severe. The near-total destruction of the ceiling, mechanical, and plumbing systems in the areas surrounding the collapsed structural framing prevented the reconnaissance team from gaining access to the perimeter of the damage zone. As seen in Figures 12(a) and 12(b), the zone of extreme damage

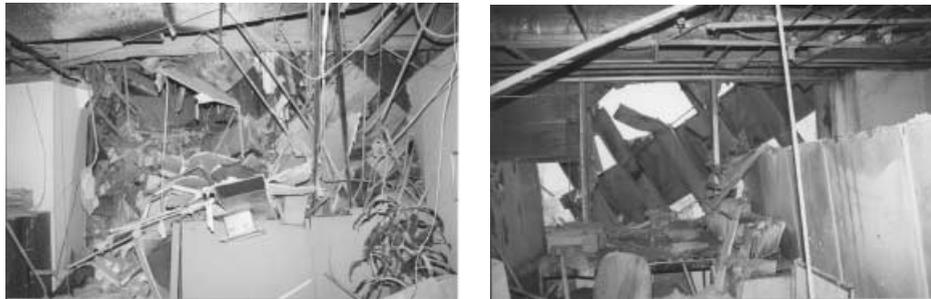
Figure 13. Building damage at Tenant Level 9

Figure 13 shows two photographs of damage at Tenant Level 9. Figure 13(a) shows the complete destruction of one zone of the floor immediately adjacent to the northern face of the building. Part (b) of the figure shows the interior face of the section of Tower 2 façade seen in Figures 4(a) and 12(b) that caused much of the damage to the building.

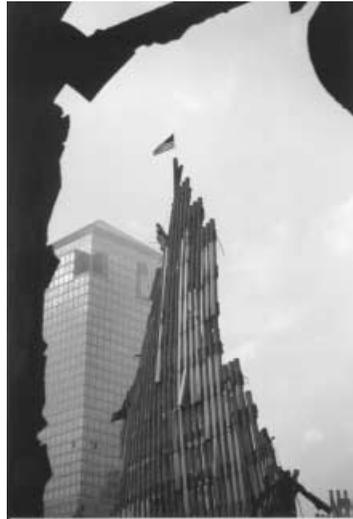
Figure 14. View of the Tower 2 façade looking north-west from the foyer of the building

building. Figure 14 is a photograph taken inside the building looking north towards a standing section of the Tower 2 façade.
