Behavior of Unreinforced Masonry Structures During the 1992 Erzincan, Turkey, Earthquake

by Michel Bruneau¹ and Murat Saatcioglu²

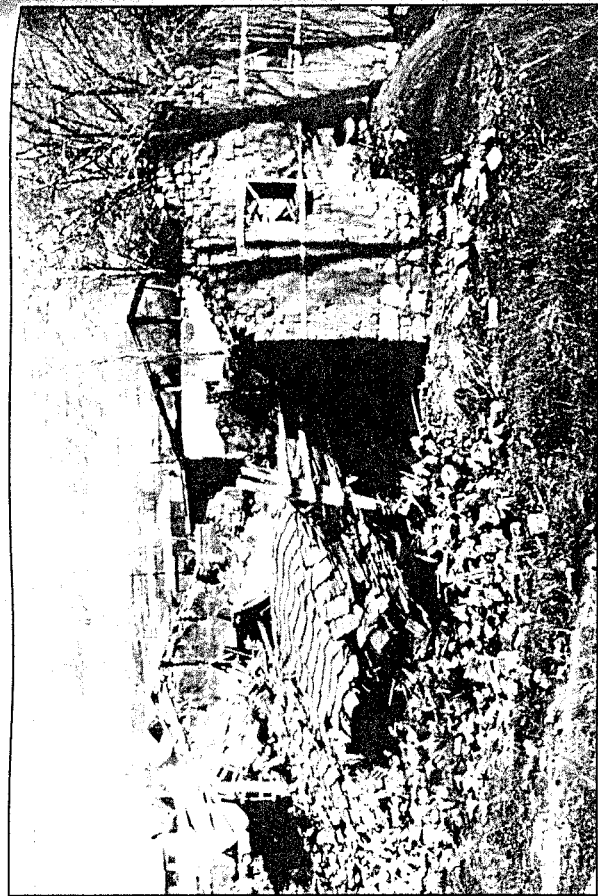
FIGURE 2. Example of collapsed mud-brick masonry construction

The spectrum of URM construction types and practices varied greatly in Erzurum. Mud brick construction of low quality was used widely in the poorest neighborhoods on the outskirts of the city, while some have collapsed (Figure 2) or suffered major damage, others survived somewhat intact. The individual seismic performance of these non-engineered dwellings is an intricate function of wall thickness, internal subdivisions, roof mass nature of the continuity with adjacent dwellings, etc. Even though these dwellings are of no engineering significance, it was sad to see their resourceless occupants rebuilding with exactly the same techniques and materials following the earthquake, often re-using surviving parts of severely damaged walls, in spite of the demonstrated poor seismic performance and high life safety hazards of these constructions.

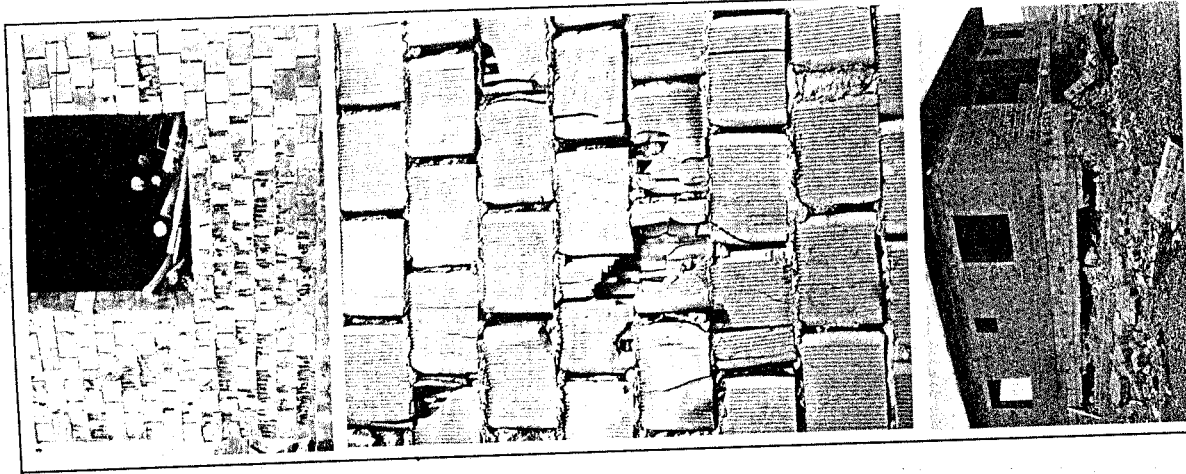
FIGURE 4. (a) Partially delaminated brick of the thin cell-walls type; (b) Close-up view of same; (c) Collapse of a URM building due to diagonal crushing of non-bearing masonry brick

severe difference in seismic performance observed over only a few hundred feet and a subjective evaluation of the local topography, such a soil effect can be, at best, only partly accountable for this damage. A closer observation revealed that, invariably, the walls built of the rectangular-cell URM blocks were severely damaged. This can be attributed to the poor resistance of these URM walls to seismically-generated compressive diagonal stresses. The very thin cell walls of these bricks proved unequal as soon as the compressive capacity was exceeded, producing an effective "delamination" accompanied by a rapid drop in strength, often leading to overall collapse (Figure 4). By comparison, very large diagonal cracking was observed to occur in walls built with circular-cell masonry blocks; a lower void ratio and thicker average brick-cell walls both contributed to an enhanced block stability under compression, and allowed some structures to survive in spite of very large diagonal in-plane cracking (Figure 5). In-plane failures dominated in this case.

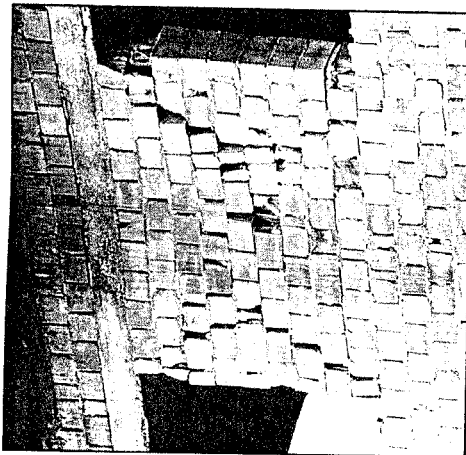
FIGURE 5. Large diagonal cracking in URM walls built with circular-cell non-bearing masonry blocks

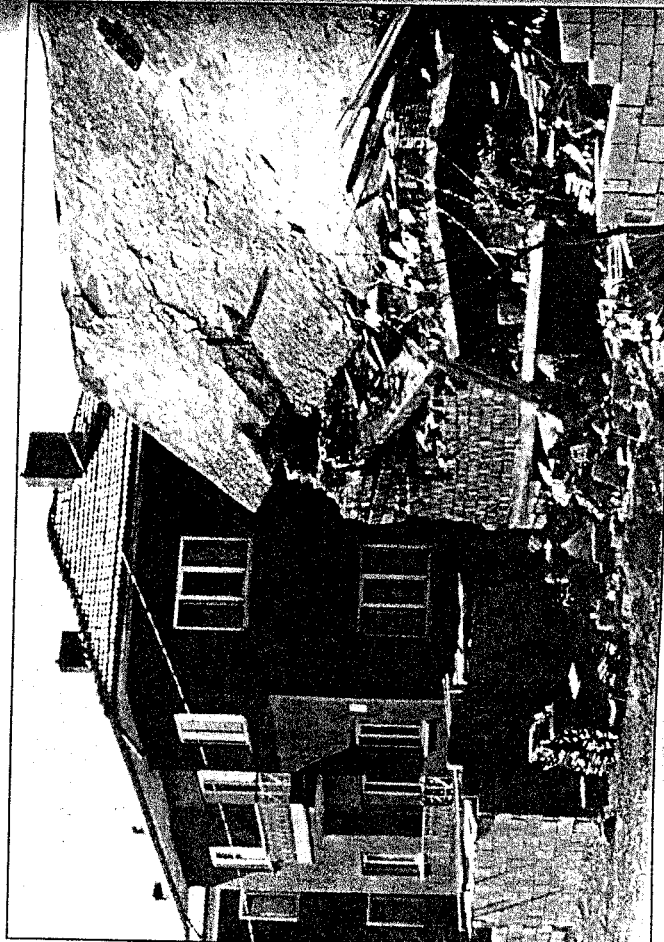
In spite of these numerous failures, many residential URM masonry structures were observed to have survived this earthquake intact (Figure 6). This excellent behavior is largely attrib-

FIGURE 6. Example of older residential URM masonry buildings that have survived intact, next to a new building collapsed while under construction

able to the high structural redundancy of the older structures; the typical living area of residential apartments in Erzurum averages 70 m² per unit, subdivided by masonry-block partitions into two or three bedrooms, living room, kitchen, and restroom. A number of other URM structures also were present in Erzurum, and their performance was similar to that observed worldwide in similar circumstances. For example, a URM warehouse completely collapsed at the Rural Services Affairs (Figure 7).

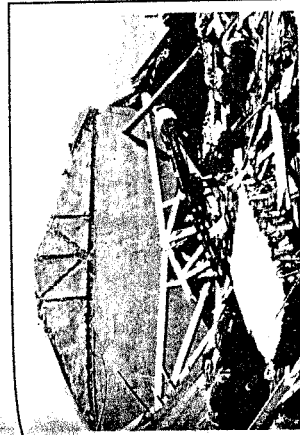
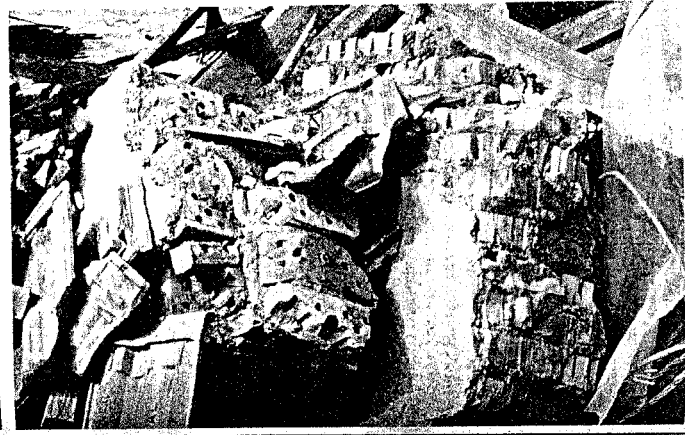
FIGURE 7. (a) Completely collapsed warehouse due to out-of-plane failure of near-solid brick masonry at the Rural Services Affairs, and (b) close-up view of the brick masonry

Constructed of 325 mm thick masonry walls of near-solid bricks, coated by more than 25 mm of stucco, for a height-to-thickness ratio of 11.5, the out-of-plane failure of this practically solid-wall rectangular enclosure occurred largely as a consequence of the absence of anchorage at roof level. Also as a consequence of a similar lack of anchorage, the out-of-plane failure of gable roofs, made of various types of masonry units, was extensive throughout Erzurum (Figure 8).

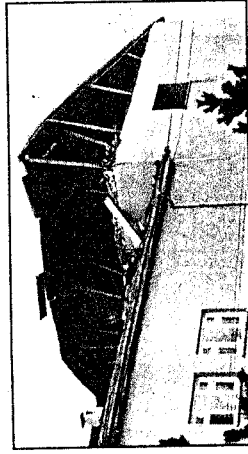
FIGURE 8. Typical out-of-plane failure of unanchored gable roofs

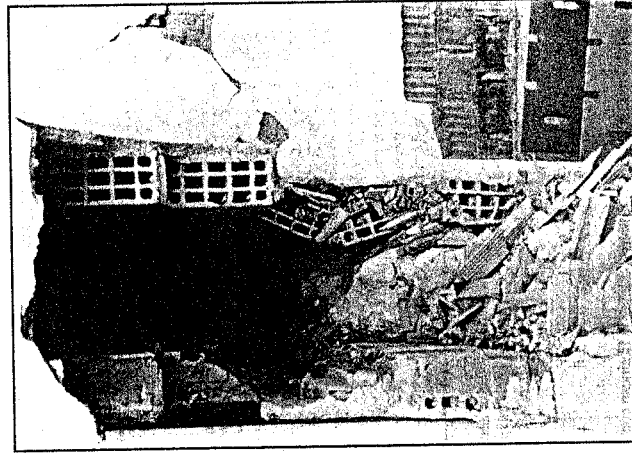
Double-layer URM walls constructed with sandwiching insulation (or sawdust used as insulation) also performed poorly; the presence of insulation prevented bond between the layers, leading to increased height-to-thickness ratios and out-of-plane damage (Figure 9). For similar reasons, other cavity walls performed

FIGURE 9. Damaged double-layer URM walls sandwiching insulation

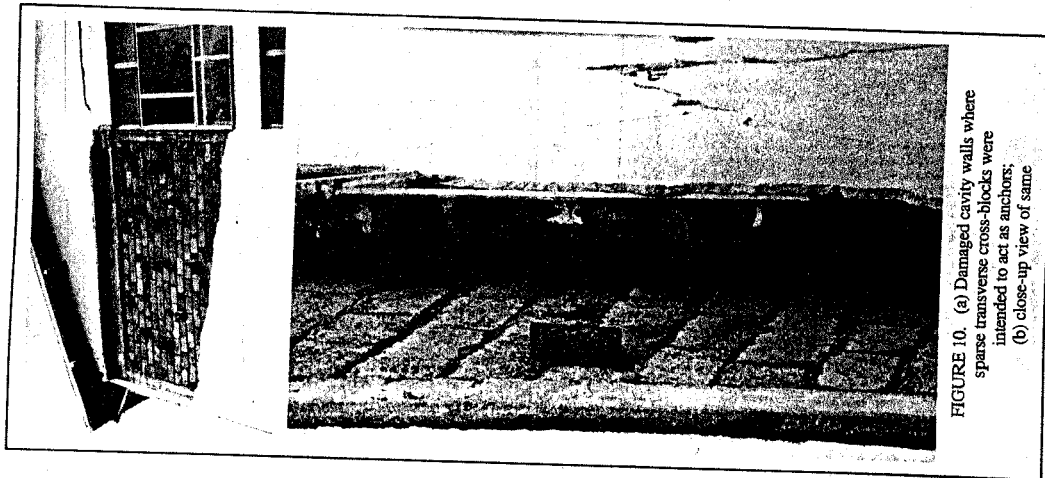
FIGURE 10. (a) Damaged cavity walls where sparse transverse cross-blocks were intended to act as anchors. (b) close-up view of same

equally poorly, regardless of the type of masonry used, and sometimes in spite of the presence of a few metal anchors or transverse cross-blocks intended as anchors (Figure 10).

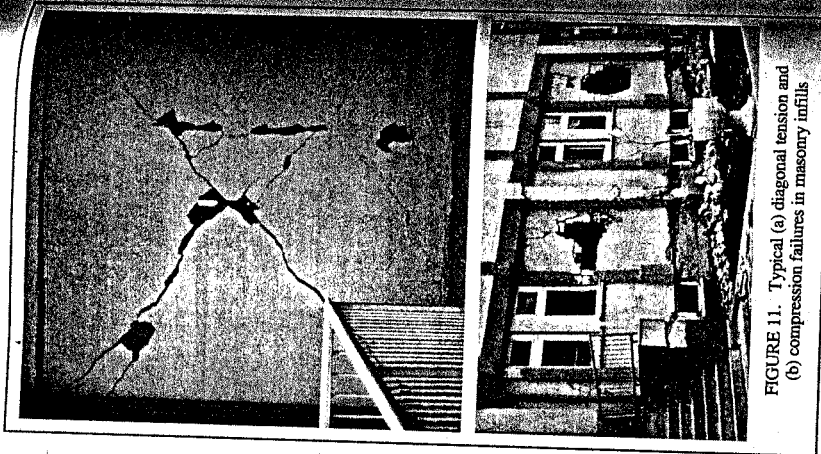
FIGURE 11. (a) Typical diagonal tension and (b) compression failures in masonry infills

able to remain elastic, particularly when non-bearing hollow brick was used as infill. These non-bearing hollow bricks did not have the strength to withstand diagonal compression generated during the earthquake, and high deformability demands of frame structures. Therefore they developed diagonal tension and compression failures as shown in Figure 11. Crushing of the cells of the hollow brick units led to the separation of the infills from the frame, as shown in Figure 12. In one of the buildings of the Sumerbank Textile Factory, this separation was followed by out-of-plane movement of the infill, as illustrated in Figure 13. In some cases, failure of individual brick units triggered more conventional out-of-plane failures of infills.

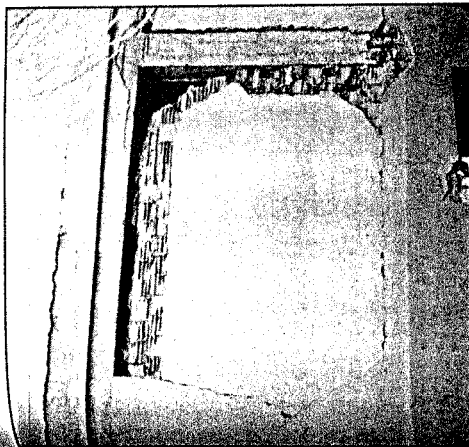
FIGURE 12. Crushing of hollow brick masonry and separation of infills from the frames

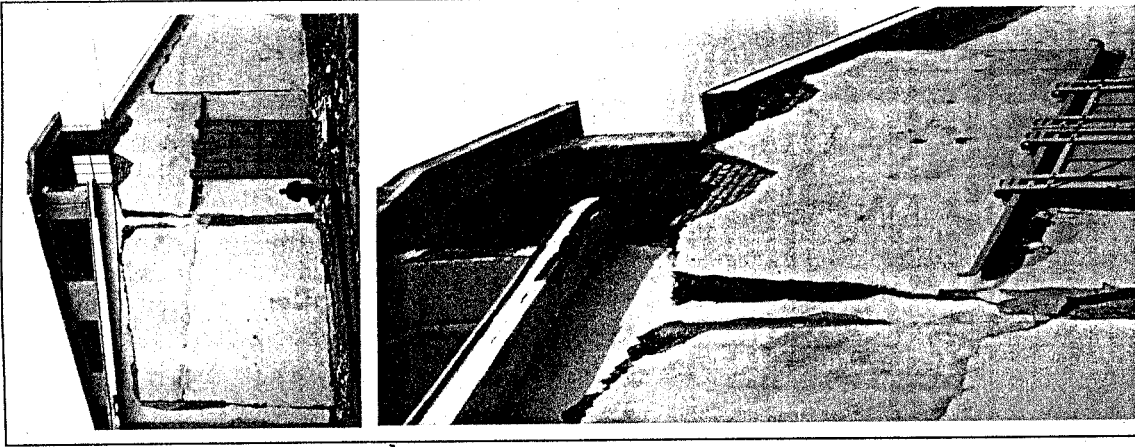
FIGURE 13. (a) Separation of URM infills from reinforced concrete frames and out-of-plane movement of part of the infill in Sumerbank textile factory. (b) close-up view of same

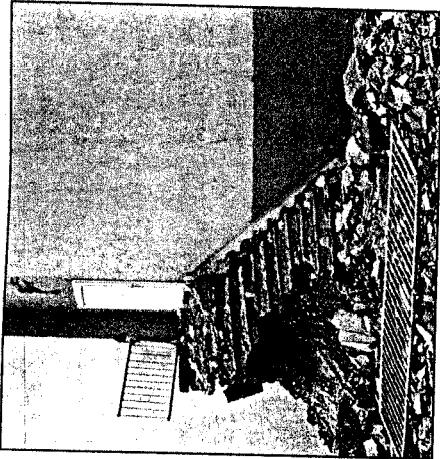
It is noteworthy that severe infill failures produced a considerable amount of falling debris which not only acted as life hazards during the earthquake, but also obstructed stairwells and passageways preventing subsequent safe egress of occupants (Figure 14). These observations partly explain why even minor separation cracks between infills and reinforced concrete frames, in otherwise sound buildings which survived the earthquake, became a major cause of concern to scared owners and tenants—most refused to re-occupy the premises, afraid that collapse was imminent.

FIGURE 14. Emergency exit obstructed by debris from URM infill failures

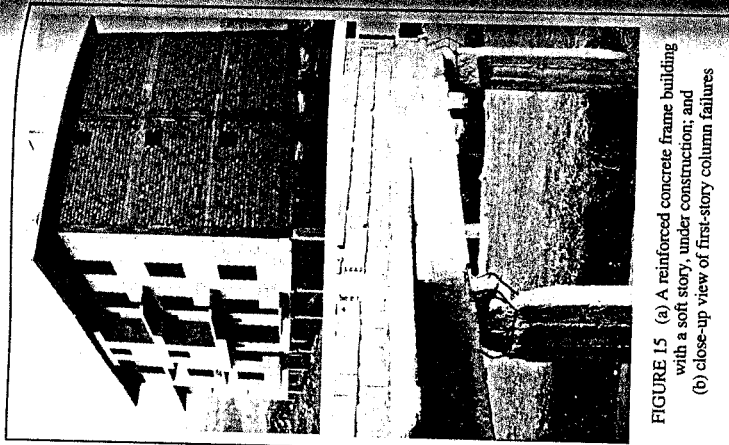
Finally, as an indirect consequence of discontinuous infill walls, a large number of residential and commercial buildings were built with soft stories at the first-floor level. First stories in Erzinçan often are used as stores and commercial areas, especially in the central part of the city. These areas are enclosed with glass windows, and sometimes with a single masonry infill at the back. Heavy masonry infills start immediately above the commercial floor. During the earthquake, the presence of a soft story increased deformation demands very significantly, and put the burden of energy dissipation on the first story columns. Many failures and collapses can be attributed to the increased deformation demands caused by soft stories, coupled with lack of deformability of poorly-designed columns. Figure 15 illustrates an example of apartment building with a soft story.

FIGURE 15 (a) A reinforced concrete frame building with a soft story, under construction; and (b) close-up view of first-story column failures
