## PERFORMANCE OF CHURCHES DURING THE DARFIELD EARTHQUAKE OF SEPTEMBER 4, 2010

Myrto Anagnostopoulou<sup>1</sup>, Michel Bruneau<sup>2</sup> and  
Henri P. Gavin<sup>3</sup>

### SUMMARY

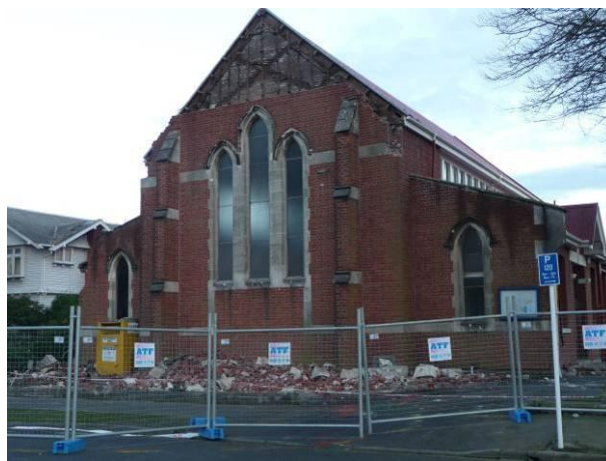
The Christchurch Chinese Methodist Church in Merivale (165 Papanui Rd, 43030'49"S-172°37'19"E) is an unreinforced masonry building with a square tower on top of which rests a pyramidal spire. The building suffered out-of-plane wall failures of its gables, as shown in Figure 1, and was characterized as unsafe to access. In order to facilitate the reconstruction and strengthening of the damaged building, the spire was lifted off its supporting tower with a crane and placed on the ground as illustrated in Figure 2 and Figure 3.

**Figure 1:** *Out-of-plane gable failure, Christchurch Chinese Methodist Church [Photo by M. Bruneau].*

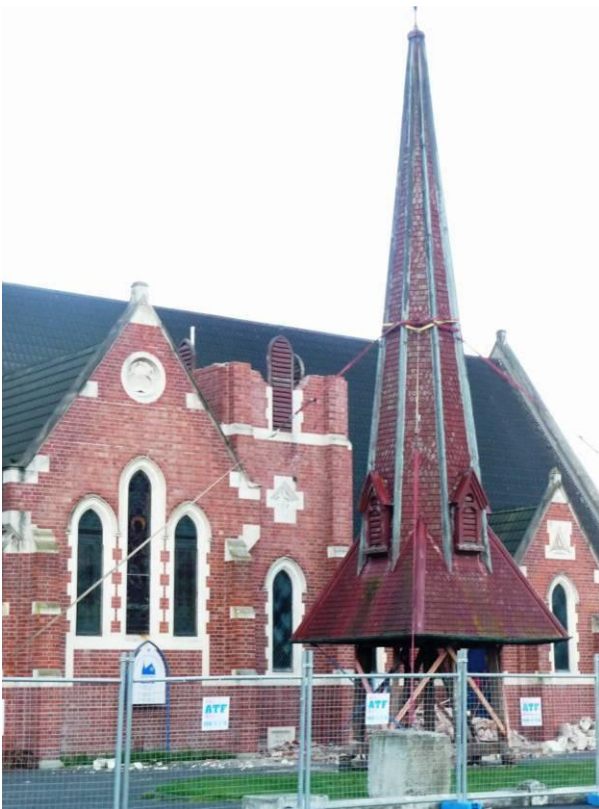
**Figure 3:** Spire supported on the ground, Christchurch Chinese Methodist Church [Photo by M. Bruneau].

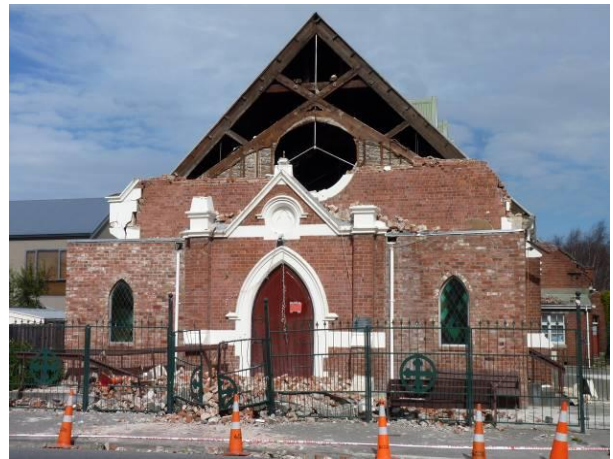
plane wall failures of its gables, as shown in Figure 4. As observed in many instances of out-of-plane failures, anchors were present in the walls that failed in order to anchor the masonry wall to its supporting timber frame. A frequently encountered type of archaic anchor is shown in Figure 5. Clearly, these existing anchors provided insufficient restraint against the seismically induced forces, and led to out-of-plane wall failures (Figure 6). This observation is not surprising as these anchors, like many other types of old anchors, were never intended to resist earthquake loads. The façade of the church was decorated by a circular shaped window and two small-size domes that collapsed during the earthquake (Figure 7). The building was determined to be unsafe to access because of the numerous out-of-plane wall failures. (A red tag on the door is visible in Figure 4.)

**Figure 4:** Front view showing significant gable failure, St Mary and St Athanasios Coptic Orthodox Church [Photo by M. Anagnostopoulou].

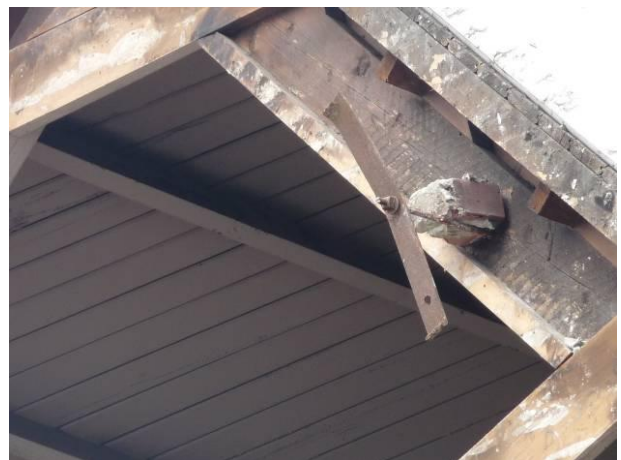
**Figure 5:** Characteristic type of anchor, St Mary and St Athanasios Coptic Orthodox Church [Photo by M. Bruneau].

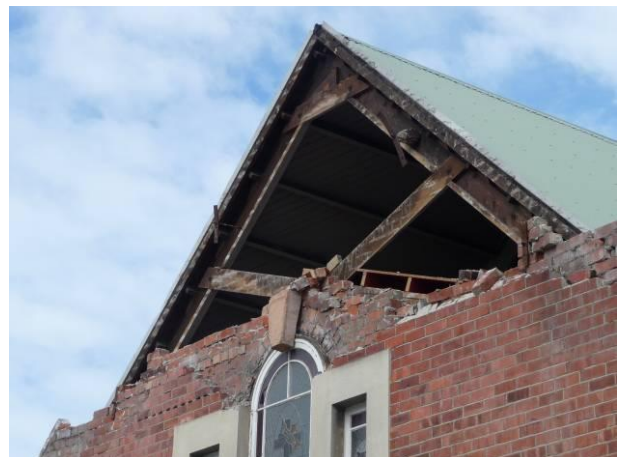
**Figure 6:** Masonry wall failure due to insufficient anchorage, St Mary and St Athanasios Coptic Orthodox Church [Photo by M. Bruneau].

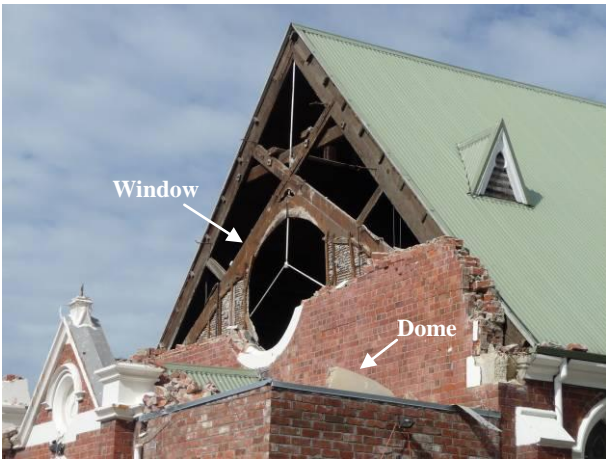
**Figure 7:** Failure of the façade's window and domes, St Mary and St Athanasios Coptic Orthodox Church [Photo by M. Bruneau].

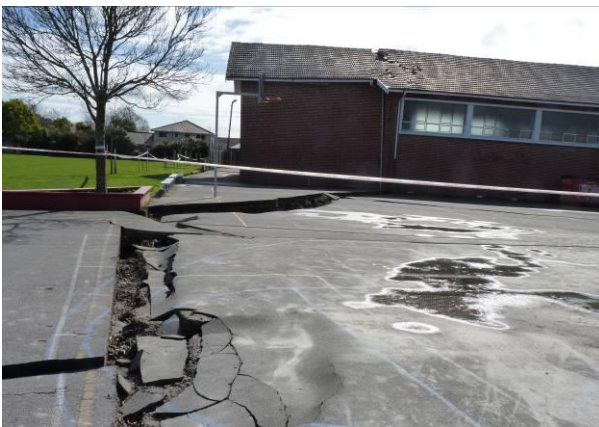
St Paul's Catholic Church in Dallington (17 Gayhurst Rd,  $43^{\circ}31'10''\text{S}$ - $172^{\circ}40'21''\text{E}$ ) was built in 1957 (Figure 8). The building has a rectangular shaped plan view and its structural system consists of concrete portal frames and masonry infill walls [2]. The 2010 earthquake caused an extensive amount of liquefaction and ground deformation in the church's surrounding area (Figure 9). As a result, significant settlement and vertical cracking were observed in the body of the building (Figure 10). Differential settlement across the length of the church separated the lower part of the structure, leaving a wide gap in the roof (Figure 11). The church was determined to be unsafe for occupancy and is to be demolished [2].

**Figure 9:** Liquefaction and ground deformation around St Paul's Catholic Church [Photo by M. Anagnostopoulou].

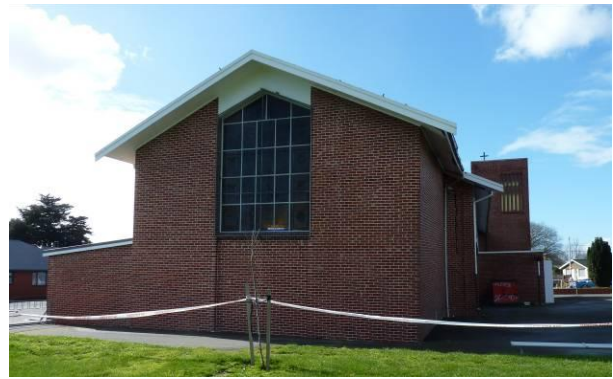
**Figure 10:** Ground settlement due to liquefaction, St Paul's Catholic Church [Photo by M. Anagnostopoulou].

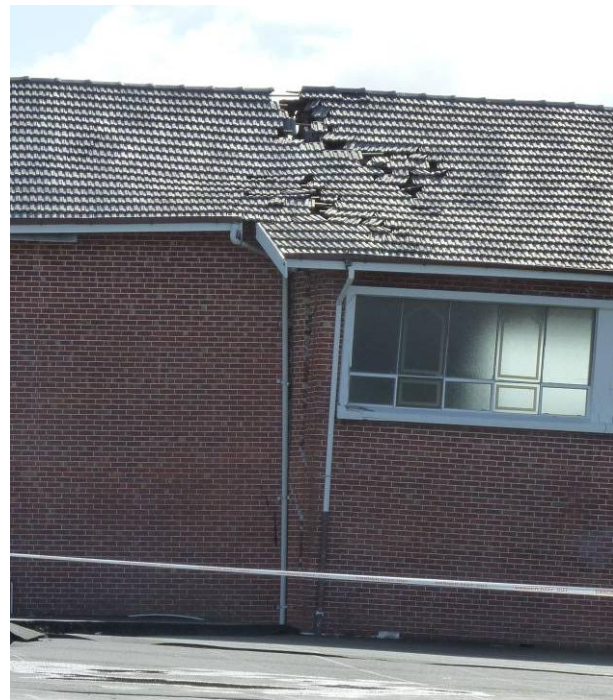
**Figure 11:** Gap in the roof and vertical cracking due to differential settlement, St Paul's Catholic Church [Photo by M. Anagnostopoulou].

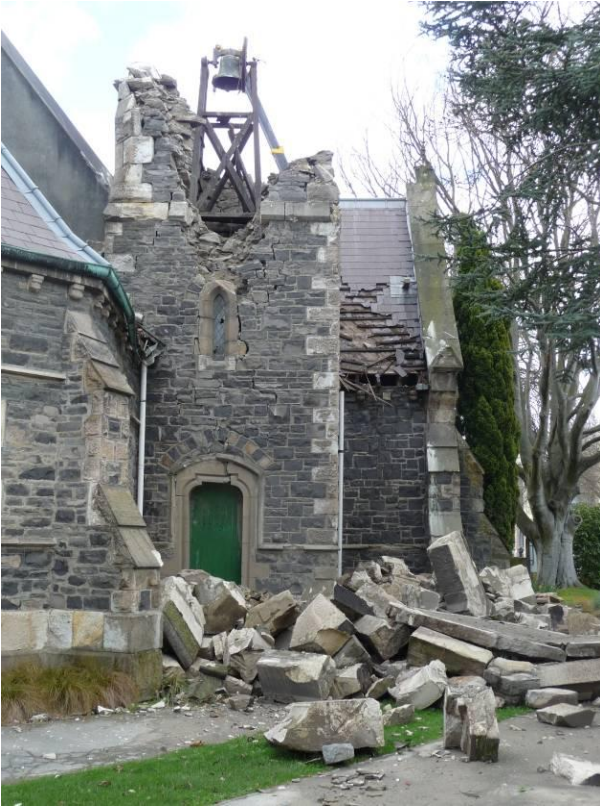
St. John's Anglican Church in central Christchurch (234 Hereford St,  $43^{\circ}31'56''\text{S}$ - $172^{\circ}38'35''\text{E}$ ) is a stone masonry building built in the late 1800s. According to the Christchurch City Libraries catalogue [3], it is one of the city's heritage buildings. The church's masonry bell tower, which was characterised by different architectural styles and structural elements along its height [4], collapsed during the 2010 earthquake as shown in Figure 12 through Figure 14. The tower collapsed away from the main church building avoiding any consequent damage. Vertical fracture of the tower over its remaining height was visible, and damage revealed the rubble infill of the stone walls (Figure 13). Moreover, out-of-plane movement of the gable left it separated from the building. This separation spread to the connection with the church's lateral walls, resulting in vertical cracking along the building's height (Figure 16). The horizontal gap at the top of the façade's gable was approximately eight centimetres. In order to prevent the church's façade from suffering more damage or collapsing into a busy thoroughfare, a heavy steel reaction frame was installed 10 days after the main shock as shown in Figure 15 and Figure 16.

**Figure 12:** Collapse and vertical fracture of bell tower, St. John's Anglican Church [Photo by M. Bruneau].

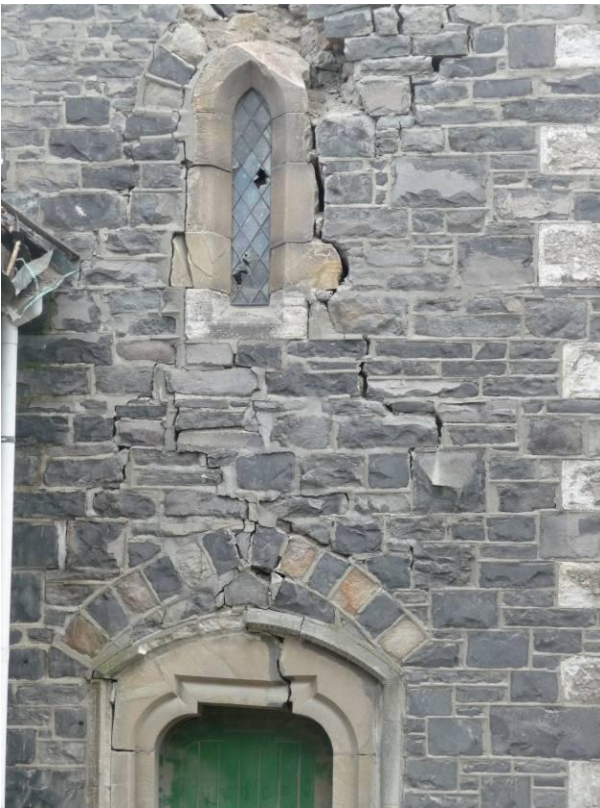
**Figure 13:** Vertical fracture of bell tower, St. John's Anglican Church [Photo by M. Bruneau].

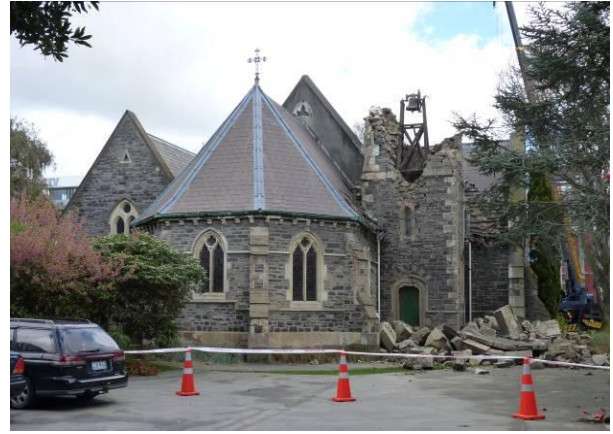
**Figure 14:** General view and bell tower failure, St. John's Anglican Church [Photo by M. Anagnostopoulou].

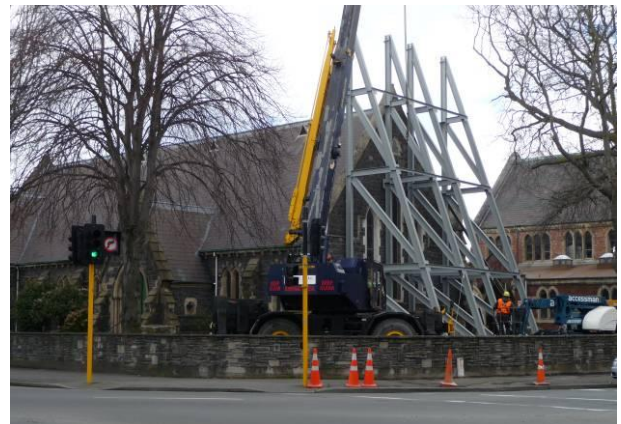
**Figure 15:** Reaction frame at façade's gable, St. John's Anglican Church [Photo by M. Bruneau].

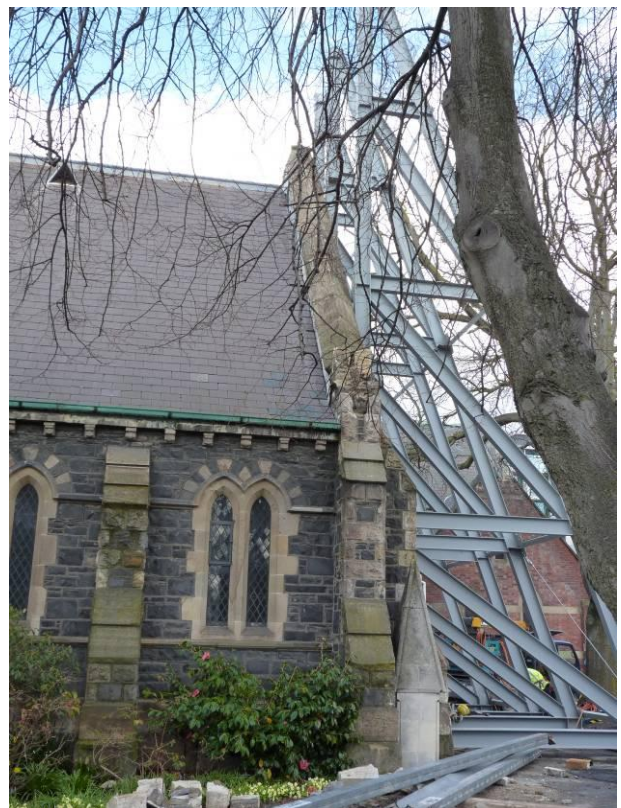
**Figure 16:** Separation of façade's gable from building and steel reaction frame, St. John's Anglican Church [Photo by M. Anagnostopoulou].

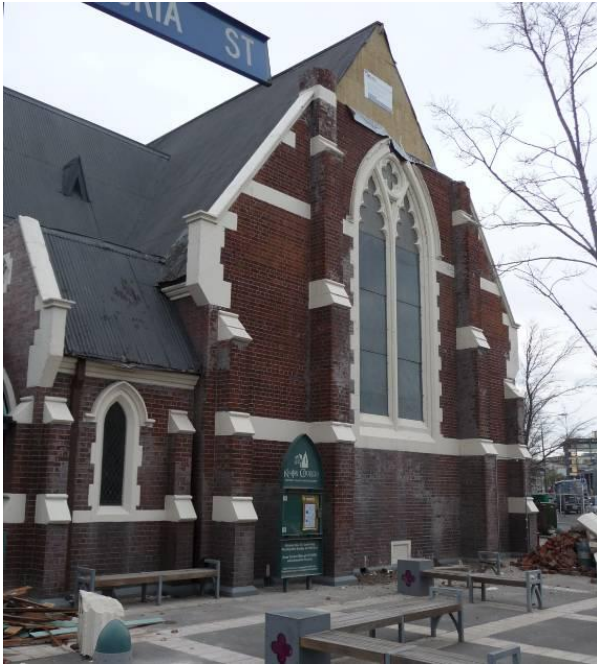
The Knox Presbyterian Church in central Christchurch (28 Bealey Av, 43°31'16"S-172°37'43"E) was built in 1964 [5]. The building's masonry gables were significantly damaged due to lack of anchorage to their supporting timber diaphragms, as shown in Figure 17 and Figure 18. The church was tagged to permit restricted access and restoration work started the week after the earthquake.

**Figure 17:** Gable failure, Knox Presbyterian Church [Photo by M. Bruneau].

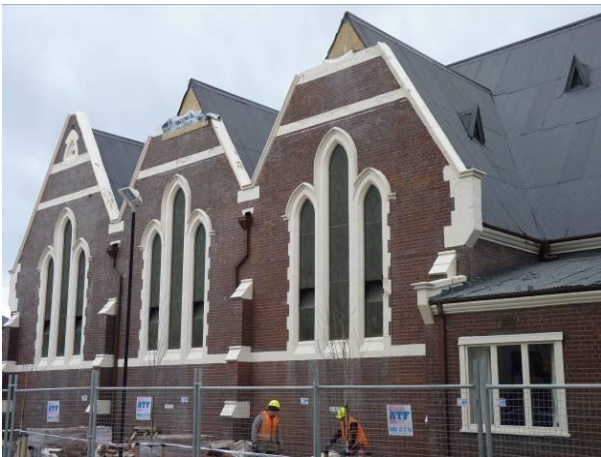
**Figure 18:** Damage in masonry gables and restoration, Knox Presbyterian Church [Photo by M. Anagnostopoulou].

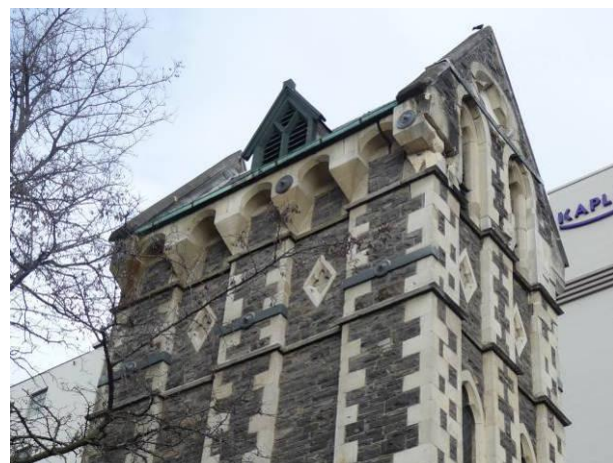
**Figure 21:** Anchor ties installed at building's tower, Trinity Congregational Church [Photo by M. Bruneau].

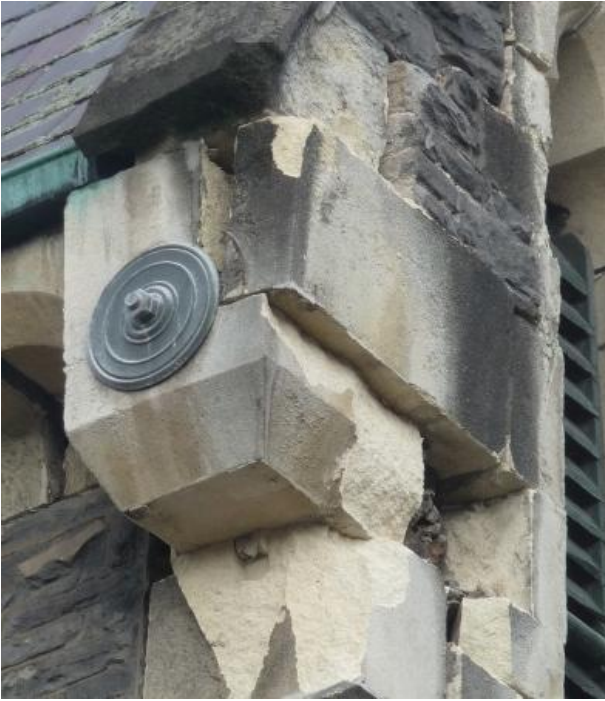
The Trinity Congregational Church in central Christchurch (124 Worcester St, 43°31'52"S-172°38'22"E) was built in 1874 and has a Gothic style [6] (Figure 19 and Figure 20). Recent retrofitting and strengthening of the building, including several anchor ties (Figure 21), appears to have reduced the damage from the 2010 earthquake. Minor cracking, spalling of the building's thick stone walls, and damage in the tower were observed (Figure 22). The building will reopen as soon as repairs are completed [7].

**Figure 22:** *Damaged tower, Trinity Congregational Church [Photo by M. Bruneau].*

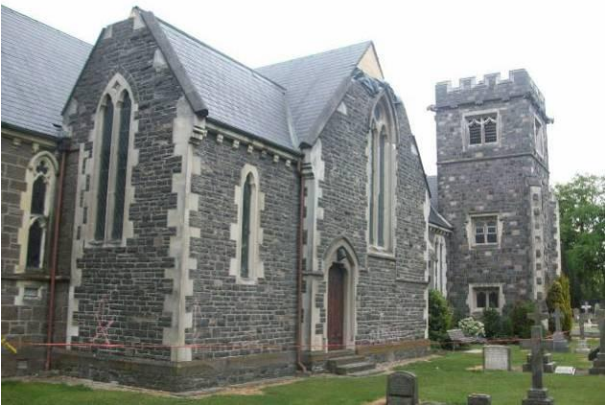
earthquake the peaks of transept parapets fell (NS direction) and peaks of quire parapets fell (EW direction) in subsequent aftershocks (Figure 23).

**Figure 23:** *Fallen quire and transept parapets, St Peter's Anglican Church [Photo by H. Gavin].*

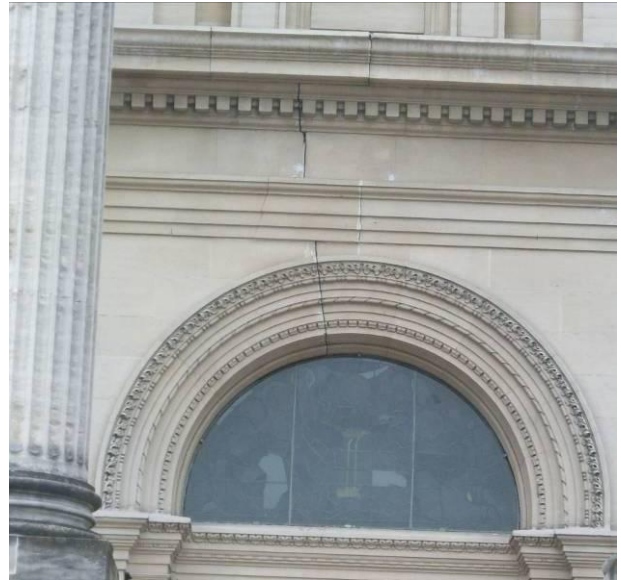
The Cathedral of the Blessed Sacrament in central Christchurch (122 Barbados St,  $43^{\circ}32'17''\text{S}$ – $172^{\circ}38'46''\text{E}$ ) has a basilica form and is constructed of poured concrete between walls of large limestone blocks [9]. The wall thickness is 1.2 meters. “The Basilica” was built over four years and opened in 1905. Seismic upgrades in 2004 included strengthening of the drum below the dome (Figure 24), the bell tower, the mezzanine floor, and the roof above the mezzanine. The drum was strengthened with cast concrete ring beams above and below the windows which were joined by pilaster columns. Spandrel beams and cross bracing were added inside the bell towers. The 2010 earthquake caused little in the way of horizontal shear cracks at construction joints in the walls or in the retrofitted portions. Repairs to cracks around the keystone of window arches and in the mezzanine floor above the sanctuary require that “the Basilica” remains closed for at least a year (Figure 25).

**Figure 25:** *Cracks around keystones in the Cathedral of the Blessed Sacrament [Photo by H. Gavin].*

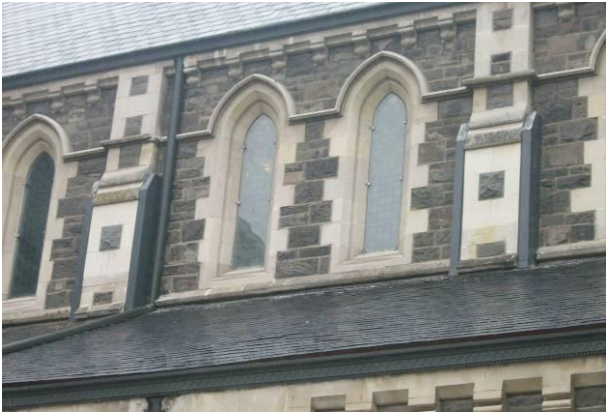
**Figure 26:** Steel channels along the ordinary buttresses, Christchurch Cathedral [Photo by H. Gavin].

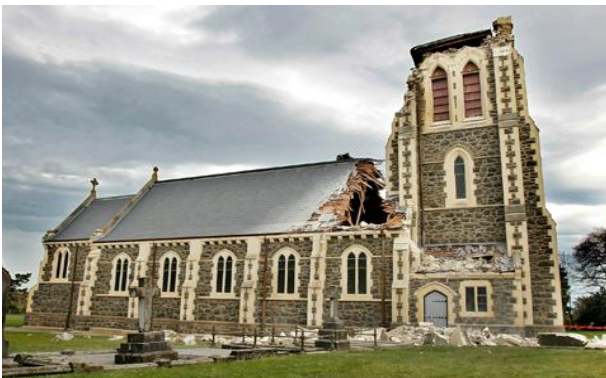
St John's Hororata Church in Darfield ( $43^{\circ}31'08''\text{S}$ - $171^{\circ}56'46''\text{E}$ ) was built in the early 1900's and is considered a heritage building [12]. It is a masonry structure located only a few kilometres away from the epicentre. During the 2010 earthquake, the church's tower collapsed causing significant damage to the west end of the nave as well as to the church organ (Figure 28 and Figure 29).

**Figure 28:** Collapsed tower, St John's Hororata Church (Retrieved October, 2010, from <http://geoconger.wordpress.com/category/anglican-church-news/anglican-church-of-aotearoa-new-zealand-polynesia/>).

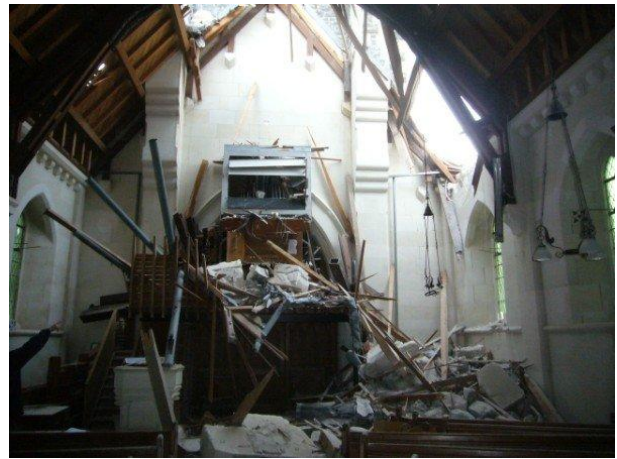
**Figure 29:** Damage in the interior of the church and organ, St John's Hororata Church (Retrieved October, 2010, from <http://www.hororataparish.co.nz/st-johns-hororata-gallery.php>).

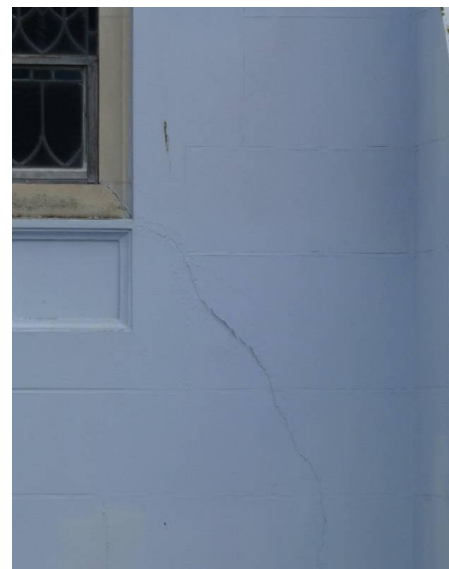
St Joseph's Catholic Church in Darfield (Telegraph Rd,  $43^{\circ}29'32''\text{S}$ - $171^{\circ}06'32''\text{E}$ ) is a masonry structure located only a few kilometres away from the epicentre (Figure 30). During the 2010 earthquake, the church suffered cosmetic wall cracks as illustrated in Figure 31.

**Figure 31:** Cosmetic wall crack, St Joseph's Catholic Church [Photo by M. Bruneau].
