PRELIMINARY REPORT ON STEEL BUILDING DAMAGE FROM THE DARFIELD EARTHQUAKE OF SEPTEMBER 4, 2010

SUMMARY

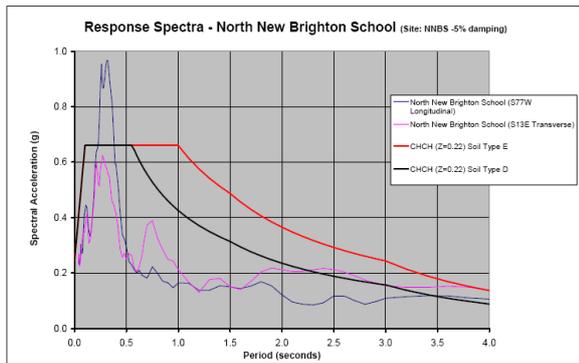
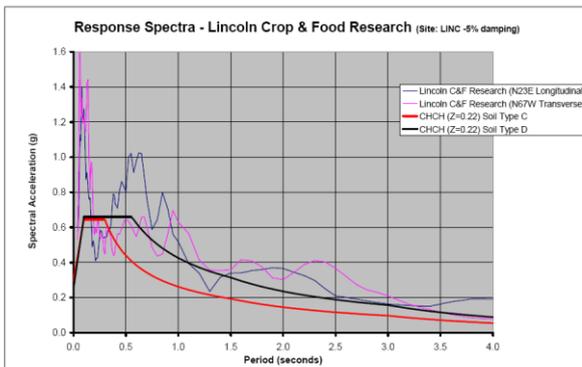
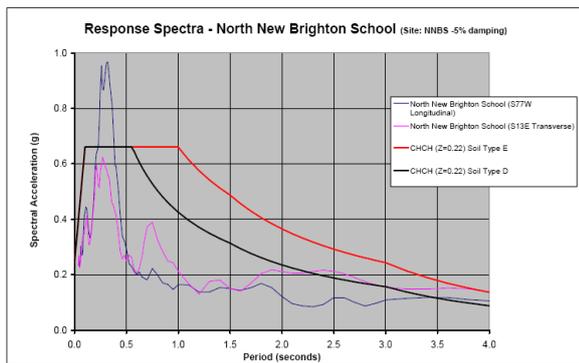
Figure 1: 5% damped spectra from various locations with design ULS spectra for the relevant soil types added; (a) from Christchurch hospital - soil type D; (b) from Lincoln crop and Food research - soil type D; (c) from North New Brighton - North east of city, soil type D/E [Generated by C. Clifton based on data retrieved from Geonet].

1. Intensity varies considerably throughout the region.
2. Modification from the underlying soils is significant.
3. In the Central Business District (CBD):
 - Ground conditions were stable;
 - The intensity was approximately 60-70% of design ultimate limit state (ULS) for periods of under 1.5 seconds and increased to 100% ULS for periods over 2 seconds, especially in the north-south direction where it exceeded the ULS design spectrum (see Figure 1a for a clear example of this);
 - The earthquake’s north-south component was noticeably stronger.
4. To the northwest/west/southwest of the city (i.e. near the epicentral region) the intensity was up to 100% ULS (see example Figure 1b).
5. To the northeast and east of the City the intensity was under 50% ULS but there was very significant soil instability and ground movement in these regions (see example Figure 1c).

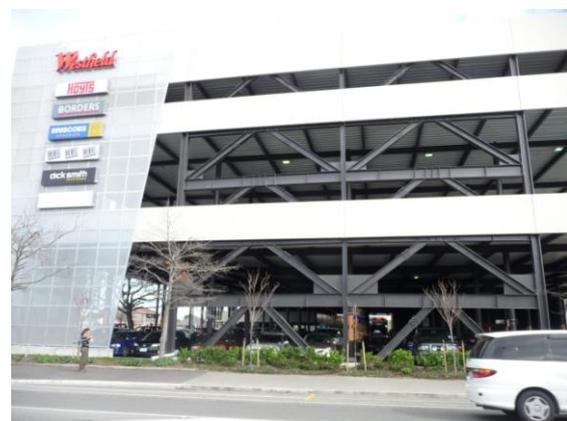
Figure 2: Global elevation of shopping mall on Dilworth St and Clarence St, Christchurch (43°31'53"S-172°36'05"E) [Photo by M. Bruneau].

Typical EBFs in the three level parking garage of a shopping mall are shown in Figure 2. Note that two-tiers of bracing were used at each level in this structure (Figure 3a), which required the addition of channels along the EBF mid-height beams to provide lateral bracing of the links (Figure 3b). None of the EBF links showed evidence of yielding. Unrelated to the performance of the EBF, steel plates tying precast panels suggested slight slippage at those ties locations, embedment plates that fastened into more than one precast panels were subject to failure as the panels slid relative to the embedment plate (Figure 3c), and a few shear failures were observed at the corners of precast units on steel supports (Figure 4). For perspective, although a few URM buildings suffered damage a block away, all other surrounding buildings were also free of visible structural damage.

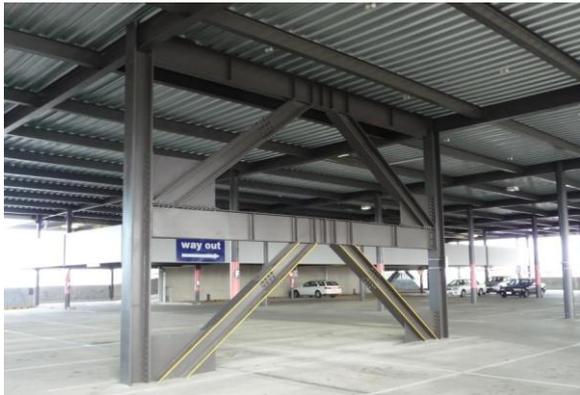
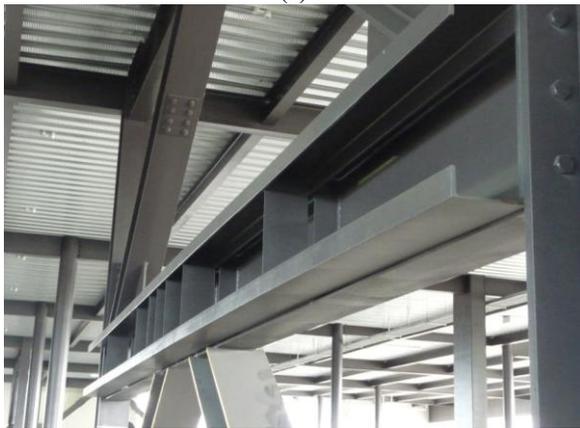
Figure 3: Shopping mall on Dilworth St and Clarence St, Christchurch; (a) Storey elevation [Photo by M. Anagnostopoulou]; (b) Lateral bracing of EBF link using channels [Photo by M. Bruneau]; (c) Failed embedment plate into precast concrete wall panels [Photo by C. Clifton].

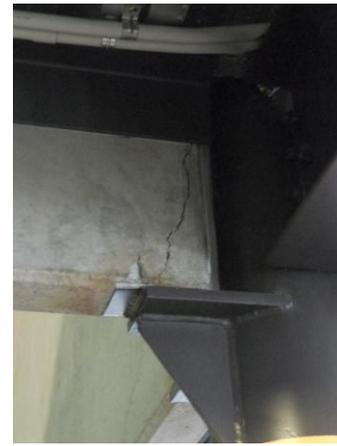
Figure 4: Shear failure at support of precast panel, shopping mall on Dilworth St and Clarence St, Christchurch [Photo by M. Bruneau].

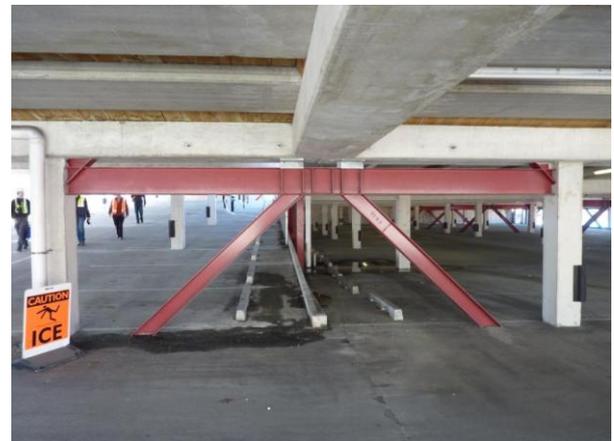
The EBFs used in a hospital parking garage also performed well (Figure 5). These differ from the previous ones in that concrete columns are used together with the steel beams and braces. The frames throughout the garage did not have evidence of inelastic action, except in a ramp built at the top level to accommodate the future addition of storeys. The EBF only supported the east end of that ramp, and the reinforced concrete columns at the ramp expansion joint west of that EBF suffered shear failures as shown in Figure 6a. Slight flaking of the paint on that EBF link also suggests it underwent some limited yielding (Figure 6b). A few other links exhibited similar instances of flaked paint. Some of the steel plates used to laterally brace the links were observed to be bent, suggesting that the link started to laterally-torsionally buckle until restrained (Figure 6c and 6d). Note that these restraints will provide effective lateral restraint to the top flange of the EBF active link only.

Figure 5: Typical bent in parking garage on St Asaph St and Antigua St, Christchurch ($43^{\circ}32'10''S-172^{\circ}37'41''E$) [Photo by M. Anagnostopoulou].

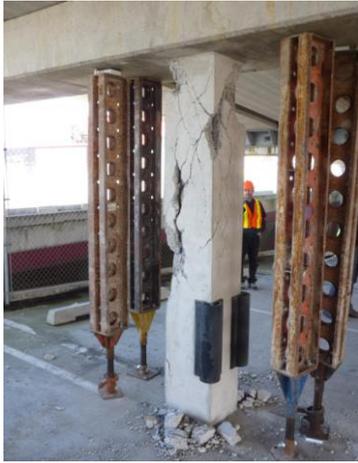
Figure 6: *Parking garage on St Asaph St and Antigua St, Christchurch; (a) Damaged reinforced concrete column [Photo by M. Anagnostopoulou; (b) Evidence of EBF link yielding [Photo by M. Bruneau]; (c) and (d) Bent lateral restraints [Photos by M. Anagnostopoulou].*

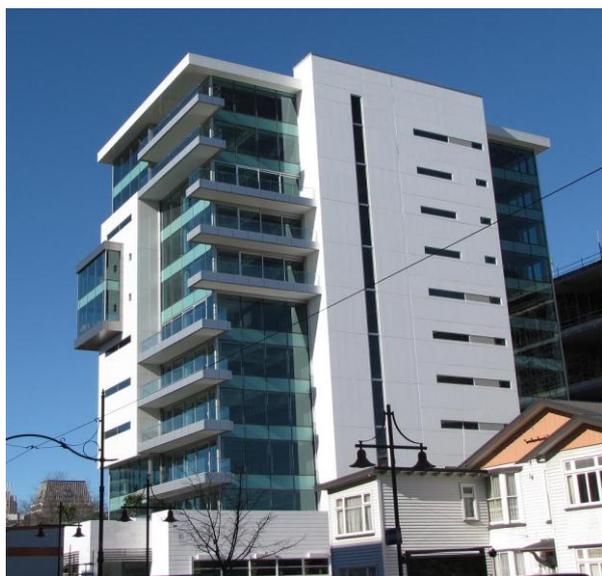
A 13-storey building (Figure 7), whose construction was completed less than a year before the earthquake, also relied on EBF as its lateral load resisting system. The EBFs were used on three sides of a stair/elevator core located on the west edge of the building. Beyond slight cracking of non-structural partitions, cracks were visible at the top of the concrete slabs parallel to the collector beams leading to the EBF (a composite metal deck slab with 80 mm deep trapezoidal profile, with approximate 150 mm overall slab thickness). These cracks, wider than hairline, suggested evidence of shear transfer in the concrete slab to the steel collector beams. The brittle intumescent paint coating used on the steel frames flaked in some of the EBF links, providing evidence of minor inelastic behaviour during the earthquake. The links were free of visible residual distortions. Interestingly, cracking patterns in the slab were observed at the fixed end of a segment of the floor cantilevering on one side of the building (a feature present only over two storeys for architectural effect); these cracks are likely to have been produced as a result of vibration modes excited by vertical ground motions.

Figure 7: *General view of 13-storey building with EBFs on Worcester Blvd, Christchurch [Retrieved November 2010; <http://www.skyscrapercity.com/showthread.php?t=474691&page=9>].*

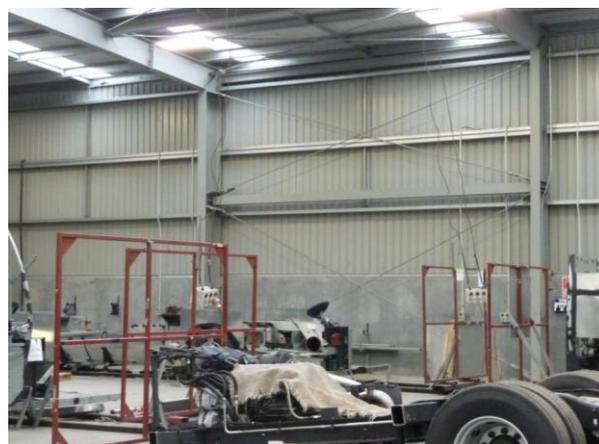
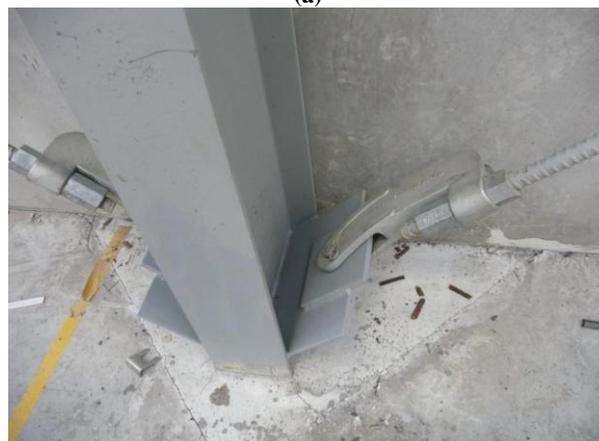
Most of these warehouses rely on concentrically braced frames built with slender steel rod braces for their lateral load resistance (Figure 8a). Braces are connected to the columns using one of various types of turn-buckle systems. One such system often used in these warehouses is a proprietary New Zealand system, which is sold as a kit and used a particular banana end fitting, as shown in Figure 8b. These are rated for earthquake loading following testing by the manufacturer, with a requirement of the test that failure occurs outside the connection region. Brace bars are typically pre-tensioned to

25% of their ultimate load using this system. A number of these braces were found to be sagging after the earthquake (by as much as 200 mm according to some technicians involved in the post-earthquake inspection and retrofitting work), both in the vertical braced bays and roof diaphragm braced bays. The loose braces were simply re-straightened by re-torquing the nuts at the end fitting after the earthquake. When tightening nuts remained in place throughout the earthquake, the presence of sag was indicative of effective axial plastic elongation of the braces.

Figure 8: *Warehouses in Rolleston; (a) Elevation of concentrically braced bay; (b) Banana end of proprietary brace connector [Photo by M. Anagnostopoulou].*

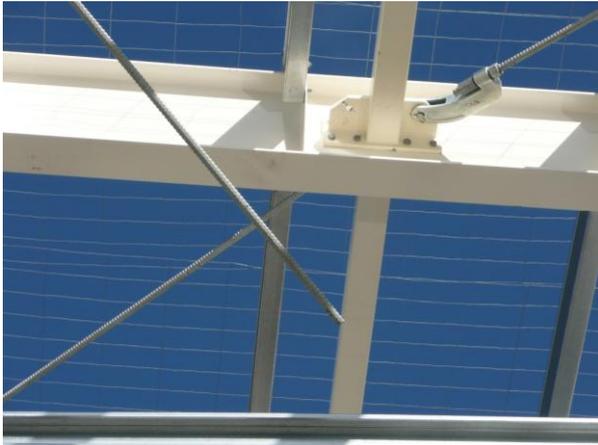
In one instance, fractures of banana bars near their pin end was observed in a roof braced bay (Figure 9a); it was alleged that this fracture occurred because the banana ends were oriented in a way that induced bending in their plates during vertical sagging of the bars, and that this would not have been the case if they had been oriented to allow rotation about their pin under gravity loads (i.e. by orienting the connector at 90 degree from how it had been installed). It was also suspected that some of these connectors were installed without pretensioning the nuts on both sides of the bar's fitting lug on the banana end, which could also explain the observed unsatisfactory behaviour; the absence of pretension creates impacts of the nuts to the connector under the reversed cycling loading, which can push the nuts away from the connector upon repeated impacts, and result in loss of bar pre-tension, followed by loss of bracing action (some nuts were reportedly found to have been displaced by as much as 200 mm from their original position). Finally, in one case, the grooves of the special purpose threaded bars used in this system were stripped within the connection itself, releasing the brace from

Figure 9: Warehouses in Rolleston; (a) Bracing with fractured connection [Photo by A. Fussell]; (b) Stripped threaded bar [Photo by M. Bruneau]; (c) Damaged garage door [Photo by M. Bruneau].

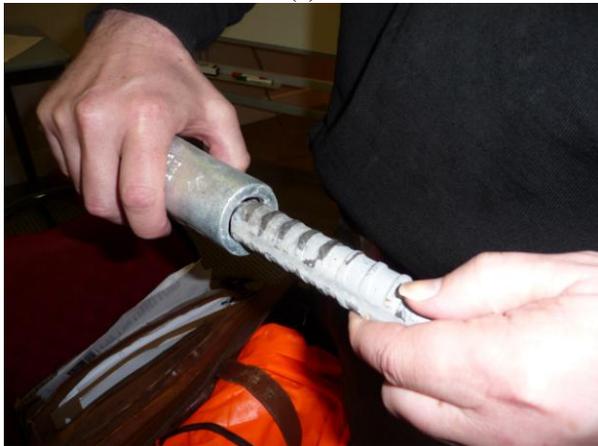
(b)

its anchorage (Figure 9b), and in a few cases, the gusset plates to which the braces were connected suffered bearing failures.

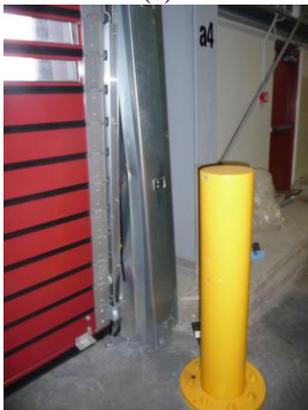
(c)

Non-structural damage in these structures was substantially more significant. For example, many warehouse doors became unhinged, moving substantial distances out-of-plane, i.e. yellow paint marks on the door shown in Figure 9c provided evidence that the door hit the yellow post during the earthquake. This was costly damage given that some of these doors cost up to \$75,000, and that some individual warehouses suffered up to a dozen such door failures. There was also

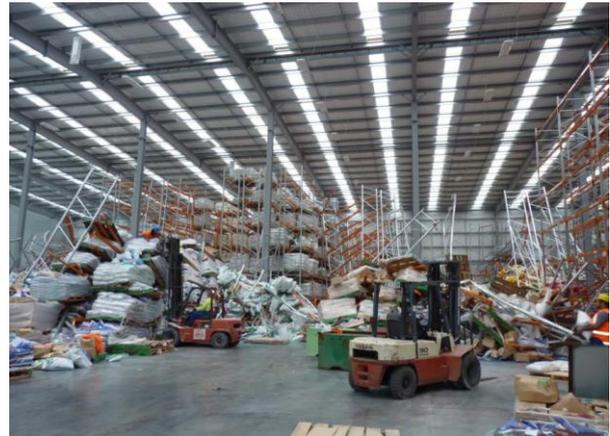
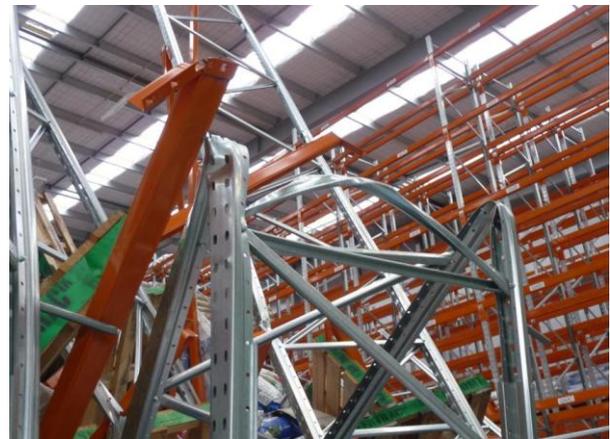
failure of cold formed steel storage systems inside some of these buildings, as shown in Figure 10a and 10b. Performance of these racks is covered in a separate paper.

Figure 10: Damaged industrial storage racks in Rolleston; (a) Global view; (b) Close-up view [Photos by M. Anagnostopoulou].

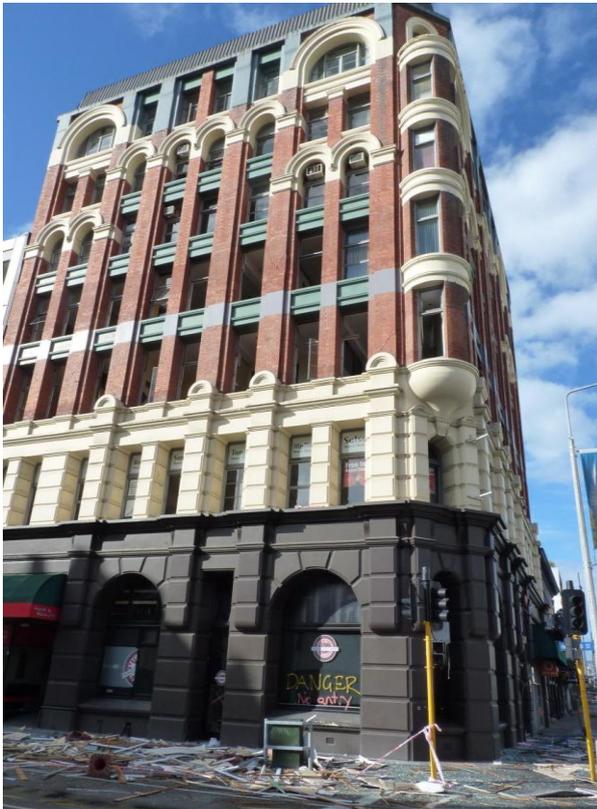
The tallest unreinforced masonry (URM) building in Christchurch is shown in Figure 11. Built in 1905-06 [4] construction was as follows:

1. Bottom two storeys of reinforced concrete with encased structural steel members;
2. Top storeys comprise timber floors supported on an internal steel gravity frame;
3. The perimeter comprises lateral load resisting piers of URM tied at each storey level with a reinforced concrete bond beam encasing a rolled steel joist (RSJ);
4. The internal structure from level 3 upwards consists of a steel frame supporting timber floors with the beams from this internal frame sitting into pockets in the ring beam above the perimeter unreinforced masonry (URM) piers;
5. There was no connection between the beams of the internal steel frame and the perimeter walls to prevent these two systems from pulling apart.

Figure 11: *Elevation of heritage building on Manchester St and Hereford St, Christchurch (43°31'56"S-172°38'23"E) [Photo by M. Anagnostopoulou].*

After considerable (and sometimes heated) debate, this building is being demolished. While it was technically possible to stabilise and retrofit the building, the URM would have had to be first stabilized and then strengthened to be able to survive undamaged an earthquake matching the design level (the September 2010 earthquake was about 60% to 70% of the design ultimate limit state earthquake for Christchurch, which, incidentally, is in some cases the mandated level of strengthening required in a retrofit). The internal steel frame would have had to be robustly tied into the perimeter walls. The URM piers on the North and West sides would have had to be restored to undamaged appearance, as it was their visual appearance to a large degree that gave the building its status (Figure 12). It was finally judged not to be economically viable to do this on the damaged building and within an acceptable timeframe.

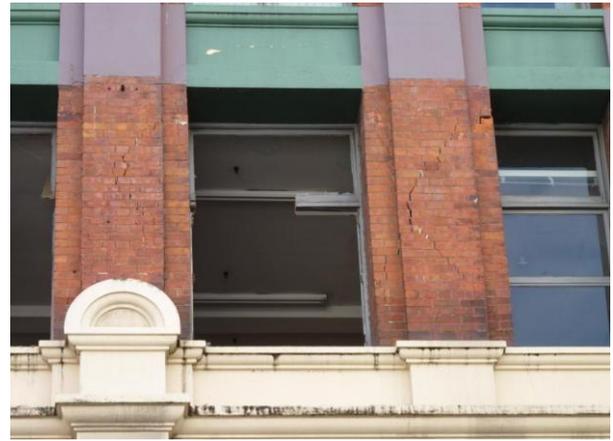
Figure 12: *Damaged front piers of heritage building on Manchester St and Hereford St, Christchurch [Photo by M. Anagnostopoulou].*

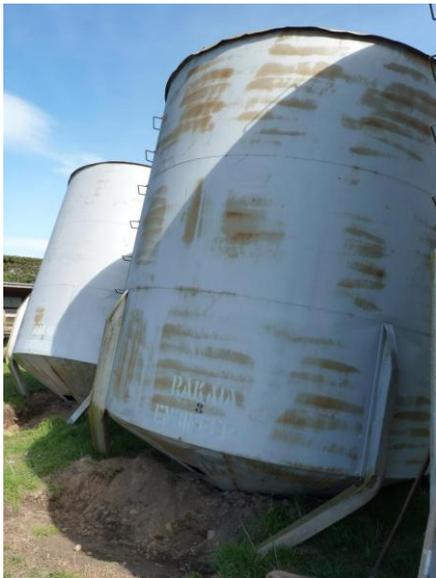
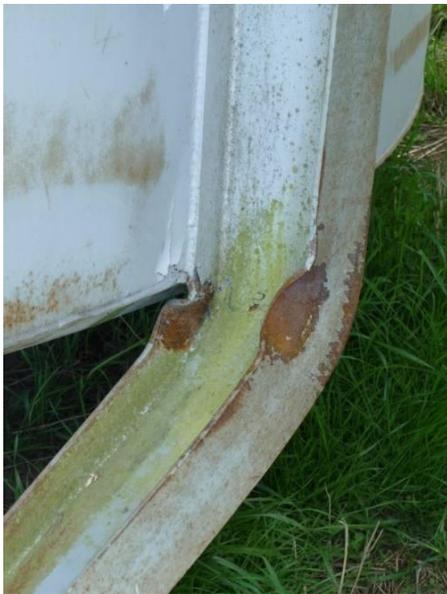
Many steel tanks collapsed during this earthquake. The failures are similar to that observed in the 1987 Edgumbe earthquake in which the most significant damage was to thin walled tanks and silos. In most instances the failures are due to one or more of the following:

- Rotational or bearing failure of short columns supporting rigid tanks due to soft storey action;
- Failure of bracing units supporting the tanks;
- Tearing failure at the attachment of the supporting structural steel frame into the thin walled tank itself;
- Foundation instability due to each supporting column being on an individual pad footing with no interconnection between the plates.

Figure 13: *Farm tanks in Darfield; (a) Example collapse [Photo by M. Anagnostopoulou]; (b) Close-up view [Photo by M. Bruneau]; (c) Tank with continuous strip footing [Photo by M. Anagnostopoulou].*

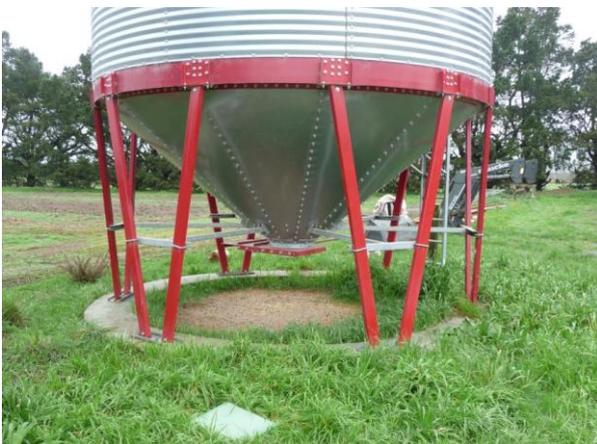
(c)

A design document [5] produced by the New Zealand Earthquake Commission (1990) following that 1987 earthquake recommended proper base support and details for tanks and silos. Figure 13c shows a well performing silo with what appears to be a detail designed to that publication.

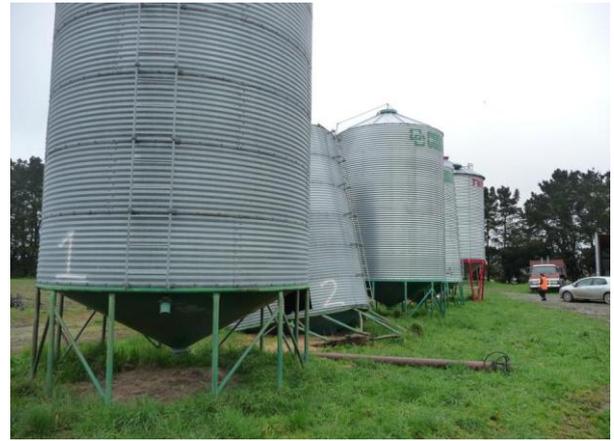
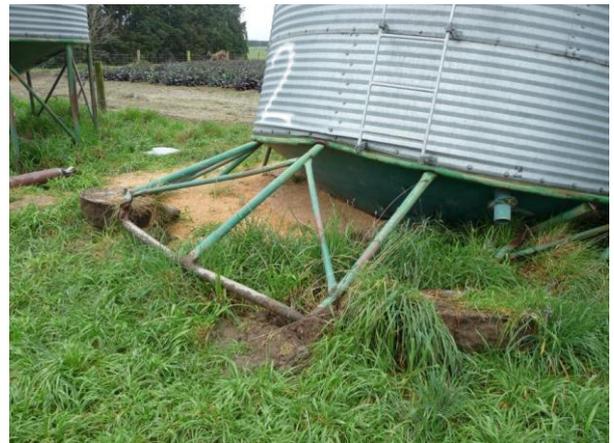
Figure 14: *Farm tanks in Darfield; (a) Tanks with brace legs; (b) Close-up view of collapse [Photos by M. Anagnostopoulou].*

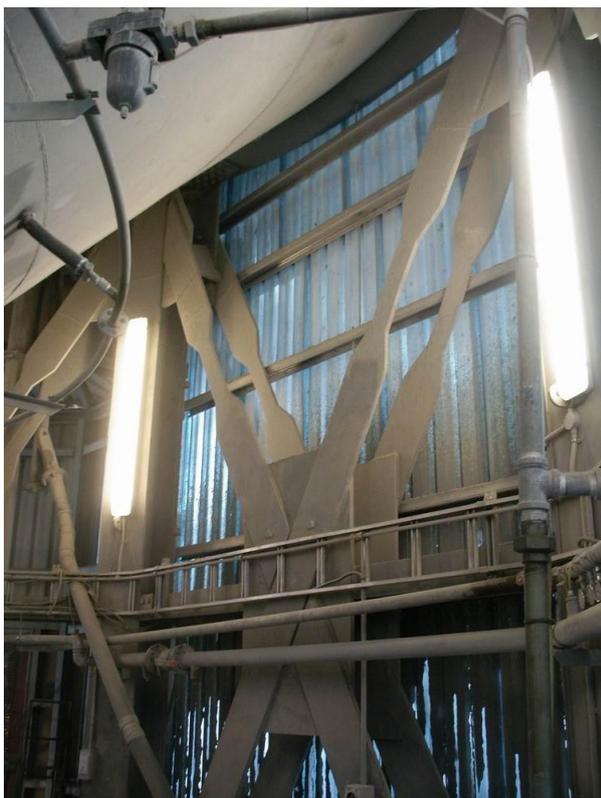
One interesting silo designed specifically for earthquake loading is Holcim's 2,000 tonne silo at Lyttelton. It is a steel silo on an 8 sided steel base. It is 9.8 metres in diameter and stands over 25 metres high. The silo was originally built in 1969, and was located at Port Otago. It was relocated from Dunedin to Lyttelton in 1990. At the time design earthquake loads in Christchurch were 25% higher than those in Dunedin, so the base had to be modified to resist the higher loads. This was done by cutting away parts of the existing diagonal braces to create a yielding tension brace system as shown in Figure 15. The remaining elements of the silo base, the ring beam and the bottom part of the silo barrel were strengthened to resist the over-strength capacity of the yielding tension braces. When the earthquake struck, the silo was completely full of cement. All of the tension braces yielded at their necked-down sections as intended, but there was no other damage to the silo or its base. The yielded tension braces are now in the process of being cut out and replaced. Information on this has been provided by Mike Fletcher with kind permission by Holcim.

Figure 15: *2,000 tonne capacity cement Silo at Holcim Depot, Lyttleton, with deformed dogbone braces [Photo by Buchanan and Fletcher].*

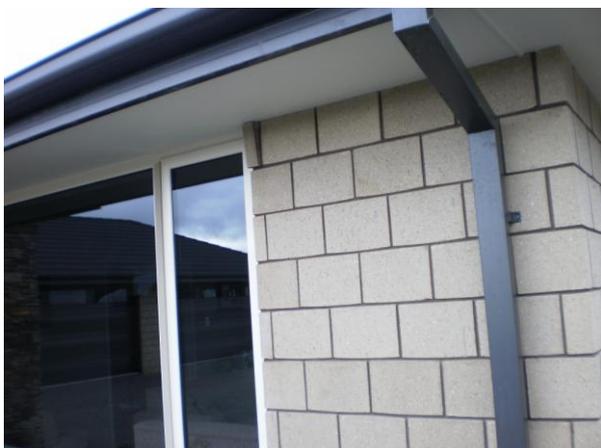
There were approximately 40 houses built with light steel frames in the strongly shaken region. They all performed well where the underlying ground remained stable, with the worst reported damage in these cases being hairline cracks in the gypsum board lining of some internal walls. In one instance, a brick of the external cladding became loose, as shown in Figure 16.

Figure 16: *Light steel frame house from epicentral region [Photo Courtesy of Graham Rundle].*
