PRELIMINARY FINDINGS ON PERFORMANCE OF BRIDGES IN THE 2010 DARFIELD EARTHQUAKE

SUMMARY

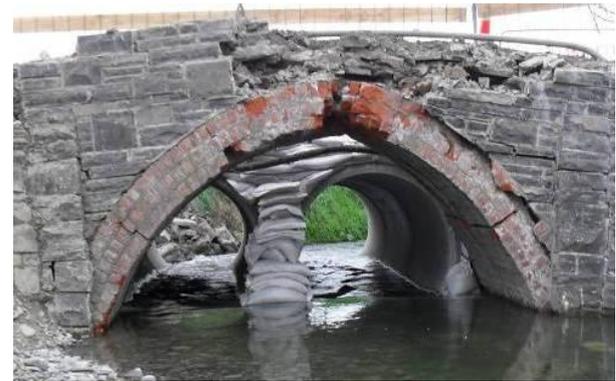
shown in Figure 4. Two culverts were installed to temporarily replace the damaged masonry arch.

Figure 4: Saby's Road Bridge arch damage [Photo by A. Palermo].

Overall the road bridges exhibited little damage to the beam and deck elements. The one case of severe super-structure damage to a road bridge was to a short-span masonry arch bridge. The bridge was on Saby's Road, approximately 31 km from the epicentre. The bridge was subjected to a large longitudinal compression force due to lateral spreading of the river bank. The bridge essentially acted as a compressive brace between the two river banks, and unable to resist the force of the riverbank, formed a three hinge mechanism as

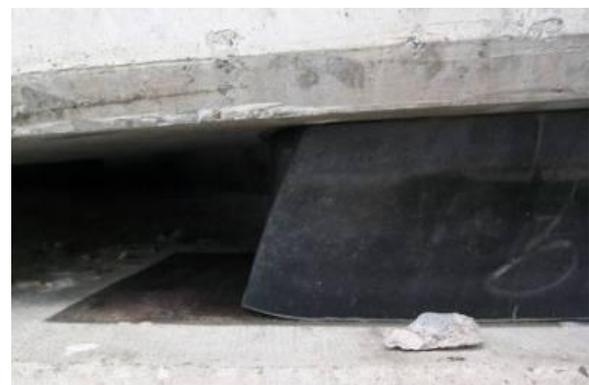
(a)

A different type of observed bearing damage was the deformation of the rubber isolation bearing pads due to large relative lateral movement between the deck and the abutment/pier. The most dramatic example of this occurred at South Brighton Bridge (Bridge Street, South Brighton, Christchurch). At this bridge the bearing pads deformed to a strain of approximately 30%, and also slipped approximately 100-150 mm (Figure 5a).

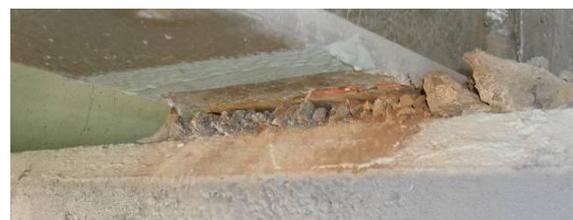
(b)

The third bearing reaction to the earthquake witnessed in road bridges was the complete crushing of the bearing. This occurred in the Old Waimakariri Motorway Bridge, where the mortar bearing pads were extensively fractured due to excessive movement of the abutment (Figure 5b).

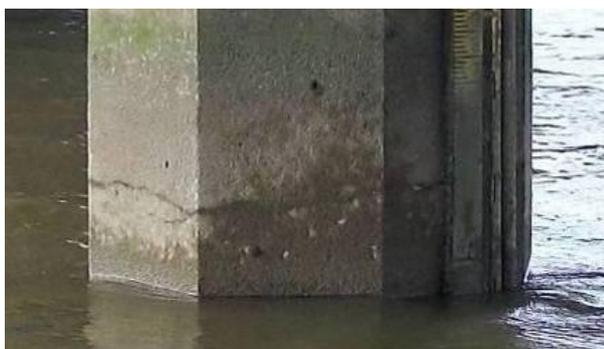
(a)

A small number of road bridges exhibited flexural cracking of the piers (Figure 6a). These cracks are part of the expected structural failure mechanism of the bridge [4] in such an event, and due to the limited damage they do not immediately compromise the structural integrity of the bridge.

However unrepaired cracks might become a potential threat to the design life of the bridges close to marine environment. The cracking pattern provides an accelerated pathway for chloride ingress and hence compromises the overall durability of the structure. Recent studies confirmed a potential loss of the seismic performance, i.e. strength and ductility under aggressive environments [5], [6].

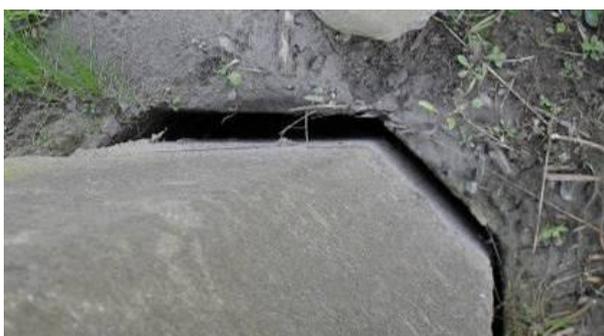
(b)

Some pier damage was observed on the twenty seven-span Old Waimakariri Motorway Bridge. This was the only bridge in which notable transverse seismic response was observed; as shown by the 20 mm gap between the pier and the ground in the transverse direction (Figure 6b). Cracking due to longitudinal movement was also observed on some piers.

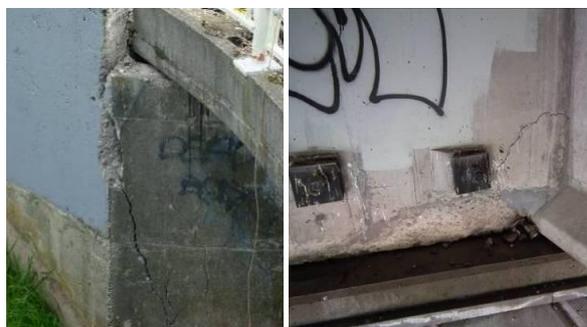
Abutment damage observed included rotation and translation of the entire abutment, abutment cracking as well as, flexural cracks on the exposed abutment piles. This was caused by the soil structure interaction phenomenon activated by laterally spreading approach slopes in areas suffering from liquefaction. This effect was seen only on bridges with deep abutments or closely spaced abutment piles (Figure 7a and Figure 7d). These types of abutments are in contrast to the current design philosophy for lateral spreading banks that uses a shallow beam type abutment, with a small number of deep piles. This allows a laterally spreading slope to spill past the abutment.

Figure 7: (a) Vertical cracks on Gayhurst Road Bridge Abutment [Photo by F. Sarti]; (b) Tie-rods into abutment on the SH1 Kaiapoi River Bridge [Photo by A. Scott]; (c) Abutment at South Brighton Bridge [Photo by G. Paganotti]; (d) Flexural crack on the abutment pile of Pages Road Bridge near Brooklands [Photo by M. Bruneau].

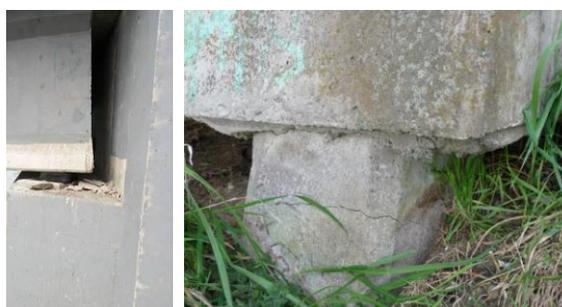
In contrast to the Kaiapoi River Bridge, these rods were not tension activated by seismic mass of the bridge but by the longitudinal push action of the soil. This caused a 5° rotation of the abutment and a gap to form between the tie-rod bearing plate and the coupling beam of approximately 100 mm (Figure 7c).

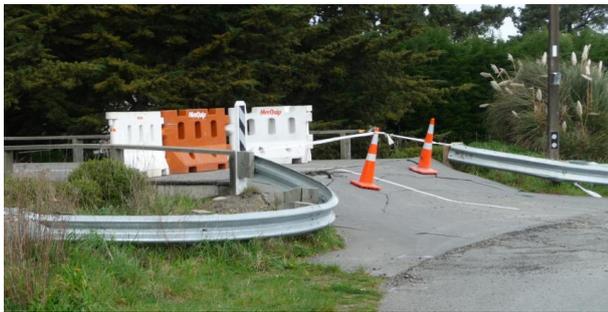
(a)

This differential movement led to the formation of a very large vertical settlement between the bridge deck and the approach at the River Road Bridge (River Road, South Lincoln). On this bridge the alignment was level before the earthquake; afterwards an evident change in elevation of 500 mm between the unmoved bridge deck, and the approach (Figure 8a) has been registered. As elaborated in the “Soil Structure Interaction” section of this report, cracks in the approaches parallel to the axis of the bridge provide evidence of the resistance against lateral spreading induced by this short monolithic span (Figure 8b).

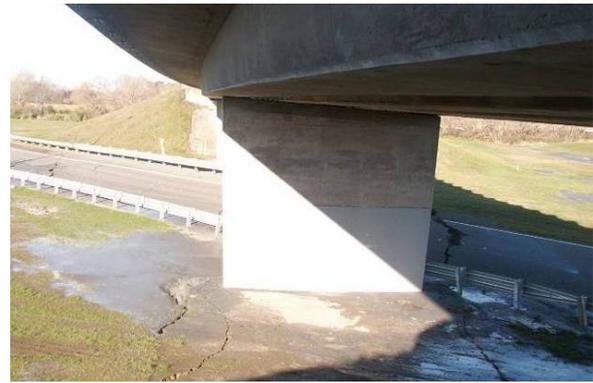
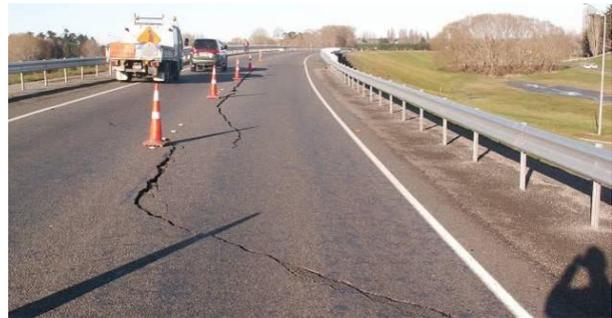
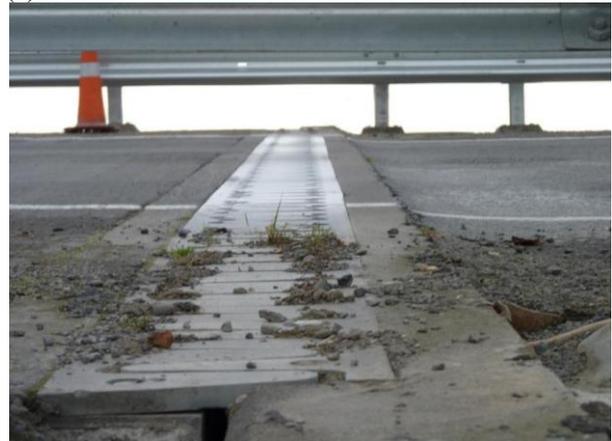
In some instances, while the bridges remained essentially intact, the approach spans partially or totally failed, making access to the bridge either more difficult or impossible. For example, the twin continuous bridges at the Chaney’s overpass on State Highway 1 north of Christchurch were found to be structurally sound, and tied to their abutment walls to prevent unseating there. However due to liquefaction of the site surrounding the bridge (Figure 9a and 9b); the approach to the southbound lanes of State Highway 1 settled by a few inches (Figure 9c). After a brief closure for inspection, this busy route was reopened with signage reducing the speed to 30 km/h (down from 100 km/h) for the safety of motorists.

Figure 9: Chaney's Overpass: (a) Extensive liquefaction around piers [Photo courtesy of Anthony Rooke, OPUS]; (b) cracking at approach [Photo courtesy of Anthony Rooke, OPUS]; (c) Deck settlement due to surrounding liquefaction [Photo by M. Anagnostopoulou].

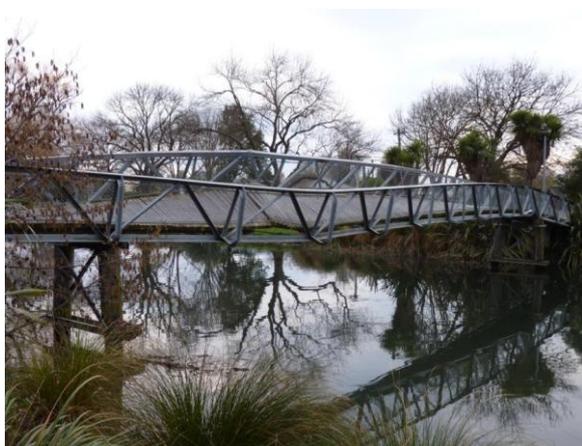
(a)

- Global lateral torsional buckling, as seen in the steel truss Avonside Drive pedestrian bridge (Figure 10a).

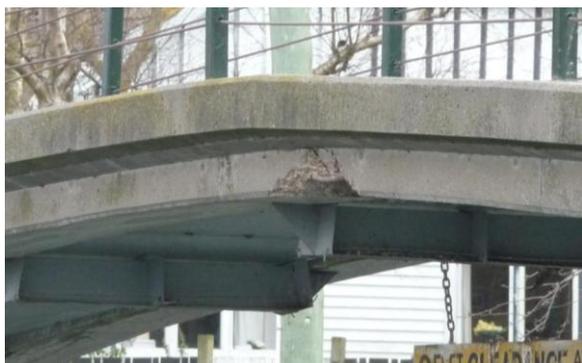
(b)

- Plastic hinging at mid-span, as seen at the Dallington reinforced concrete arch pedestrian bridge (Figure 10b).
- Longitudinally rocking of towers, at the Mandeville pedestrian suspension bridge in Kaiapoi (Figure 10c), and consequent opening-up of existing hinges that consisted of in-contact horizontal wood splices (and that were not effectively restrained from opening up during the rotation of the towers).
- Plastic hinging near abutments, at the concrete prestressed tee-beam pedestrian bridge at Porritt Park.

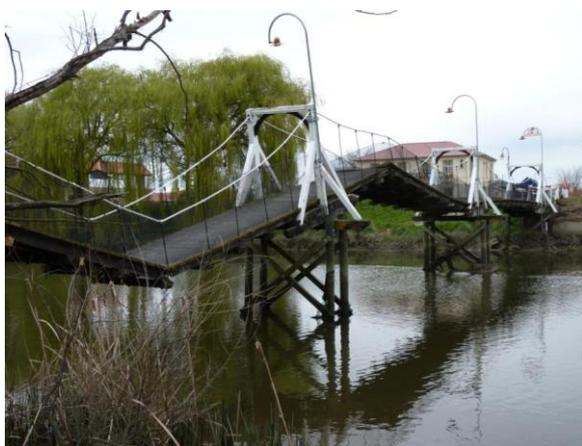
Figure 10: (a) Global lateral torsional buckling at Avonside Drive Pedestrian bridge [Photo by M. Anagnostopoulou]; (b) Plastic hinge at apex of arch of Dallington Pedestrian bridge [Photo by M. Bruneau]; (c) Failure mechanism of the Mandeville Pedestrian Bridge [Photo by M. Anagnostopoulou].

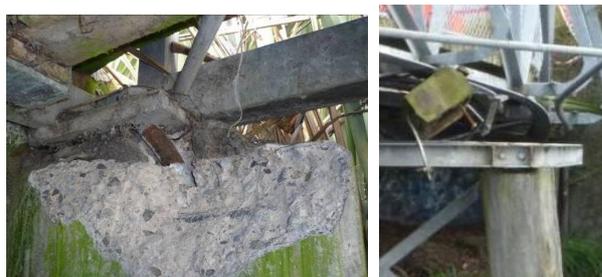
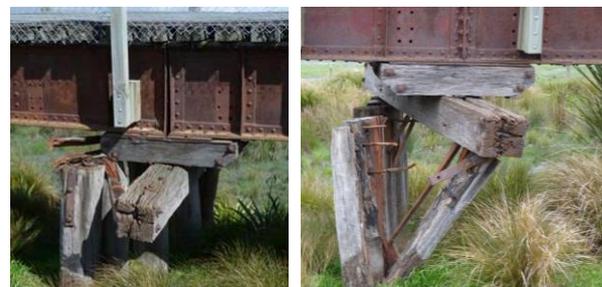
The pedestrian bridges which were near to collapse did not have any form of lateral isolation between the super-structure and the abutments and/or piers. This resulted in major damage in the connections between the bridge deck and the abutments and piers. Observed modes of failure included fracturing and yielding of connection steel rods (Figure 11a); spalling of concrete around the connection; uplifting of the deck off the pier; rotation at the interface between the deck and the pier (Figure 11b); and total horizontal translation of the bearing connector off several piers.

Figure 11: (a) Yielding lug, with concrete spalling on the Avonside Drive Pedestrian Bridge abutment; (b) Bearing lifted off pier on Avonside Drive Pedestrian Bridge; (c) Bearing translated off pier on Courtenay Stream Pedestrian Bridge, Kaiapoi [Photos by F. Sarti]; (d) Pile split along the vertical plane on Courtenay Stream Pedestrian Bridge in Kaiapoi [Photo by M. Anagnostopoulou].

Almost all pedestrian bridges did not suffer any damage to their piers with the exception of a disused historic railway bridge. In fact this bridge crossing Courtenay stream in Kaiapoi lost support over part of its length (Figure 11c). Many of those piers split along the vertical plane in which bolts were used to connect the spans to the pier (Figure 11d). Evidence of the lateral pressure on the piers was provided by the large gaps between the soil and piers on one side of the piers.

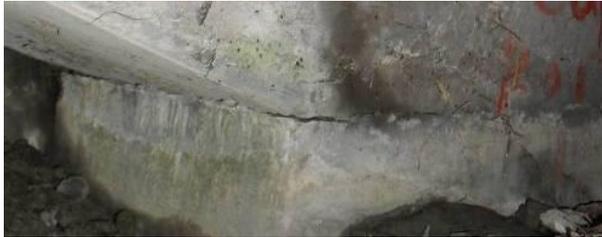
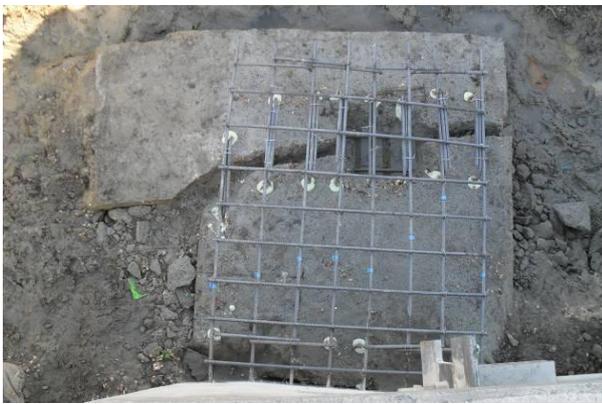
Two pedestrian bridges showed visible damage to the abutments. In both cases, significant lateral spreading had occurred on at least one river bank. It is worth noting that of all the damaged pedestrian bridges observed, these two were the only bridges with a concrete main superstructure element. At the Dallington Pedestrian Bridge, a horizontal crack split the entire abutment at each end of the bridge (Figure 12a). The same bridge also exhibited severe damage to the pile caps of the abutment on the side of the river that was subjected to extensive lateral spreading. Figure 12b shows this damage

Figure 12: (a) *Horizontal shear crack seen on entire abutment of Dallington Pedestrian Bridge [Photo by M. Le Heux]; (b) Wing of pile cap of Dallington Pedestrian Bridge, showing exposed crack, and repairs [Photo by M. Le Heux]; (c) Rotation and plastic hinge formation at Porritt Park Pedestrian Bridge [Photo by L. Hogan].*

while the repair is in progress. The other case, Porritt Park Pedestrian Bridge, experienced large rotation and translation of the south abutment (Figure 12c). This abutment sits on six small piles approximately 200 mm diameter. It is likely that the piles do not extend very deep. As such, they provided minimal lateral stiffness to the system, and only served to increase the surface area the soil wedge interacted with, thus exacerbating the problem. This rotation resulted in extensive cracking at the abutment face, as well as hinging at the deck-abutment connection.

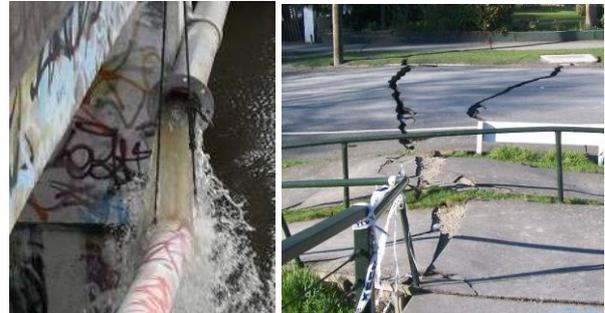
In general over Christchurch, there were several minor leaks in pipes on bridges caused by the earthquake. However the Kianga Road Bridge showed the only major failure of a pipe on a bridge when a sewer pipe fractured, contaminating the river with raw sewage (Figure 13a). Incidentally, flexural cracks were observed at this bridge on the abutment piles that were exposed as a consequence of soil lateral spreading (Figure 7d).

Figure 13: (a) *Sewage leak at Kianga Road Bridge [Photo by A. Palermo]; (b) Crack in approach pavement running in the longitudinal direction of the Dallington Pedestrian Bridge [Photo by L. Hogan].*

Conversely, the effect of this phenomenon on the soil was that spreading of the slope around the abutment lead to soil gapping from differential movement, passive soil wedge failure, and large cracks forming on the approach running parallel to the longitudinal bridge axis. The cracks in the approach running longitudinally with the bridge were unique, in that all other cracks in the surrounding area ran parallel with the river (i.e. transversely to the bridge). These cracks were potentially the cause of damage to the services in the road running transversely to some bridges as highlighted by the Dallington Pedestrian Bridge (Figure 13b).

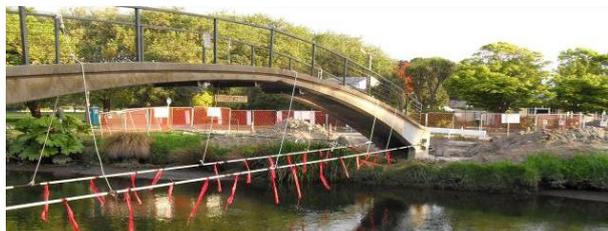
The greatest success story for retrofitting and life-line programs to come out of this earthquake is the 1960s built Dallington Pedestrian Bridge (Figure 15). Although pedestrian bridges are not usually identified as key life-line assets, this bridge was designated as a key-link due to the 66 kV electricity cables that pass over the Avon River. Orion New Zealand, the owners of the electricity cable and the bridge (at the time of the retrofit the bridge and cables were actually owned by Southpower), undertook an in-depth geotechnical and structural investigation into the expected performance during the earthquake. This investigation and subsequent retrofit took place circa 2000 (Figure 15).

Figure 15: Pedestrian Bridge in Dallington undergoing earthquake damage repairs [Photo by M. Le Heux].

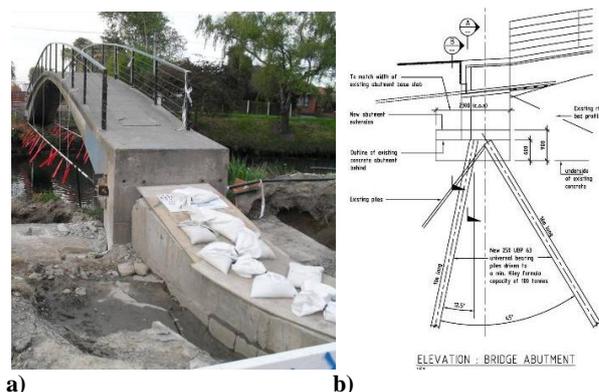
The retrofit scheme was considered a success. Although plastic hinging occurred at the apex of the bridge (Figure 10b), and considerable abutment and pile cap cracking also occurred, the bridge did not collapse, and the electricity cables remained operational. The bridge would have most likely collapsed and caused disruption to the power supply if no retrofitting had been carried out.

Figure 16: (a) Dallington pedestrian bridge with retrofit work exposed, showing 66 kV cable cradle entering bridge [photo by M. Le Heux]; (b) close up of the new raked pile detail [Courtesy of John Mackenzie, ELMAC Consulting Engineers].

used, was the placement of raked wing piles on the abutment driven down into the stronger soil. This retrofit solution is depicted in Figure 16. Retrofitting was also carried out on the cable cradles on the approach to the bridge to reduce the level of deformation that the 66 kV cables would be placed under during an earthquake.
