LESSONS LEARNT FROM 2011 CHRISTCHURCH EARTHQUAKES: ANALYSIS AND ASSESSMENT OF BRIDGES

SUMMARY

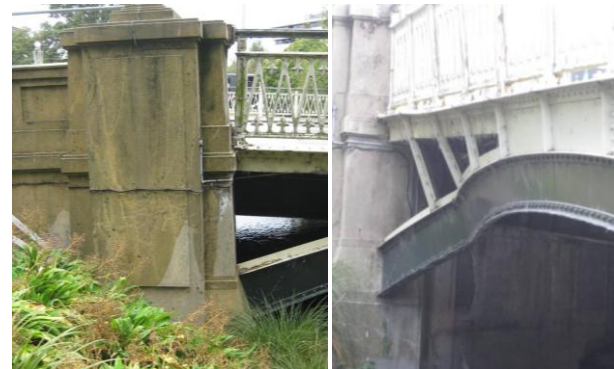
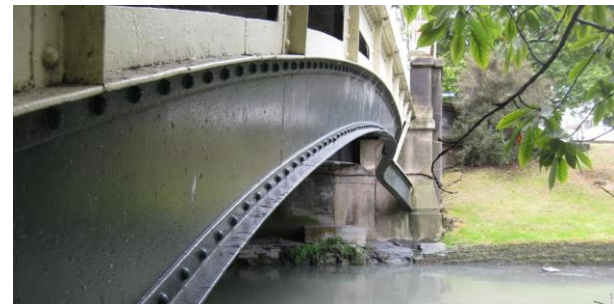
The lateral displacement of the banks behind the abutment contributed to the large cracks observed in the abutments and their back-rotation. Abutment wall rotation was observed on both sides of the bridge, but was more pronounced at the north abutment (Figure 5a). It appears that the abutment wall is restrained at the top by the bridge superstructure and may have rotated outwards at the bottom due to earthquake earth pressures or lateral displacement towards the river. The north abutment pilasters also rotated outwards as a result of the lateral spreading pressures on the wingwalls, with vertical cracks in the abutment wall.

Significant damage identified following the Christchurch earthquake involved severe buckling of the arched edge

girders both on the upstream and downstream sides of the bridge (Figure 5b-c). Moreover, the cast iron handrail attached to the top of the arched edge girders became unstable. Connection of the pilasters to the rest of the abutment may be questioned, but irrespectively, even if the pilasters were well connected to the rest of the abutments, abutment rotations produced a larger horizontal displacement at their base than at their top, resulting in buckling of the arches. Because of additional movements and damage resulting from the June 2011 earthquakes, the bridge was still closed at the time of writing (September 2011).

Figure 5: Colombo Street Bridge (a) Rotation of the abutment [Courtesy of Opus]; (b) Buckling of steel arch [Photo by M. Yashinsky]; (c) Close up view of the steel arch [Courtesy of Opus].

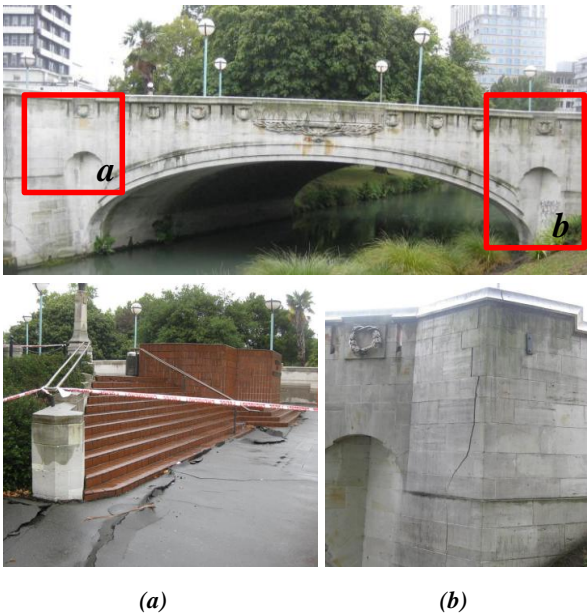
Figure 6: *Bridge of Remembrance (a) Damage to steps on western approach [Courtesy of Opus]; (b) Damage to north-eastern wingwall [Courtesy of Opus].*

This bridge suffered moderate superficial damage as a result of the 2011 Christchurch earthquake. However, the Triumphal Arch over the bridge sustained more significant structural damage. In terms of the bridge, reported damage included paving damage at the approaches (Figure 6a), large vertical cracks to all wingwalls (Figure 6b) and widespread cracks near the base of arch, along the full length at base of both parapets and through the buttress of the arch above the east abutment. The width of some of these cracks increased after the 13 June 2011 aftershocks.

The majority of the damage has resulted from settlement of the approach fill, lateral spreading soil pressures resulting in deflection and rotation of the wingwalls and possibly the abutments. Minor rotation of all four wingwalls caused cracking of the stone facades. The concrete sections behind the cracked stonework are also likely to have been cracked. This is not considered a major concern at present, as the wingwalls are independent from the main bridge structure and are founded on concrete pads.

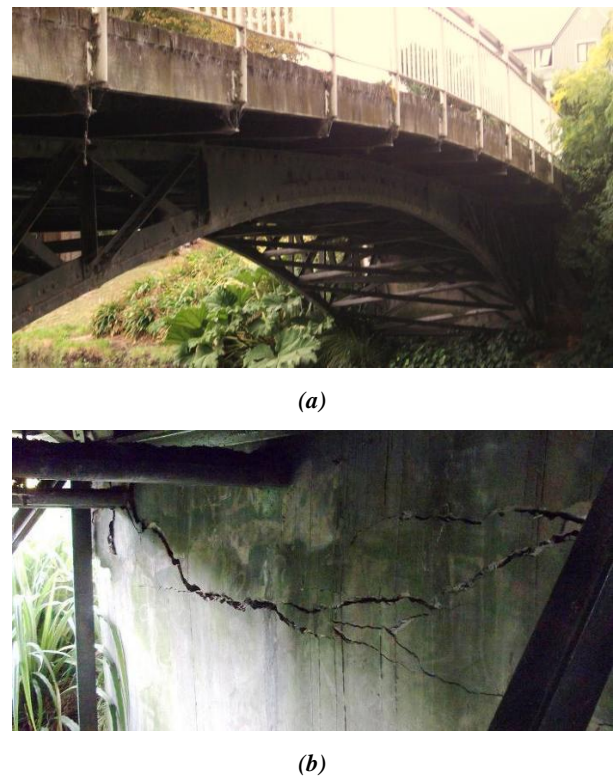
The majority of the observed damage resulted from localized liquefaction and/lateral spreading pressures. The lack of piles and lack of reinforcement in the abutments can be considered a critical structural weakness for this bridge. These have resulted in shear failure of the concrete abutments and wingwalls, with the top of the abutment wall being restrained by the bridge superstructure. While this has reduced the capacity of the abutments, they are likely to have some residual shear capacity due to the aggregate interlock of the concrete at the cracked sections.

Figure 7: *Antigua Street Footbridge (a) View underneath showing hogging [Courtesy of Opus]; (b) Damaged north-eastern abutment [Courtesy of Opus].*

The abutment displacement and rotation caused the vertical deflection and hogging of the steel arch truss (Figure 7a). This hogging meant some cross bracing members failed adjacent to more rigid, corroded joints (Figure 8b). The shear failure of the concrete wingwalls has caused the supports to the timber footbridge beams to fail (Figure 8a). These supports had very little anchorage into the concrete wingwalls, and would not have required much movement to cause them to fail. The failure of these supports is not a major concern, as they only support a very small section of the footway, which is currently supported by the rigid handrail.

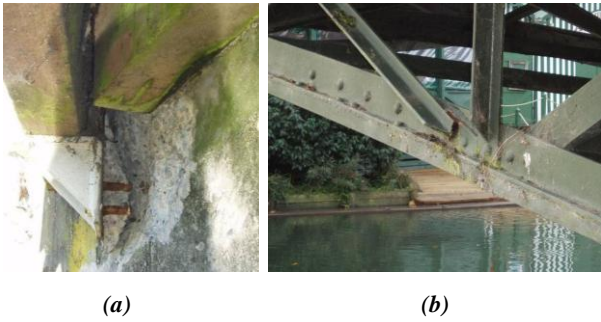
Figure 8: *Antigua Street Footbridge (a) Typical failure of end support of timber footway beams [Courtesy of Opus]; (b) Typical failure of cross bracing member adjacent to corroded joint [Courtesy of Opus]*

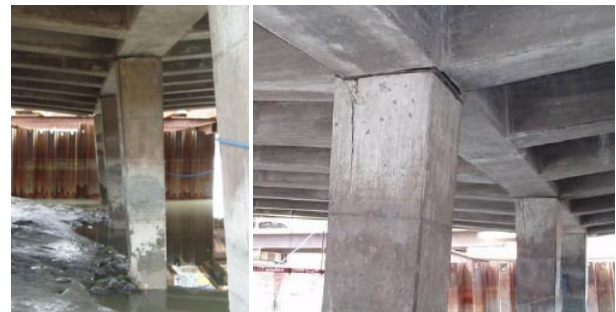
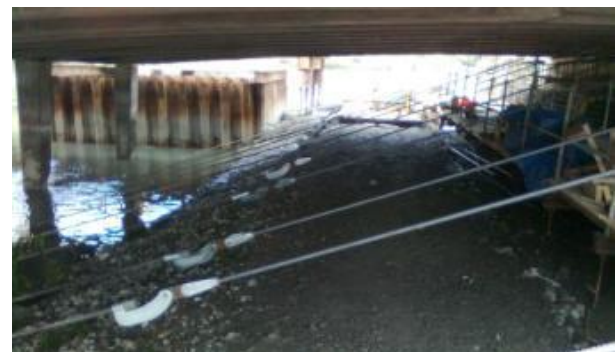
The Ferrymead Bridge was the only bridge along the Heathcote River to suffer significant damage. Lateral spreading caused significant damage to the new abutment components and temporary construction platforms. The existing structure also sustained damage due to lateral spreading, with permanent rotation and cracking of a number of the piers situated in the estuary (Figure 13a).

Figure 13: Ferrymead Bridge (a) Tilted piers [Courtesy of Opus]; (b) Close-up view of flexural cracks at the top of the piers [Courtesy of Opus]; (c) Securing works of Ferrymead Bridge [Courtesy of Opus].

The bridge was temporarily repaired with prestressed rods connecting the bottom of the piers to the abutments (Figure 13b). This limited further movements of piers inwards

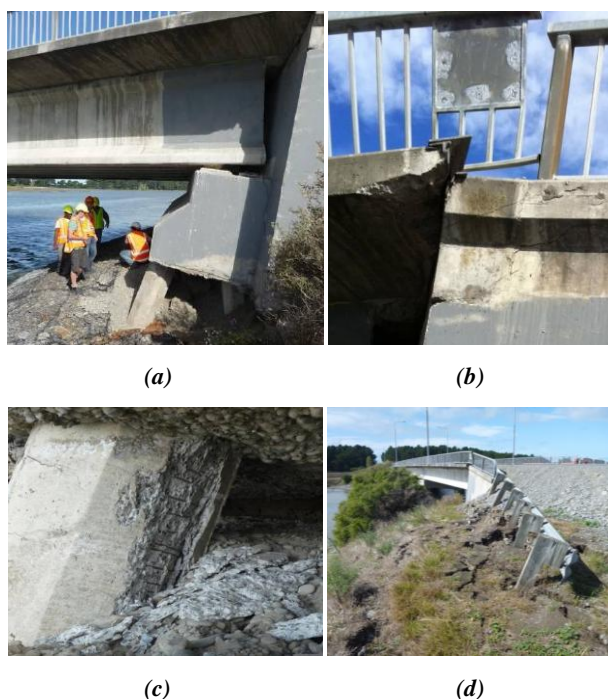
The primary cause of damage was from lateral spreading of the reclaimed embankment soil on which the abutments are located. Situated in an estuary, the underlying soils were heavily prone to liquefaction and after the onset of shaking, loss of soil stability caused failure and spreading throughout the approach to the bridge (Figure 14a). Flow of soil against the wingwall, abutment and through the piles resulted in abutment back-rotation due to the restraint provided at the top of the abutments by the superstructure. Transverse translation of the skewed abutments relative to the bridge deck was a result of lateral spreading perpendicular to the bridge axis, and some pounding between the deck and abutments (Figure 14b).

Flexural hinging, cracking and spalling was observed in the abutment piles at their connection to the pile cap caused by both the rotation and the translation of the abutments (Figure 14a). Slumping of soil around the abutments due to lateral spreading exposed the tops of the abutment piles. Hinging at the top of the piles was accompanied by flexural cracking and

spalling in the exposed sections of the piles under both abutments. The crack patterns observed on the piles indicate that the piles were subjected to bi-directional bending during the earthquake due to the rotation of the abutments and the transverse translation (Figure 14c). Crack widths on the west piles were greater than on the east piles suggesting larger deformations. Uncertainty remains with regards to potential plastic hinging below the ground surface.

Figure 14: *Bridge Street Bridge (a) Back-rotated abutments [Photo by M. Bruneau]; (b) Pounding of the deck on the abutment [Photo by A. Kivell]; (c) Plastic hinging in abutment piles of Bridge Street Bridge [Photo by M. Bruneau]; (d) West approach settlement and temporary repair [Photo by S. White].*

Major cracking and settlement of the approach pavement and embankments impeded vehicle access to the bridge (Figure 14d). Non-structural components such as guard rails and handrails founded in slumping soil were heavily damaged. The amount of approach settlement at the west end of the bridge was significantly more than observed at the east end, with large amounts of aggregate required to build up the approach road level to that of the bridge before it could return to service. The deck was largely undamaged with damage limited to spalling at the ends due to pounding against the abutments.

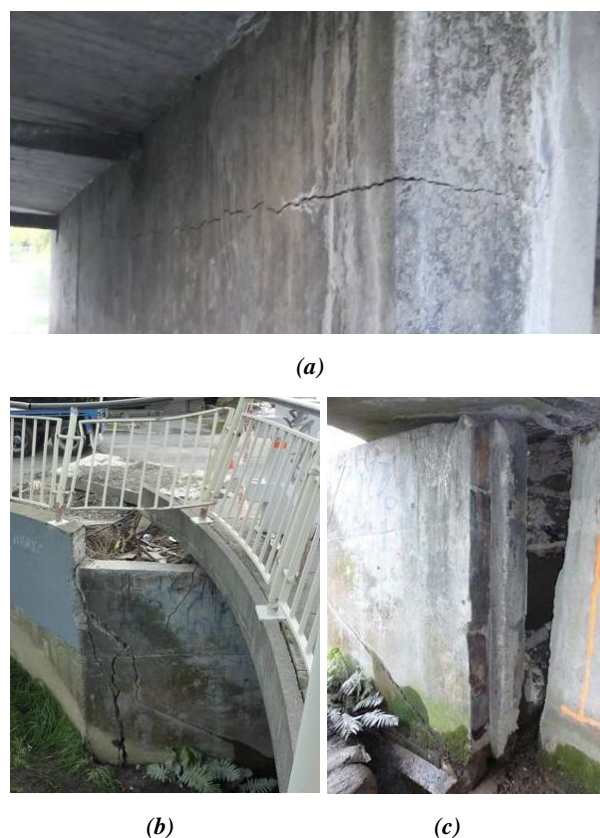
Lateral spreading resulted in rotation and displacement of the northern abutment backwall and wingwalls (Figure 15b). Wingwalls displaced towards the river and rotated in plan with their outer, more poorly restrained, edges moving towards the river causing the development of flexural cracks in both abutment-to-wingwalls and abutment-to-deck connections. The top of the wingwalls on both sides of the northern abutment displaced 900 mm towards the river relative to the edge of the bridge deck, with lateral movement of 100-150 mm at their base. This rotation/translation of the structural element resulted in high flexural stresses in the abutment and eventually cracking, as shown in Figure 15b. The differential settlement of the soil beneath the abutment and the ground shaking may also have contributed to the formation of cracks. A worsening of the cracking was evident after the 13 June aftershocks, resulting in a total displacement of the top of the wingwalls of 1,300 mm towards the river relative to the backwall. The rotation and translation of the wingwalls meant they completely detached and moved in front of the backwall (Figure 15c). Conversely, there was little indication of damage to the southern abutment, with no significant displacement or rotation accompanying minor cracking.

Lateral spreading exerted a lateral force on the pier base, causing a large moment at the stiff pier-deck interface, inducing cracking of the pier. A single horizontal crack along one face of a pier, approximately one metre from the deck soffit, developed during the 2010 Darfield earthquake and increased after 2011 Christchurch earthquake (Figure 15a). Liquefaction would have reduced the lateral stiffness of the pier foundation system, allowing rotation of the bottom of the pier towards the centre of the river.

Figure 15: *Gayhurst Road Bridge (a) Damaged pier with flexural cracking [Photo by L. Hogan]; (b) Flexural cracks at the north-western wingwall [Photo by L. Wotherspoon]; (c) Displacement of north-western wingwall [Photo by L. Wotherspoon].*

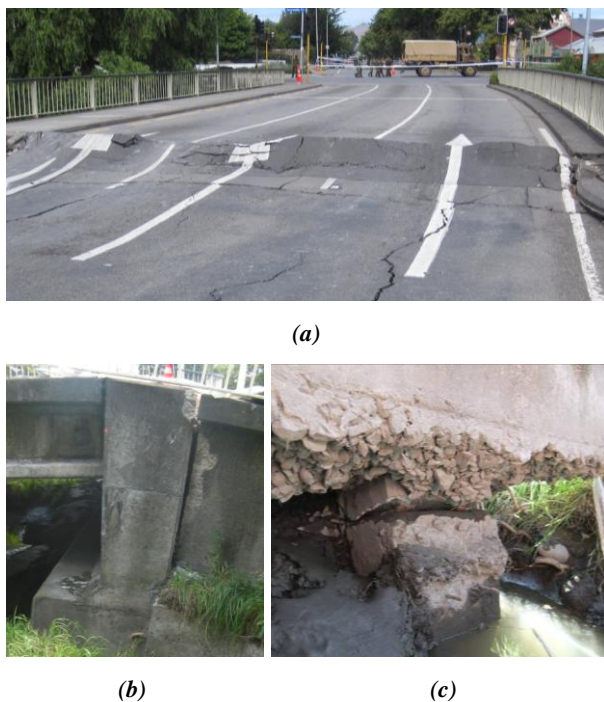
Figure 16: *Fitzgerald Avenue Bridge (a) Damage at the approach of the eastern bridge [Photo by A. Kivell]; (b) Back-rotated abutments [Courtesy of Opus]; (c) Flexural cracks on the piles [Photo by L. Hogan].*

Following the 2011 Christchurch earthquake the Fitzgerald Avenue Bridges were closed to traffic for several weeks. Closure was necessary because of severe spreading of the road north of the bridges which developed large fissures (Figure 16a), and Christchurch City Council's decision to place an emergency cordon around the 'four avenues' of the Christchurch CBD, of which Fitzgerald Avenue is one. Large amounts of settlement occurred at the bridge approaches primarily on the northern bank; this was accompanied by two directional lateral spreading. The combination of these factors resulted in the back-rotation of the northern bridge abutments (Figure 16b). Moderate pounding damage was observed at the

Rotation of abutments placed high demands on the northern abutment piles. Figure 16c shows the damage to the eastern-most pile of the eastern bridge. Failure occurred in tension with a 30 mm crack opening up across the entire section. In some cases, heavy cracking and spalling due to hinging of the piles at their connection with the pile cap occurred resulting in exposure of prestressing tendons. Cracks ranging from 0.1 mm to 1.5 mm were present on the river side of all the piles. Below ground pile performance was unable to be determined but it would be expected that differential movements between liquefied and non-liquefied layers caused damage in addition to that at the pile to pile cap connection.

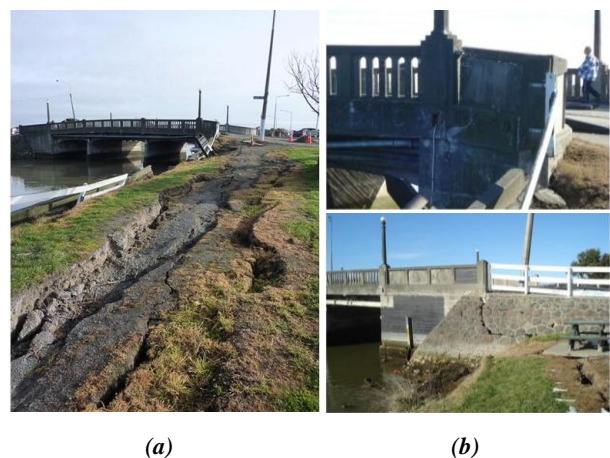
Figure 17: *Pages Road Bridge. (a) Lateral spreading to the south of the eastern abutment following the June 13 aftershocks; (b) Rotation and cracking of the south-east wingwall (top) and cracking of rock facing and lateral spread crack at north-west corner following June 13 aftershocks (bottom) [Photos by L. Wotherspoon].*

latter region. Cracking and settlement of the approaches developed at both abutments as a result of lateral spreading, with movements perpendicular to the river on the west approach, and movements towards the south-west on the east approach. There was a large volume of ejecta and flooding around the western abutment. The region to the north-east of the bridge suffered less liquefaction induced damage compared to the other areas. Following the 13 June aftershocks, there was further minor settlement of the approaches and additional lateral spreading. A large lateral spread immediately to the south of the eastern abutment is shown in Figure 17a.

Following the 2011 Christchurch earthquake all wingwalls hinged and rotated at the interface with the abutment backwall, but there was no visible rotation of the abutment structure. Rock facing supporting the approaches near the wingwalls also moved and cracked, as indicated in Figure 17b. Damage to the wingwalls was increased following the 13 June 2011 aftershocks, with further rotation. Additional cracking and collapse of a section of the rock facing to the south-east of the bridge occurred as a result of lateral spreading.

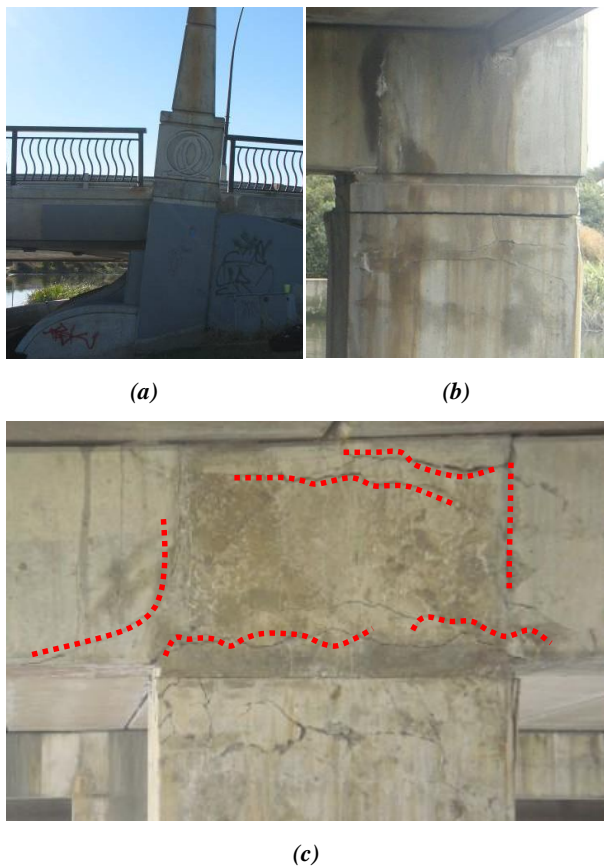
Significant structural damage was observed following the strong shaking in the 2011 Christchurch earthquake. Lateral spreading of the approaches caused the abutment piles and beam seatings to rotate about 8° (Figure 19a). Cracking and spalling was observed at the beam-column joints in the piers and some of the pier columns rotated up to 2° (Figure 19b). Damage was more pronounced at the outer of the three columns in each pier. There was also significant lateral spreading and settlement of the approach pavements and embankments. Concrete walkway structures under each end of the bridge moved towards the river about 300 mm and 500 mm at the north and south ends respectively. No significant additional structural damage was reported following the 13 June 2011 aftershocks.

Figure 19: *Anzac Drive Bridge (a) Back-rotation of southern abutment [Photo by A. Palermo]; (b) Flexural cracks at the central pier [Photo by N. Chow]; (c) Plastic hinging at pier cap [Photo by N. Chow].*

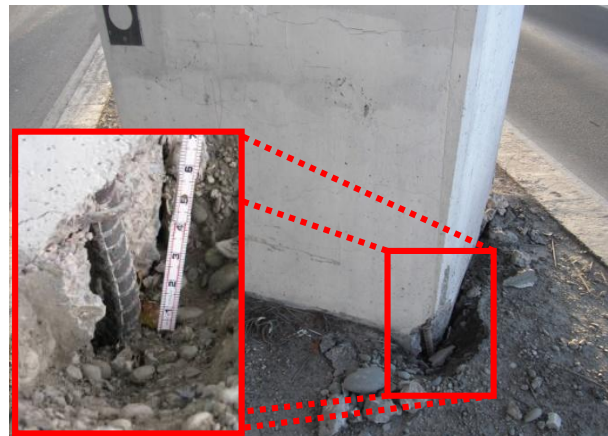
Down slope soil movement on the abutment slopes under the bridge resulted in wide cracks in the soil and at the contact between the soil and abutment face under the south-east abutments. Wide cracks running parallel to the roadway at the top of the approach embankment developed in the soil on the east side at the south-east end of the bridges. There was also minor settlement and displacement of the approach pavement and back-fill at the abutments.

Figure 21: Port Hills Overbridge. Buckling of reinforcing steel at the base of the piers [Courtesy of Opus].

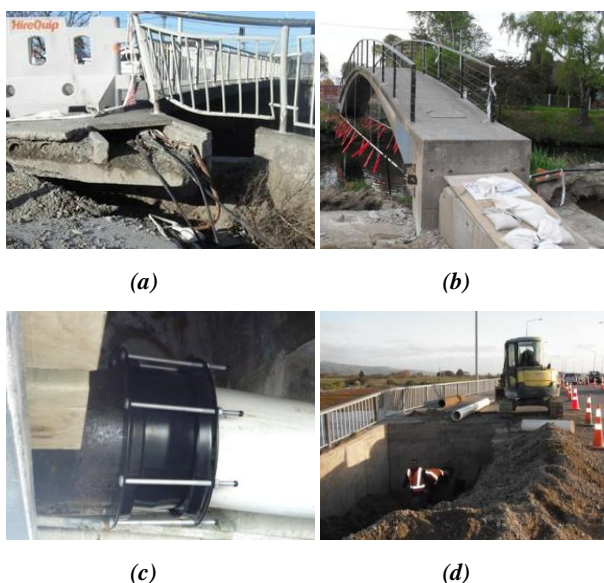
An example of important services carried on a bridge is the Dallington Pedestrian Bridge, where lateral spreading created extensive cracking parallel to the bridge and perpendicular to the alignment of the road and buried pipes, potentially leading to damage to sewer pipes in the road. This bridge has two 66 kW power cables placed under the bridge deck, providing electricity to 20,000 inhabitants, making this modest pedestrian bridge a structure with strategic importance. Some moderate to extensive damage was observed at many road bridges where pipes were distorted and/or leaking in the proximity of the connections from deck-to-abutment, and abutment-to-approaches. The main issues arose with stiff pipes, such as sewage and water pipes, as they are fully fixed to the deck and usually run through the abutments. On the other hand, the flexibility of power and/or telephone cables were able to accommodate larger displacement demands.

Figure 22: (a) *Gayhurst Road Bridge, damage to lifelines [Photo by A. Palermo];* (b) *Dallington Pedestrian Footbridge, damage to electrical services to the Dallington area [Photo by M. Le Heux];* (c) *Repair to water pipe at Bridge Street Bridge [Photos by A. Campbell];* (d) *Repairing works at Bridge Street Bridge [Photo by A. Palermo].*
