Multistorey steel framed building damage from the Christchurch earthquake series of 2010/2011

ABSTRACT: This paper presents preliminary field observations on the performance of selected steel structures in Christchurch during the earthquake series of 2010 to 2011. The Christchurch earthquake series comprised 6 damaging earthquakes, on 4 September and 26 December 2010, February 22, June 6 and two on June 13, 2011. Most notable of these was the 4 September event, at M7.1 and MM7 (MM as observed in the Christchurch CBD) and most intense was the 22 February event at M6.3 and MM9-10 within the CBD. The earthquakes impacted on a range of steel framed buildings, from single storey to the tallest building in Christchurch at 22 storeys. Many of the multi-storey buildings used eccentrically braced framed seismic-resisting systems (EBFs) and this earthquake series was the first time these systems have been pushed into the inelastic range. This paper gives an overview of the performance of selected buildings, with an emphasis on EBFs. Their performance in particular was very good and possible reasons for this are presented.

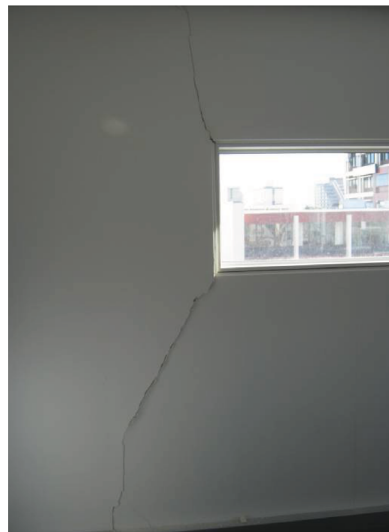
(b) cracking of partition in cantilevering portion of story

through assessment of the visible state of the metal in the yielded web of the active link and secondly through estimate of the peak interstorey drift. Both methods gave a peak shear strain of between 3% and 4%. The links were free of visible residual distortions. Assessment of damage accumulation in the steel at a peak shear strain of 4% over an estimated two complete cycles of loading using the damage criterion developed by Seal, (2009) and change in transition temperature based on the work of Hyland, (2006) showed that the yielded active links have sufficiently robust metallurgical properties to be left in place. Previously reported slab cracking (Bruneau et al., 2010) could not be detected as the concrete floor slab was covered by floor carpeting, except at one location at the fixed end of a segment of the floor cantilevering on one side of the building (a feature present only over two stories for architectural effect). Crack widths after February 22, 2011 appeared similar to what had been observed after September 4, 2010, being localised only. Substantial shear cracking of the gypsum plaster board (sheetrock) finish on the exterior wall of that cantilevering part of the floor was also observed (Figure 2b); only hairline cracking of gypsum plaster board finishes was observed elsewhere throughout the building, supporting post-earthquake survey measurements showing that the building has a post-earthquake residual drift of only 0.1%. One non-structural masonry block wall installed for sound proofing purposes adjacent to mechanical units on the pedestal roof suffered minor shear cracking, where it had been placed hard against a cantilevering floor beam.

Overall, the building was designed for a slightly lower level of structural ductility demand than is typical for an EBF, due to its height and plan dimensions, and performed well during the earthquake. No structural repairs were required; non-structural remedial work consisted of minor dry wall crack repair and realignment of the lift guide rails. The building was open and fully reoccupied in July 2011, becoming the first normal importance high rise building in Christchurch to be returned to use following the earthquake series.

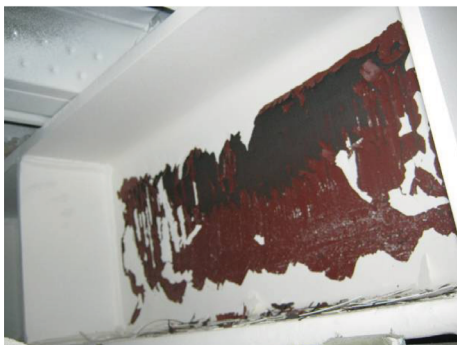
(c) paint flaking of EBF link in the ceiling space

Given the magnitude of the earthquake excitations, with demands above the ULS design level, substantial yielding of the EBF links would have been expected. EBFs designed in compliance with the NZS 3404 (SNZ, 1997/2001/2007) provisions are typically sized considering a ductility factor (μ , equivalent to R in US practice) of up to 4, corresponding to a level of link deformations that would correspond to significant shear distortions of the links. Yet, yielding was below that determined necessary in subsequent detailed assessment to require structural replacement of the EBF active links. Beyond the usual factors contributing to overstrength in steel frames (e.g., expected yield strength exceeding nominal values, modelling assumptions, etc.), a number of additional factors can explain behaviour in this particular case, including strength of the composite floor slab action (neglected in design), mobilization of the solid non-structural wall concrete cladding adjacent to the staircase, elastic stiffness of the gravity frame especially the columns and the relatively short duration of earthquake excitation.

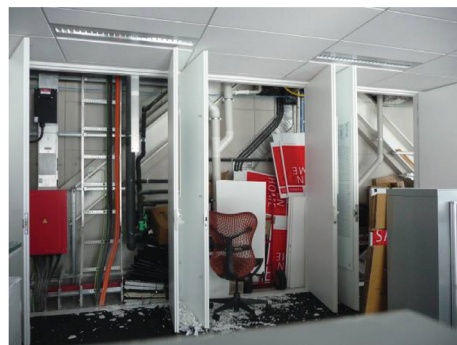
(d) global view of EBF braces obstructed by various utility runs

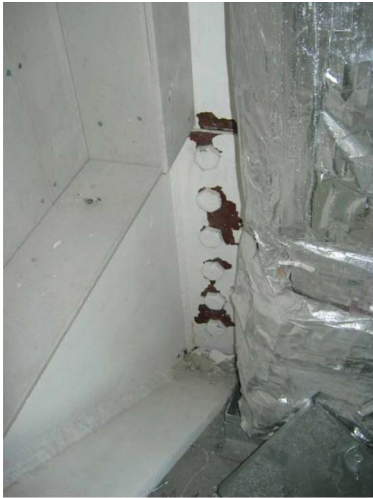
Connections in Club Tower, as in other modern steel framed buildings, performed very well and as expected. Two examples from Club Tower are shown. Figure 3(a) shows a brace/beam/column connection in which the gusset plate is welded to the beam and bolted to the column with a flexible end-plate connection, which is designed and detailed to be rigid for vertical load transfer and flexible in the horizontal direction, to accommodate change in the angle between beam and column during the earthquake. This flexible end-plate has undergone limited out-of-plane yielding, protecting the gusset plate from inelastic demand as required by NZS 3404 for gusset plates. Figure 3(b) shows a flush endplate splice in a MRF beam that has performed well. Bolted splices in seismic-resisting systems inspected showed no signs of slip, consistent with expectations in NZS 3404 and HERA Report R4-76.

(a) Brace/beam/column connection showing out-of-plane yielding in endplate but no inelastic demand in gusset plate

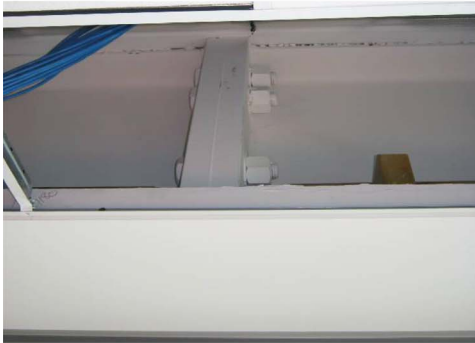
(b) Flush moment endplate splice connection

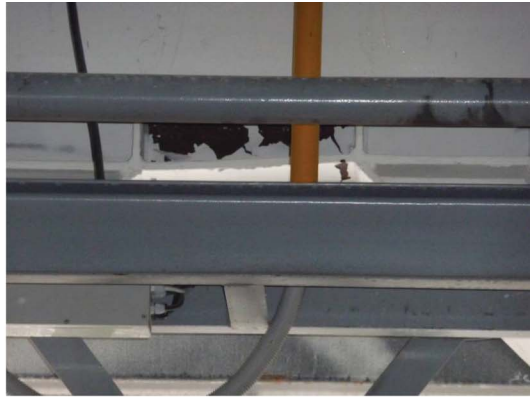
Paint flaking and residual link shear deformations were observed in the EBF links at those levels. Design of the EBFs in that building was governed by the need to limit drift, with a corresponding resulting design ductility factor (μ) of 1.5 (even though up to 4.0 is permitted for EBF systems, as mentioned earlier). This is typical of EBFs in tall buildings in New Zealand's moderate to low seismic zones; Christchurch is moderate in accordance with the earthquake loadings standard, NZS 1170.5. When the initial internal inspections were undertaken, there was an absence of significant damage to architectural and other non-structural finishings except at level 6 where a few of the hotel room doors along the corridor could not be closed, suggesting greater residual deformations at that level. This level was the first in which a detailed evaluation was undertaken. One fractured EBF active link was discovered (Figure 4d) in the top level (underside of Level 6) of the EBF system at the North-Western corner of the building in August 2011, 6 months after the February event. When the fracture was caused is not known, however slightly concentrated non-structural damage at that level following the February event may indicate that it happened then. The frame sits behind the louvre system nearest the camera in Figure 4a. This link had undergone at least one full cycle of web panel yielding, as evidenced by the diagonal pattern of Luders' lines in the web panel, prior to a fracture propagating from one top corner across the active link region and resulting in significant residual deformation. Temporary strap cross-bracing was welded to the active link frame to provide lateral load resistance while a repair strategy was implemented, which comprised cutting out the damaged link, welding on an endplate system to each collector beam/brace face and replacing with a replaceable site bolted endplate active link. The replacement is scheduled for early October 2011 and is the only repair to the structural frame required for this building. A detailed evaluation was undertaken of all active links in the adjacent storeys and throughout the building, with no further links requiring replacement being found and discussion ongoing about replacing the link shown in Figure 4b. This inspection required removal of architectural finishes.

(b) Flaked paint on EBF active link with residual deformation

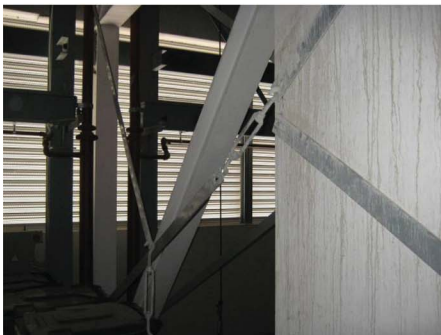
(c) Multi-story mechanical garage stacker failed braces

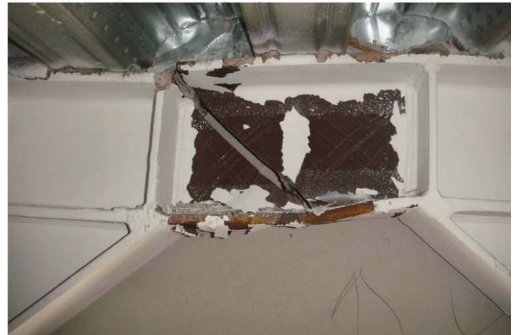
This type of failure has not been reported in either EBFs tested in the laboratory or from damage reports from other earthquakes; the reasons for this link fracture are not currently clear and it is to be the subject of a detailed metallurgical and structural evaluation once removed.

(d) Fractured EBF active link in top level of EBF system in front face of atrium

The discovery of a fractured active link in a 22 storey building, in which all other links performed well, is unexplained at the time of writing this paper, and it will be a priority to determine the cause of that fracture when the damaged link is removed and accessible for close inspection.

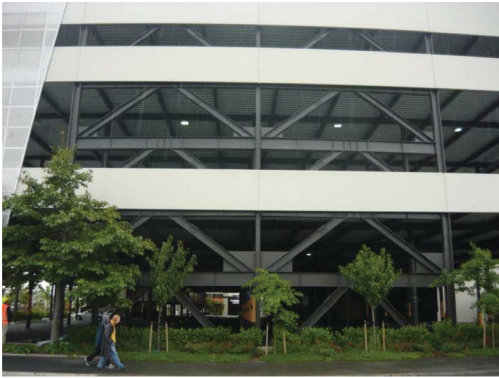
The EBFs in a three level parking garage of a shopping mall west of the CBD did not exhibit inelastic deformations (Figure 5a). The basically elastic response of the EBFs is not surprising in this case, given that these frames had been designed to accommodate three additional parking levels to be added at a later time and the intensity of shaking

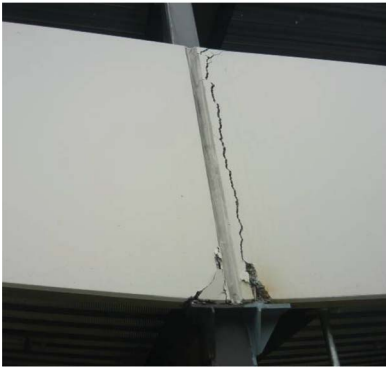
(b) Fracture of Precast Spandrel Beams on

was lower than in the CBD. Live load present at the time of the earthquake may also have been less than considered in design, although it was higher than in the September earthquake when the shopping mall was not occupied. Movement of precast units previously reported was observed to have intensified. This resulted in fracture of the spandrel panels beside the epoxy mastic connection between panels, presumably indicating that the epoxy mastic was stronger than the precast panels in tension (Figure 5b). These fractures occurred in all panels over the height of the structure. These spandrel panels were also designed to carry gravity loads in the parking structure so their fracture compromised the serviceability of the building. No further damage has been reported from the three June earthquakes.

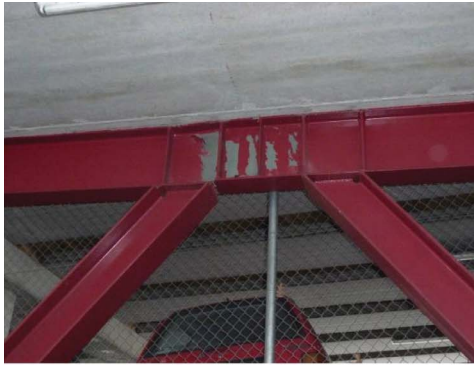
This parking structure was also designed to accommodate two additional floors. Yet, some of the links at the first story showed paint flaking as evidence of inelastic deformations. Evidence of minor soil liquefaction was also observed over parts of the slab on grade. Depending on the foundation type, liquefied soils can act as a sort of base isolation or as a method to lengthen the period. This generally results in a lower yield acceleration and lower structural demands. As such, it is possible that this parking garage was not subjected to ground motions as severe as those shown in Figure 1. However, because these EBFs were not drift dominated, they were designed for the maximum $\mu = 4$ ductility demand. Also these active links were added as finished components into the largely precast concrete structure and so were not tied into the floor slab with shear studs as they were for the taller buildings previously discussed. This meant that they did not have the same strength enhancement due to resistance to out of plane deformation of the floor slab as the taller buildings had.

(a) Evidence of EBF link yielding

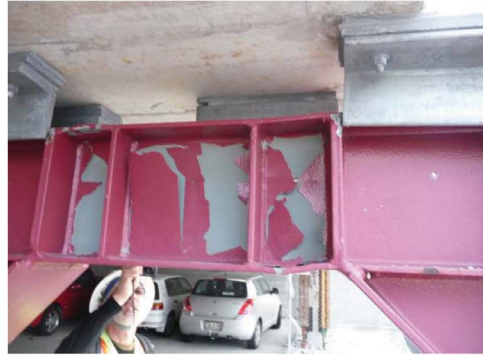
An EBF braced hospital parking garage closer to the epicentre (Bruneau et al., 2010) also performed well, with limited damage to the links and gravity load carrying system and no visible residual drift, although some link fractures were observed in two braced bays (Figures 6b and 6d). At least six

- where the flanges of the brace line up with the stiffeners, as in the right hand side of the active link shown in Figure 6(b) or the panel zone shown in Figure 6(d), there was no damage to this panel zone region.

(b) One of the two active links with fractures

The lateral bracing of the active links in the building shown in Figure 6 was only in the form of a confining angle each side of the top flange, as shown in Figure 6(b) and 6(d). No lateral movement or twisting of the ends of the active links was observed,

As of mid-2011, the fractured active links have been cut out and are being replaced to bring the building back into service in advance of when public access is restored to this area. This includes welding on end plates to the damaged active links and fitting a specific measured active link to the gap.

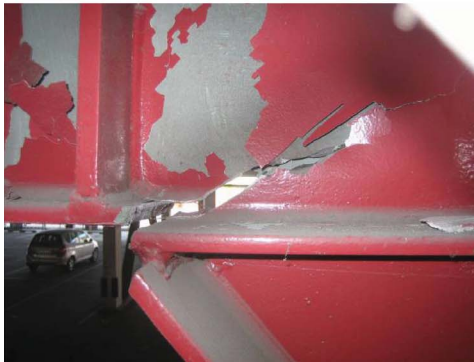
The fractures, as shown in close-up in Figure 6b and c, were of particular concern as these were the first fractures recorded in EBFs worldwide (the Pacific Tower fracture as mentioned above was discovered later). Further puzzlement was added by the fact that the fracture plane, shown in Figure 6c, indicated a ductile overload failure rather than a brittle fracture. However, the likely explanation lies in the offset of the brace flange from the stiffener. This offset is shown in Figure 6(c) and means that, when the brace was loaded in tension, the axial tension force in the brace fed into the active link/collector beam panel zone through a flexible beam flange rather than directly into the stiffener. This meant that the junction between the unstiffened beam flange and the beam web was severely overloaded, leading to fracture between these two surfaces and this fracture spreading across the beam flange and through the web. Evidence in support of this is from the following:

(c) Close-up view of most severely fractured active link

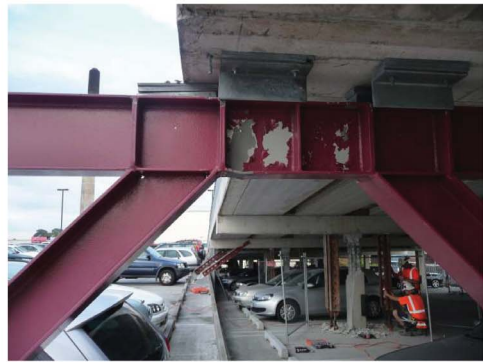
(d) Active link at top storey supporting partially completed ramp to future new level

Also, the ramp at the top level, built in anticipation of future additional stories, suffered damage as the only EBF on the upper segment of the ramp was located at the east end of that ramp, inducing torsional response and shear failure of the columns in moment-frame action at the west end of the ramp—these shear failures had not been repaired by the time of the aftershock and exhibited more significant damage (temporary lateral bracing were installed to prevent further sway motions). Steel angles, originally added at the expansion joint to meet the design requirement for support length of hollow-core slab prevented unseating of the ramp. The EBF link at the ramp level itself exhibited substantial inelastic distortions.

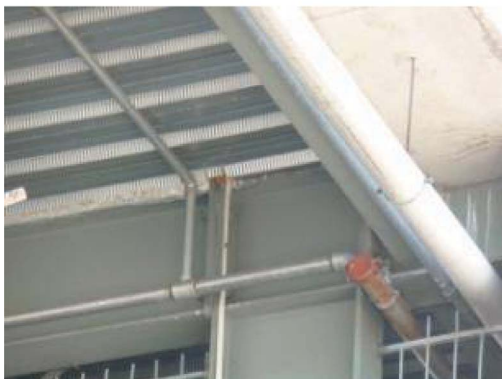
to have performed very well, with no visible sign of inelastic deformation at the beam-to-column connections (Figure 7) or in any other part of the structure. However, this assessment could only be done from the ground below as a collapsed concrete car parking building next door precluded access into the building.

(b) Typical moment resisting beam to column connections.

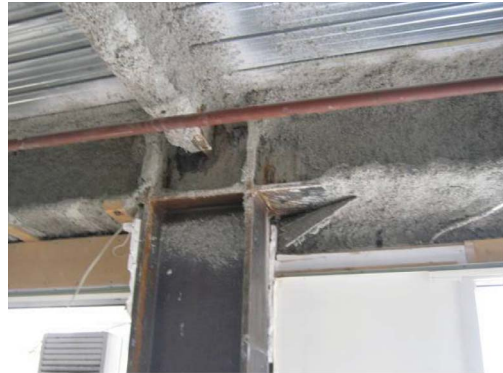
Figure 8a shows a welded beam to column connection in one of the first steel framed buildings of the modern era. It is a 7 storey perimeter moment resisting frame (PMRSF) building, located in a region of unstable ground. The performance is covered in section 6.

Finally, a 7 storey building, located in a region of the CBD that exhibited significant ground instability was inspected inside and out. The structure consists of a perimeter moment resisting frame along all 4 sides, with a non-structural stair and services core and composite floor. Inspection of the steel frame and floor showed no visible damage (e.g., Figure 8a), however the perimeter frame had sunk a noticeable amount in relation to the core and had acted as pinned base, causing significant interstorey drift which has subsequently

(a) Typical beam to column connection with fire protection partially removed for inspection

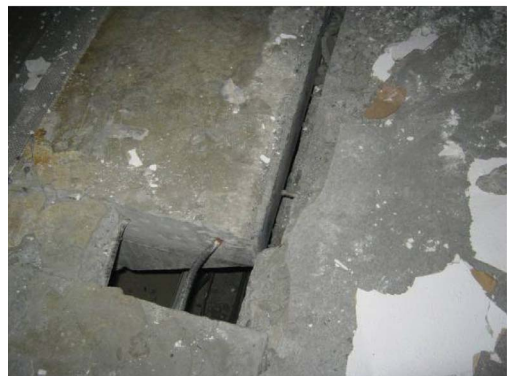
(b) Gap opening in stair at landing due to lateral movement (stairs had independent structural support).

significantly damaged stairs (Figure 8b) and non-structural components. The extent of ground movement around the building was considerable and it is likely that significant foundation movement has occurred. The question of what to do with this building will rest on what has happened below ground.
