# STEEL BUILDING DAMAGE FROM THE CHRISTCHURCH EARTHQUAKE SERIES OF 2010/2011

By: Charles CLIFTON<sup>1</sup>, Michael BRUNEAU<sup>2</sup>, Greg MACRAE<sup>3</sup>, Roberto LEON<sup>4</sup> and Alistair FUSSELL<sup>5</sup>

## Summary

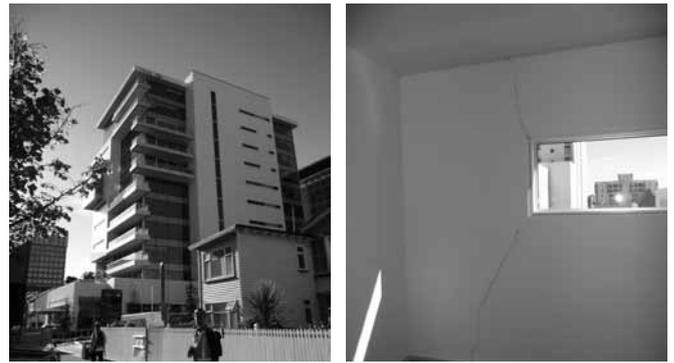
The Club Tower Building (Figure 2(a)) has eccentrically braced frames located on three sides of an elevator core eccentrically located closer to the west side of the building, and a ductile moment resisting frame (DMRF) along the east façade. The steel frame is supported on a concrete pedestal from the basement to the 1st storey, and foundations consist of a 1.6 m thick raft slab. Only the EBFs on the east side of that core could be visually inspected without removal of the architectural finishes

a) Global view

b) Cracking of partition in cantilevering portion of story

Following repair of non structural wall cracking, the building was returned to full service in June 2011, being the first normal important multi-storey building in Christchurch to be back in operation. Realignment of the lift guide rails is ongoing to prevent increased wear of the lift system over time. Given that the building's residual drift is 0.1% it appears that lift shafts are the most sensitive building service component to post-earthquake deformation and also that the 0.3% residual limit proposed by some for successful low damage building performance is too high.

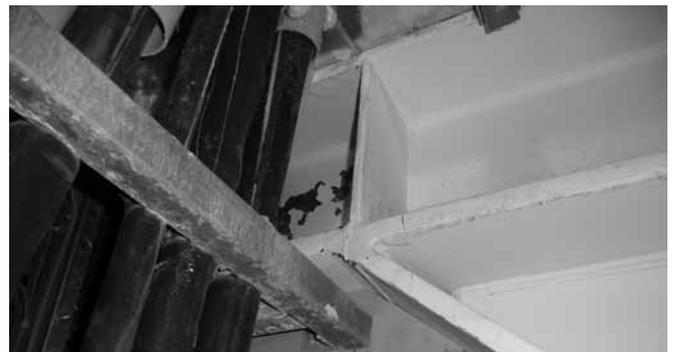
(Figure 2(d)). As observed following the September 2010 (Bruneau et al. 2010), evidence of inelastic deformation was limited to flaking of the brittle intumescent paint on the EBF links at some levels (Figure 2c). However later investigations have shown slightly more yielding in the active links of EBFs in the East-West direction. The links were free of visible residual distortions. Previously reported slab cracking (Bruneau et al. 2010) could not be detected as the concrete floor slab was covered by floor carpeting, except at one location at the fixed end of a segment of the floor cantilevering on one side of the building (a feature present only over two stories for architectural effect). Crack widths appeared similar to what had been previously observed. Substantial shear cracking of the gypsum plaster board (sheetrock) finish on the exterior wall of that cantilevering part of the floor was also observed (Figure 2(b)); only hairline cracking of gypsum plaster board finishes was observed elsewhere throughout the building. One non-structural masonry block installed for sound proofing purposes adjacent to mechanical units on the pedestal roof suffered minor shear cracking where it had been placed hard against a cantilevering floor beam.

c) Paint flaking of partially hidden EBF link

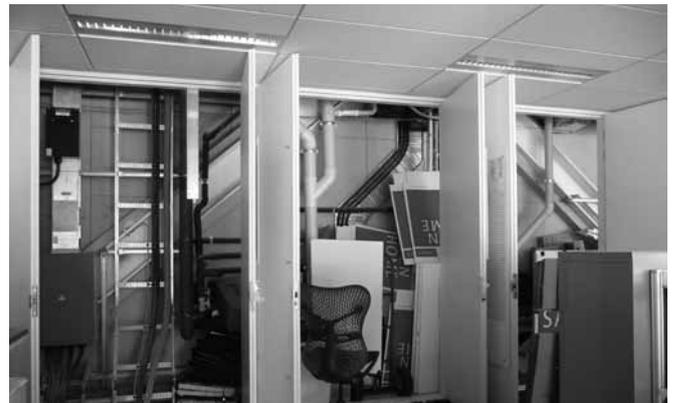
d) Global view of EBF braces obstructed by various utility runs

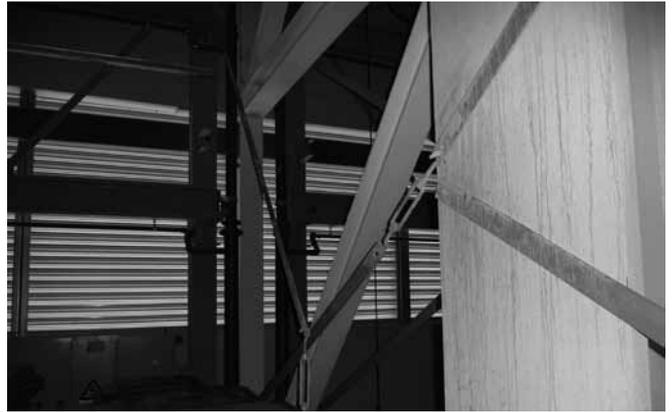
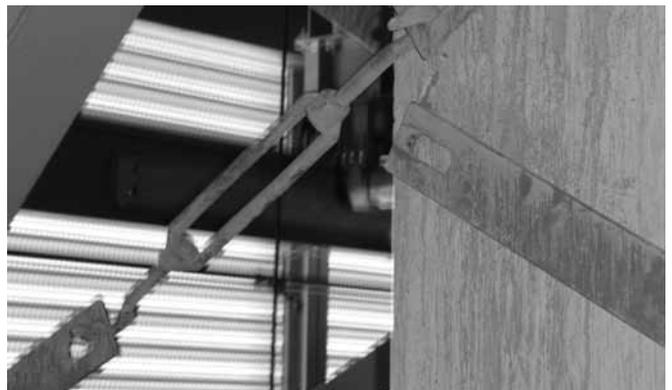
As a new landmark and the tallest building on the Christchurch skyline<sup>7</sup>, the 22-storey Pacific Residential Tower consists of perimeter EBFs up to the sixth floor (one on each building face), shifting to EBFs around the elevator core above that level, with a transfer slab designed to horizontally distribute the seismic loads at that transition point. EBFs at levels below the transfer slab were visible, as these levels housed a mechanical multilevel parking elevator system. The separate bracing system of that mechanical device consisted of flat plates connected with turnbuckles and hooks. Some of those details failed as the bars un-hooked when returning

into compression after tension yielding excursions that elongated the braces. The EBFs at intermediate locations were not integral with the floor slab and so did not benefit from the strength increase provided at lower stories. A range of views for this structure are given in Figure 3.

(b) and (c) Multistorey mechanical garage failed braces

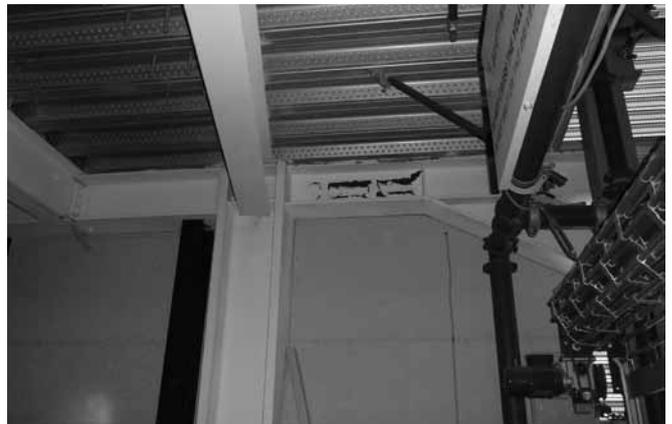
Paint flaking and residual link shear deformations were observed in the EBF links at those levels. Design of the EBFs in Pacific Residential Tower building was governed by the need to limit drift, with a corresponding resulting design ductility factor ( $\mu$ ) of 1.5 (even though up to 4.0 is permitted for EBF, as mentioned earlier). This is typical of EBFs in tall buildings in New Zealand's moderate to low seismic zones; Christchurch is moderate in accordance with the earthquake loadings standard, NZS 1170.5, at the time of writing. The EBF at all other levels were hidden in architectural finishes, and absence of damage to those finishes suggested limited inelastic deformation, which has been confirmed by subsequent detailed evaluation. Initial concern that inelastic demand was higher in level 6 which is the level of a horizontal transfer diaphragm between the podium and tower was found not to be the case in this detailed evaluation.

(d) Flaked paint on EBF link

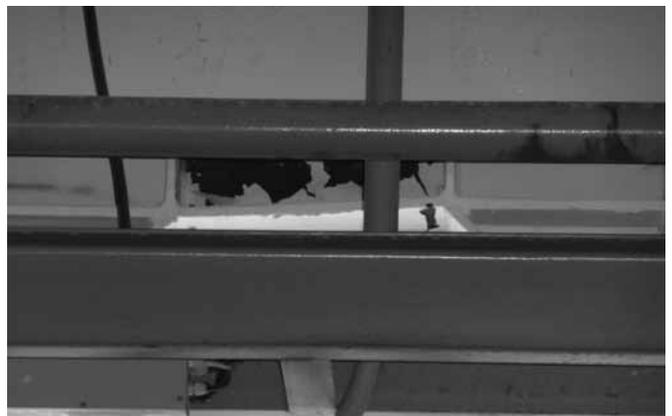
(e) Residual shear deformations of EBF link

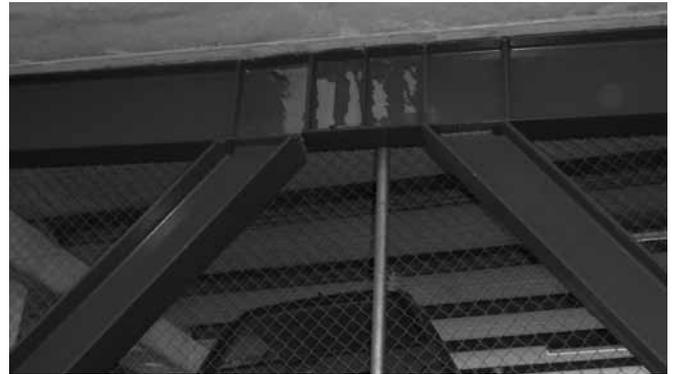
- where the flanges of the brace line up with the stiffeners, as in the right hand side of the active link shown in Figure 5(b) or the panel zone shown in Figure 5(e), there was no damage to this panel zone region

(b) Evidence of EBF link yielding

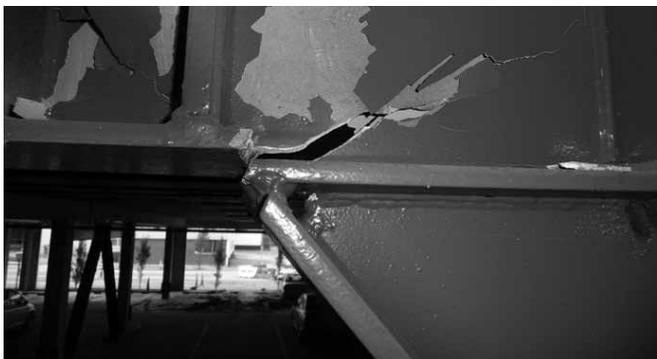
The fractures, as shown in closeup in Figure 5(c) were of particular concern as these were the first fractures recorded in EBFs worldwide. Further puzzlement was added by the fact that the fracture plane, shown in Figure 5(c), indicated a ductile overload failure rather than a brittle fracture. However, the likely explanation lies in the offset of the brace flange from the stiffener. This offset is shown in Figure 5(d) and means that, when the brace was loaded in tension, the axial tension force in the brace fed into the active link/collector beam panel zone through a flexible beam flange rather than directly into the stiffener. Thus the junction between the unstiffened beam flange and the beam web was overloaded, leading to fracture between these two surfaces and this fracture spreading across the beam flange and through the web. This is supported by the following facts:

- the damage to the panel zone region is directly proportional to the eccentricity between the brace flange and the active link end stiffener

This shows that the load path through the as-constructed detail is particularly important when inelastic demand is required from the system.

(c) Fractured link at lower level EBF

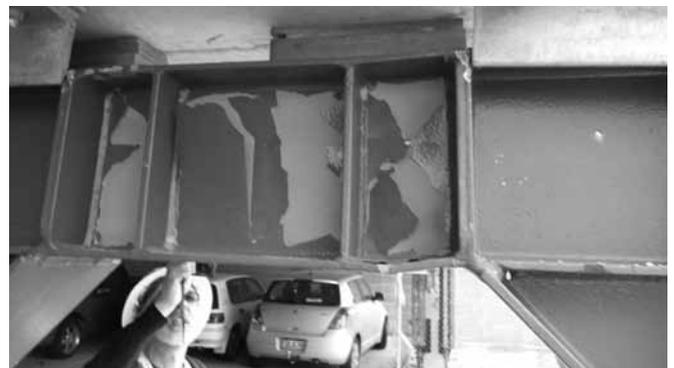
The lateral bracing of the active links in the building shown in Figure 5 was only in the form of a confining angle each side of the top flange, as shown in Figure 5(d) and 5(e). No lateral movement or twisting of the ends of the active links was observed, indicating that the lateral restraint provisions had been adequate despite only being applied to the top flange and for EBFs not integral with the slab above.

(d) Evidence of inelastic deformations at top level EBF

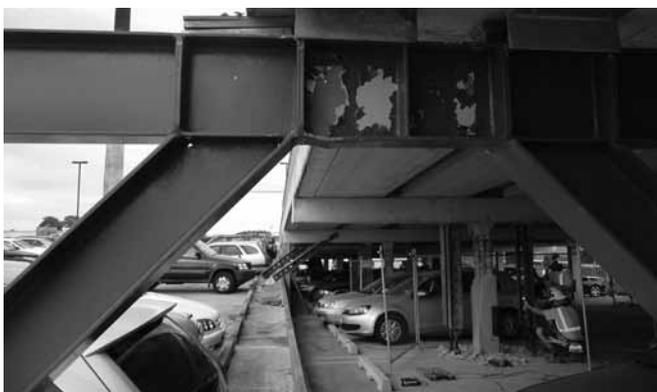
(e) Close-up view of same

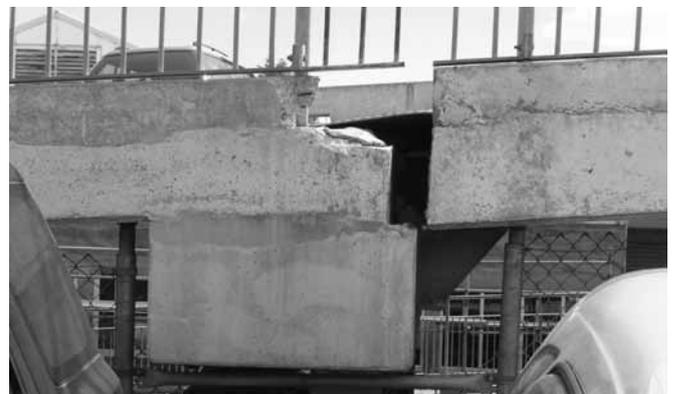
Also, the ramp at the top level, built in anticipation of future additional stories, suffered damage as the only EBF on the upper segment of the ramp was located at the east end of that ramp, inducing torsional response and shear failure of the columns in moment-frame action at the west end of the ramp. These shear failures had not been repaired by the time of the aftershock and exhibited more significant damage (temporary lateral

bracing was installed to prevent further sway motions). Steel angles, originally added at the expansion joint to meet the design requirement for support length of hollow-core slab prevented unseating of the ramp. The EBF link at the ramp level itself exhibited substantial inelastic distortions.

(f) Displacement at expansion joint, top ramp

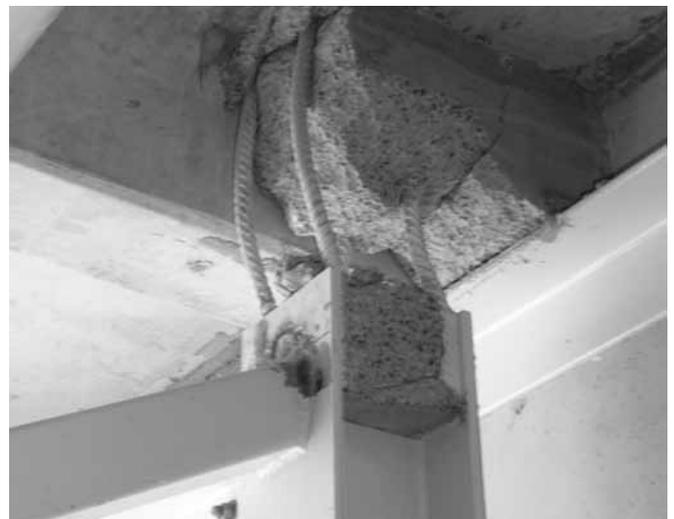
A single suspended level parking garage with concentrically braced frame (CBF) was found to have performed poorly (Figure 7). The garage had solid pre-cast panel walls on three sides, and two individual CBF bays along the fourth side (one bay on each side of the garage door). While the columns of the westernmost CBF tied to a steel beam at their top, the easternmost CBF was not similarly aligned with a steel beam. A non-ductile reinforced concrete extension framing into a concrete beam at the top performed poorly. The other brace of that frame failed at the welds under tension loads; these welds did not appear to be designed to develop the tension capacity of the brace according to the capacity design principles of NZS 3404. The westernmost CBF performed better, without fractures, with visible post-earthquake residual buckling as a consequence of brace elongation.

*(a) Poor column connection detail*

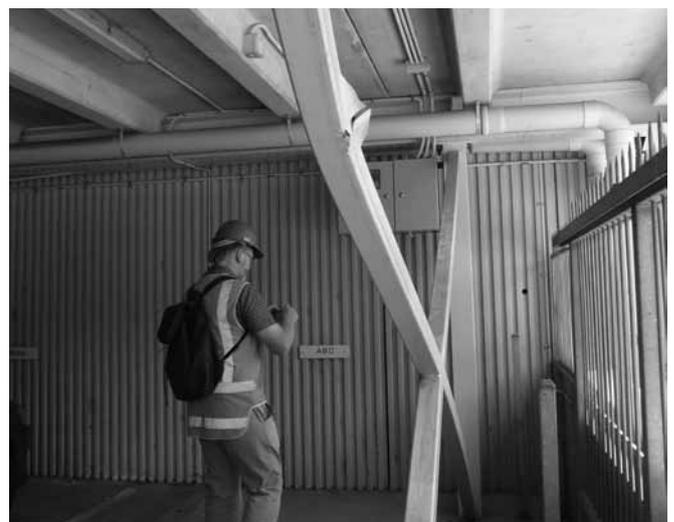
*(b) Buckled brace*

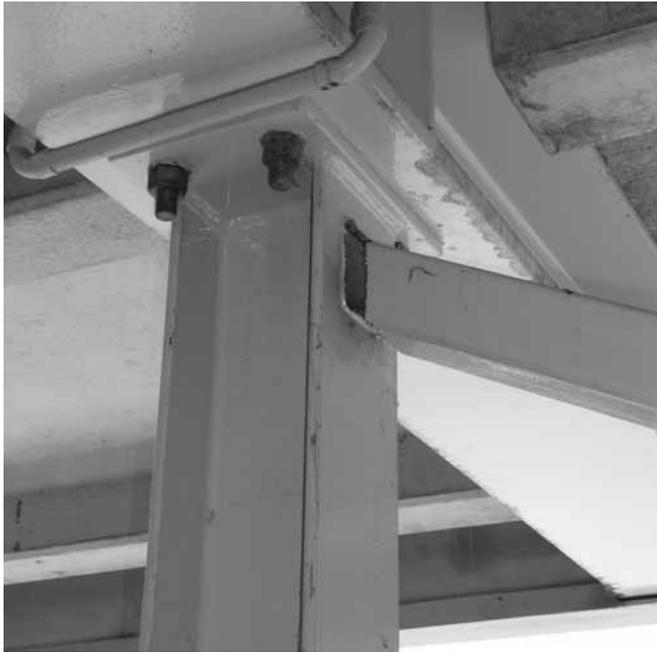
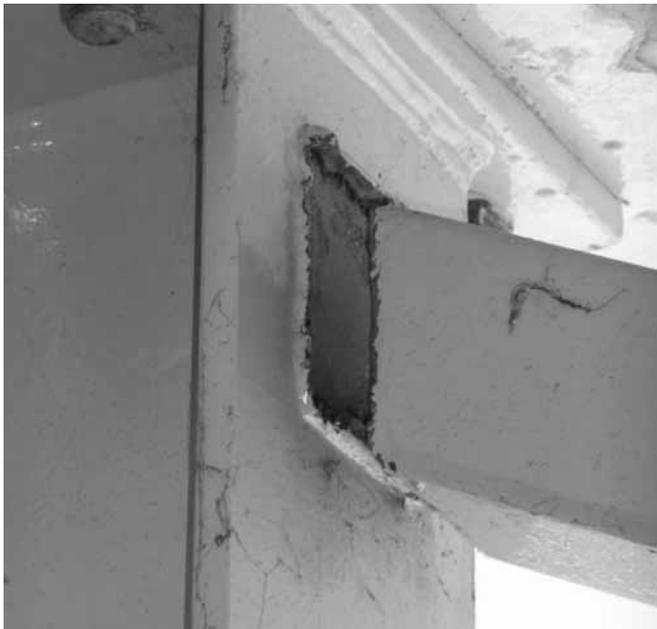
*(c) and (d) Fractured non-ductile brace-to-column connection*

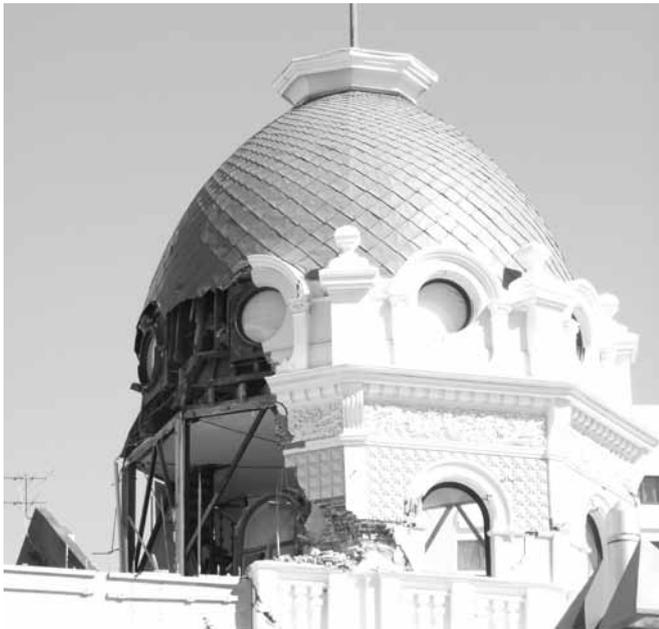
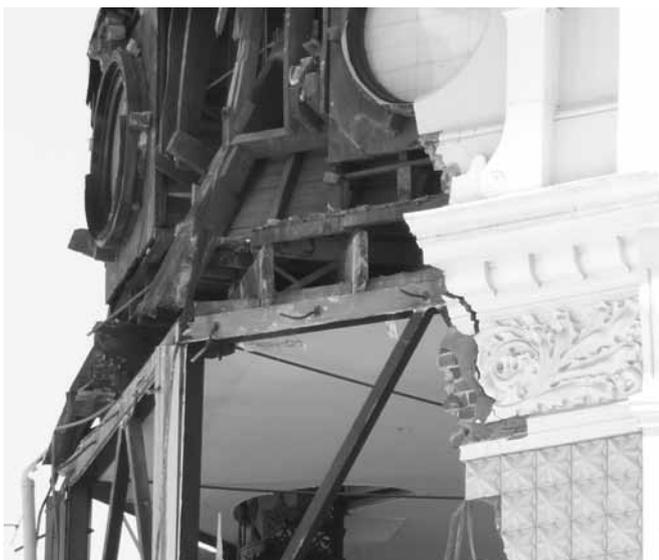
Partial out-of-plane failure around the dome at the top of the Regent Theatre) Building revealed that a braced steel frame had been used there (Figure 9). Although subsequent inspection will be required to verify the integrity of the connections, it appeared to be in good condition from a distance. The building was built before 1910 and the scene was reminiscent of pictures of similar buildings following the 1906 San Francisco earthquake. However, the CBFs appeared to be welded construction (to be verified) which means they are likely to be newer than the rest of the building and had been added in a subsequent retrofit.

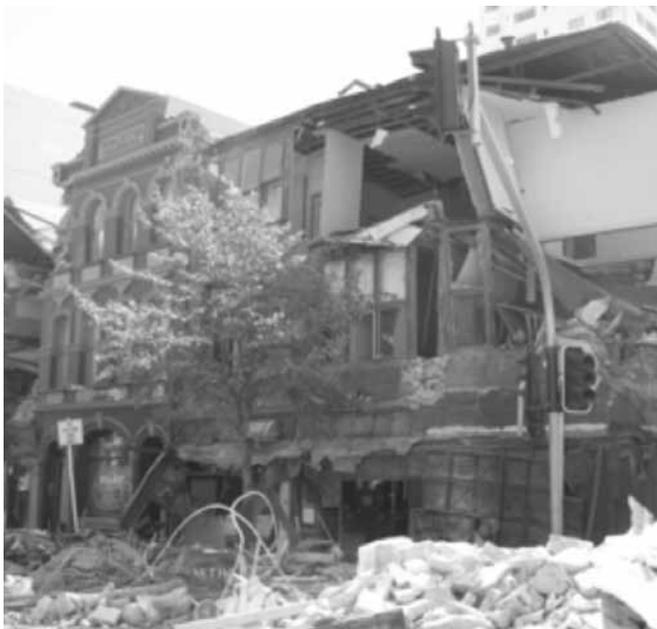
Buildings in the CBD that had been strengthened prior to the September 2010 earthquake typically suffered minimal to no damage in that event. They were not so fortunate in the much stronger February 2011 event. In part this is likely because the acceptable strengthening requirements were less than full design levels demanded of modern buildings. Figure 11 shows one group of three buildings, with (a) showing these following the September 2010 event and (b) showing (from a different vantage point) the three following the February 2011 event. Note especially the strengthened building on the corner has collapsed.

(b) Following the February 2011 event, taken from a slightly different view-point

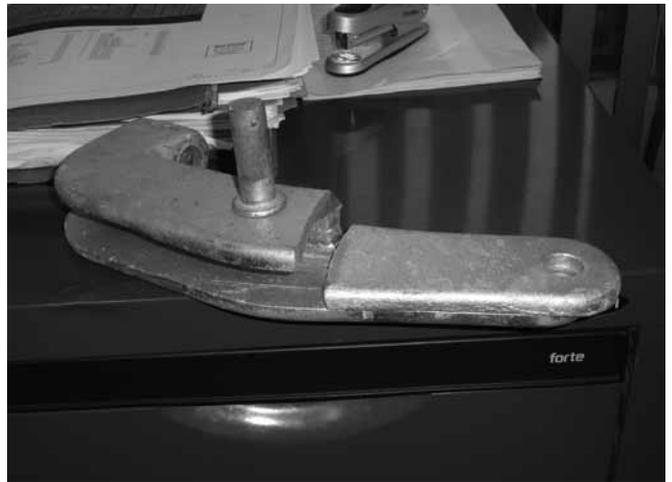
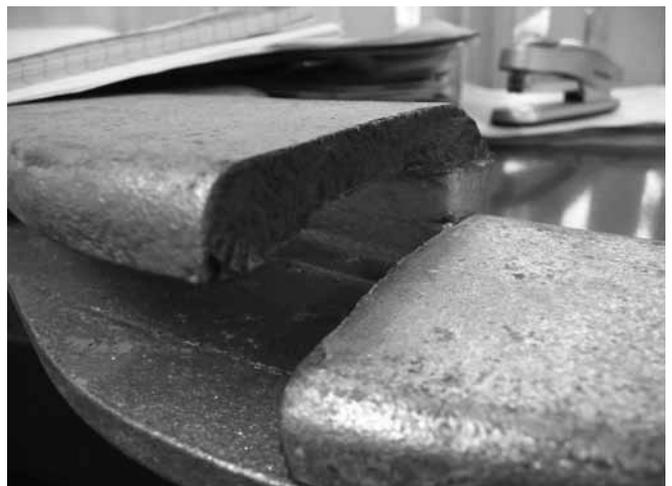
As was the case following the September 2010 Darfield earthquake, a proprietary system often used in these warehouses (sold as a kit) which used a particular banana end fitting, suffered some brittle failures of the cast-steel connectors (as shown in Figure 12). These occurred in a new warehouse when the fitting fell to the ground following the shearing of the pin retaining clip. Some engineers have expressed concerns regarding their potential brittleness and believe that their performance needs to be validated under a dynamic test regime.

Figure 12: Example of fractured banana end of proprietary brace connector in the roof plane of a long span steel portal frame building [Photos by M. Bruneau]

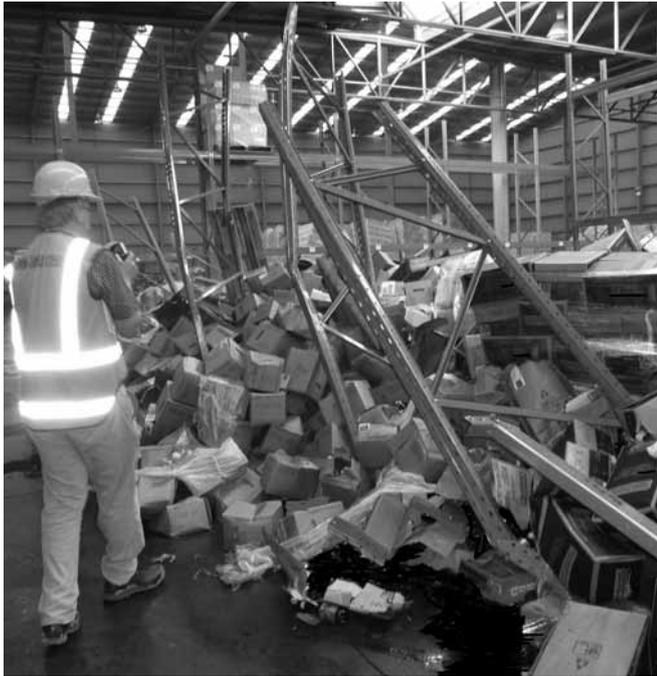
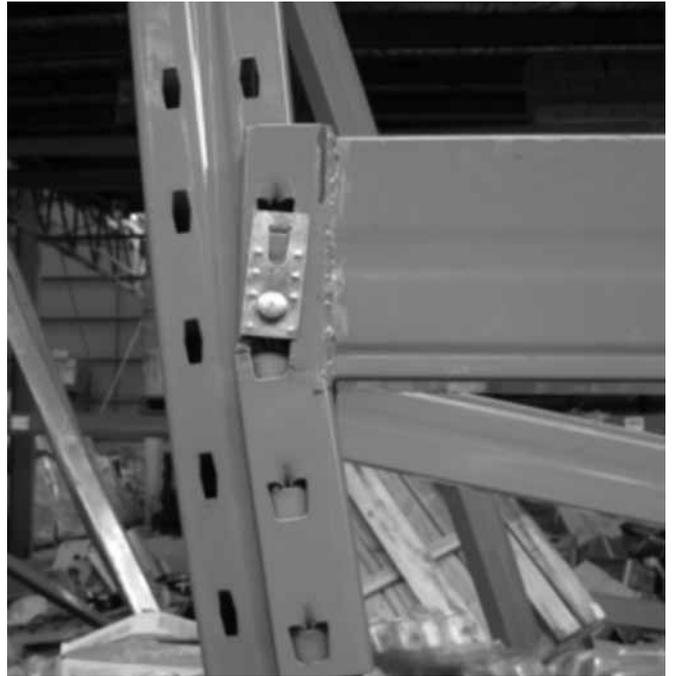
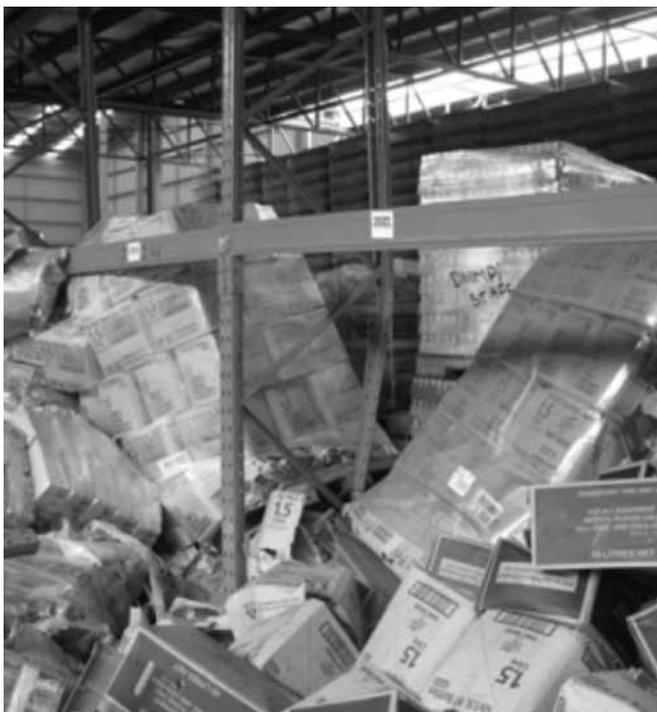
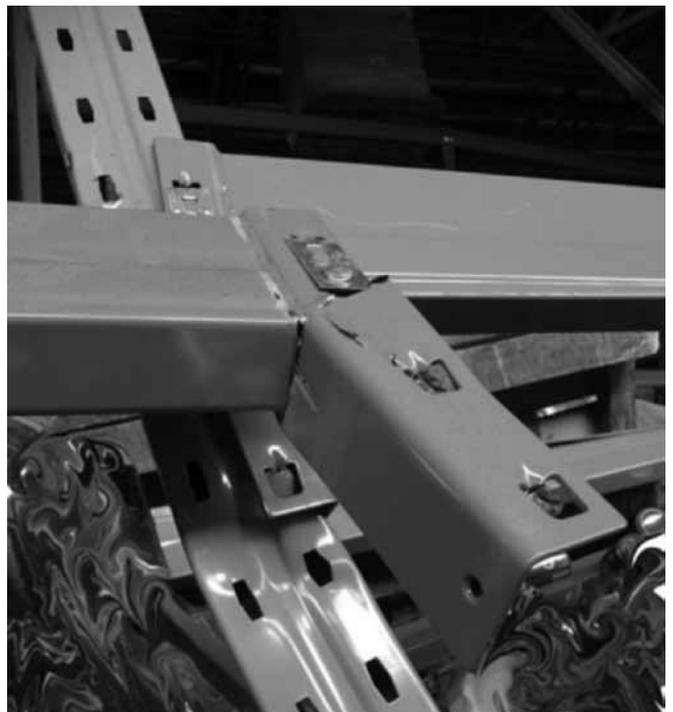
total collapse, as shown in Figure 13. It appeared that the semi-rigid beam to column connections in the longitudinal direction were too weak for the intensity of shaking and imposed gravity loads. In the transverse direction there were examples of brace system failure due to baseplate tearout from the floor when the column went into tension, which forced the seismic base shear into the compression column leading to rapid failure of this column.

*Figure 13: Example of collapsed industrial storage racks [Photos by M. Bruneau and G C Clifton]*

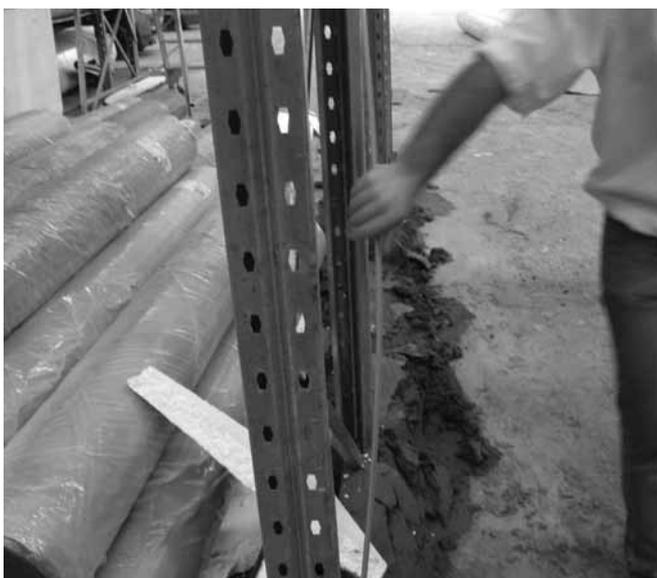
Anecdotally, in another facility, existing racks had been retrofitted by coupling two racks back-to-back with flat bar braces (Figure 14). These bars showed evidence of elongation and residual buckling, but did not collapse, in spite of floor movements due to liquefaction, whereas the only rack that was not retrofitted (for it was not adjacent to a second rack to which it could have been tied) collapsed.

(b) Close-up of buckled brace

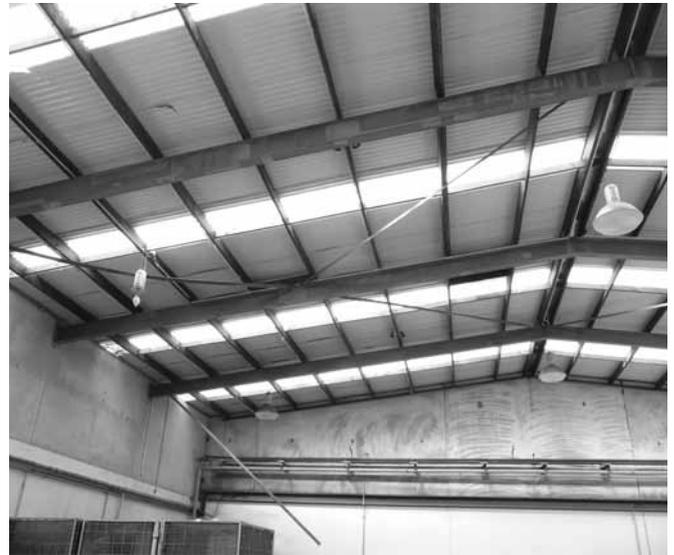
Multiple examples of tilt-up panel movements due to ground liquefaction were observed, sometimes leading to fracture of non-ductile braces unable to accommodate the imposed deformations. One such example is seen in Figure 15, showing a fractured brace and its counterpart buckled brace.

(a) Global view, showing buckled brace and fractured brace

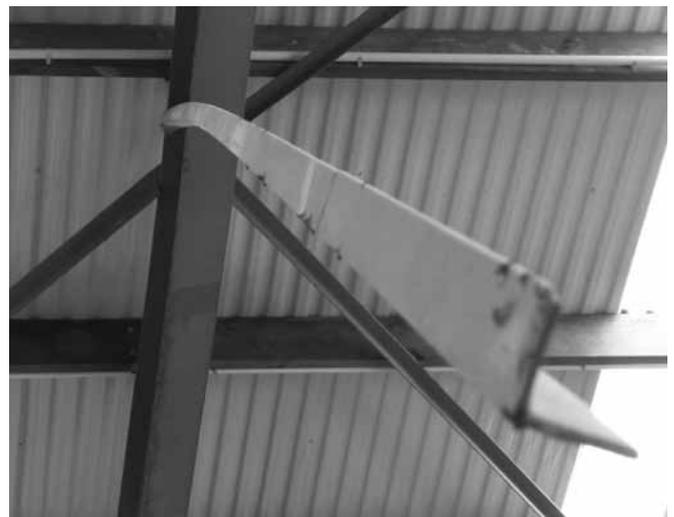
(b) Close-up view of fractures weld of tension brace

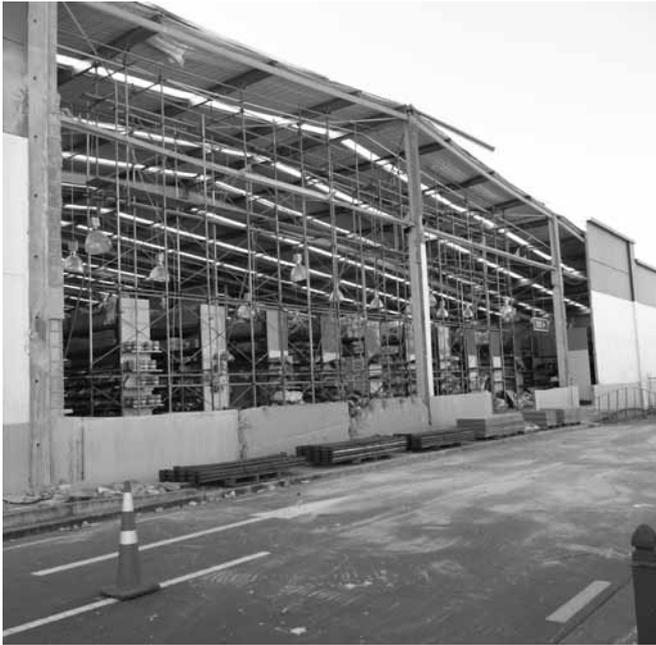
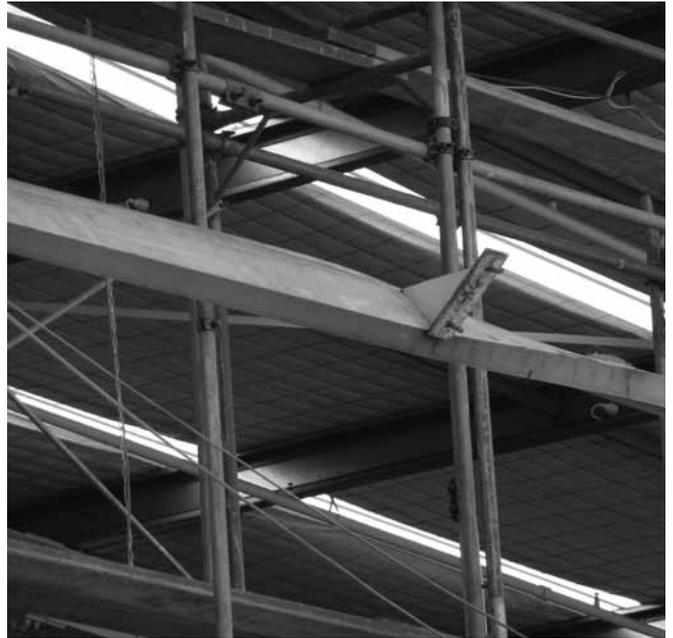
Anchorage of tilt-up walls to steel structures also failed in a few instances. Figure 16 shows roof beams buckled in compression by the inward movement of the tilt-up panels, and failure of the anchors due to their outward movement (i.e. away from the building). Given that this happened in modern construction, and because tilt-up walls of greater slenderness have progressively been implemented in New Zealand, a careful re-assessment of their seismic design provisions may be desirable.

*(b) Close-up view of fractures connection*

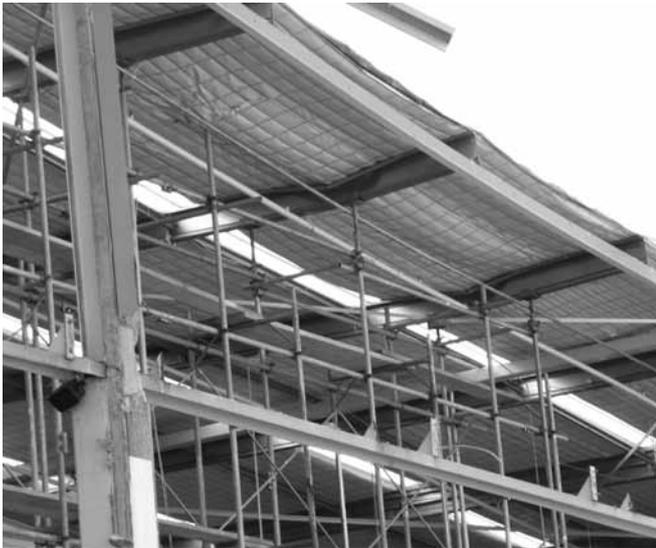
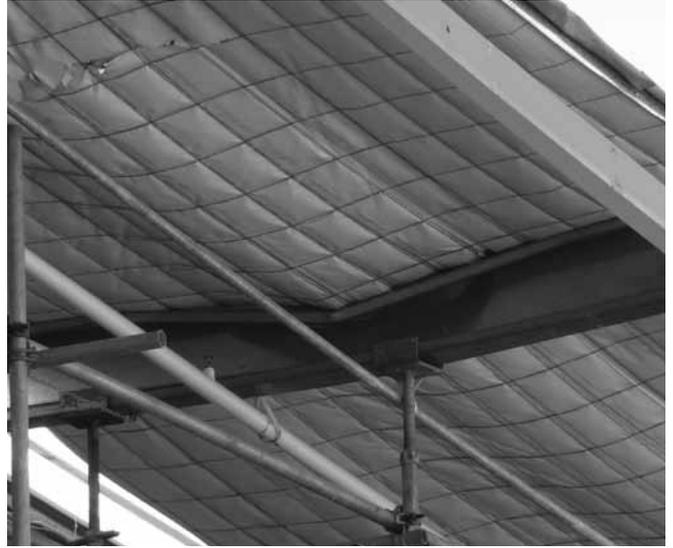
*(c) Global view of buckled beams*

*(d) Local view of one such beam*

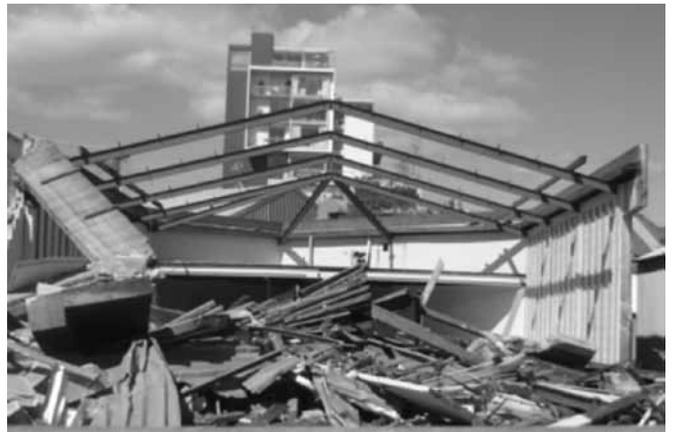
Figure 17 shows the steel structure standing when the roofing has collapsed. This shows remarkable performance of the steel members, but poor performance of the roofing/connections.

*Figure 17 : Failure of roof and walls in older industrial facility on Salisbury Street [Photos by G. MacRae]*

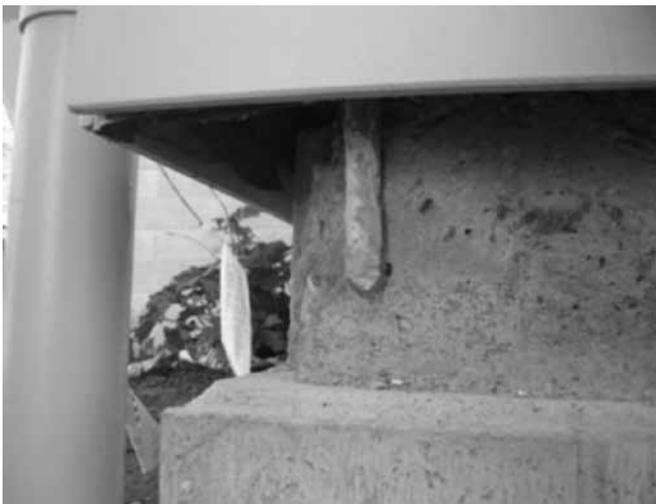
At Heathcote Valley Primary School some of the most extreme shaking during the event was recorded. There was one new single storey building with a steel moment frame and block walls as shown in Figure 18(a). After the earthquake the wall was leaning to the east at the southern end, and to the west at the northern end. The concrete baseplate was blown out on the southeast side of the building as shown in Figure 18(b).

(b) Baseplate bolt at SE corner of the building

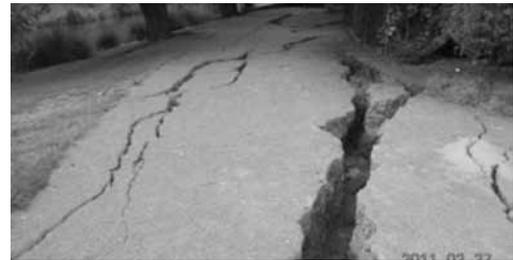
*(a) Slumping of riverbank close to bridge*

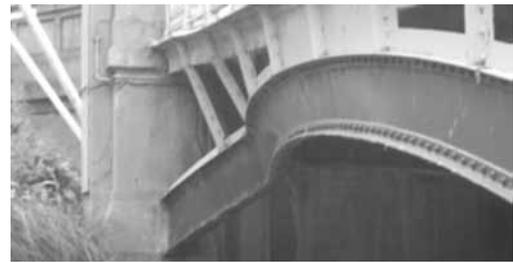
Although substantial liquefaction occurred along the Avon River near the CBD, the only older steel bridge in this area did show spectacular buckling of its fascia arches; the actual bridge, supported on straight riveted girders appeared undamaged even though large settlements had occurred at the abutments (Figure 21). The old rail bridge over the Waimakariri river behaved well even though it was clear that the pier had moved over 100 mm toward the river and back during this shake (Figure 22(a)). The old road bridge suffered some longitudinal buckling of the lower flange of one beam (Figure 22(b)) as well as some spalling of concrete on the west side of the abutment. The only major modern steel bridge at the Port of Lyttleton, a three-span continuous plate girder, had only minor damage at the abutment (Figure 23).

*(b) Buckling of fascia arches*

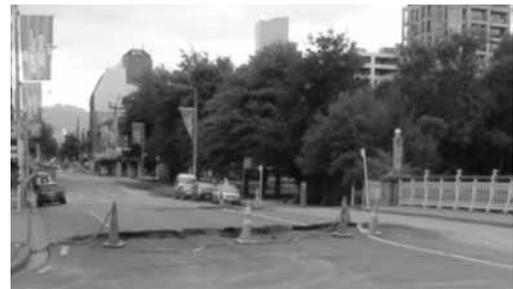
*(c) Slumping of abutments at end of bridge*

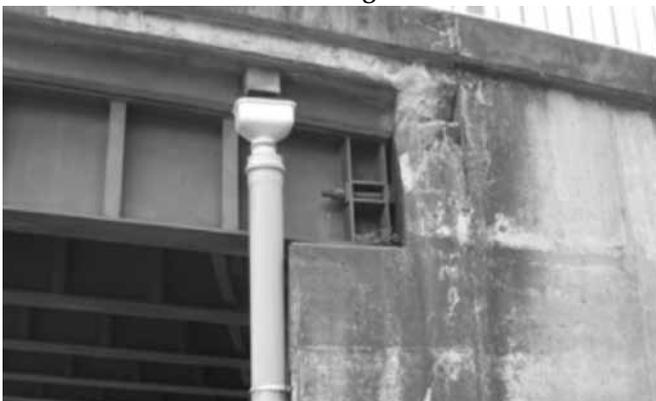
(b) Abutment spalling
