OVERVIEW OF BRIDGE PERFORMANCE DURING THE 2011 CHRISTCHURCH EARTHQUAKE

by A. Palermo⁽¹⁾, L. Wotherspoon⁽²⁾, L. Hogan⁽²⁾, A. Kivell⁽¹⁾,
M. Yashinsky⁽³⁾, M. Bruneau⁽⁴⁾ & E. Camnasio⁽⁵⁾

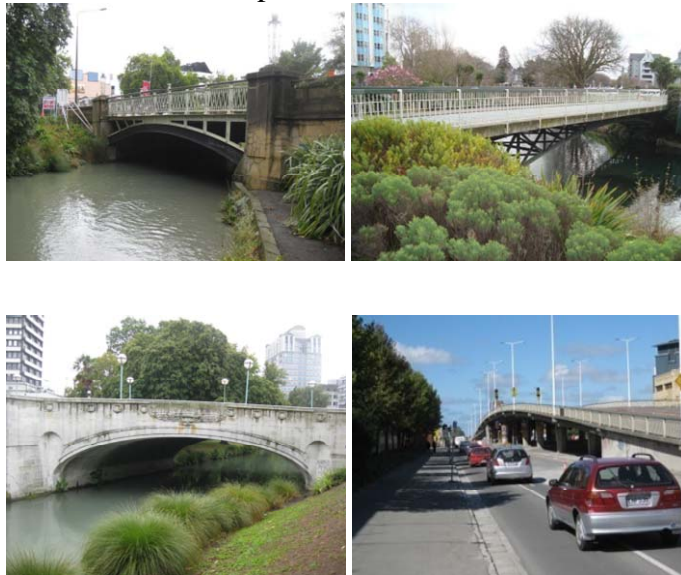
The good performance of the main spans of these bridges was mainly due to their monolithic structure, acting as a stiff strut between river banks affected by lateral spreading. No collapses were registered and bridges maintained their vertical load carrying capaci-

Figure 3. Selection of damaged bridges in the CBD area. Clockwise from top left: Colombo Street Bridge; Antigua Street Footbridge; Bridge of Remembrance; Moorhouse Avenue Overpass.

ty after the earthquake. Nevertheless, for this same reason the majority of damage was registered at the abutments (flexural cracking) and at the approaches (settlement and spreading).

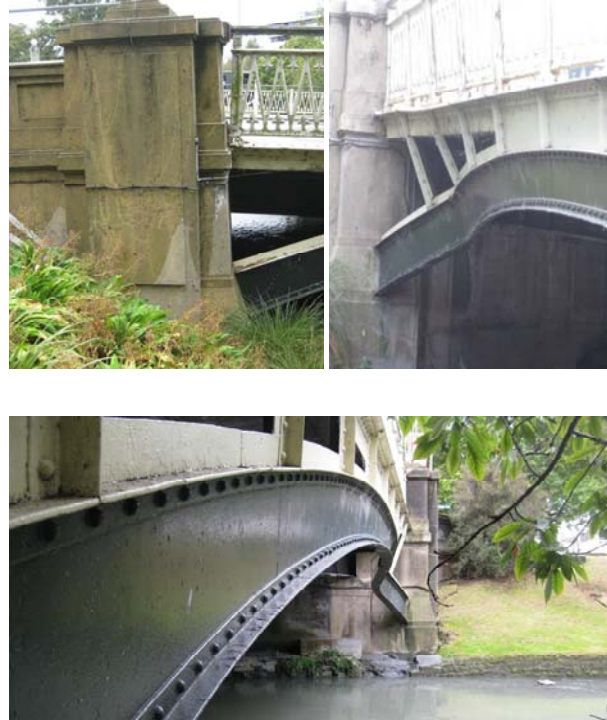
The Colombo Street Bridge (-43.5271, 172.6366), is a single span steel bridge with concrete pilasters, supported by shallow foundations. After the Christchurch earthquake there was evidence of severe liquefaction in the bridge vicinity, with lateral spreading of both approaches. The lateral displacement of the banks behind the abutment contributed to the large cracks observed in the abutments and their back-rotation. Abutment wall rotation was observed on both sides of the bridge, but was more pronounced at the north abutment (Figure 4). The north abutment pilasters also rotated outwards as a result of the lateral spreading pressures on the wingwalls, with vertical cracks in the abutment wall.

Significant damage involved severe buckling of the arched edge girders both on the upstream and downstream sides of the bridge (Figure 4). The assessed damage confirmed a poor detail for the wingwalls, which were not properly connected to the existing structure causing the inevitable buckling of the arches. Because of additional movements and damage resulting from the 13 June 2011 aftershock, the bridge has remained closed.

Figure 4. Colombo Street Bridge. Clockwise from top left: rotation of the abutment [Courtesy of OPUS]; buckling of steel arch [Photo by M. Yashinsky]; close up view of the steel arch [Courtesy of OPUS].

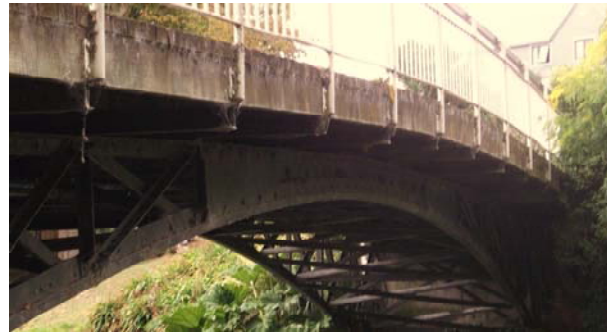
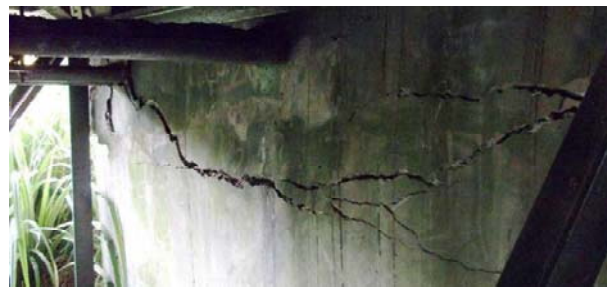
Additional damage was observed after the 13 June 2011 aftershock. The hog in the longitudinal profile of the bridge was approximately 450mm at the centre of the span. Both abutments have back-rotated between 1-1.5 degrees (Figure 5b), and displaced towards the river, with the truss arch compressing. The vertical and diagonal truss members adjacent to the north eastern abutment have disconnected due to rotation of a low level concrete retaining wall, causing the riveted connection to fail.

The abutment displacement and rotation caused the vertical deflection and hogging of the steel arch truss (Figure 5a). This hogging meant some cross bracing members failed adjacent to more rigid, corroded joints. The shear failure of the concrete wingwalls has caused the supports to the timber footbridge beams to fail (Figure 6a). These supports had very little anchorage into the concrete wingwalls, and would not have required much movement to cause them to fail.

Figure 5. Antigua Street Footbridge. (a) View underneath showing hogging [Courtesy of OPUS]; (b) Damaged north-eastern abutment [Courtesy of OPUS].

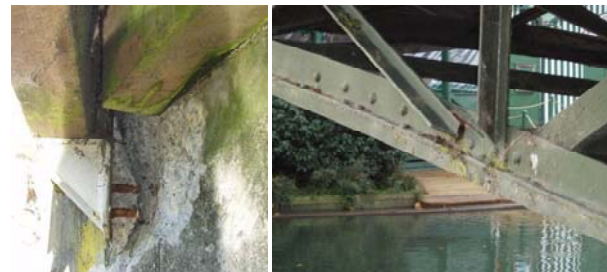
Figure 6. Antigua Street Footbridge. (a) Typical failure of end support to timber footway beams [Courtesy of OPUS]; (b) Typical failure of cross bracing member adjacent to corroded joint [Courtesy of OPUS].

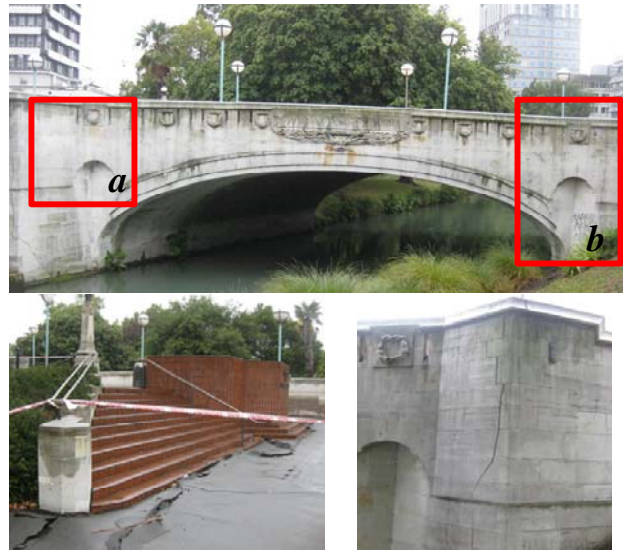
The Bridge of Remembrance (-43.5332, 172.6334), is a single span, stone faced reinforced concrete arch, of variable thickness and skewed in plan. Horizontal earth thrusts are resisted by massive arch thickenings, which extend over the full width of the bridge. This bridge suffered moderate superficial damage as a result of the February 2011 earthquake. However, the Triumphal Arch over the bridge sustained more significant structural damage. In terms of the bridge, reported damage included paving damage at the approaches (Figure 7a), large vertical cracks to all wingwalls (Figure 7b) and widespread cracks near the base of arch, along the full length at base of both parapets and through the buttress of the arch above the east abutment. The width of some of these cracks increased after the 13 June 2011 aftershock.

The majority of the damage has resulted from settlement of the approach fill, lateral spreading soil pressures resulting in deflection and rotation of the wingwalls and possibly the abutments. Minor rotation of all four wingwalls caused cracking of the stone facades. The concrete sections behind the cracked stonework are also likely to have been cracked. This is not considered a major concern at present, as the wingwalls are independent from the main bridge structure and are founded on concrete pads. Cracking of the parapets may indicate some deflection and hogging of the main arch of the Bridge of Remembrance. However, collapse of this robust structure under earthquake induce soil loading/lateral spreading is highly unlikely.

Figure 7. Bridge of Remembrance. (a) Damage to steps on western approach [Courtesy of OPUS]; (b) Damage to north-eastern wingwall [Courtesy of OPUS].

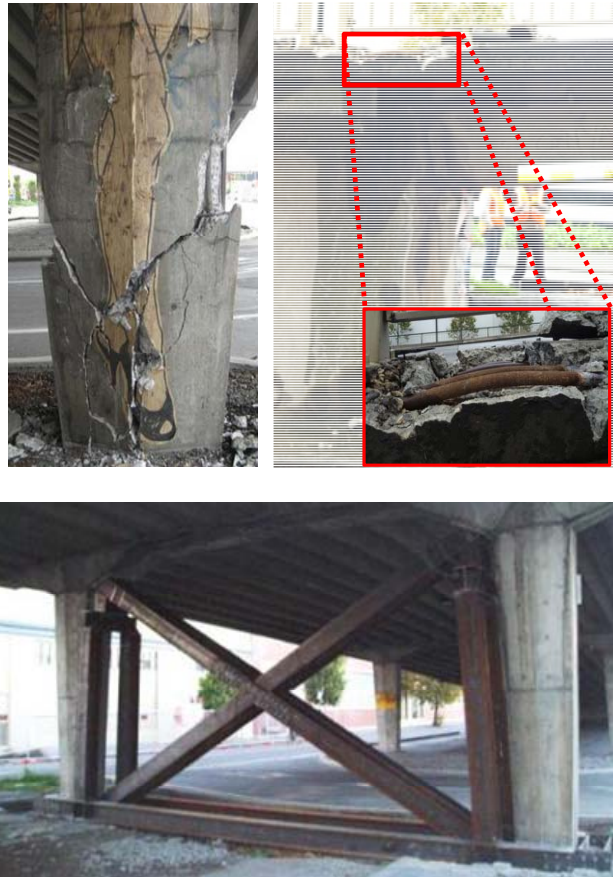
Significant pier damage developed during the Christchurch earthquake due to transverse ground shaking. The overall performance of the structure was unsatisfactory, with significant shear cracking and buckling of the piers. This damage affected the vertical load carrying capacity of the structure along with the lateral capacity. As a result of this damage, the bridge was closed following the February 2010 earthquake for over five weeks while strengthening works were undertaken.

The bridge sustained damage to one column near the north-east approach where a deck expansion joint was located. The insertion of steel rod linkages in the deck at the expansion joint at only one side of the bridge induced irregularity in the structures transverse response. In fact, with the west and central part of the bridge linked, the bridge pier at the eastern expansion joint suffered extensive displacement demand. The slenderness of the pier affected the vertical load carrying capacity of the structure along with its lateral capacity. The columns also had widely spaced transverse reinforcement, making the structure susceptible to shear failure (Figure 9a). Observations after the Christchurch event indicated that the damaged columns had started to buckle putting the central span at risk of collapse. In this instance, damage was induced by extensive ground shaking; large transverse horizontal accelerations may have caused a flexural-buckling failure mechanism in the columns.

Due to the higher displacement demand in the west-central part of the bridge, the deck pounded against the south-west abutment of the bridge causing extensive spalling and bar buckling (Figure 9b). This has occurred as the abutment is also taking some of the longitudinal lateral load of the centre section due to the placement of steel ties.

Figure 9. Moorhouse Avenue Overpass. (a) Shear failure mechanism of the pier at the expansion joint [Photo by A. Palermo]; (b) Concrete spalling and bar buckling at south-west side abutment [Photo by A. Kivell] [Palermo *et al.* 2011a]; (c) Temporary propping [Photo by G. Whitla].

After initially temporary strengthening works being erected around the failed pier, a multi-span structural steel frame was designed and constructed spanning between the two failed columns. This solution did not provide any additional lateral stability and so the overbridge was not reopened to vehicle traffic until the final temporary solution was implemented. To improve the transverse capacity of the damaged structure Opus (consulting engineers) elected to construct dual cross-bracing units at each of the piers. These straddled the piers and used doubled up steel sections to act as a diagonal bracing system and is shown in Figure 9c.

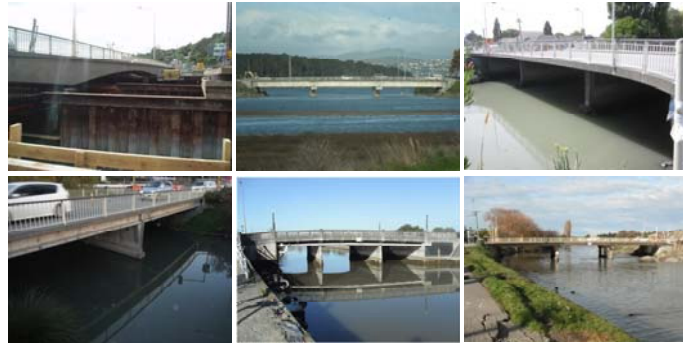
Damage to bridges outside of the CBD focused on structures spanning the Avon River, which flows from the CBD through the eastern suburbs of Christchurch. Soil conditions and shaking in this region resulted in large settlements and lateral spreading due to liquefaction. Liquefaction was not observed to the same extent along the other major waterway passing through southern Christchurch, the Heathcote River, contributing to less damage observed to bridges along this river (Figure 10).

Figure 10. Selection of damaged road bridges. Clockwise from top left: Ferrymead Bridge; Bridge Street Bridge; Gayhurst Road Bridge; Avondale Road Bridge; Pages Road Bridge; Fitzgerald Avenue Bridge.

Being the structures very robust and stiff, damage to road bridges was concentrated to the substructure and approaches, with the superstructure, sustaining mainly pounding damage and minor cracking. Nevertheless, while structural damage did not restrict vehicle use following the Christchurch earthquake, many bridges were out of service for a number of hours due to settlement and lateral spreading approach damage. Temporary repairs were quickly in place in most cases, but interruption to emergency services at such a critical time raises concerns. Similarly, services carried on bridges (water, electricity) were often incapacitated with services not being returned for several weeks.

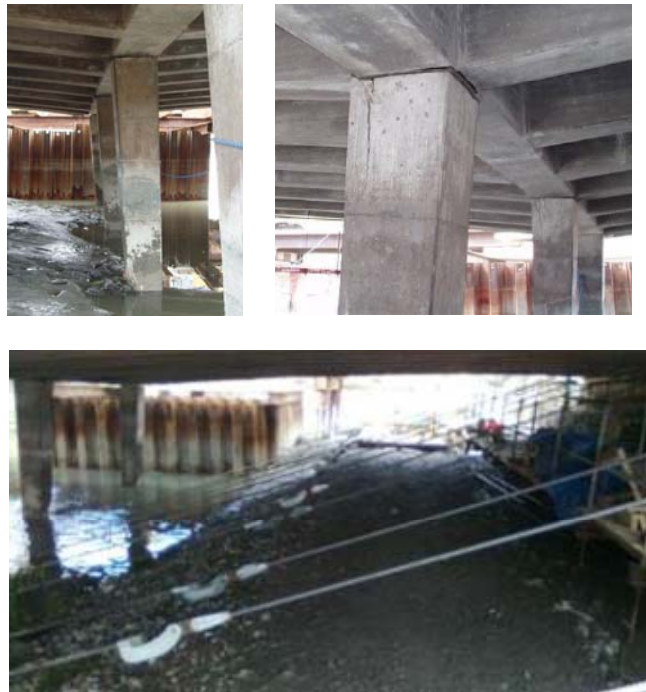
Figure 11. Ferrymead Bridge. (a) Tilted piers [Courtesy of OPUS]; (b) Close-up view of flexural cracks at the top of the piers [Courtesy of OPUS]; (c) Securing works of Ferrymead Bridge [Courtesy of OPUS].

Ferrymead Bridge was the only bridge along the Heathcote River to suffer significant damage. Lateral spreading caused significant damage to the new abutment components and temporary construction platforms. The existing structure also sustained damage due to lateral spreading, with permanent rotation and cracking of a number of the piers situated in the estuary (Figure 11a).

Ferrymead Bridge was temporarily repaired with prestressed rods connecting the bottom of the piers to the abutments (Figure 11b). This limited further movements of piers inwards towards the river/estuary which could compromise the overall stability of the bridge. Due to the earthquake damage, heavy vehicle restrictions had been placed on the bridge following the 2011 Christchurch earthquake.

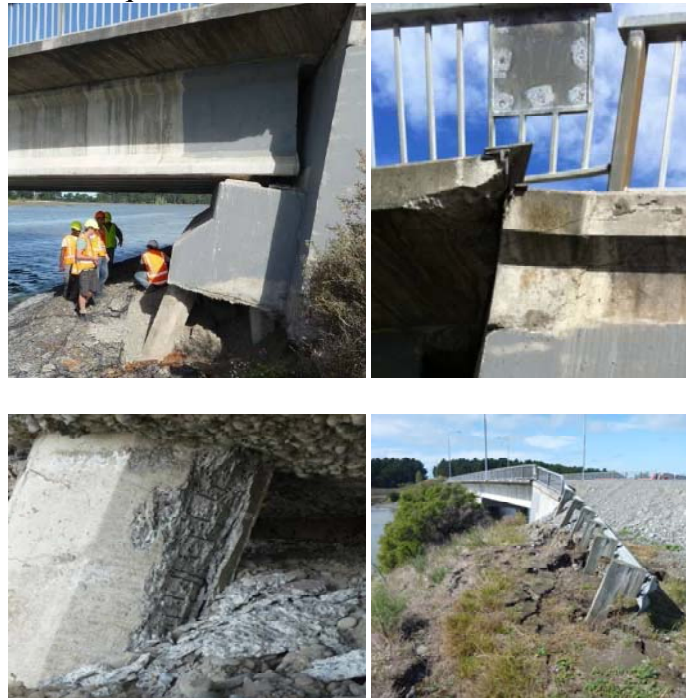
The primary cause of damage was from lateral spreading of the reclaimed embankment soil on which the abutments are located. Situated in an estuary, the underlying soils were heavily prone to liquefaction and after the onset of shaking, loss of soil stability caused failure and spreading throughout the approach to the bridge (Figure 12). Flow of soil against the wingwall, abutment and through the piles resulted in abutment back-rotation due to the restraint provided at the top of the abutments by the superstructure. Transverse translation of the skewed abutments relative to the bridge deck was a result of lateral spreading perpendicular to the bridge axis, and some pounding between the deck and abutments (Figure 12).

Figure 12. Bridge Street Bridge. Clockwise from top left: Back rotated abutments [Photo by M. Bruneau]; pounding of the deck on the abutment [Photo by A. Kivell]; West approach settlement and temporary repair [Photo by S. White]; plastic hinging in abutment piles of Bridge Street Bridge [Photo by M. Bruneau].

Flexural hinging, cracking and spalling was observed in the abutment piles at their connection to the pile cap caused by both the rotation and the translation of the abutments (Figure 12). Slumping of soil around the abutments due to lateral spreading exposed the

tops of the abutment piles. Hinging at the top of the piles was accompanied by flexural cracking and spalling in the exposed sections of the piles under both abutments. The crack patterns observed on the piles indicate that the piles subjected to bi-directional bending during the earthquake due to the rotation of the abutments and the transverse translation (Figure 12). Crack widths on the west piles were greater than on the east piles suggesting larger deformations. Uncertainty remains with regards to potential plastic hinging below the ground surface.

Major cracking and settlement of the approach pavement and embankments impeded vehicle access to the bridge (Figure 12). Non-structural components such as guard rails and handrails founded in slumping soil were heavily damaged. The amount of approach settlement at the west end of the bridge was significantly more than observed at the east end. The deck was largely undamaged with damage limited to spalling at the ends due pounding against the abutments.

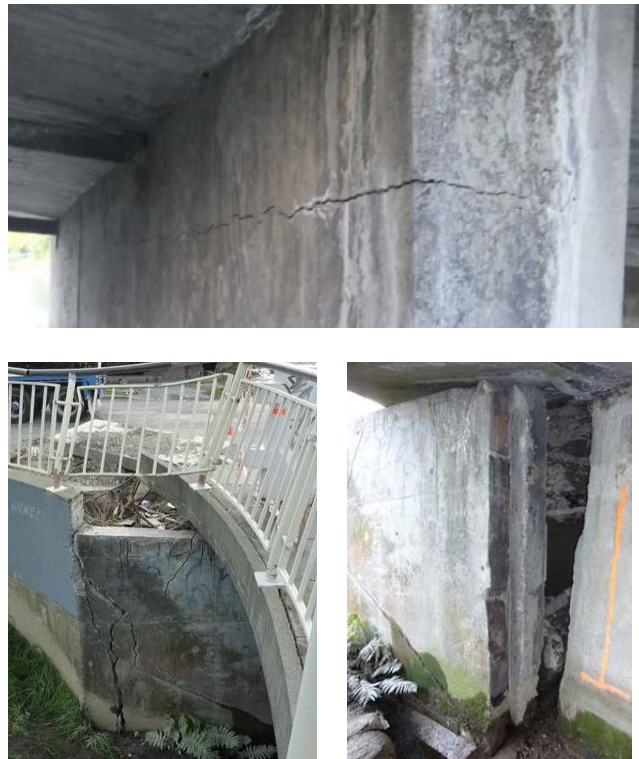
Lateral spreading resulted in rotation and displacement of the northern abutment backwall and wingwalls (Figure 13a). The top of the wingwalls on both sides of the northern abutment displaced 900mm towards the river relative to the edge of the bridge deck, with lateral movement of 100-150mm at their base. This rotation/translation of the structural element resulted in high flexural stresses in the abutment and eventually cracking, as shown in Figure 13b. The differential settlement of the soil beneath the abutment and the ground shaking may also have contributed to the

Figure 13. Gayhurst Road Bridge. (a) Damaged pier with flexural cracking [Photo by L. Hogan]; (b) Flexural cracks at the north-western wing-wall [Photo by L. Wotherspoon]; (c) Displacement of north-western wing-wall [Photo by L. Wotherspoon].

formation of cracks. The rotation and translation of the wingwalls completely detached them and moved them in front of the backwall (Figure 13c). Conversely, there was little indication of damage to the southern abutment, with no significant displacement or rotation accompanying minor cracking.

Lateral spreading exerted a lateral force on the pier base, causing a large moment at the stiff pier-deck interface, inducing cracking of the pier. A single horizontal crack along one face of a pier, approximately one meter from the deck soffit, developed during the 2010 Darfield event and increased after the February 2011 Christchurch Earthquake (Figure 13a). Liquefaction would have reduced the lateral stiffness of the pier foundation system, allowing rotation of the bottom of the pier towards the centre of the river.

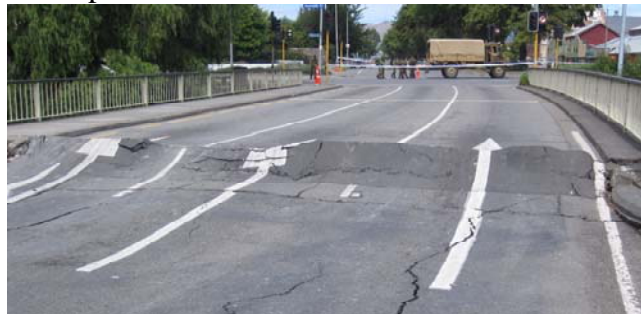
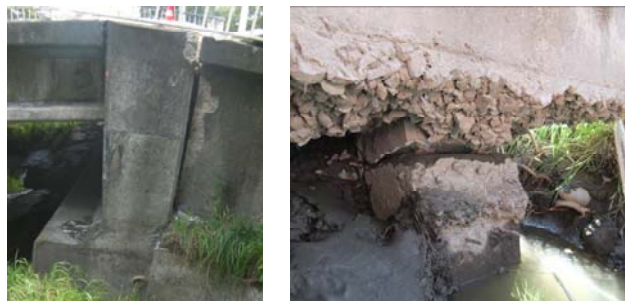
Following the February, 2011 Christchurch Earthquake the Fitzgerald Avenue Bridges were closed to traffic for several weeks. Closure was necessary because of severe spreading of the road north of the bridges which developed large fissures (Figure 14a). Large amounts of settlement occurred at the bridge approaches primarily on the northern bank; this was accompanied by two directional lateral spreading. The combination of these factors resulted in the back-rotation of the northern bridge abutments (Figure 14b). Moderate pounding damage was observed at the ends of the simply supported deck beams, exposing reinforcing steel in some regions.

Figure 14. Fitzgerald Avenue Bridge. (a) Damage at the approach of the eastern bridge [Photo by Anton Kivell]; (b) Back rotated abutments [Courtesy of OPUS]; (c) Flexural cracks on the piles [Photo by L. Hogan].

Rotation of abutments placed high demands on the northern abutment piles. Figure 14c shows the damage to the eastern-most pile of the eastern bridge. Failure occurred in tension with a 30mm crack opening up across the entire section. In some cases, heavy cracking and spalling due to hinging of piles at their connection with the pile cap occurred resulting in exposure of prestressing tendons. Below ground pile performance was unable to be determined but it would be expected that differential movements between liquefied and non-liquefied layers caused damage in addition to that at the pile to pile cap connection.

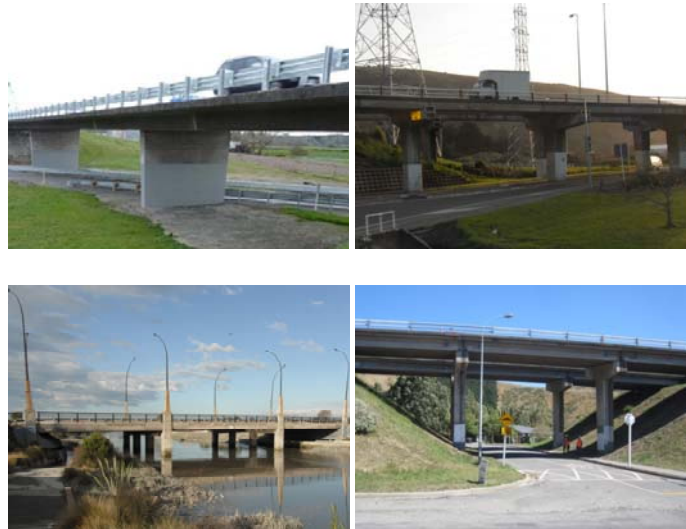
The post-earthquake investigations have not been in depth enough to ascertain level of demand that these devices experienced during the seismic shaking. Lateral spreading had been identified as an issue on some key life-line bridges. In some instances, while the bridges remained essentially intact, the approach spans partially or totally failed, making access to the bridge either more difficult or impossible. For example, the twin continuous bridges at the Chaney's Overpass (-43.4297, 73.9860) on State Highway 1 north of Christchurch (Figure 15, top left) were found to be structurally sound, and tied to their abutment walls to prevent unseating there. However due to liquefaction of the site surrounding the bridge, the approach to the southbound lanes of State Highway 1 settled by a few inches. After a brief closure for inspection, this busy route was reopened with signage reducing the speed to 30 km/h (down from 100km/h) for the safety of motorists.

Figure 15. Overall view of some damaged highway bridges after February 22, 2011. Clockwise from top left: Chaney's Overpass [Photo by M. Anagnostopoulou]; Port Hills Overbridge [Courtesy of OPUS]; Horotane Overbridge [Courtesy of OPUS]; Anzac Drive Bridge [Photo by E. Camnasio] [Palermo *et al.* 2011a].

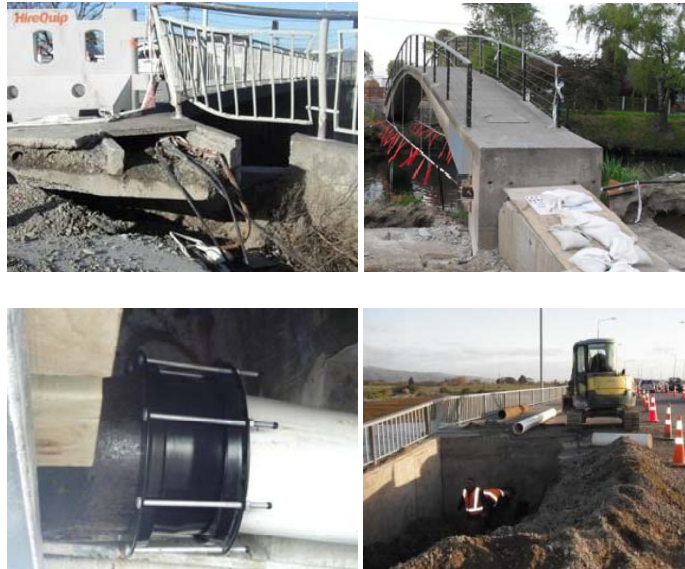
ential settlement between the bridge and the surrounding soil. This indicated that pipe connections were not appropriately designed to accommodate deck-to-pipe, or abutment-to-pipe relative displacements. Figure 16 shows some of the typical damage reported.

An example of important services carried on a bridge is the Dallington Pedestrian Bridge where lateral spreading creating extensive cracking parallel to the bridge and perpendicular to the alignment of the road and buried pipes, potentially leading to damage to sewer pipes in the road. This bridge has two 66kW power cables placed under the bridge deck, providing electricity to 20,000 inhabitants, making this modest pedestrian bridge a structure with strategic importance.

Some moderate to extensive damage was observed at many road bridges where pipes were distorted and/or leaking in the proximity of the connections from deck-to-abutment, and abutment-to-approaches. The main issues arose with stiff pipes, such as sewage and water pipes, as they are fully fixed to the deck and usually run through the abutments. On the other hand, the flexibility of power and/or telephone cables were able to accommodate larger displacement demands.

Figure 16. Damage to service lines. Clockwise from top left: Gayhurst Road Bridge: exposed lifelines [Photo by A. Palermo]; Dallington Pedestrian Footbridge: damage to electrical services to the Dallington area [Photo by M. Le Heux]; Repairing works at Bridge Street Bridge [Photo by A. Palermo]; Repair to water pipe at Bridge Street Bridge [Photos by A. Campbell].
